State Route 128 Russian River Bridge Bank Stabilization Project

Draft 2010 Annual Report

On Route 128 at Post Marker 5.4

Sonoma County, California

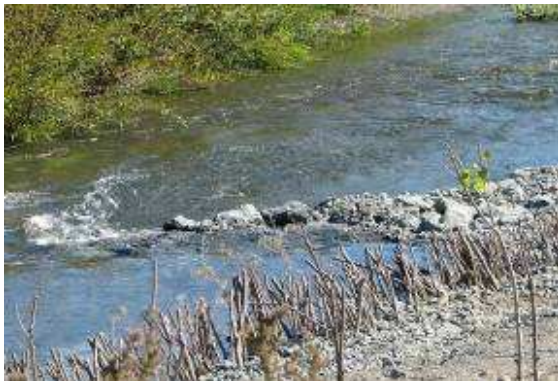
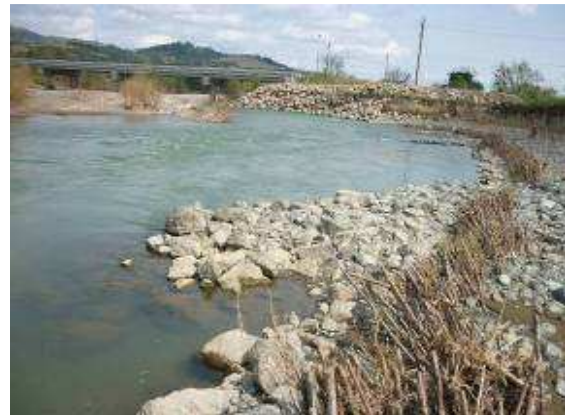
The rock vanes installed at the Project location were composed of graded rock of various sizes ranging from $\frac{3}{4}$ Ton to smaller rock. Gravel was placed to fill in the voids and crevices at the surface of the vanes during installation. The smaller rocks, which were visible at the completion of the installation (see Photo 1) were washed away during the winter storm events (see Photo 2). The tips of the rock vanes were also washed away during the winter storm events. The live staked willows installed along the trench in front of the LPSTP structure survived the winter storm events and covered the top of the rock vanes during the site visits in August and September 2011.

Photo 1. Vane 2 (October 7, 2010)

Photo 2. Vane 2 (April 13, 2011)

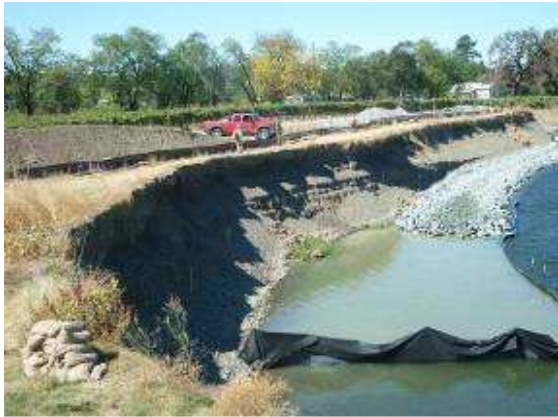
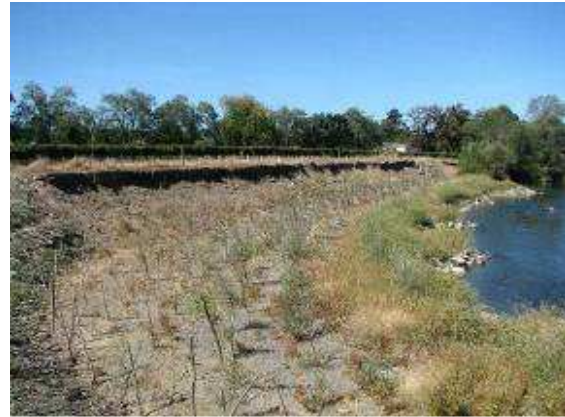
During year one, the rock vanes fulfilled their purpose of shifting the low flow channel away from the western bank. This was even evident during construction when the opposite bar underwent scour due to re-directed flow. Previously, the summer low flows that were in contact with the western bank before construction (see Photo 3) were not in contact with the low flow after completion of the Project (see Photo 4).

Photo 3. West Overbank during the Construction (September 28, 2010)

Photo 4. West Overbank, Looking Upstream (September 17, 2011)

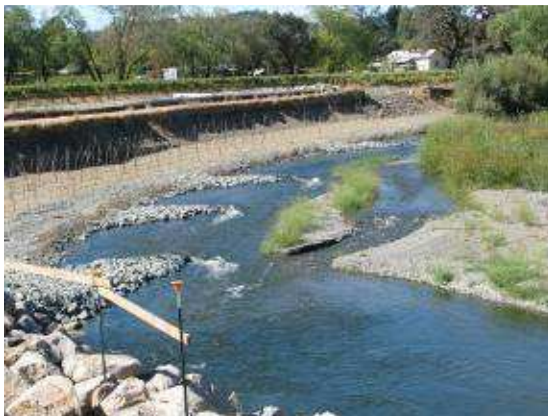
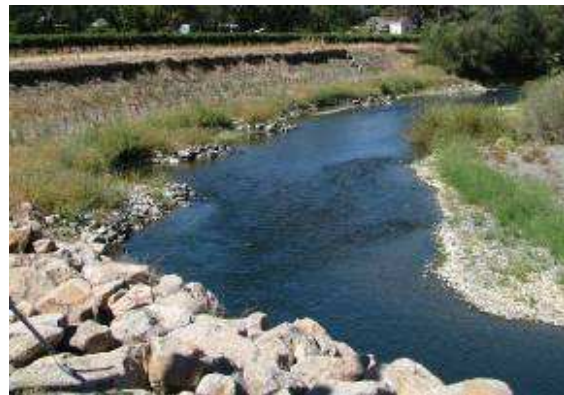
The low flow channel also shifted away from the western bank after the completion of construction in October 2010. The gravel bar on the middle of the channel has slightly shifted towards away from the rock vanes (see Photo 5 and Photo 6). In addition, the created overbank area was not eroded except for a portion between Vanes 1 and 2 at the upstream-most end of the constructed overbank area. The erosion was not excessive.

Photo 5. Low Flow Channel, Looking Upstream (October 09, 2010)

Photo 6. Low Flow Channel, Looking Upstream (September 17, 2011)

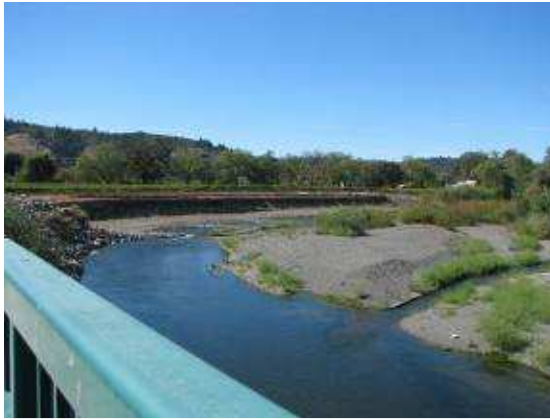
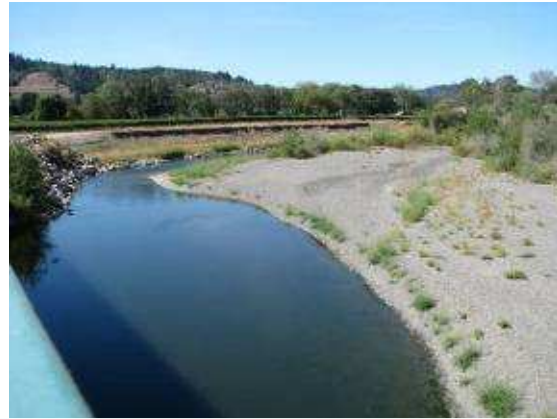
Based on the field visits, the extent of the thalweg shift caused by the vanes appears to be limited at the downstream key-in of the LPSTP where the channel makes a bend. Based on the field observations in October 2010 and September 2011, the direction of the flow downstream of the LPSTP did not change significantly during the wet season in year one (see Photo 7 and Photo 8).

Photo 7. Direction of Flow Downstream of LPSTP (October 09, 2010)

Photo 8. Direction of Flow Downstream of LPSTP (September 17, 2011)

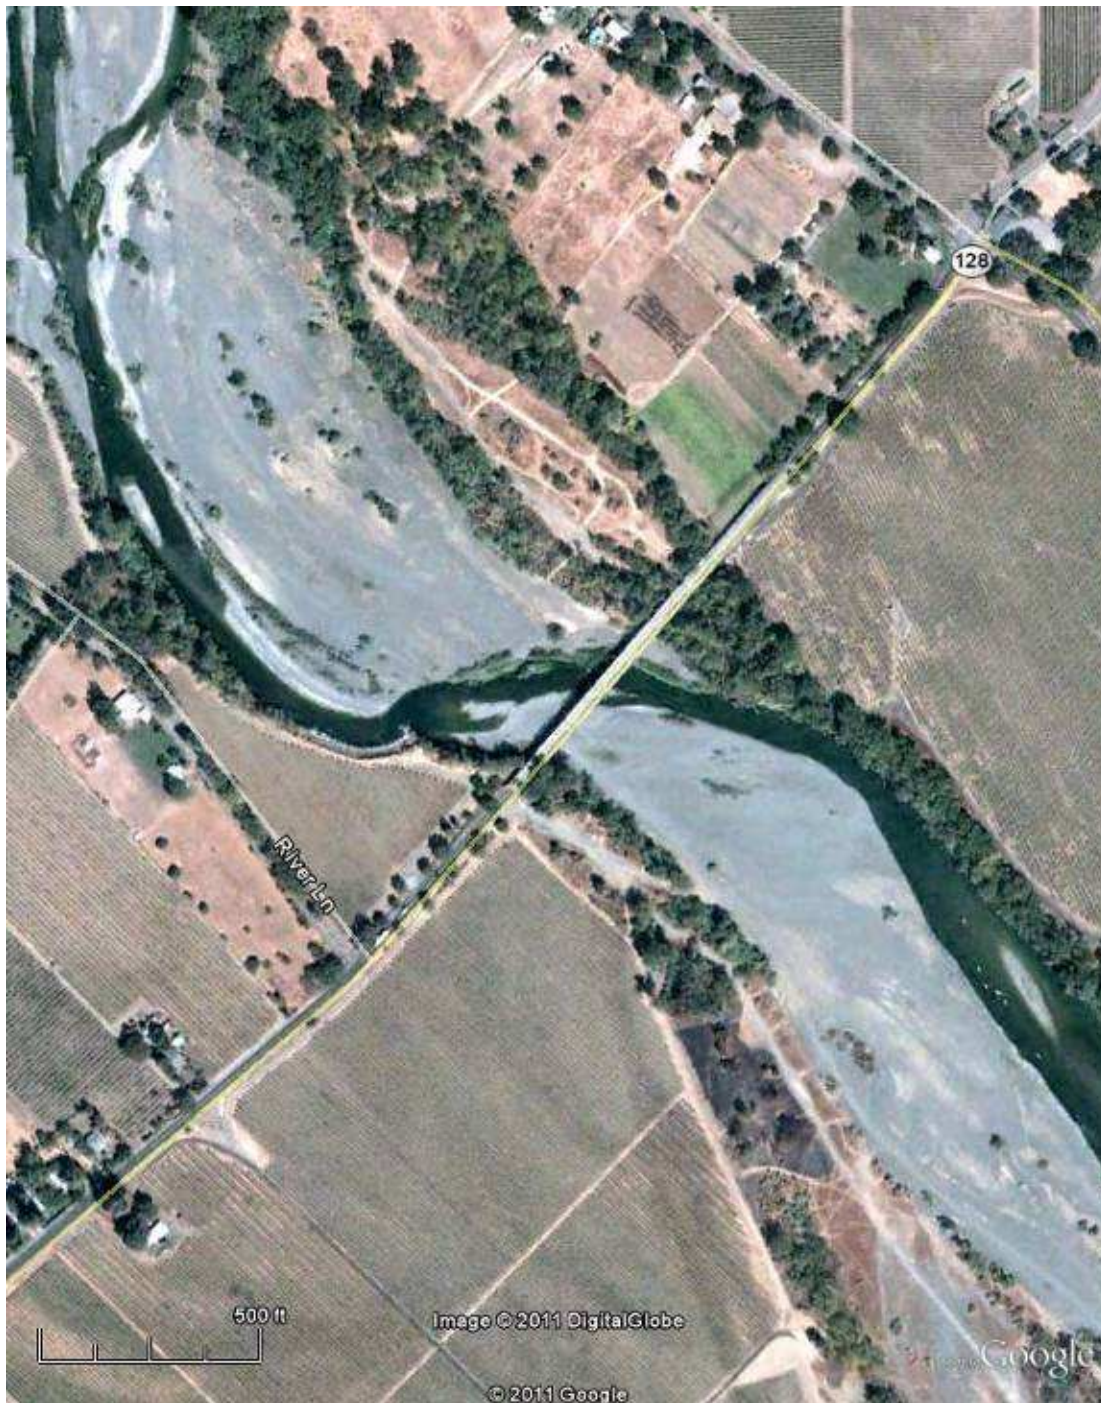
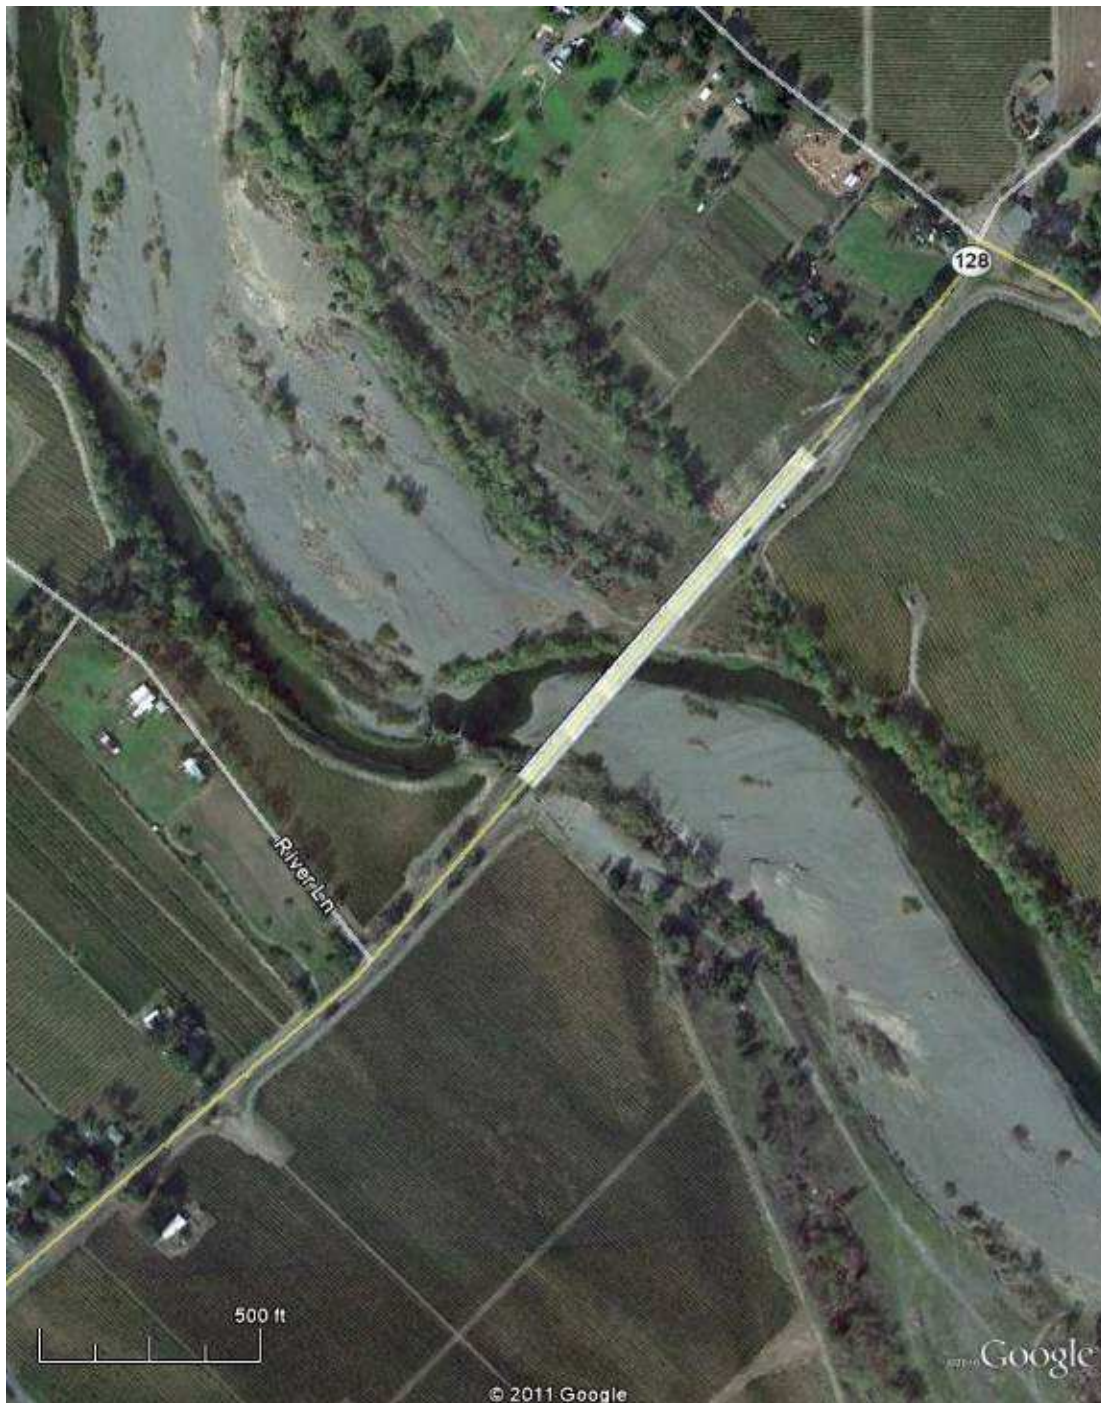
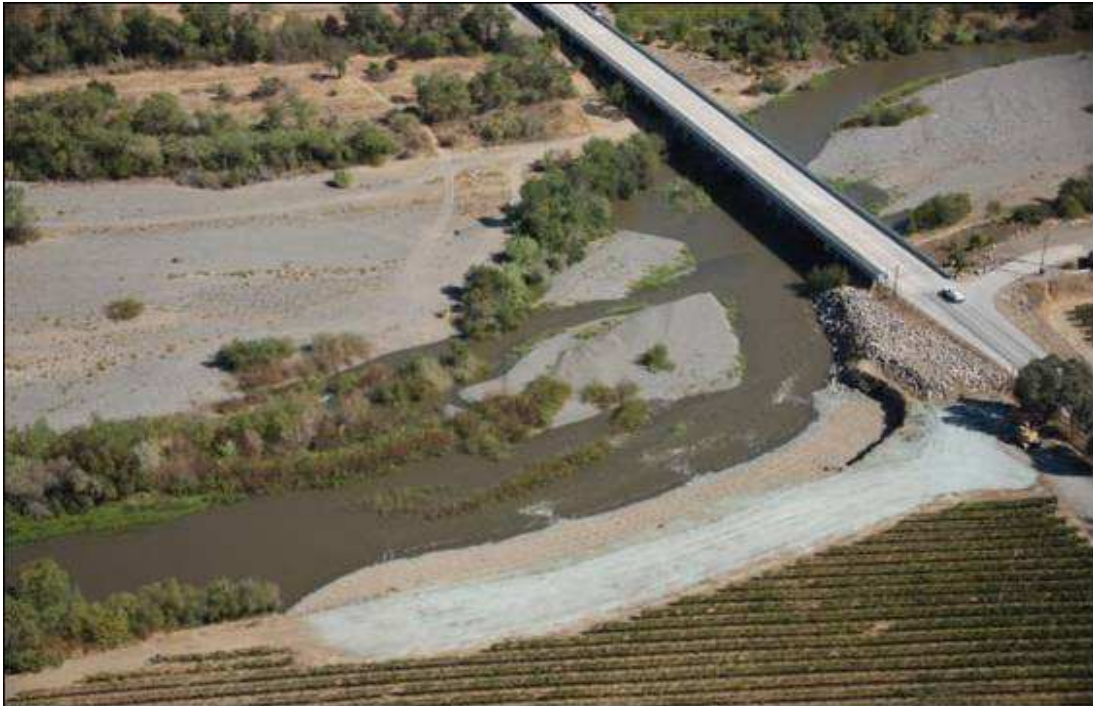
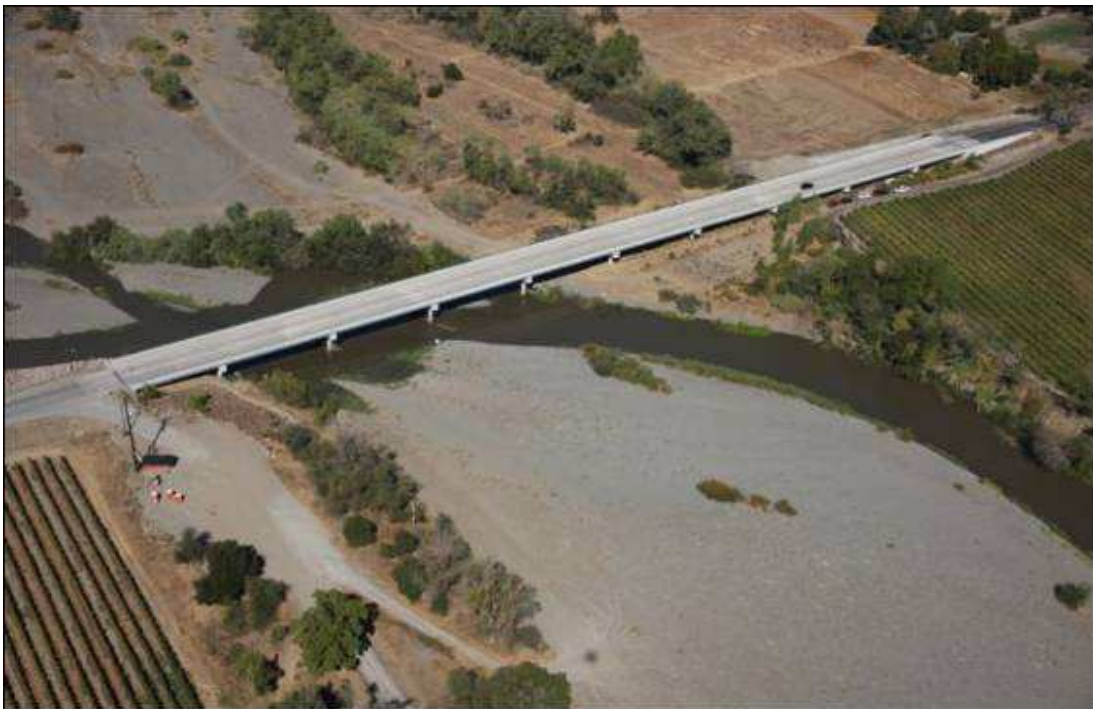
Although the thalweg appears to angle toward the eastern bank downstream of the bridge, based on the aerial images dated 2003 and 2009, this direction of flow was present before the installation of the LPSTP and rock vanes (see Figure 4 and Figure 5). The thalweg location in the vicinity of SR 128 Bridge has not changed significantly between 2003 and after completion of construction in October 2010 (see Figure 4 through 7).

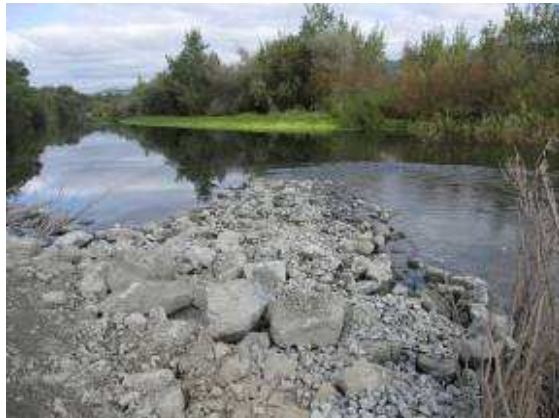
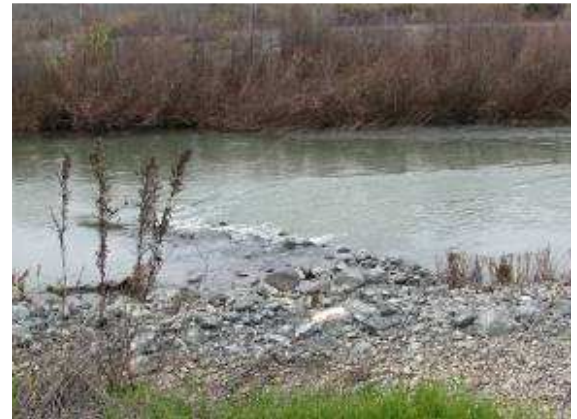
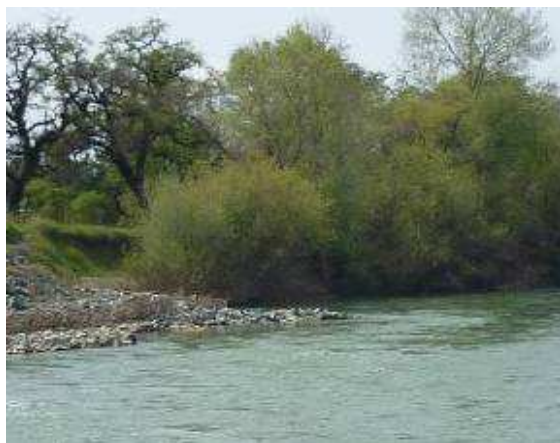
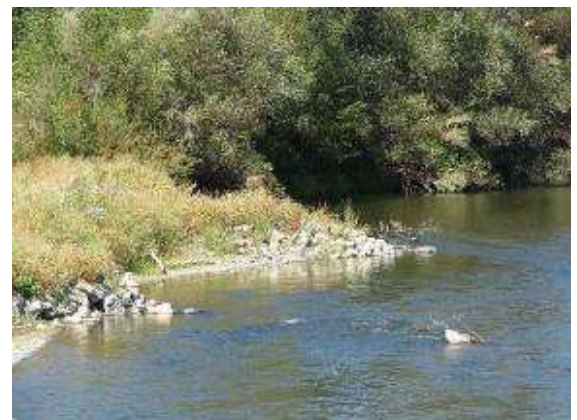
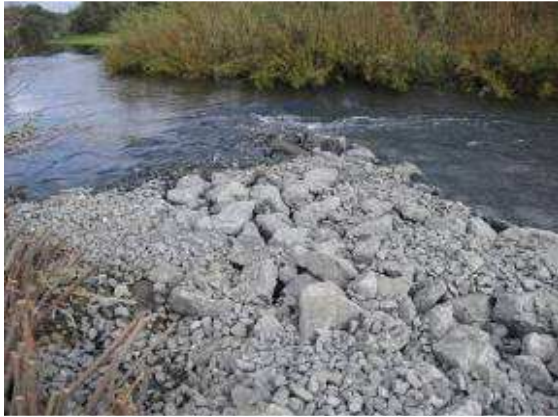
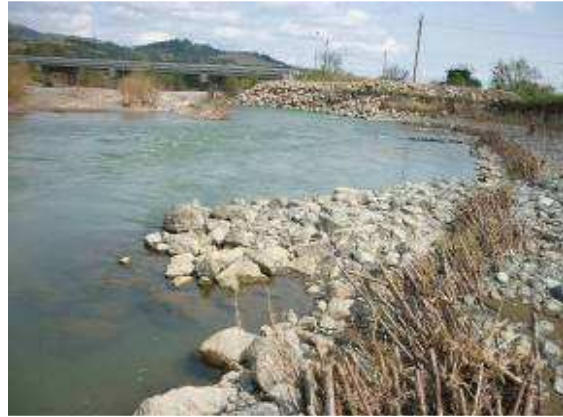
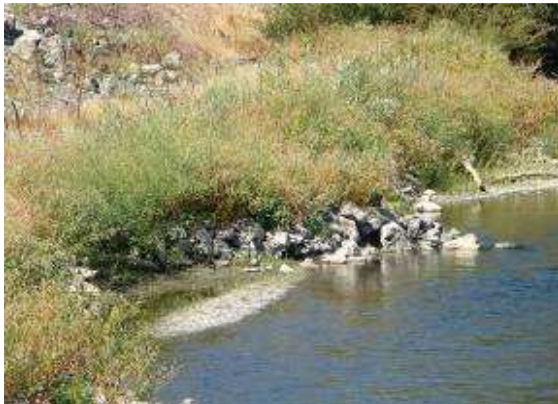
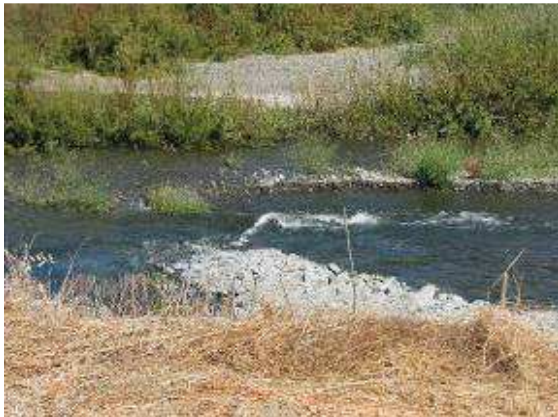
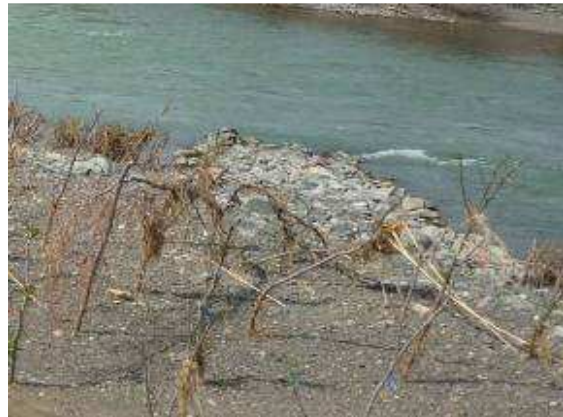
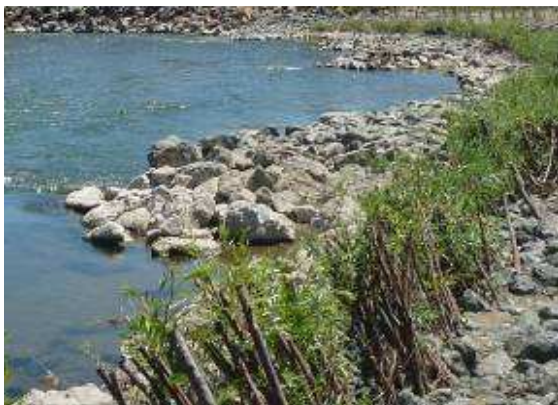
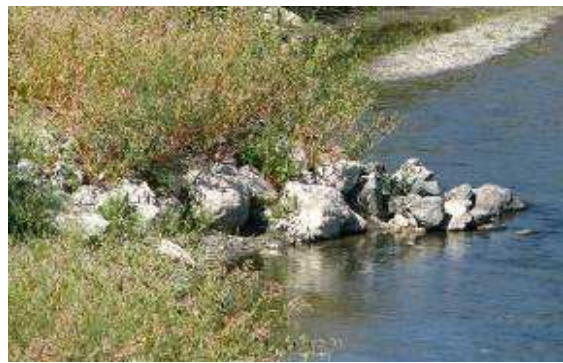
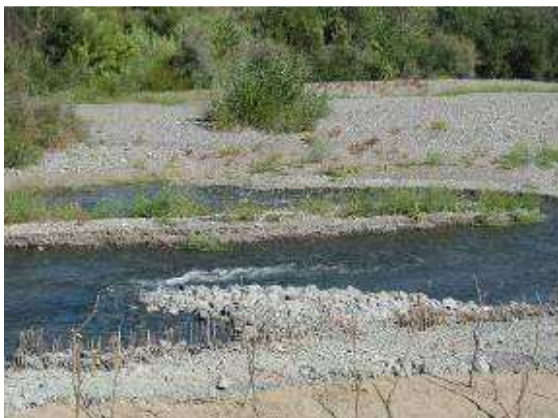
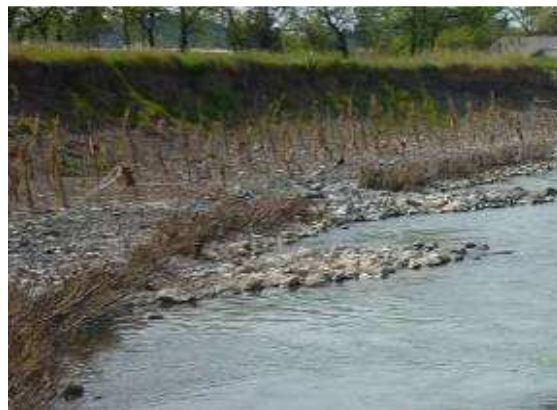
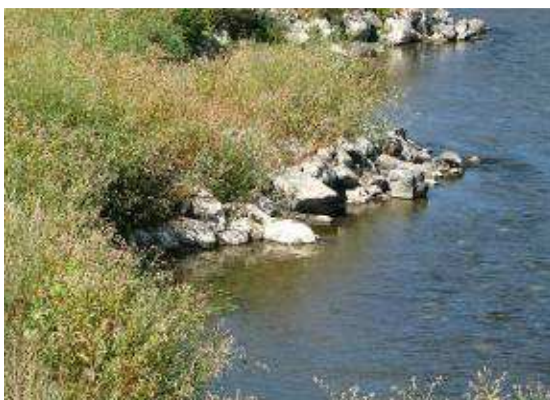
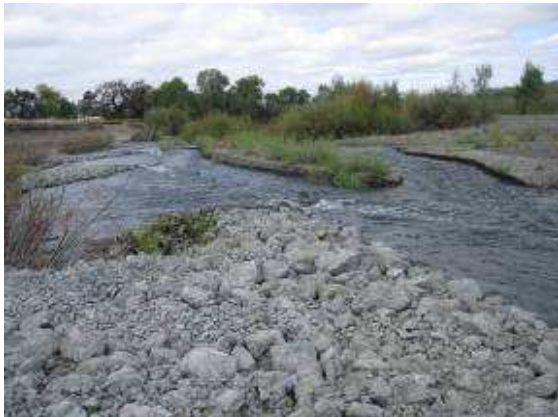
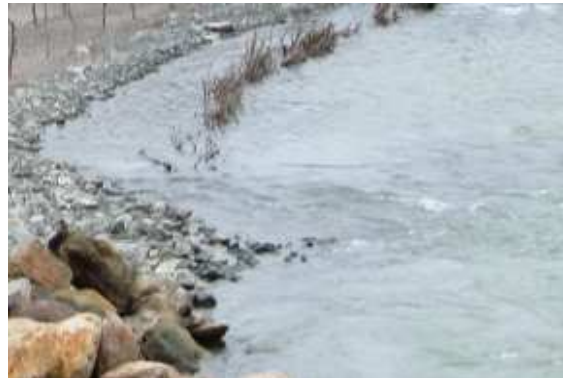
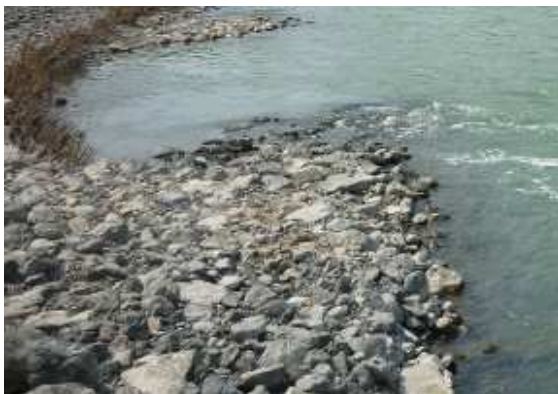
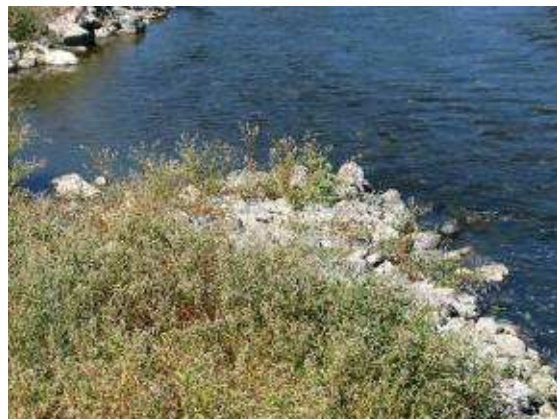
The rock vanes performed as intended throughout the first year of monitoring. However the tips of the vanes, and the smaller rocks within the vanes were observed to deteriorate and wash away during the high flow events. The deterioration was expected and is a sign of the adjacent thalweg developing in depth and breadth as the vanes adjust to yearly flows. The condition of the vanes is not expected to experience further significant degradation, as the remaining structure of the vanes is made up of primarily large rocks, and the thalweg has developed. The vanes will continue to be monitored and observed from the winter of 2011 to spring of 2012 following high flow events to document further changes in conditions and identify any concerns that may arise. The need for further work to enhance or restructure the rock vanes with RSP will be assessed following review of recent bathymetry surveys. If the vanes appear to have uniformly shifted and settled into the river bed, then the need to perform any further work may not be necessary.

Although portions of the rock vanes at the tips are designed as somewhat sacrificial, the observed degradation could be repaired to promote the eastward migration of the thalweg. However, the benefit of enhancement may not be warranted, as the river has already been re-directed away from the west bank. The vanes will be monitored accordingly to assess any further degradation.

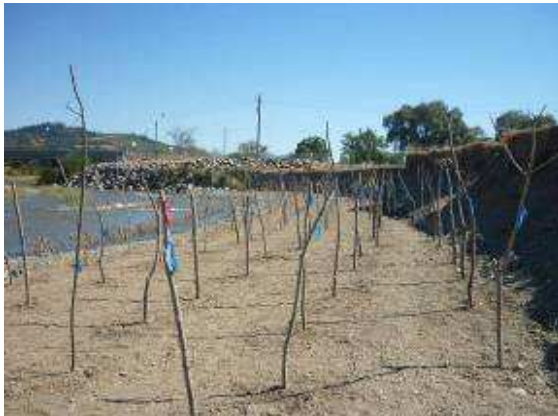
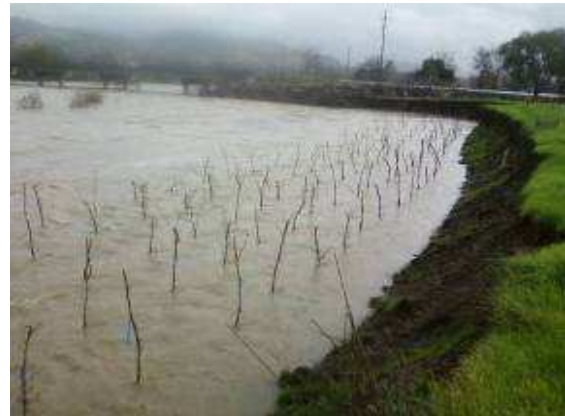
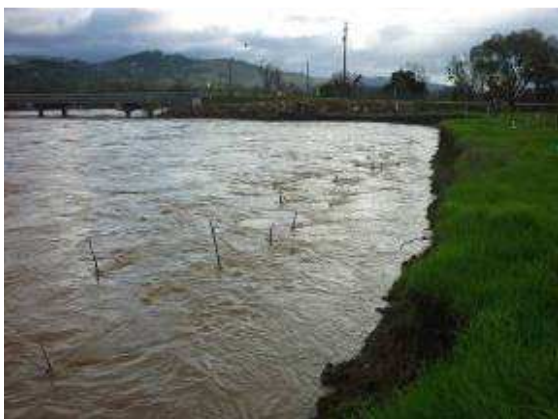
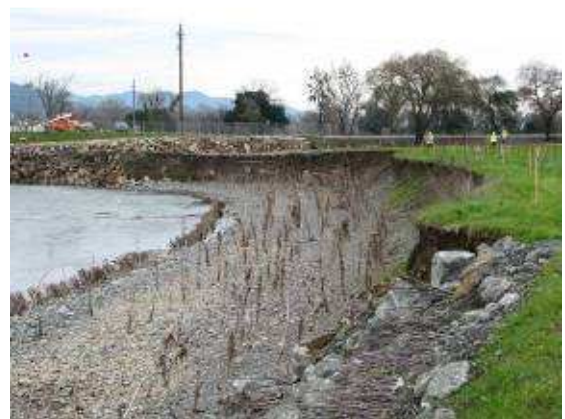
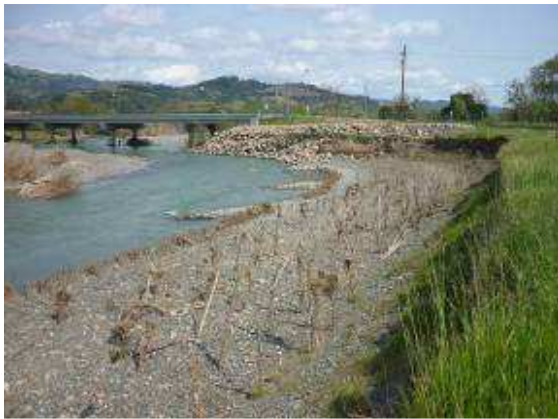
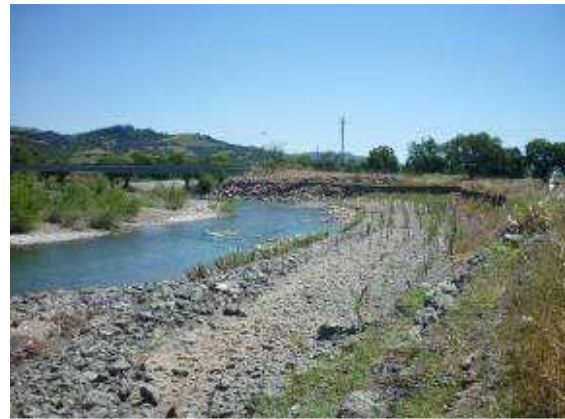
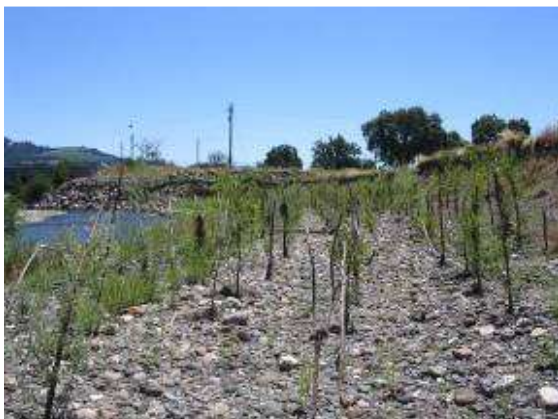
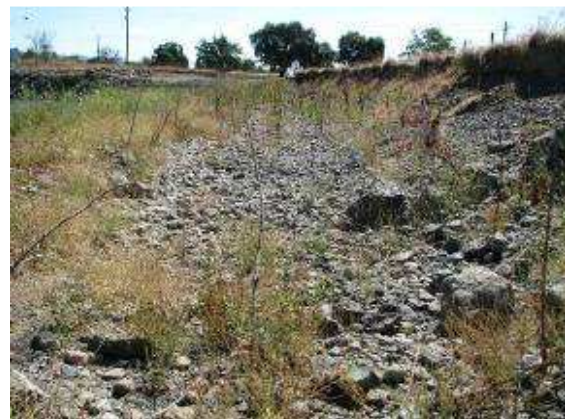
In the pre-project condition, the western bank of Russian River was in direct contact with the summer low flows. The project filled the existing low flow channel with bar material, sand backfill to create an overbank area (floodplain), and the overbank area was planted with willow and Cottonwood poles (see Photo 27). During the winter storm events, the western bank area (overbank area) was fully submerged (see Photo 28 and Photo 29). The channel flow velocities in the overbank area were generally slower than the flow velocity on top of the low flow channel. The smaller grain particles exposed at the surface were washed away during the winter storm events at the upper end of the west overbank area from Vanes 1 to 2, while deposition occurred along the lower bend of the overbank area from Vanes 3 to 4. The overbank area was stable throughout the field visits in spring and summer 2011, but the bar materials were exposed on the surface (see Photos 28 through 32).

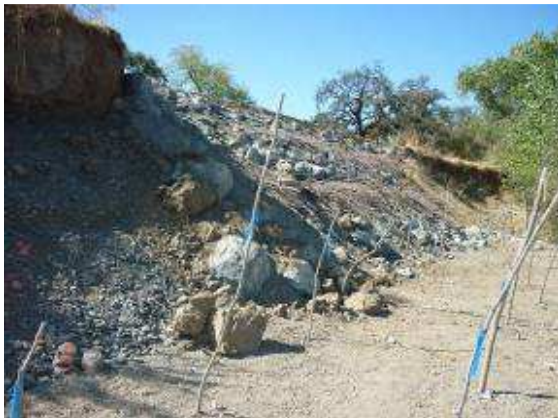
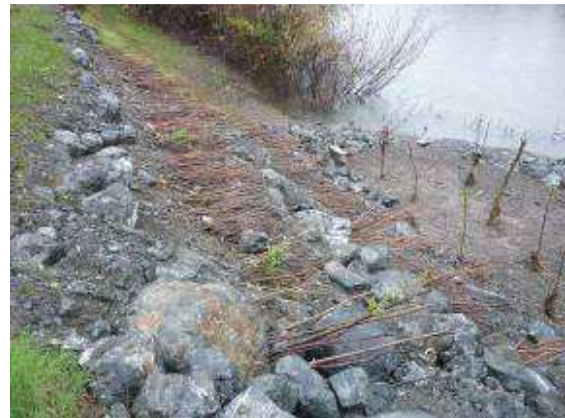
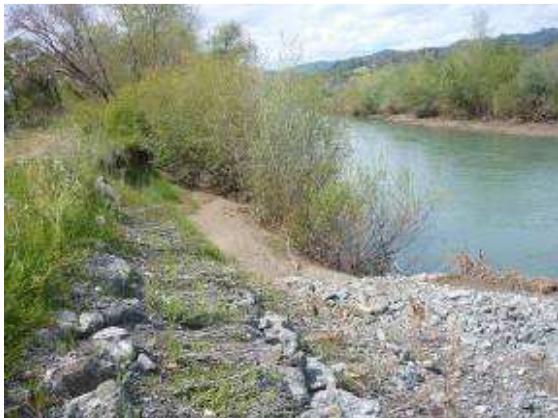
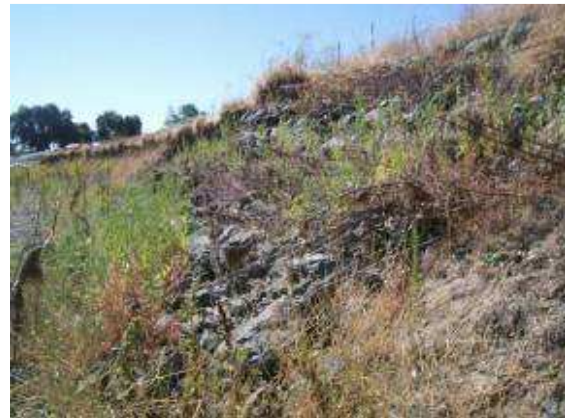
The upstream access into the site was backfilled (keyed-in) as the final grading component of the summer 2010 improvements. The purpose of the key-in was to secure the upstream end of the LPSTP into the existing bank. The backfill was composed of layers of rock slope protection (RSP), native soil and layered willow stakes (mostly Arroyo willow) (see Photo 35). There is existing vegetation on the upstream side of the upstream key-in (see Photo 36 and Photo 37). The channel flow velocity of the upstream key-in area during the winter storm events was approximately 4 ft/sec when the main channel flow velocity was over 10 ft/sec. Because of the reduced flow velocity and dense vegetation upstream of the access backfill, no major damage to the RSP and layered willows was observed during the field visit after the winter storm events (see Photo 37 and Photo 38). The willows are growing and appear to have been established within the embankment backfill.

The upstream key-in was observed to function adequately throughout the 2010/2011 wet season, despite the significant high waters and high velocity flows it experienced. During the summer of 2011, additional bank stabilization work was performed downstream at the scoured crescent area as described earlier. The modification included an embankment reconstruction and a new key-in to the existing bank above the OHWM. The 2011 work will be monitored to document its performance over the remainder of the mitigation monitoring period. See attached for Summer 2011 design plans. (As-builts are to be developed).

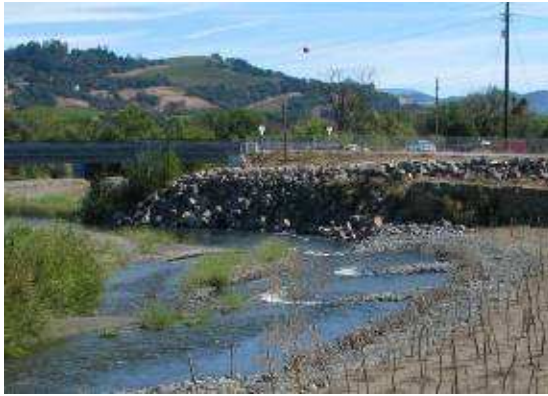
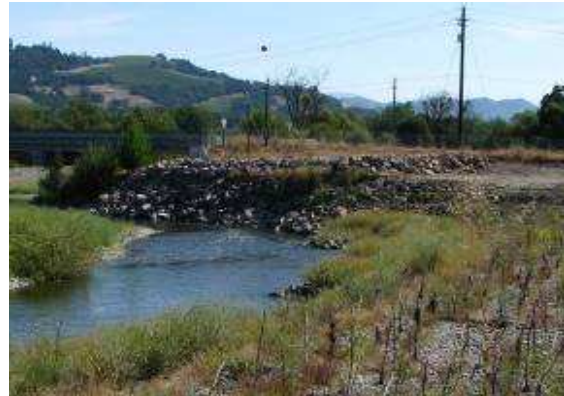
The existing RSP currently protecting the west abutment and west approach of the SR 128 Bridge over the Russian River was installed in late January 2010 under emergency conditions without engineered backing or geotextiles (Photo 39 and Photo 40). The existing RSP appears to be shifting, and it has voids that allow water to freely circulate behind. This allows the in-situ fines below and behind the RSP to be eroded, particularly during the drawdown after high flow events. The existing RSP is not considered stable or sufficient during high flow events.

Photo 39. Existing RSP (October 9, 2010)

Photo 40. Existing RSP (September 17, 2011)

Although the Project has successfully diverted the main force of the Russian River away from the western escarpment during high flows, the steep ungraded RSP extending from the SR 128 Bridge abutment to the LPSTP is a concern for failure. Slope failure will result in exposure of erodible material and shifting of flow patterns. If a wide scale failure of the RSP slope occurred, some energy of flow during high flow events may divert to the west and put the recent bank stabilization work and bridge approach at risk. Preliminary design work is under way to assess alternatives for reconstruction at this location. Early analysis shows that RSP re-engineering could result in an approximately 25 to 30 ft encroachment further into the river channel (see Figures 8 and 9). This may not be an acceptable preferred solution due to the extent of encroachment into the channel. Other alternative options are being explored.

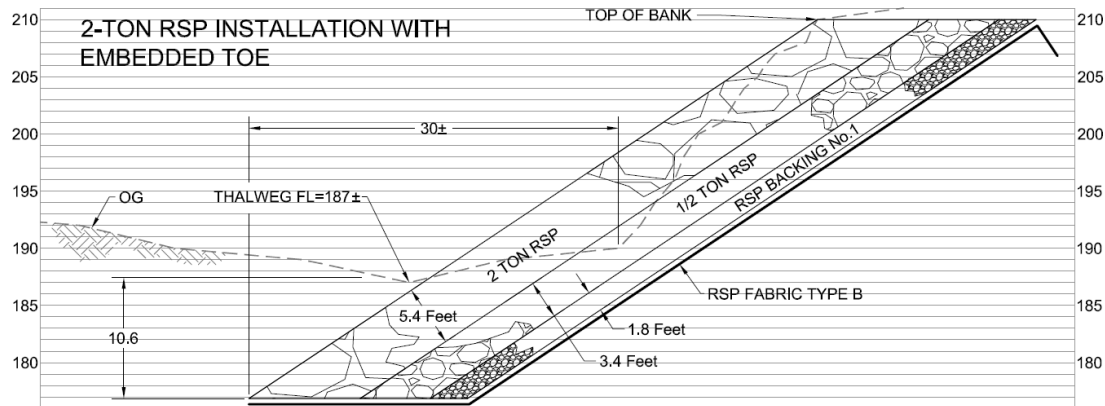
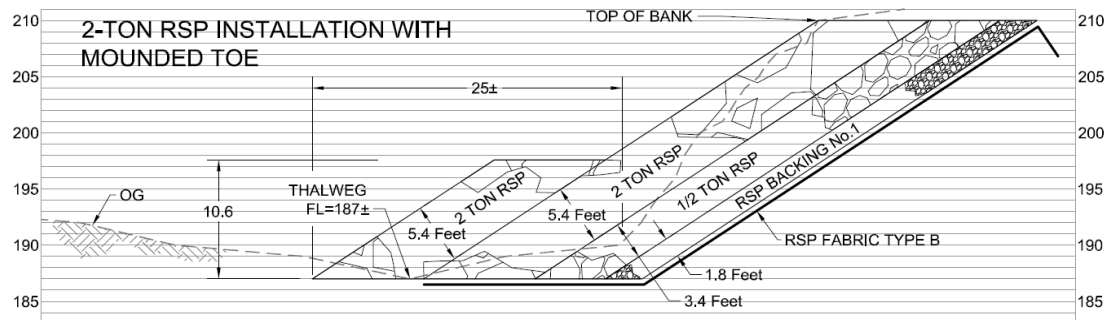
Figure 8. Engineered RSP with Embedded Toe

Figure 9. Engineered RSP with Mounded Toe

As discussed, replacement of the existing RSP revetment with an engineered RSP revetment may provide stable long-term protection, but it would also result in a significant incursion into the channel. The preliminary engineering of an RSP revetment determined that the design would include 2-Ton rock revetment with either a mounded or

embedded toe. The installation would include an inner layer of ½ Ton RSP, overlaid on a Backing No. 1 with RSP fabric. Figures 8 and 9 indicate a cross section of the existing thalweg and RSP revetment based on bathymetric and topographic surveys performed in early 2011.

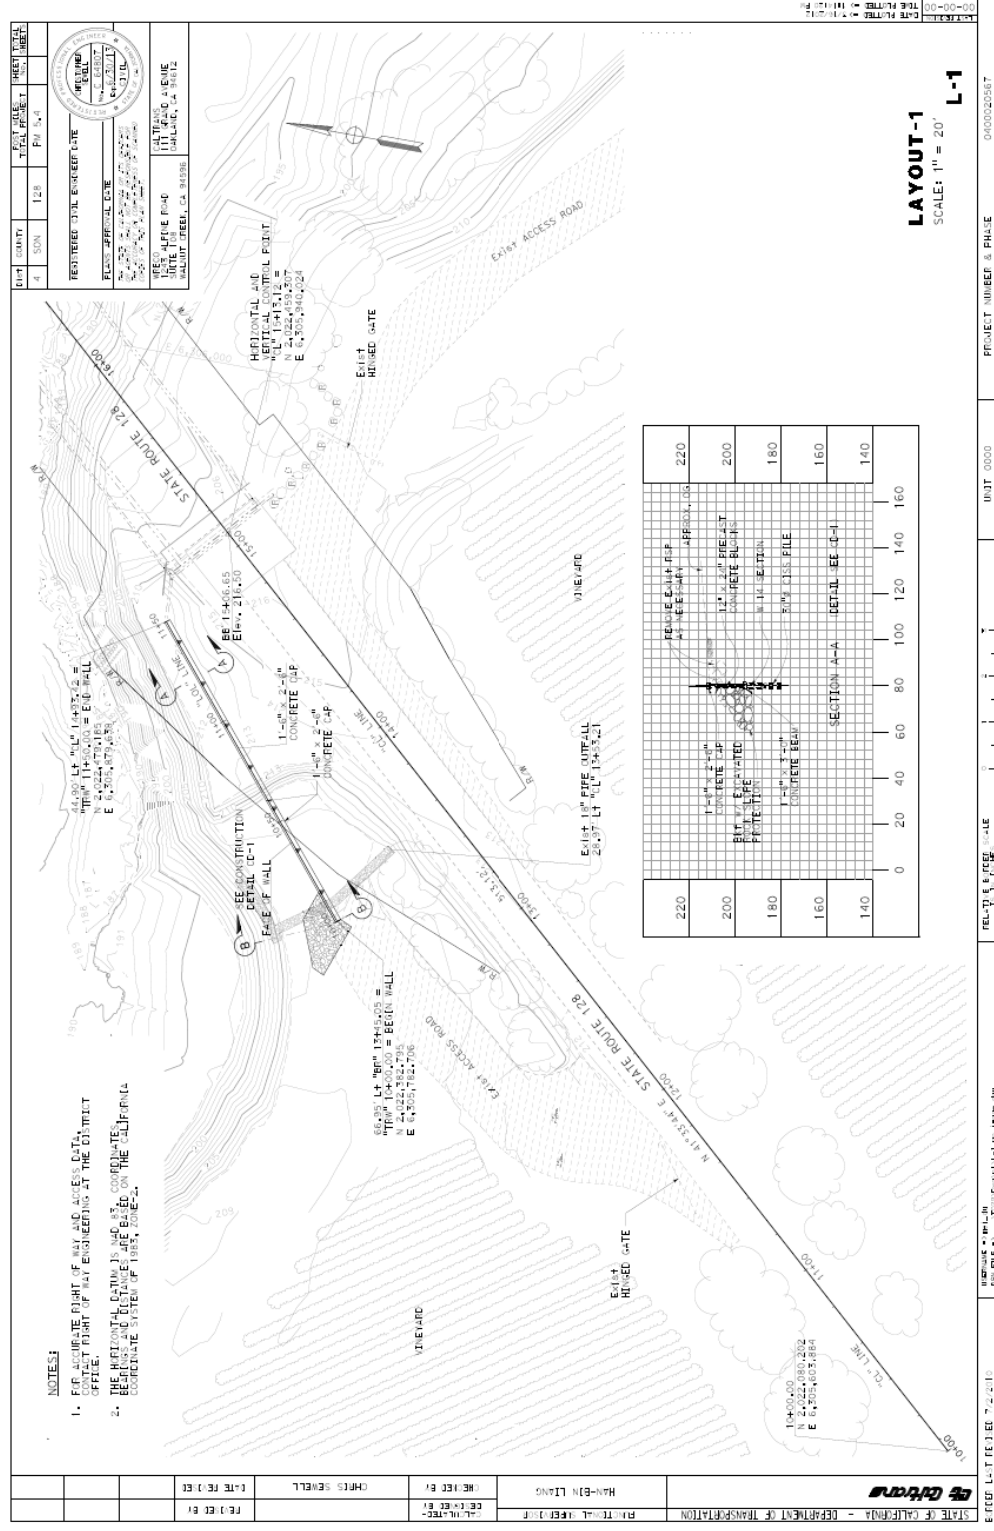
As discussed, the existing RSP will eventually fail and self launch into the river. However, with the recent embankment reconstruction in place, and proposed installation of a buried rock wall perpendicular to the extended bridge wingwall that conforms to the recently reconstructed embankment, any redirected flow due to self launching into the river will resist flows that may seek to scour the embankment to the west (see Figure 10).

Figure 10. 2011 Reconstructed Embankment and Proposed Wingwall Extension

Our current interpretation of recent monitoring, underwater surveys and preliminary re-engineering of the existing RSP suggests that the combination of a wingwall extension behind the existing RSP along with a buried rock wall is the preferred recommended work for summer 2012. This recommendation would involve no in-water work.

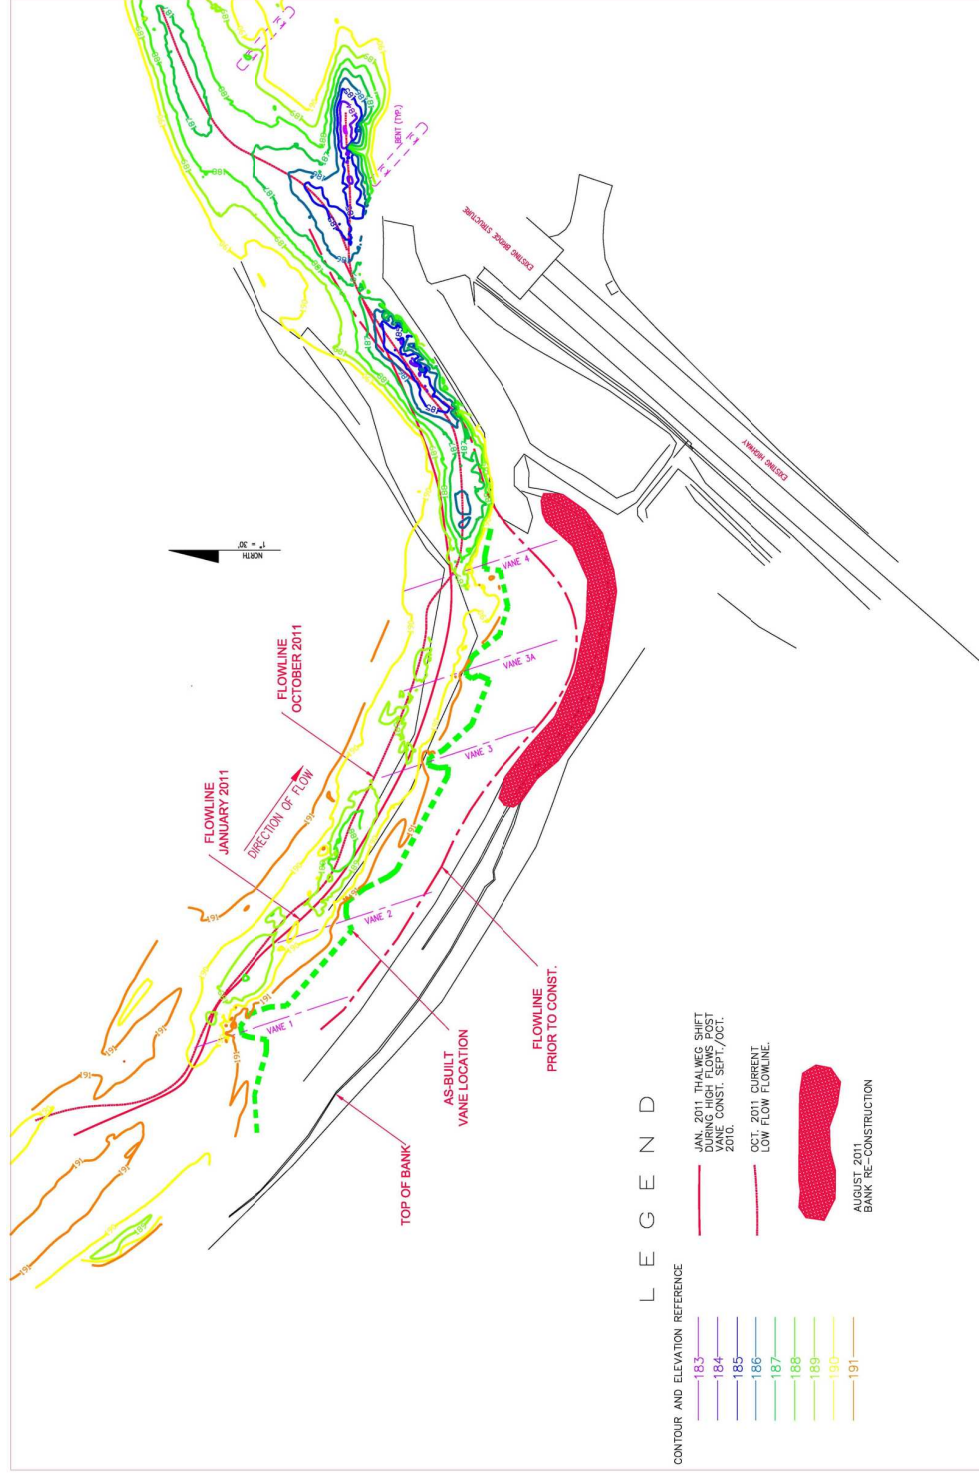
The Department conducted underwater surveys to assess the bathymetric changes to the river bottom following 2010/2011 high water flows. The results indicate that flow line adjustments have occurred which show the flow line maintaining its location just beyond the tips of the existing vanes, but shifts back to the bank quickly past the last downstream vane as shown in Figure 11. A deepening of the river bottom occurs below where the existing RSP is located, which is evident in the blue coloration also shown in Figure 11. Based on this information, it is presumed that the existing RSP will eventually fail during high flows and rock will self launch into the deepened area . .

Figure 11. Comparison of January 2011 and October 2011 Thalweg
