CAZENOVIA CR. @ STEPHENSON ST. BRIDGE

**REPLACEMENT OF ONE BANK
OF A CONCRETE-LINED
CHANNEL**

**HAW CREEK, PIKE COUNTY, MISSOURI-
TRIB TO SALT RIVER**

GOODWIN CREEK, MS.

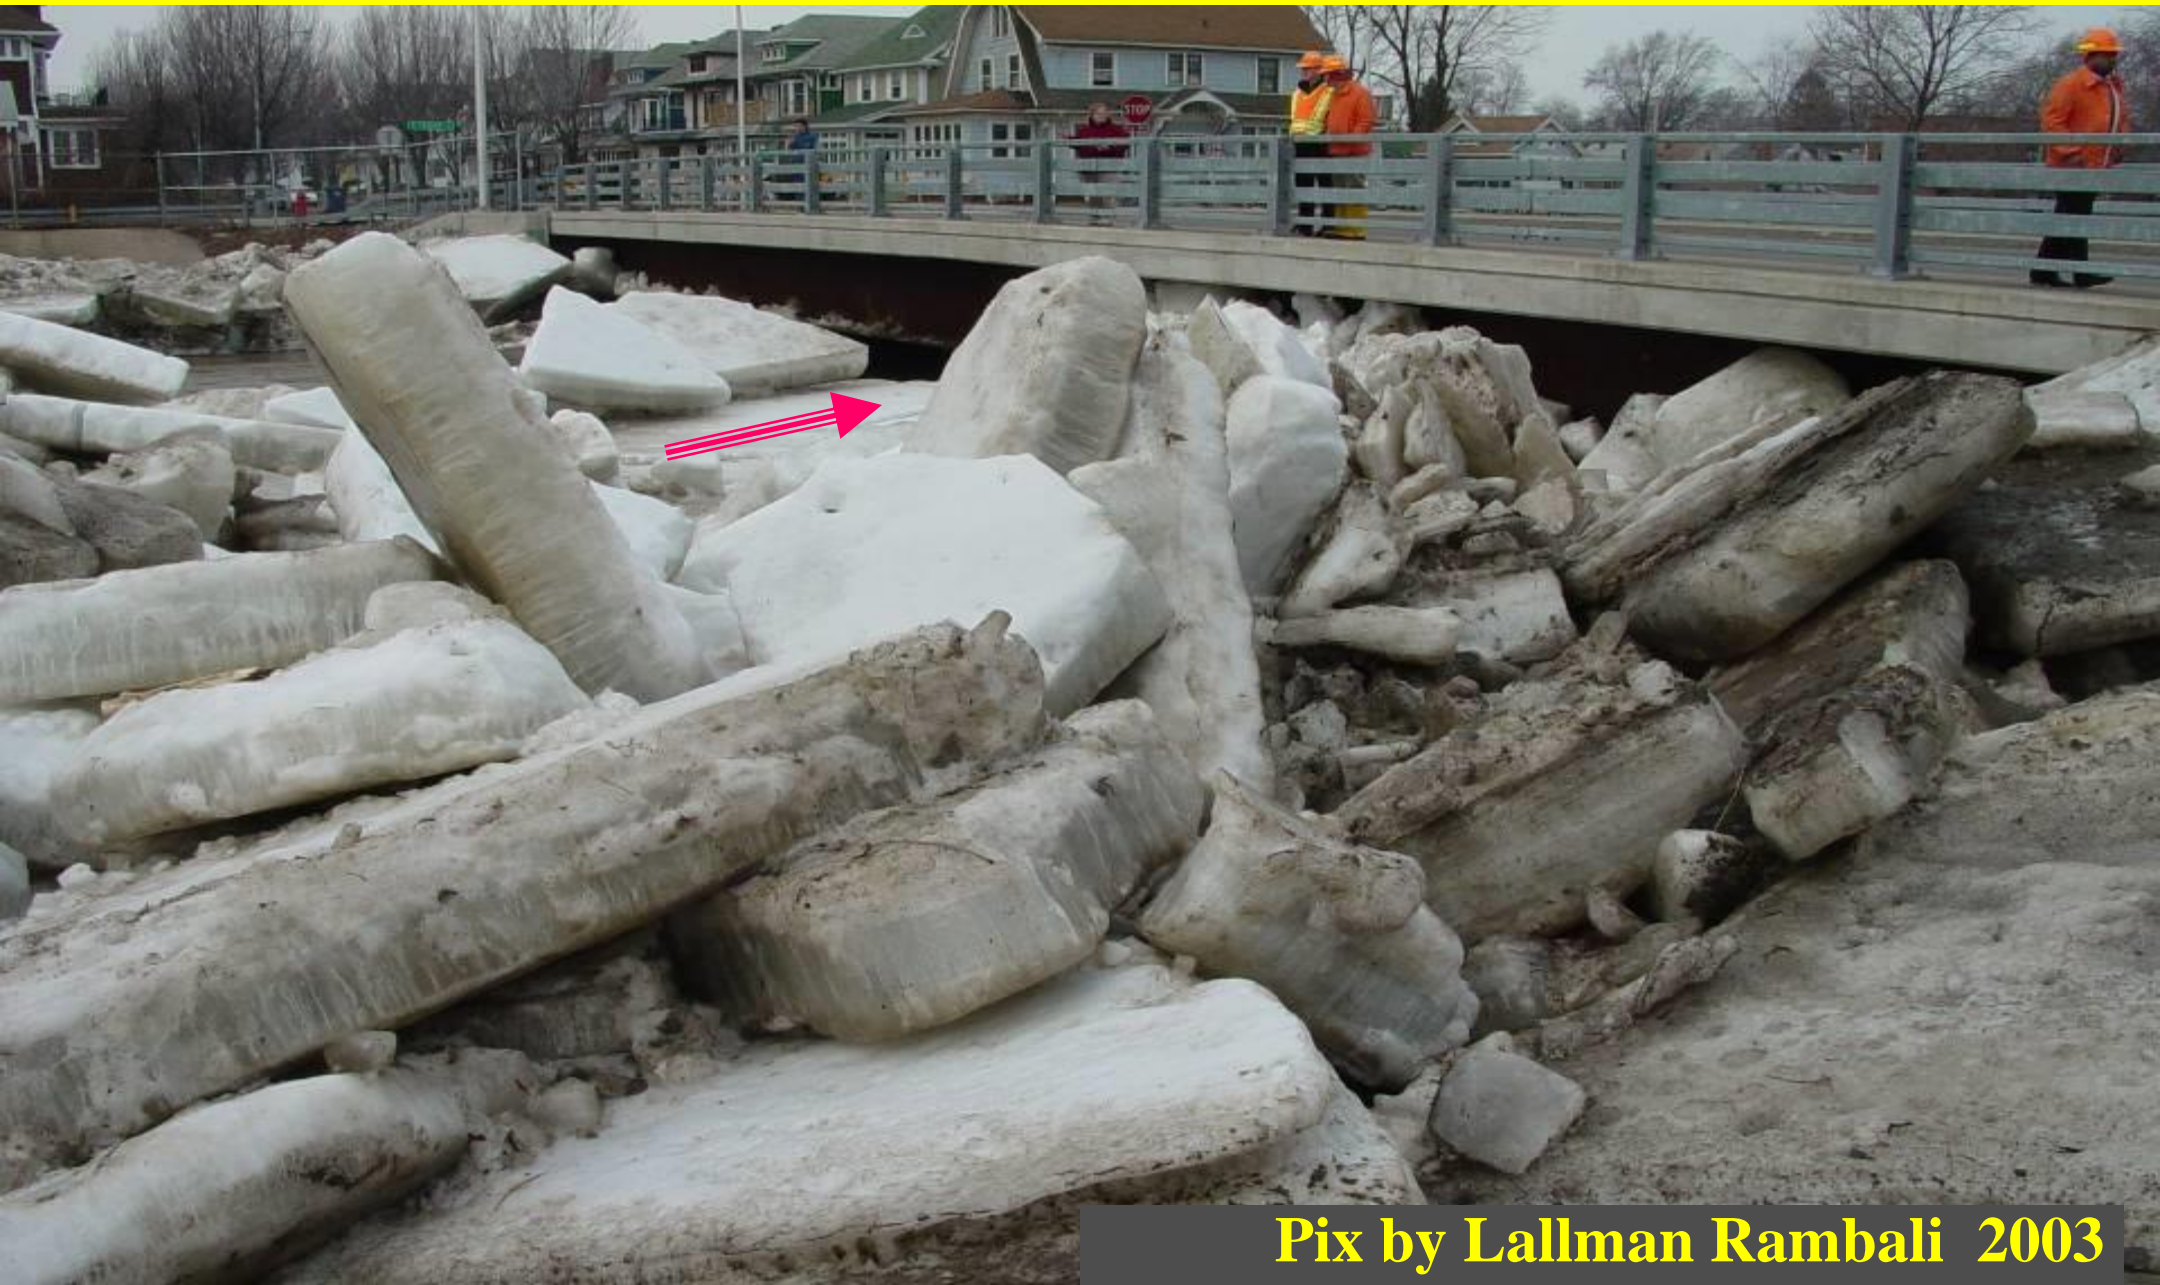
Ice on US side of Stephenson Street bridge.

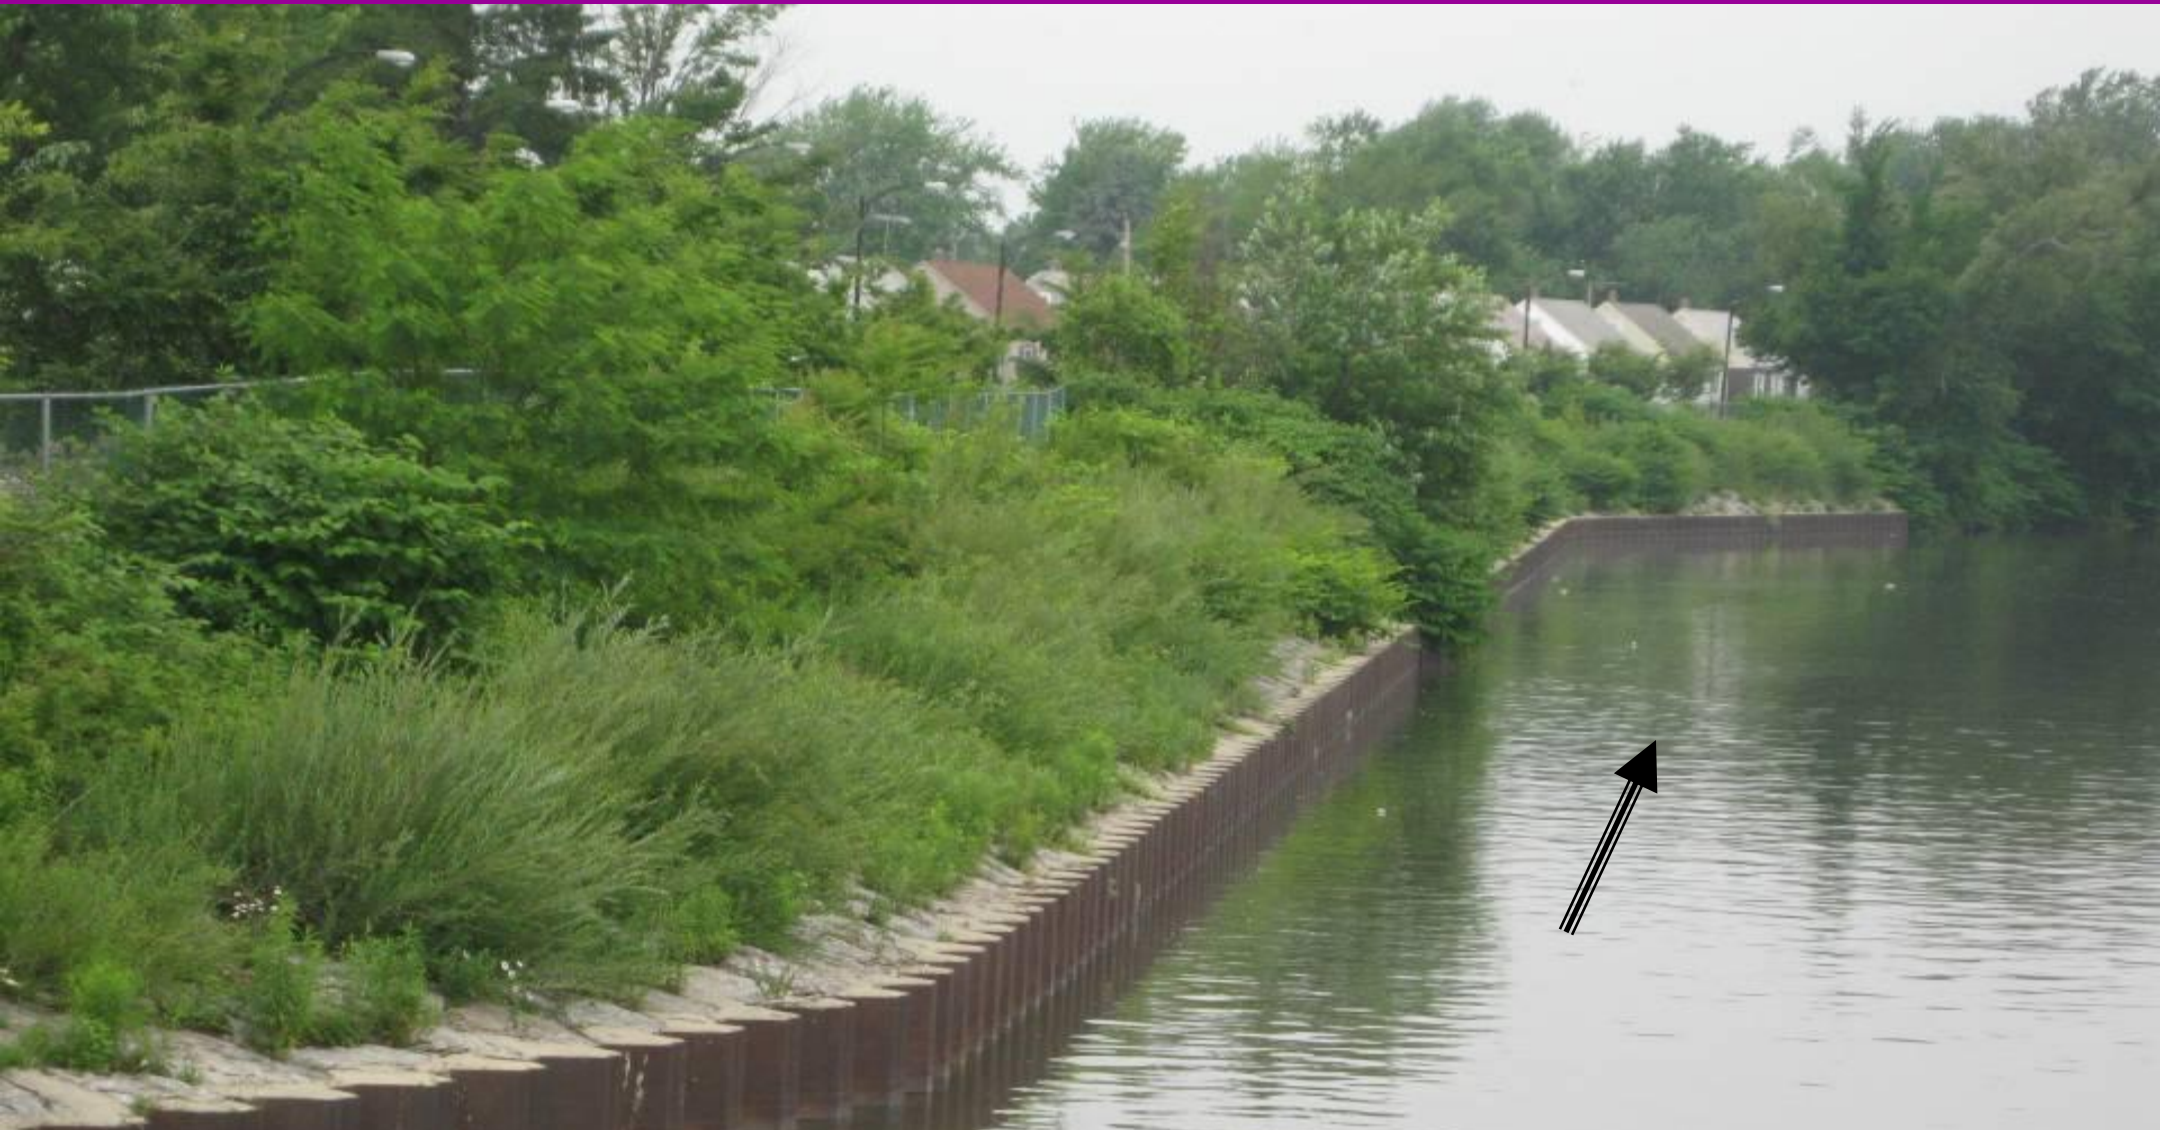
4.66 years after completion. From the bridge looking DS. Except for narrow band of stone at toe, dense veg has covered the entire bank.

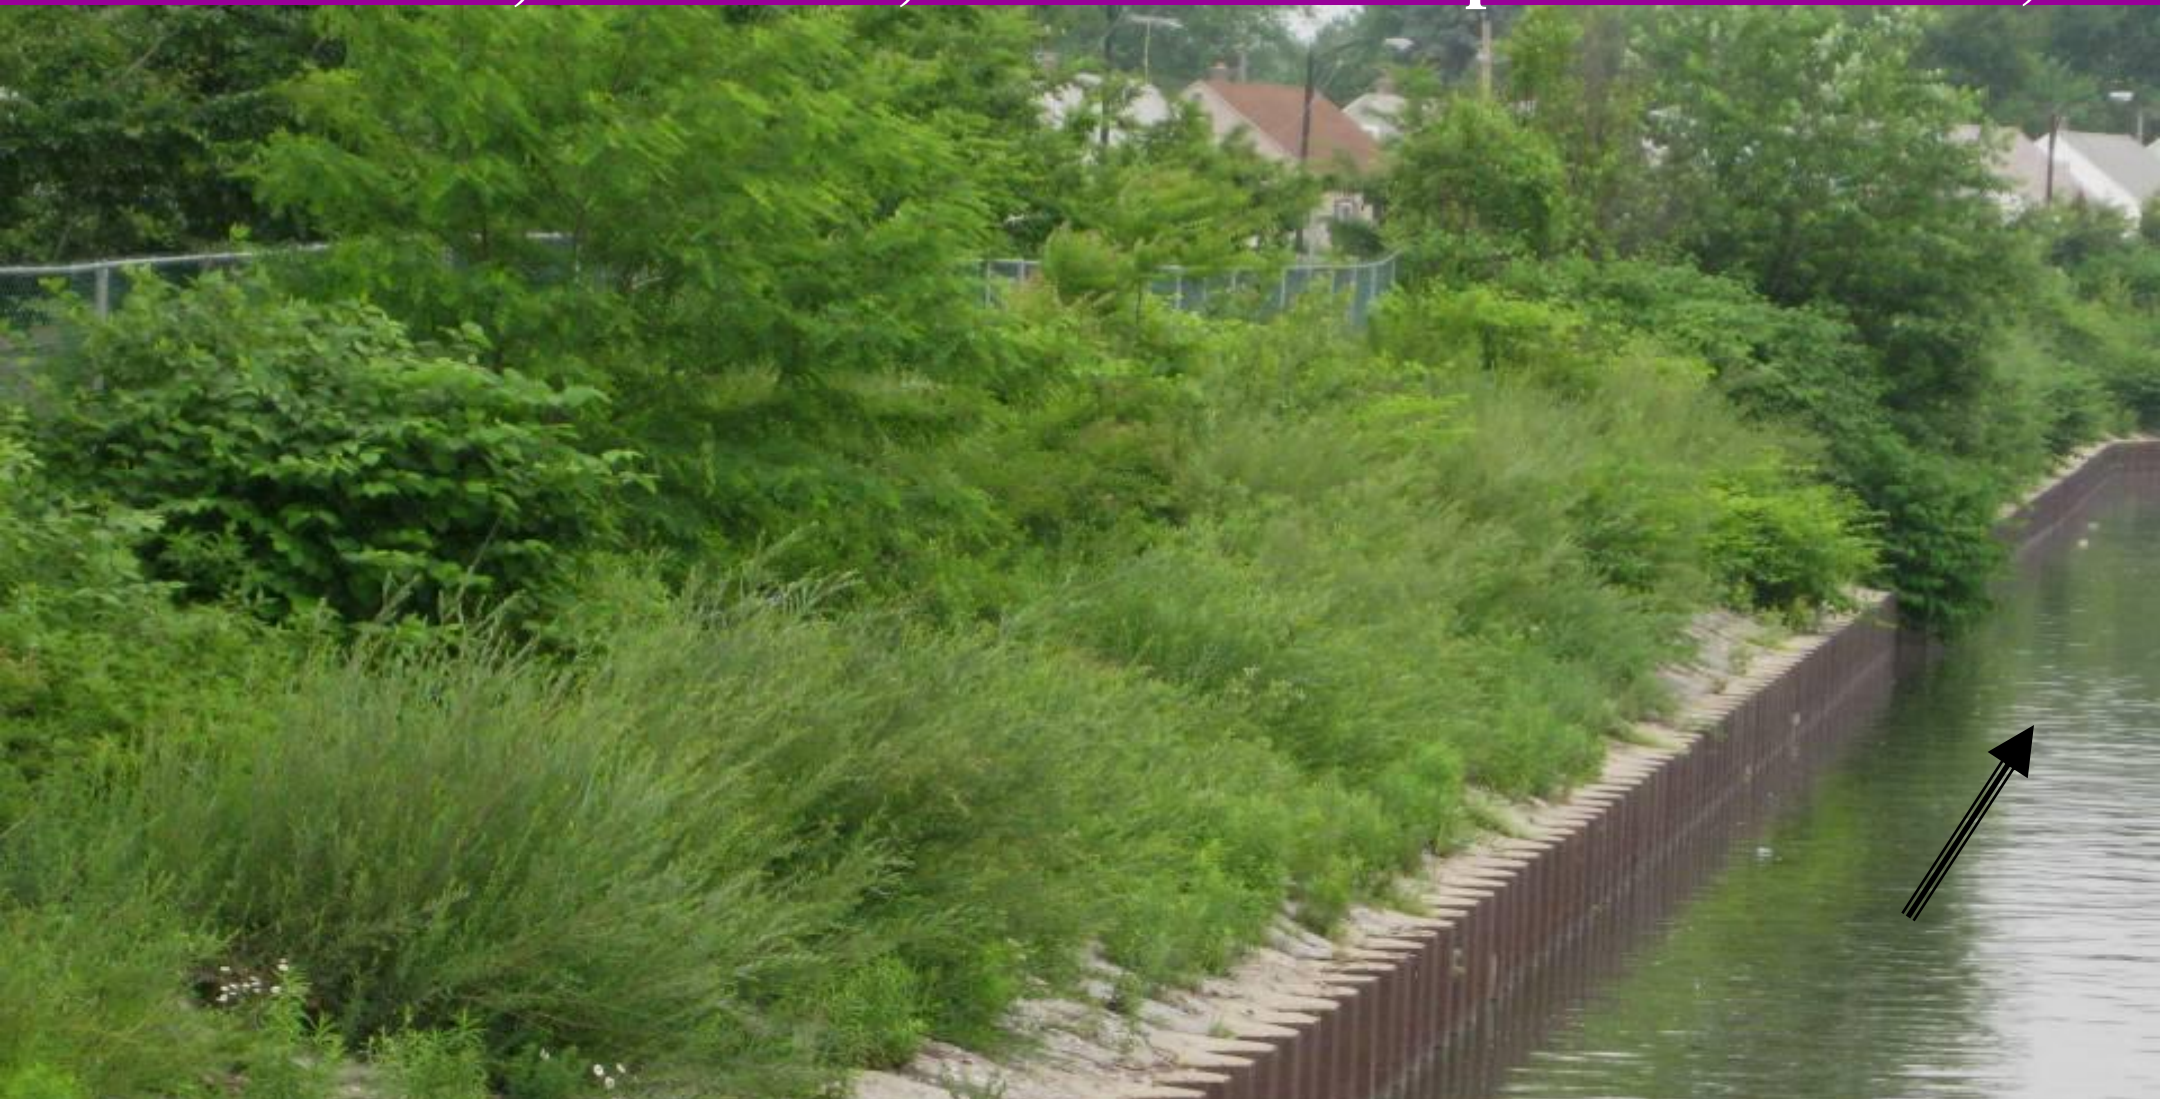
4.66 years after completion. From the bridge looking DS. Good diversity of plant species with some volunteer plants (Cottonwood, Black Locust, herbaceous, some invasive Japanese Knotweed).

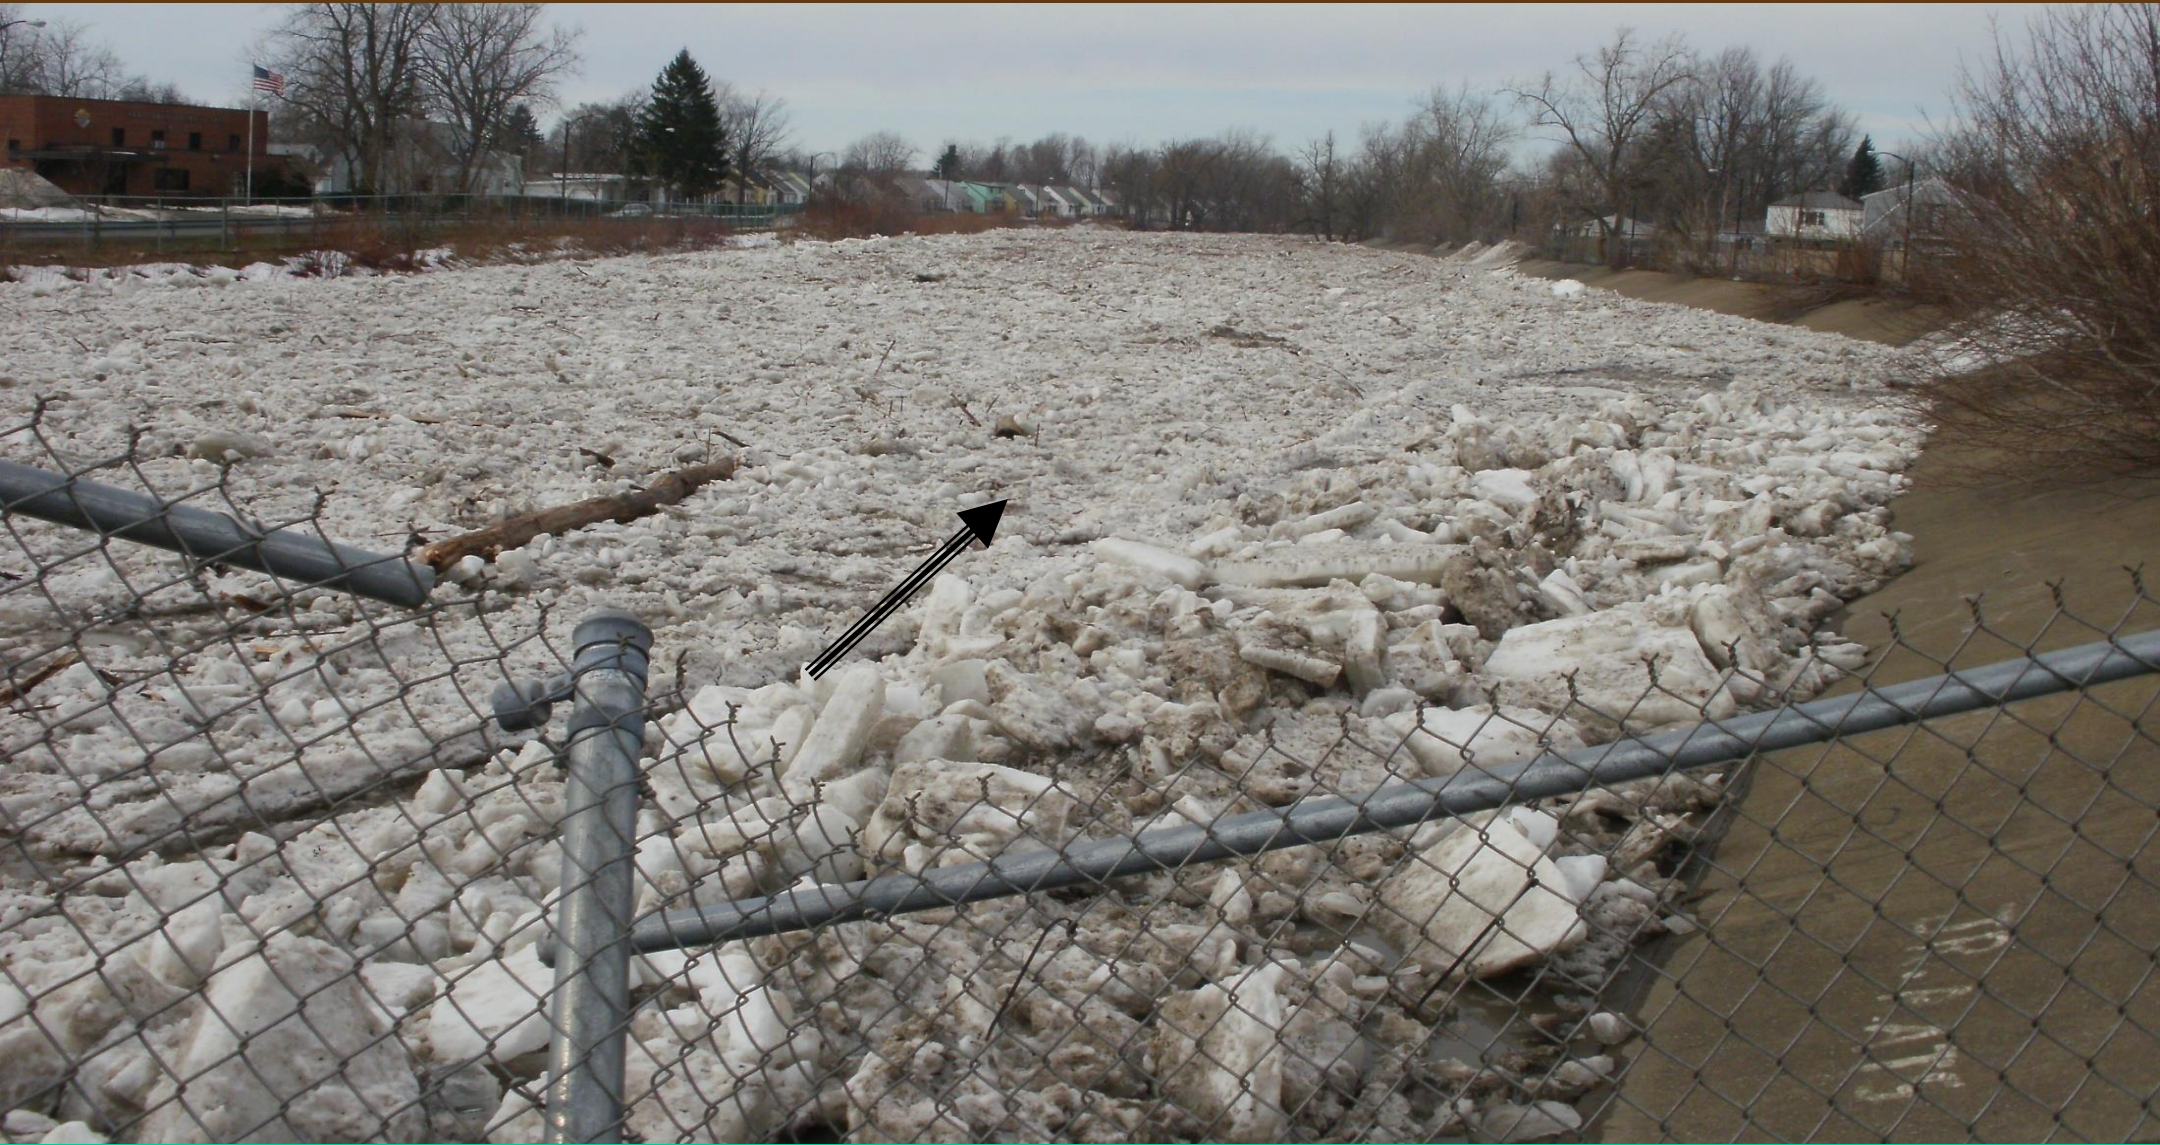
**5 YEARS AFTER PROJECT COMPLETION. Ice is back!!
DOT closed the bridge for 2 days, concrete channel UGLY**

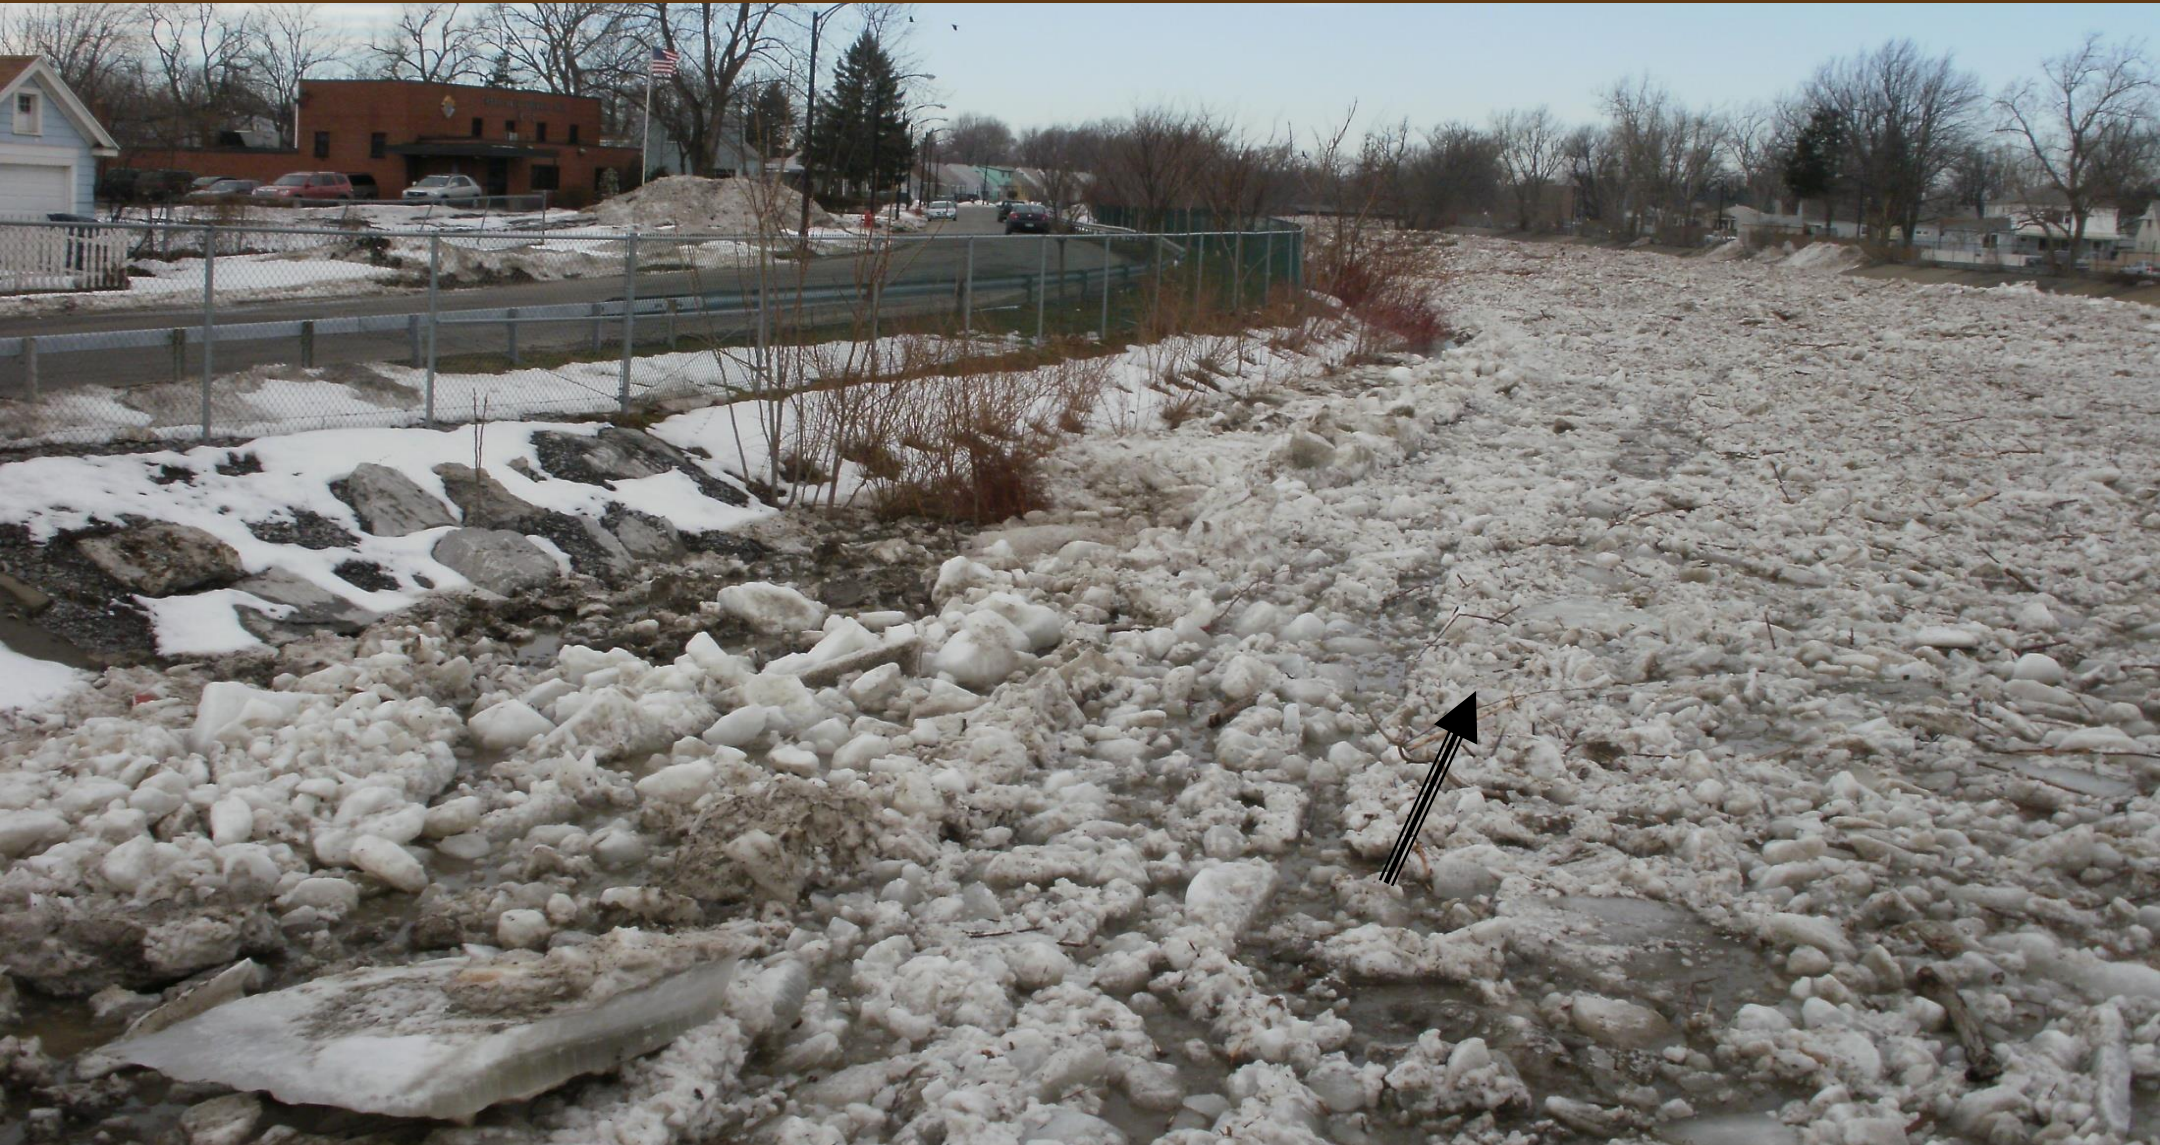
**5 YEARS AFTER PROJECT COMPLETION. Ice flowing
around plants & pounding project, plants look OK!!!**

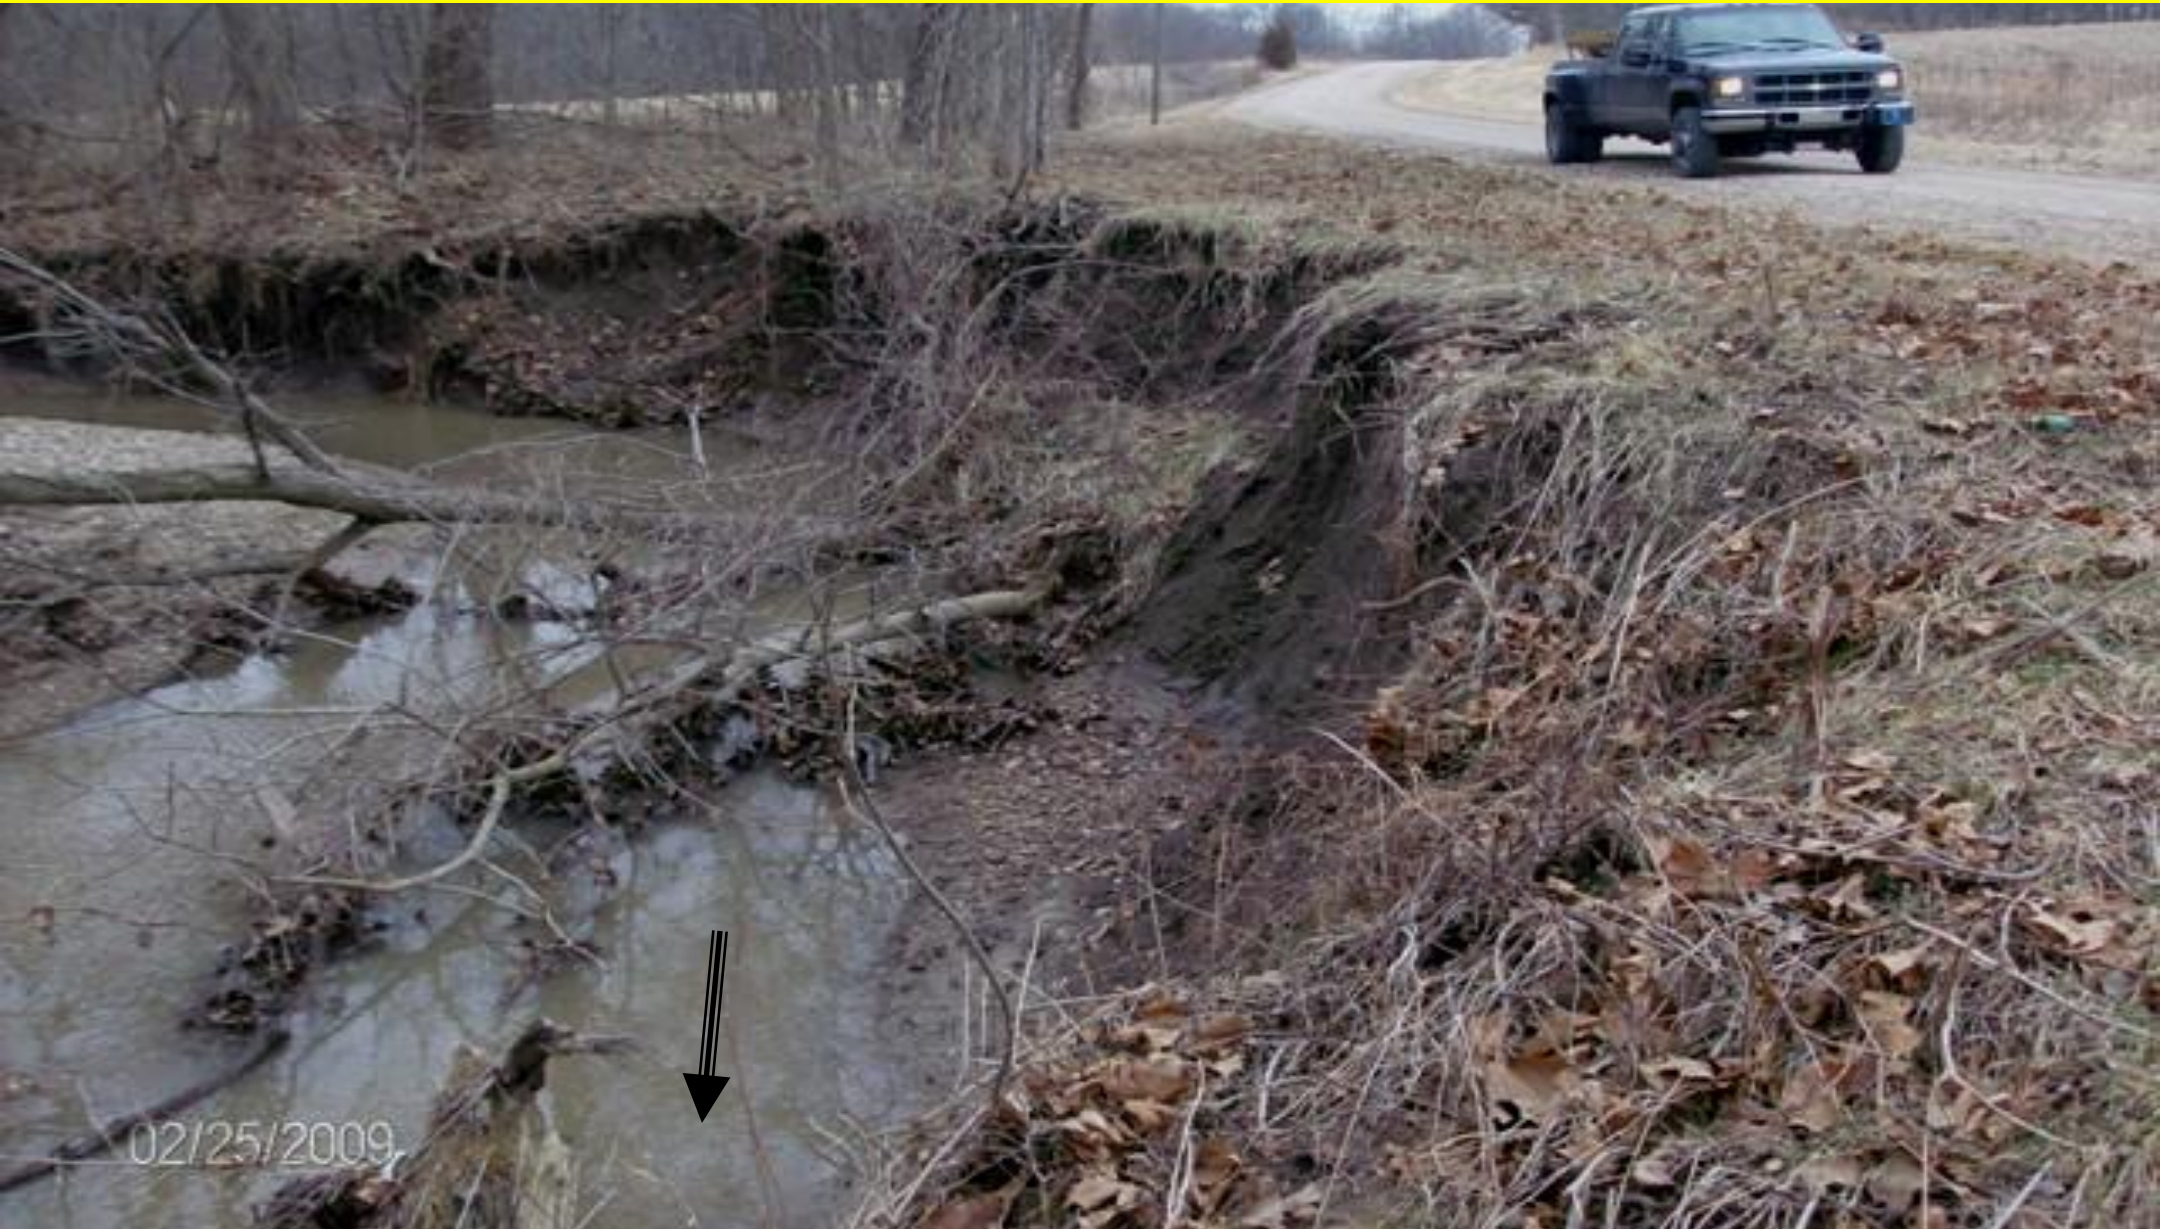
Looking US @ the project bend. Road is 4 ft from 14 ft tall eroding bank.

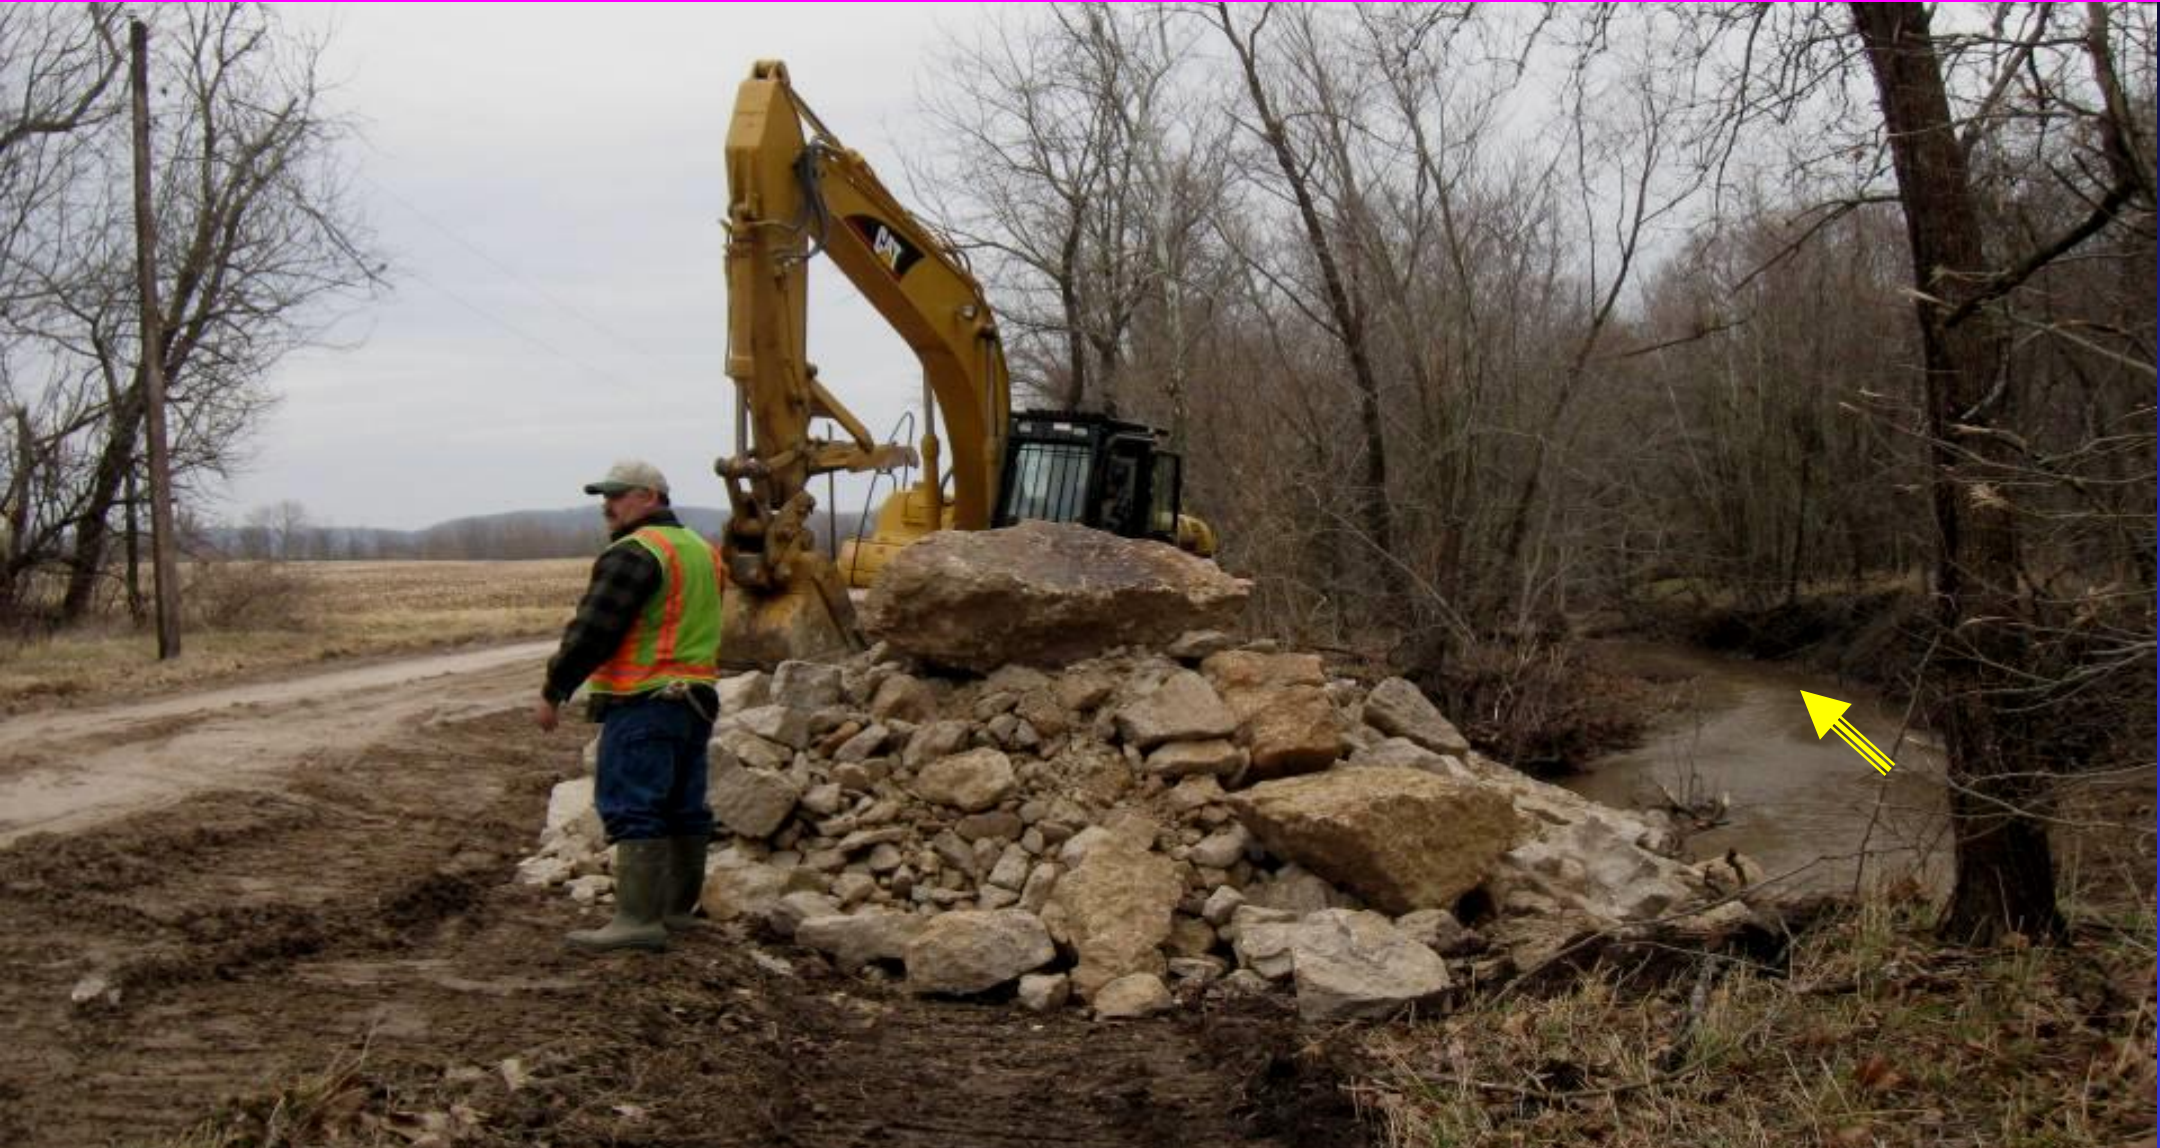
Stone used for keys & LPSTP was a sub-standard shot rock of questionable hardness. The amount of fine material was close to 20-30%. This was a self-filtering stone, but not well-graded, & not self-adjusting.

Stone is not well-graded & too many fines. The stone is self-filtering, but not self-adjusting, but only \$4.70/ton delivered.

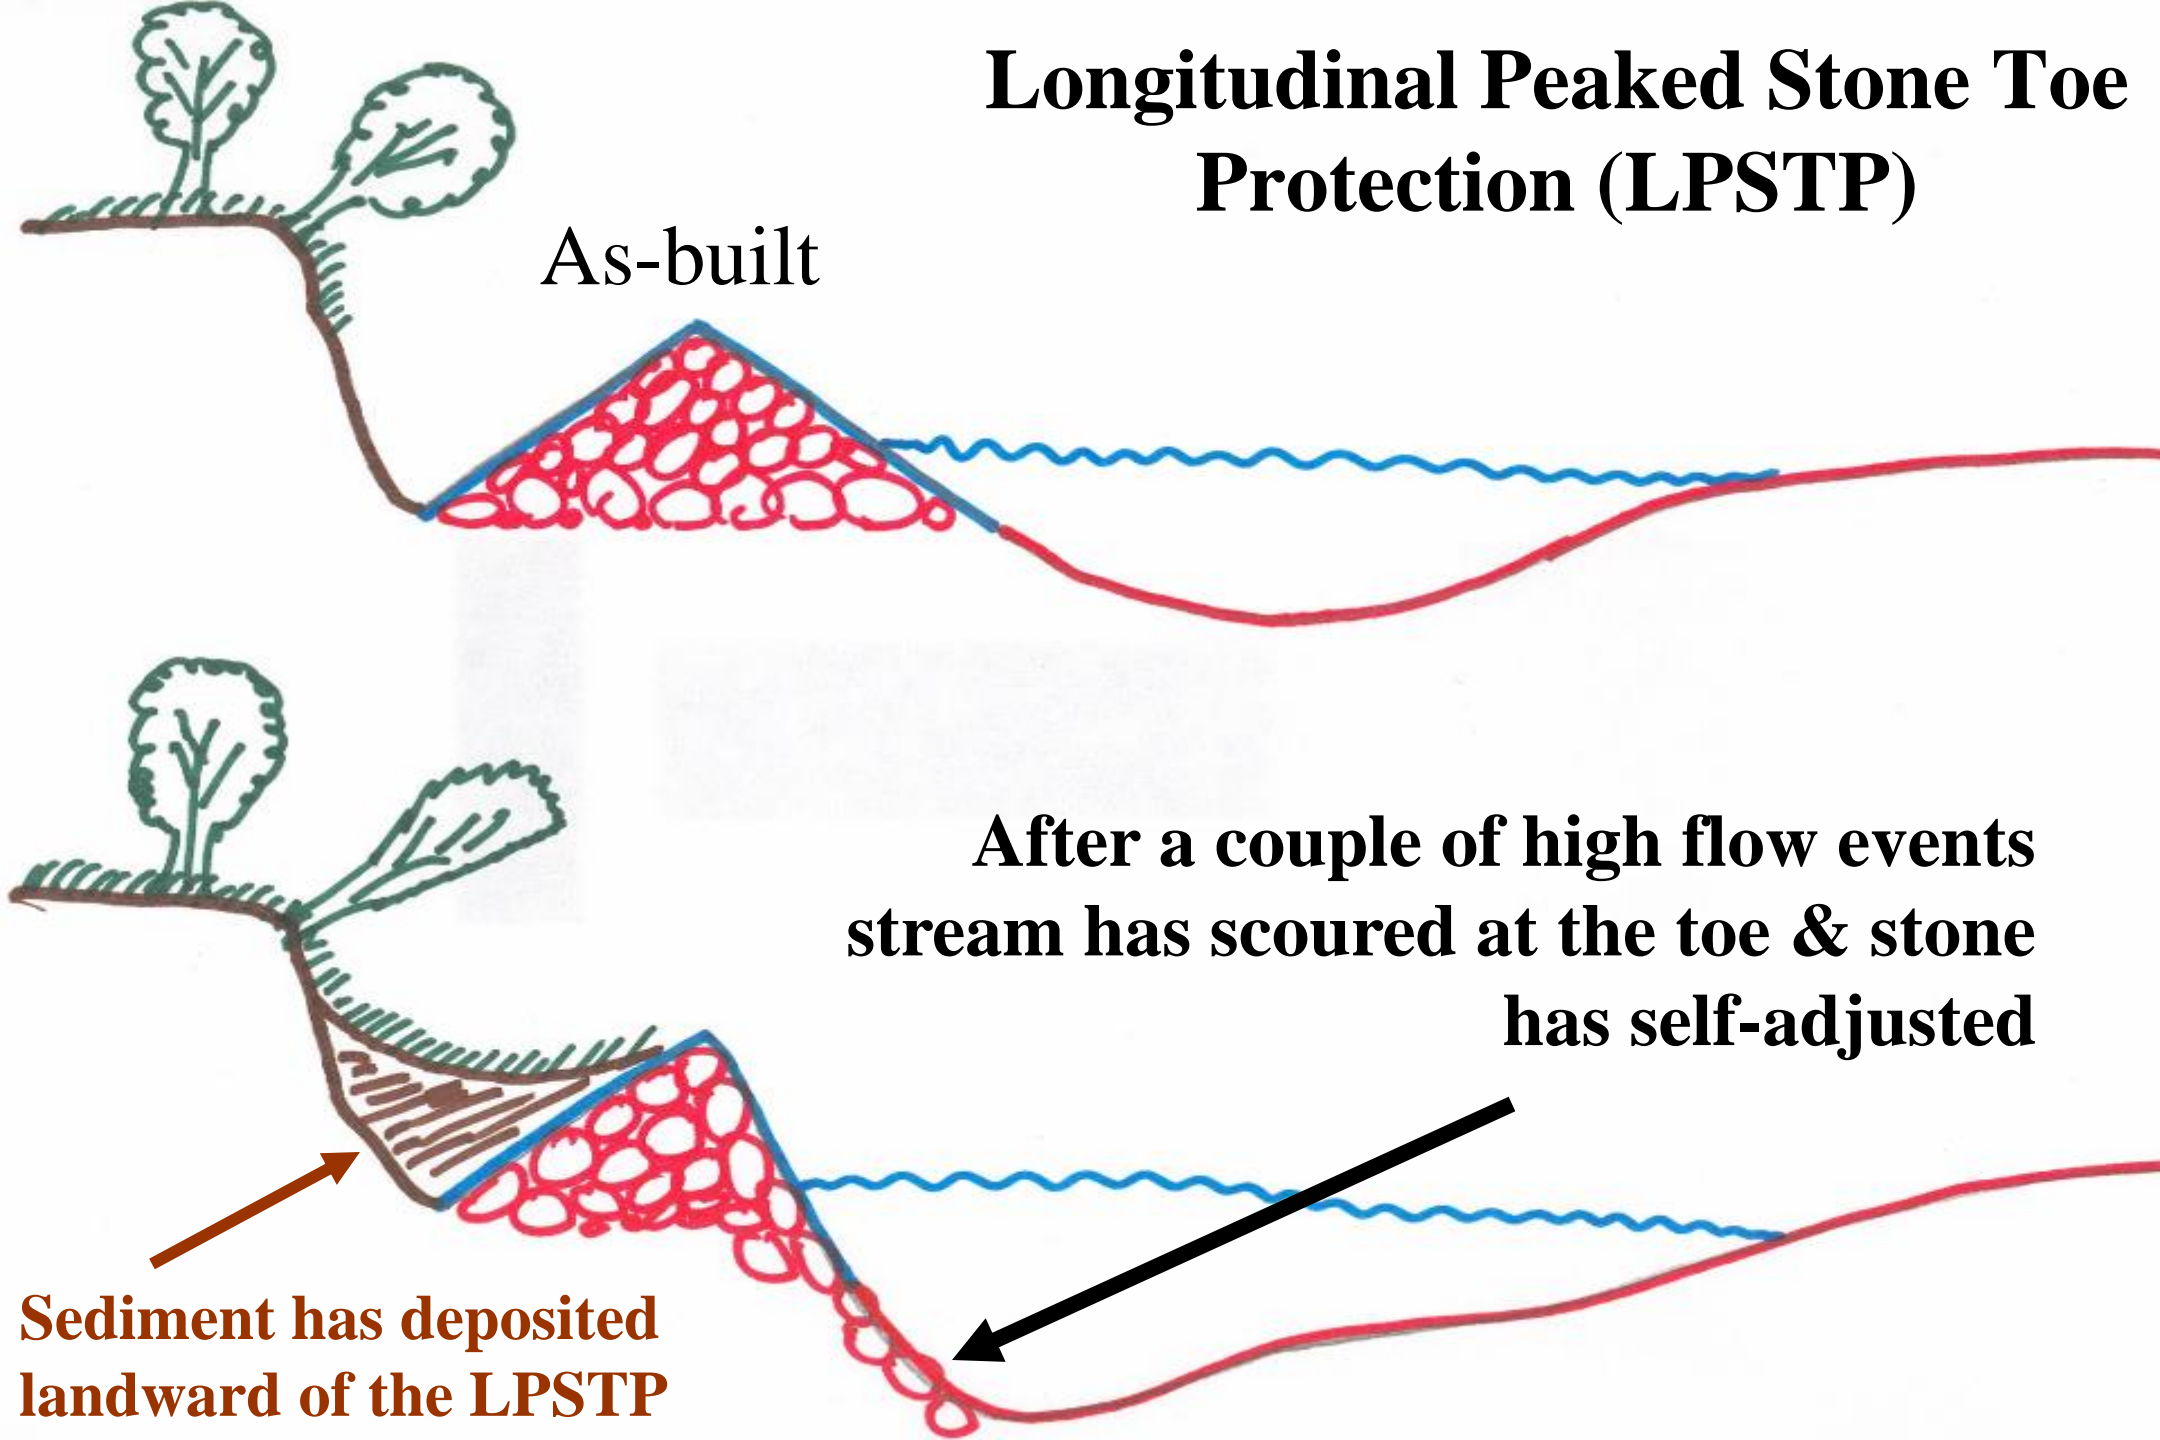
After a couple of high flow events
stream has scoured at the toe & stone
has self-adjusted

Sediment has deposited
landward of the LPSTP
