CAZENOVIA CR. @ STEPHENSON ST. BRIDGE

**REPLACEMENT OF ONE BANK
OF A CONCRETE-LINED
CHANNEL**

**HAW CREEK, PIKE COUNTY, MISSOURI-
TRIB TO SALT RIVER**

GOODWIN CREEK, MS.

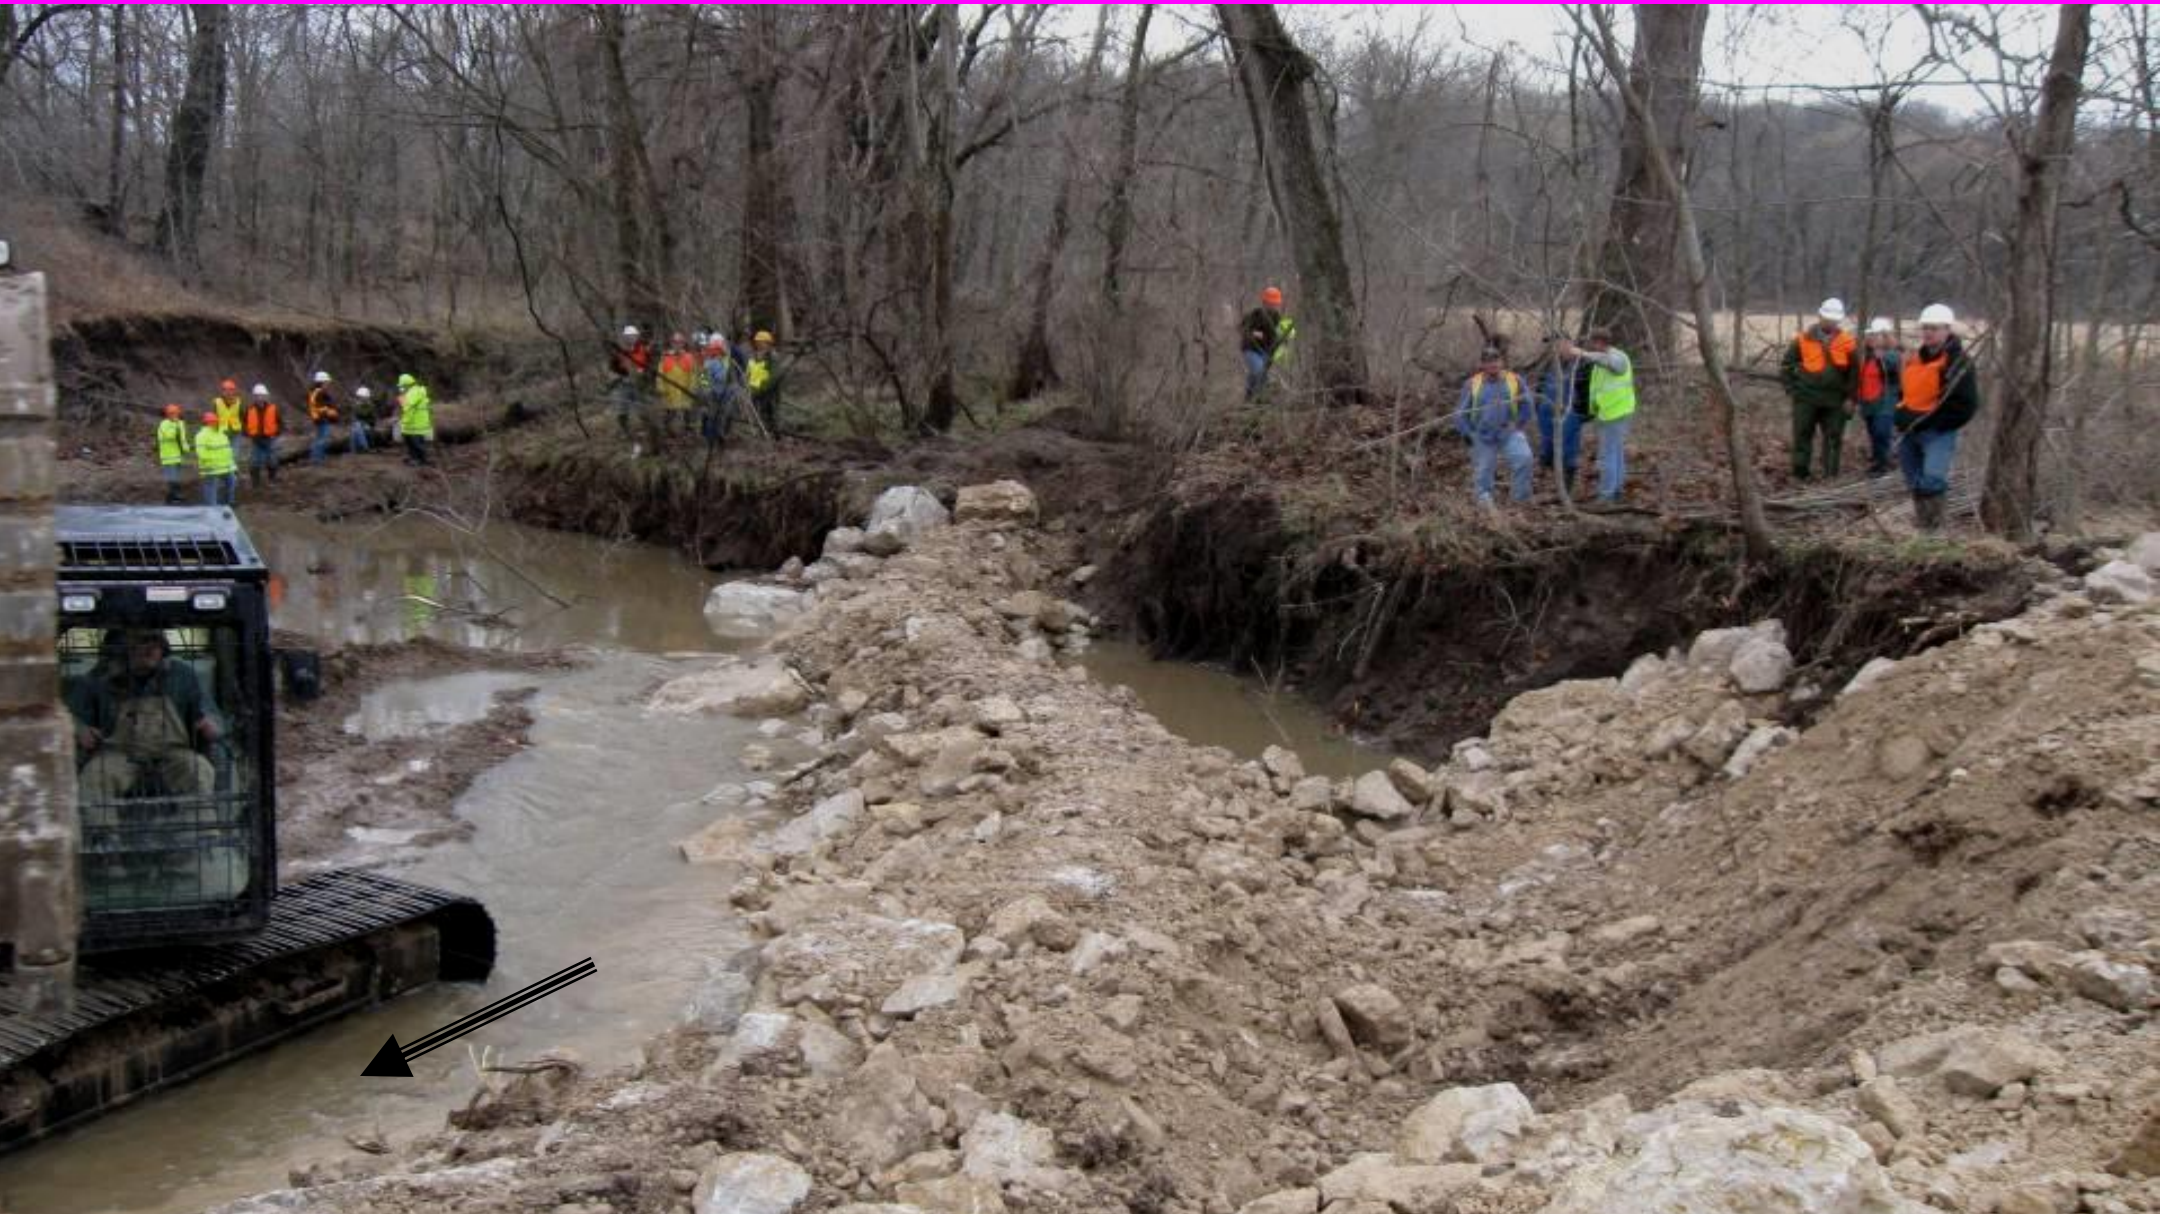
Looking US. LPSTP crest is 4 ft above base flow stage.

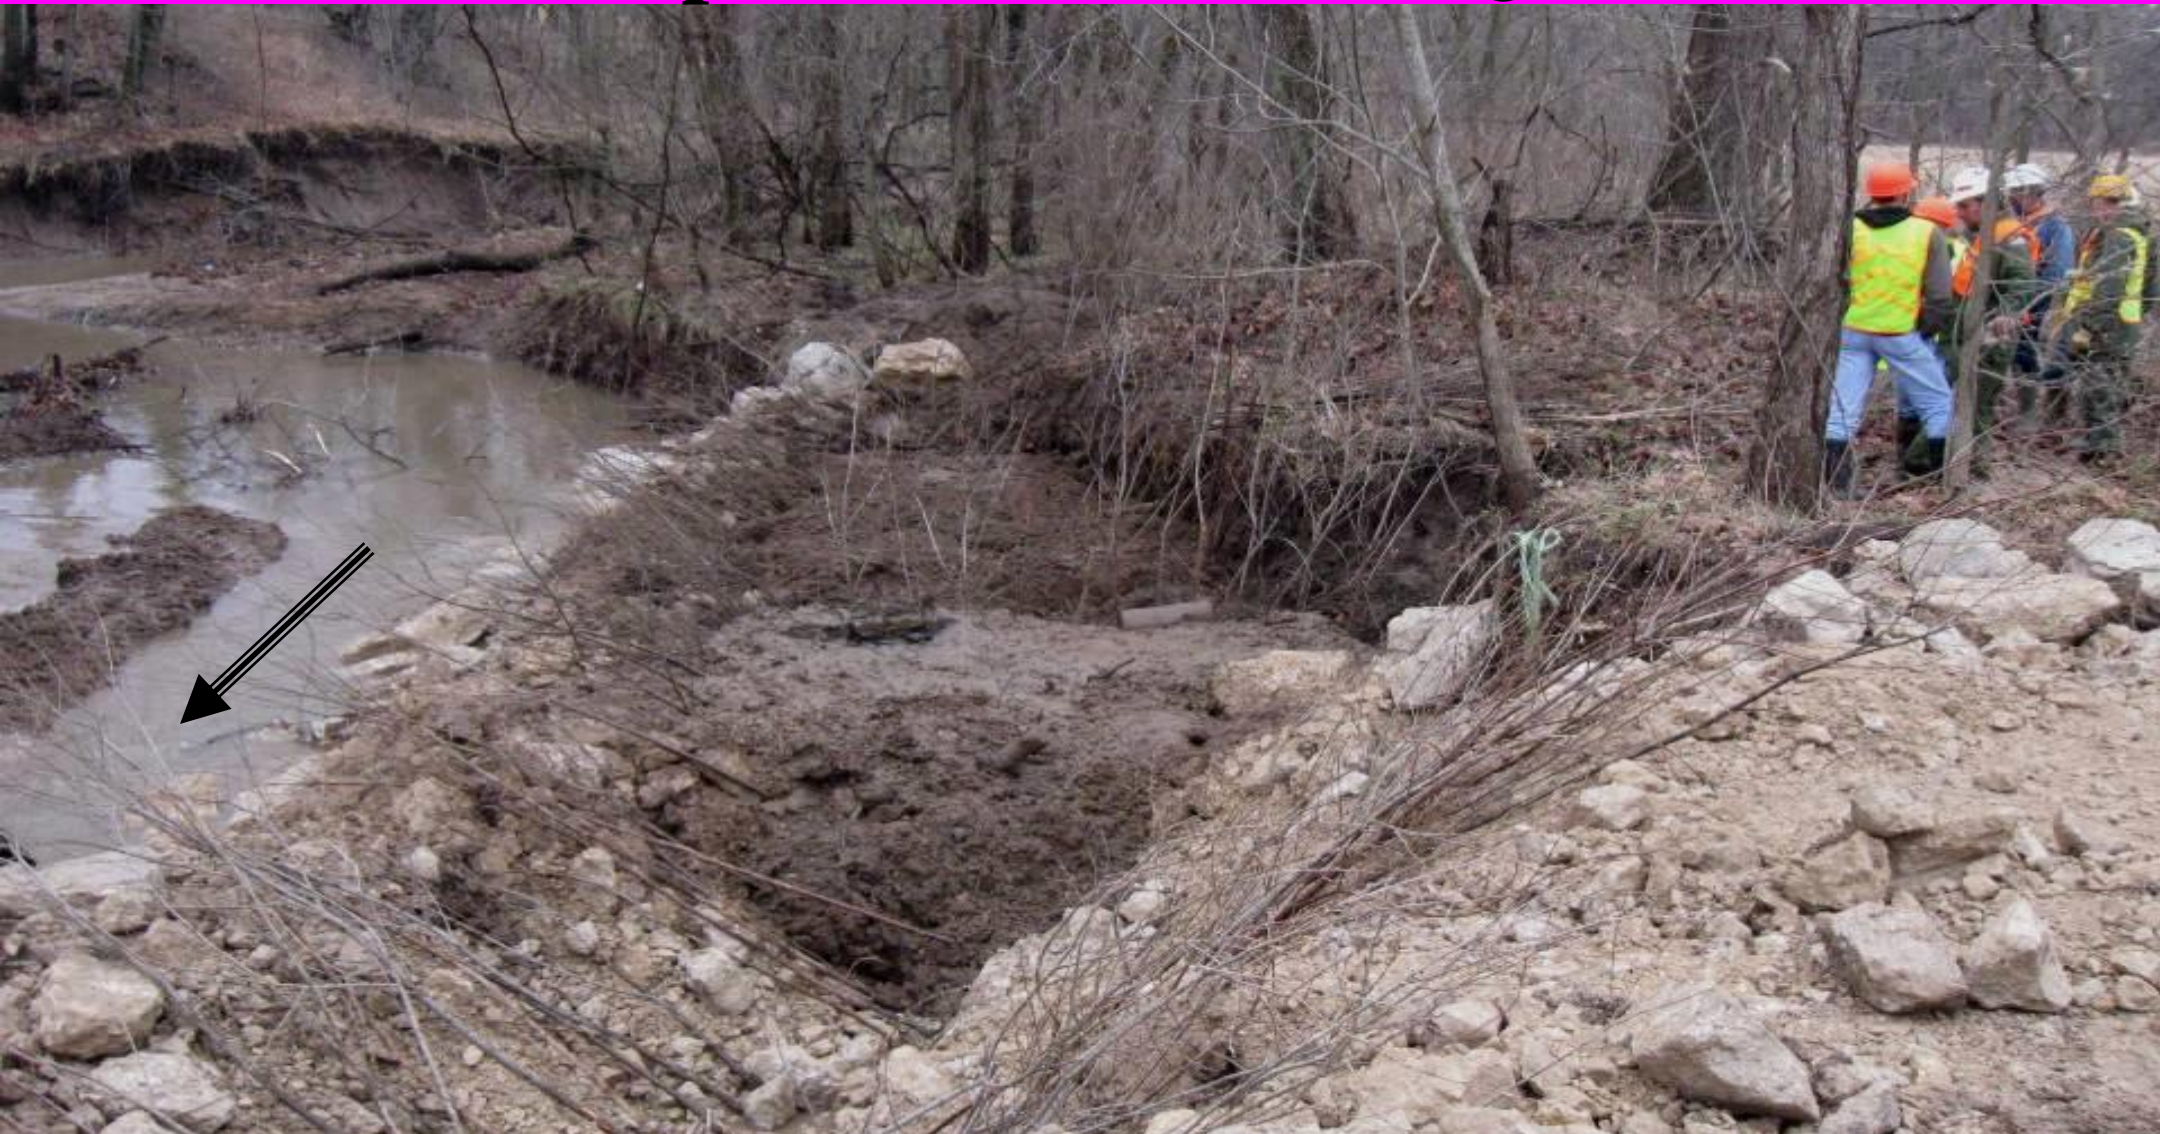
**Looking DS. Backfilling between LPSTP & bank
to form floodplain bench @ the Q-2 elevation.**

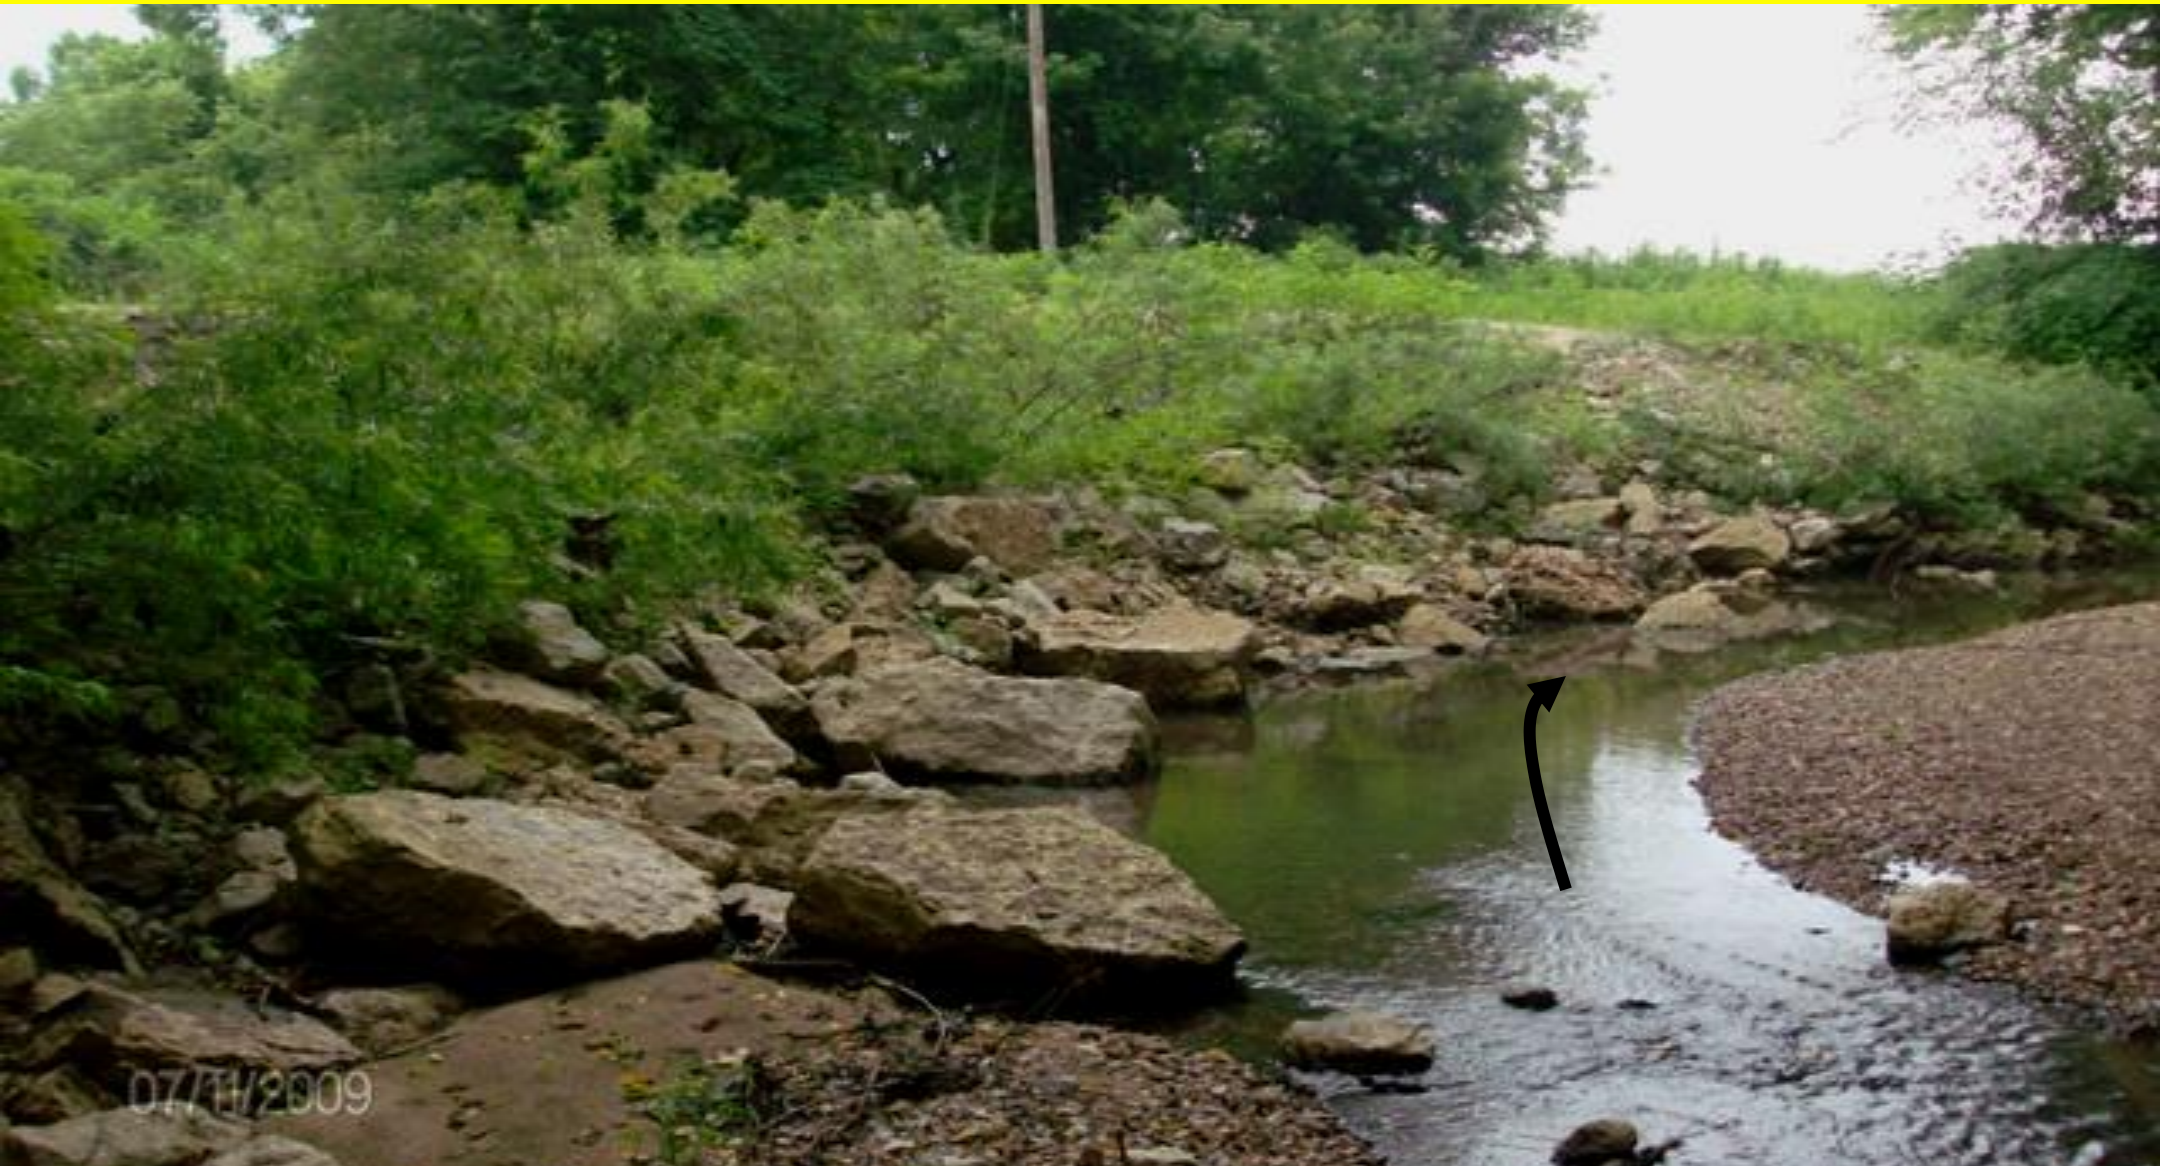
**4 MONTHS LATER-Looking DS @ the thalweg trace, LPSTP,
Single Stone Bendway Weirs & the floodplain bench.**

**After 4 months, great growth
from the 500 willows we
planted! LaDon says the
floodplain bench has about
6 inches of sediment
deposition on it.**

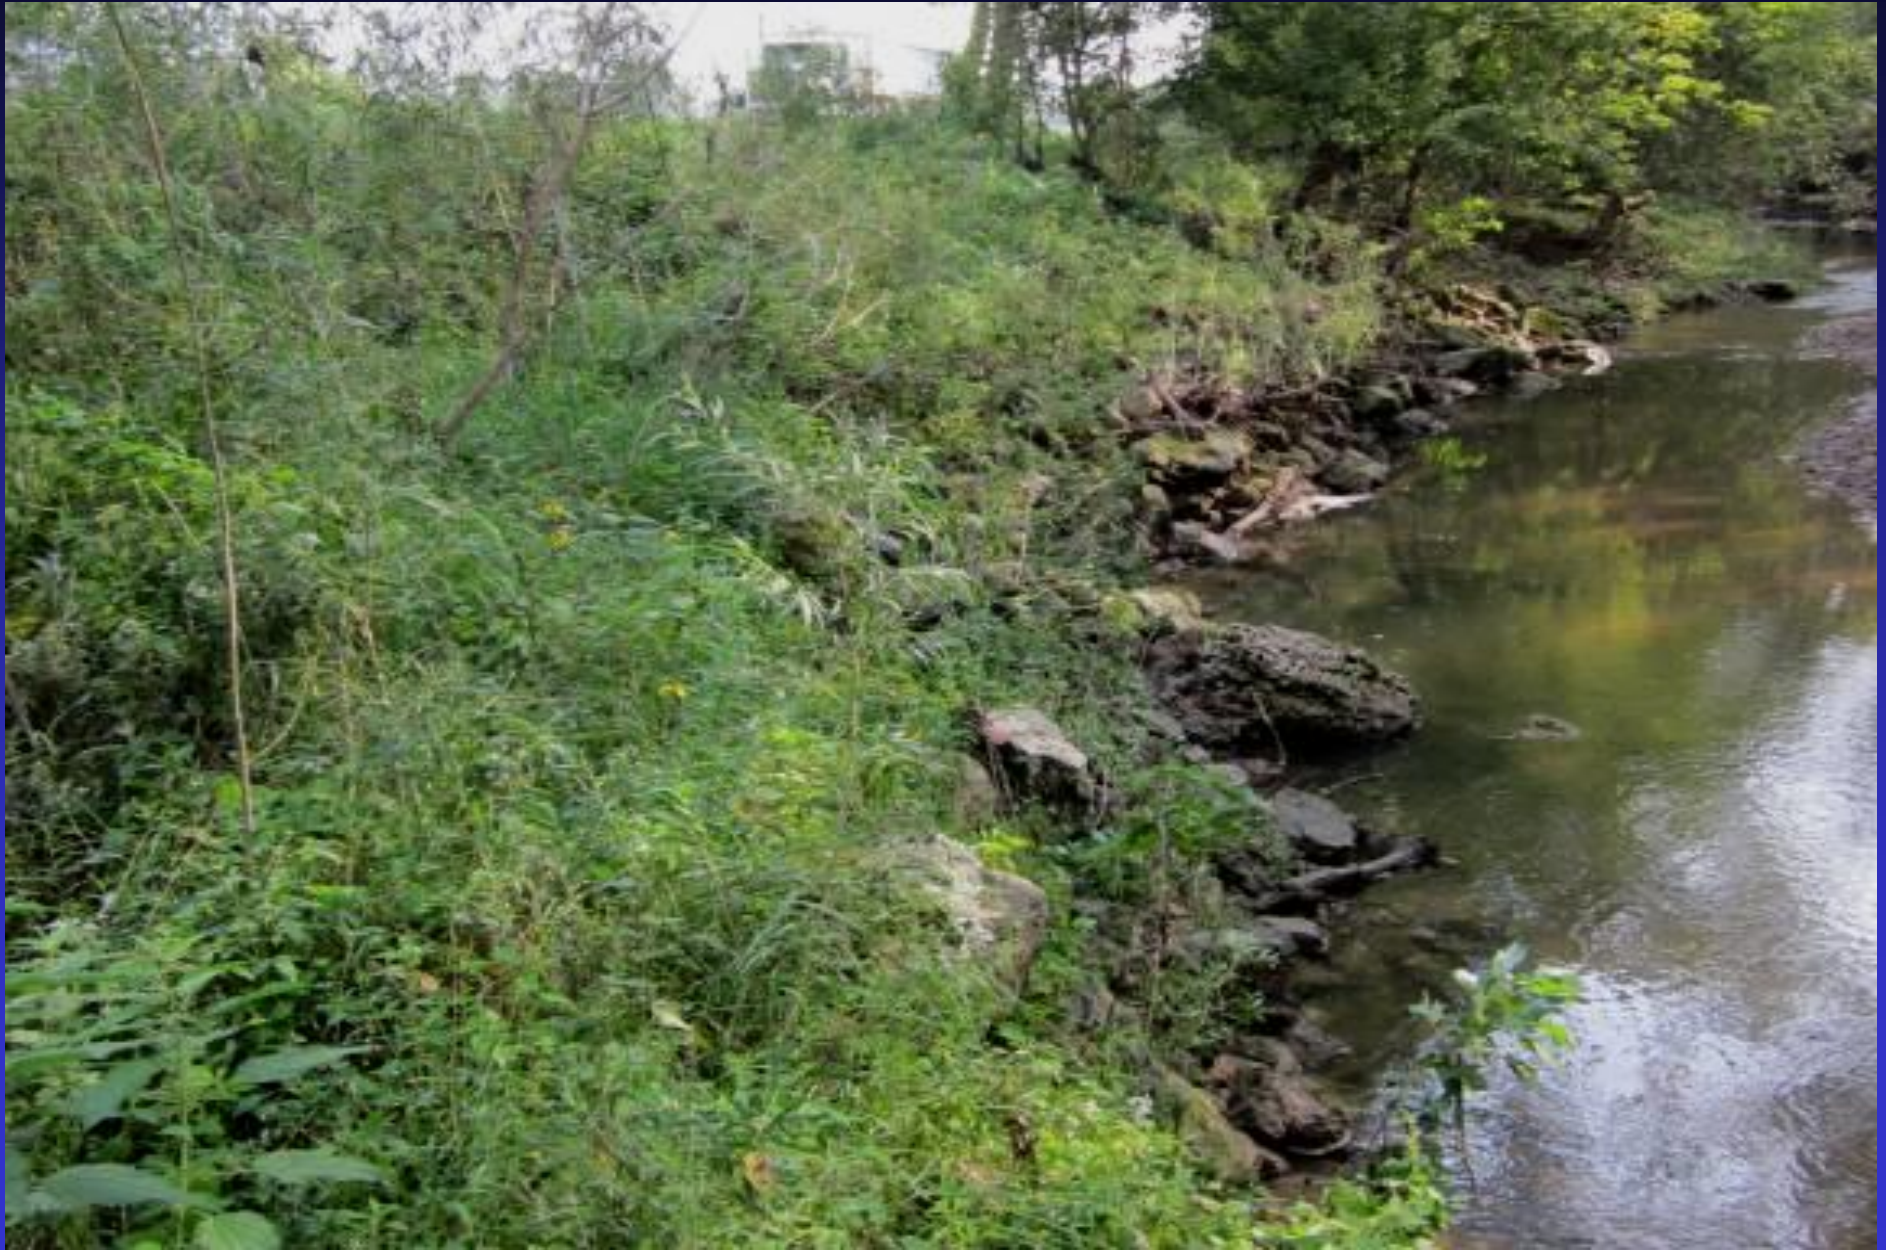
Looking downstream from left descending bank. The vegetation has almost completely grown over the rock – Sept 2010

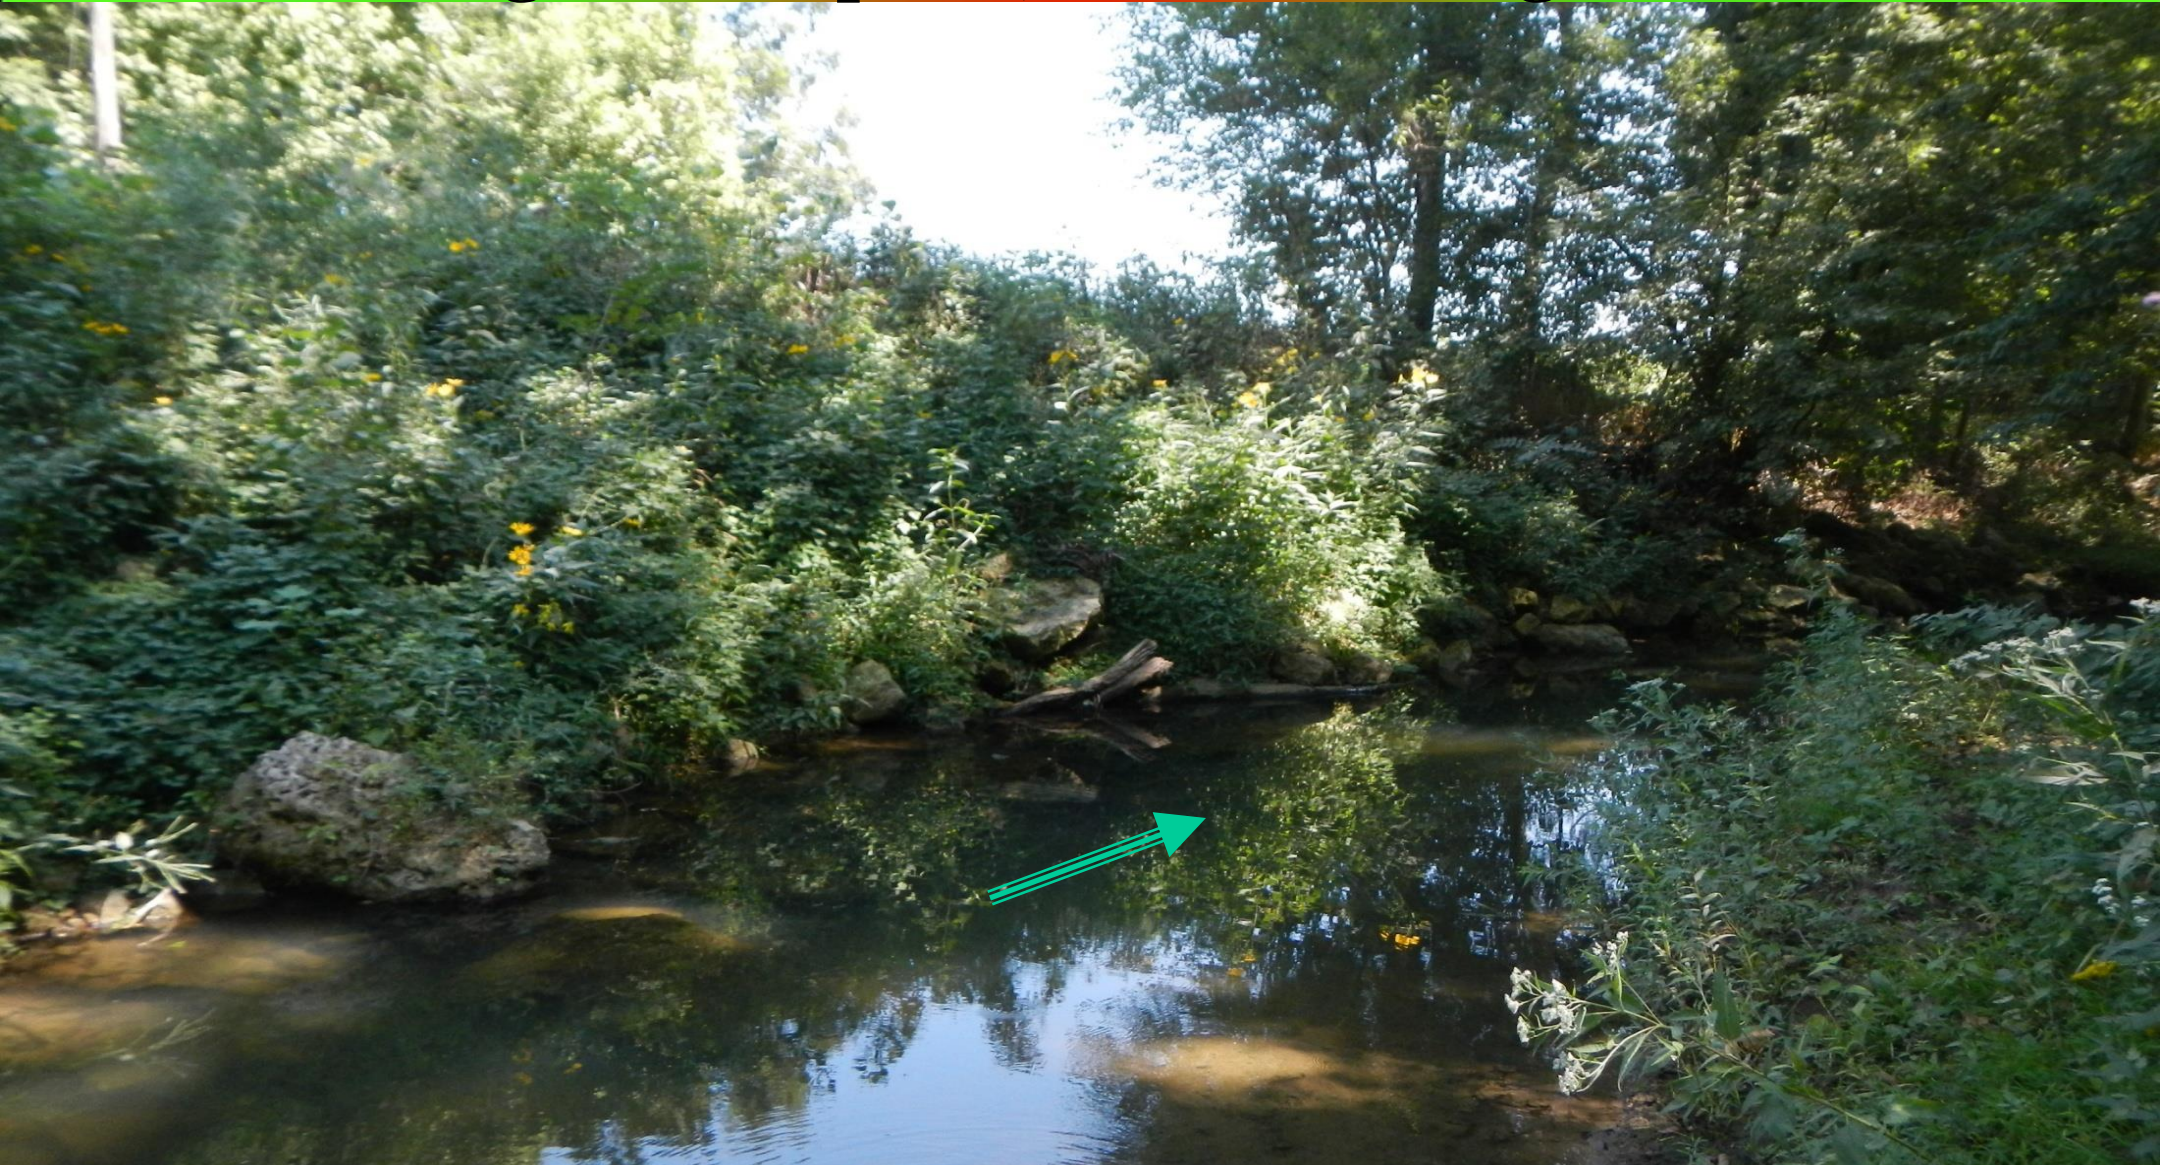
**4.5 YEARS LATER-Looking DS @ DS end of project.
Locked Logs still in place, Joint Plantings are vibrant!**

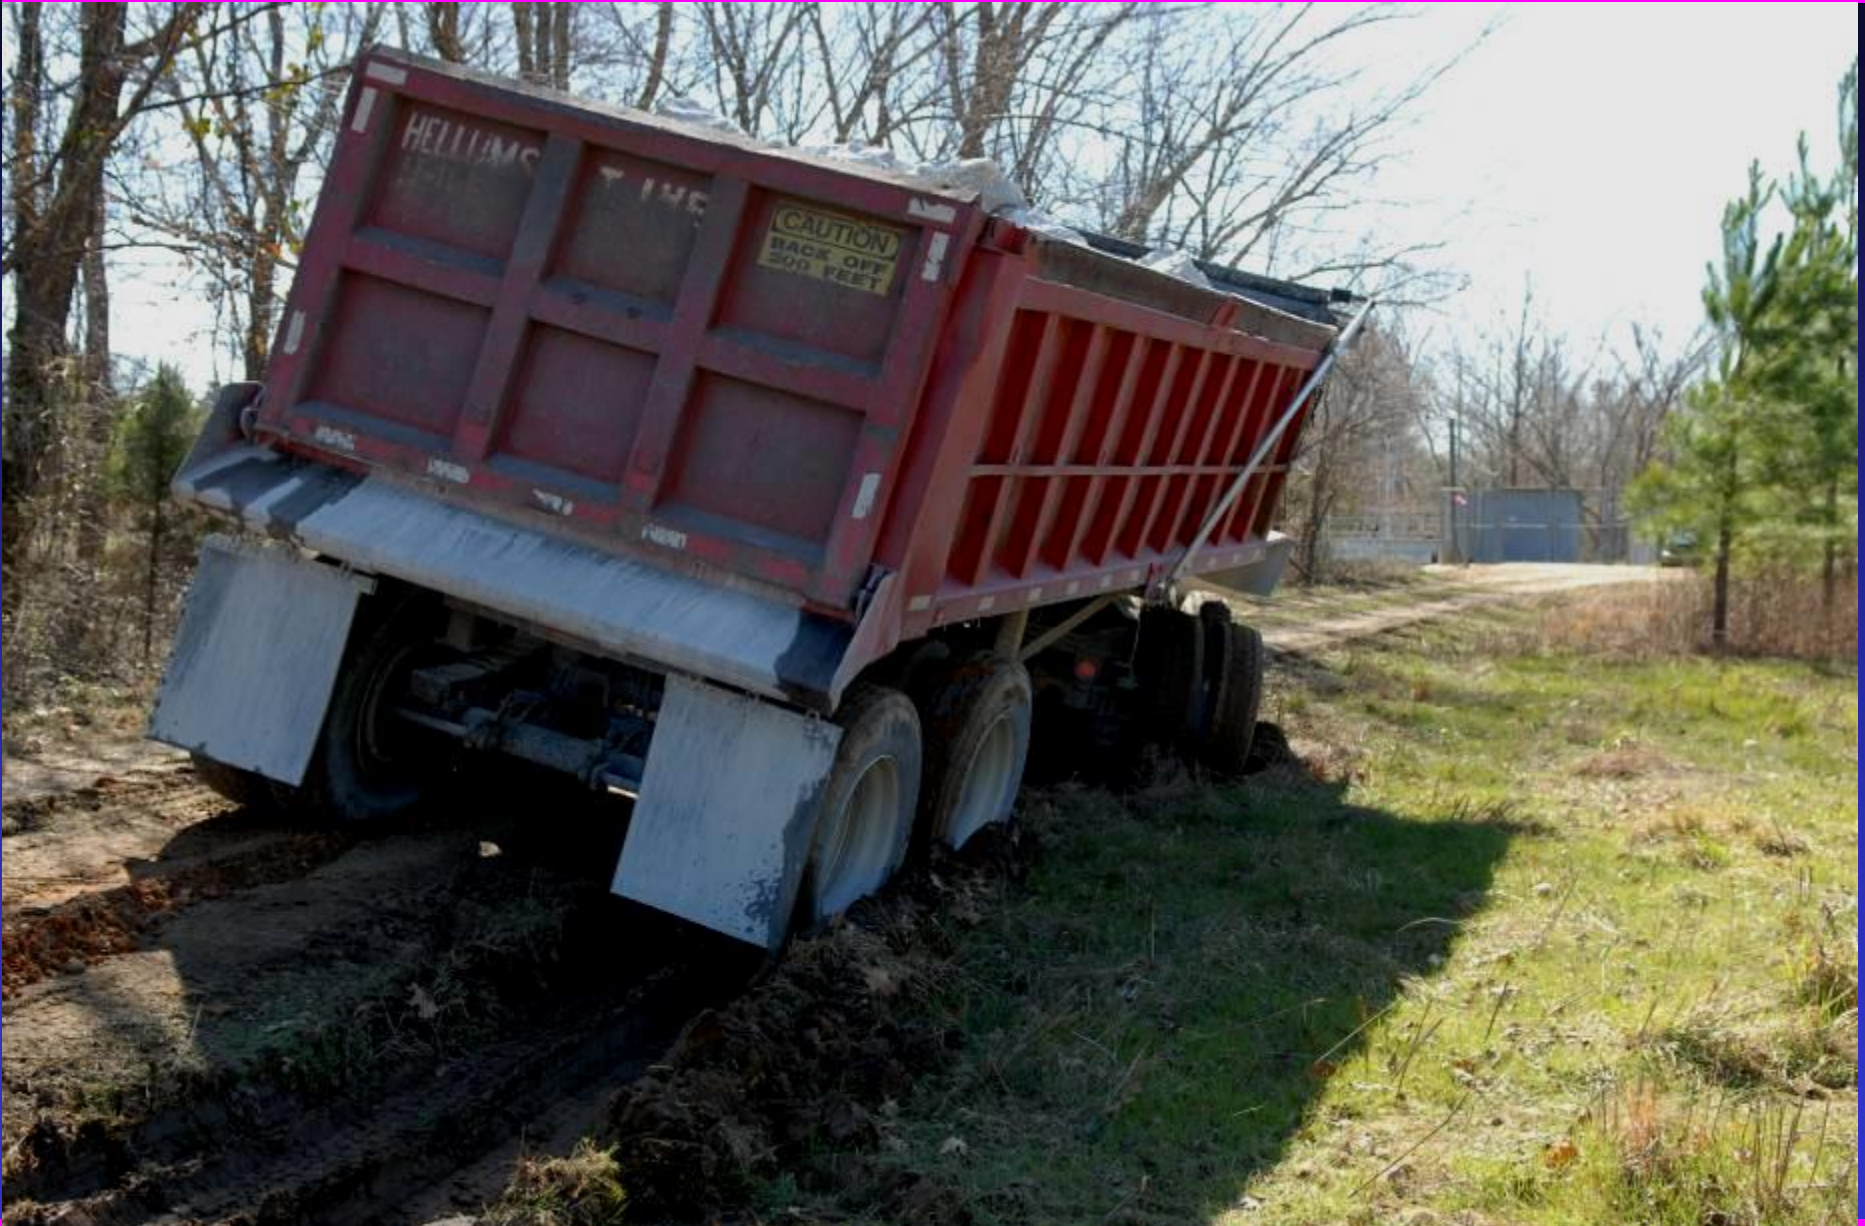
1 of 7 trucks stuck
