Sulphur Creek @ Dunnigan Burn Dump,

Yolo County, CA.

BUILT 1998

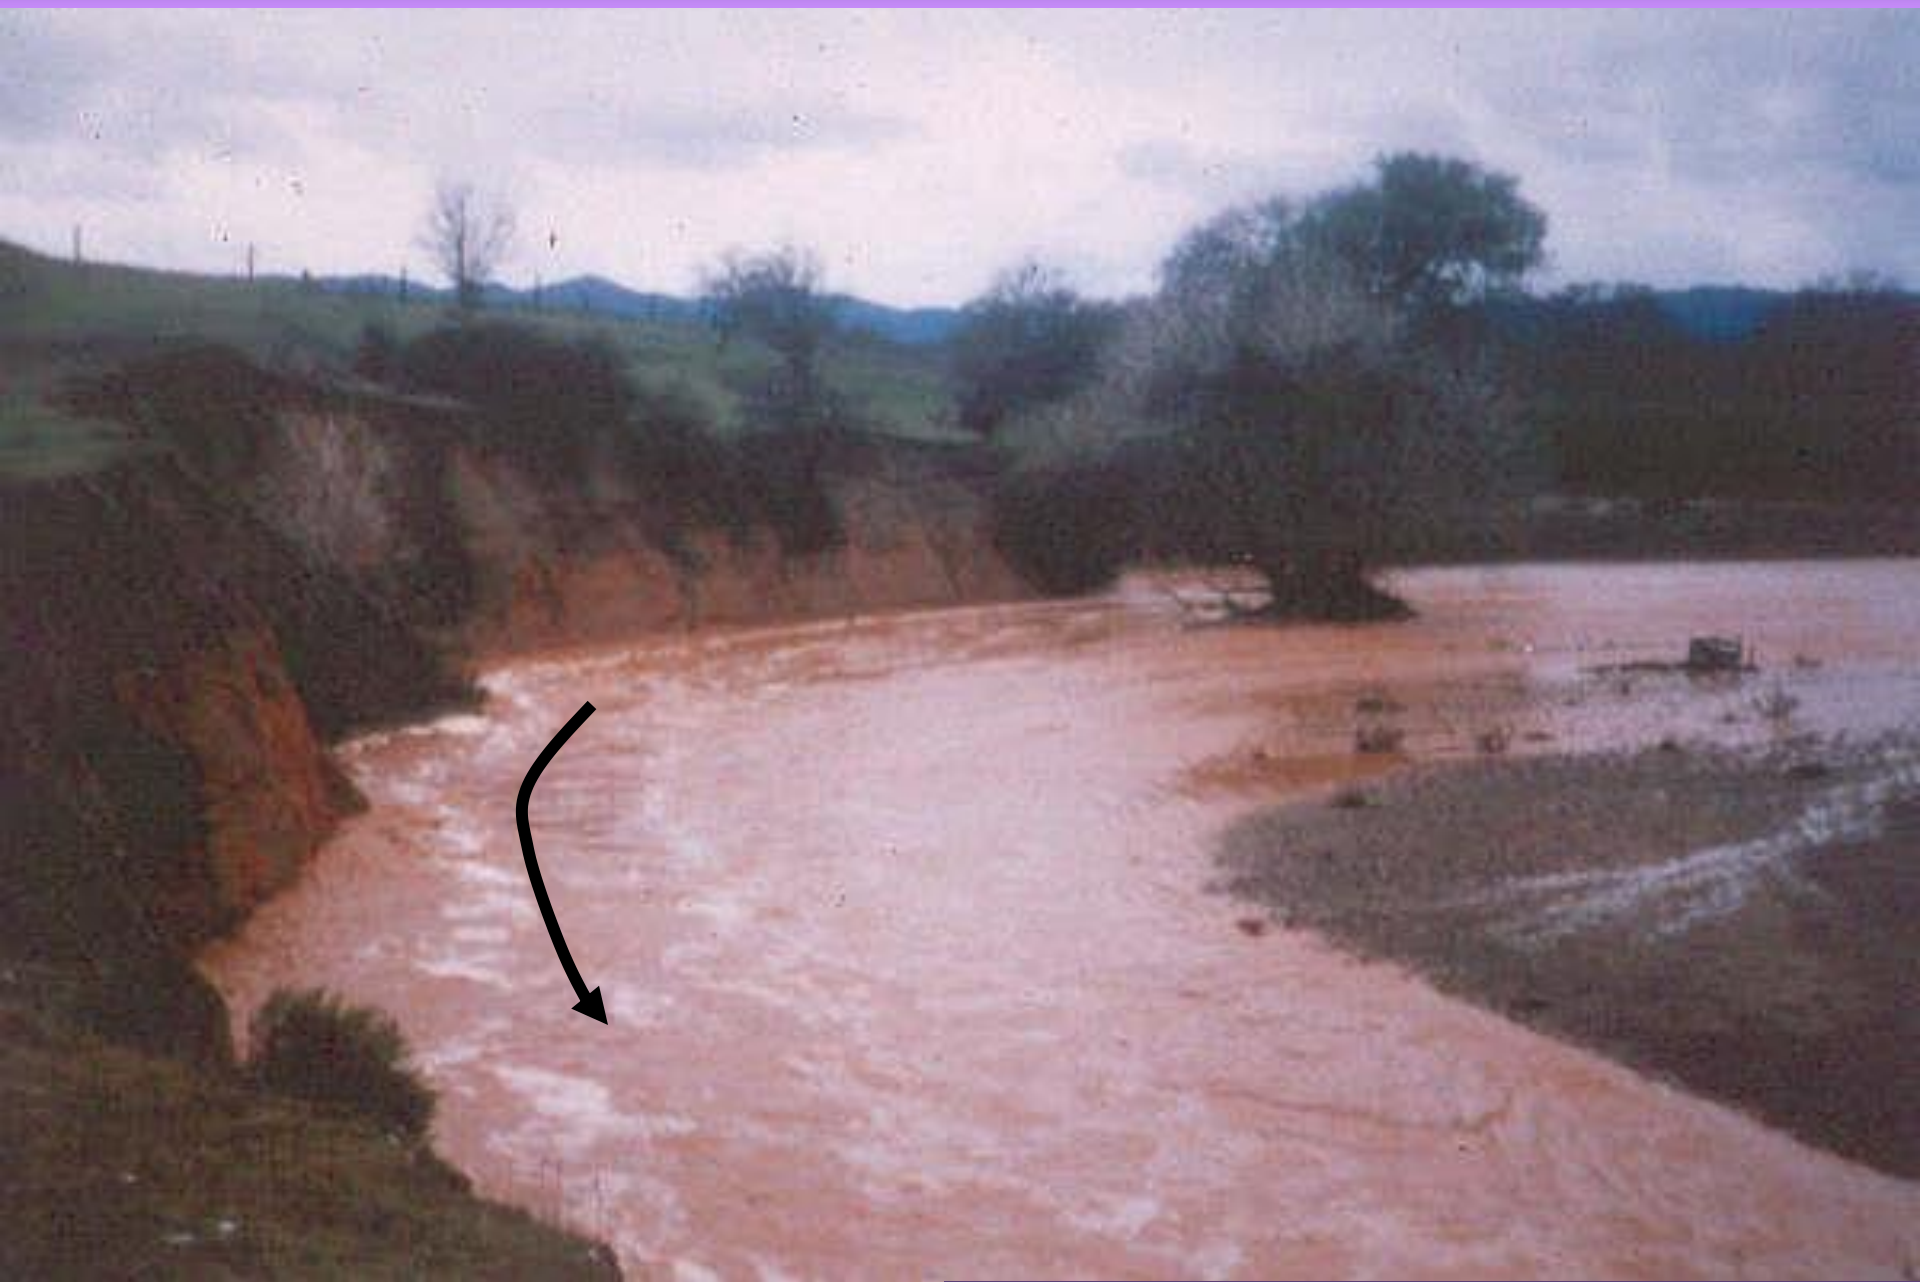
Pre-Project conditions-High water, looking US. Thalweg @ toe of cliff.

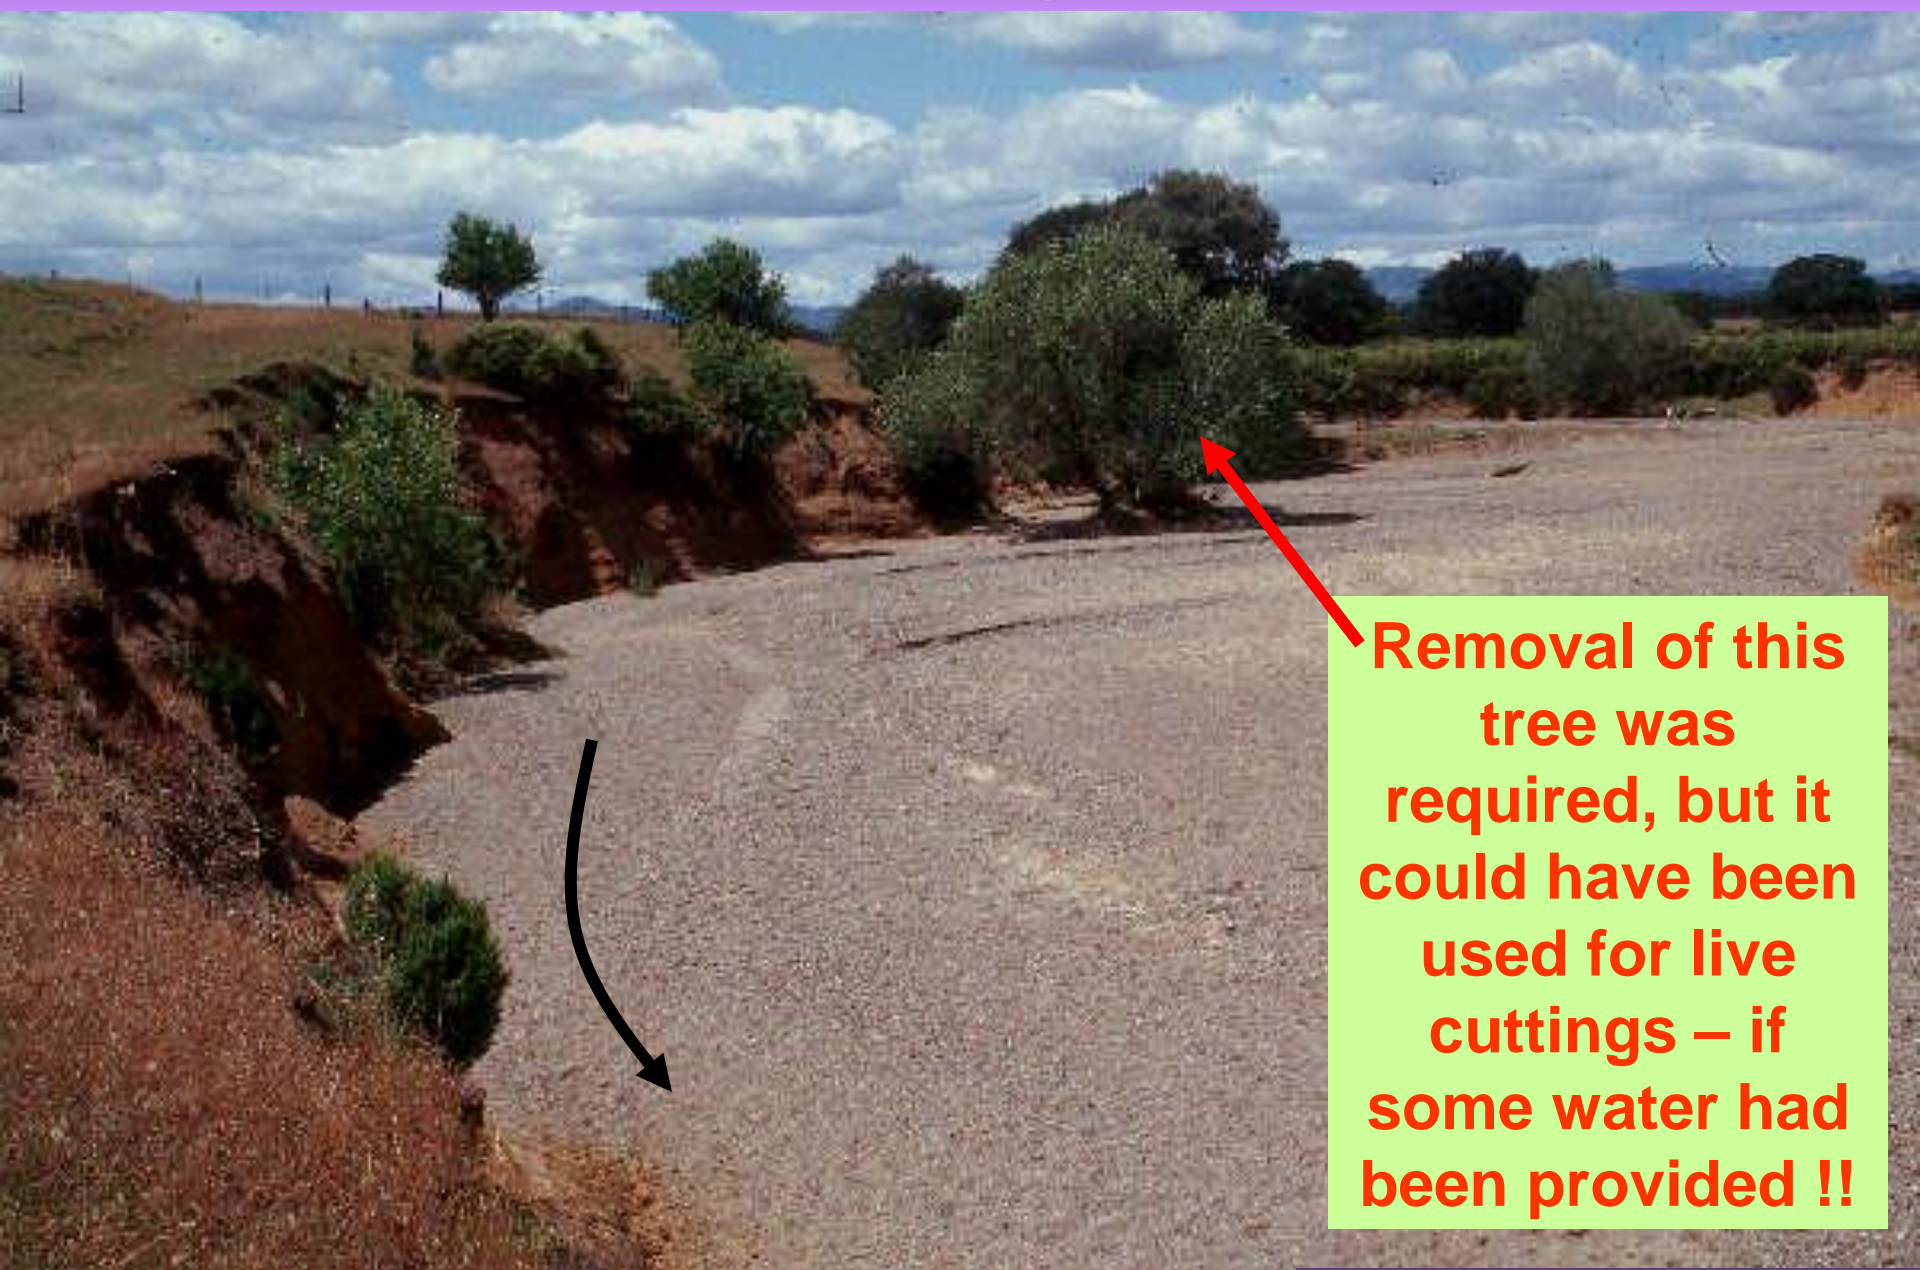
Pre-Project conditions-Looking US @ US end of project.

Removal of this tree was required, but it could have been used for live cuttings – if some water had been provided !!

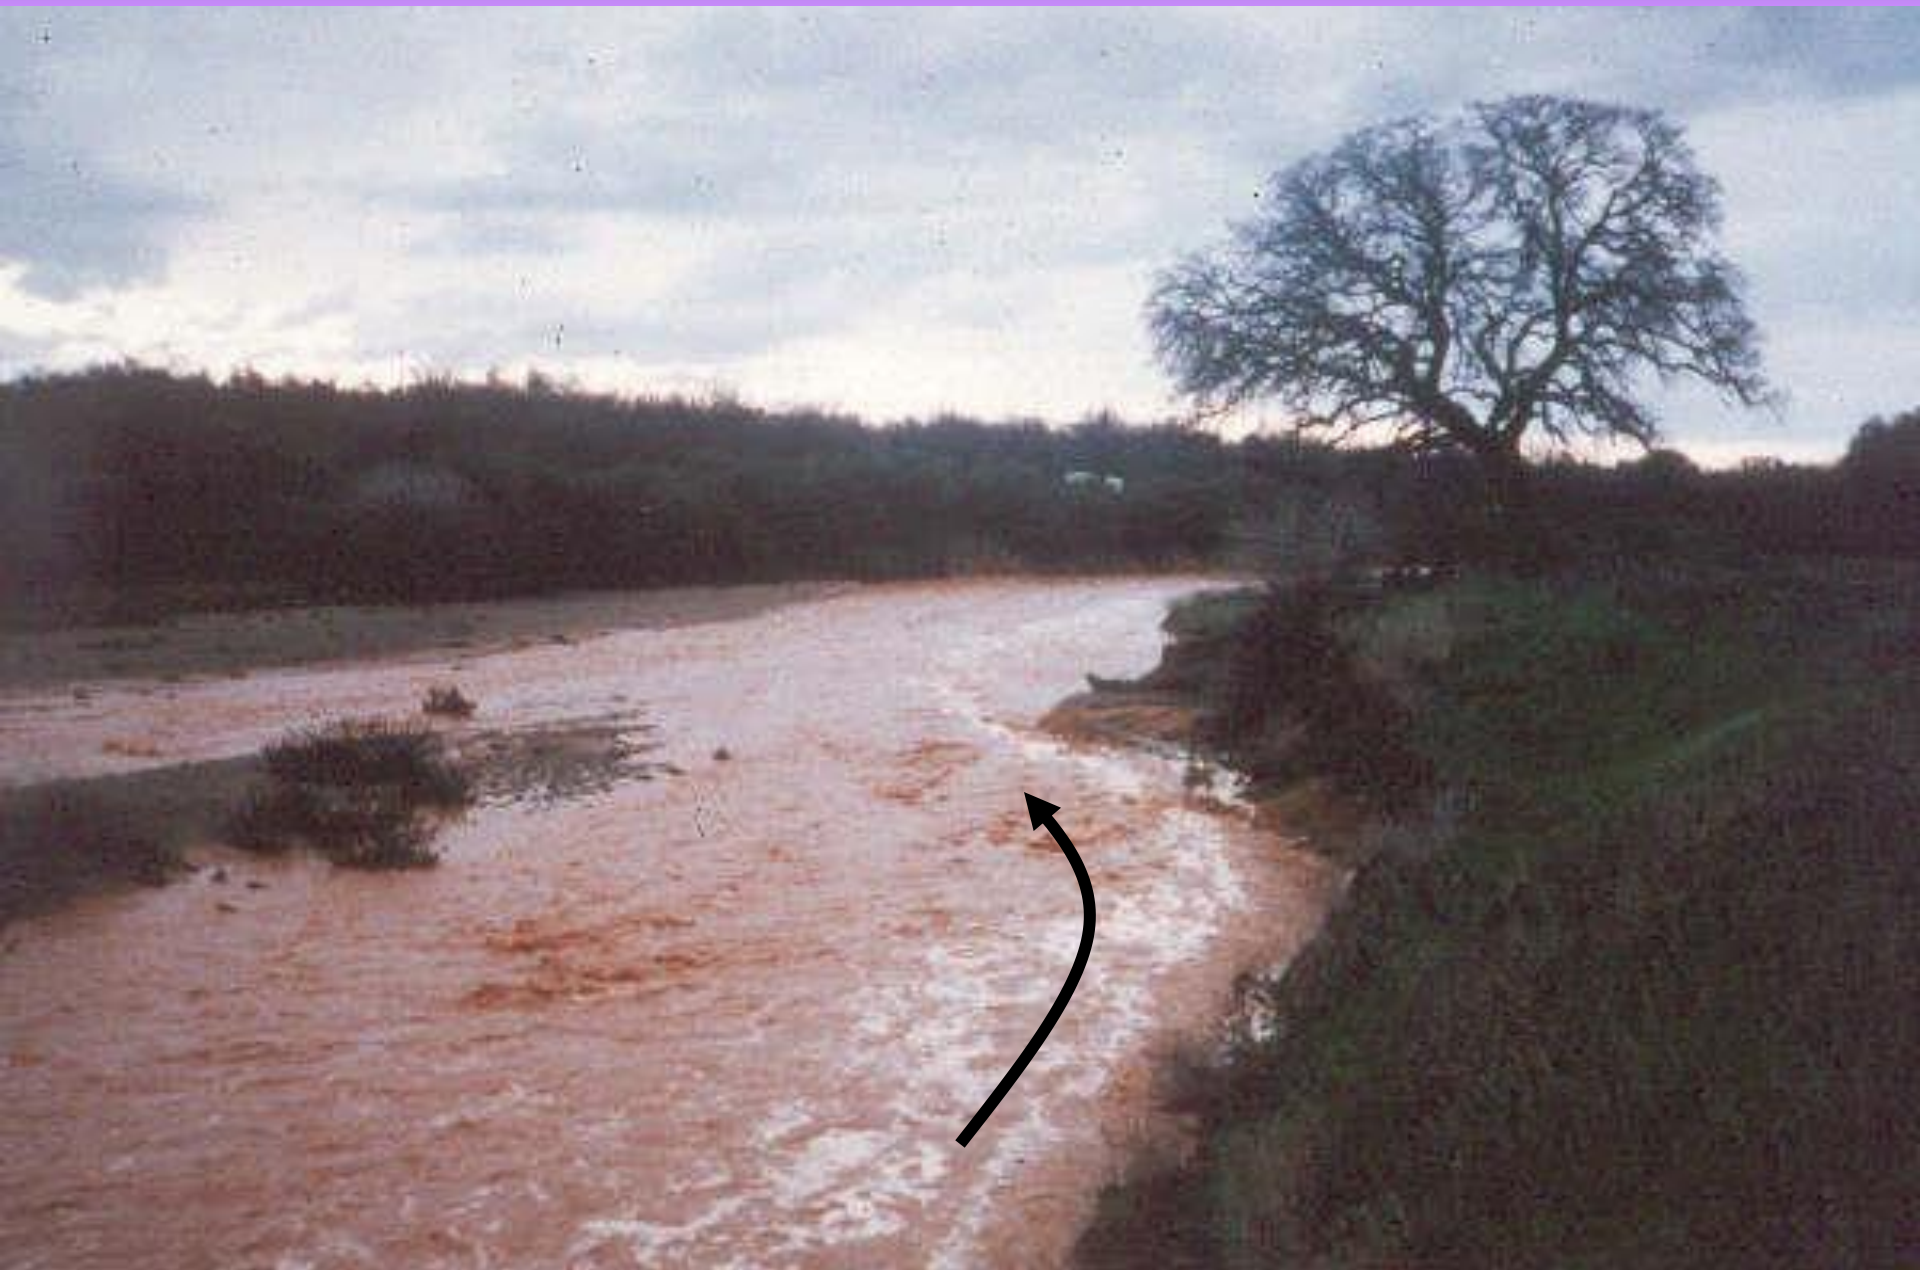
Pre-Project conditions, high water, looking DS @ project area.

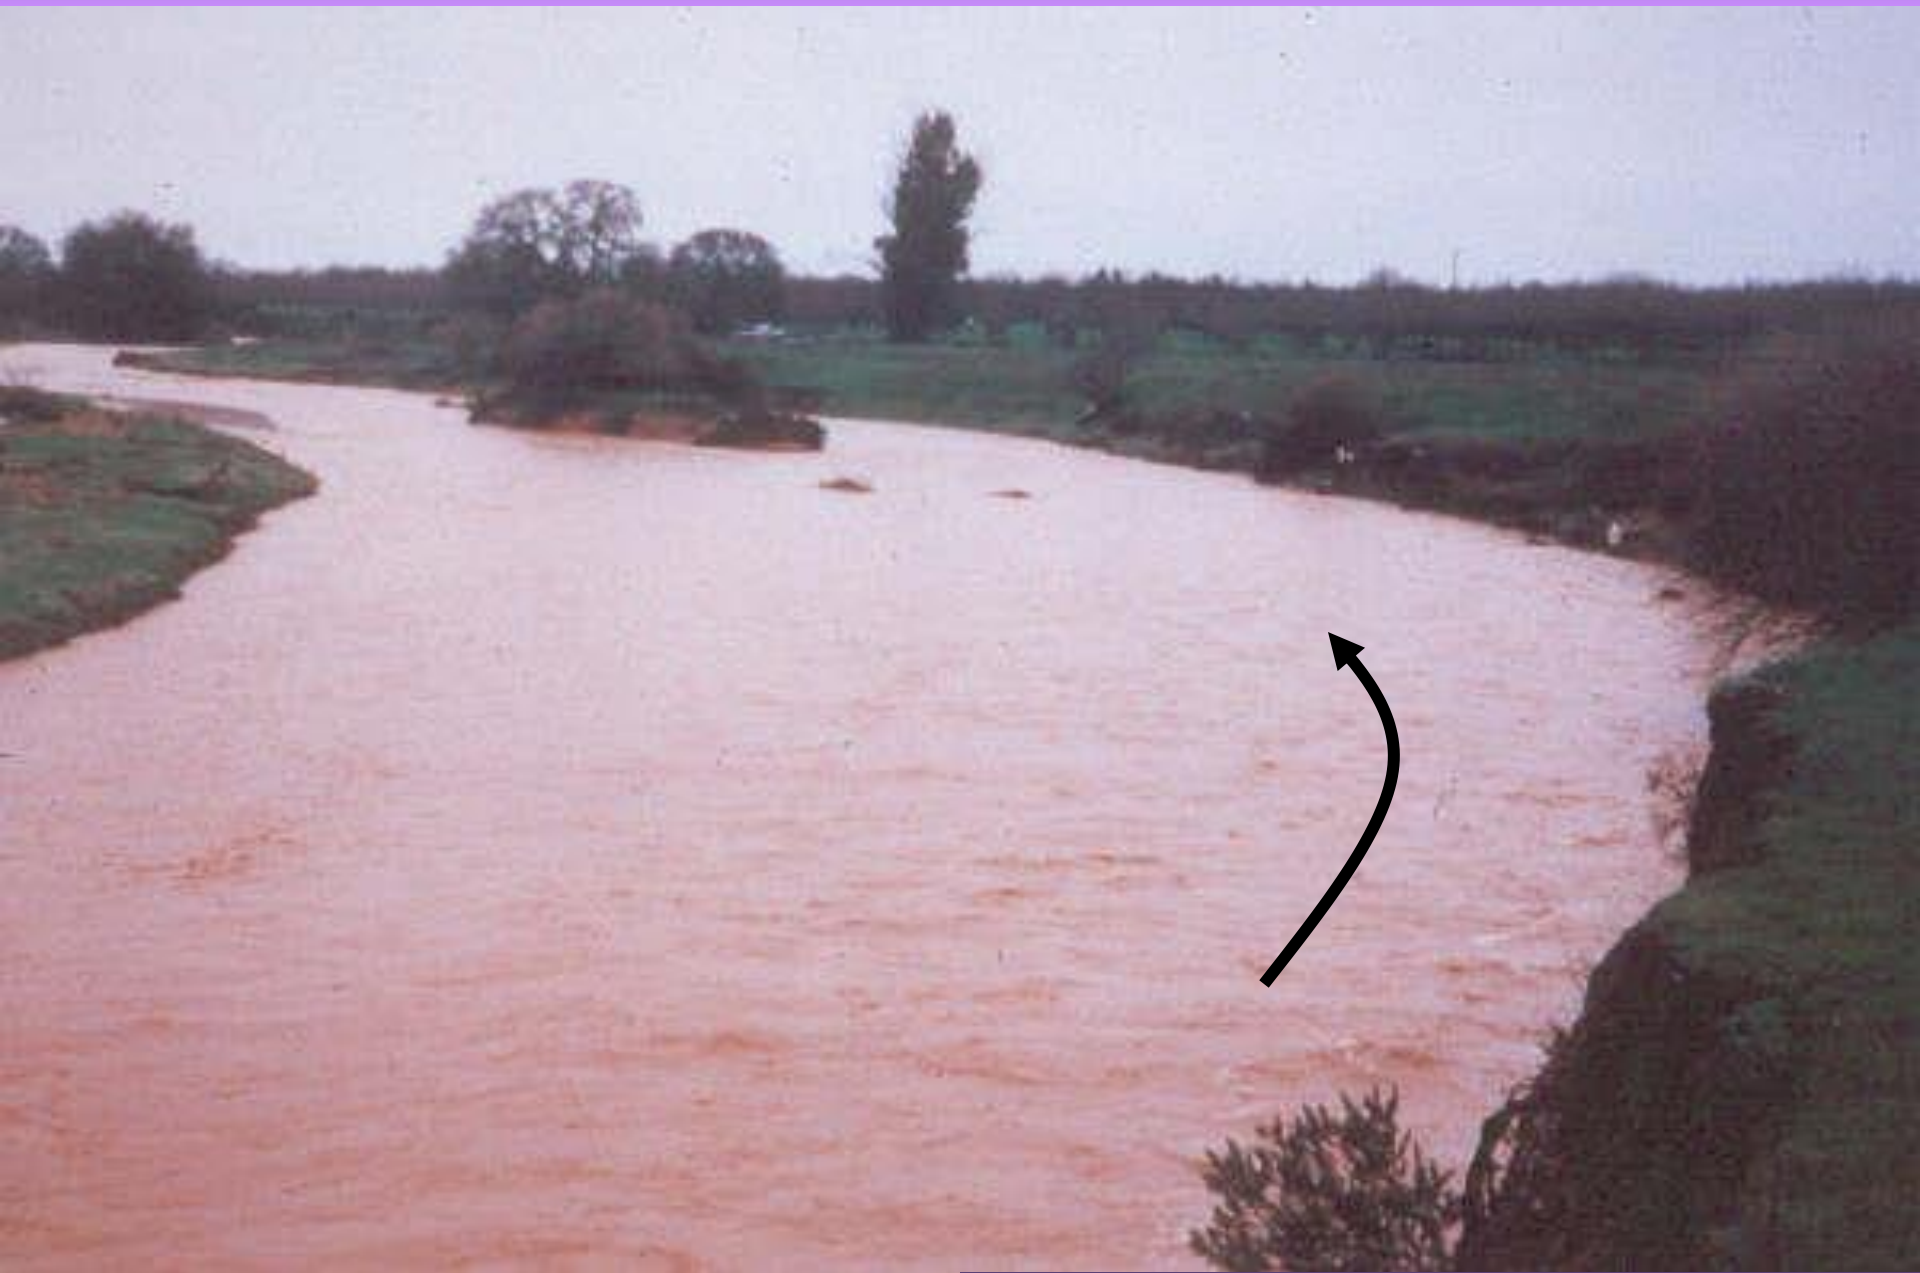
Pre-Project conditions-High water, looking DS @ project area.

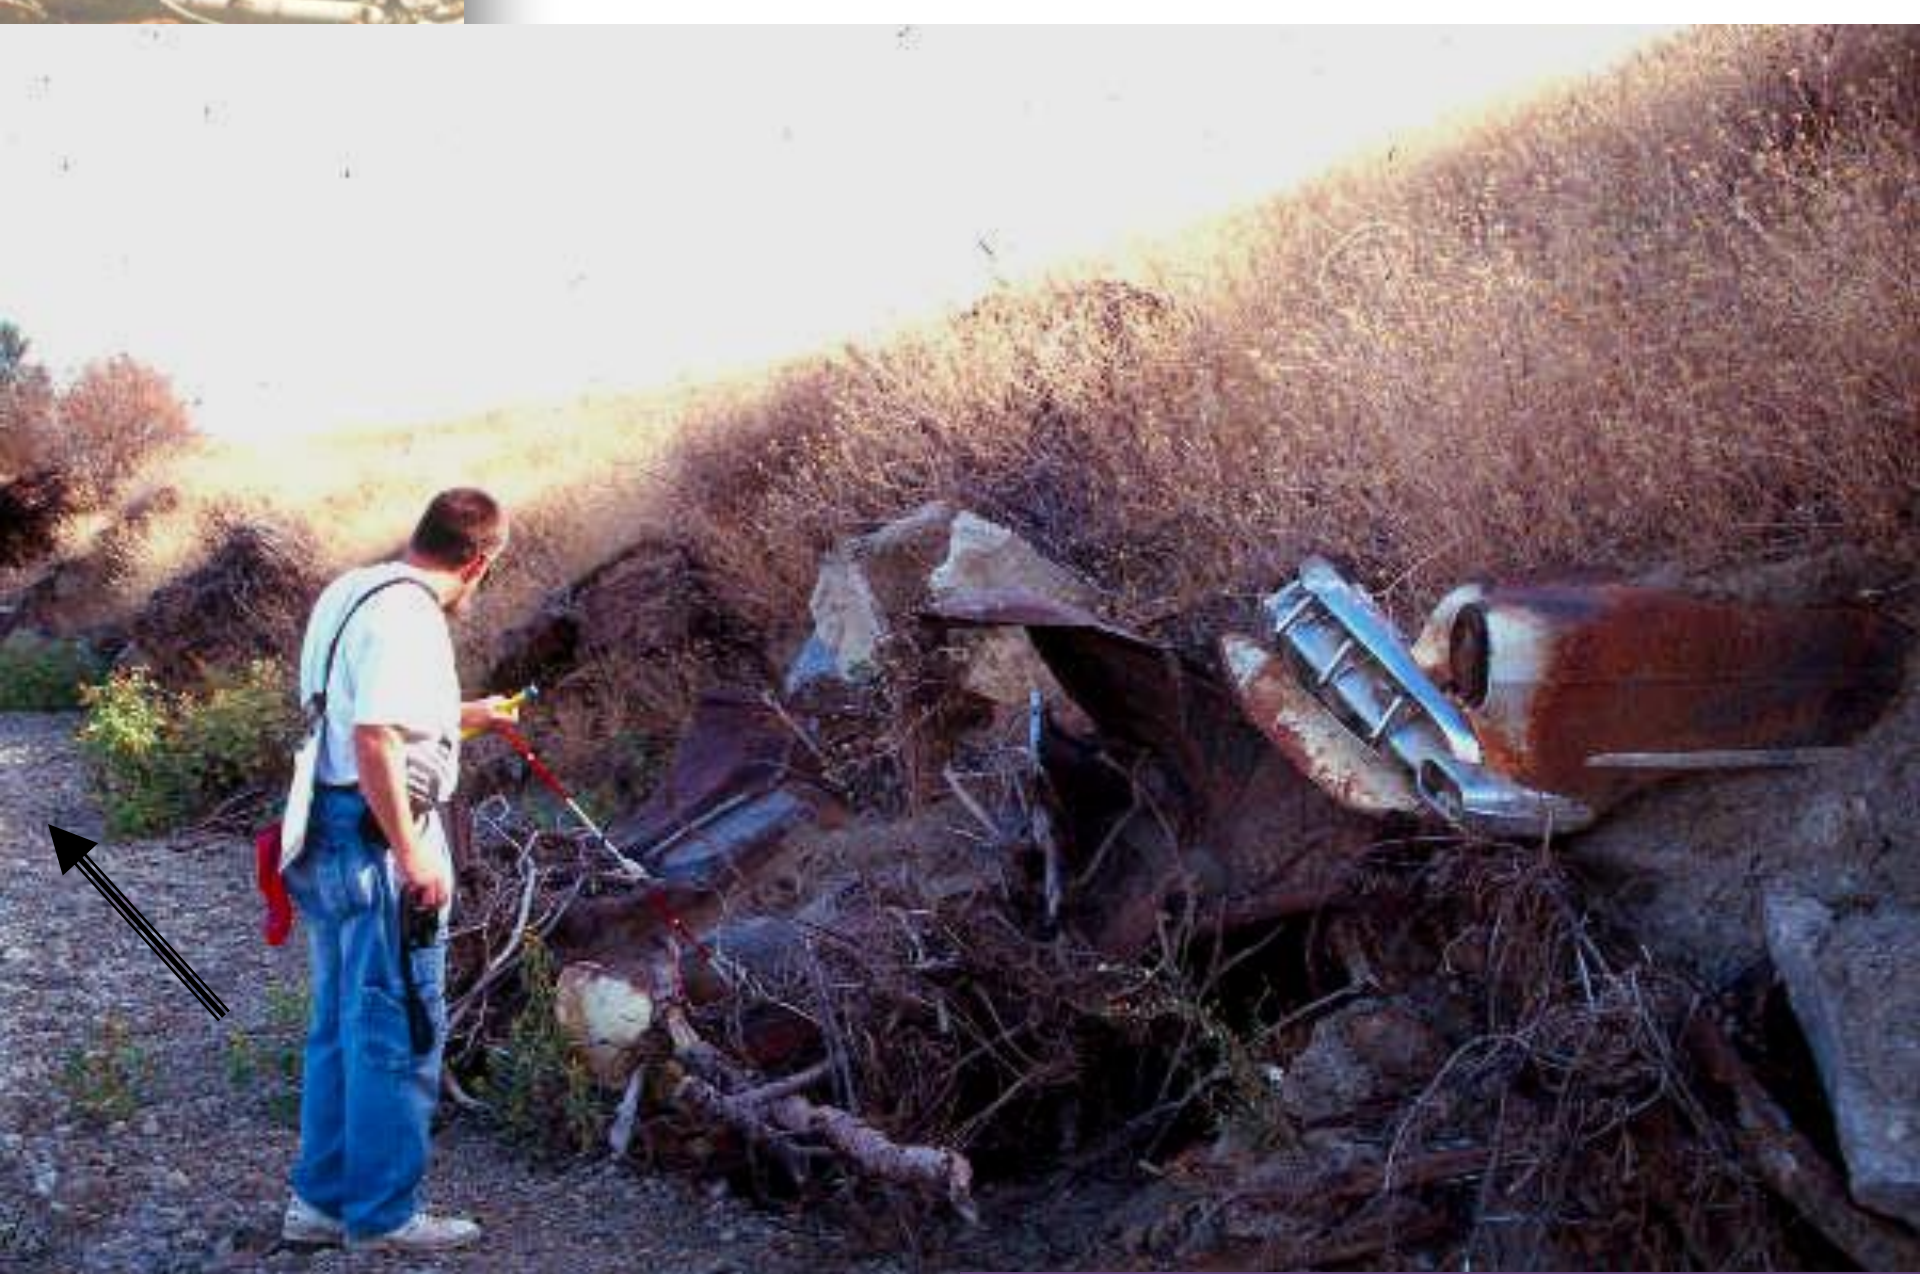
Pre-Project conditions-Looking DS @ exposed burn dump material.

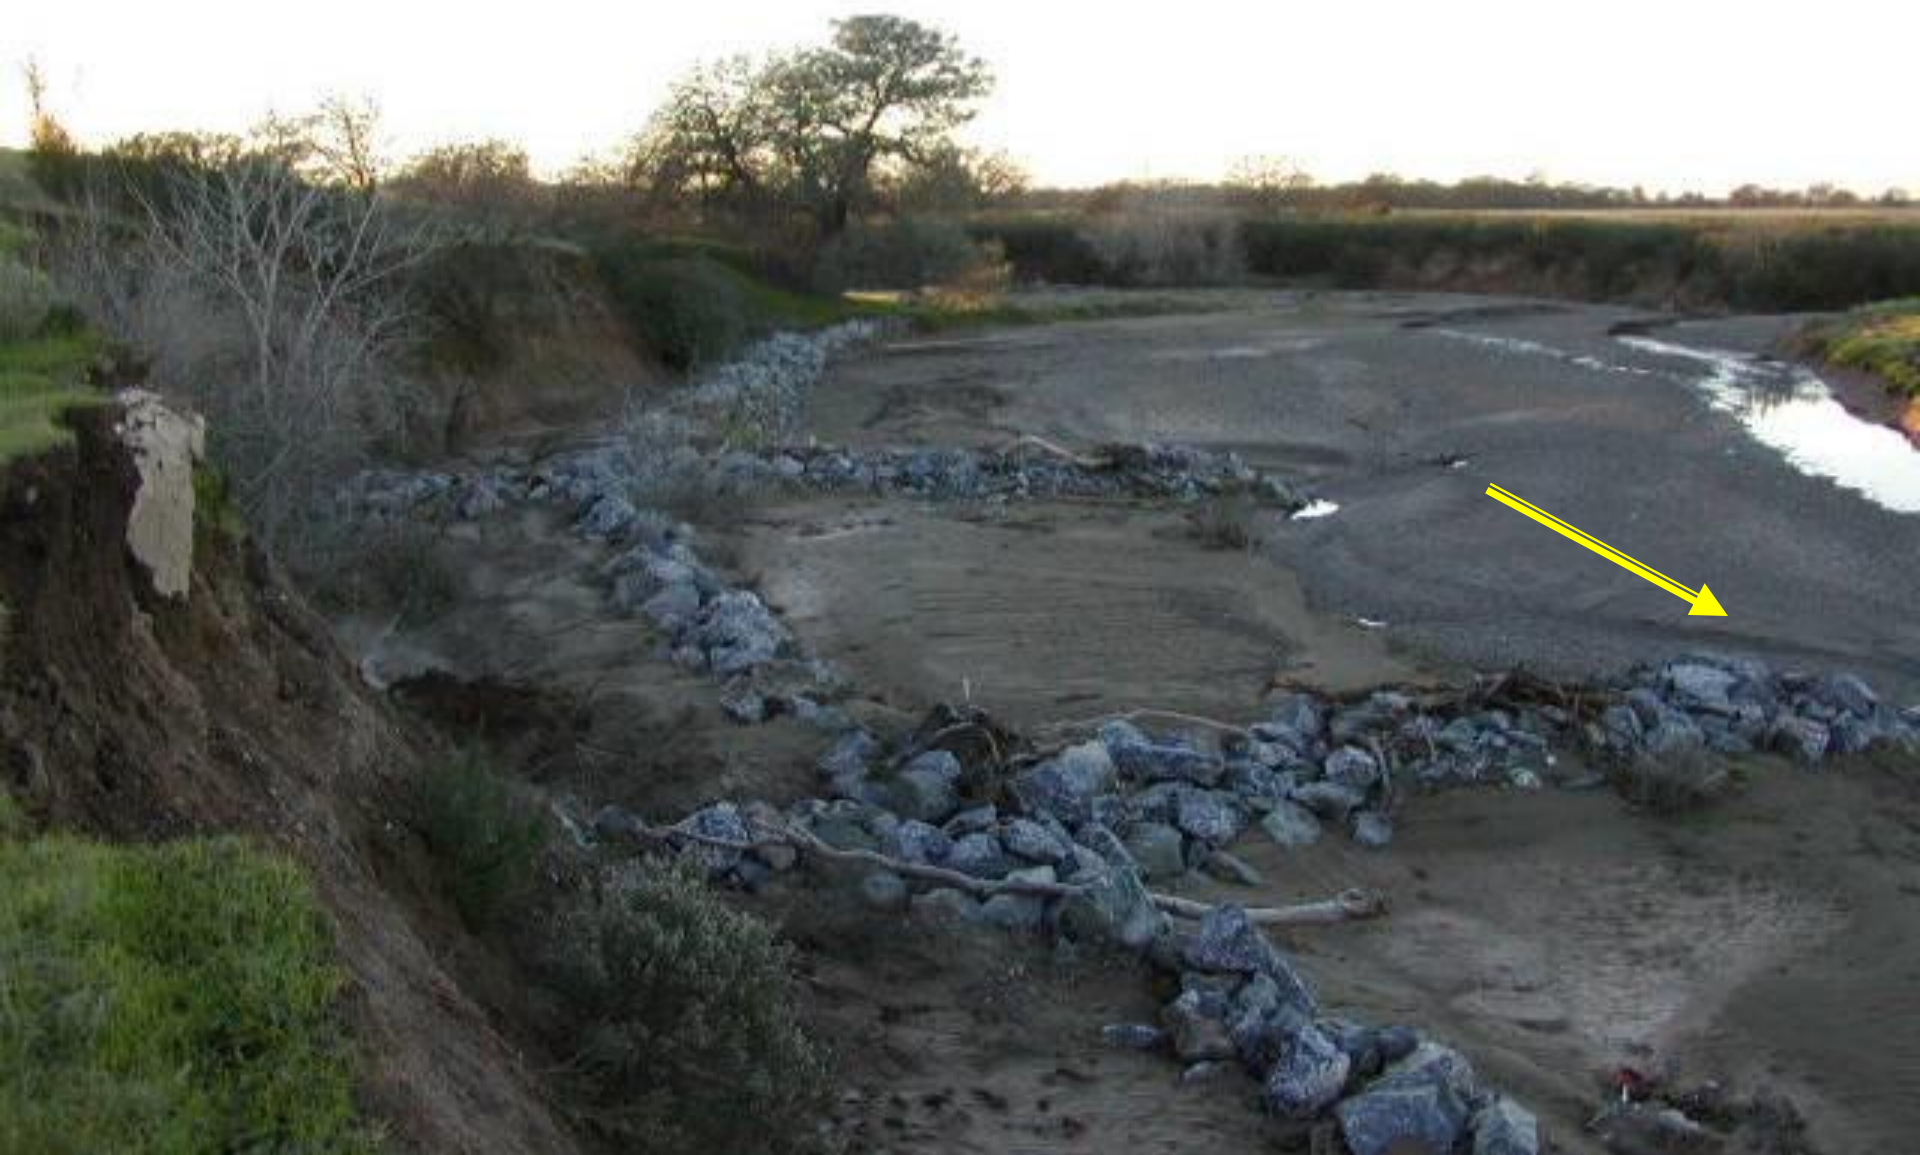
3+ Years later-Looking US @ confluence near US end of project.

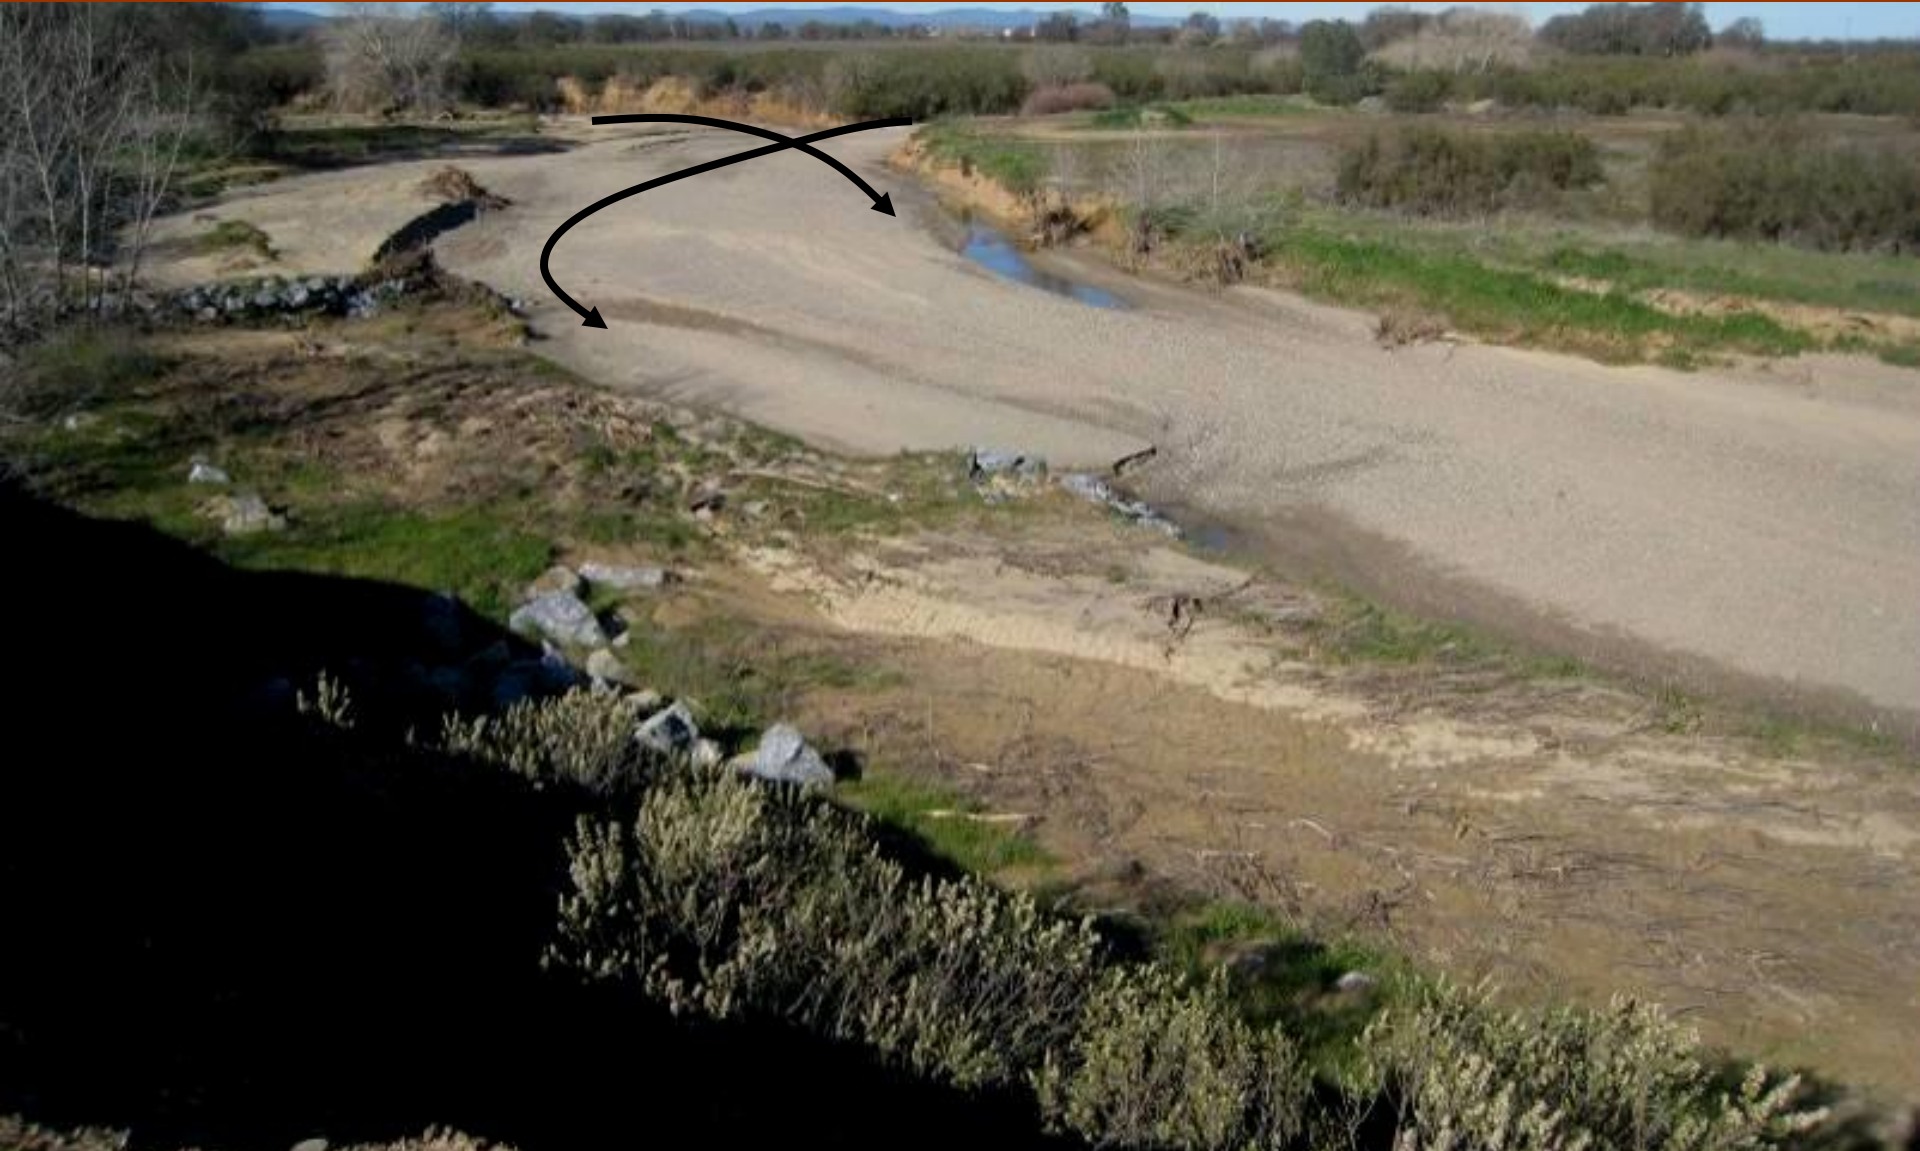
9+ Years Later-Looking US @ confluence of two creeks coming into the project

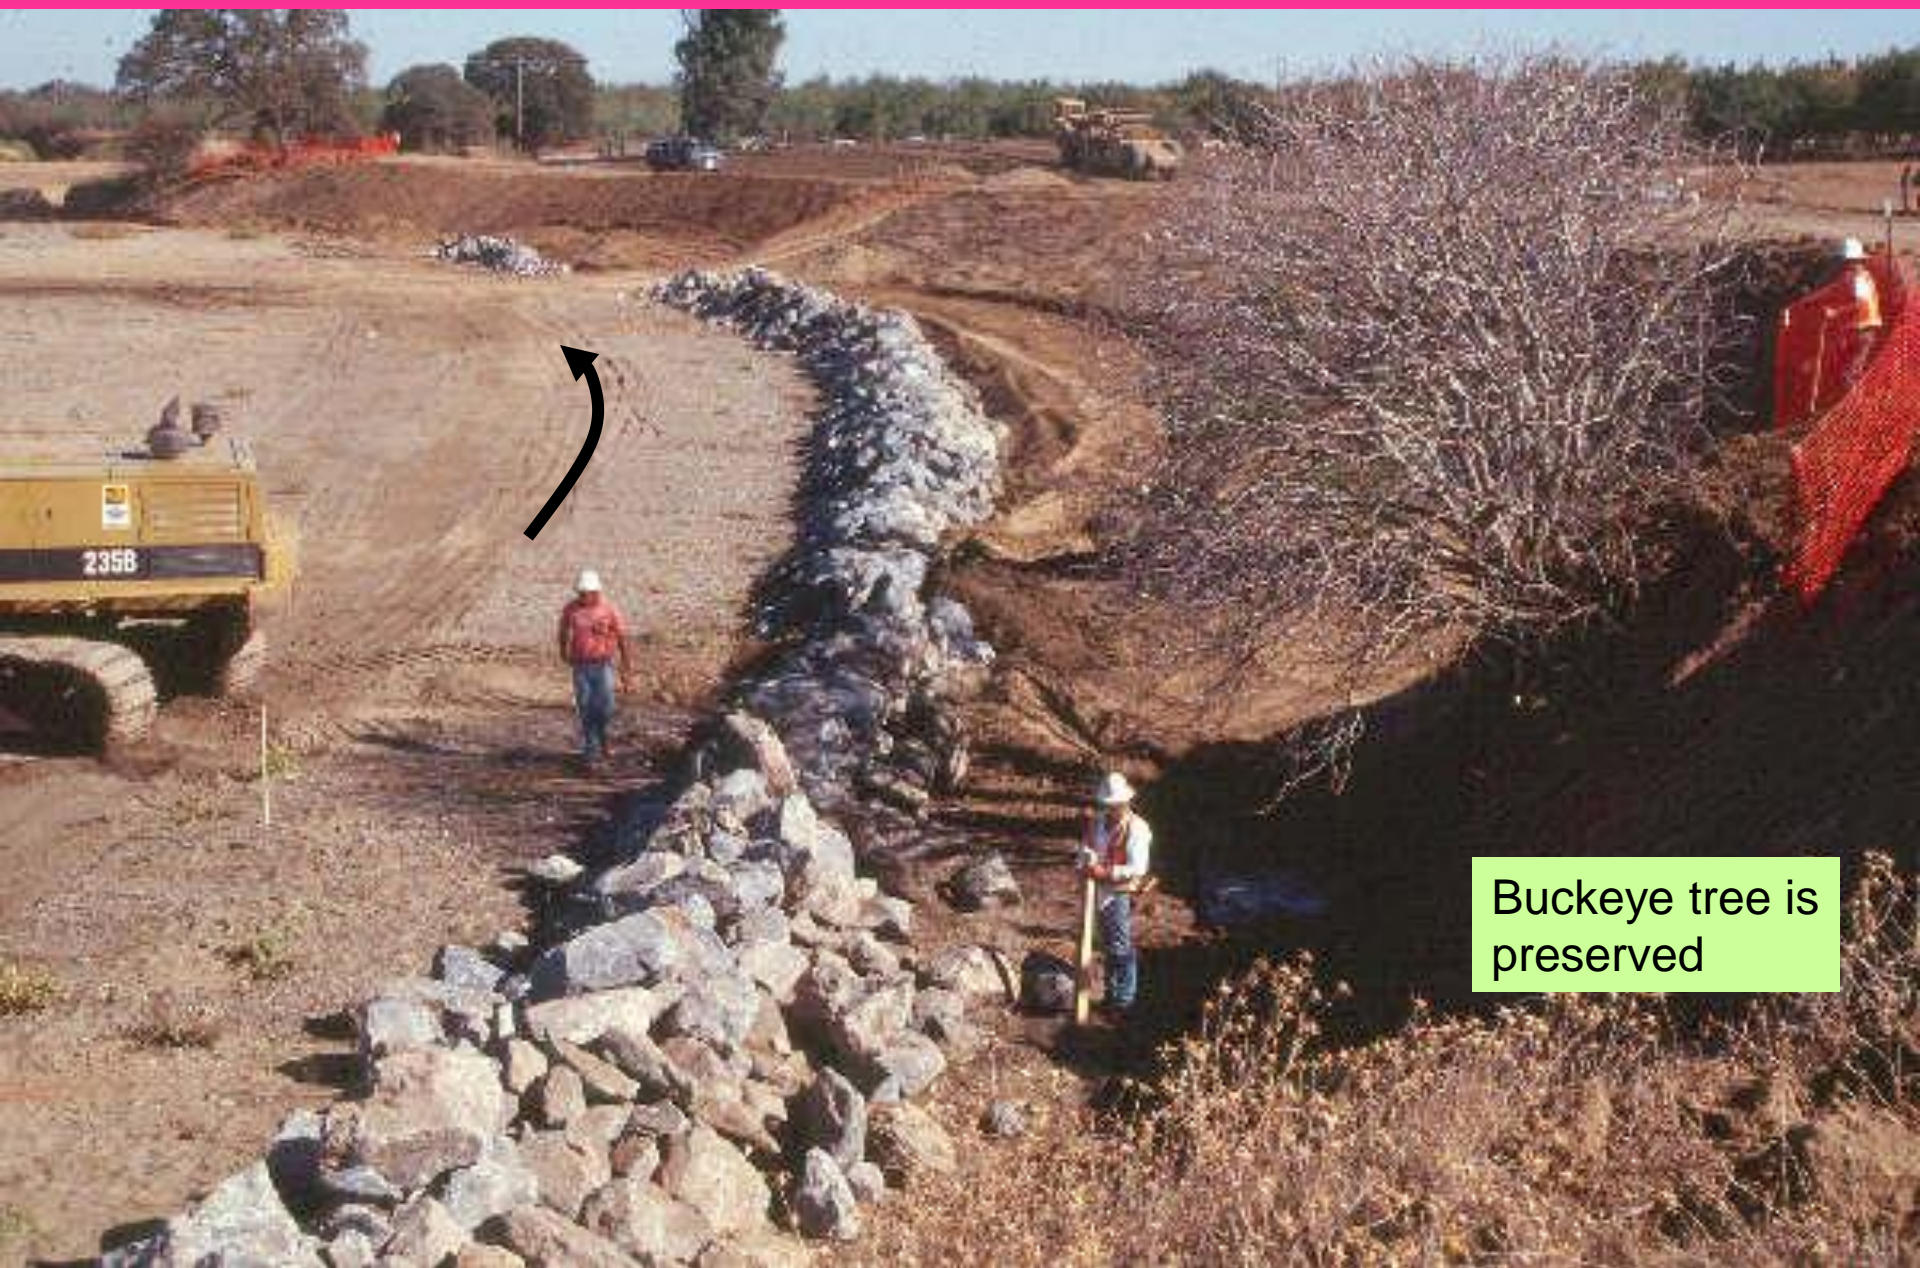
DURING CONSTRUCTION-Looking DS @ LPSTP.

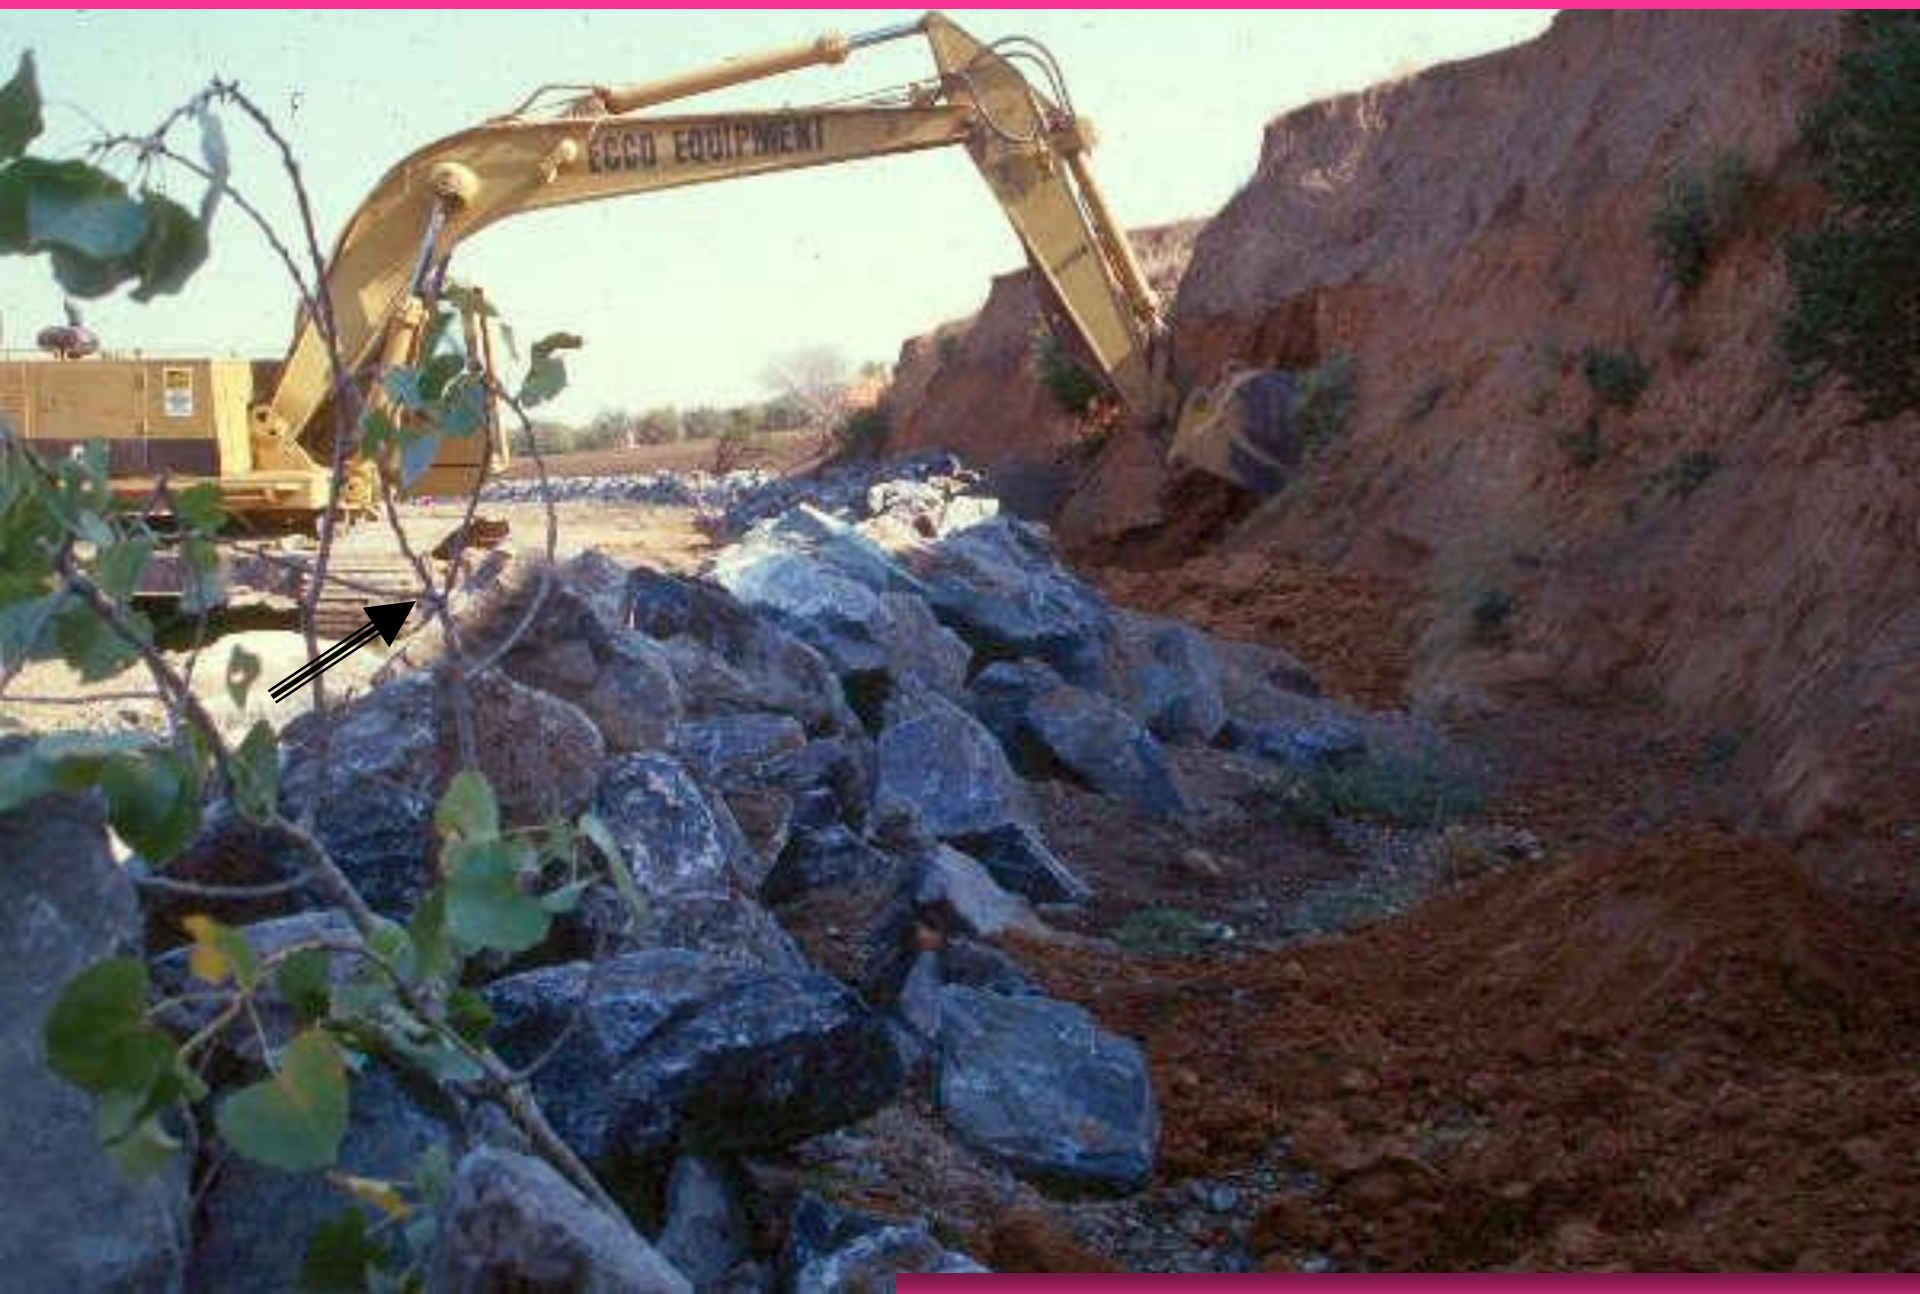
DURING CONSTRUCTION-Digging a key trench.
