Sulphur Creek @ Dunnigan Burn Dump,

Yolo County, CA.

BUILT 1998

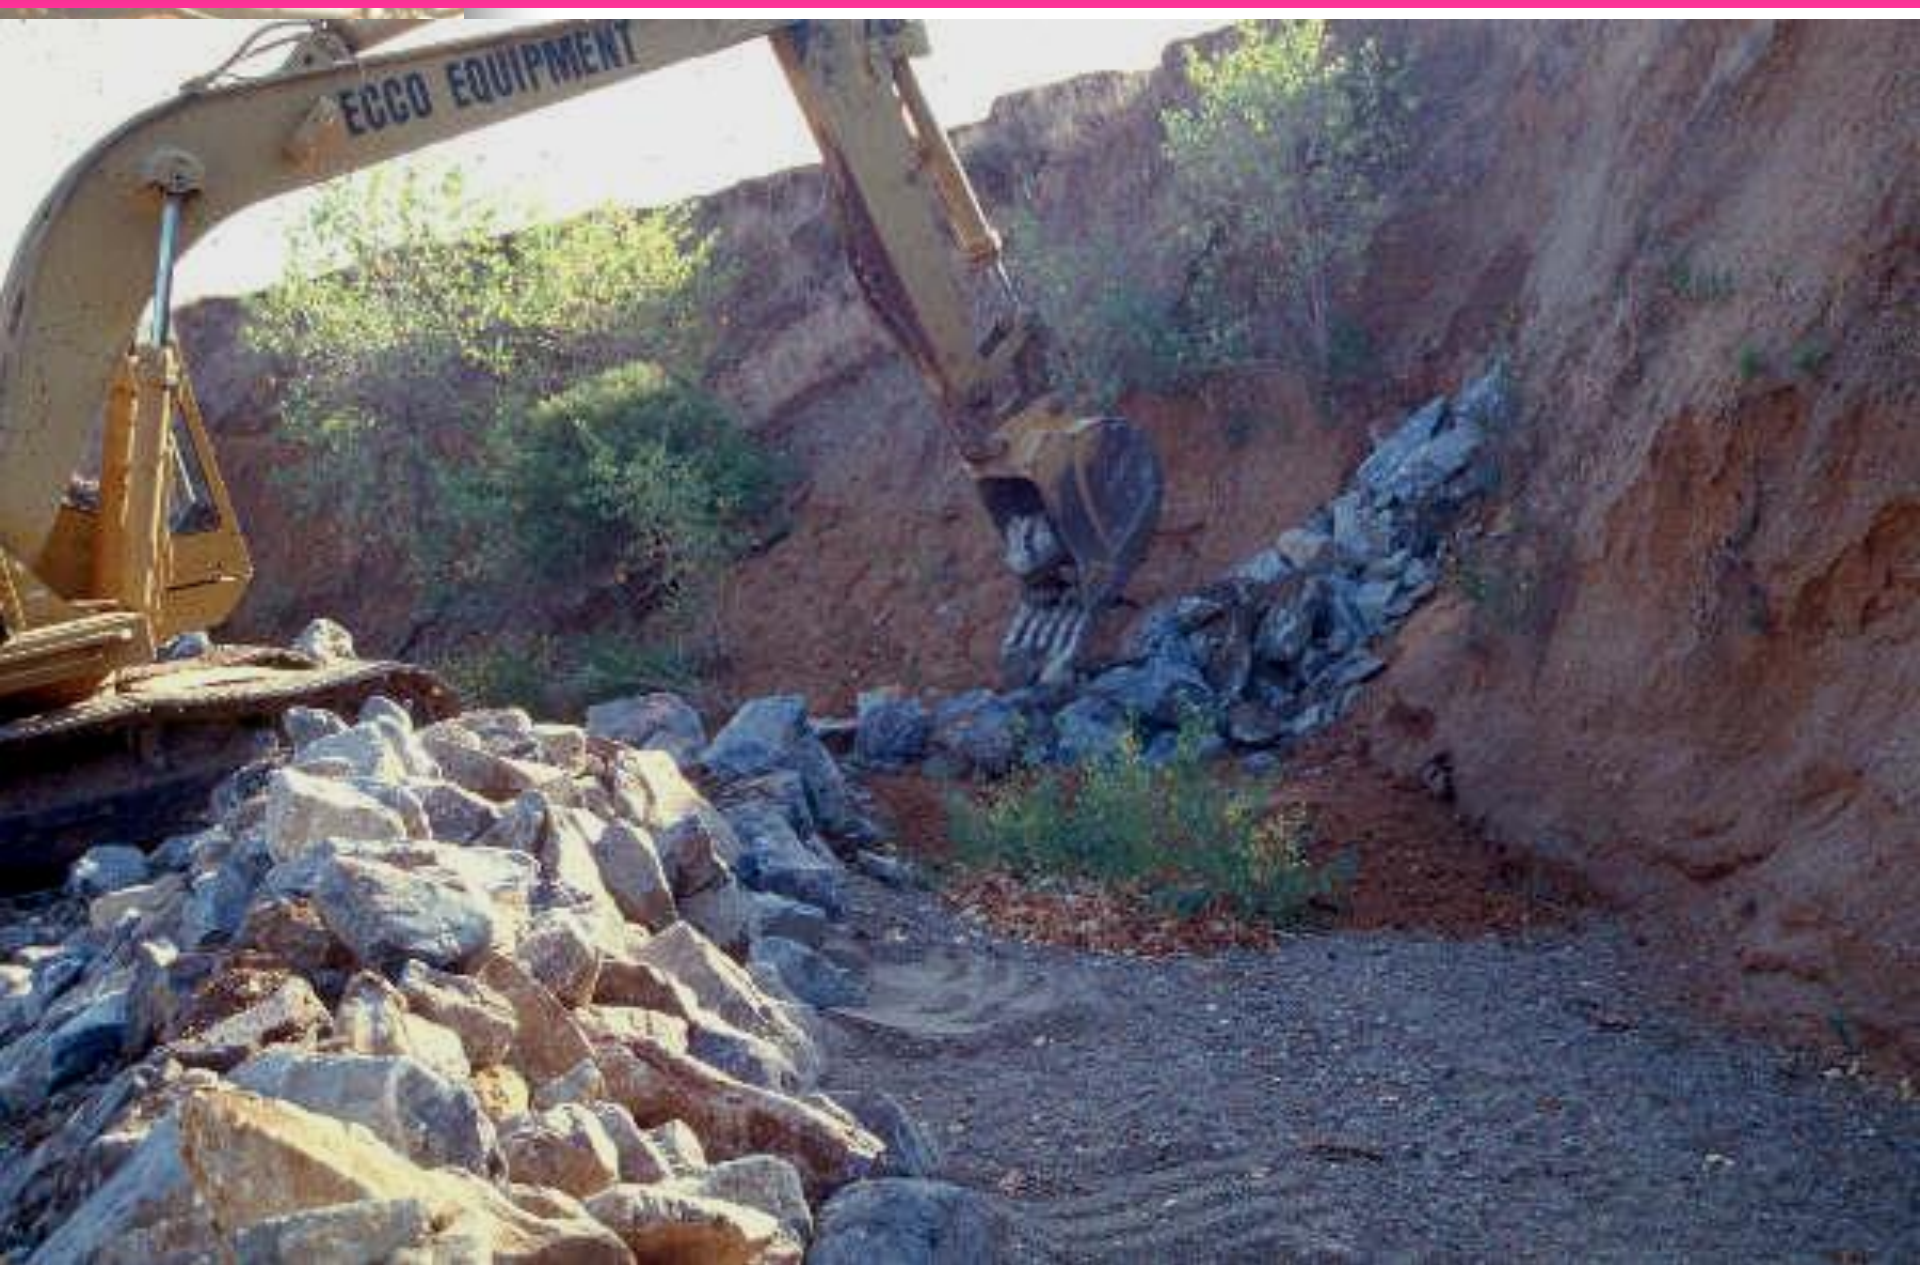
DURING CONSTRUCTION-Placing key stone in key trench.

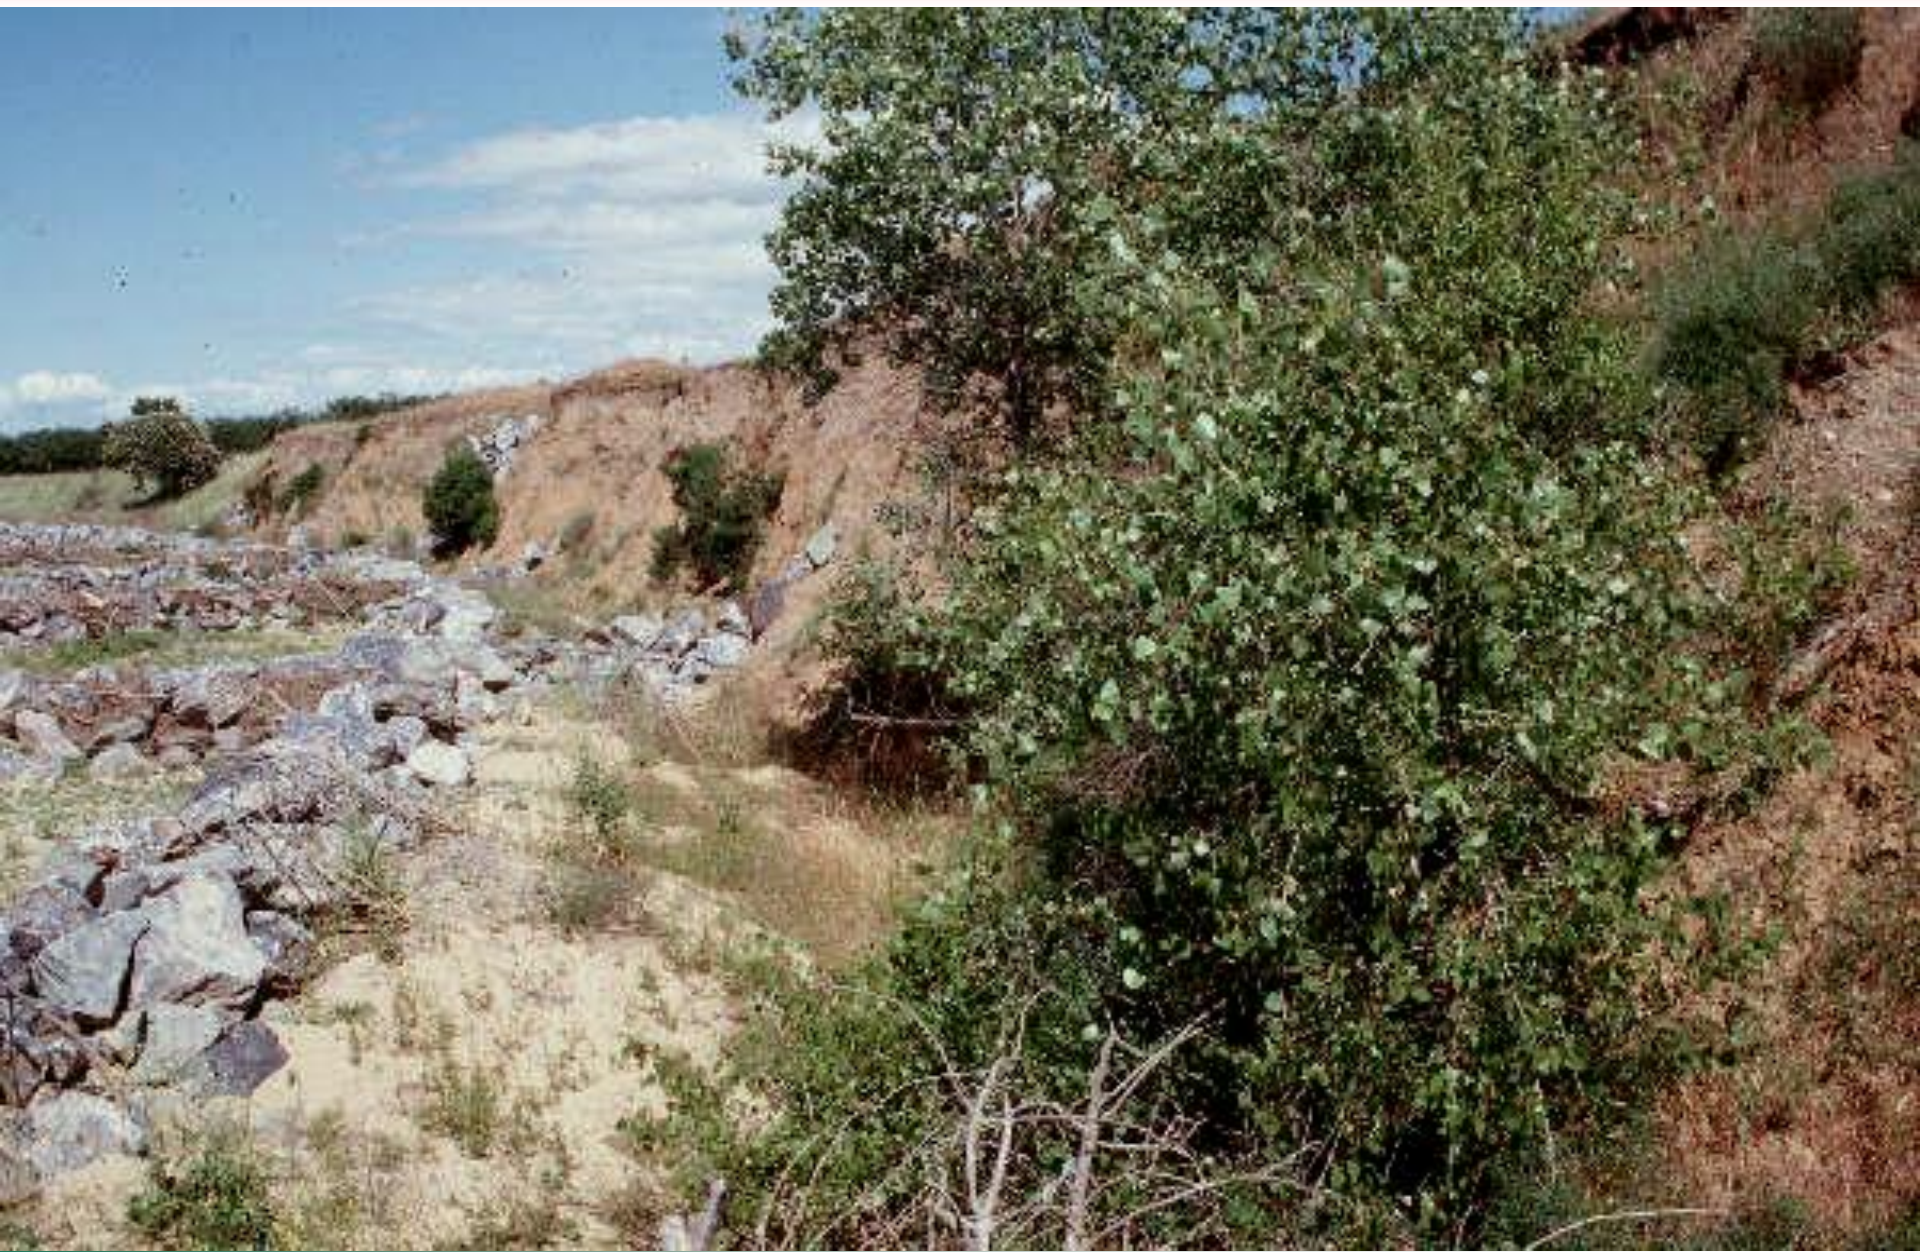
6 months later-Looking DS @ LPSTP with deposition.

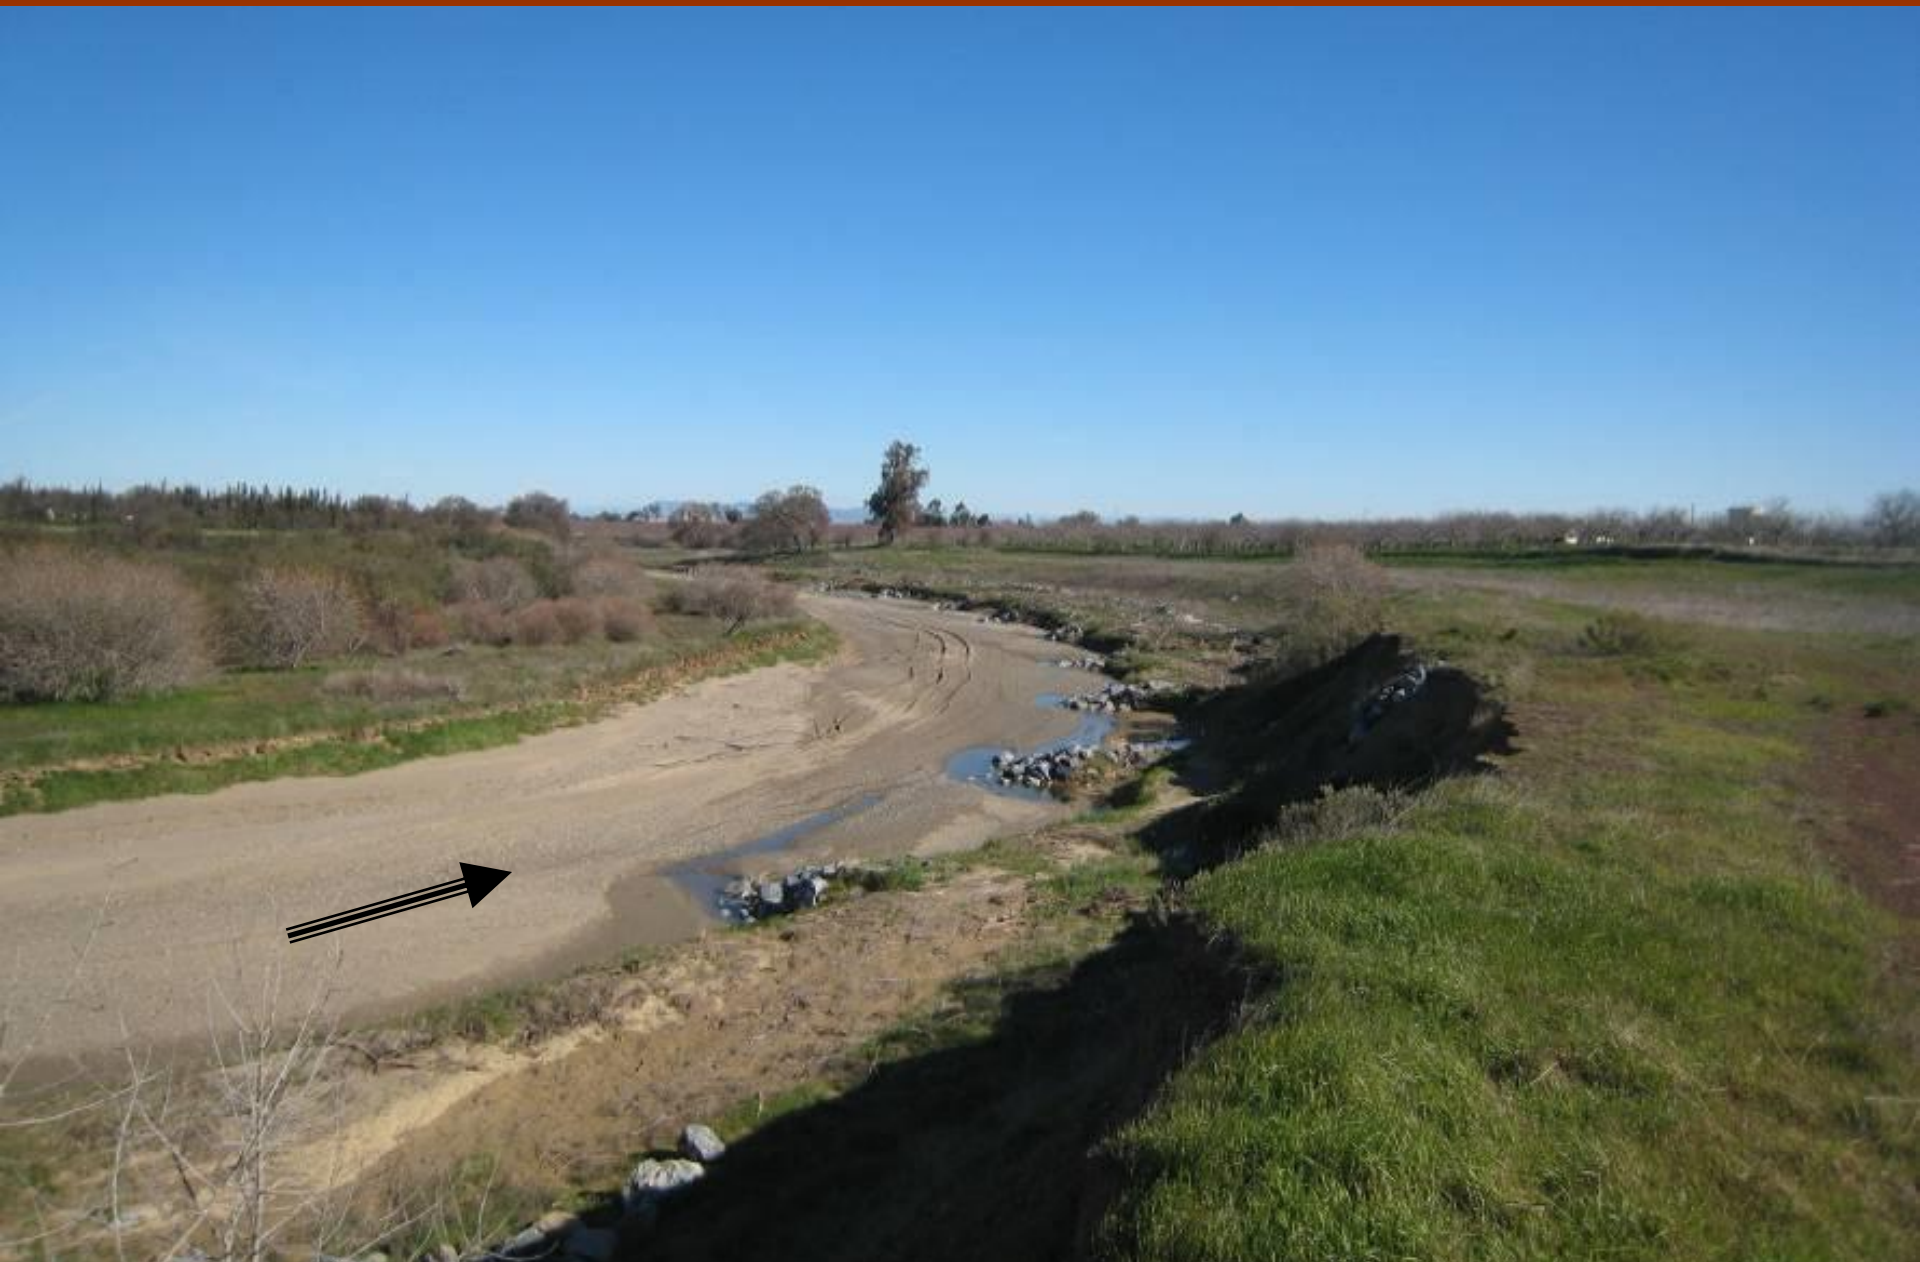
9+ Years Later-Looking DS @ deposition in weir field at cliff area

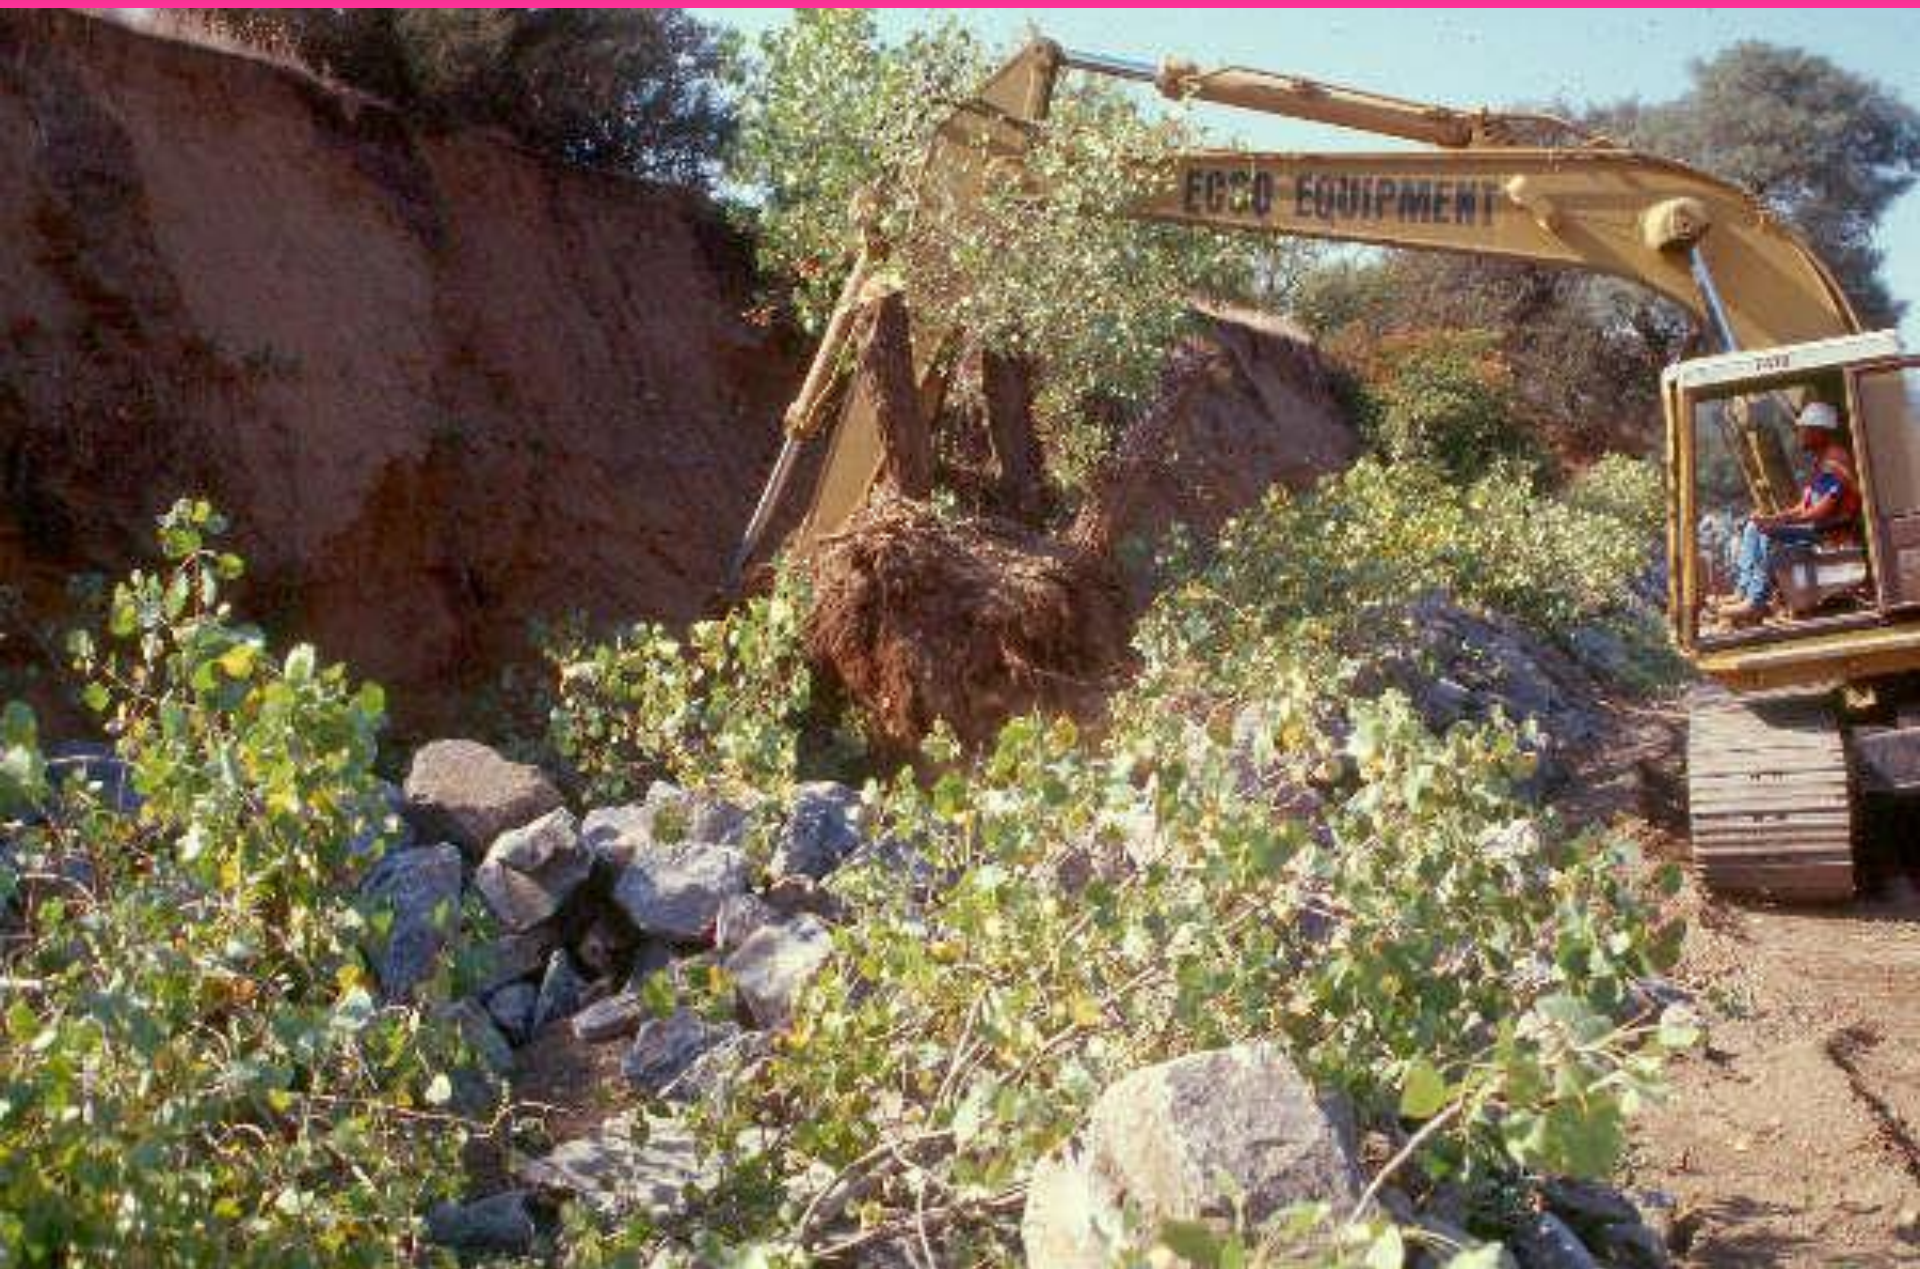
DURING CONSTRUCTION-Transplanting tree behind LPSTP.

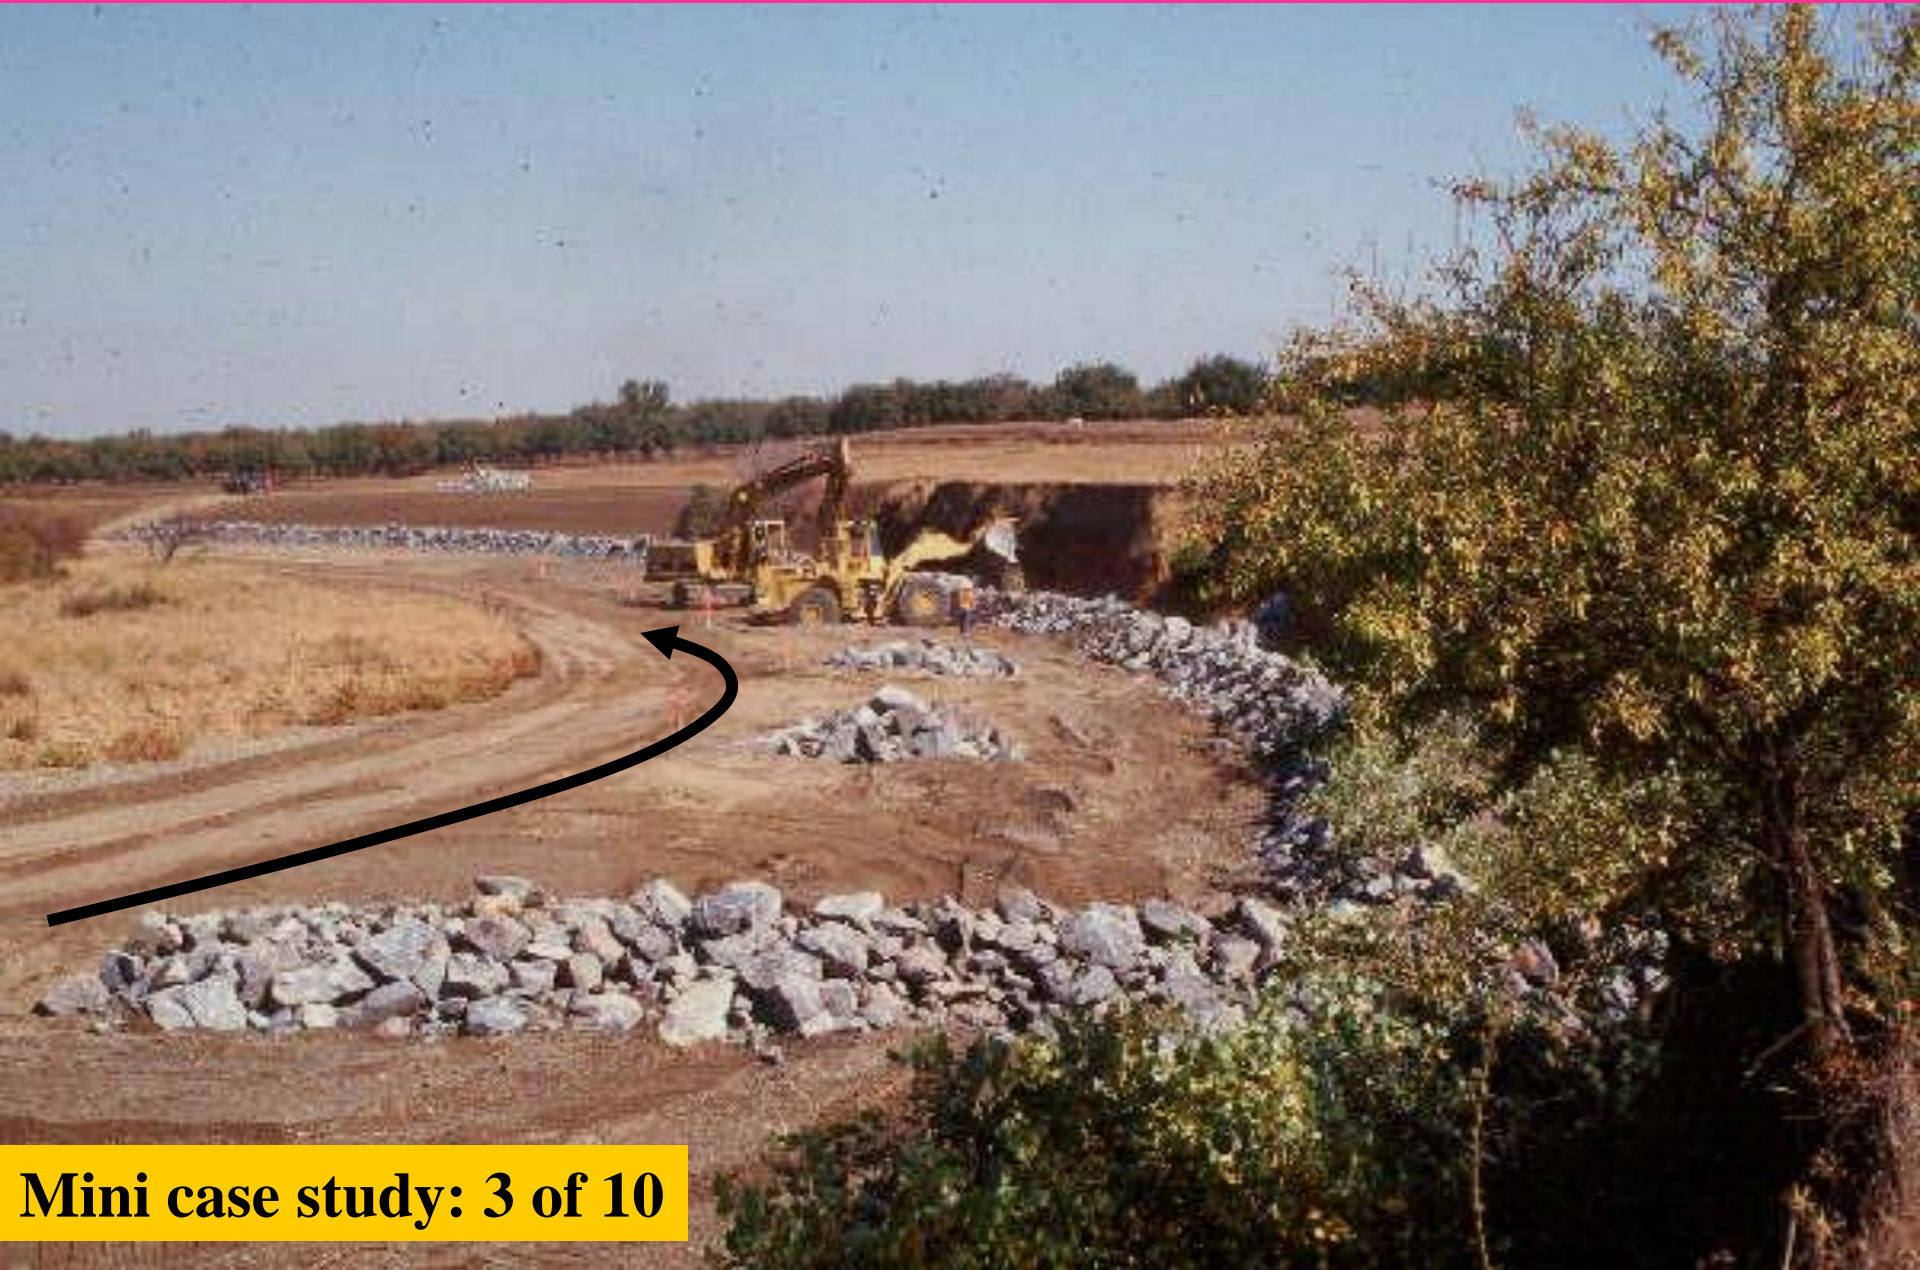
Mini case study: 3 of 10

DURING CONSTRUCTION-Looking DS @ LPSTP & 1 Bendway Weir

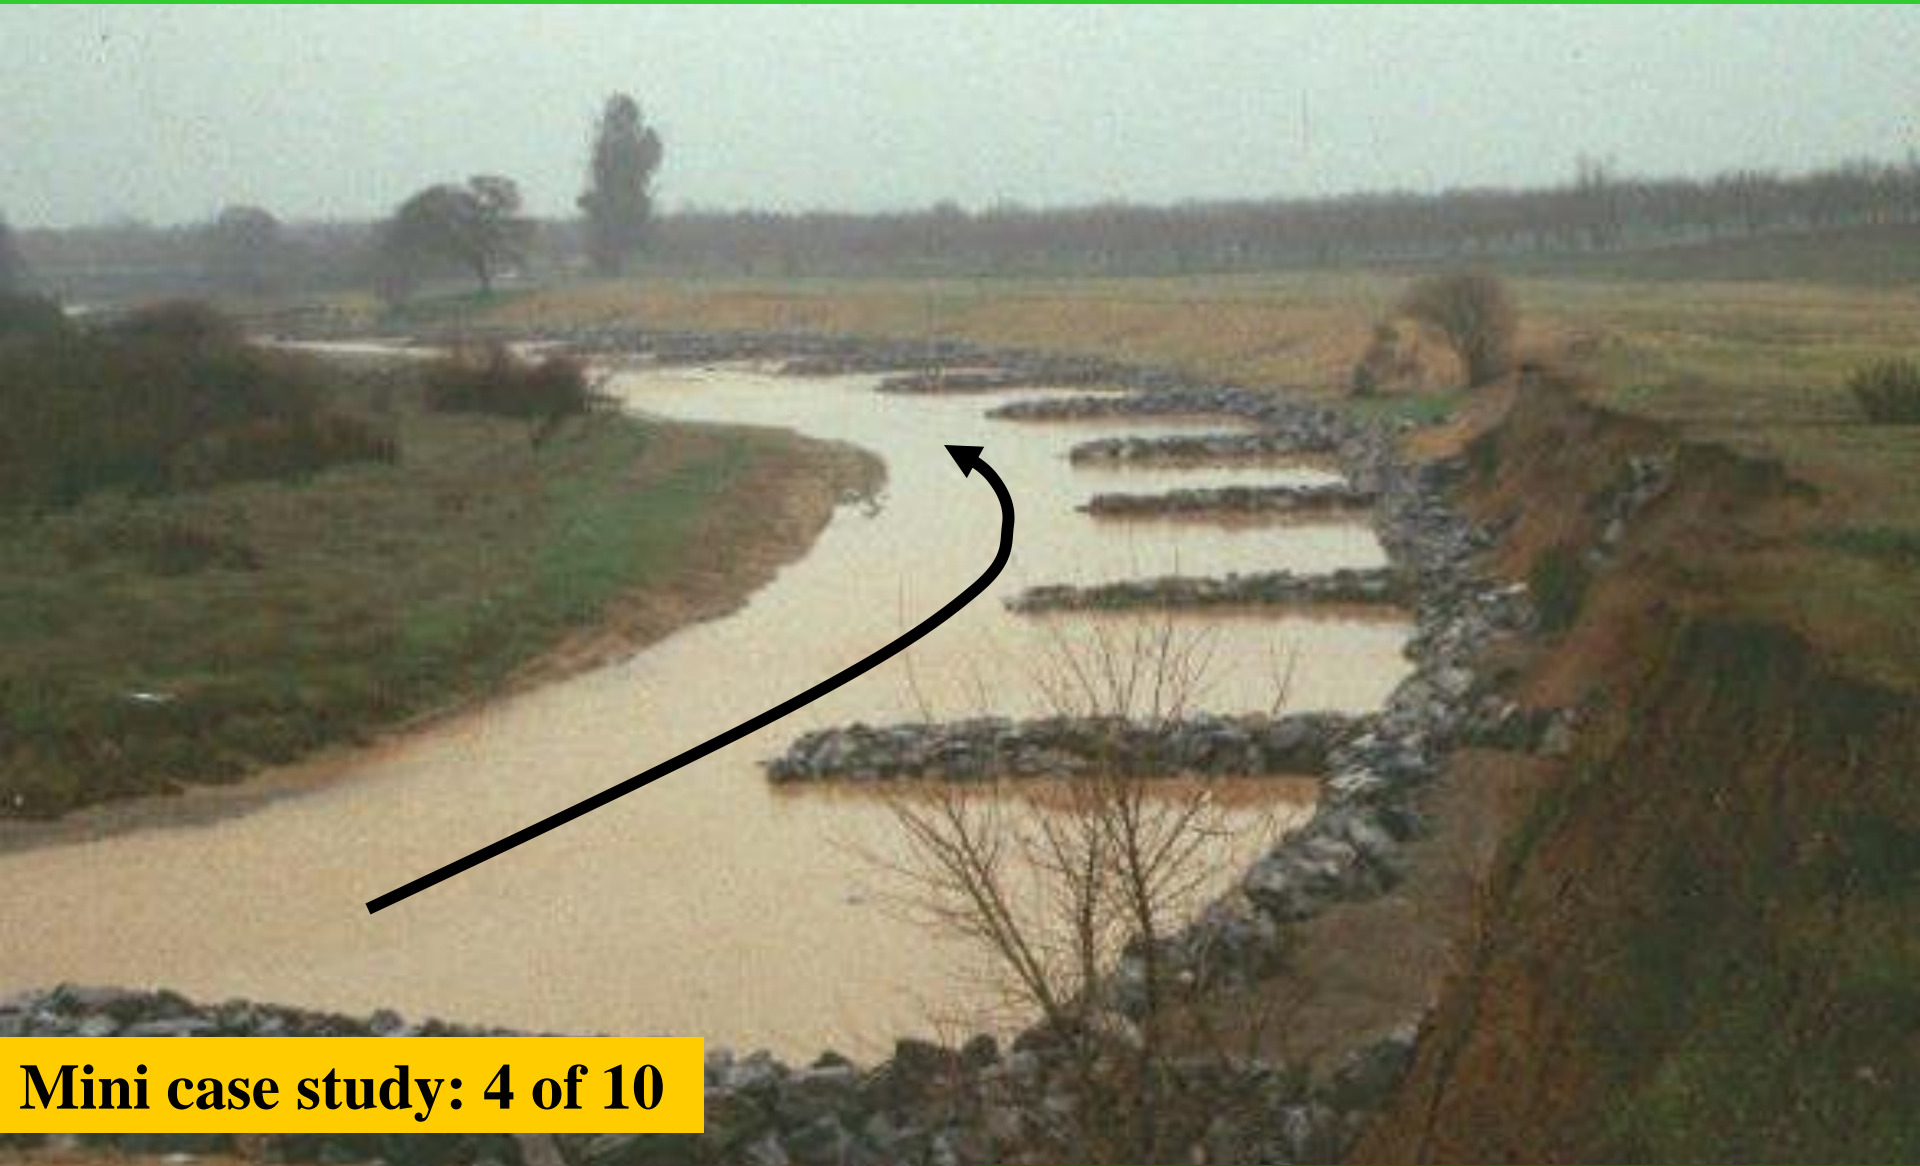
Mini case study: 4 of 10

3 months later-Looking DS @ tall cliff area. The weirs were not overtopped the first winter.

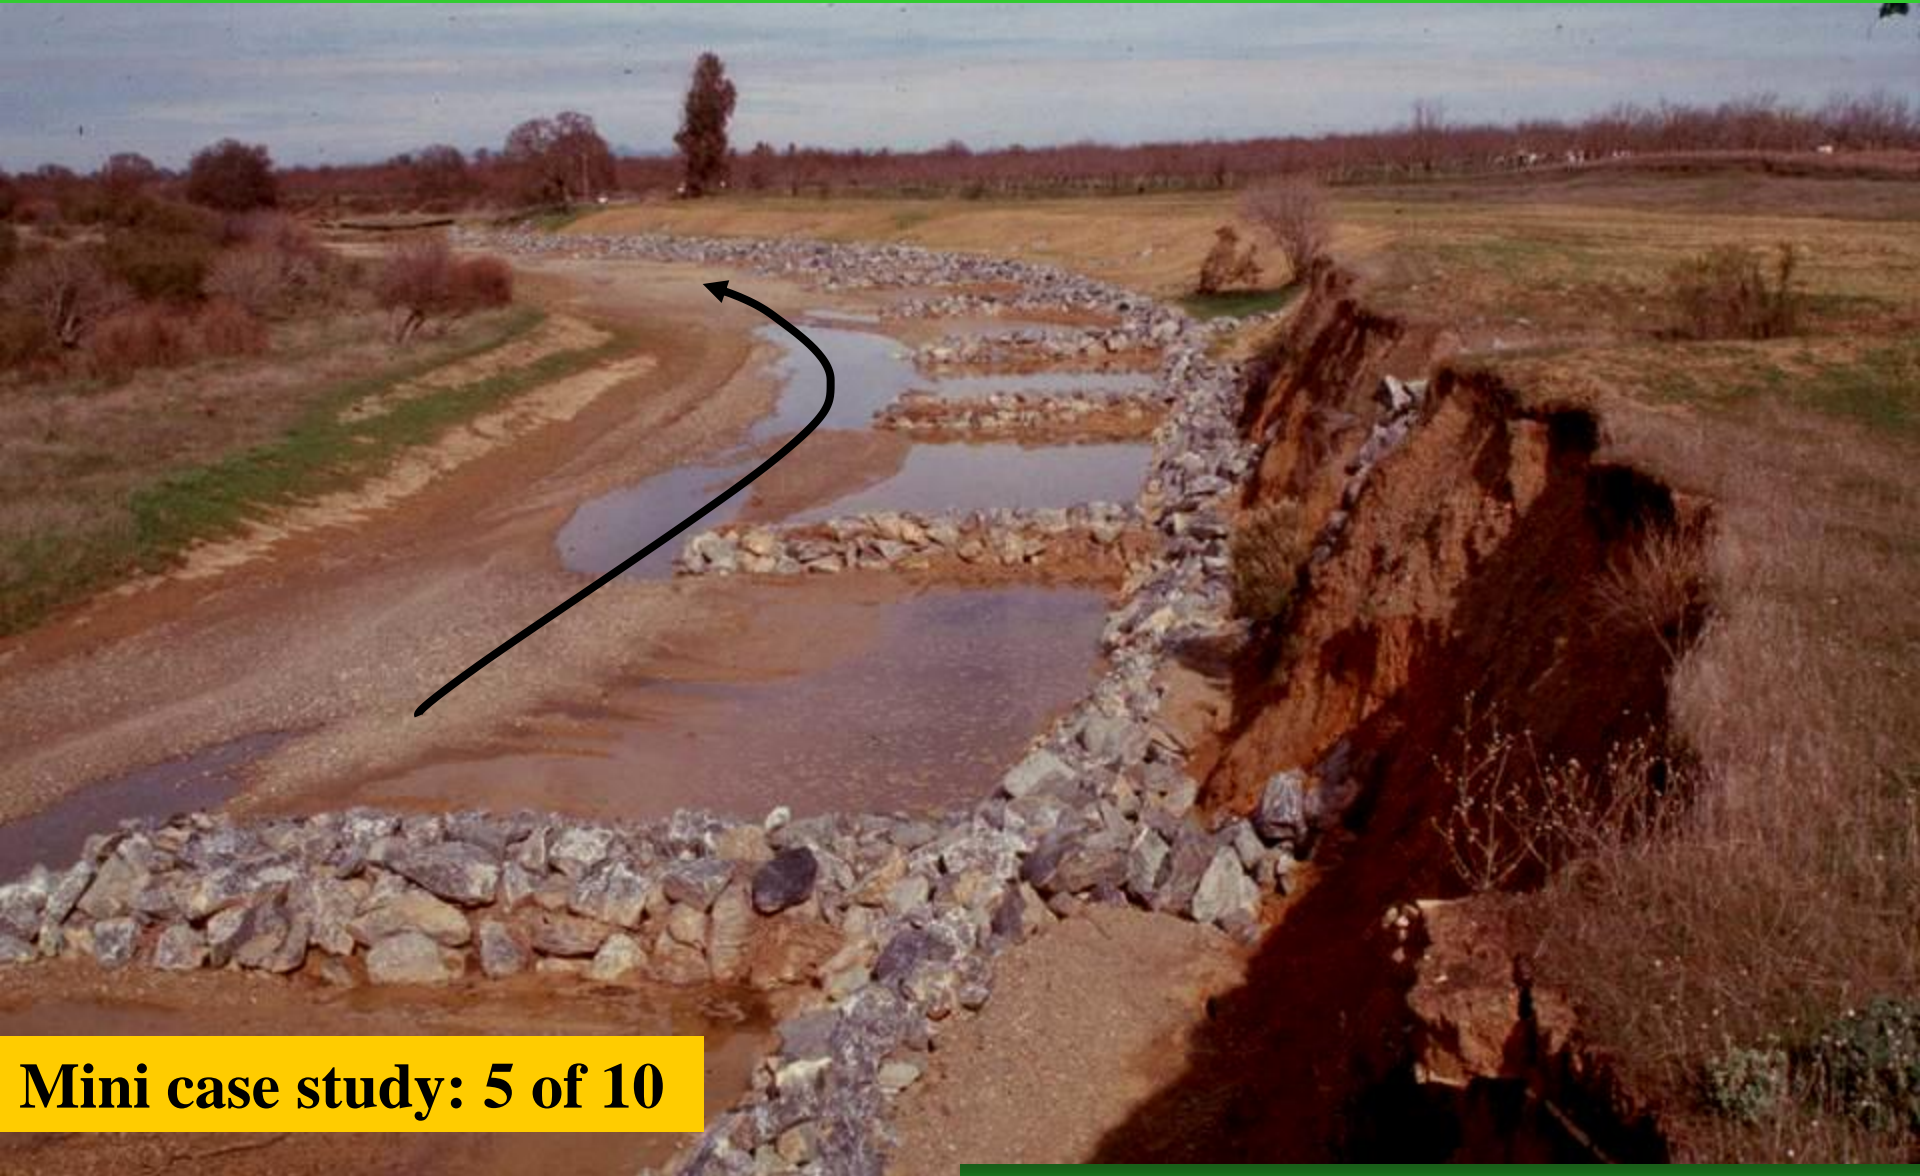
Mini case study: 5 of 10

**3 months later-after the water receded-Looking DS.
Note very little deposition between weirs.**

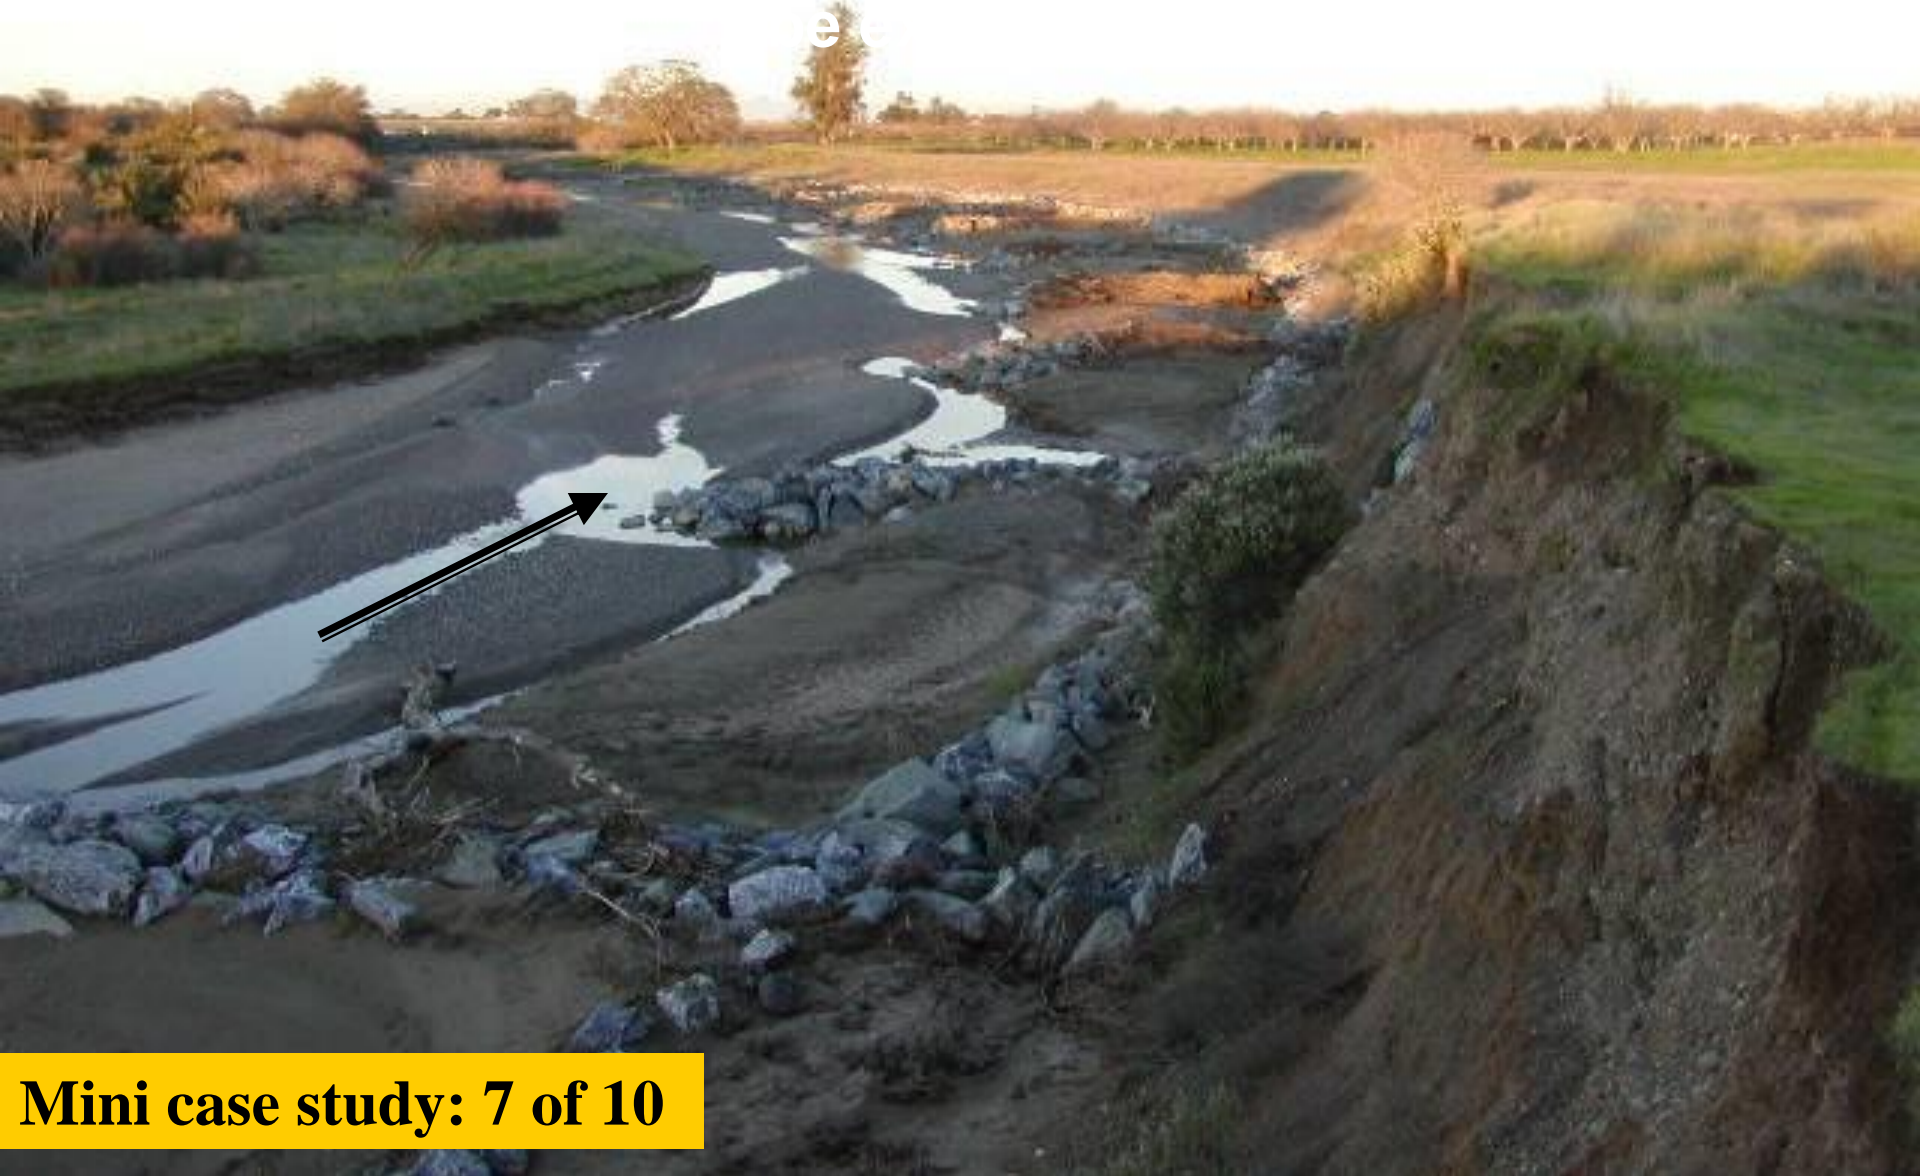
Mini case study: 7 of 10

3+ Years later-Looking DS @ deposition in weir field with some scalloping of deposited material at stream ends-as can

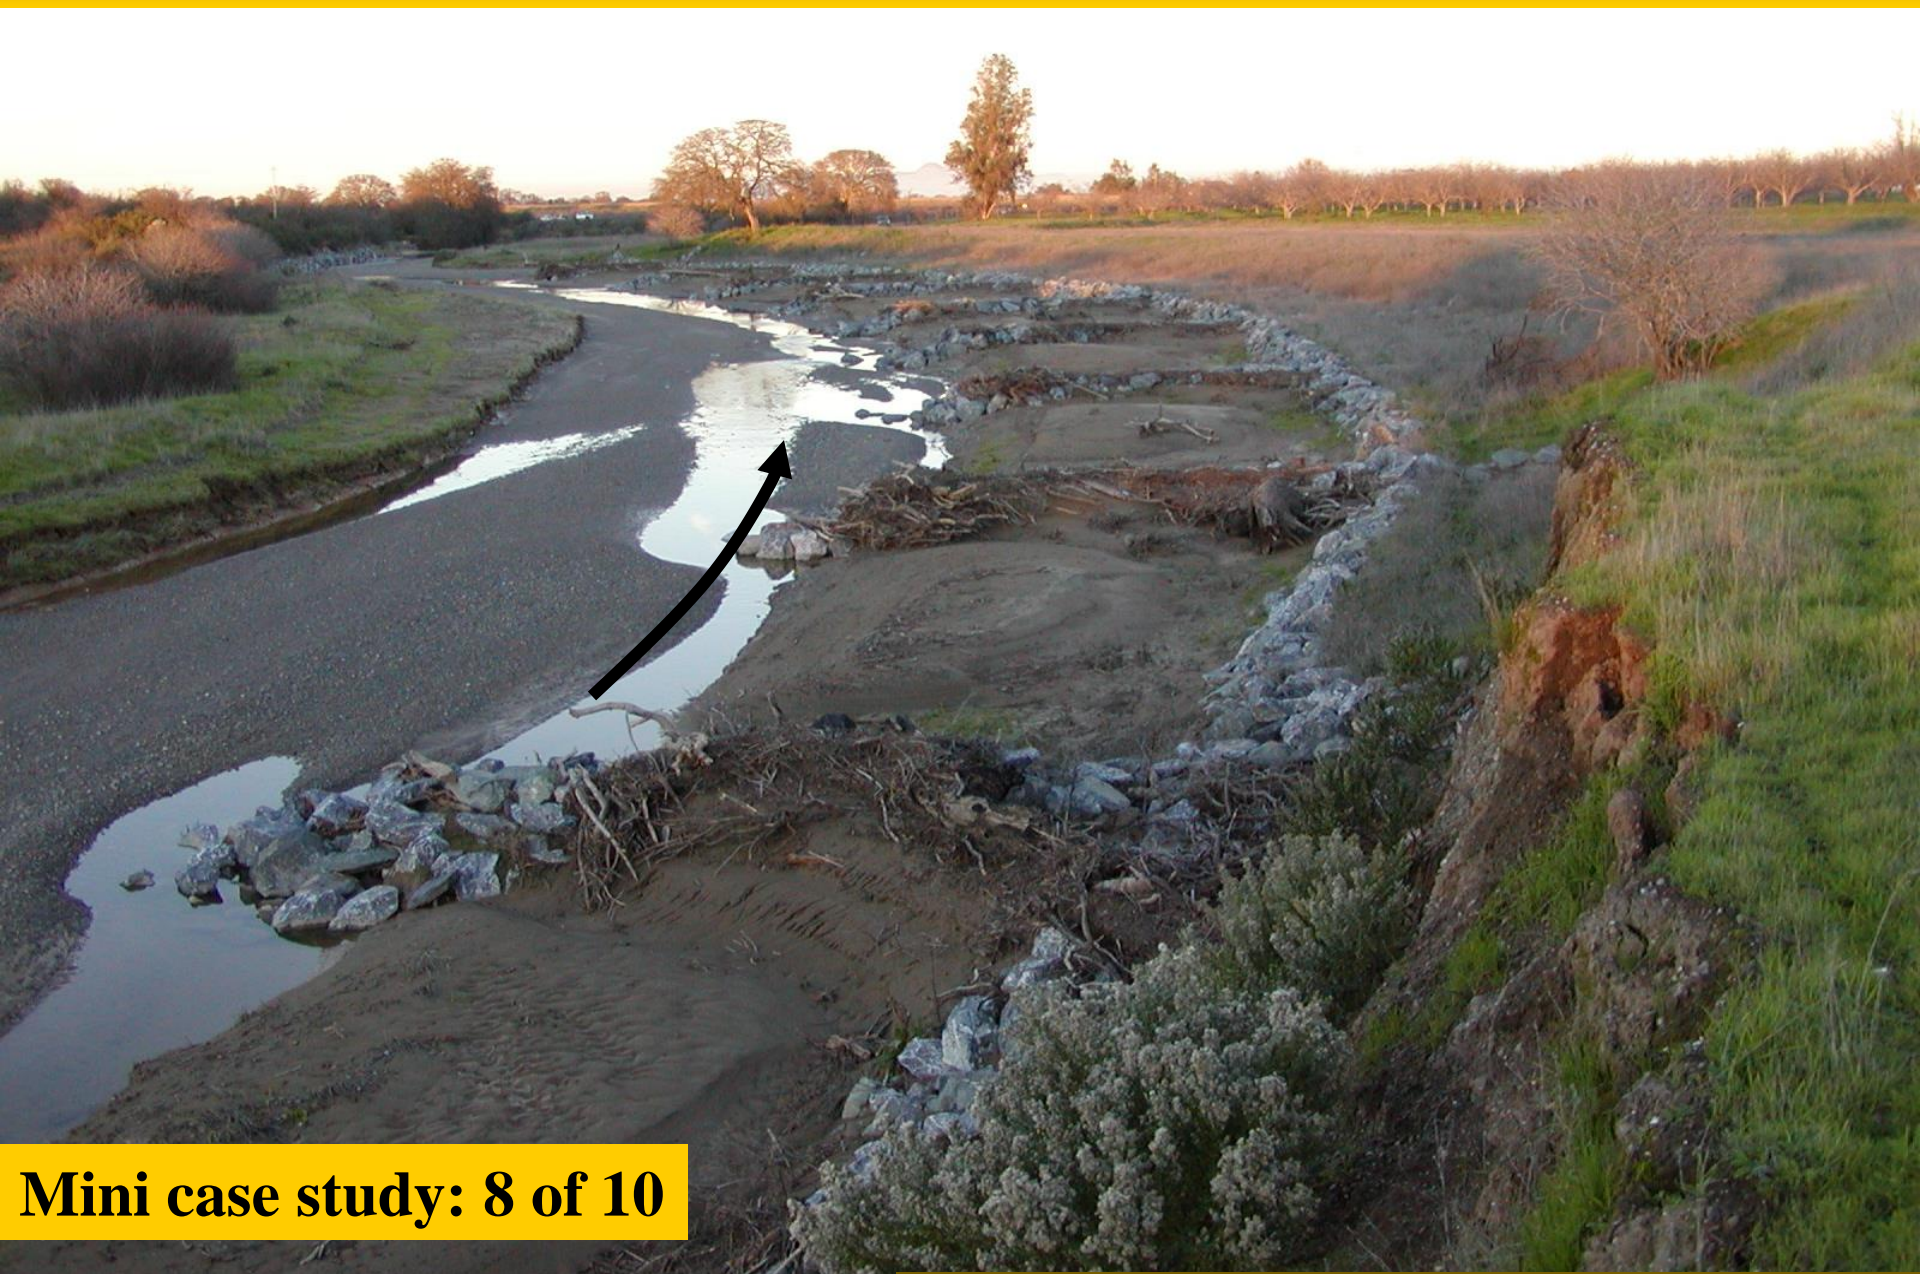
Mini case study: 8 of 10

3+ Years later-Looking DS @ BW with racked debris on each
