Sulphur Creek @ Dunnigan Burn Dump,

Yolo County, CA.

BUILT 1998

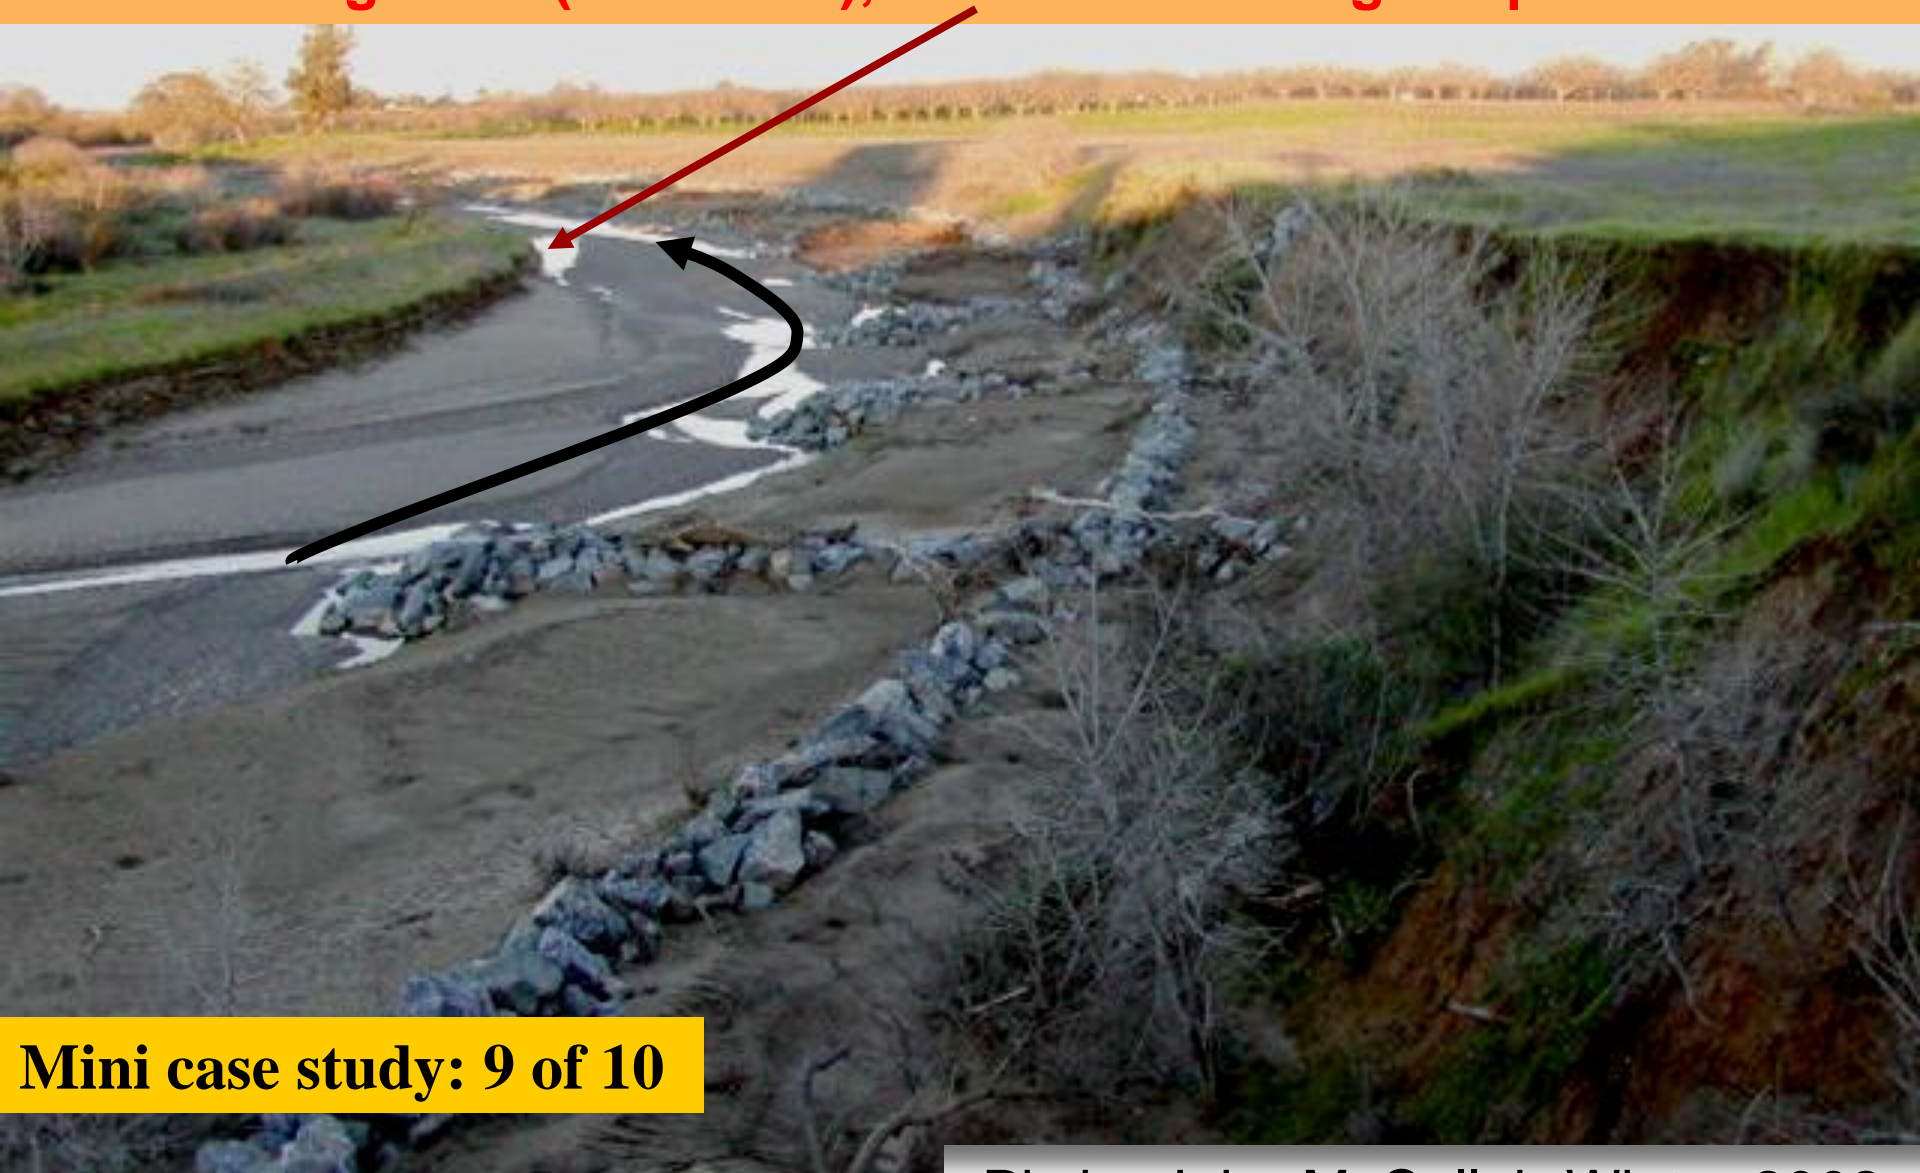
Mini case study: 9 of 10

4 yrs later, looking DS, BW's & LPSTP separate Dunnigan Burn Dump from the stream erosion, note deposition between weirs, thalweg trace (black line), & cutbank on edge of pointbar.

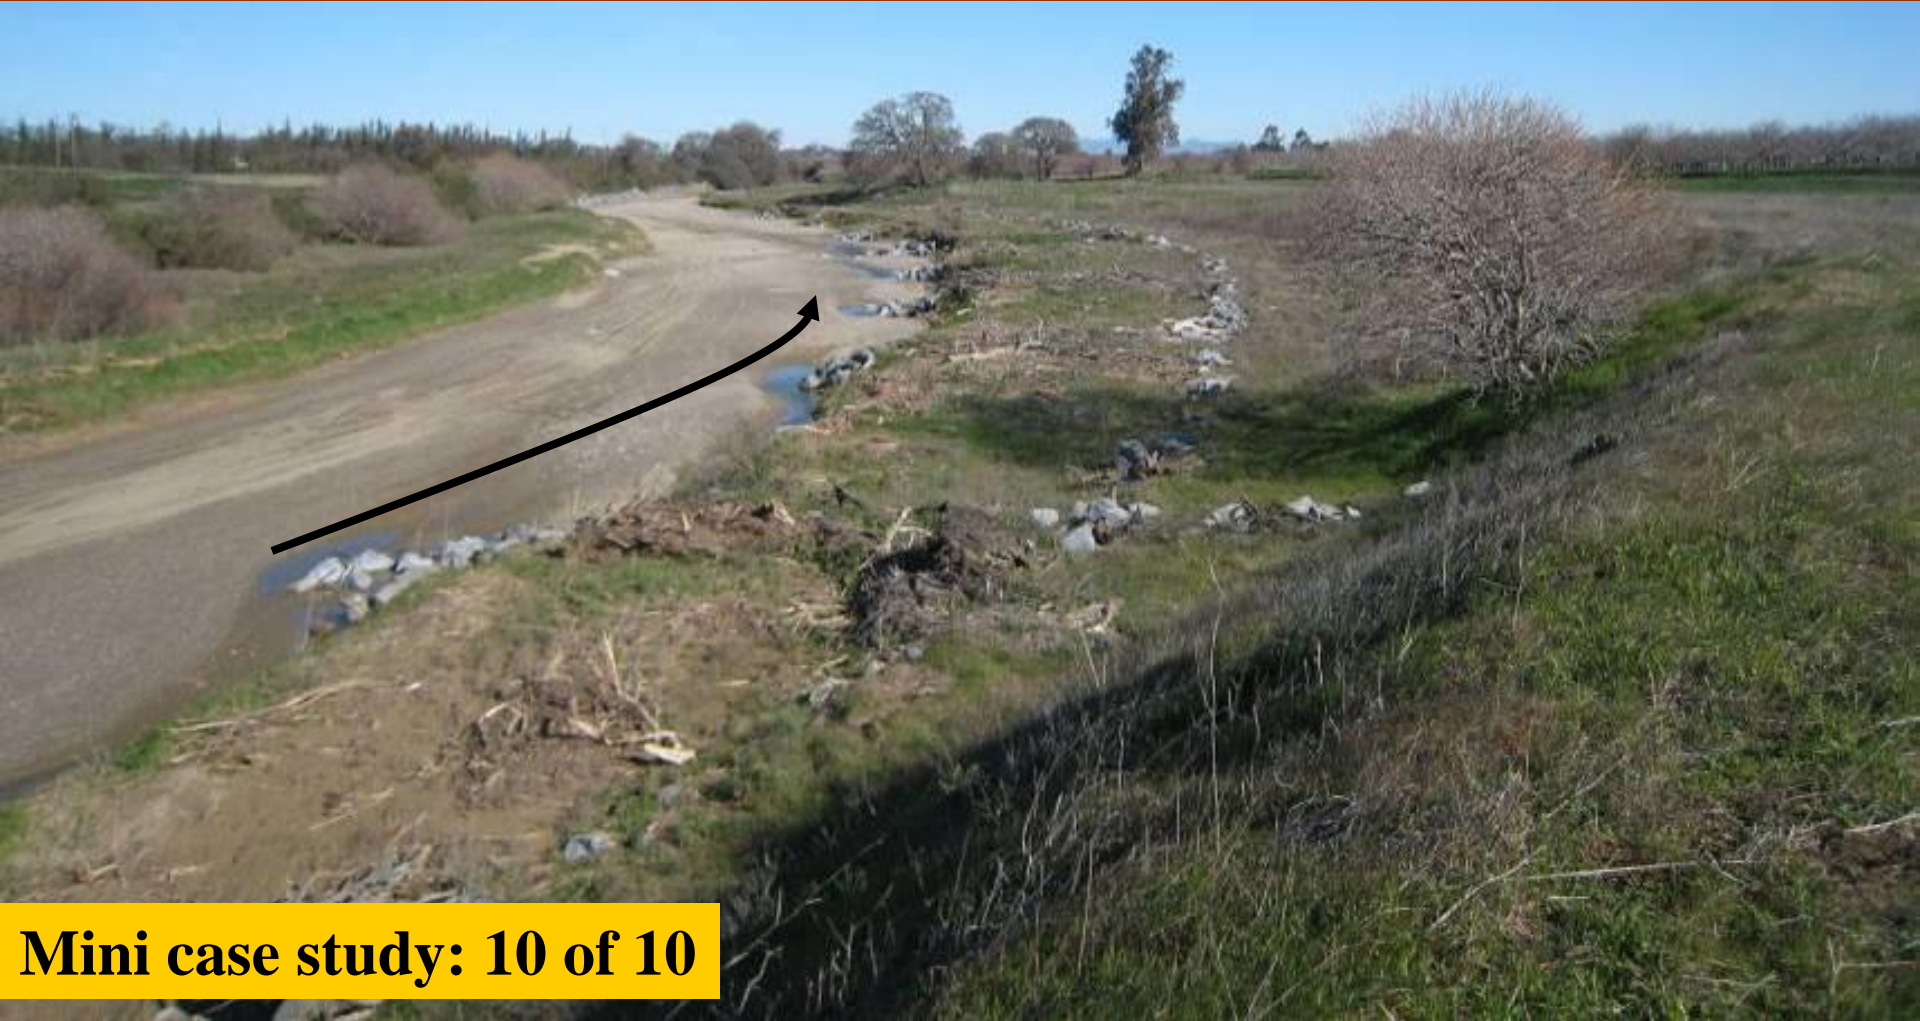
Mini case study: 10 of 10

**9+ Years Later-Looking DS @ completely filled in
Bendway Weir field results in a wide buffer of
protection for the burn dump.**

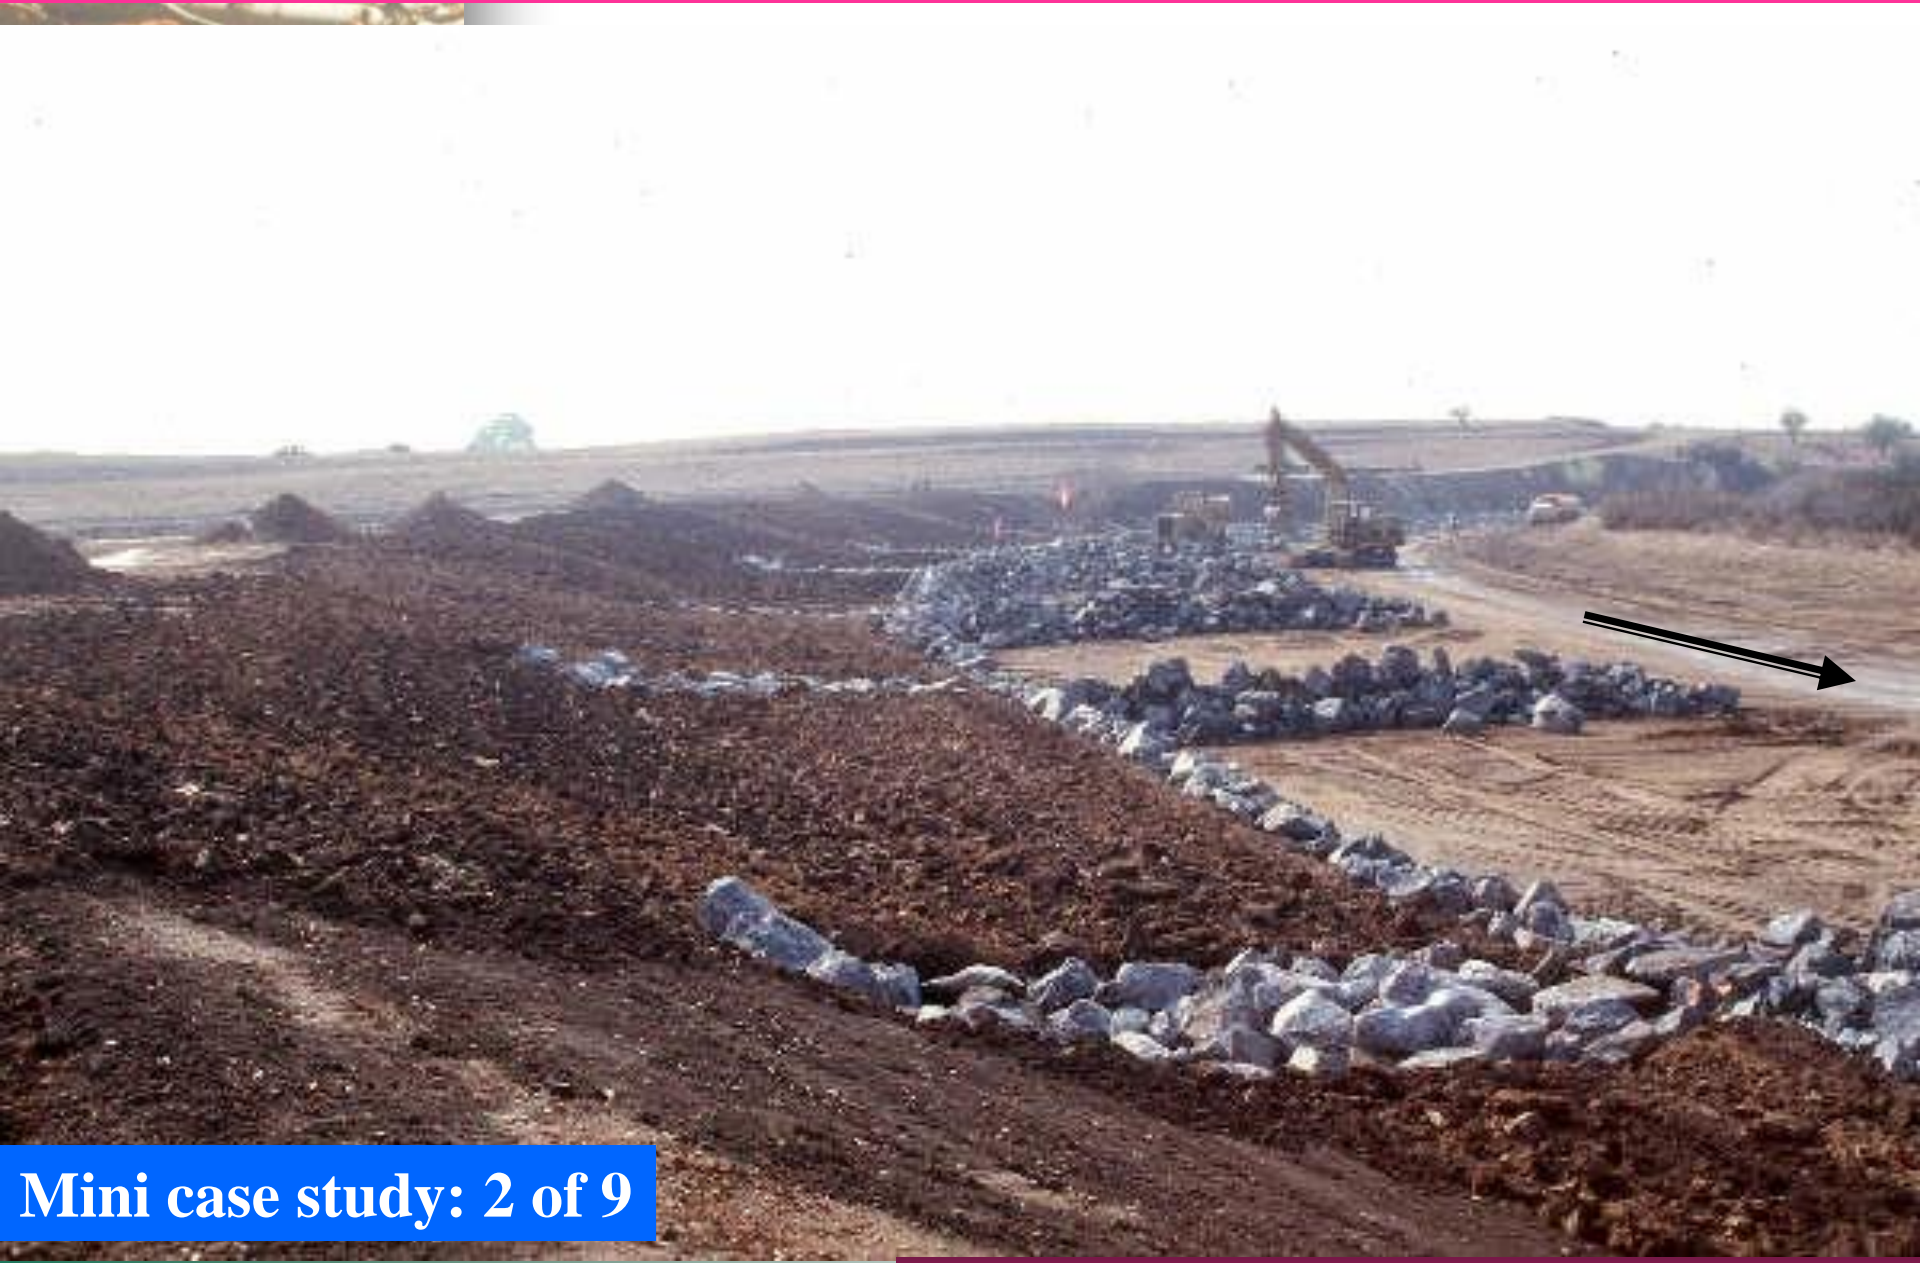
Mini case study: 2 of 9

DURING CONSTRUCTION-Looking US @ LPSTP (next to dump)

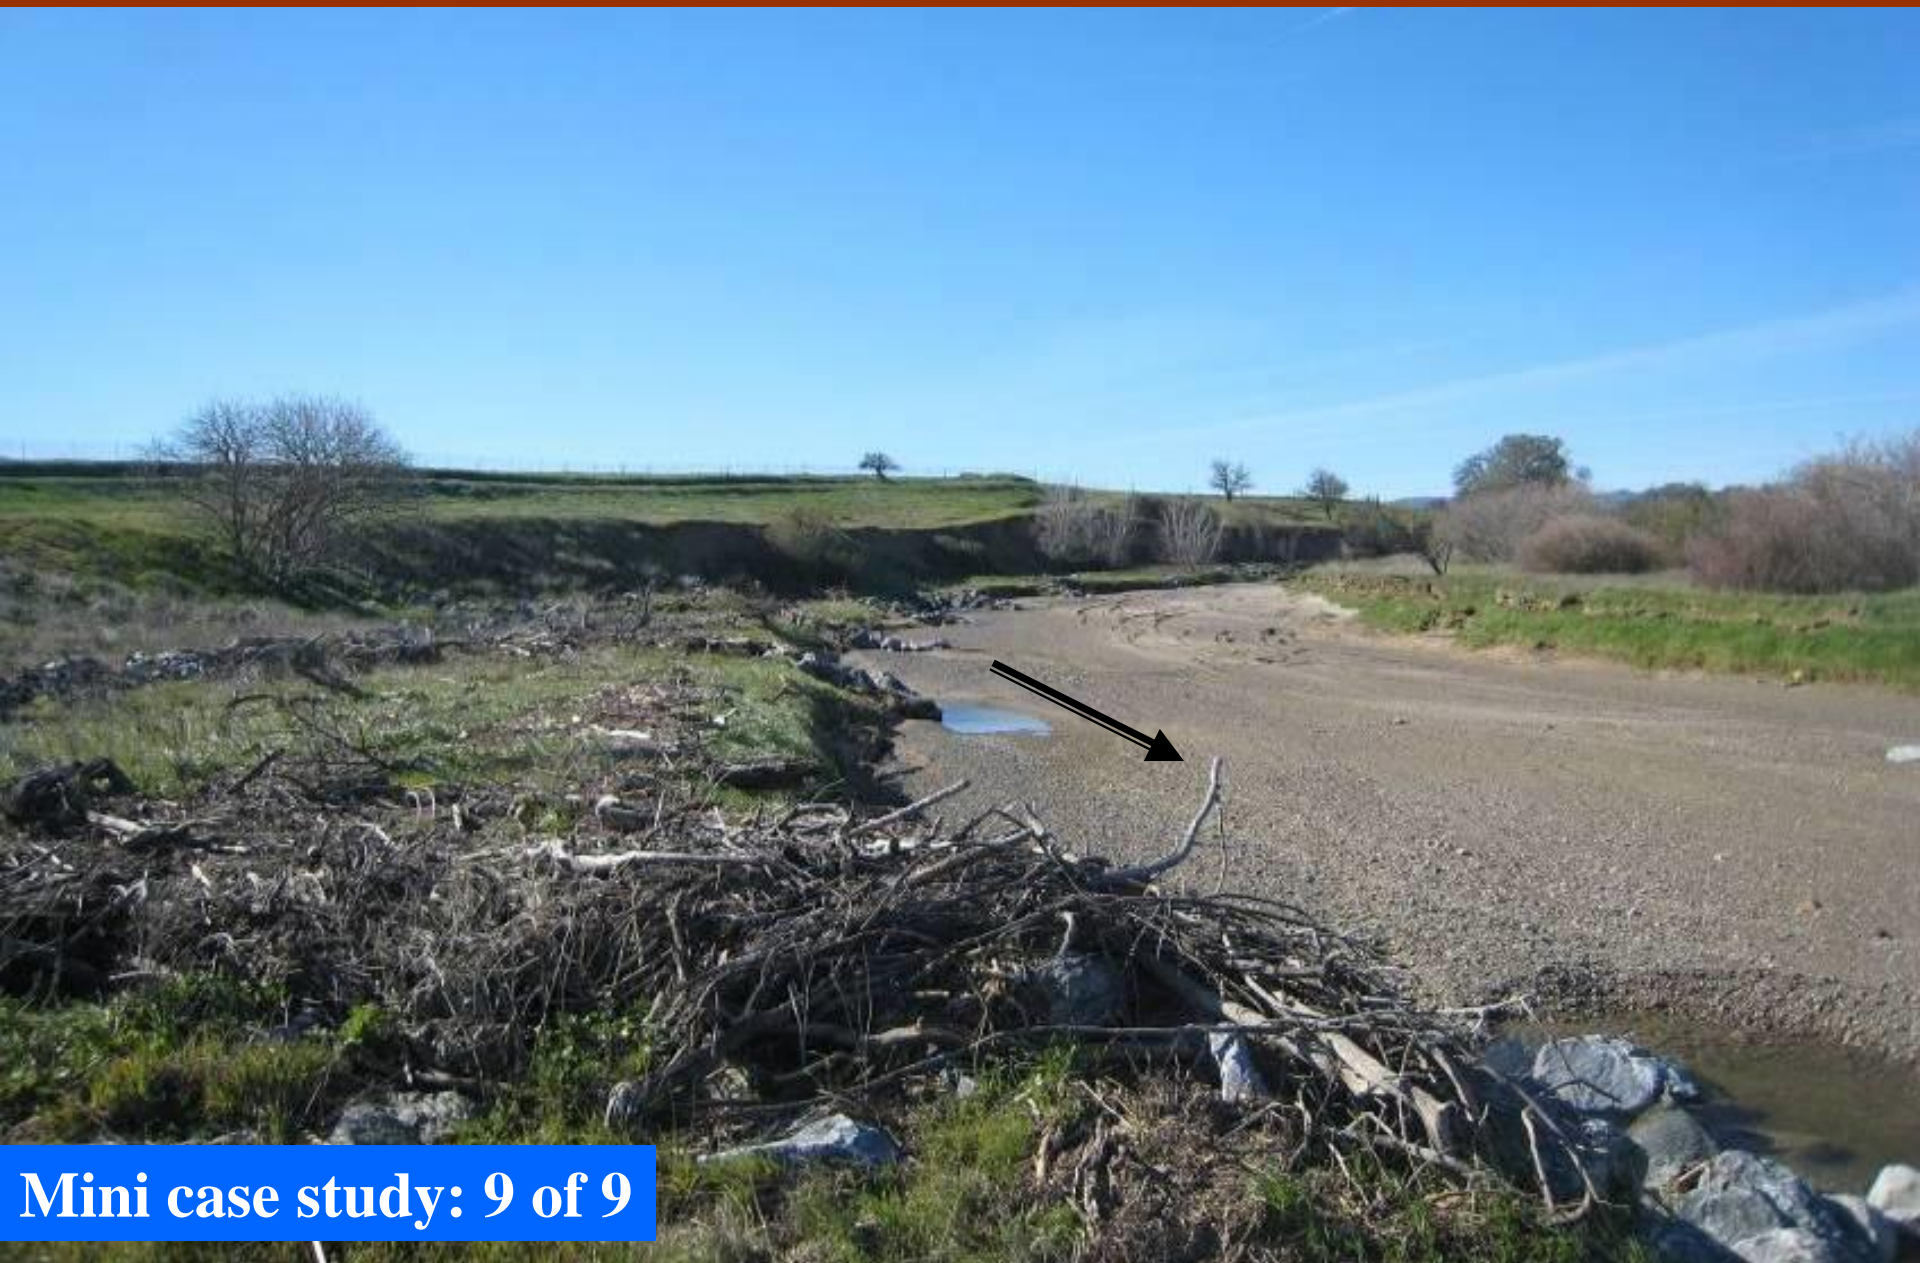
Mini case study: 9 of 9

9+ Years Later-Looking US @ deposition in weir field.

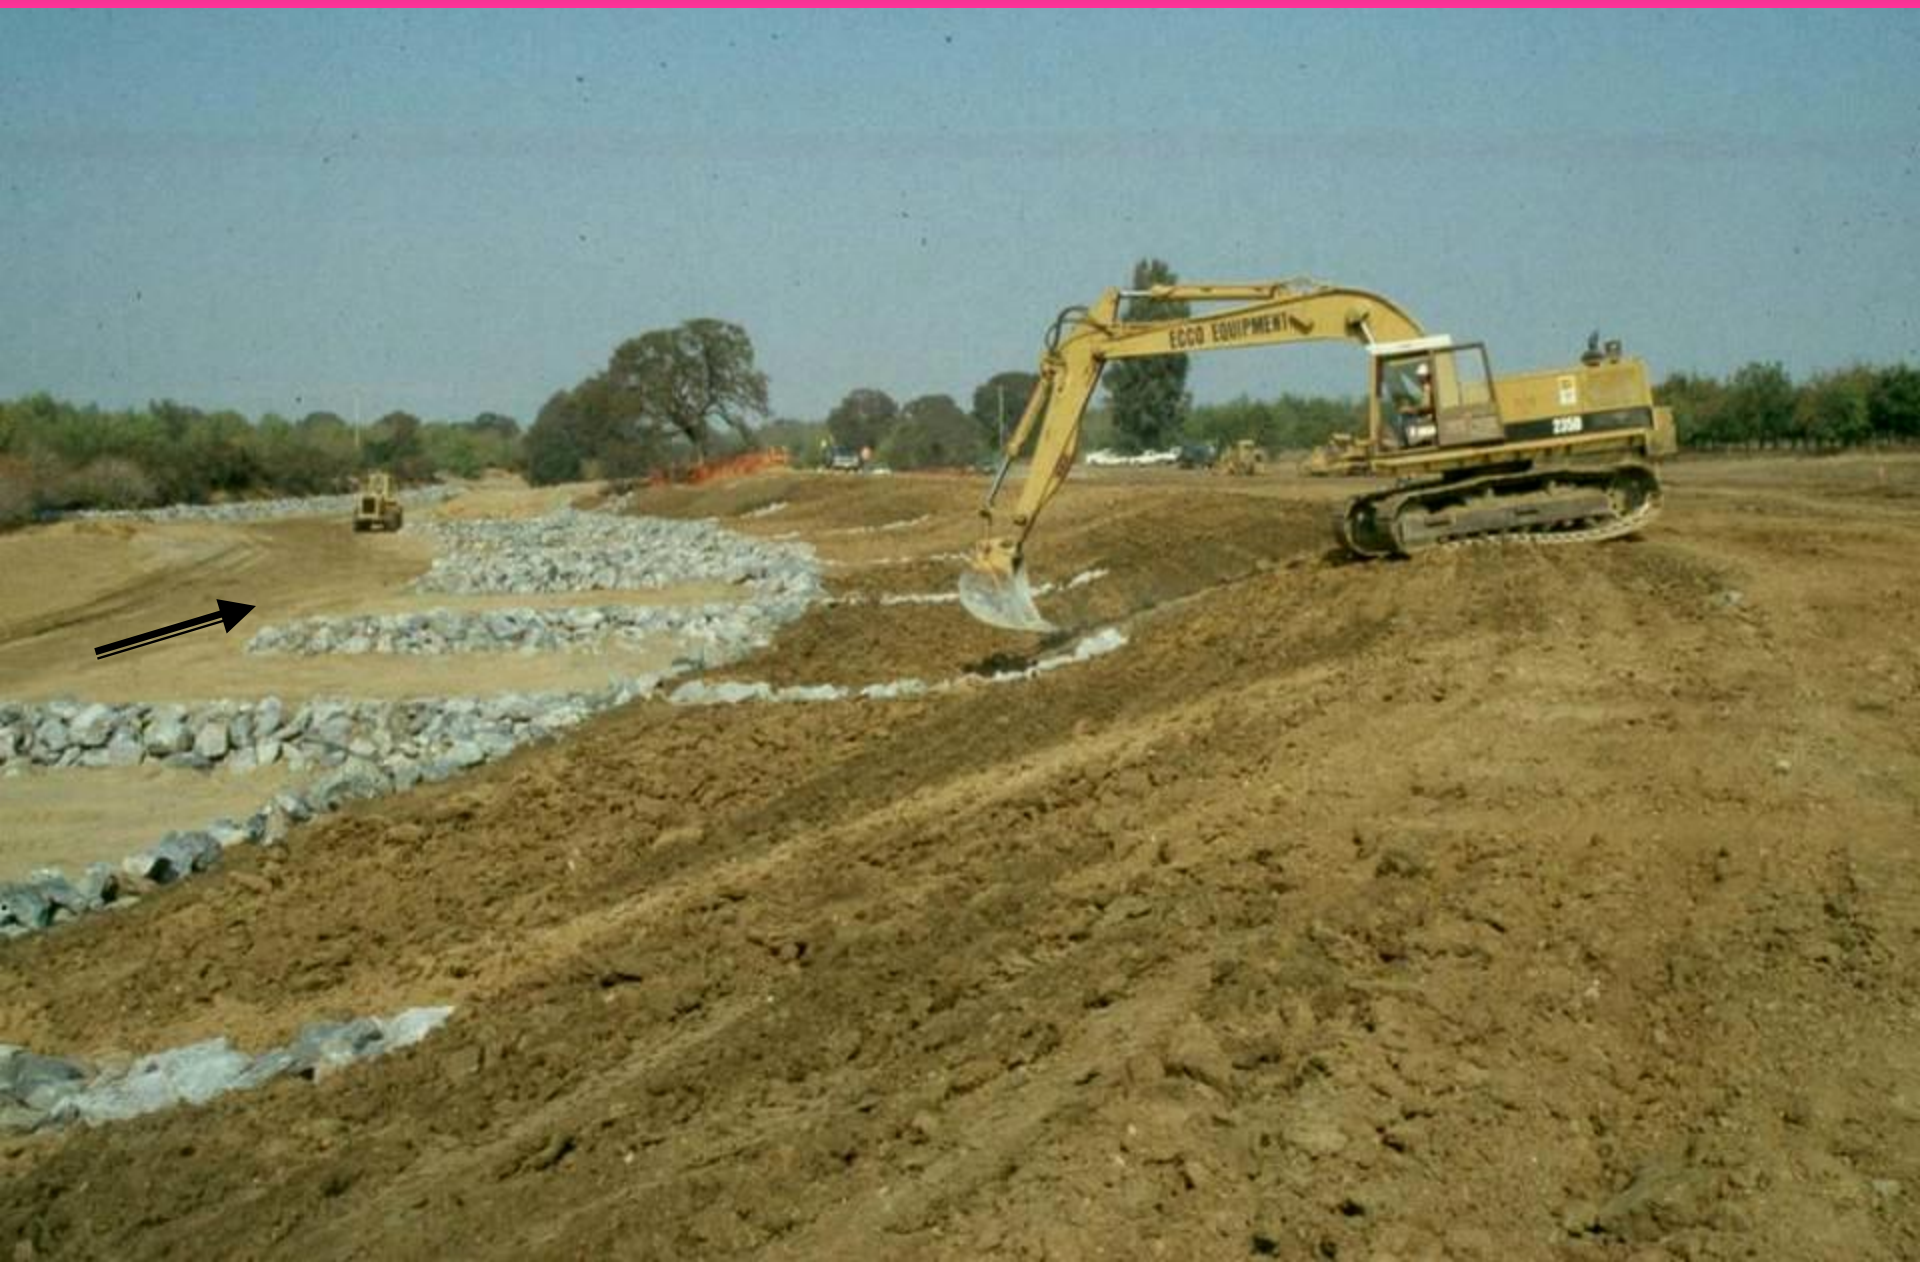
DURING CONSTRUCTION-Looking DS @ LPSTP (next to dump)

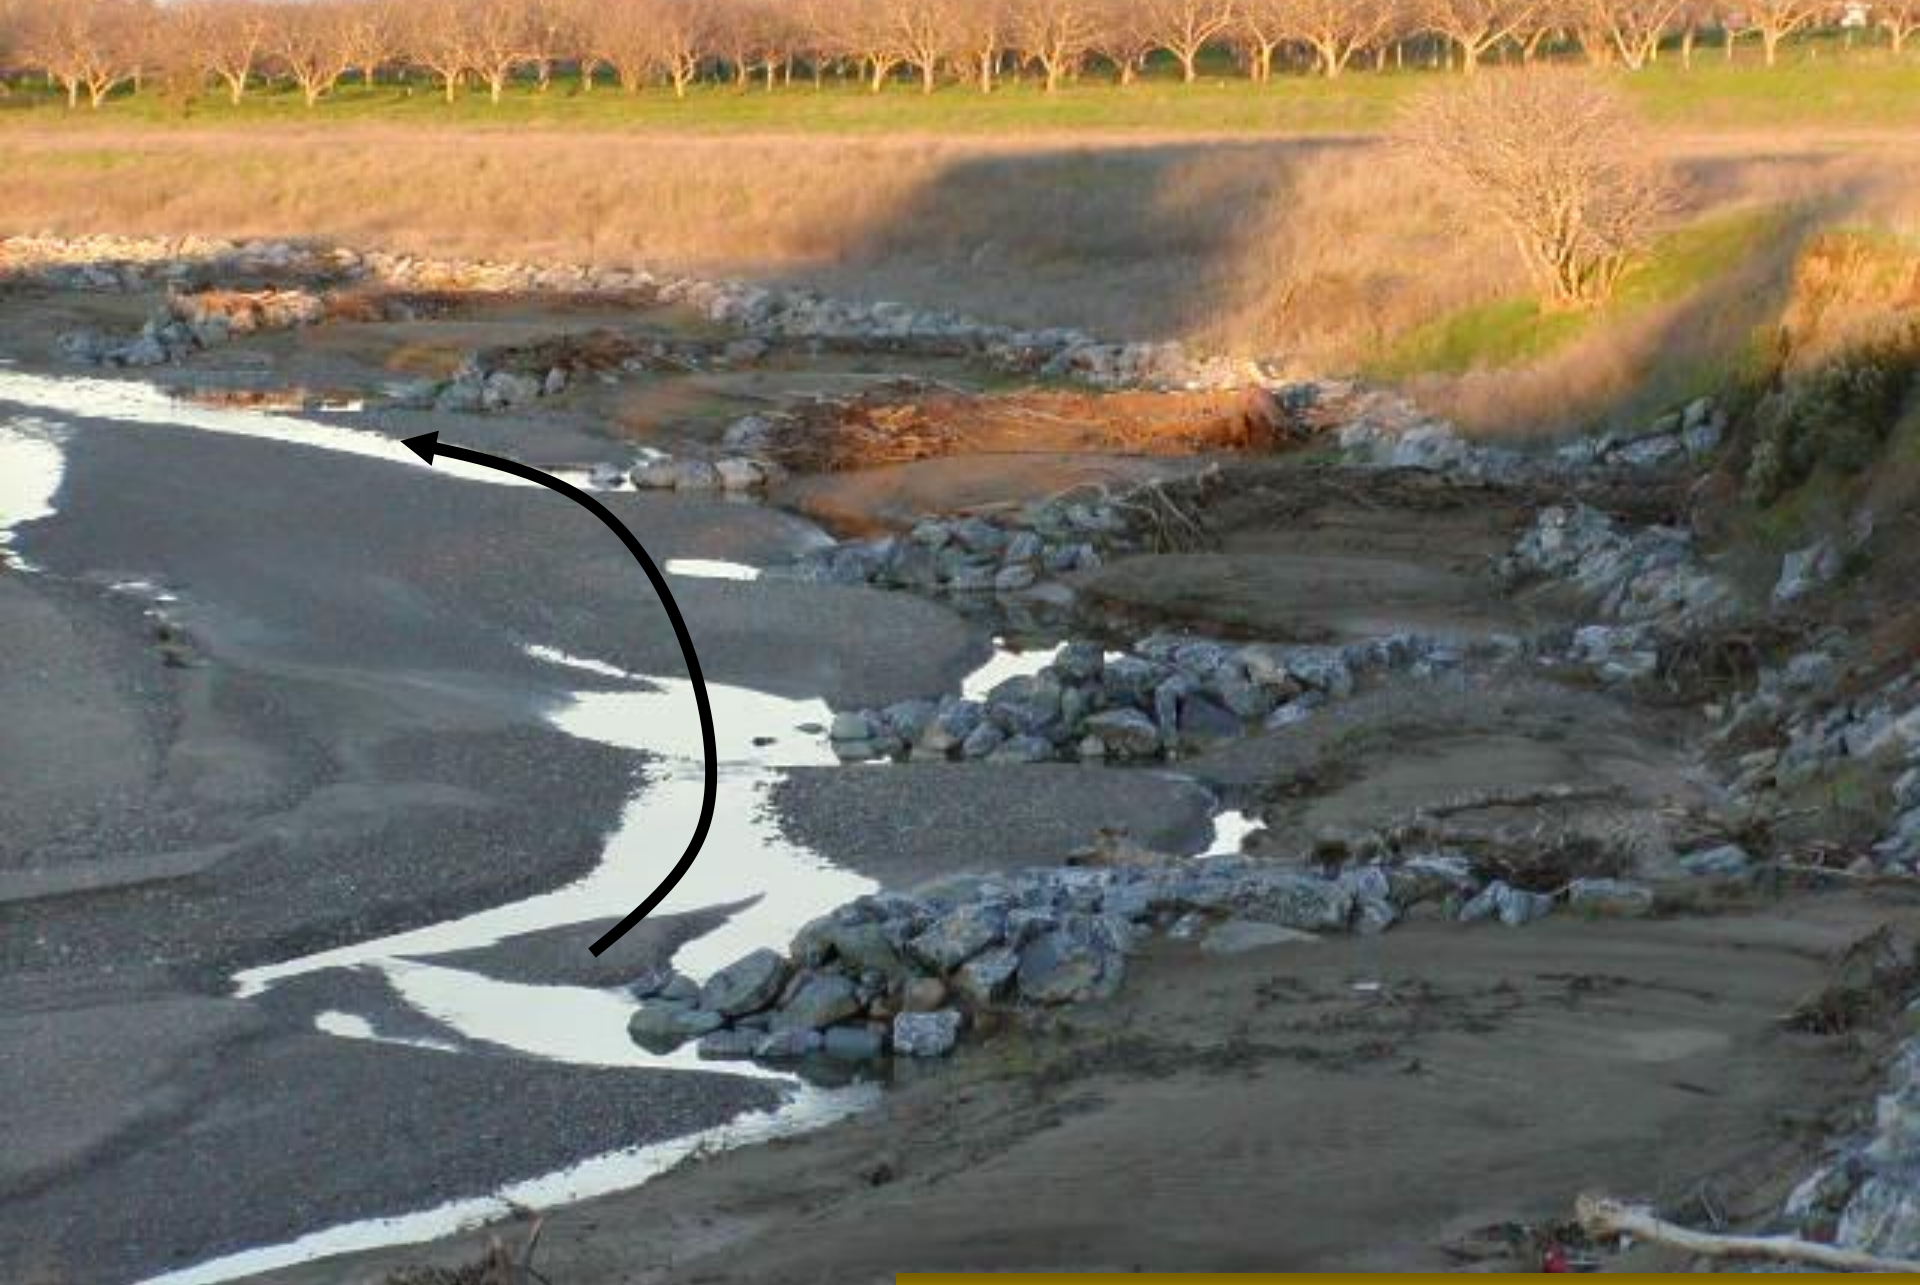
3+ Years later-Looking DS @ scour, debris, & deposition in weir field

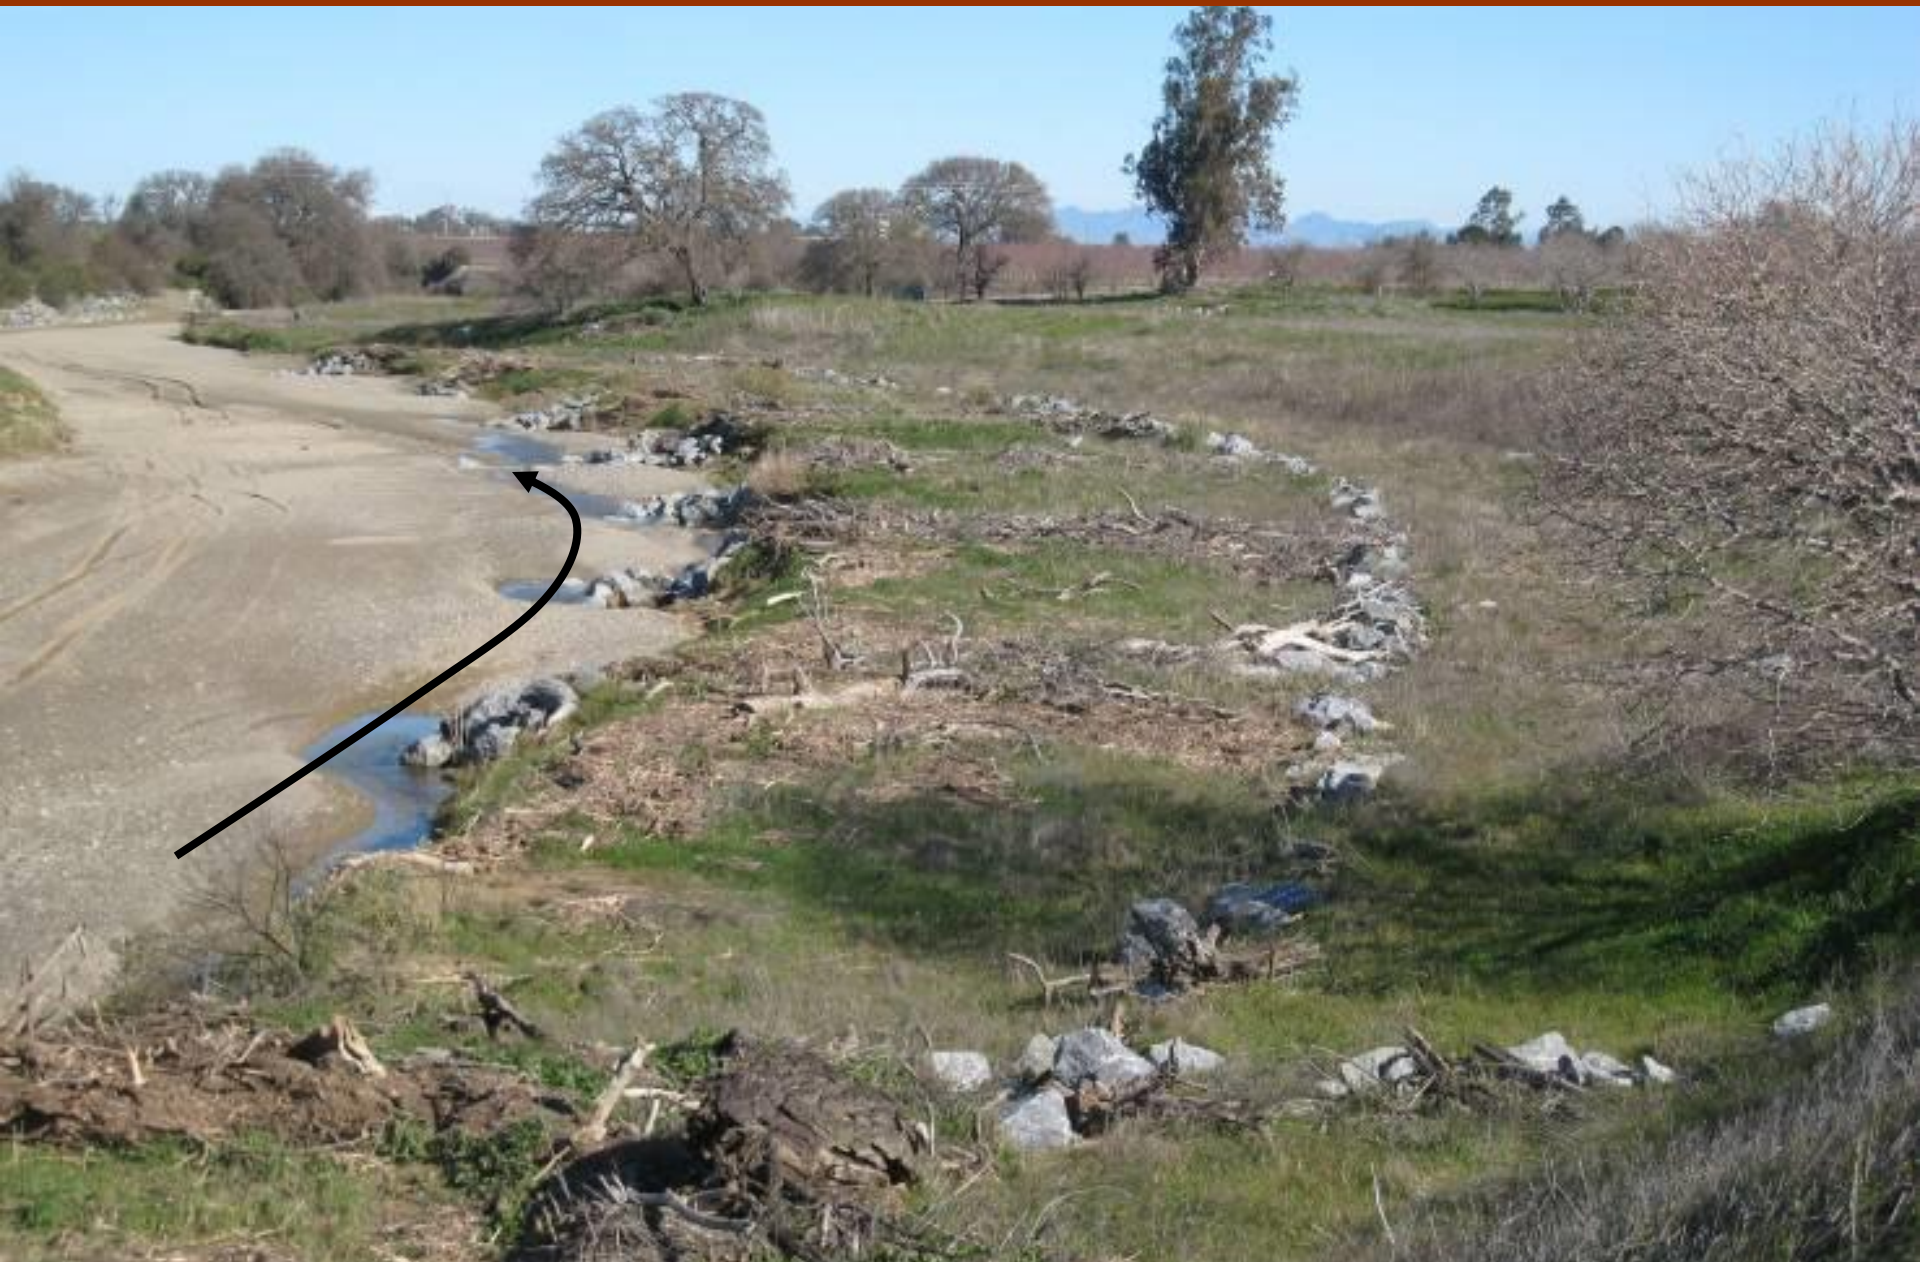
9+ Years Later-Looking DS @ completely filled in Bendway Weir field

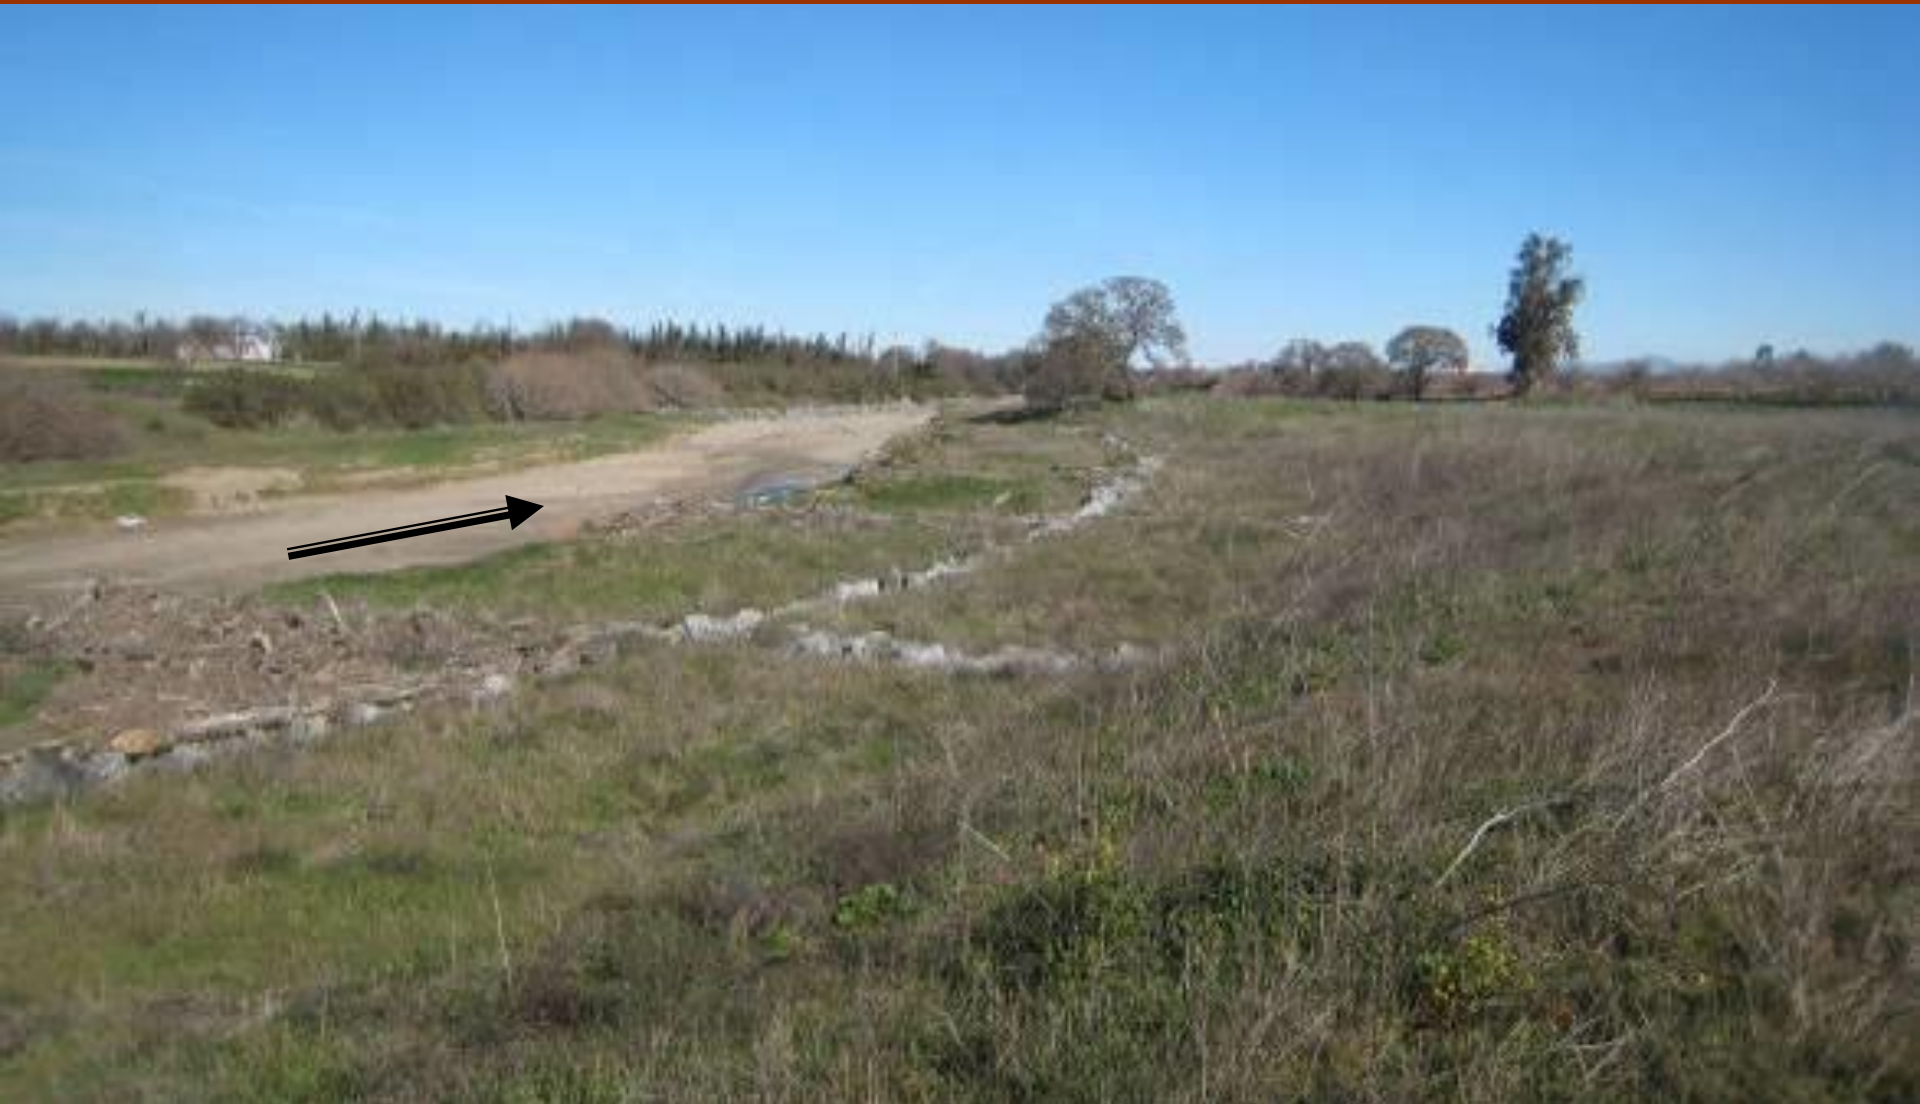
9+ Years Later-Looking DS @ burn dump in foreground, keys, top of LPSTP, completely filled in Bendway Weir field, & excellent transition from the right bank to the left bank (“S” shaped bend)

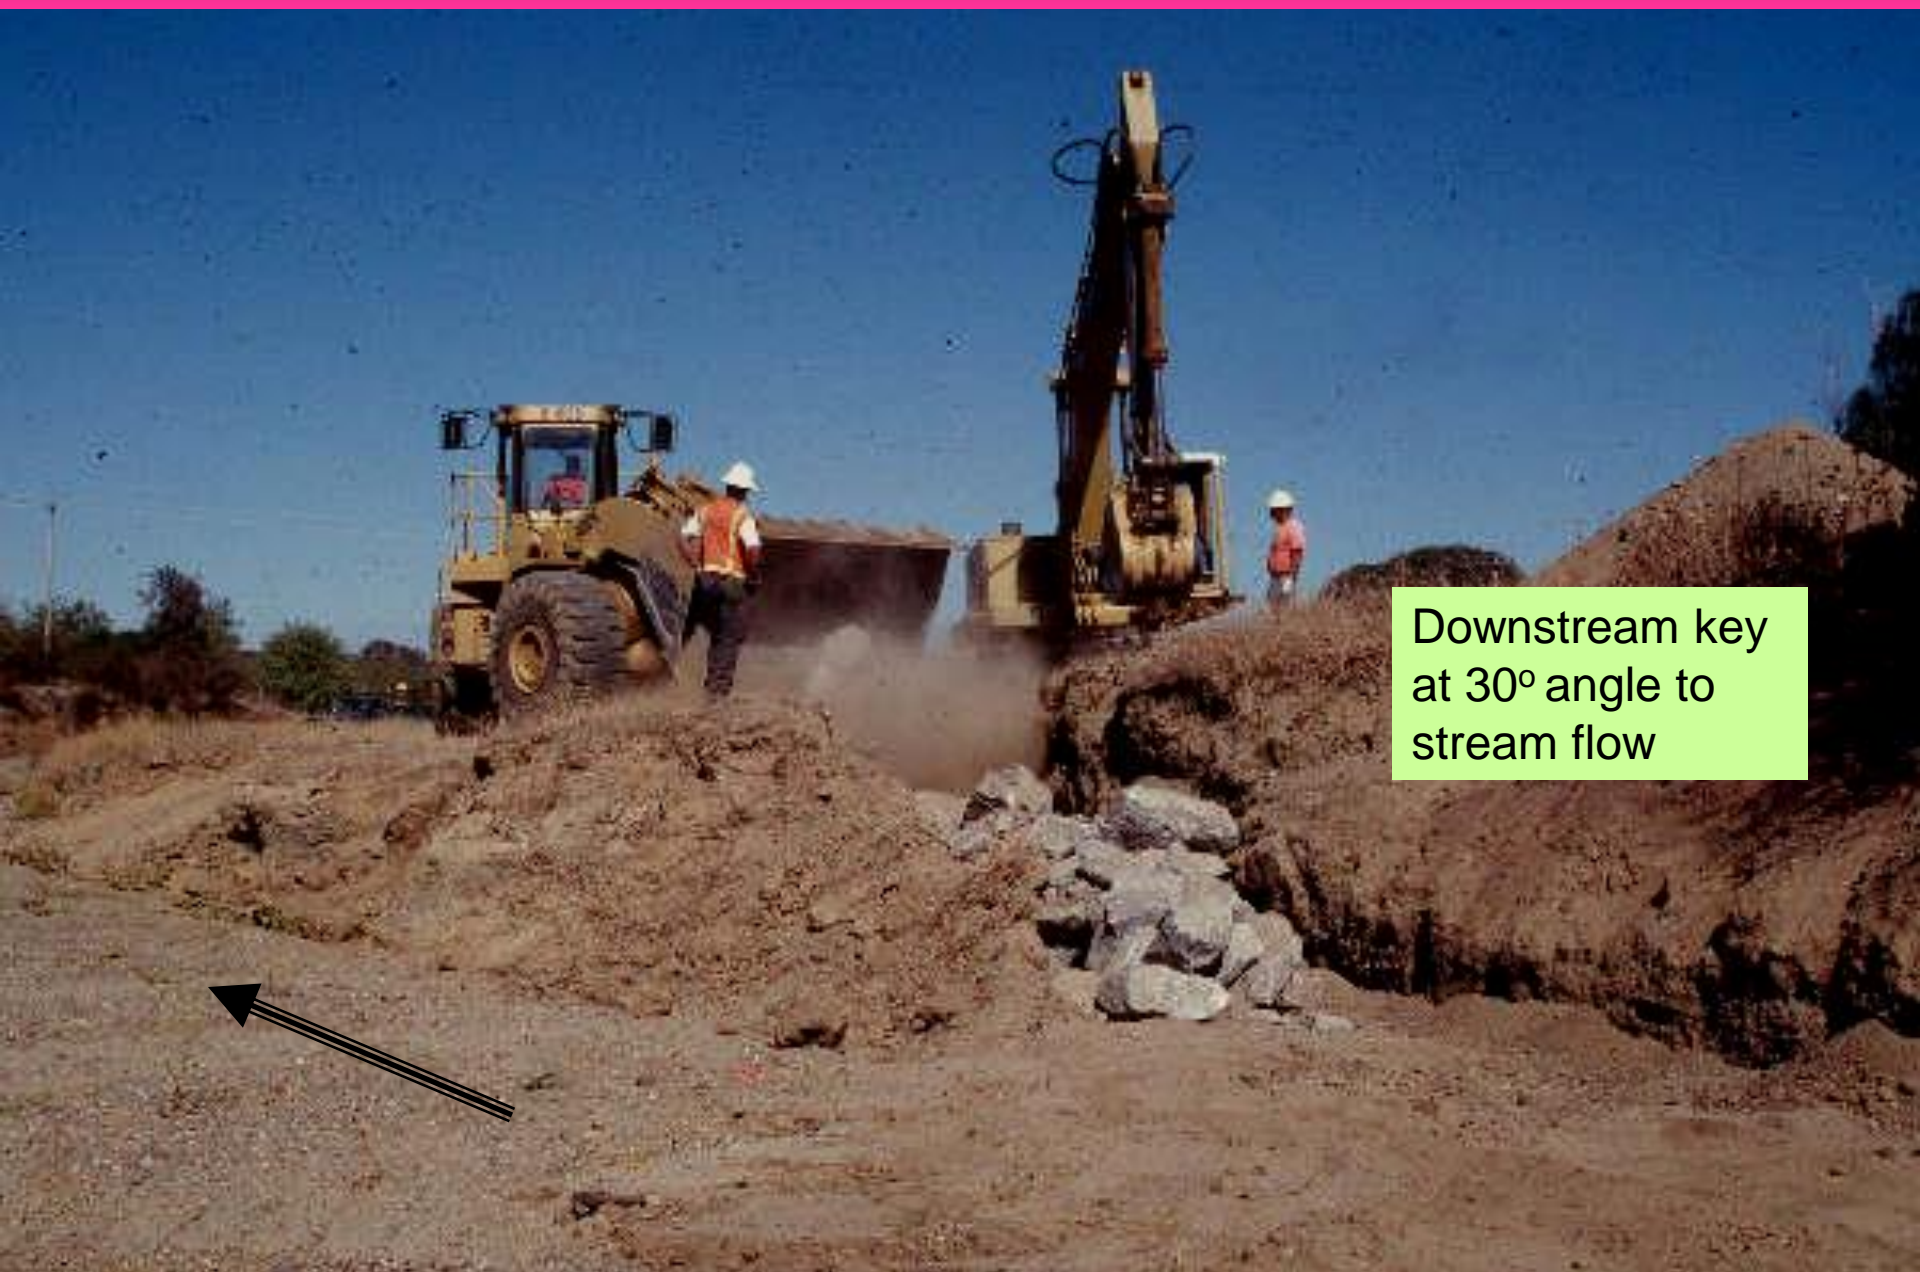
DURING CONSTRUCTION-Looking DS @ the right bank DS key.
