Sulphur Creek @ Dunnigan Burn Dump,

Yolo County, CA.

BUILT 1998

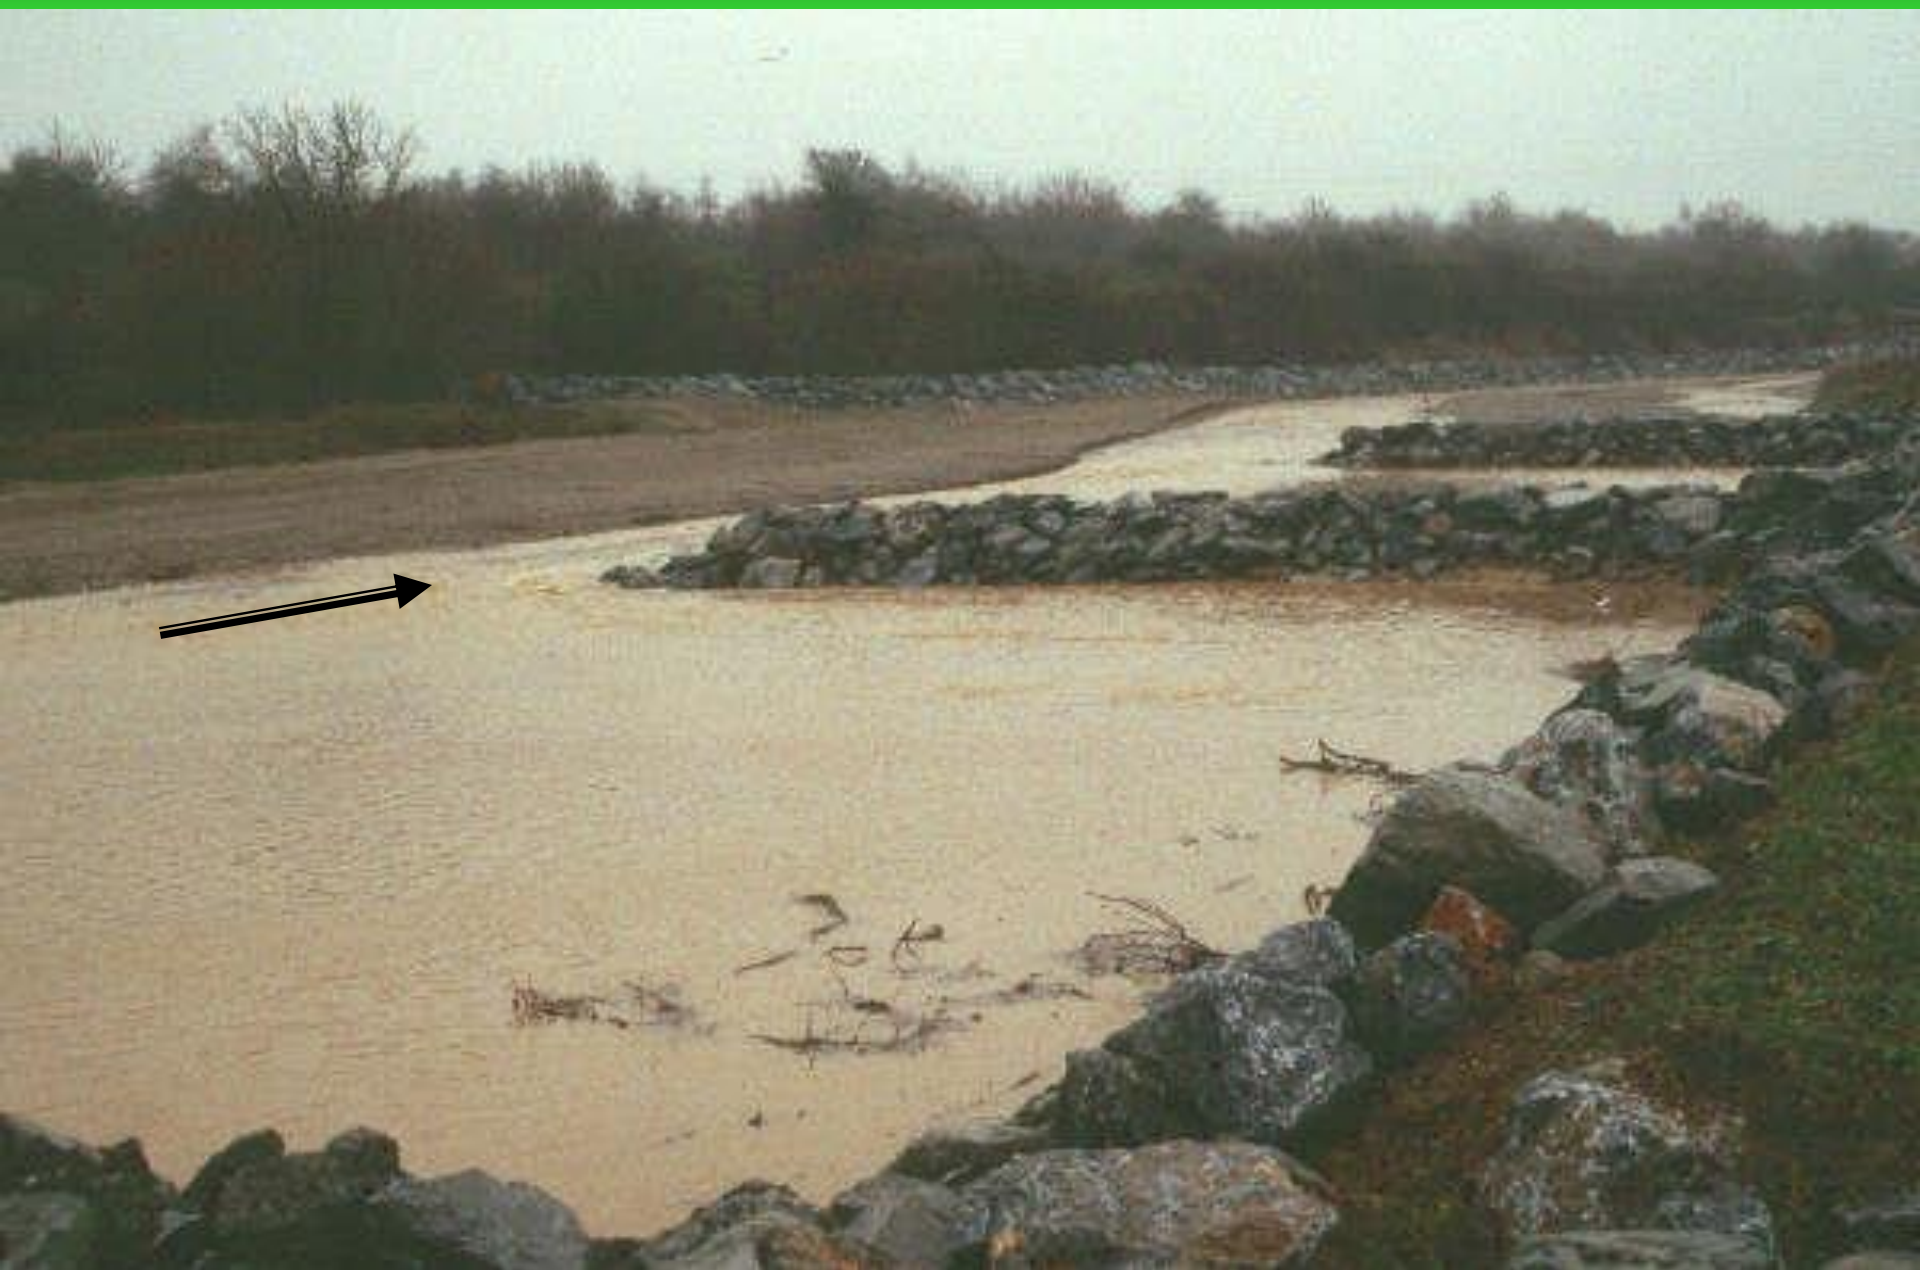
3 months later-Looking DS @ Bendways and left bank LPSTP

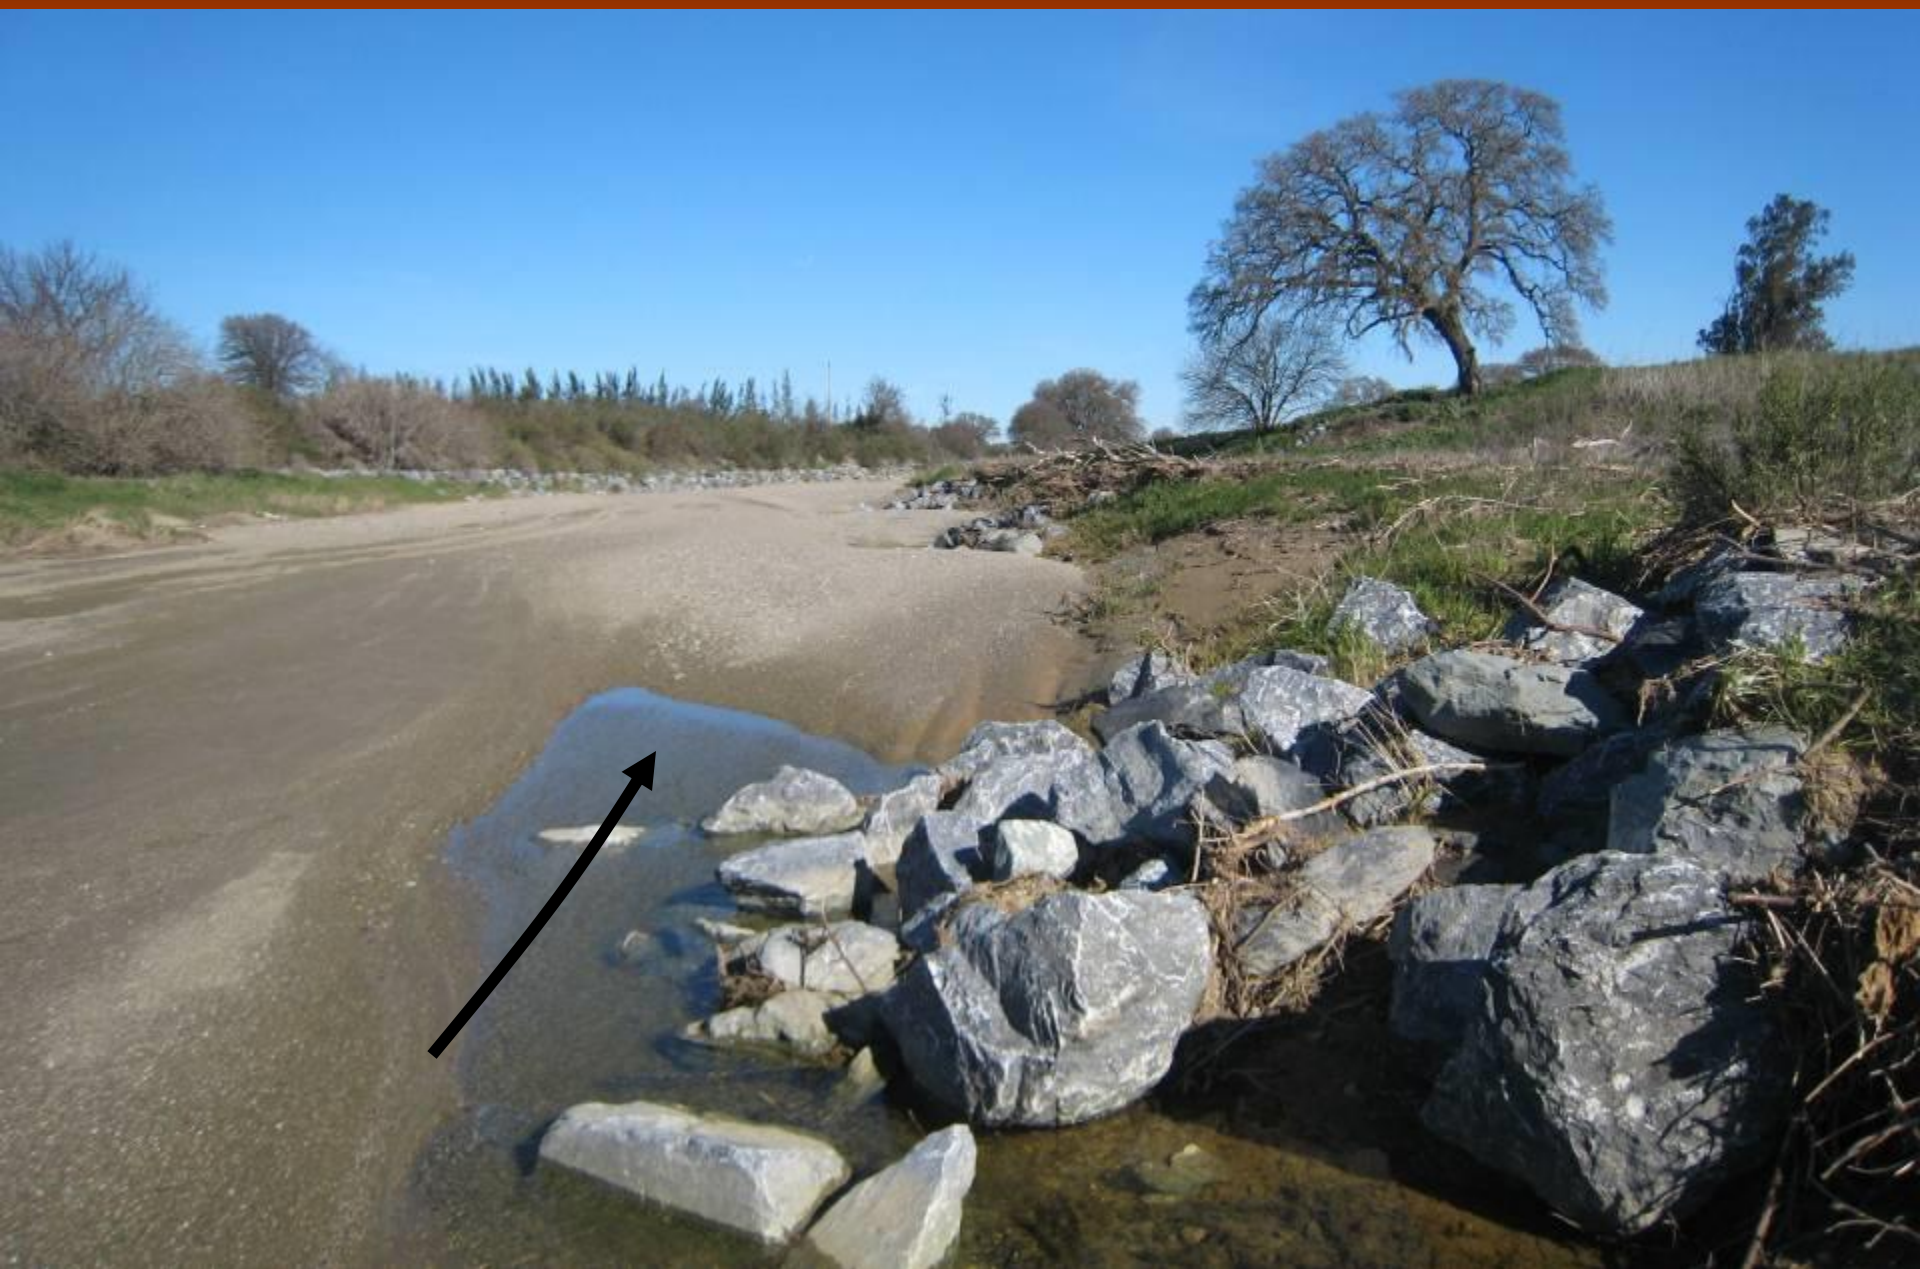
9+ Years later-Looking DS @ ends of BW's & left bank LPSTP protection

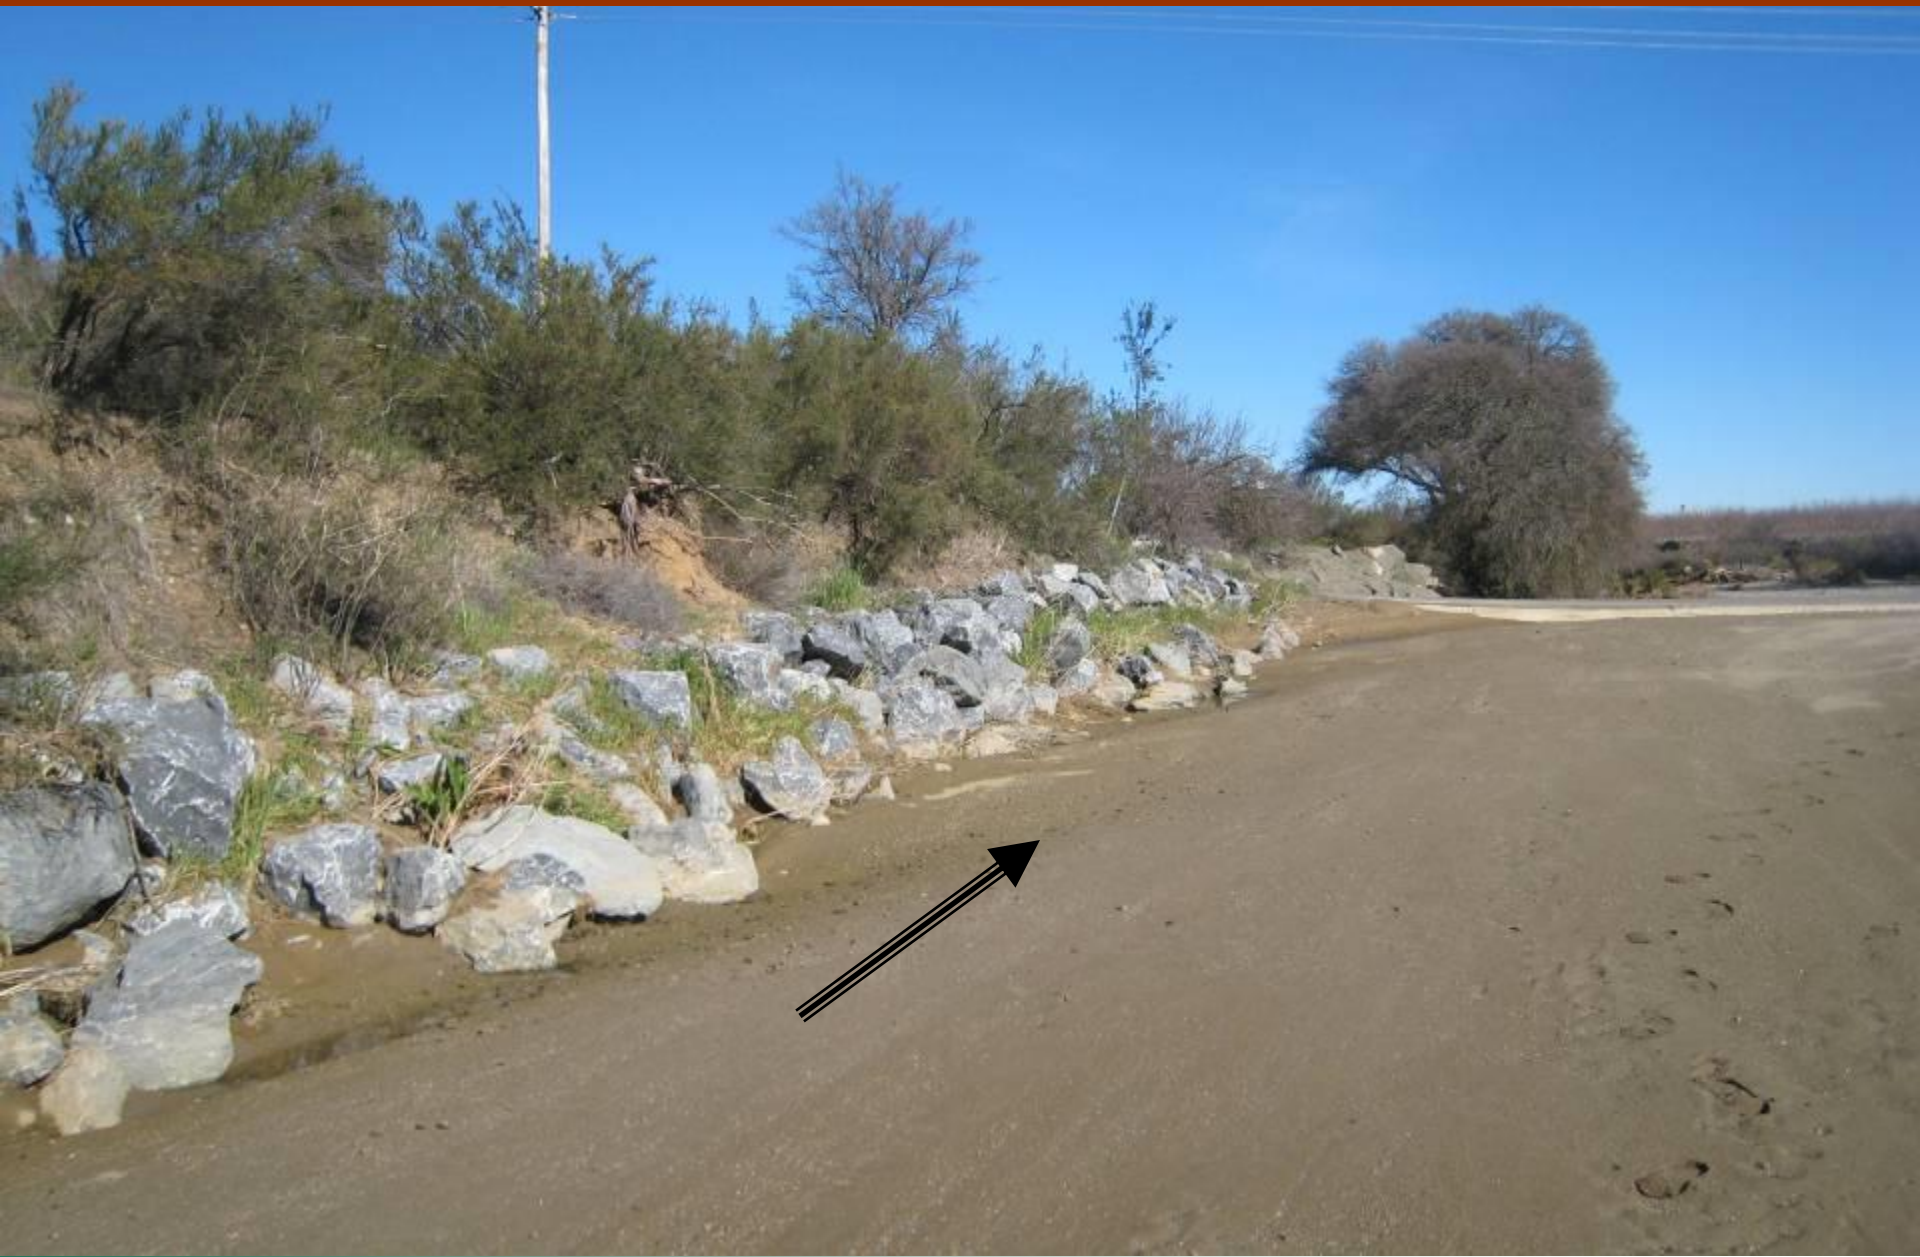
9+ Years Later-Looking DS @ left bank LPSTP with road @ DS end

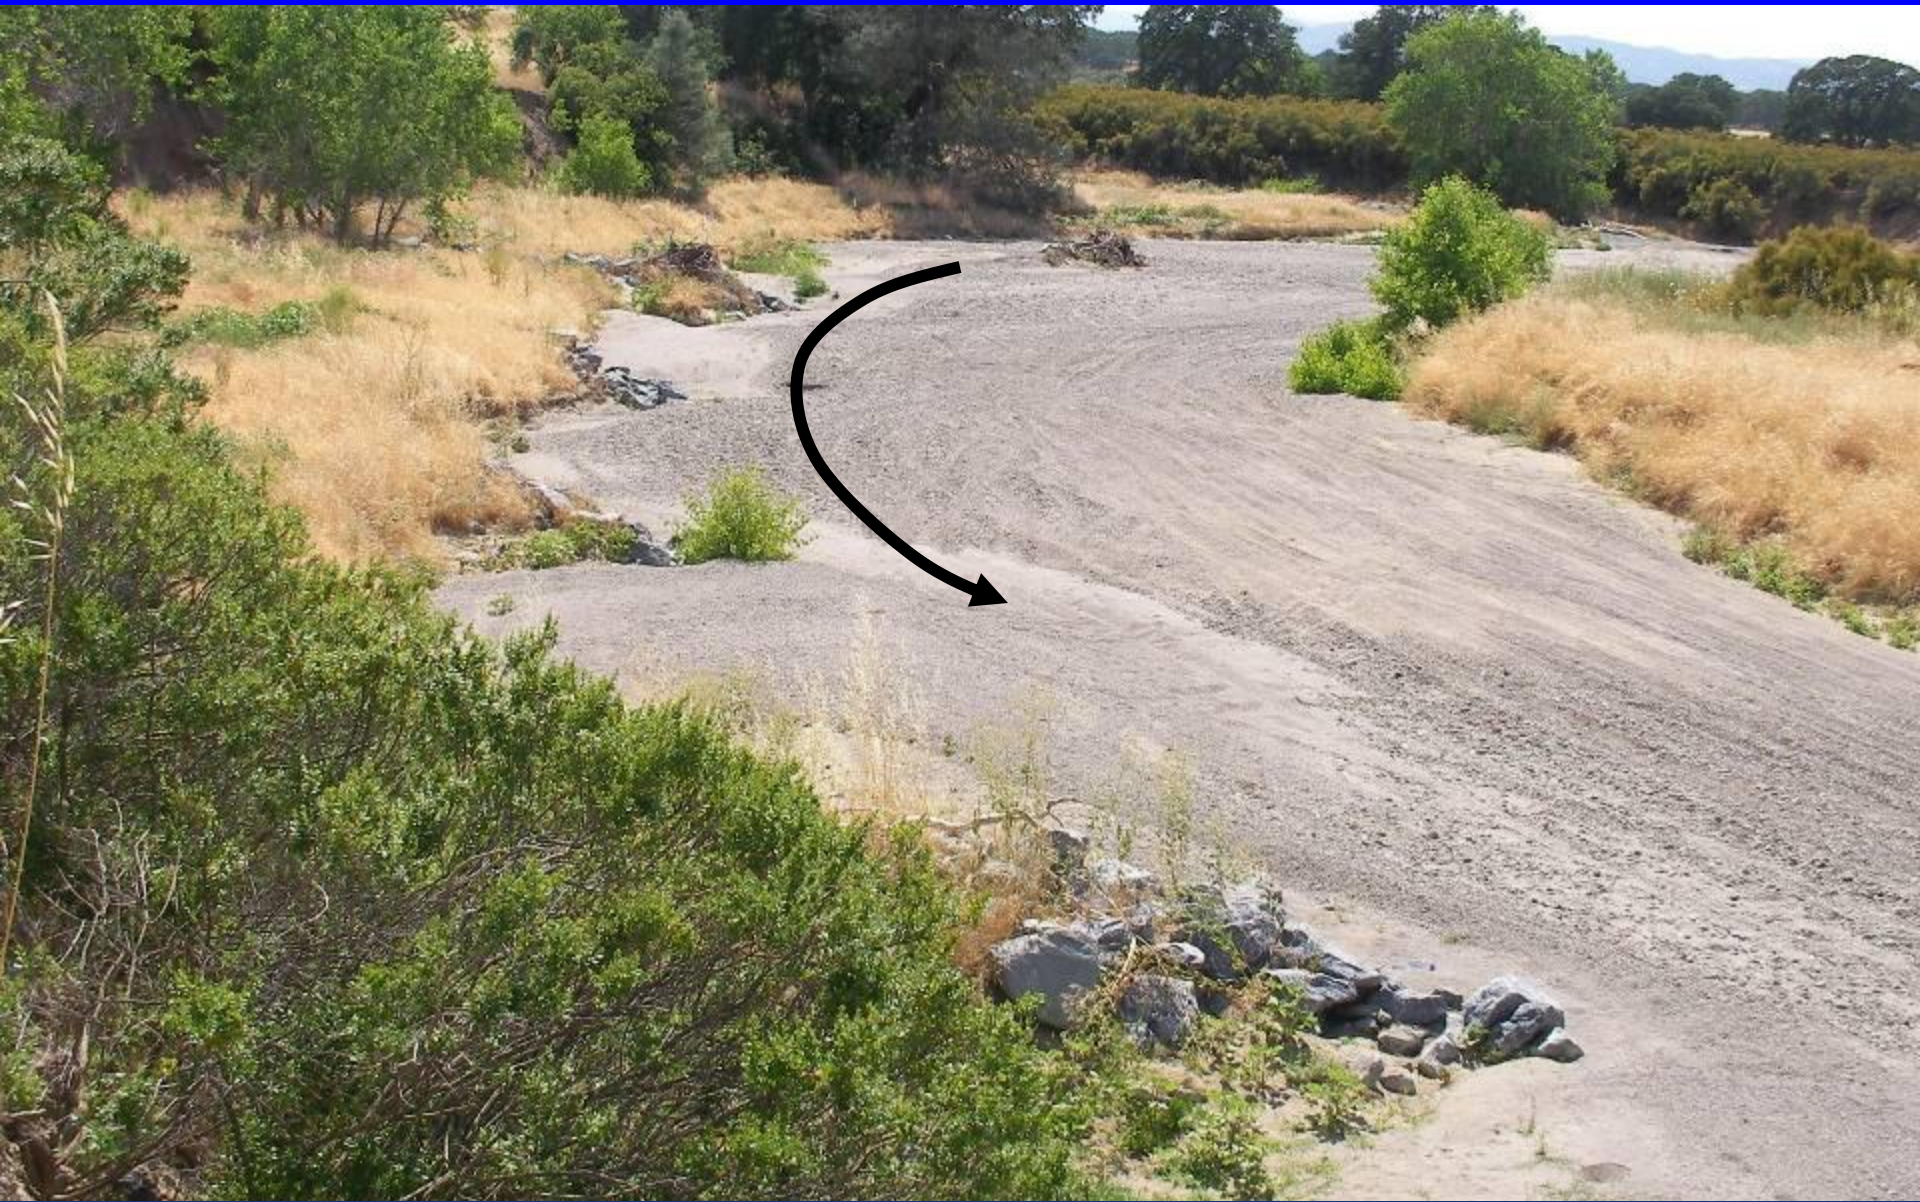
9+ Years-Looking @ the US end of the project. The US key extends far upstream of the current flow attack area. Channel is stable in all dimensions.

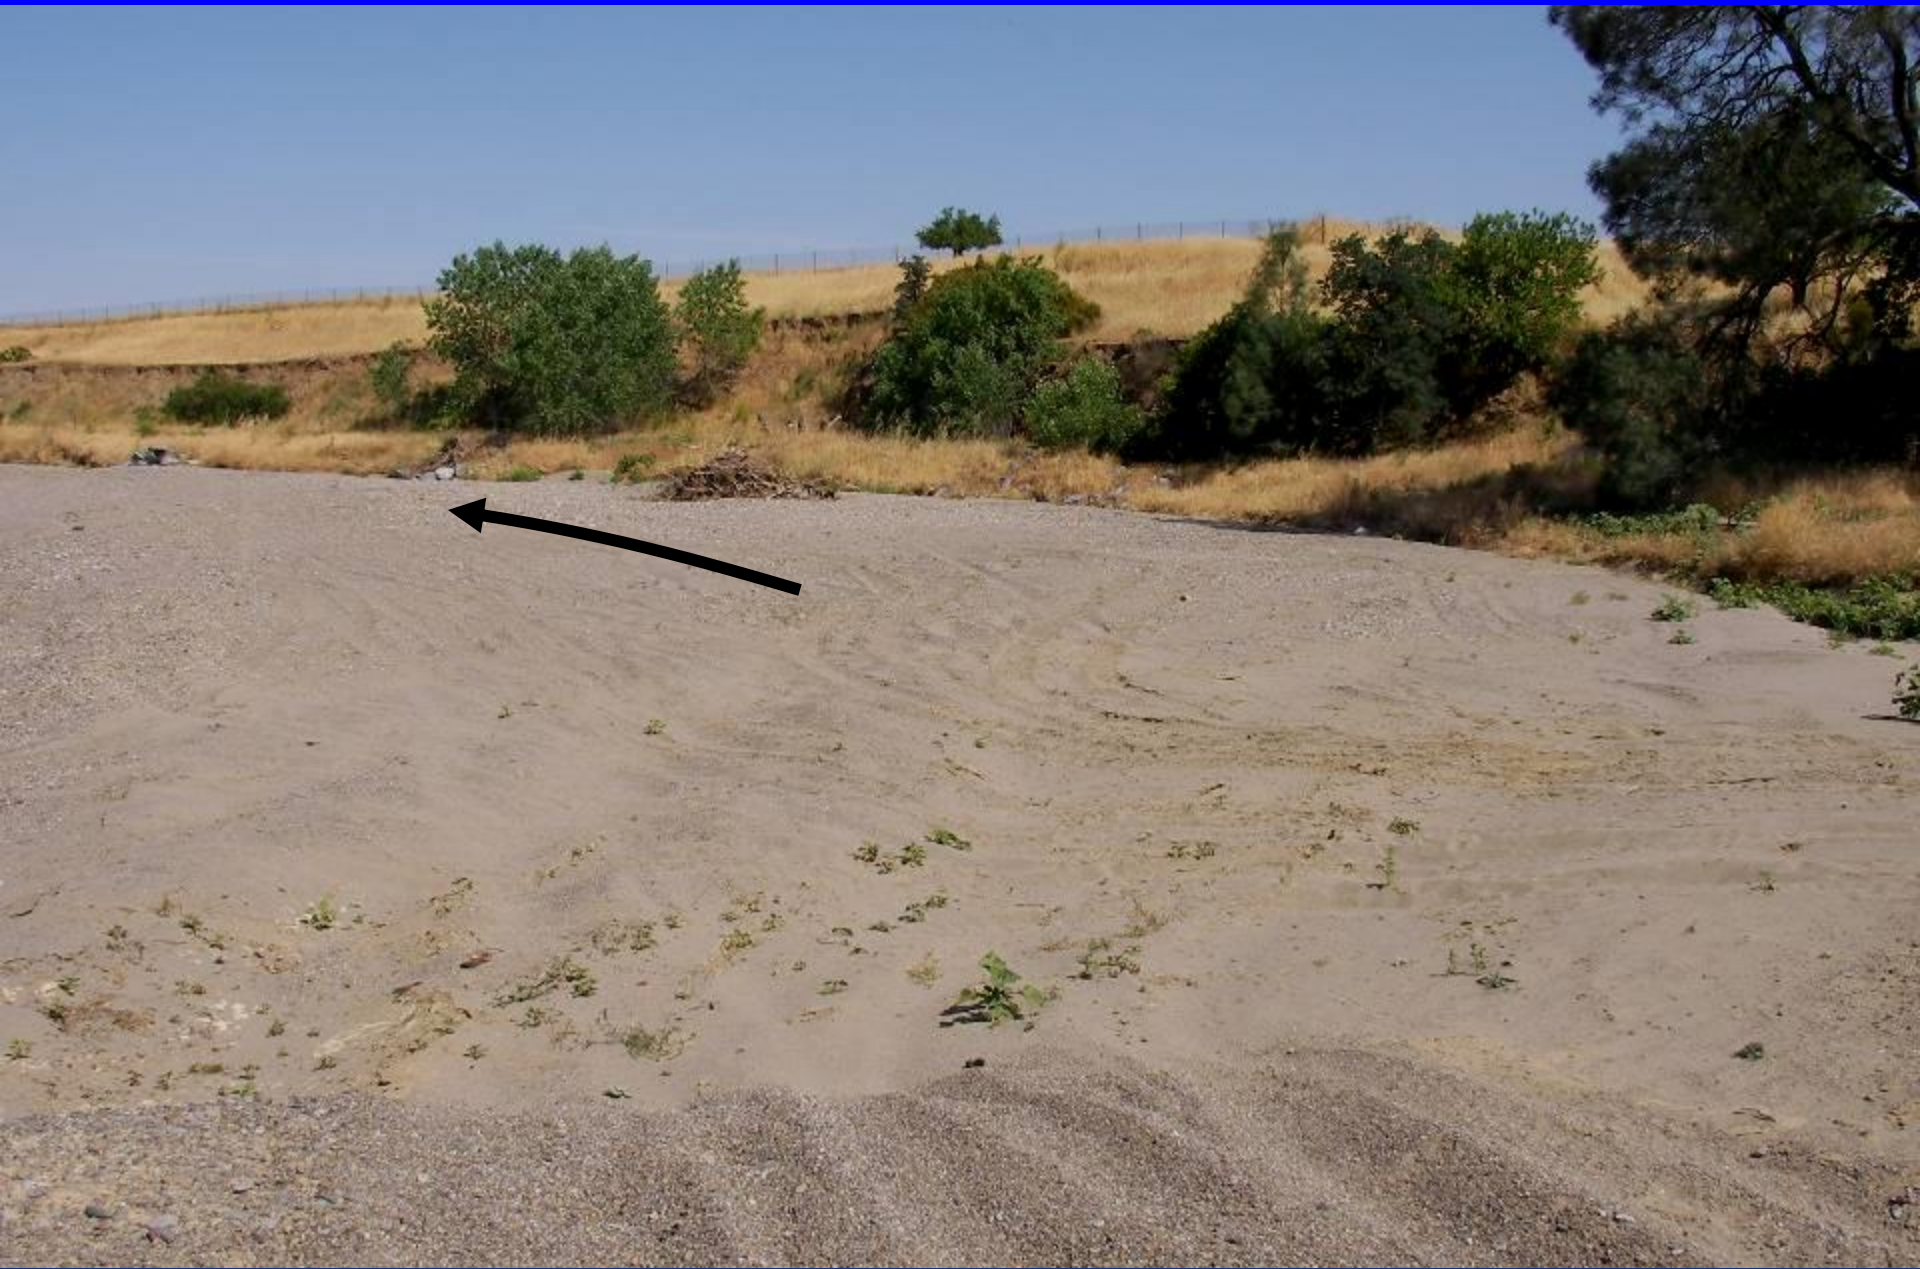
9+ Years-Looking DS @ flow in cliff area. All stable (veg in weir field area)

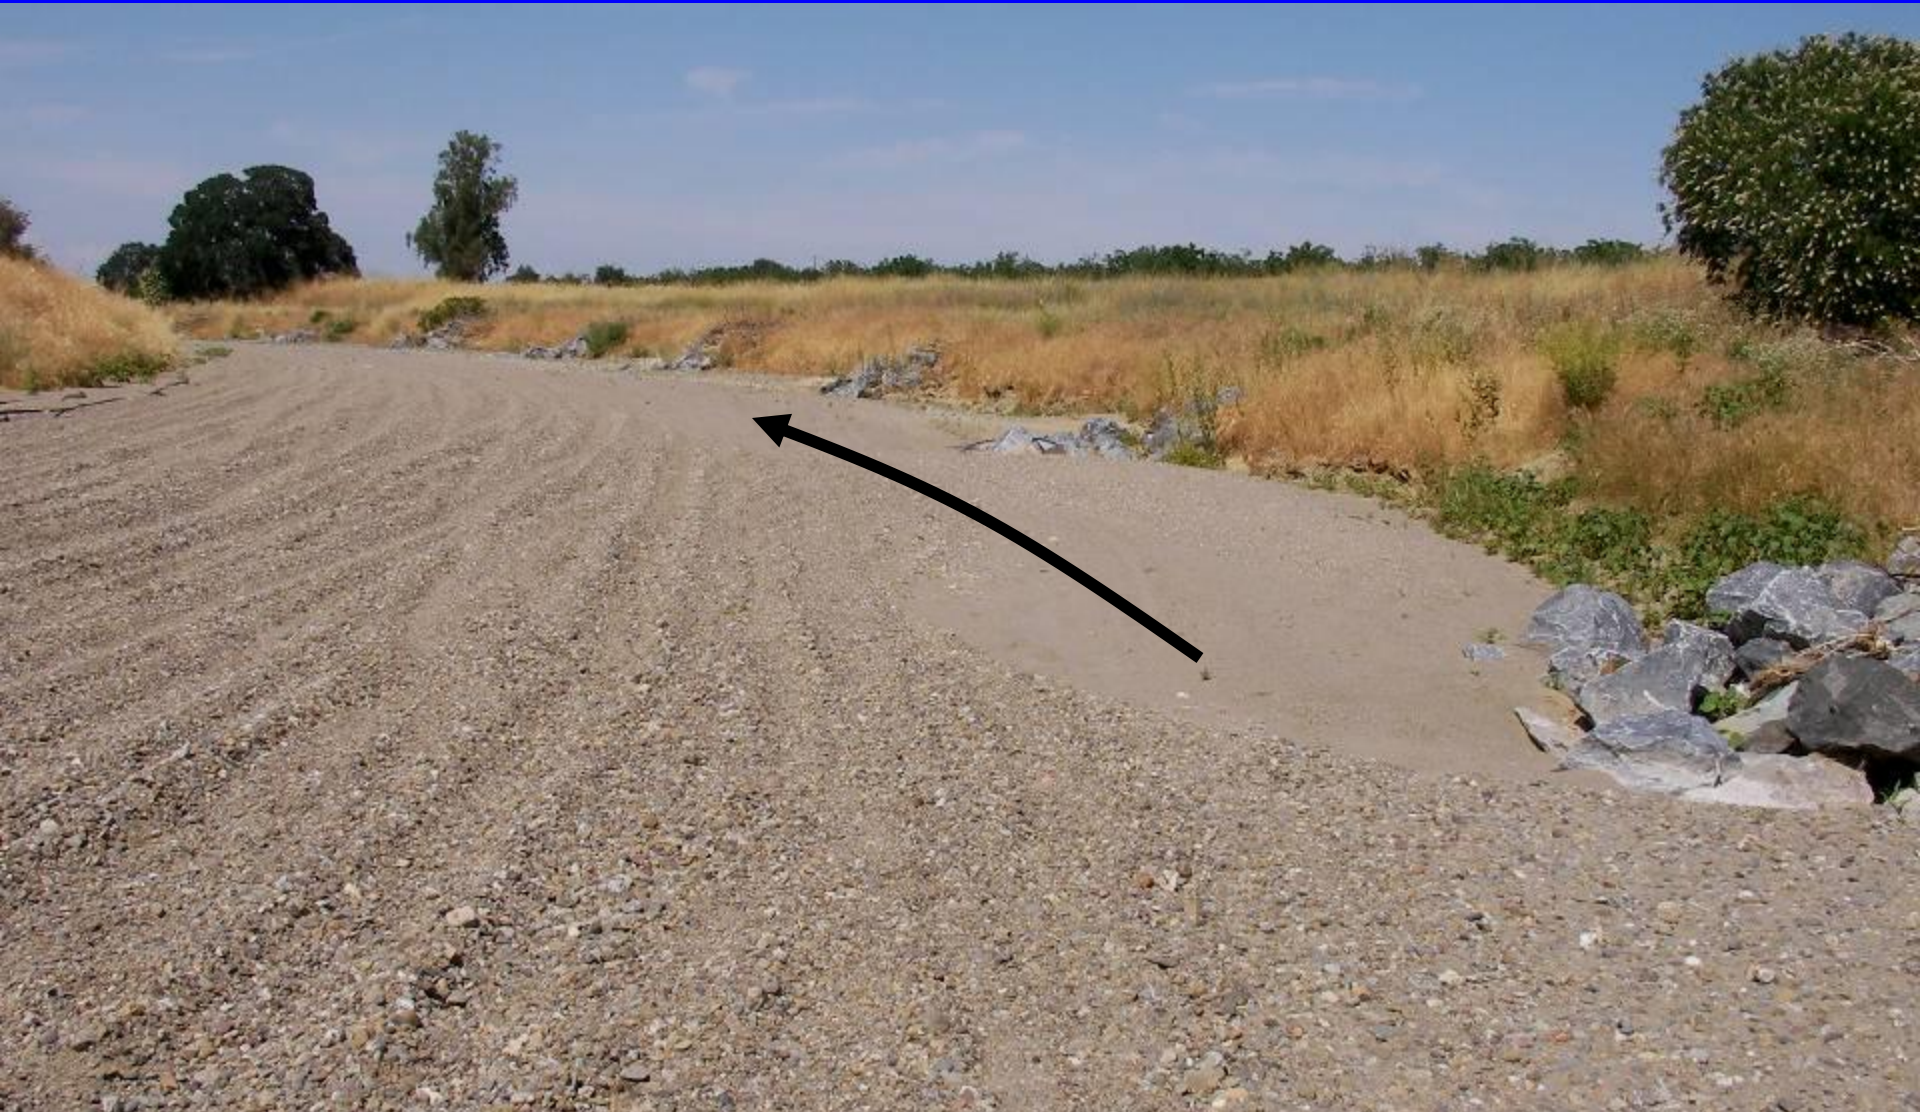
9+ Years-Looking DS @ channel alignment adjacent to burn dump area. Deposition in weir field, Bendway Weirs in good shape, smooth channel alignment results in stability through this entire critical reach.

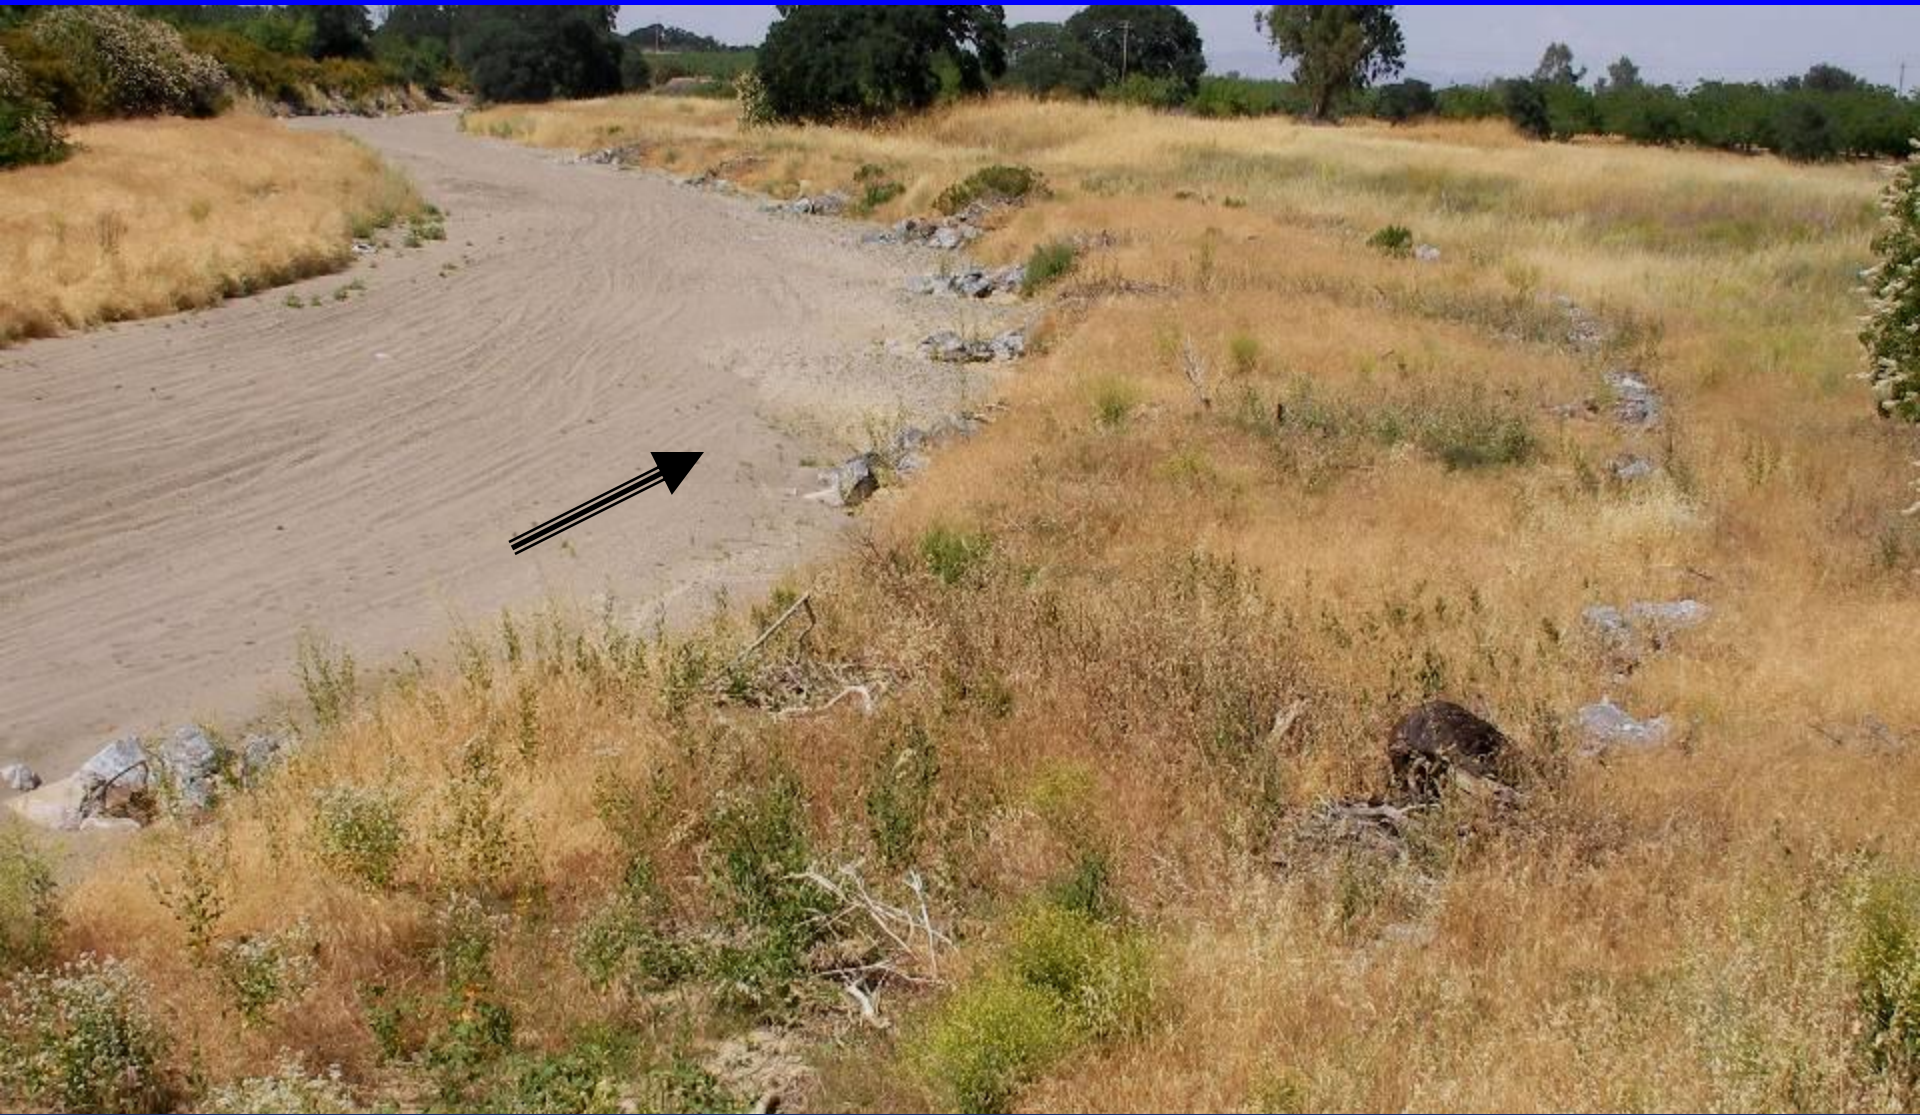
**9+ Years-Looking DS @ deposition within weir field provides 50 ft wide buffer between stream and LPSTP bank protection for dump area.
Note smooth transition from right bank to left bank flow.**

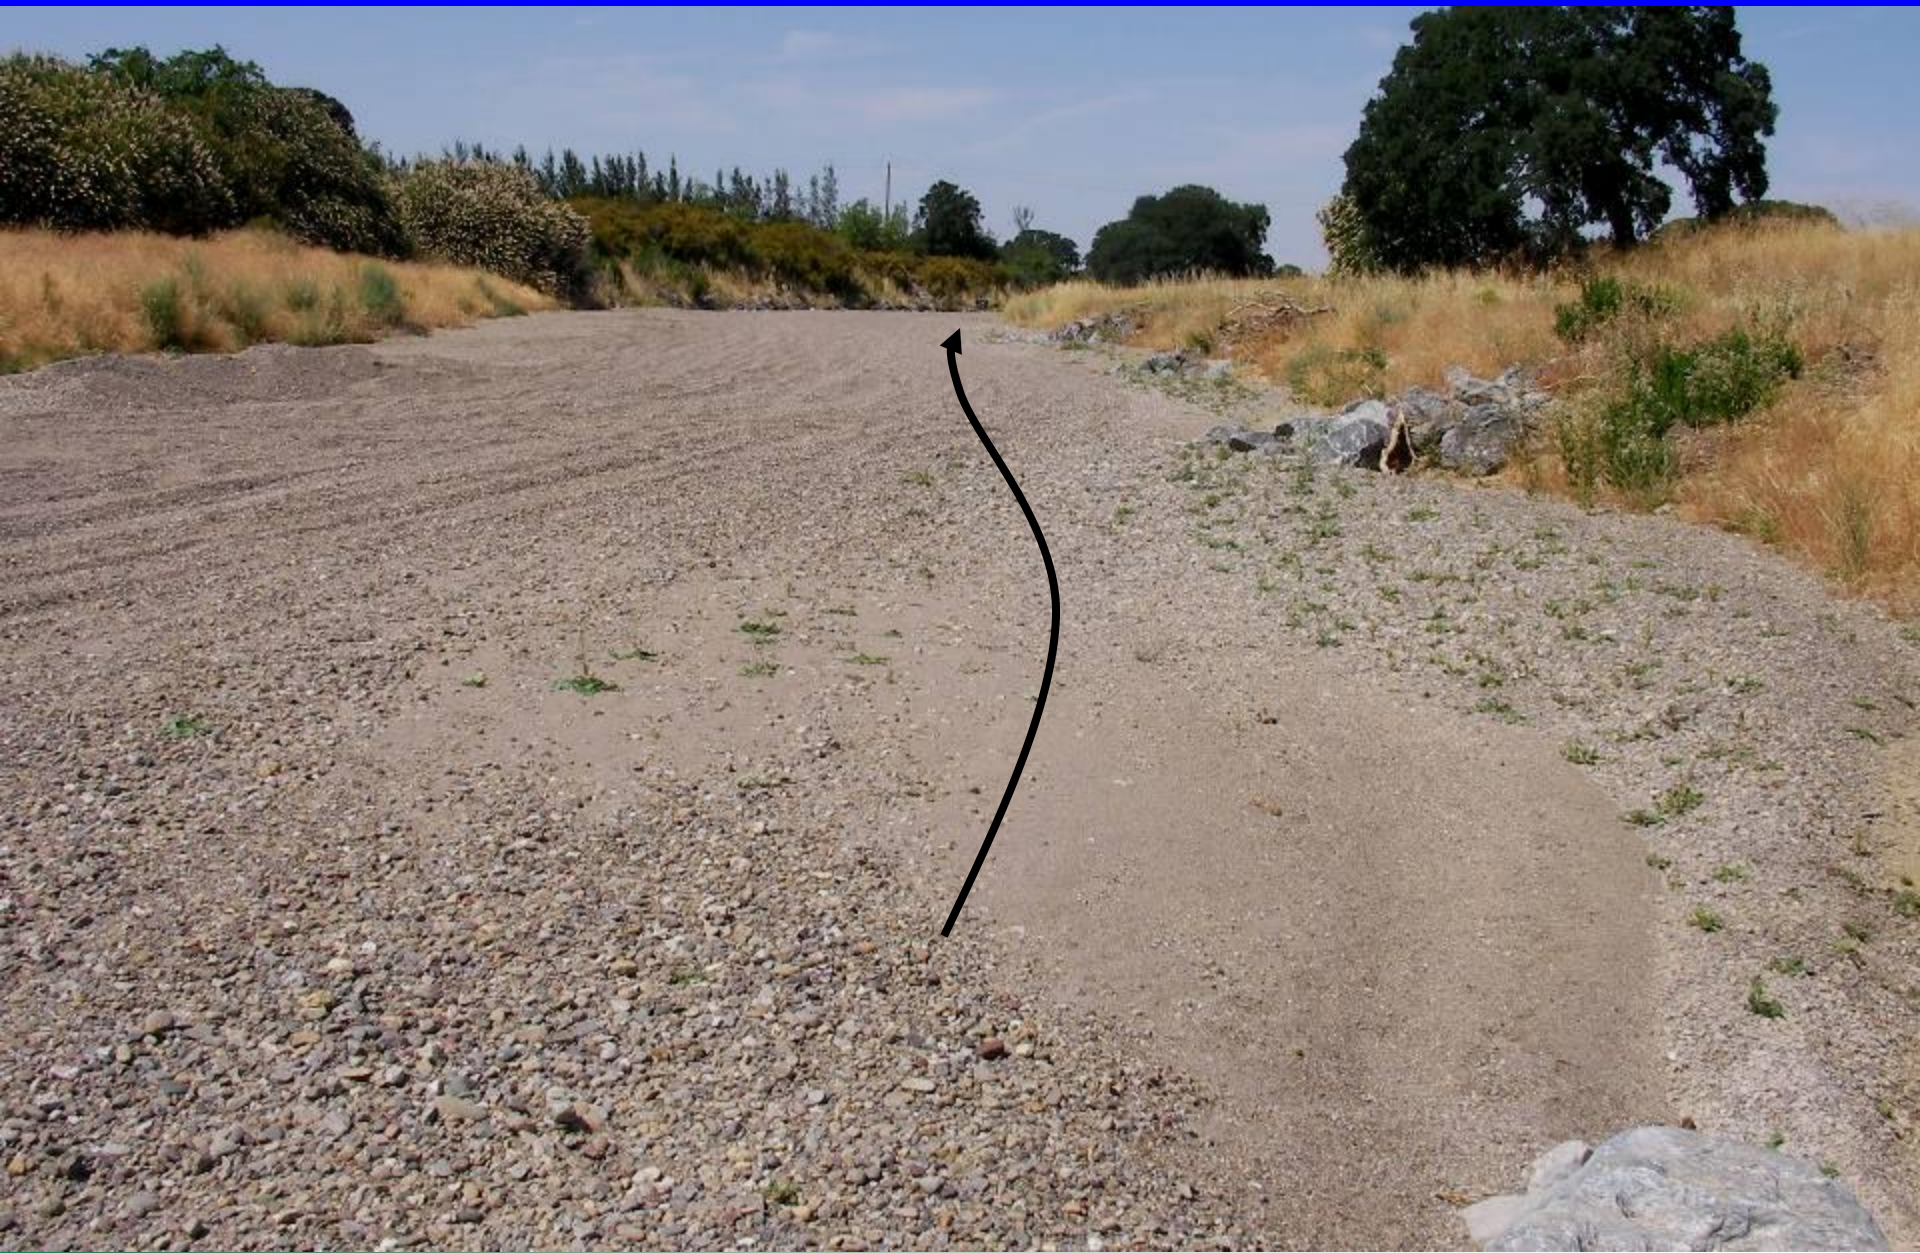
9+ Years-Looking DS @ transition of flow from right bank to left.

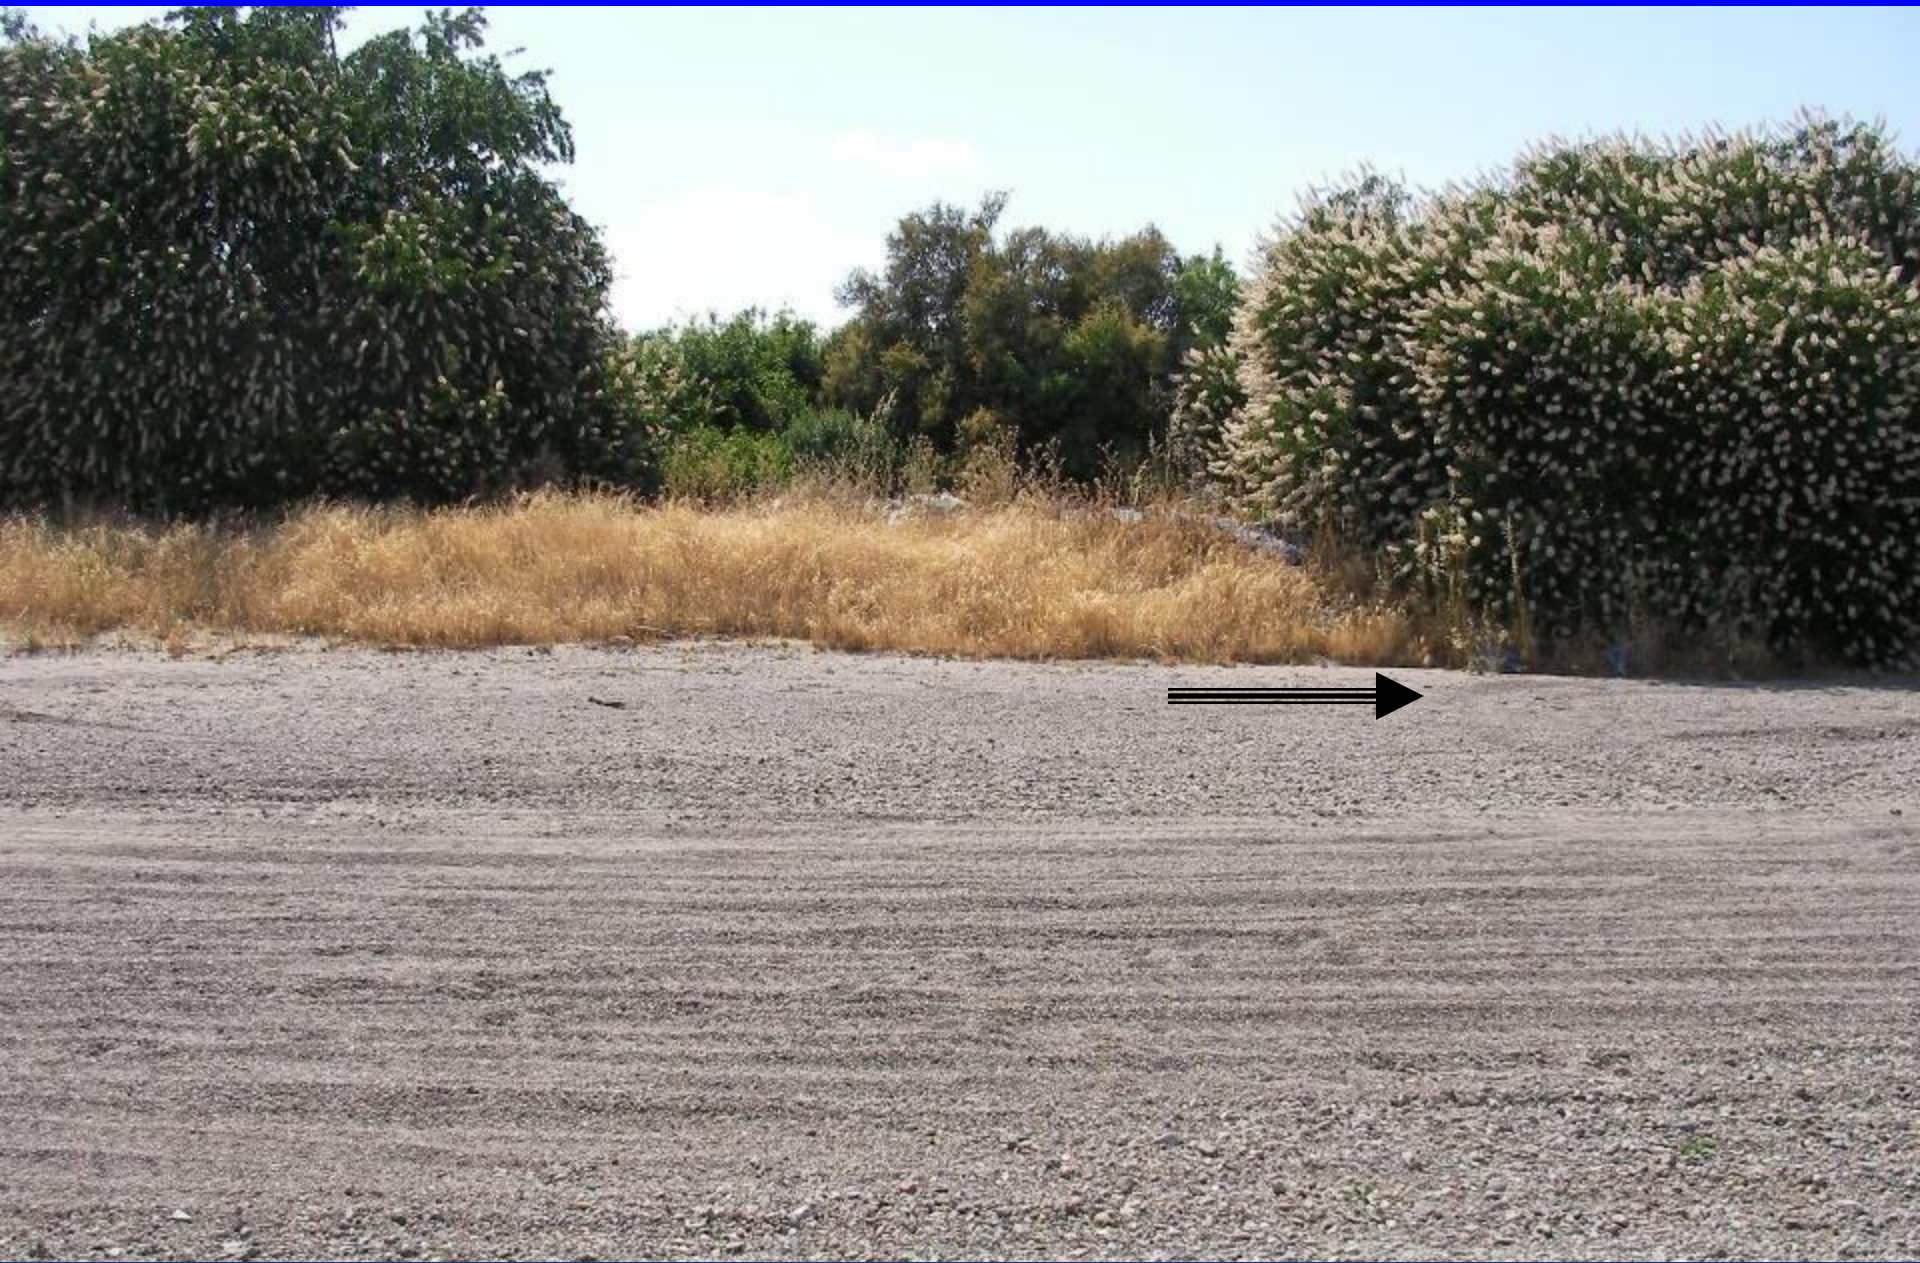
9+ Years-Looking @ deposition streamward of left bank US key.
