Sulphur Creek @ Dunnigan Burn Dump,

Yolo County, CA.

BUILT 1998

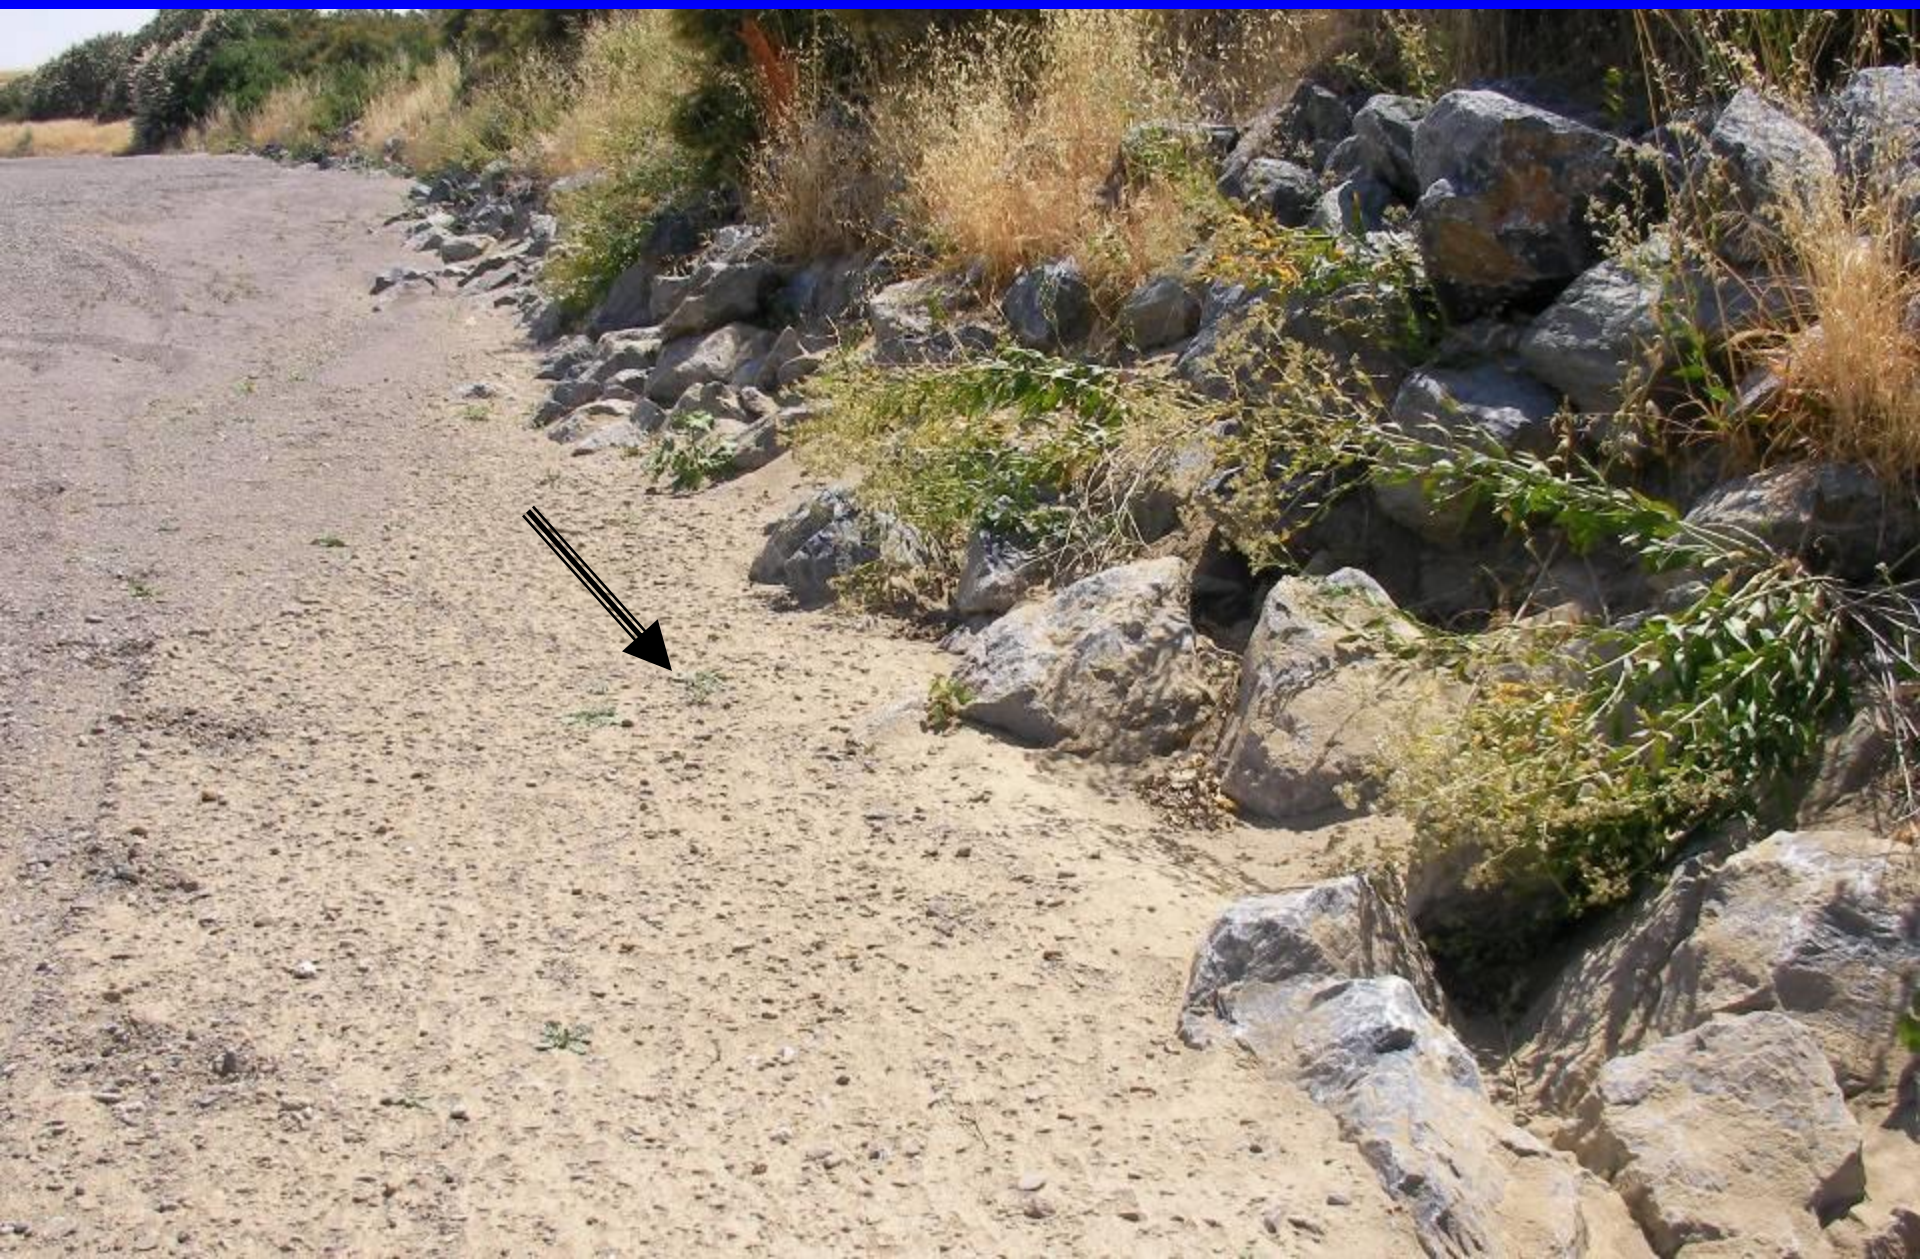
9+ Years-Looking US @ self-adjusting stone & veg in left bank protection

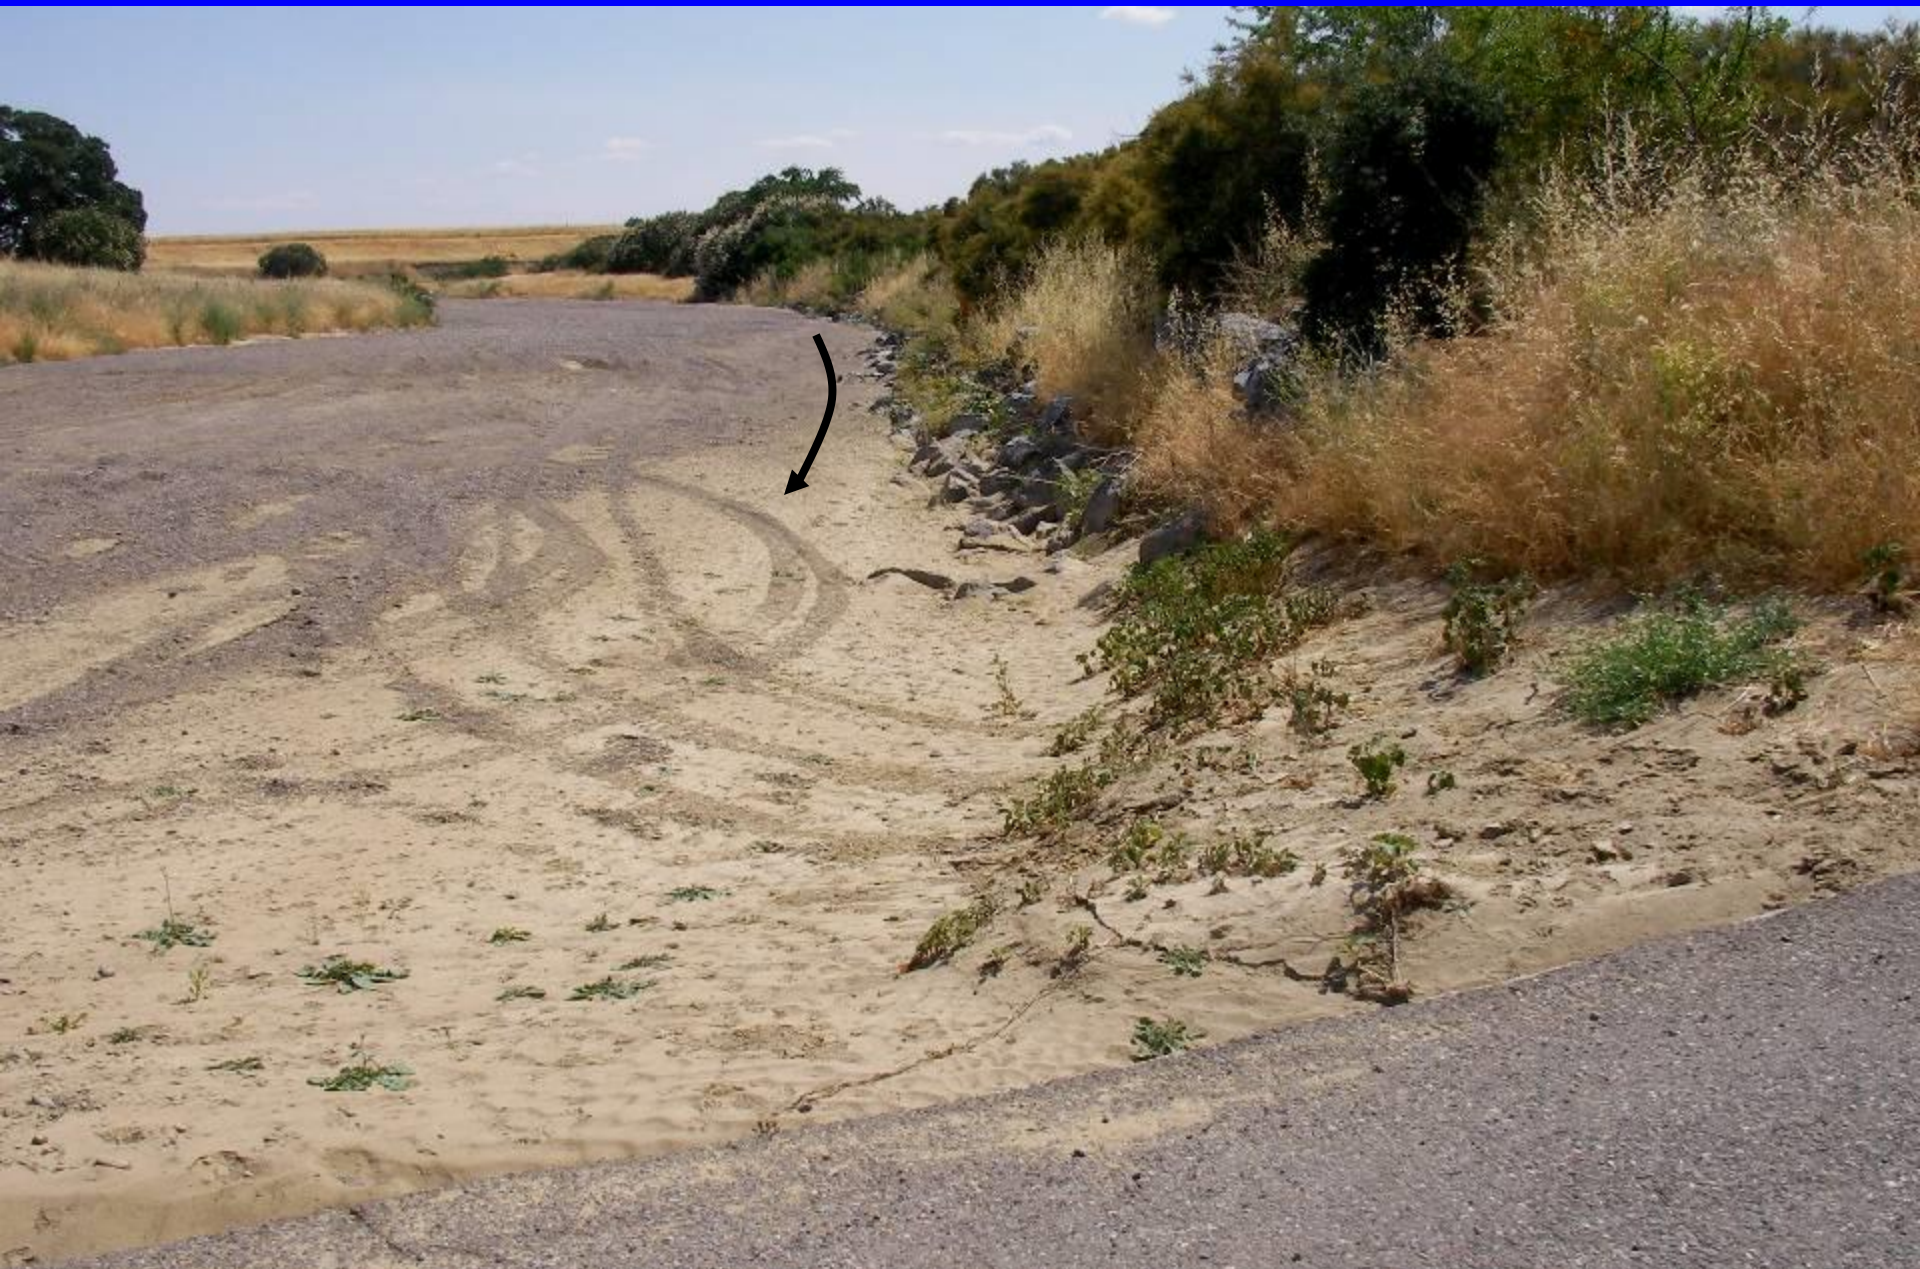
9+ Years-From road looking US @ left bank protection & DS key, all stable
