Little Blue River, Kansas: Over Nine Miles of River Stabilization & 166 Acres of Riparian Corridor Establishment

**By Phil Balch, with a little
help from Dave Derrick**

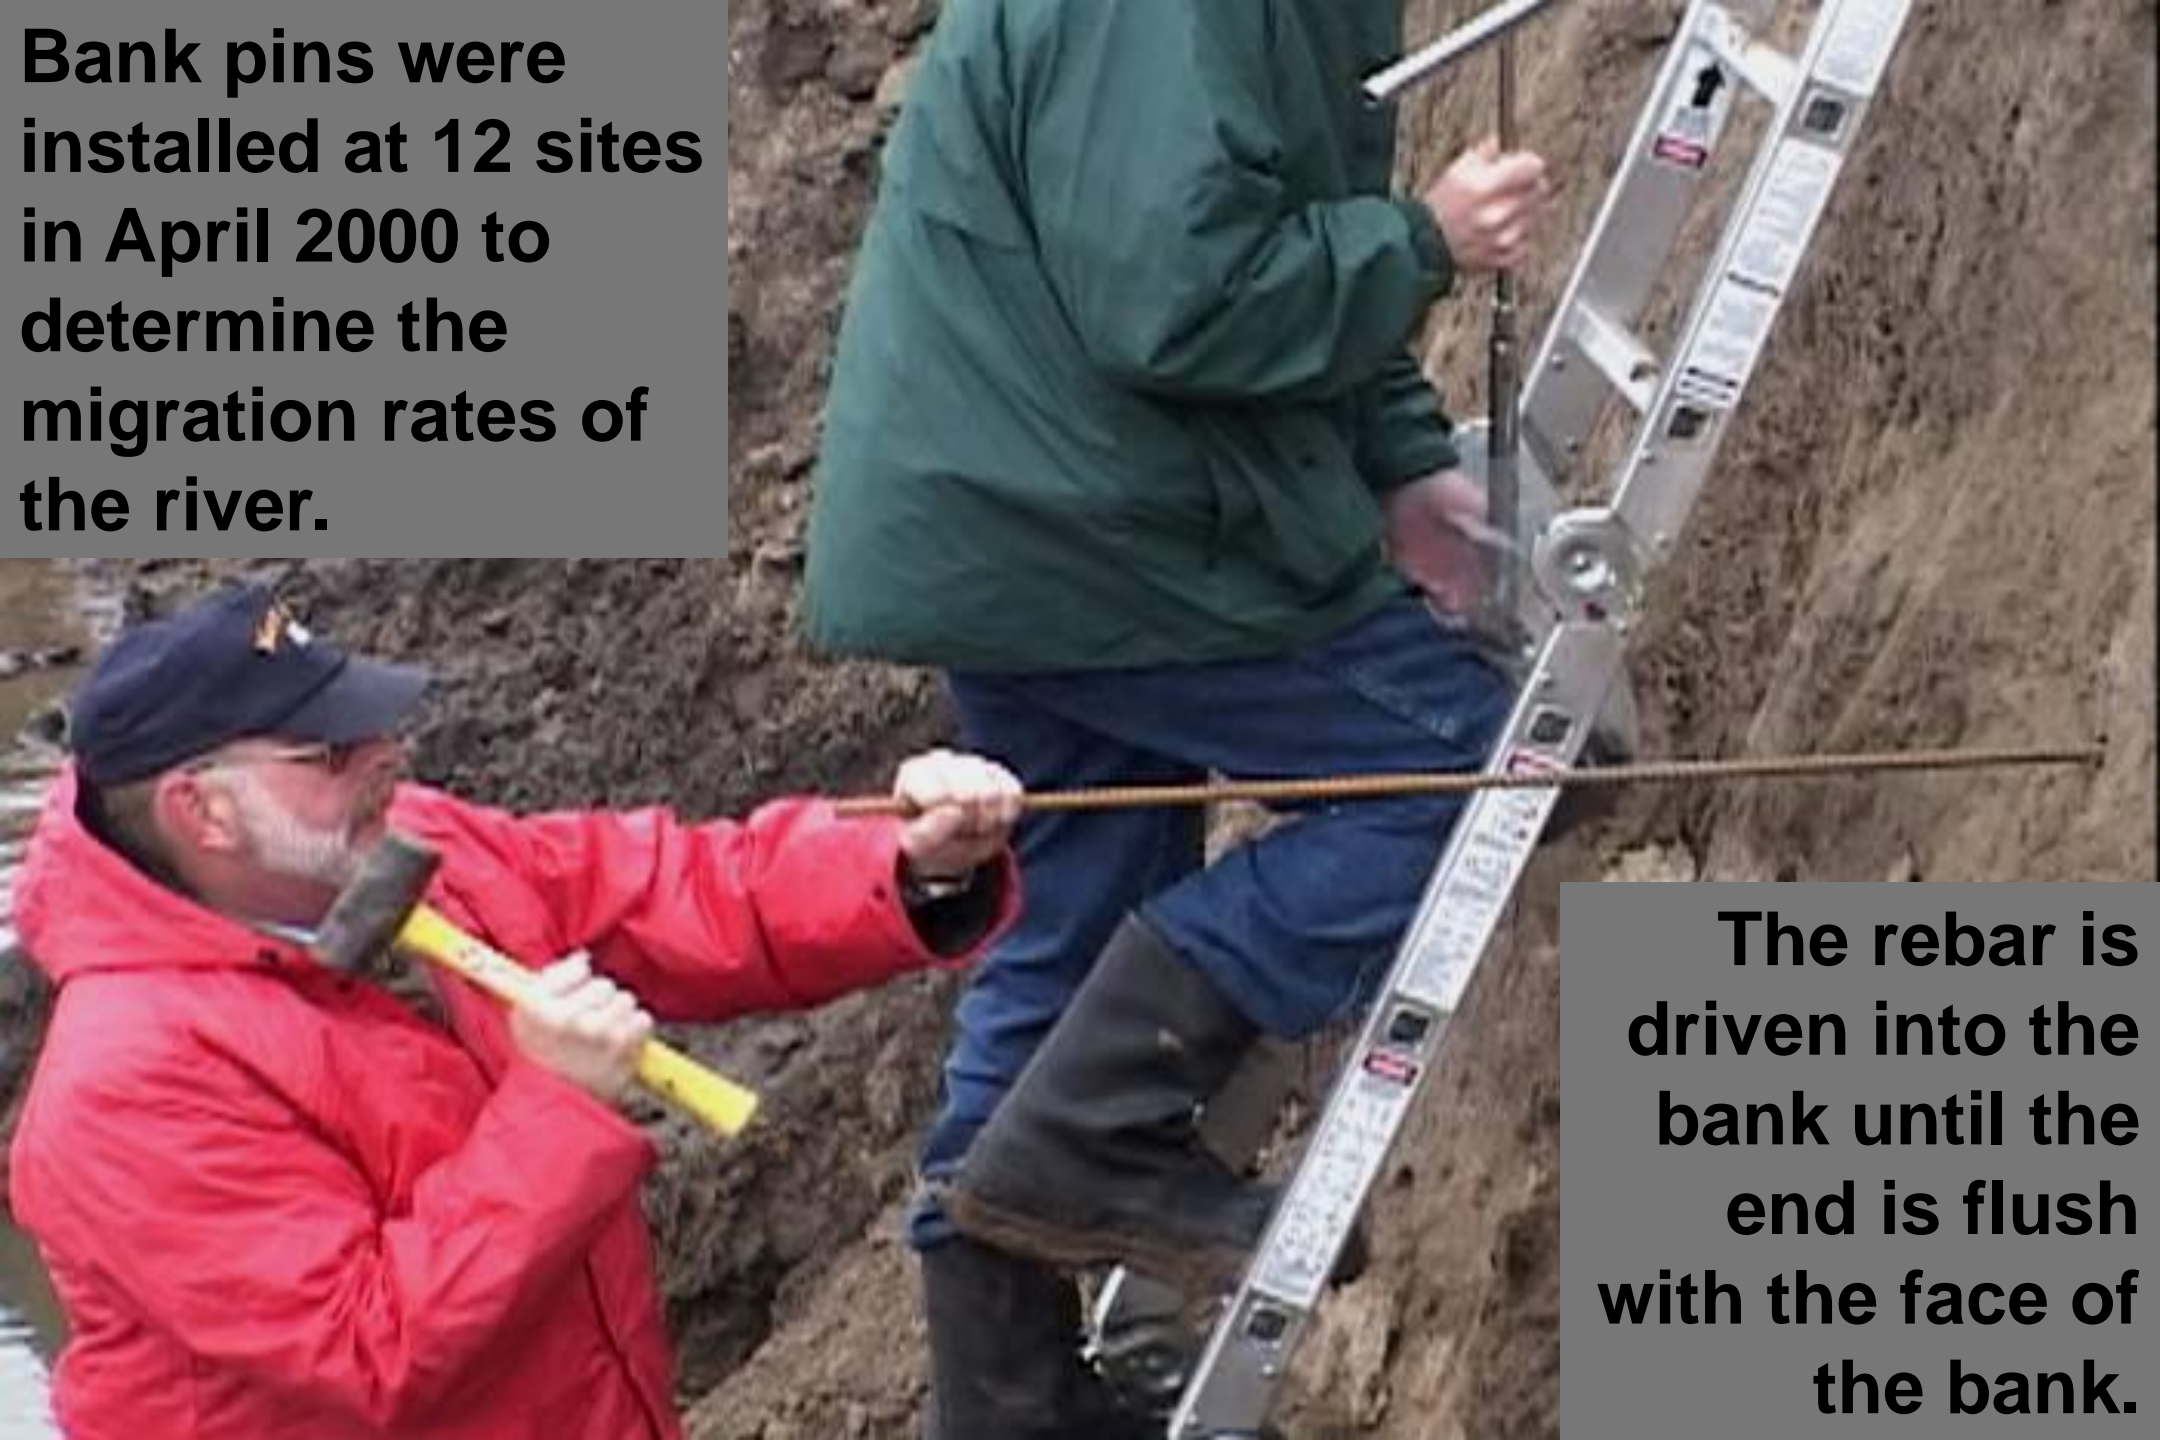
Bank pins were installed at 12 sites in April 2000 to determine the migration rates of the river.

The rebar is driven into the bank until the end is flush with the face of the bank.

*Bank erosion pins both
horizontal & vertical*

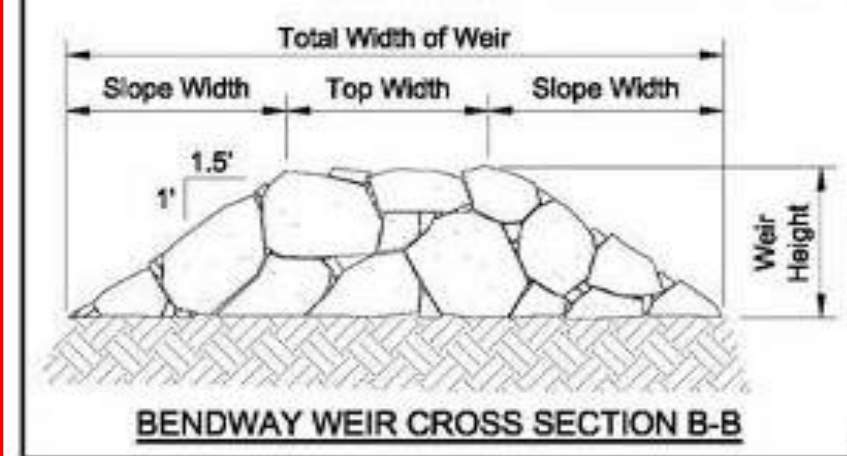
Detailed P & S for Bendway Weirs

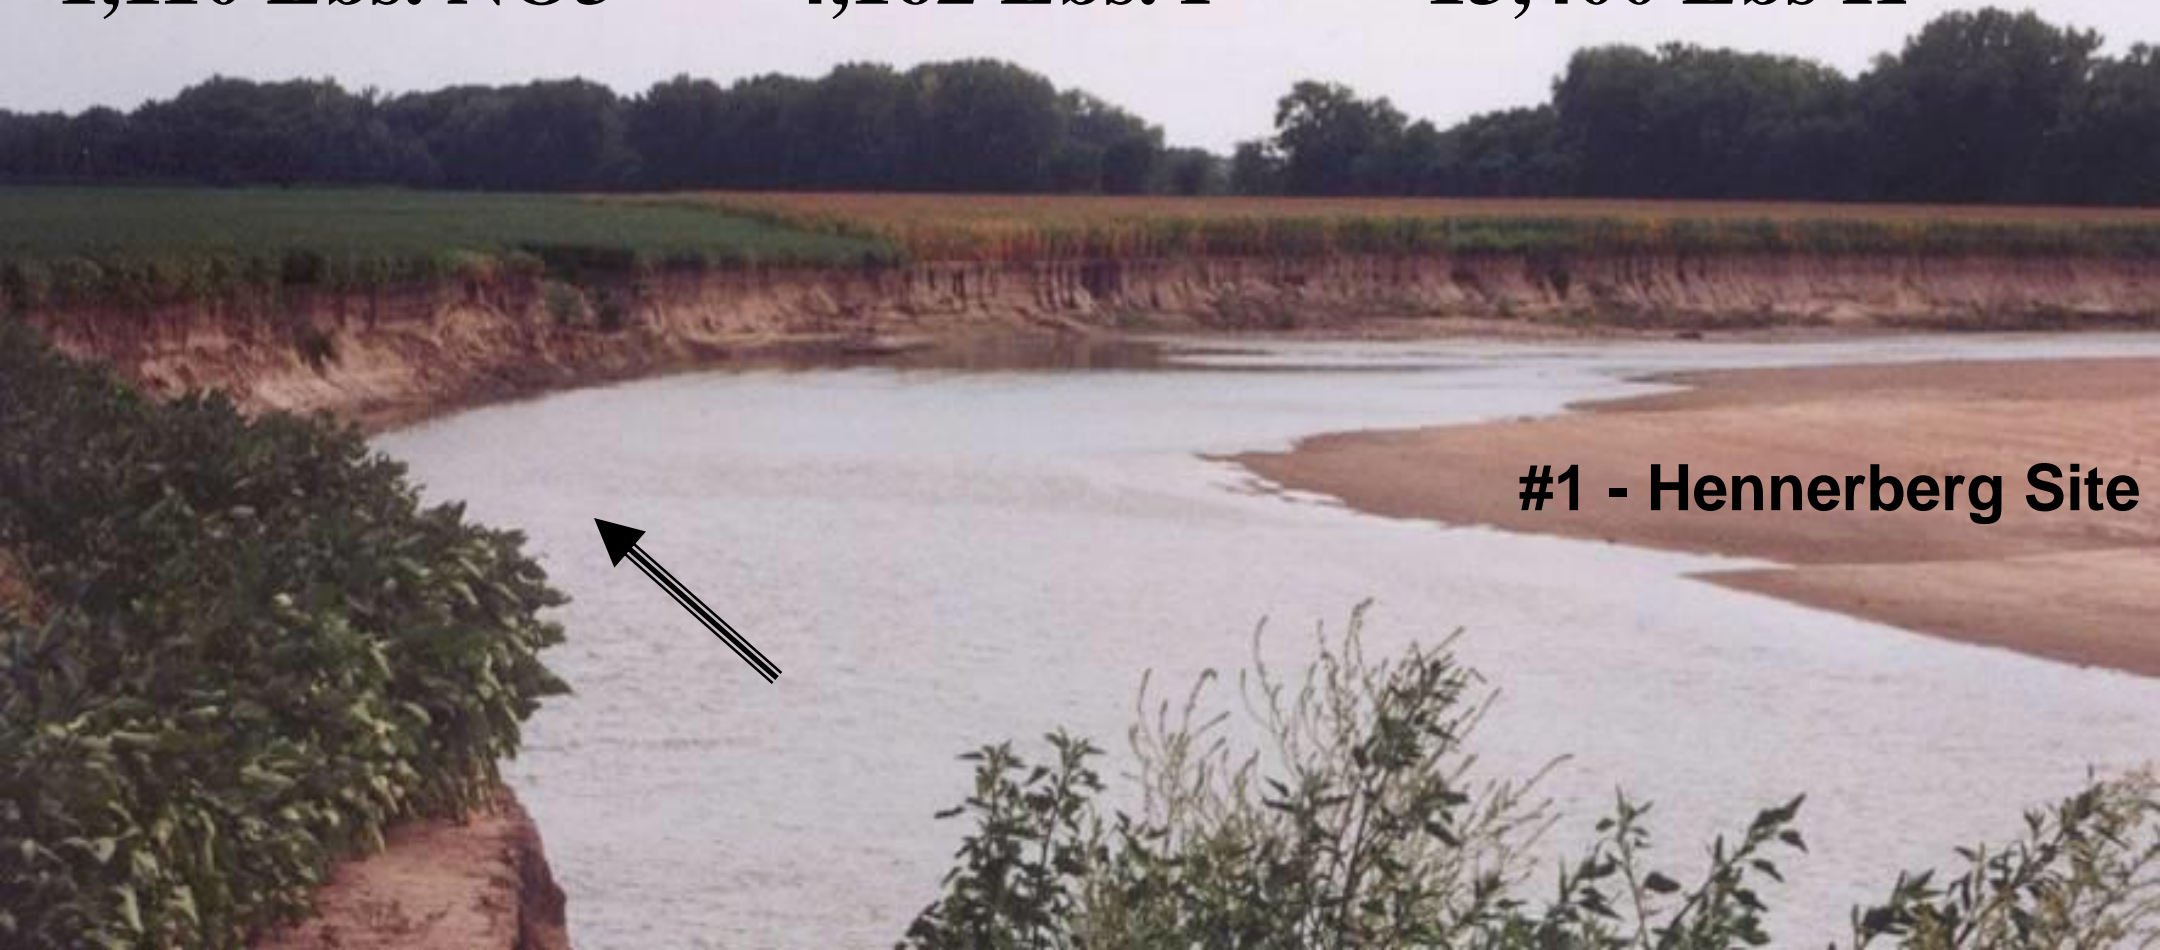
Site # 1 Hennerberg

An aerial photograph of a river bend. A red line is drawn along the outer bank of the bend, indicating the path of lateral migration. Three yellow arrows point to specific locations along this red line: one at the top of the bend, one further down, and one at the bottom. The surrounding landscape is a mix of fields and trees.

Rosgen Stream Type = C4c

**Lateral Migration (Erosion) from
March 2000 to August 2001 = 205 ft.**

Amount of soil loss = 231,200 tons

**Nutrient Content = 1,110 Lbs. NO₃,
4,162 Lbs. P, 13,400 Lbs K**

**Volumes contributed to stream from 3/2000 to
8/2001 - 17 months (without a big flood!!)**

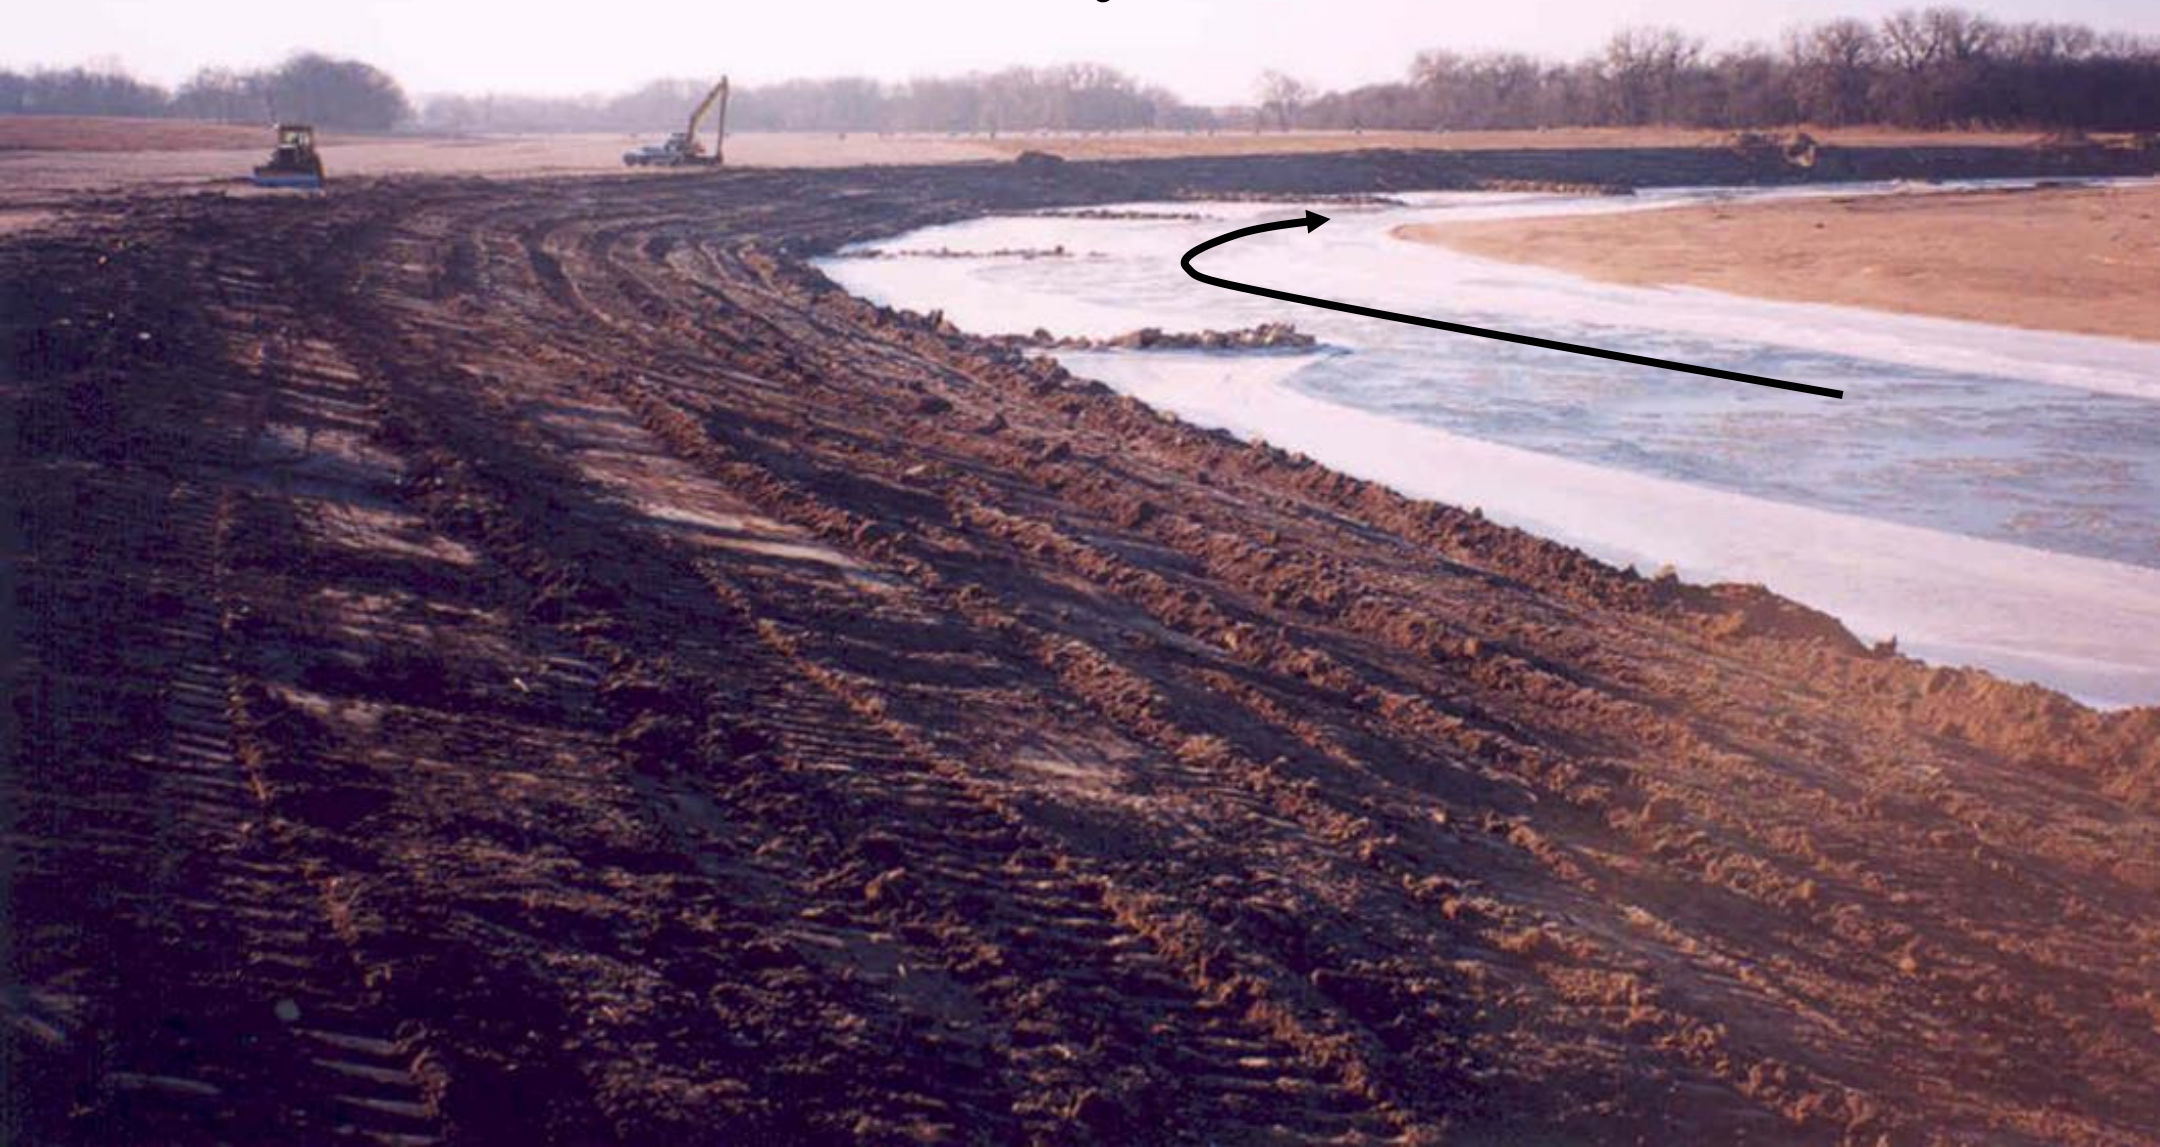
**Hennerberg Project, Little Blue River, Bendway Weirs
constructed, bank laid back, no plantings or seeding yet.
January 2002**

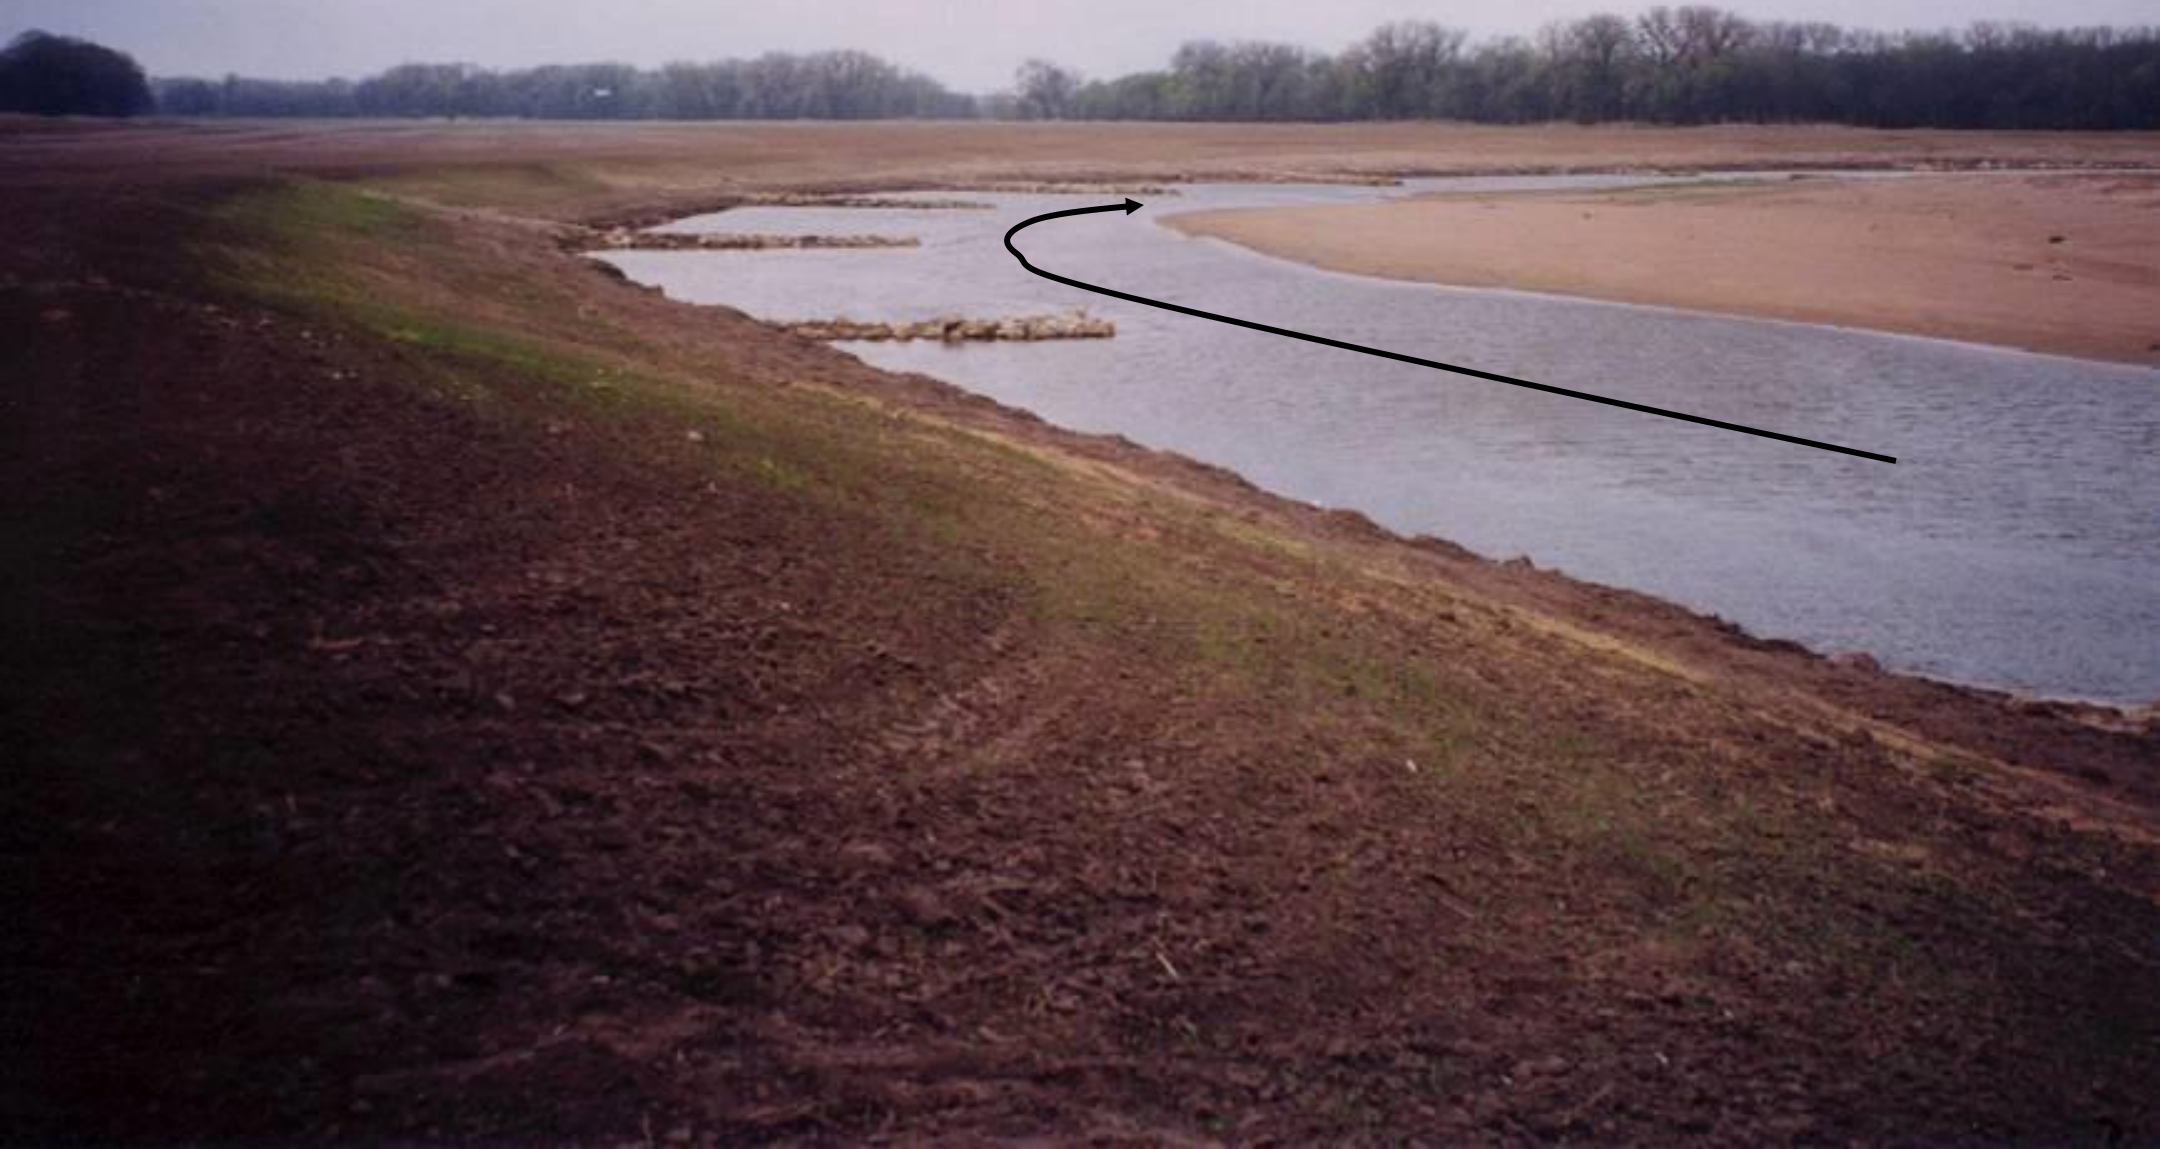
**Site # 1 - Hennerberg – March 2002 – Bendway
Weirs built, bank sloped & seeded.**

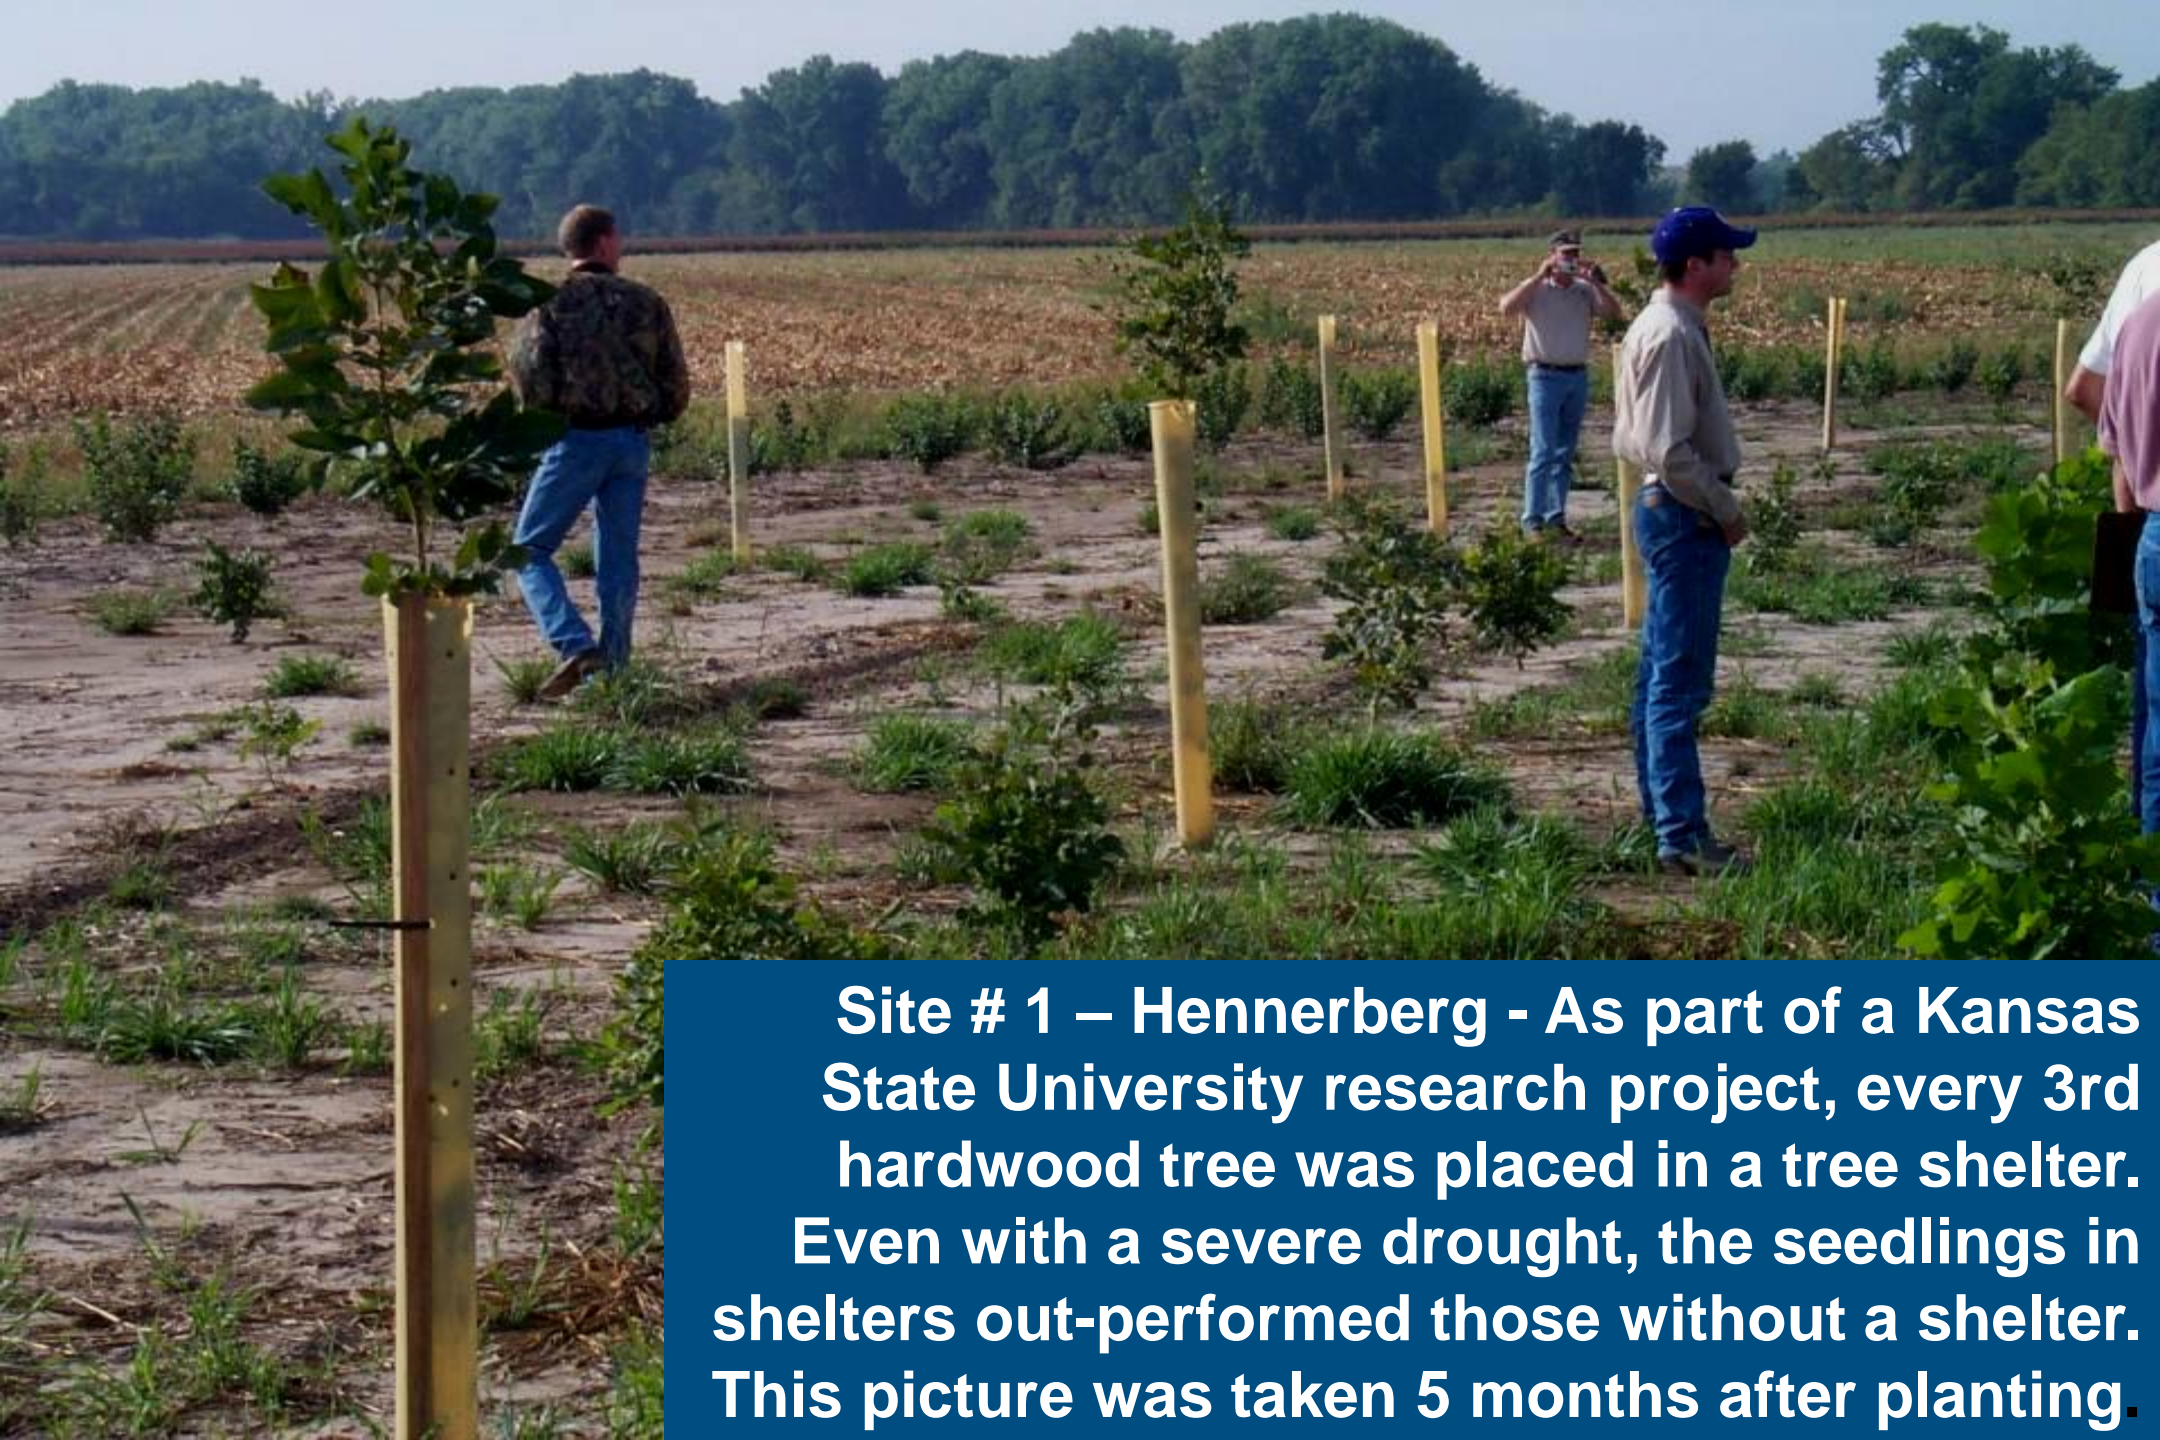
Site # 1 – Hennerberg - As part of a Kansas State University research project, every 3rd hardwood tree was placed in a tree shelter. Even with a severe drought, the seedlings in shelters out-performed those without a shelter. This picture was taken 5 months after planting.

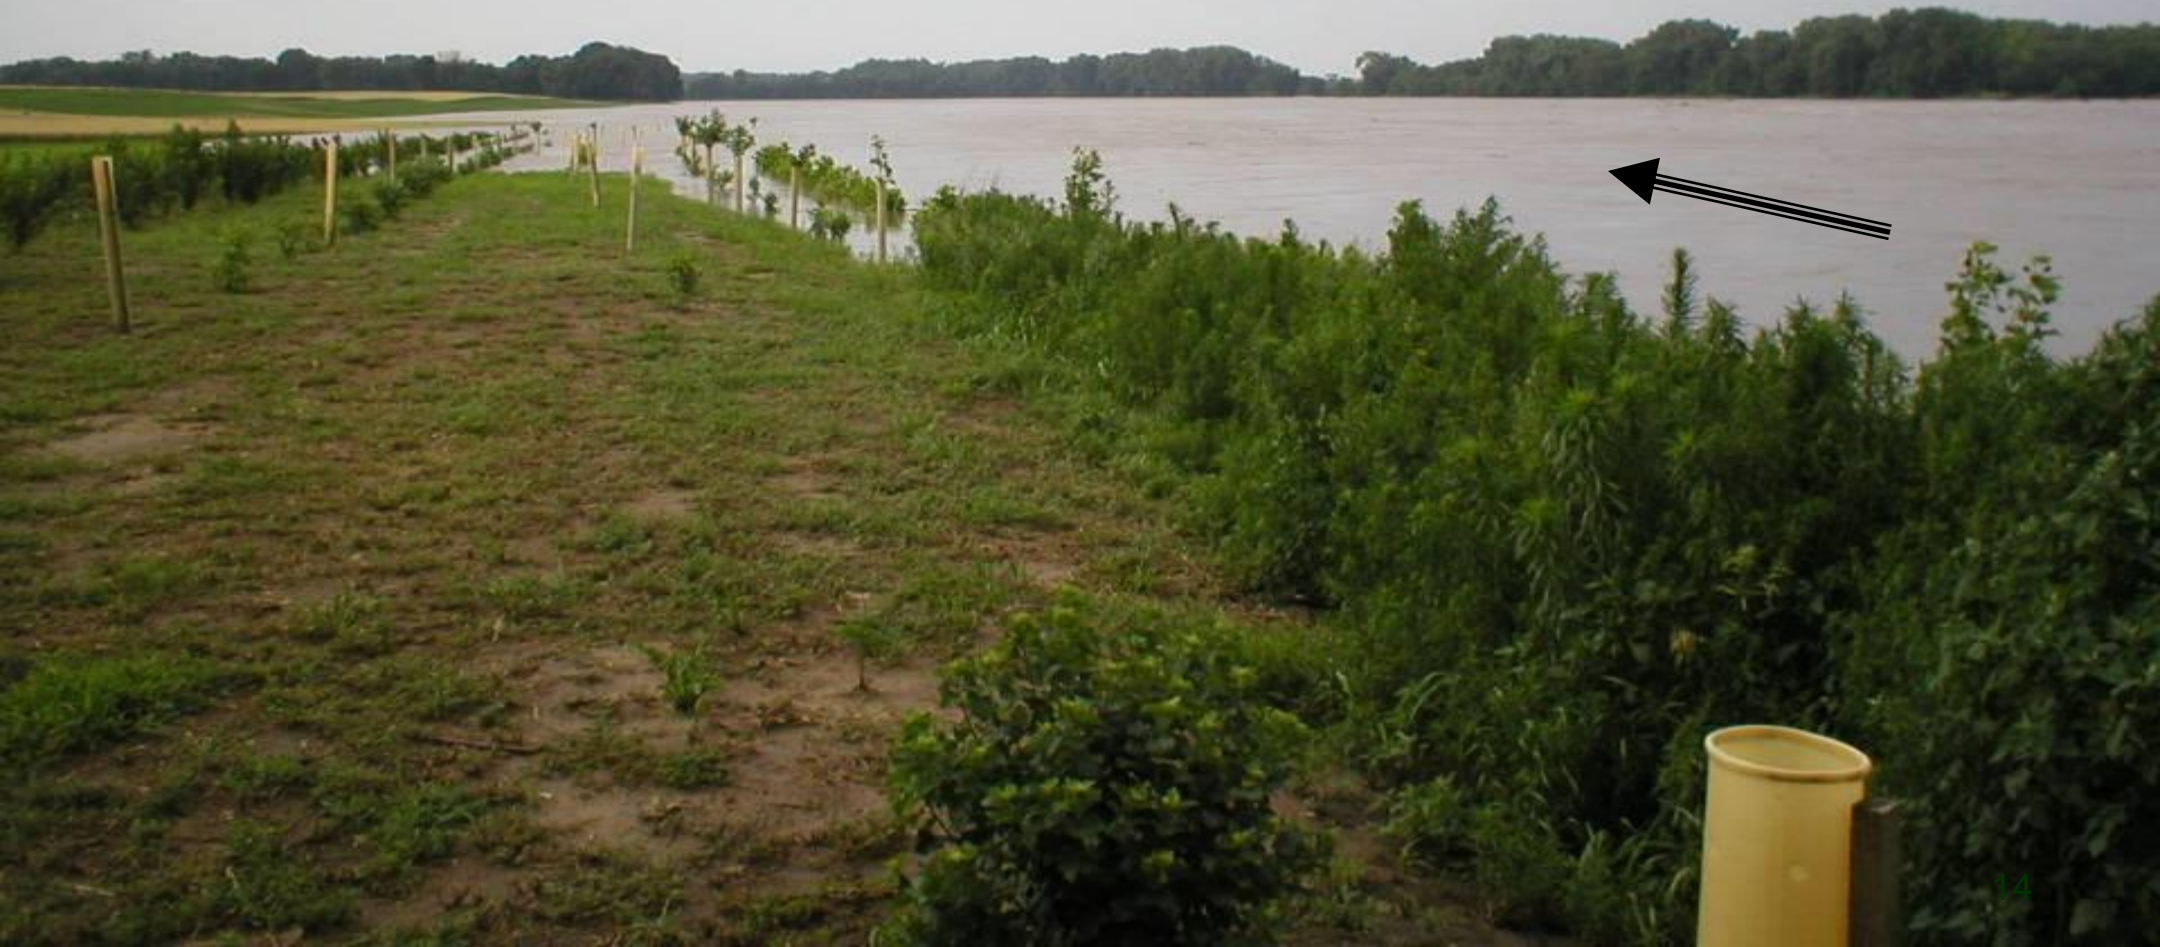
Site # 1 - Hennerberg 6/24/2003 – 42,000 + cfs flood

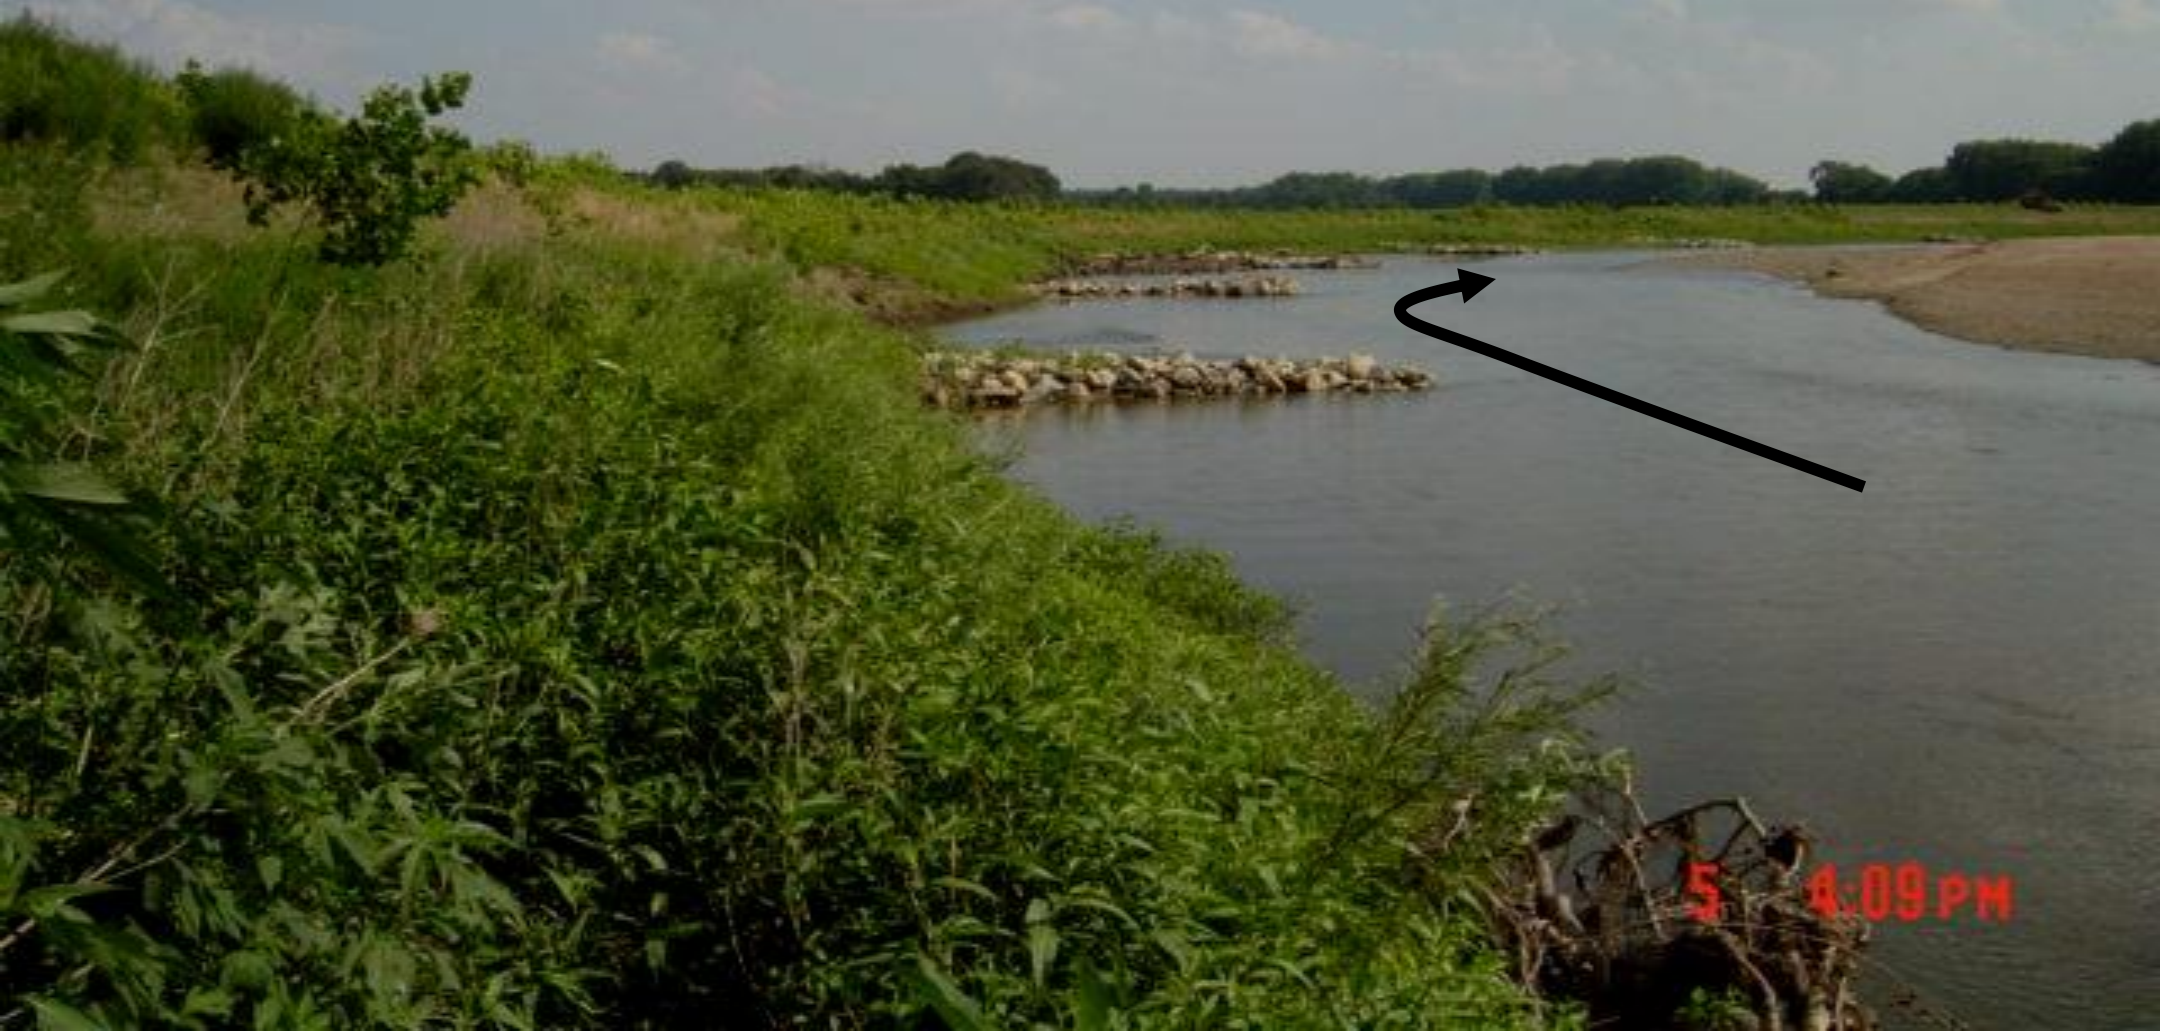
Bendway Weirs at the Hennerberg Site, Little Blue River. Looking Downstream after 2 Growing Seasons

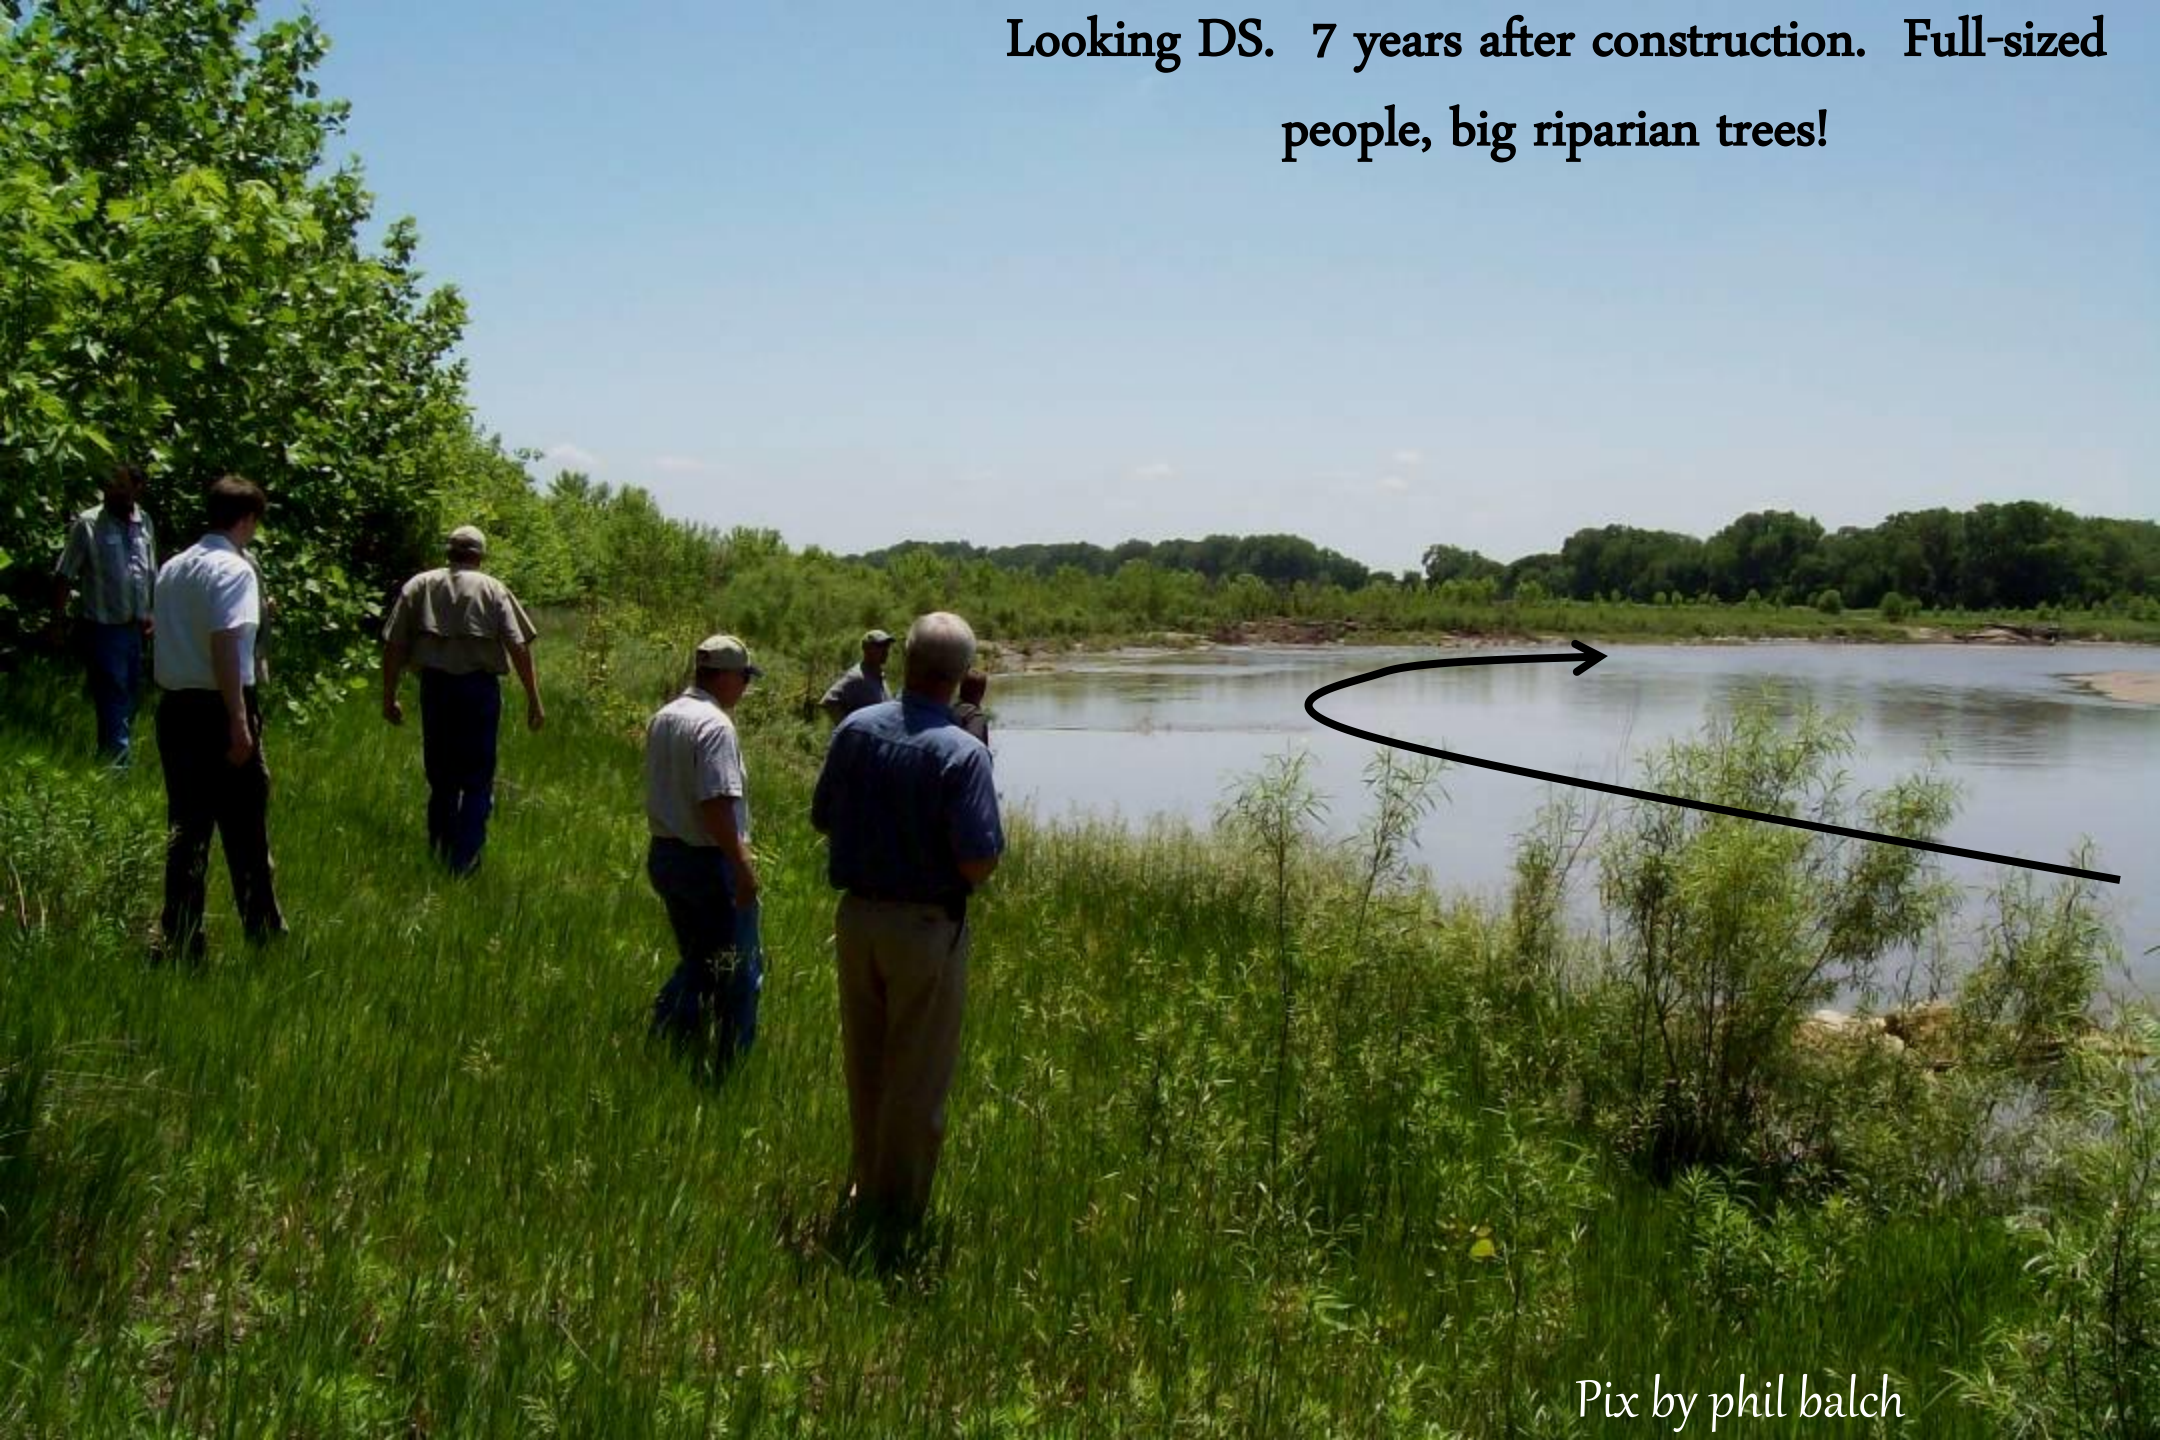
Looking DS. 7 years after construction. Full-sized
people, big riparian trees!
