Little Blue River, Kansas: Over Nine Miles of River Stabilization & 166 Acres of Riparian Corridor Establishment

**By Phil Balch, with a little
help from Dave Derrick**

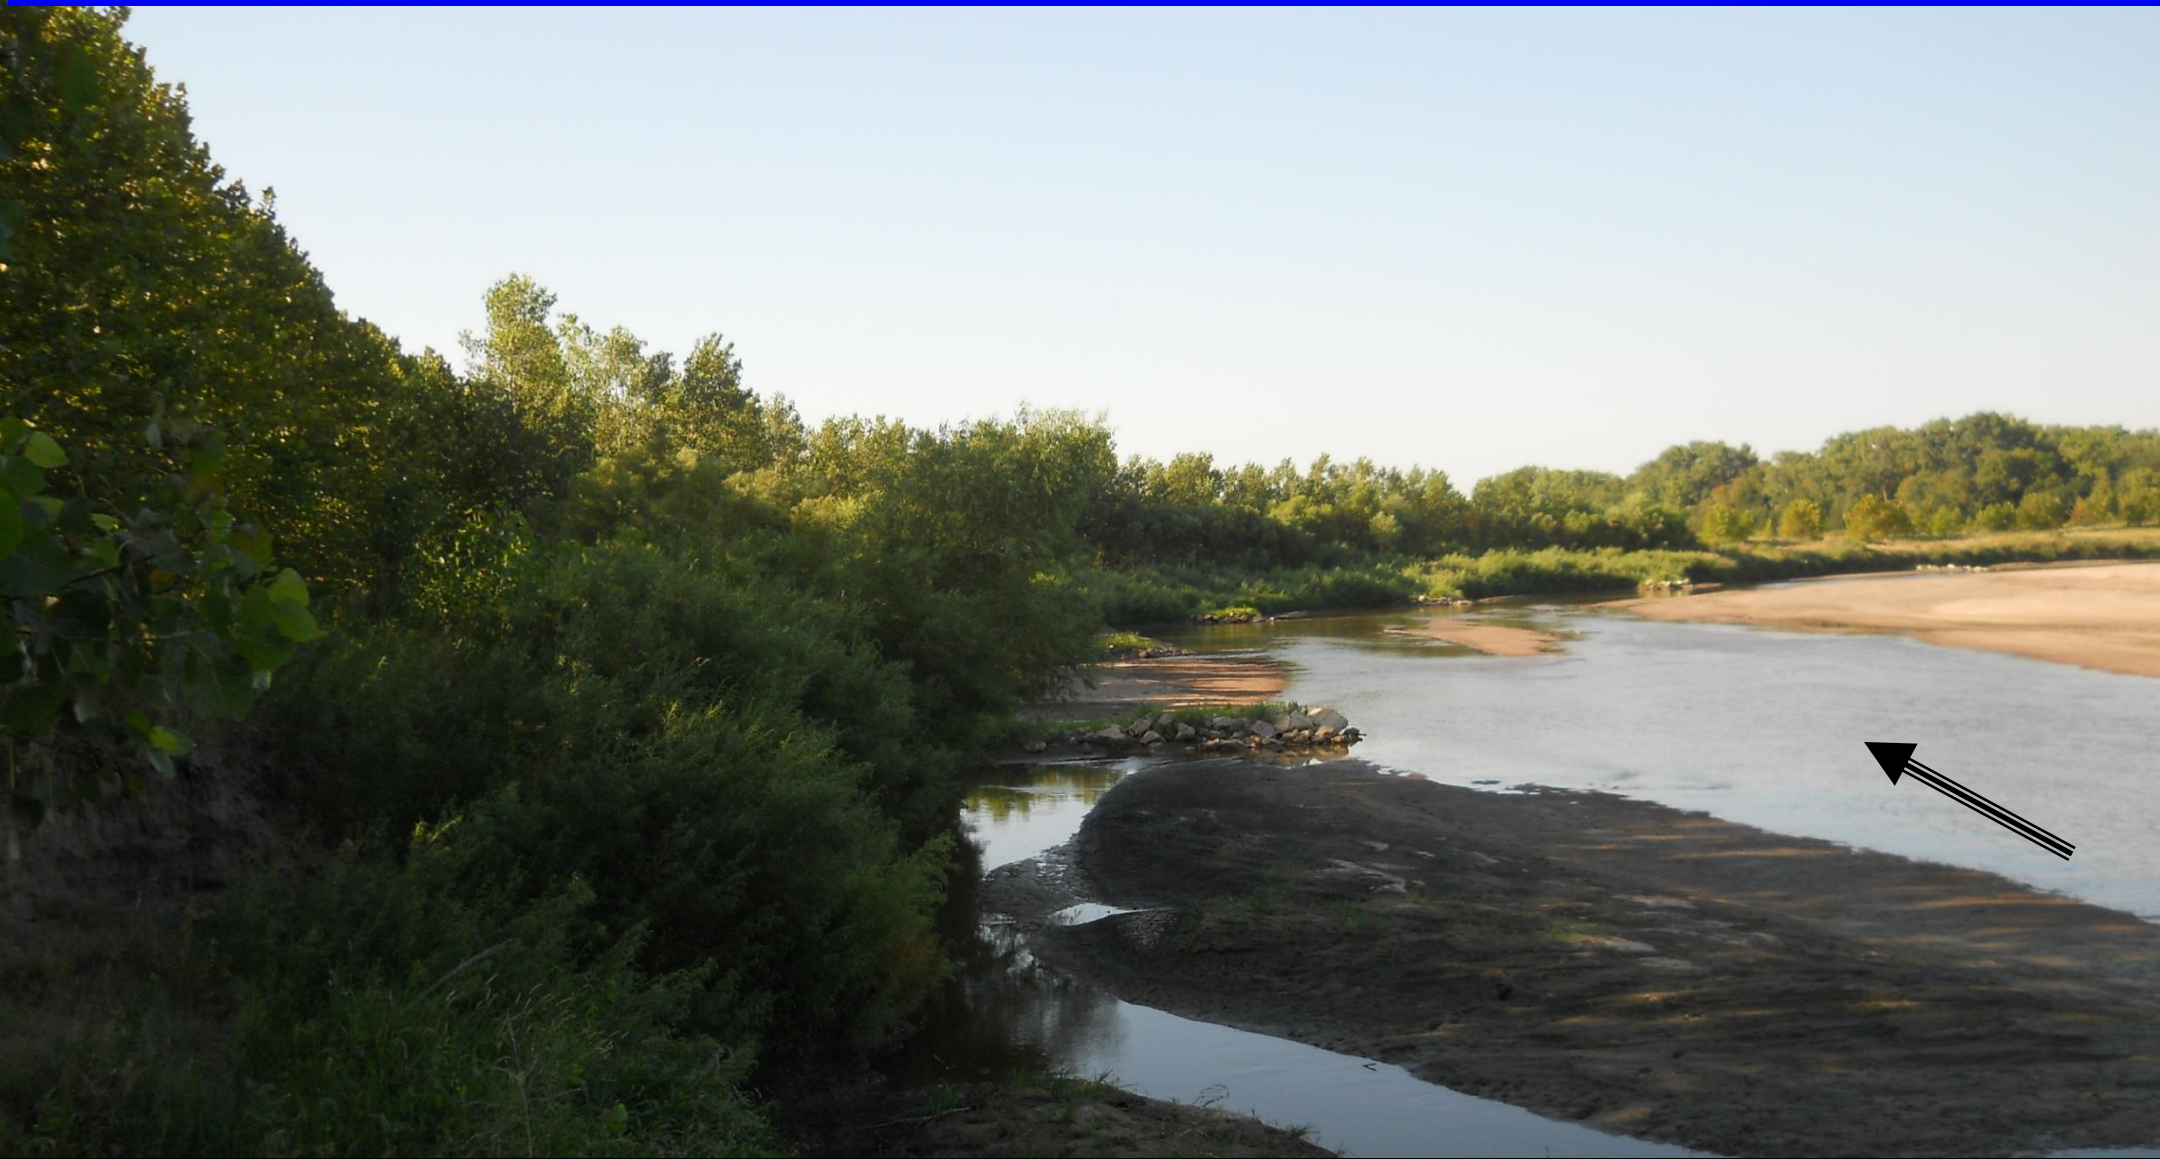
10 YEARS LATER-LTL BLUE R-HENNERBERG SITE- DERRICK-7/20/2012

10 YEARS LATER-Looking DS @ fantastic riparian, stable bank & diversity & complexity within the river channel. Great job Phil!!!!

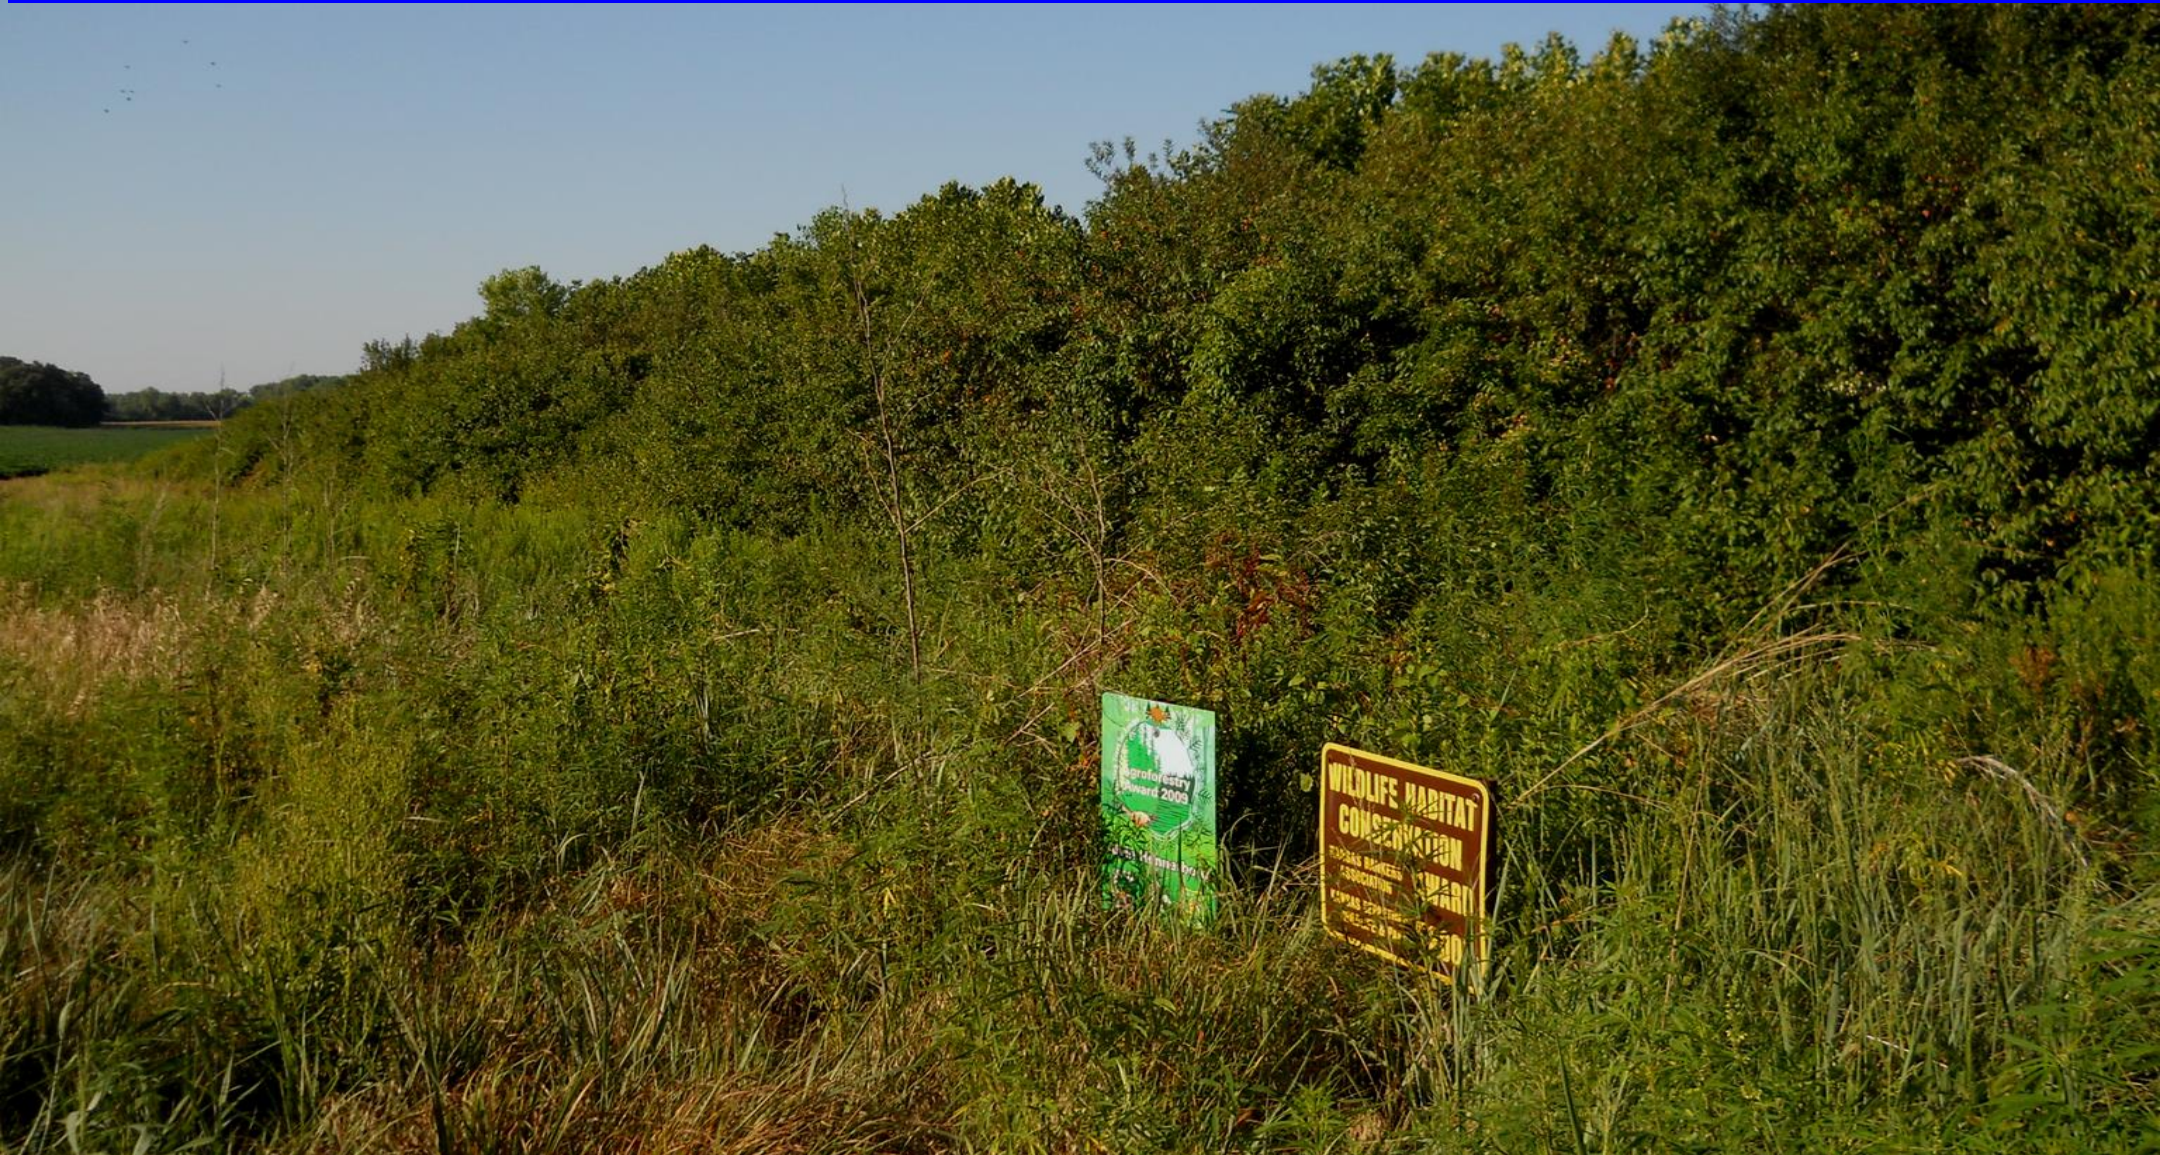
10 YEARS LATER-LTL BLUE R-HENNERBERG SITE- DERRICK-7/20/2012

10 YEARS LATER-Looking @ the herbaceous filter strip (field side of riparian corridor). Excellent growth intercepts nutrients & pesticides

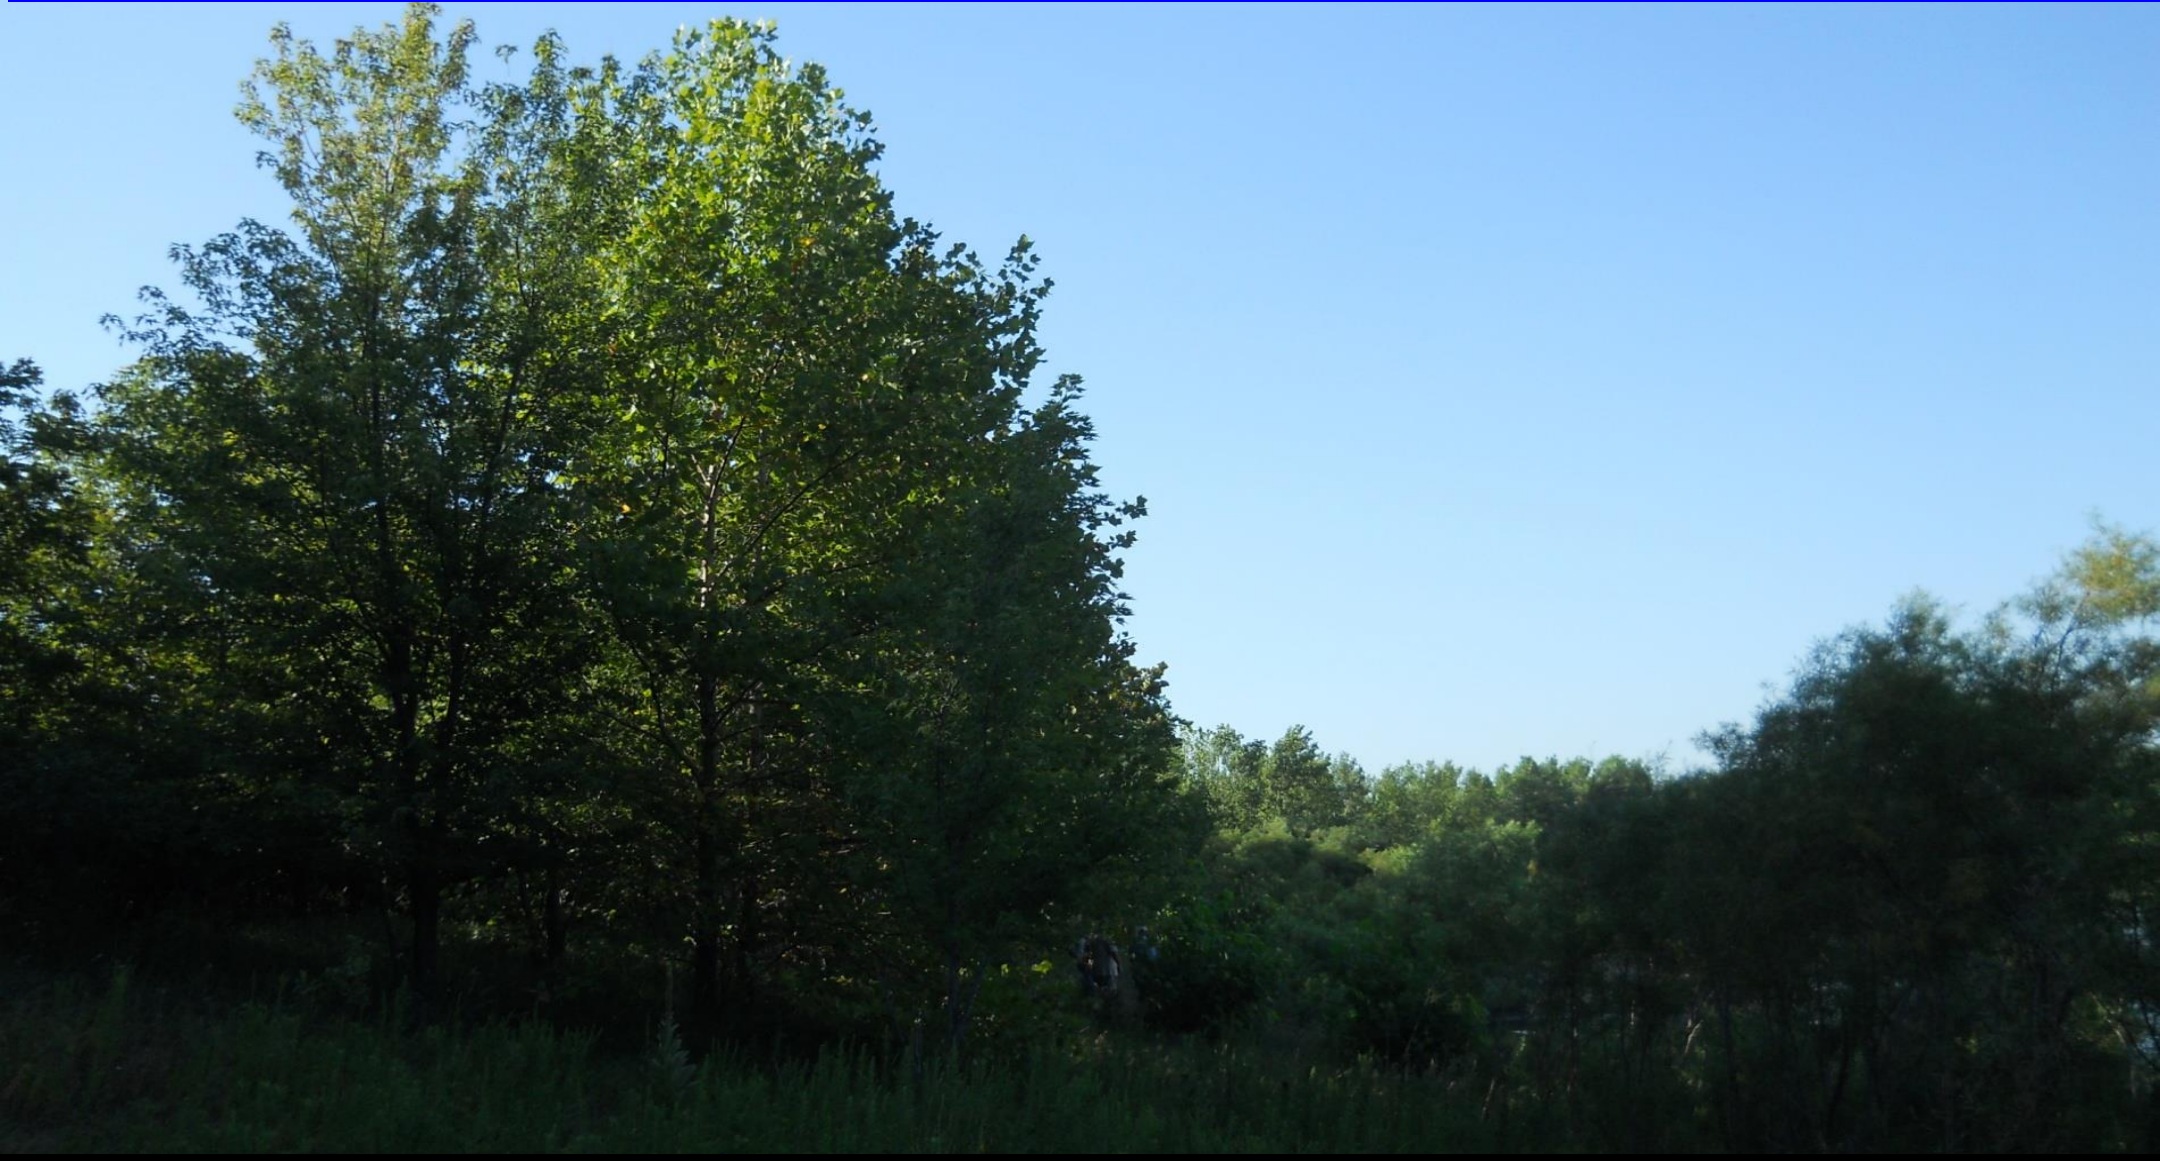
10 YEARS LATER-LTL BLUE R-HENNERBERG SITE- DERRICK-7/20/2012

10 YEARS LATER-Looking DS @ rows of different species have all grown well. Providing stability, riparian functions & roughness during floods

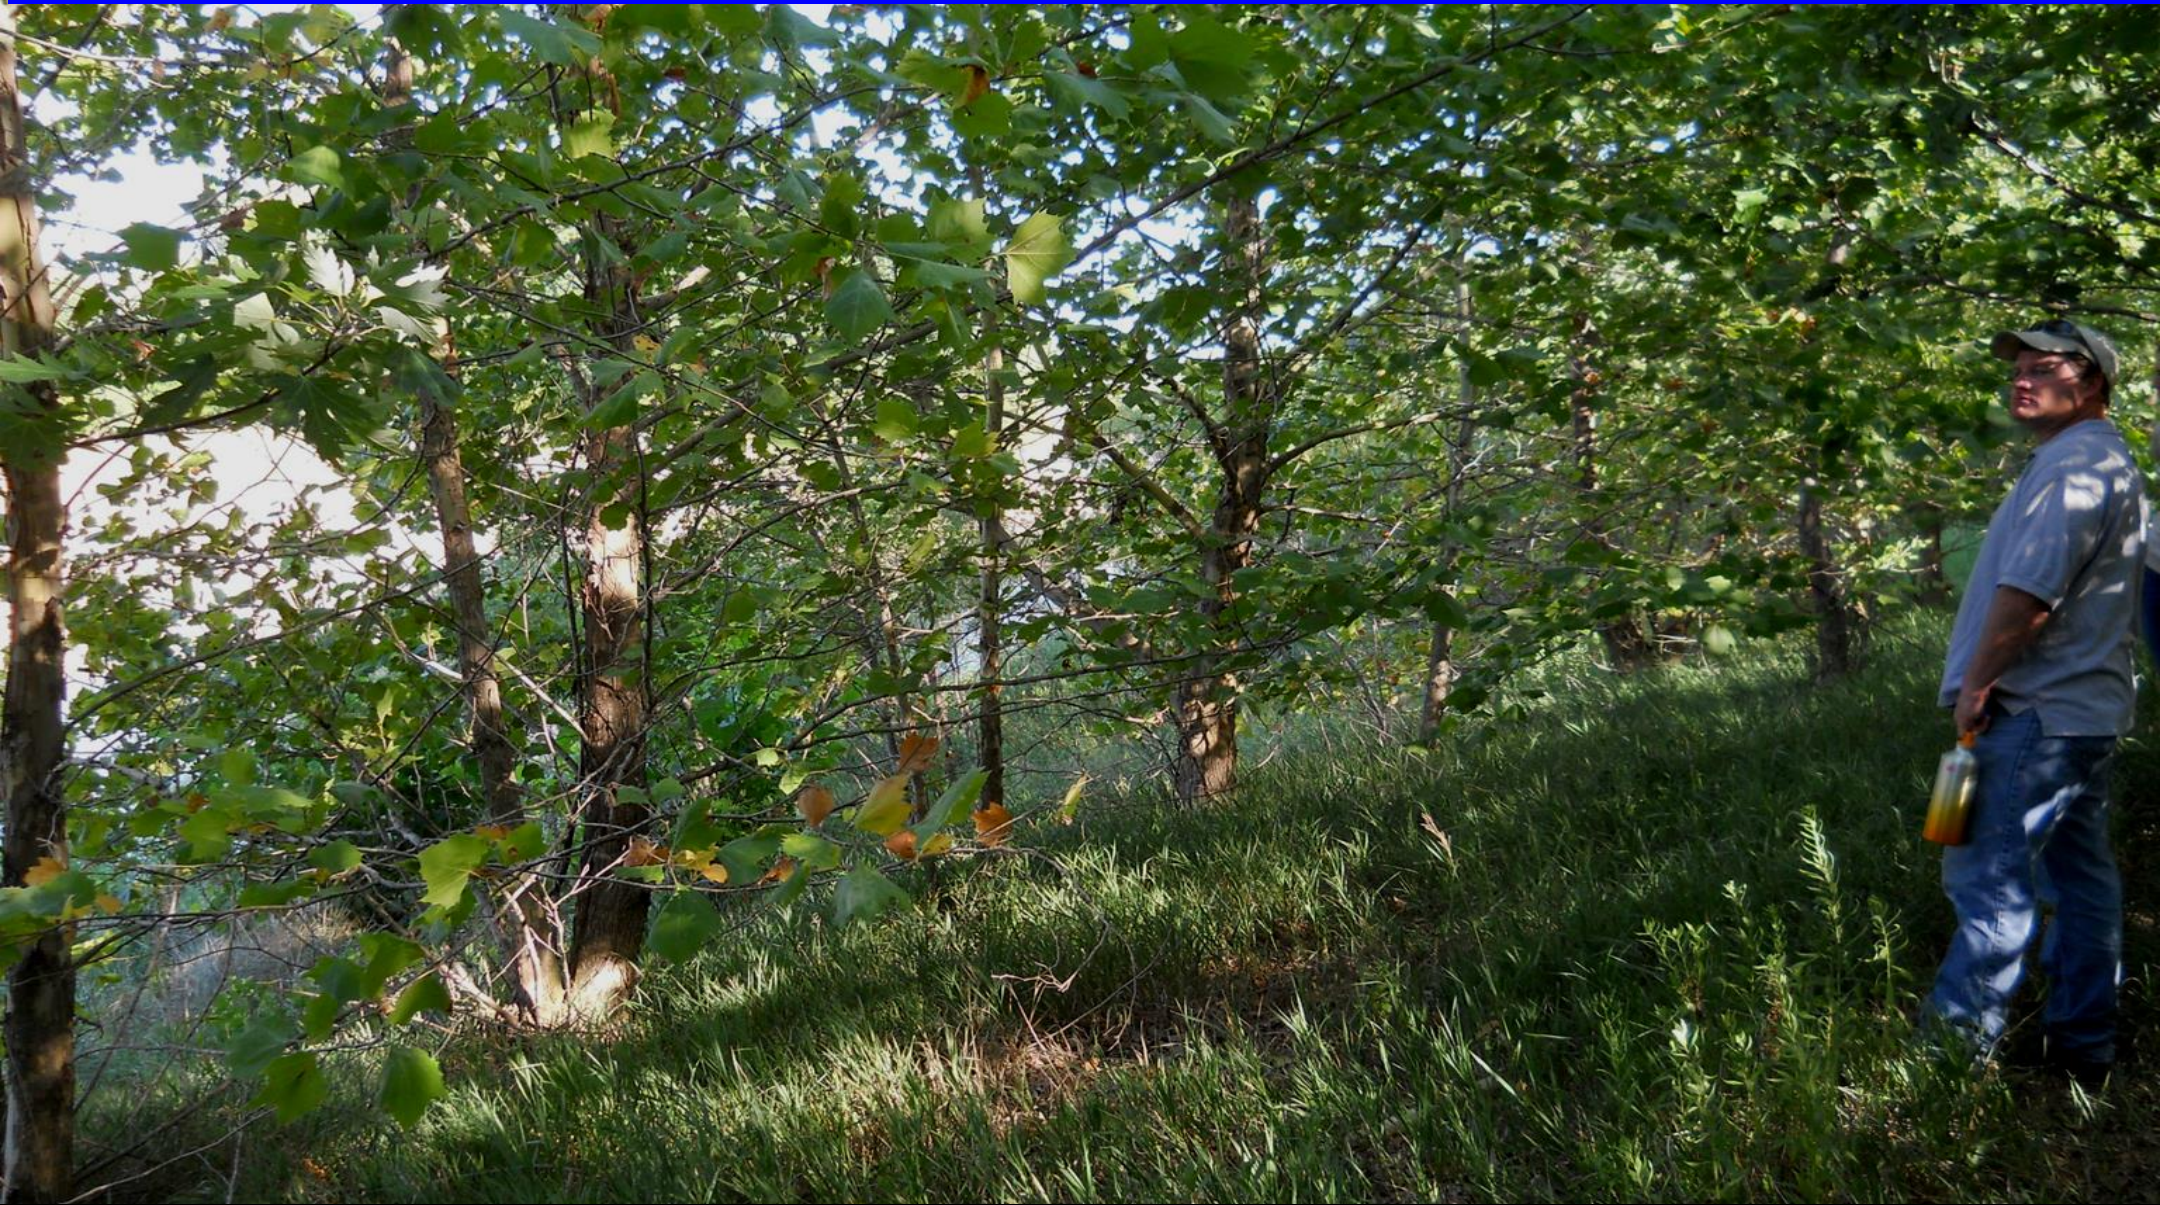
10 YEARS LATER-LTL BLUE R-HENNERBERG SITE- DERRICK-7/20/2012

10 YEARS LATER-Sycamore growth is outstanding!

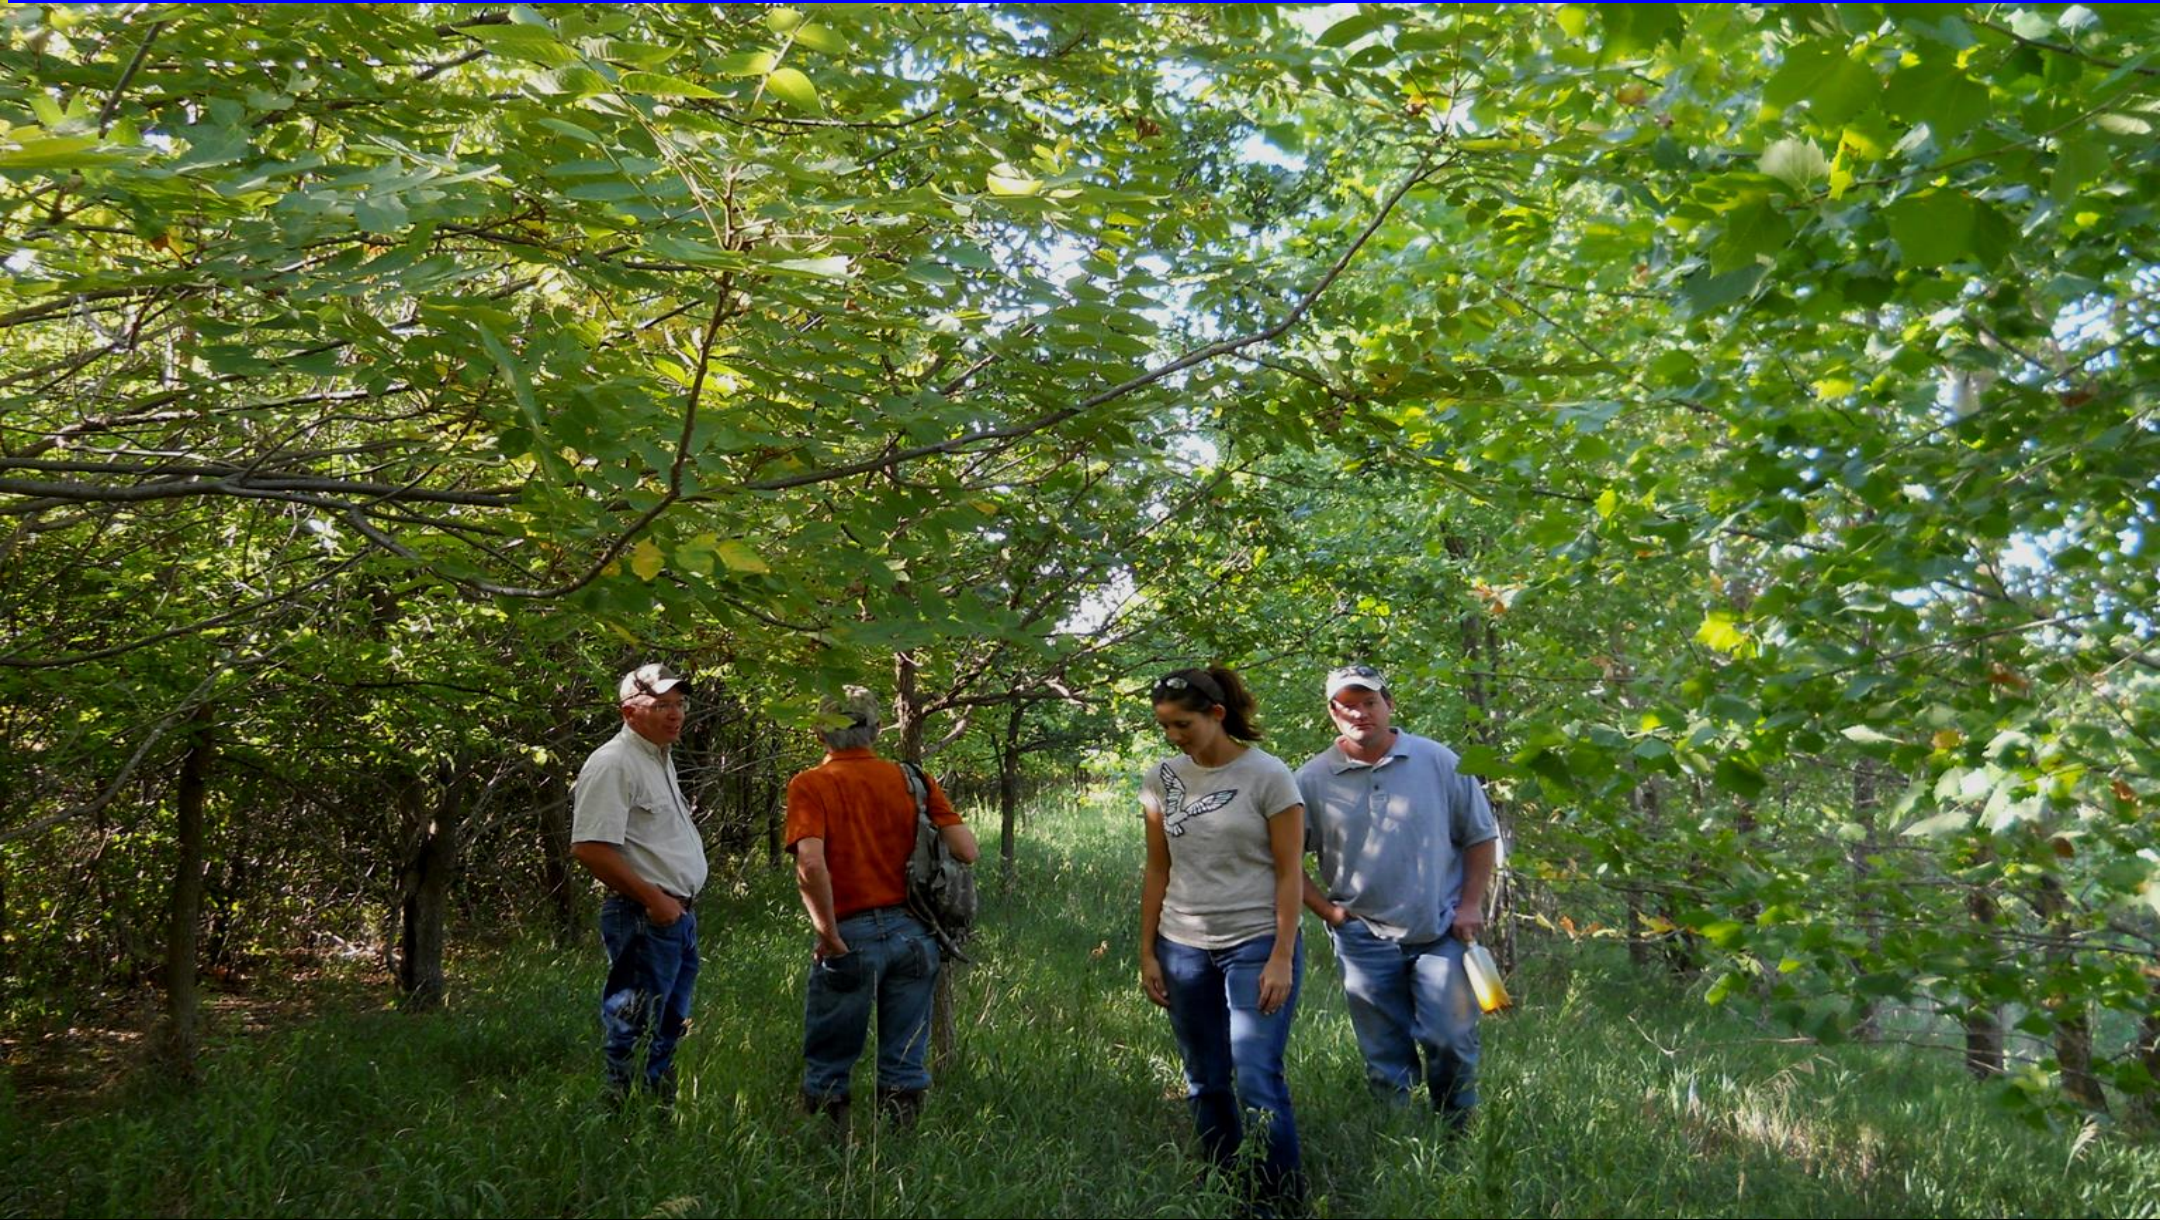
10 YEARS LATER-LTL BLUE R-HENNERBERG SITE- DERRICK-7/20/2012

10 YEARS LATER-Understory & overstory both robust!!

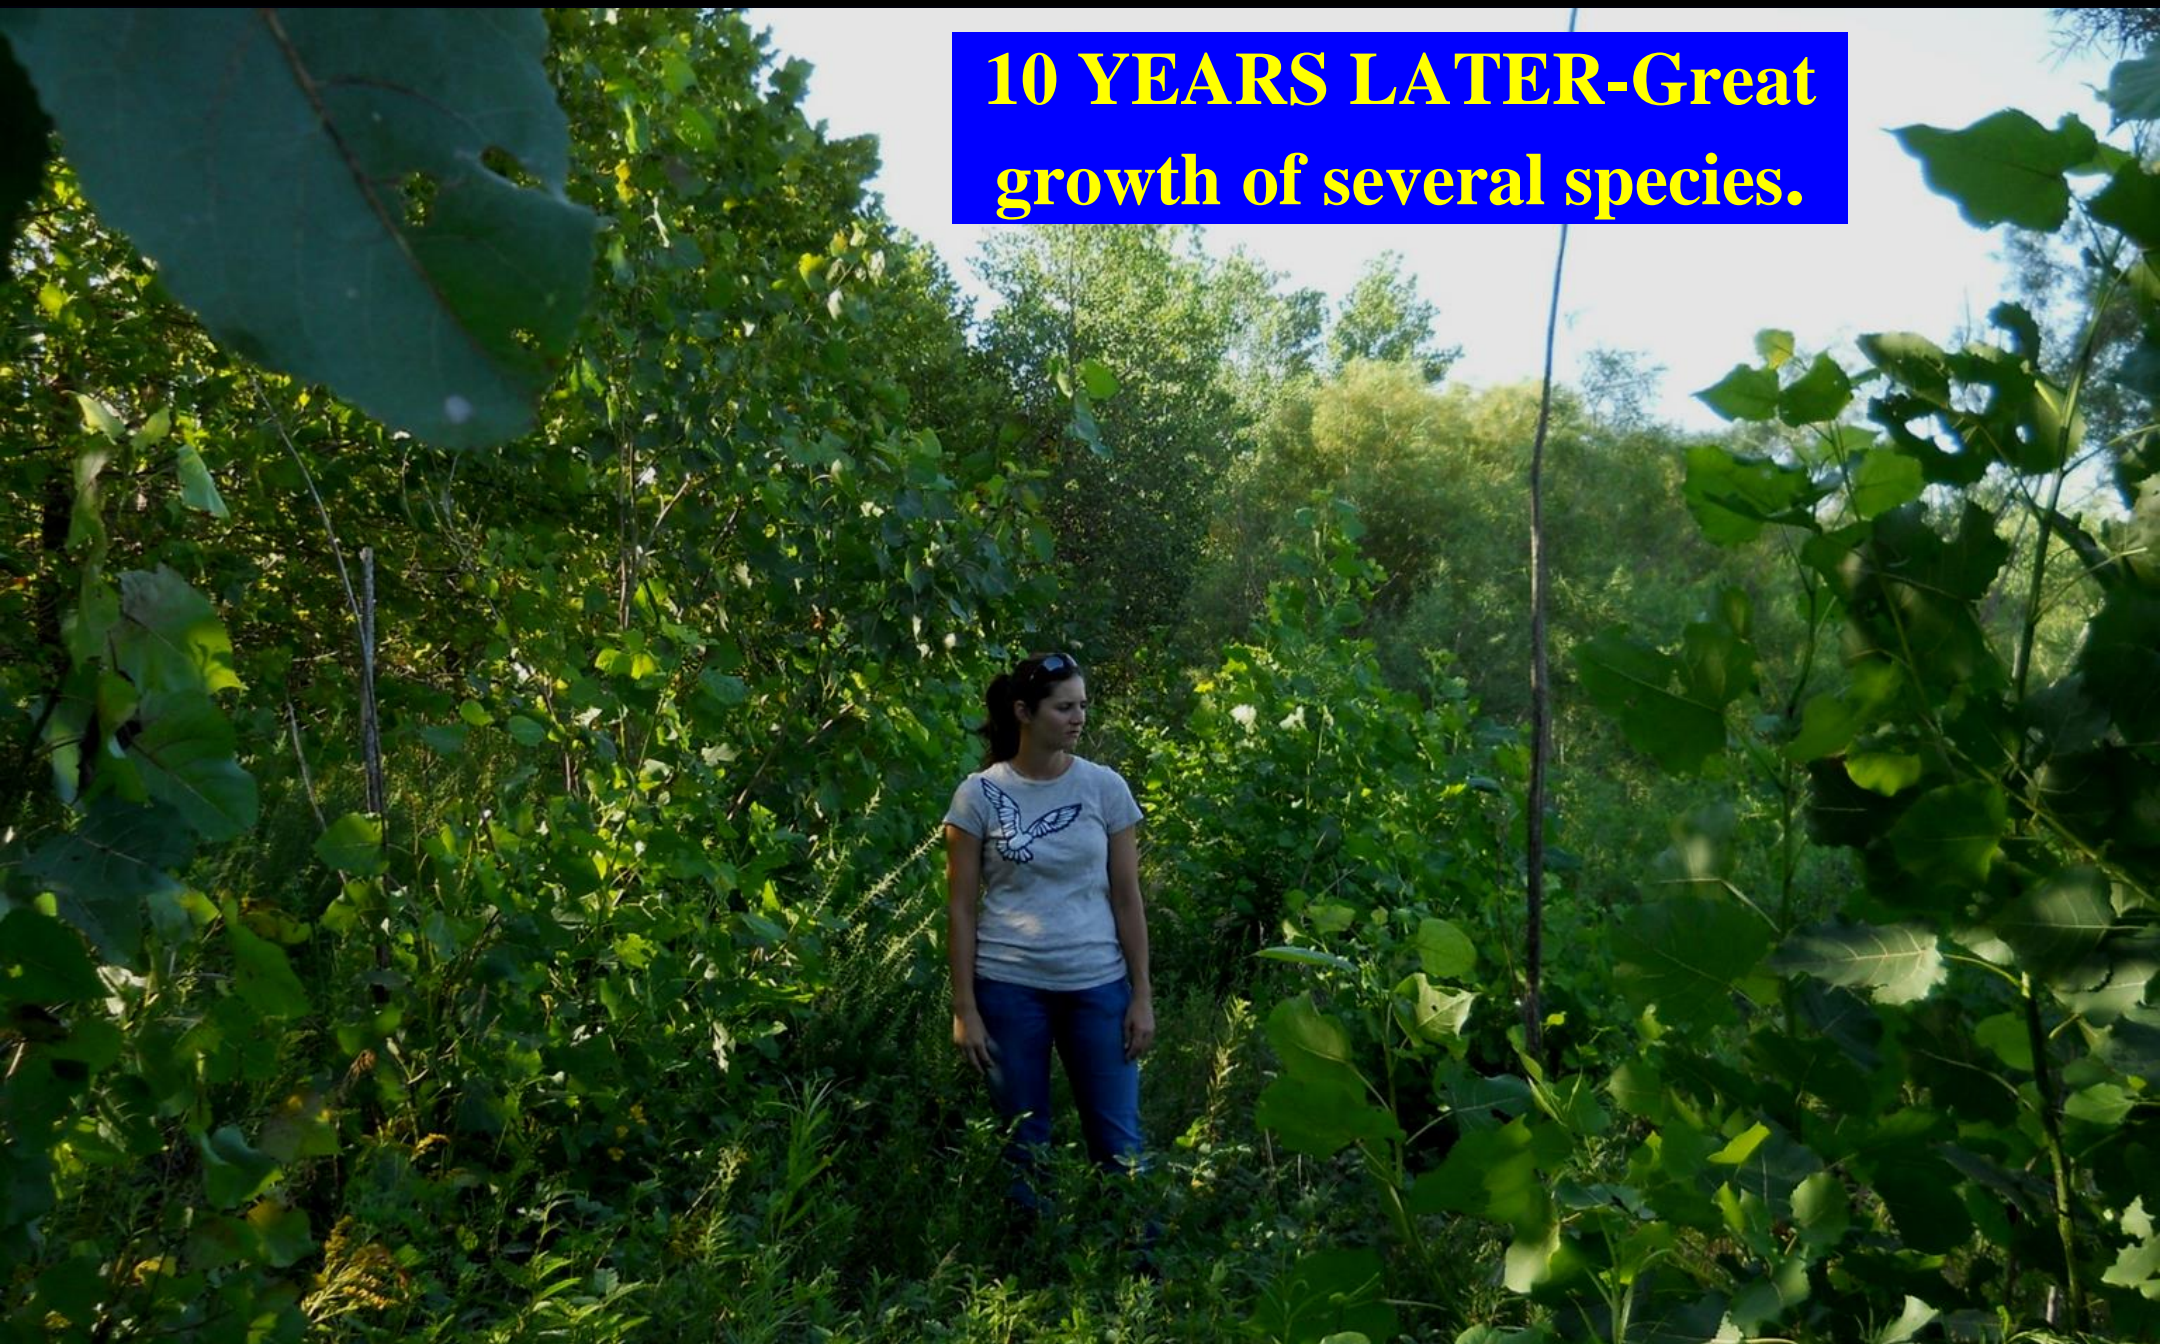
10 YEARS LATER-LTL BLUE R-HENNERBERG SITE- DERRICK-7/20/2012

**10 YEARS LATER-Great
growth of several species.**

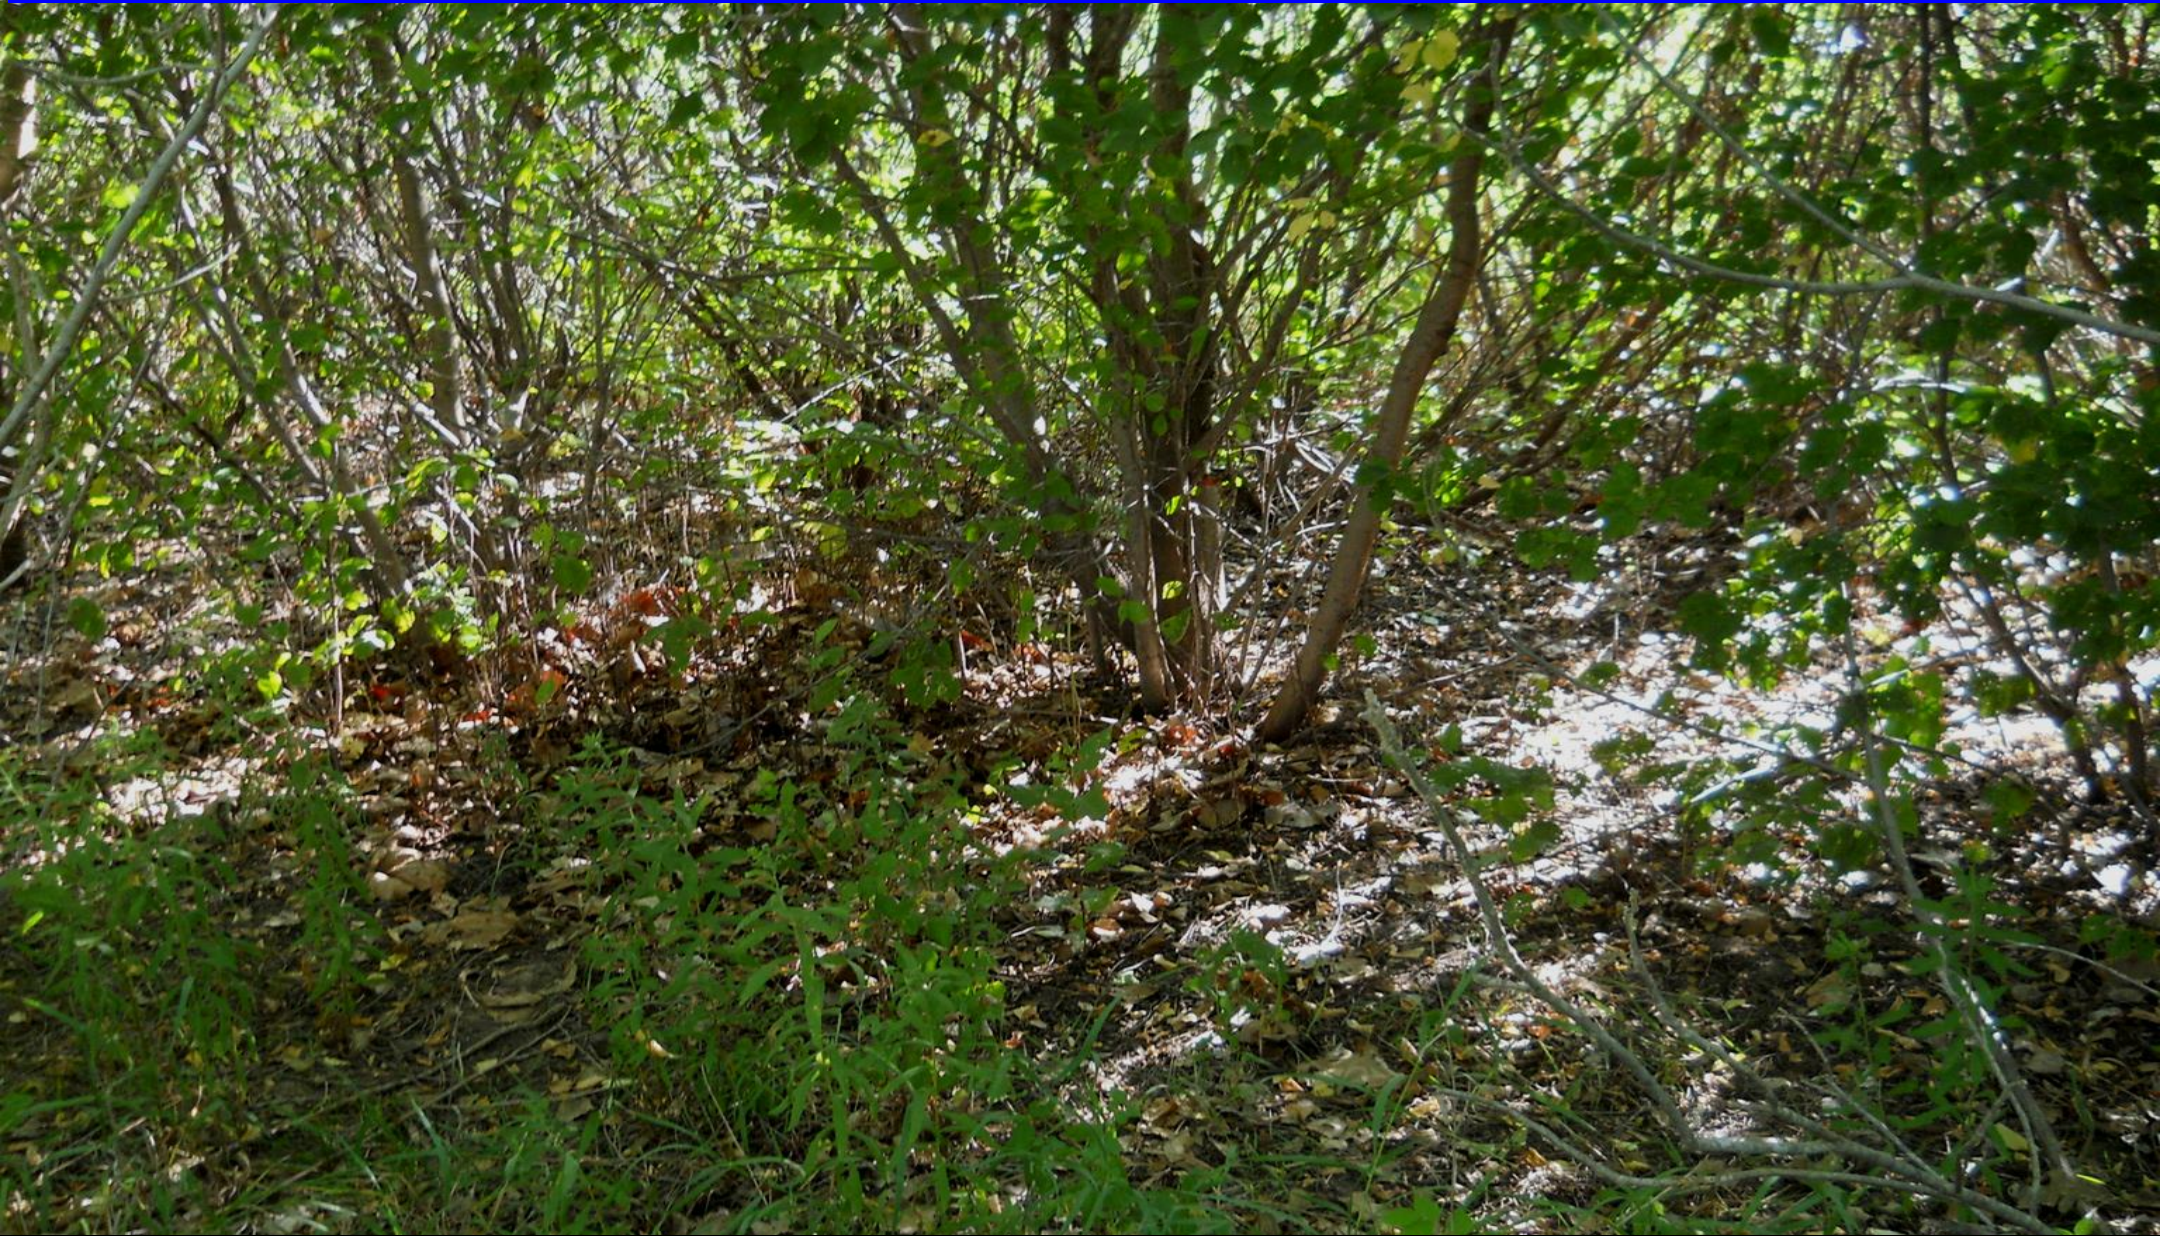
10 YEARS LATER-LTL BLUE R-HENNERBERG SITE- DERRICK-7/20/2012

10 YEARS LATER-Dense native plum grow shades out understory

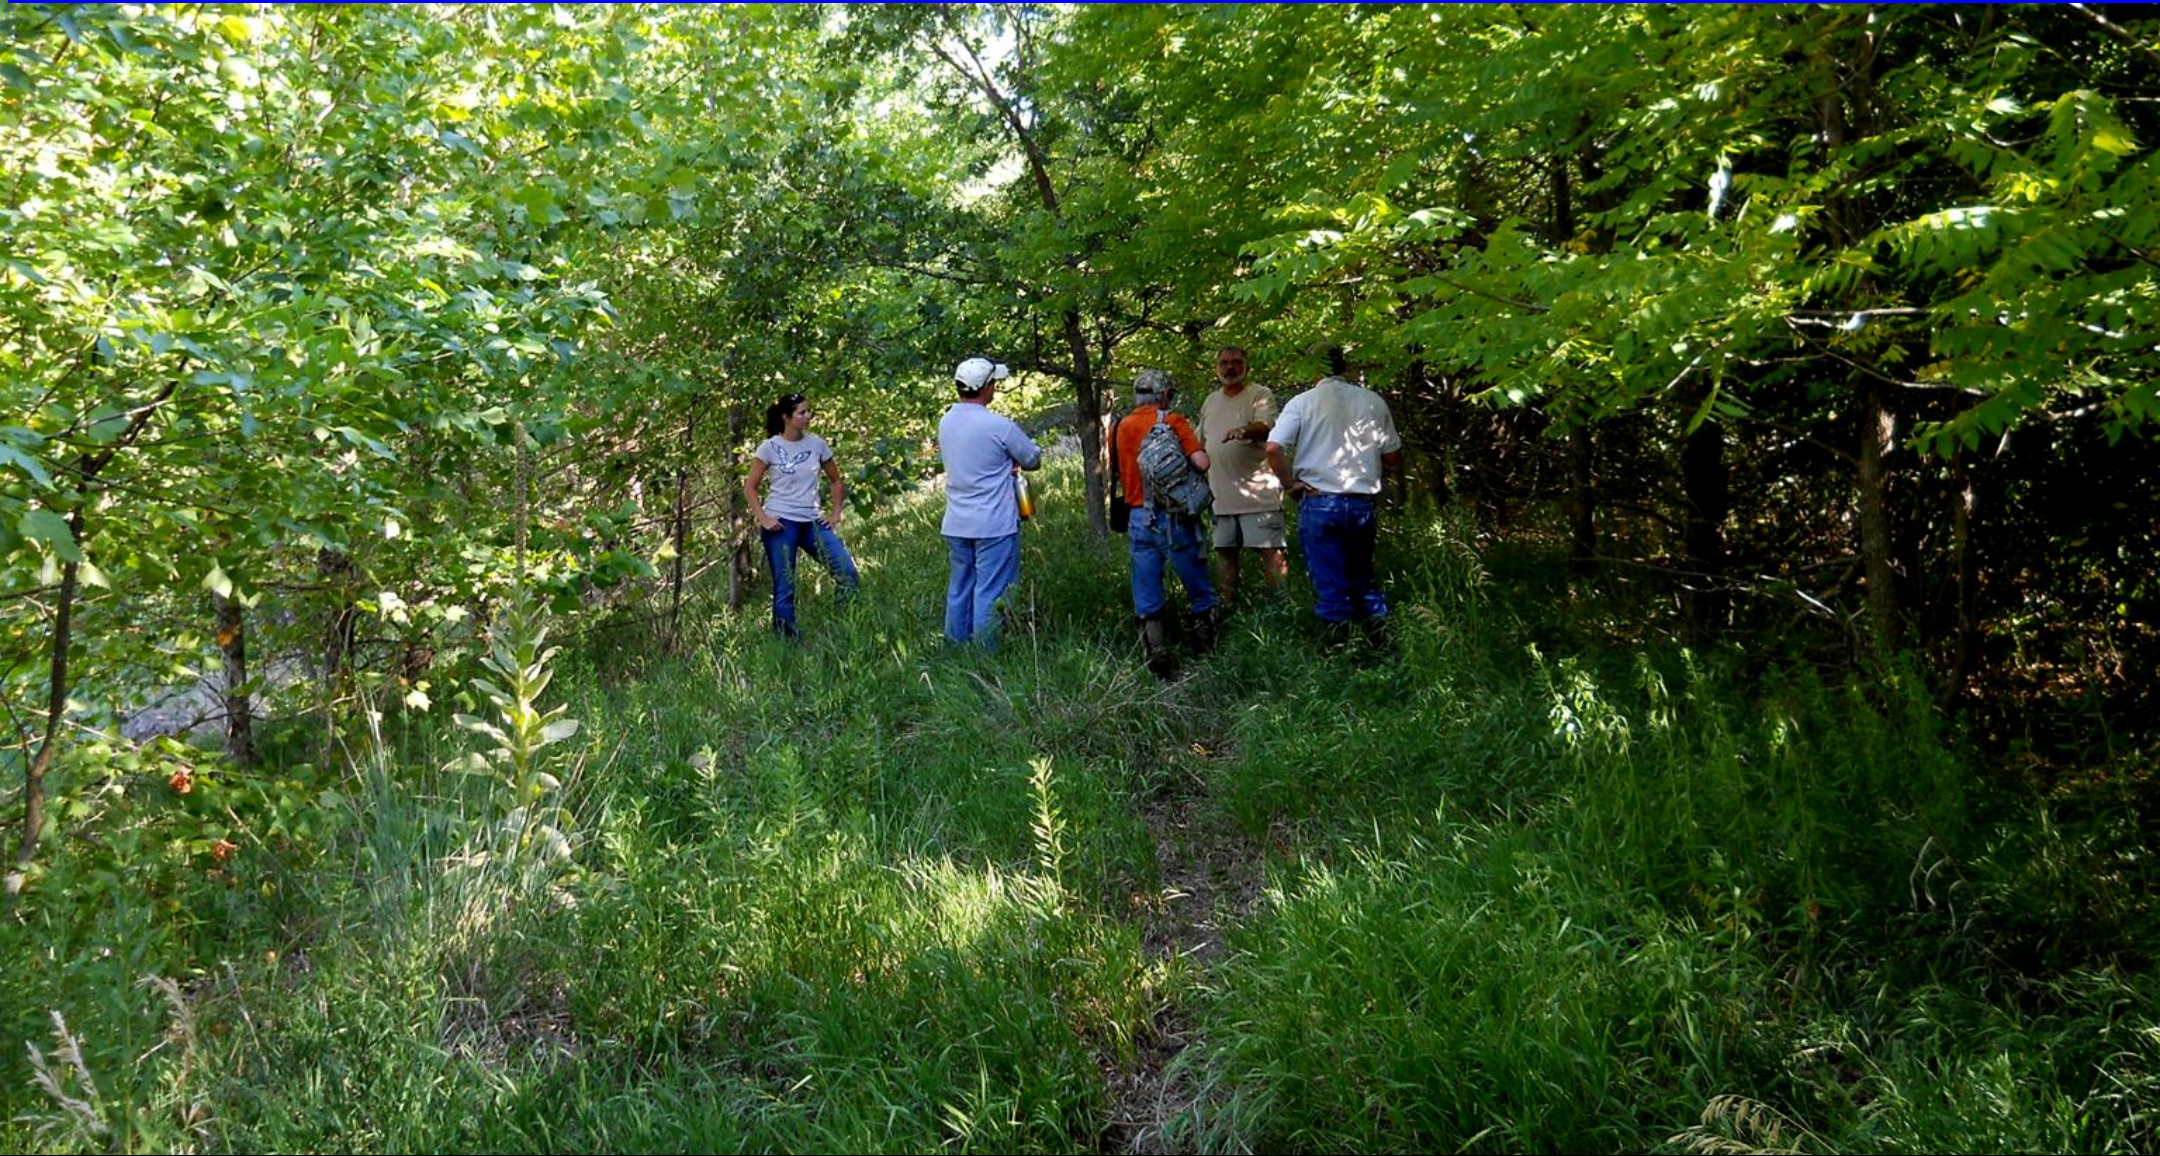
10 YEARS LATER-LTL BLUE R-HENNERBERG SITE- DERRICK-7/20/2012

10 YEARS LATER-Tall dense veg provides screening, less dense veg provides movement corridors for wildlife (deer trail) .
