Little Blue River, Kansas: Over Nine Miles of River Stabilization & 166 Acres of Riparian Corridor Establishment

**By Phil Balch, with a little
help from Dave Derrick**

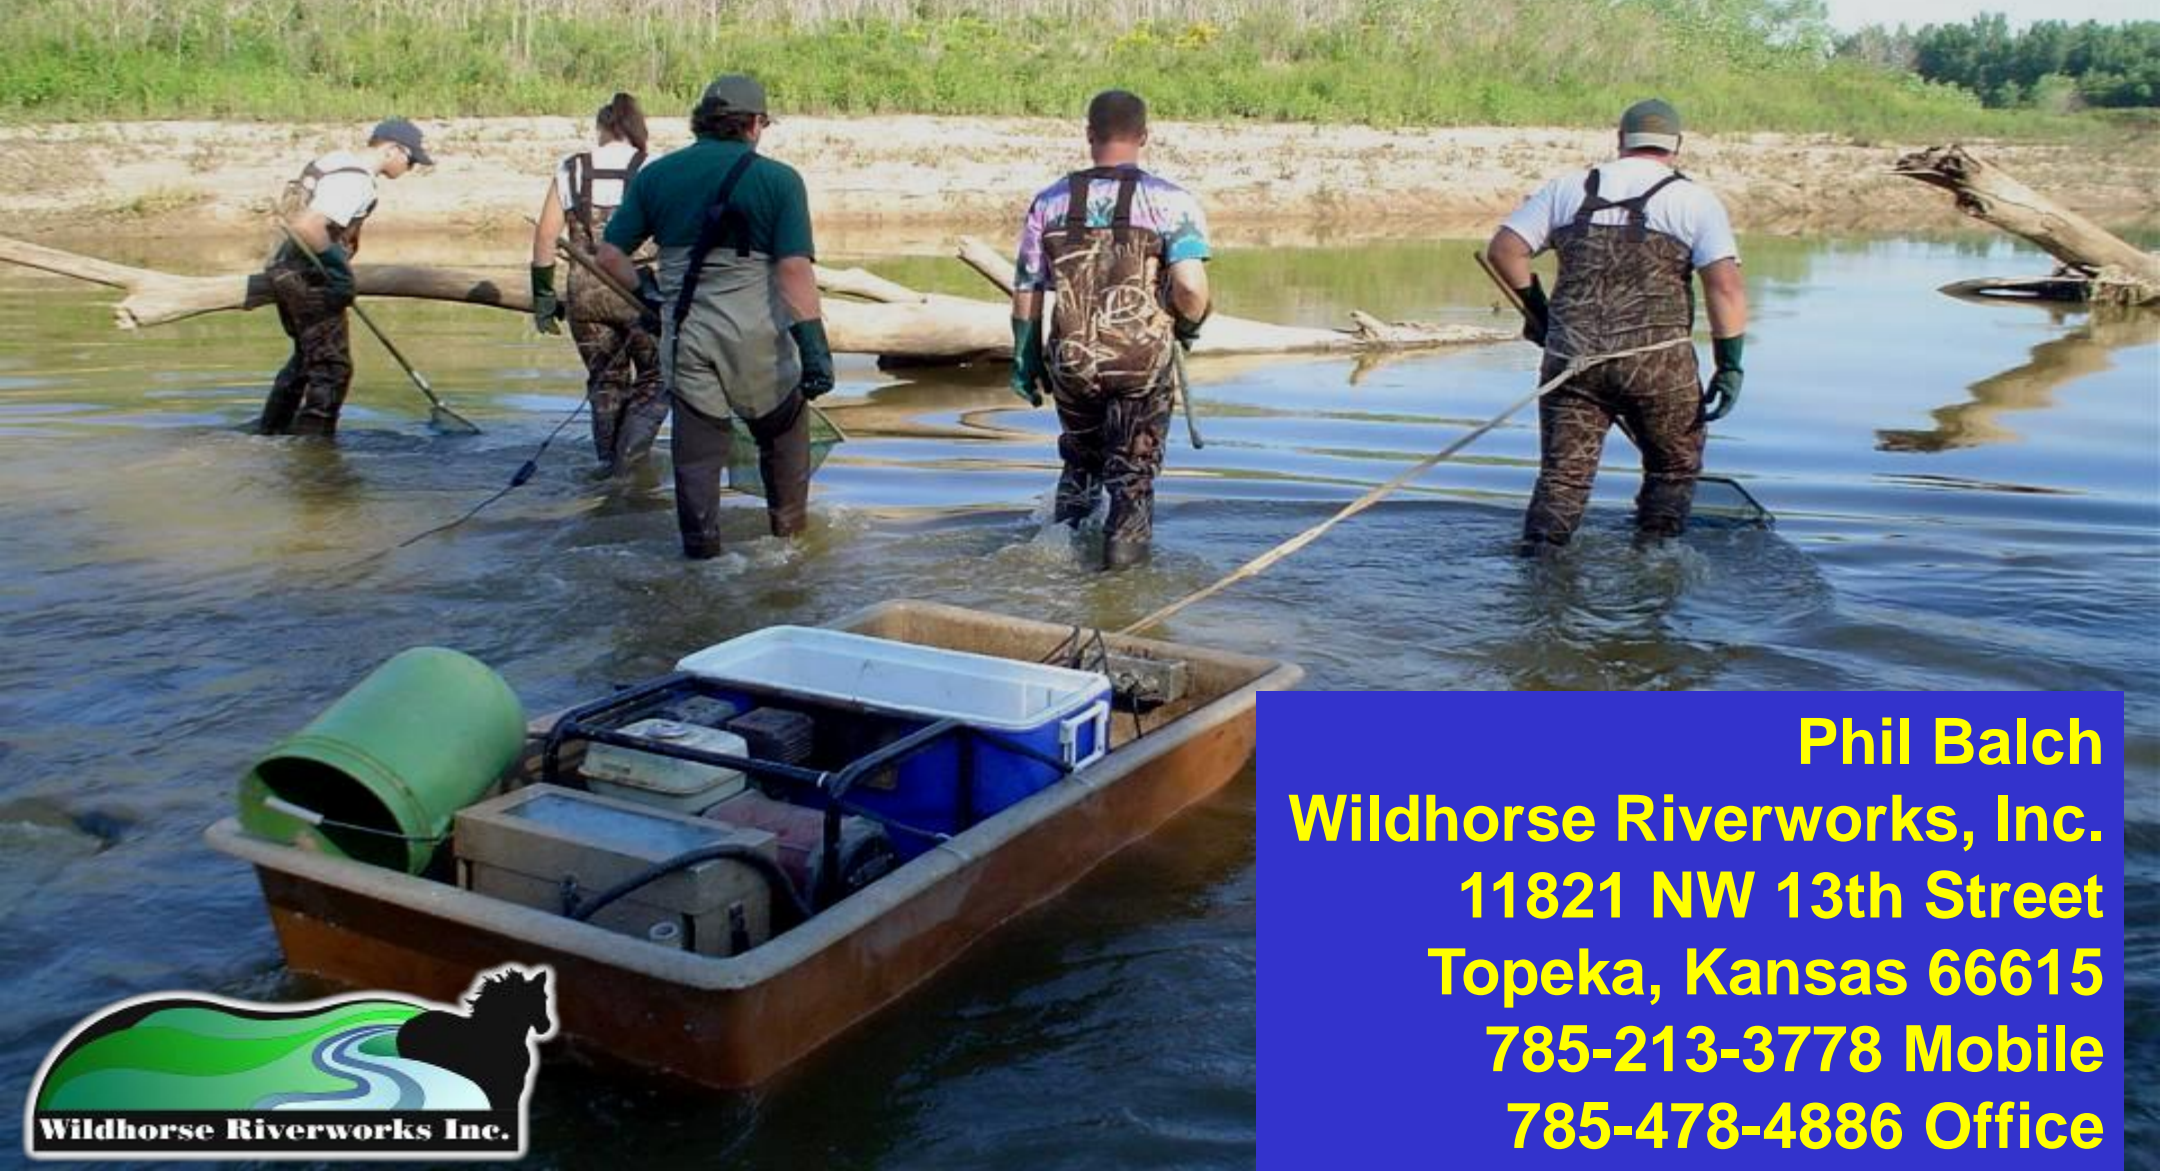
***FISH COMMUNITY
RESPONSE TO BENDWAY
WEIR INSTALLATION AT
TWO SITES ON THE
LITTLE BLUE RIVER, KS. 5
YEARS AFTER
CONSTRUCTION.***

FISH COMMUNITY CHANGES AT TWO BENDWAY WEIR STREAMBANK STABILIZATION PROJECTS ,5 YEARS AFTER CONSTRUCTION ON THE LITTLE BLUE RIVER, KS.

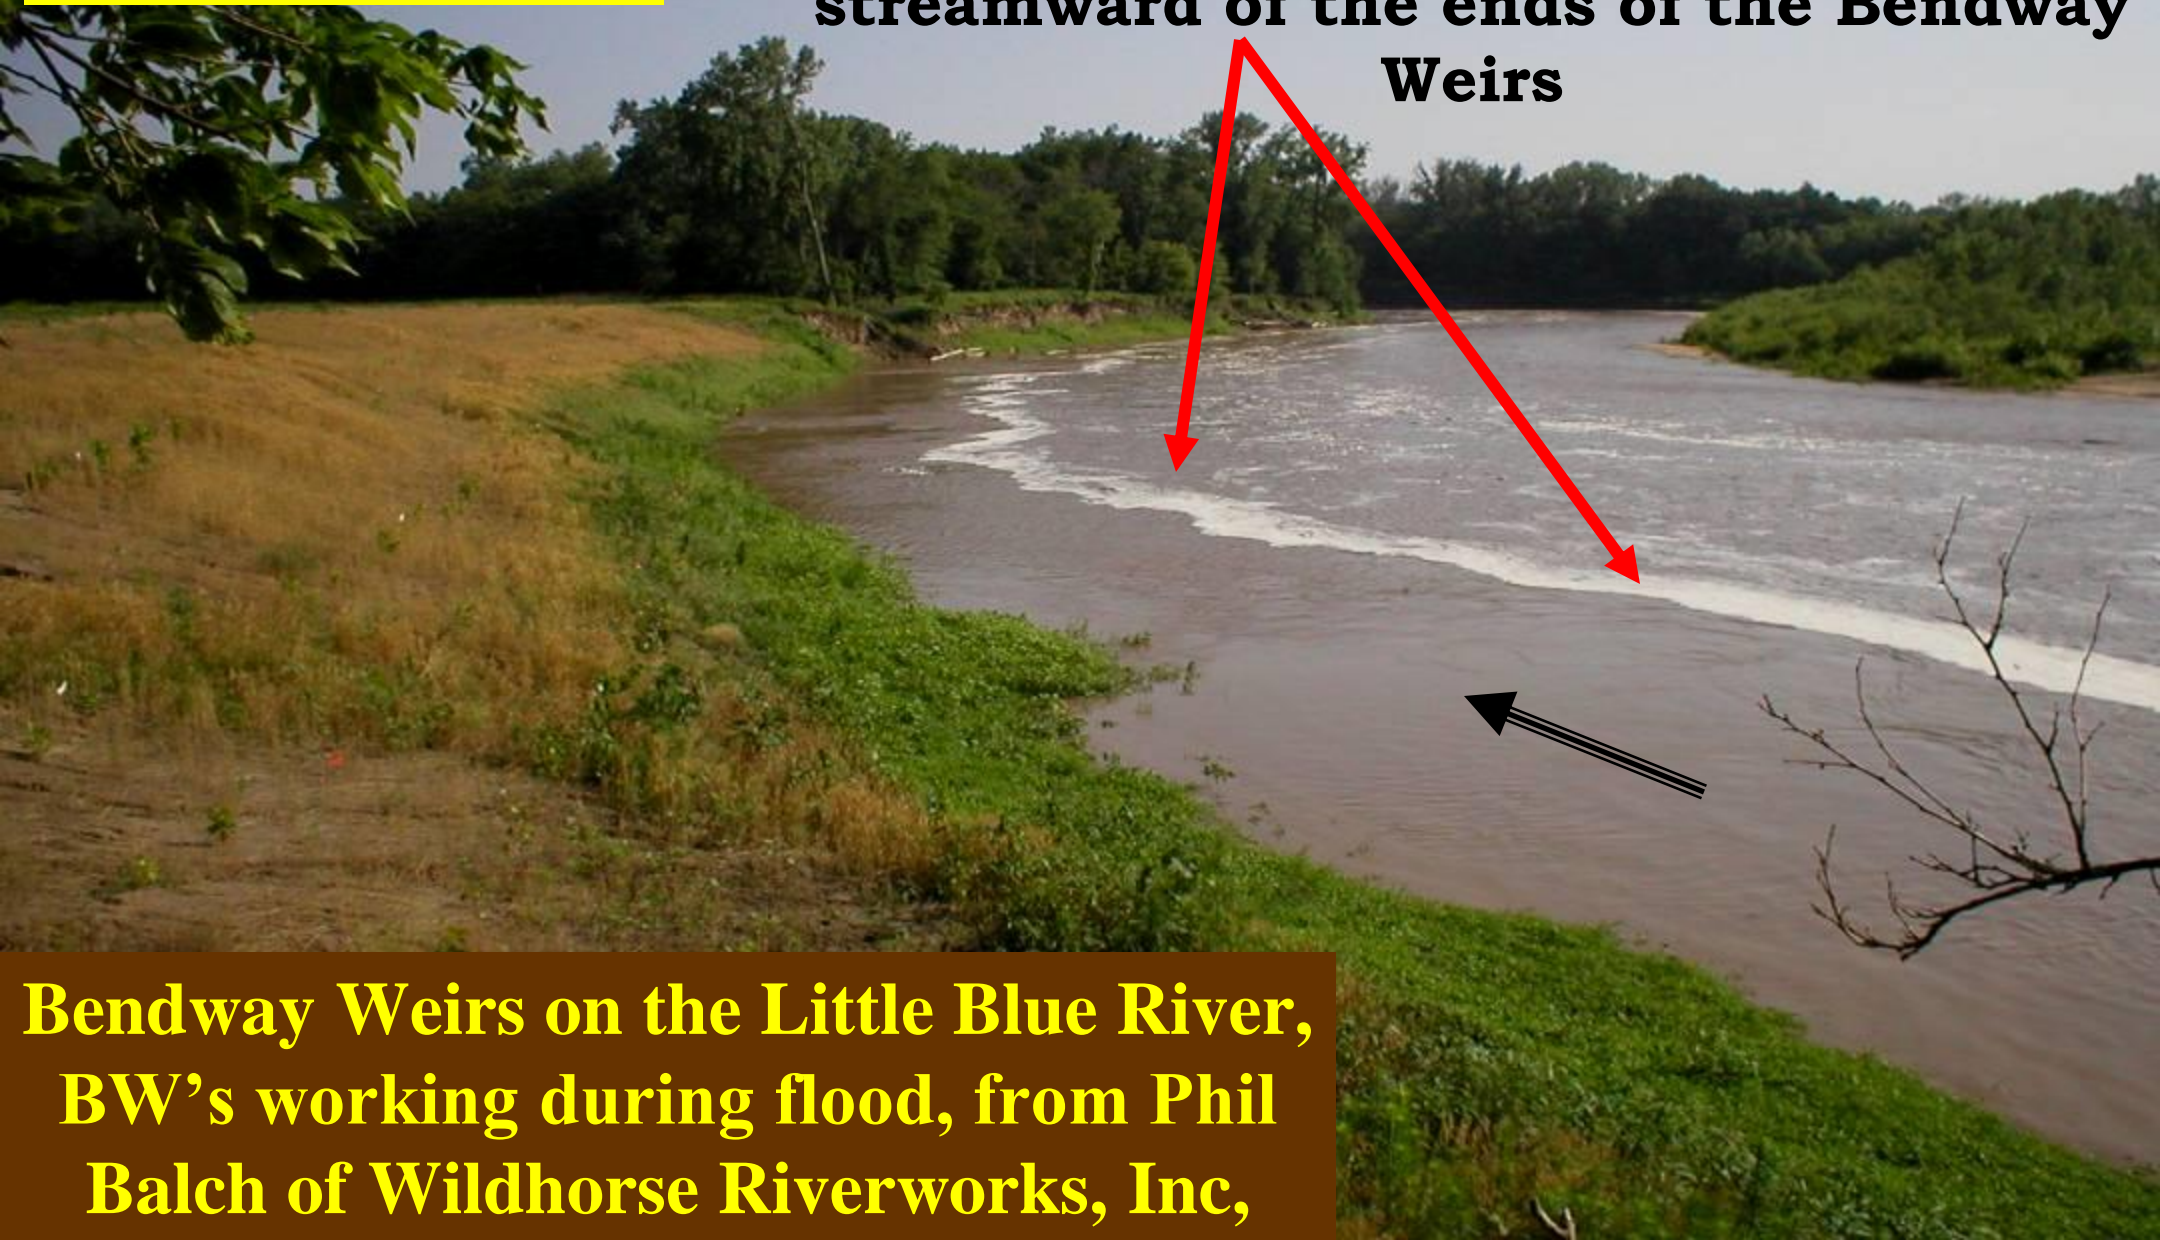
**Looking DS with the river rising on a
32,000 cfs flood. Note thalweg is
streamward of the ends of the Bendway
Weirs**

**Bendway Weirs on the Little Blue River,
BW's working during flood, from Phil
Balch of Wildhorse Riverworks, Inc,**

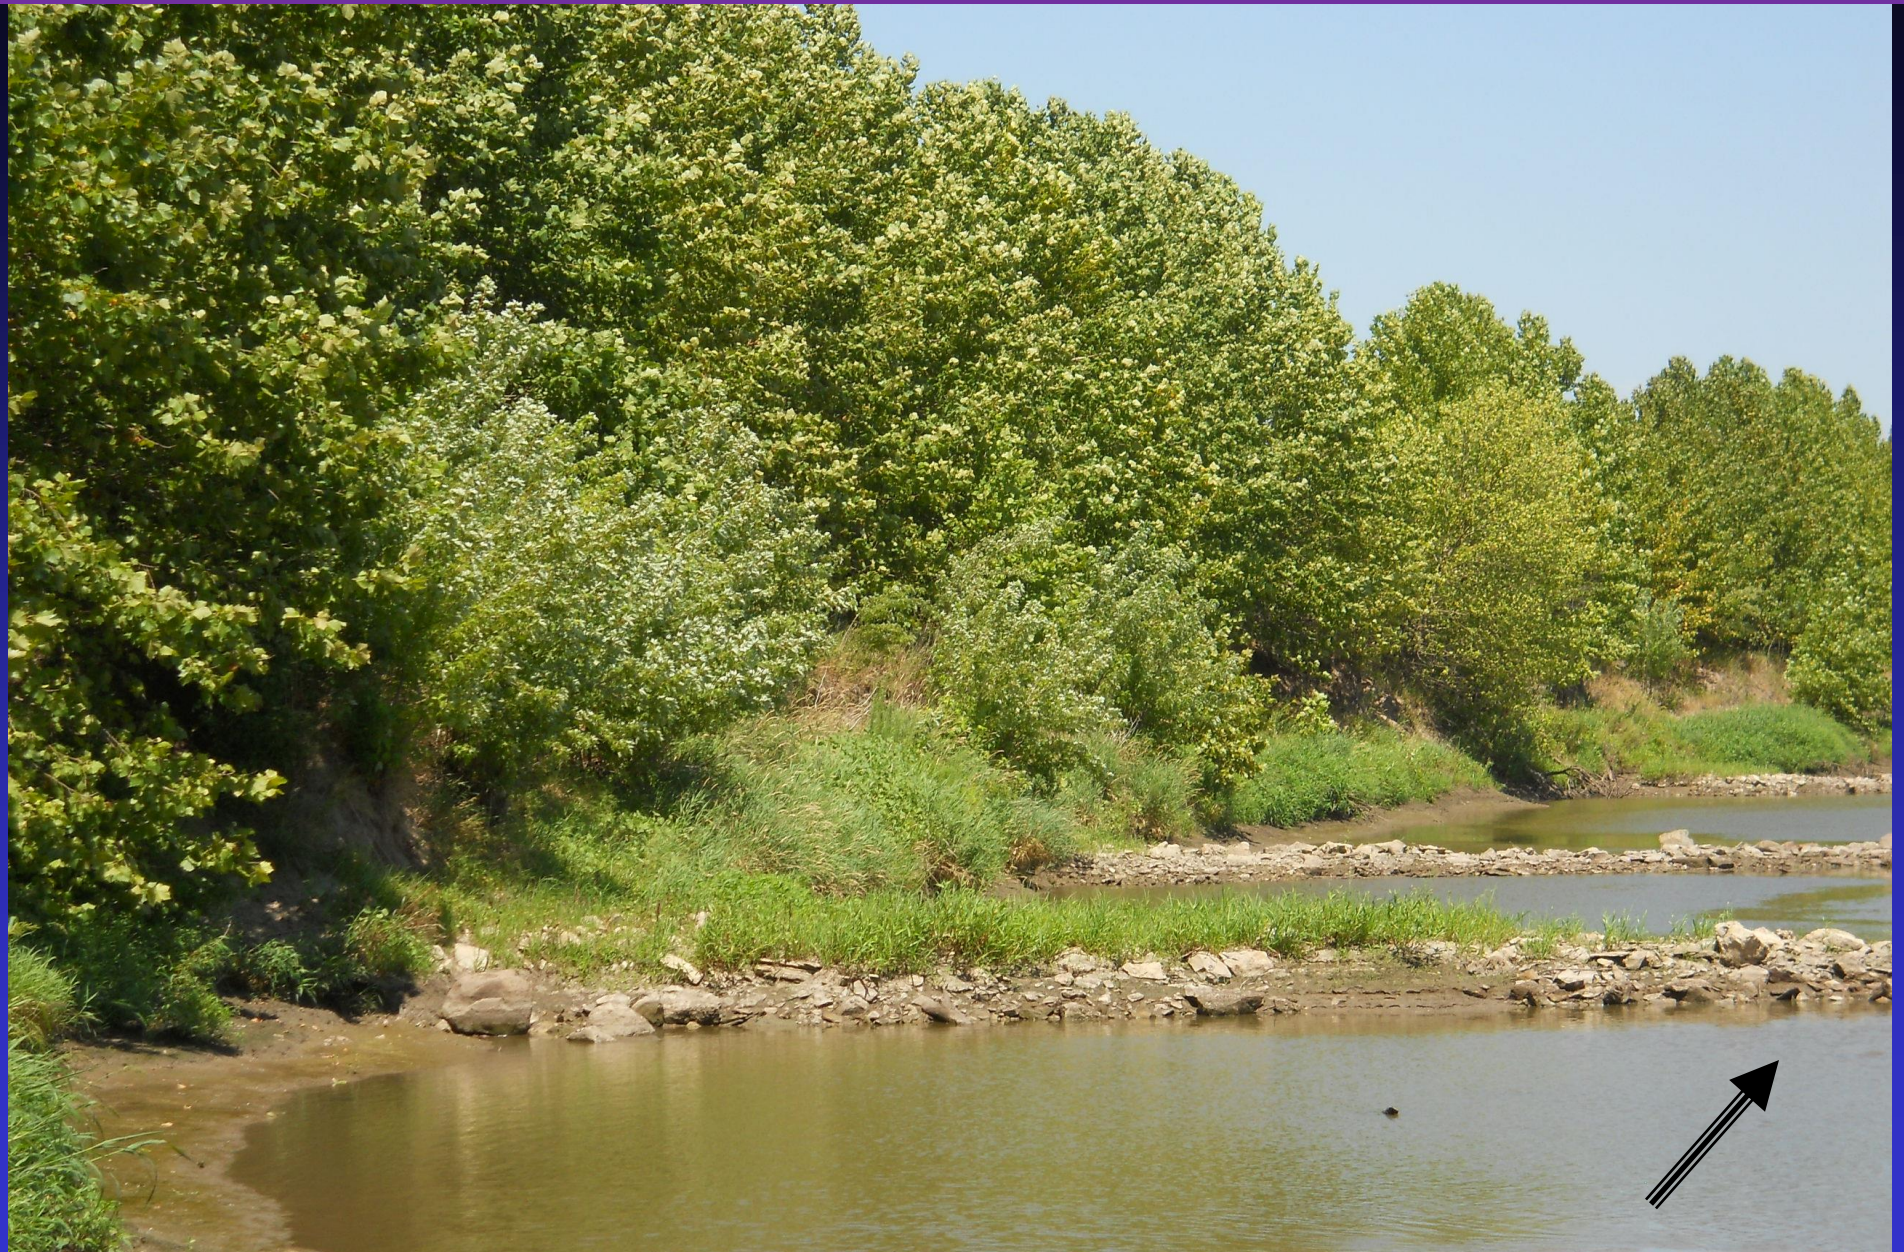
9 YEARS LATER-LTL BLUE R-KRAINBILL SITE- DERRICK-7/20/2012

9 YEARS LATER-Looking DS close-up of great riparian zone.

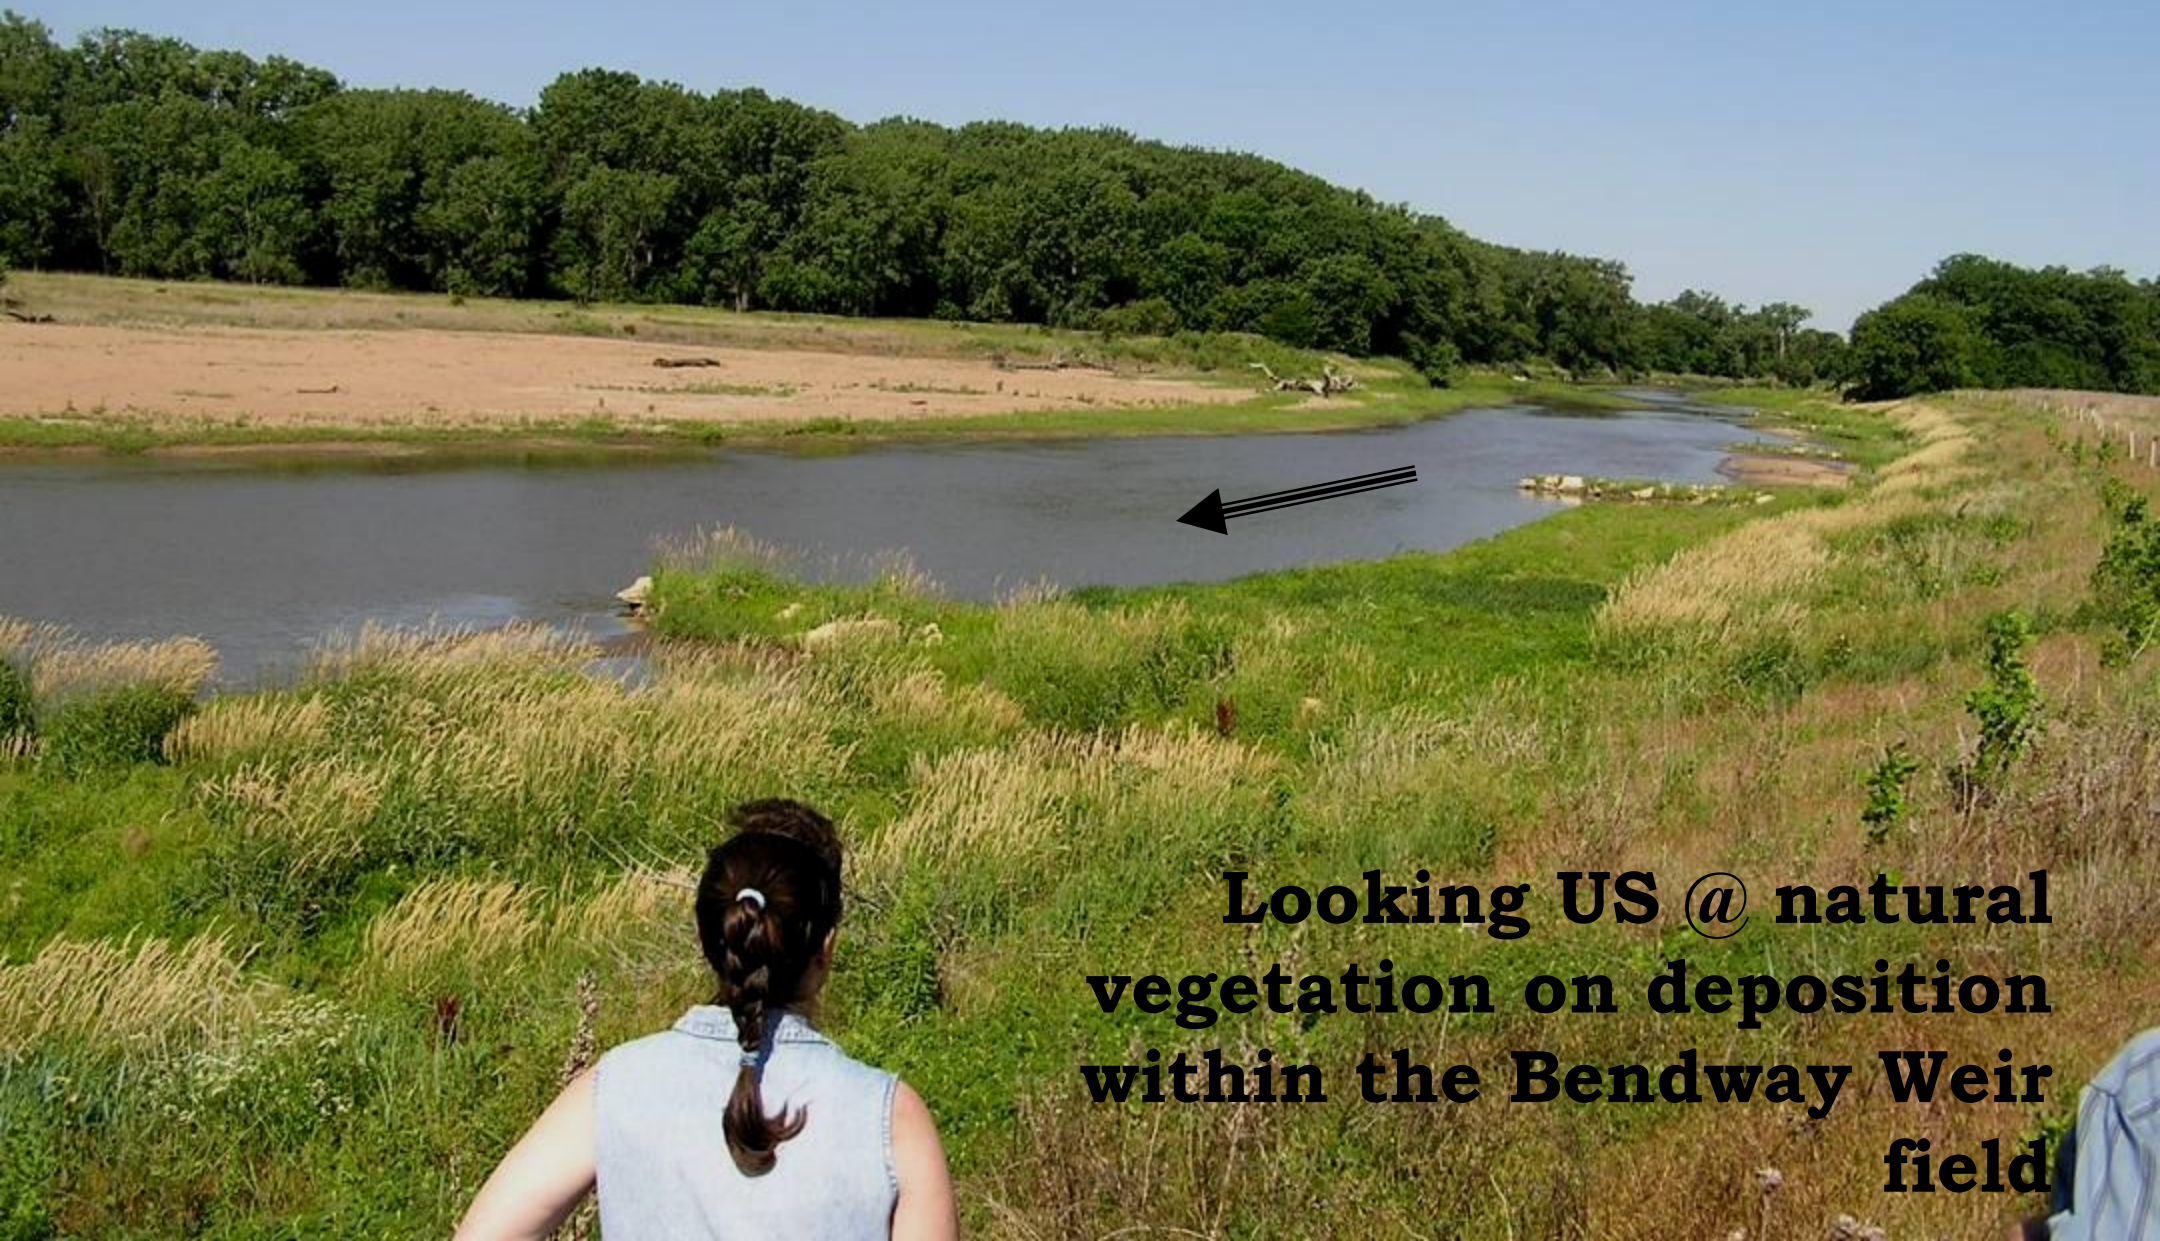
Tina Brenneis Site 6-2006 - almost 3 yrs later

**Looking US @ natural
vegetation on deposition
within the Bendway Weir
field**

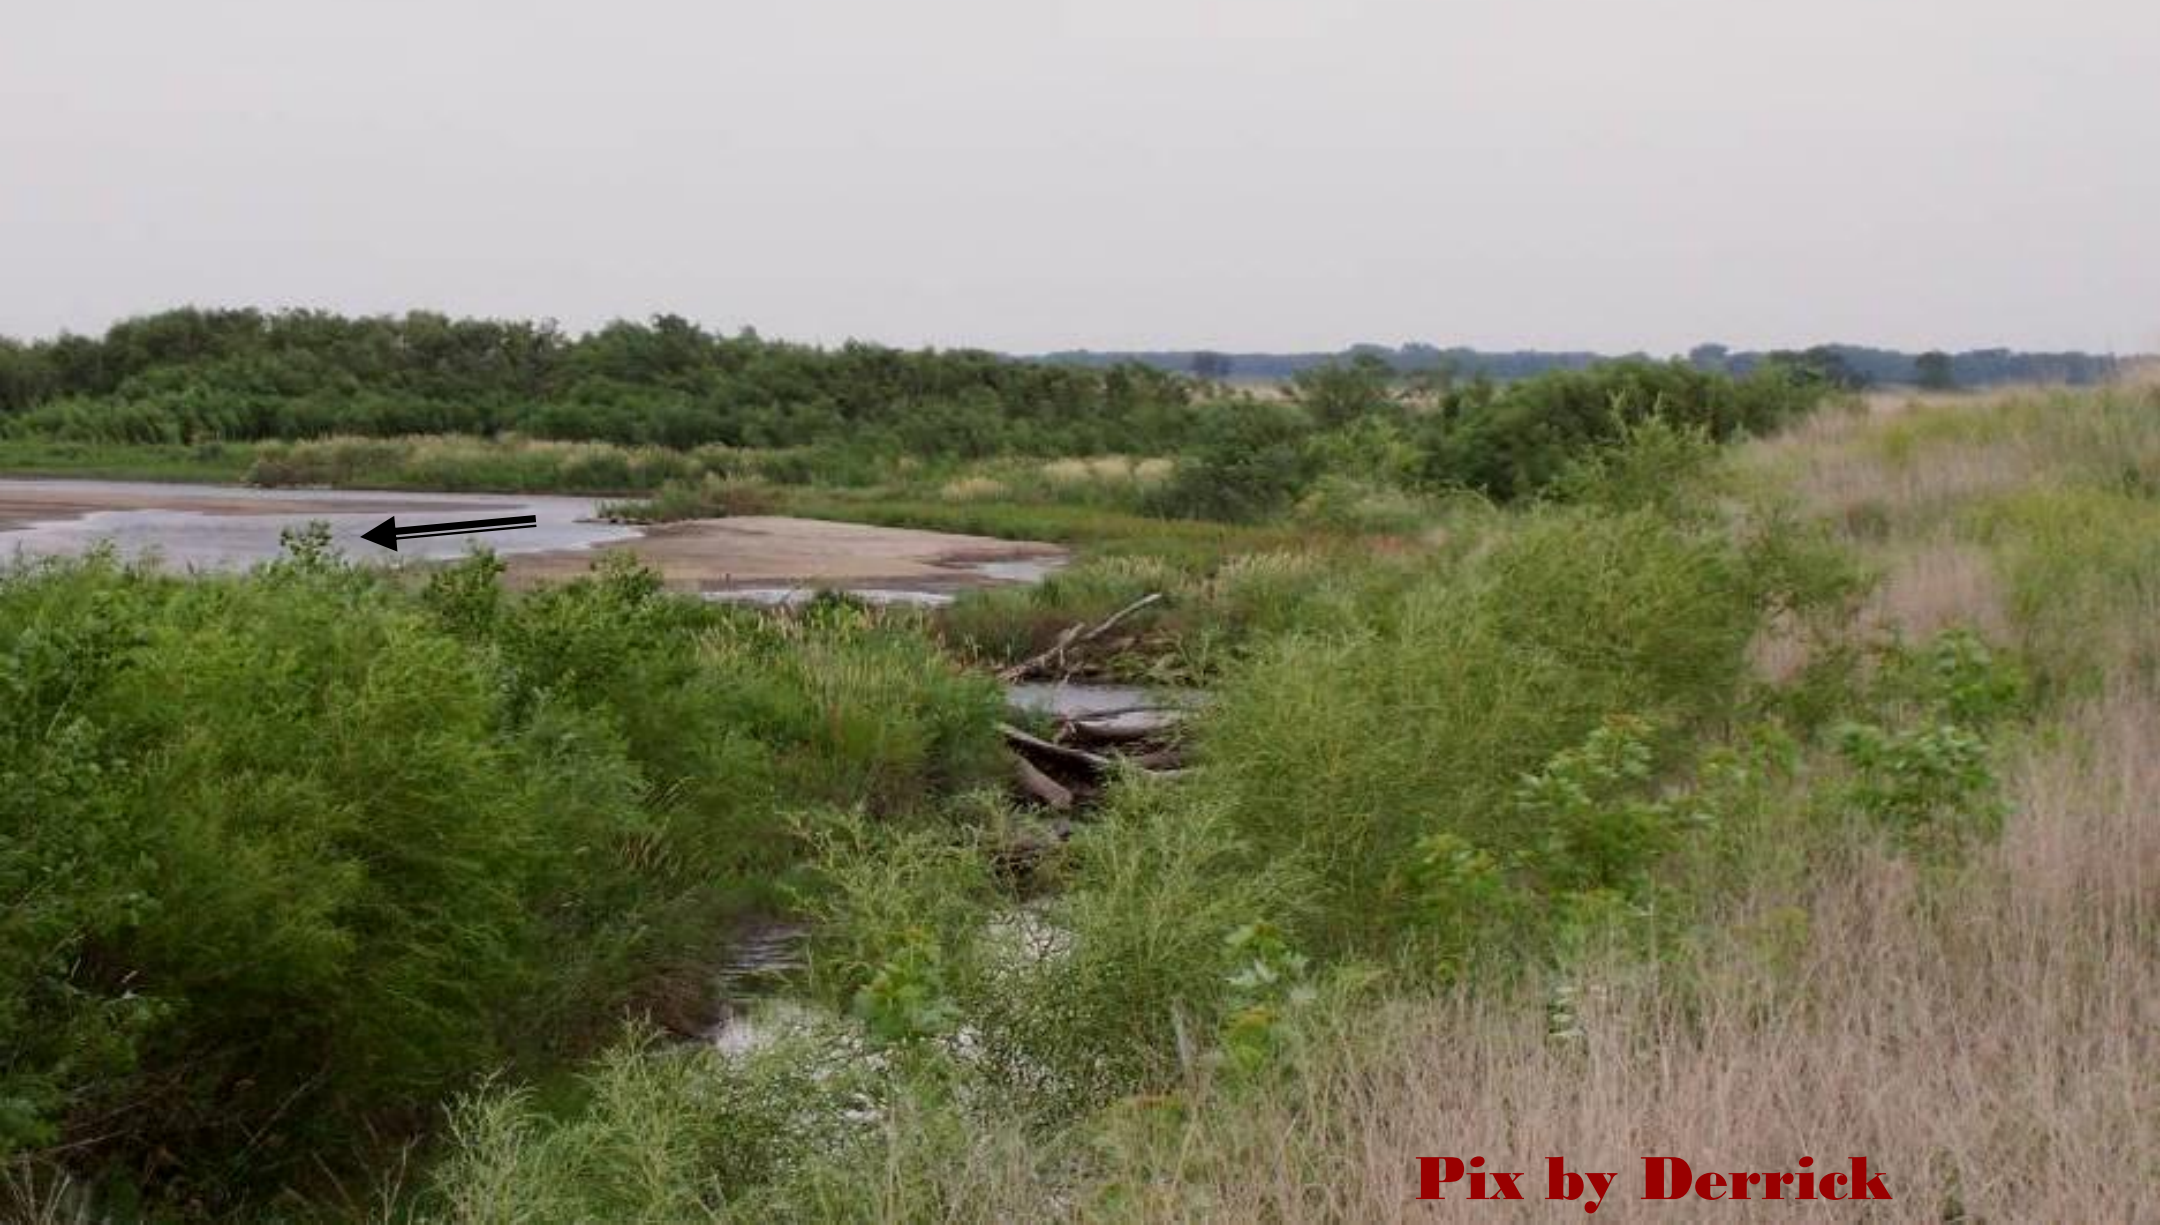
Wonderful diversity & complexity within the Bendway Weir field (hemi-wetlands). [Republican River](#), Clay County, KS.
