Biotechnical Soil Stabilization of Decomposed Granite Soils on Buckhorn Mountain

by John McCullah

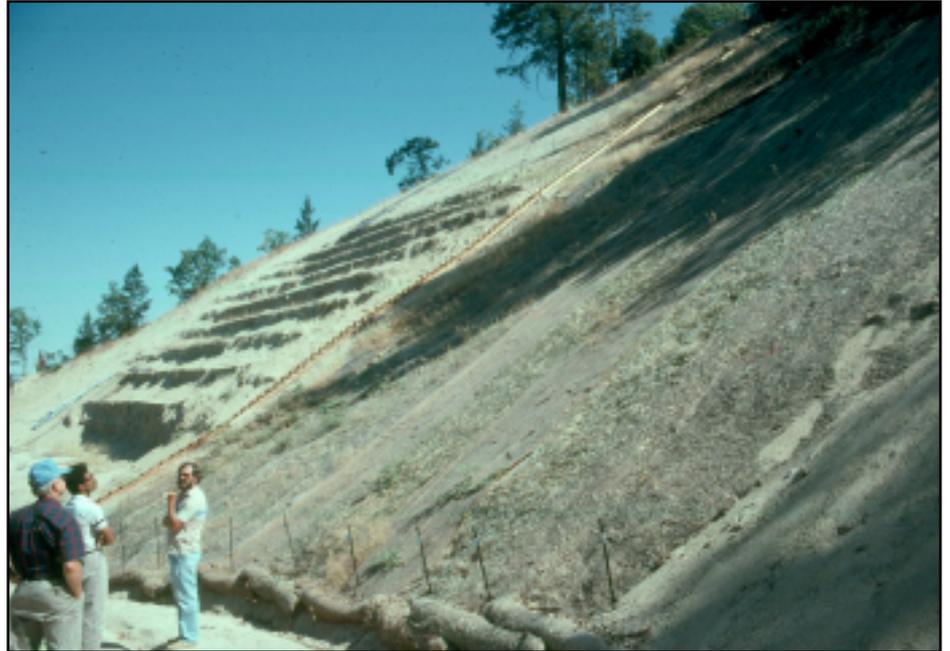
Early experiments in 1990 tested benched slopes and surface treatments. Note the rolls of ECBs, precursors to straw wattles, at the toe of the treatments.

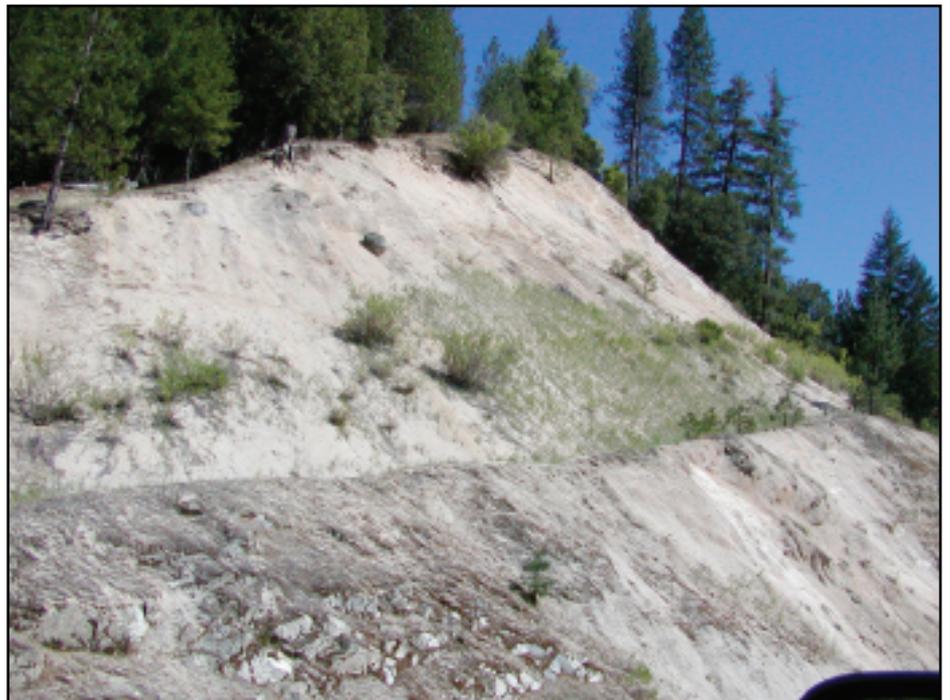
In the early 1980s slopes were treated with jute netting, hydroseeding, and willow wattles and stakes. Notice how the willow bushes have persisted, though not vigorous, for 25 years.

Early in the 1980s the SCS (now the NRCS) and Humboldt State University conducted several early hydroseeding applications, installations of jute netting and bioengineering techniques (willow staking) on the cut slopes in Trinity County. Twenty-five years later some

willow stakes have persisted and survived without irrigation in this environment of 2000 foot elevation and 100 degree summers, although the slopes are still raveling. A selection of alternative techniques and native grasses would most likely have better results.

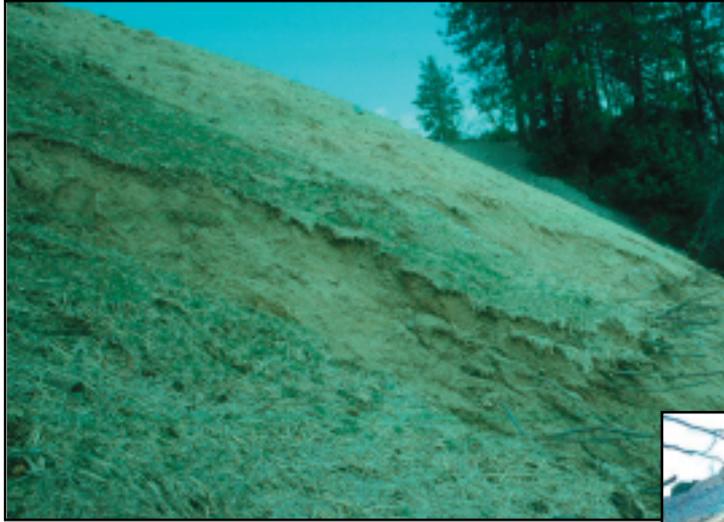
Site, revealed that nearly as much sediment was produced by freeze-thaw and gravity as was produced by rainfall erosion.

The experiment also indicated that the best remedy for both of the sediment-producing mechanisms, freeze-thaw and raindrop erosion, was the same – maintaining or establishing a good vegetative

In 1990 a Caltrans research project on a cutslope, known as Kelsey's Site, revealed that nearly as much sediment was produced by freeze-thaw and gravity as was produced by rain-fall erosion.

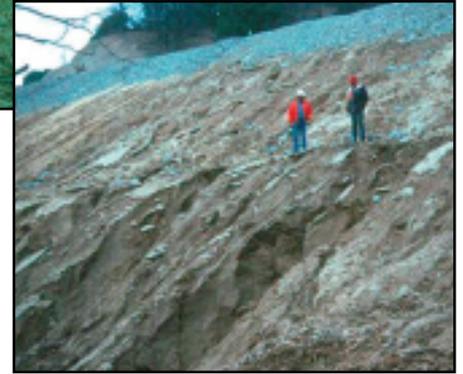
Top: The slope with Brushlayering required minor repair. Inset: The "standard" construction failed and required complete reconstruction.

In several instances we have tried, unsuccessfully, to build un-reinforced fill slopes steeper than 2:1 that were then treated with standard erosion control practices. The worst case scenario was a fill slope that was by necessity 1.5:1 and longer than 100 ft. In 1991 Caltrans constructed two - 300 foot long "sliver fills", as part of a safety and curve correction project. The first fill slope was designed with drainage benches and standard erosion control (punched in straw mulch and hydro seeding) while the adjacent slope had one of the earliest brush layering trials. Early winter storms exposed the newly constructed slopes to a severe "rain on snow" event - nearly 1 ft of snow followed by almost 7 in. of rain. The first slope failed that winter and ultimately had to be reconstructed while the slope reinforced with brushlayering required only hand labor to repair the gullies and rills. The primary failure mechanism appeared to be saturated soil failure followed by gully erosion. The brushlayered slope apparently remained stable because the willow branches, though not rooted

yet, provided internal drainage, reduced pore pressure, and soil reinforcement while the branches emanating from the face increased slope roughness. A brush-layer every 6 ft. vertical instead of the 12 ft. interval chosen would have been more effective.

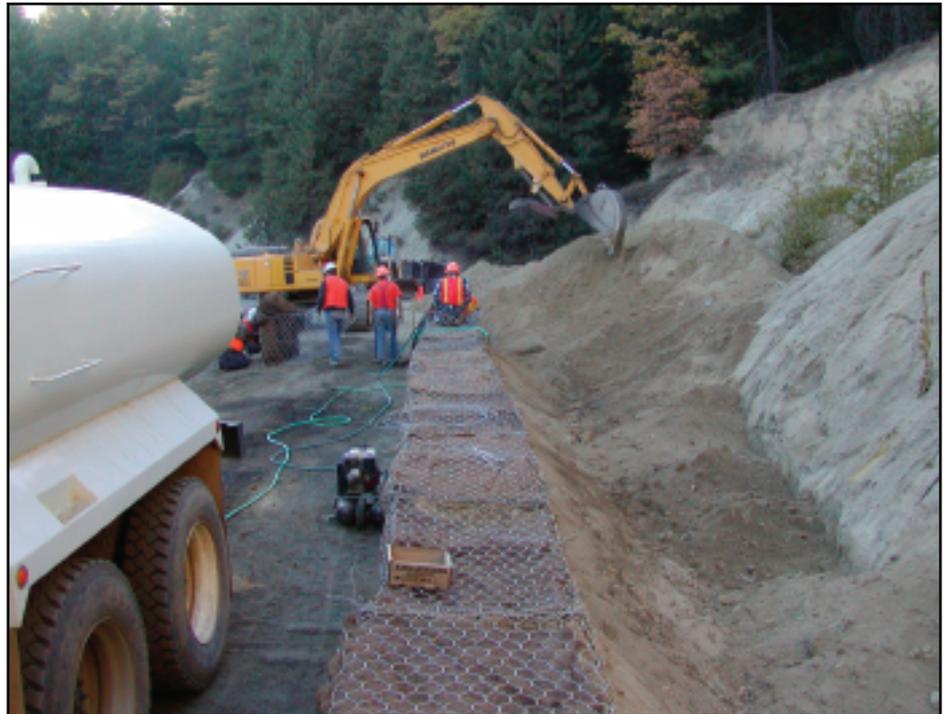
Soil-filled gabions used as gravity toe wall.

Slope stability on this site was achieved by constructing a soil-filled gabion basket toe wall, reinforced with willow poles inserted through the baskets

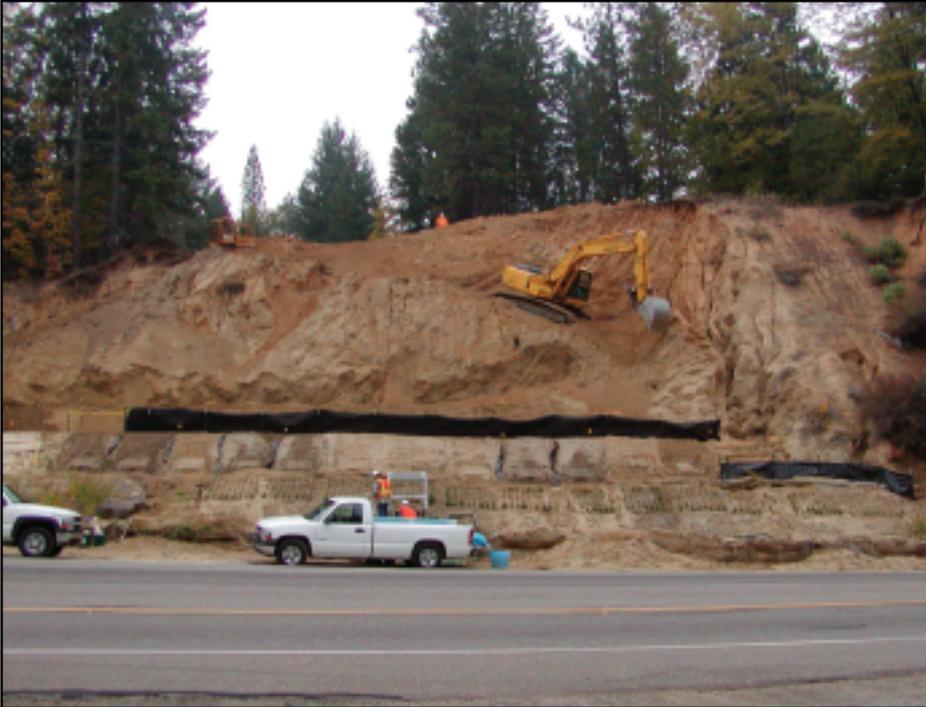
Fall 2003 begin construction of 'fill-cut' and 'soil flaps' while UC Davis researchers monitor compost trials.

A very innovative and cost-effective technique was successfully completed in the fall of 2003. This trial was a research project funded by the Caltrans Stormwater Program and administered by the Caltrans Landscape Architecture Program and Caltrans District 2. UC Davis, Department of Land, Air, and Water Resources, and Salix Applied Earthcare, Redding, CA conducted the research. The project was part of a larger, 3-year study intended to look at reducing erosion and restoring slopes with adverse soil conditions.

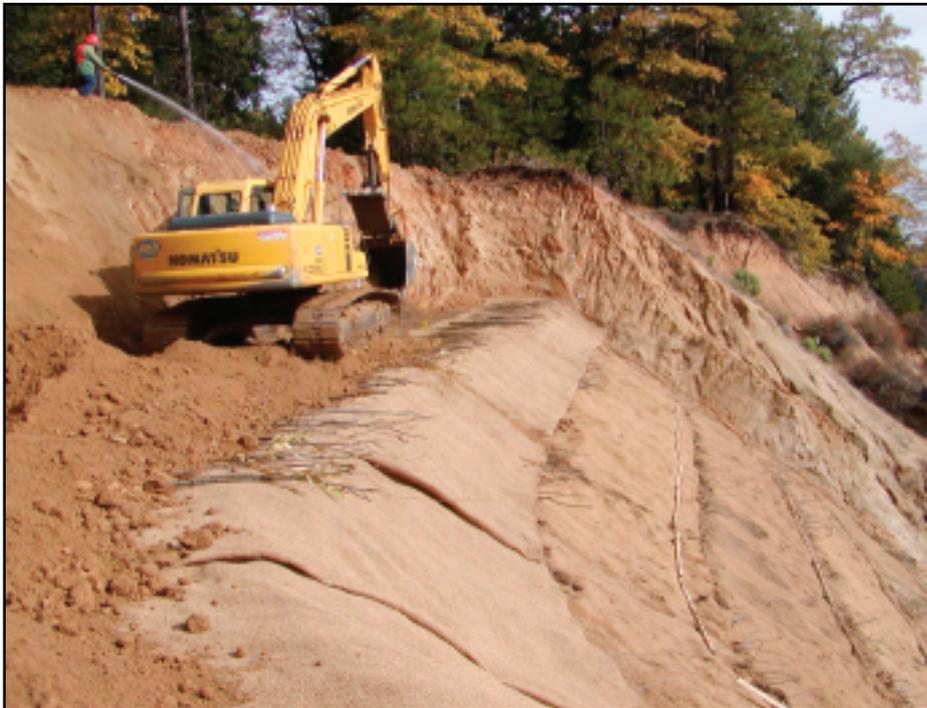
Fill-cut and soil flaps nearly completed at day three.

A 4 meter-wide (13 ft.) roll of the coir geotextile was laid out on the bench with 2.7 meters (9 ft.) flapping over the face. The next lift was built and a soil

flap is installed and this technique was continued up the slope. For cost-effectiveness and constructability, brush layering was not installed continuously across each terrace, but instead they were installed in a staggered, crosshatched pattern.

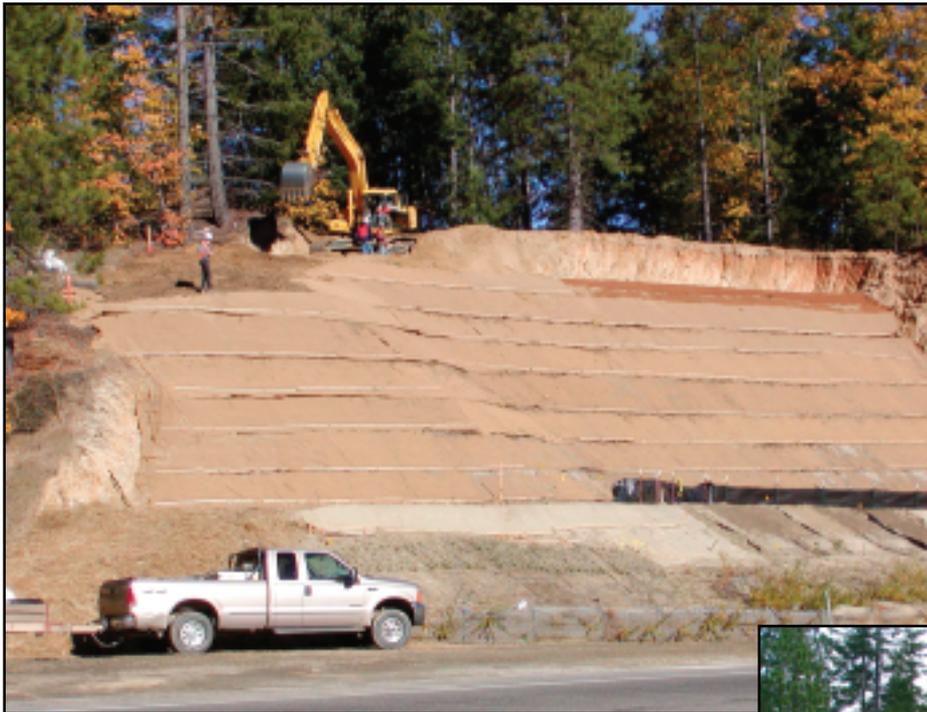
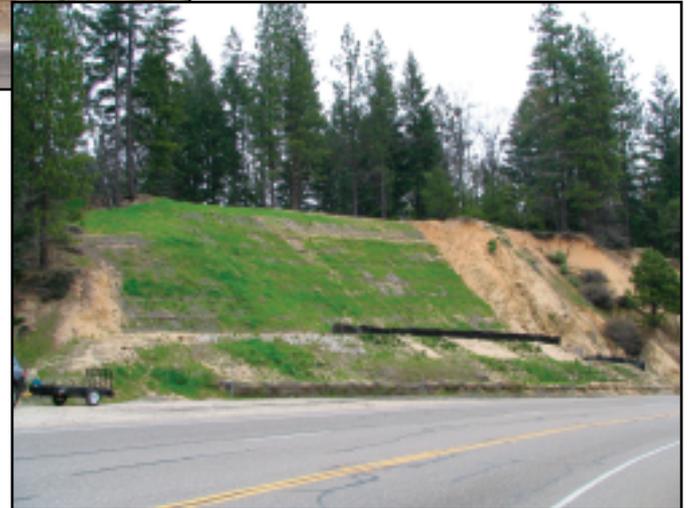
Top: October 2003, Day 4, soil flap near completion. Inset: April 2005, after two winters the slope remains stable.

The slope has withstood several significant winter storms including snowfall events over the last three years. During the first winter season, severe storms hit within weeks after construction, and several months later storms produced 5 inches of precipitation in three (3) days but the slope remained stable. No slumping or failures occurred, suggesting that the flaps succeeded in neutralizing the
