Coastal Bluff Repair Santa Cruz, California

John McCullah
President
Salix Applied Earthcare LLC

Pleasure Point

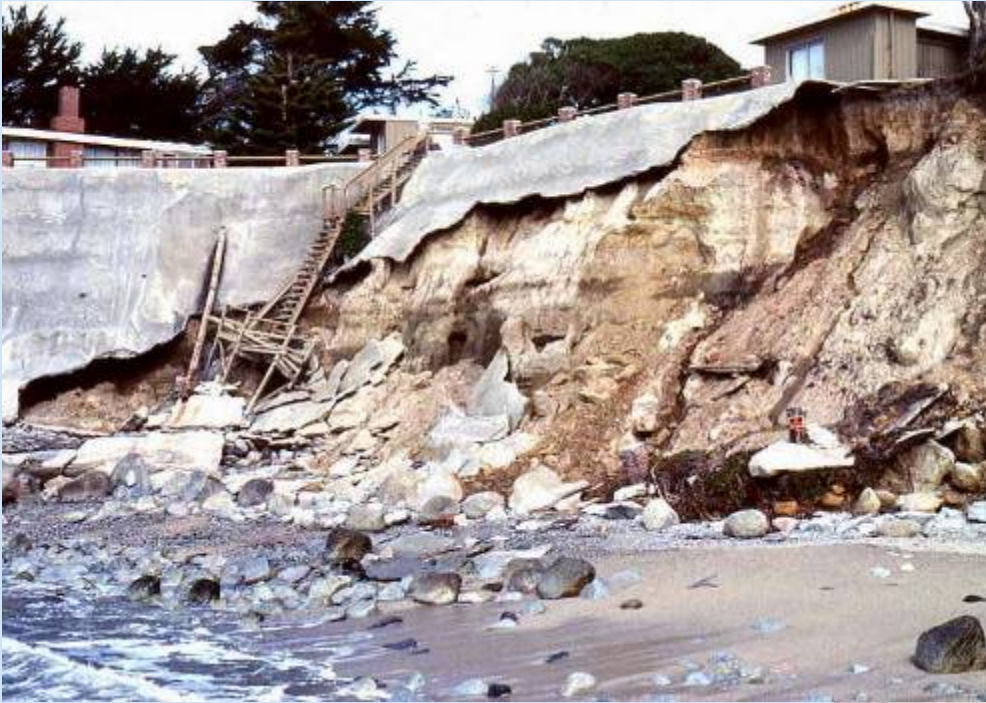
How Not to Repair Coastal Bluff

<---failed concrete (gunnite)
protective curtain

Curtain was blown out as a result
of unrelieved pore-water pressure
build up in bluff behind curtain

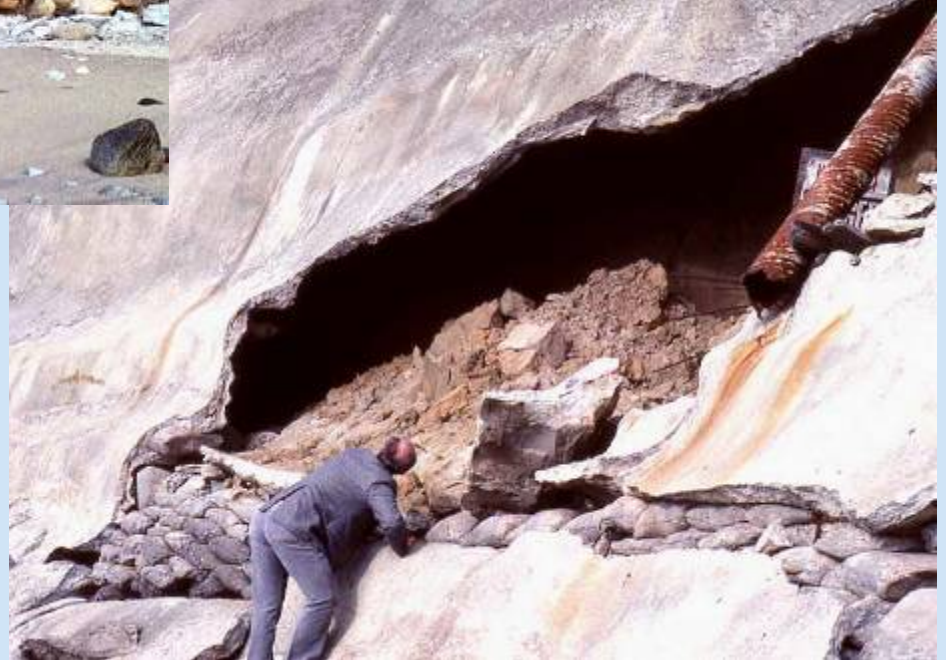
Eroded Bluff (before repair)

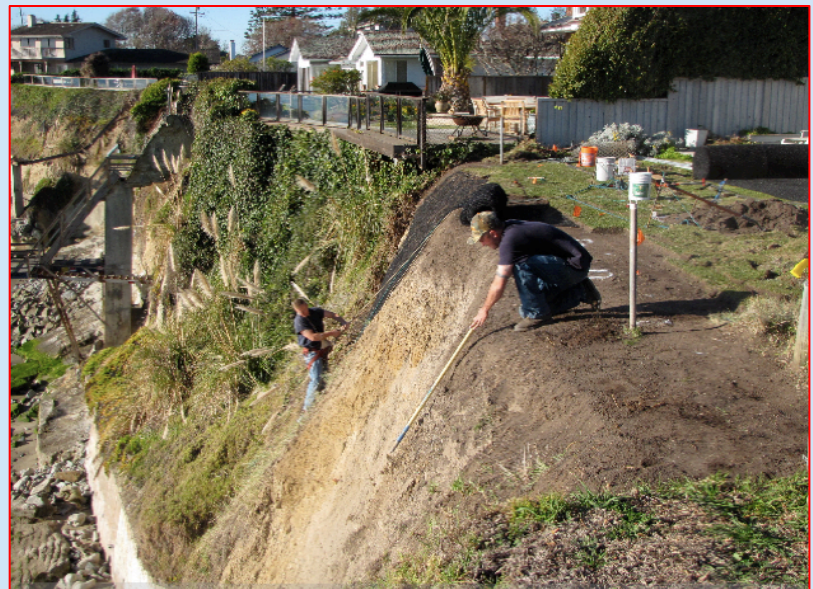
Preparing to install (drape)
Enka mat over bluff face

Enka Mat anchored 1' oc

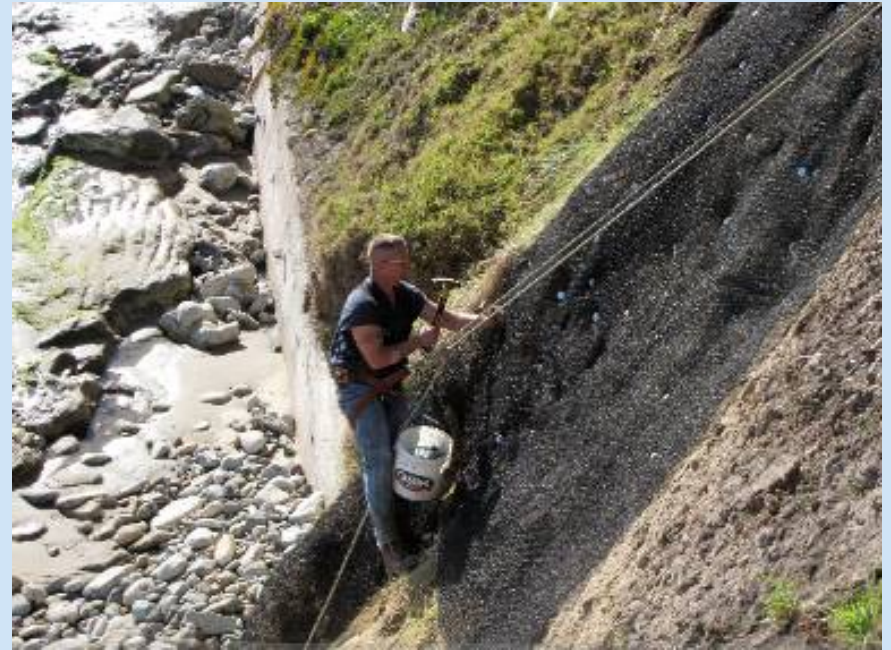
Anchoring (“nailing”) Enka mat to bluff face

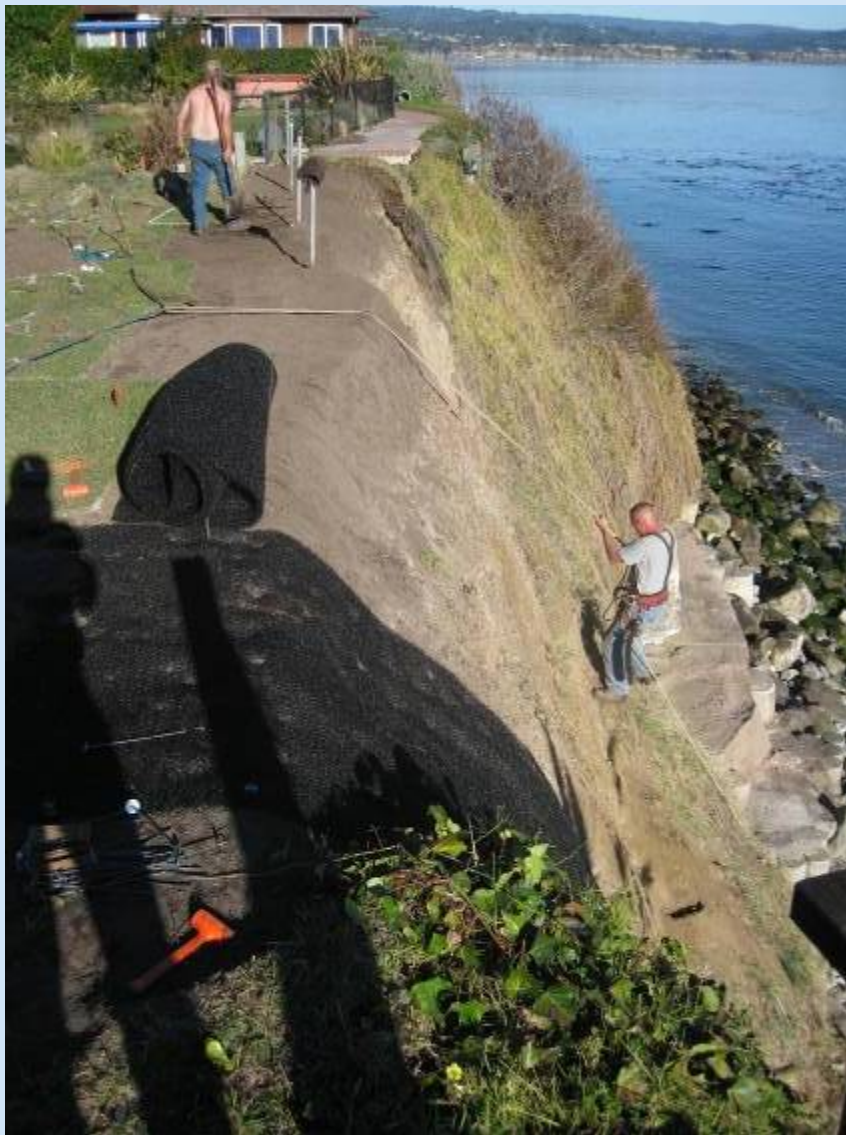
<---Enka mat anchored to bluff face

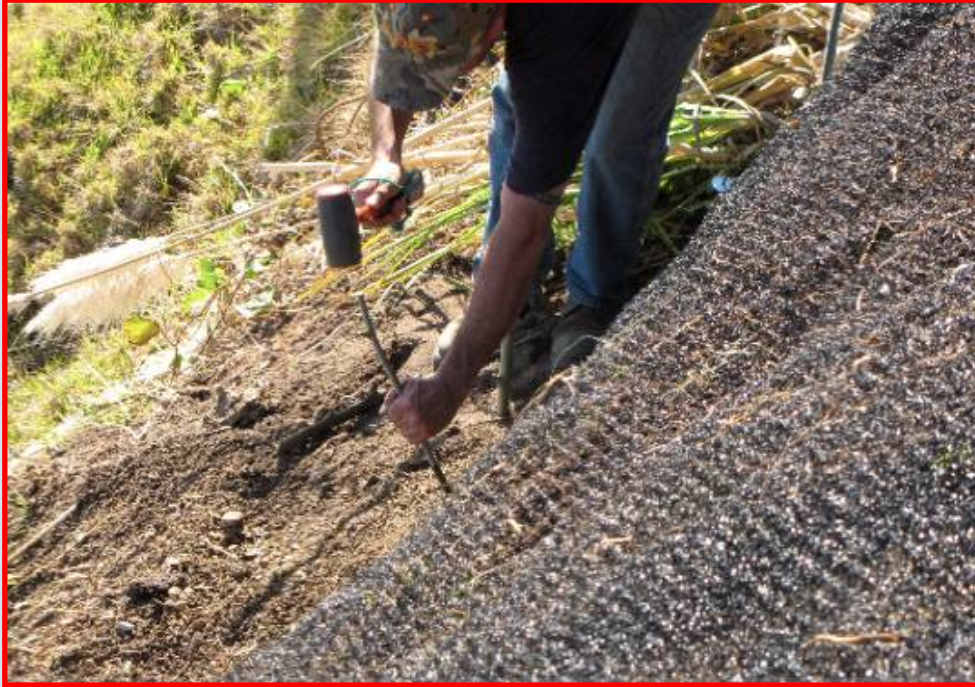
Inserting (tamping)--->
live cuttings thru
mat into bluff face

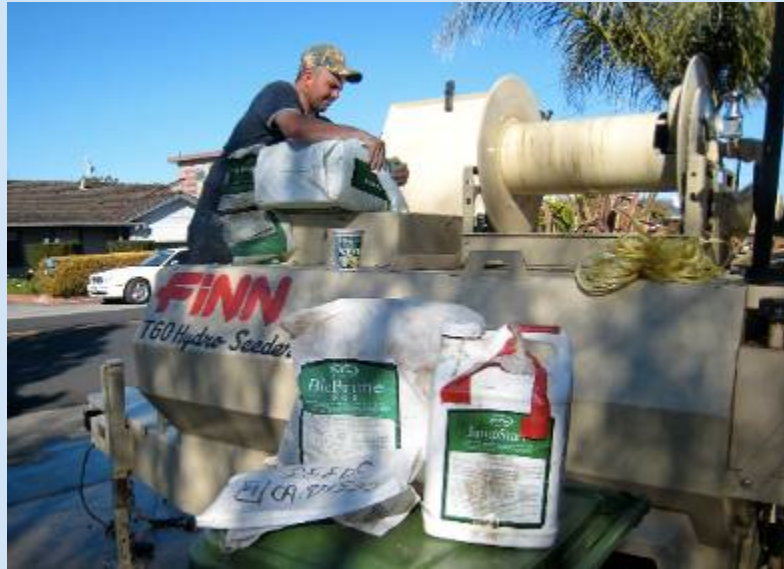
- Flexterra @ 4000# /ac
- Native Grass seeds (Maritime)
- Jumpstart (Profile) humic acid
- BioPrime (Profile) mychorrizae,

Applying (spraying) hydroseed solution to bluff face ----->

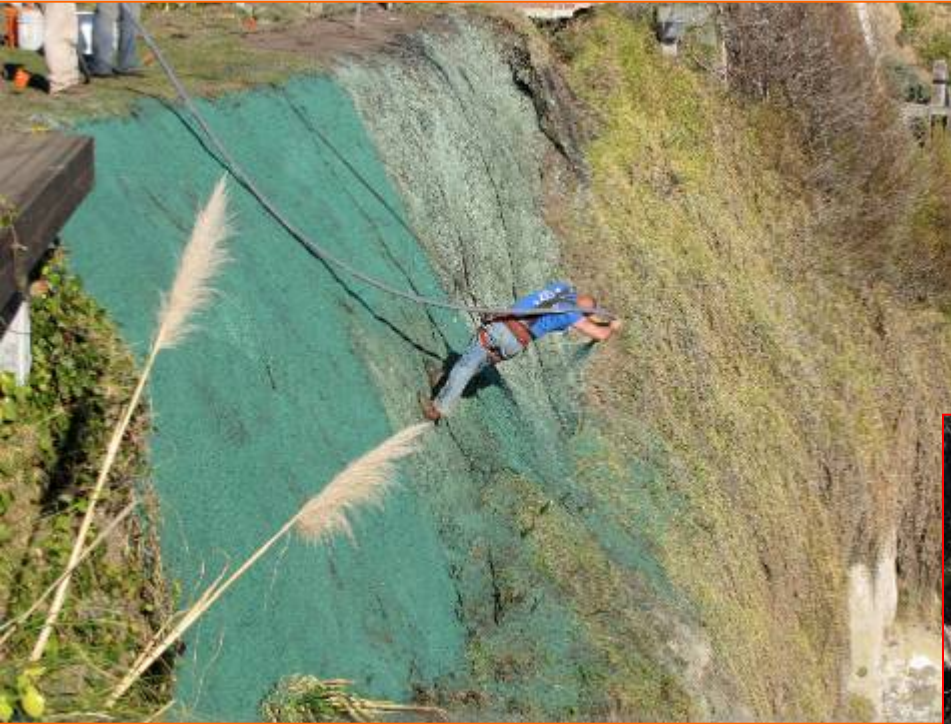
Spraying hydro mulch--->
over (& thru) Enka mat

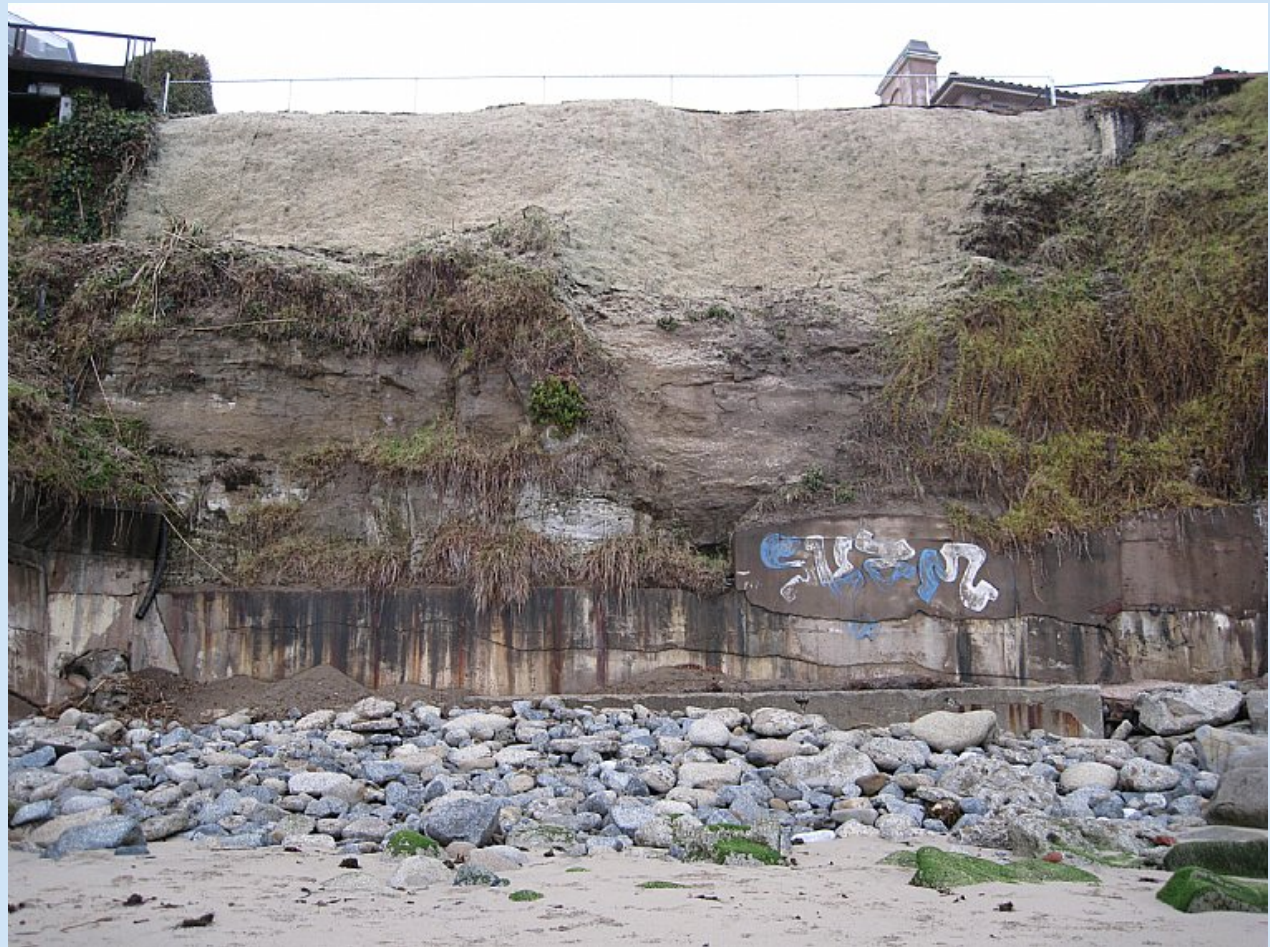
7" rain in the first week after construction
