**THE CHANNEL EVOLUTION
MODEL (CEM), CHANNEL
INCISION, ENVIRONMENTALLY
COMPATABLE GRADE
CONTROL,
GC BUT NO BANK
STABILIZATION,
& SYSTEM-WIDE GC**

Channel Evolution Model (Schumm, et al. 1984)

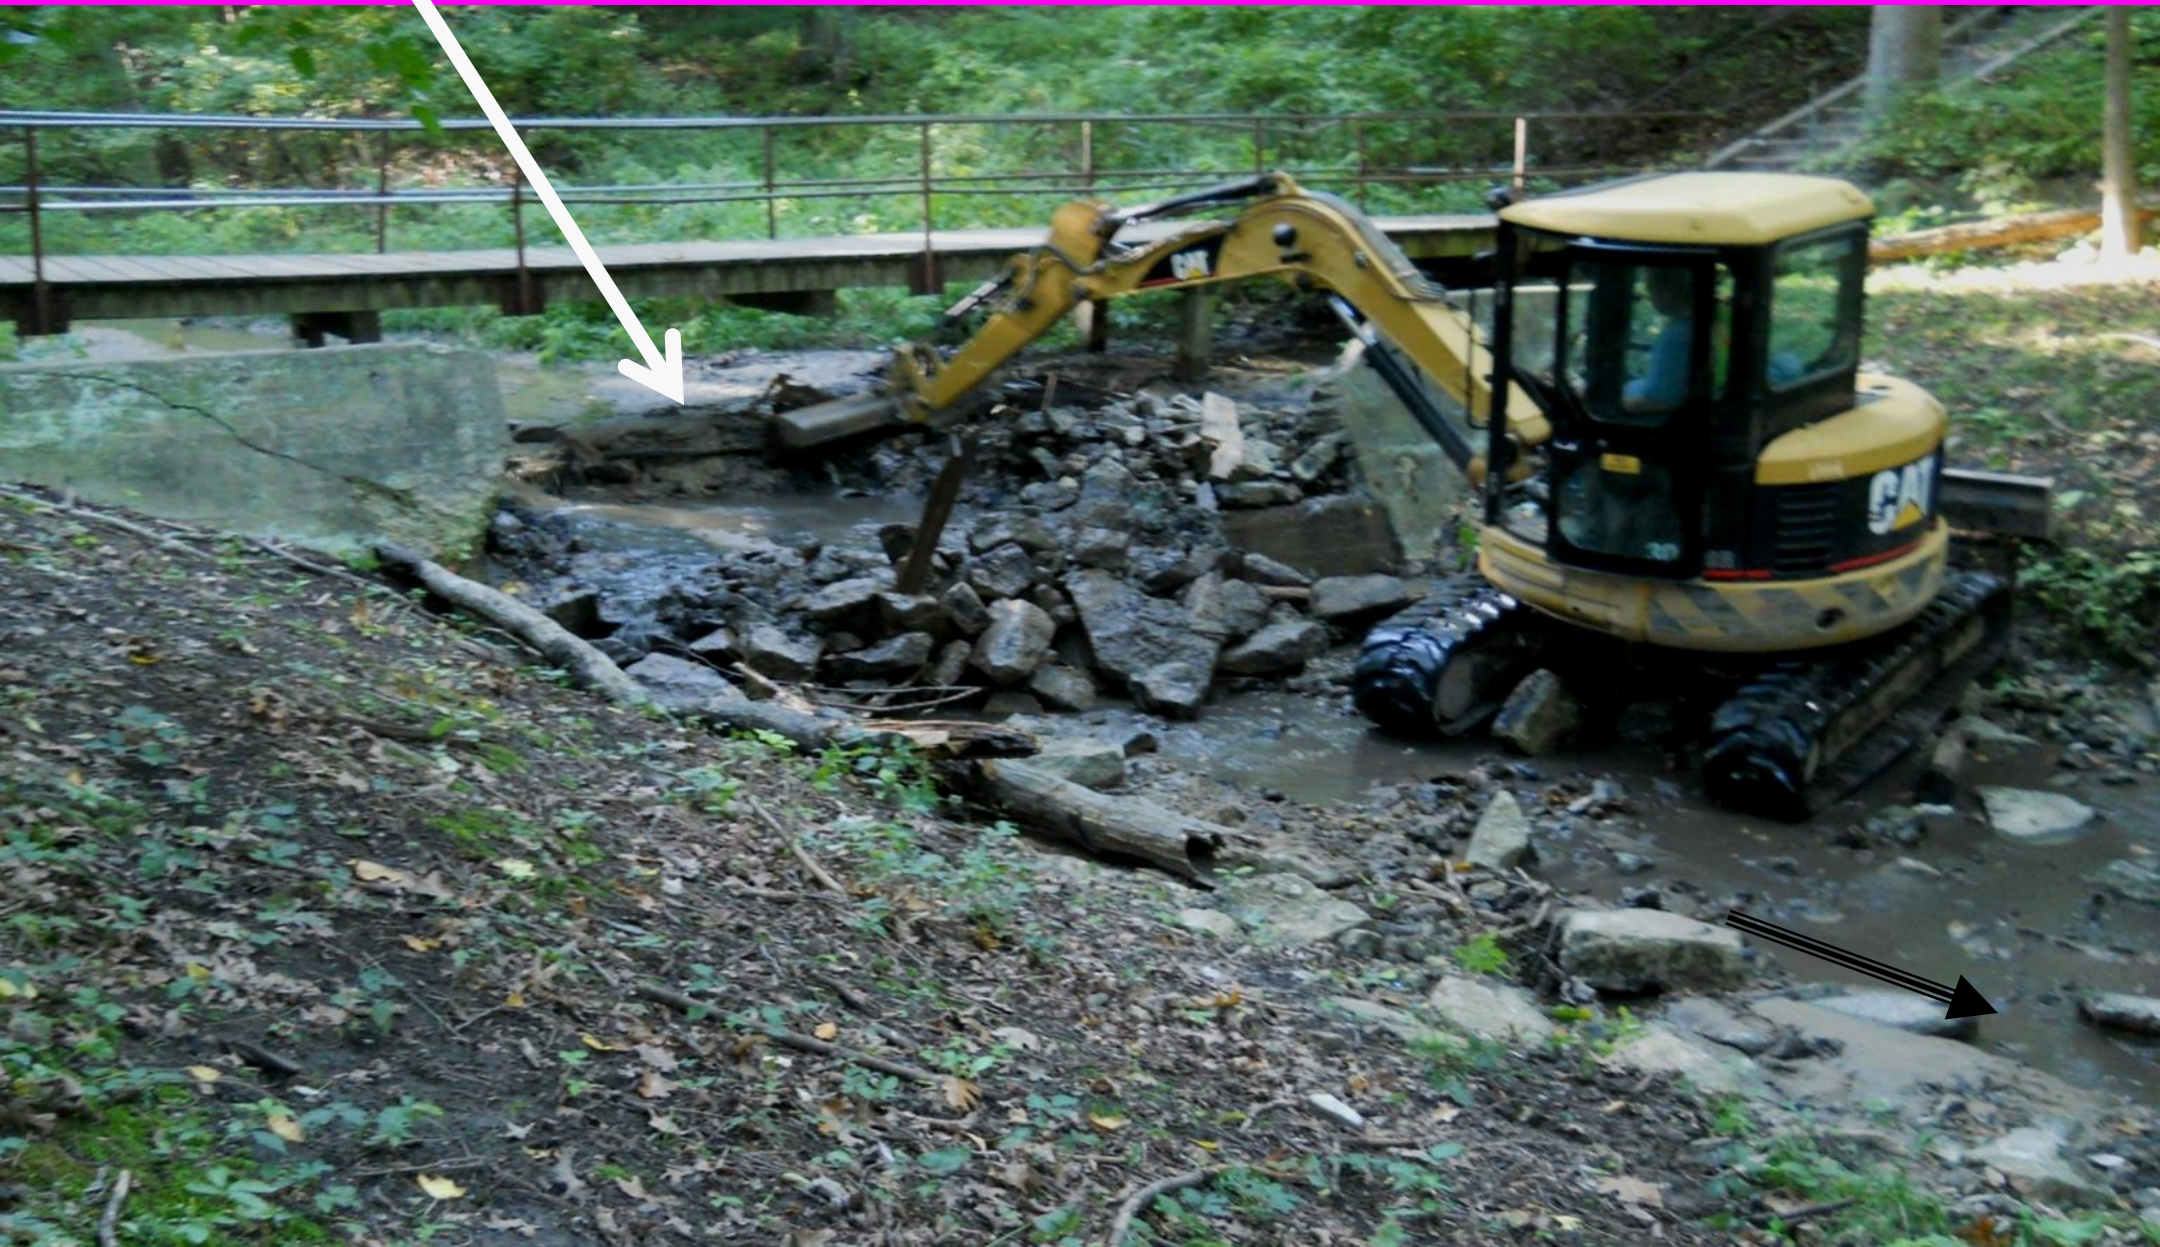
CONSTRUCTION – HARTMAN DITCH-REACH #1 - DERRICK 9-20-2012

Note height of soil. THIS STARTED THE EXCITEMENT!!!

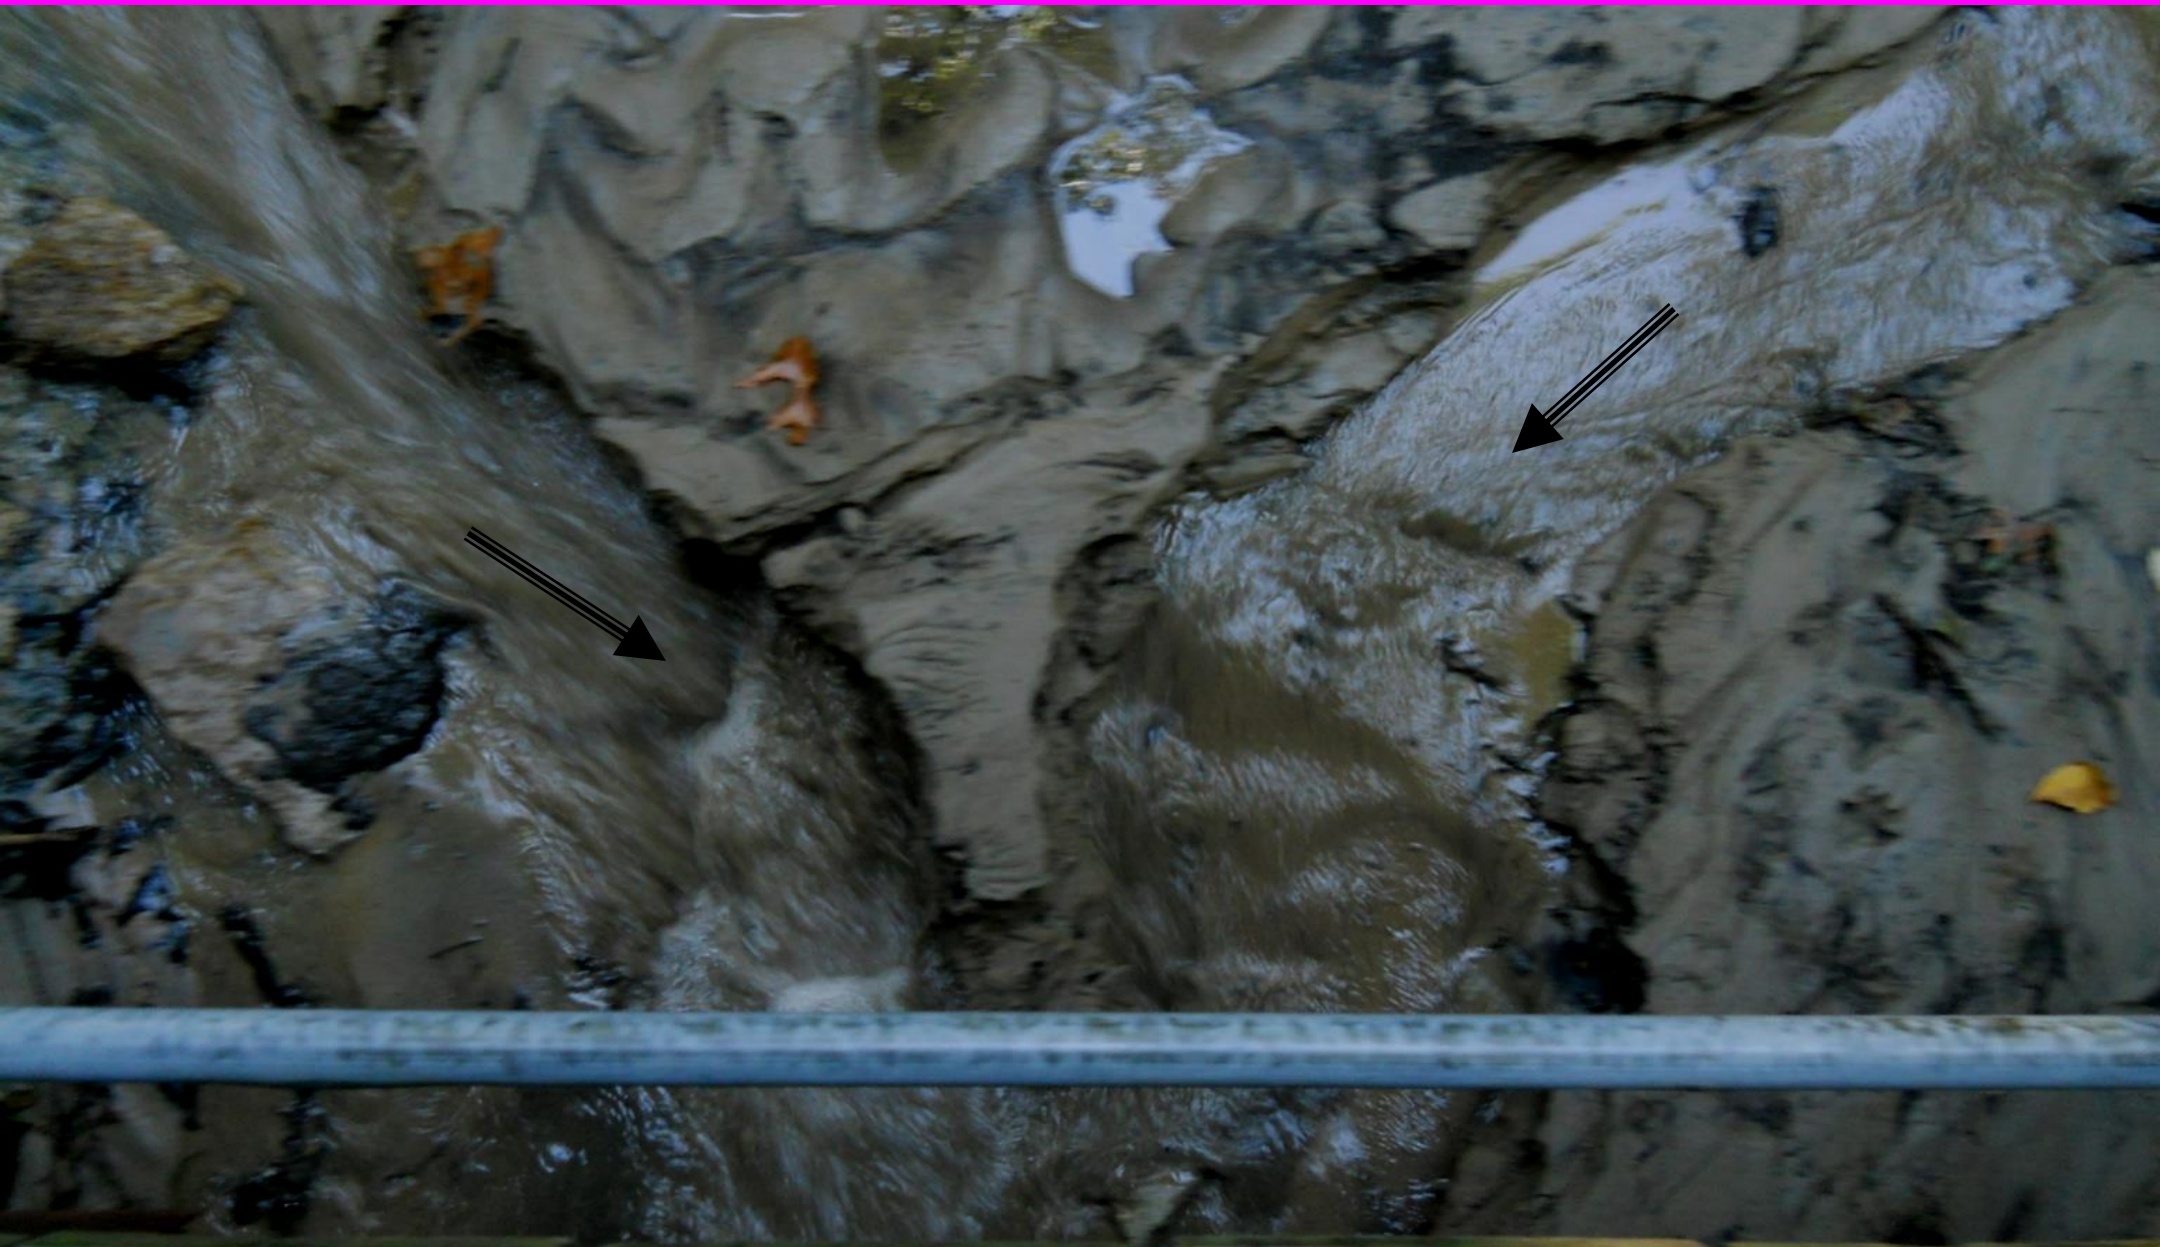
CONSTRUCTION – HARTMAN DITCH-REACH #1 - DERRICK 9-20-2012

Headcut moved upstream & underneath the bridge in minutes!

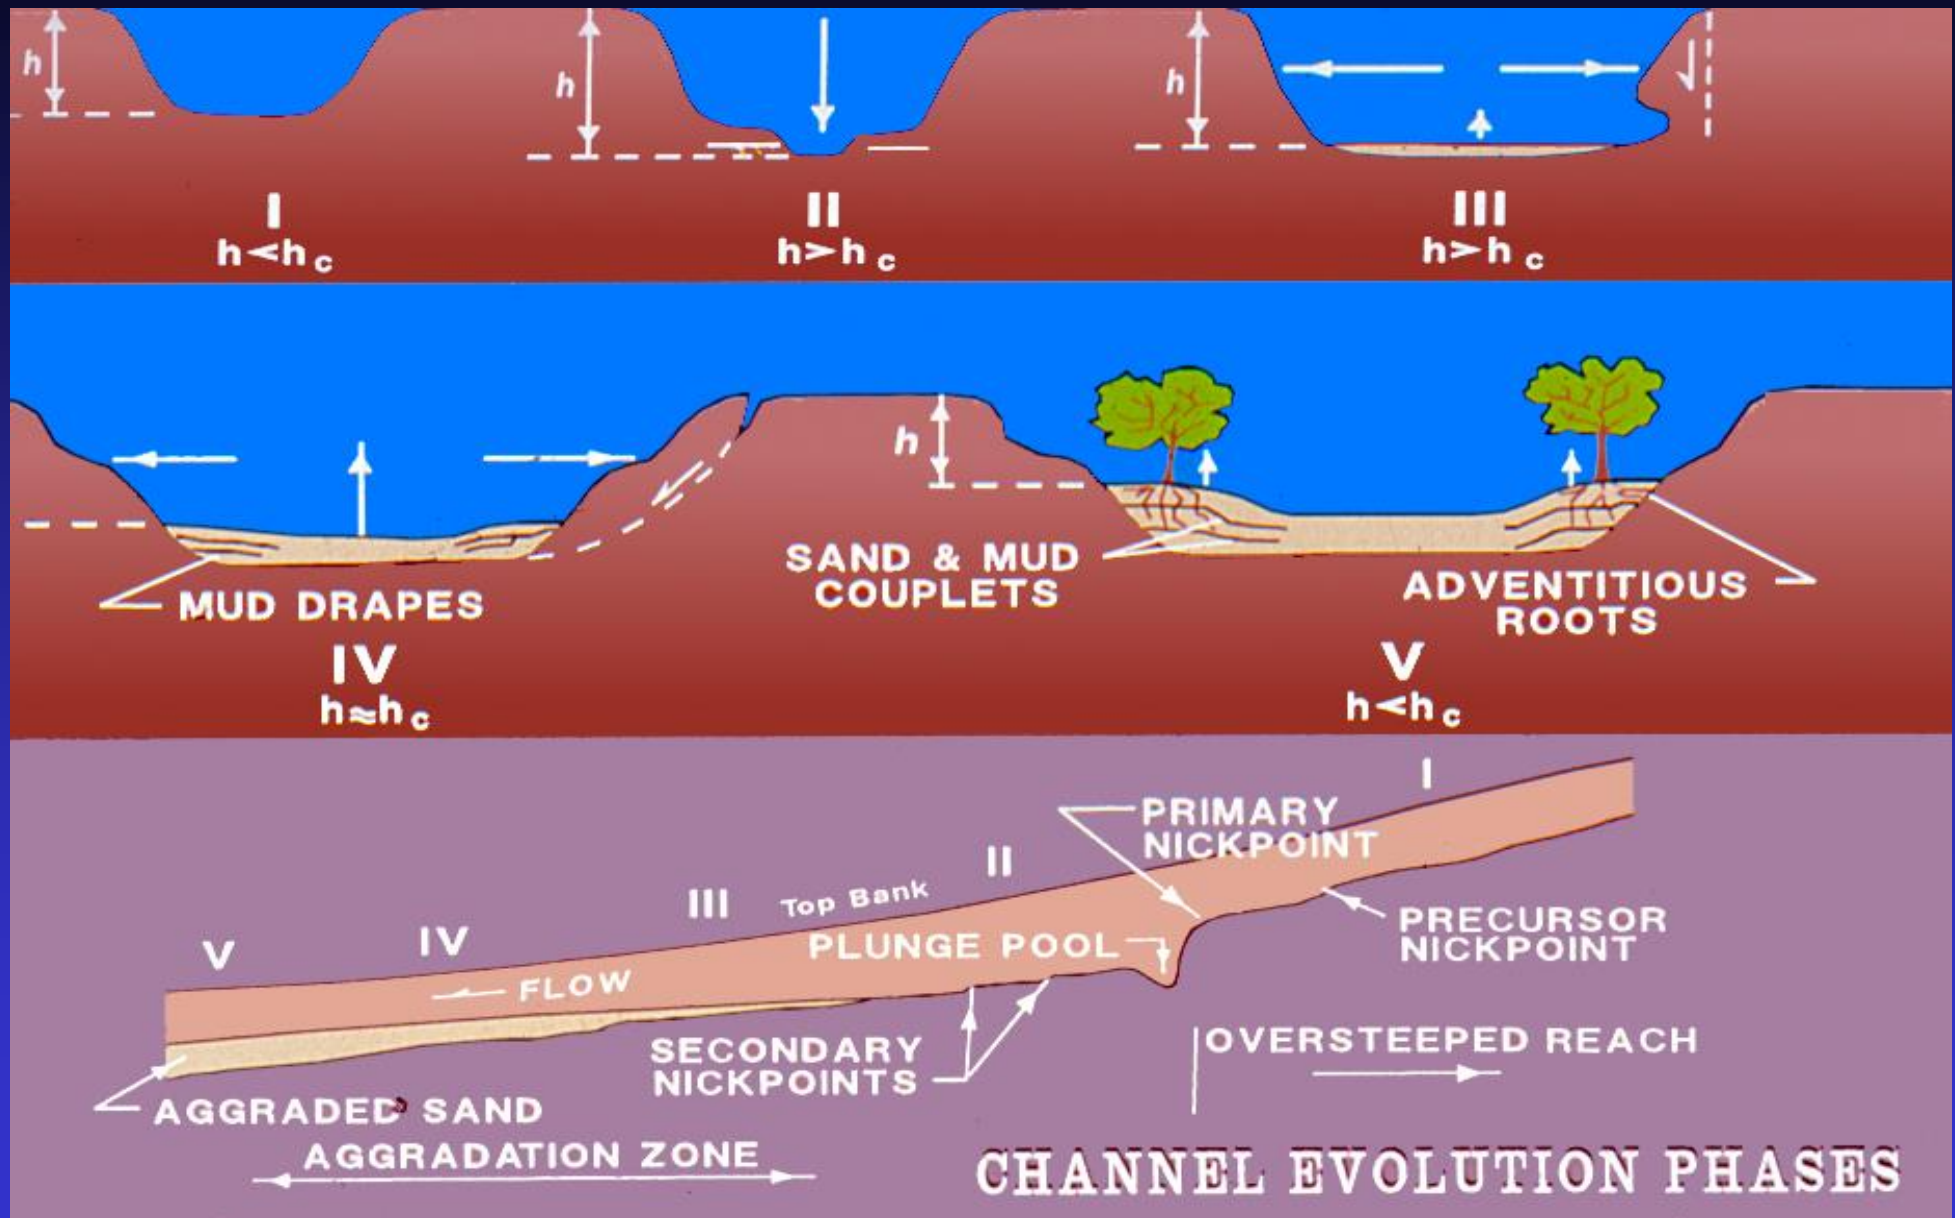
Channel Evolution Model

A location-time substitution conceptualization is used to generate a five-reach type incised channel evolution model

In an idealized stream Types I-V will occur in sequence (series)

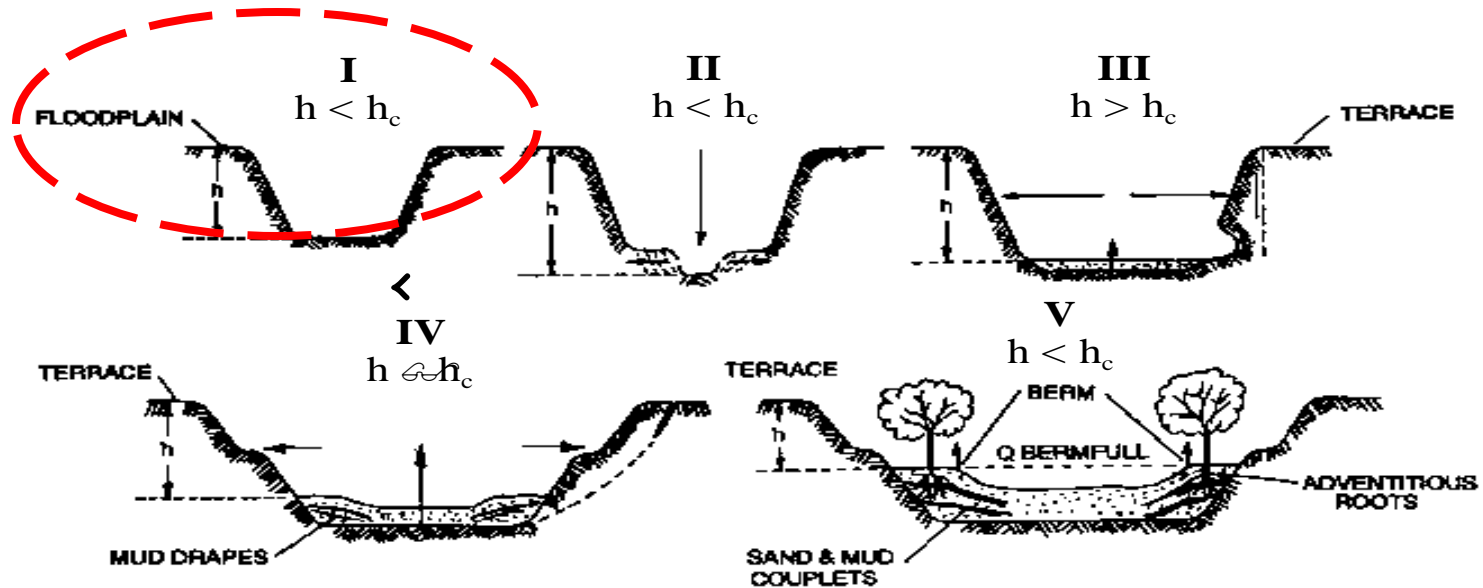
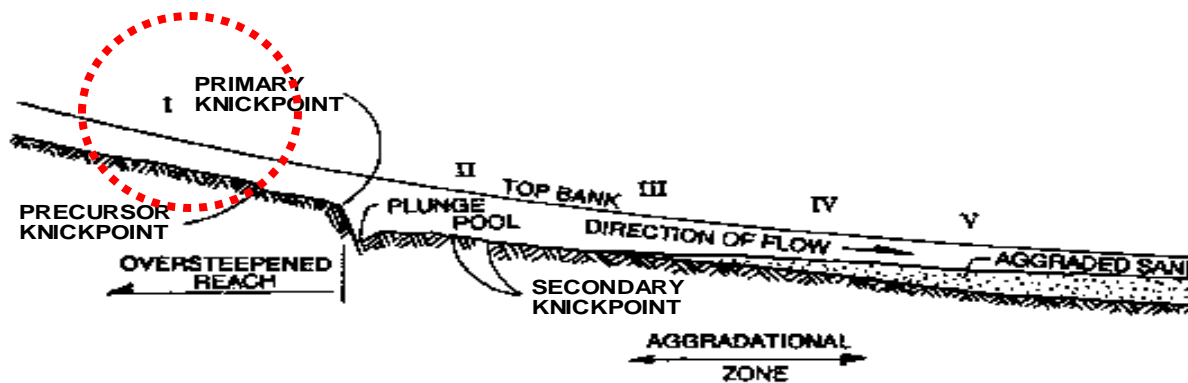
INCISED CHANNEL EVOLUTION PHASES

Type I reaches are generally characterized by a U-shaped cross section with little or no sediment stored in the channel bed.

Type I reaches are located upstream of the actively degrading reach and have not yet experienced significant bed or bank instabilities.

Type I is upstream of active incision

$h_c = \text{CRITICAL BANK HEIGHT}$

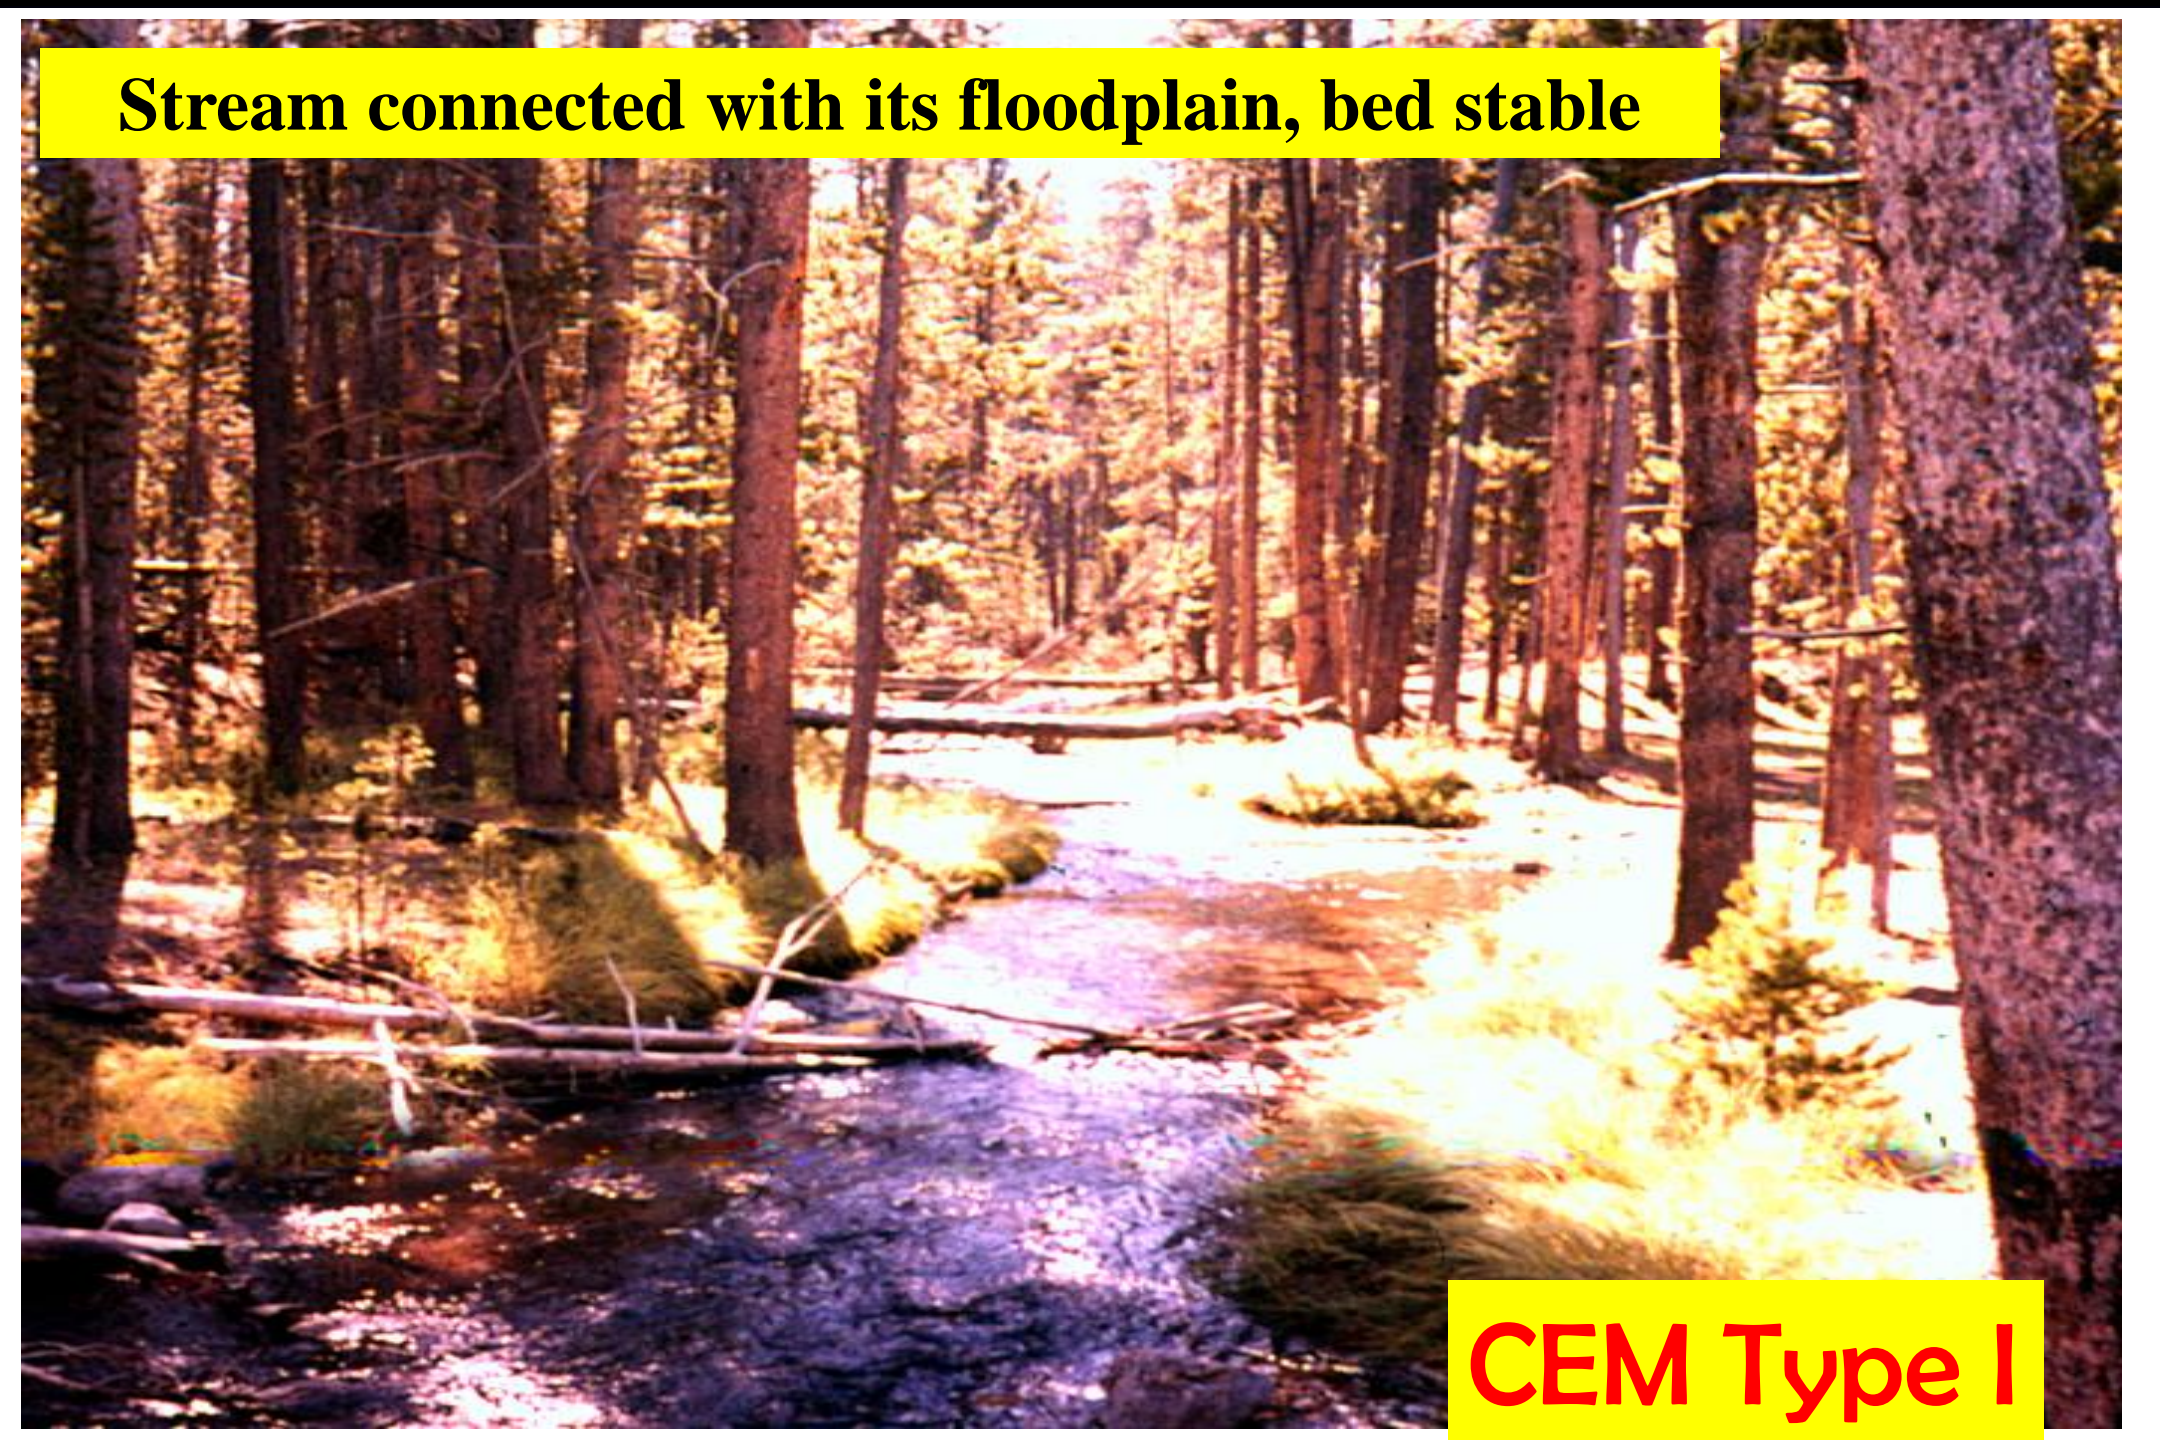
CEM Type I

Stream connected with its floodplain, bed stable

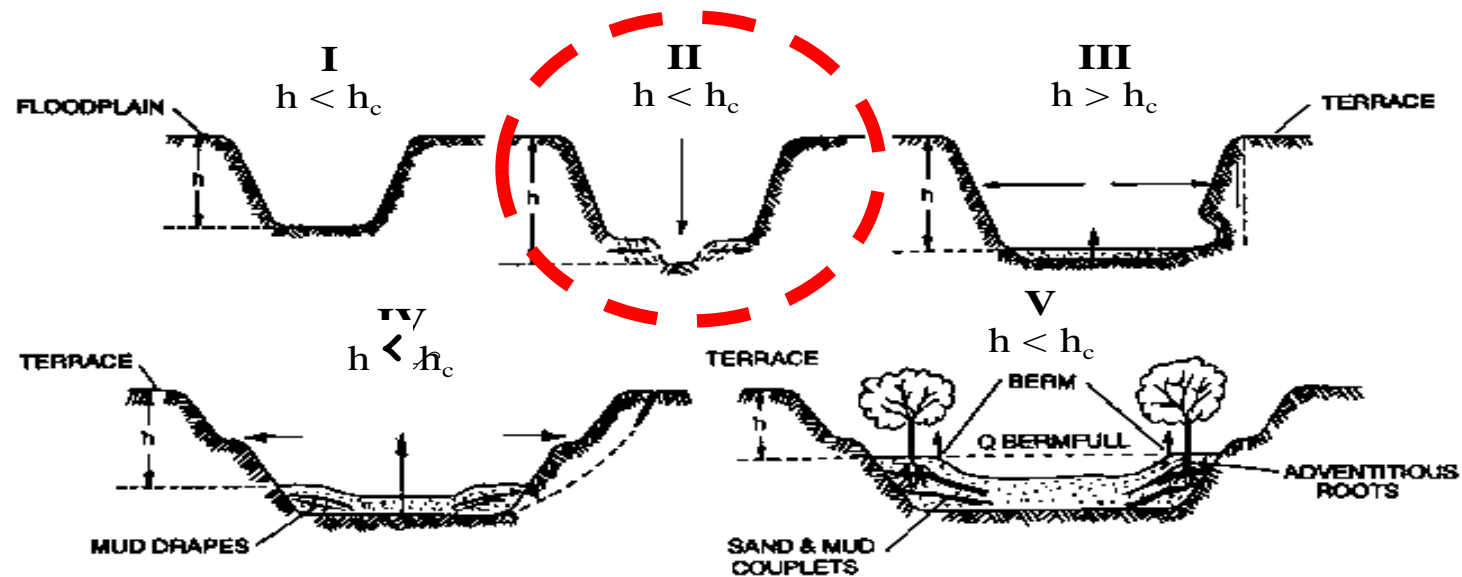
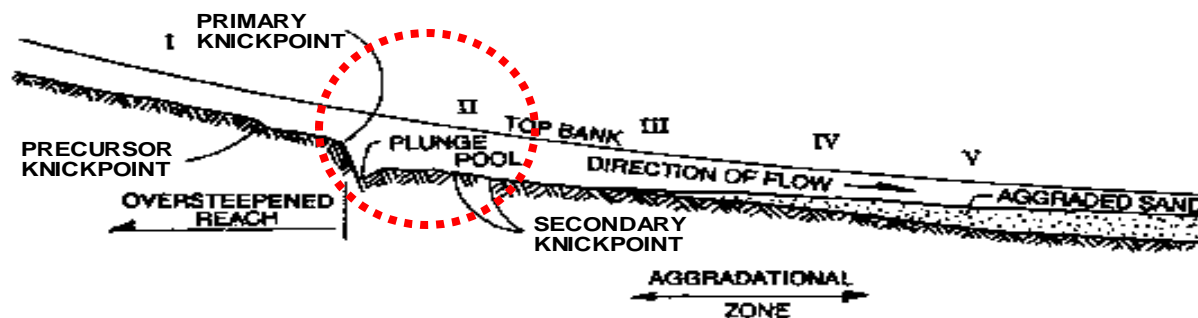
INCISED CHANNEL EVOLUTION PHASES

Immediately downstream of Type I reaches, Type II reaches are encountered. Bed degradation is the dominant process in the Type II reach.

Type II channels are steepened reaches where the sediment transport capacity exceeds the sediment supply.

Although the channel is actively degrading in a Type II reach, the bank heights (h) have not exceeded the critical bank height (h_c). Therefore, banks are not geotechnically unstable.

Type II reaches are actively incising, although mass wasting of bank has not been initiated ($h < h_c$)

$h_c = \text{CRITICAL BANK HEIGHT}$

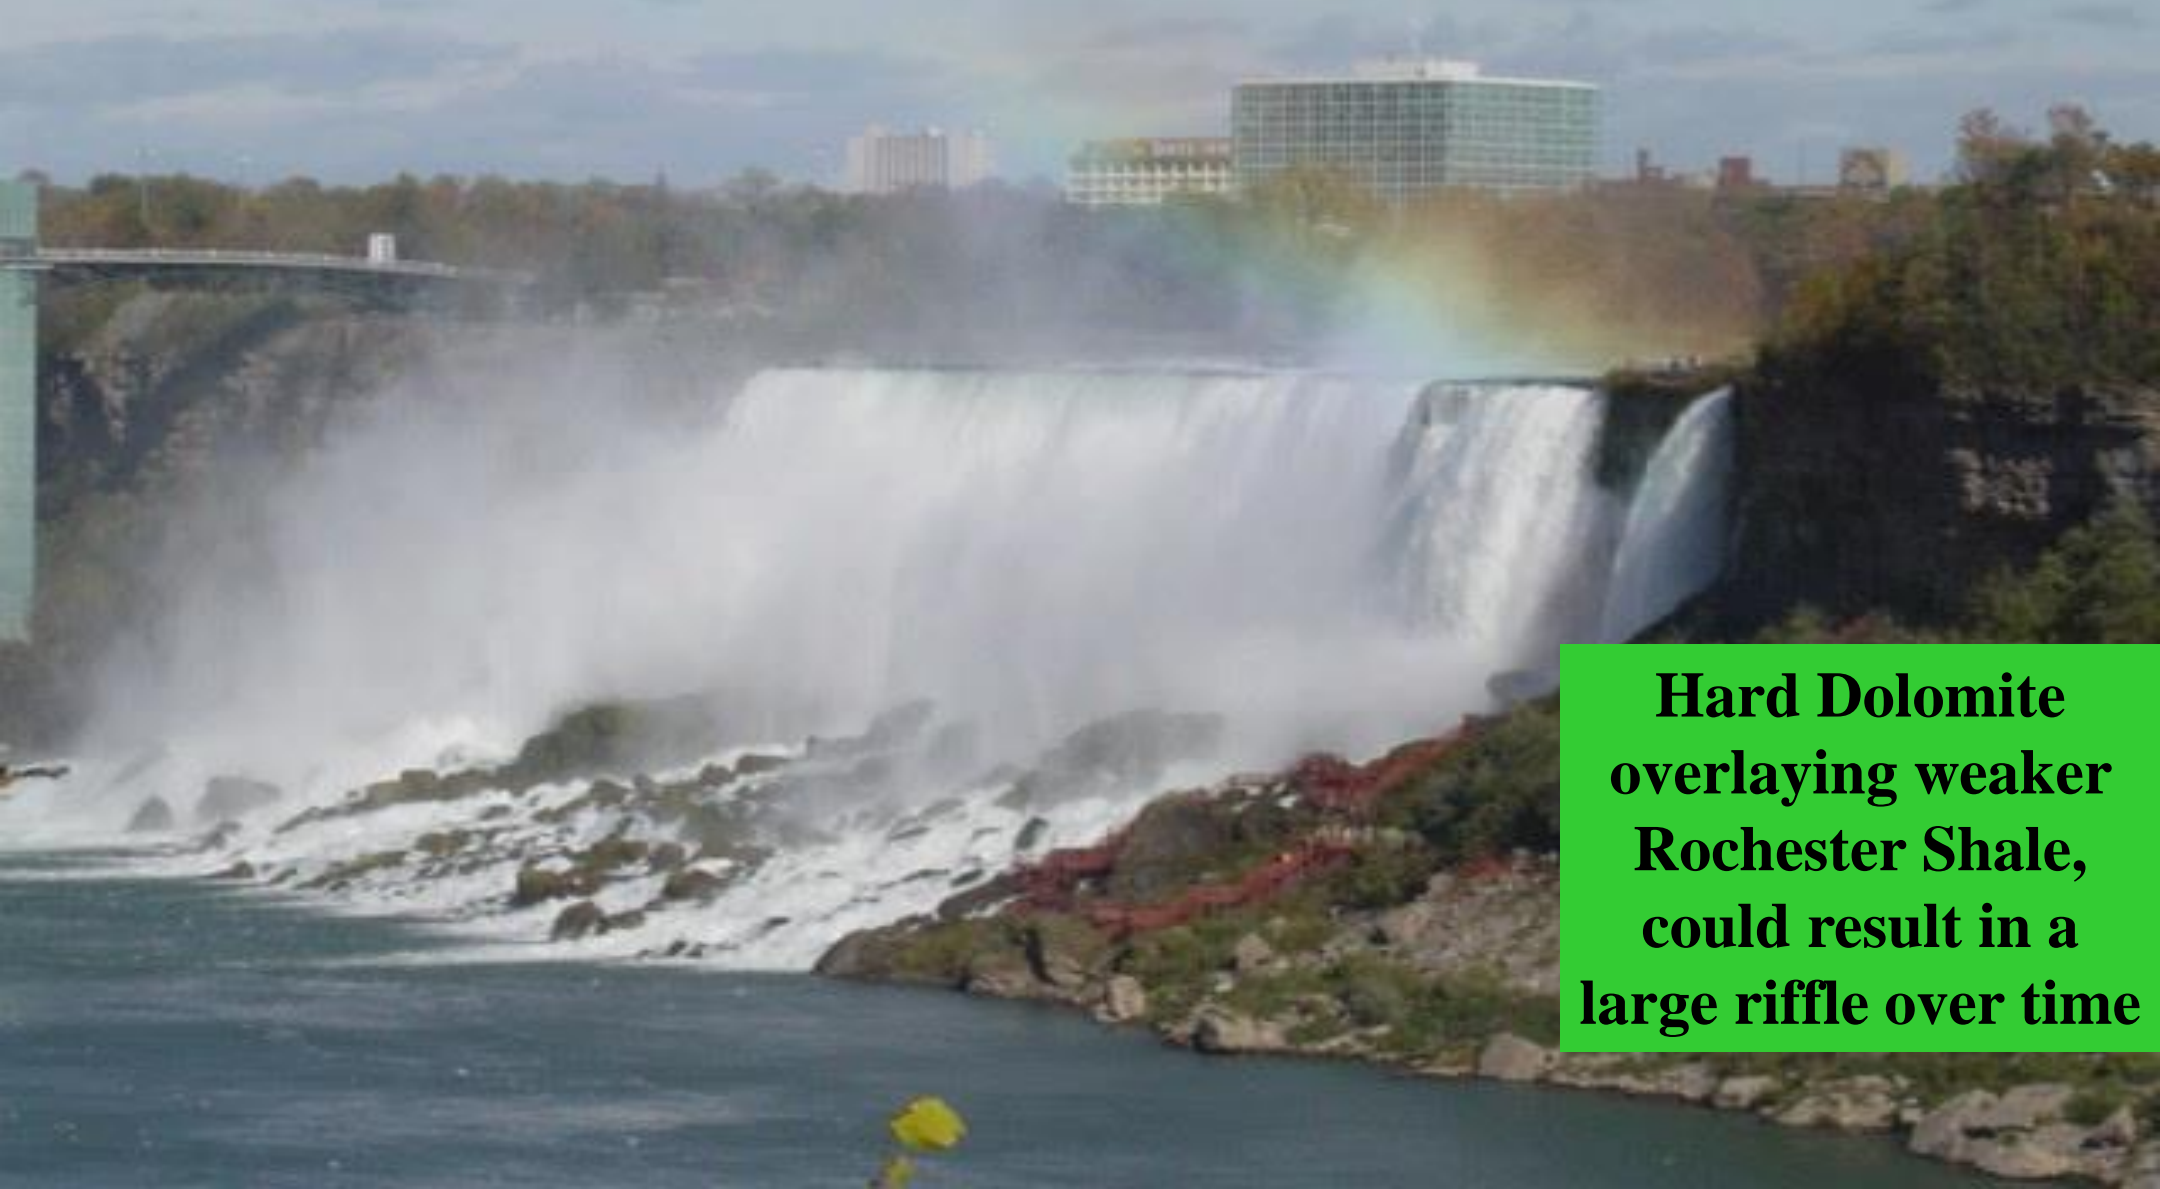
**A large knickpoint, Niagara Falls (American Falls)
(This headcut moves on average 2.5 ft per year)**

**Hard Dolomite
overlaying weaker
Rochester Shale,
could result in a
large riffle over time**

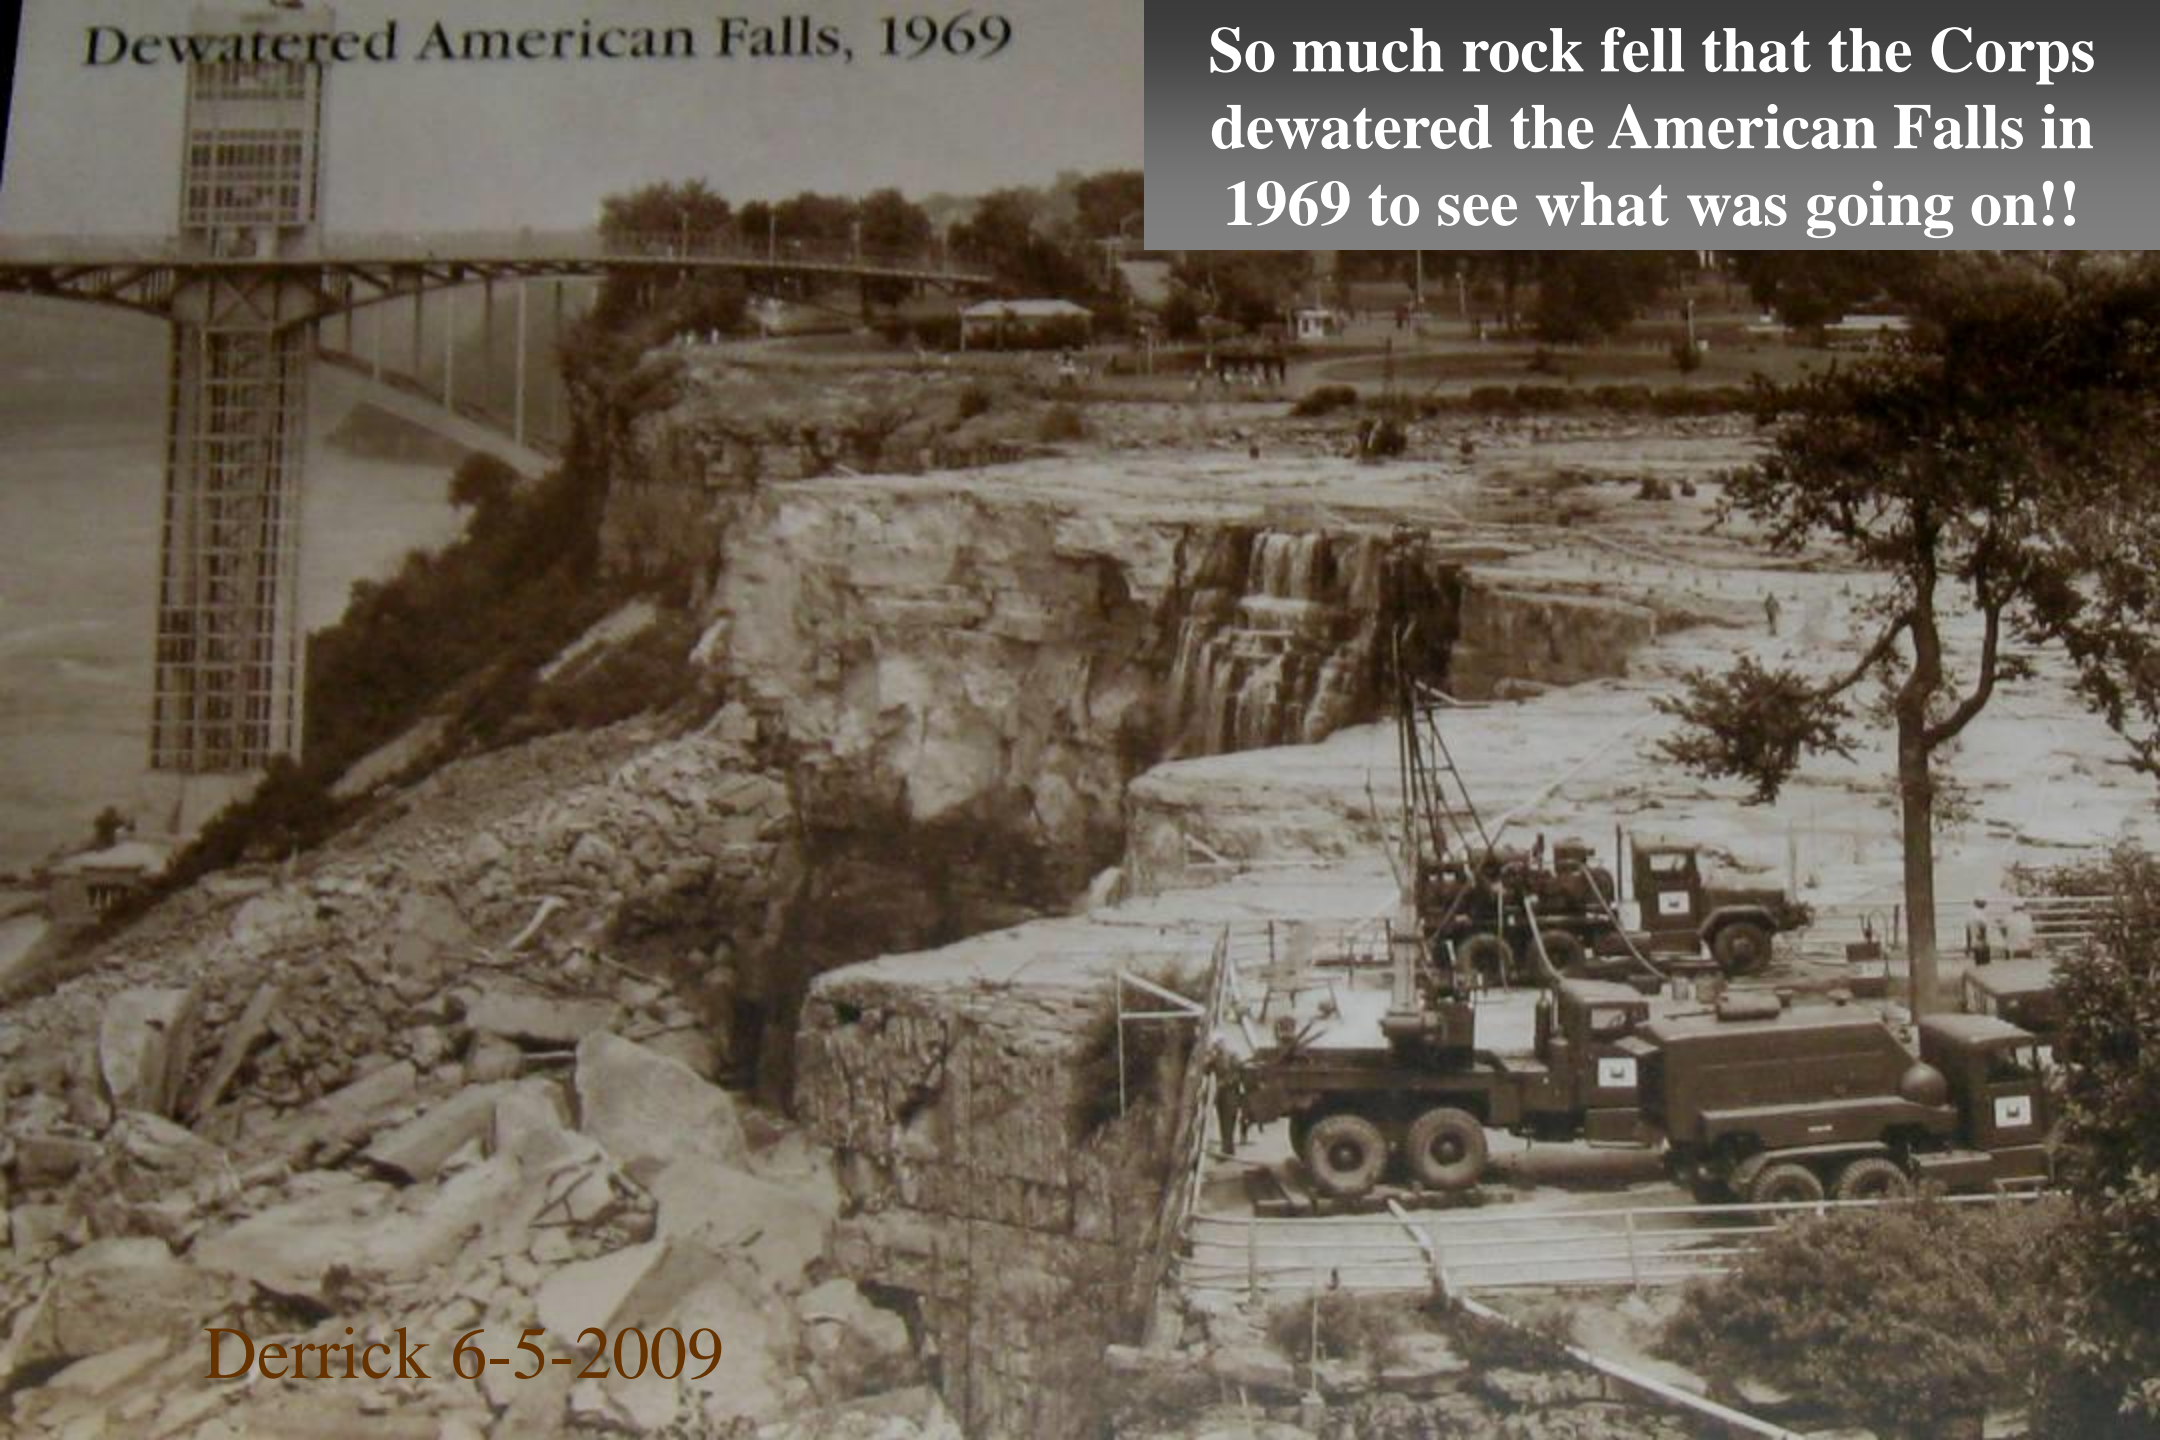
Dewatered American Falls, 1969

**So much rock fell that the Corps
dewatered the American Falls in
1969 to see what was going on!!**

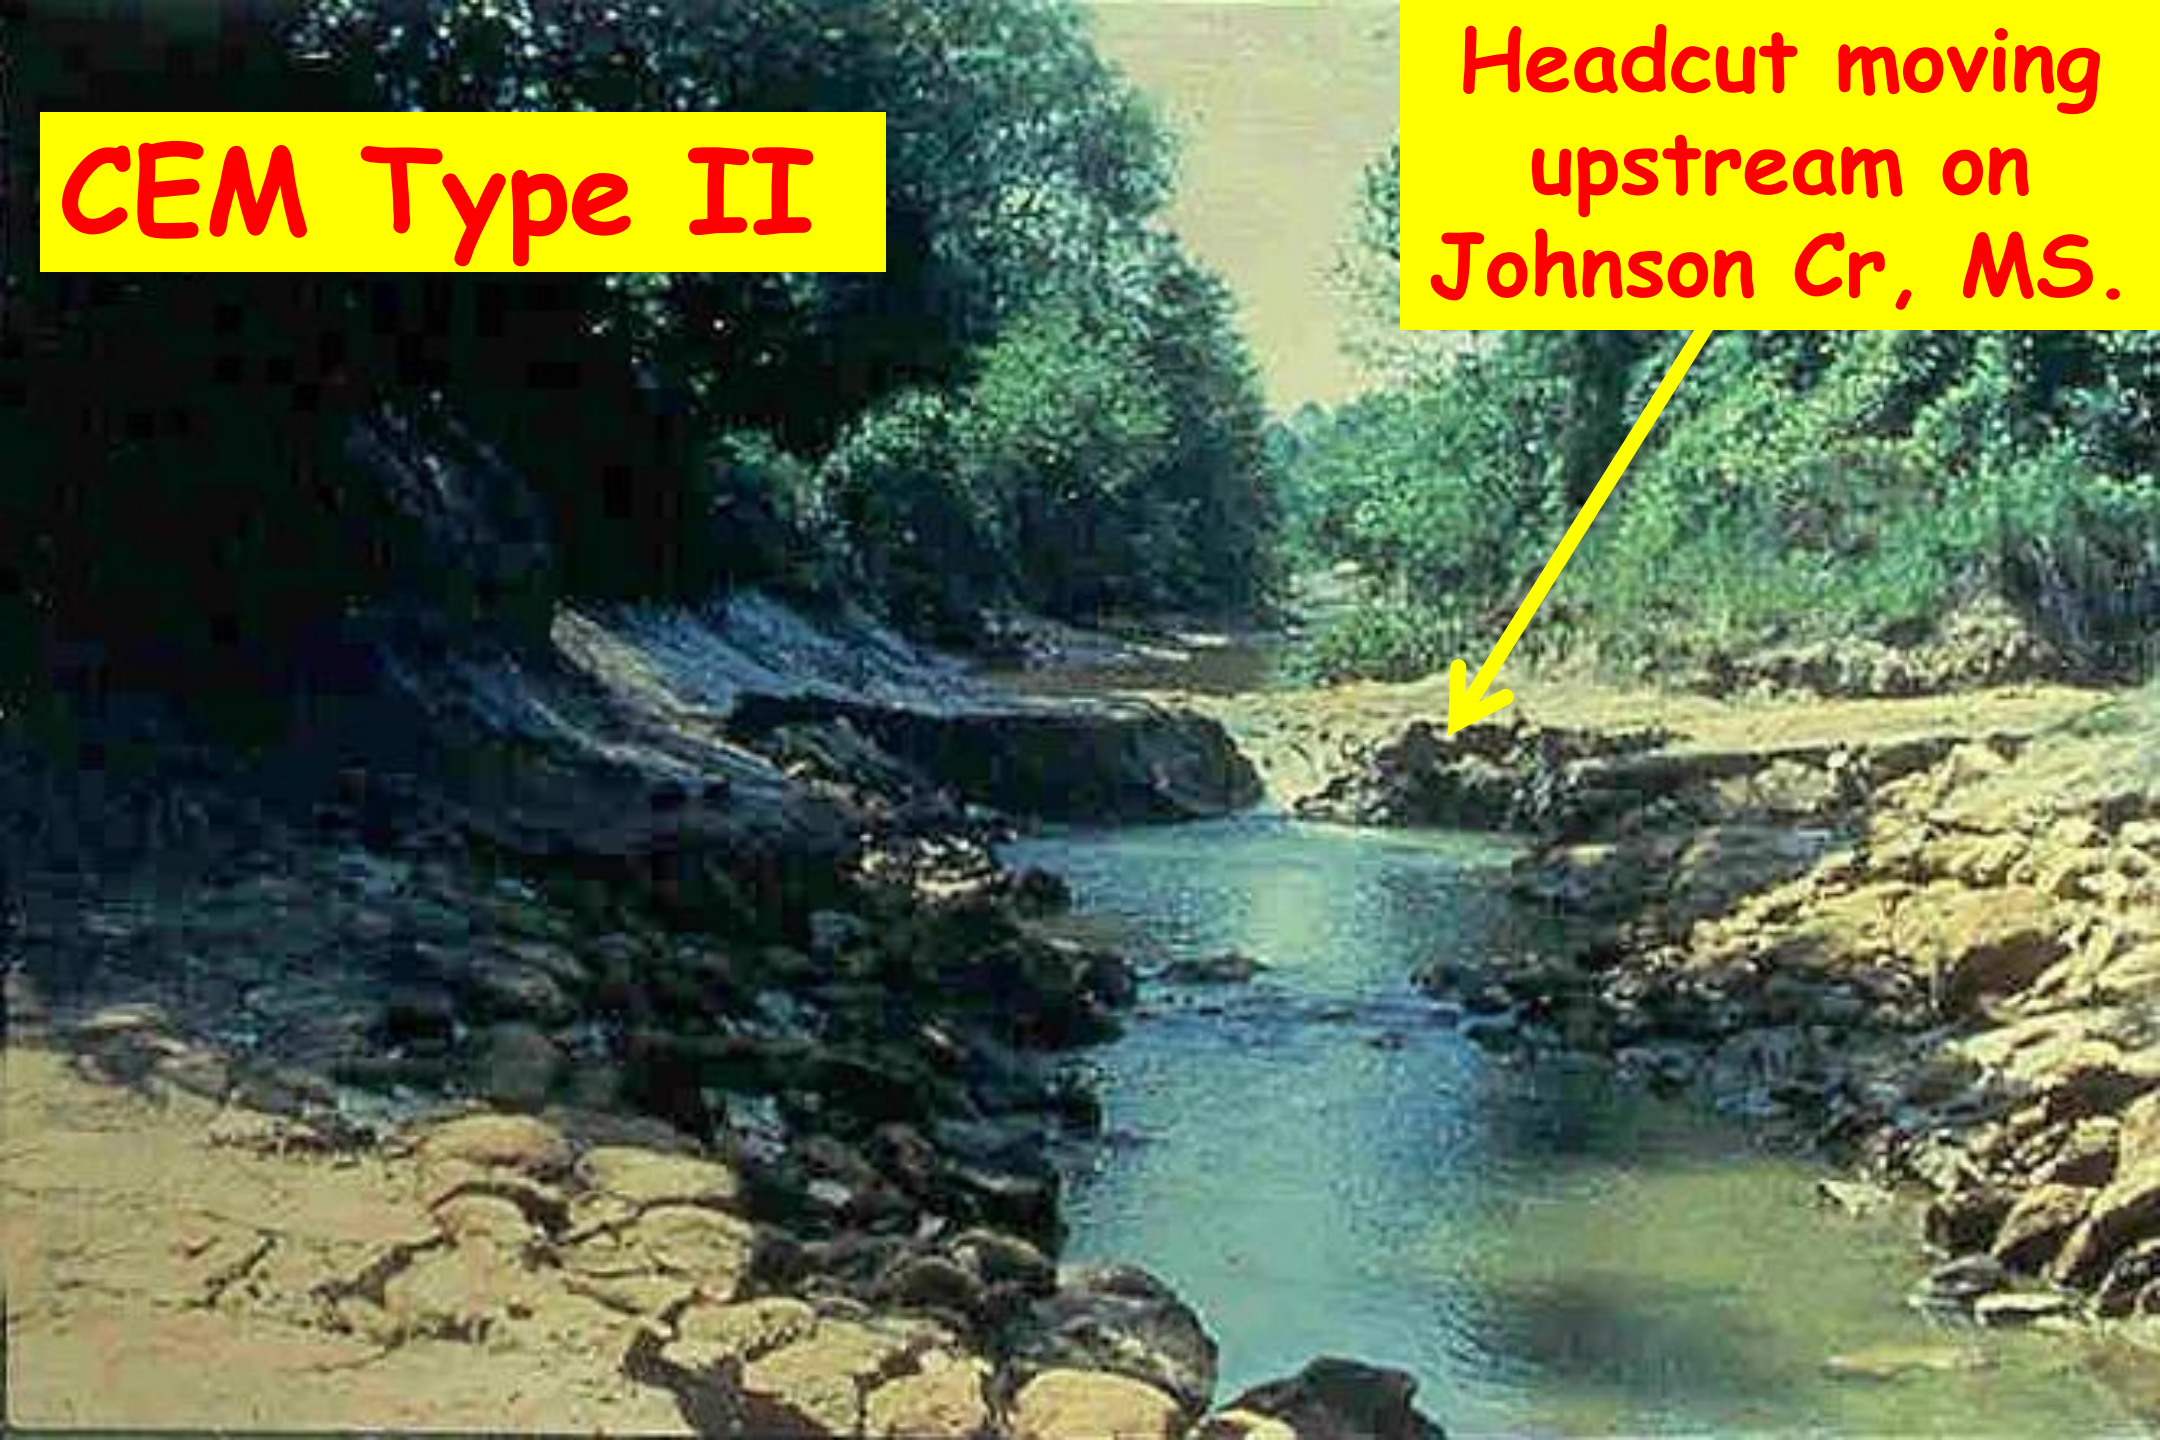
CEM Type II

**A headcut has to move
upstream over time
(toward the headwaters
of the stream), if the
waterfall does not move,
it is not a headcut!!!**

**Headcut moving
upstream on
Johnson Cr, MS.**
