**THE CHANNEL EVOLUTION
MODEL (CEM), CHANNEL
INCISION, ENVIRONMENTALLY
COMPATABLE GRADE
CONTROL,
GC BUT NO BANK
STABILIZATION,
& SYSTEM-WIDE GC**

Channel Evolution Model (Schumm, et al. 1984)

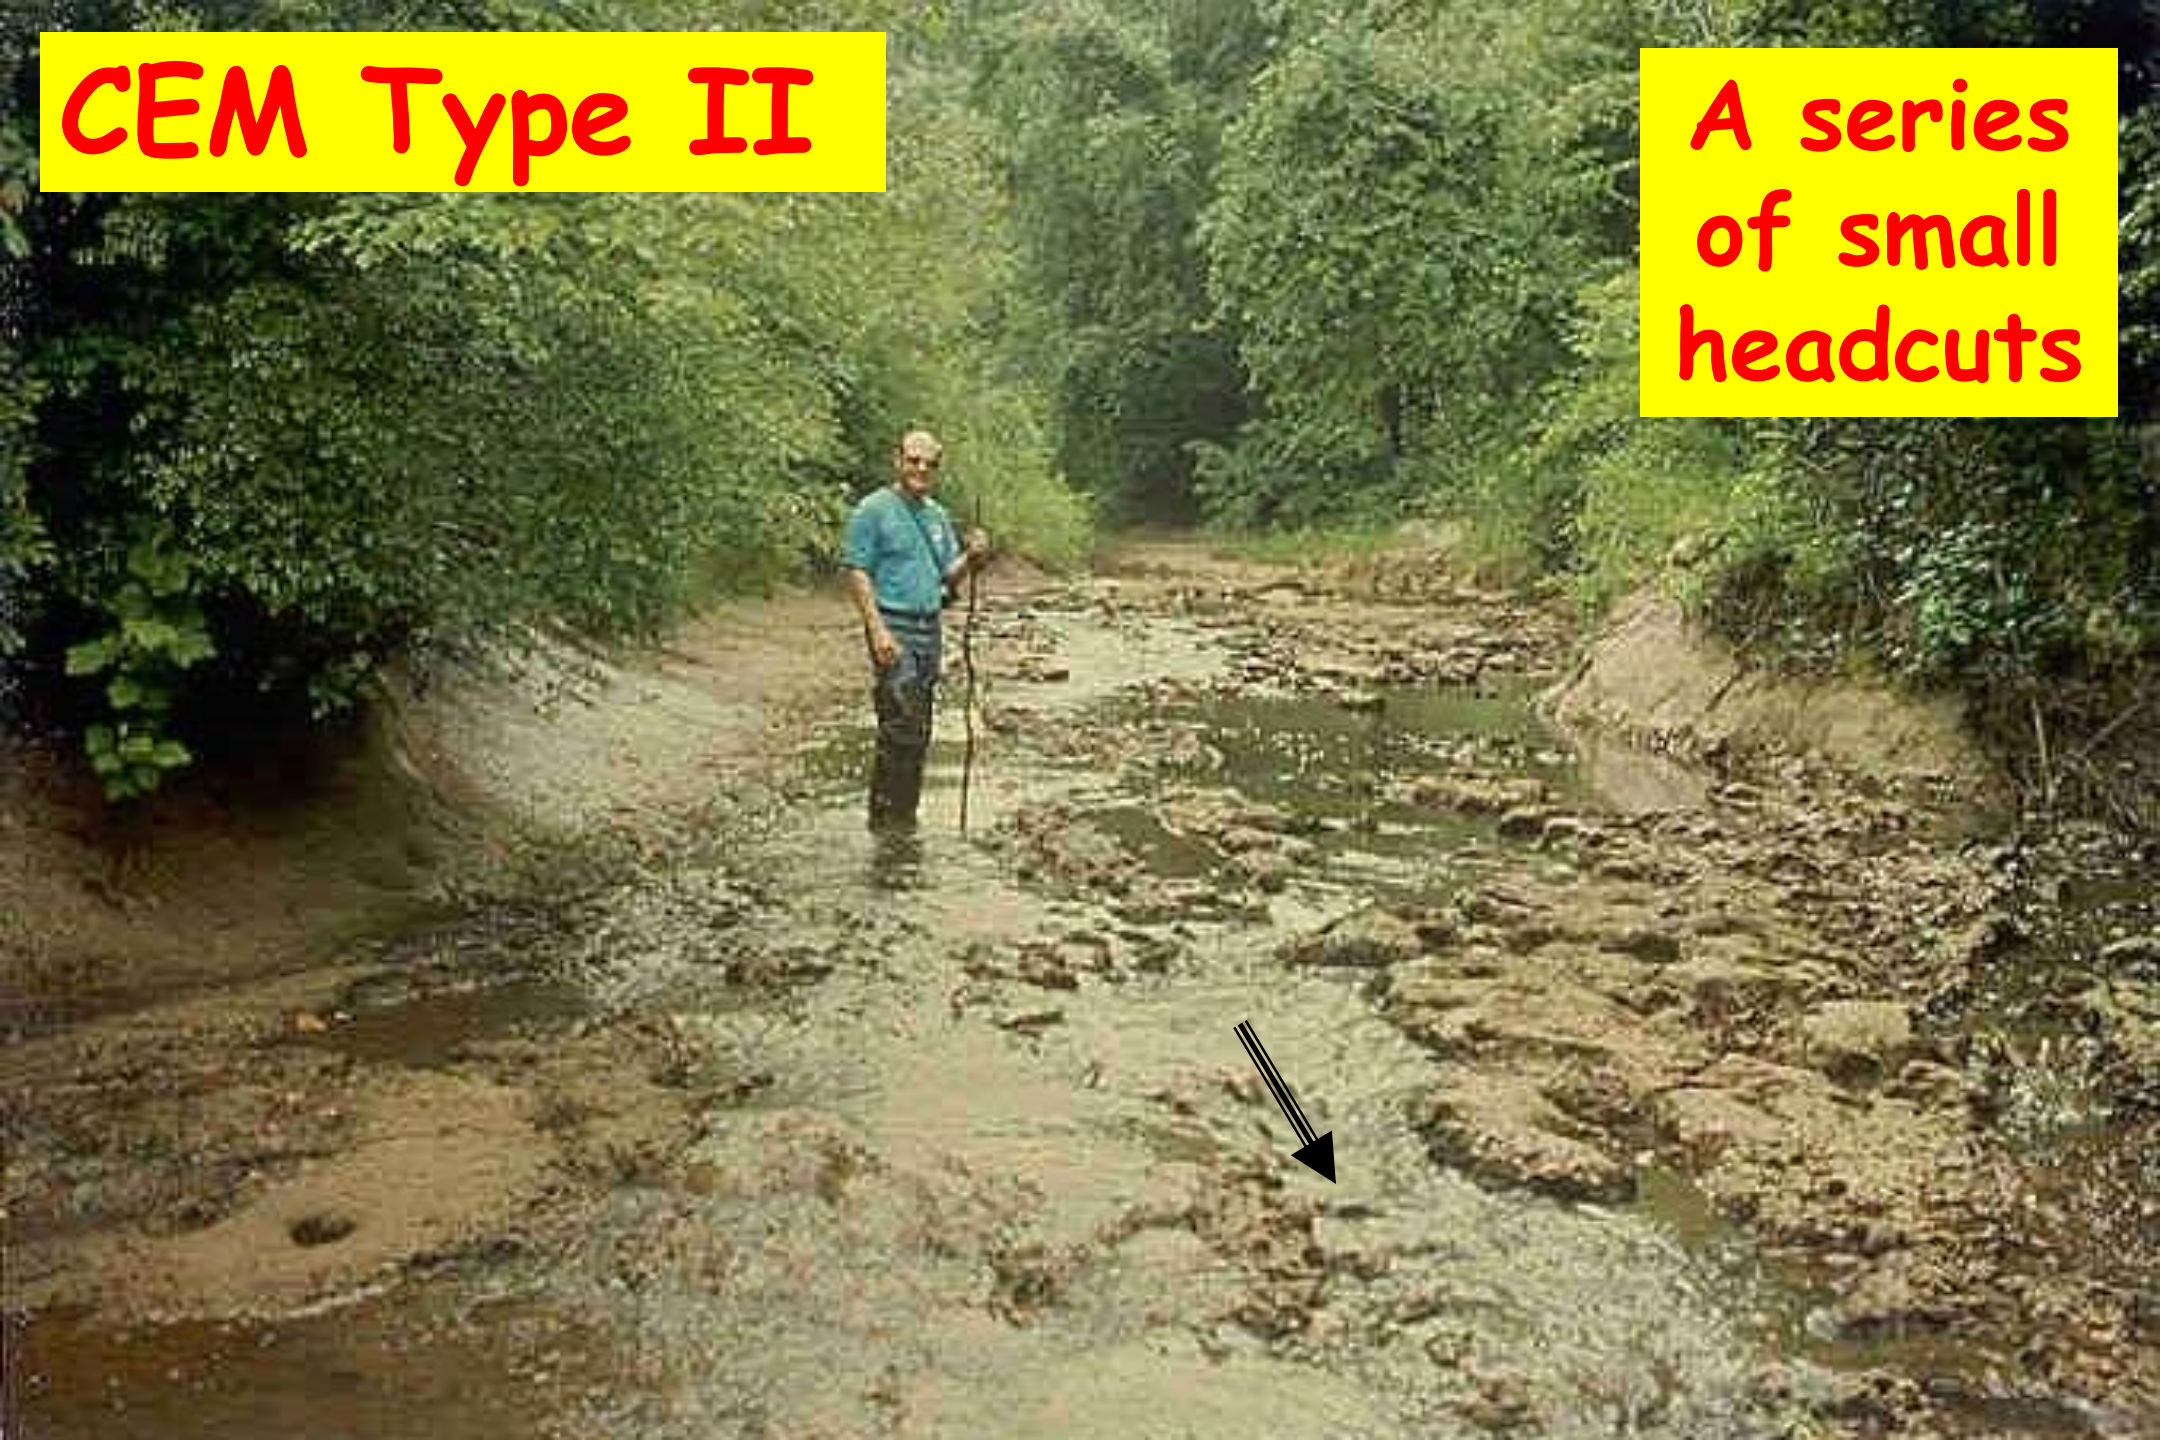
CEM Type II

Typically knickpoints will not occur in non-cohesive materials (sands, etc.).

Sand will not stand vertically with water flowing over it.

**A series
of small
headcuts**

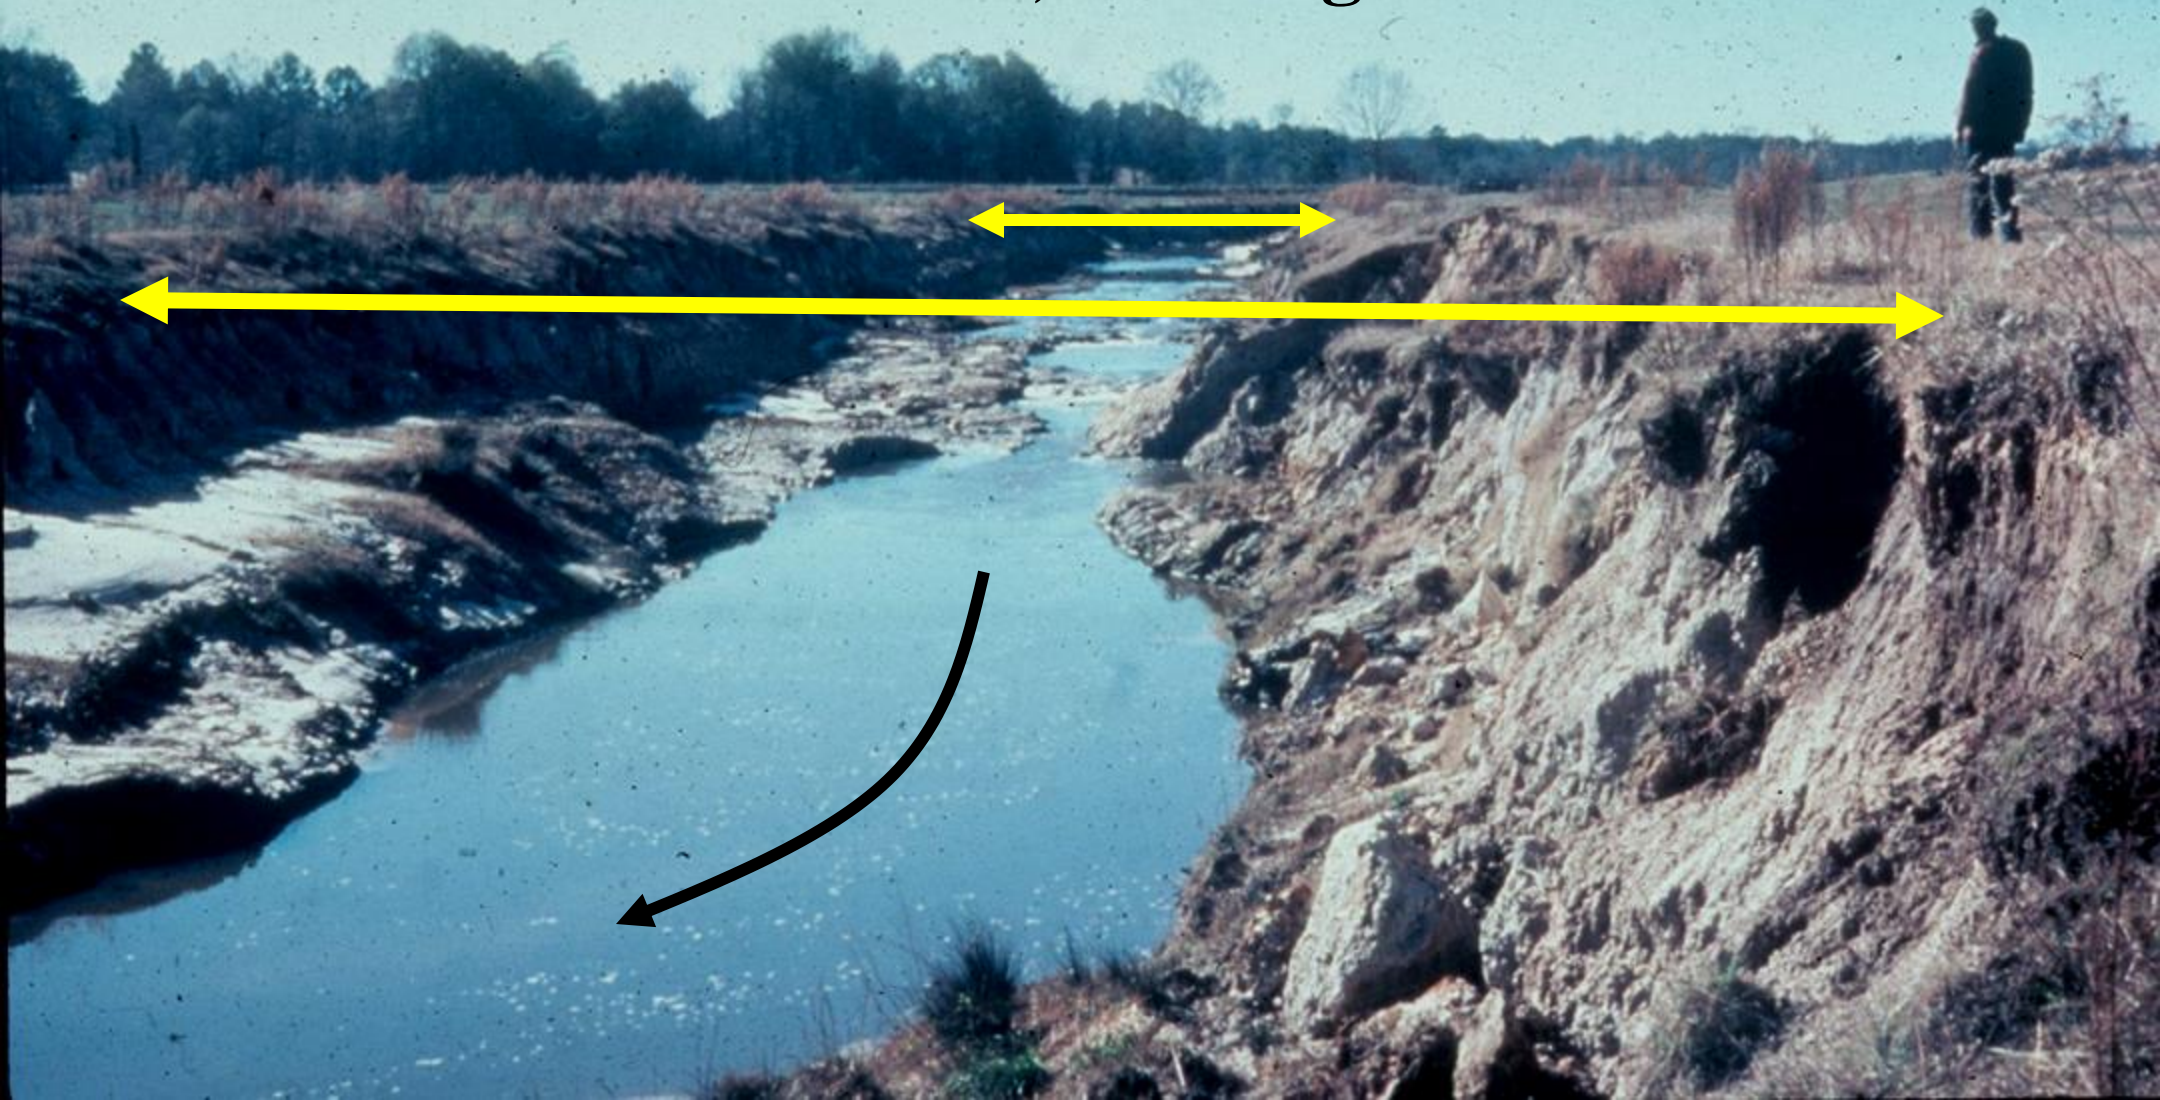
**Looking US at a North Miss. stream, CEM Type II
upstream (downcutting) & Type III (almost immediately
twice as wide) in foreground.**

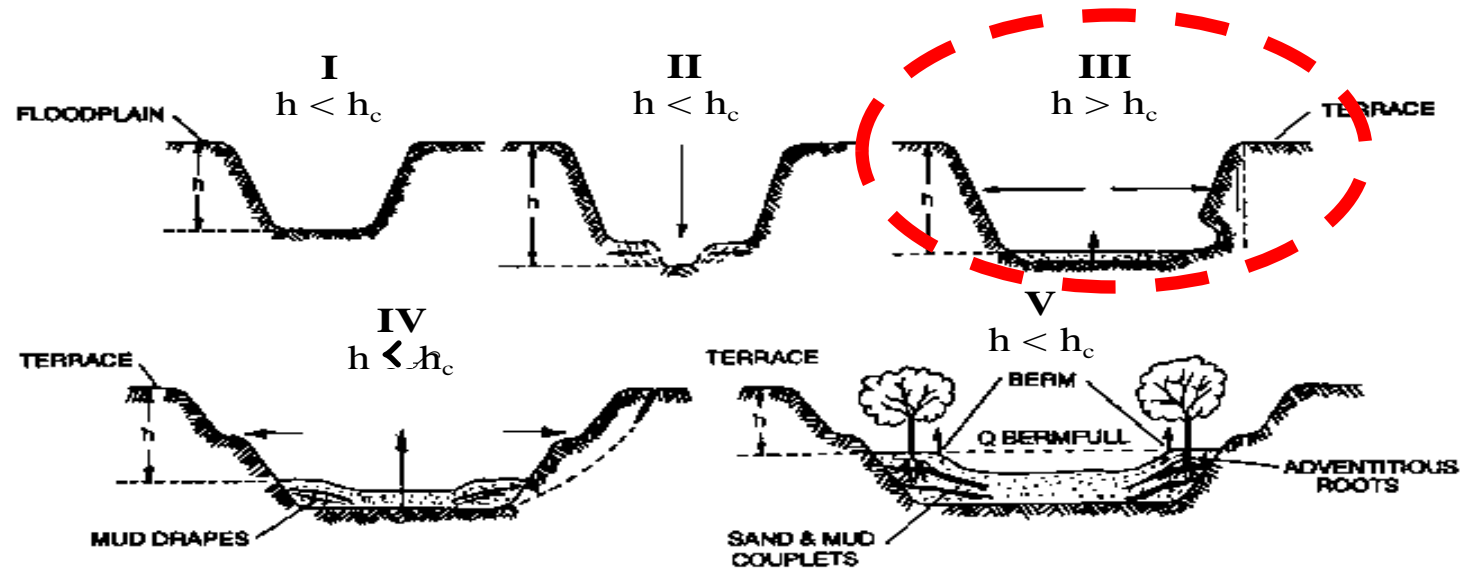
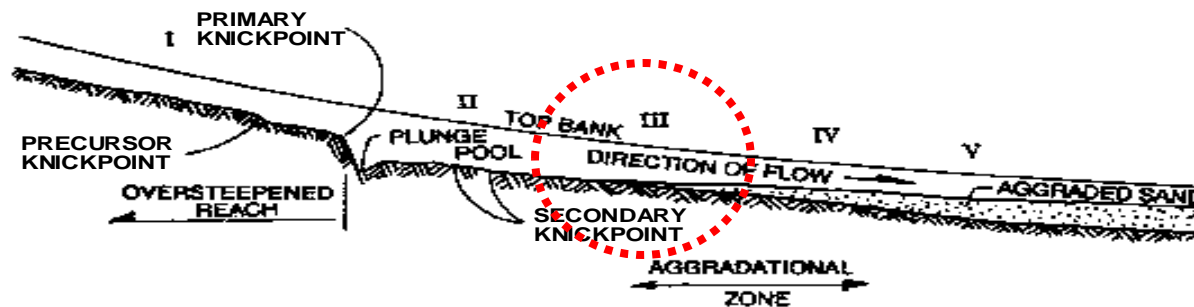
INCISED CHANNEL EVOLUTION PHASES

As bed degradation continues, the bank heights and angles will continue to increase.

When the bank heights have exceeded the critical bank height for stability, mass failures (geotechnical instability) begin to occur in the Type III reaches.

The dominant process in the Type III reach is channel widening.

In the Type III reach, mass wasting of the banks with rapid channel widening is the dominant process

$h_c = \text{CRITICAL BANK HEIGHT}$

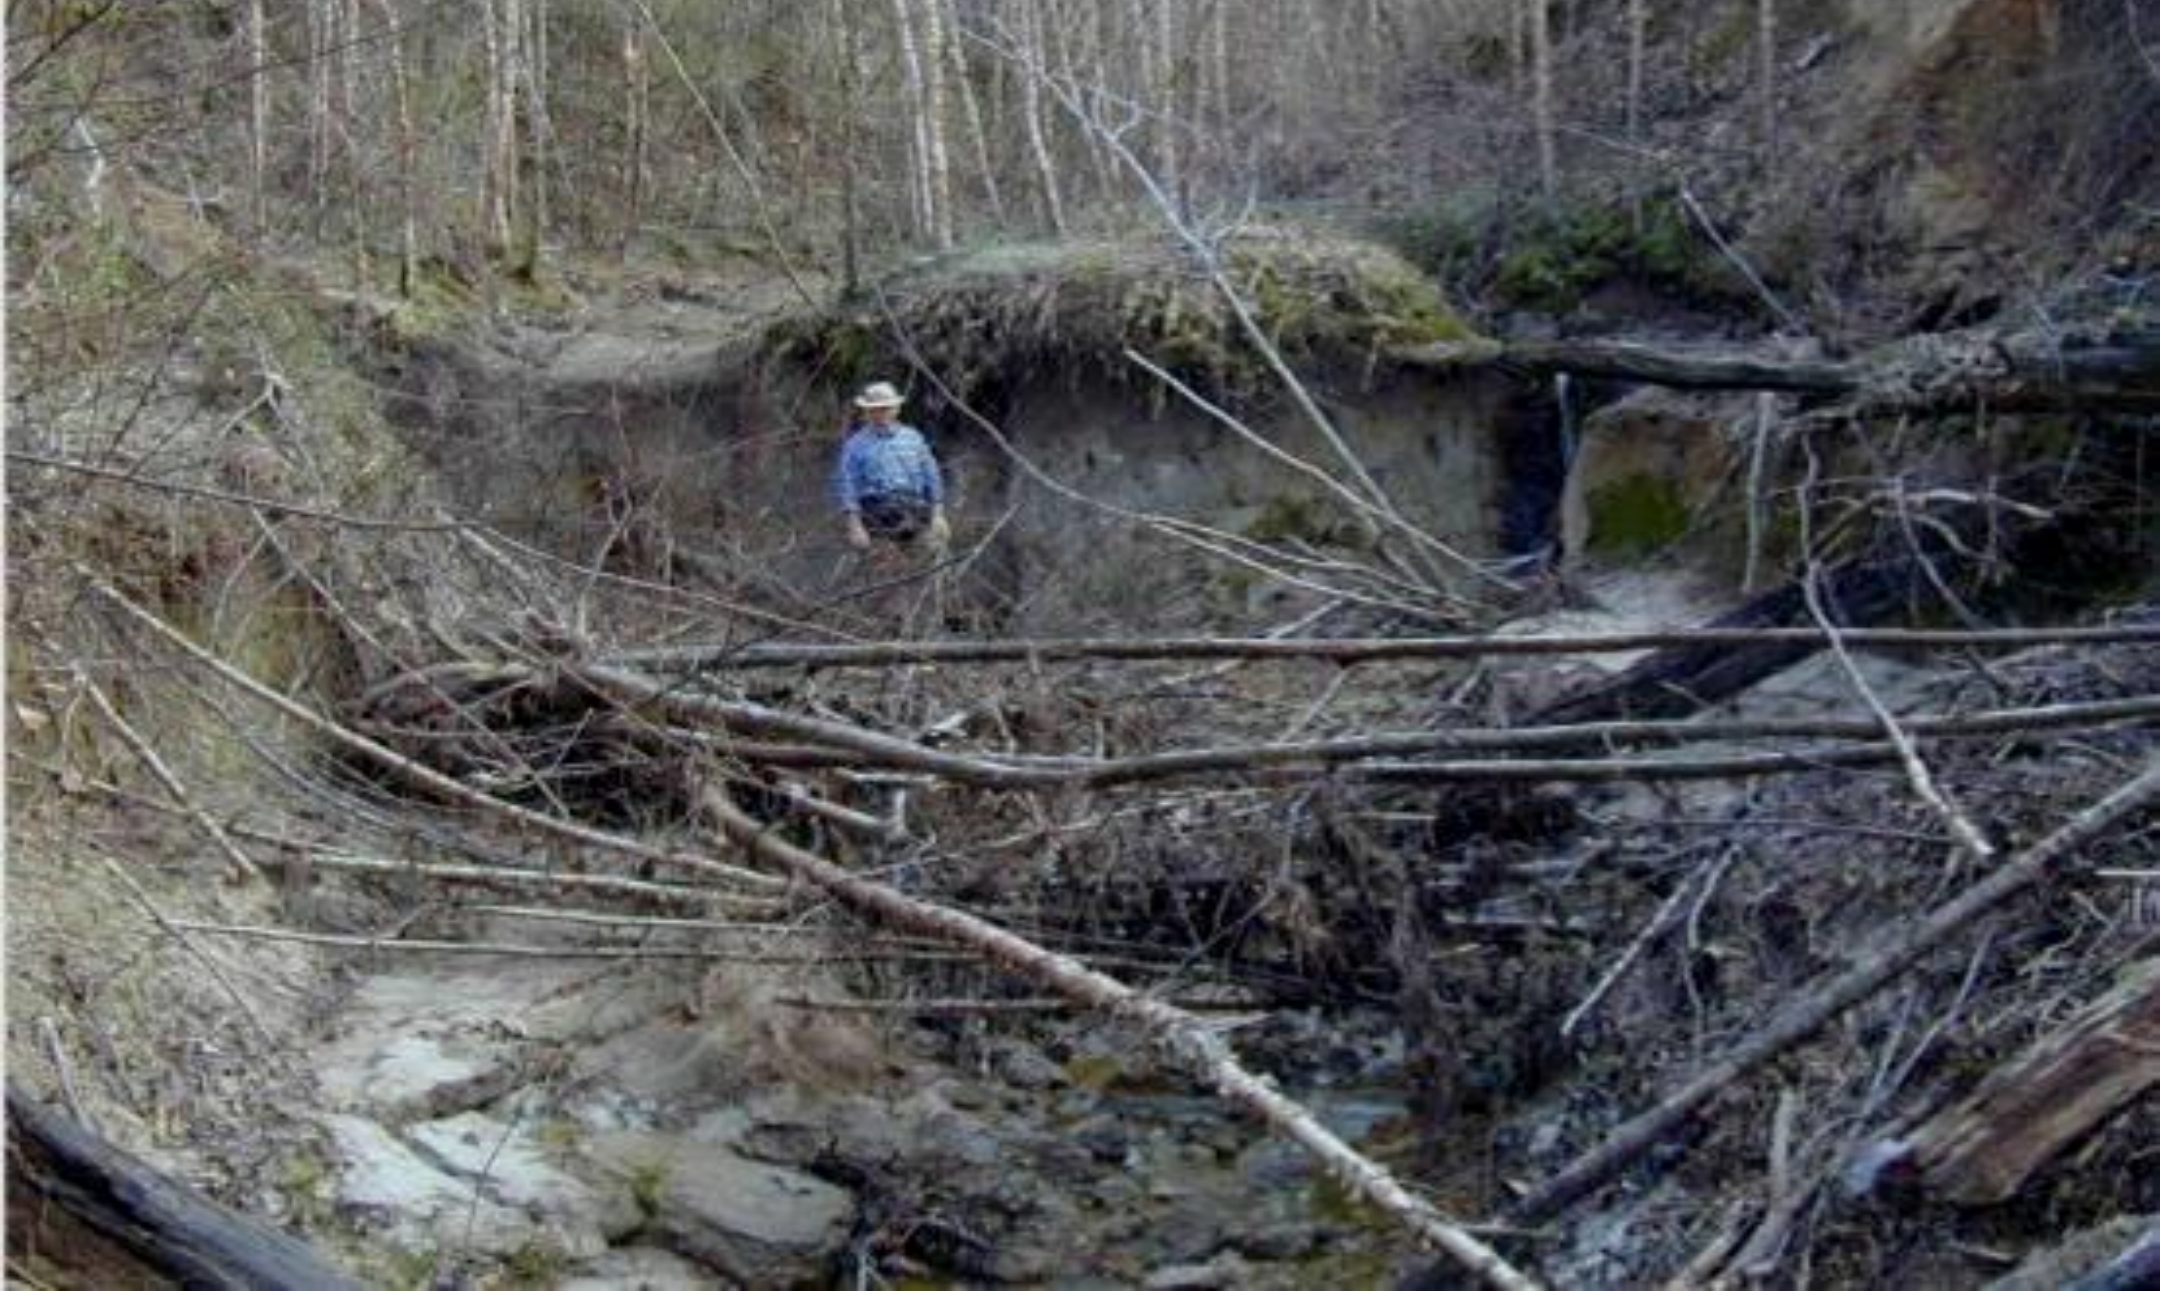
CEM Type III, rapid over widening of stream

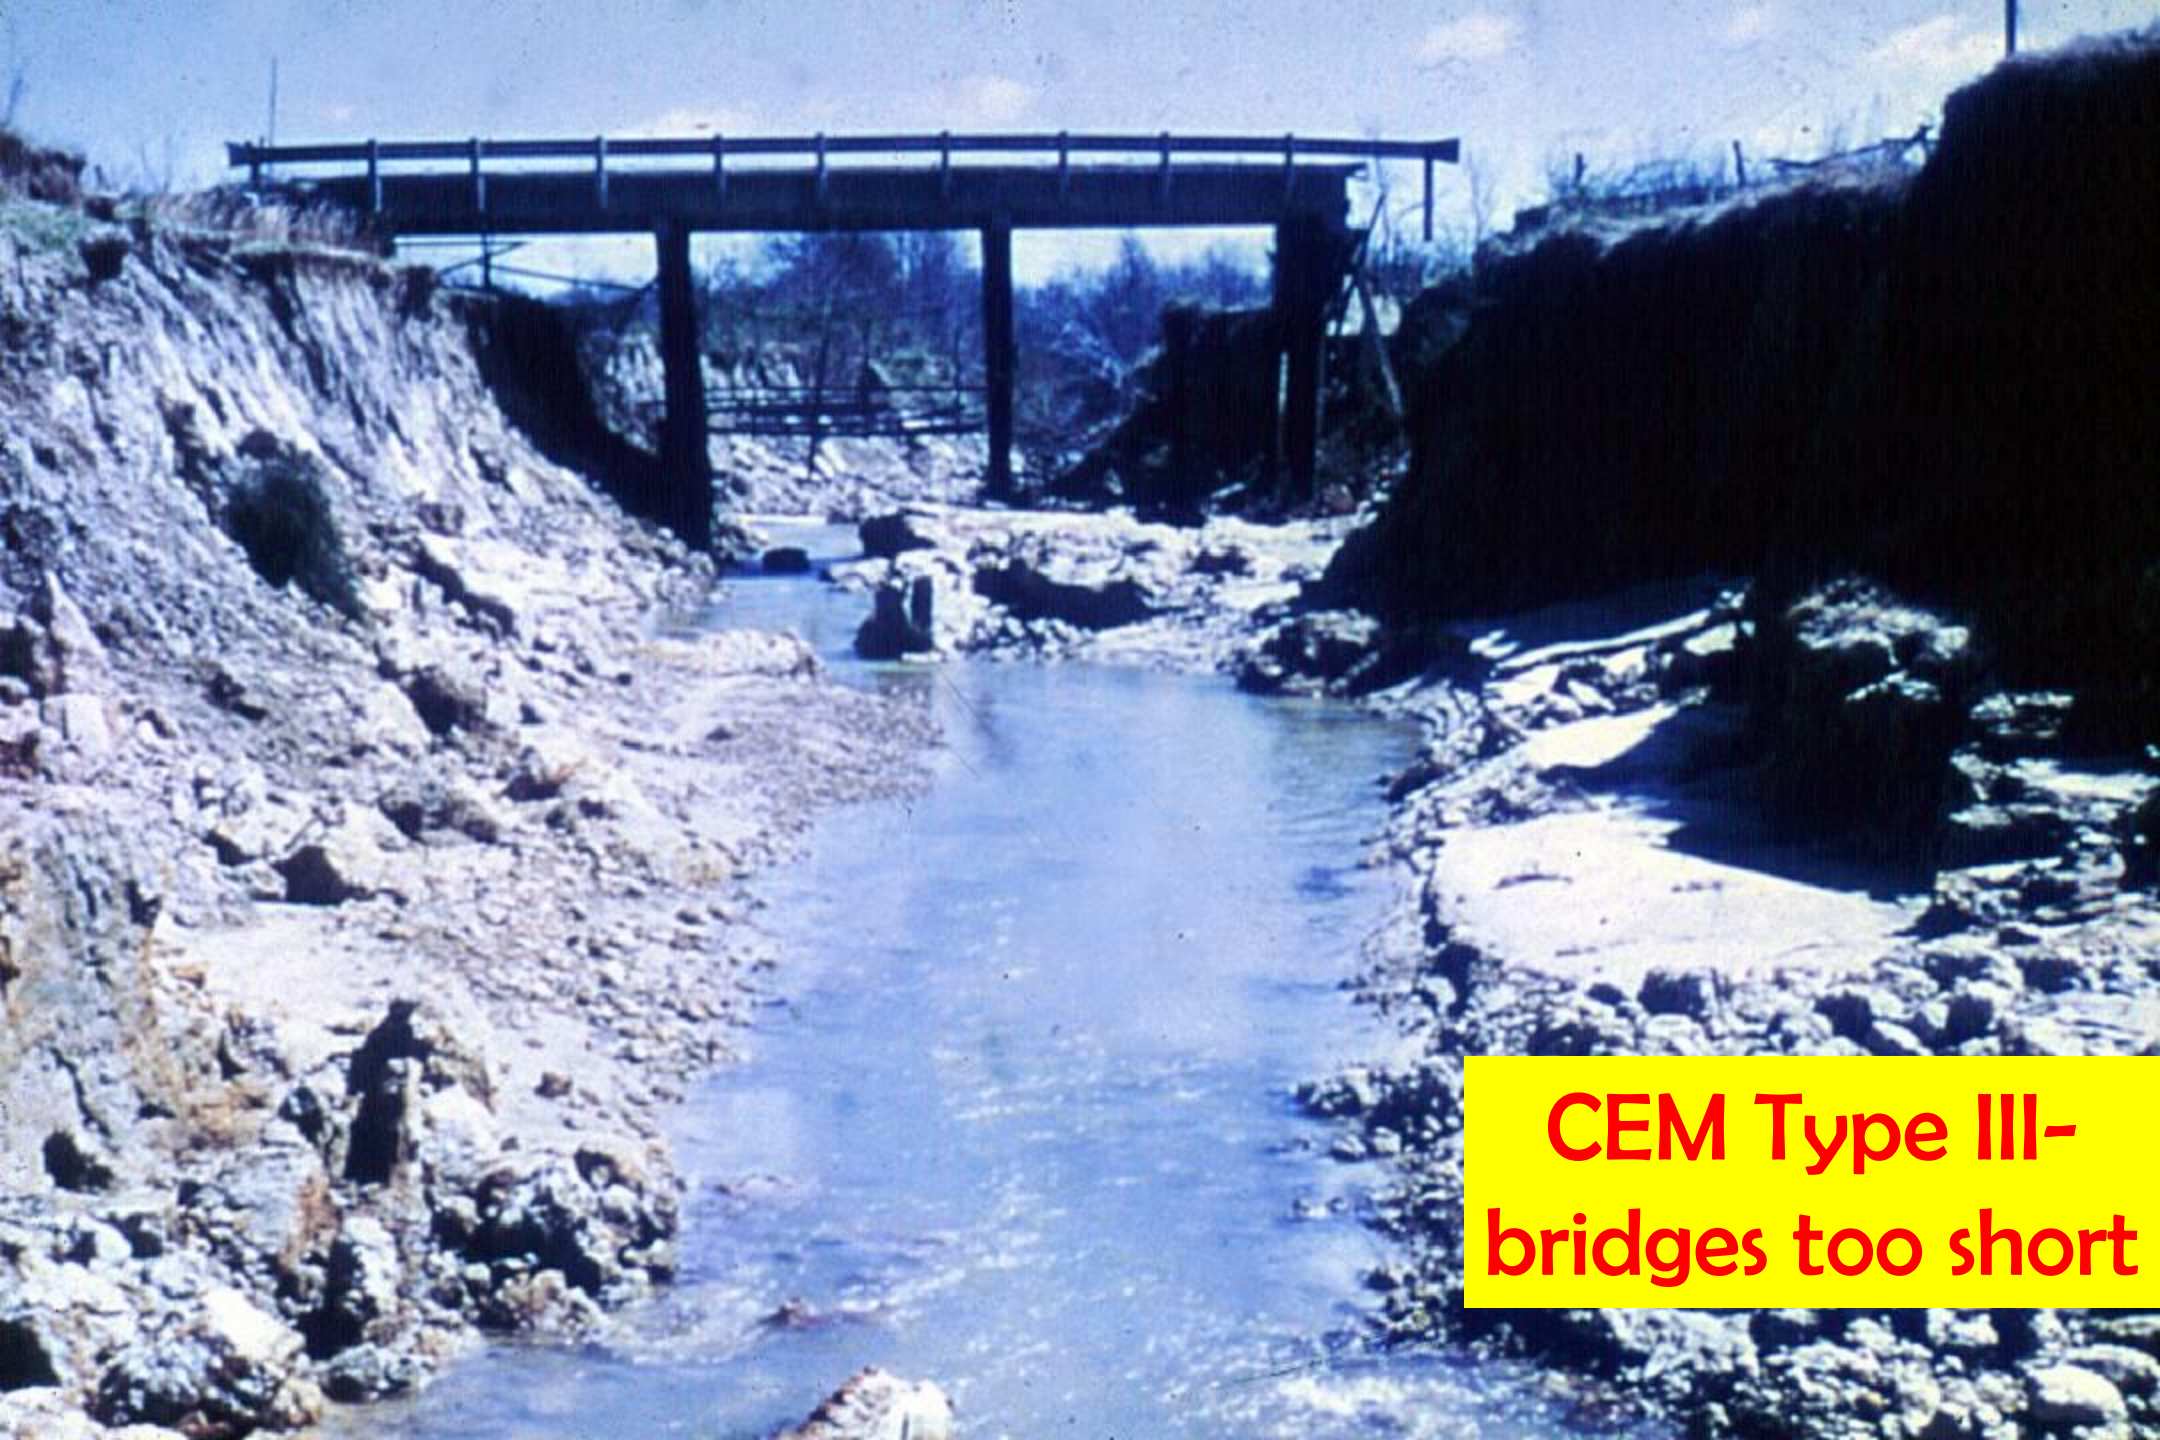
**CEM Type III-
bridges too short**

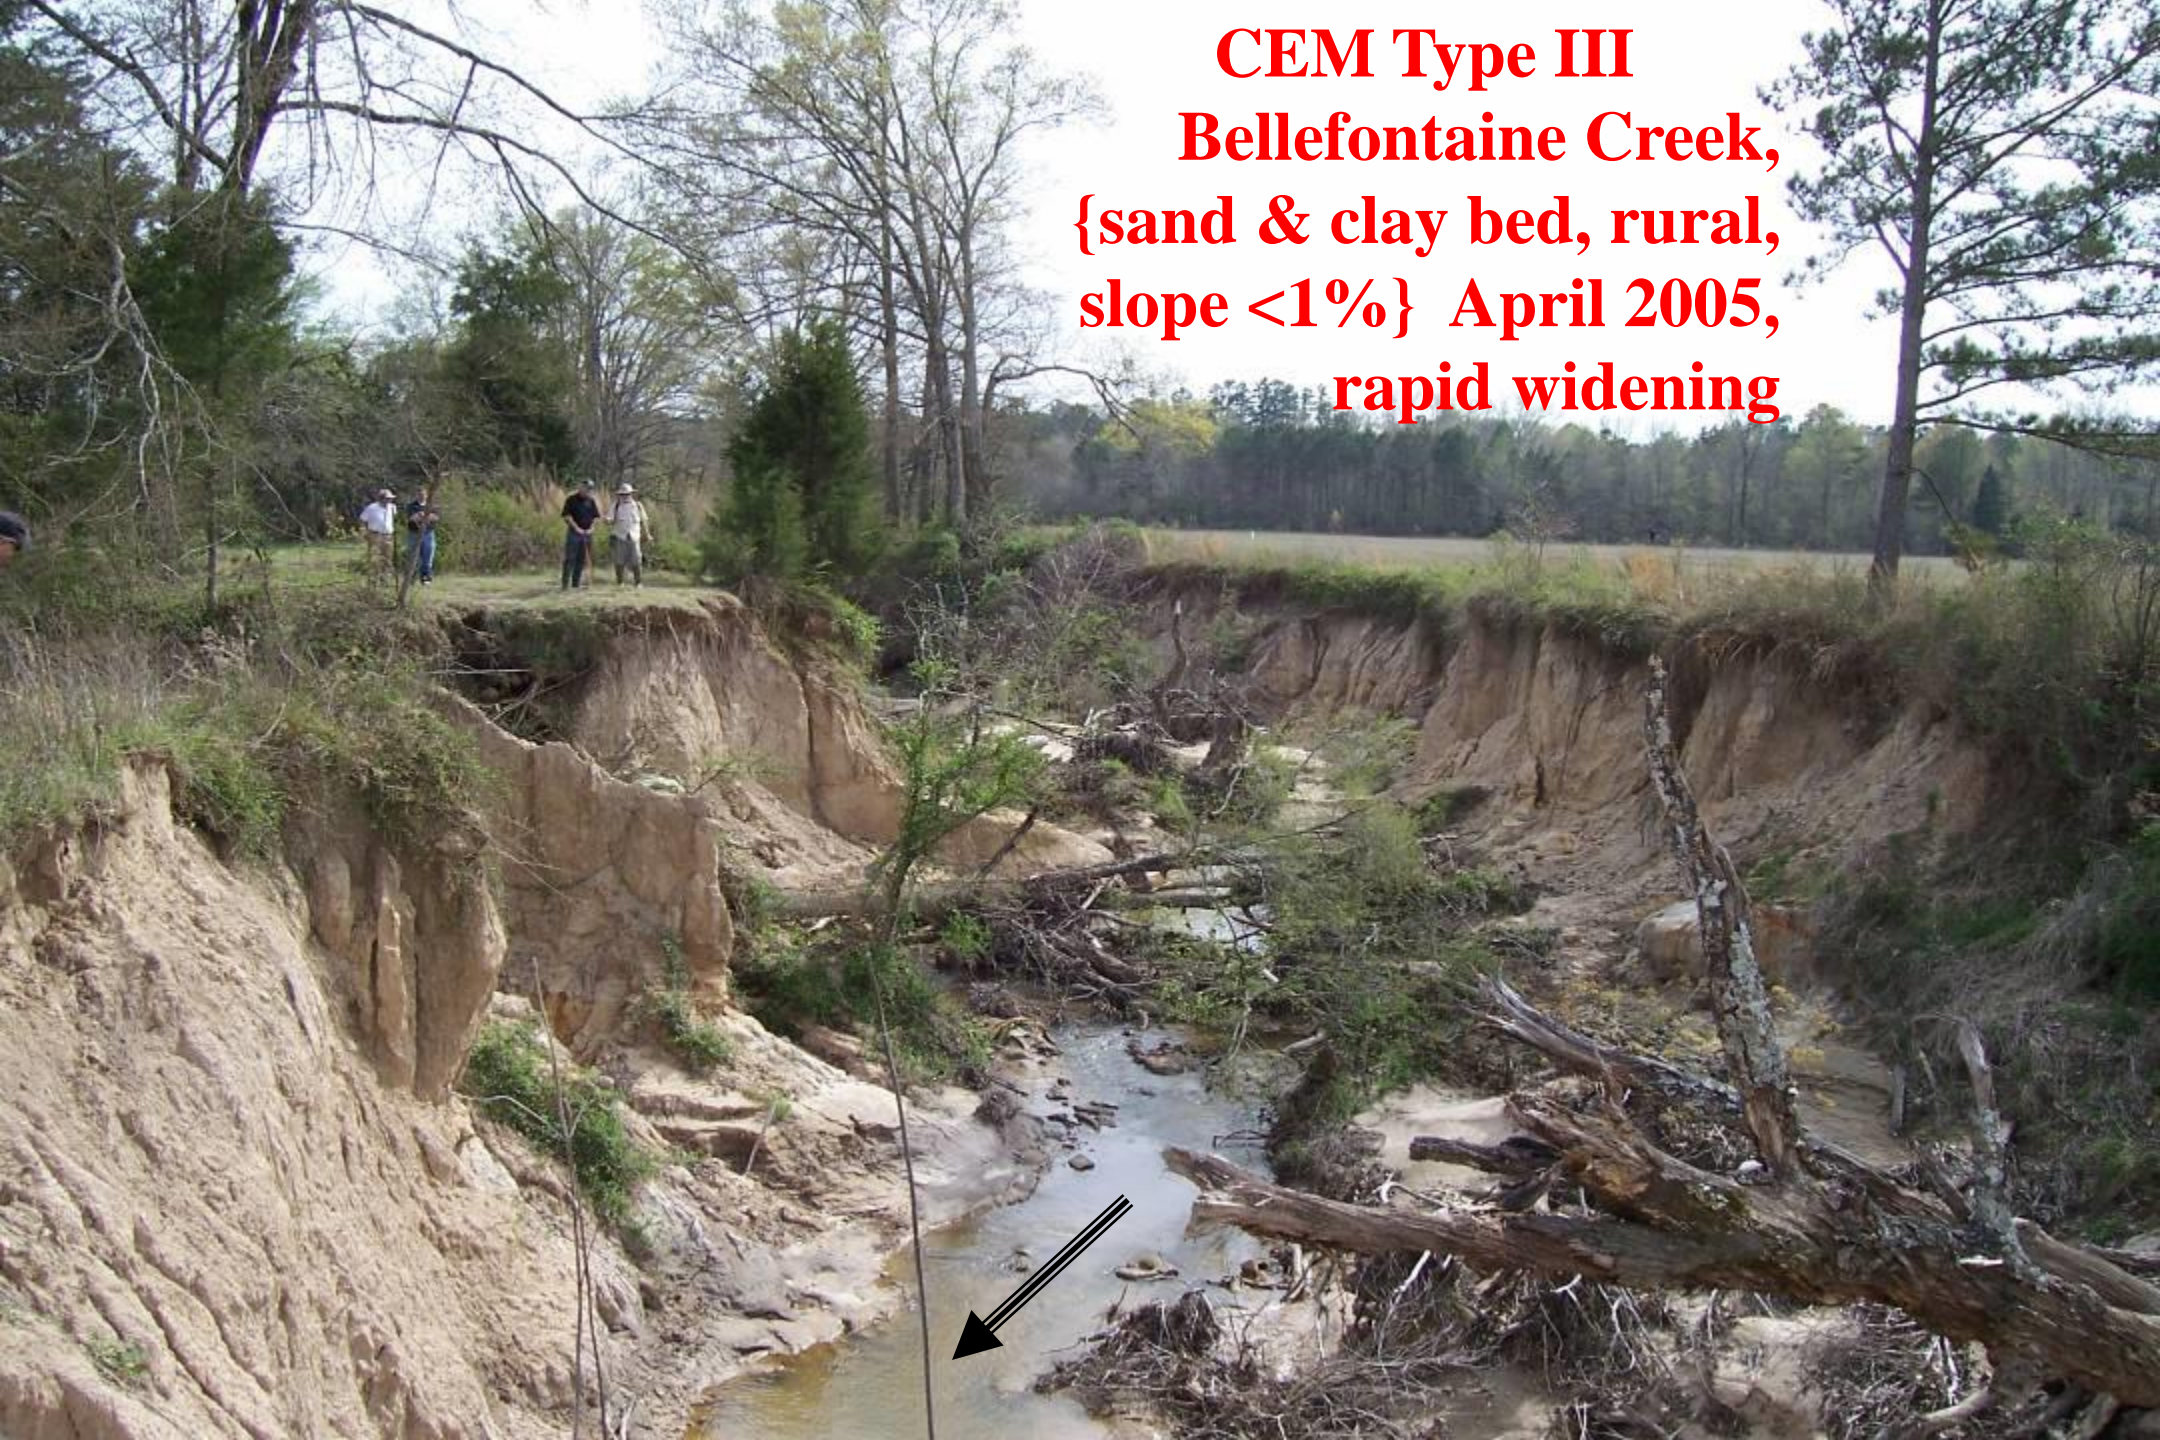
CEM Type III
Bellefontaine Creek,
{sand & clay bed, rural,
slope <1%} April 2005,
rapid widening

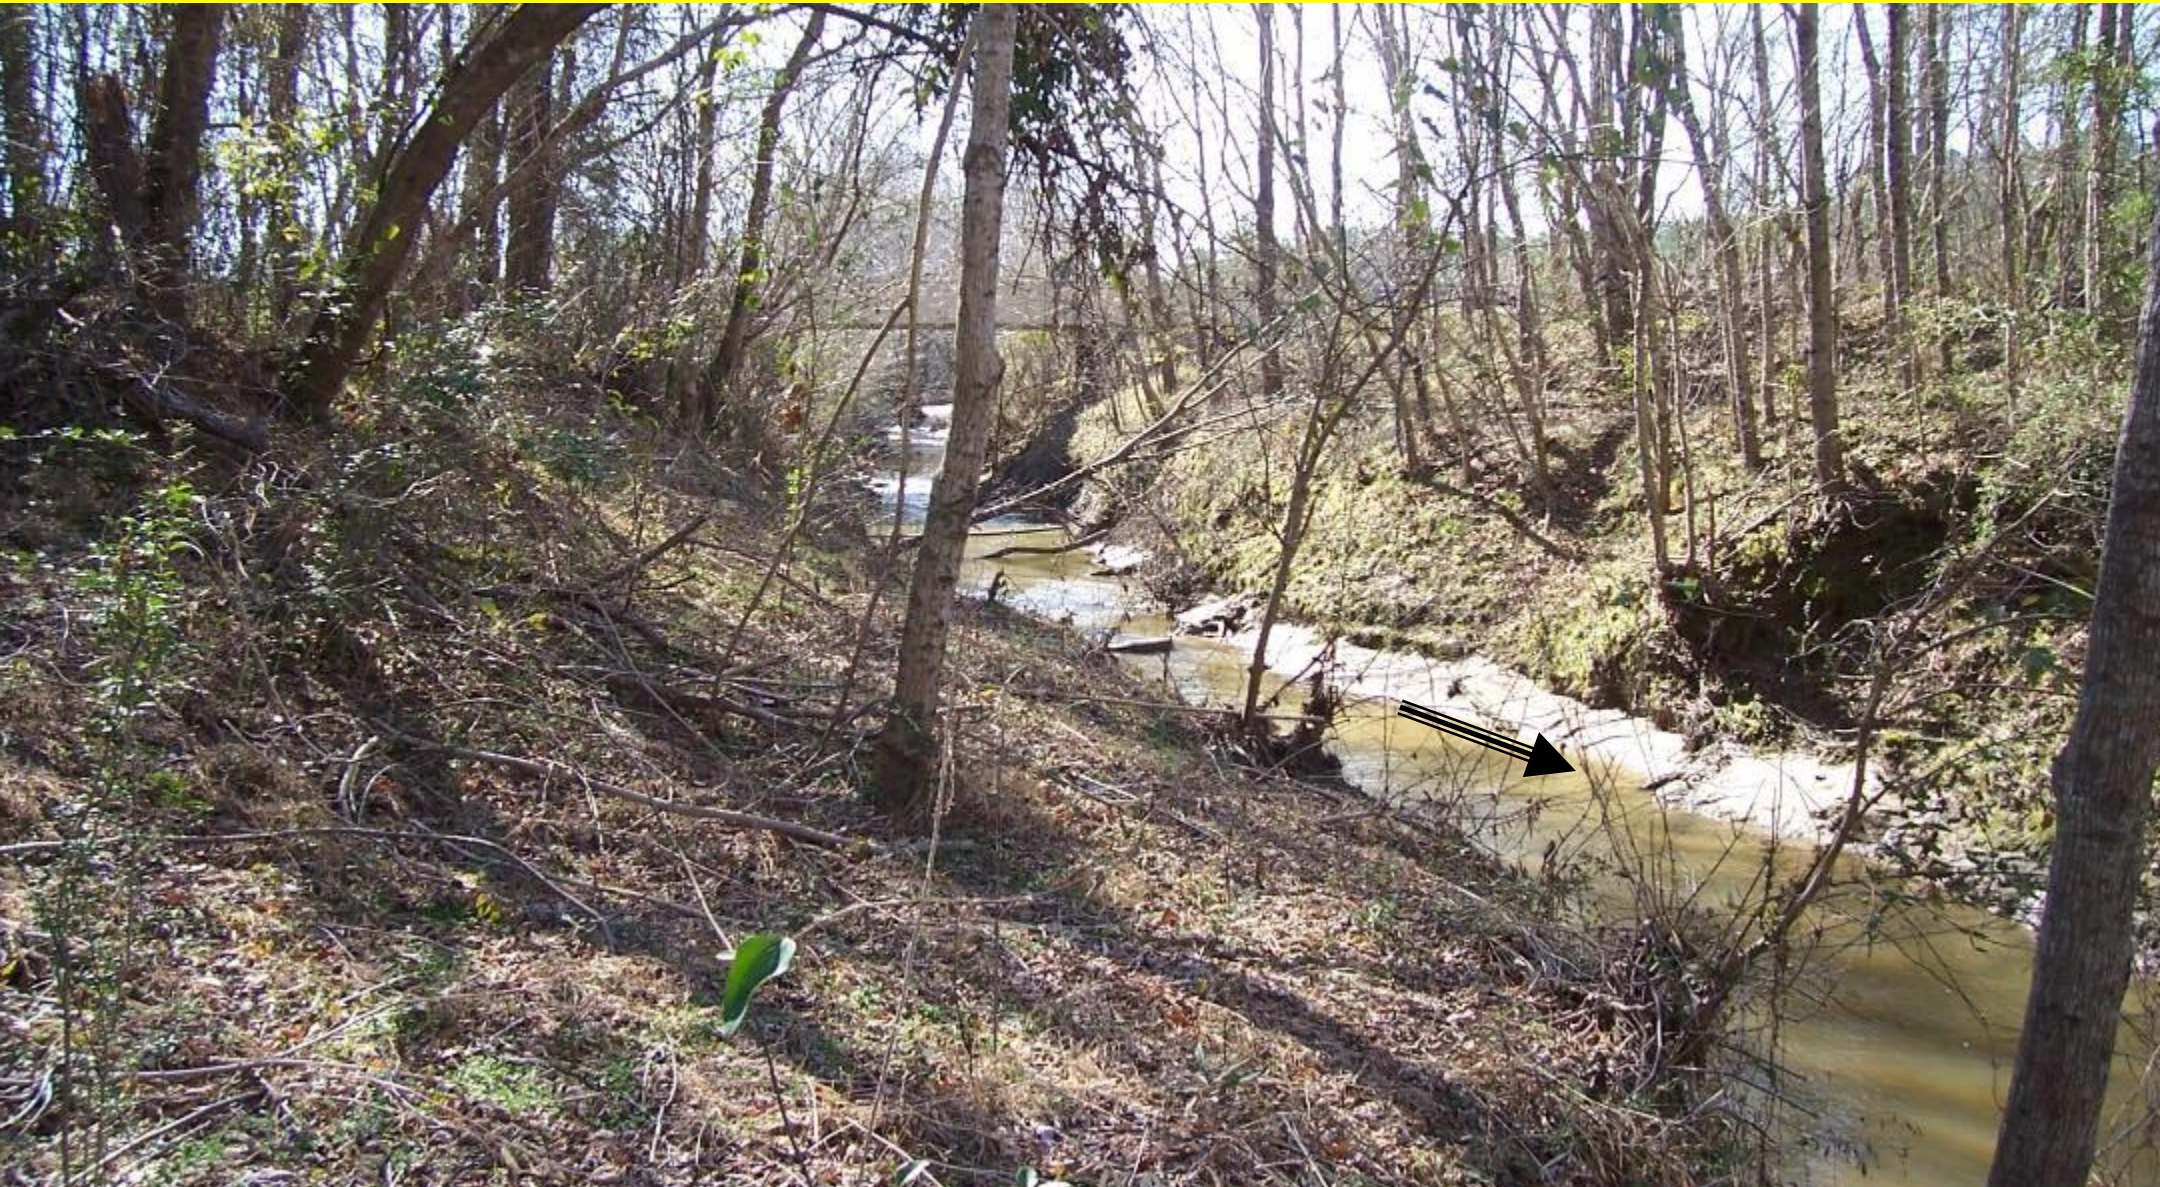
Bellefontaine Creek about 700 ft US of the previous picture. CEM Type II, but the headcut is coming, followed by channel widening

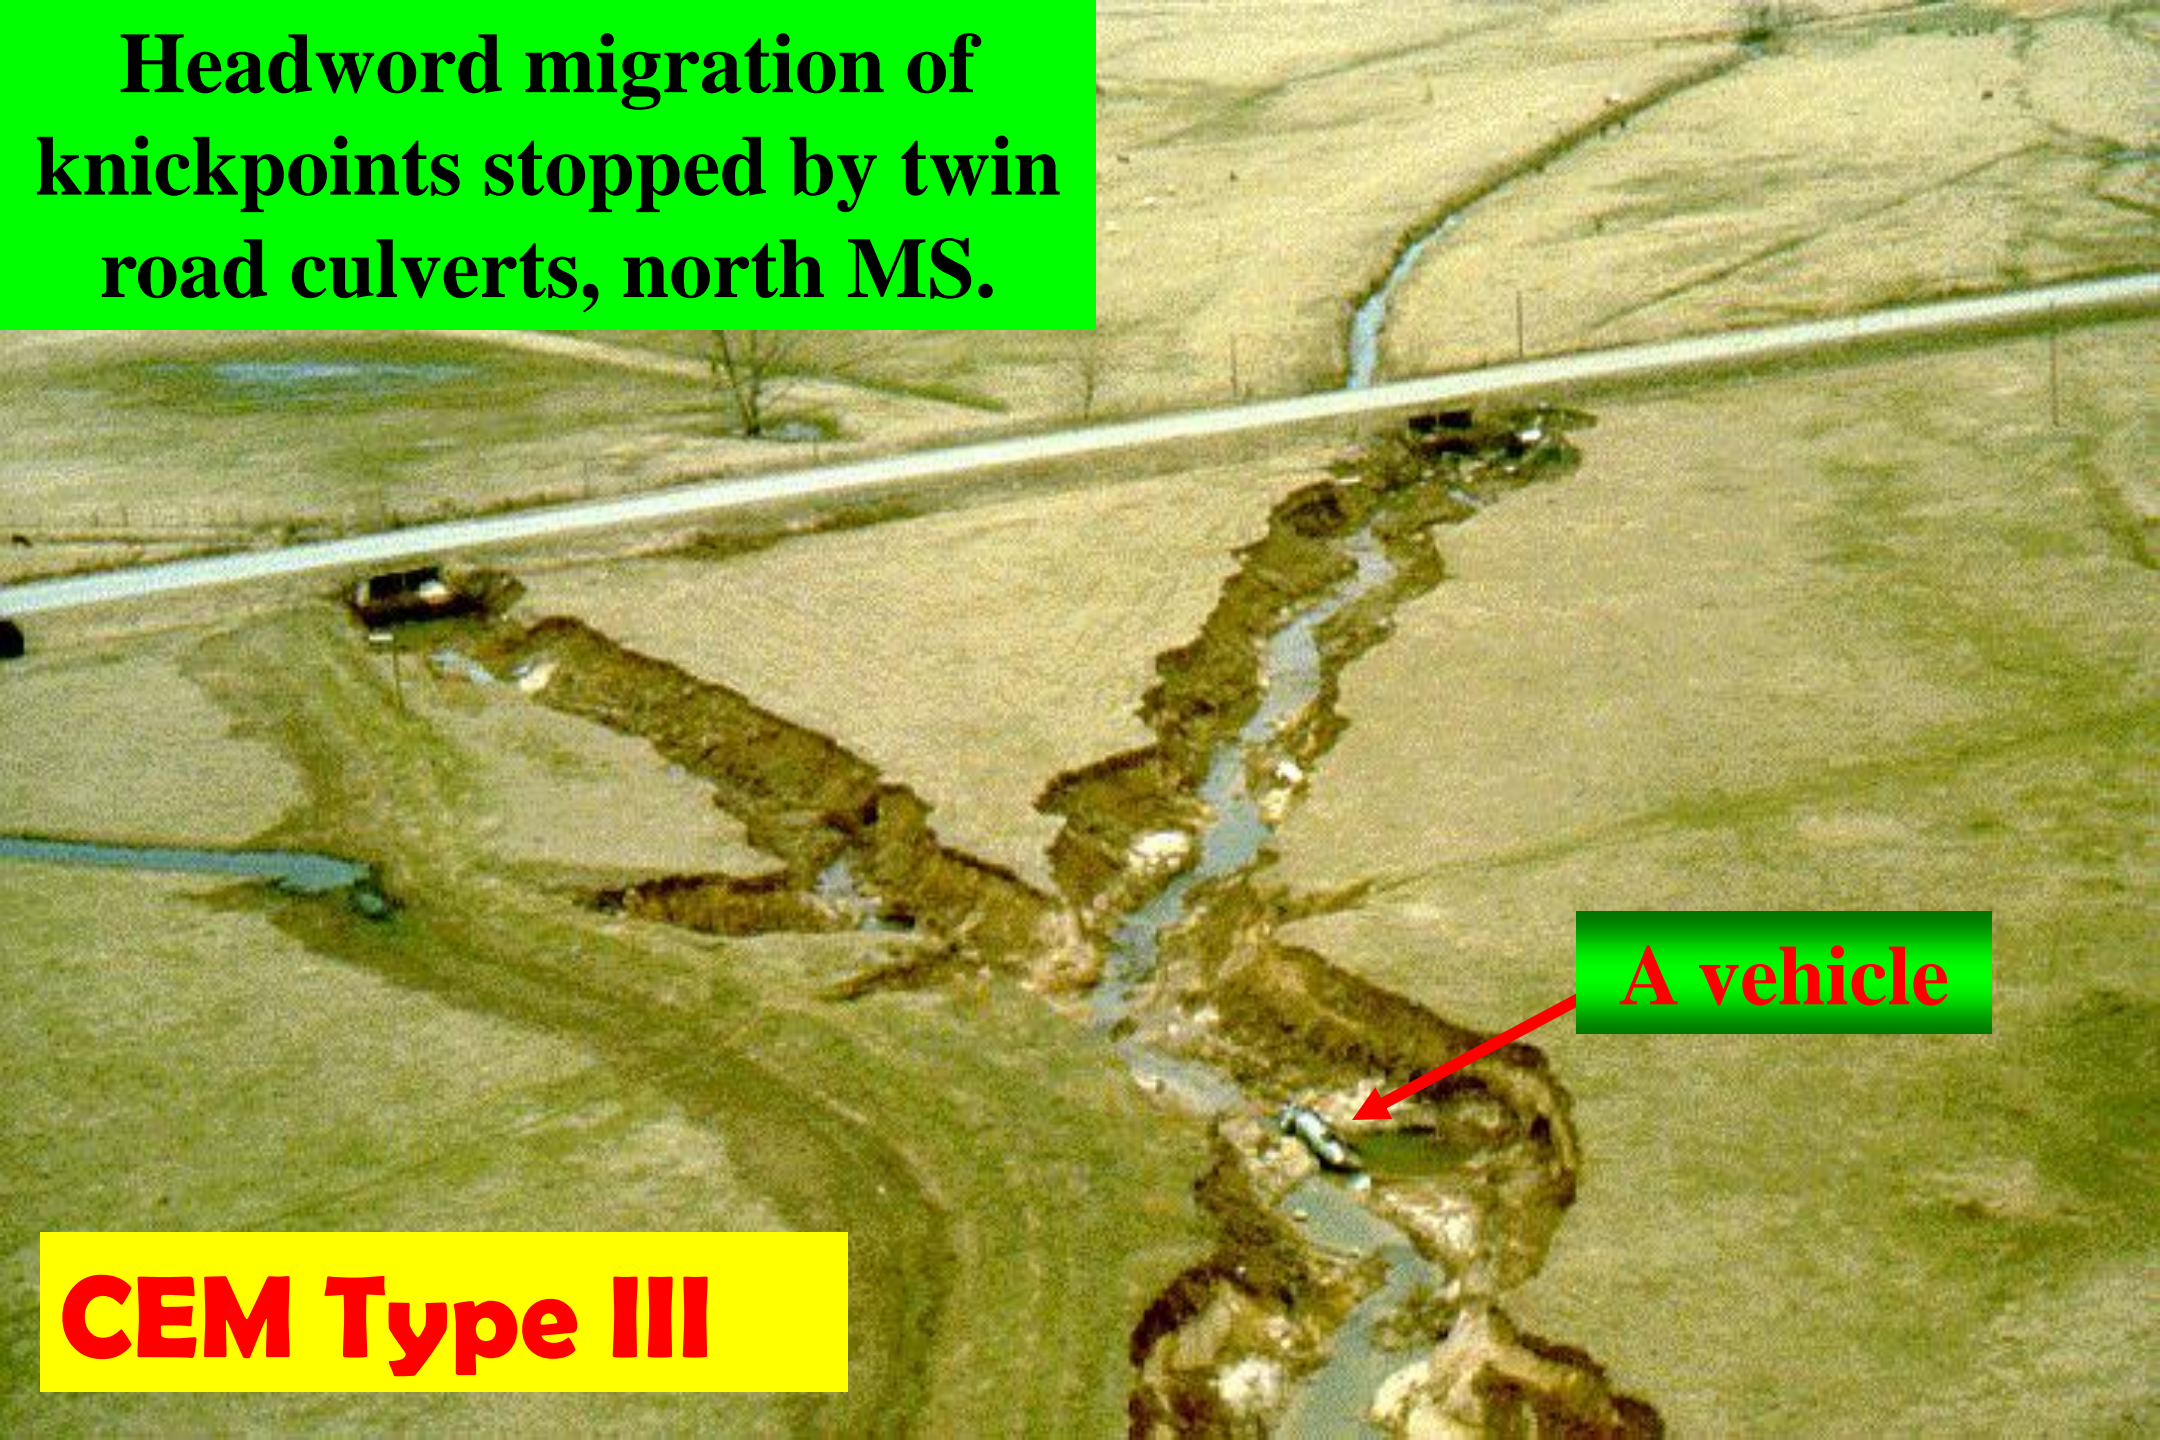
**Headword migration of
knickpoints stopped by twin
road culverts, north MS.**
