**THE CHANNEL EVOLUTION
MODEL (CEM), CHANNEL
INCISION, ENVIRONMENTALLY
COMPATABLE GRADE
CONTROL,
GC BUT NO BANK
STABILIZATION,
& SYSTEM-WIDE GC**

Channel Evolution Model (Schumm, et al. 1984)

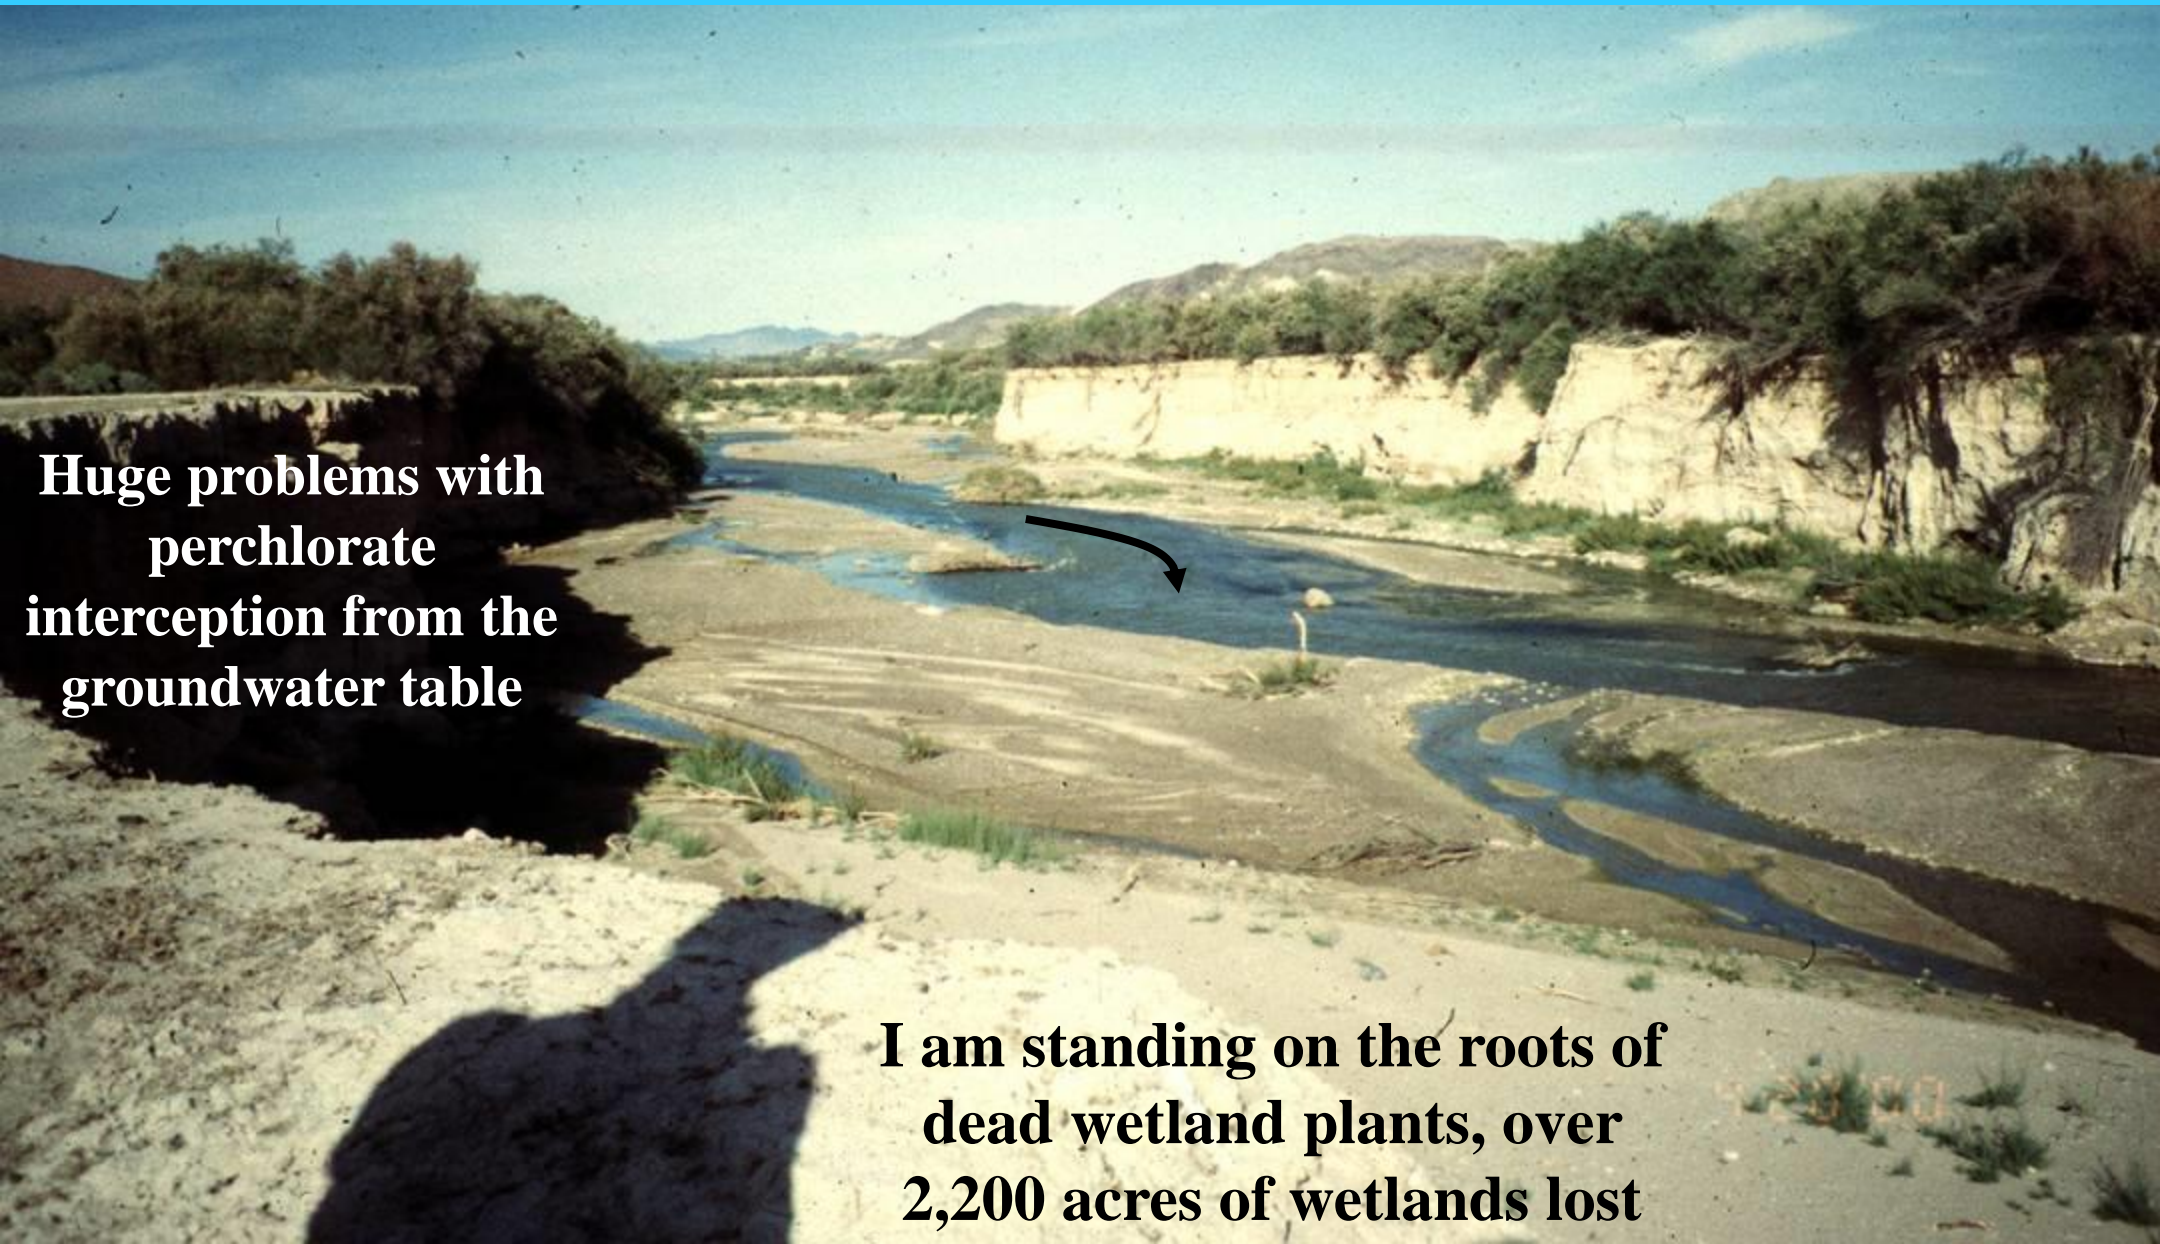
CEM Type III

Las Vegas Wash, NV. has degraded from a 1 ft deep by 100 ft wide channel in 1975, to a 40 ft deep by 1,000 ft wide channel in 1995!!

**Huge problems with
perchlorate
interception from the
groundwater table**

**I am standing on the roots of
dead wetland plants, over
2,200 acres of wetlands lost**

**ANALYSIS OF RATIOS OF
BED DEGRADATION VS.
INCREASE IN CHANNEL
WIDTH ON DIFFERENT
STREAMS NATIONWIDE
SHOWS THE RATIO TO
VARY FROM 1 to 5, to 1 to 22
(1 ft drop=22 ft wider channel)!!!!**

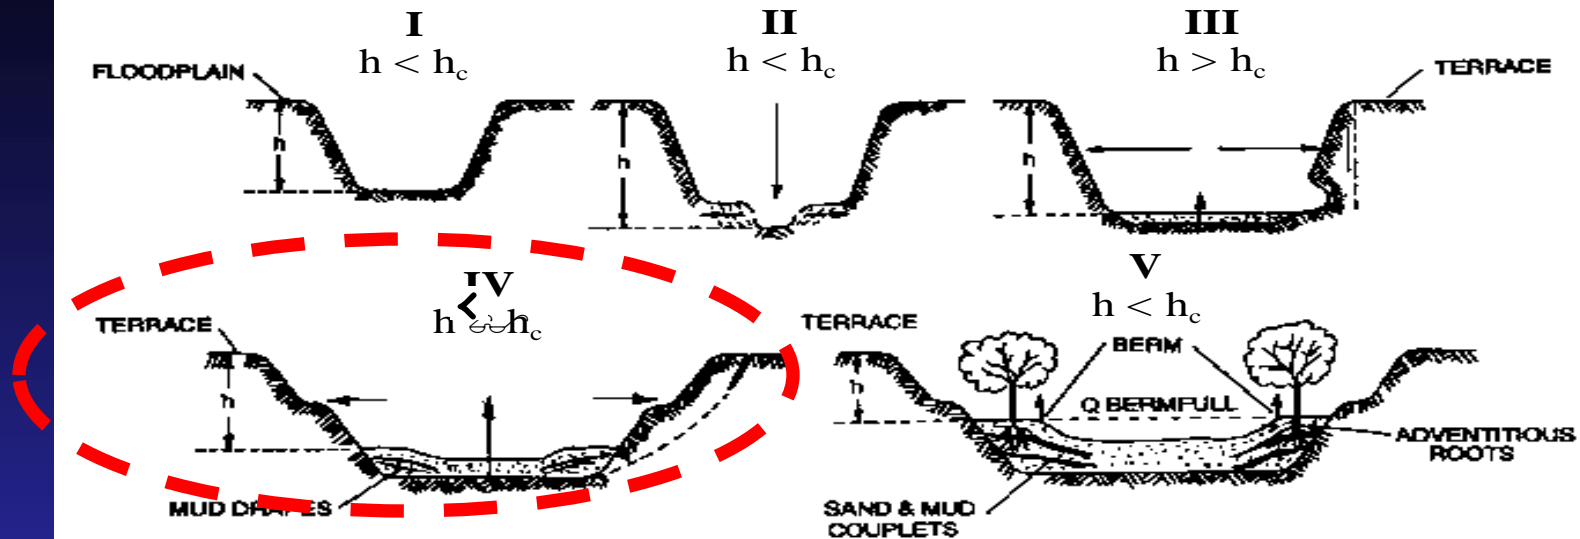
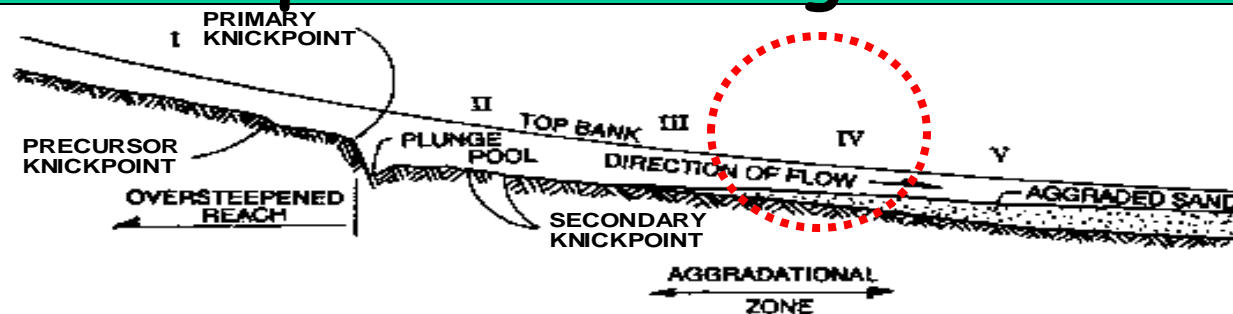
INCISED CHANNEL EVOLUTION PHASES

The Type IV reaches are downstream of the Type III reaches and represent the first manifestation of the incised channel returning to a new state of dynamic equilibrium.

In the Type IV reach, geotechnical bank instabilities and channel widening may continue, but at a much reduced rate.

Channel widening continues at a much reduced rate in the Type IV reach. The first manifestation of a new equilibrium emerges.

$h_c = \text{CRITICAL BANK HEIGHT}$

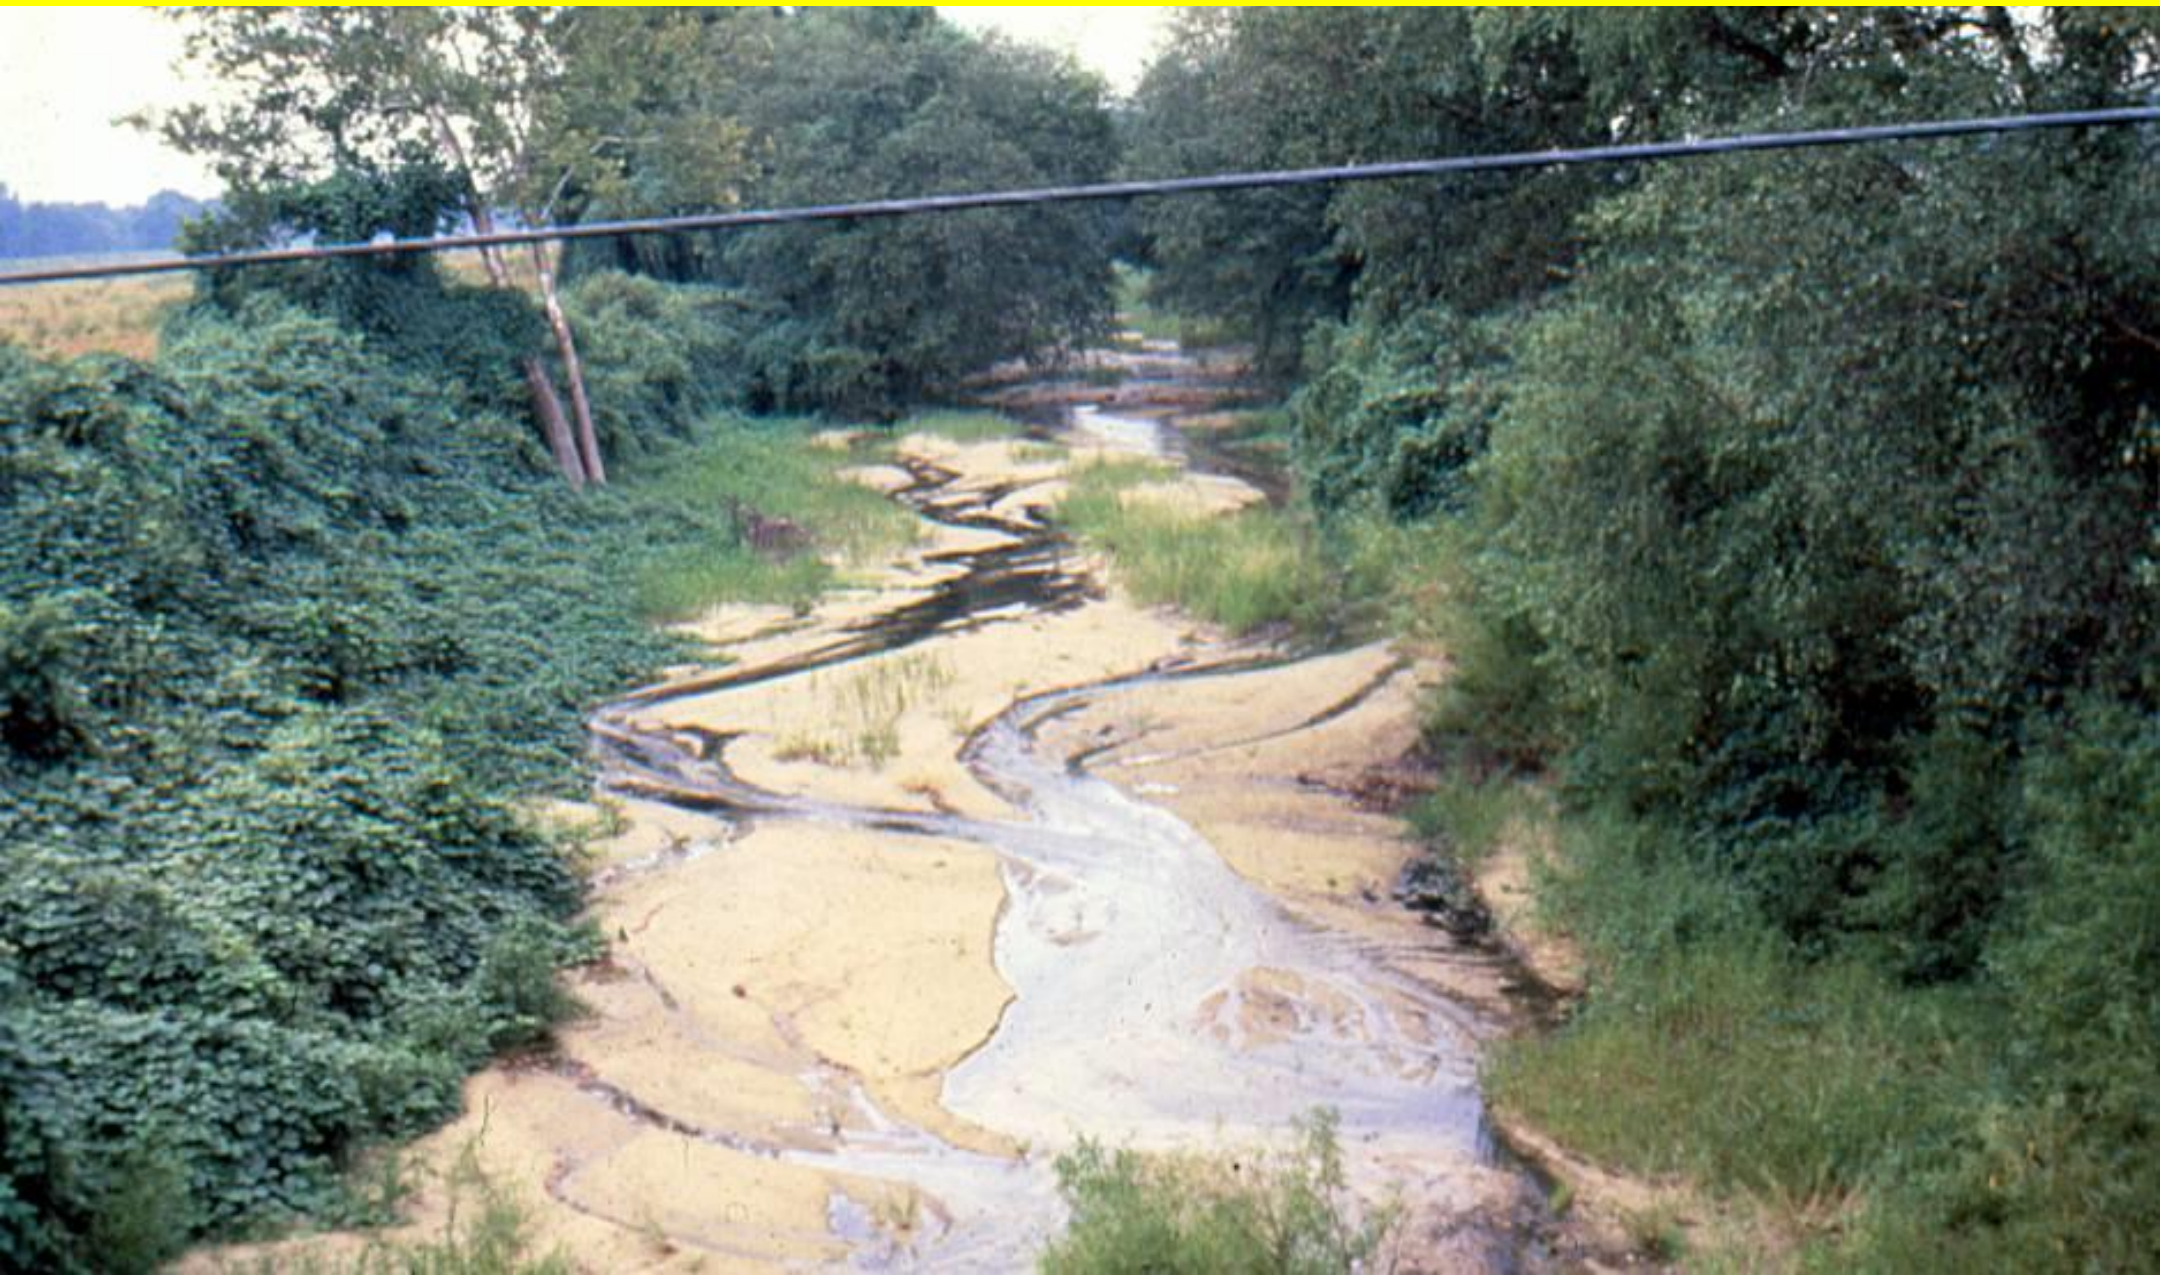
CEM Type IV, MS., should be a single-thread channel

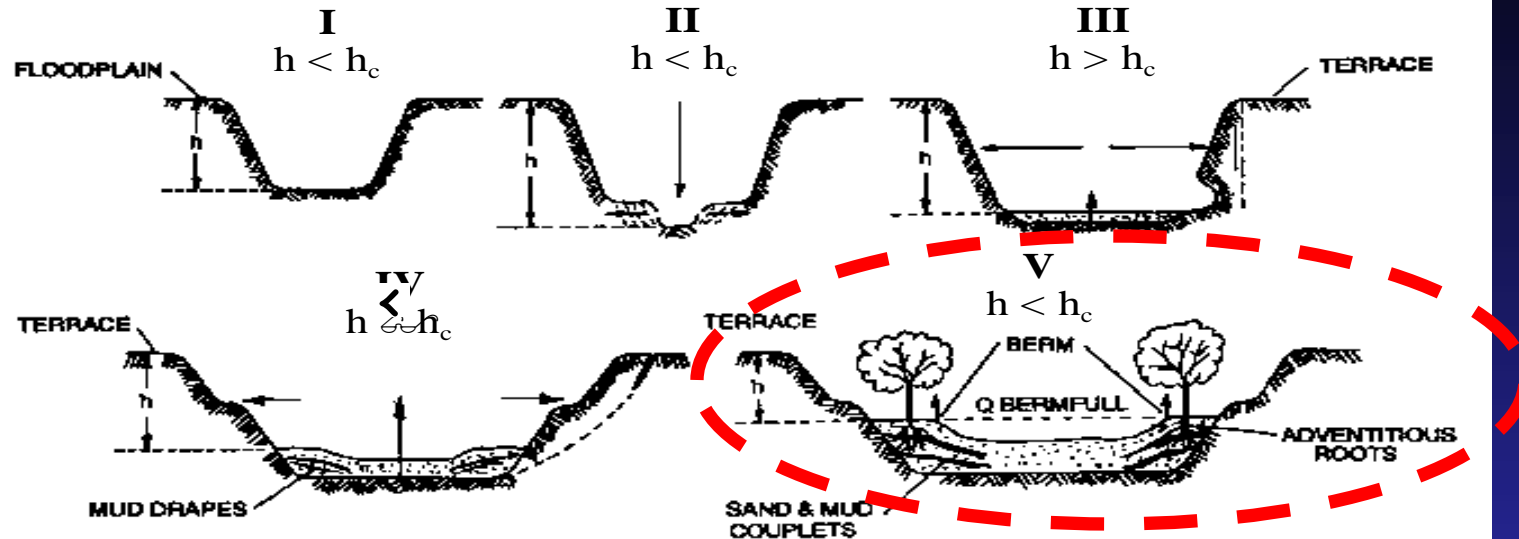
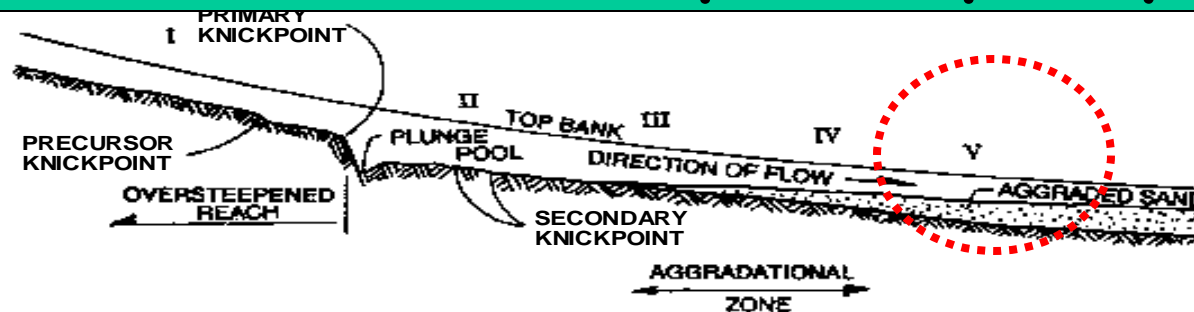
INCISED CHANNEL EVOLUTION PHASES

Type V reaches represent a state of dynamic equilibrium with a balance between sediment transport capacity and sediment supply.

Bank heights in the Type V channel are generally less than the critical bank height, and therefore, geotechnical bank instabilities do not exist.

Type V reaches represent a state of dynamic equilibrium with a balance between sediment supply and sediment transport capacity.

h_c = CRITICAL BANK HEIGHT

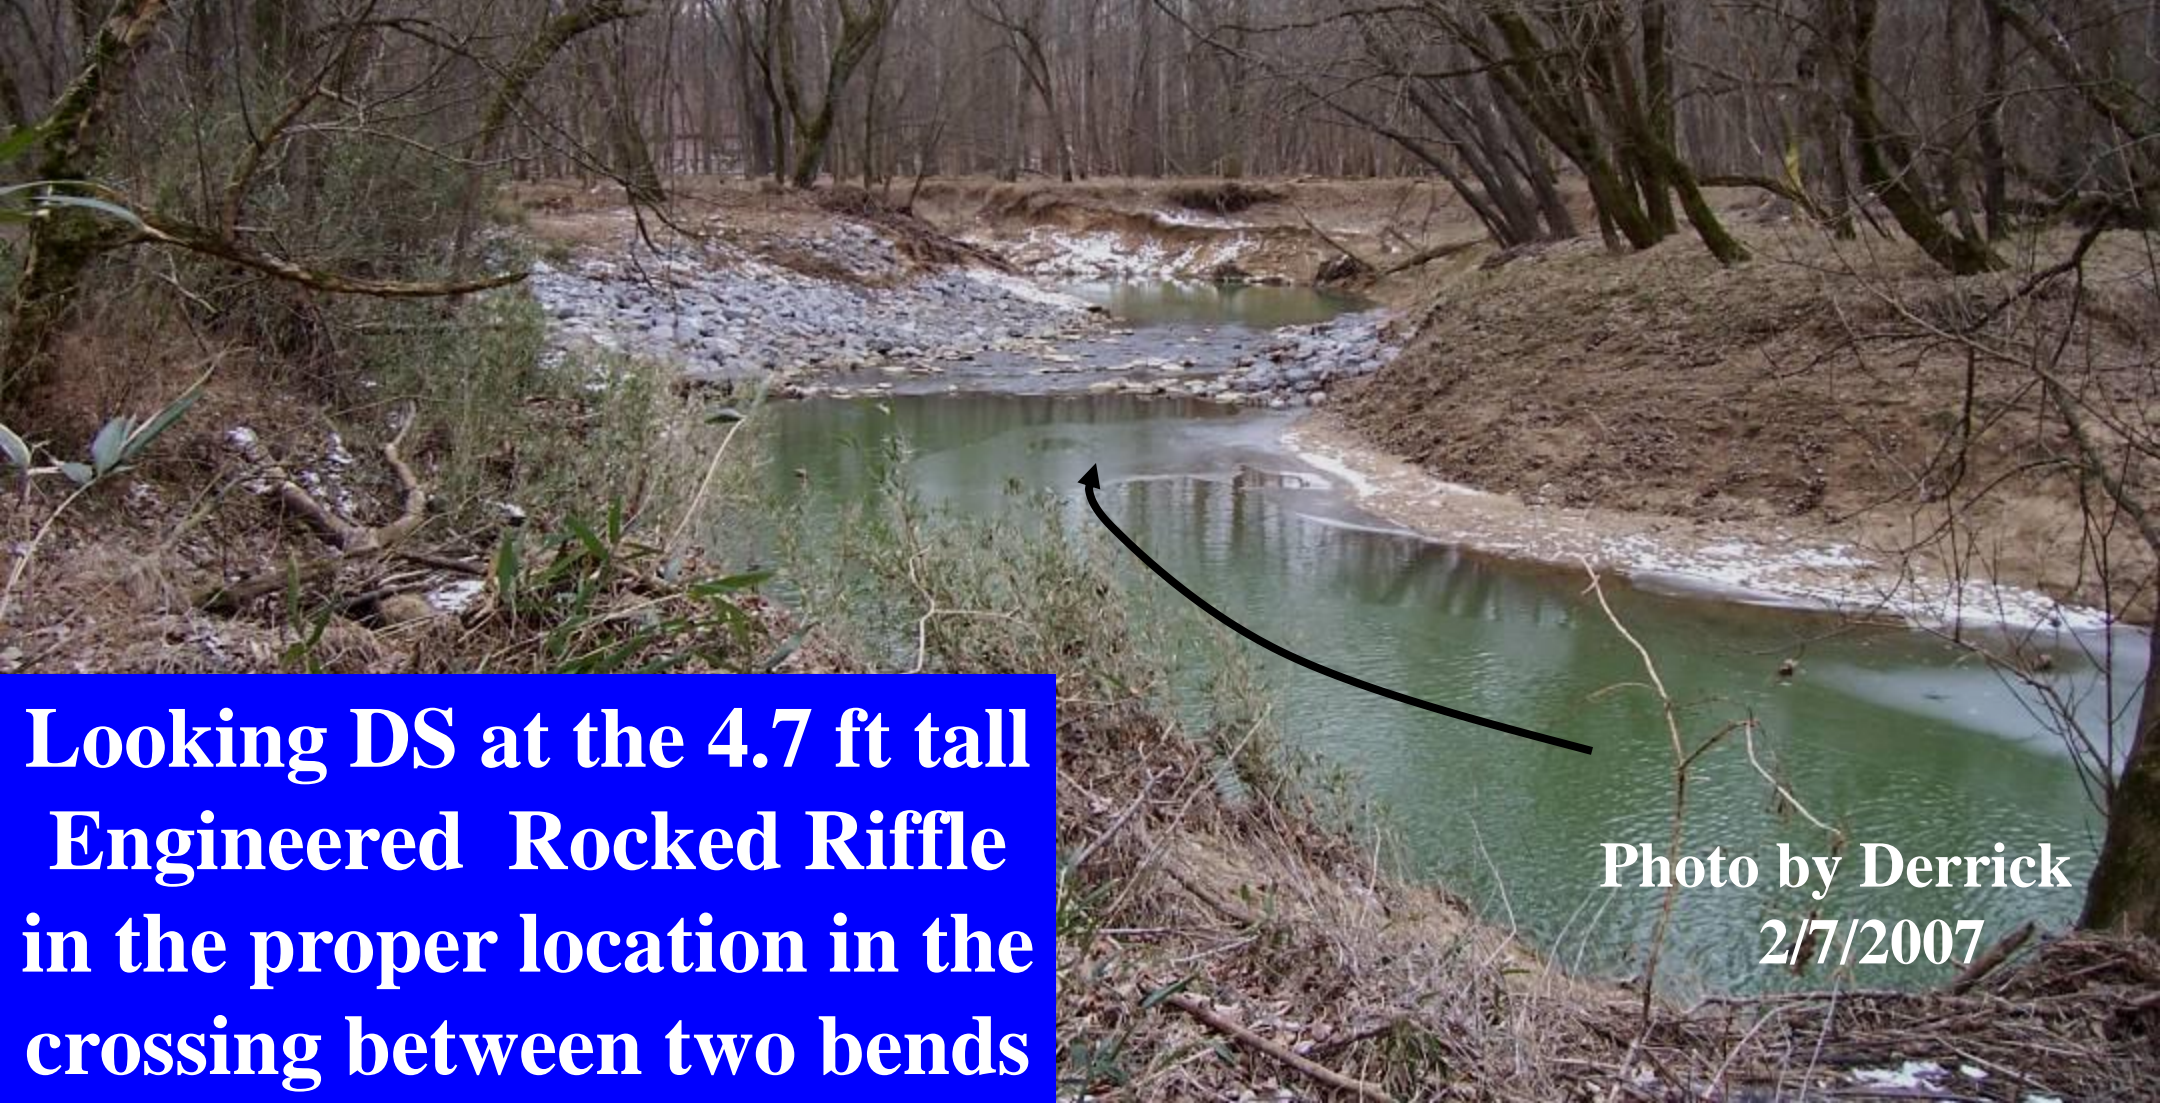
Mini case study: 2 of 10

**A 4.7 ft tall ERR, Big Creek, Union
County, IL. {rural, sand-gravel, pool-
riffle-pool, meandering, incised}
Designed by Wayne Kinney**

**Looking DS at the 4.7 ft tall
Engineered Rocked Riffle
in the proper location in the
crossing between two bends**

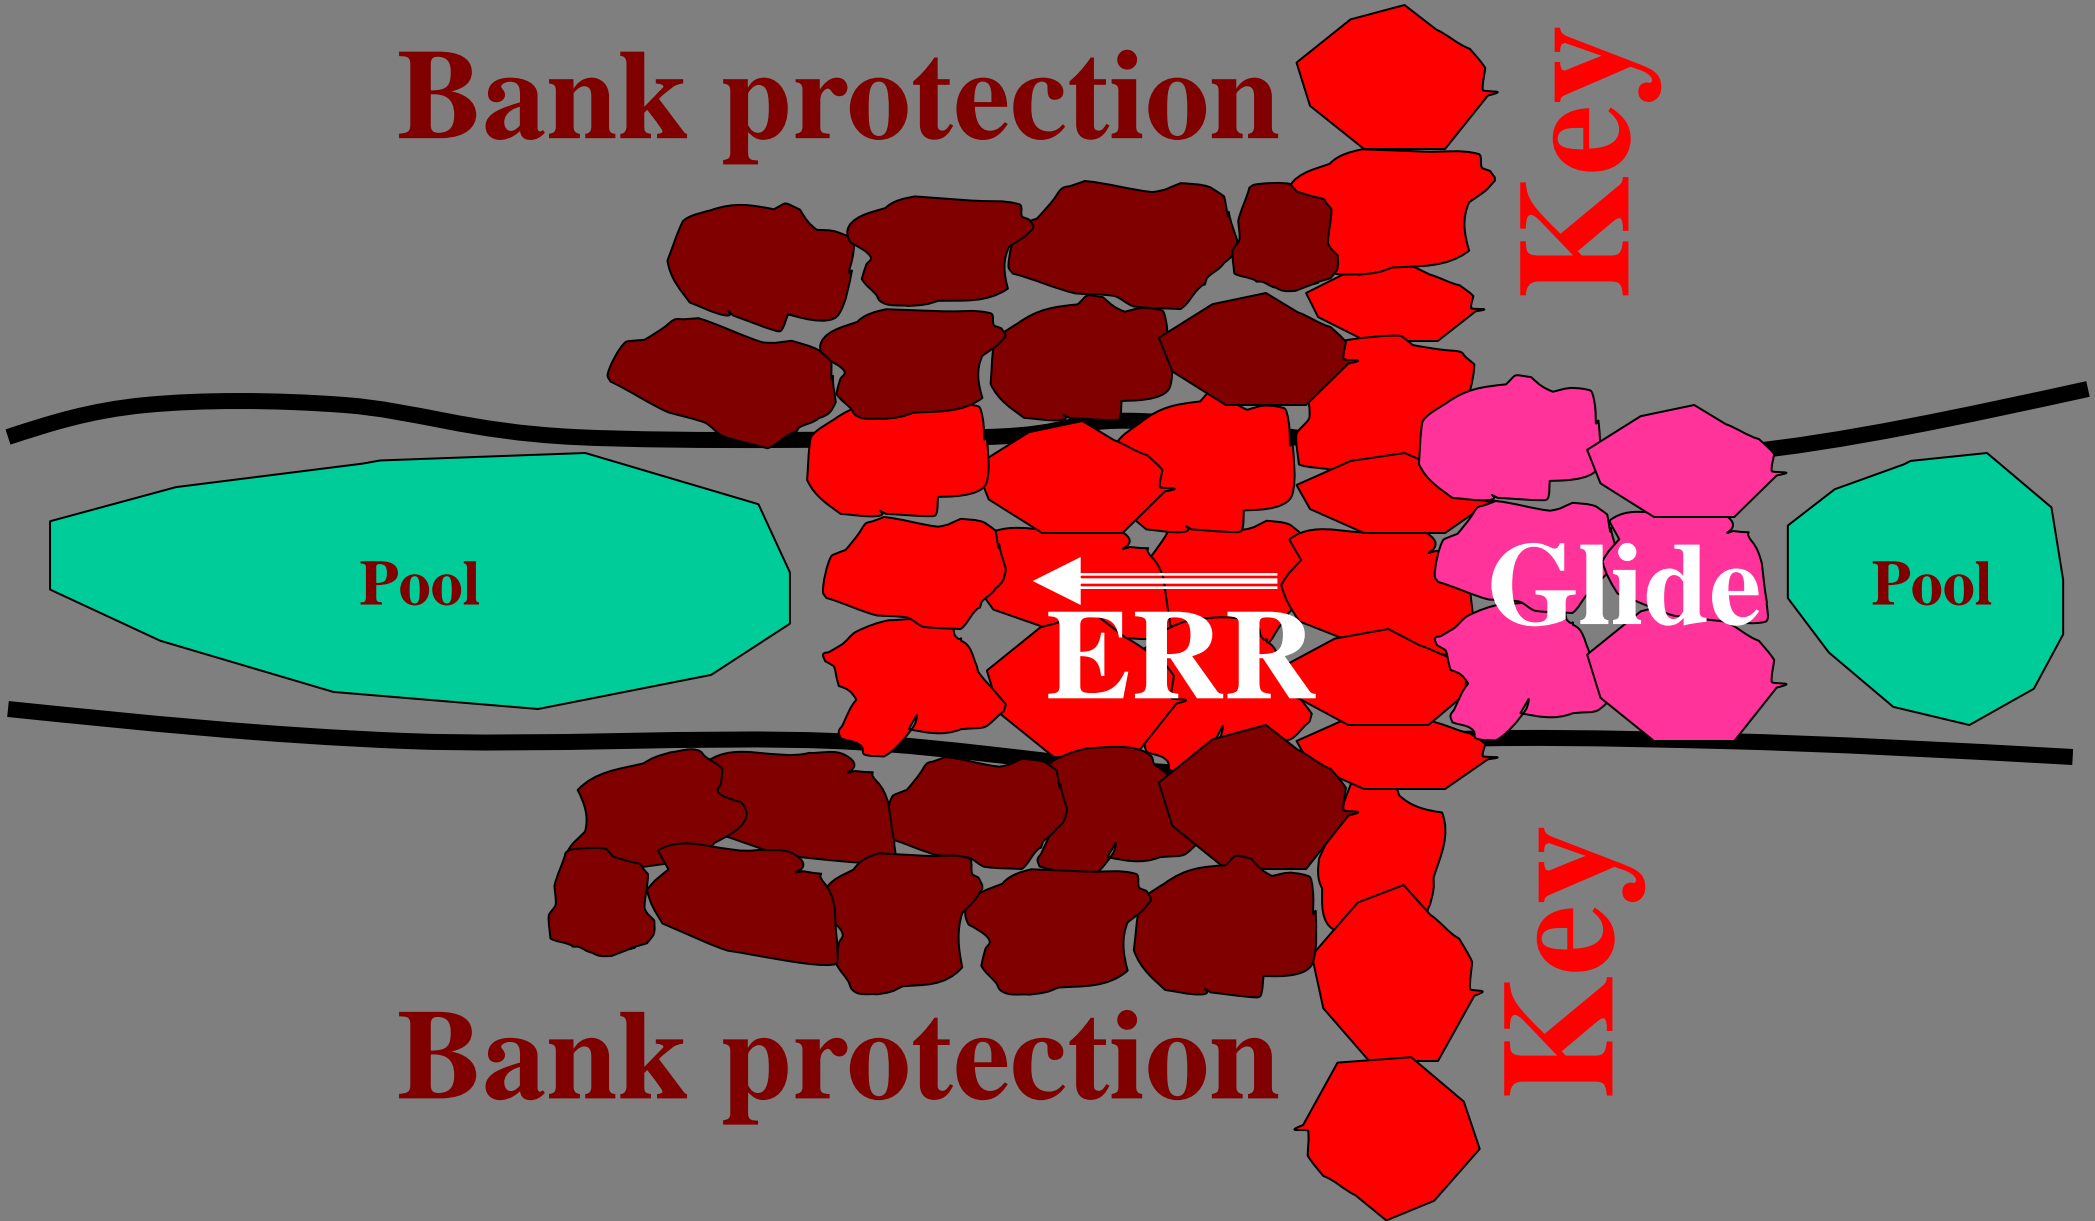
When building a series of Newbury RR Bob always puts a NRR "at grade" (buried) at the DS end of the project to protect against DS headcuts, max height of a NRR is 1.5 ft, & **Bob always puts a tailwater of 1/3 the height of the upstream NRR on the upstream NRR. This provides energy dissipation into the tailwater pool, but also provides sediment continuity (sediment does not deposit between NRR's & stream does not meander & flank the DS NRR)**

**←
ERR**

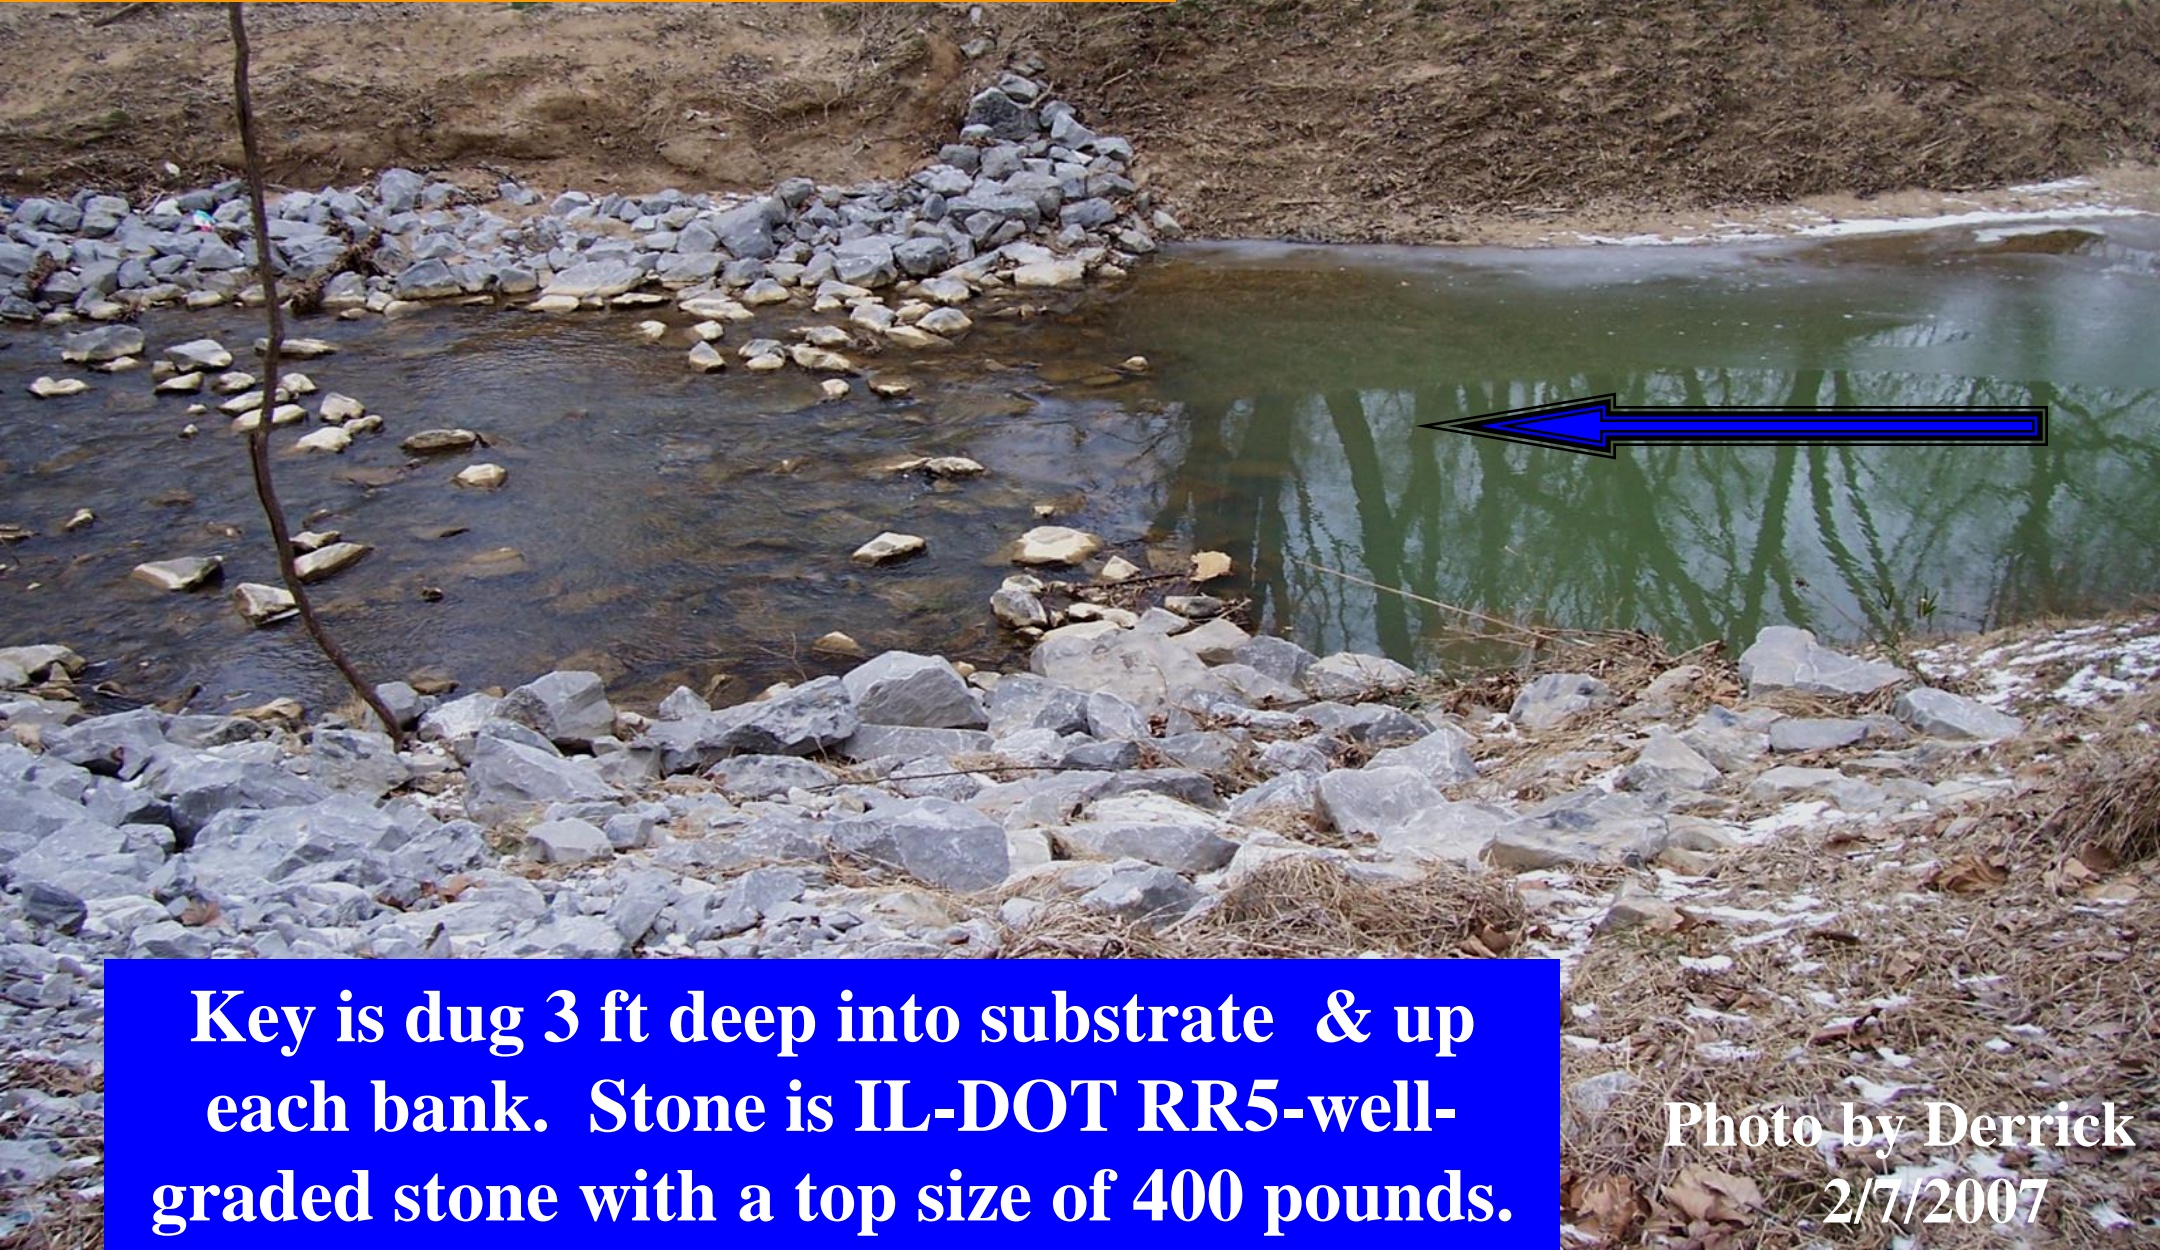
Mini case study: 4 of 10

A 4.7 ft tall ERR, Big Creek, Union County, IL. Designed by Wayne Kinney

Key is dug 3 ft deep into substrate & up each bank. Stone is IL-DOT RR5-well-graded stone with a top size of 400 pounds.

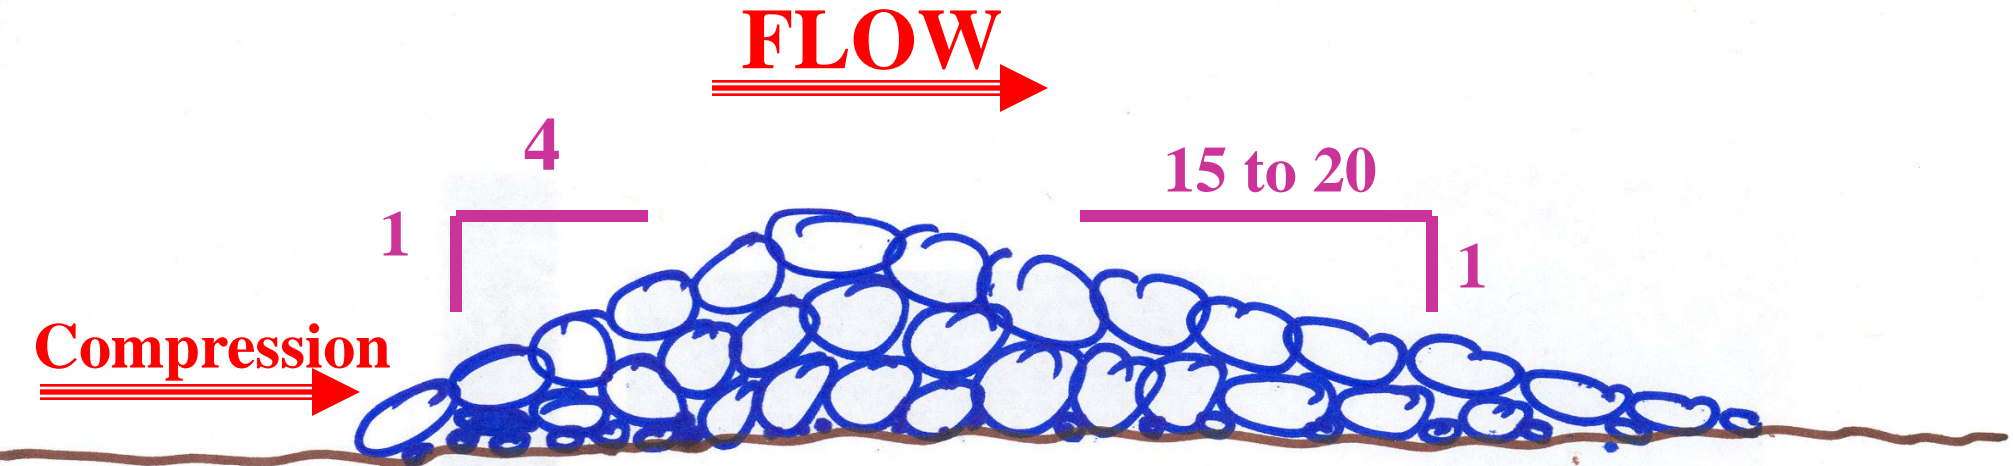
AN ENGINEERED ROCKED RIFFLE

Use well-graded, self-adjusting stone. Bigger stone is better.

Choke stone so all flow goes over the top (not through) the ERR. Upstream face is in **compression** (due to water flow), so smaller stone or spawning gravel can be used. Slope might have to be flatter for some spawning species.

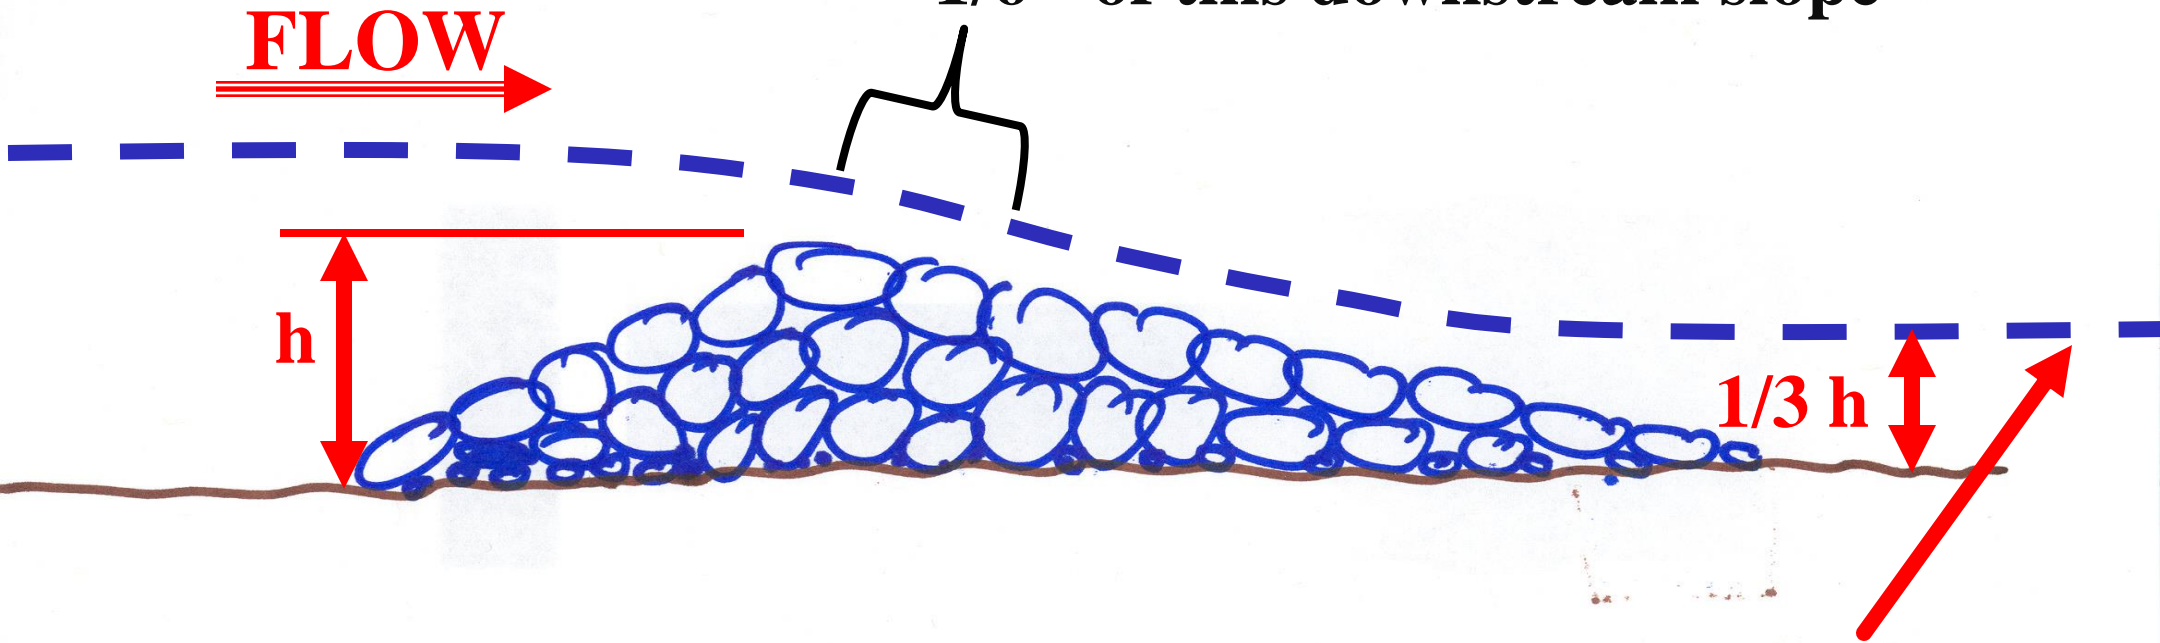
AN ENGINEERED ROCKED RIFFLE

Greatest shear stress is on upper
 $\frac{1}{6}^{\text{th}}$ of this downstream slope

Newbury says the backwater should be $\frac{1}{3}$ the total height of the structure to dissipate energy, & also pass sediment through the system.

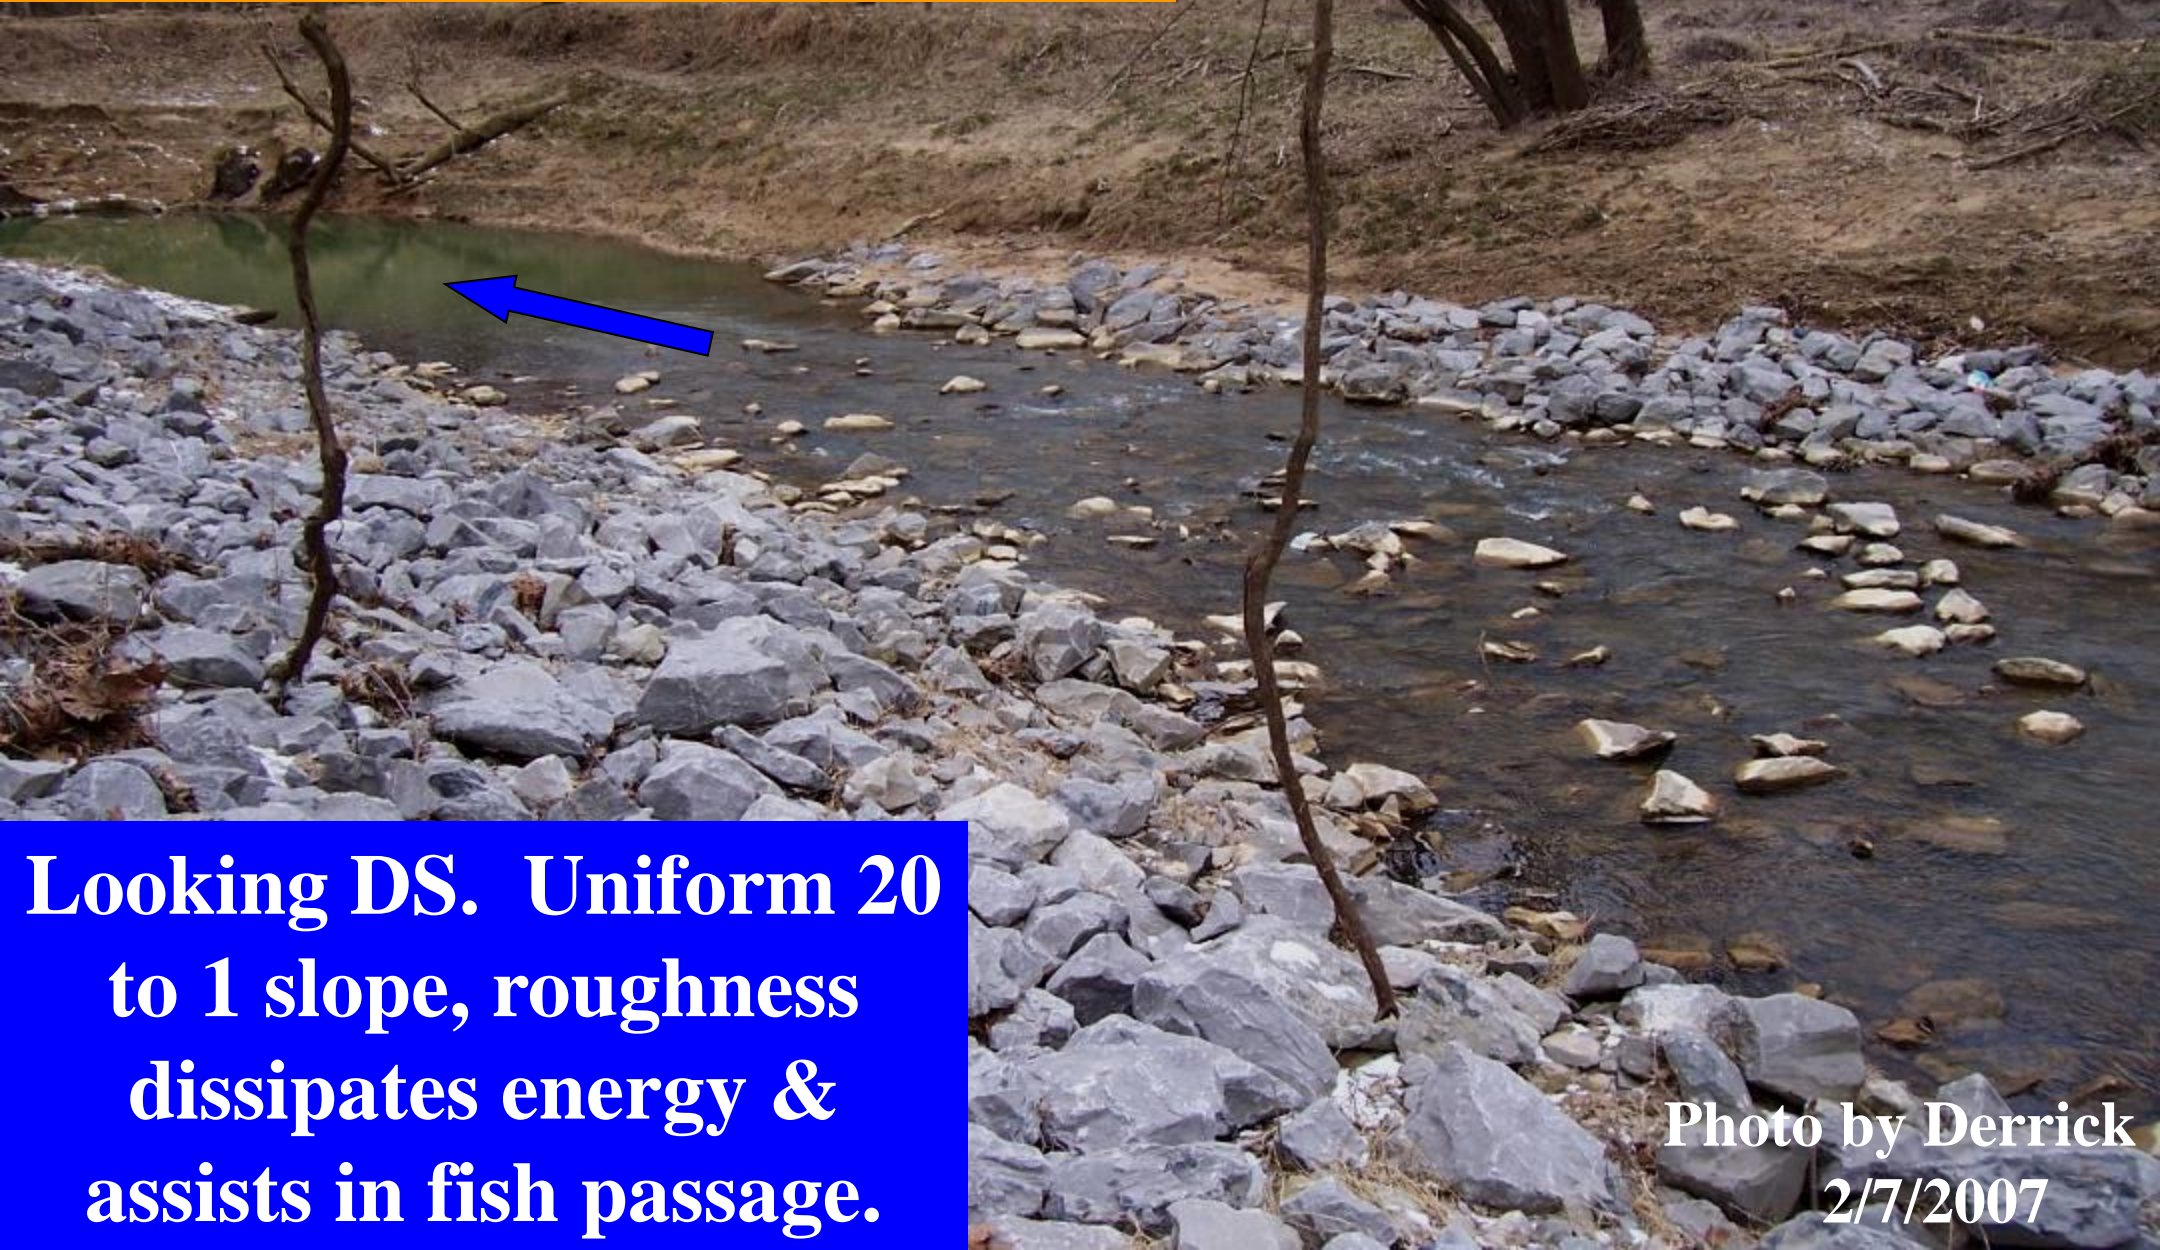
Mini case study: 5 of 10

A 4.7 ft tall ERR, Big Creek, Union County, IL. Designed by Wayne Kinney

Looking DS. Uniform 20 to 1 slope, roughness dissipates energy & assists in fish passage.
