**THE CHANNEL EVOLUTION
MODEL (CEM), CHANNEL
INCISION, ENVIRONMENTALLY
COMPATABLE GRADE
CONTROL,
GC BUT NO BANK
STABILIZATION,
& SYSTEM-WIDE GC**

Channel Evolution Model (Schumm, et al. 1984)

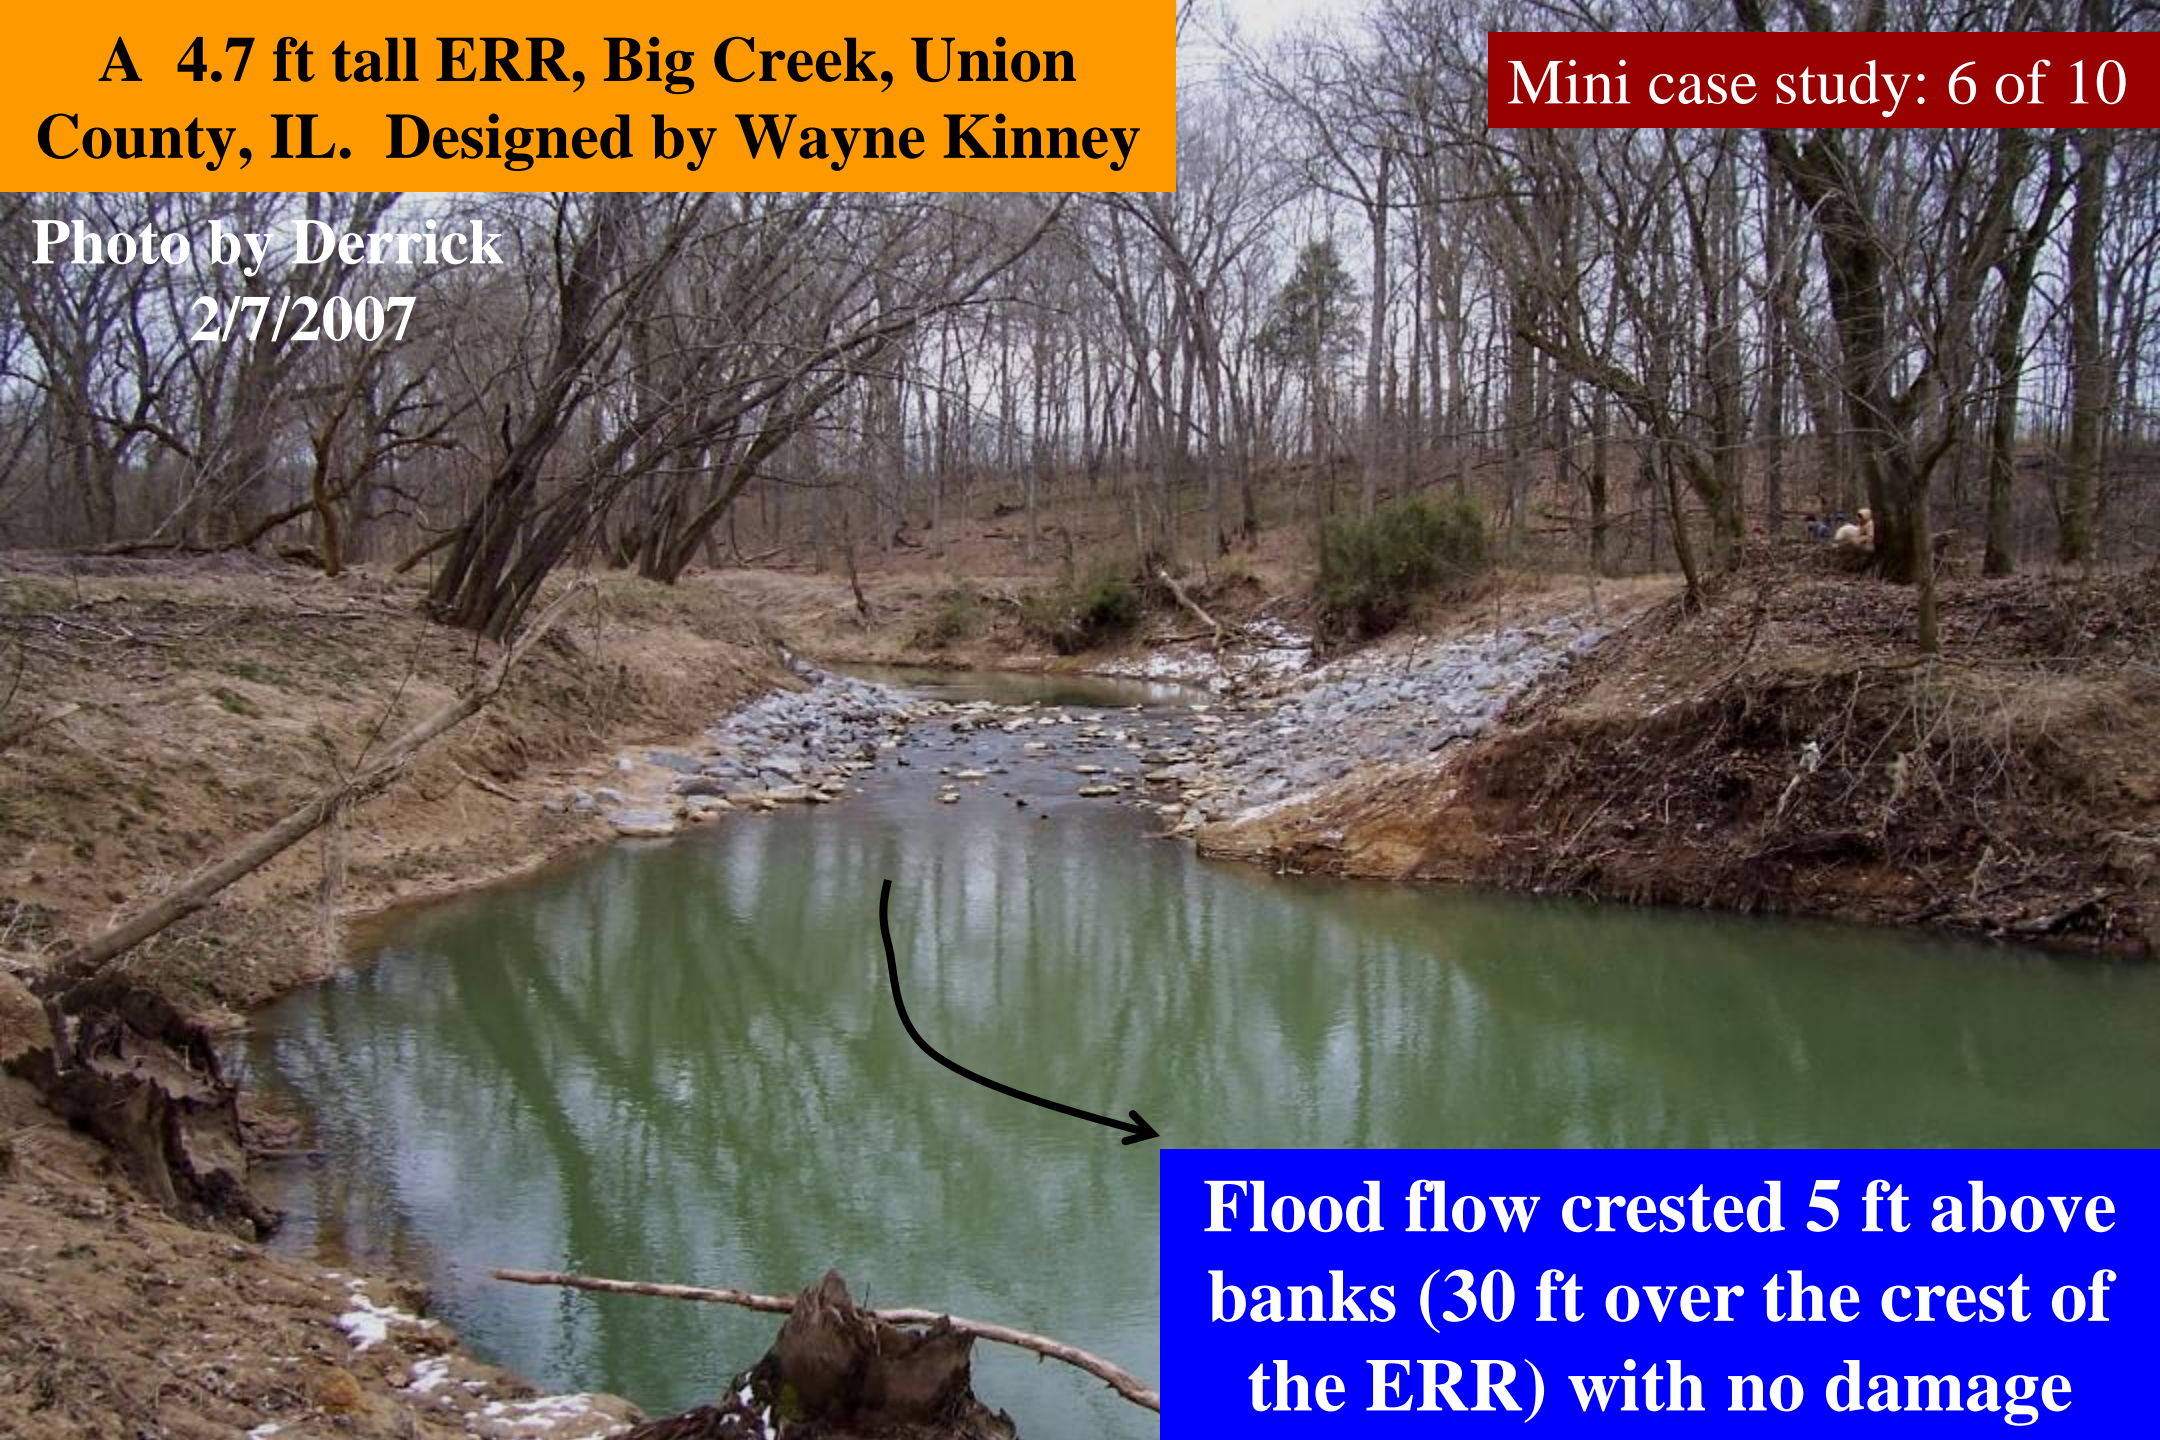
Mini case study: 6 of 10

**Flood flow crested 5 ft above
banks (30 ft over the crest of
the ERR) with no damage**

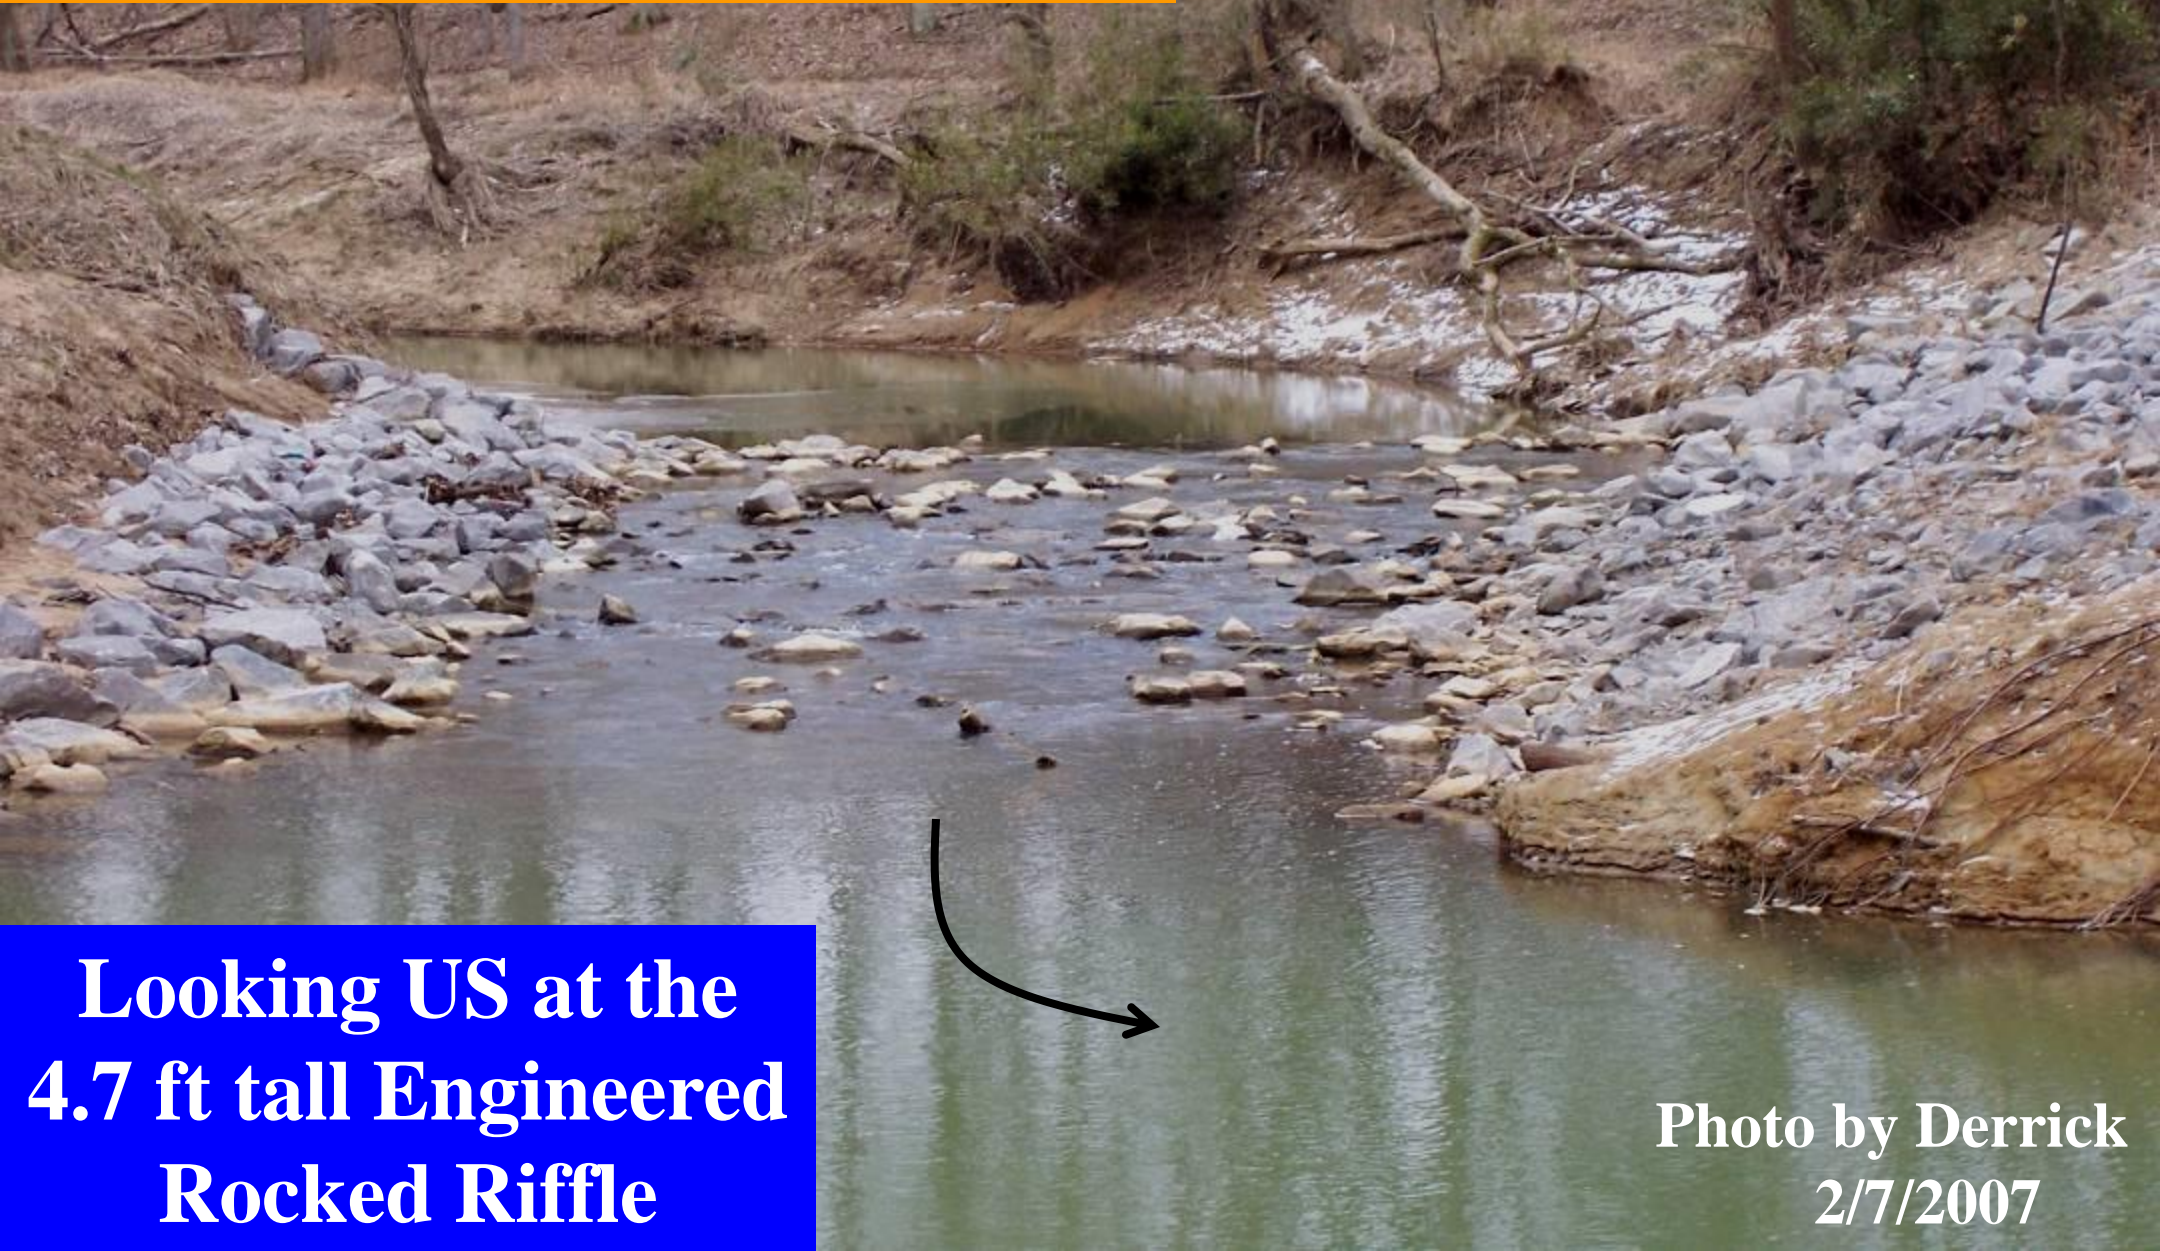
Mini case study: 7 of 10

**Looking US at the
4.7 ft tall Engineered
Rocked Riffle**

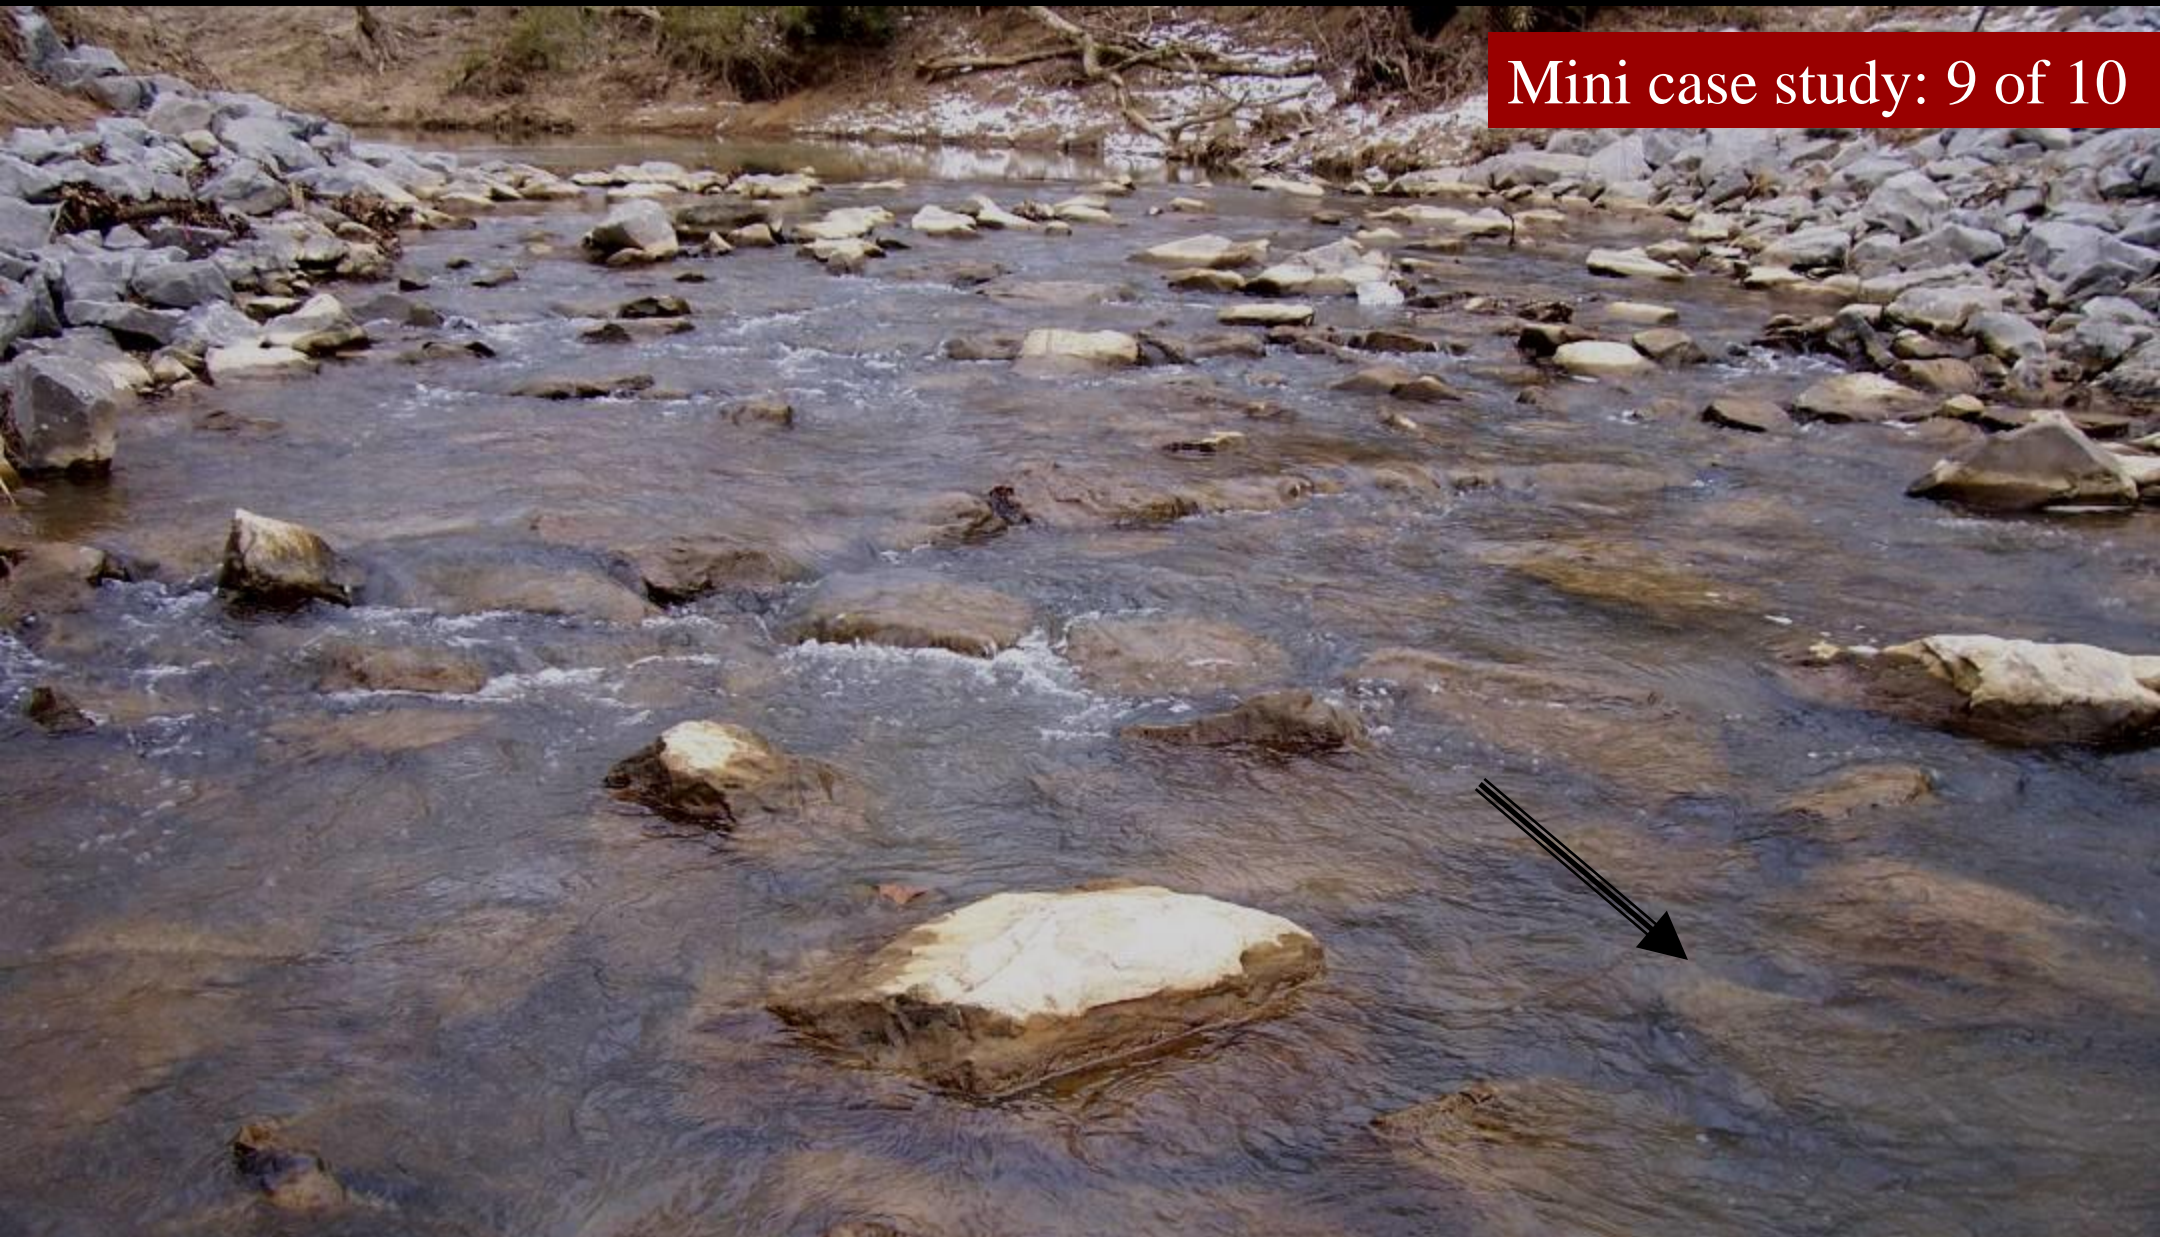
Looking US. A thing of beauty!! Stone was track-walked in to increase stability

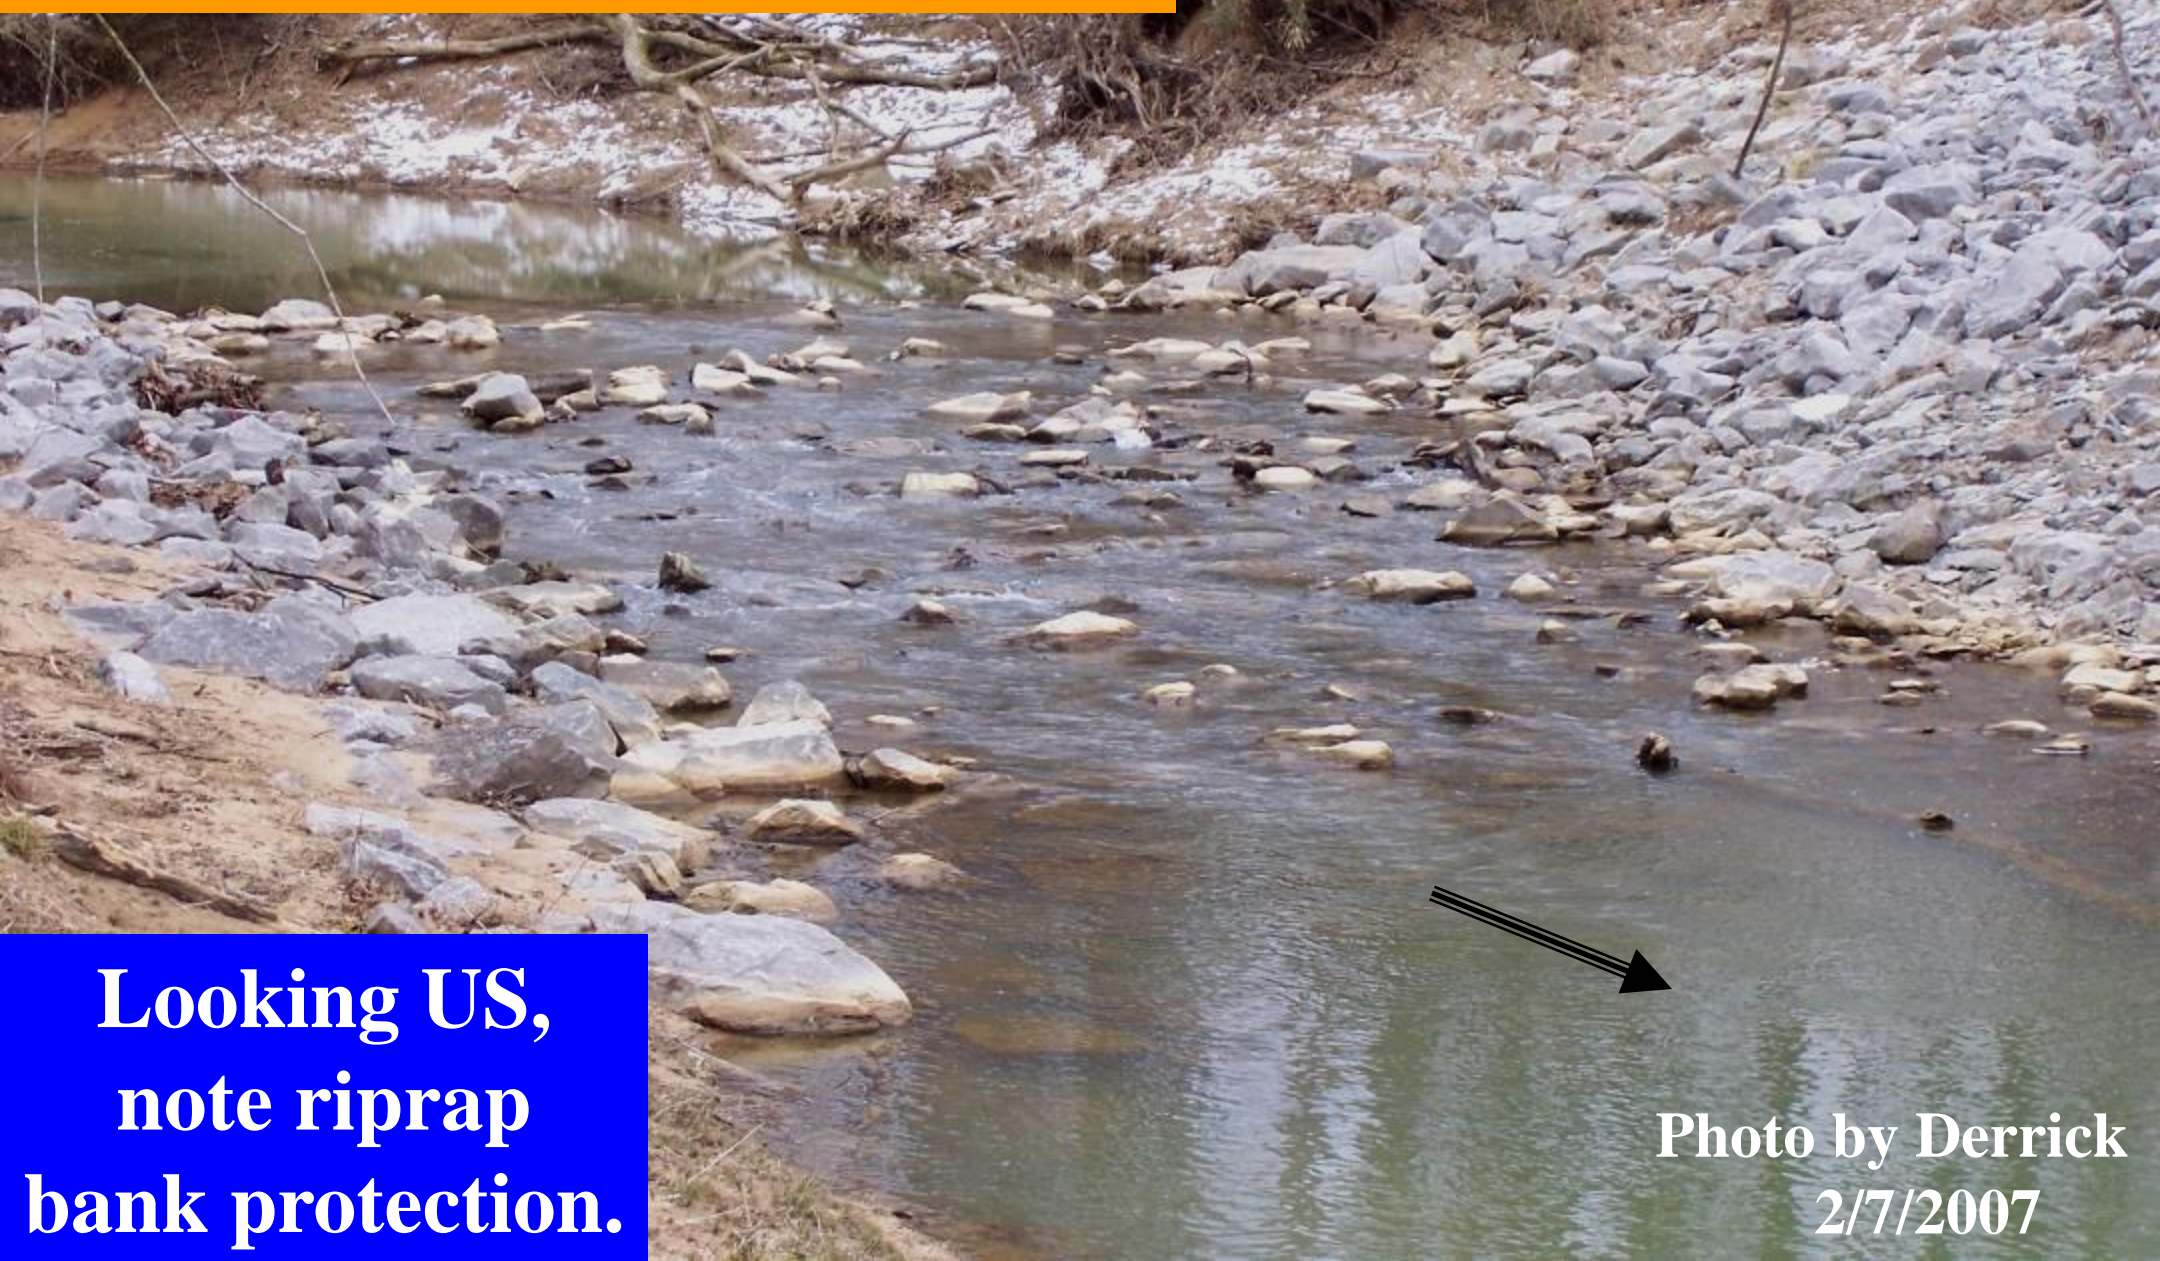
Mini case study: 10 of 10

**Looking US,
note riprap
bank protection.**

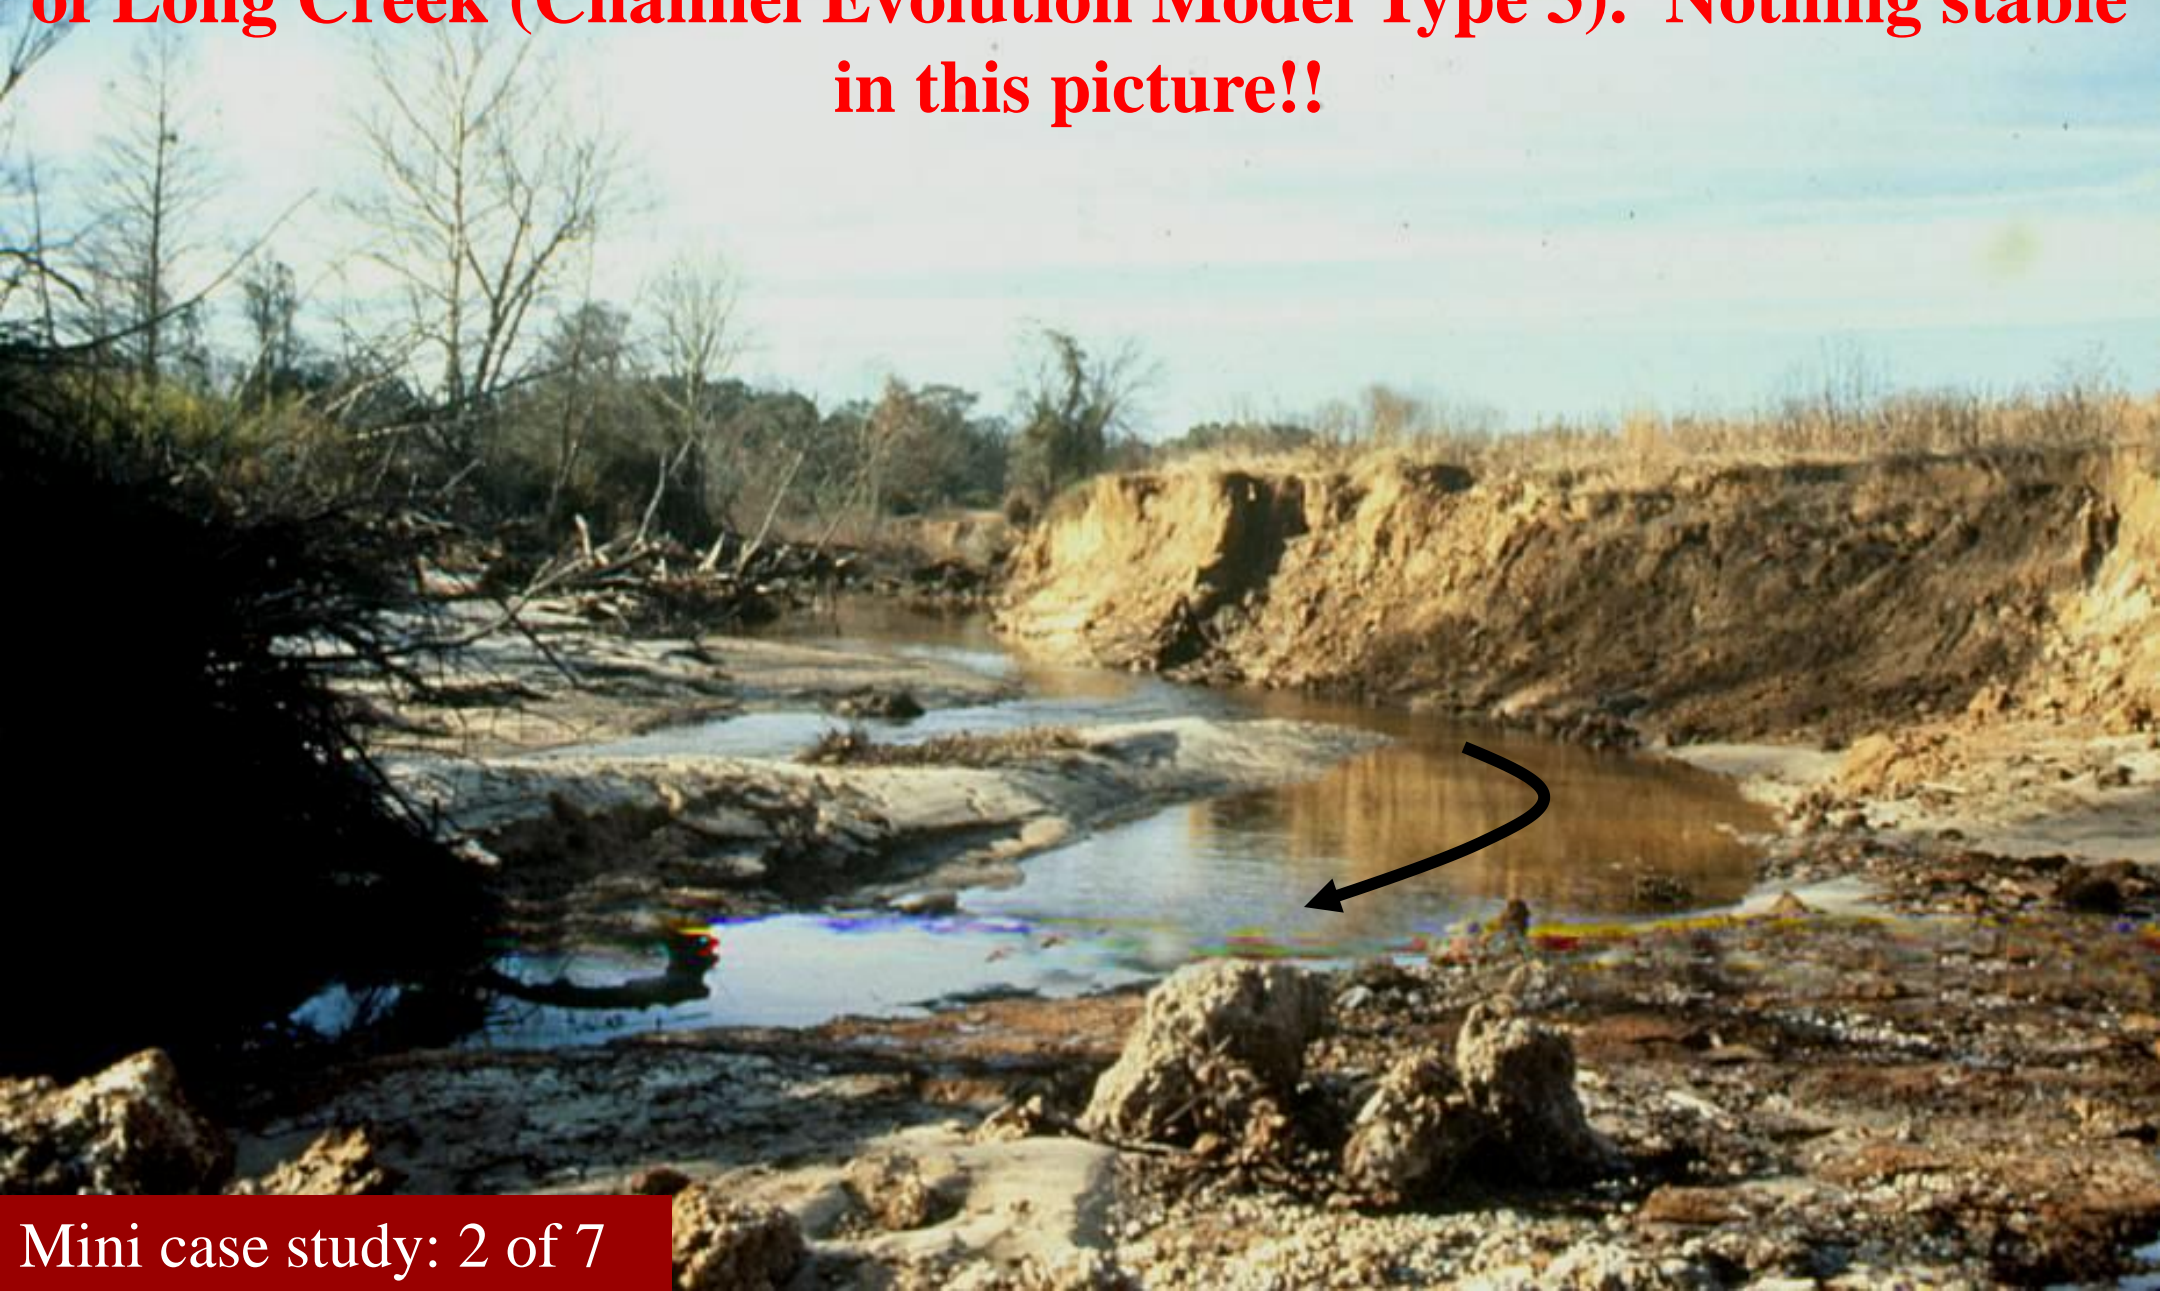
Looking US at a typical section of incised, highly disturbed section of Long Creek (Channel Evolution Model Type 3). Nothing stable in this picture!!

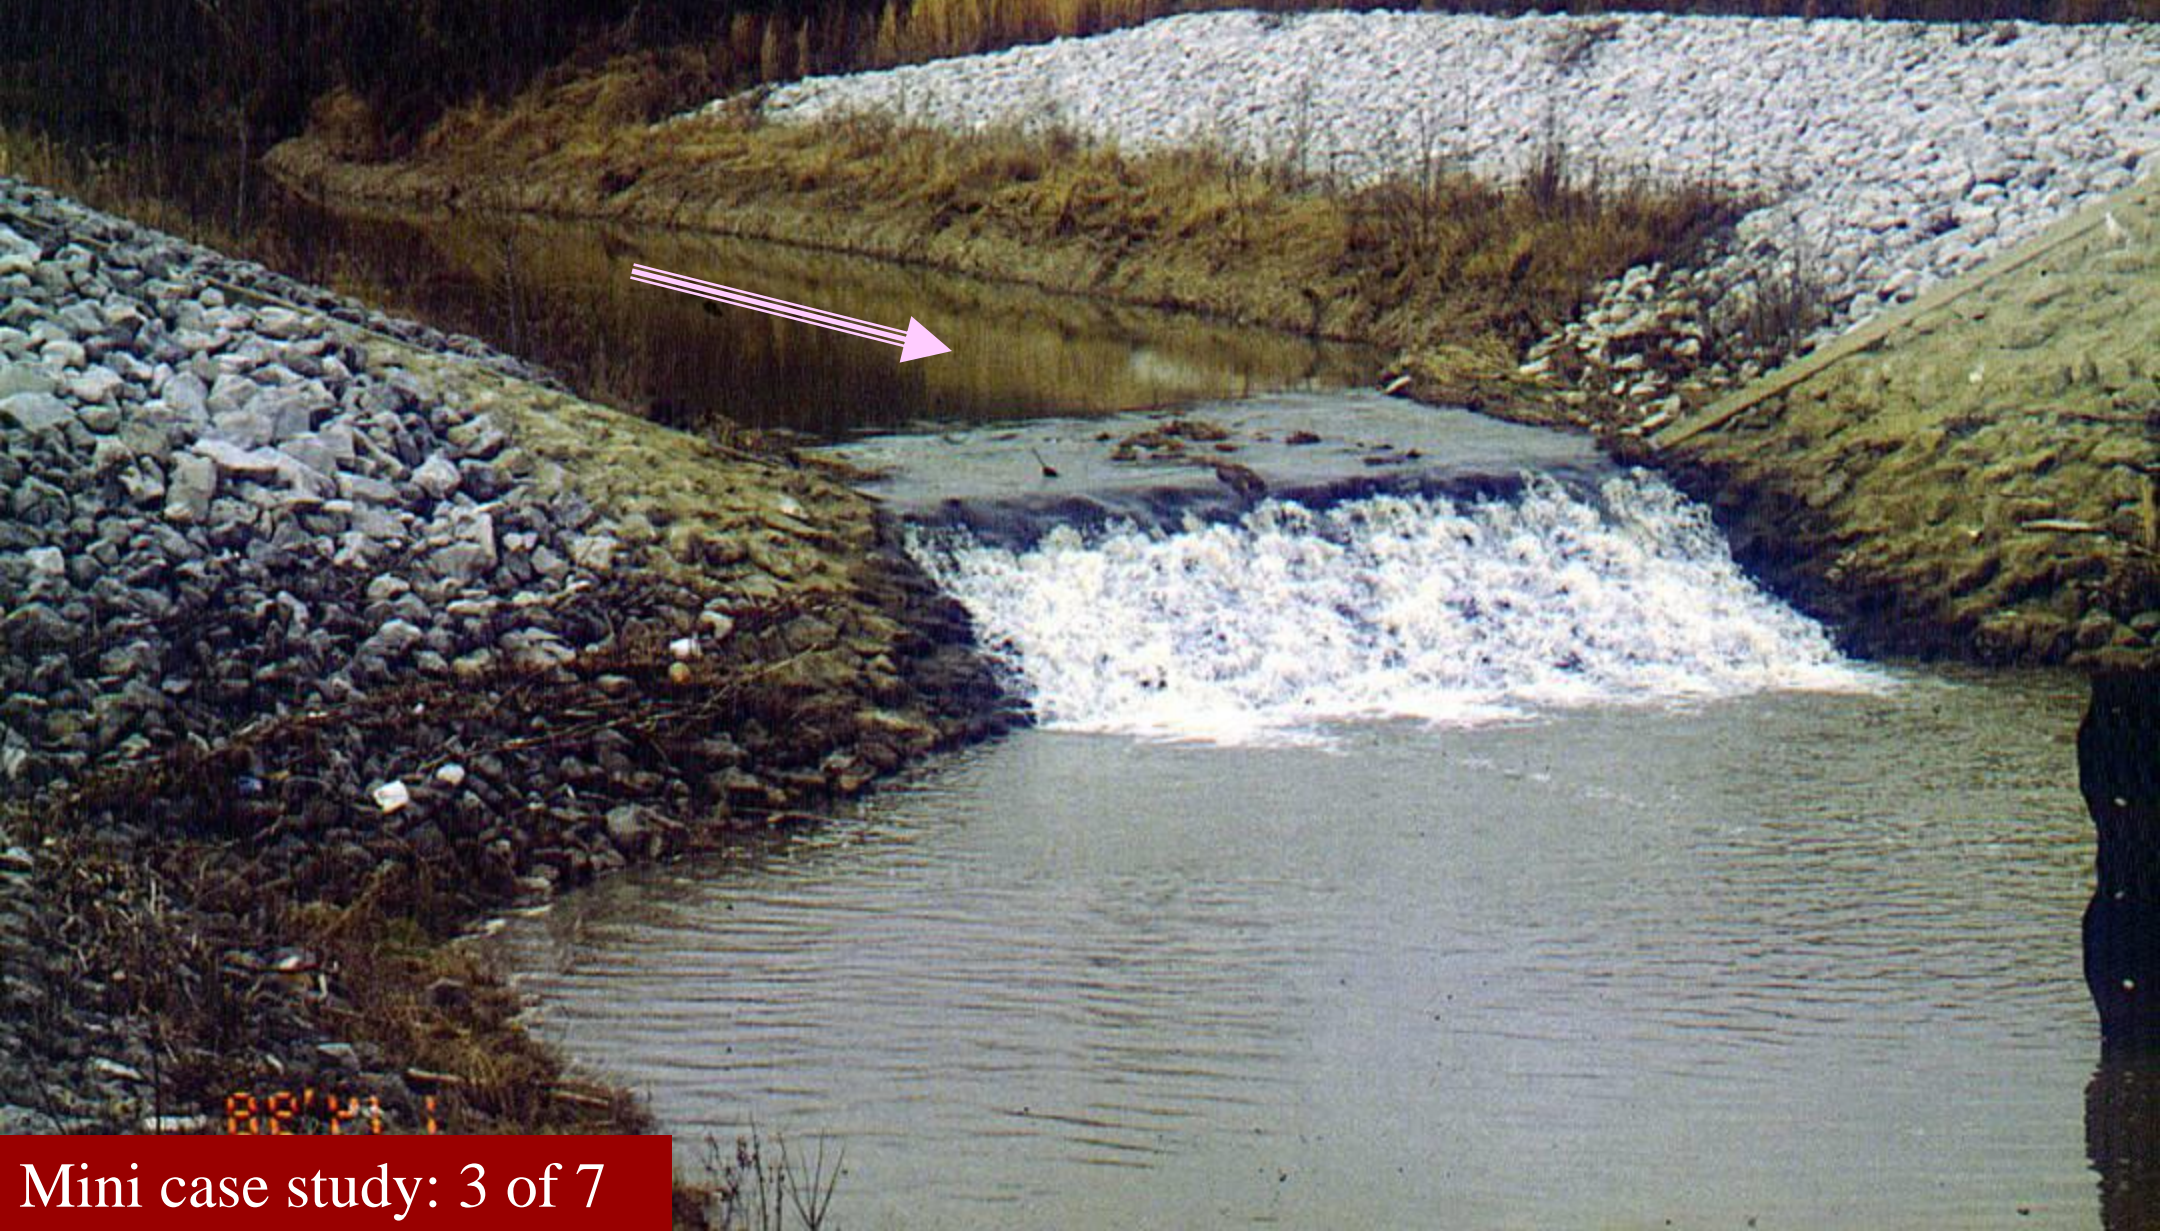
Three ARS style sheet-pile low drop (4 to 7 ft tall) grade control structures were built over a long section of Long Creek

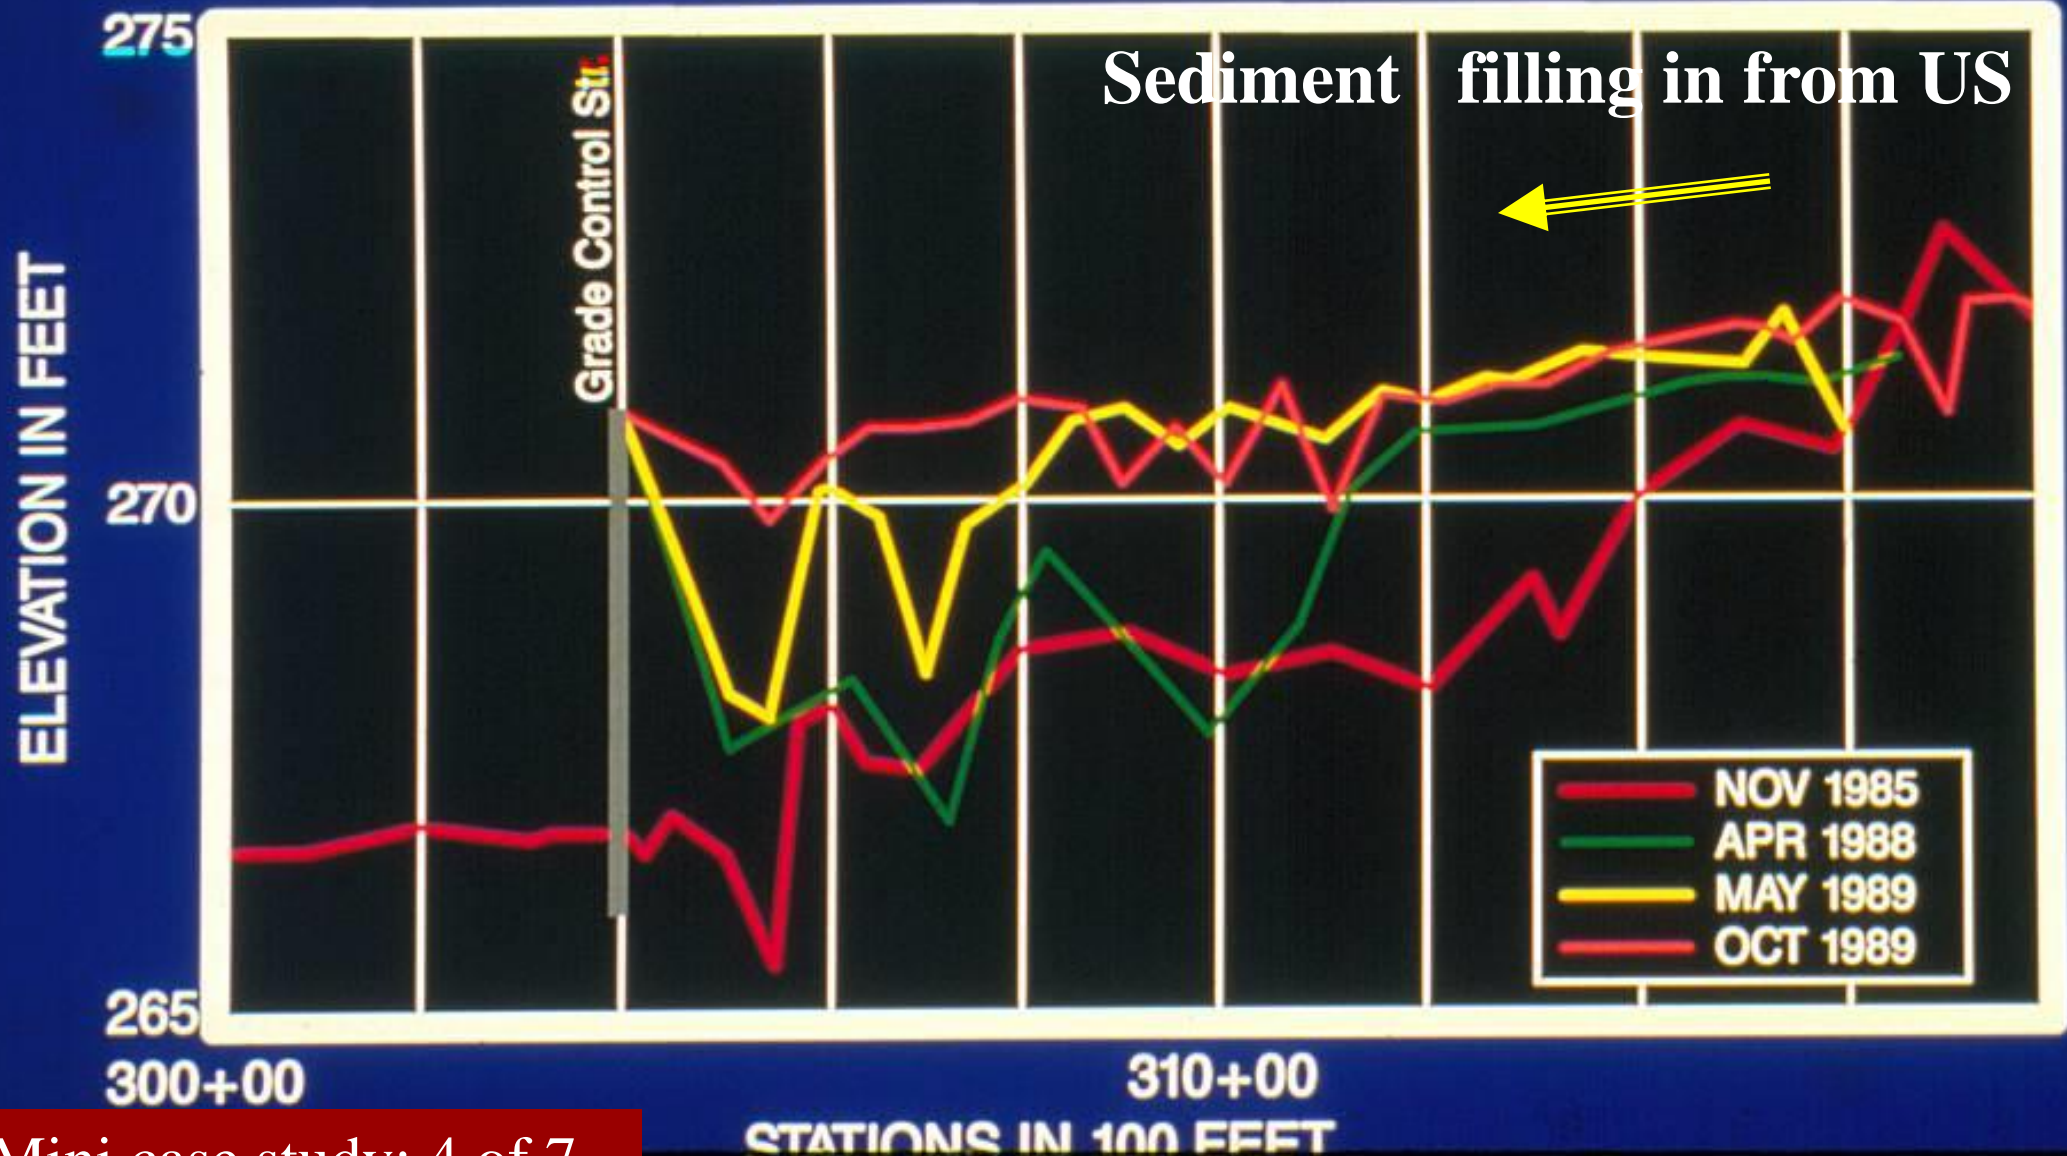
Comparative Thalweg Profile Long Creek Upstream of Low Drop Grade Control Structure

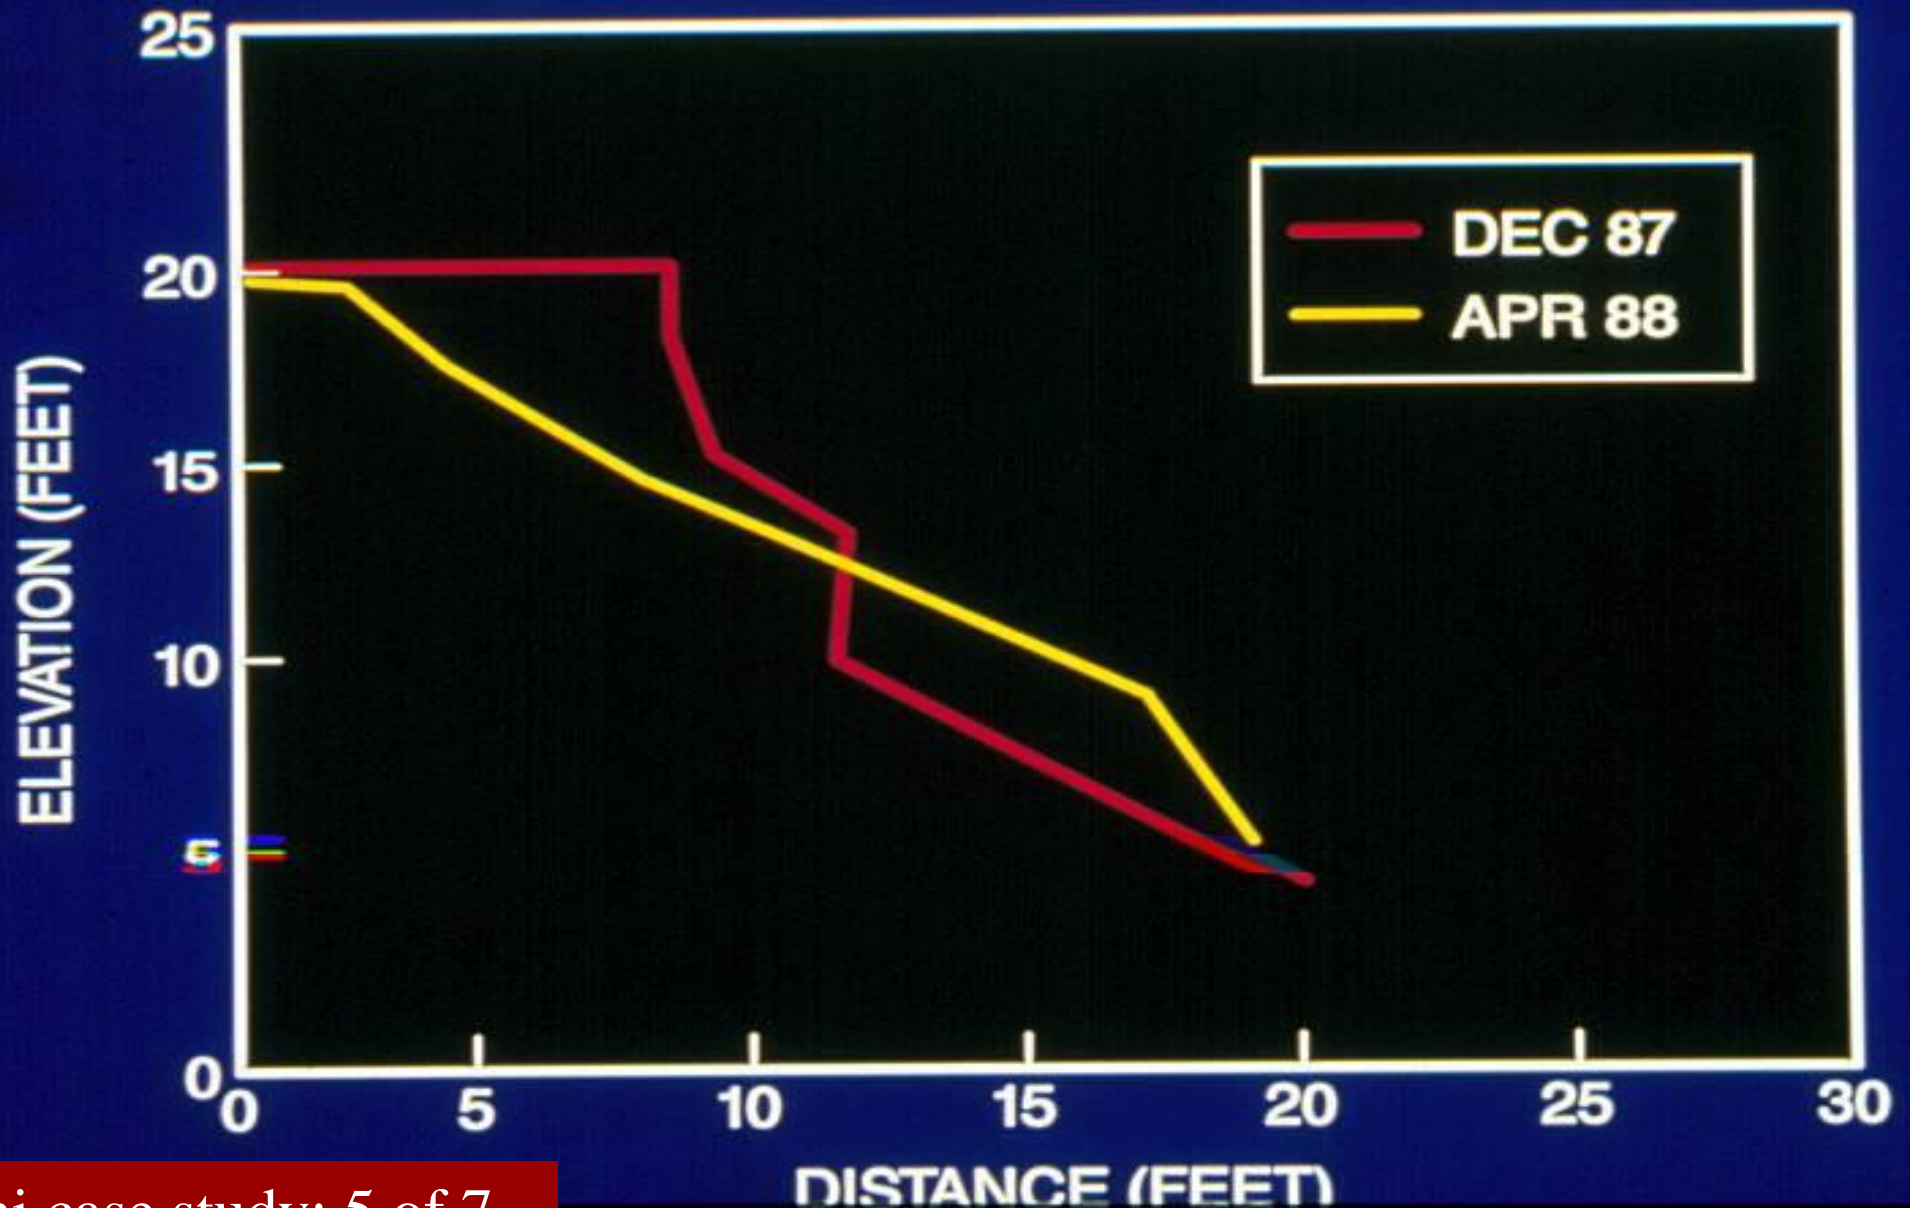
Long Creek Bank Evolution
