**THE CHANNEL EVOLUTION
MODEL (CEM), CHANNEL
INCISION, ENVIRONMENTALLY
COMPATABLE GRADE
CONTROL,
GC BUT NO BANK
STABILIZATION,
& SYSTEM-WIDE GC**

Channel Evolution Model (Schumm, et al. 1984)

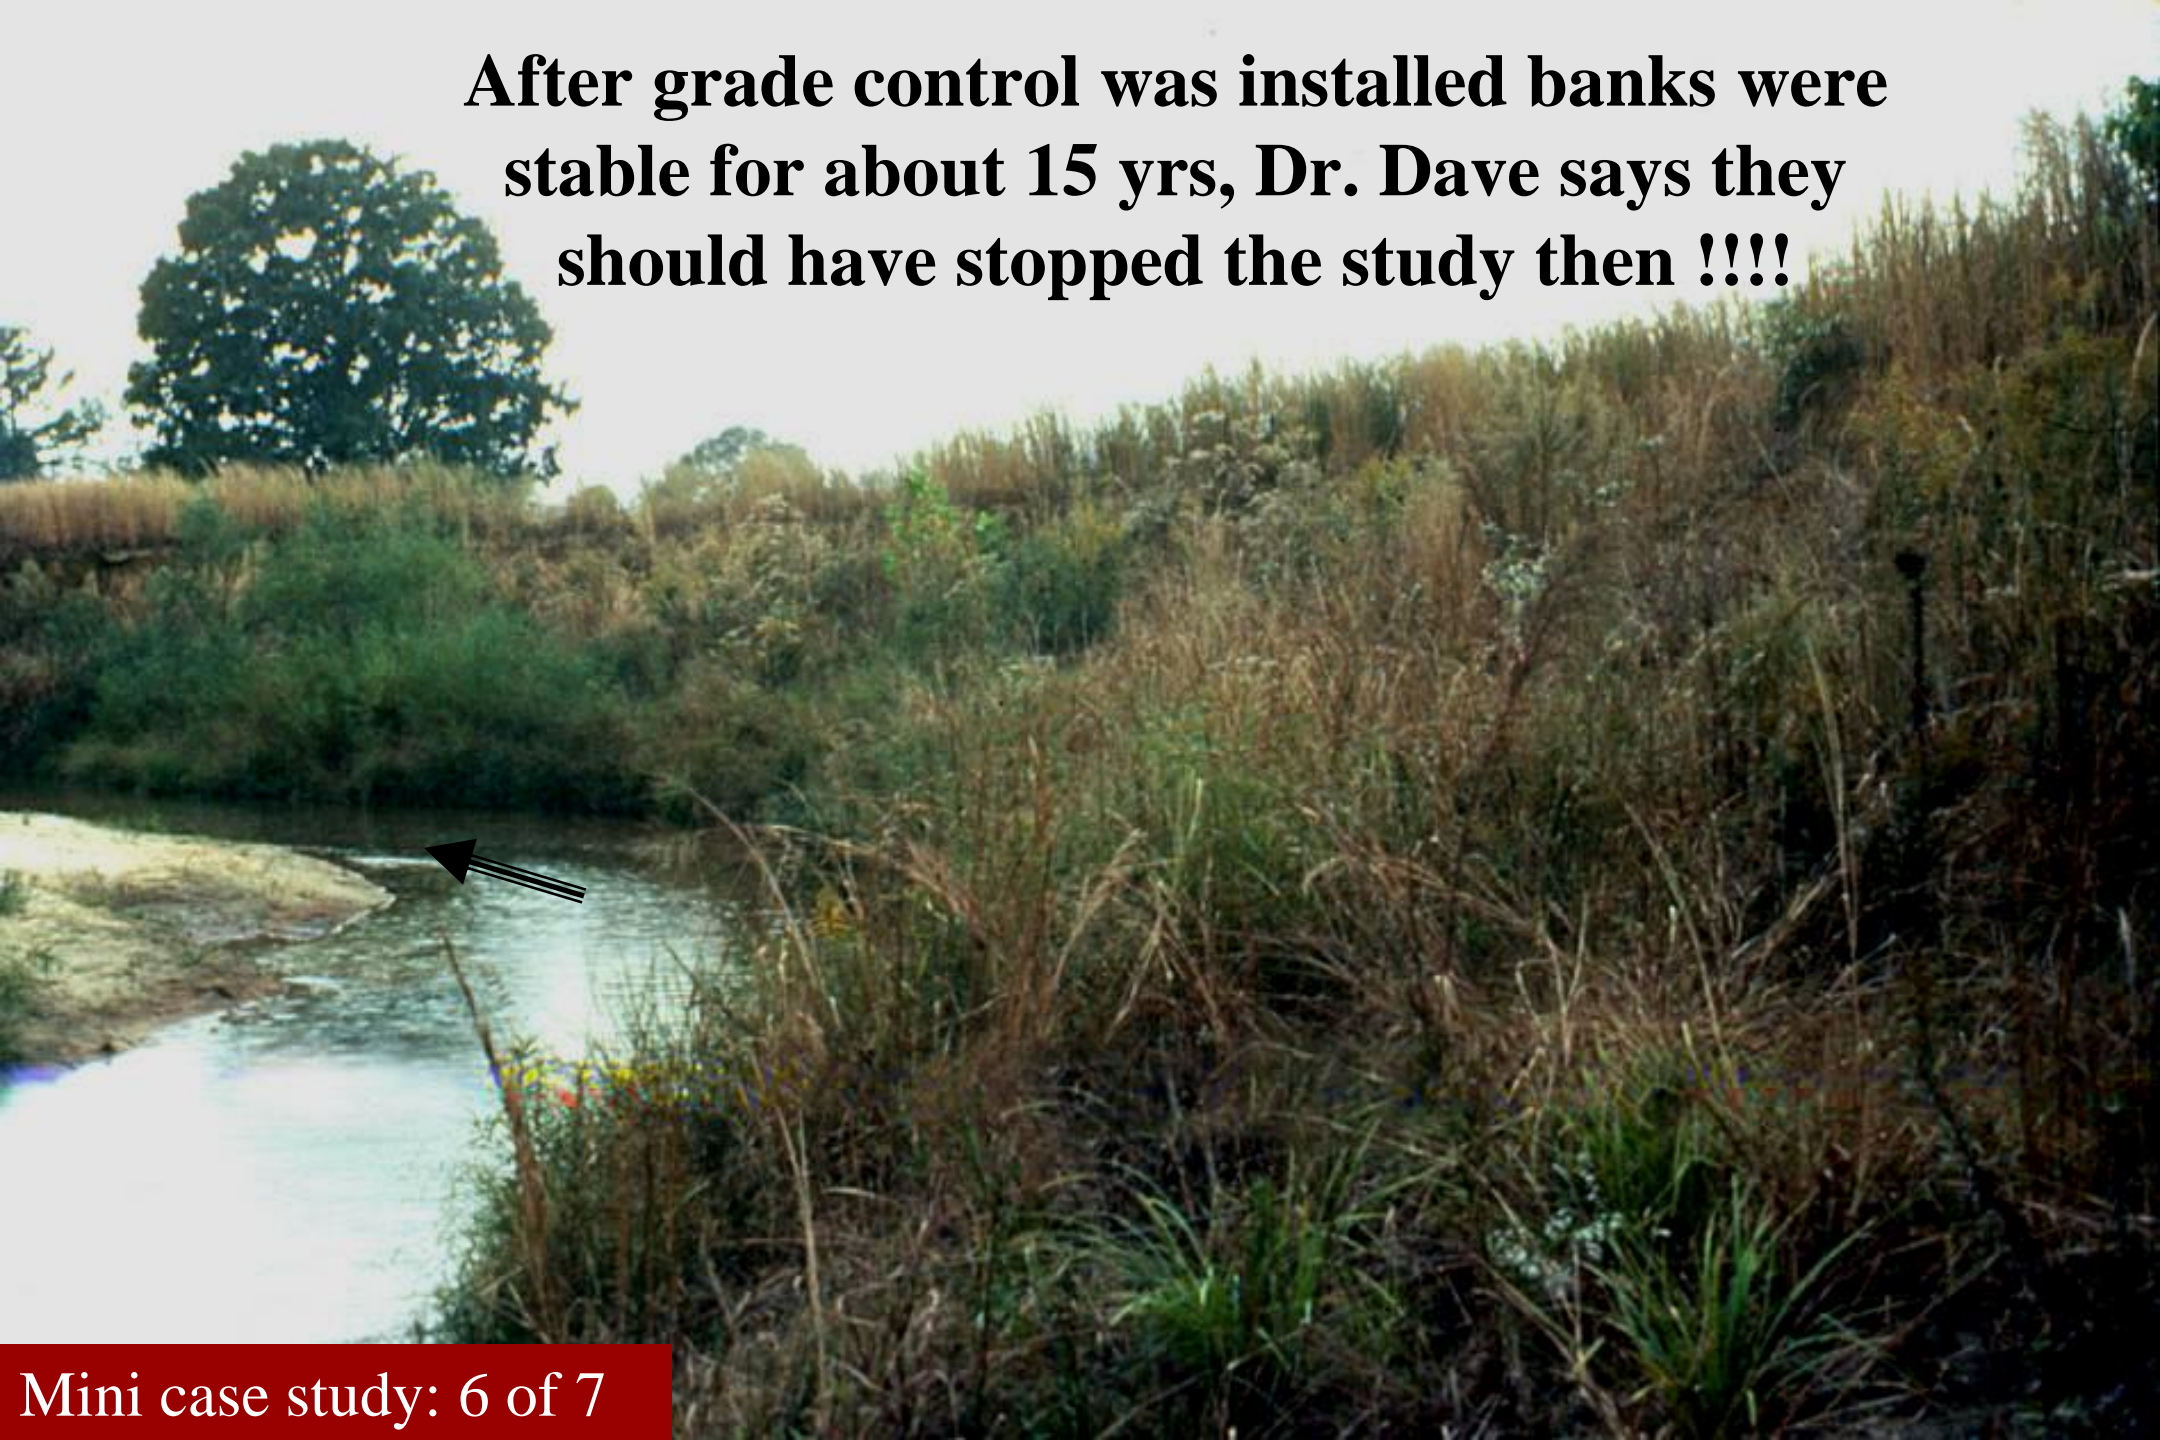
After grade control was installed banks were stable for about 15 yrs, Dr. Dave says they should have stopped the study then !!!!

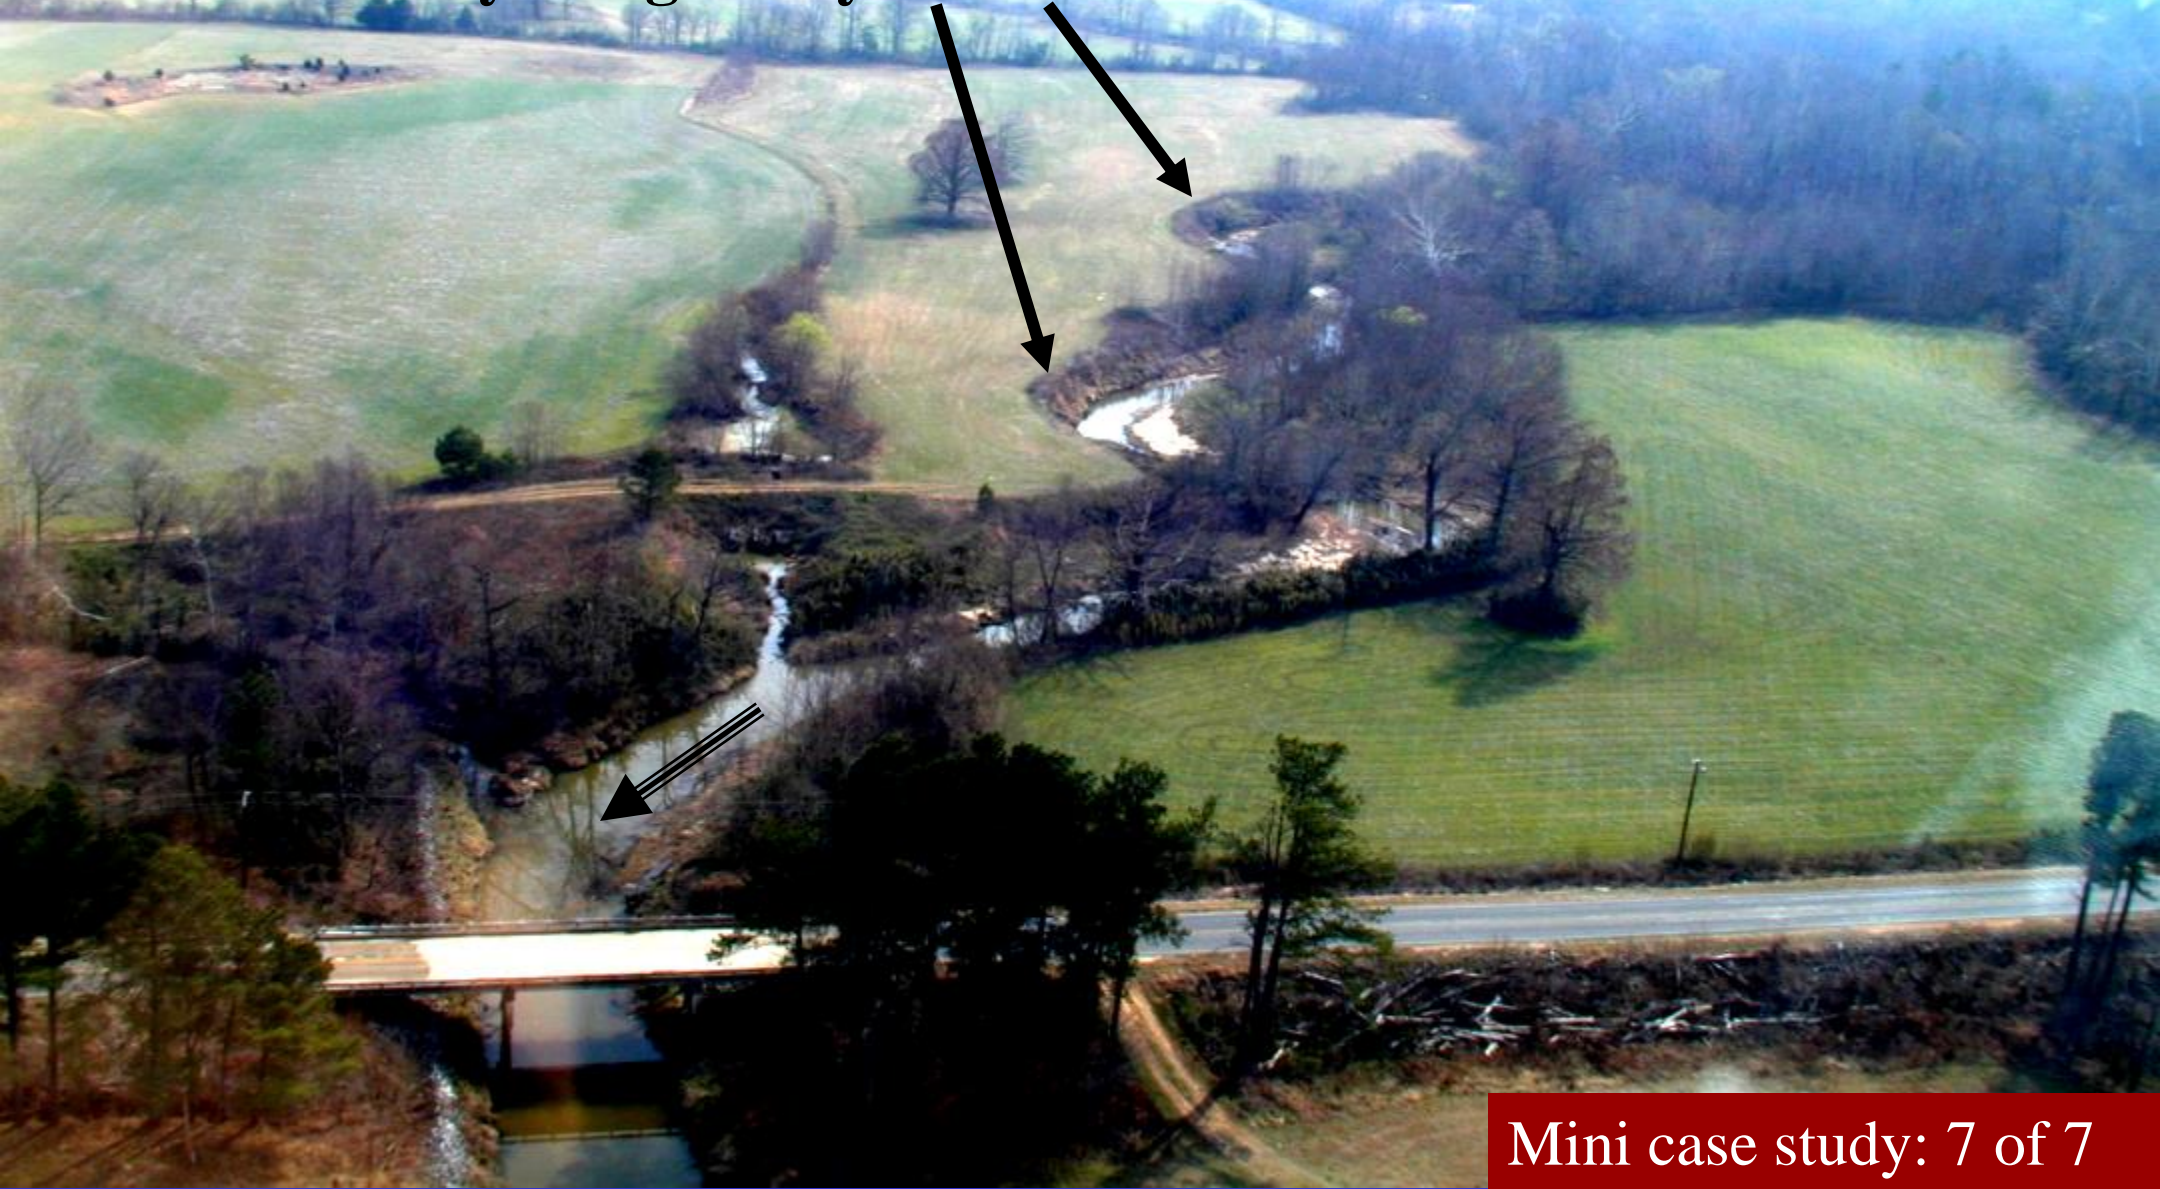
**Of course they did not, & after that period significant erosion occurred.
Why?? No one really knows, it appears to have crossed a threshold.
But they did get 15 years of bank stabilization for free!!**

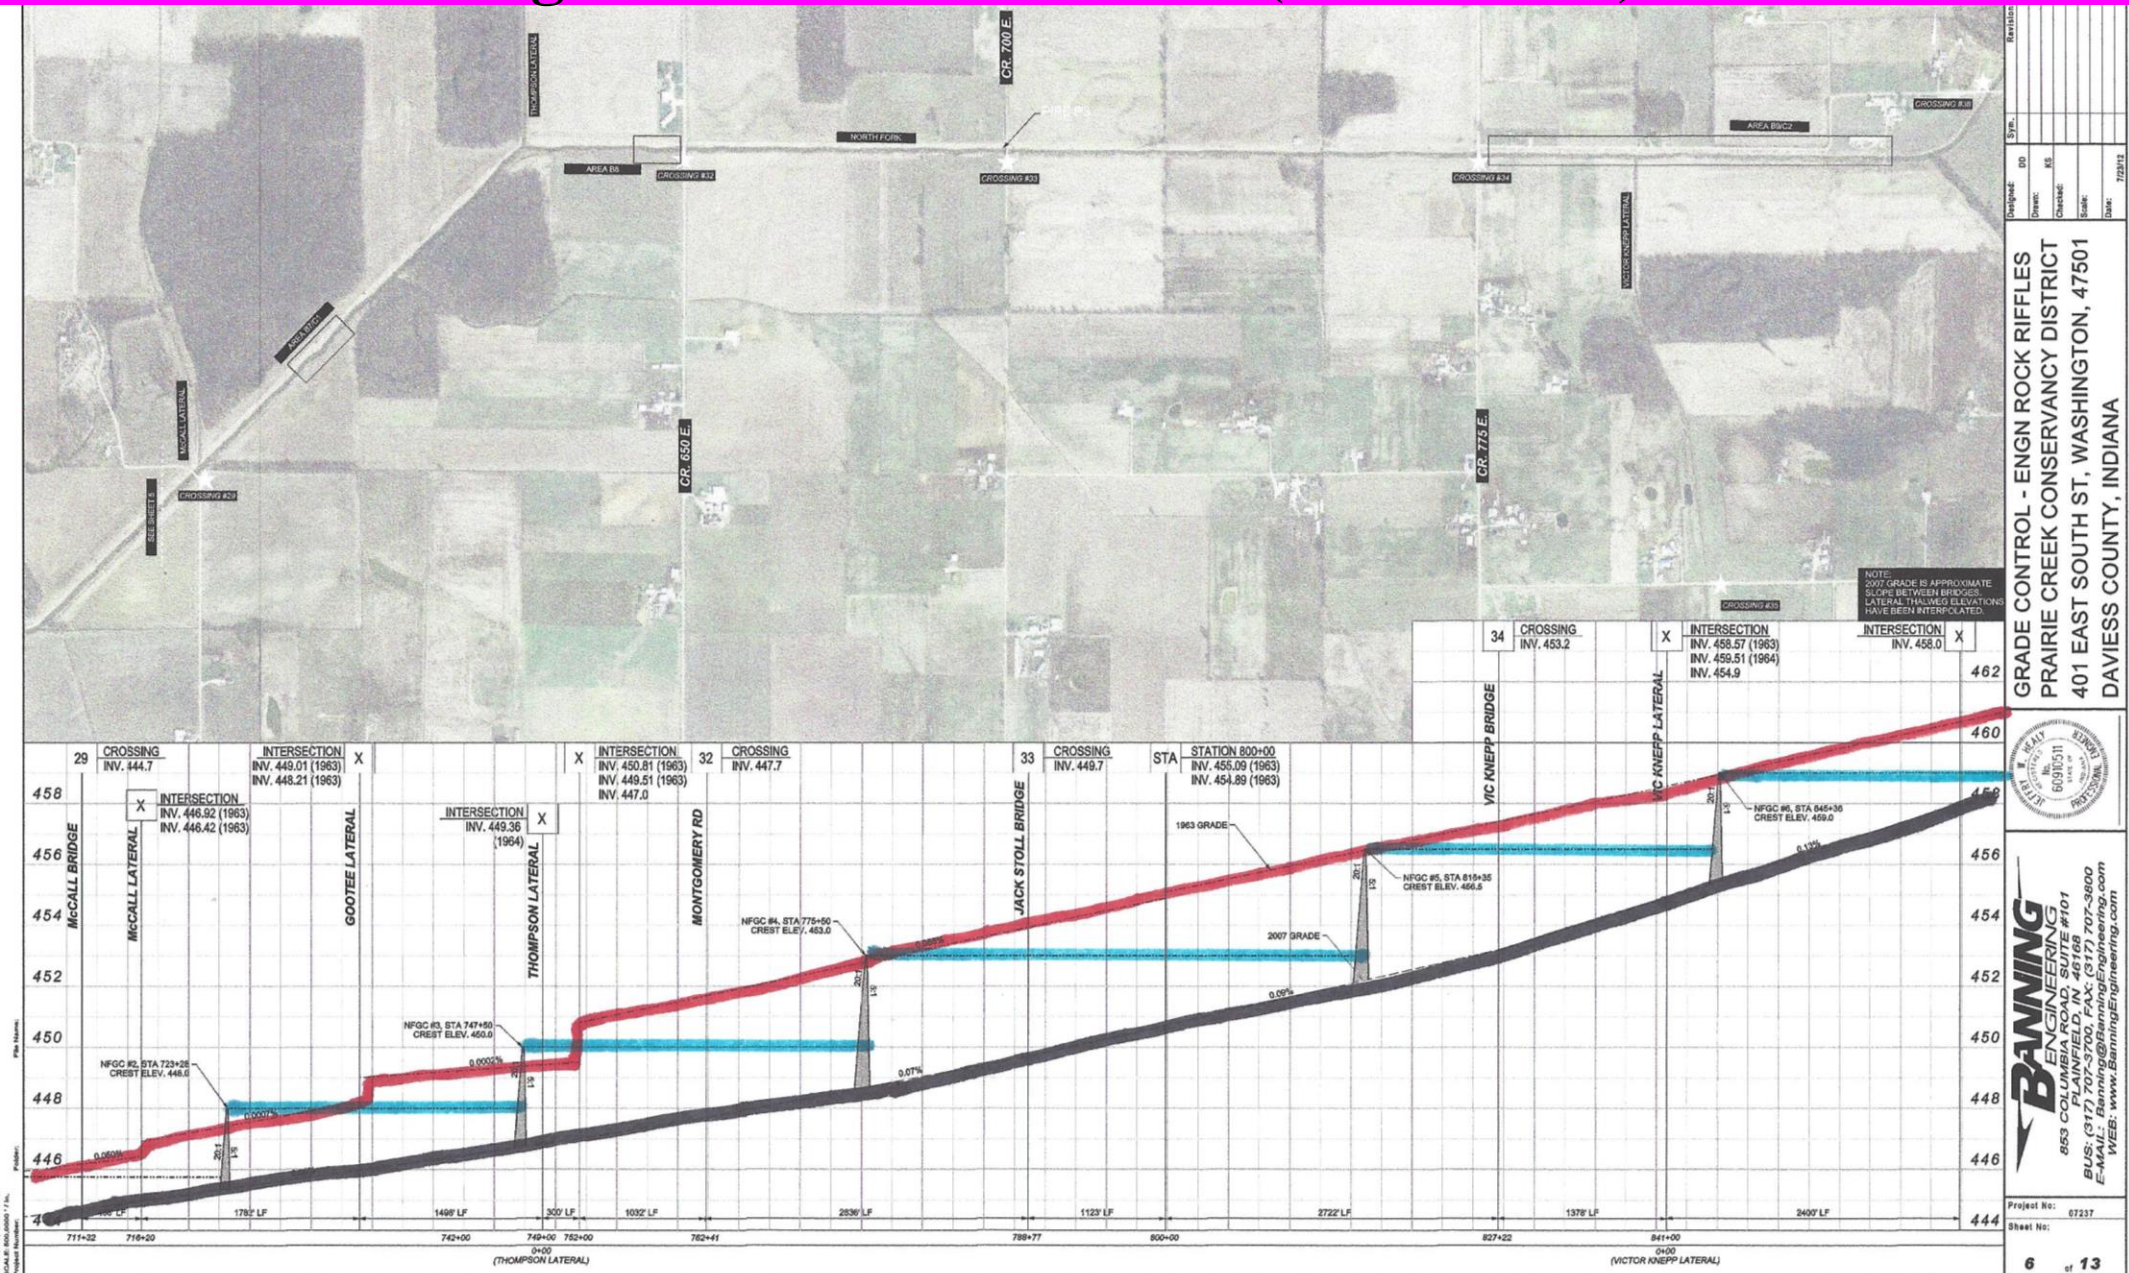
**COMPARING THE BED
PROFILES FROM 1963 &
2007 SHOW THAT THE BED
OF PRAIRIE CREEK HAS
DROPPED ANYWHERE
FROM 2 TO 9 FT,
DEPENDING ON LOCATION.**

PART OF THE PRAIRIE CREEK GRADE CONTROL PLAN

**(27 grade control
structures over 40 miles of
straightened stream)**

Red line is bed in 1963, black line is bed in 2007. Blue line is water surface after grade control structures (small dams) are installed

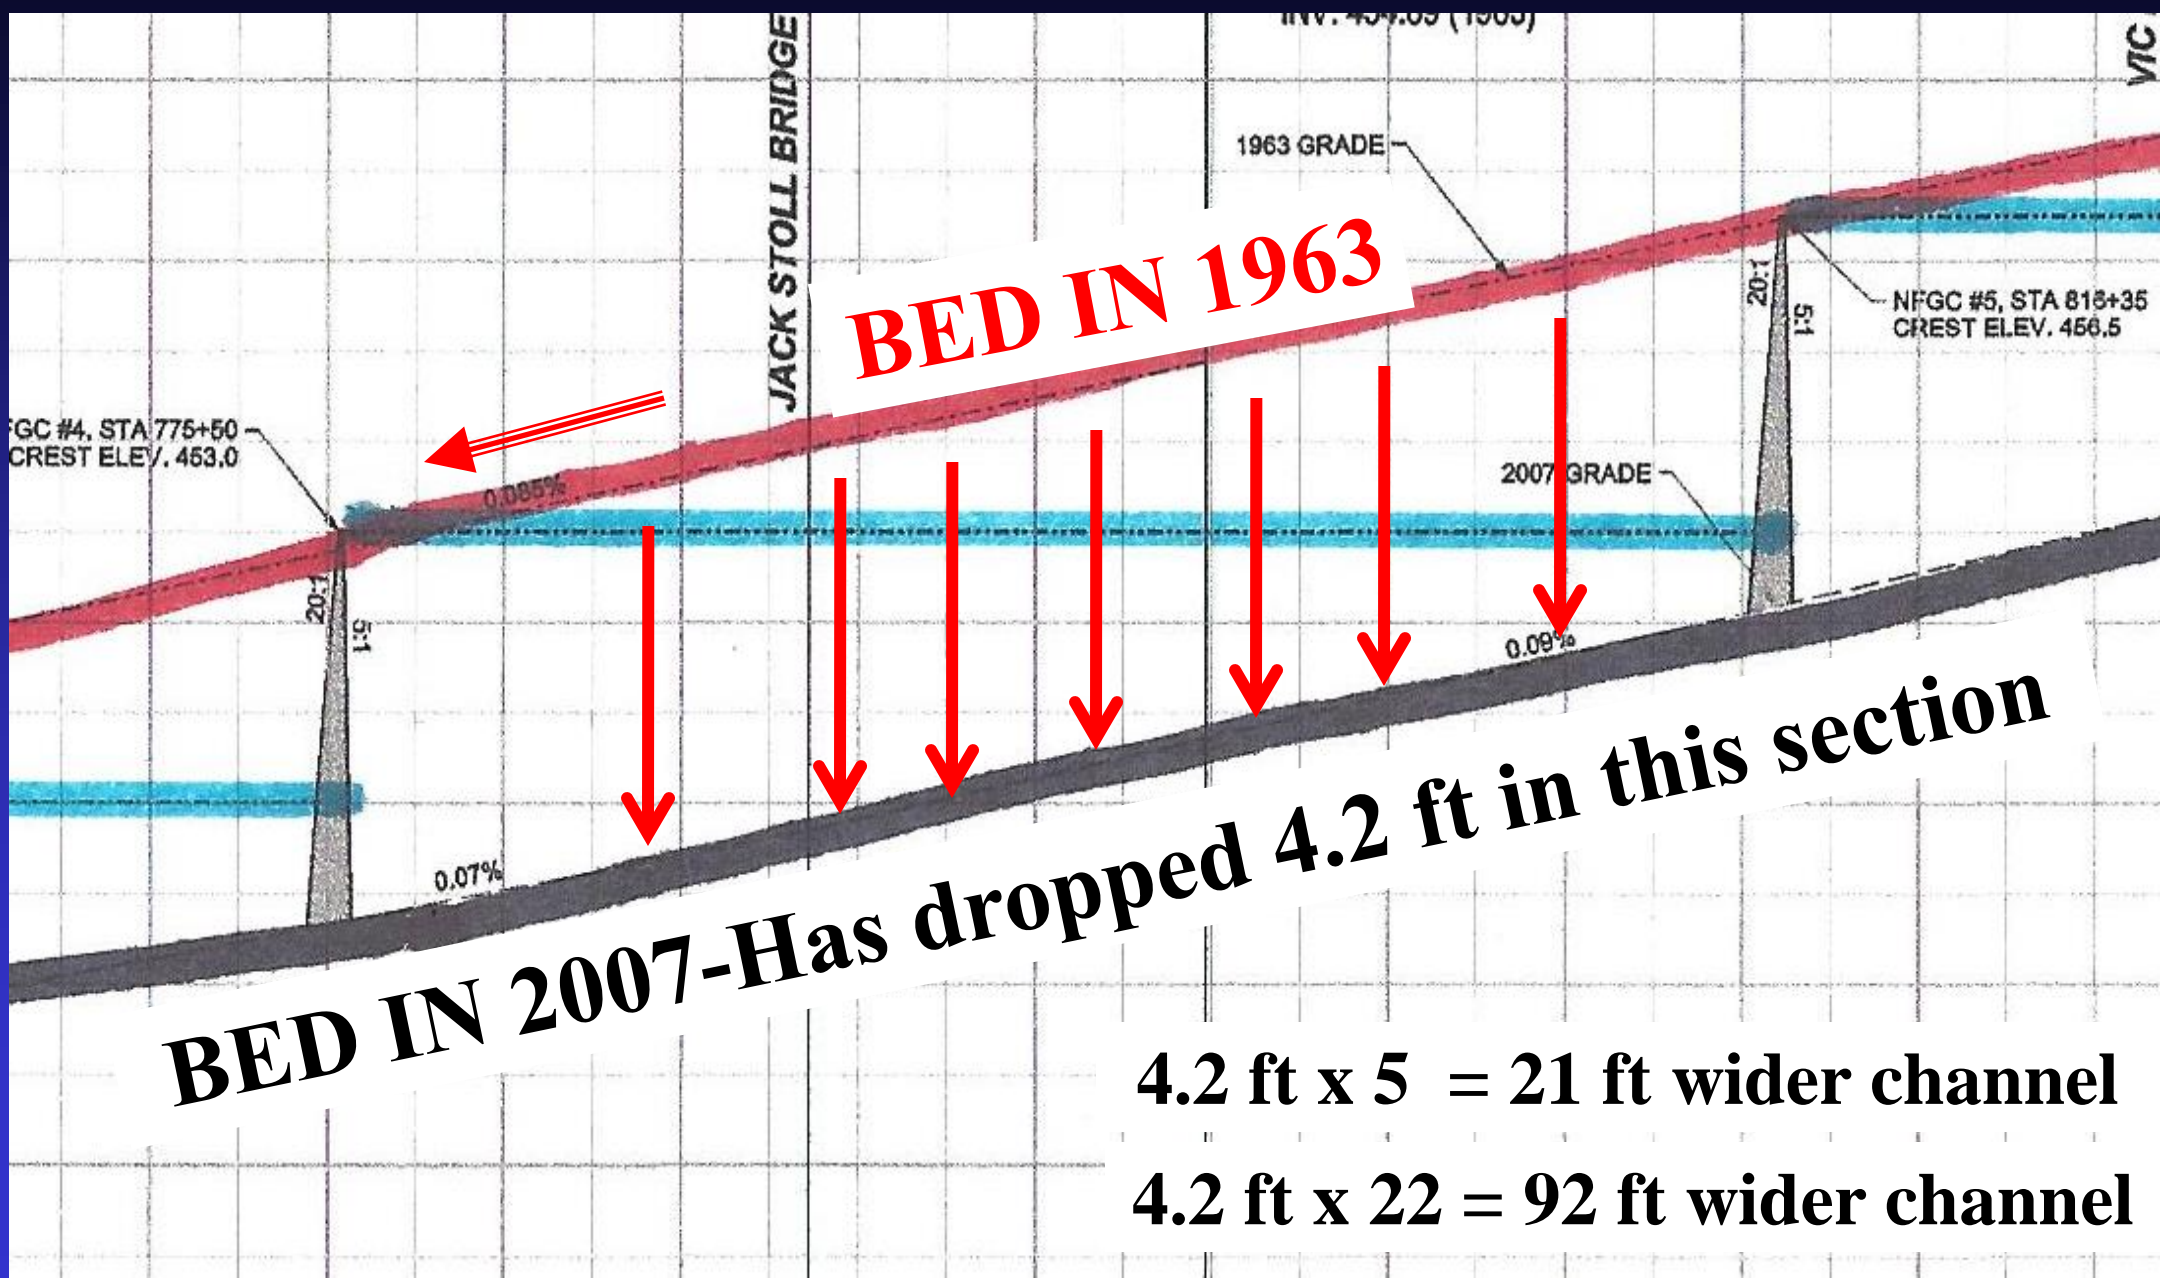
**ANALYSIS OF RATIOS OF
BED DEGRADATION VS.
INCREASE IN CHANNEL
WIDTH ON DIFFERENT
STREAMS NATIONWIDE
SHOWS THE RATIO TO
VARY FROM 1 to 5, to 1 to 22
(1 ft drop=22 ft wider channel)!!!!**

Red line is bed in 1963, black line is bed in 2007. Blue line is water surface after Rocked Riffle grade control structures are installed

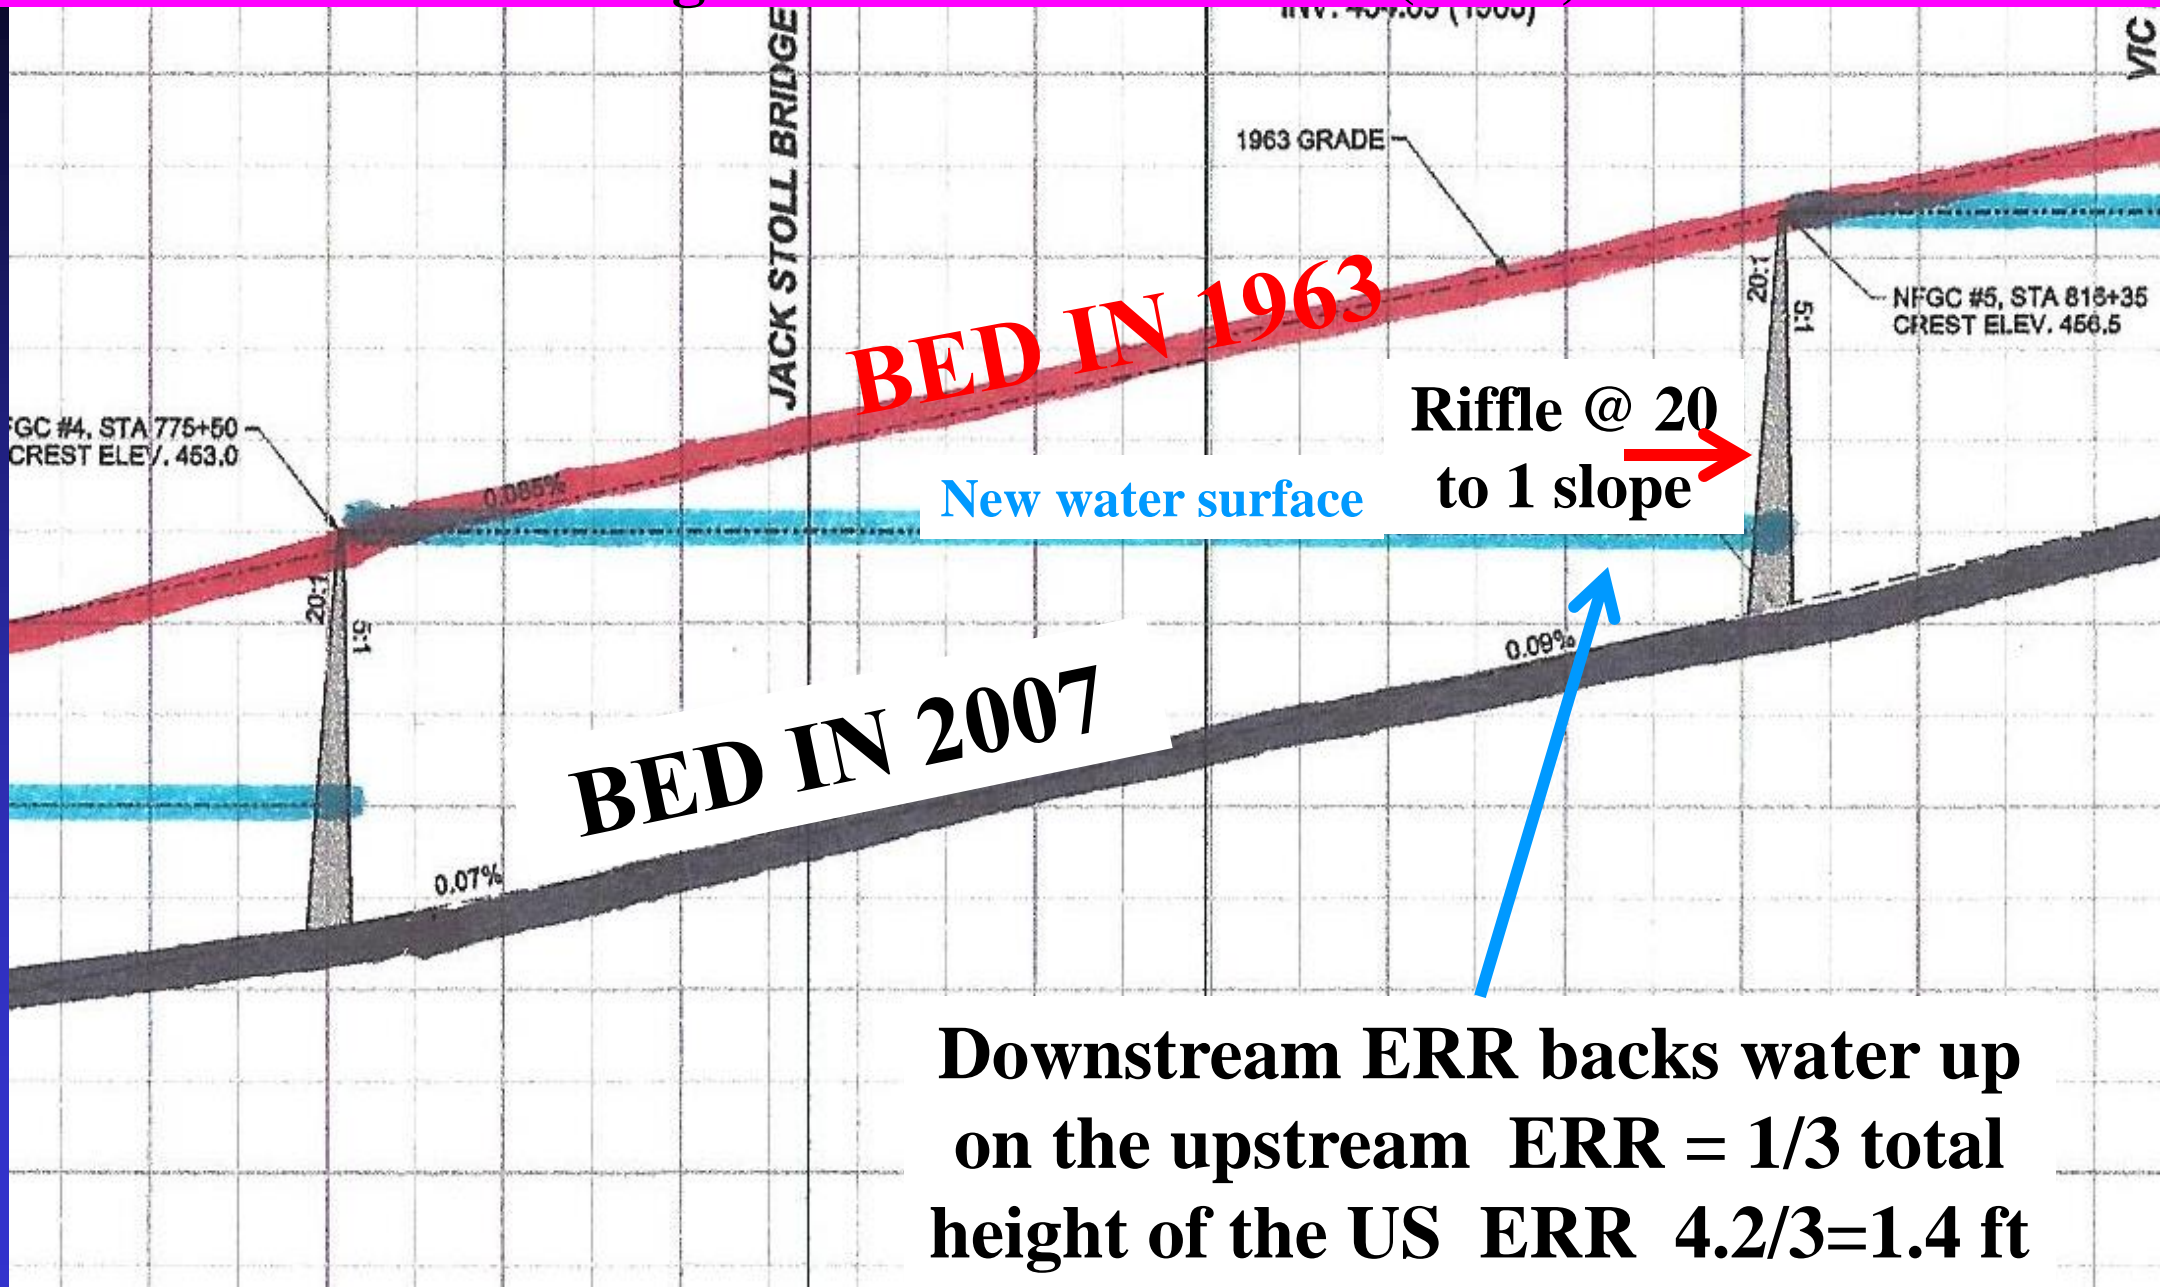
$4.2 \text{ ft} \times 5 = 21 \text{ ft}$ wider channel

$4.2 \text{ ft} \times 22 = 92 \text{ ft}$ wider channel

Red line is bed in 1963, black line is bed in 2007. Blue line is water surface after Engineered Rocked Riffles (ERR) are installed

Downstream ERR backs water up
on the upstream $ERR = \frac{1}{3}$ total
height of the US $ERR \frac{4.2}{3} = 1.4$ ft

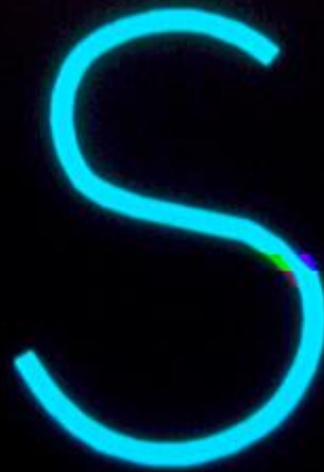
1. Most Rivers Operating in a Sedimentary Environment, Develop Sinuous Channels That Look Like This:

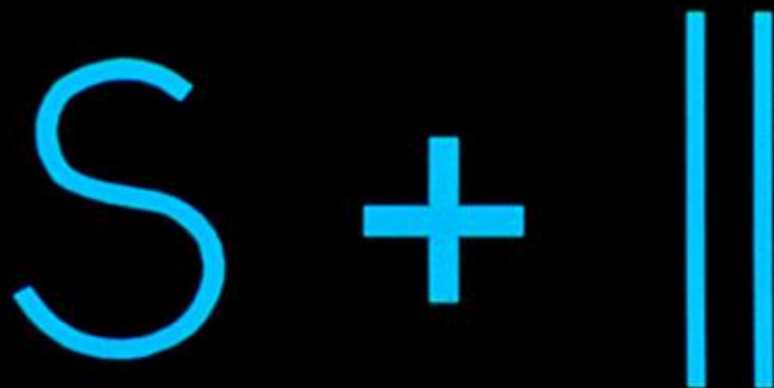
3. Straightening a Sinuous Channel Increases its Slope, Thus Giving it More Energy and the Result Has Often Been An Increase in Bank Caving and Other Problems That Require Intermittent or, in Some Cases Constant Maintenance. The Single Factor That Has Led to the Successful Operation of These Straightened Channels, Has Been to Combine the Good Points of Both the Sinuous and the Straight Channels

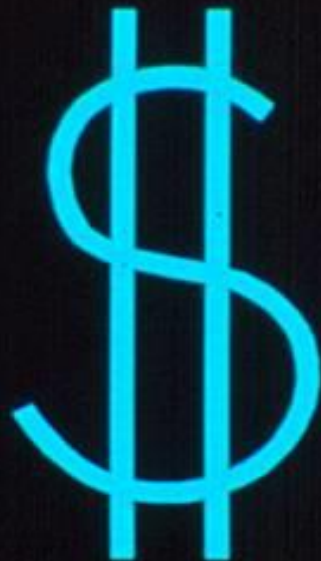
**4. This Combined Symbol Represents the
Only Successful Means of Maintaining Straight
Channels**
