**COMBINATIONS OF RESISTIVE
& REDIRECTIVE METHODS:
CASE STUDY- Duck Creek East of
Eastern Avenue, Davenport, Iowa
Constructed June-July. 2008**

**Longitudinal Peaked Stone Toe
Protection {LFSTP} with interspaced
Short Bendway Weirs & Locked Logs**

LONGITUDINAL PEAKED STONE TOE PROTECTION {LPSTP}

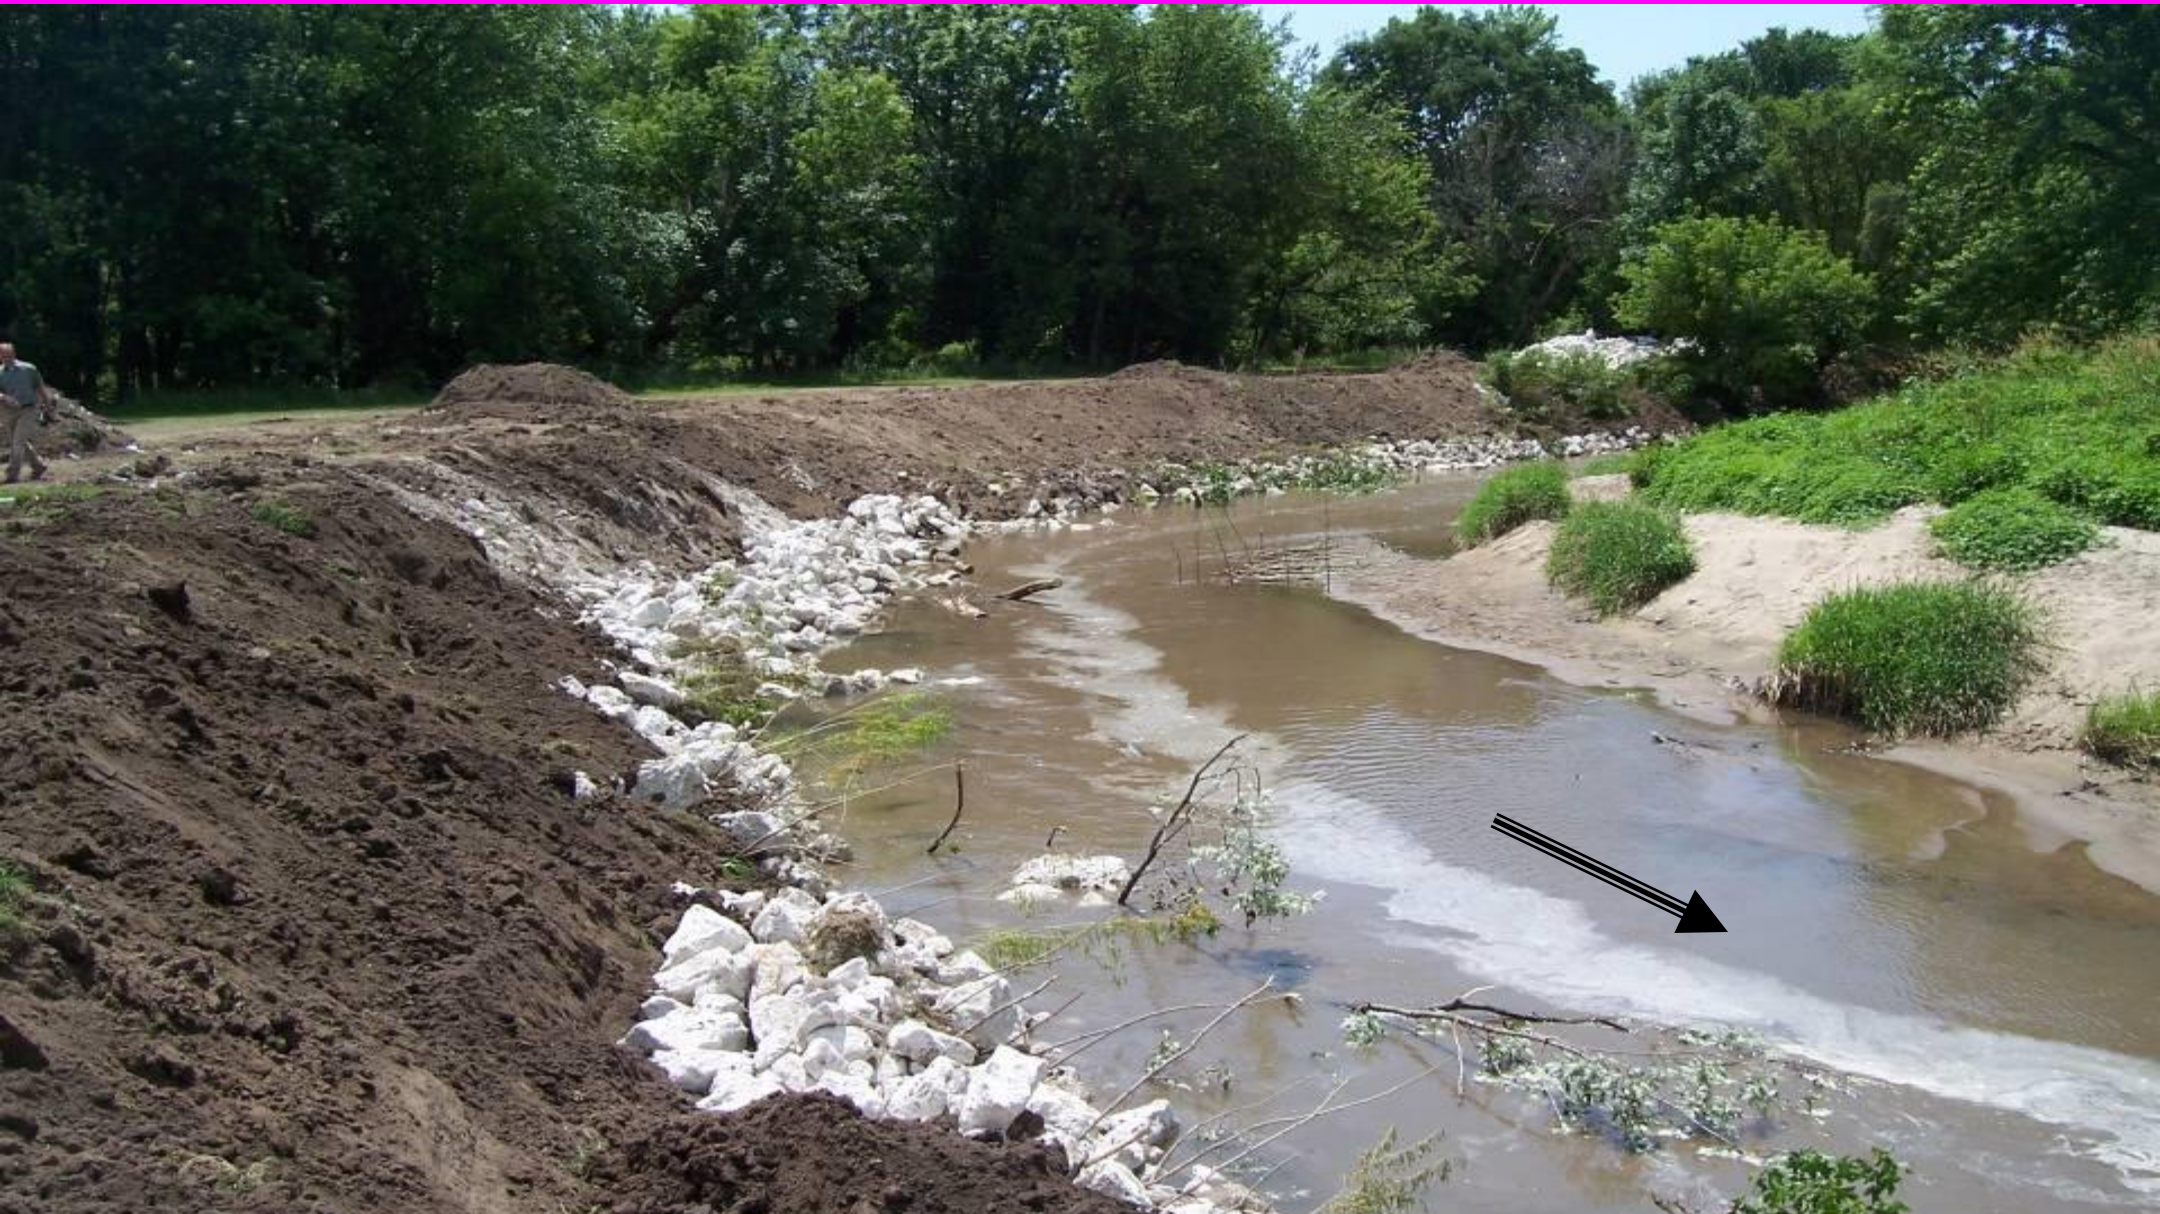
CONSTRUCTION-DUCK CR. E. OF EASTERN AVE. PIX BY DERRICK 7-1-2008

**FROM DOWNSTREAM
LOOKING UPSTREAM
AT THE THALWEG
ALIGNMENT**

From DS looking US @ thalweg trace.

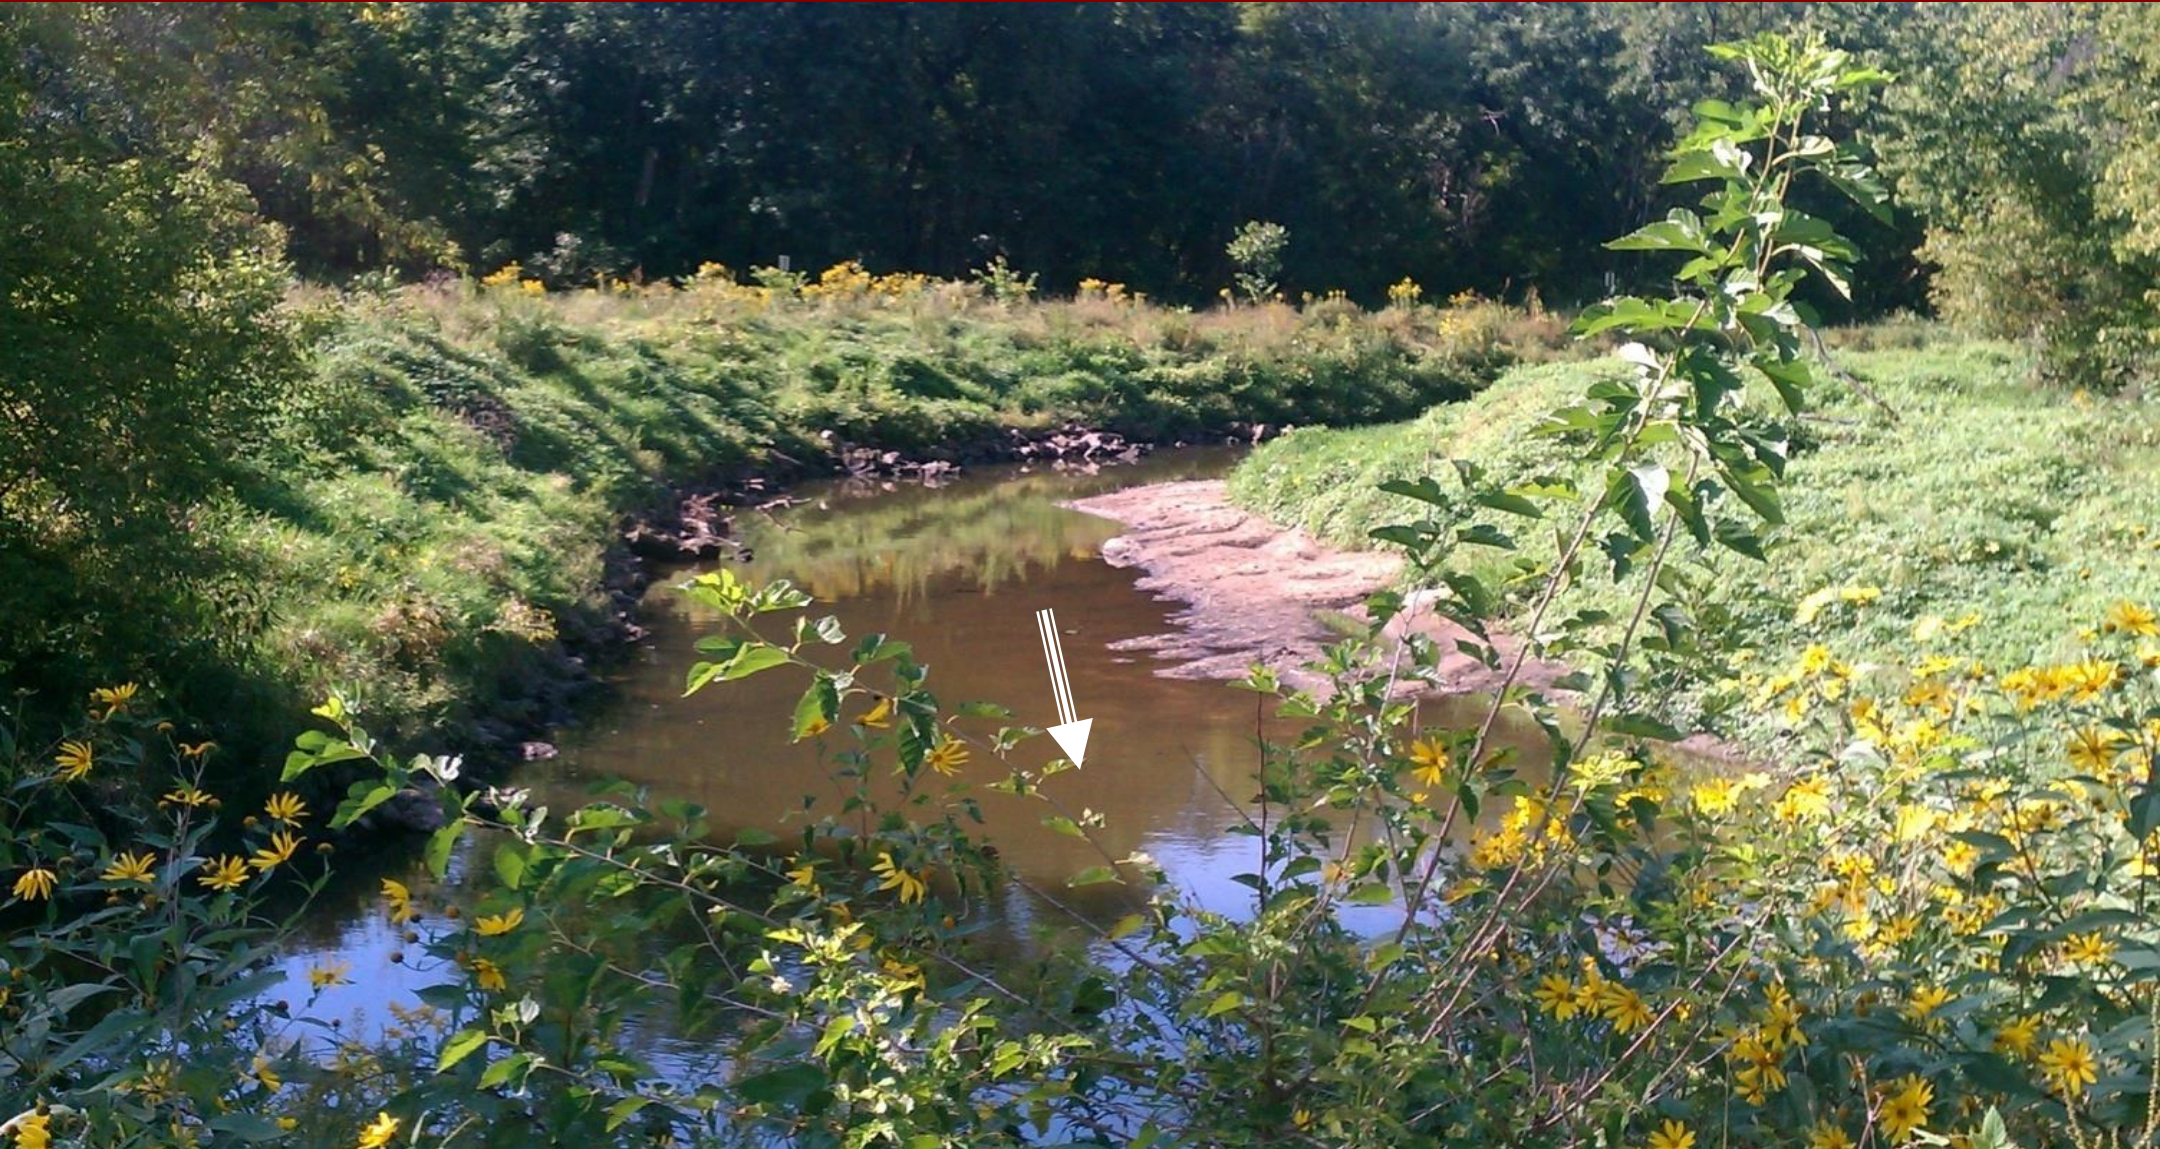
3 YEARS LATER-DUCK CR-BRIAN STINEMAN 9-2011

3 YEARS LATER-From DS bend looking US. All stable & fully functional. Great diversity & complexity of vegetation.

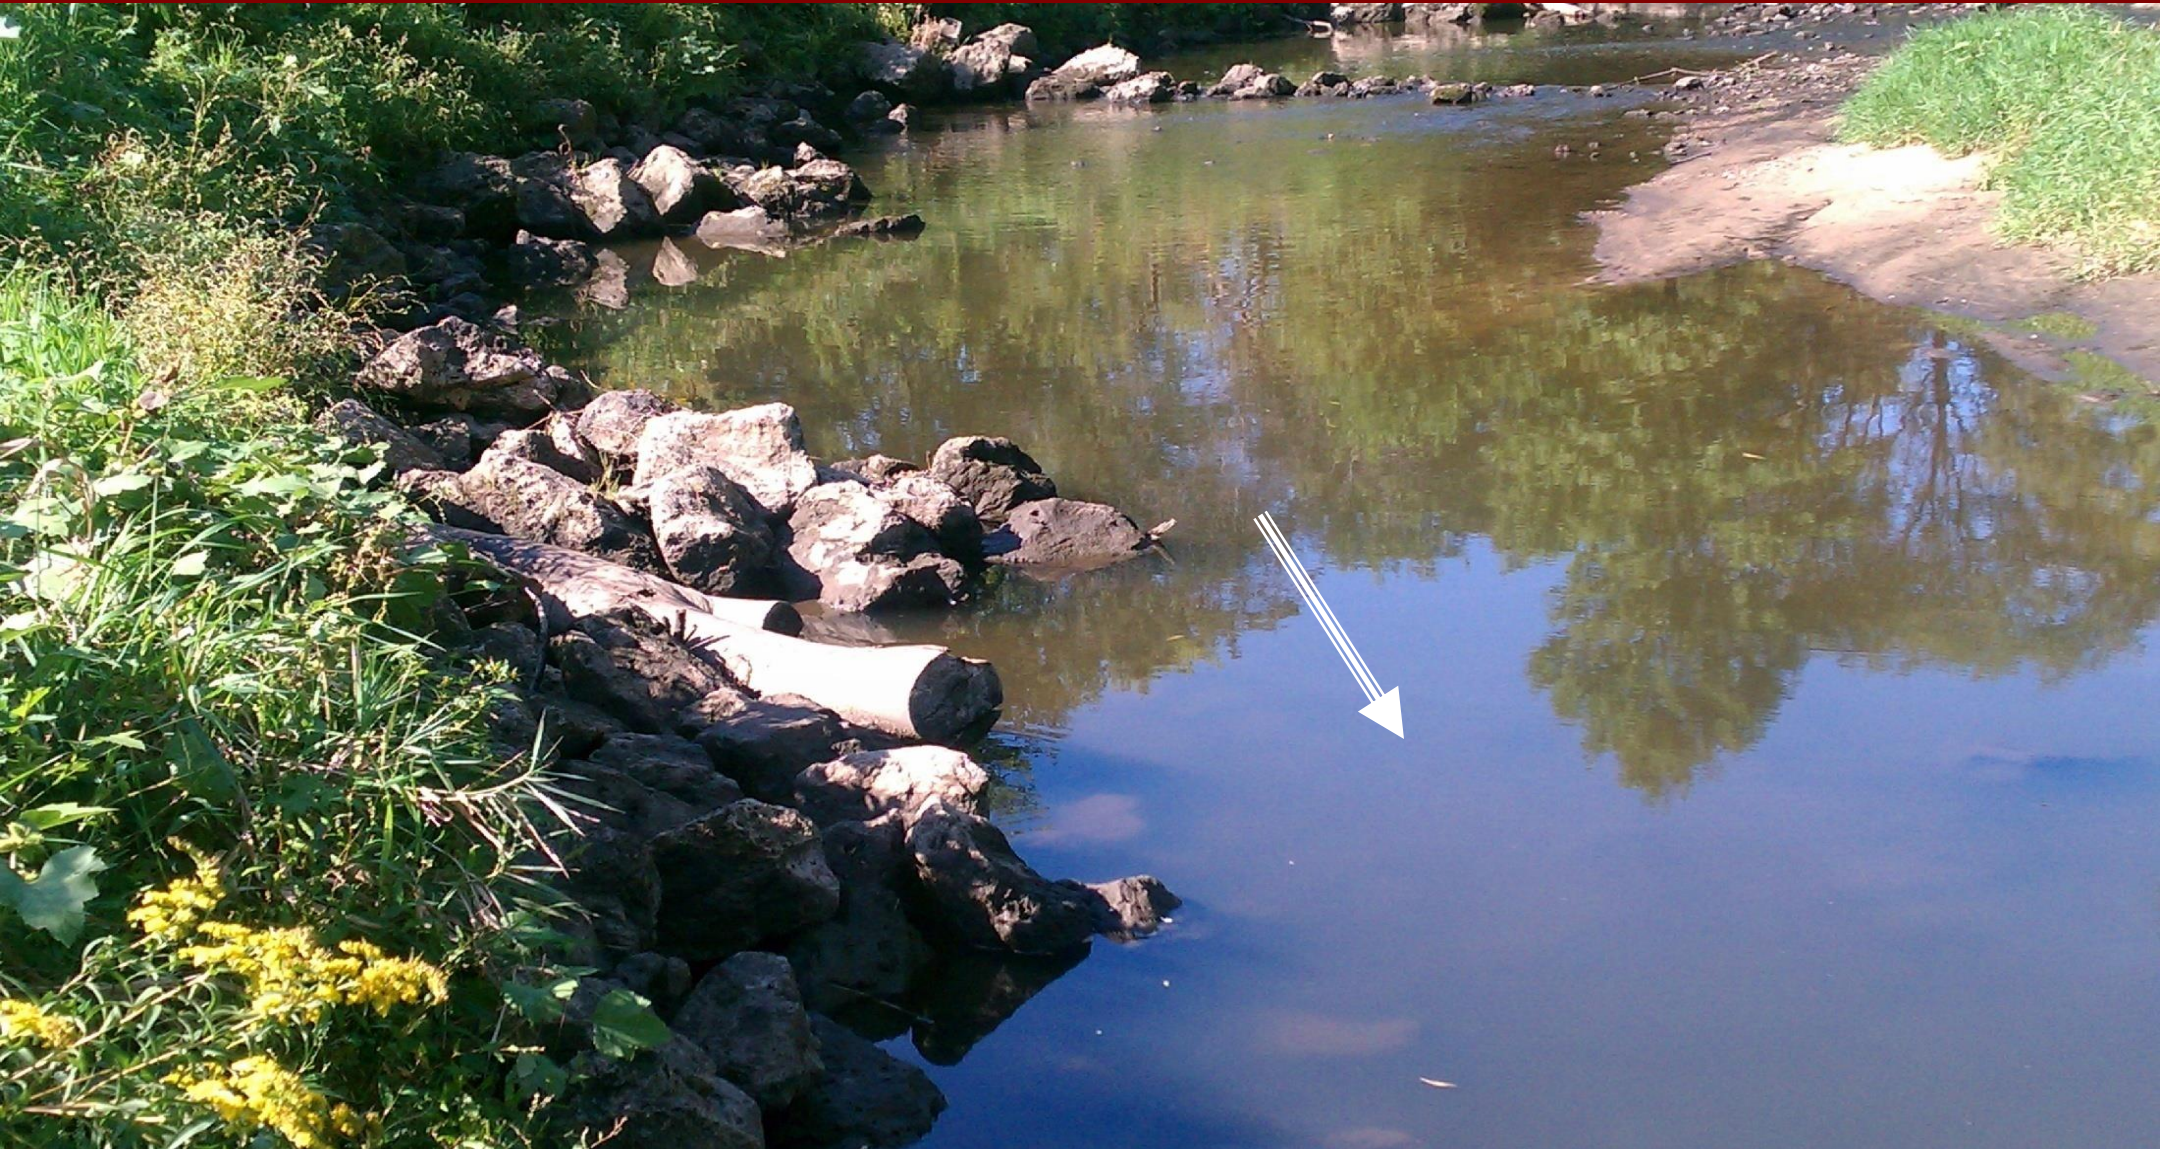
3 YEARS LATER-DUCK CR-BRIAN STINEMAN 9-2011

**3 YEARS LATER-Looking US in the bite of the bend @ Bendway Weirs
& Locked Logs providing hyd. roughness & habitat**

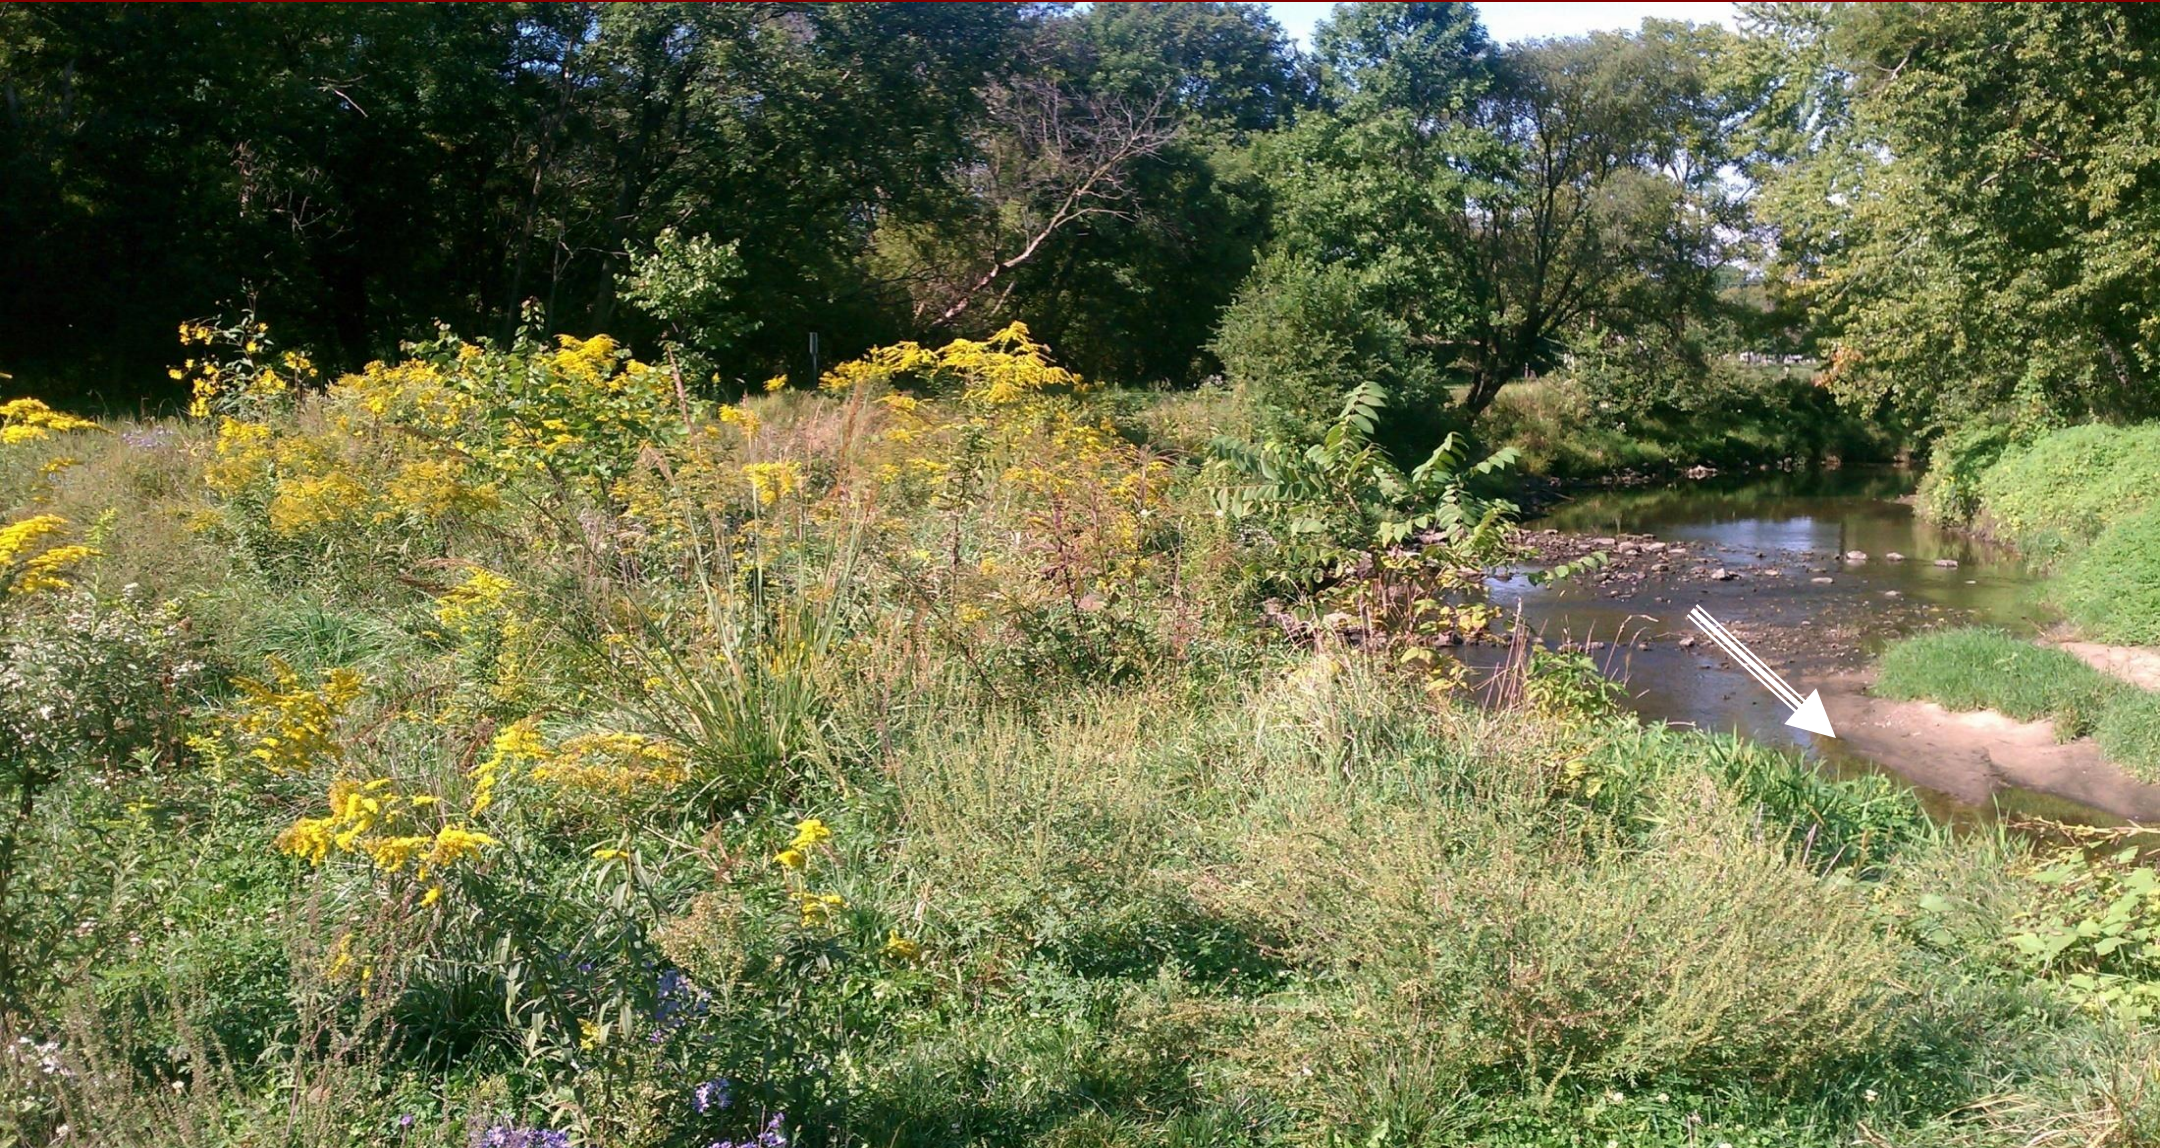
3 YEARS LATER-DUCK CR-BRIAN STINEMAN 9-2011

3 YEARS LATER-Looking US @ no-mow riparian corridor that connects two forested areas. Fully functional!!

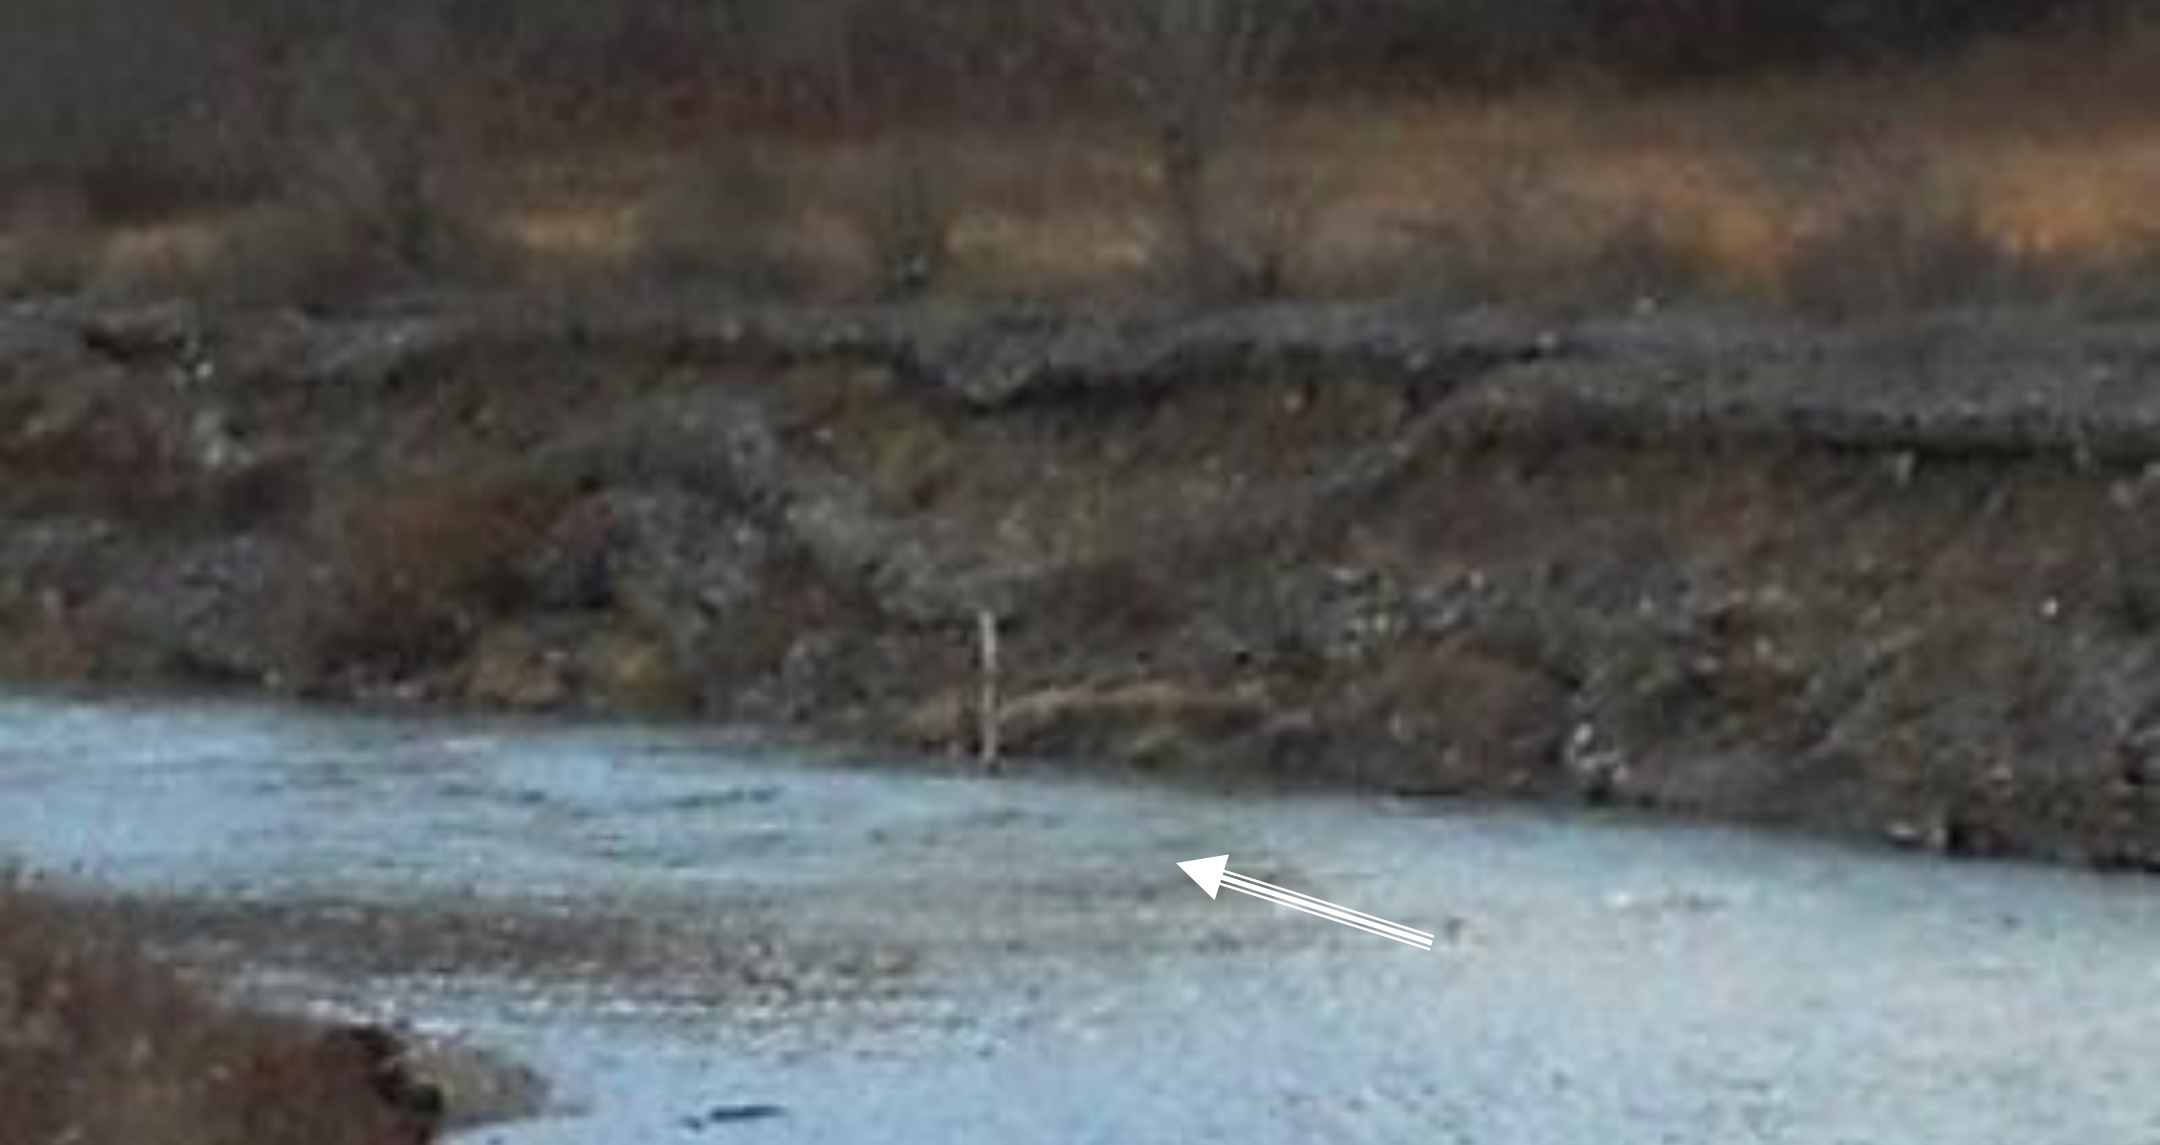
CATTAURAGUS CR @ HAUK ROAD DERRICK 12-8-2011

If the foundation is erodeable, the bank protection method might have to be toed down (excavated) to the level of maximum anticipated scour (at least below the thalweg elevation), then add a factor of safety.

Looking DS @ failed gabion baskets. A good meander on those baskets!! Foundation is important with this method!!!

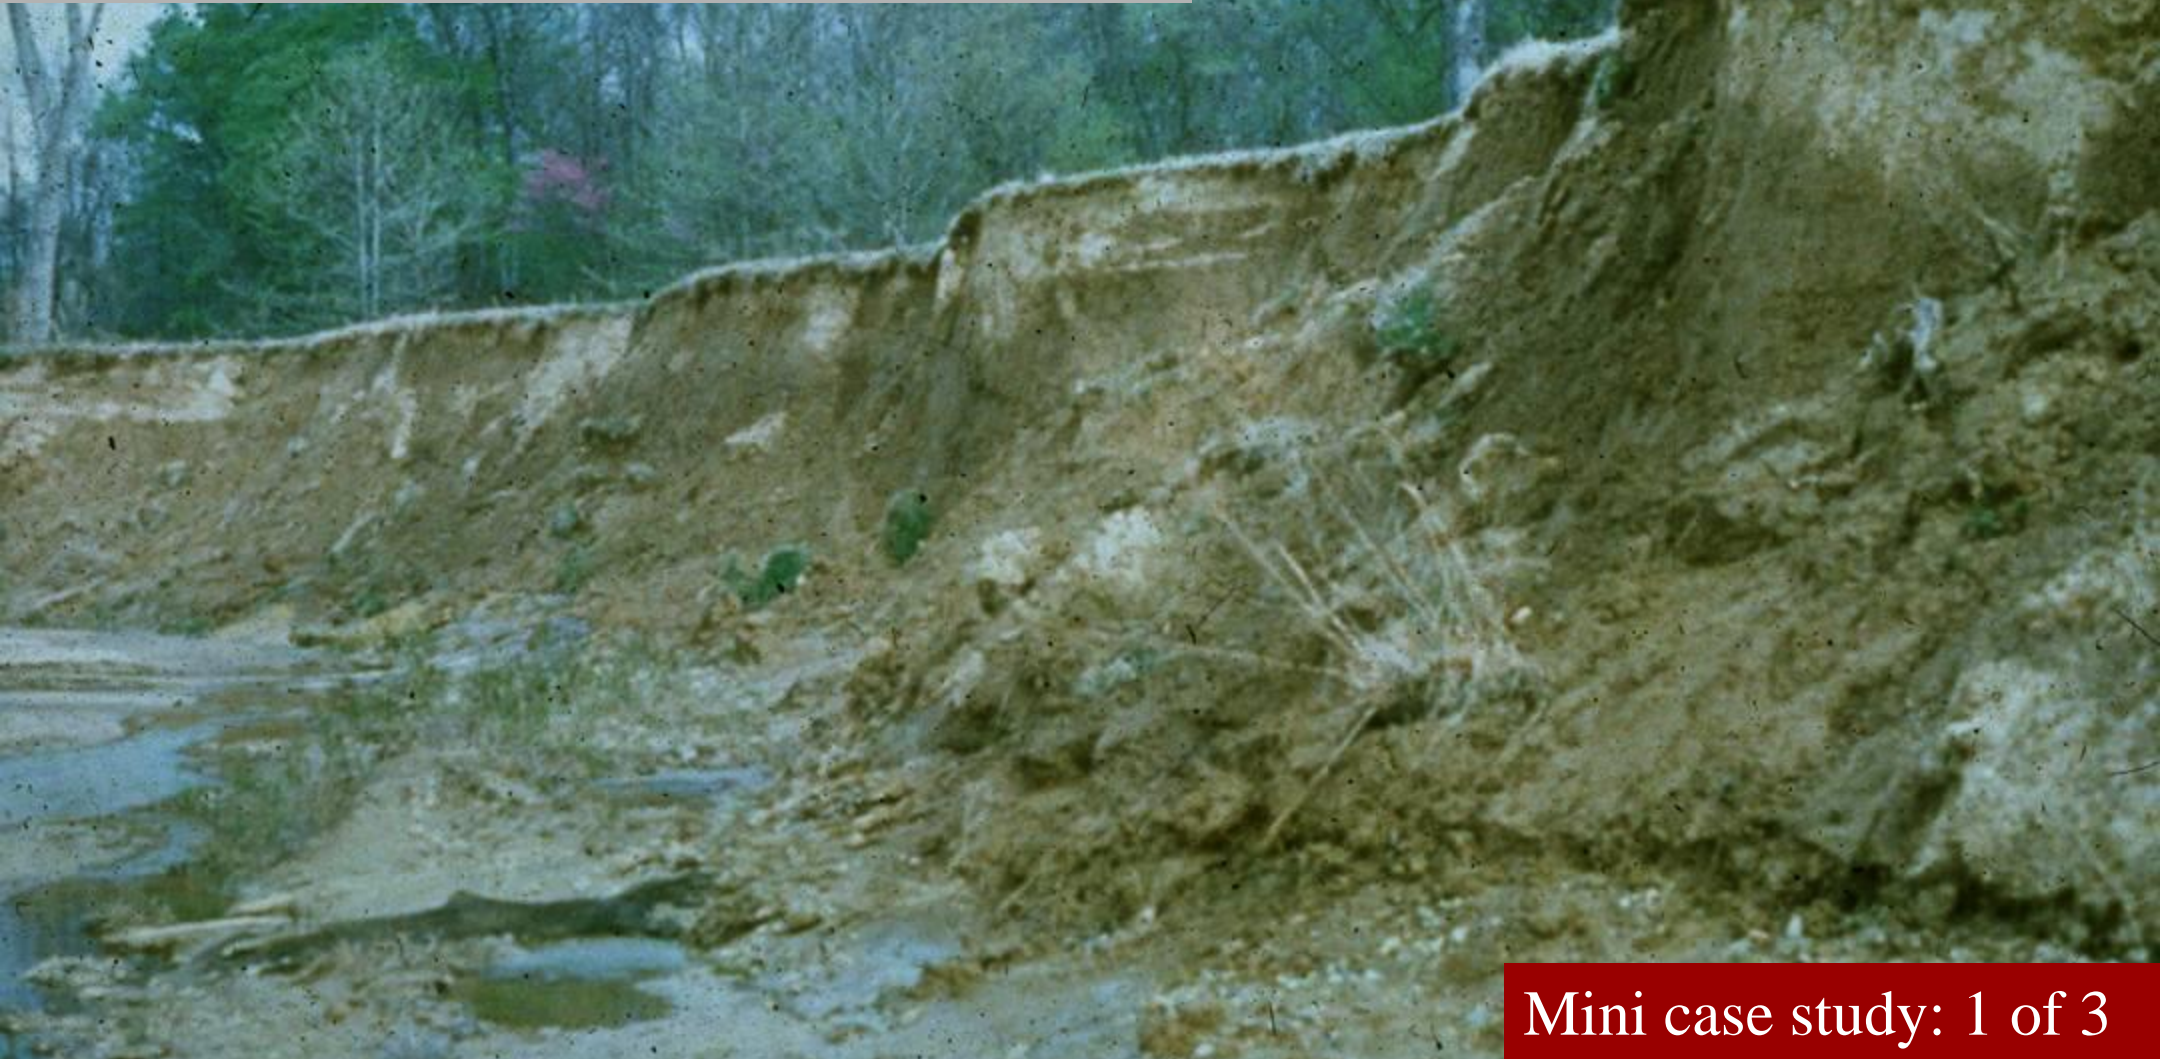
**Johnson Creek, MS. Pre-project
rapidly eroding near-vertical bank
{rural, sand bed, slope < 1%, pool-
riffle-pool, meandering, incised}**

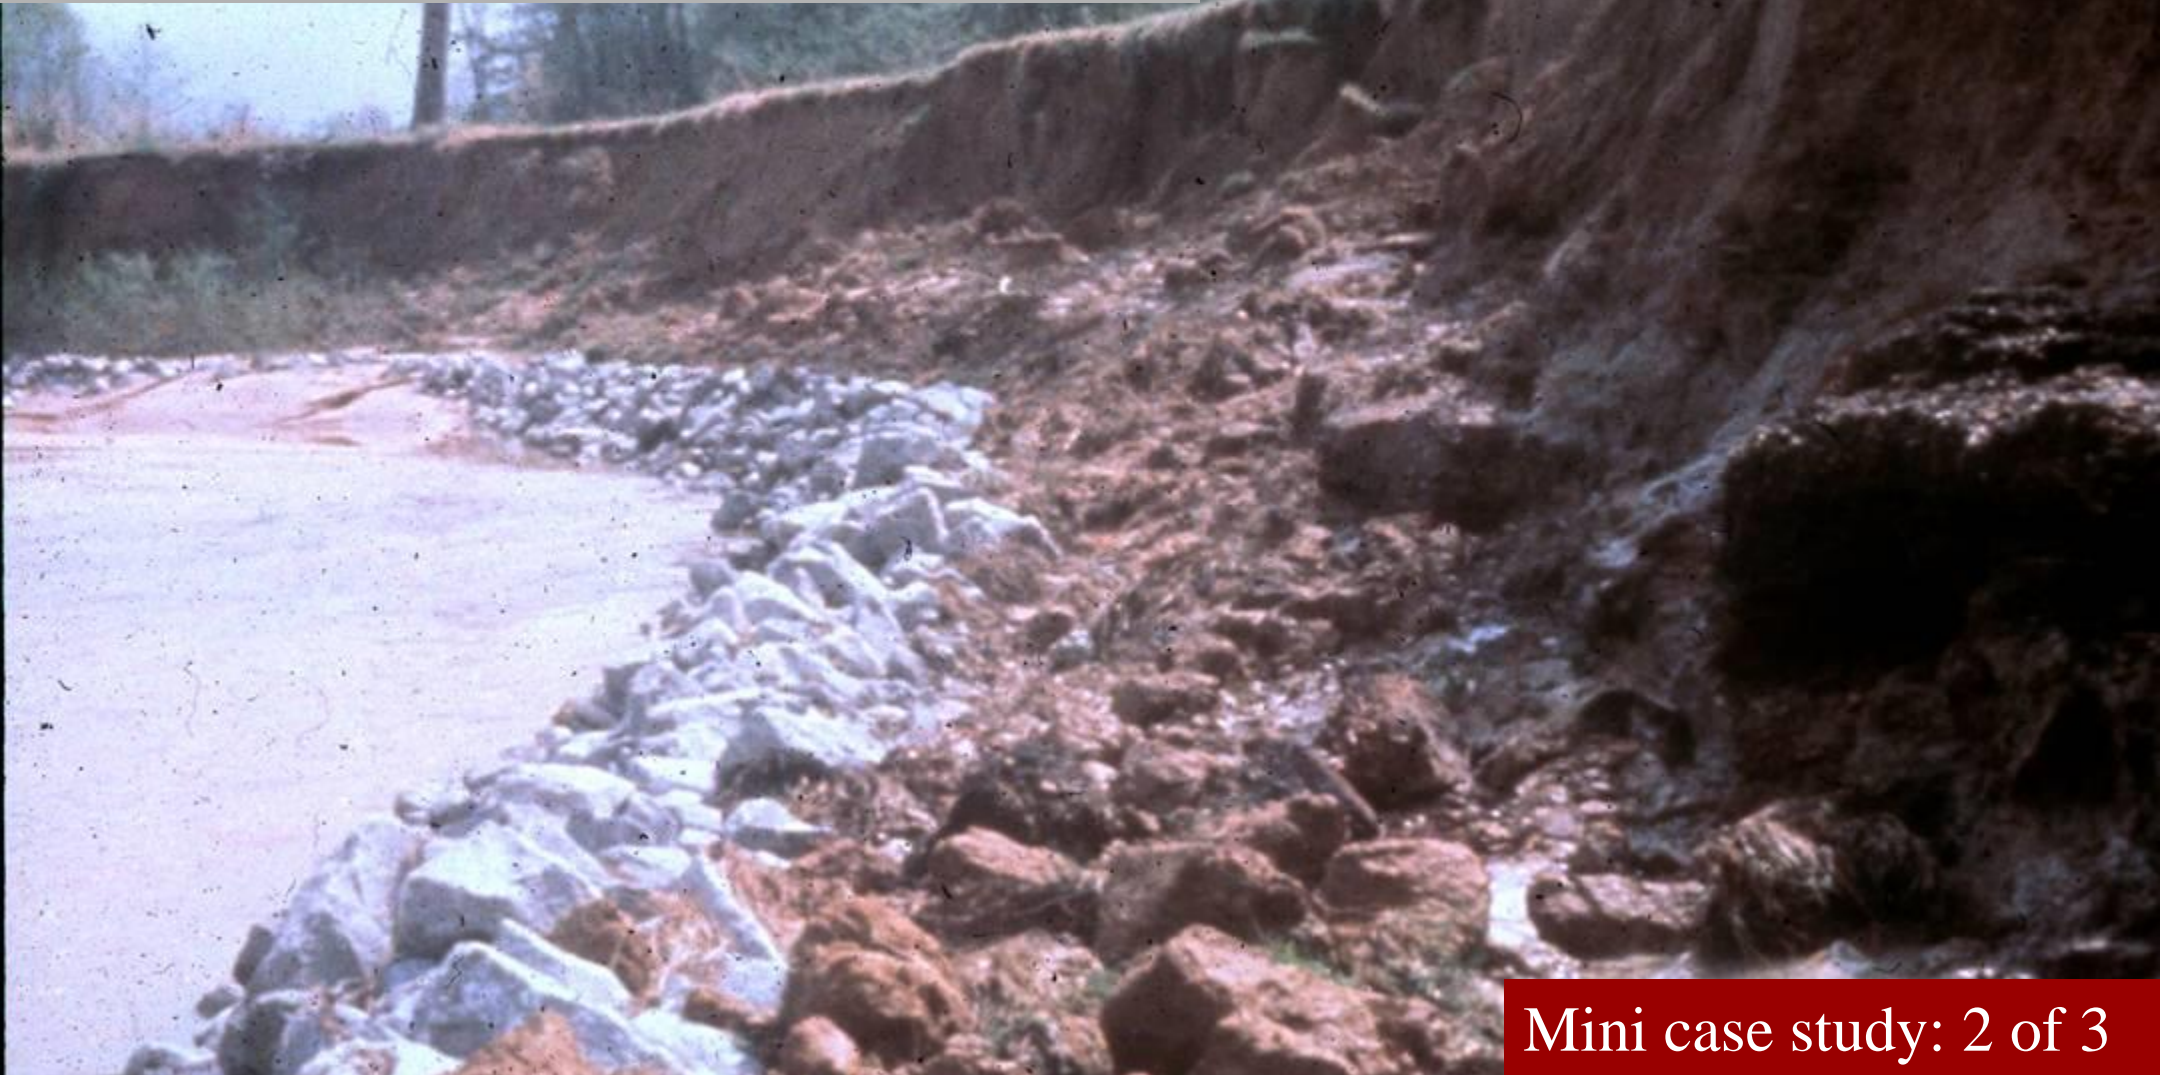
**Johnson Creek, MS. As-built
protection consists of Longitudinal
Peaked Stone Toe protection
(LPSTP) applied at 1 ton/ lineal foot**

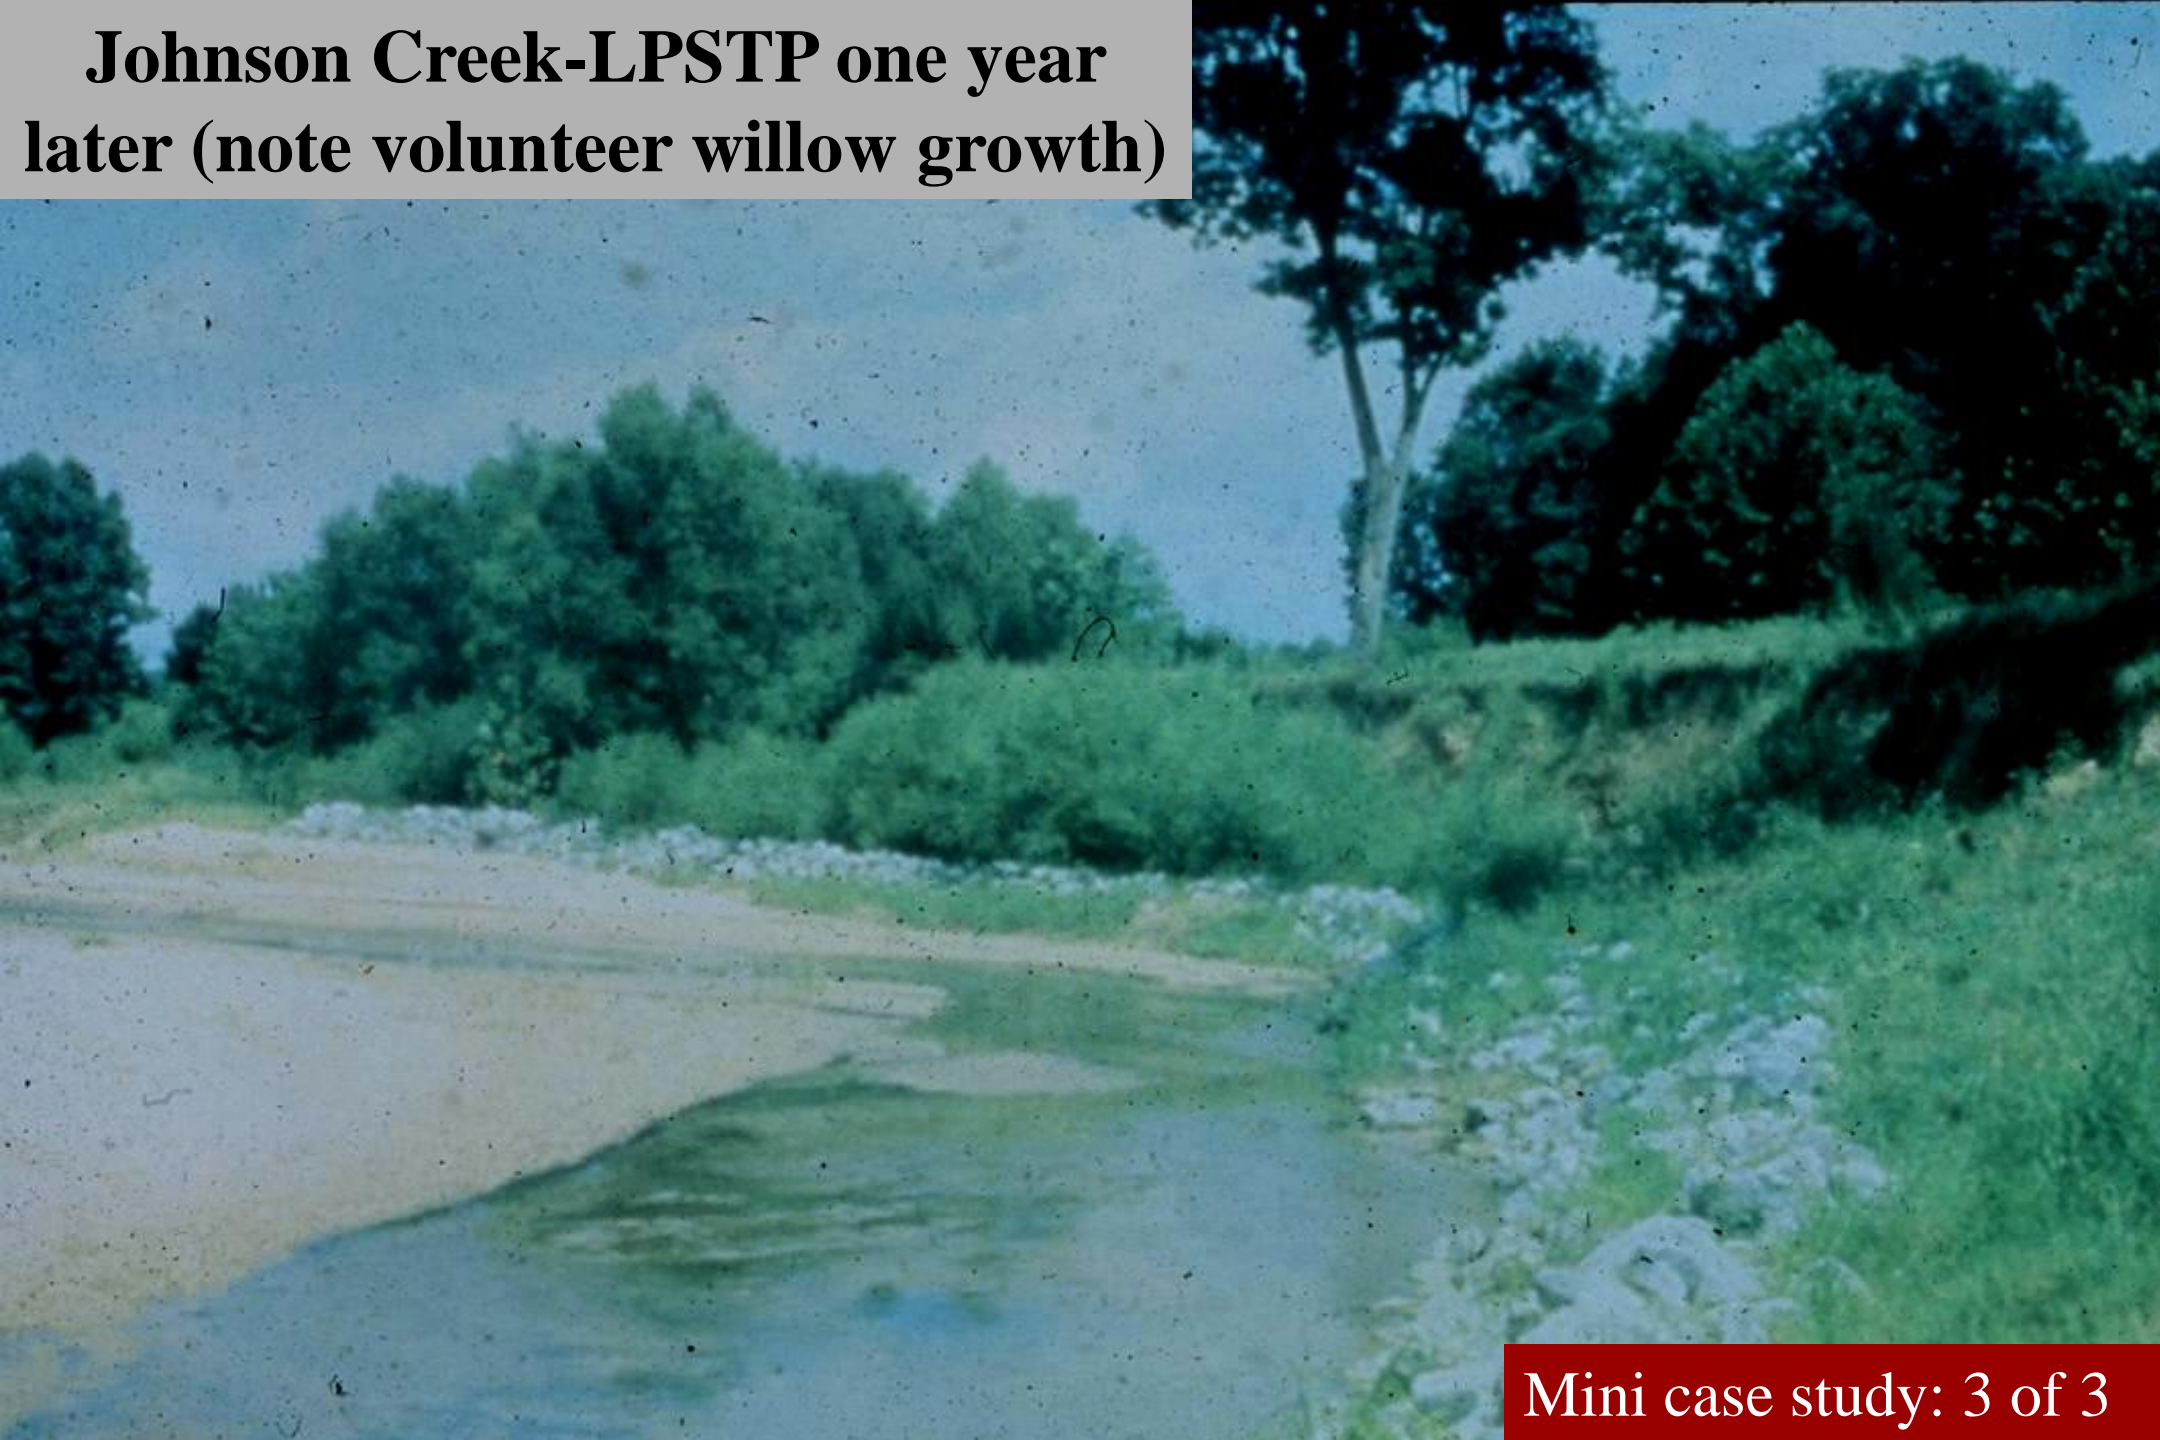
**Johnson Creek-LPSTP one year
later (note volunteer willow growth)**

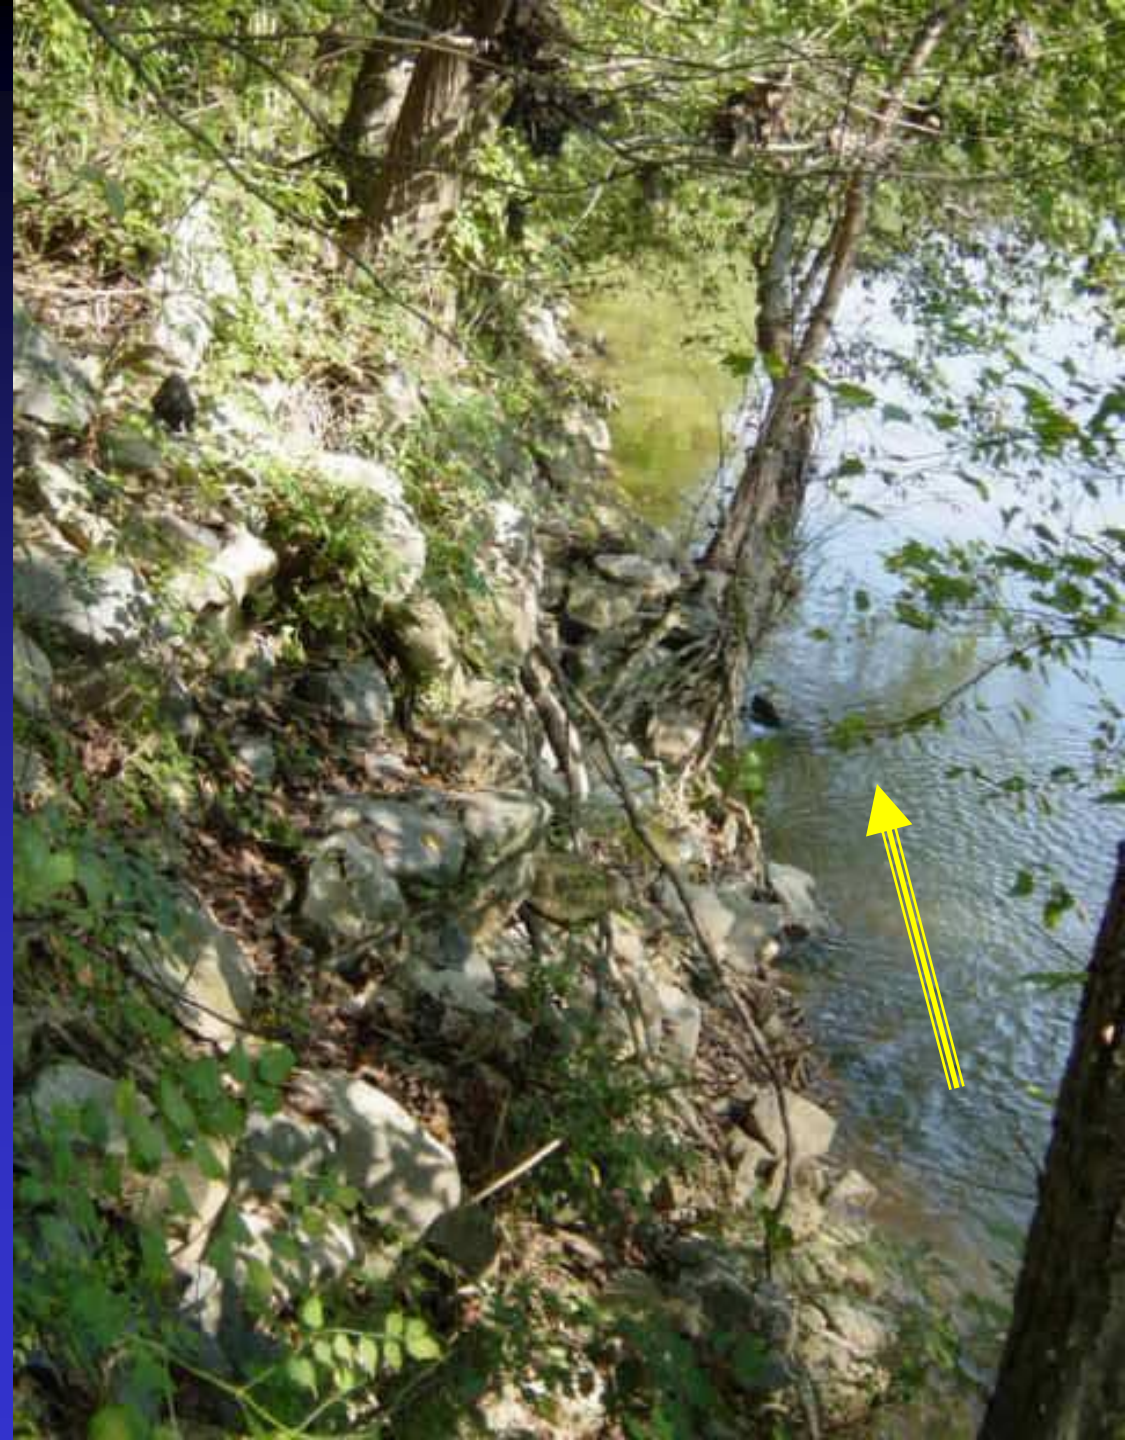
**Longitudinal Peaked Stone
Toe Protection {installed
1977, picture taken Sept
2003} at Batapan Bogue,
Grenada, MS.**

**LPSTP has launched as
intended (note steep angle
of repose), armored the
scour hole as expected, &
mature vegetation is
assisting with overall bank
stability**
