**COMBINATIONS OF RESISTIVE
& REDIRECTIVE METHODS:
CASE STUDY- Duck Creek East of
Eastern Avenue, Davenport, Iowa
Constructed June-July. 2008**

**Longitudinal Peaked Stone Toe
Protection {LFSTP} with interspaced
Short Bendway Weirs & Locked Logs**

LONGITUDINAL PEAKED STONE TOE PROTECTION {LPSTP}

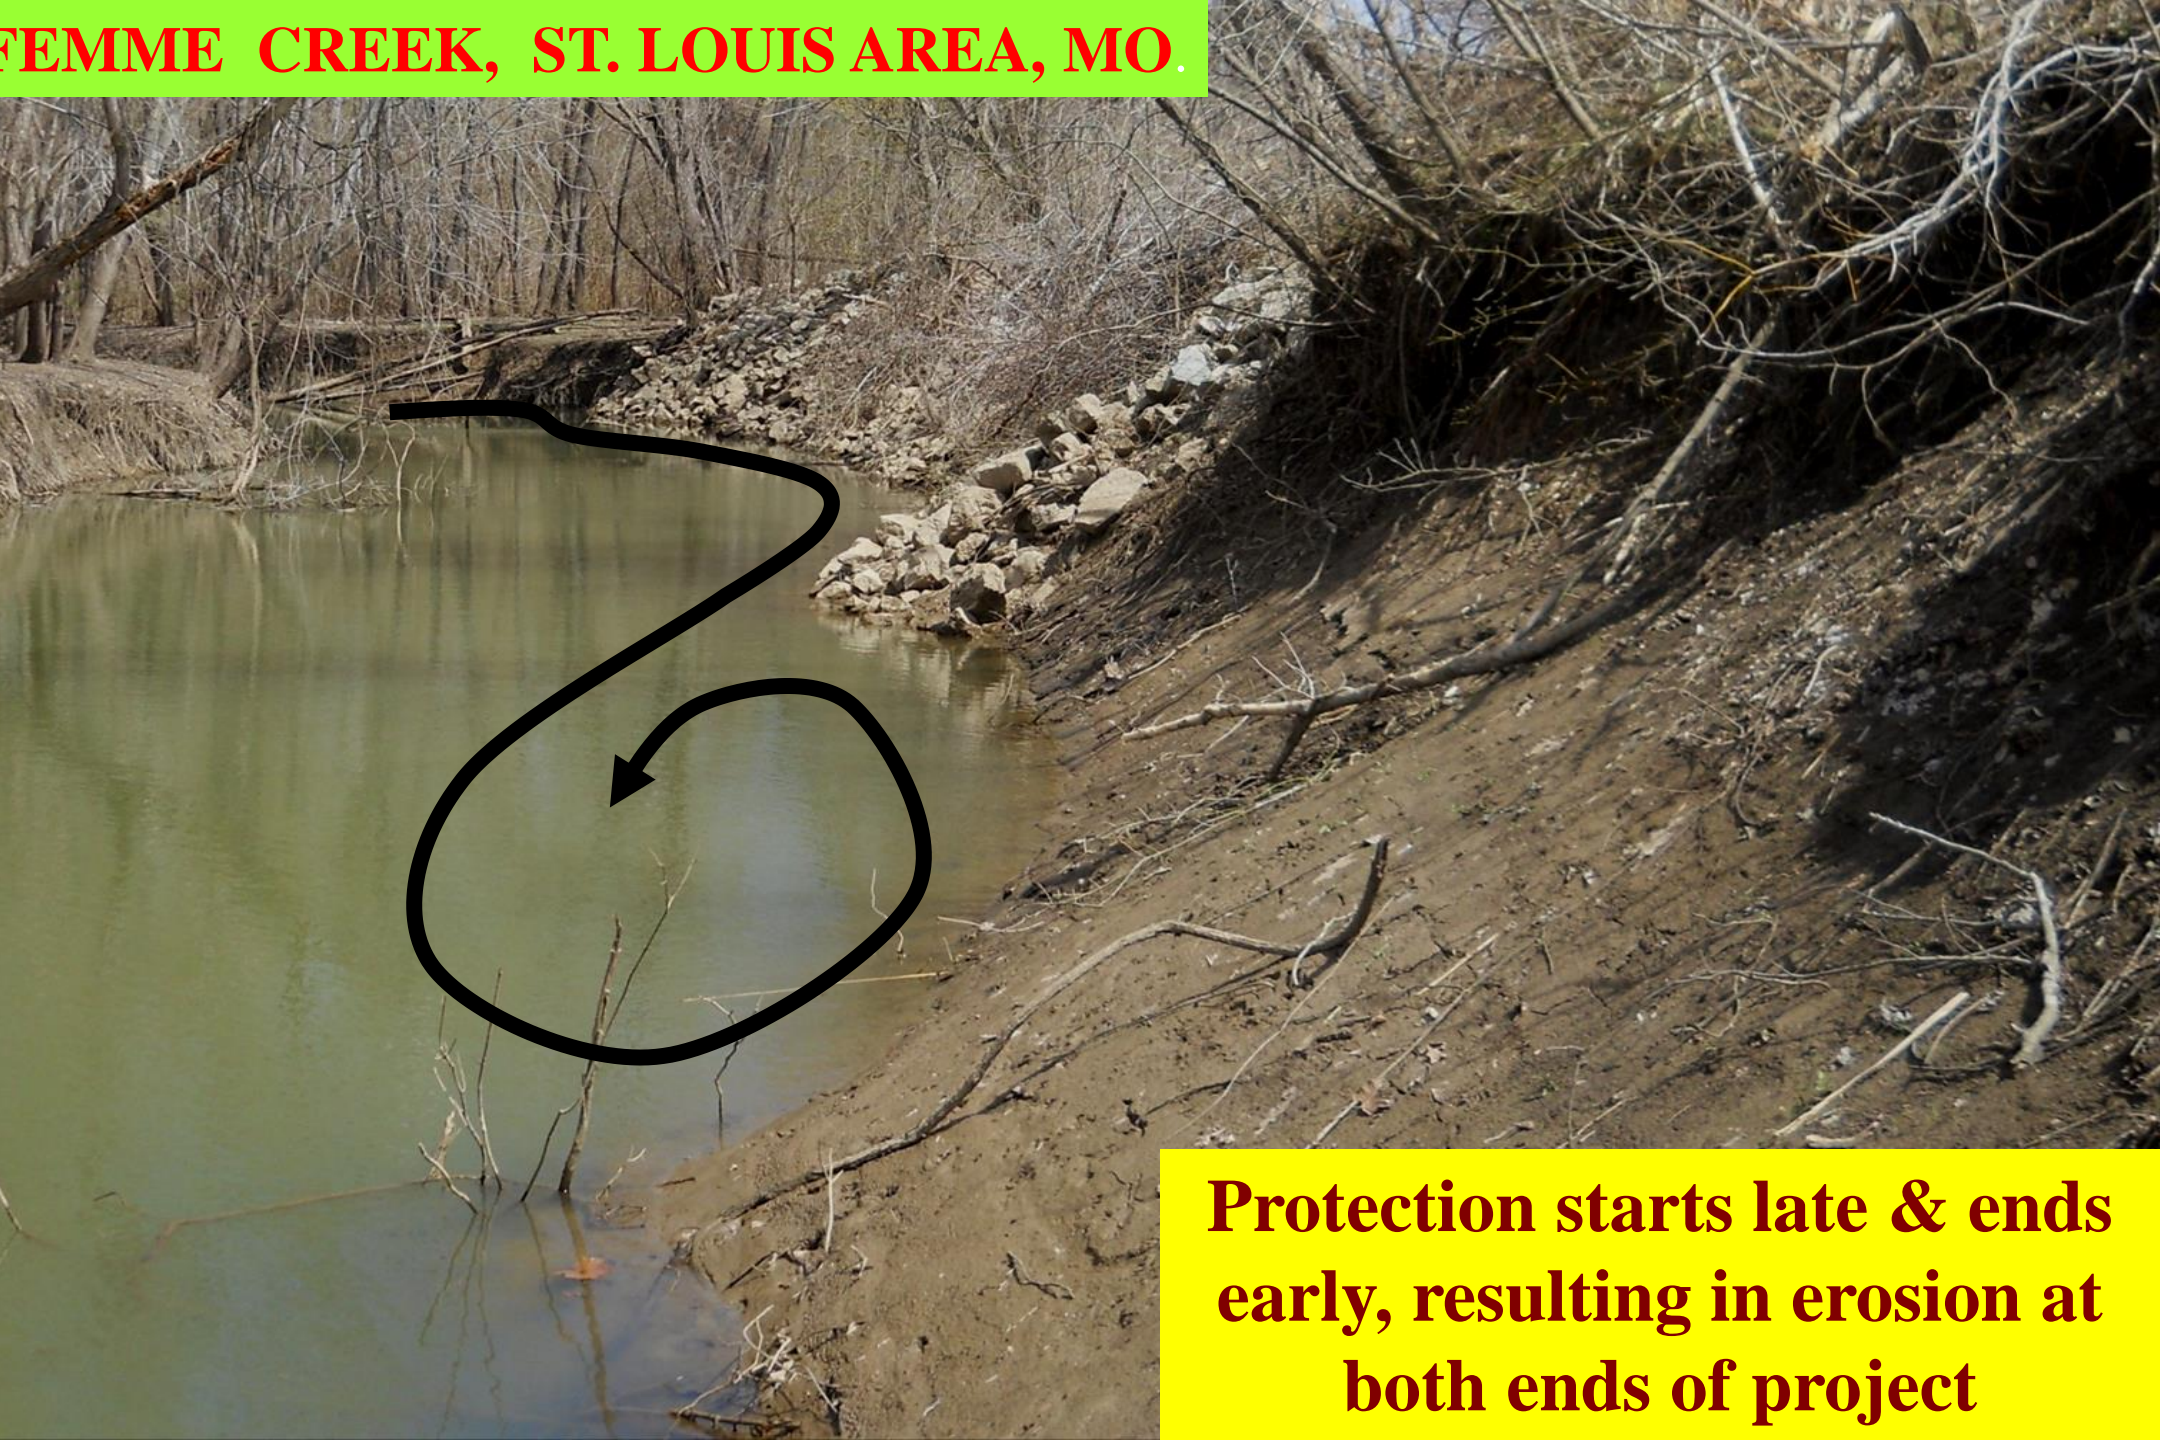
FEMME CREEK, ST. LOUIS AREA, MO.

**A bank protection
project should start
& end in stable
(usually depositional)
areas.**

Protection starts late & ends early, resulting in erosion at both ends of project

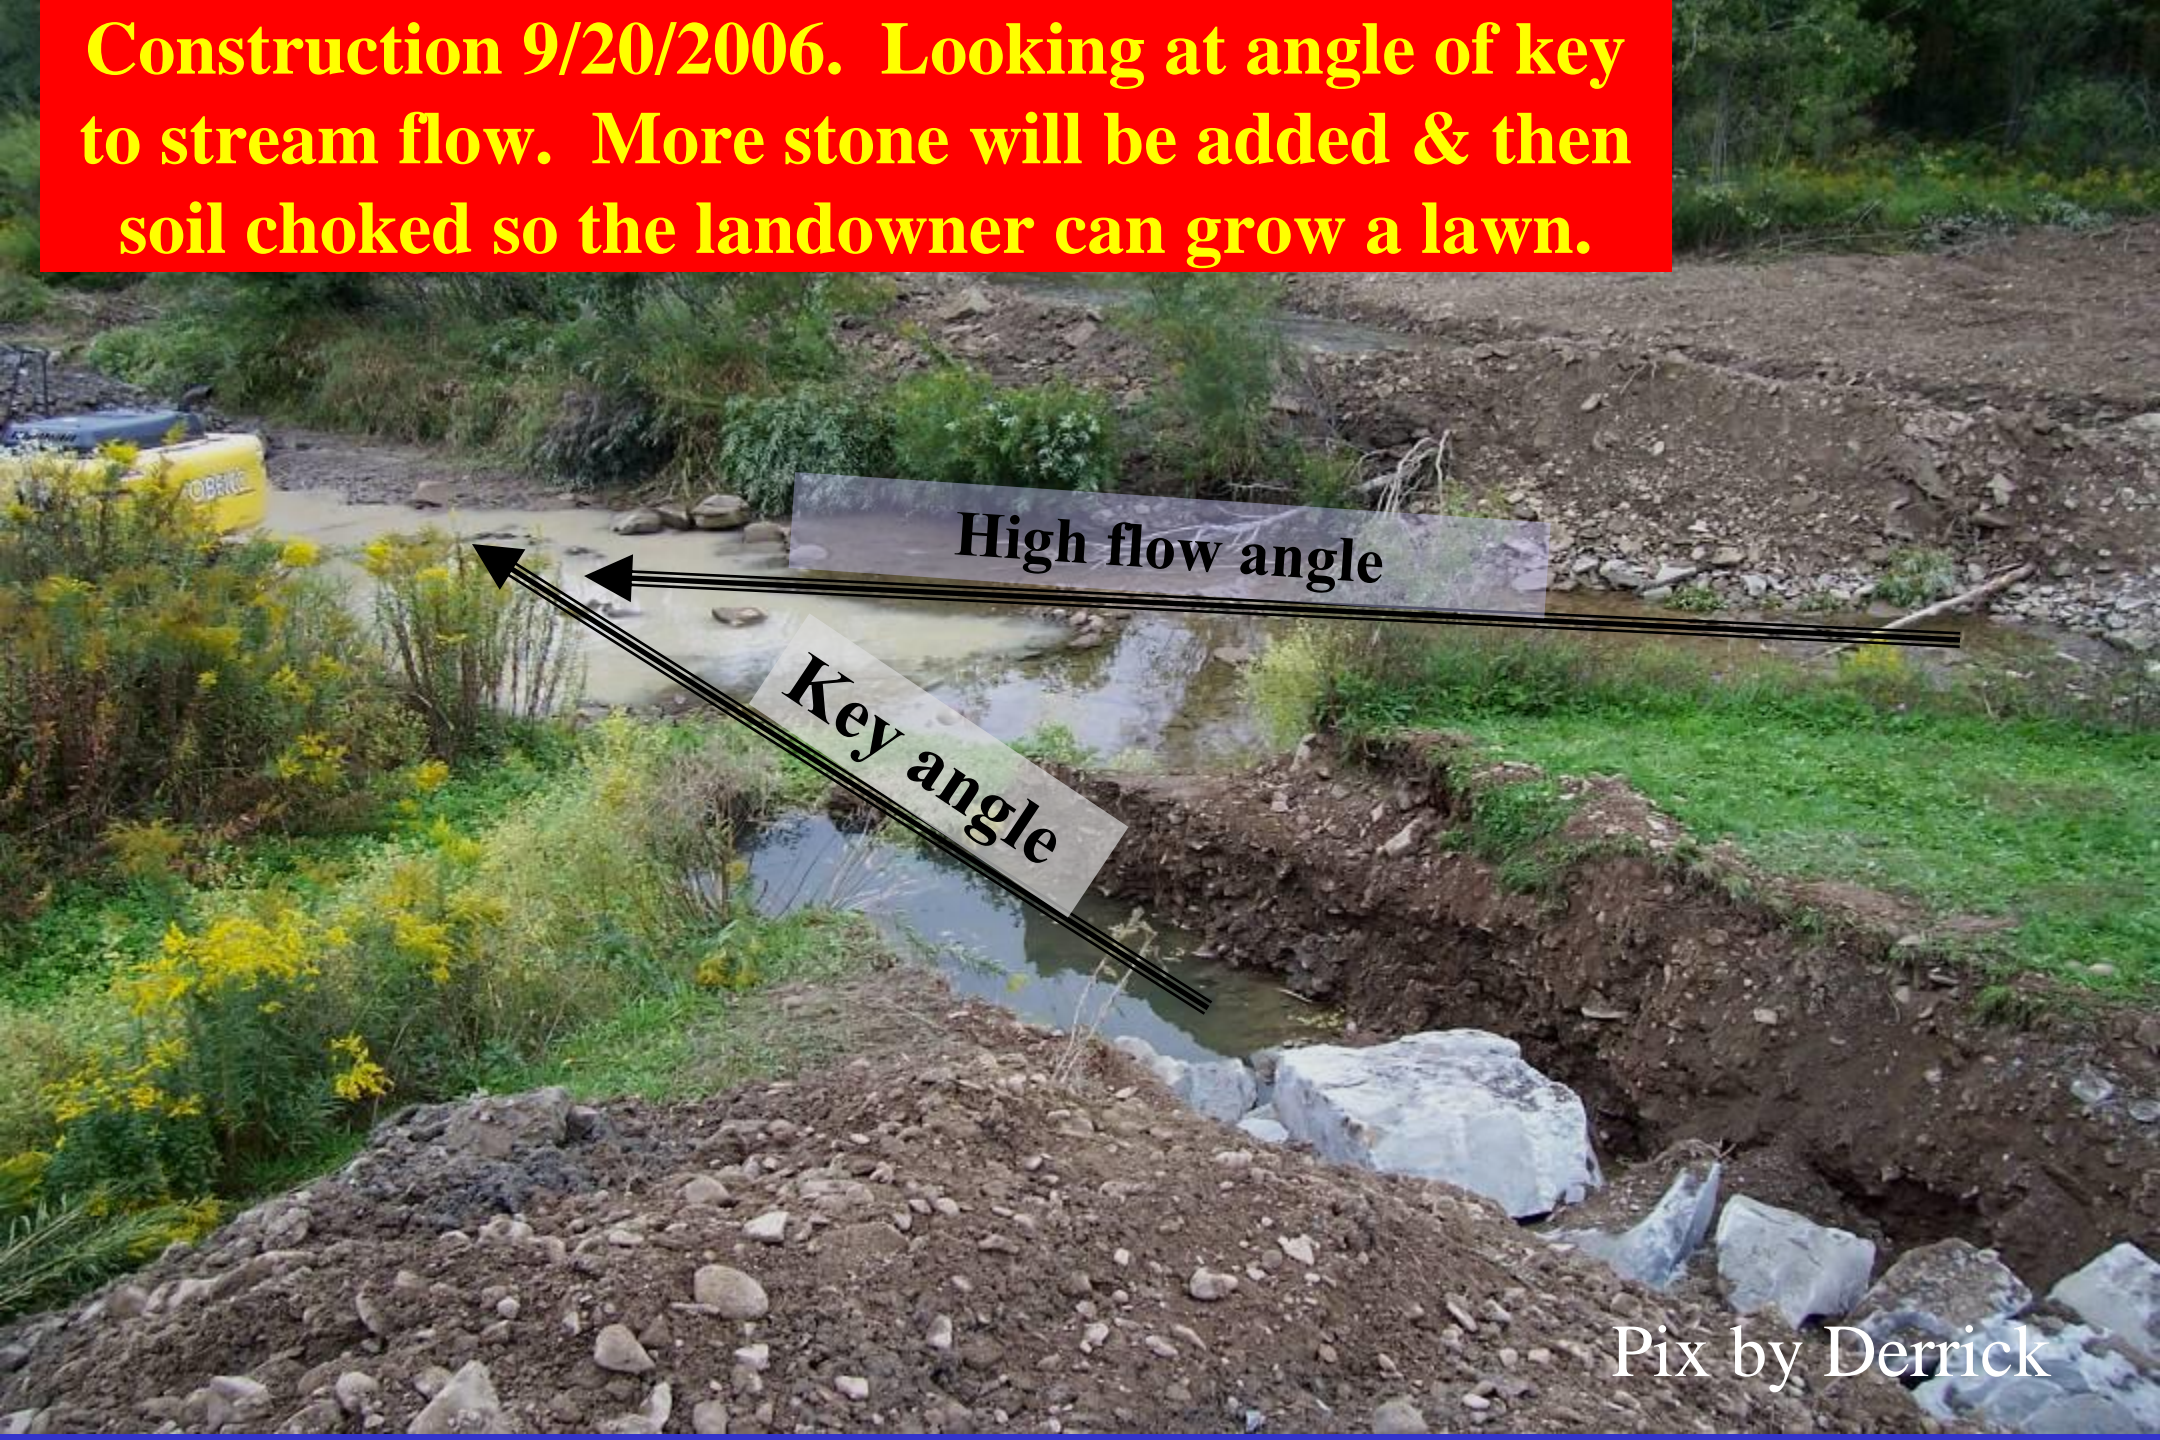
Pix by Derrick

The upstream key on Chenunda Creek, Wellsville NY. The key is angled 30 degrees to dominant (high) flow. This same angle should be used for the downstream key.

Construction 9/20/2006. Looking at angle of key to stream flow. More stone will be added & then soil choked so the landowner can grow a lawn.

High flow angle

Key angle

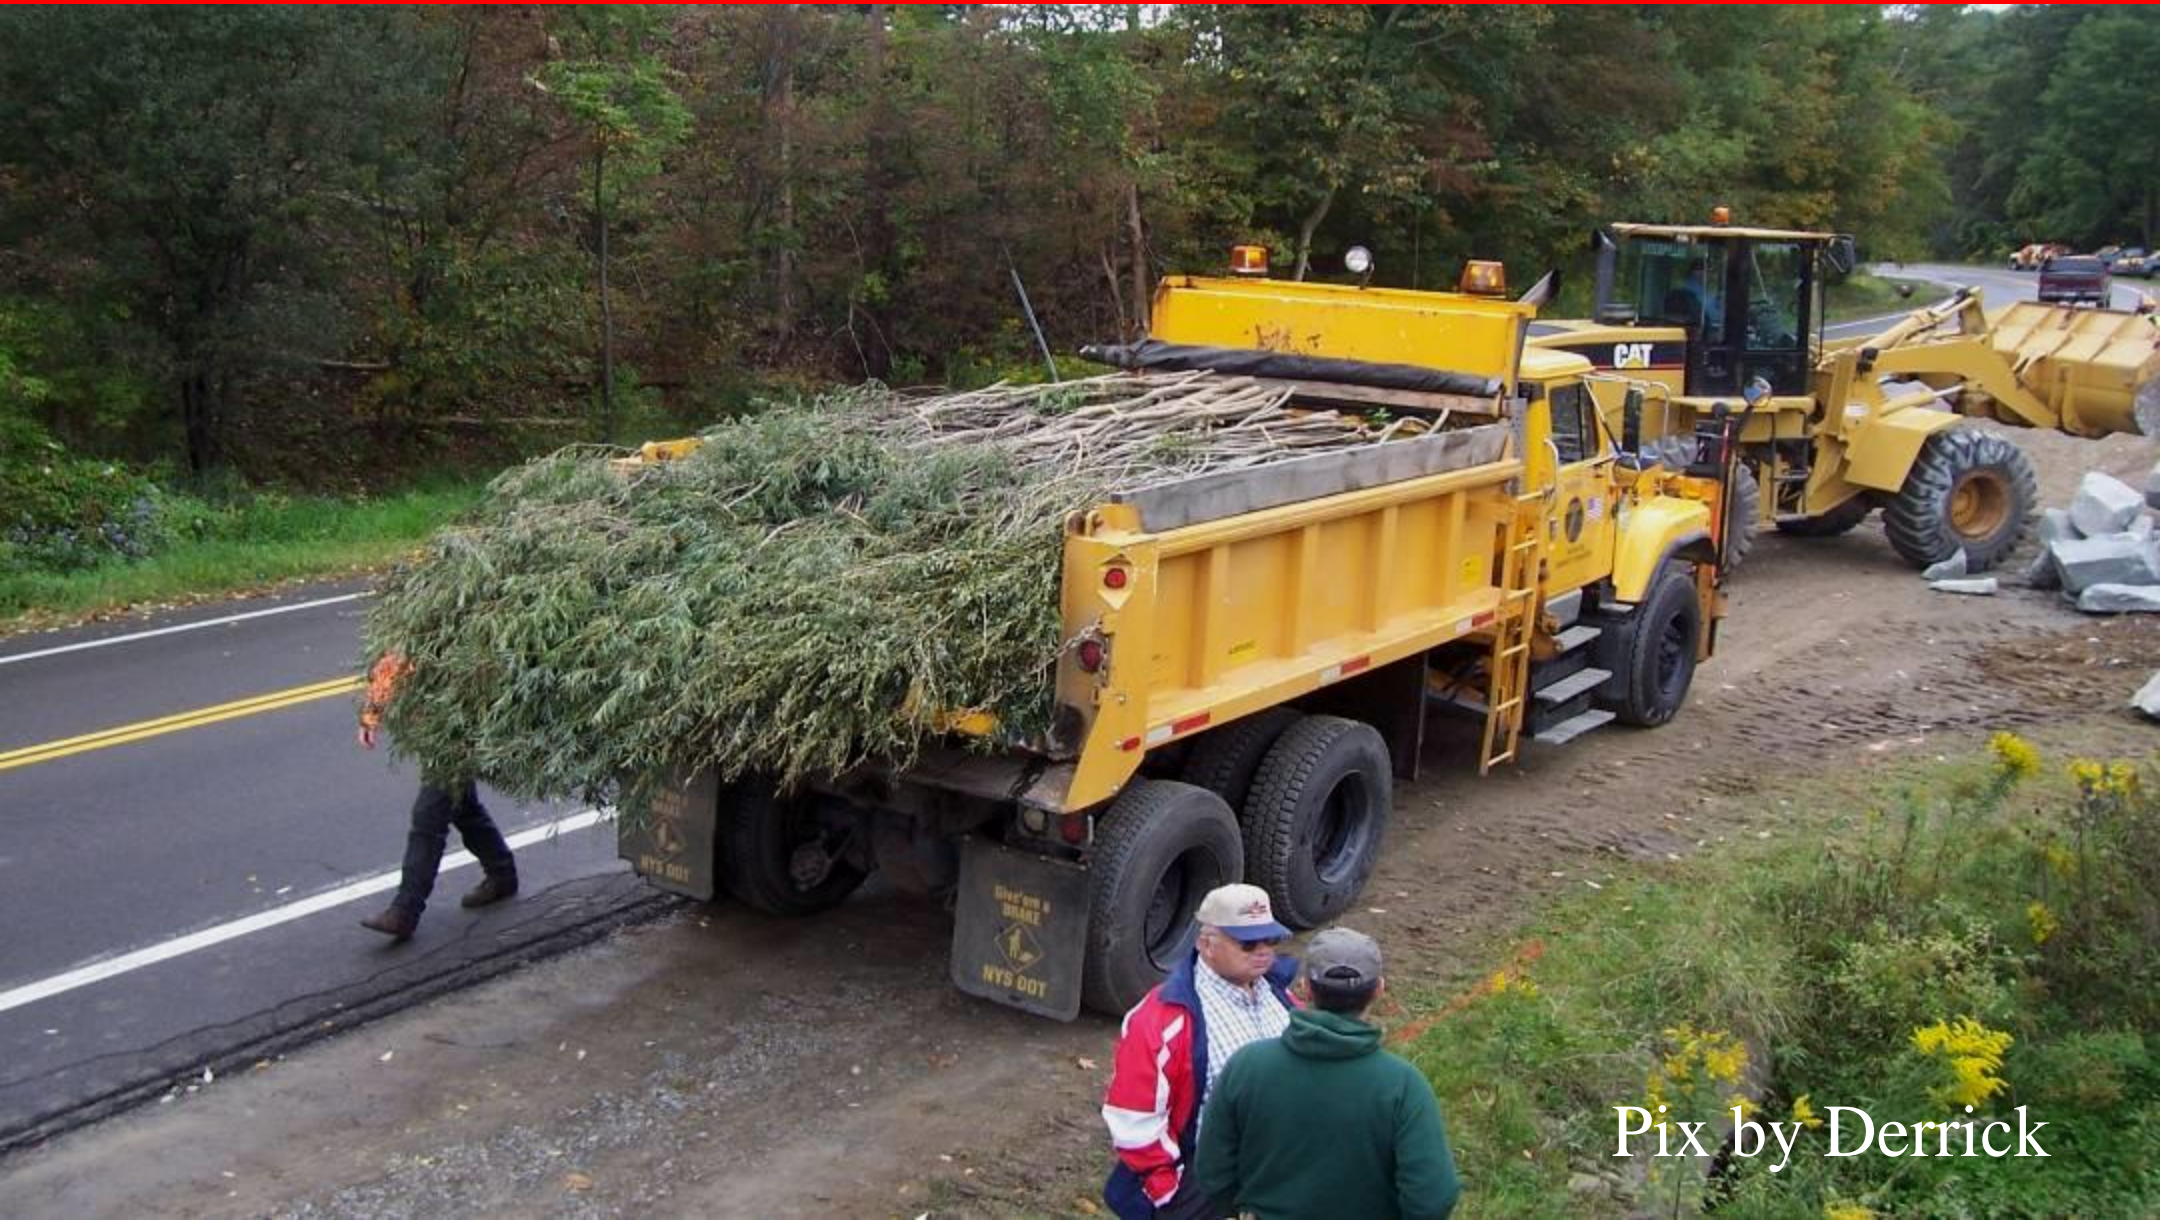
Pix by Derrick

Dump truck load level full of Sandbar & Streamco Willow, & Ruby Red osier dogwood, (1,500 poles total).

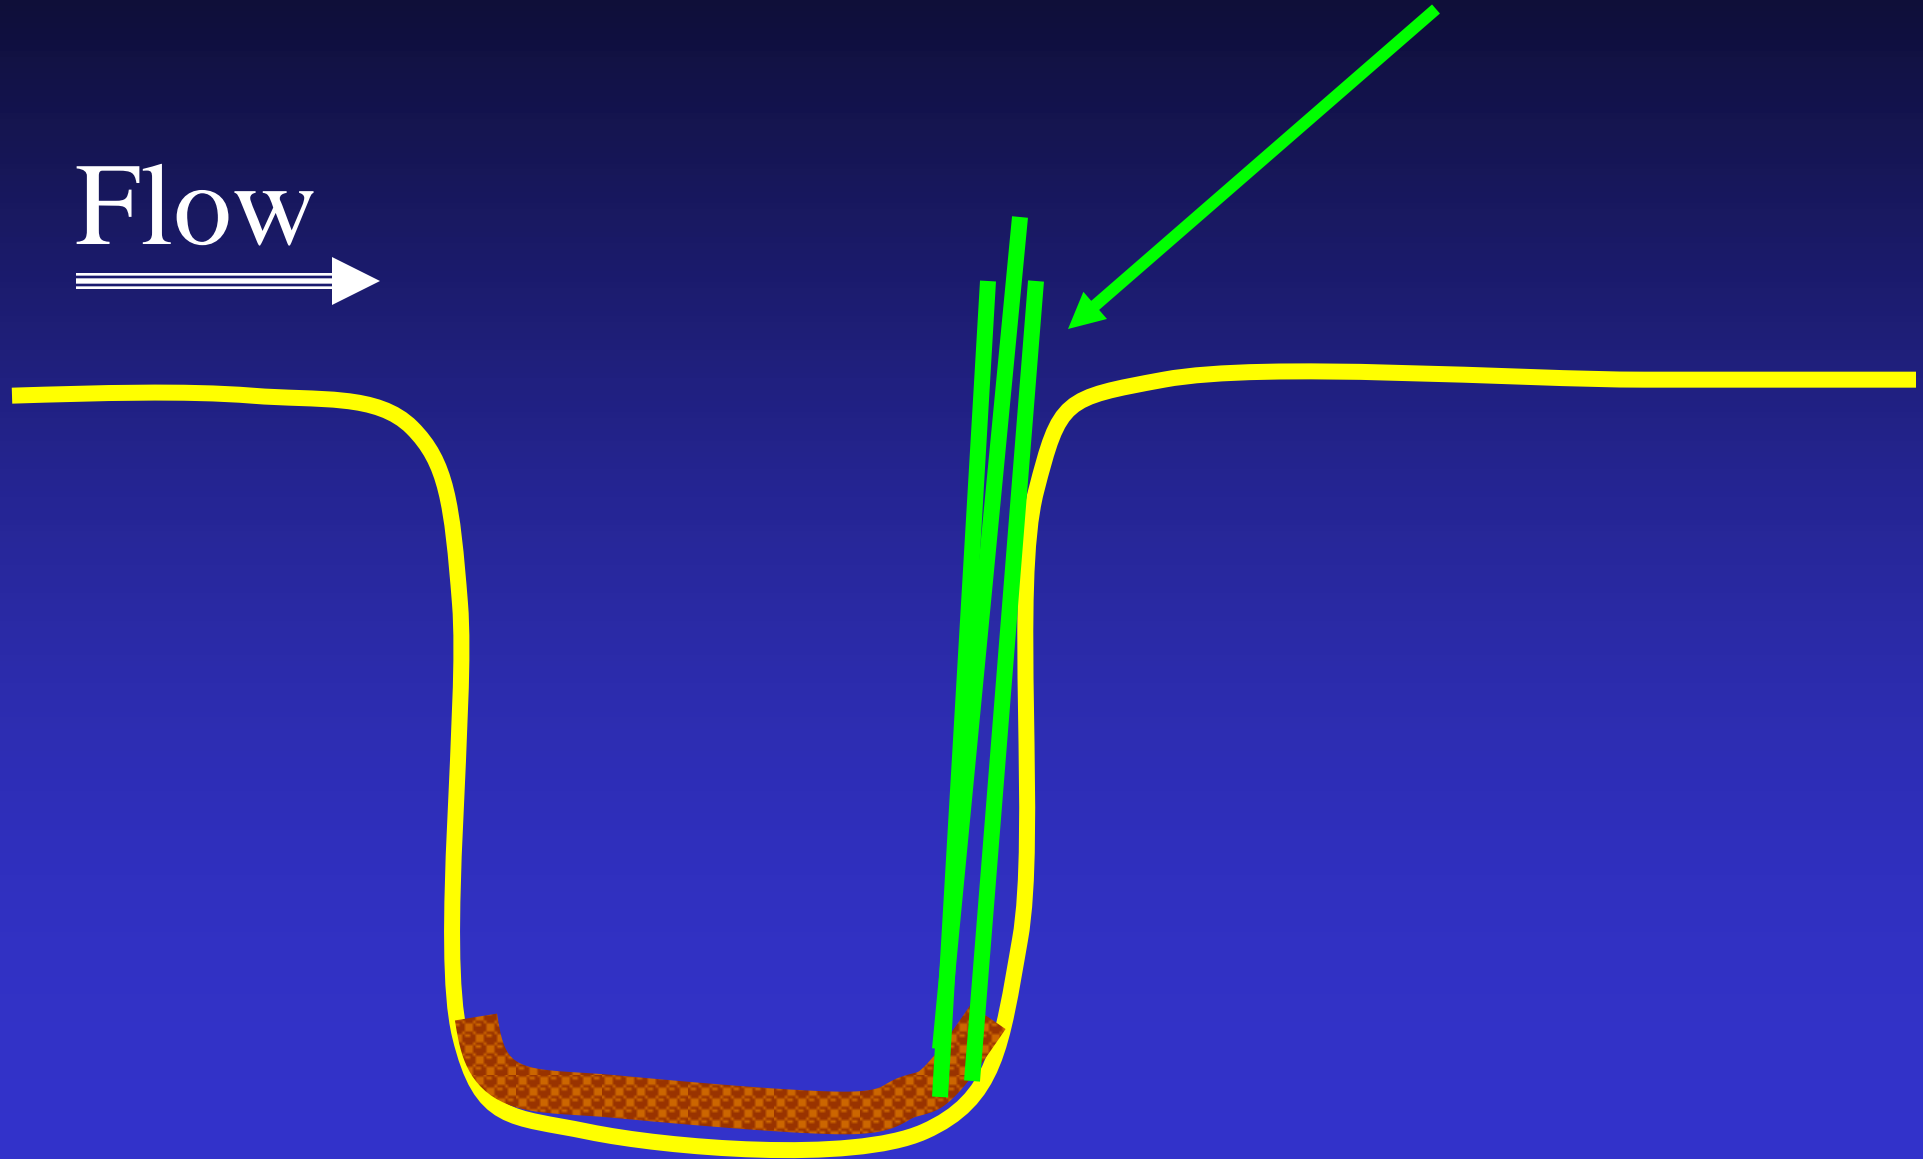
Detail for key

**Place Willow Poles against one
or both sides of trench**

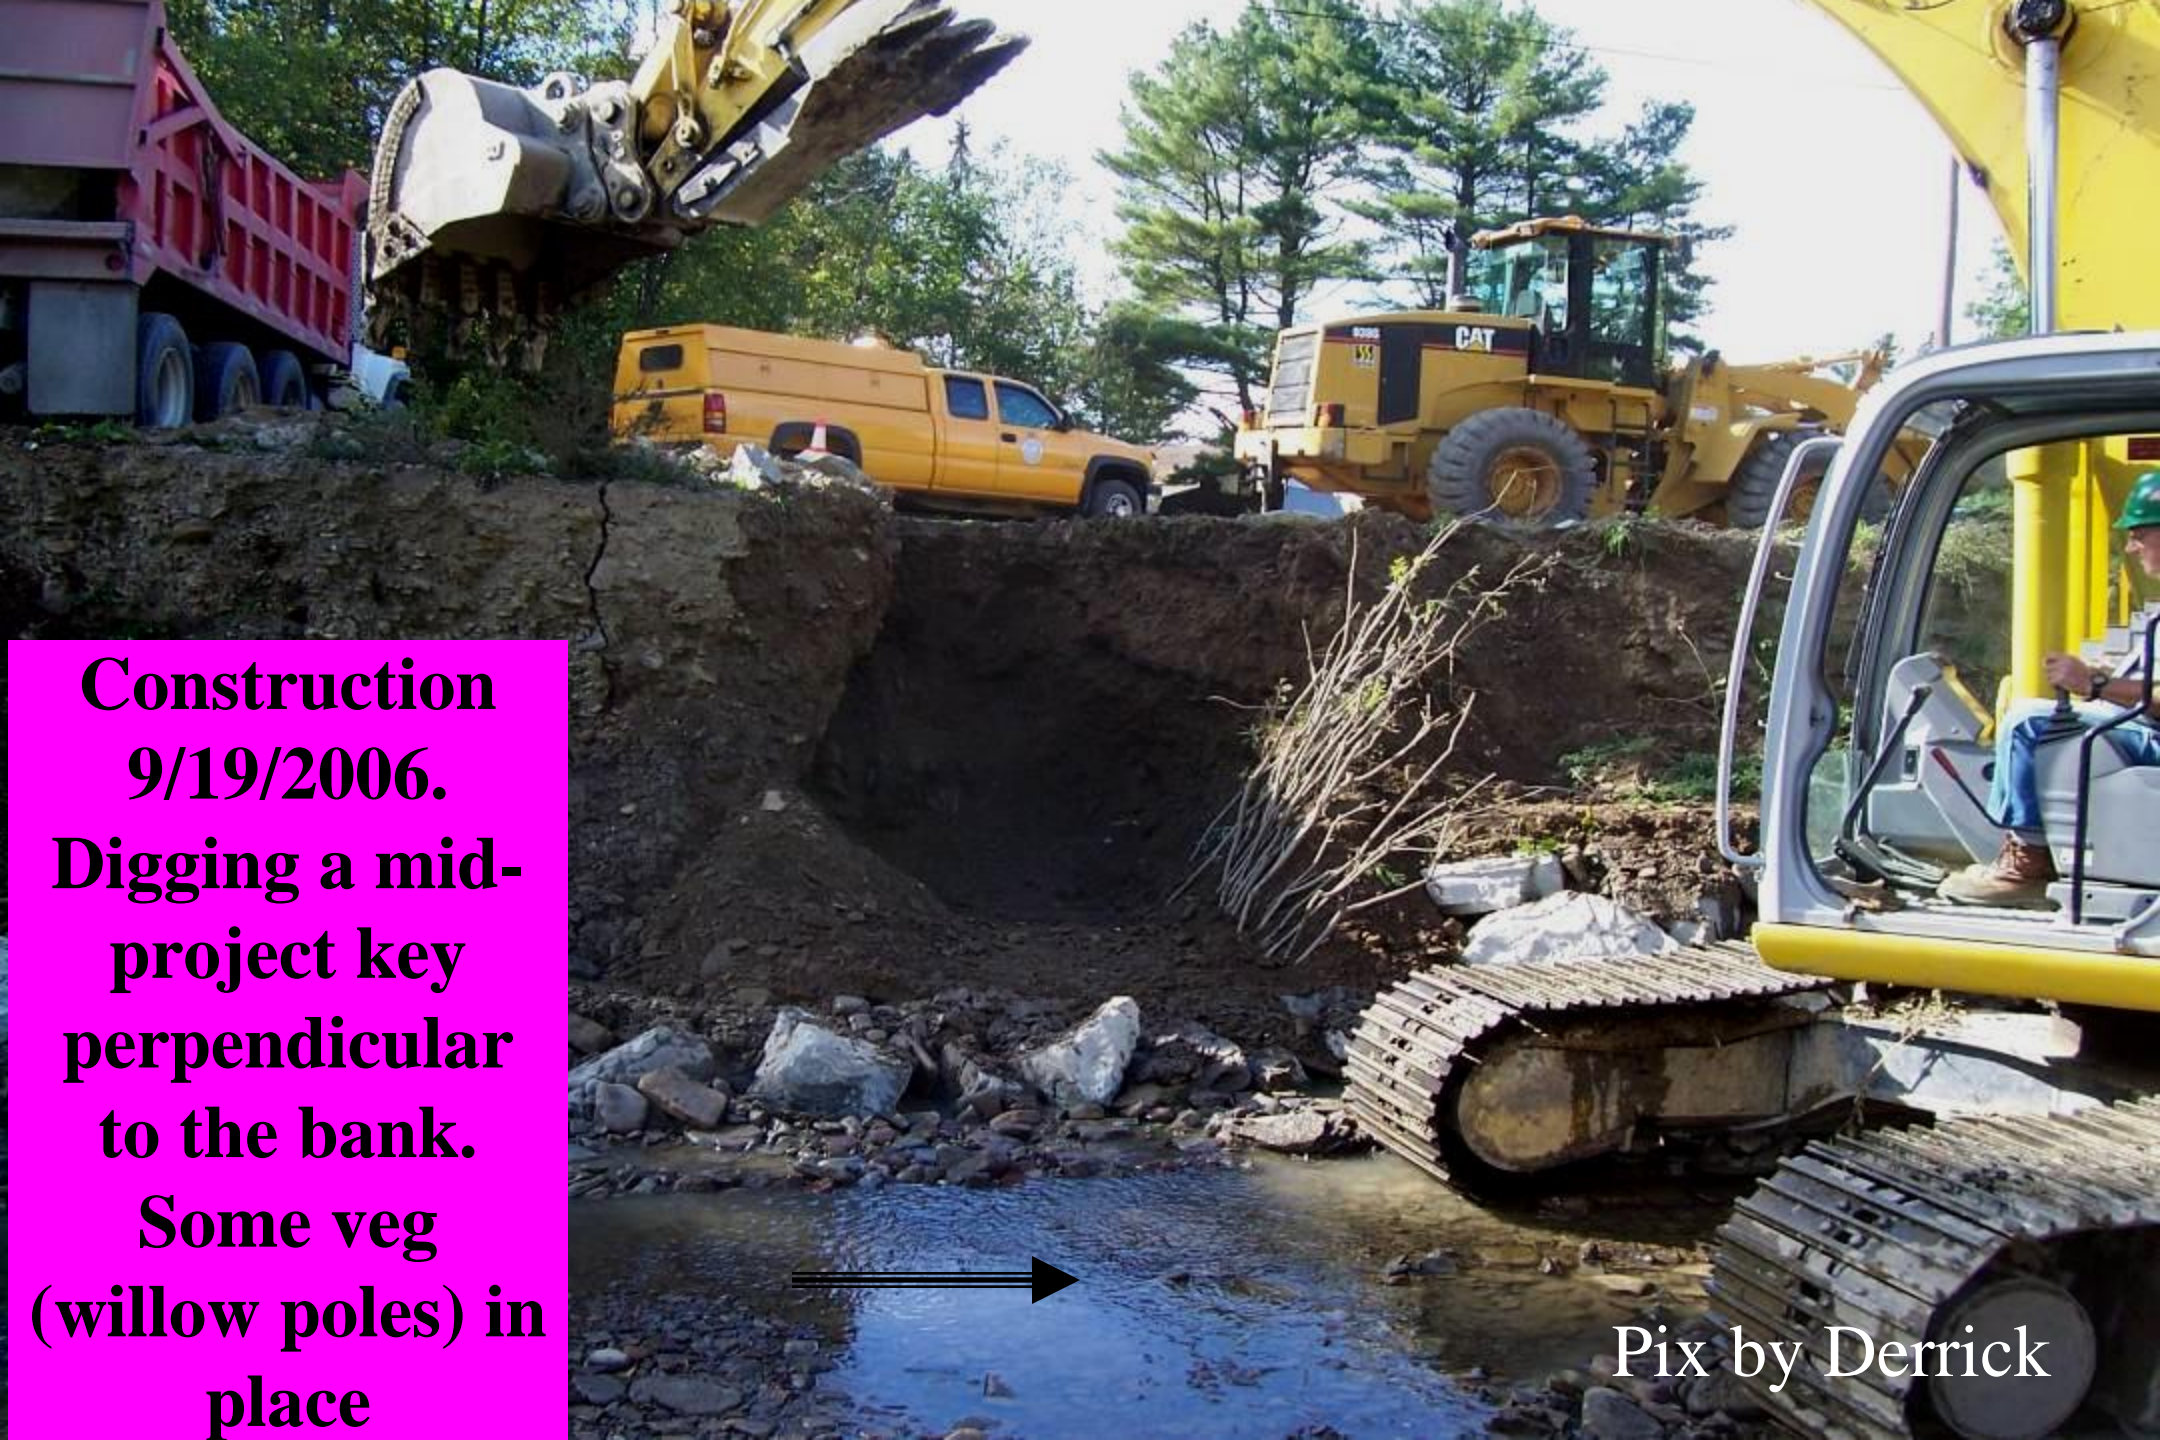
Pix by Derrick

**Construction
9/19/2006.
Digging a mid-
project key
perpendicular
to the bank.
Some veg
(willow poles) in
place**

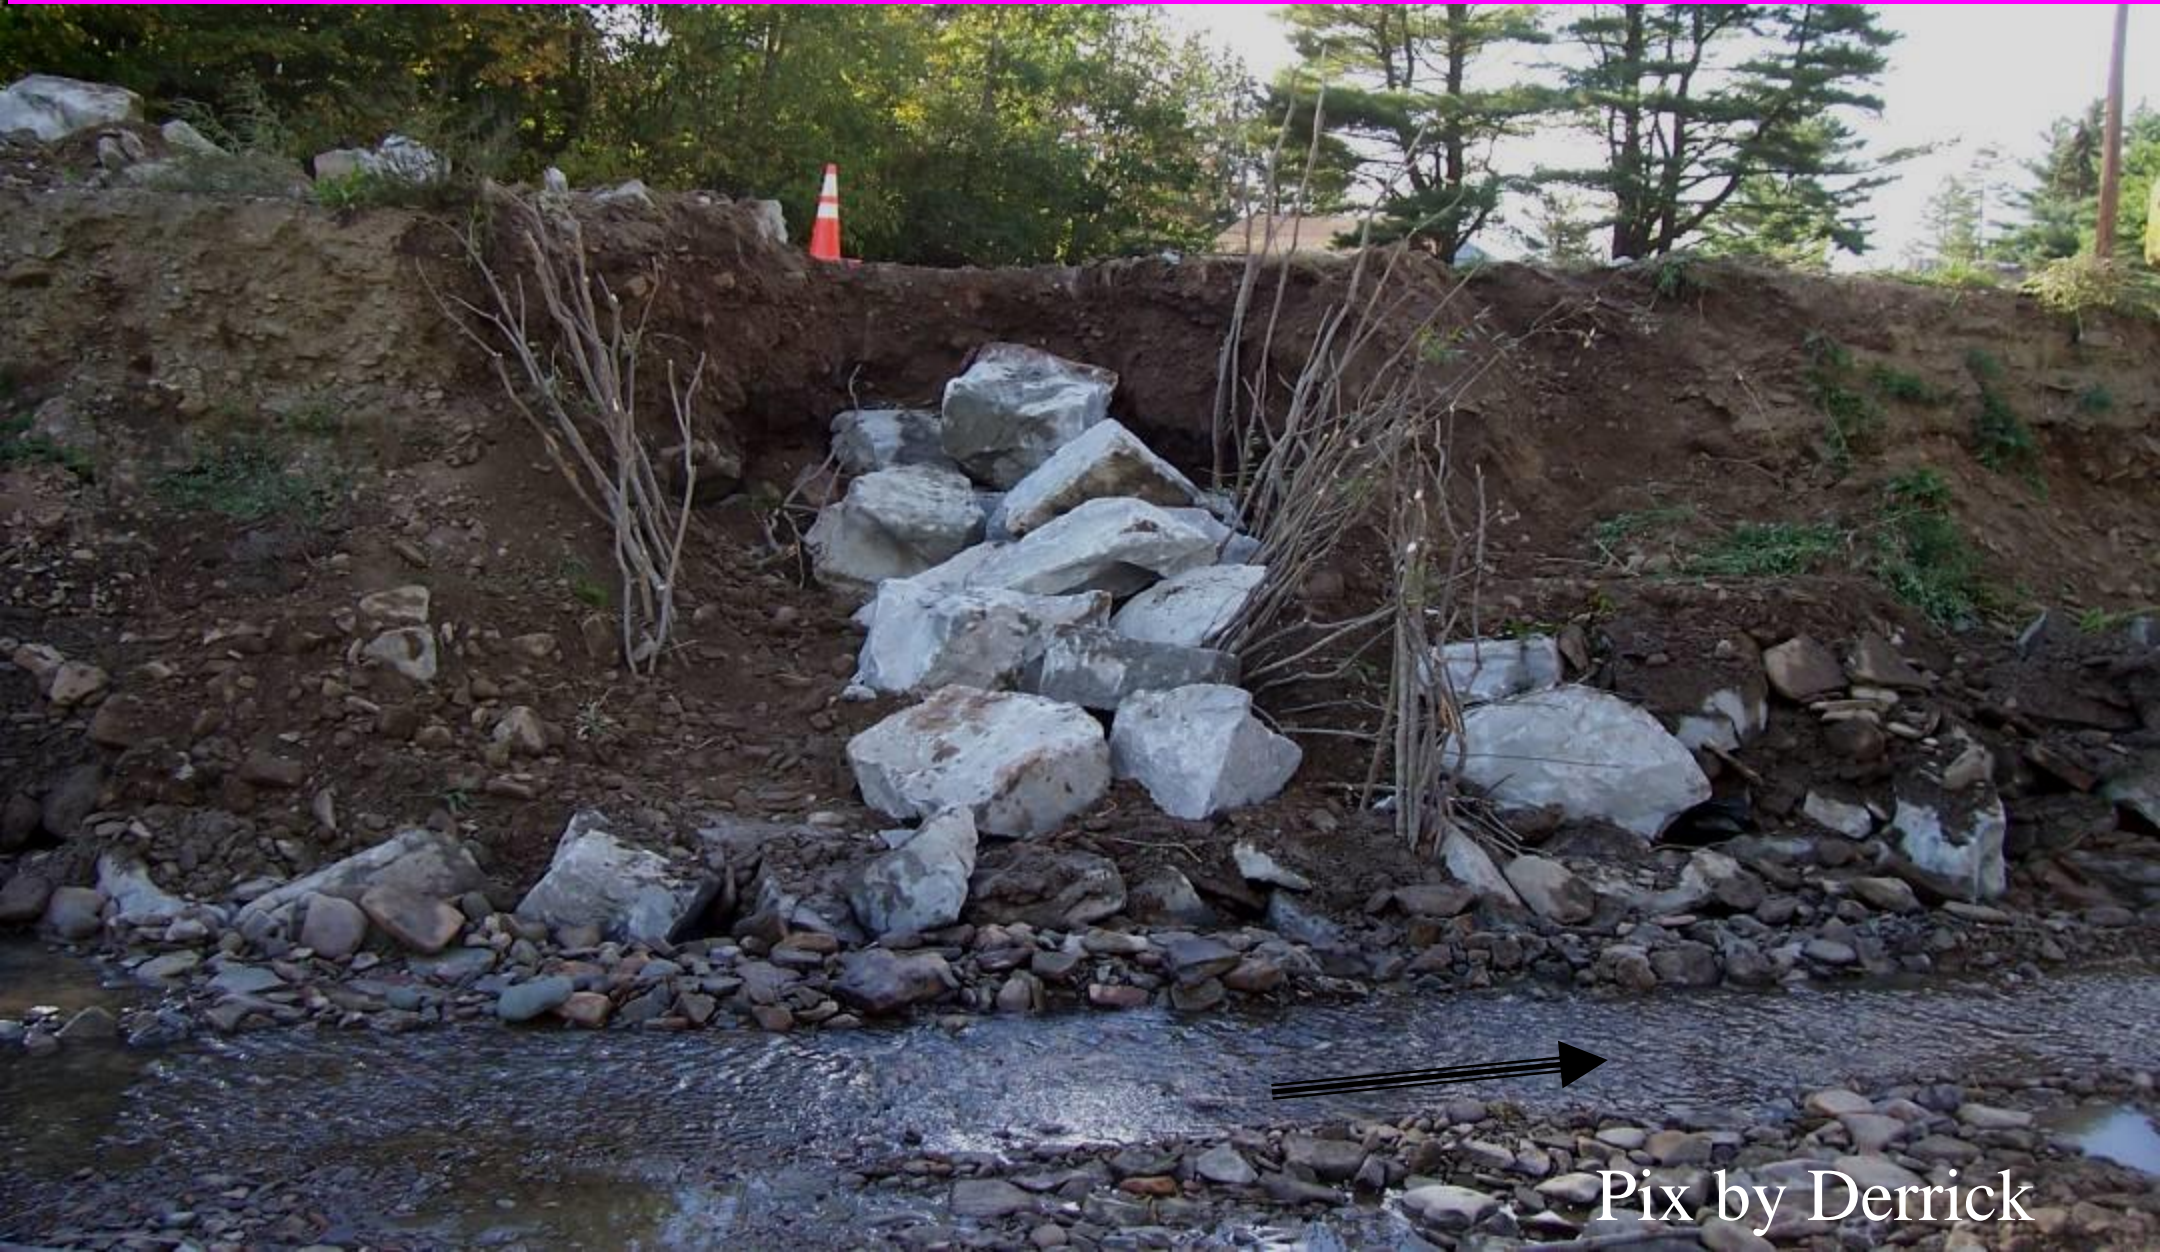
Pix by Derrick

Construction 9/19/2006. Looking at key. Butt ends of willow & dogwood poles down deep.

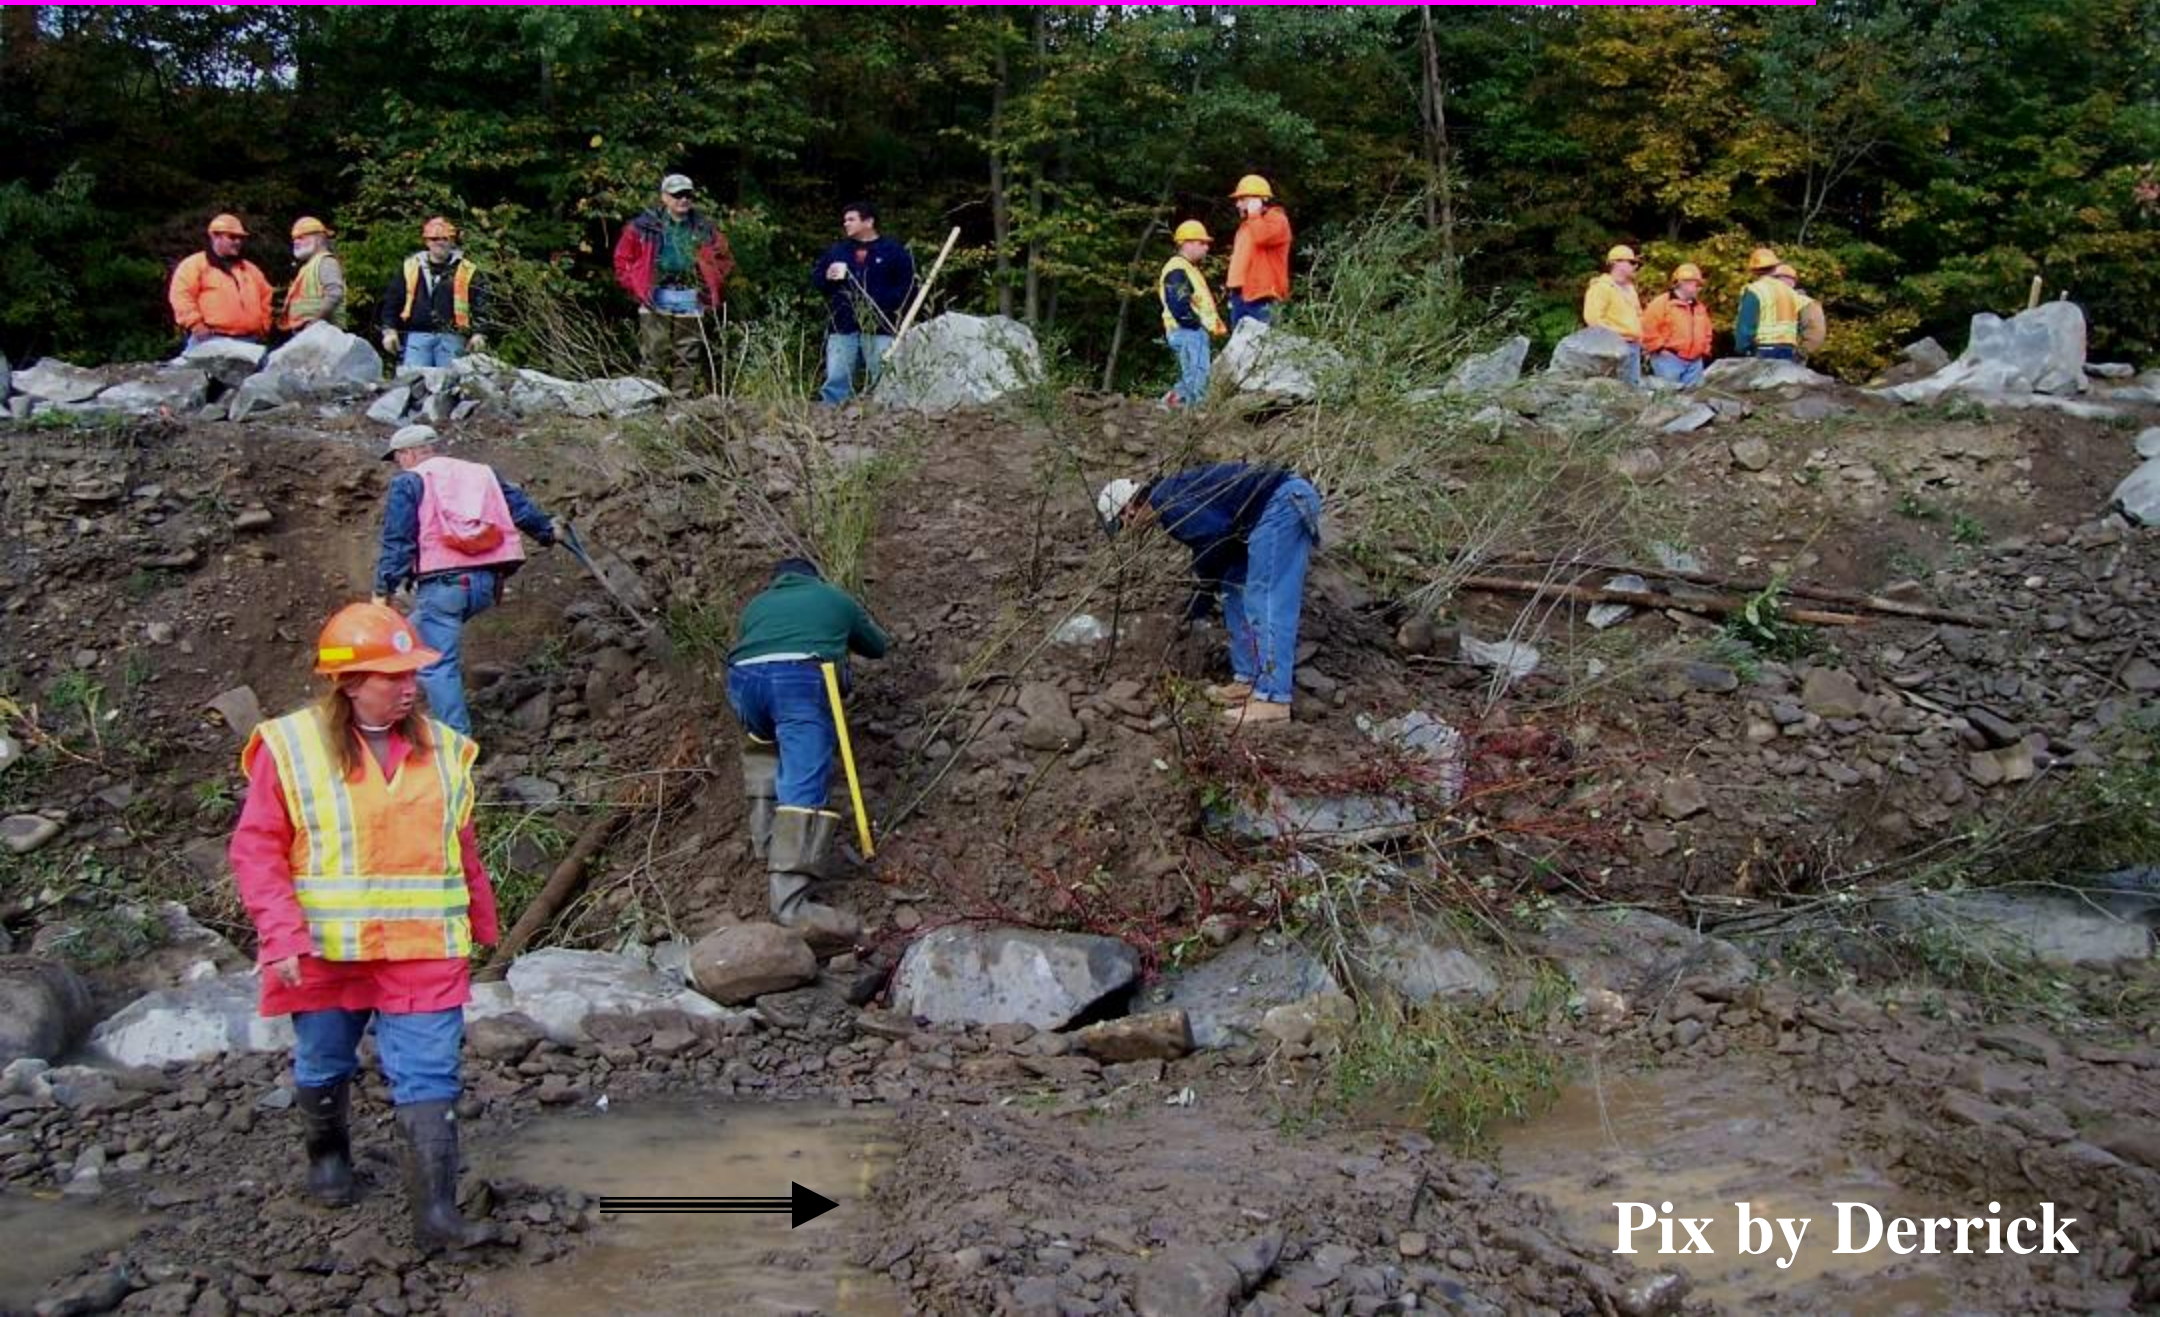
Pix by Derrick

Construction 9/21/2006. Key stone is now soil-choked.

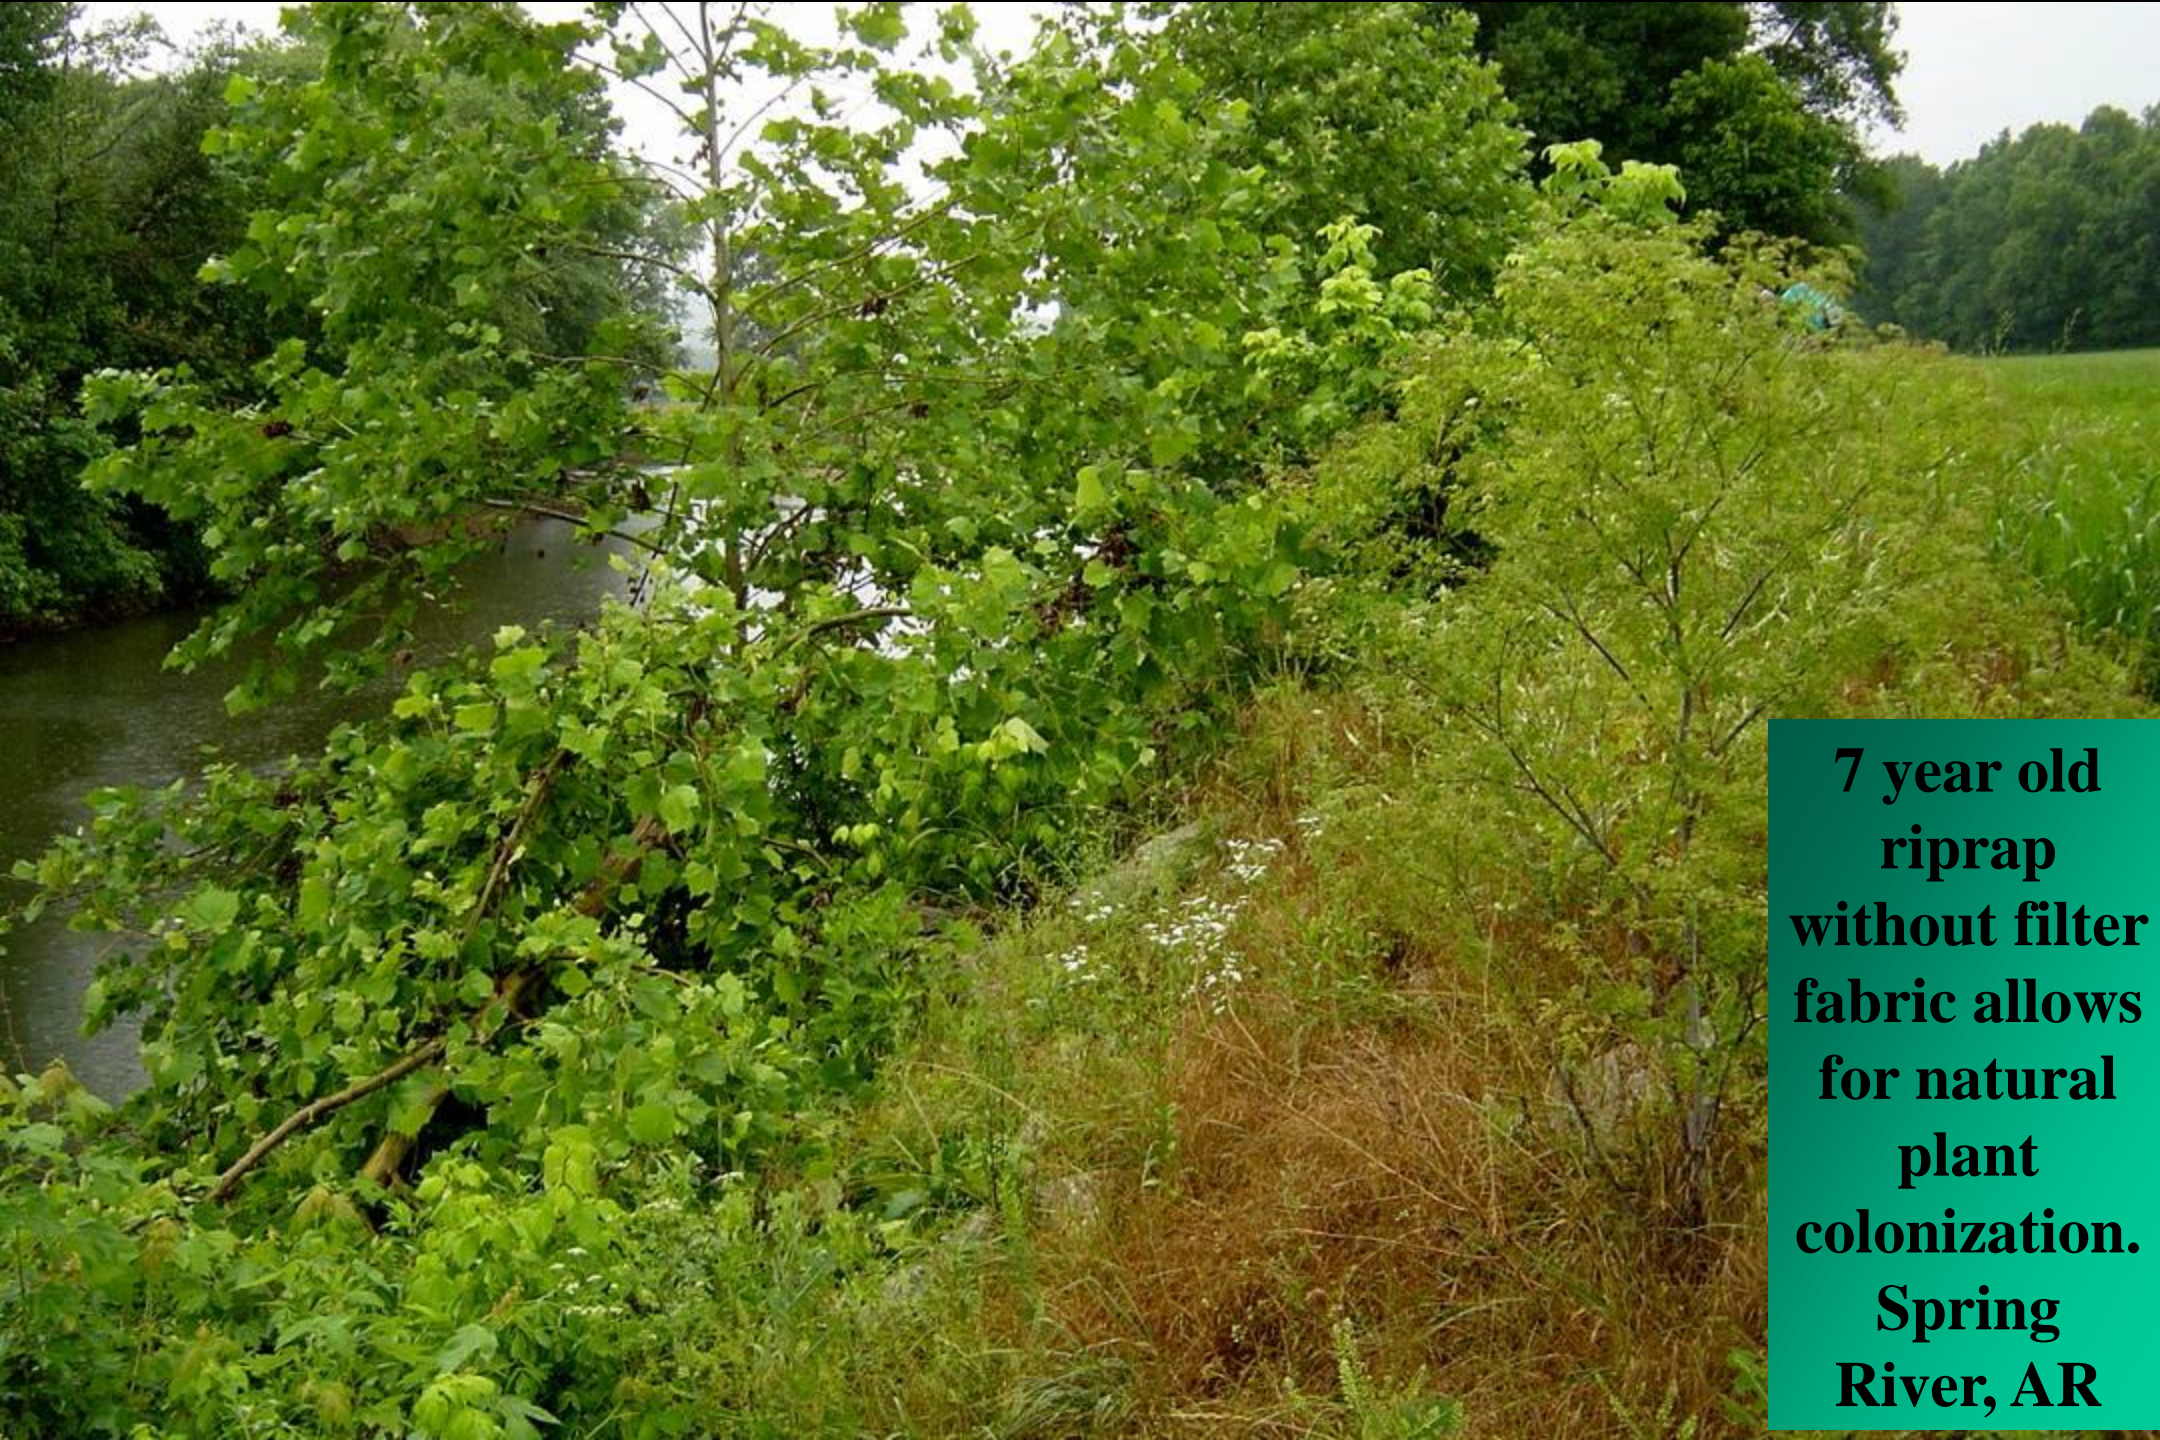
**7 year old
riprap
without filter
fabric allows
for natural
plant
colonization.
Spring
River, AR**
