**COMBINATIONS OF RESISTIVE
& REDIRECTIVE METHODS:
CASE STUDY- Duck Creek East of
Eastern Avenue, Davenport, Iowa
Constructed June-July. 2008**

**Longitudinal Peaked Stone Toe
Protection {LFSTP} with interspaced
Short Bendway Weirs & Locked Logs**

LONGITUDINAL PEAKED STONE TOE PROTECTION {LPSTP}

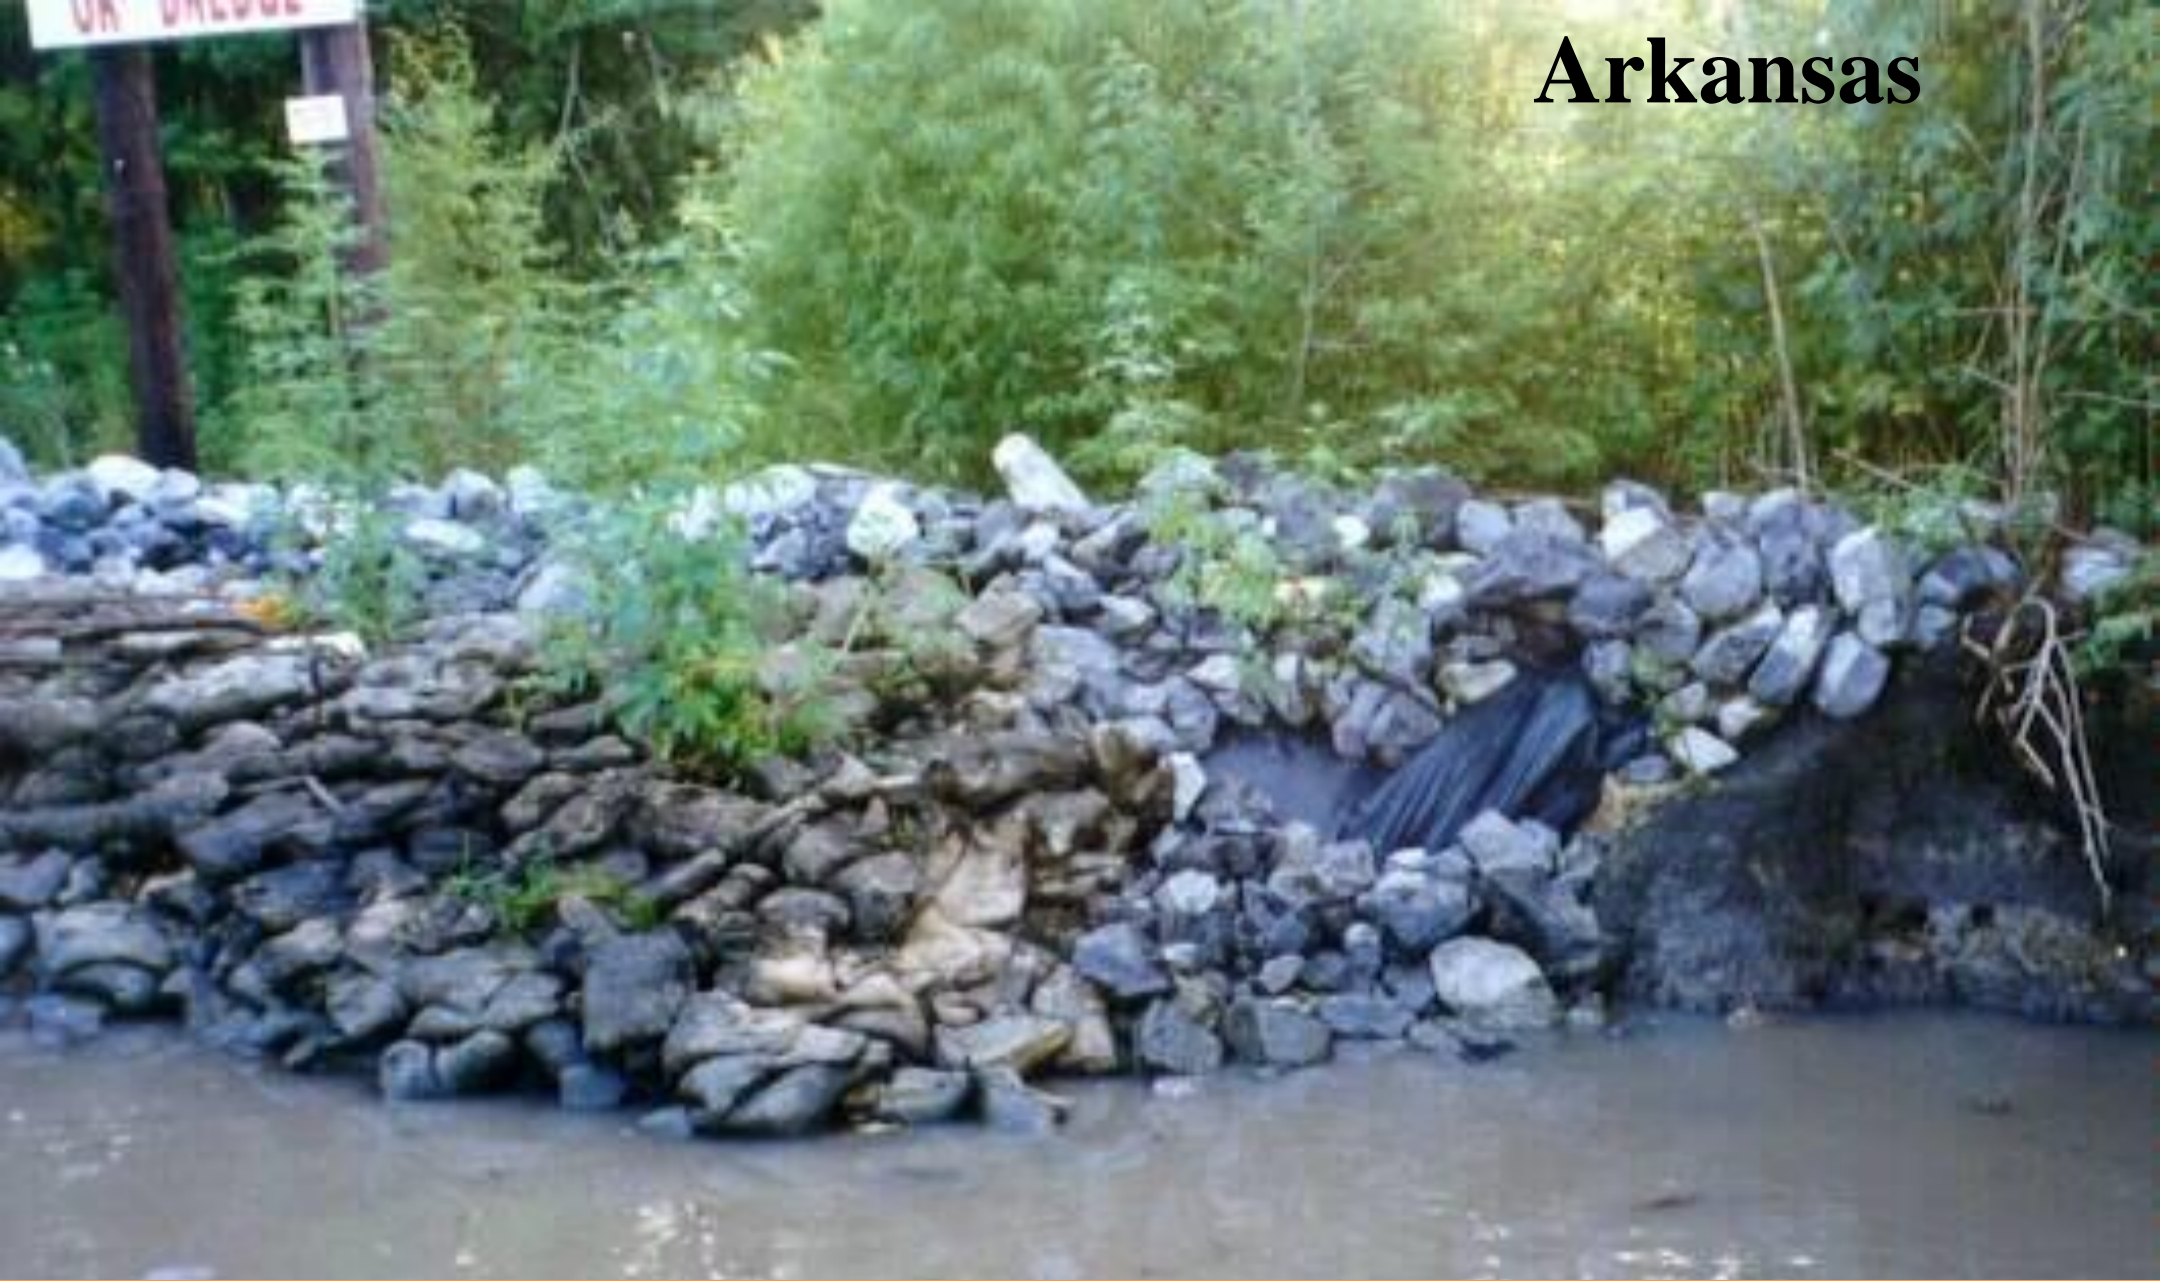
Arkansas

Filter fabric could prove problematic with over-launching of stone (shown), interferes with root architecture, plus roots can “run” on filter & open up overlaps

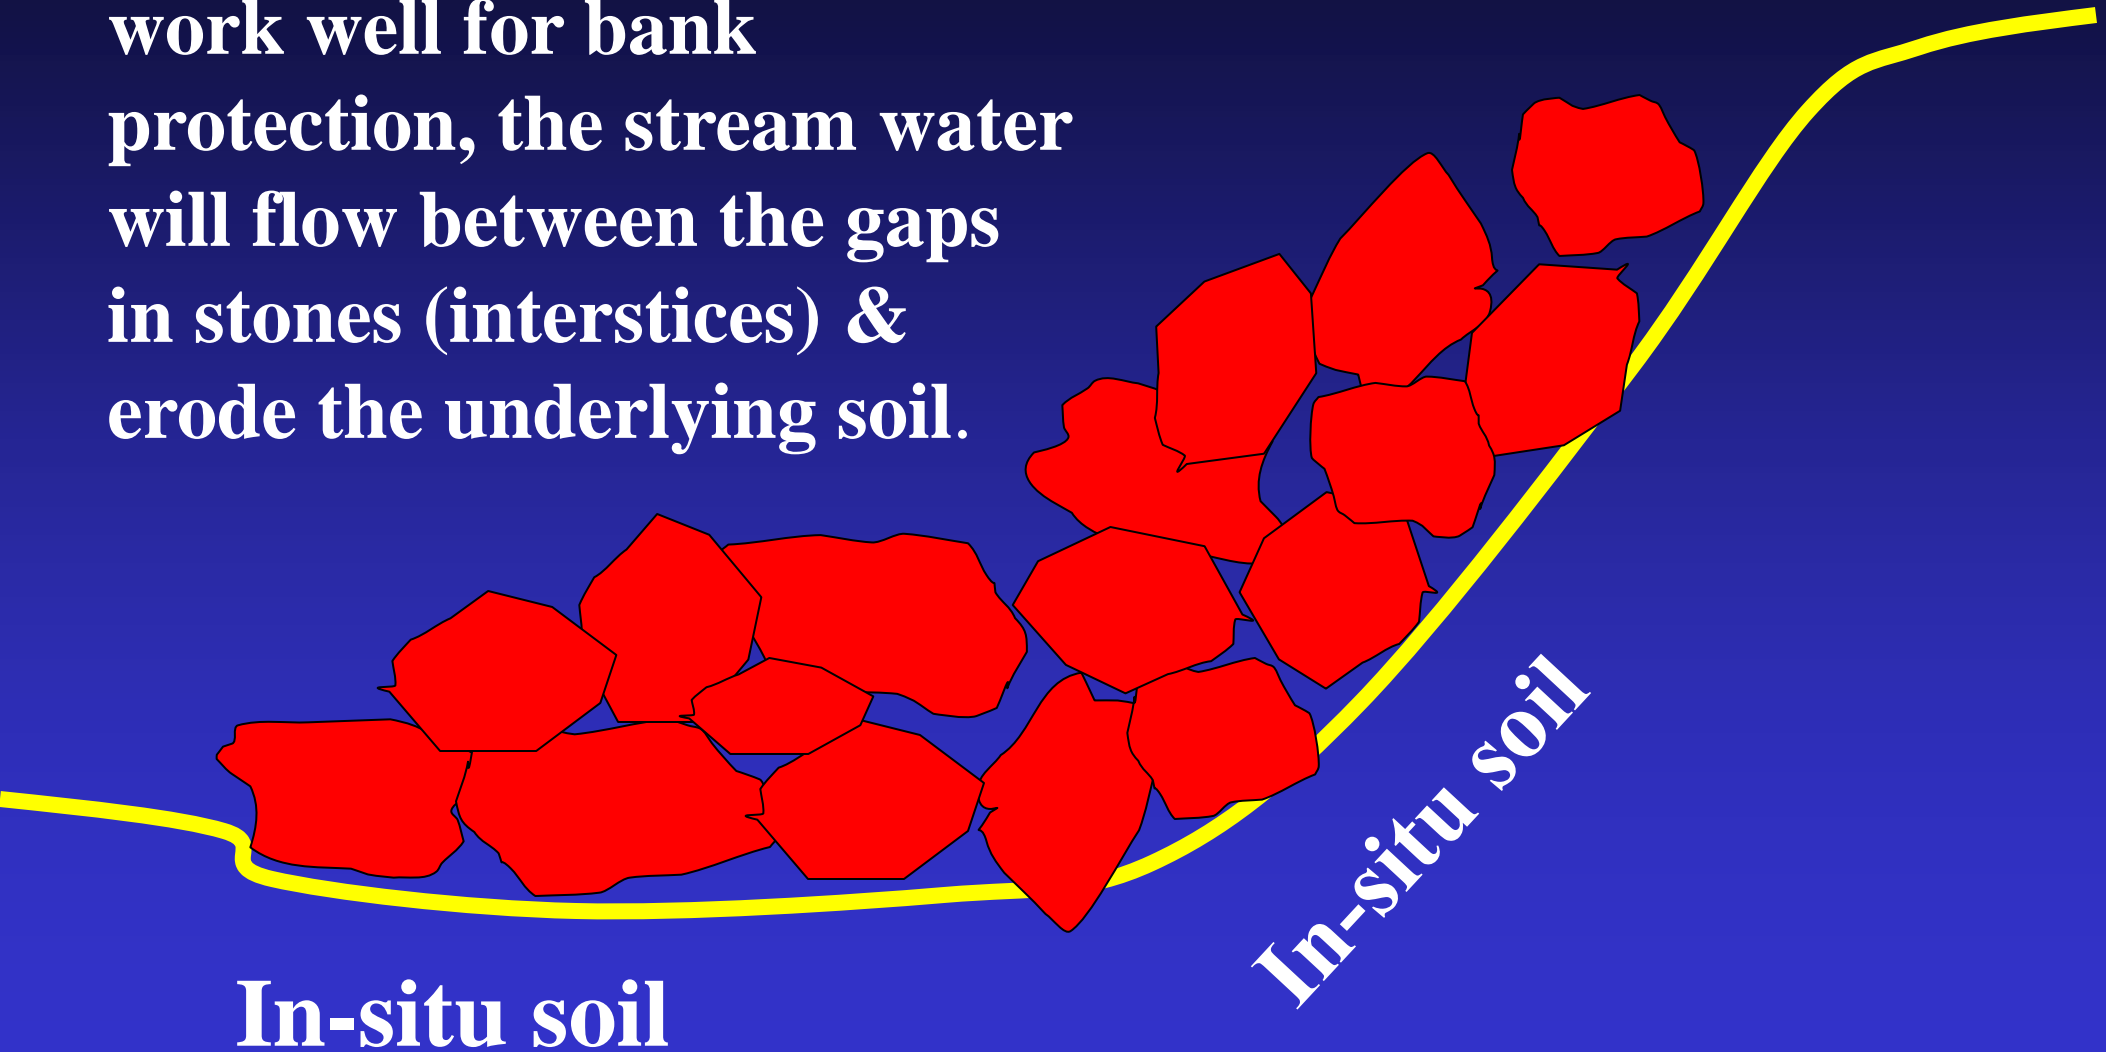
No filter with large stone

Big stones alone will not work well for bank protection, the stream water will flow between the gaps in stones (interstices) & erode the underlying soil.

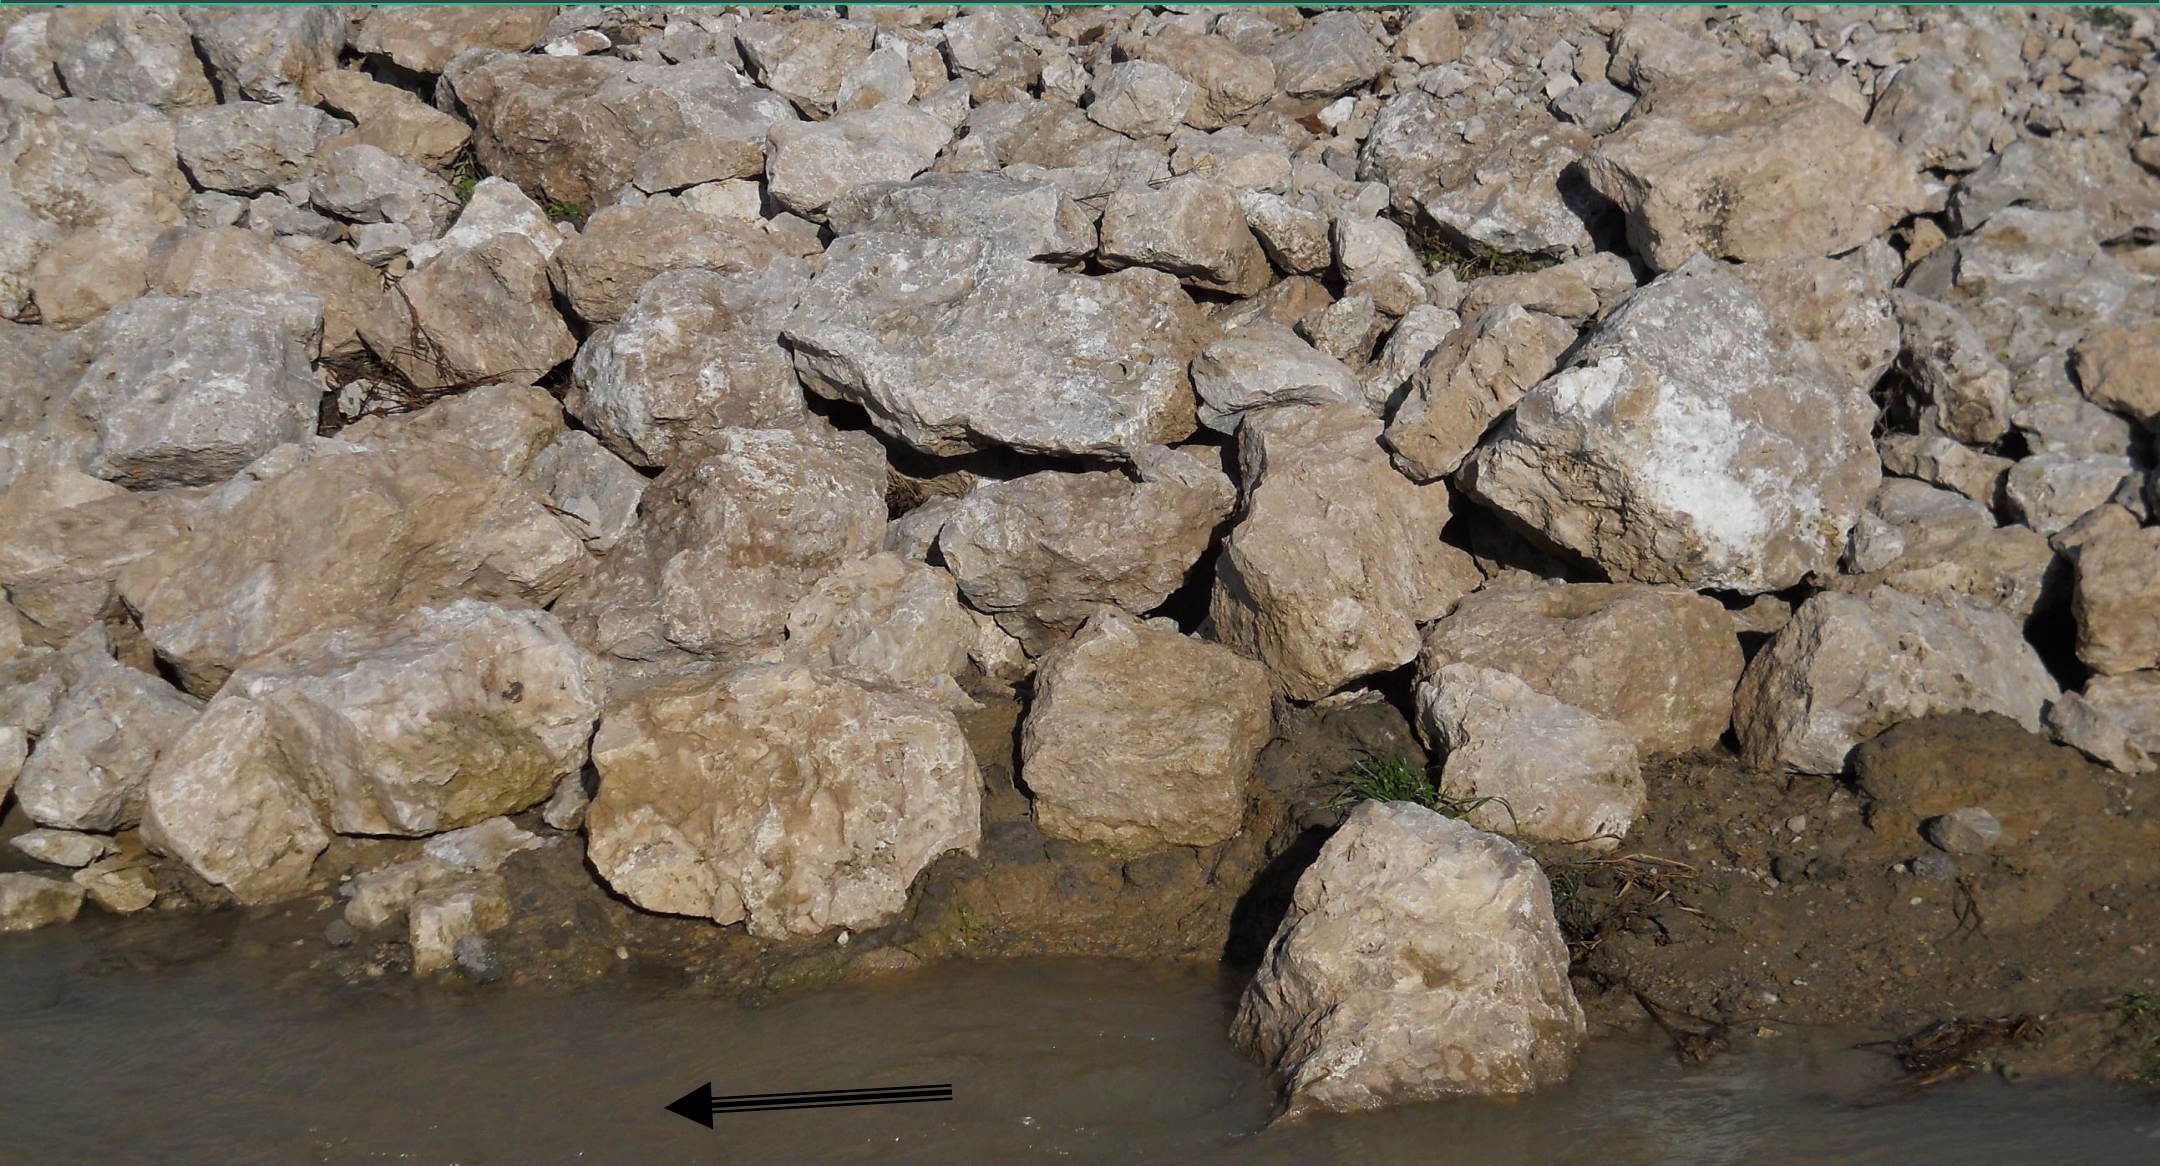
BIG DITCH – OREGON, OHIO - DERRICK 11-30-2011

Large stone as bridge protection. Voids will allow water to flow through & under stone protection. No filter size stone

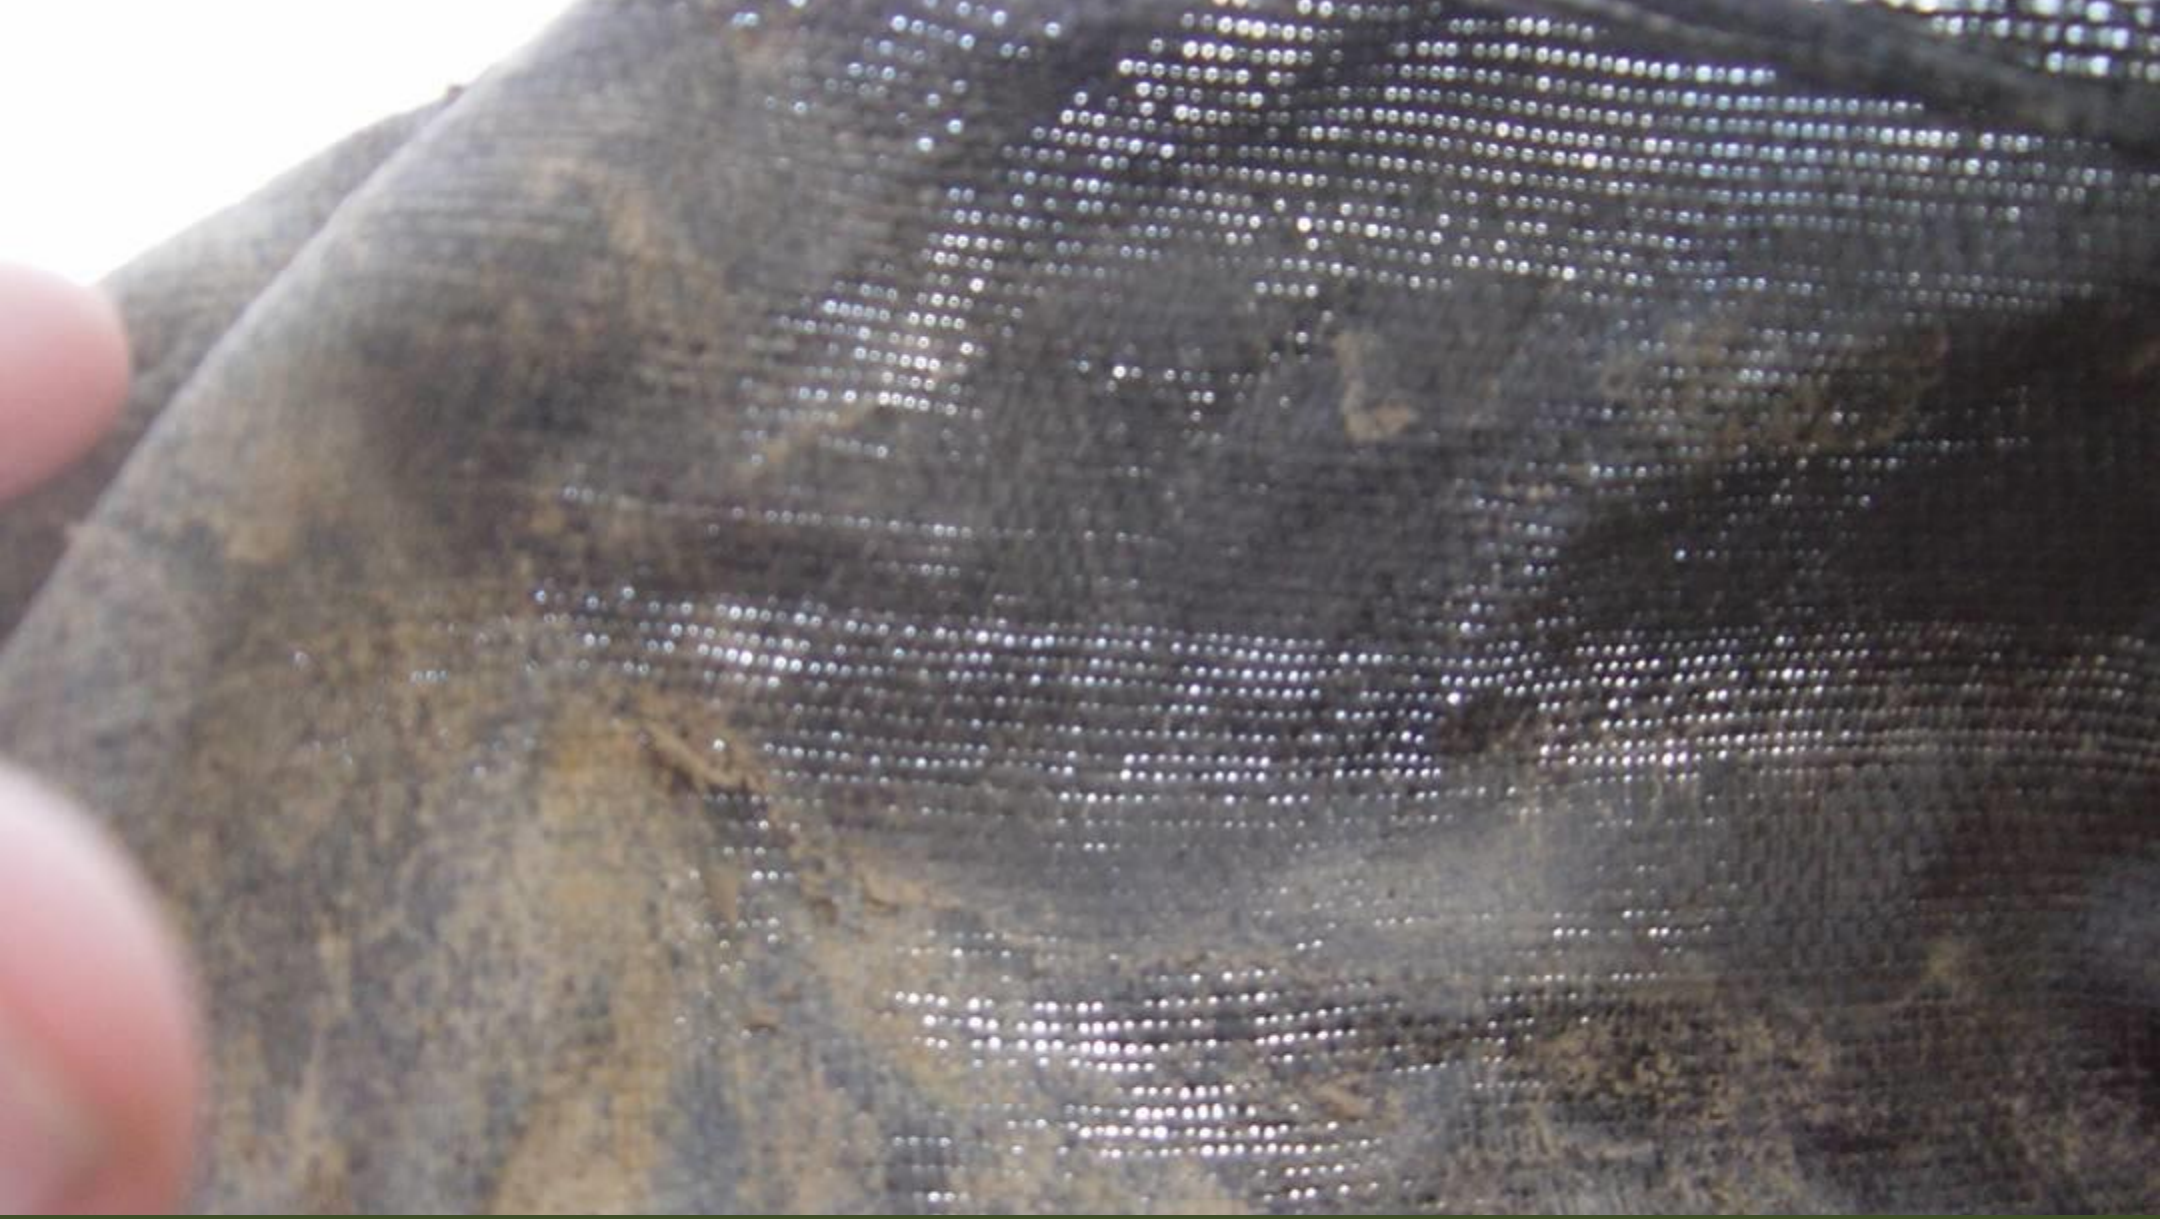
Woven filter, not blinded, sunshine visible through weave. Woven filters can sometimes be blinded from either the river or bank side

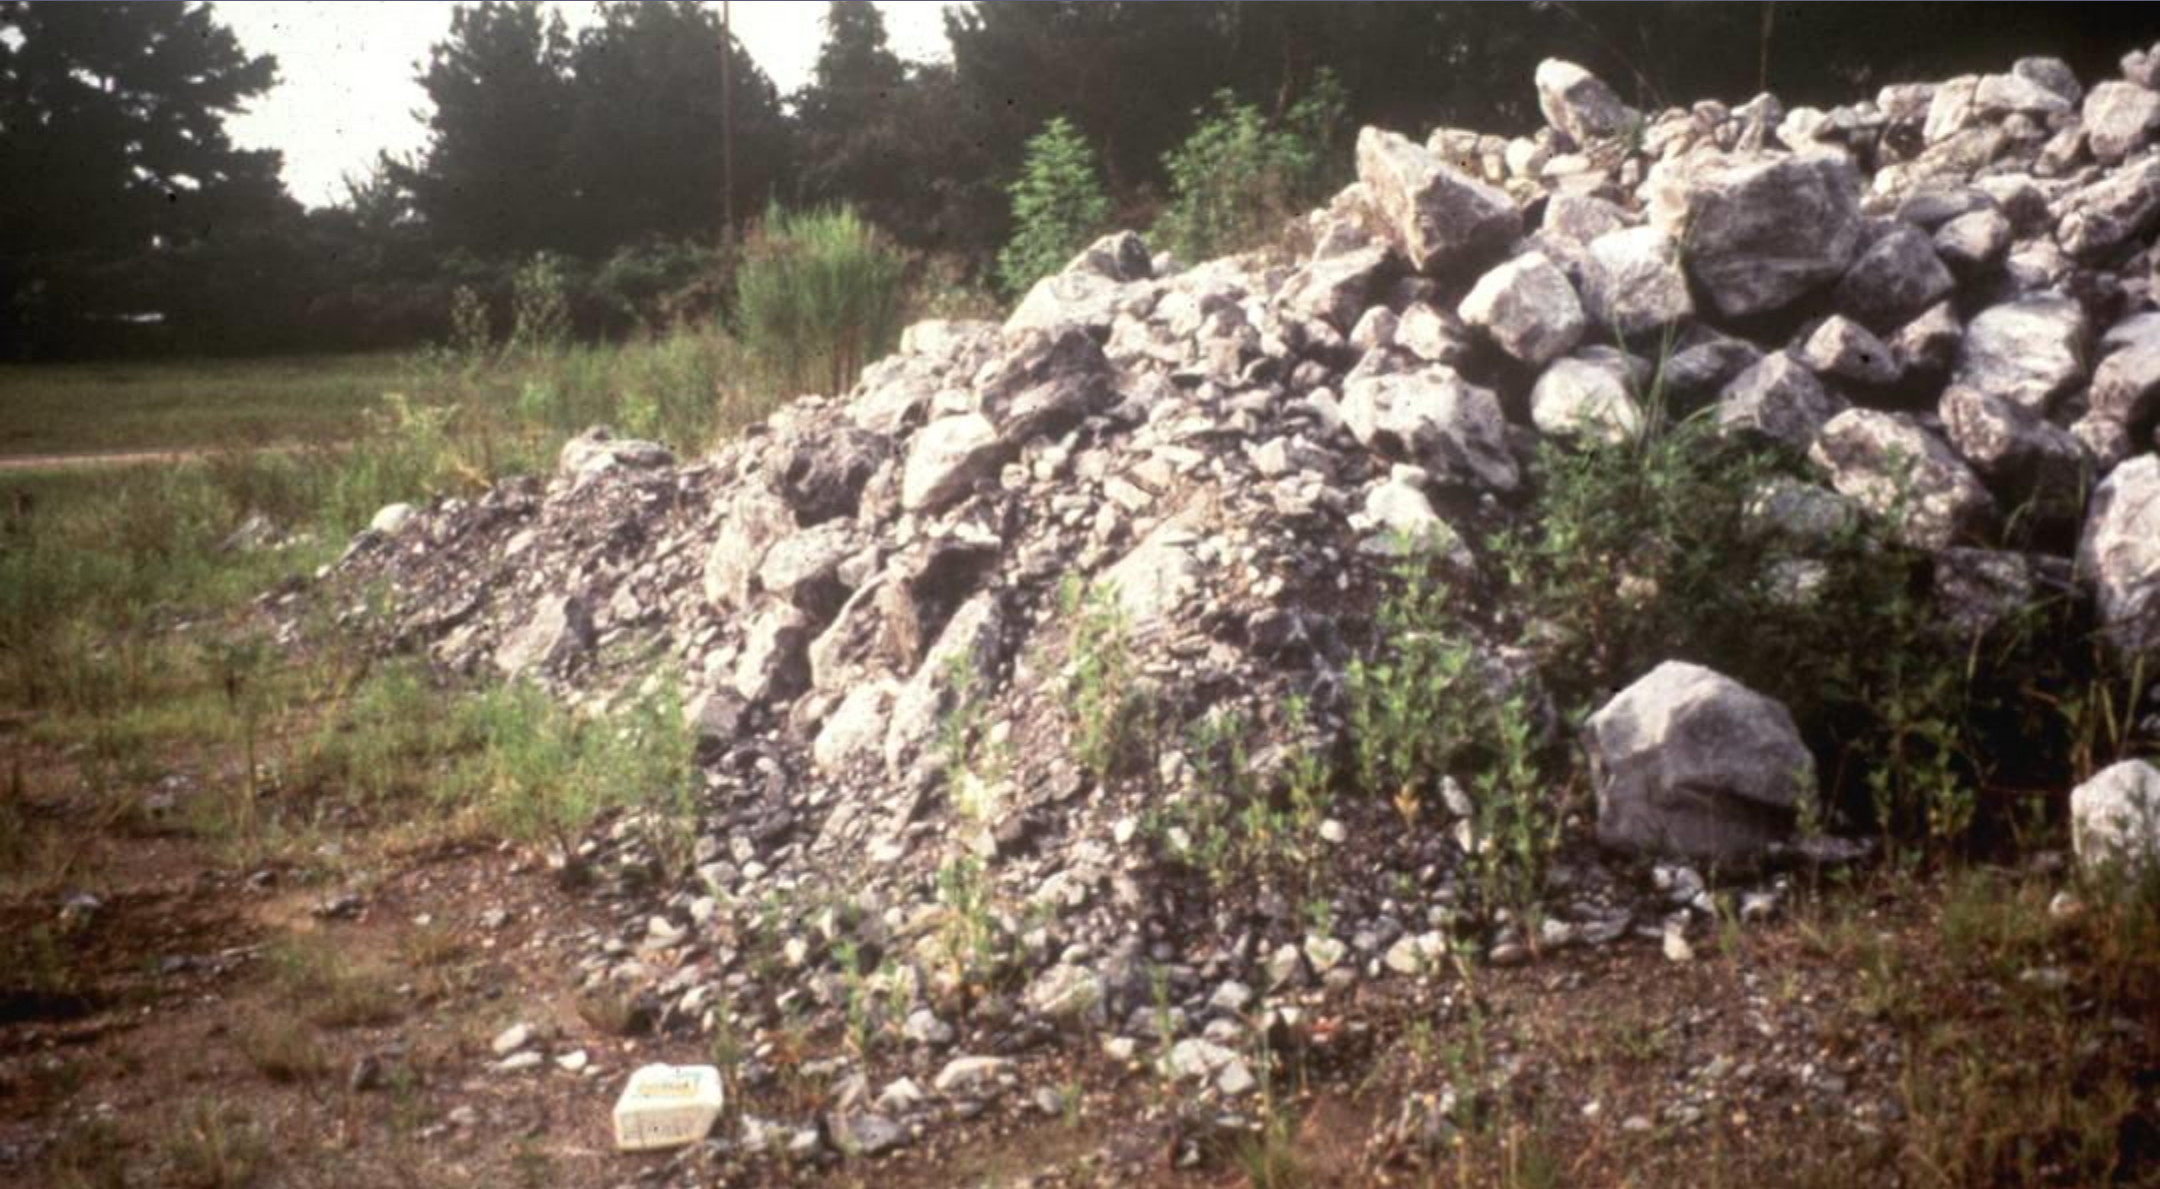
An ugly pile of rock!! Median of I-220, Jackson MS. Self filtering, in fact too many fines, but steep angle of repose shows that stone will not self-adjust. This is due to the lack of medium-sized stone (stone is not well graded).

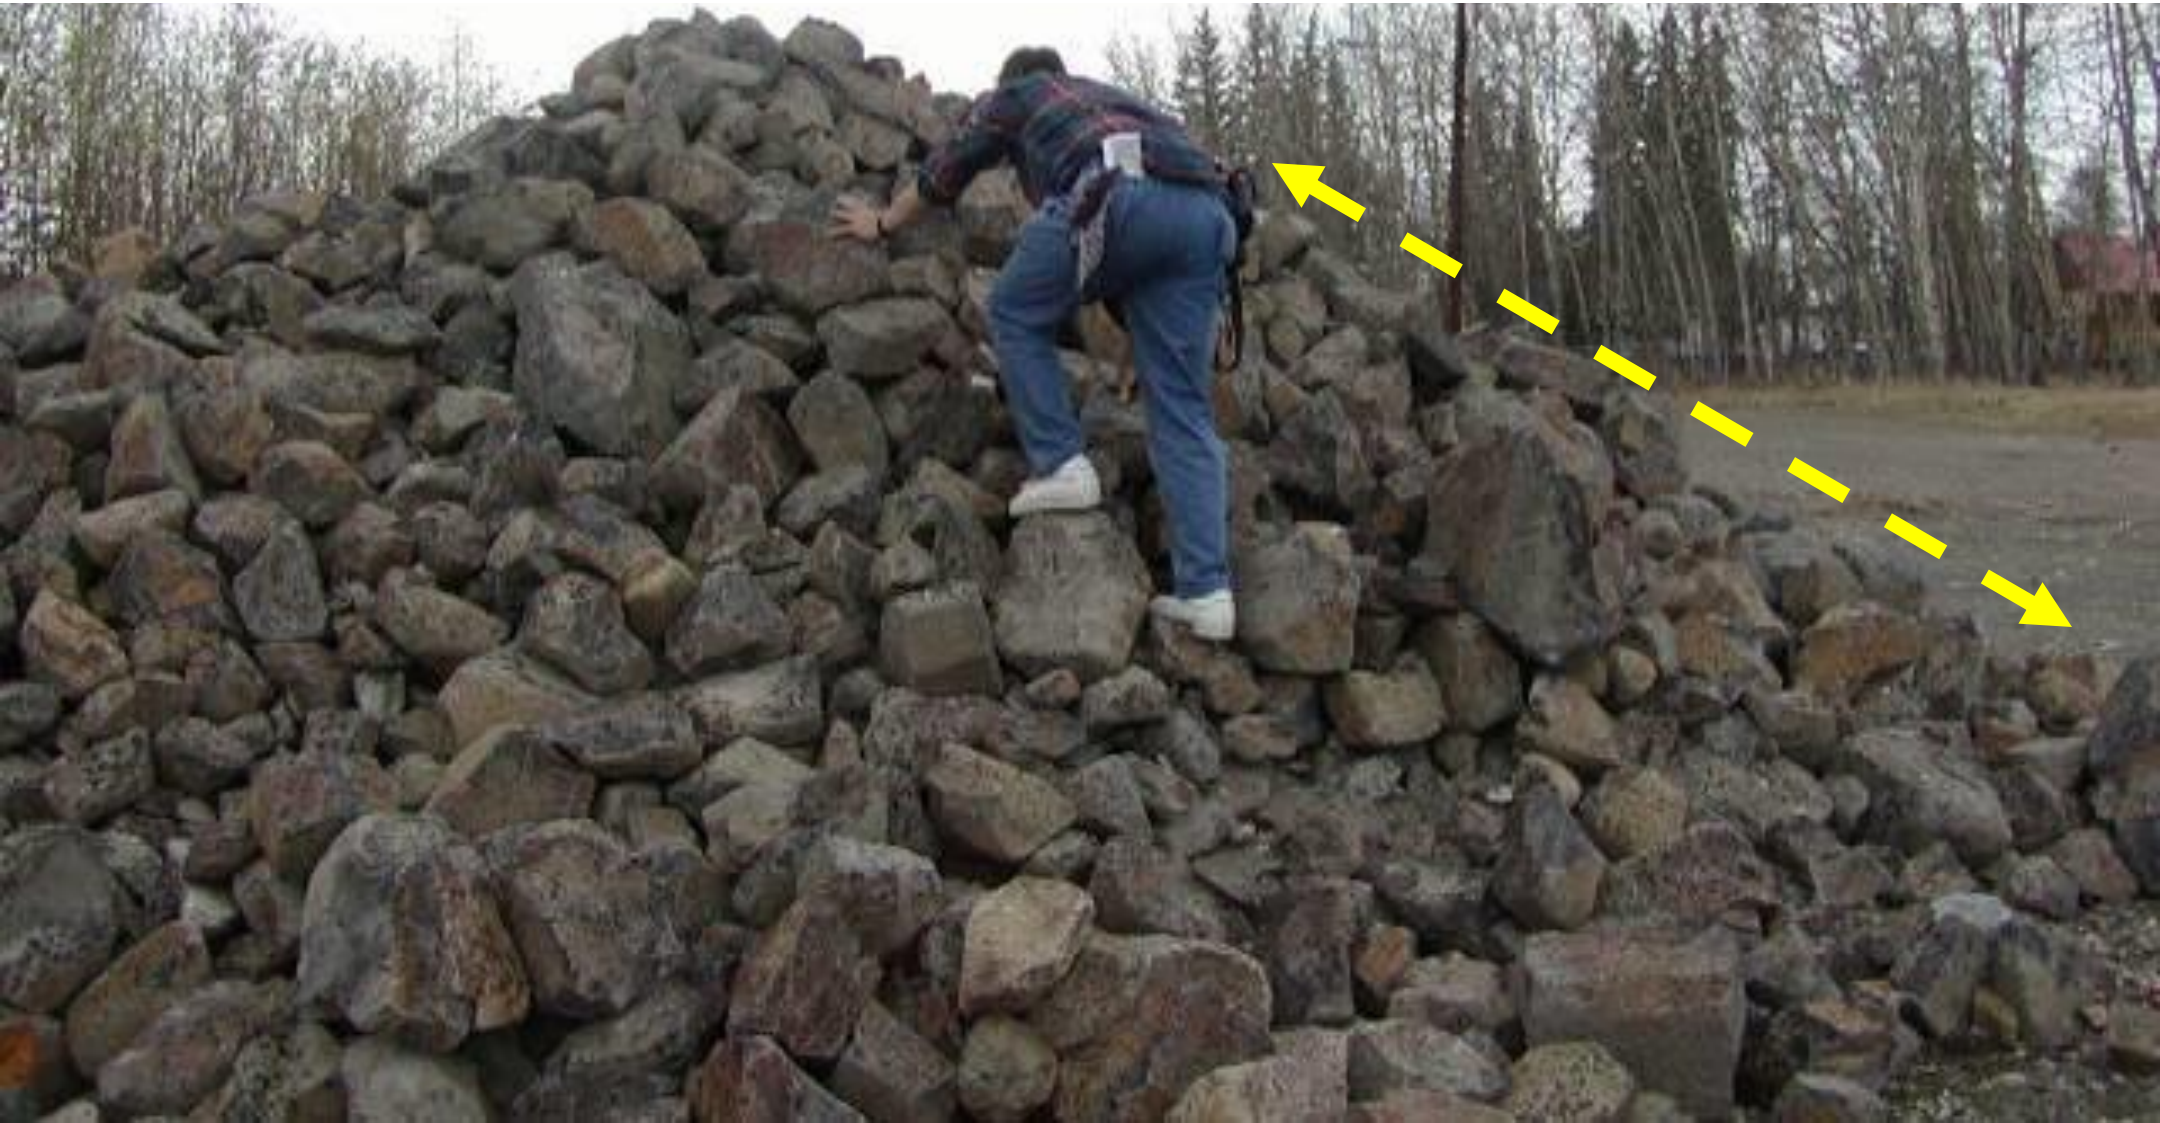
Medina Quarry, TX.

Analyze gradation, amount of “fines”, look at pile side slopes (flatter is better). Climb the pile, if it moves that is the stone you need. This is well graded stone, note flat angle of pile

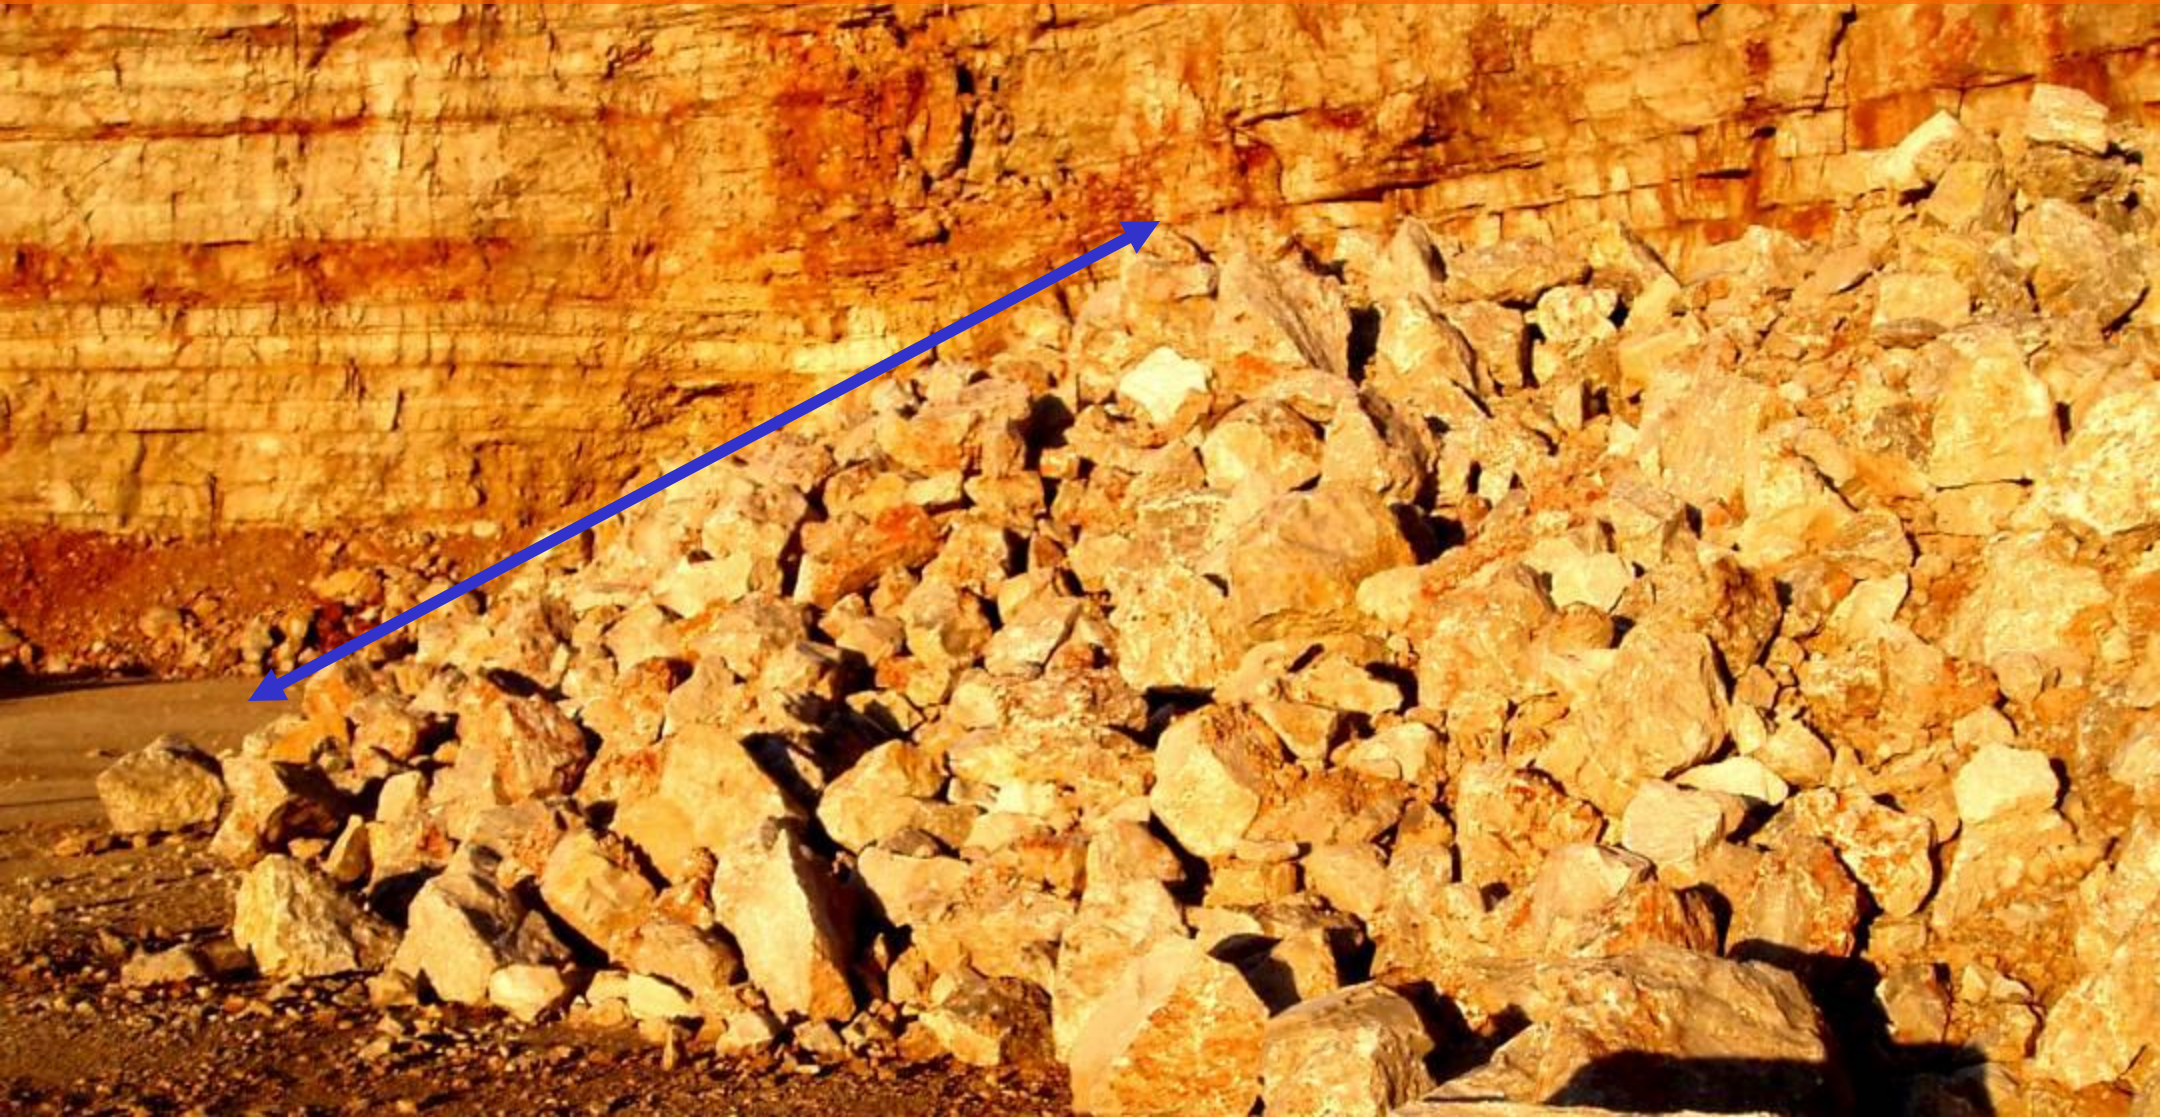
**Better looking stone, *note flat pile*, Medina Quarry, TX.
We mixed the two piles of stone from the previous picture
to come up with a well-graded stone that will self-adjust.**

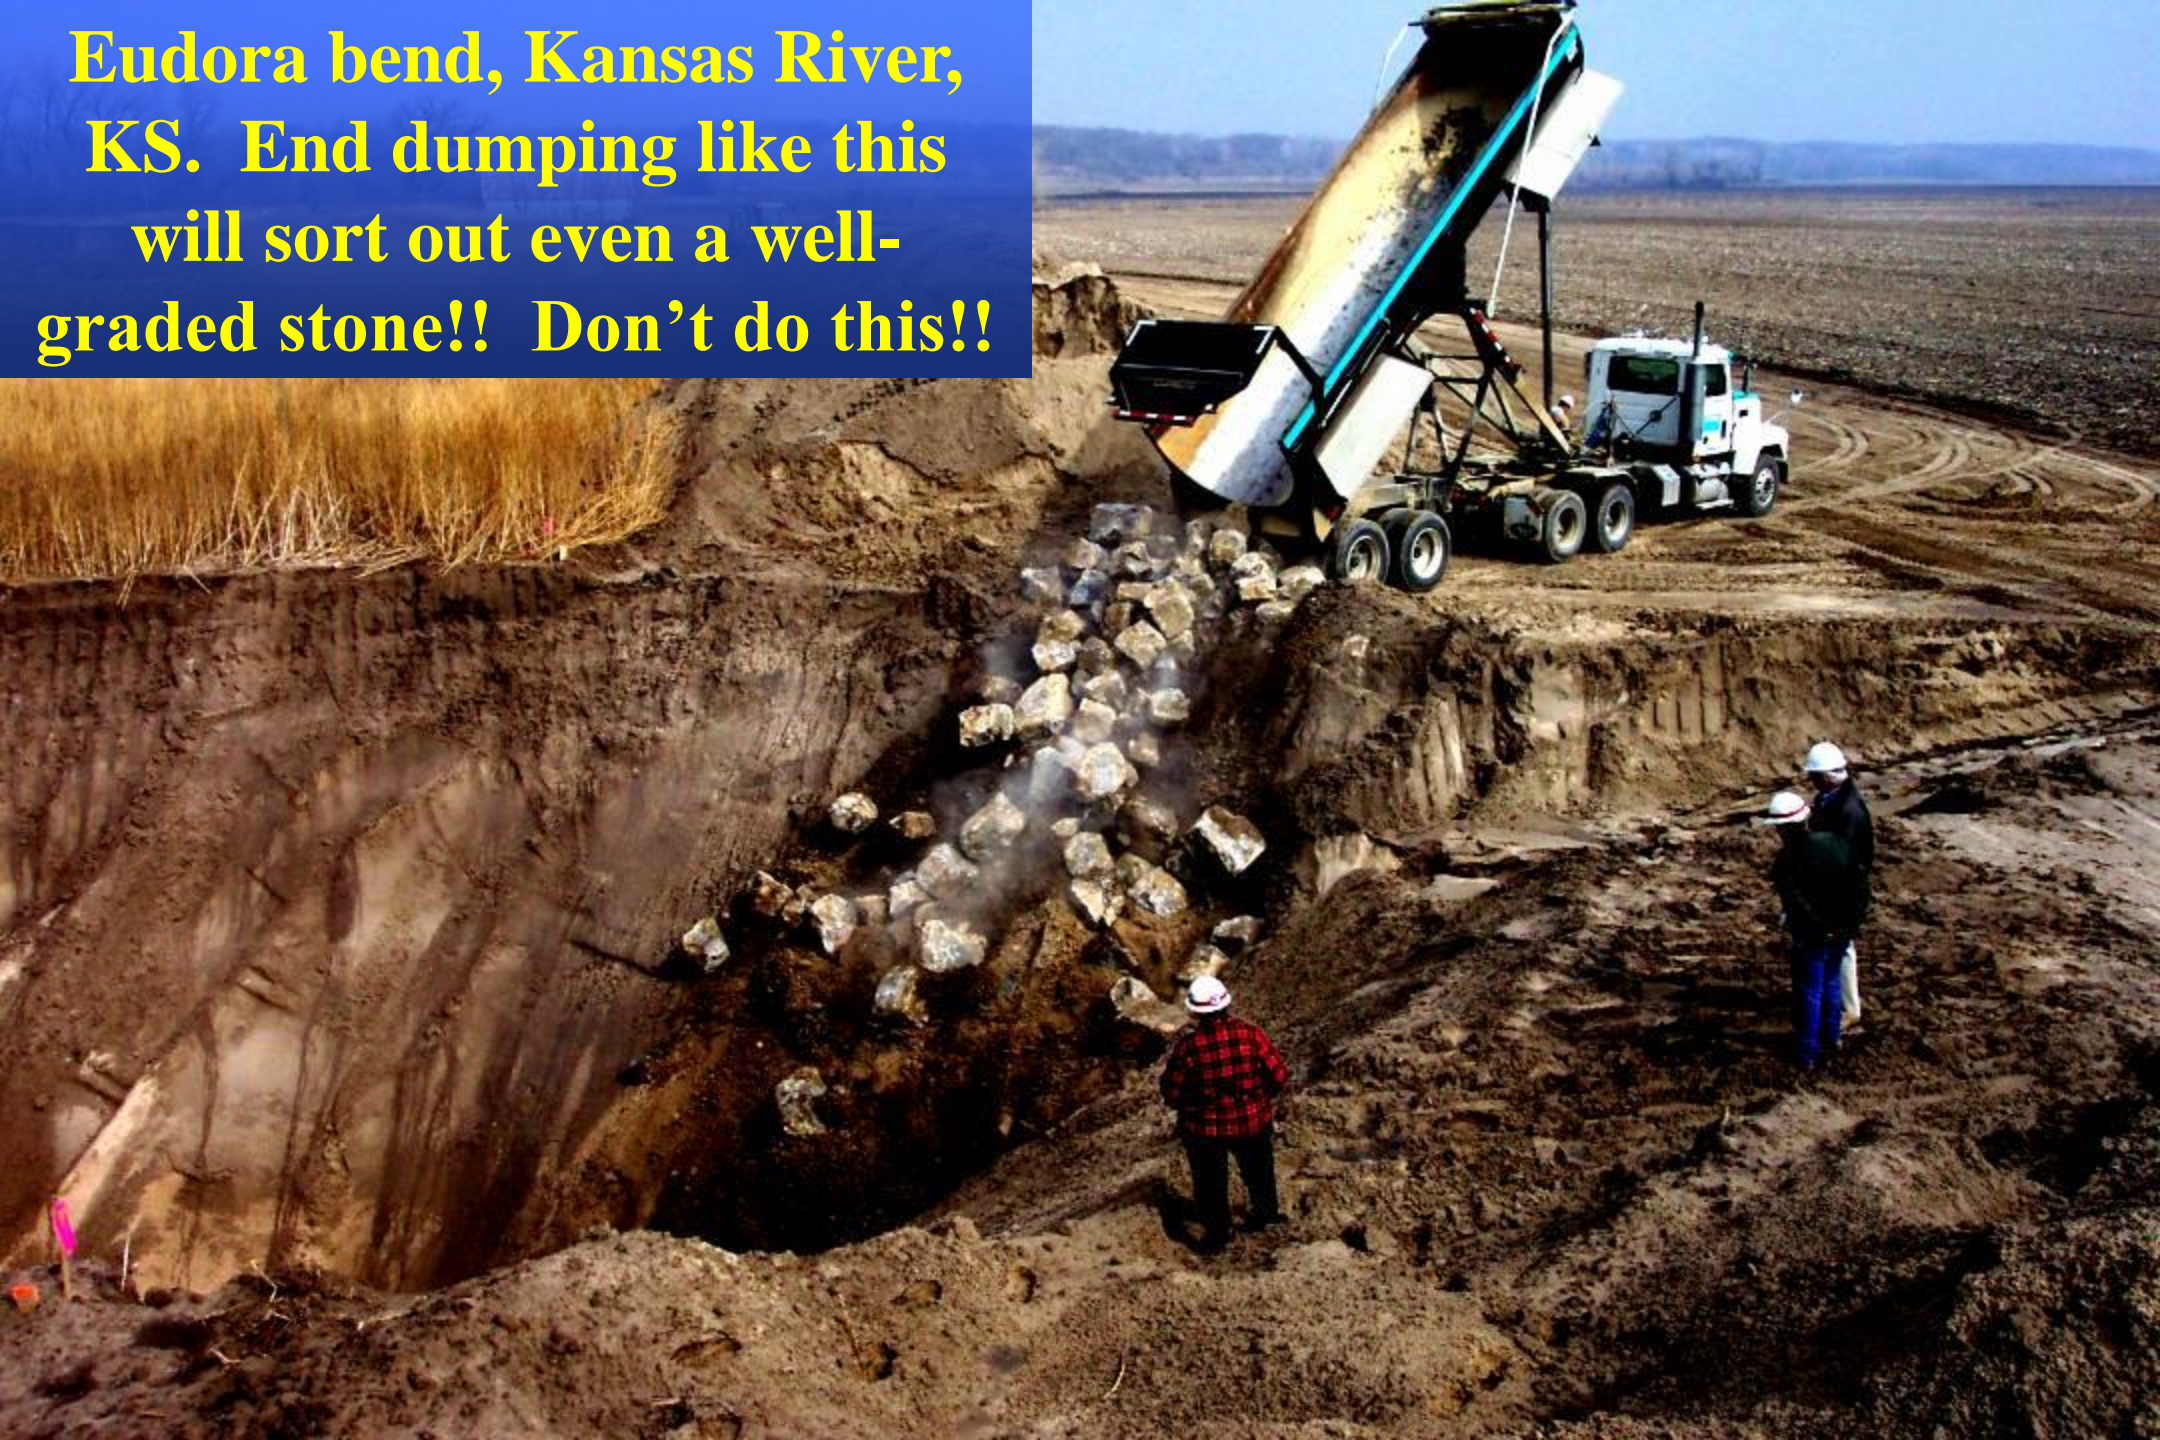
**Eudora bend, Kansas River,
KS. End dumping like this
will sort out even a well-
graded stone!! Don't do this!!**
