**COMBINATIONS OF RESISTIVE
& REDIRECTIVE METHODS:
CASE STUDY- Duck Creek East of
Eastern Avenue, Davenport, Iowa
Constructed June-July. 2008**

**Longitudinal Peaked Stone Toe
Protection {LFSTP} with interspaced
Short Bendway Weirs & Locked Logs**

LONGITUDINAL PEAKED STONE TOE PROTECTION {LPSTP}

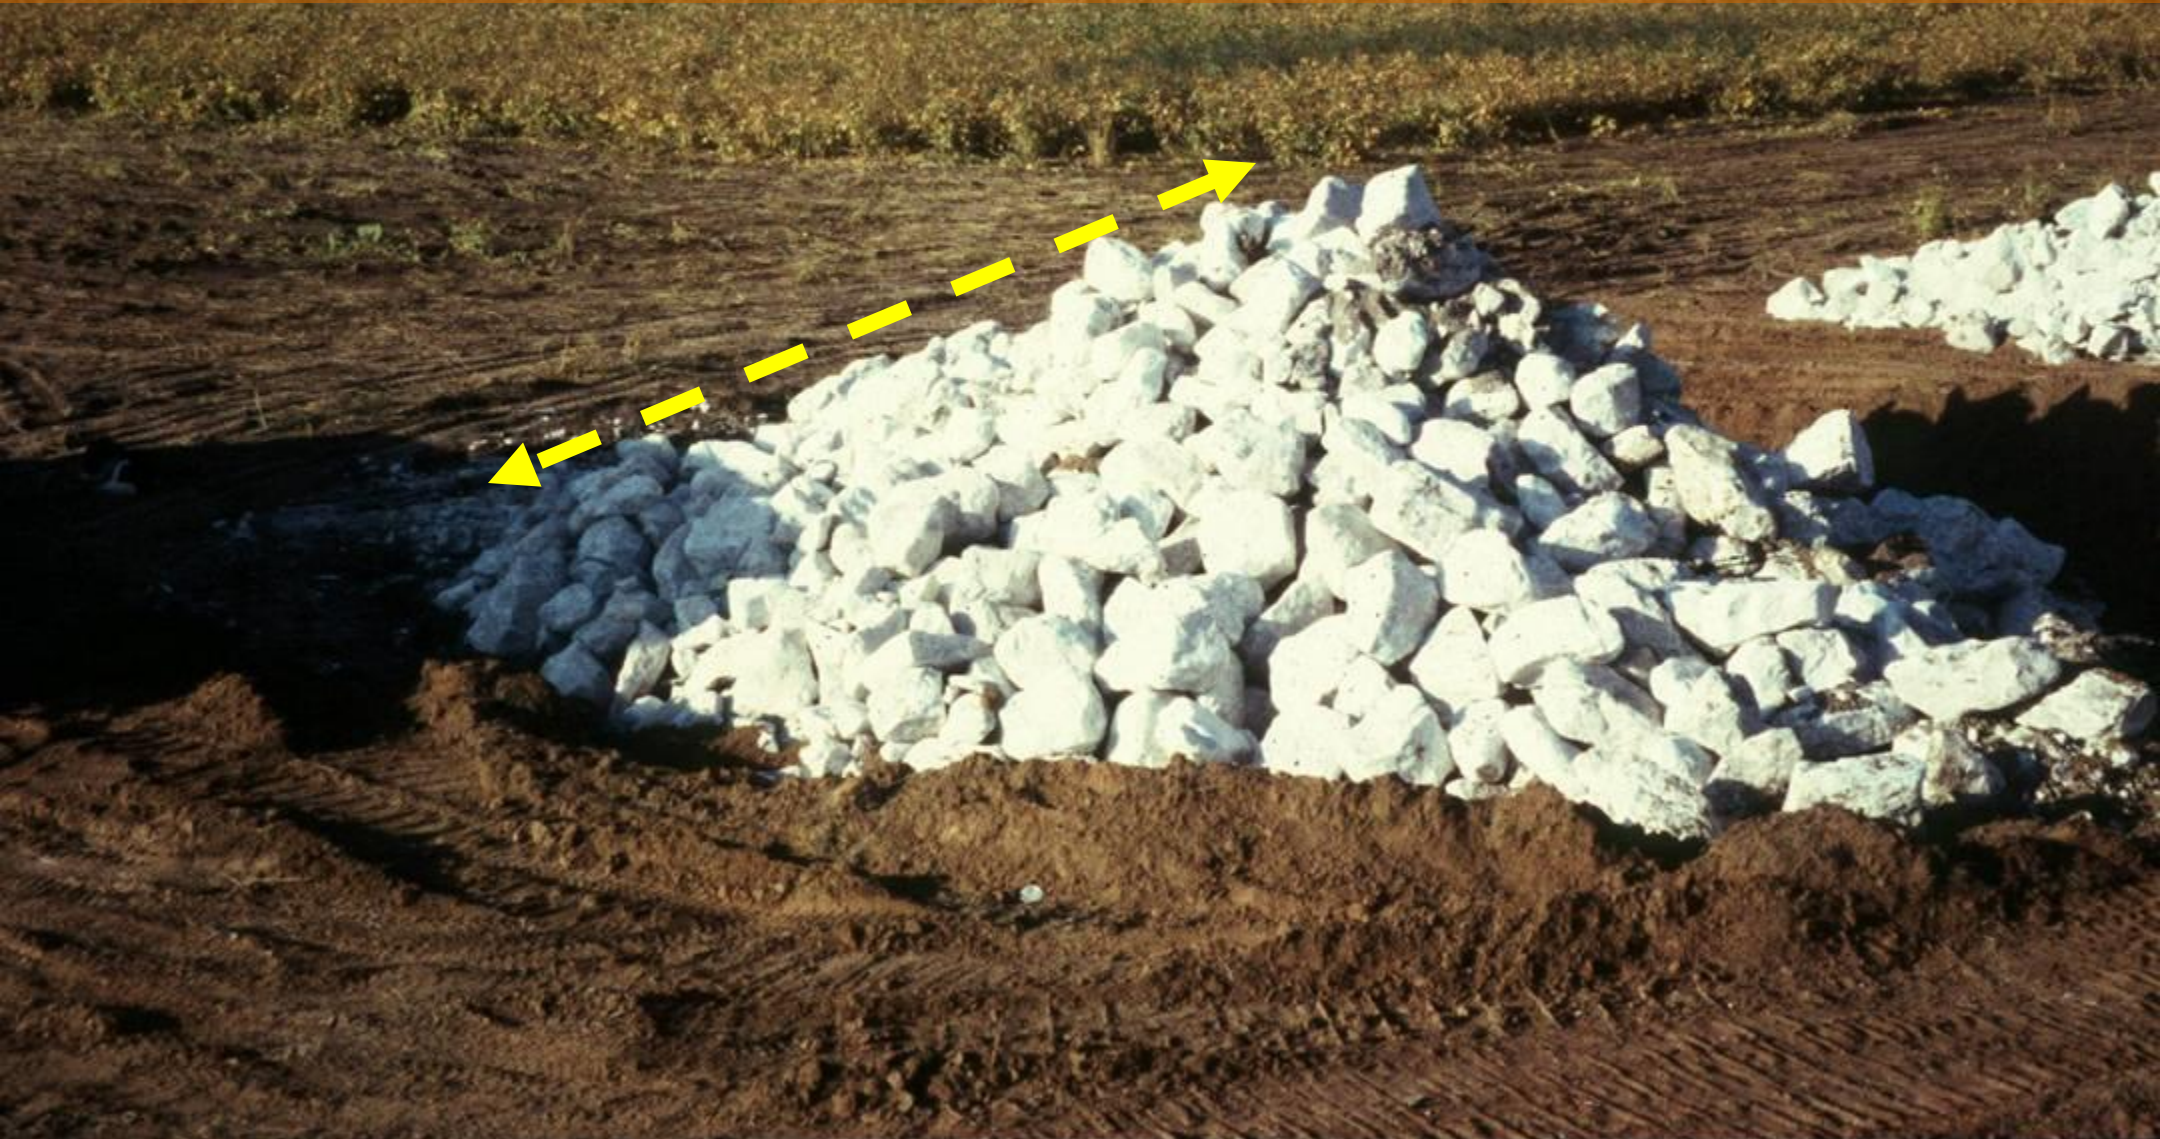
Well-graded stone, but few fines, for Skunk River project, Denmark, IA. To effectively use this stone we installed a granular filter of 1 to 3 inch stone, then installed this stone.

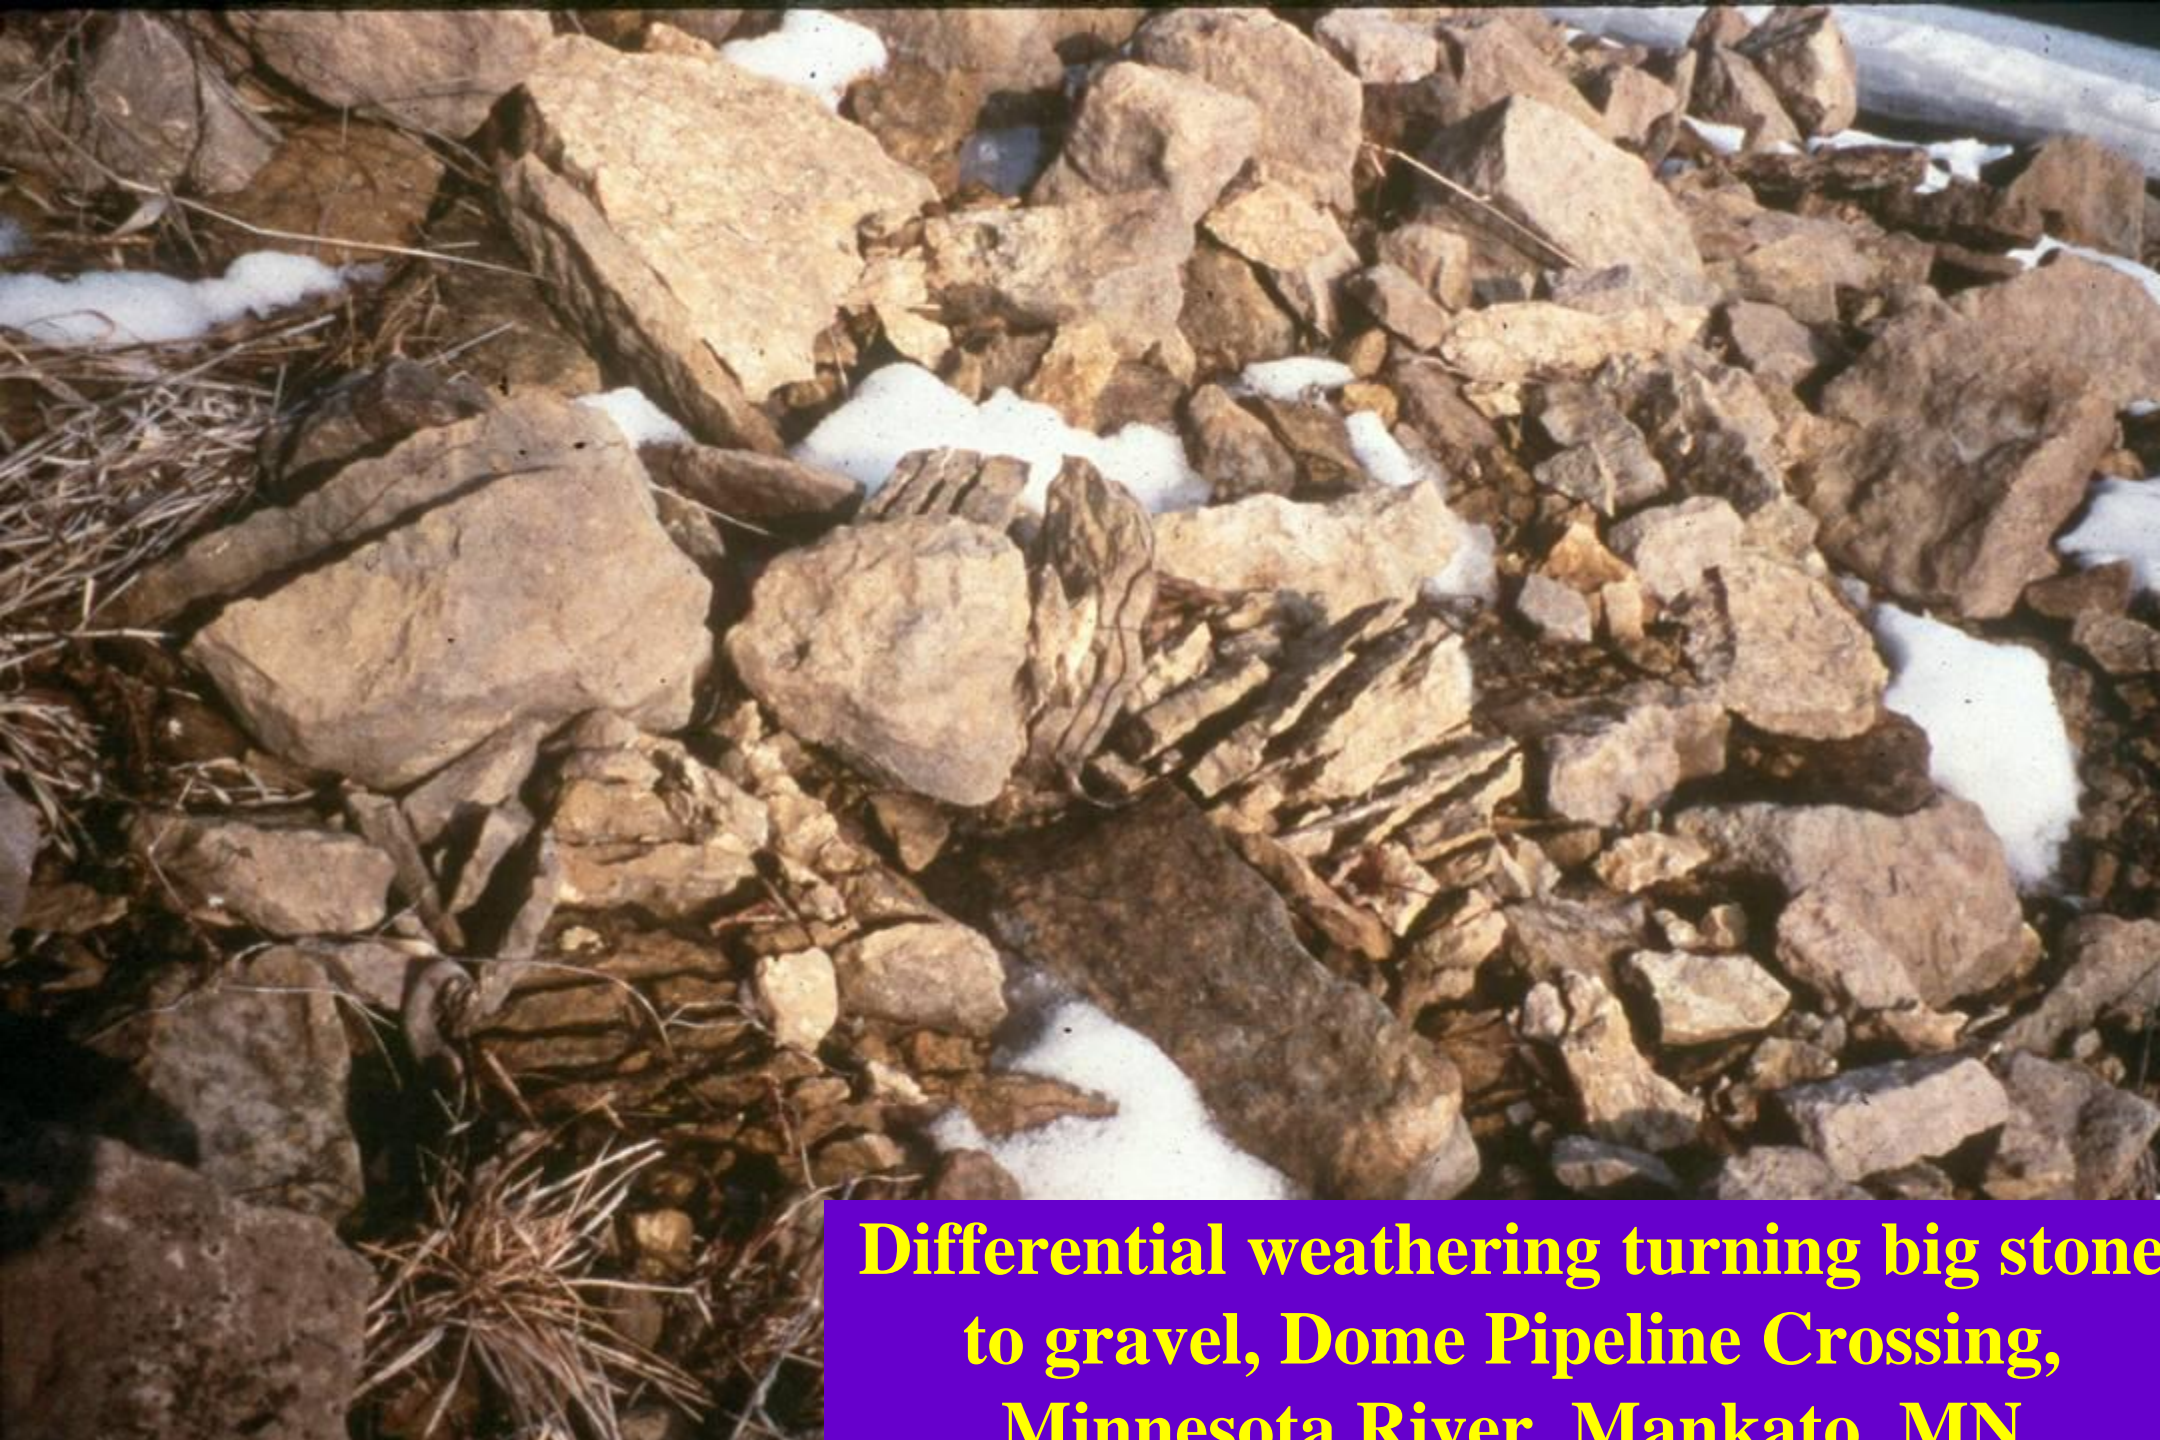
**Differential weathering turning big stone
to gravel, Dome Pipeline Crossing,
Minnesota River Mankato, MN**

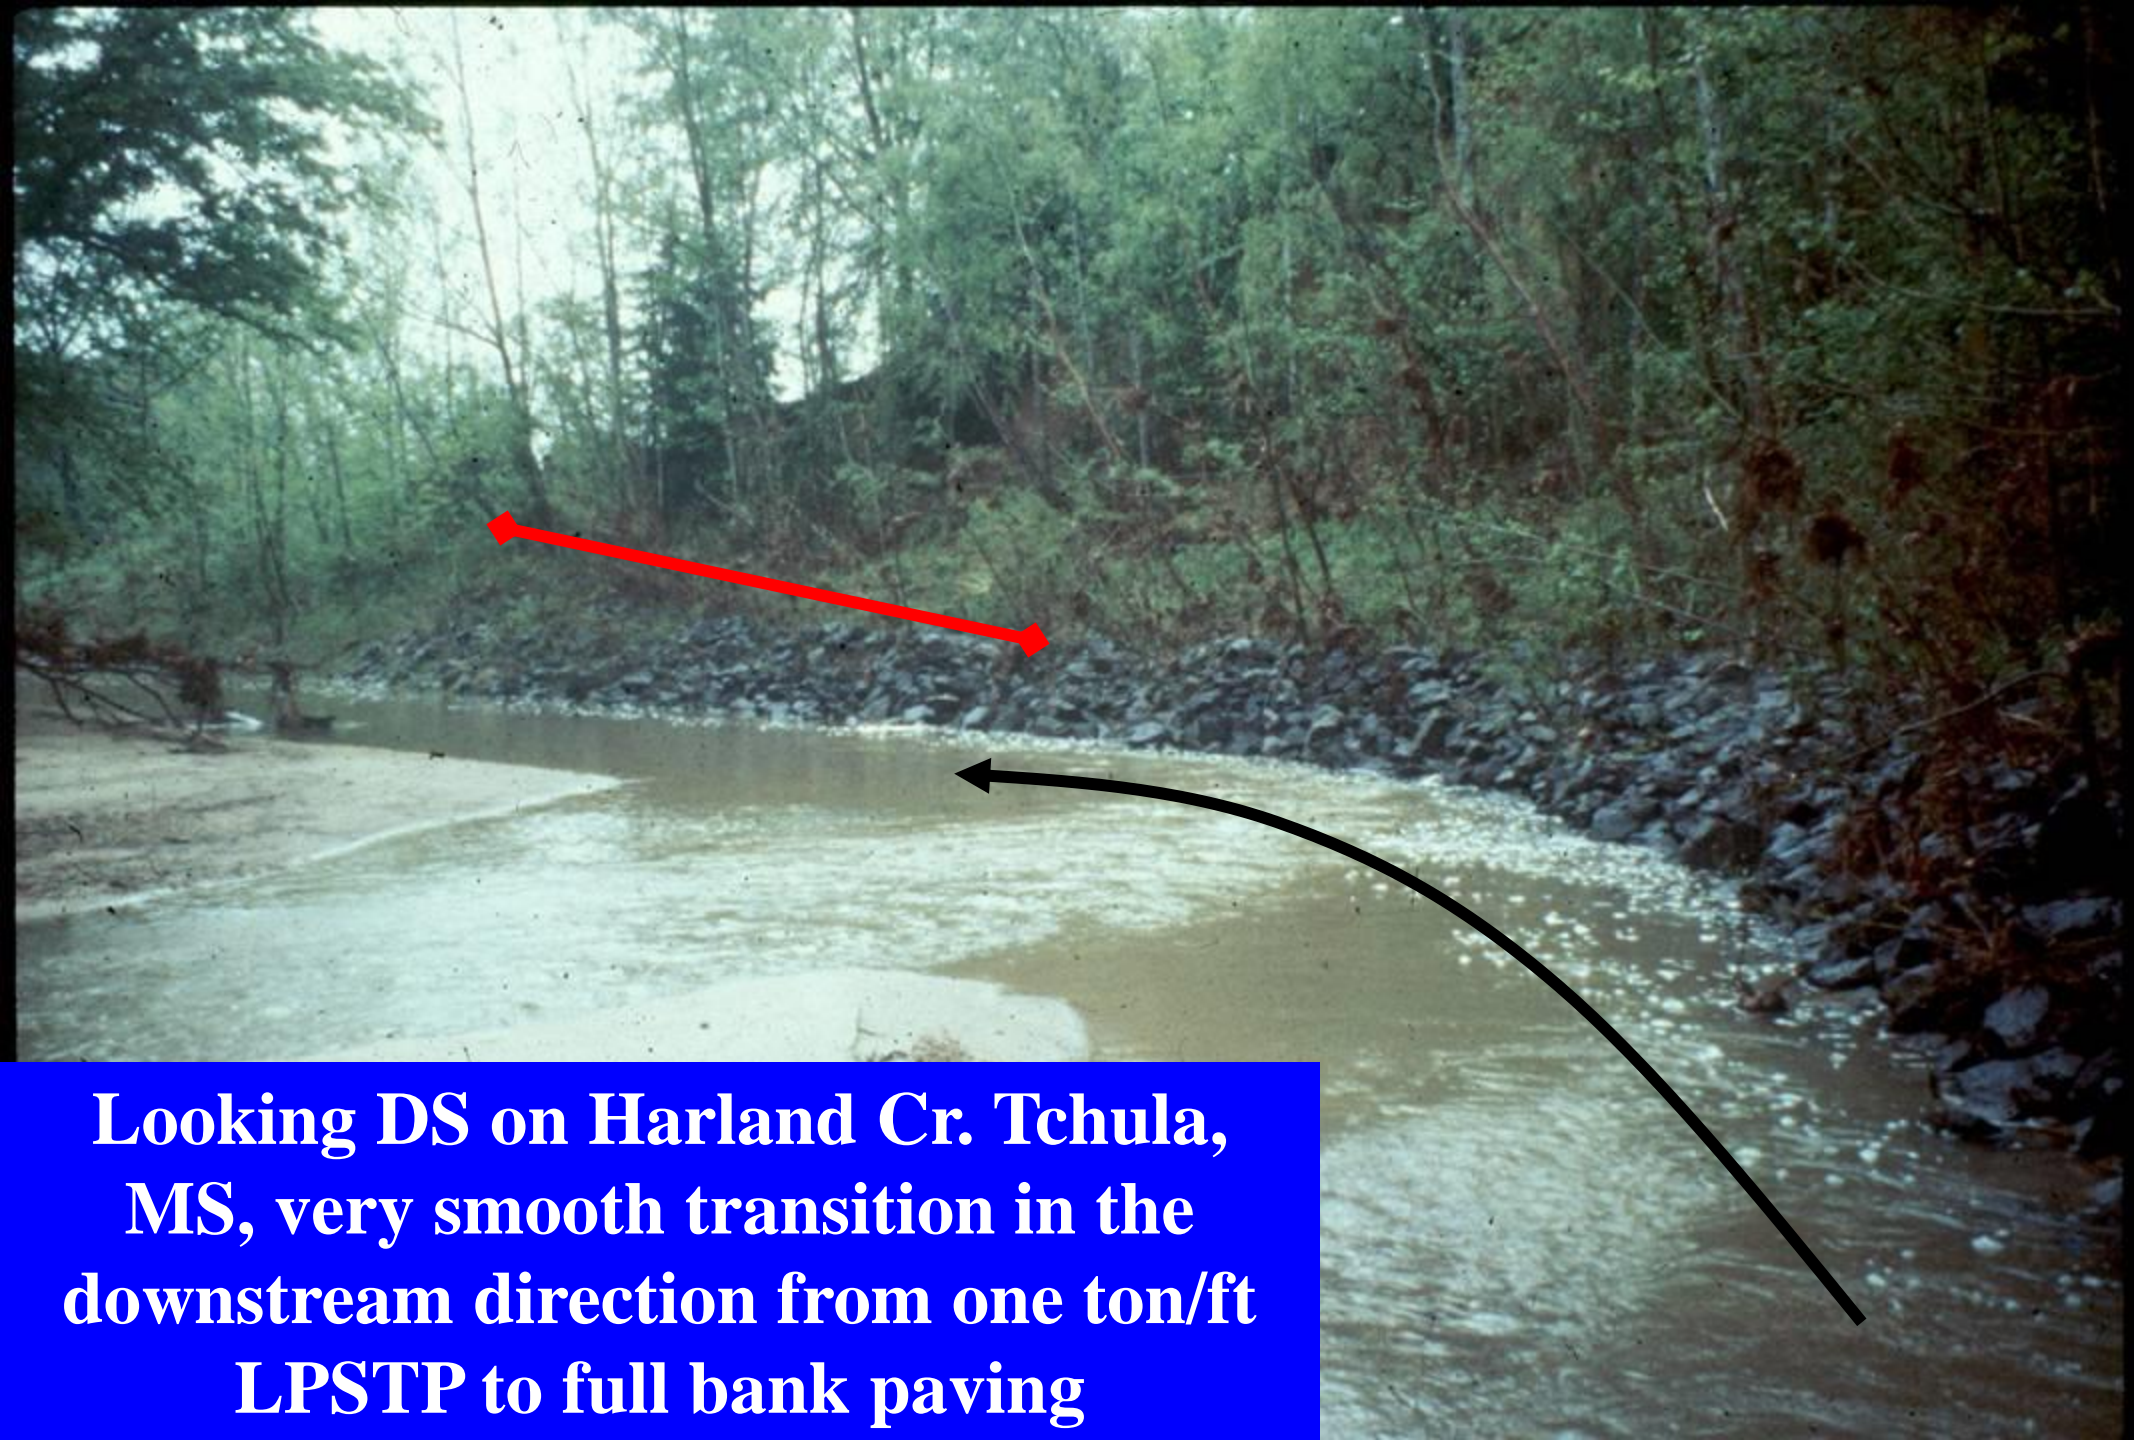
**Transitioning from LPSTP to full
bank paving**

**Looking DS on Harland Cr. Tchula,
MS, very smooth transition in the
downstream direction from one ton/ft
LPSTP to full bank paving**

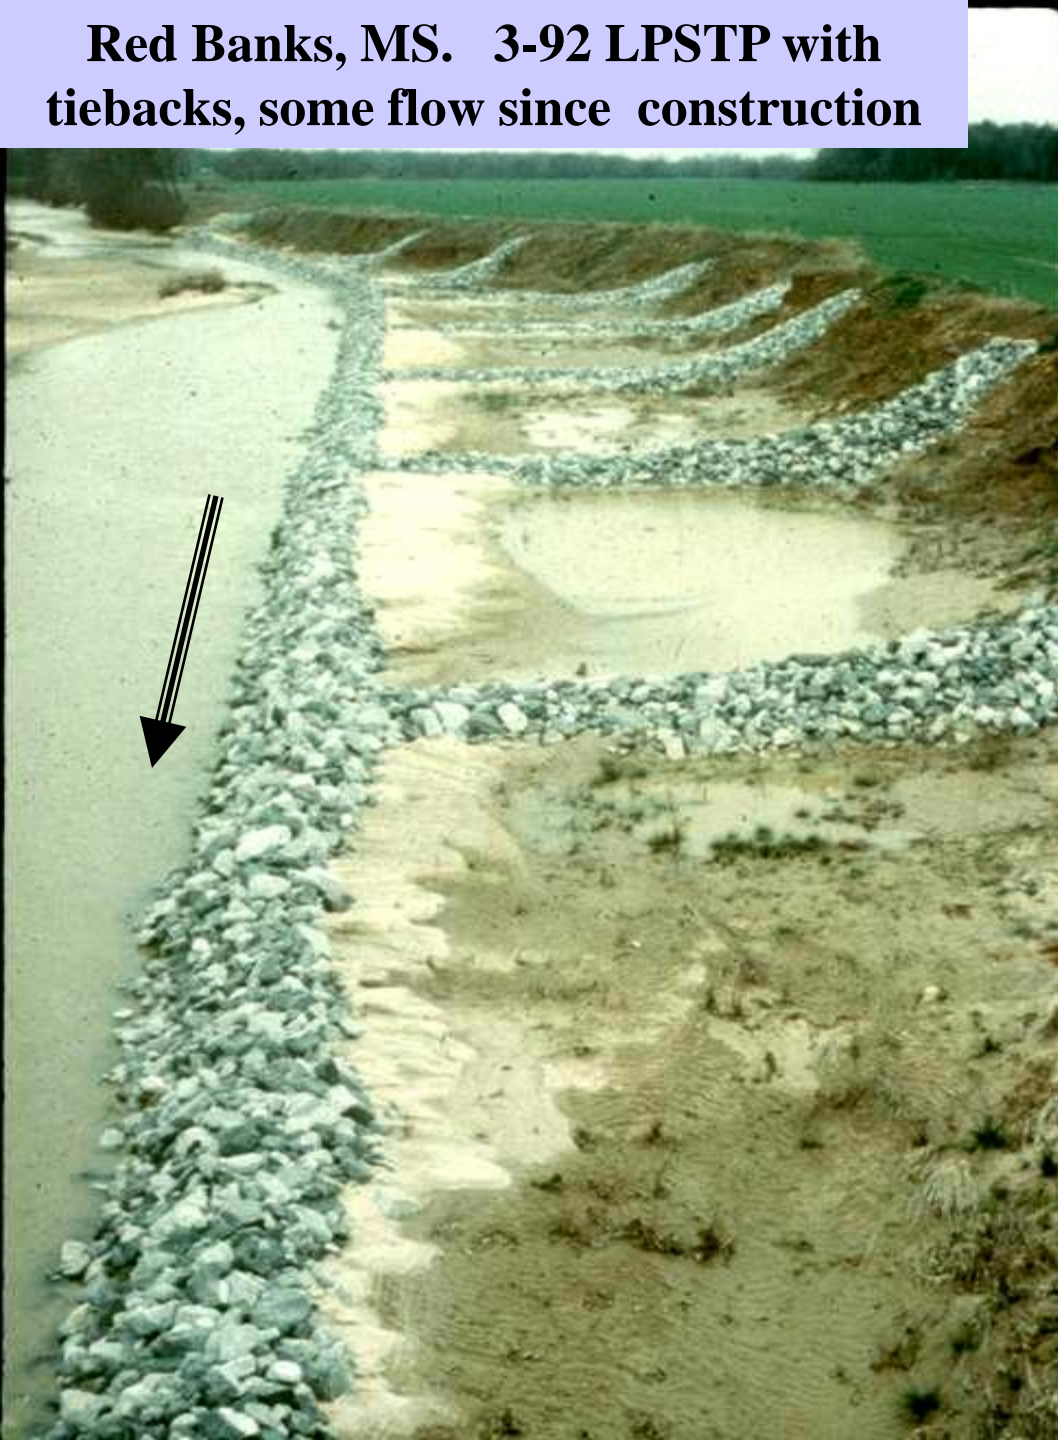
Red Banks, MS. 3-92 LPSTP with tiebacks, some flow since construction

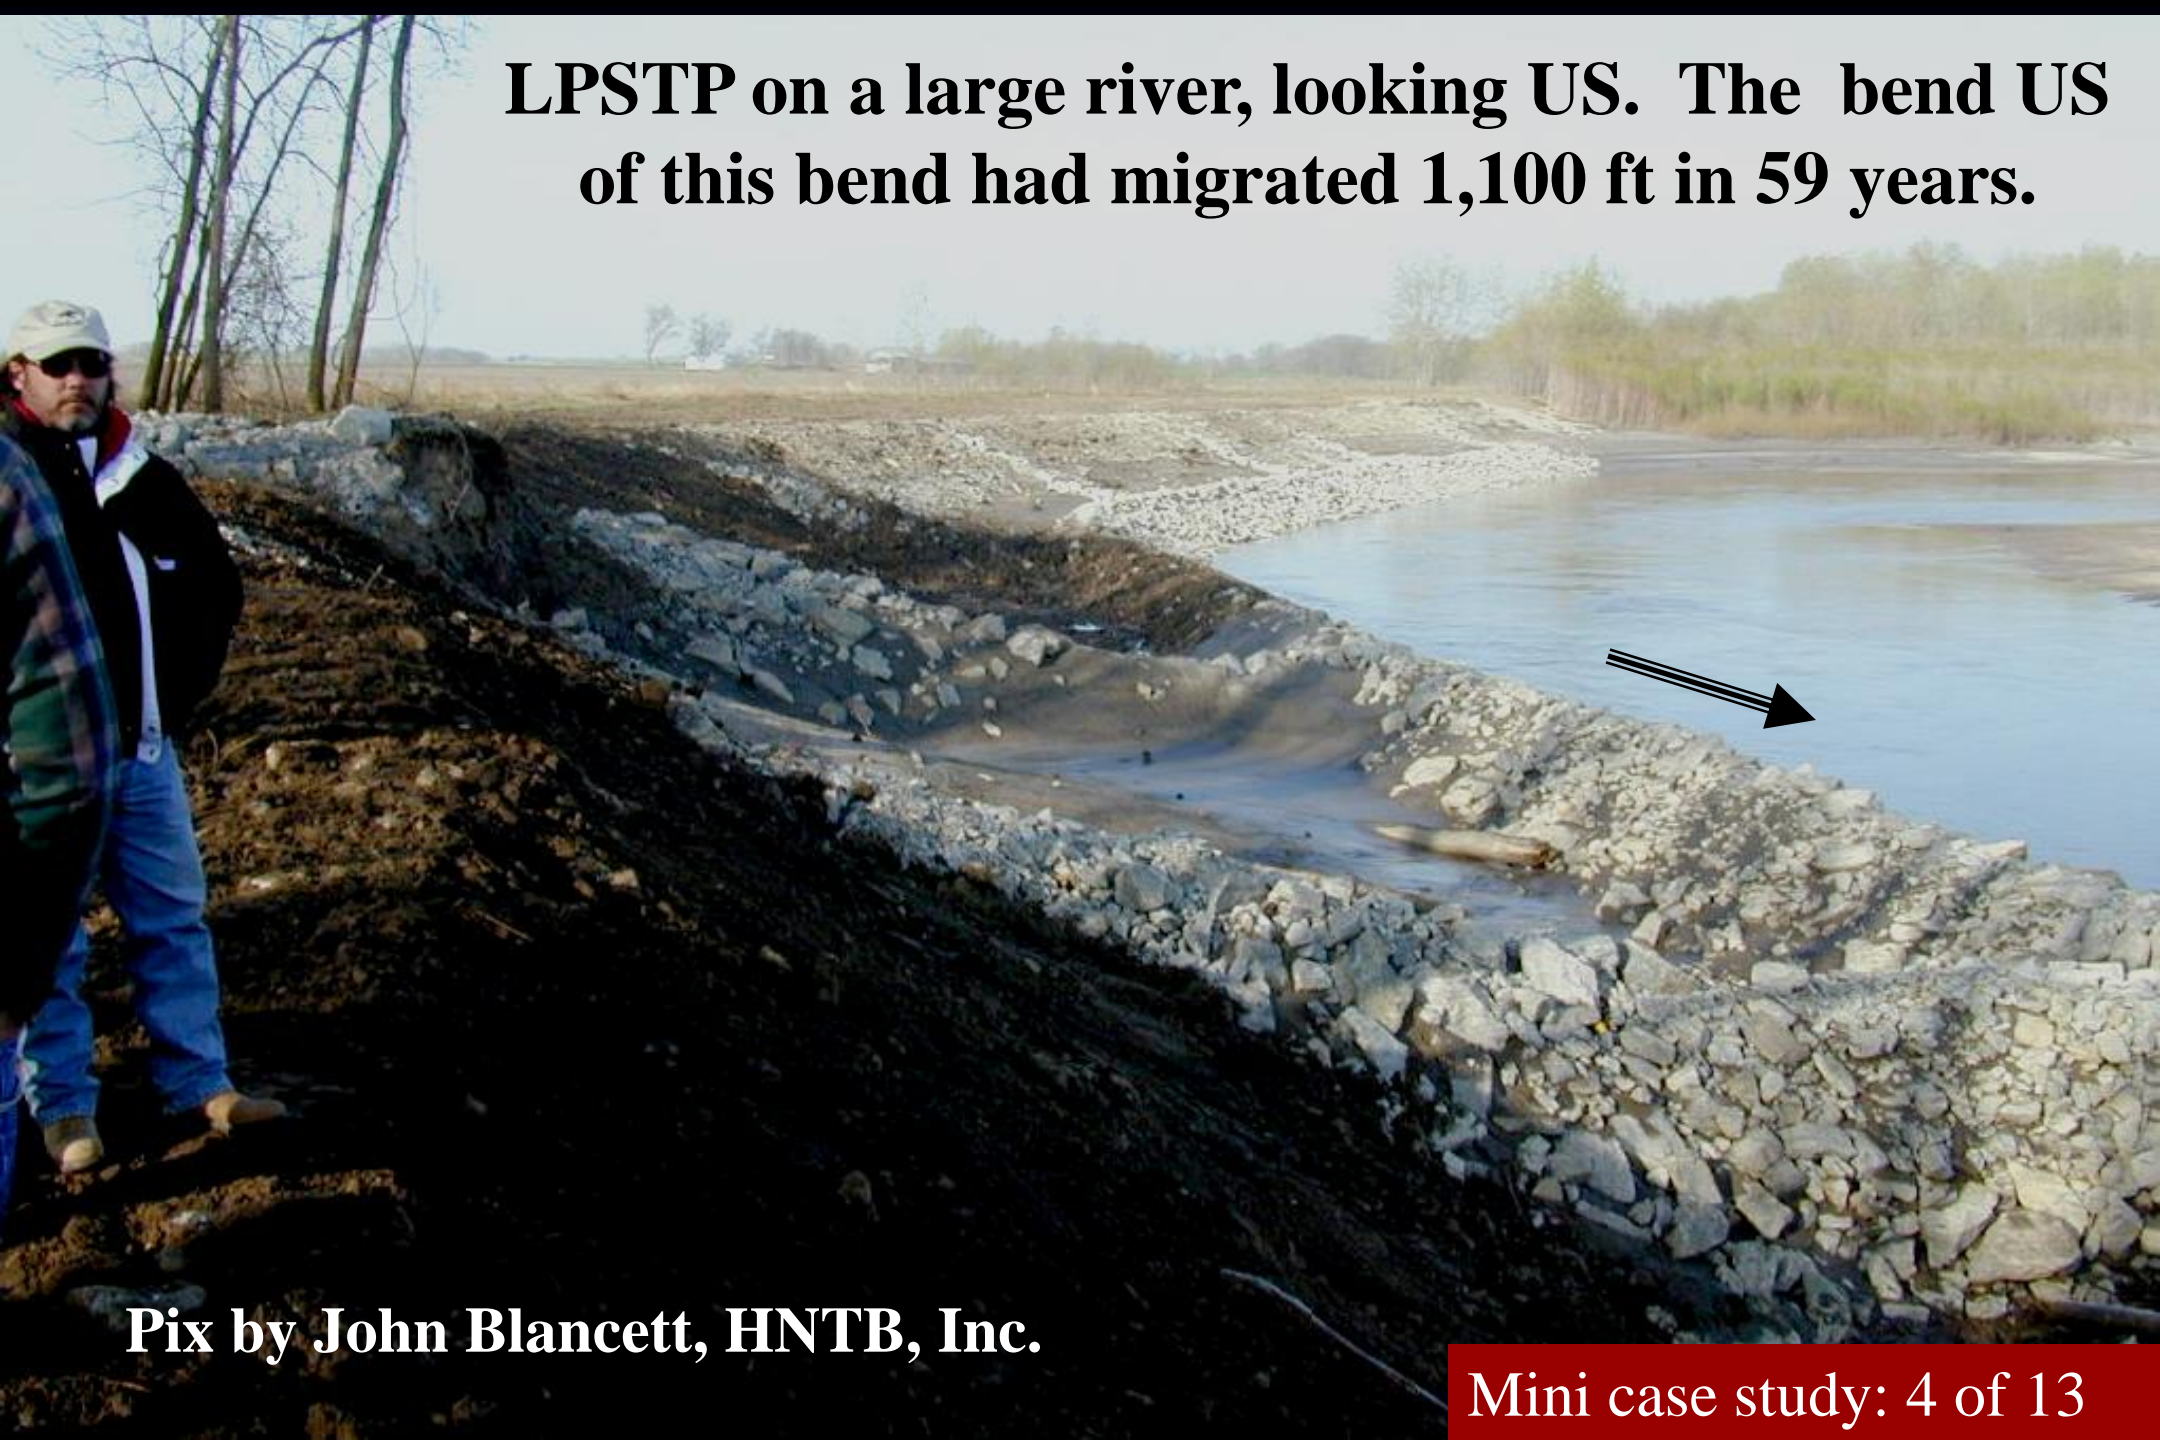
**LPSTP on a large river, looking US. The bend US
of this bend had migrated 1,100 ft in 59 years.**

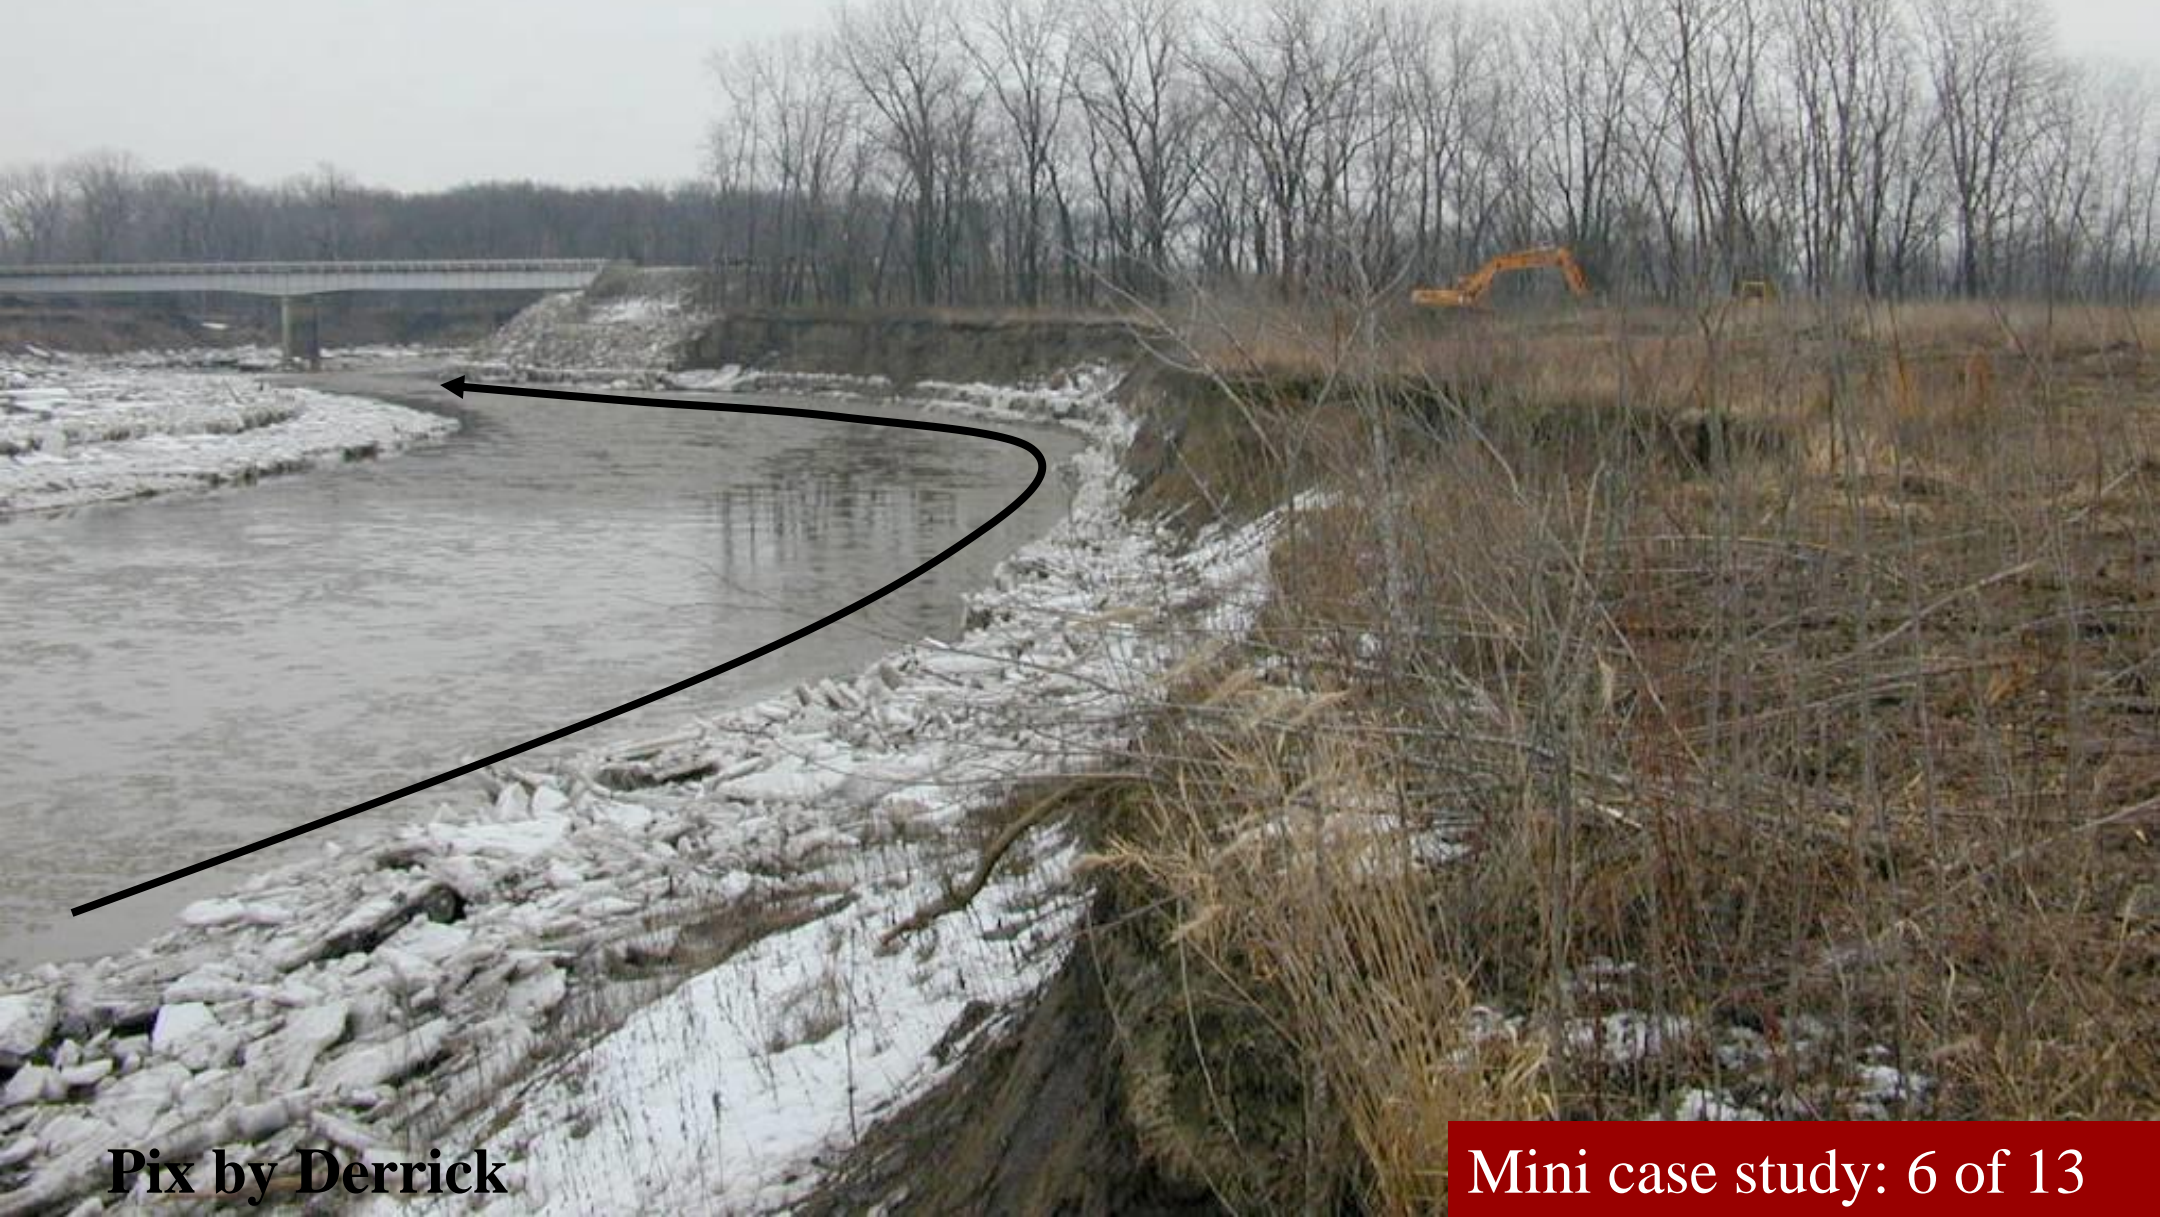
Looking DS, Grand River, very poor flow alignment into Route “A” bridge opening, pre-project conditions

LPSTP was moved away from existing bank (false backline) so as to improve flow through the bridge opening and to reduce erosive pressure on opposite bank downstream of bridge.

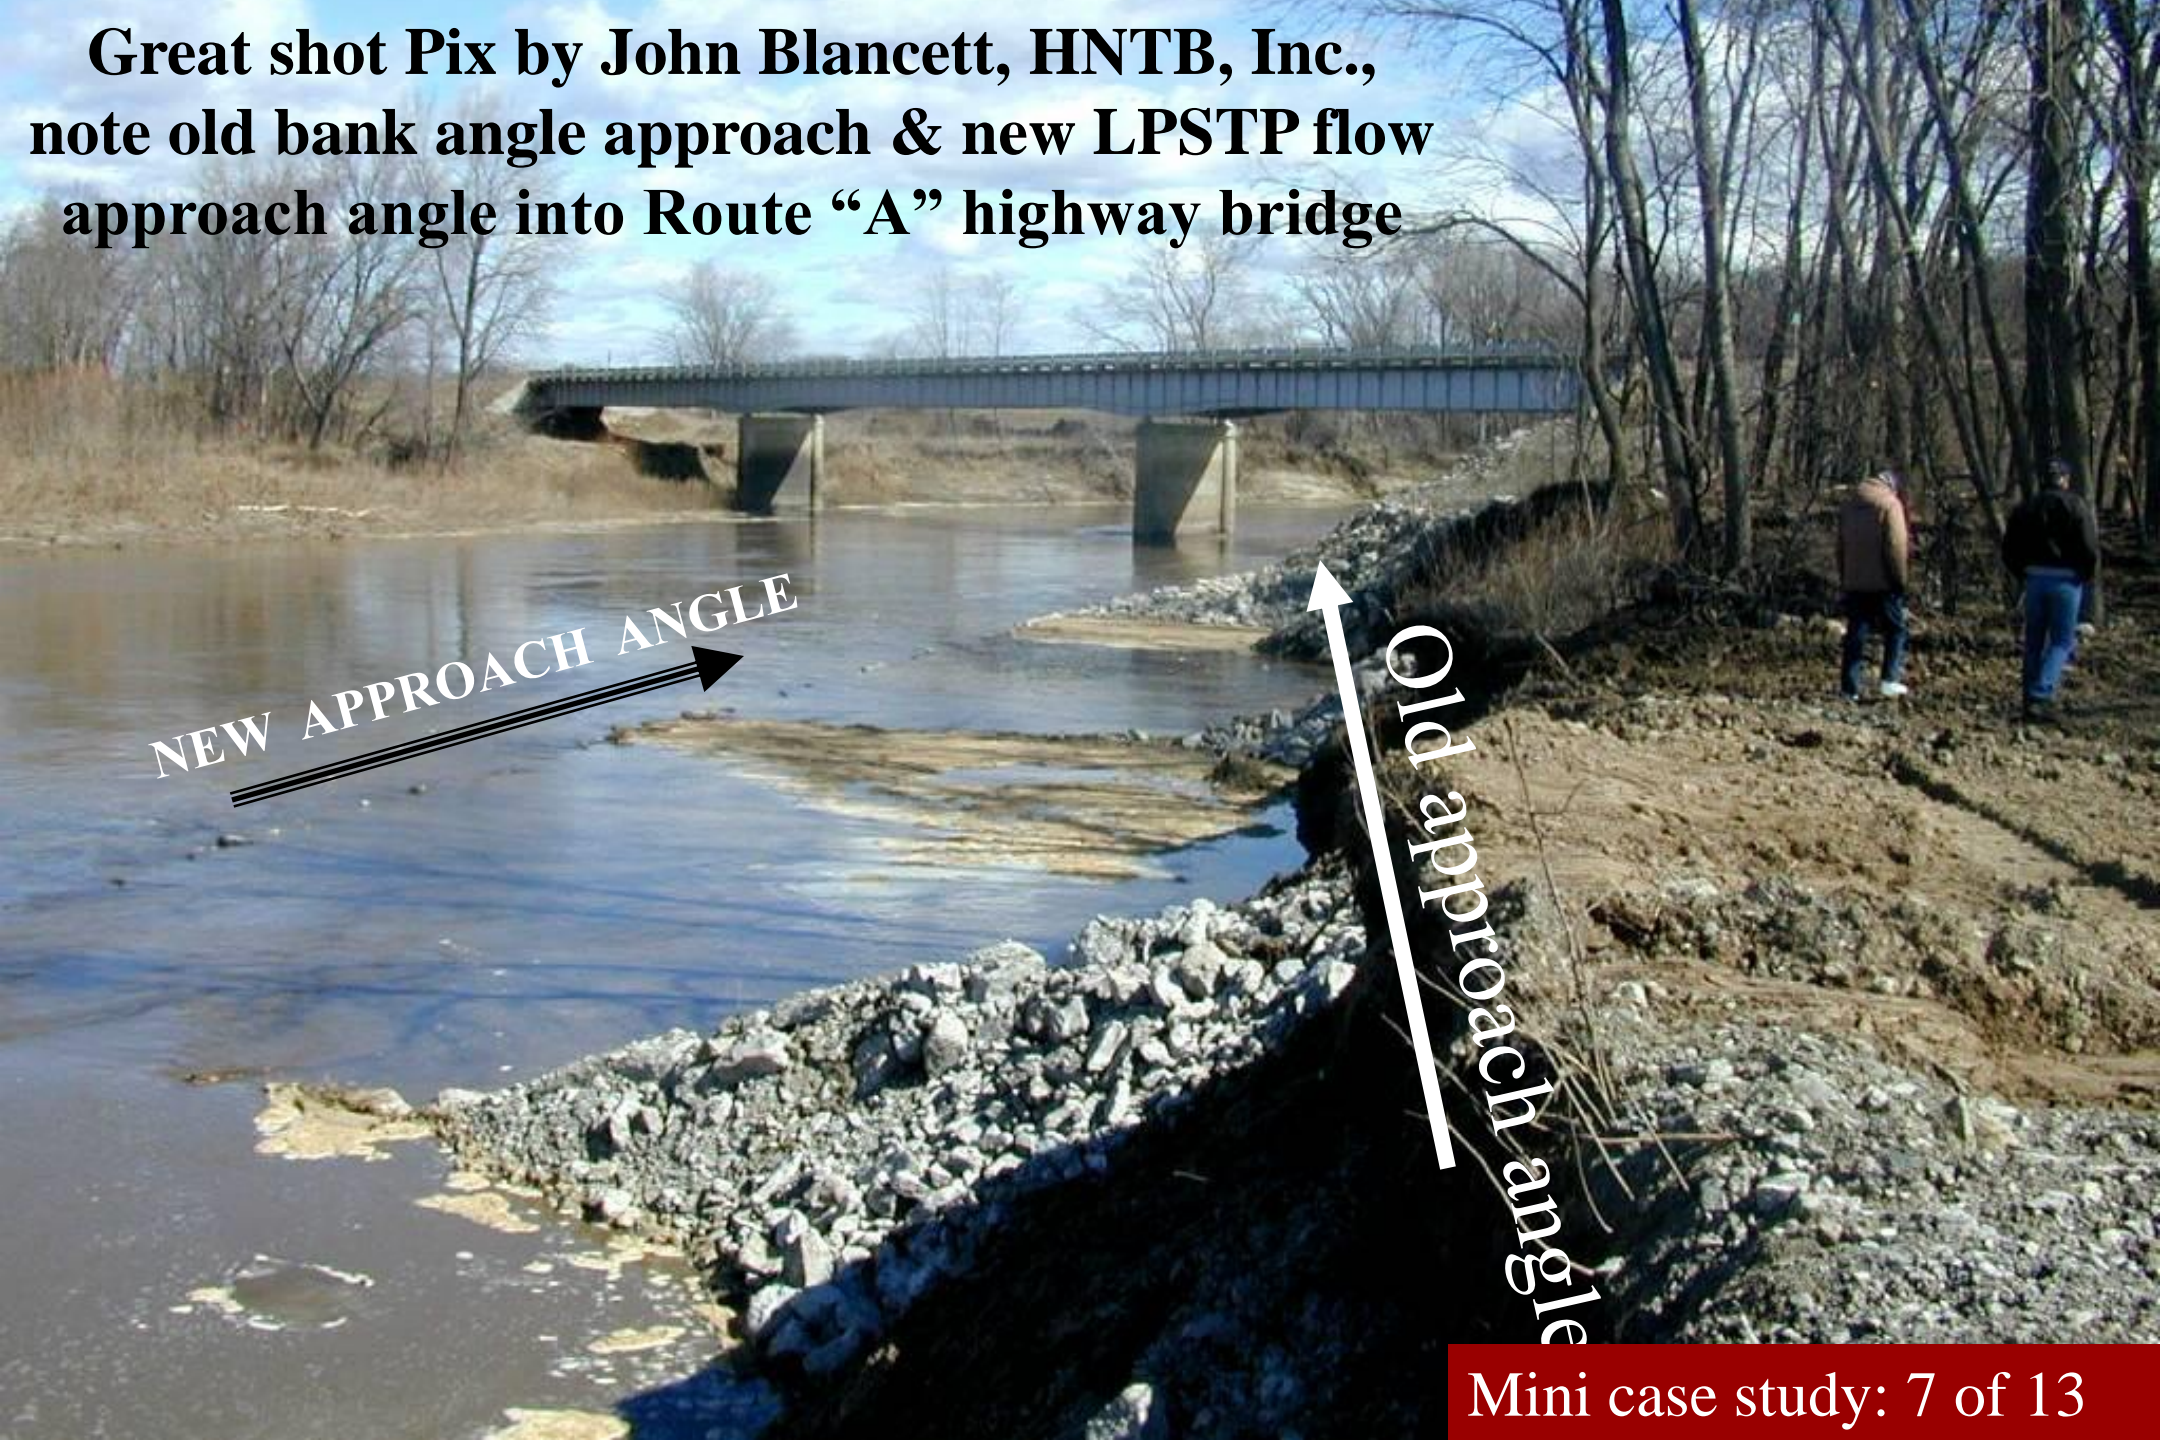
**Great shot Pix by John Blancett, HNTB, Inc.,
note old bank angle approach & new LPSTP flow
approach angle into Route “A” highway bridge**

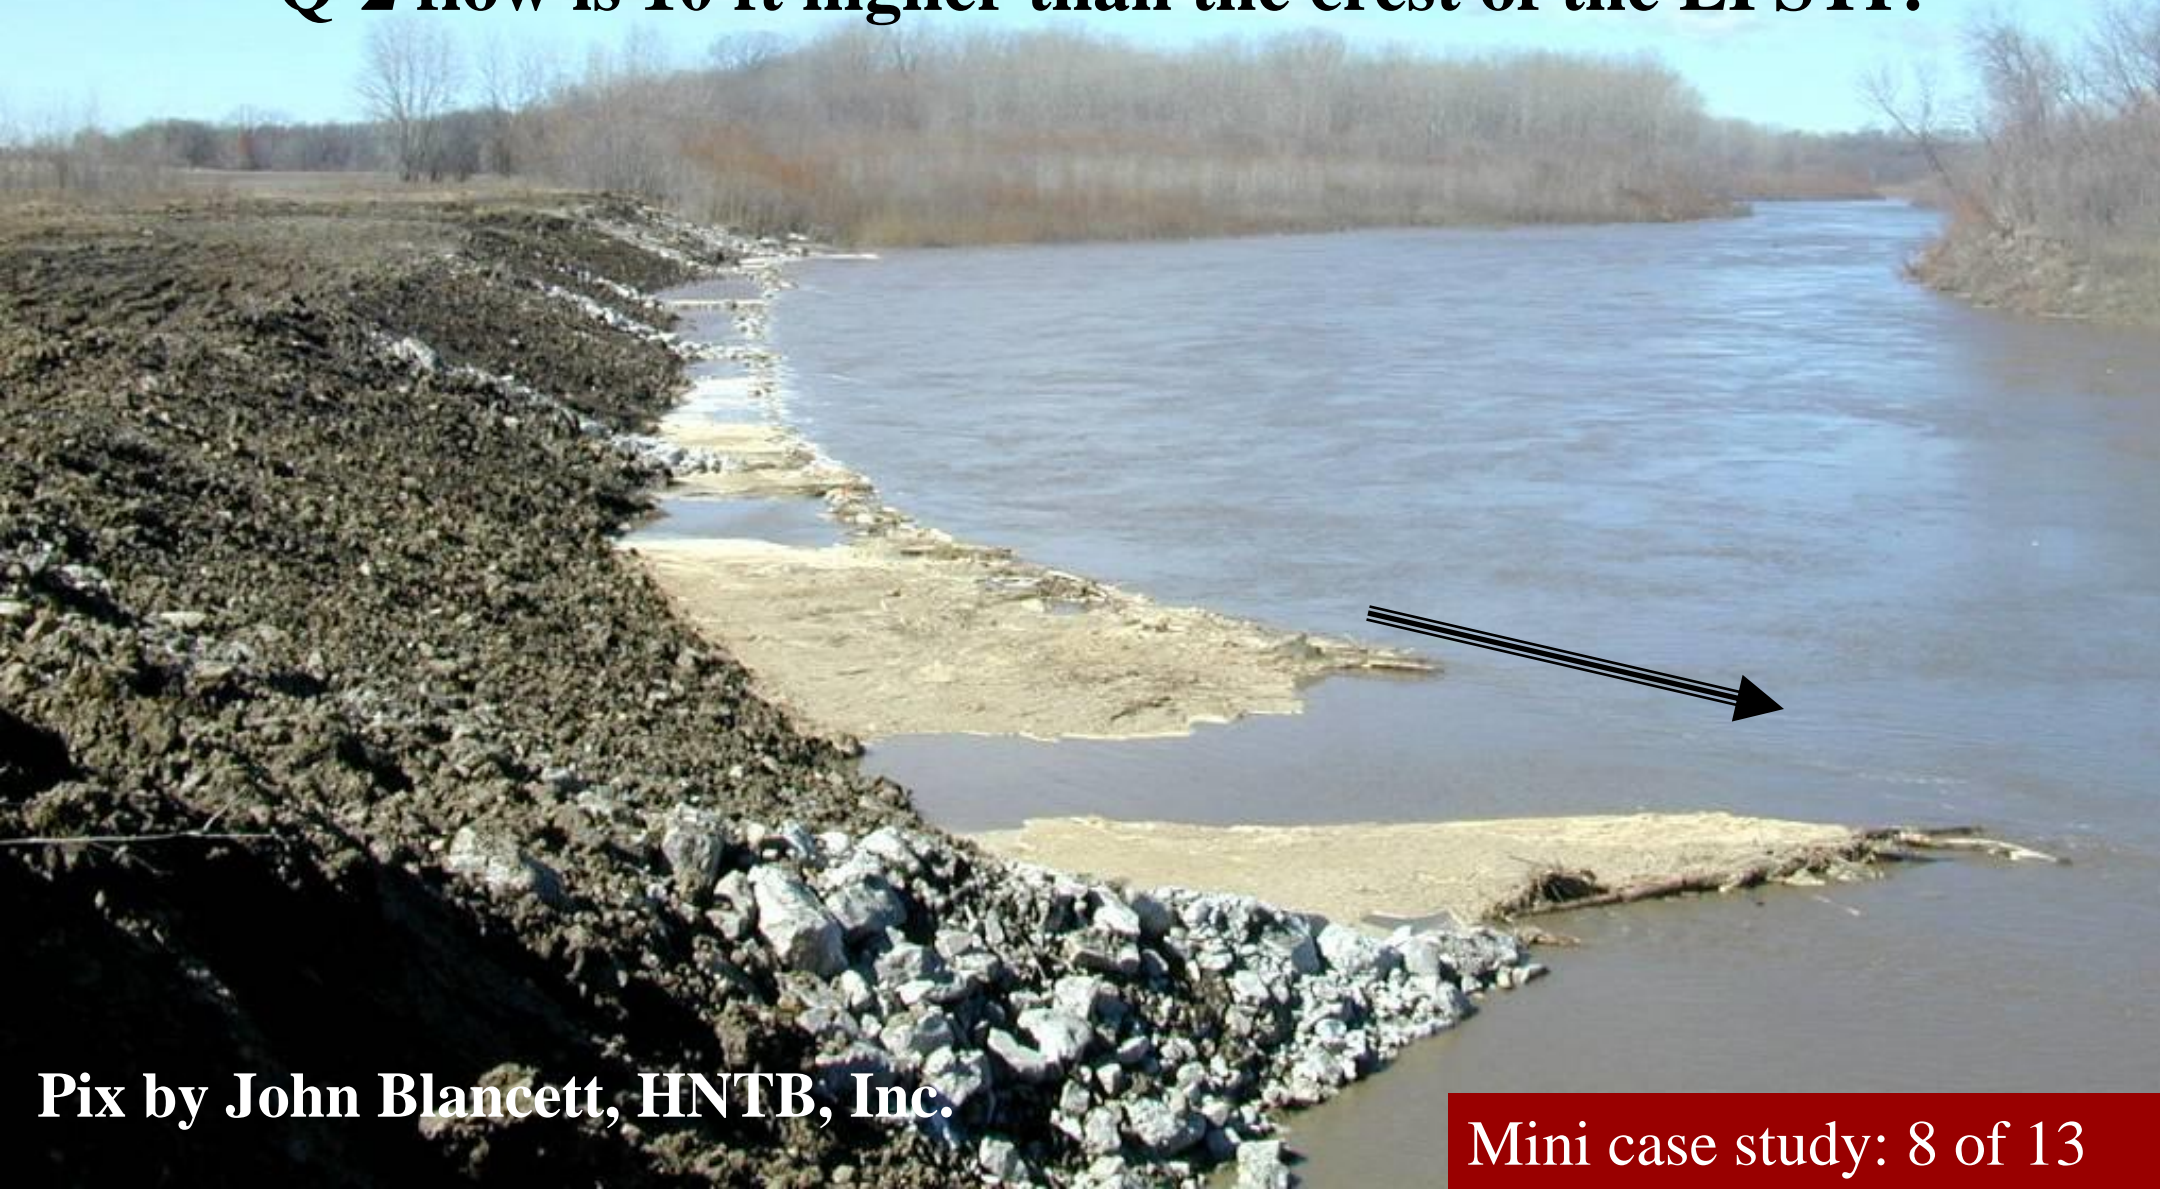
**Looking US, flow at crest of LPSTP, Grand River at Route “A”,
South of Albany, MO. Q-2 flow would be 3 ft below top bank.
Q-2 flow is 10 ft higher than the crest of the LPSTP.**
