**COMBINATIONS OF RESISTIVE
& REDIRECTIVE METHODS:
CASE STUDY- Duck Creek East of
Eastern Avenue, Davenport, Iowa
Constructed June-July. 2008**

**Longitudinal Peaked Stone Toe
Protection {LFSTP} with interspaced
Short Bendway Weirs & Locked Logs**

LONGITUDINAL PEAKED STONE TOE PROTECTION {LPSTP}

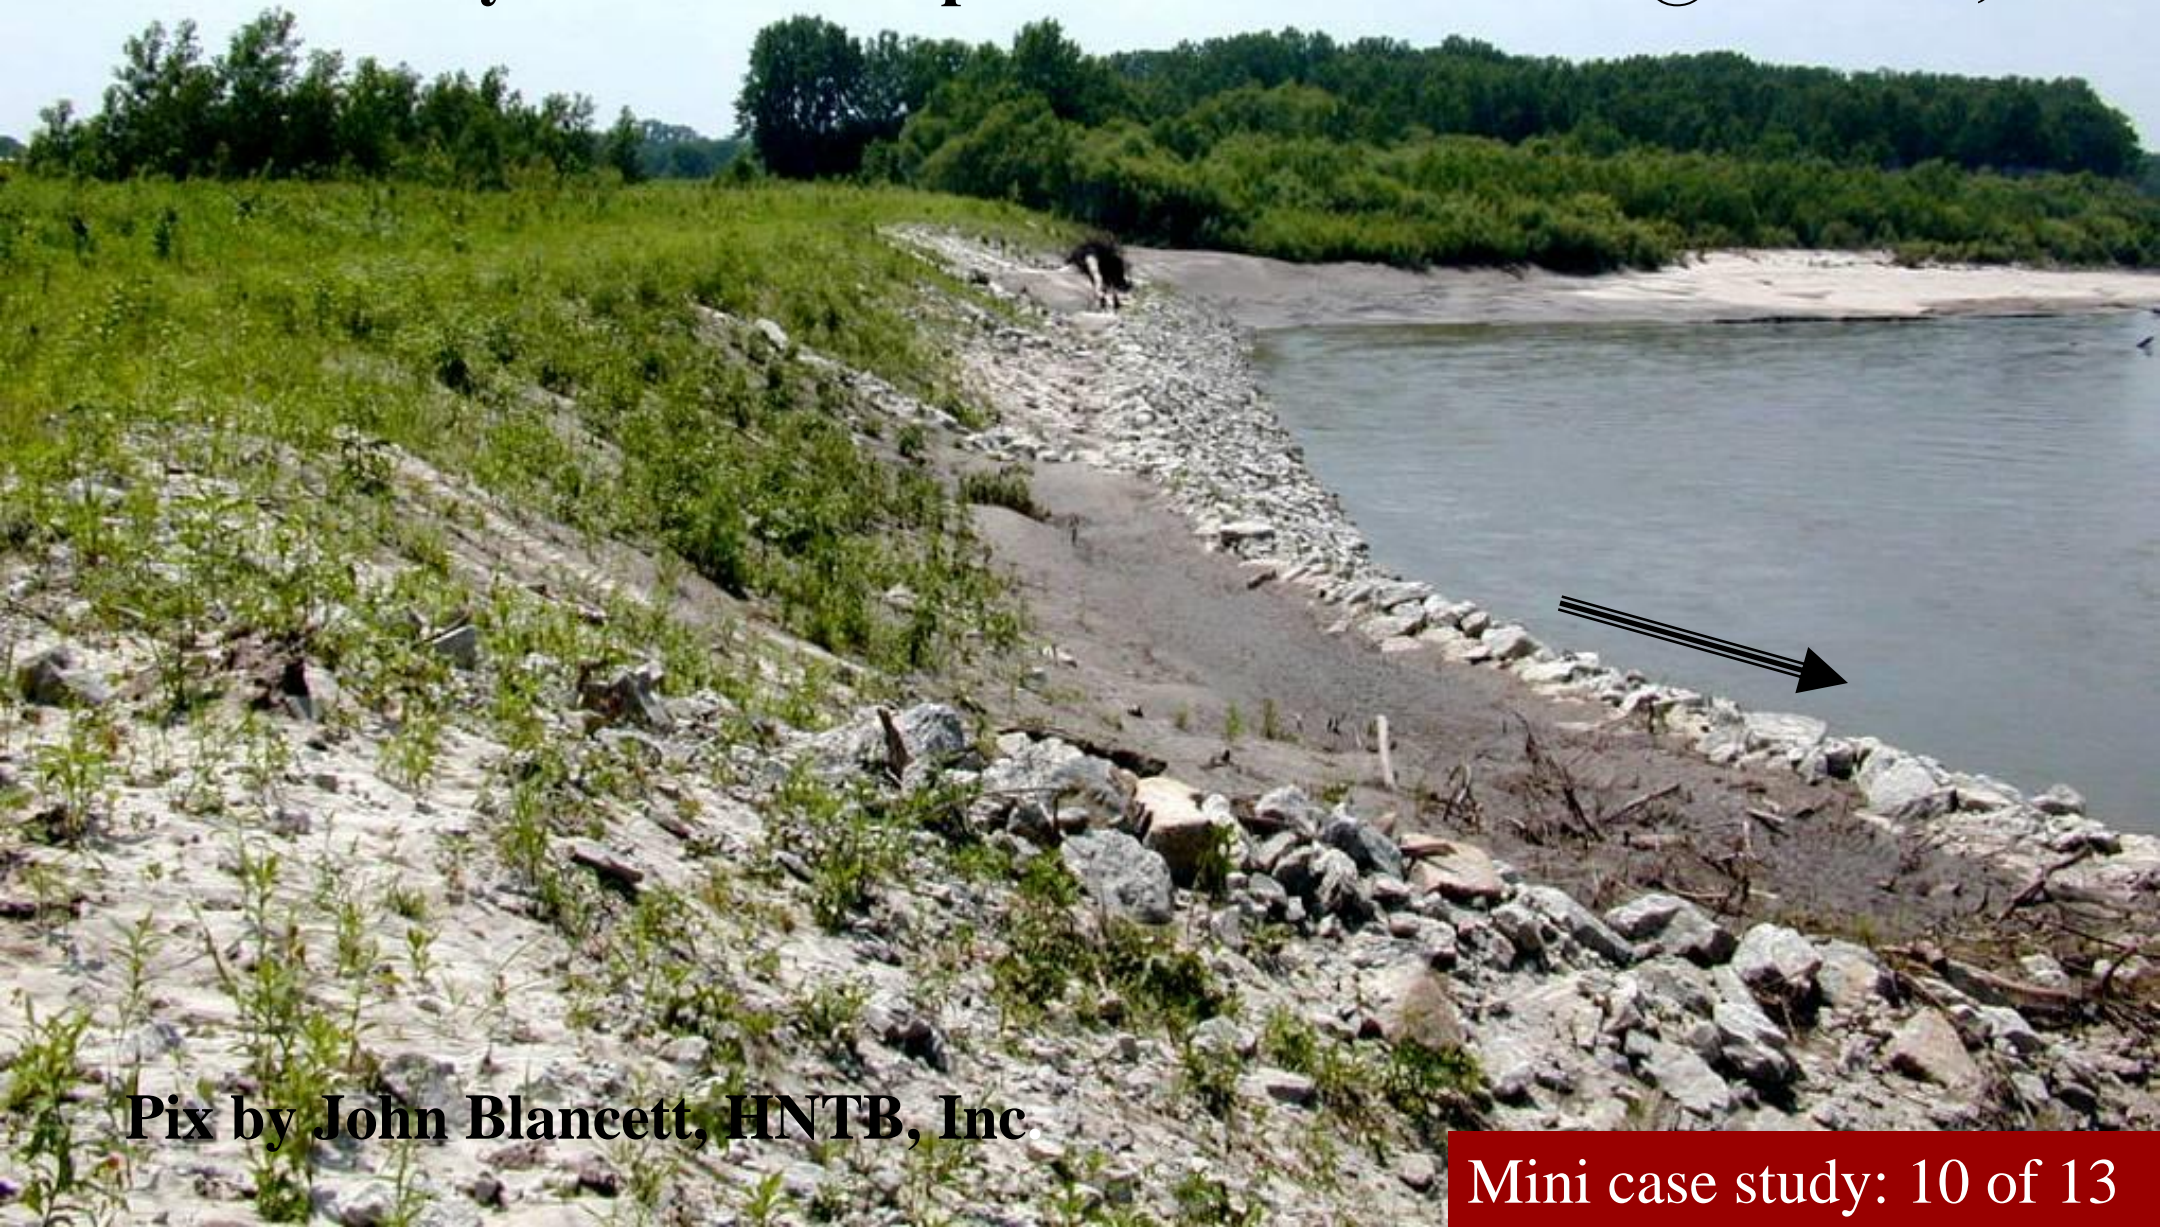
Looking US. Note deposition and veg within first year after completion. Grand River @ Rt. “A”, MO

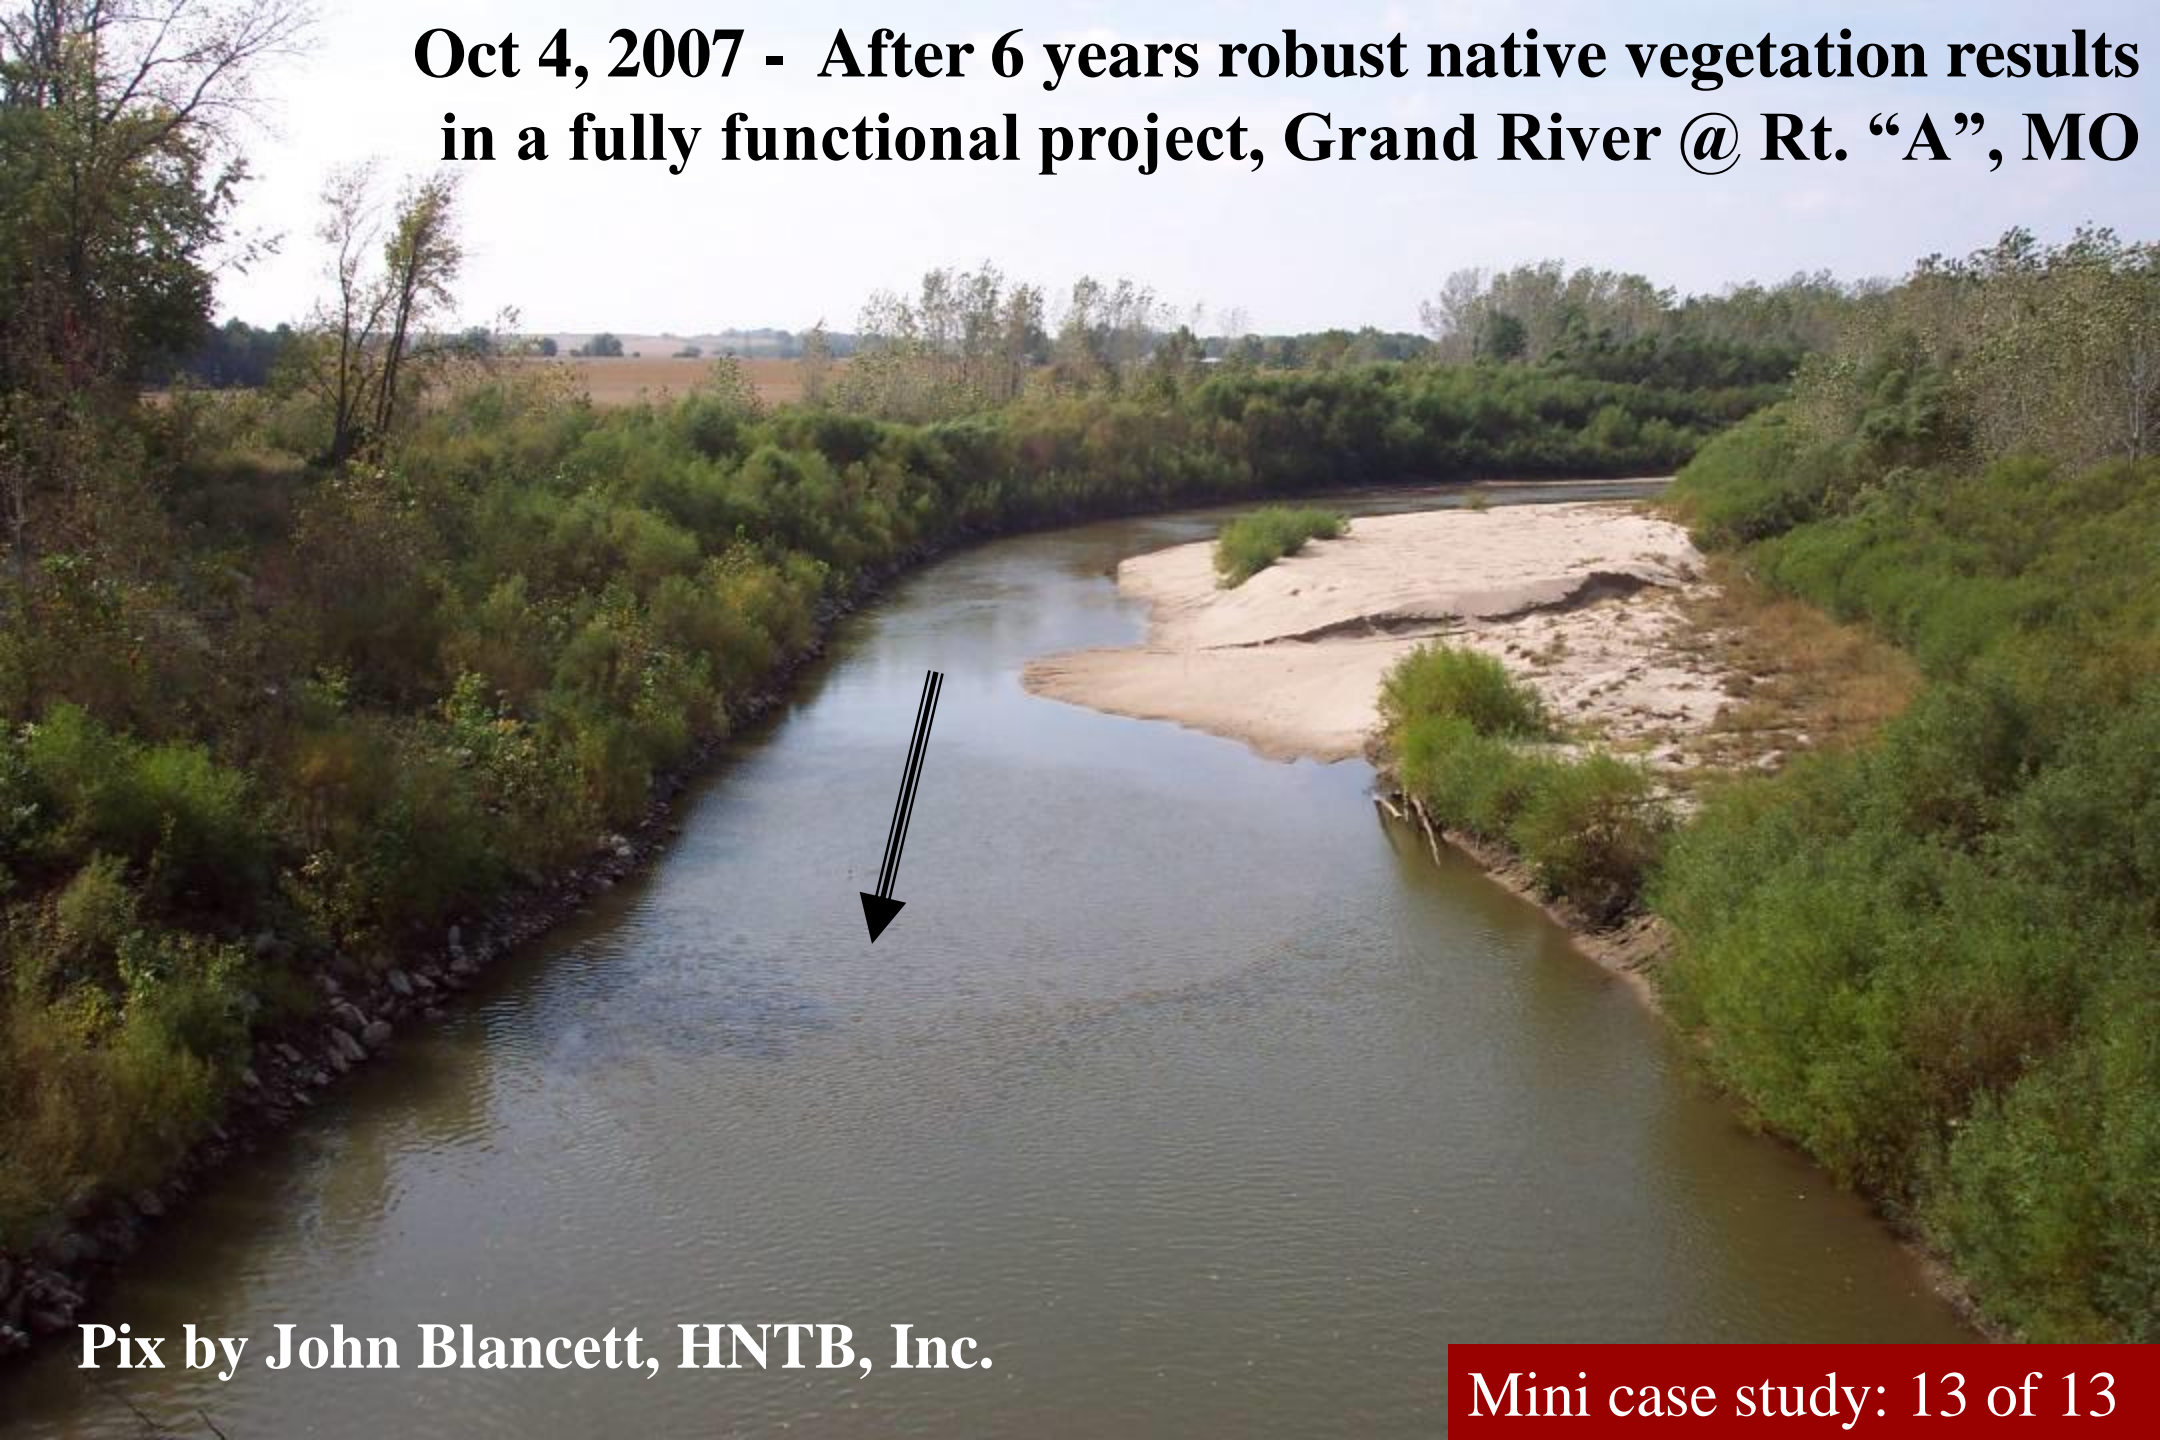
**Oct 4, 2007 - After 6 years robust native vegetation results
in a fully functional project, Grand River @ Rt. “A”, MO**

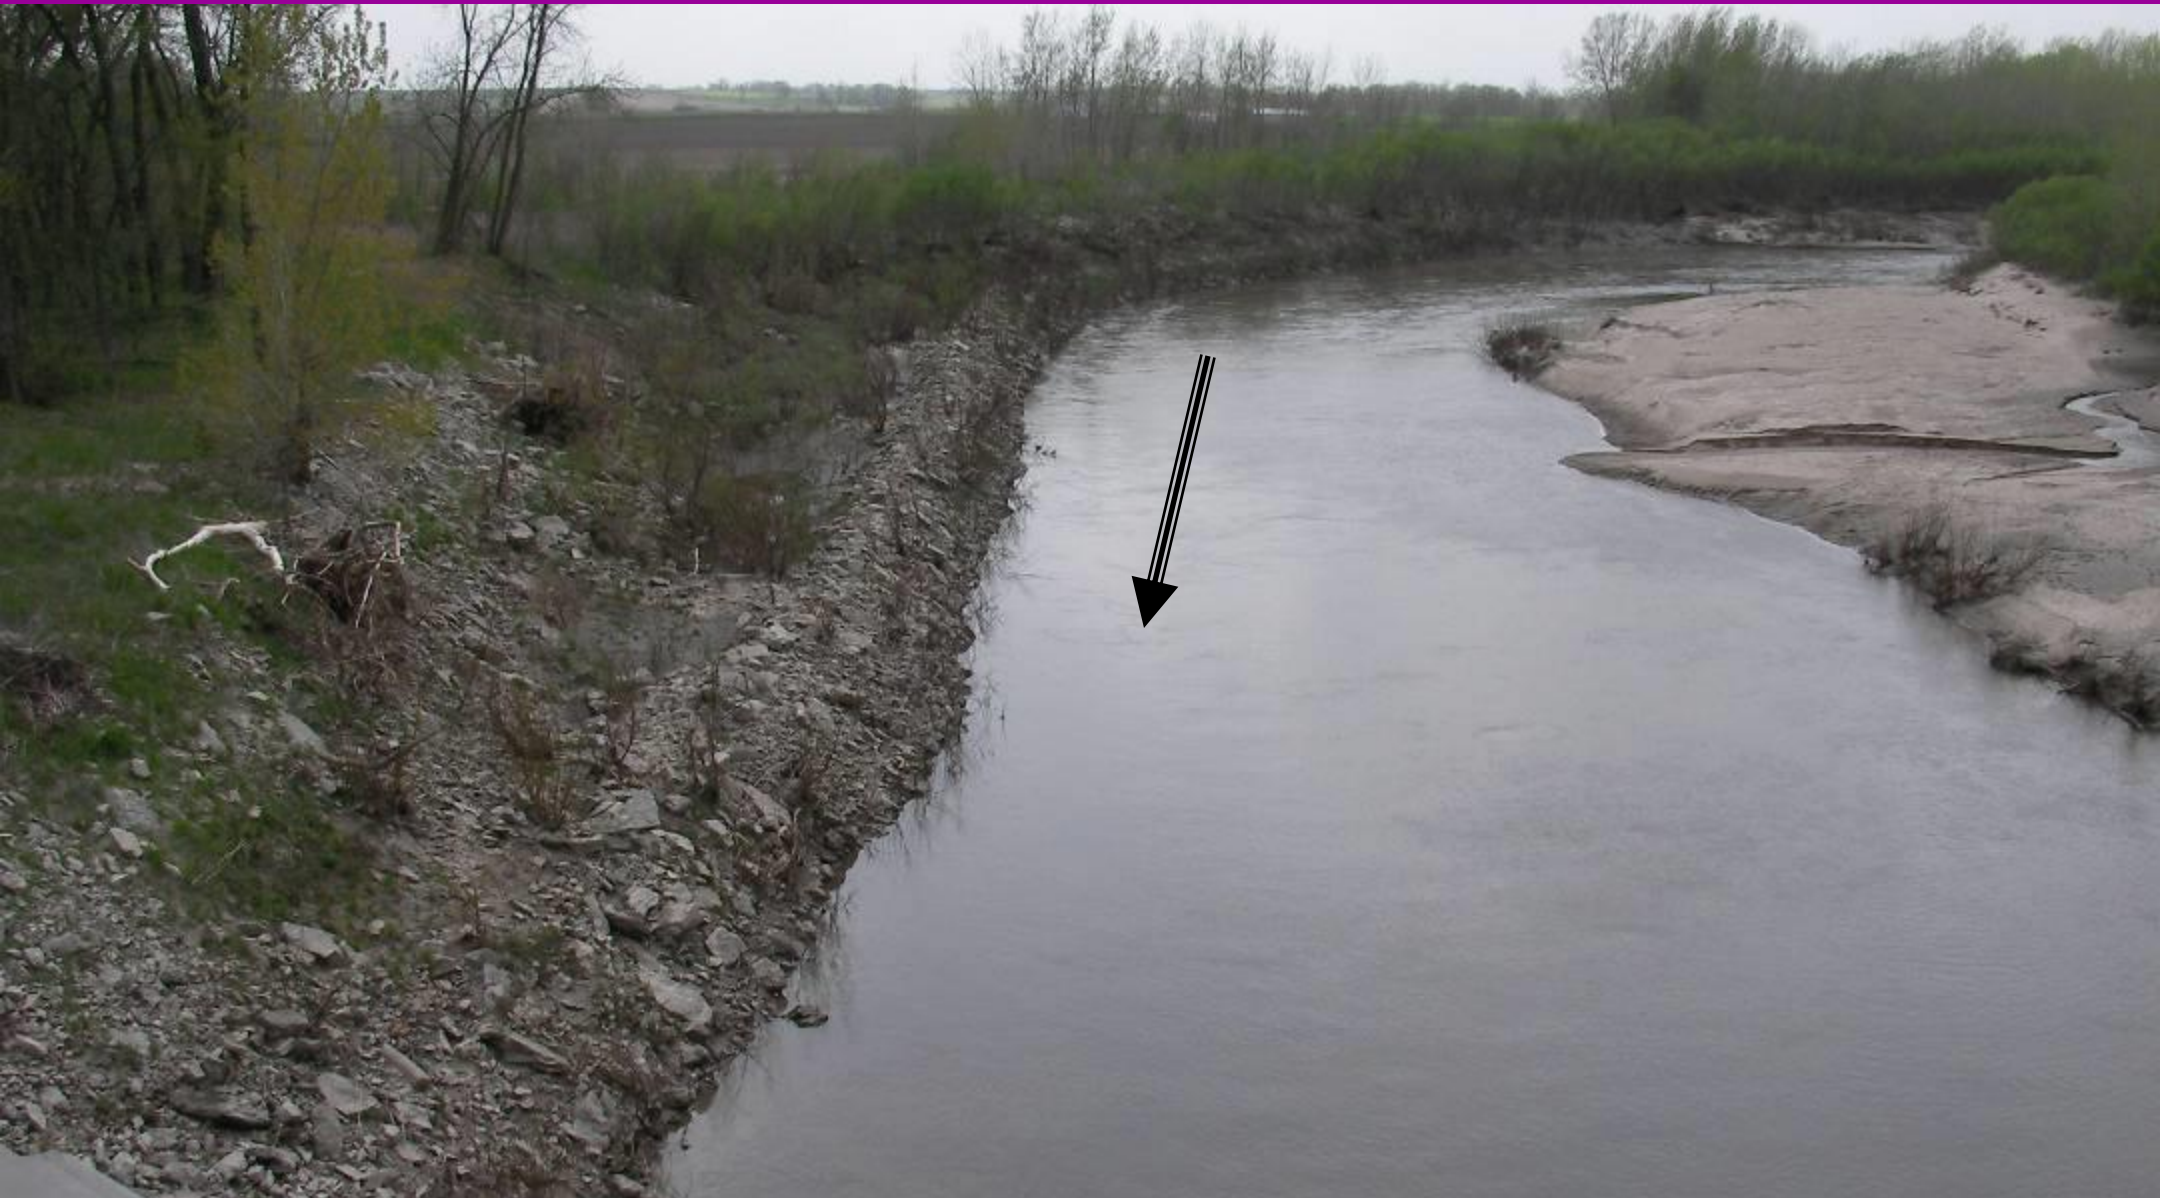
7 YEARS LATER - Looking US @ project. High velocity flow has stripped leaves off of almost all plants growing within the project.

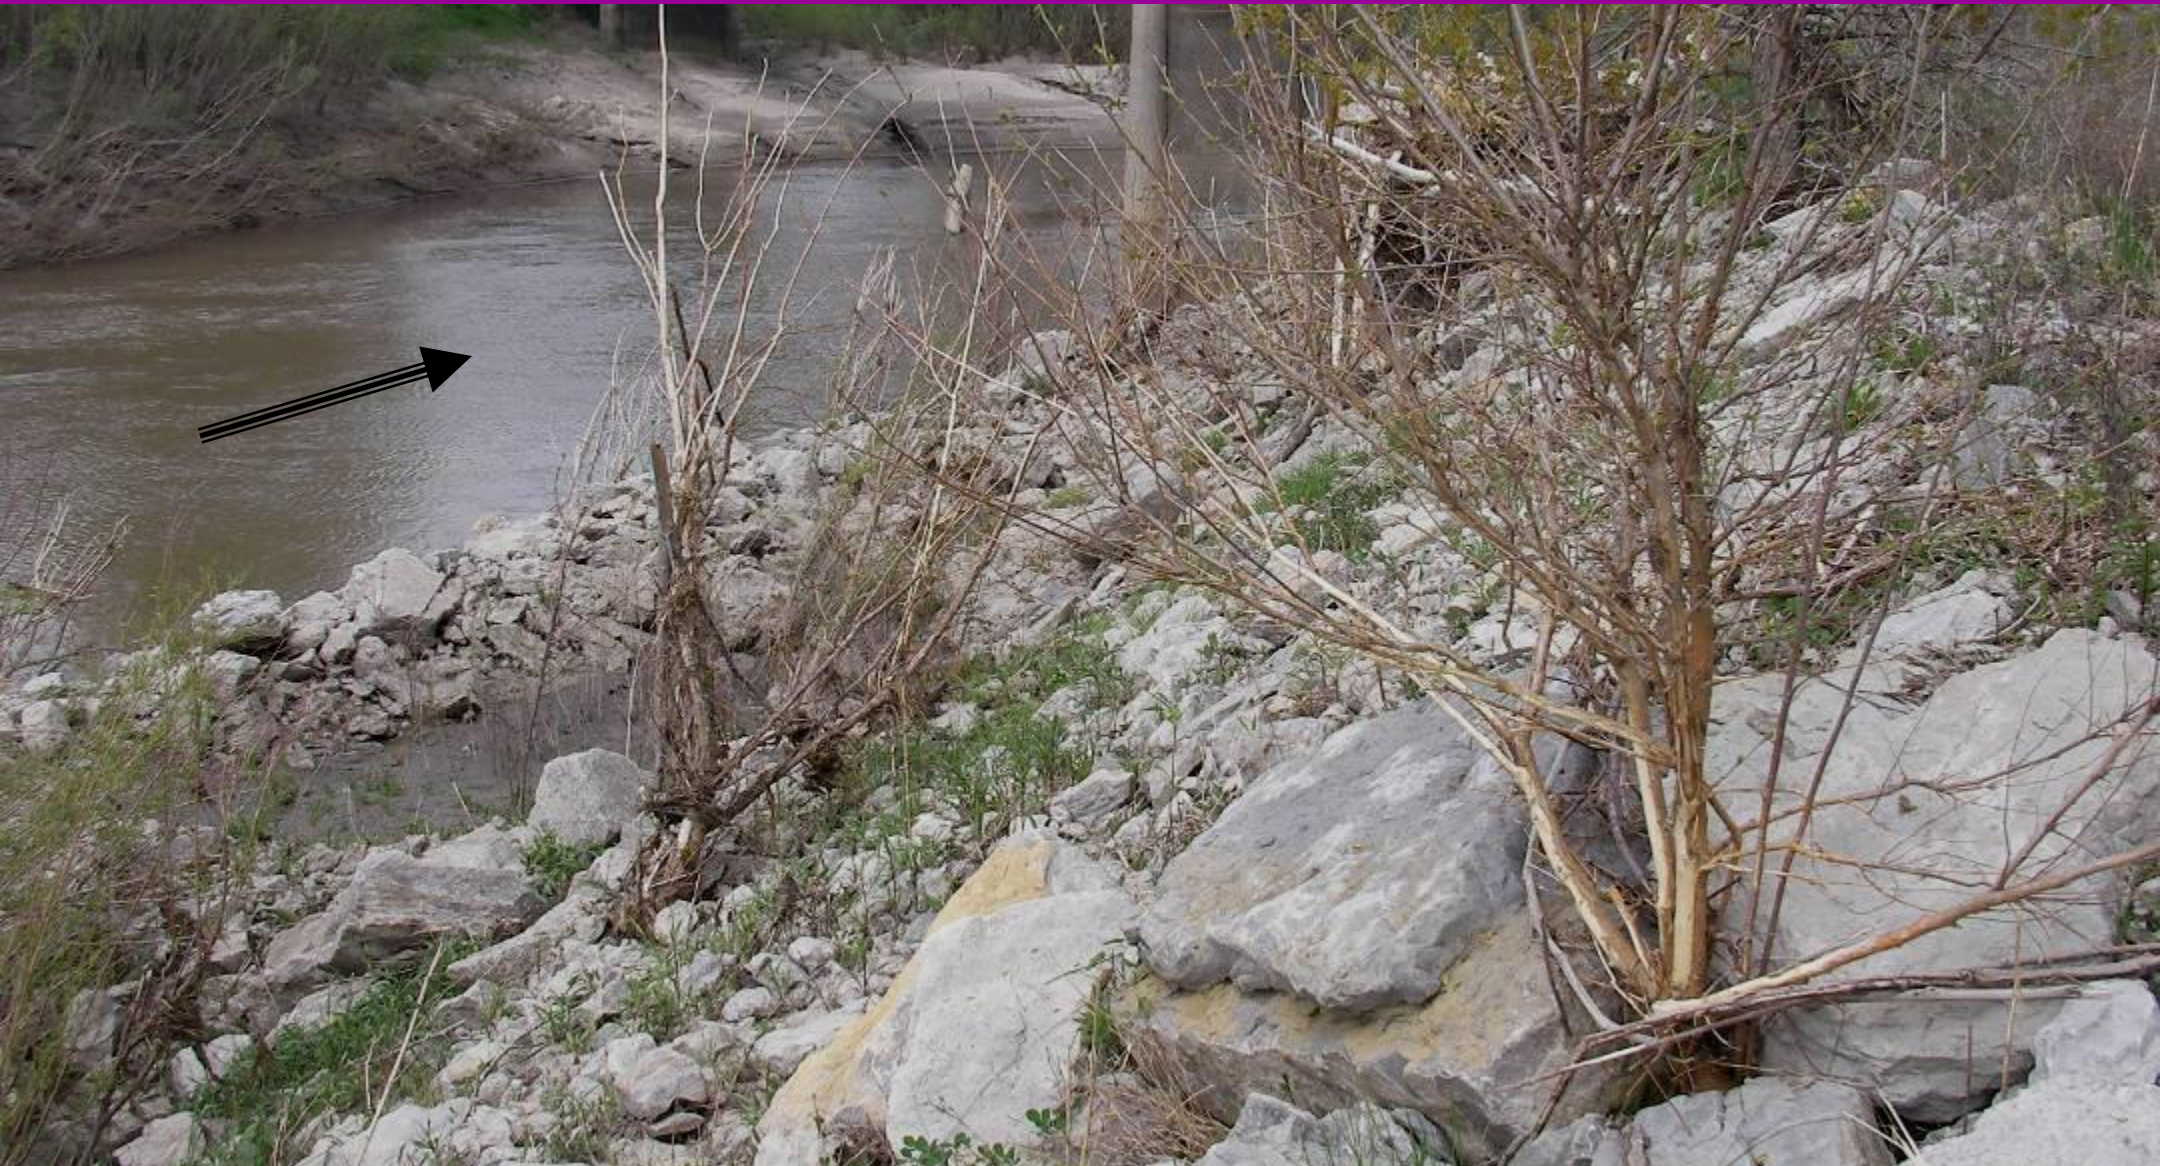
**7 YEARS LATER – Close-up of bark & leaves stripped from
PLANTS AT TOP BANK due to high flow velocities.**

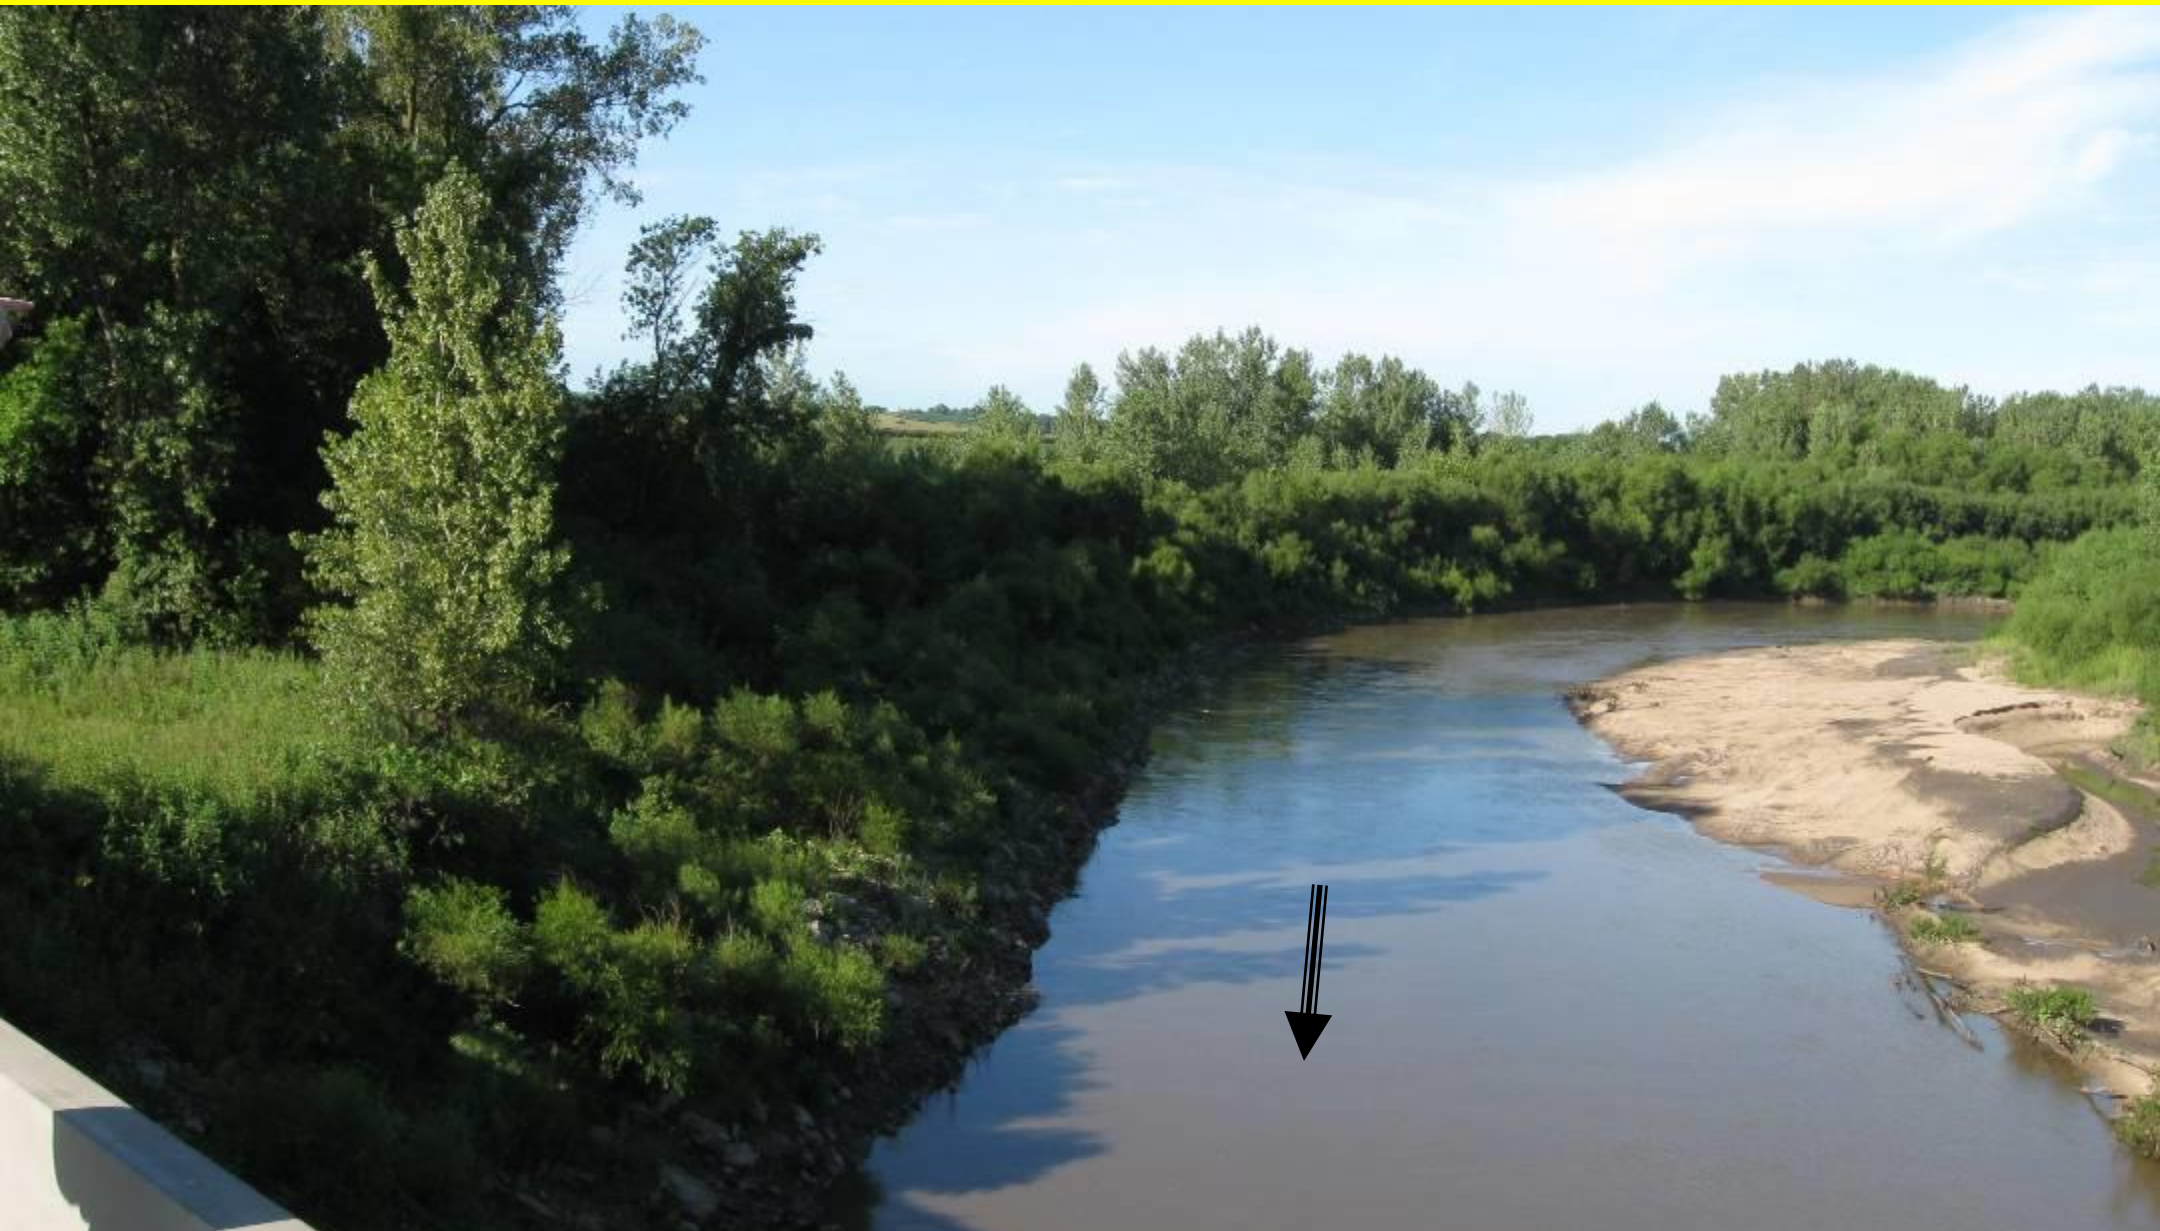
8 YEARS LATER-Looking US @ willow recovery.

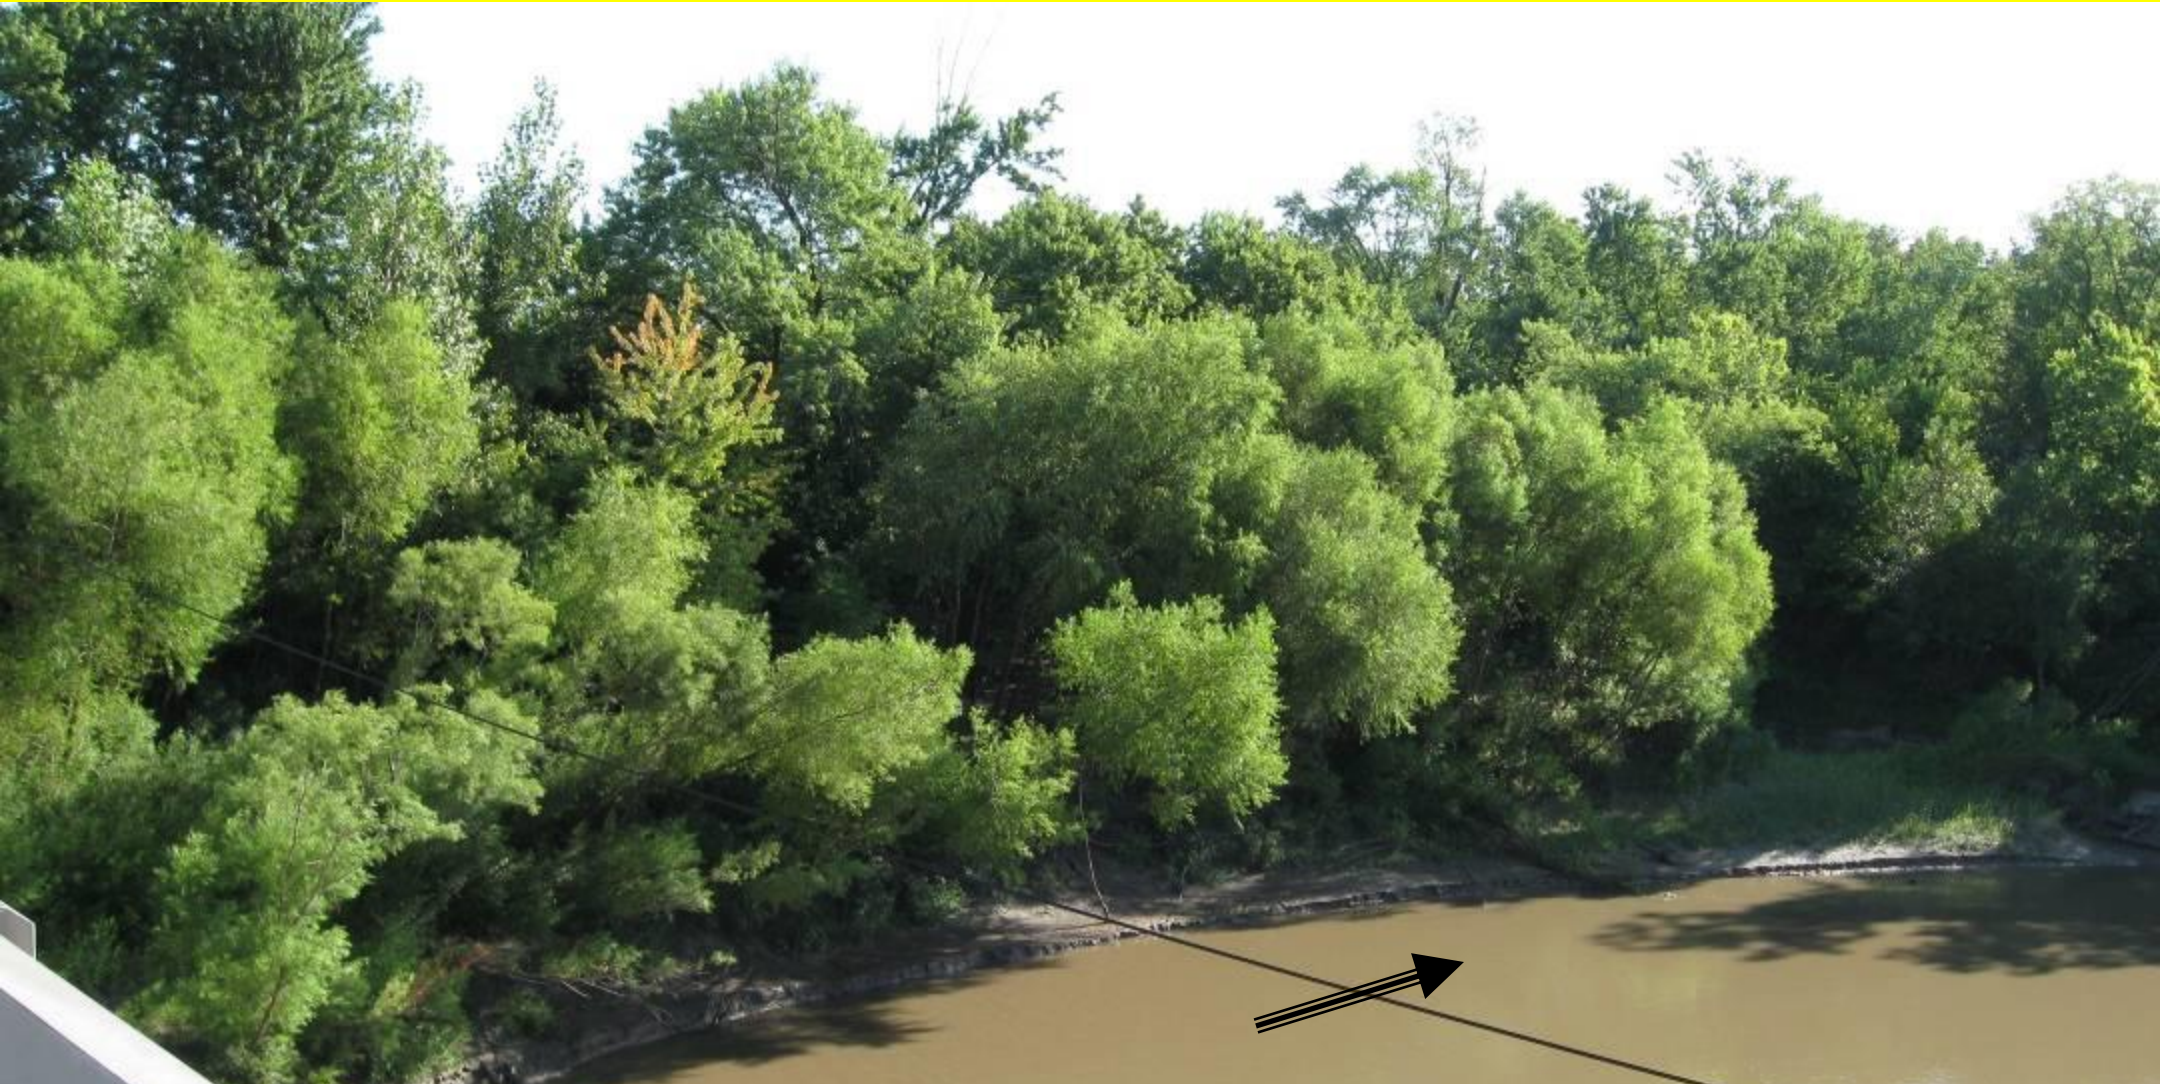
8 YEARS LATER-Looking DS of bridge, opposite bank. Was severely eroded pre-project, but redirection of flow thru bridge resulted in deposition & willow growth.

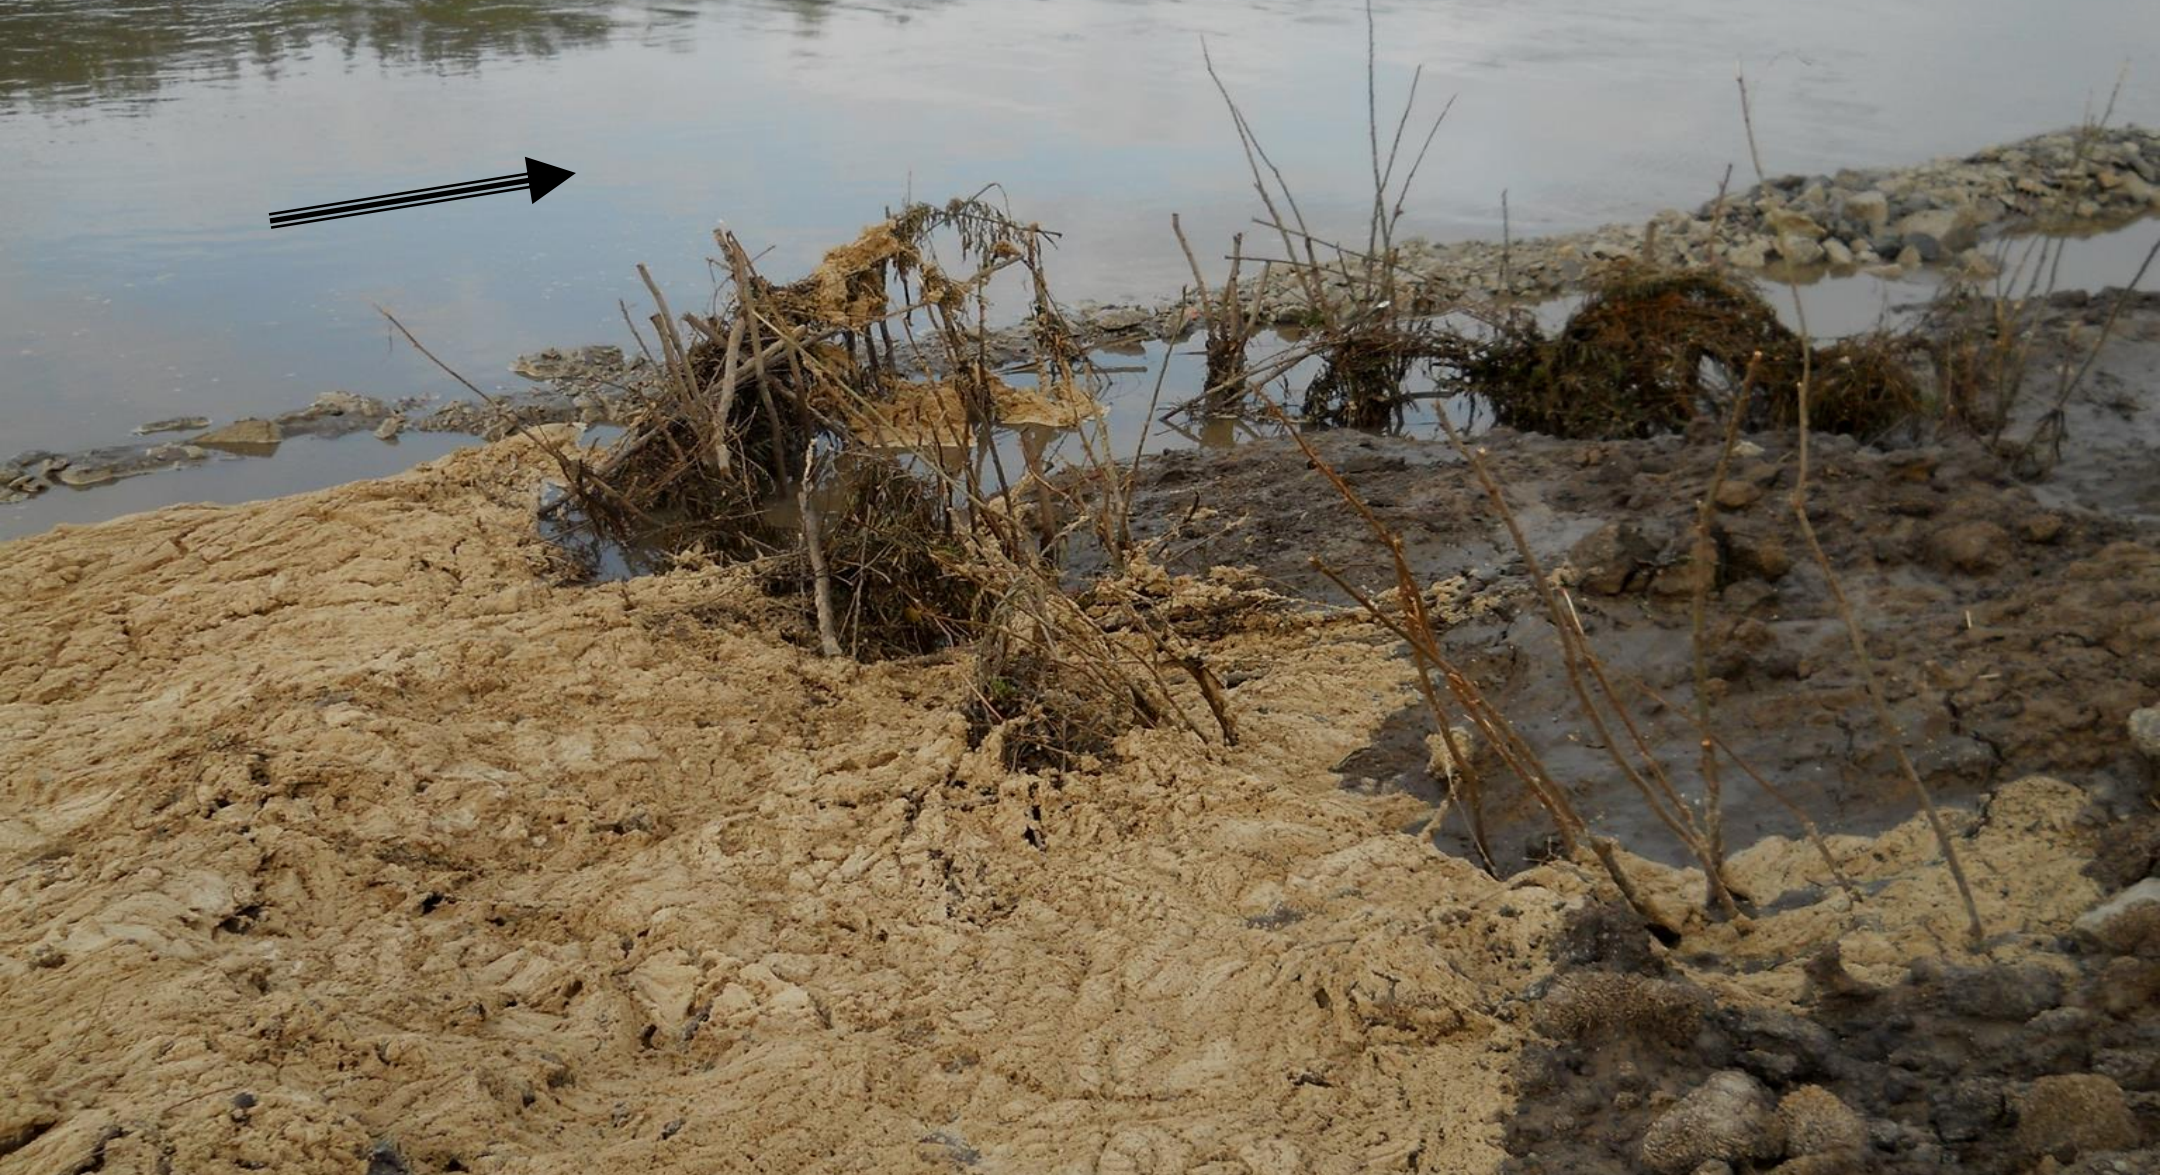
HIGH WATER OVER THE WEIRS-Looking @ willows in perpendicular key caught debris, took a licking, still look great.

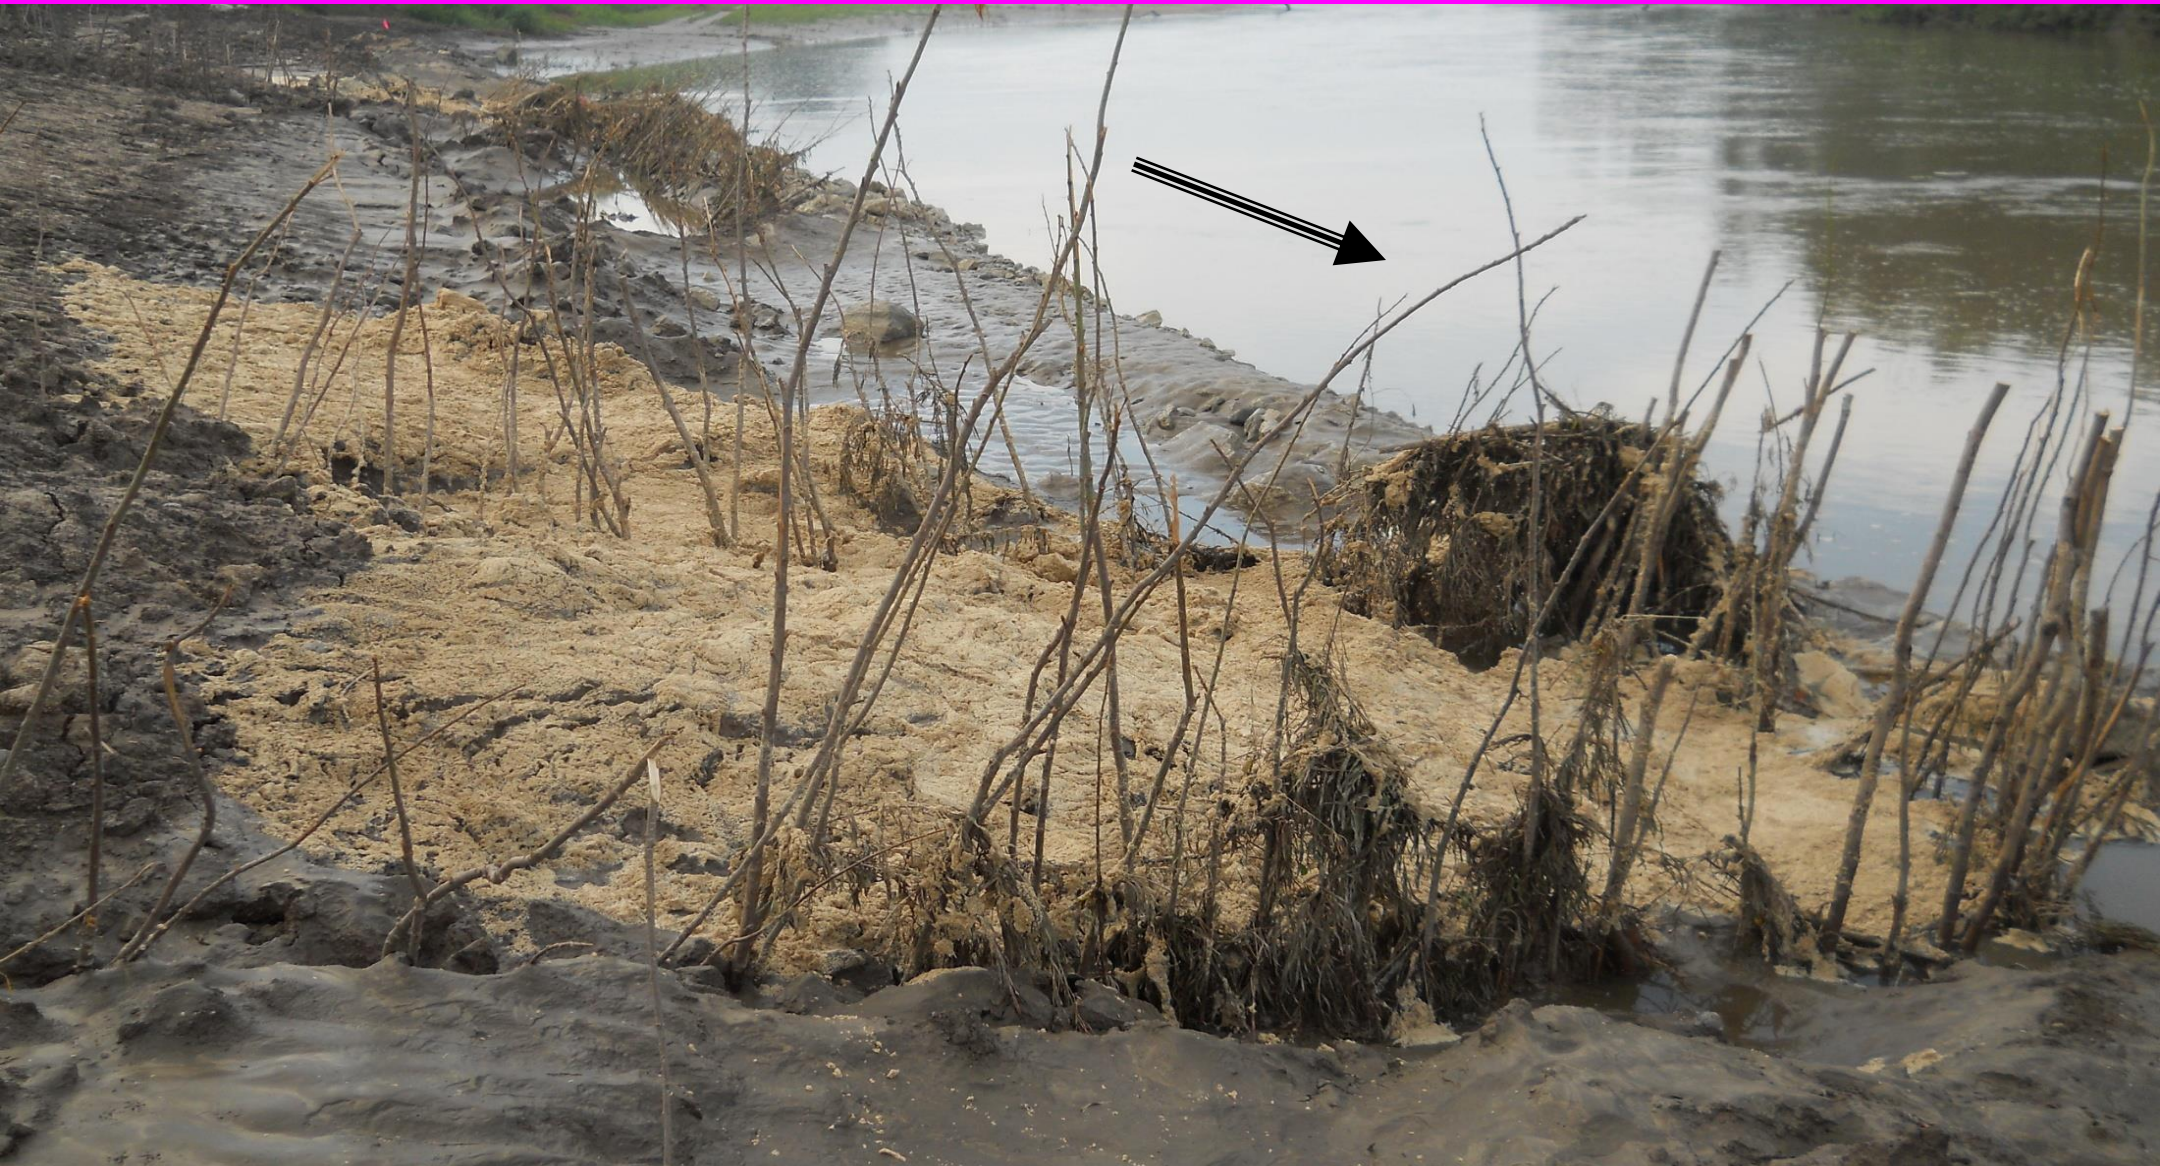
**HIGH WATER OVER THE WEIRS-Close-up, looking US @
deposition on LPSTP, foam, & debris on willows.**
