**COMBINATIONS OF RESISTIVE
& REDIRECTIVE METHODS:
CASE STUDY- Duck Creek East of
Eastern Avenue, Davenport, Iowa
Constructed June-July. 2008**

**Longitudinal Peaked Stone Toe
Protection {LFSTP} with interspaced
Short Bendway Weirs & Locked Logs**

LONGITUDINAL PEAKED STONE TOE PROTECTION {LPSTP}

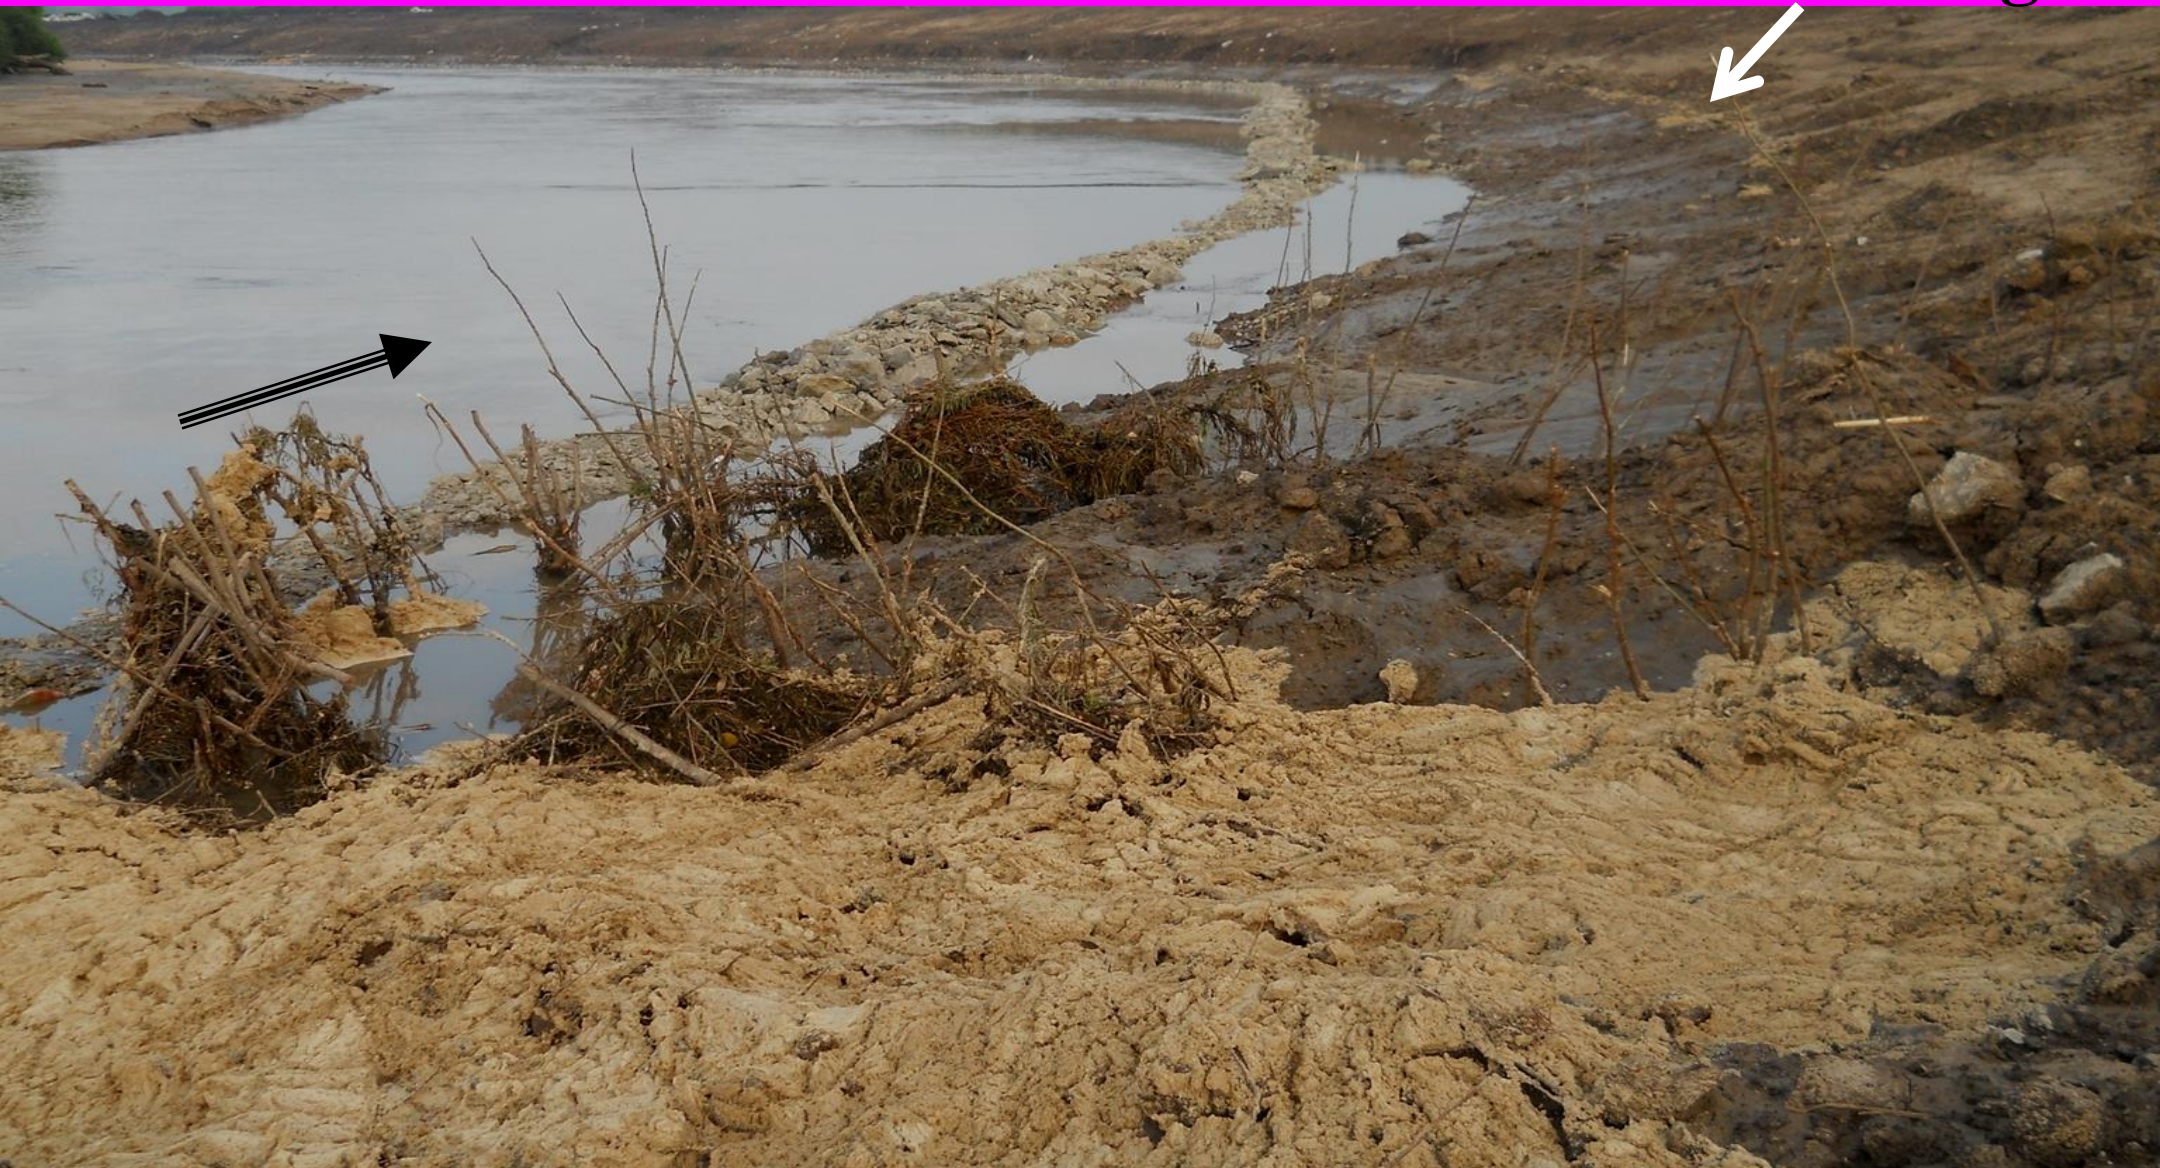
HIGH WATER OVER THE WEIRS-Looking DS @ no sediment on LPSTP. Foam line on bank shows flood height.

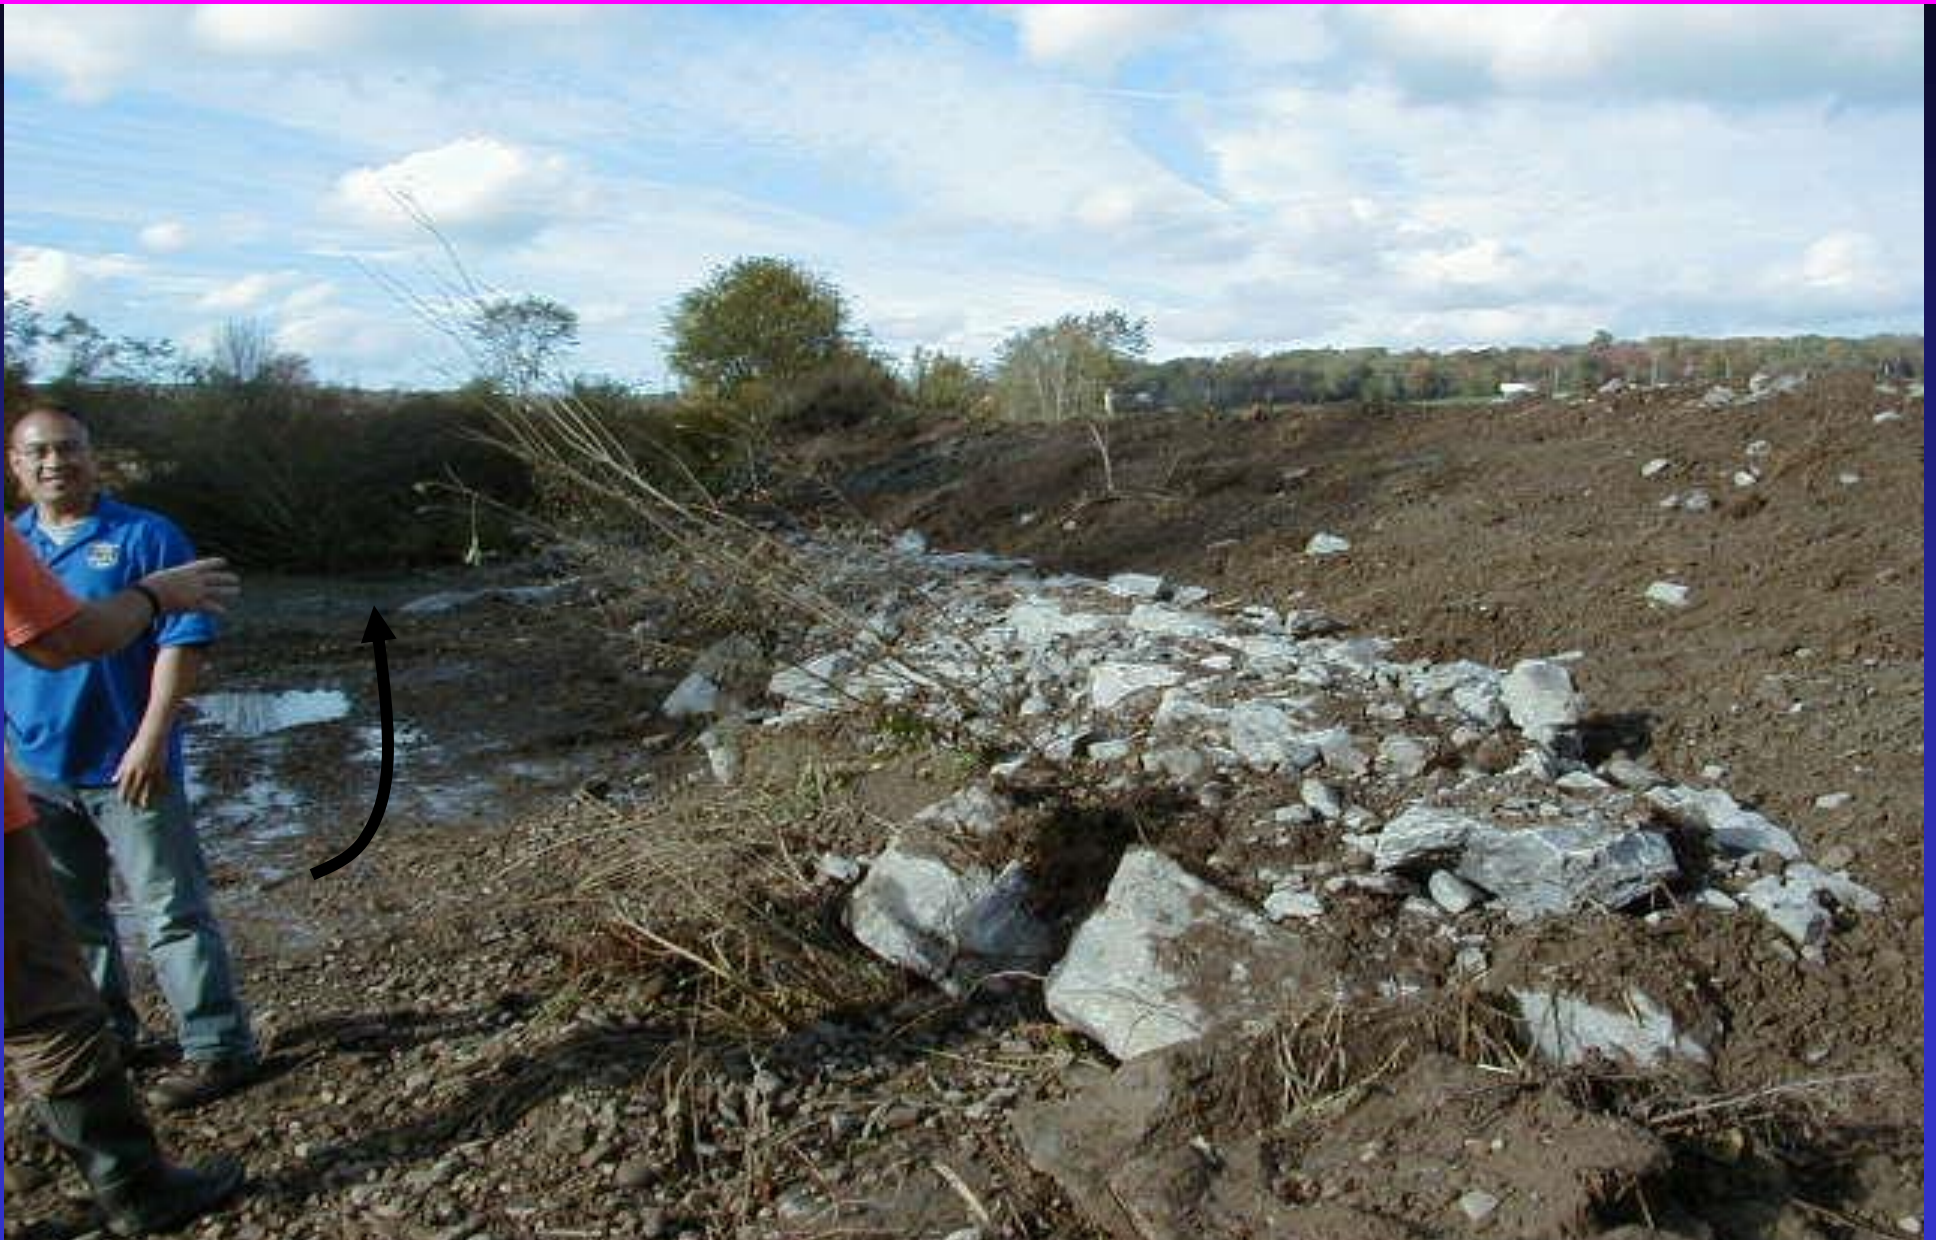
Looking DS. Vegetation integrated thru LPSTP.

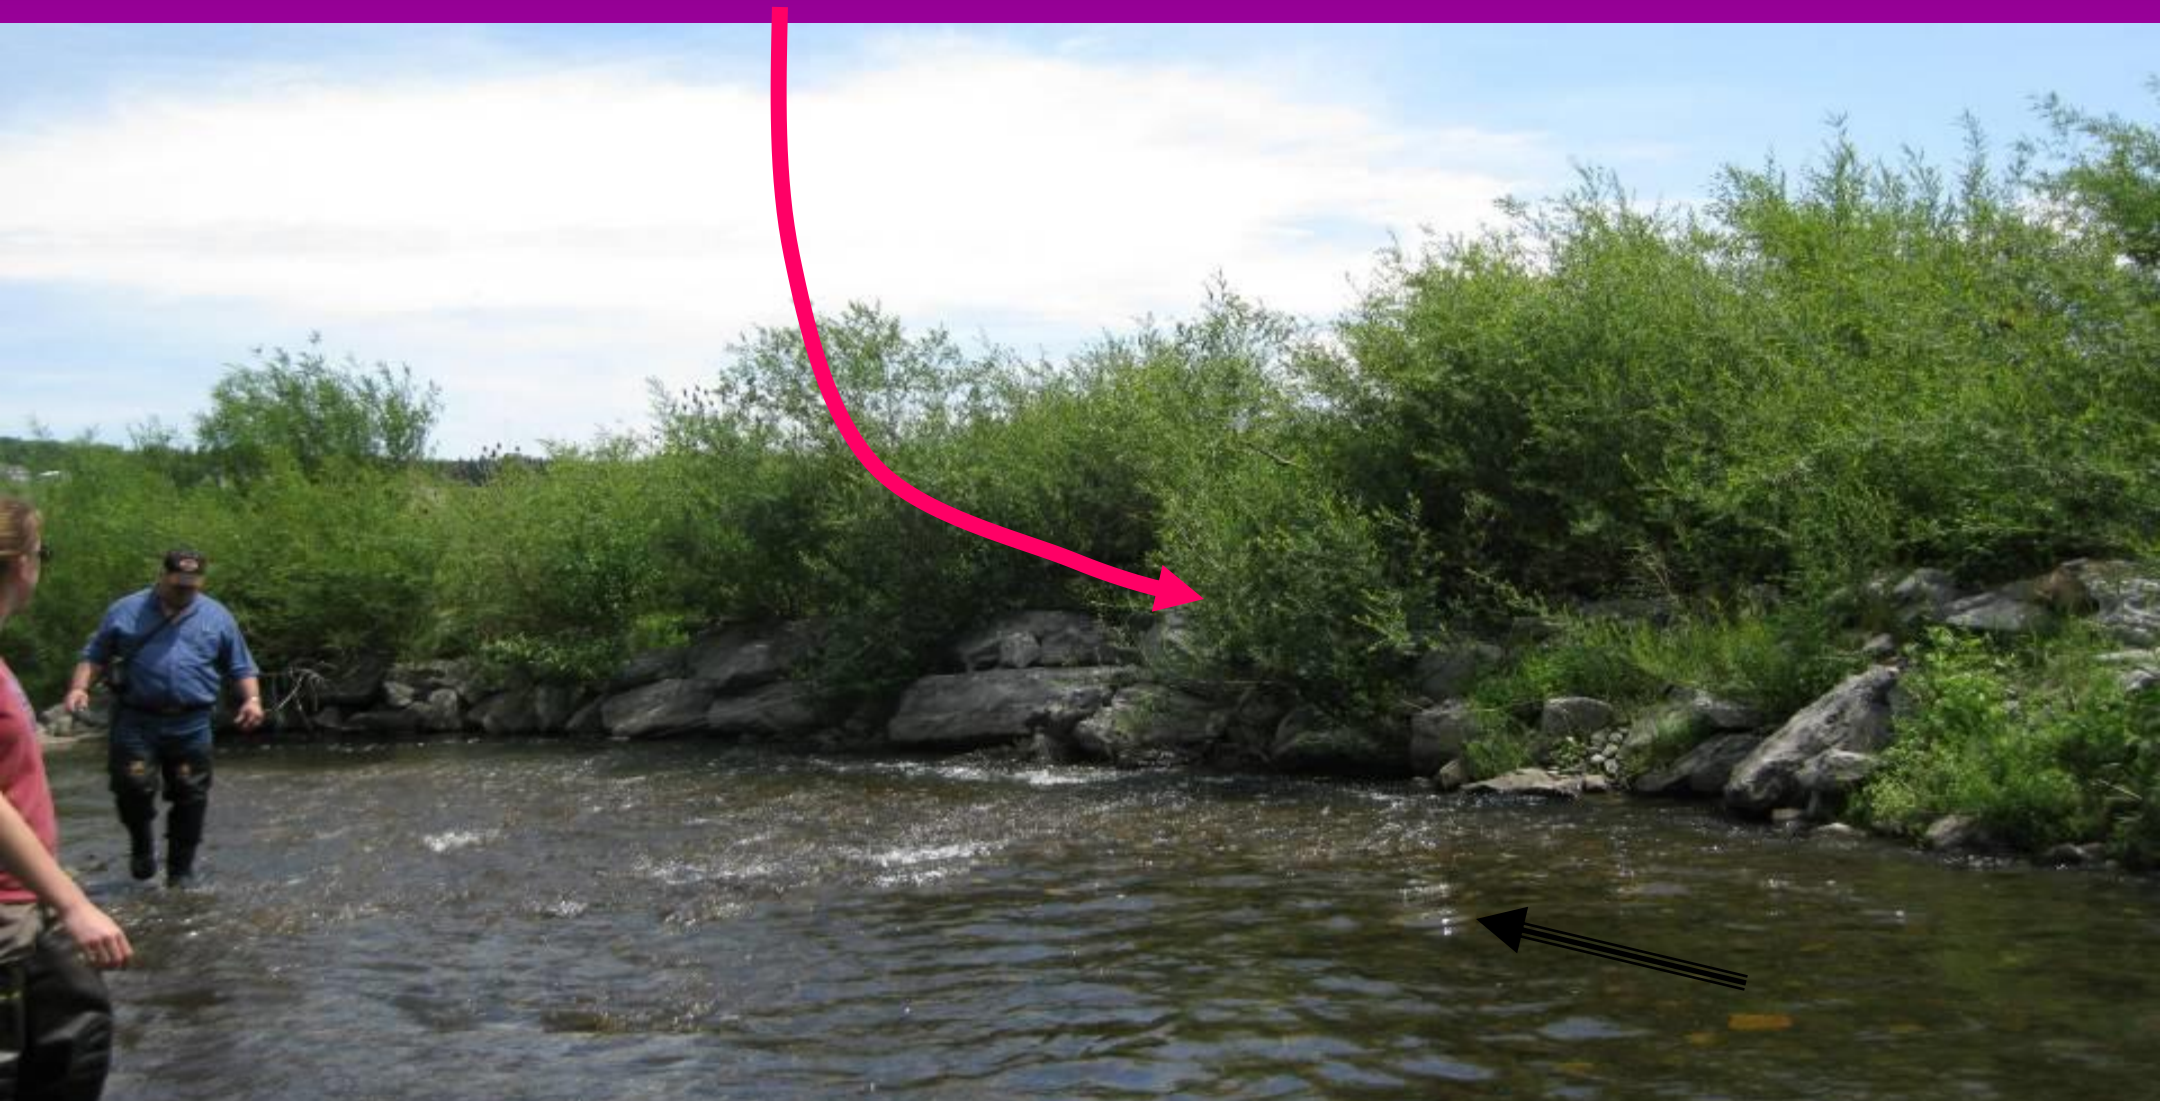
2 years & 8 months after completion. Looking DS @ the apex of the bend. Live Siltation & transplanted willows & dogwood growing well. Nice deep pool to dissipate energy. WILLOW PLANTED WITHIN STONE TOE

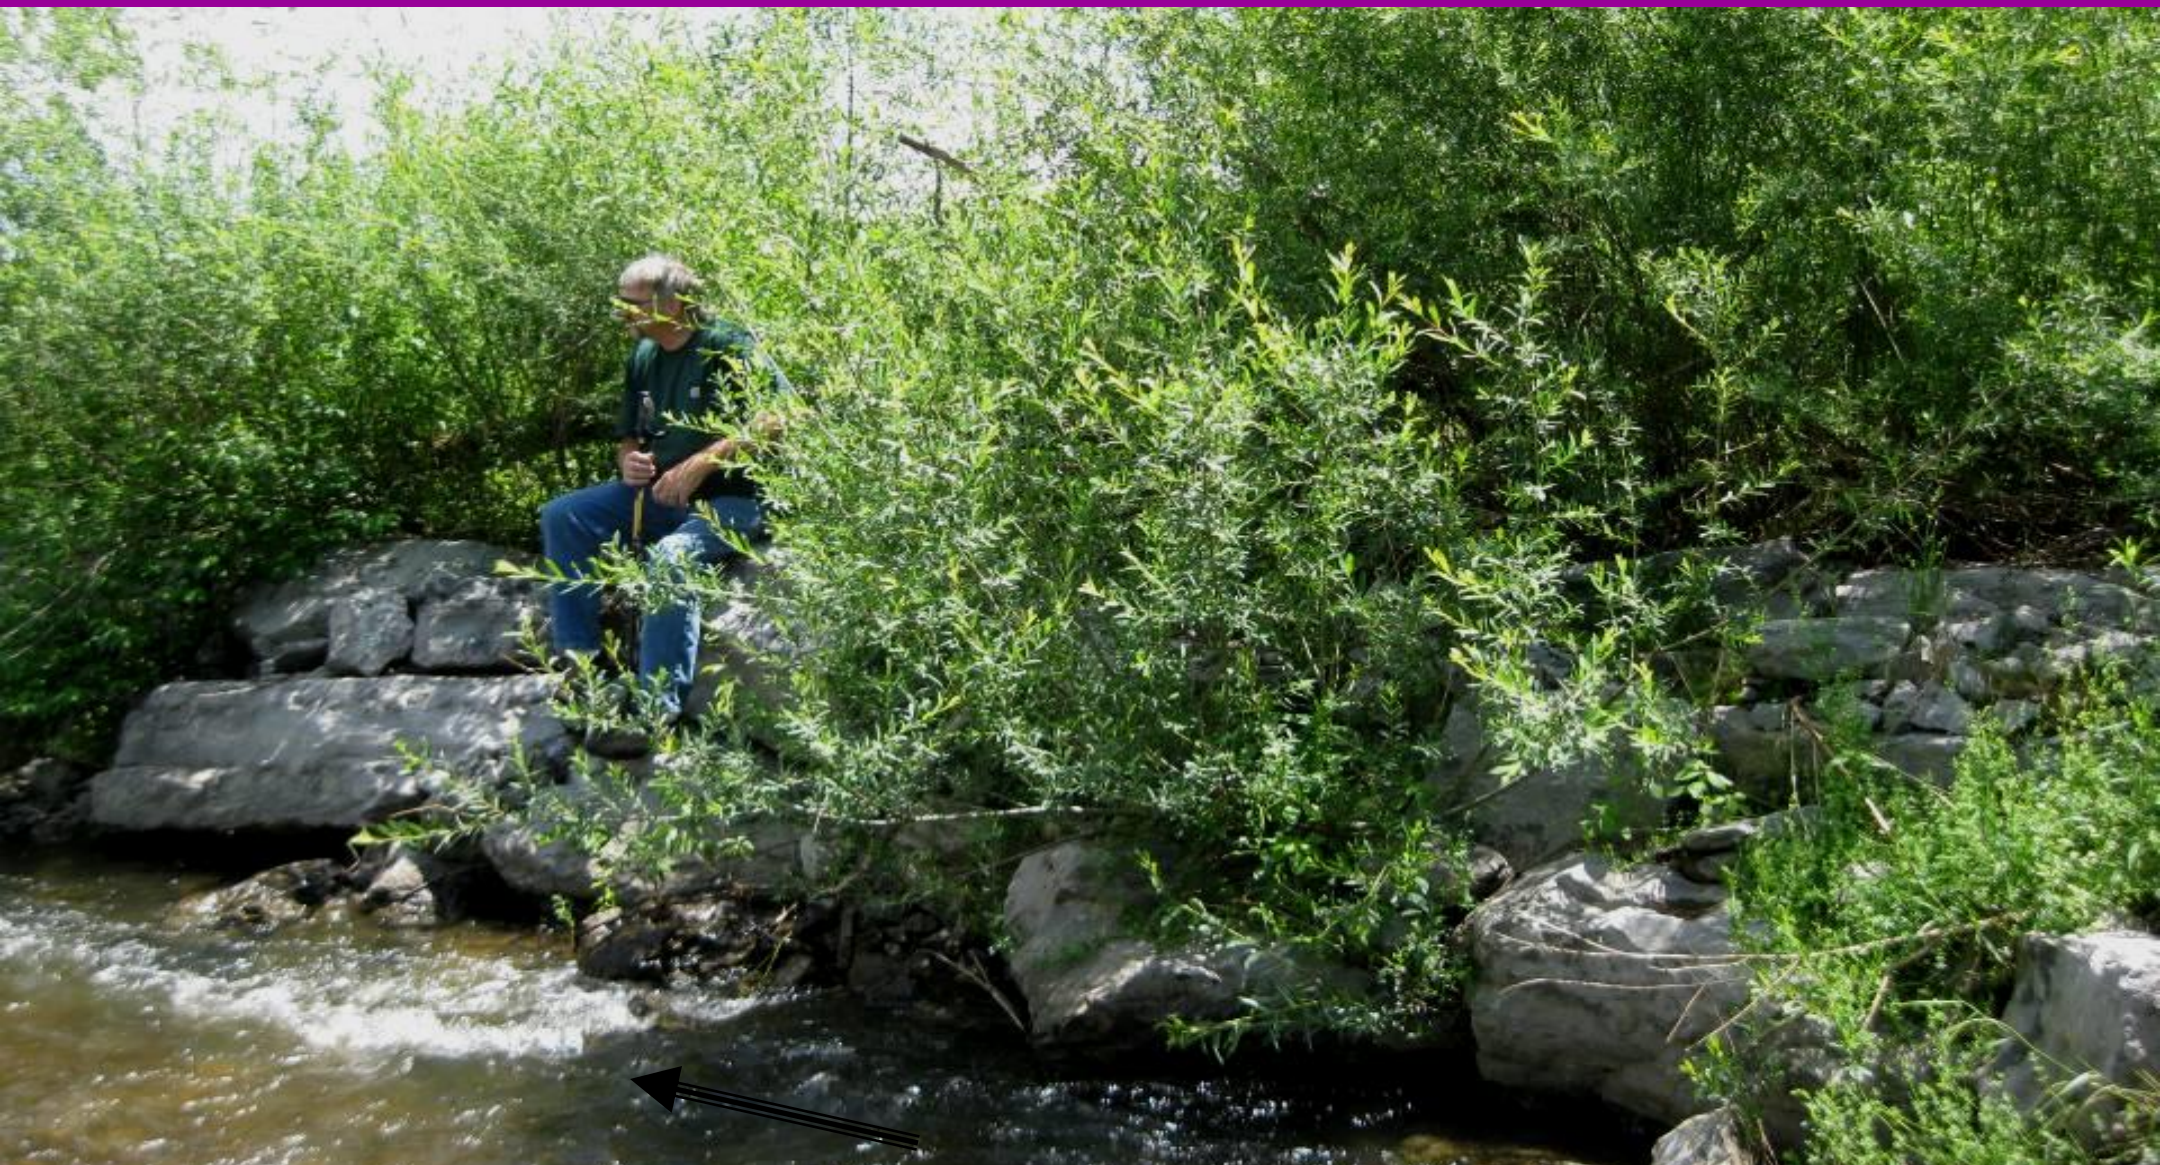
2 years & 8 months after completion. Close-up of stacked stone wall with Live Siltation behind & some planted willow & dogwood growing through the stone wall

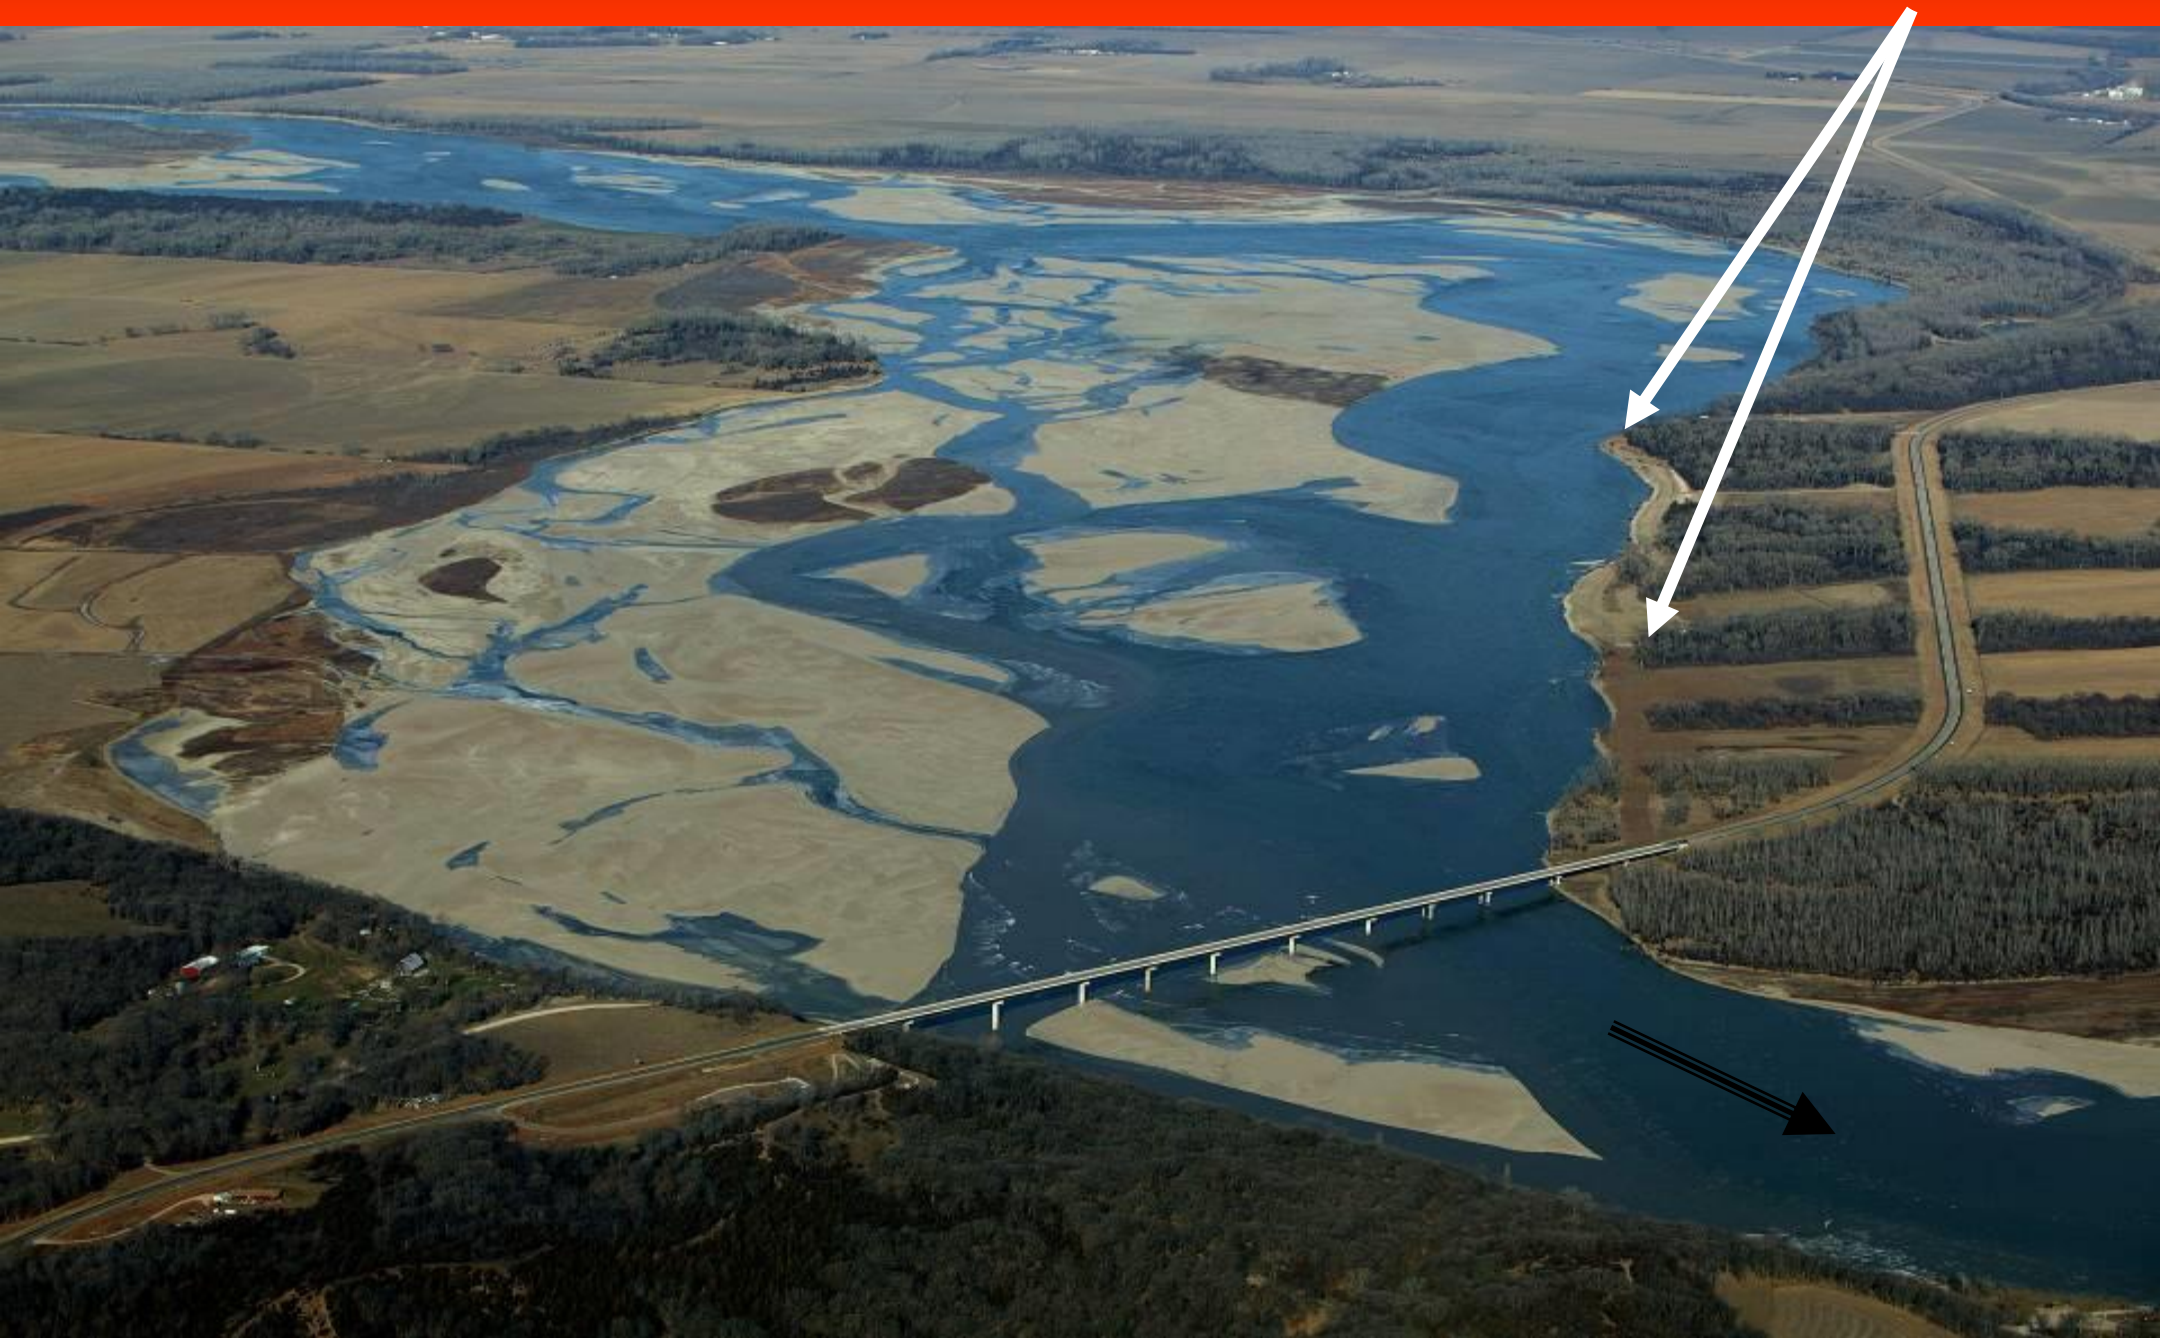
Aerial shot fall 2007. Looking US @ completed mile-long L & C project.

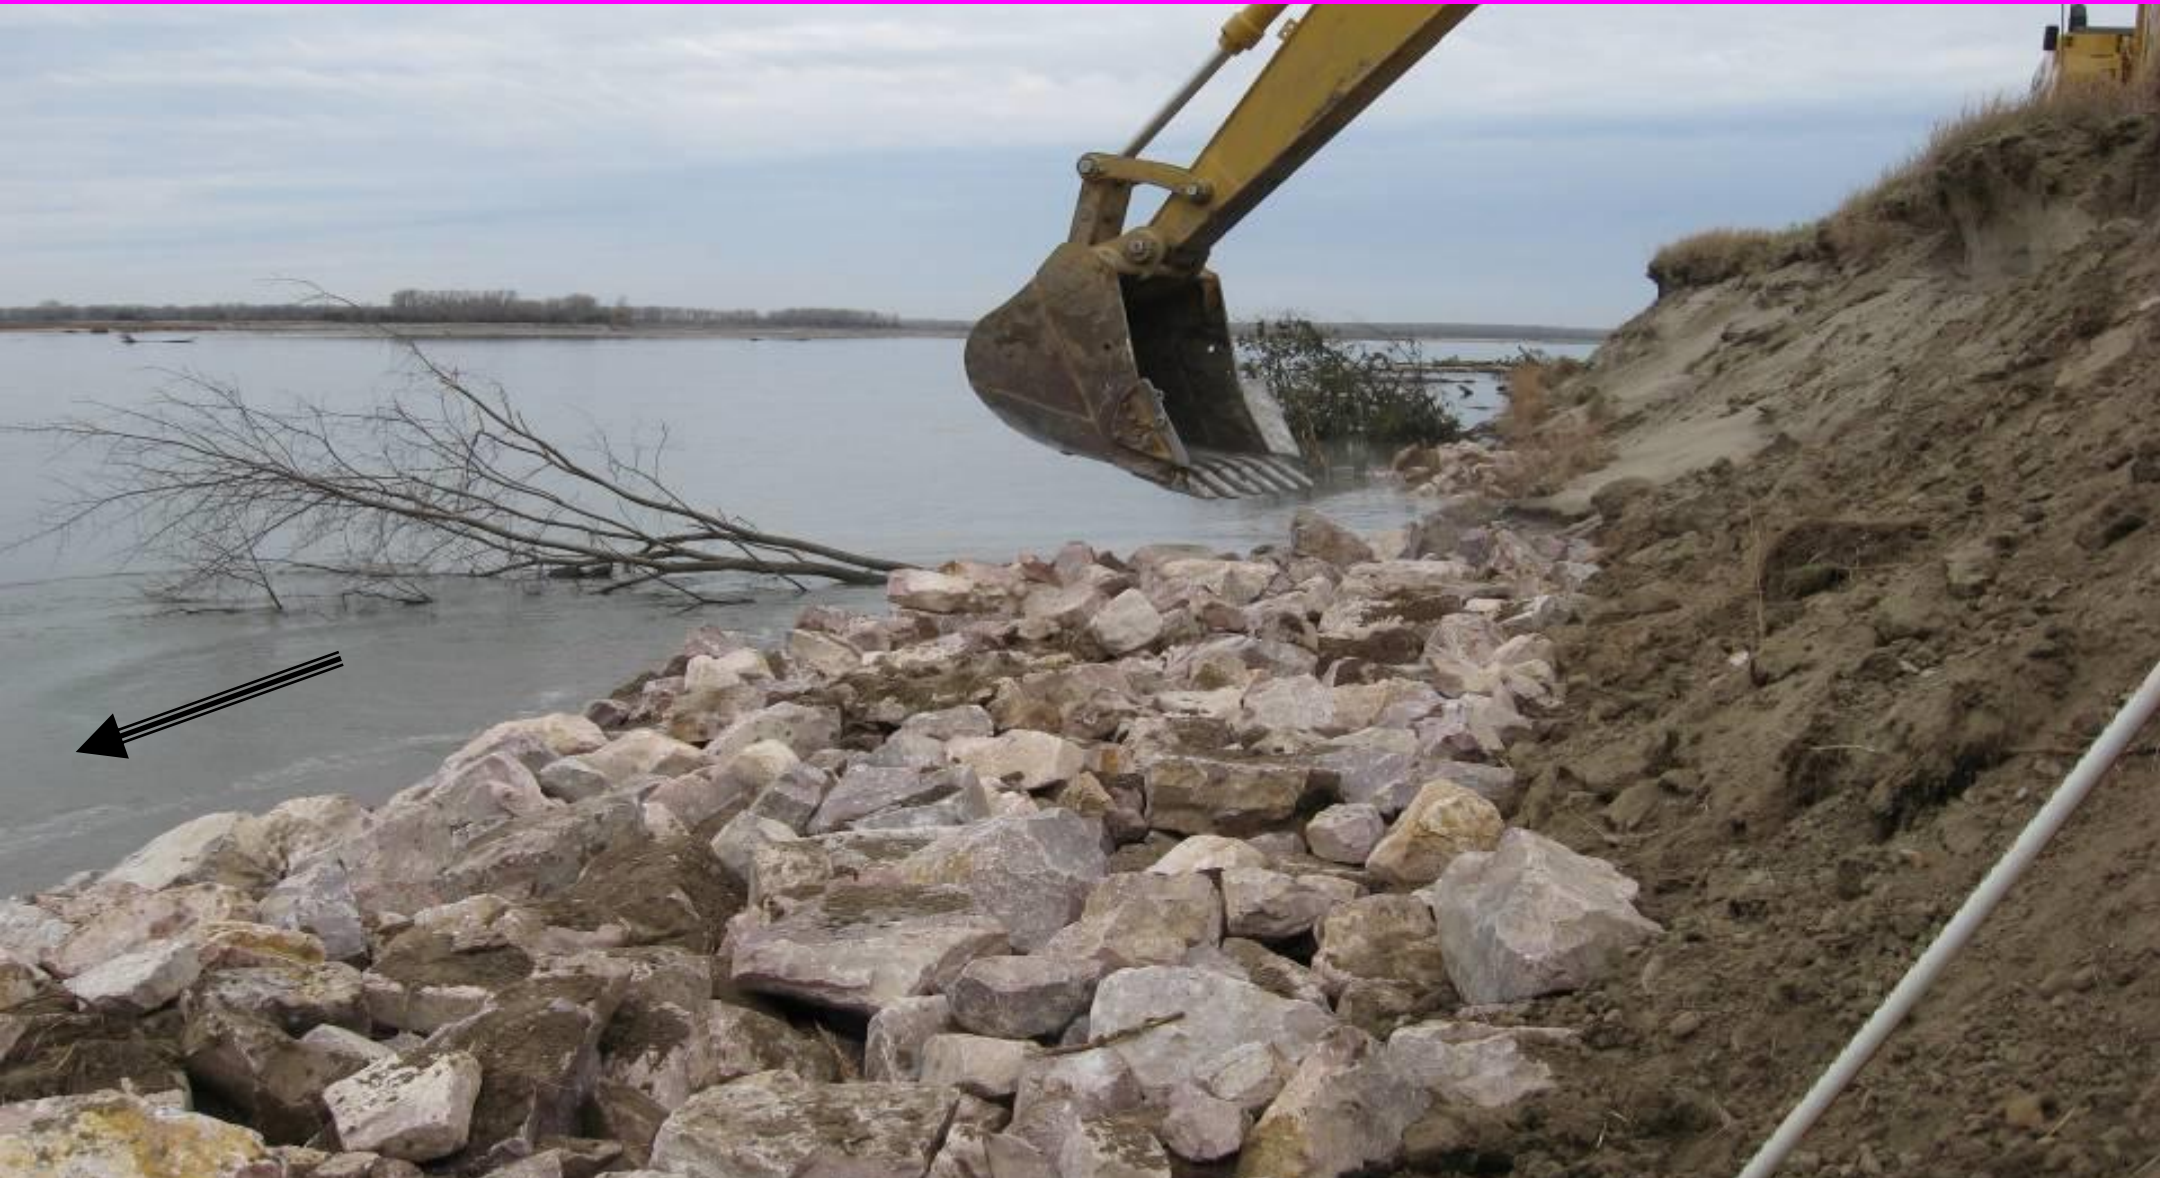
CONSTRUCTION-MISSOURI RIVER @ L & C-TERRY STOLTENOW-11/8/07

**Looking US @ the 10 ft wide Longitudinal Fill Stone Toe Protection.
The bank will be graded to 3 on 1 with riprap & integrated veg**

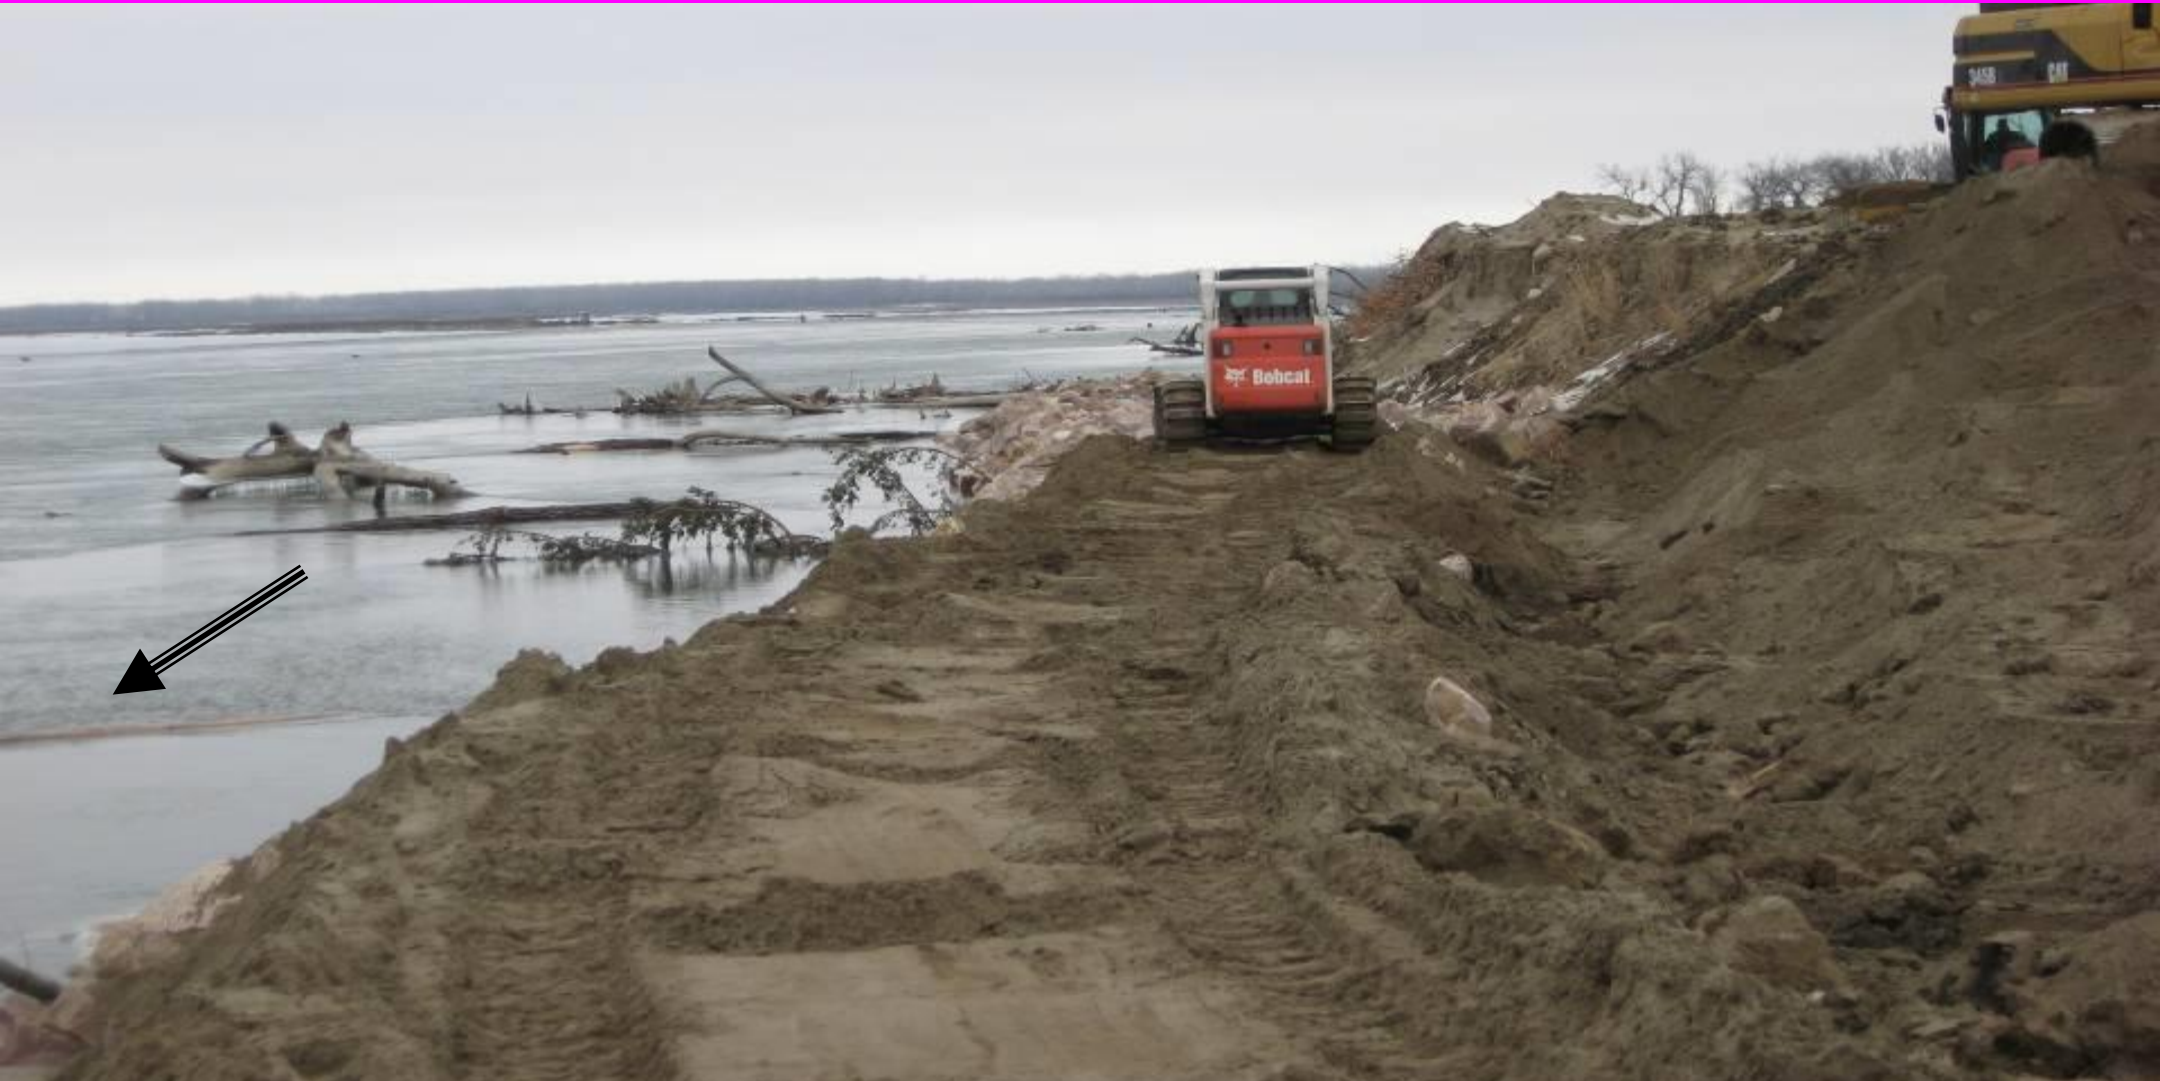
**Looking US. Smoothing choke soil with the Bobcat.
Minimum of 6 inches of soil choke, but contractor applied
12 inches almost everywhere. Some settling will occur.**

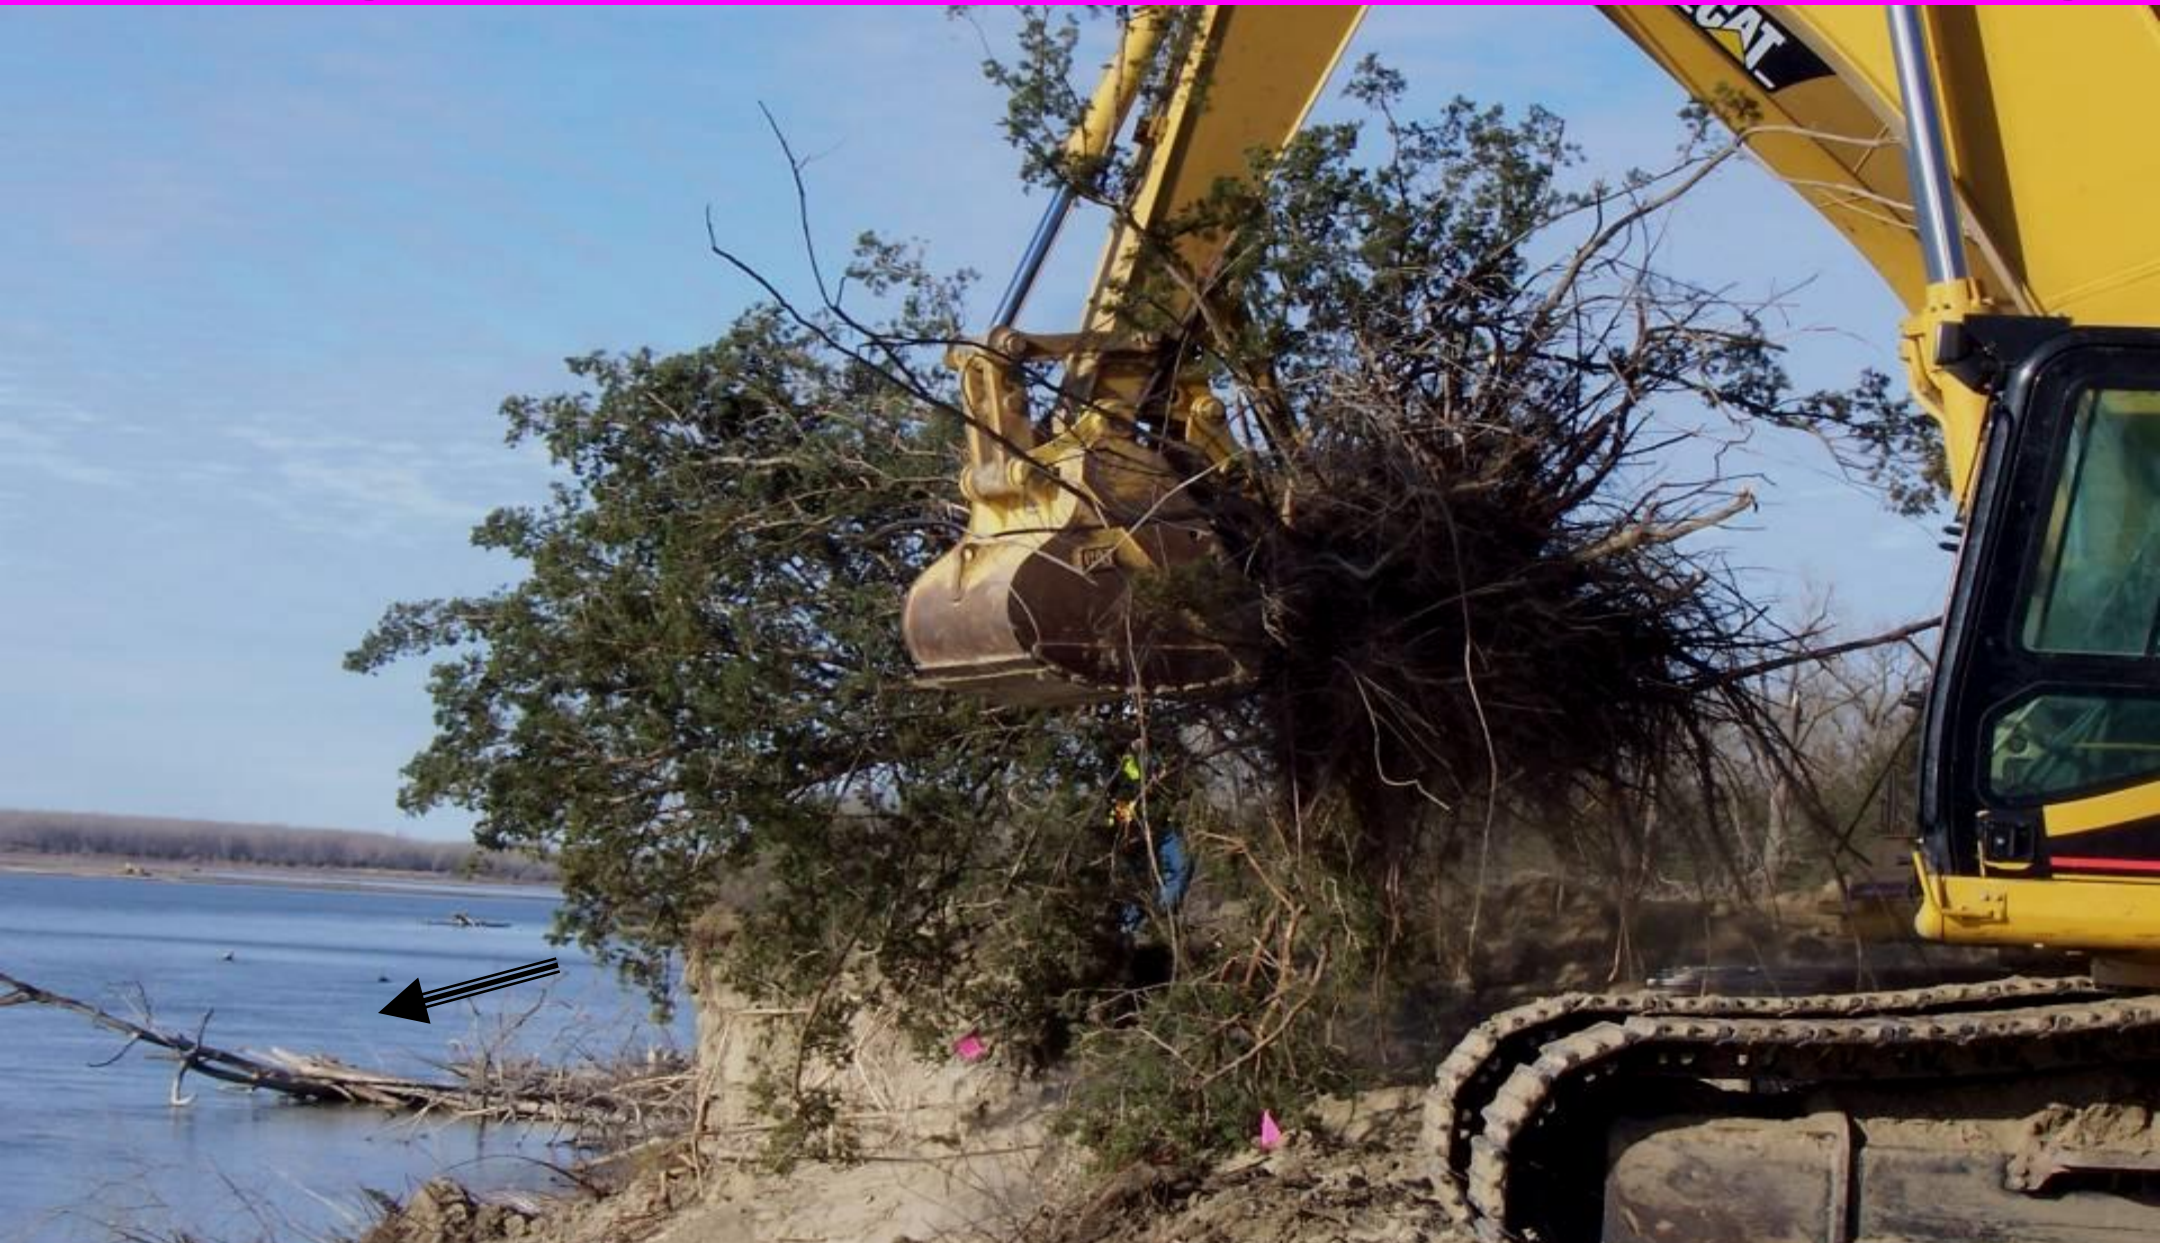
CONSTRUCTION-MISSOURI RIVER @ L & C-DERRICK-NOV 15, 2007

Looking US. A cedar Fuzzy Extreme Locked Log

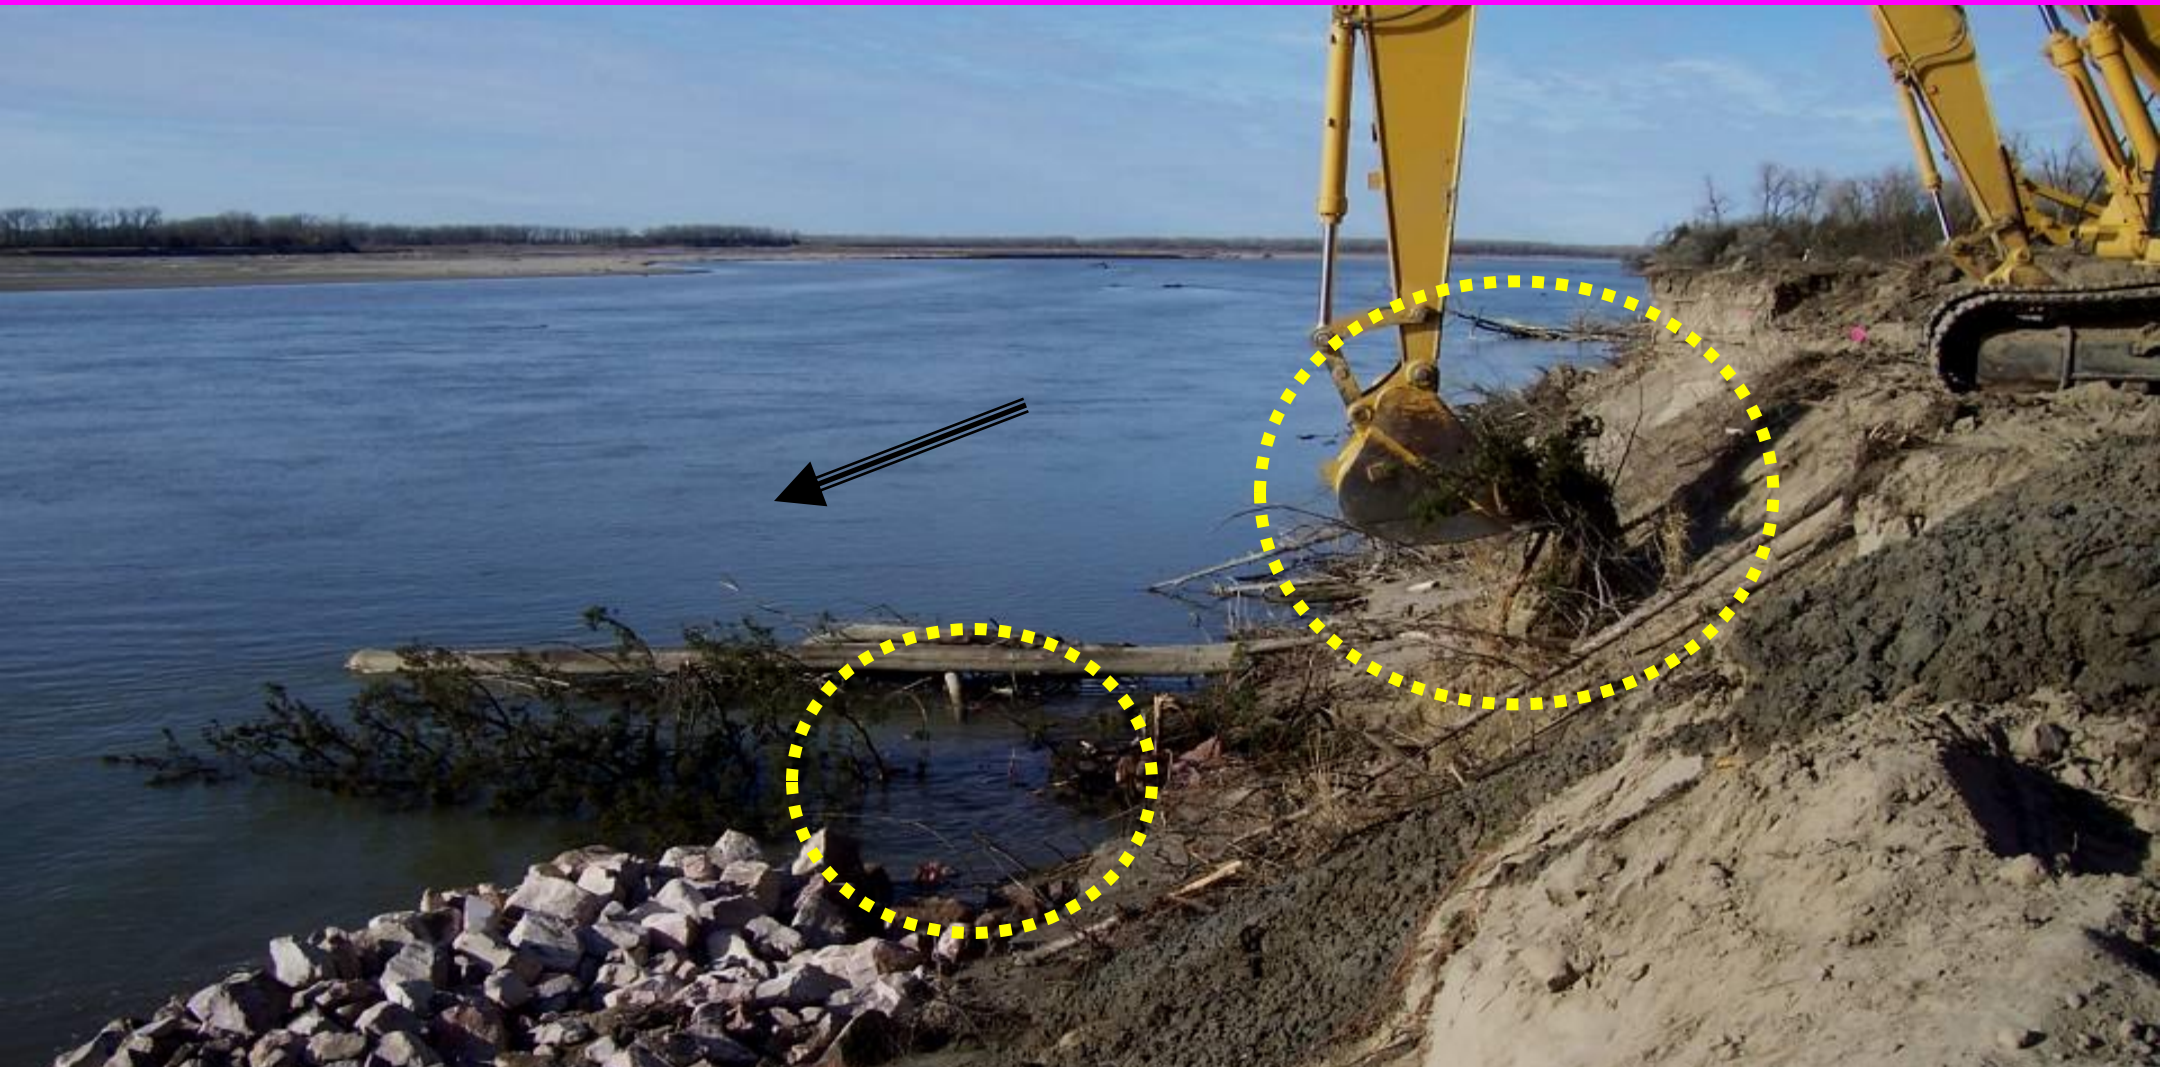
CONSTRUCTION-MISSOURI RIVER @ L & C-DERRICK-NOV 15, 2007

Looking US. Scraping branches off of the lower 15 ft of the Fuzzy Extreme Locked Log so stone to trunk contact is made, & then the Locked Log is truly locked in place.
