**COMBINATIONS OF RESISTIVE
& REDIRECTIVE METHODS:
CASE STUDY- Duck Creek East of
Eastern Avenue, Davenport, Iowa
Constructed June-July. 2008**

**Longitudinal Peaked Stone Toe
Protection {LFSTP} with interspaced
Short Bendway Weirs & Locked Logs**

LONGITUDINAL PEAKED STONE TOE PROTECTION {LPSTP}

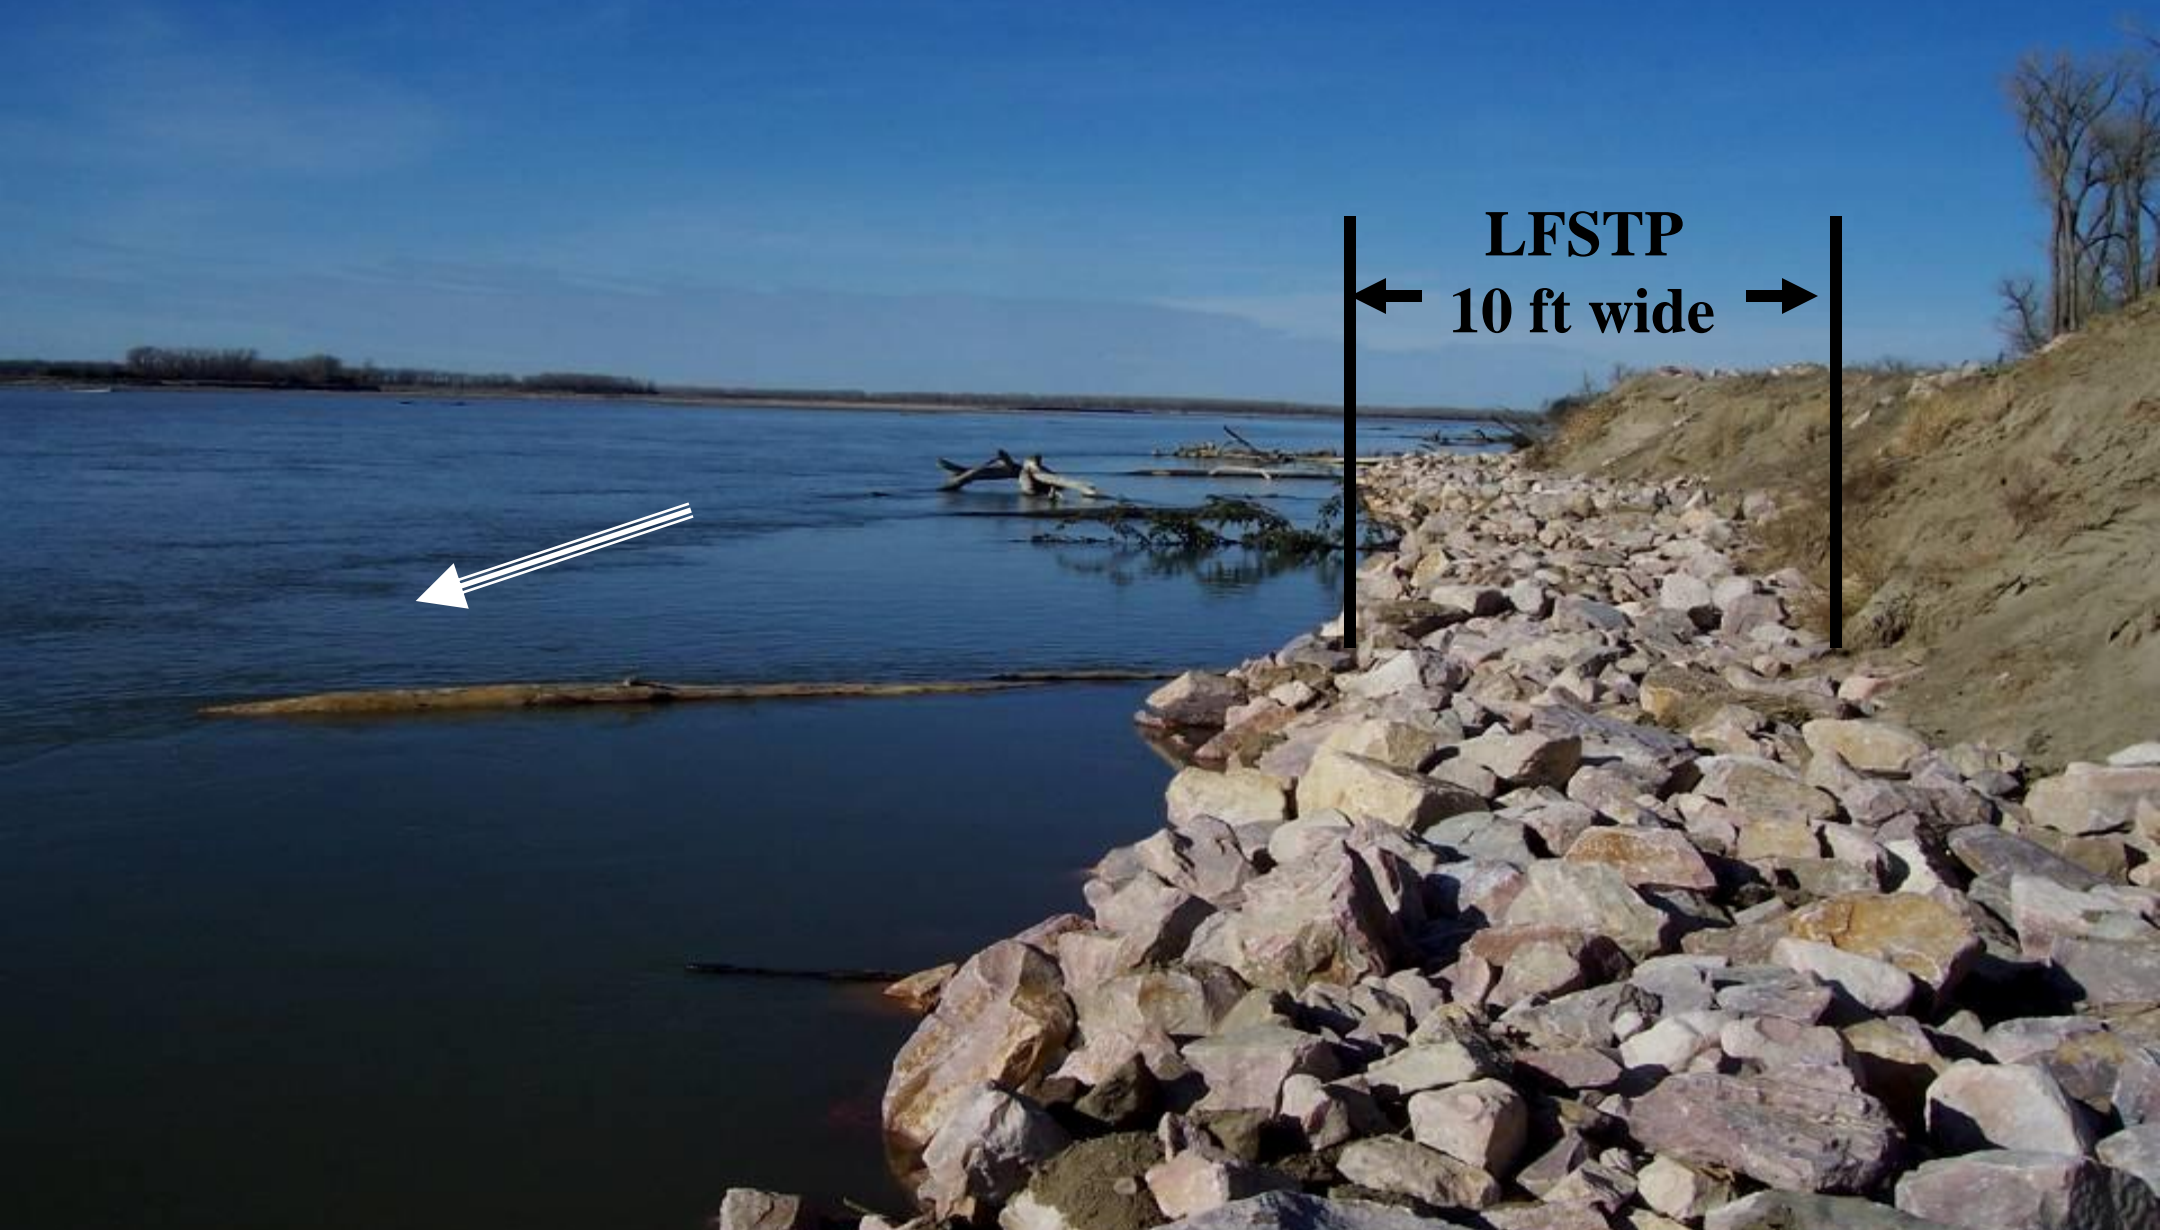
CONSTRUCTION-MISSOURI RIVER @ L & C-DERRICK-NOV 15, 2007

Looking US. Note calm water between Locked Logs.

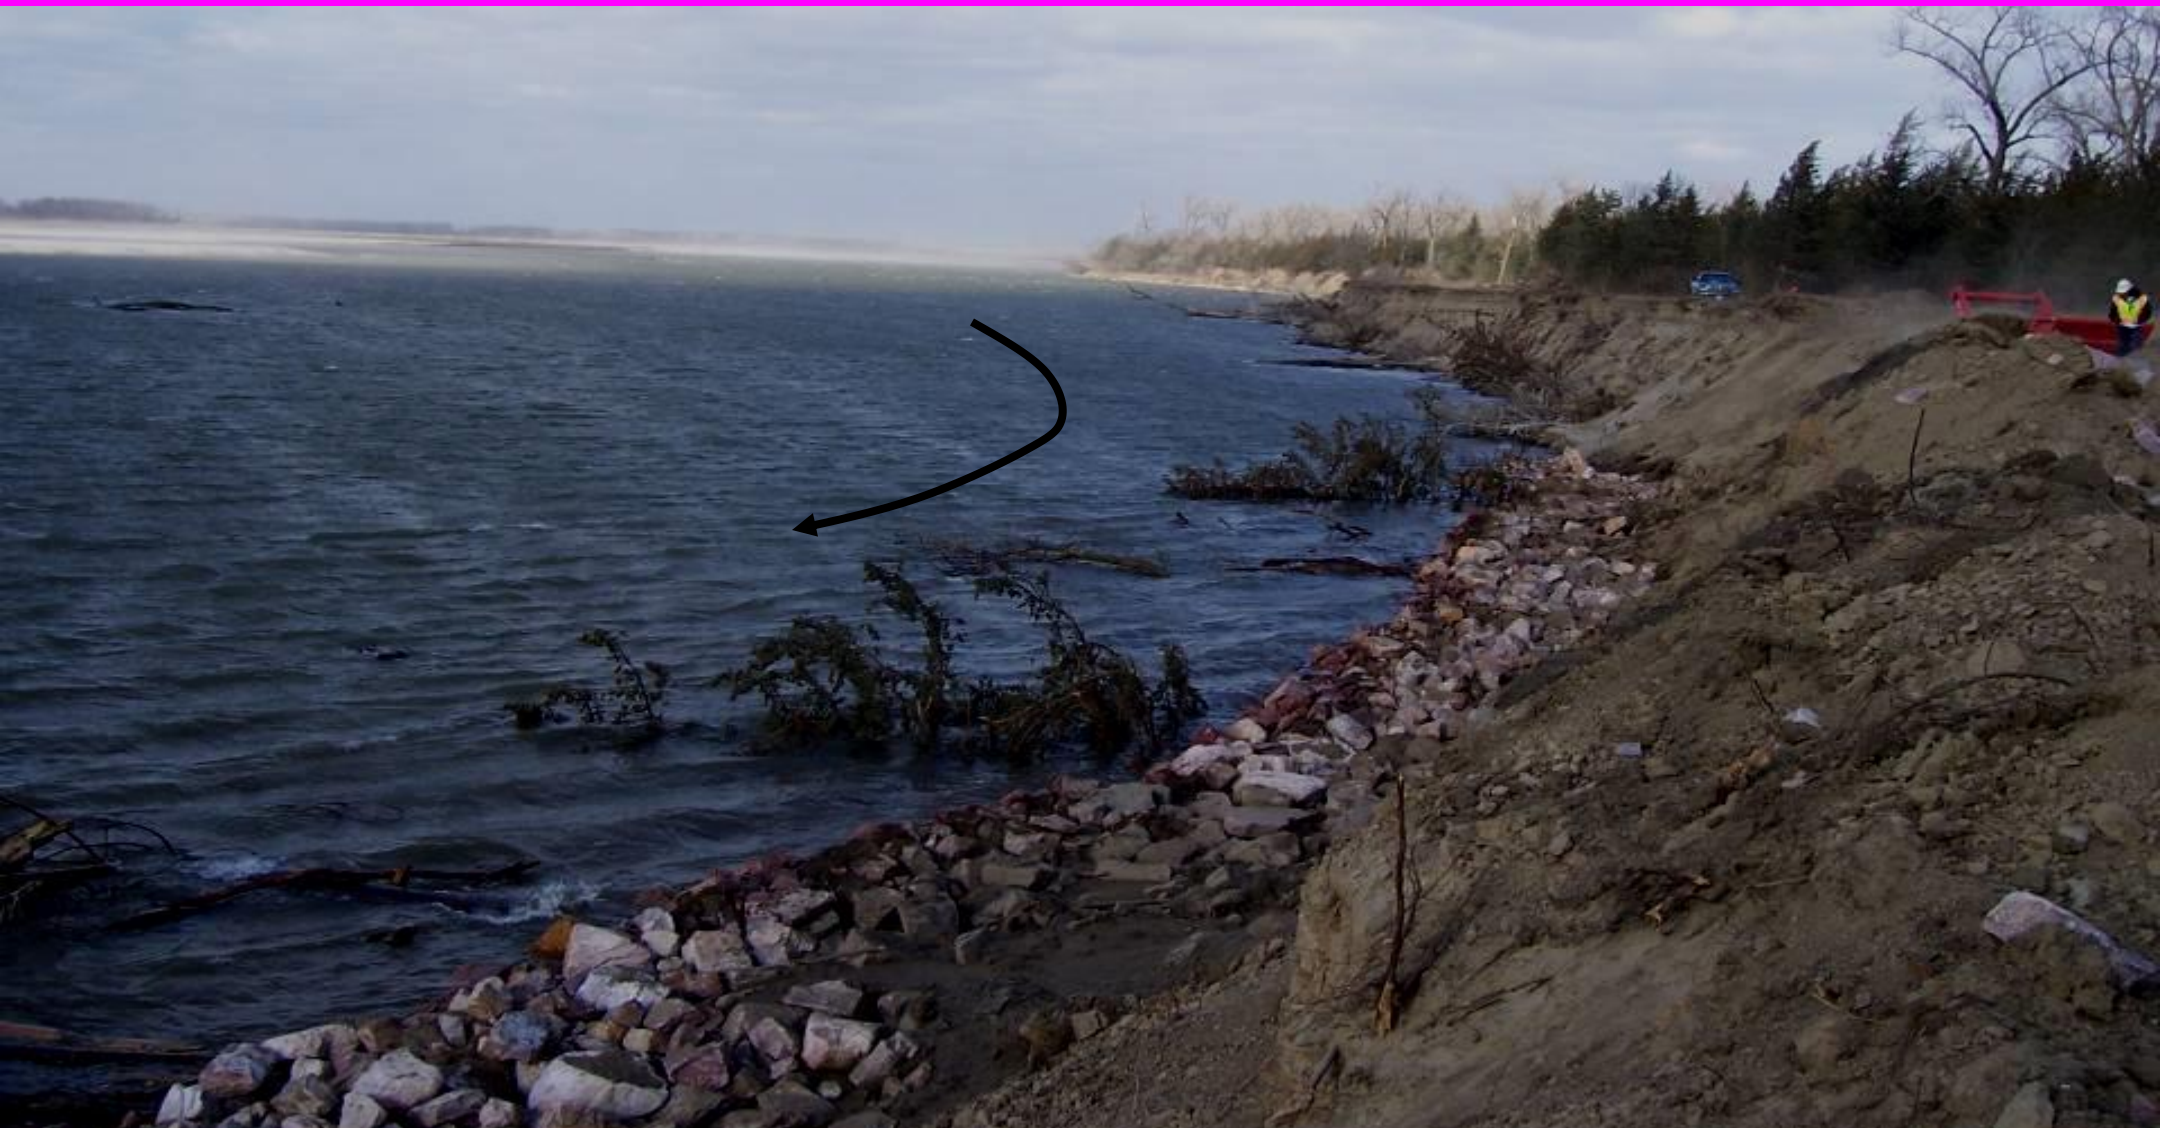
CONSTRUCTION-MISSOURI RIVER @ L & C-DERRICK-NOV 15, 2007

Looking US @ self-adjusting toe stone & Extreme Locked Logs, note natural bank with wood upstream.

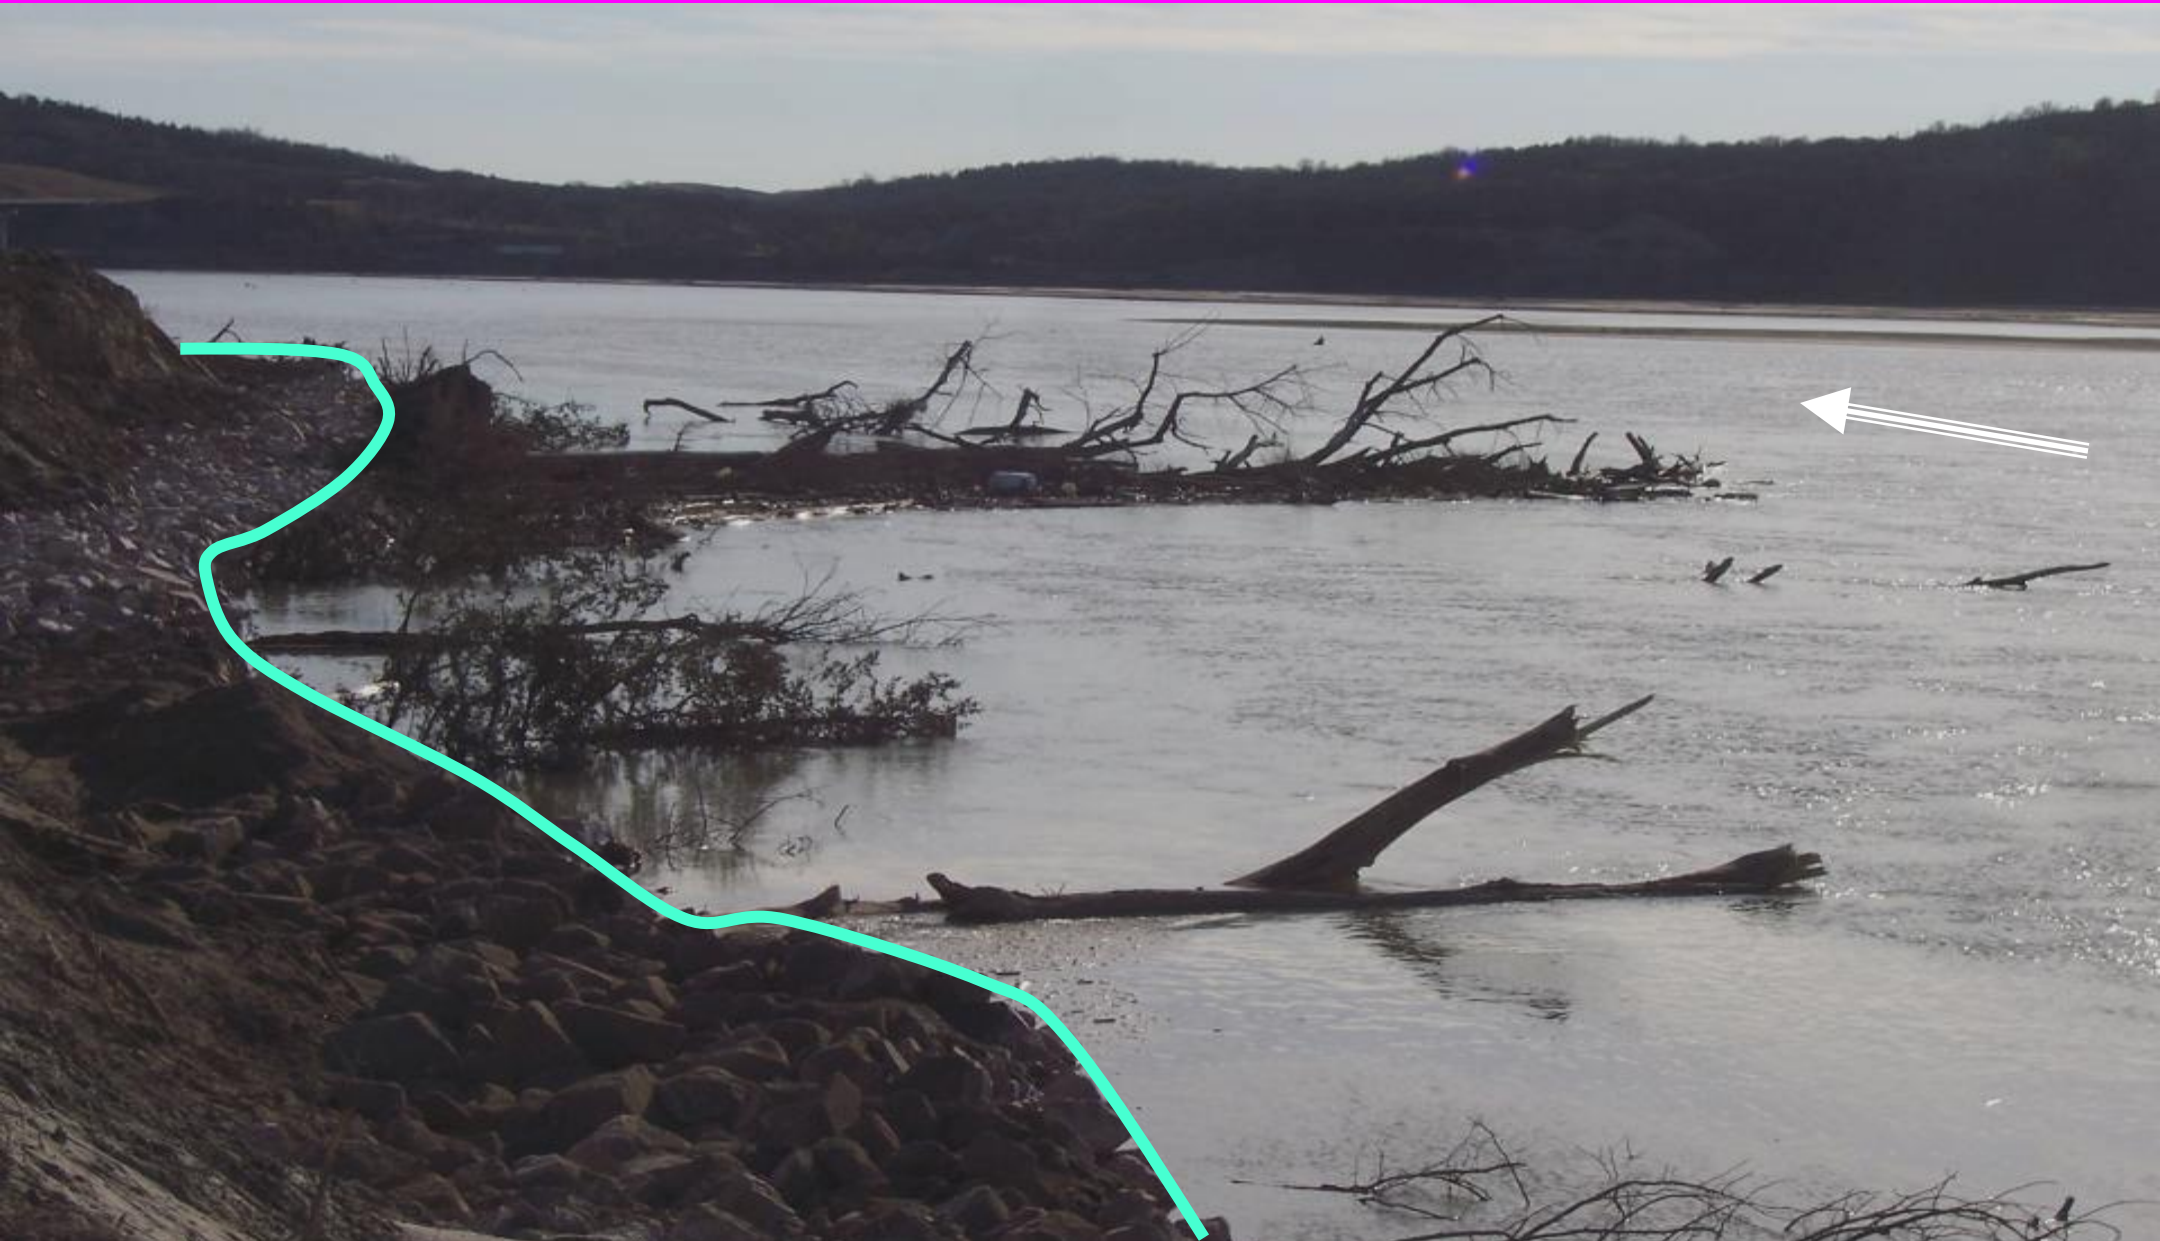
CONSTRUCTION-MISSOURI RIVER @ L & C-DERRICK-NOV 15, 2007

Looking DS. Irregular bankline mimics natural shore

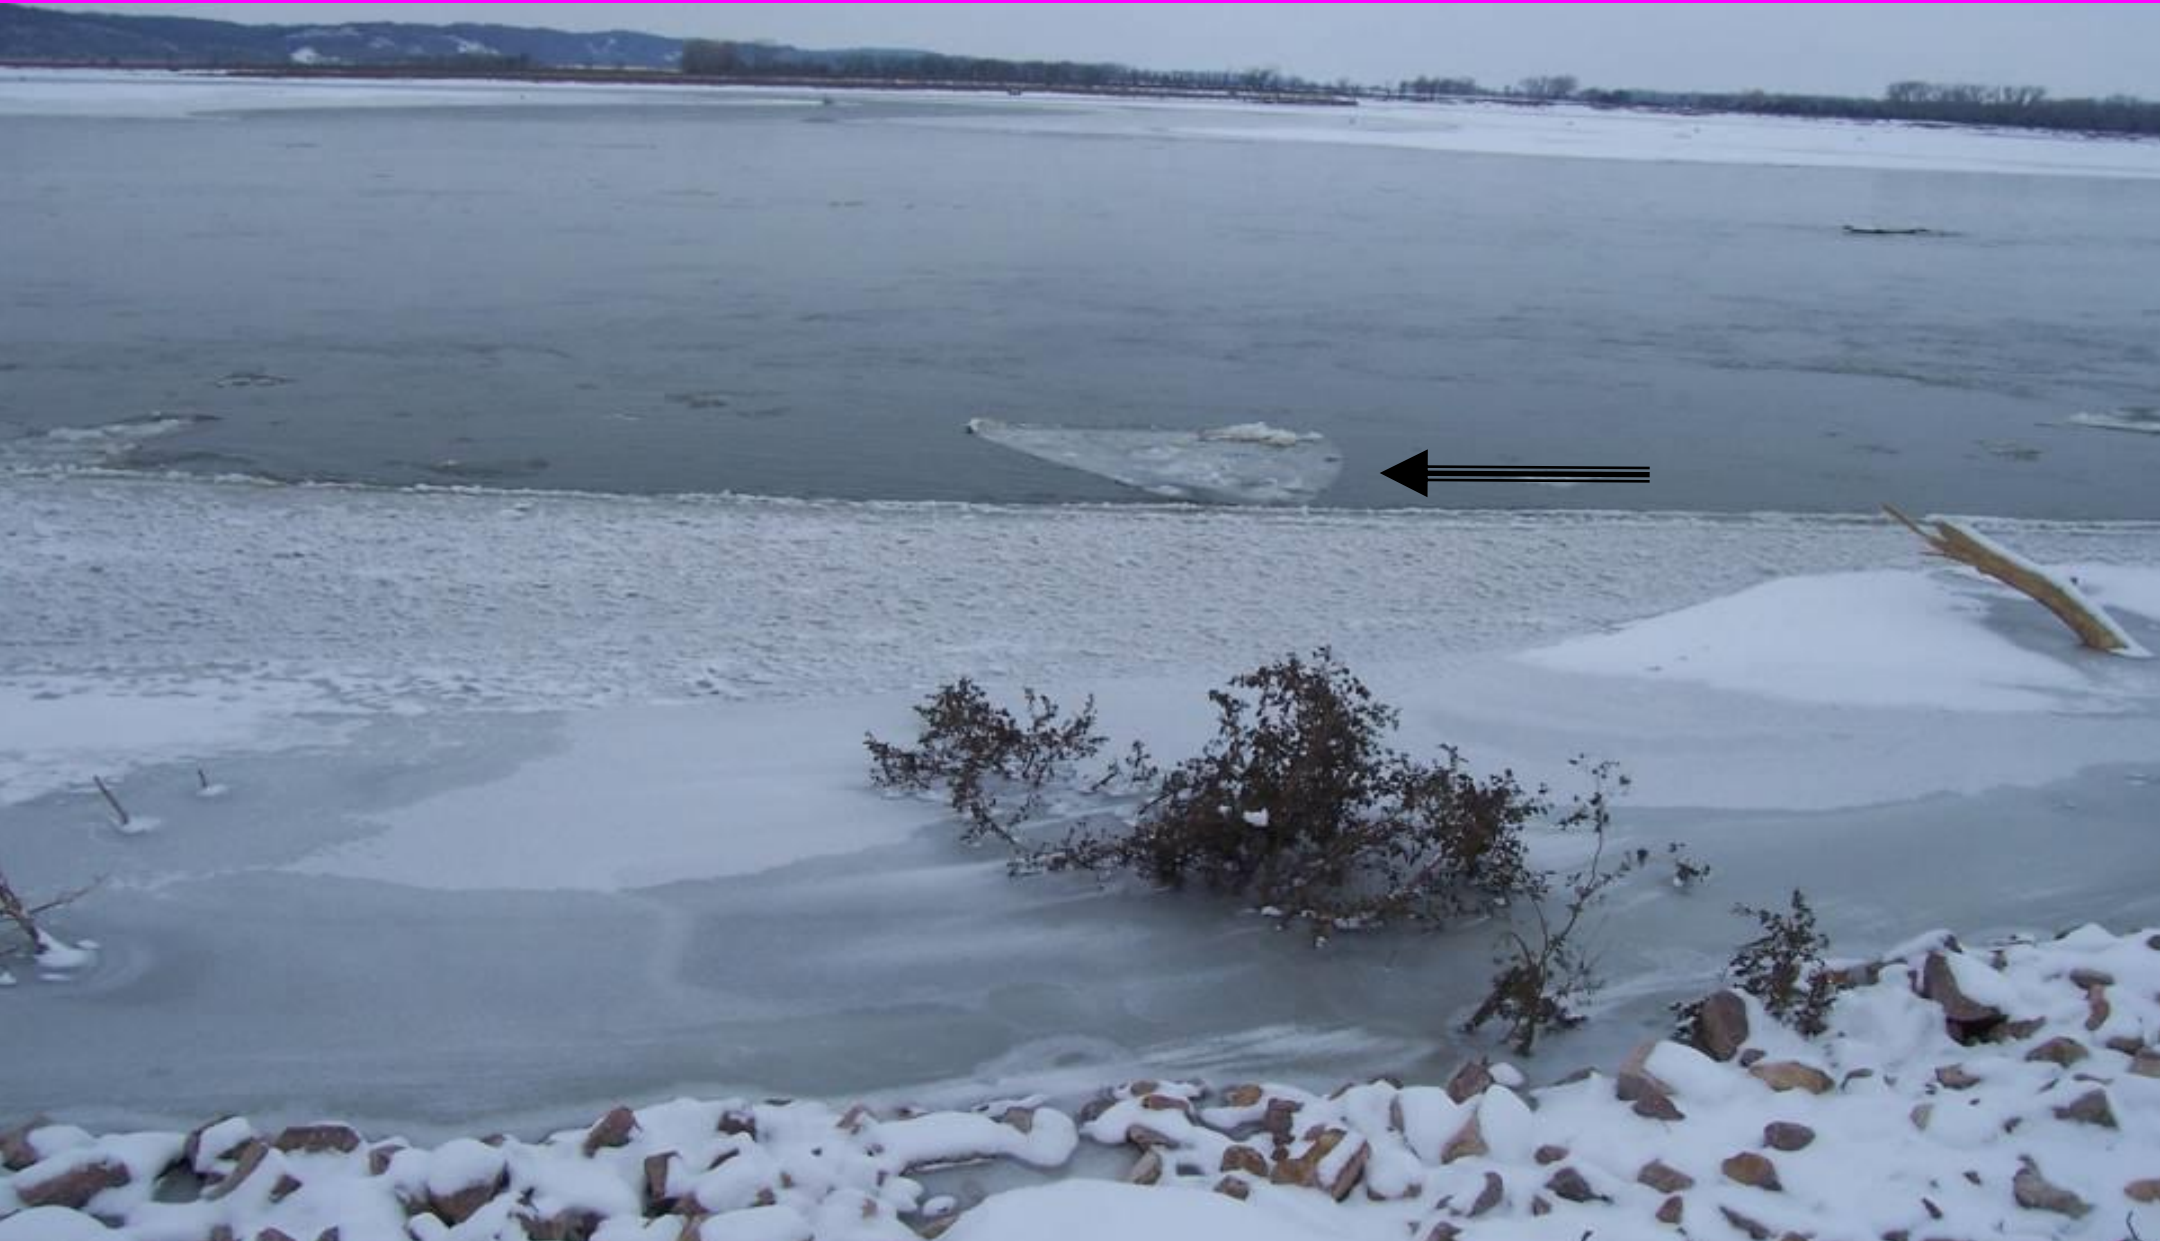
CONSTRUCTION-MISSOURI RIVER @ L & C-DERRICK-DEC 11, 2007

**EXTREME
LOCKED
LOGS WITH
ICE**

Ice surrounding ExLL fends off moving ice floes.

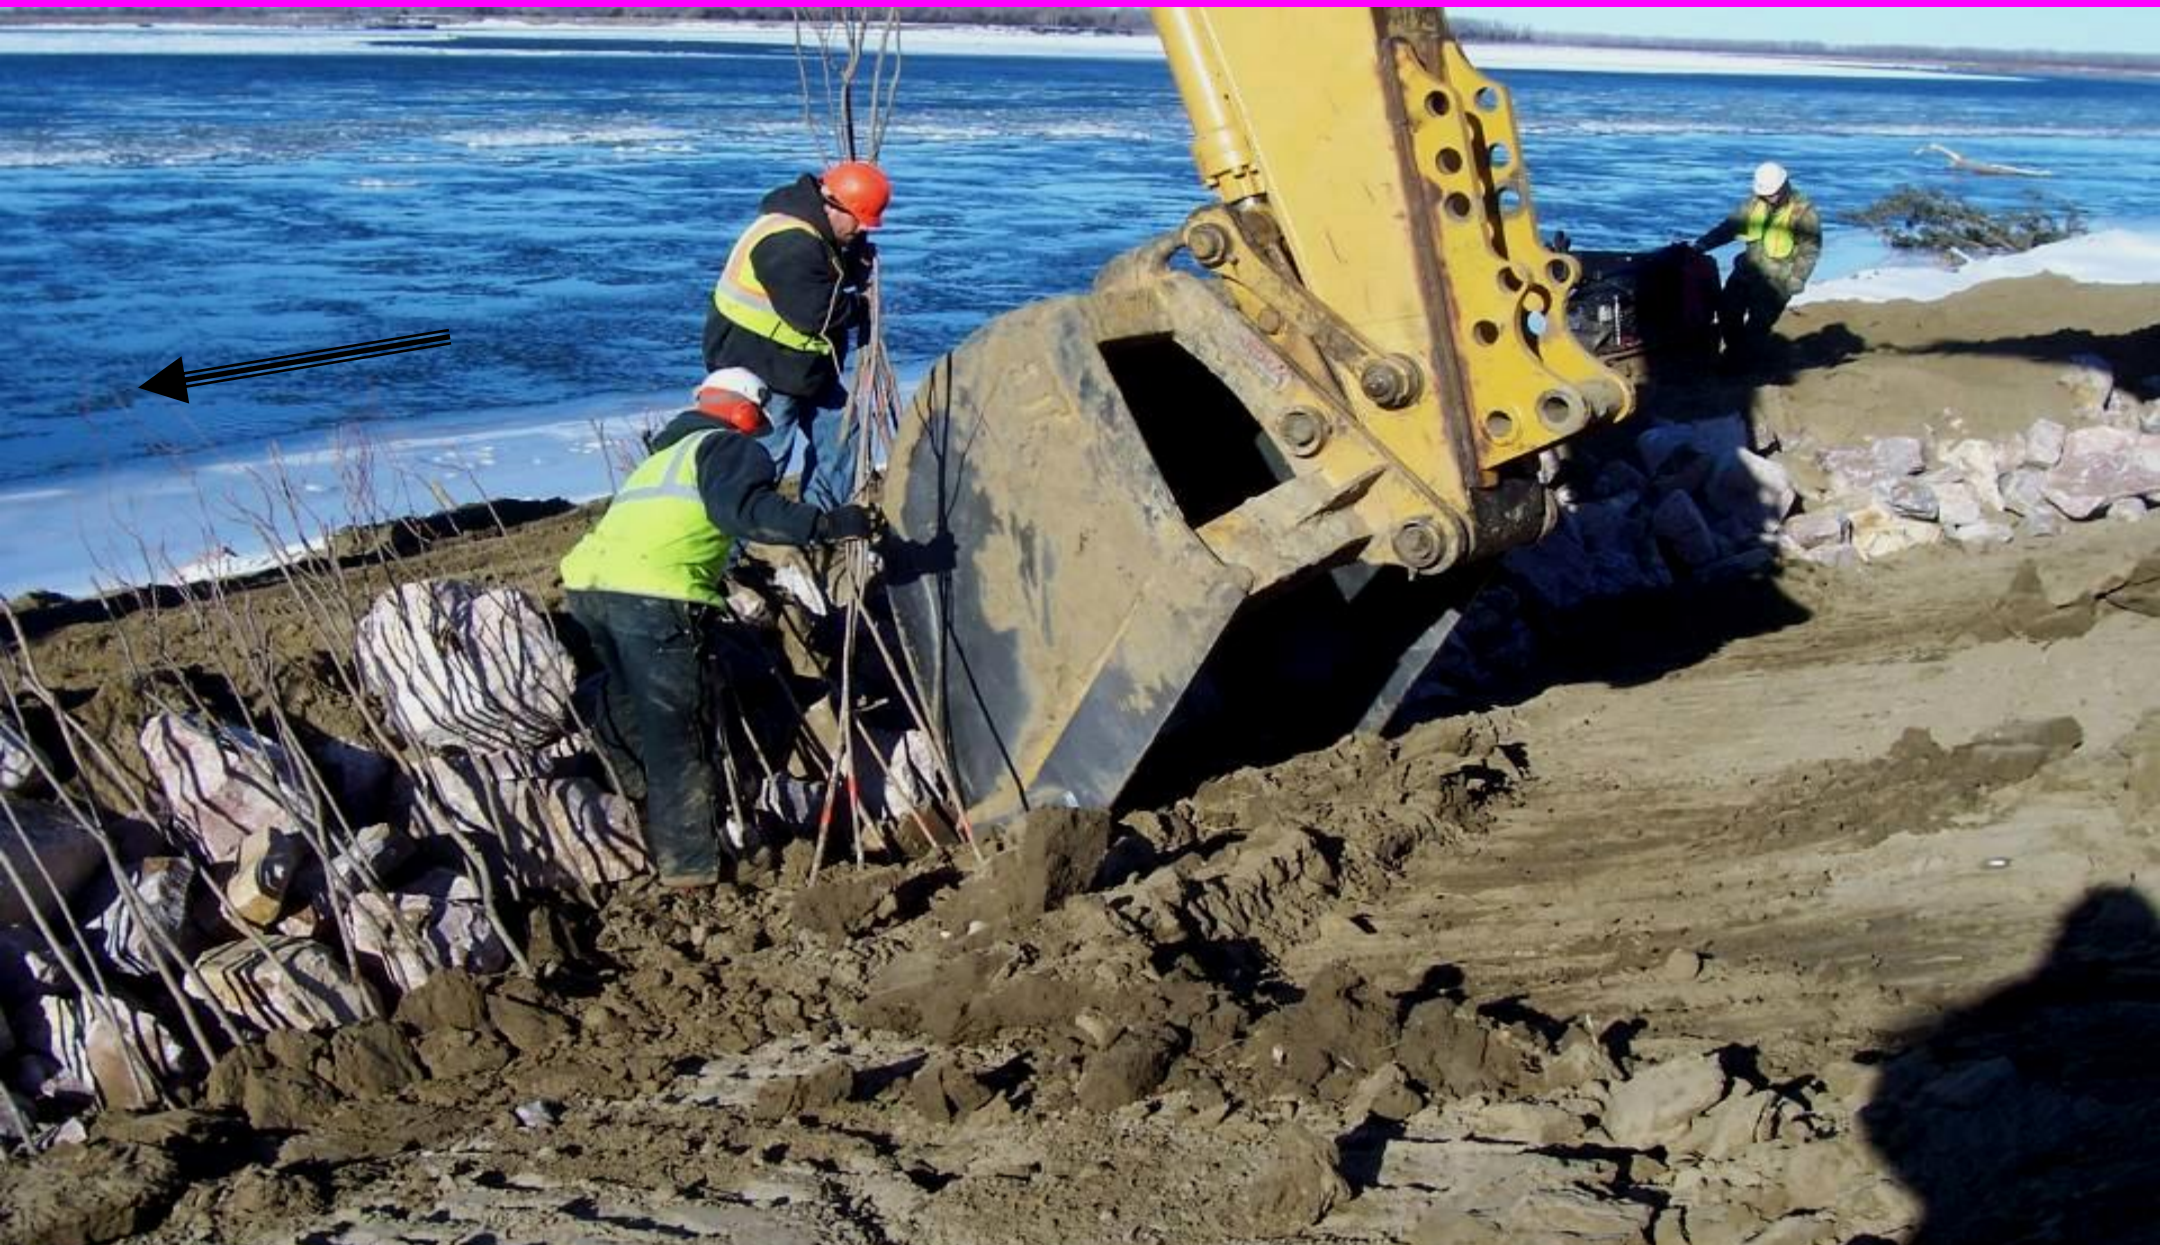
CONSTRUCTION-MISSOURI RIVER @ L & C-DERRICK-Dec 13, 2007

Pull bucket back 8", lean willow poles against stone.

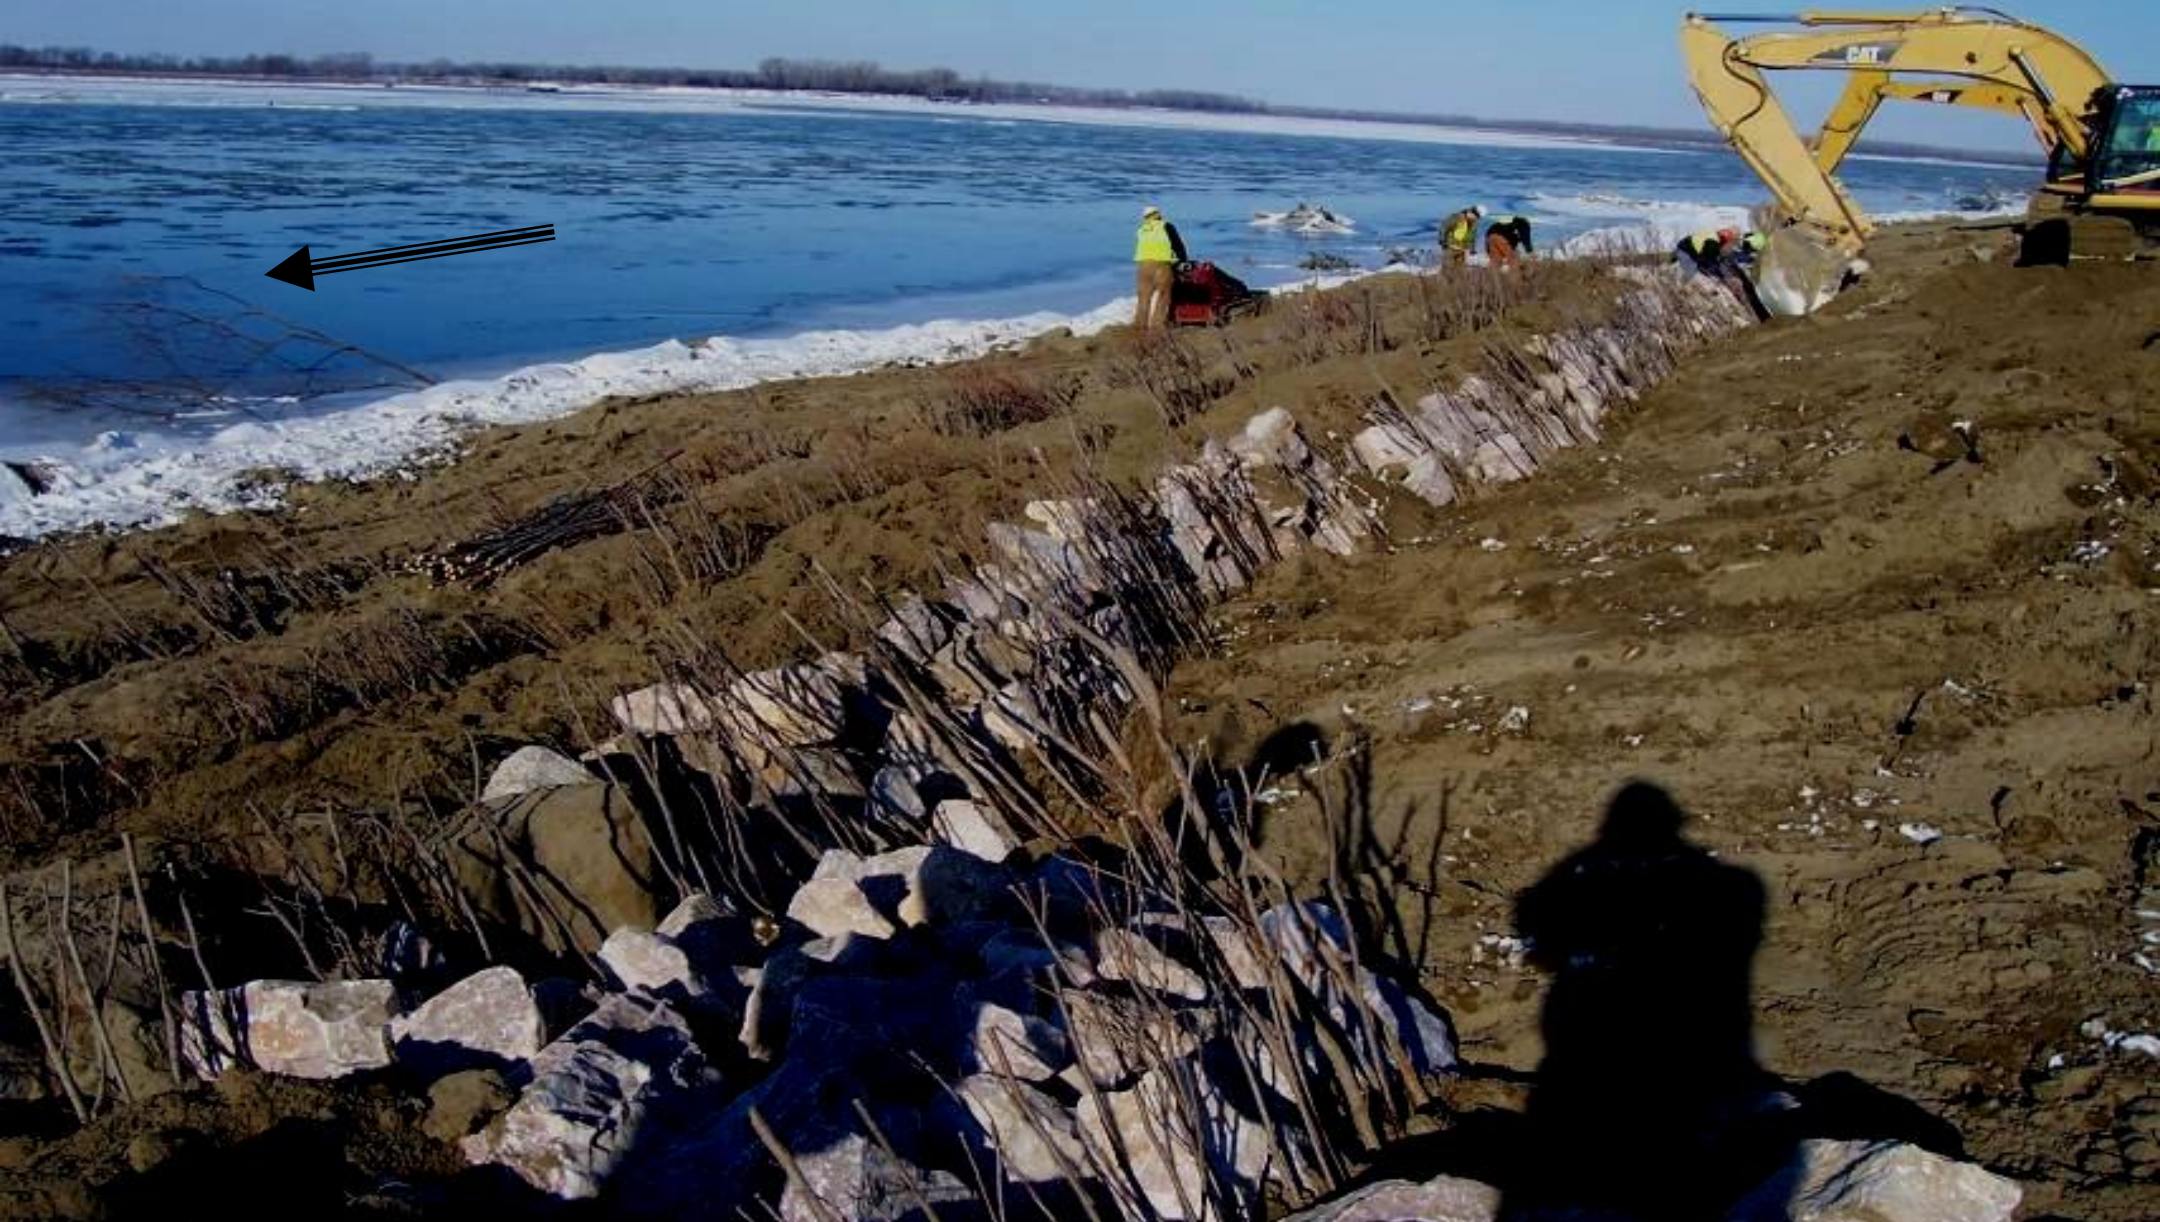
CONSTRUCTION-MISSOURI RIVER @ L & C-DERRICK-Dec 12, 2007

Looking US. All 4 rows of willows

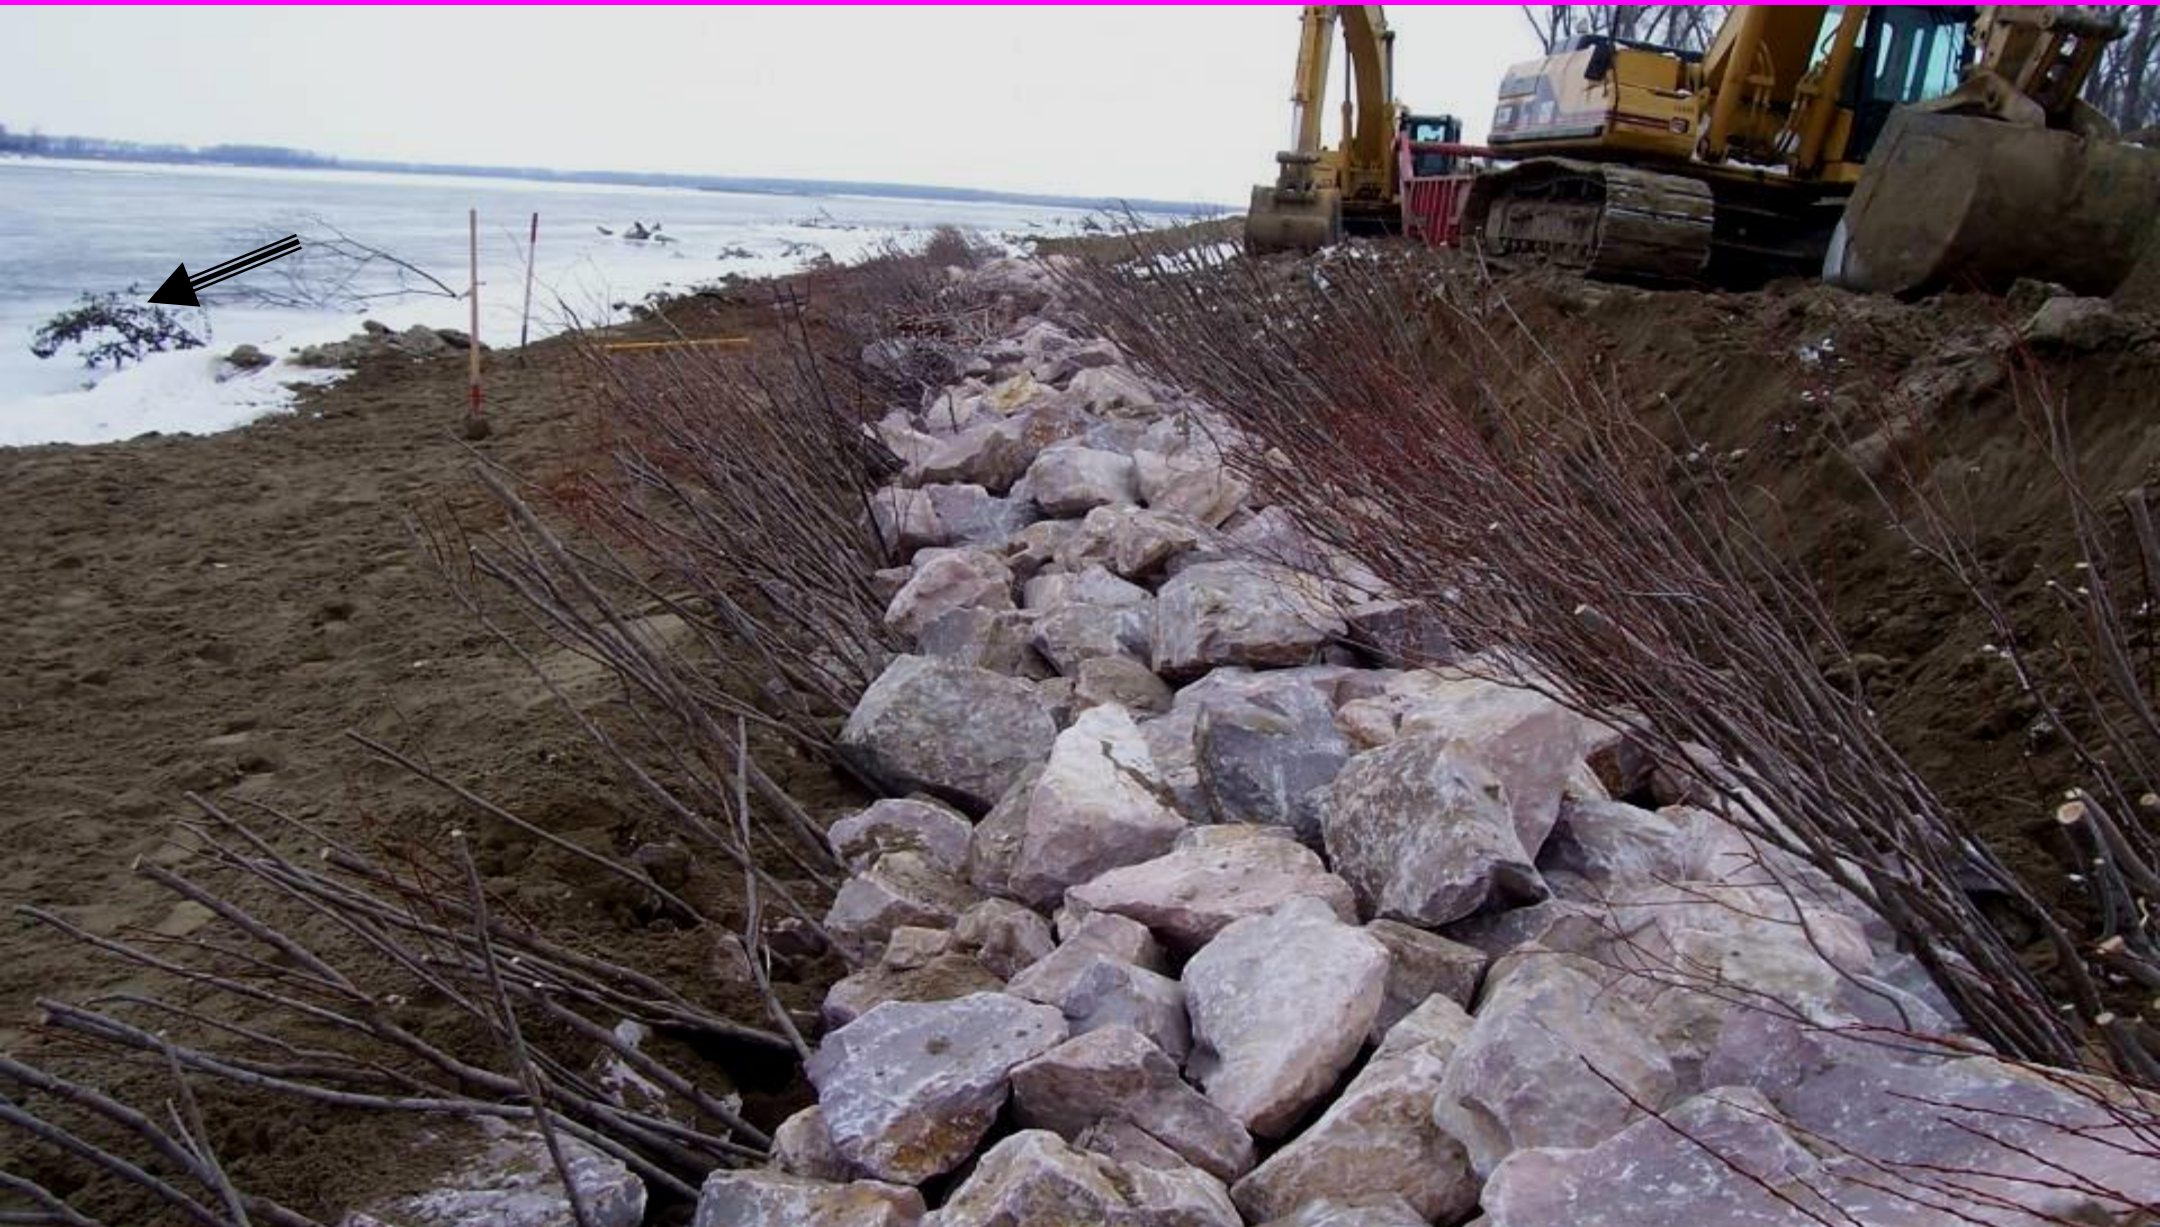
CONSTRUCTION-MISSOURI RIVER @ L & C-DERRICK-DEC 11, 2007

Looking US at willows & stone.

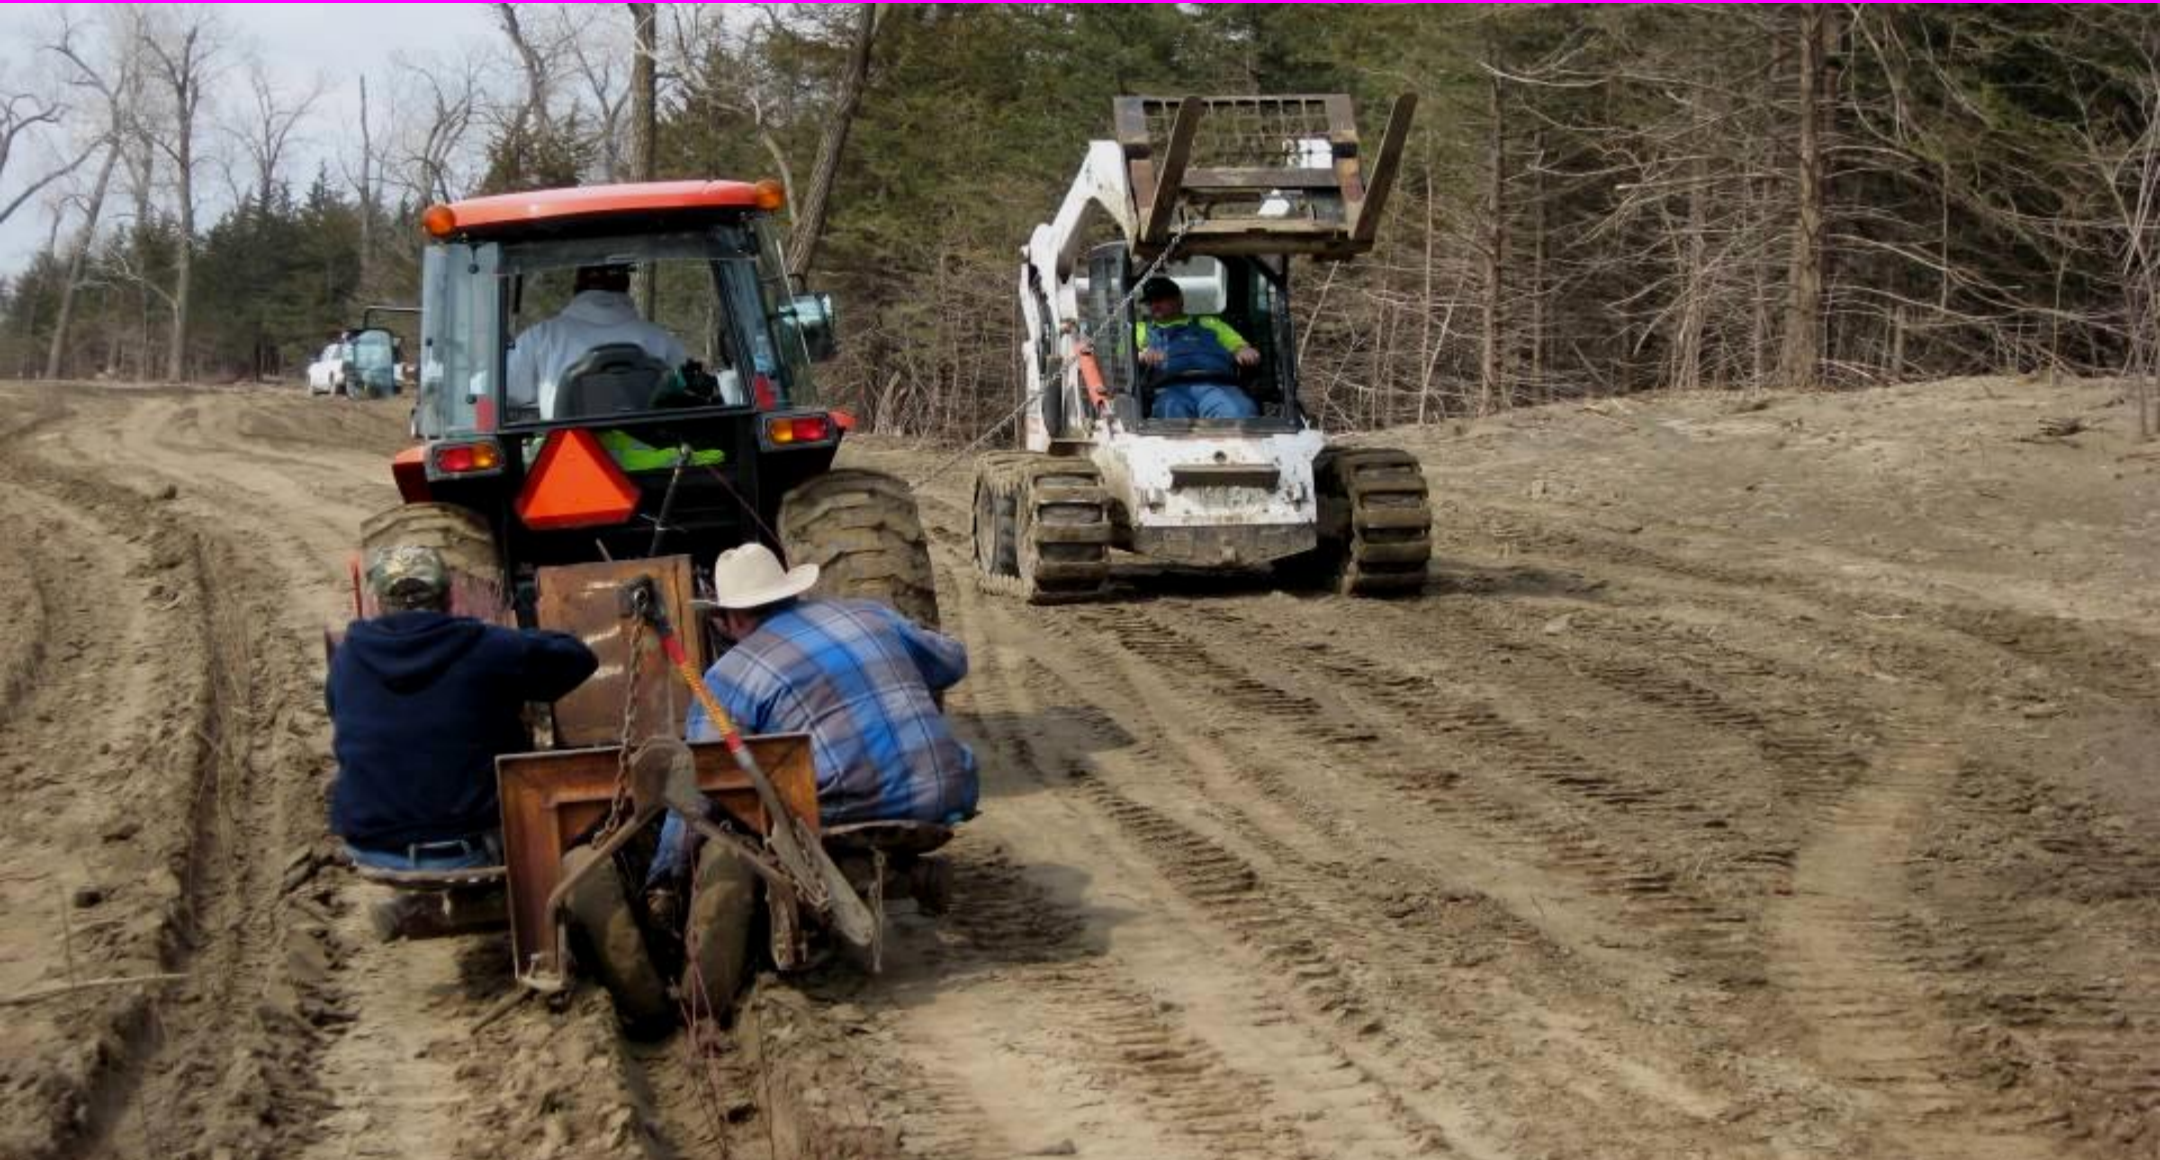
CONSTRUCTION-MISSOURI RIVER@L & C-TERRY STOLTENOW-4/3/08

Ancient two seat single row planter was used to plant 8,000 rooted stock plants per day, finished 4/28/2008, 3 months ahead of schedule.
