**COMBINATIONS OF RESISTIVE
& REDIRECTIVE METHODS:
CASE STUDY- Duck Creek East of
Eastern Avenue, Davenport, Iowa
Constructed June-July. 2008**

**Longitudinal Peaked Stone Toe
Protection {LFSTP} with interspaced
Short Bendway Weirs & Locked Logs**

LONGITUDINAL PEAKED STONE TOE PROTECTION {LPSTP}

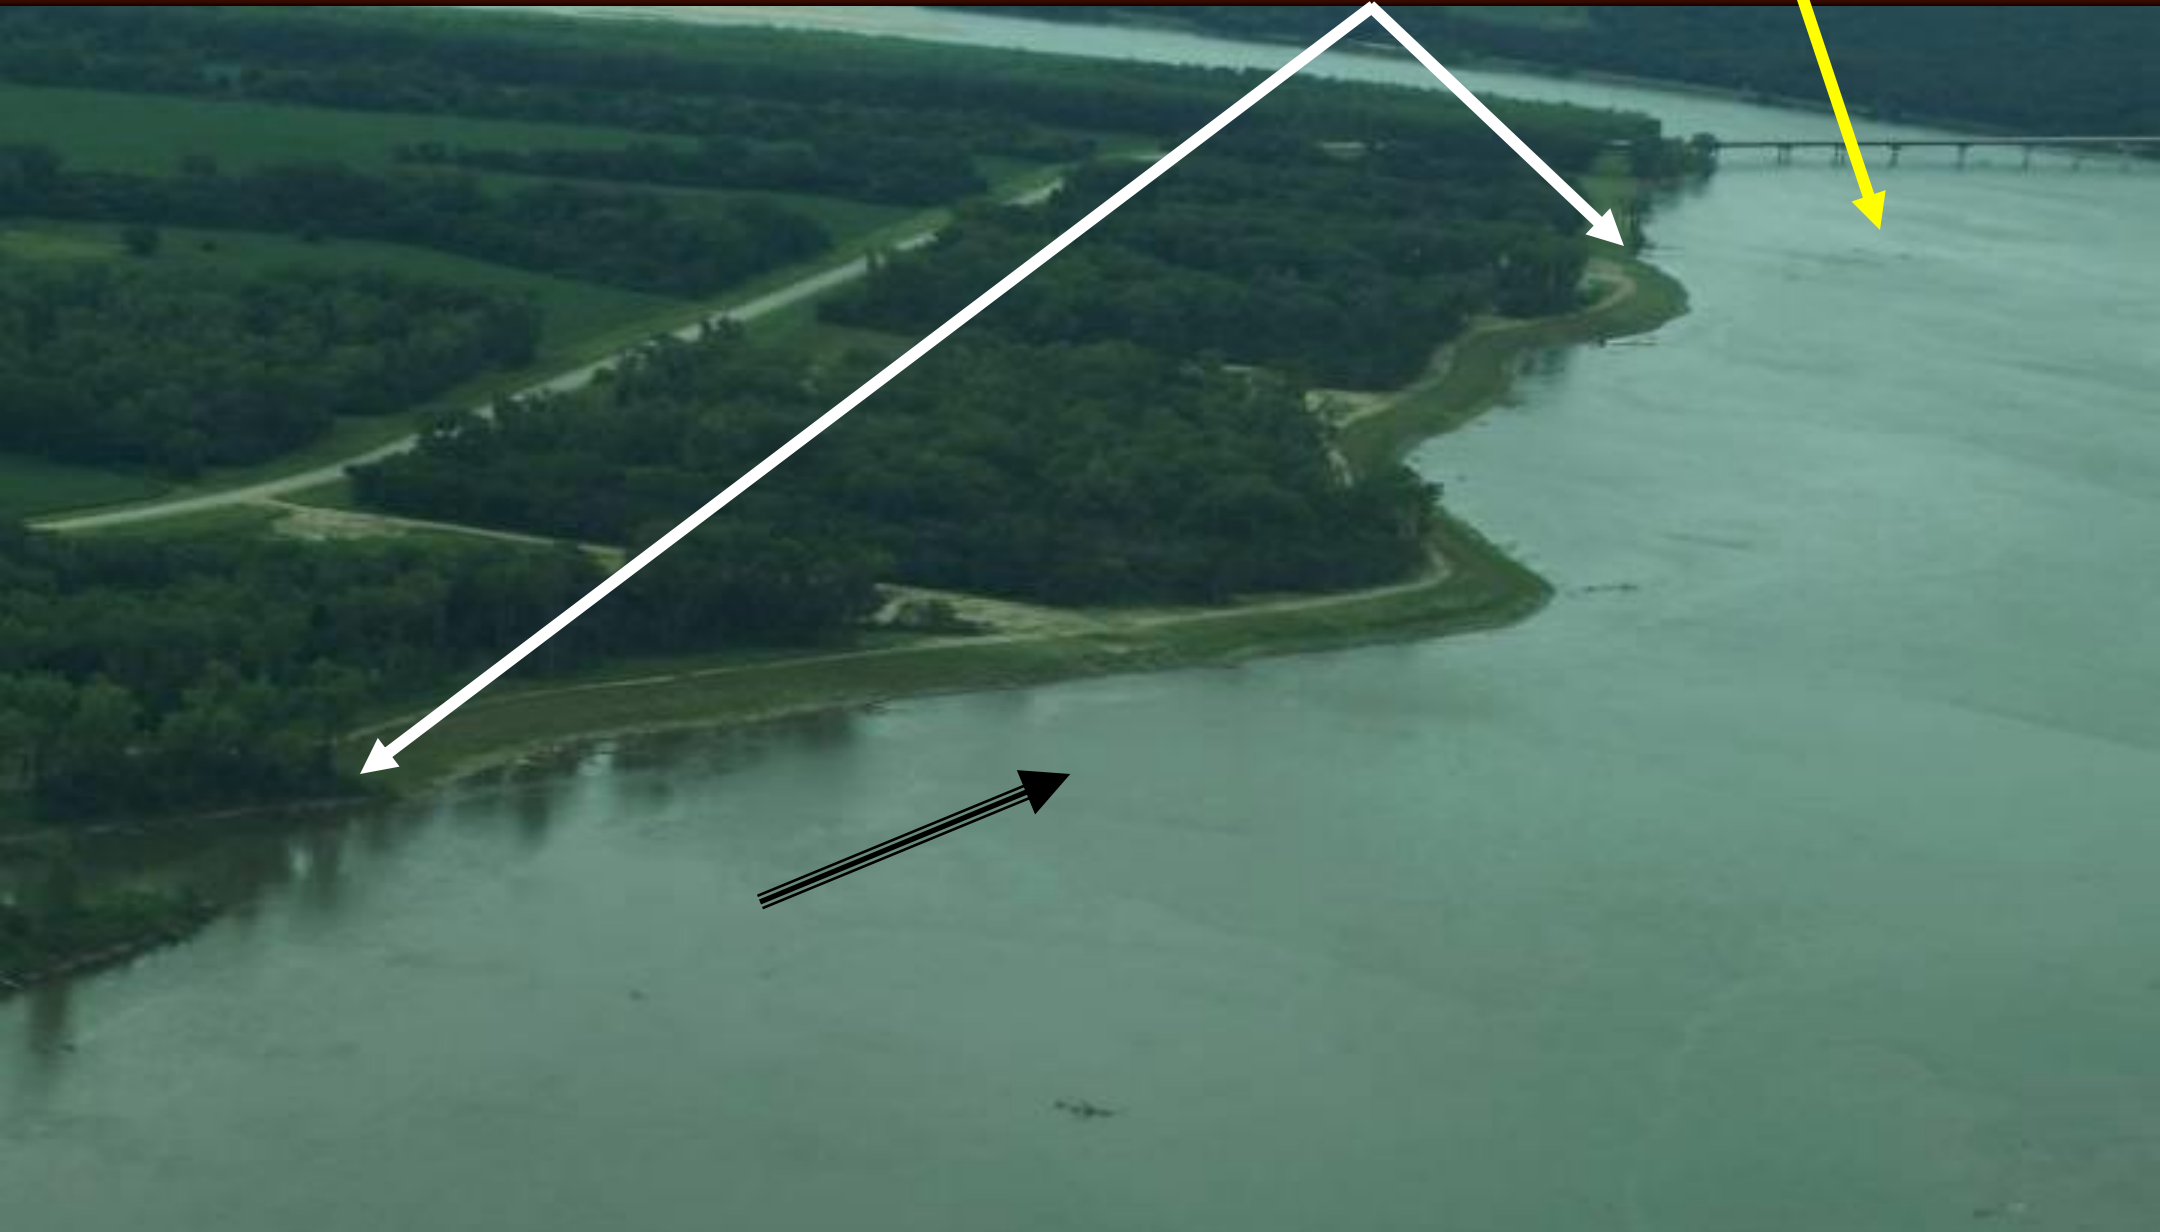
3 MONTHS LATER- MISSOURI R.@L & C-PIX BY DERRICK 8-1-2008

3 months after completion, looking DS @ L & C project & highway bridge.

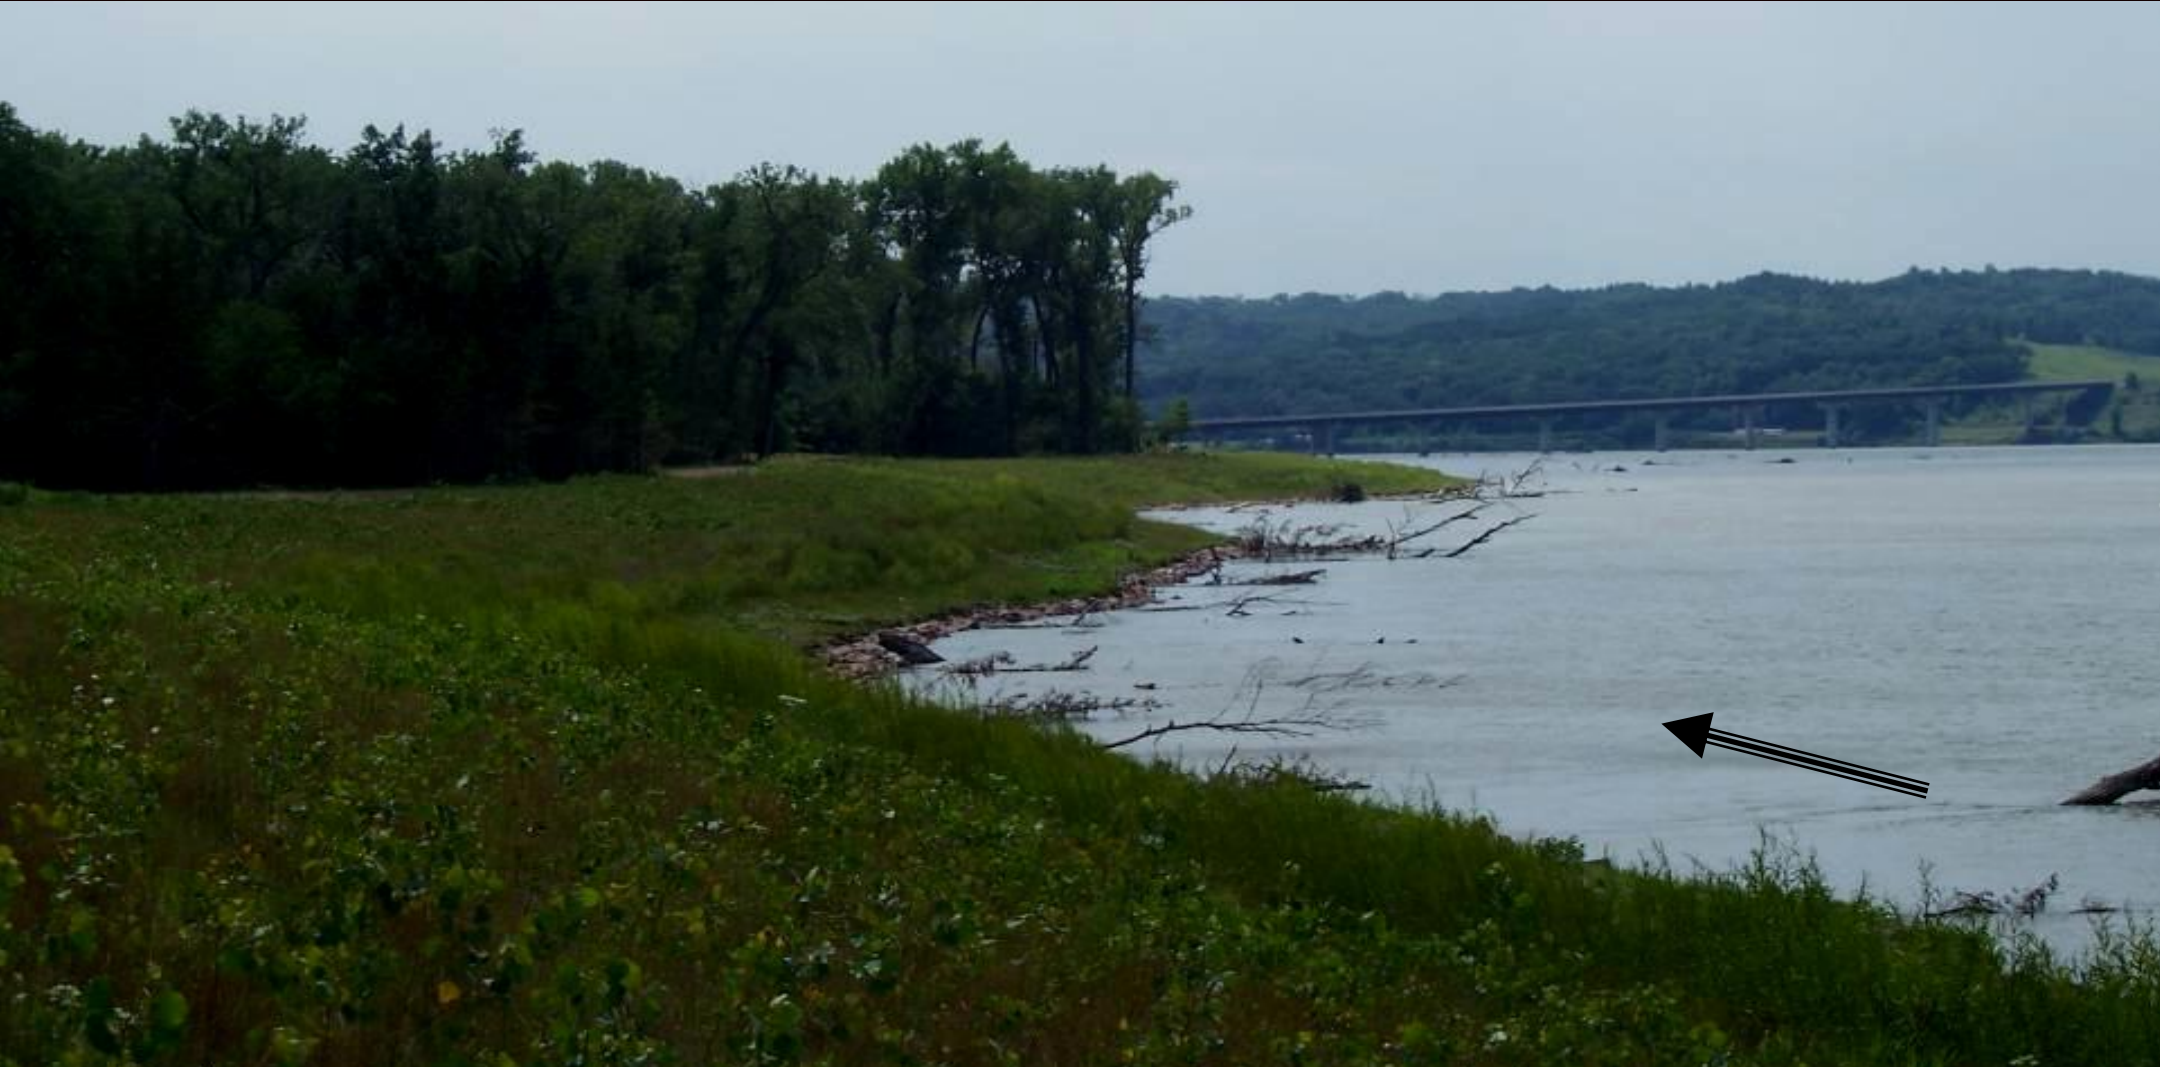
3 MONTHS LATER- MISSOURI R.@L & C-PIX BY DERRICK 8-1-2008

From upper section of project looking DS toward bridge. Willow, cottonwood & dogwood growth 3 months after planting is robust. Some erosion of soil at water's edge & slight launching of stone.

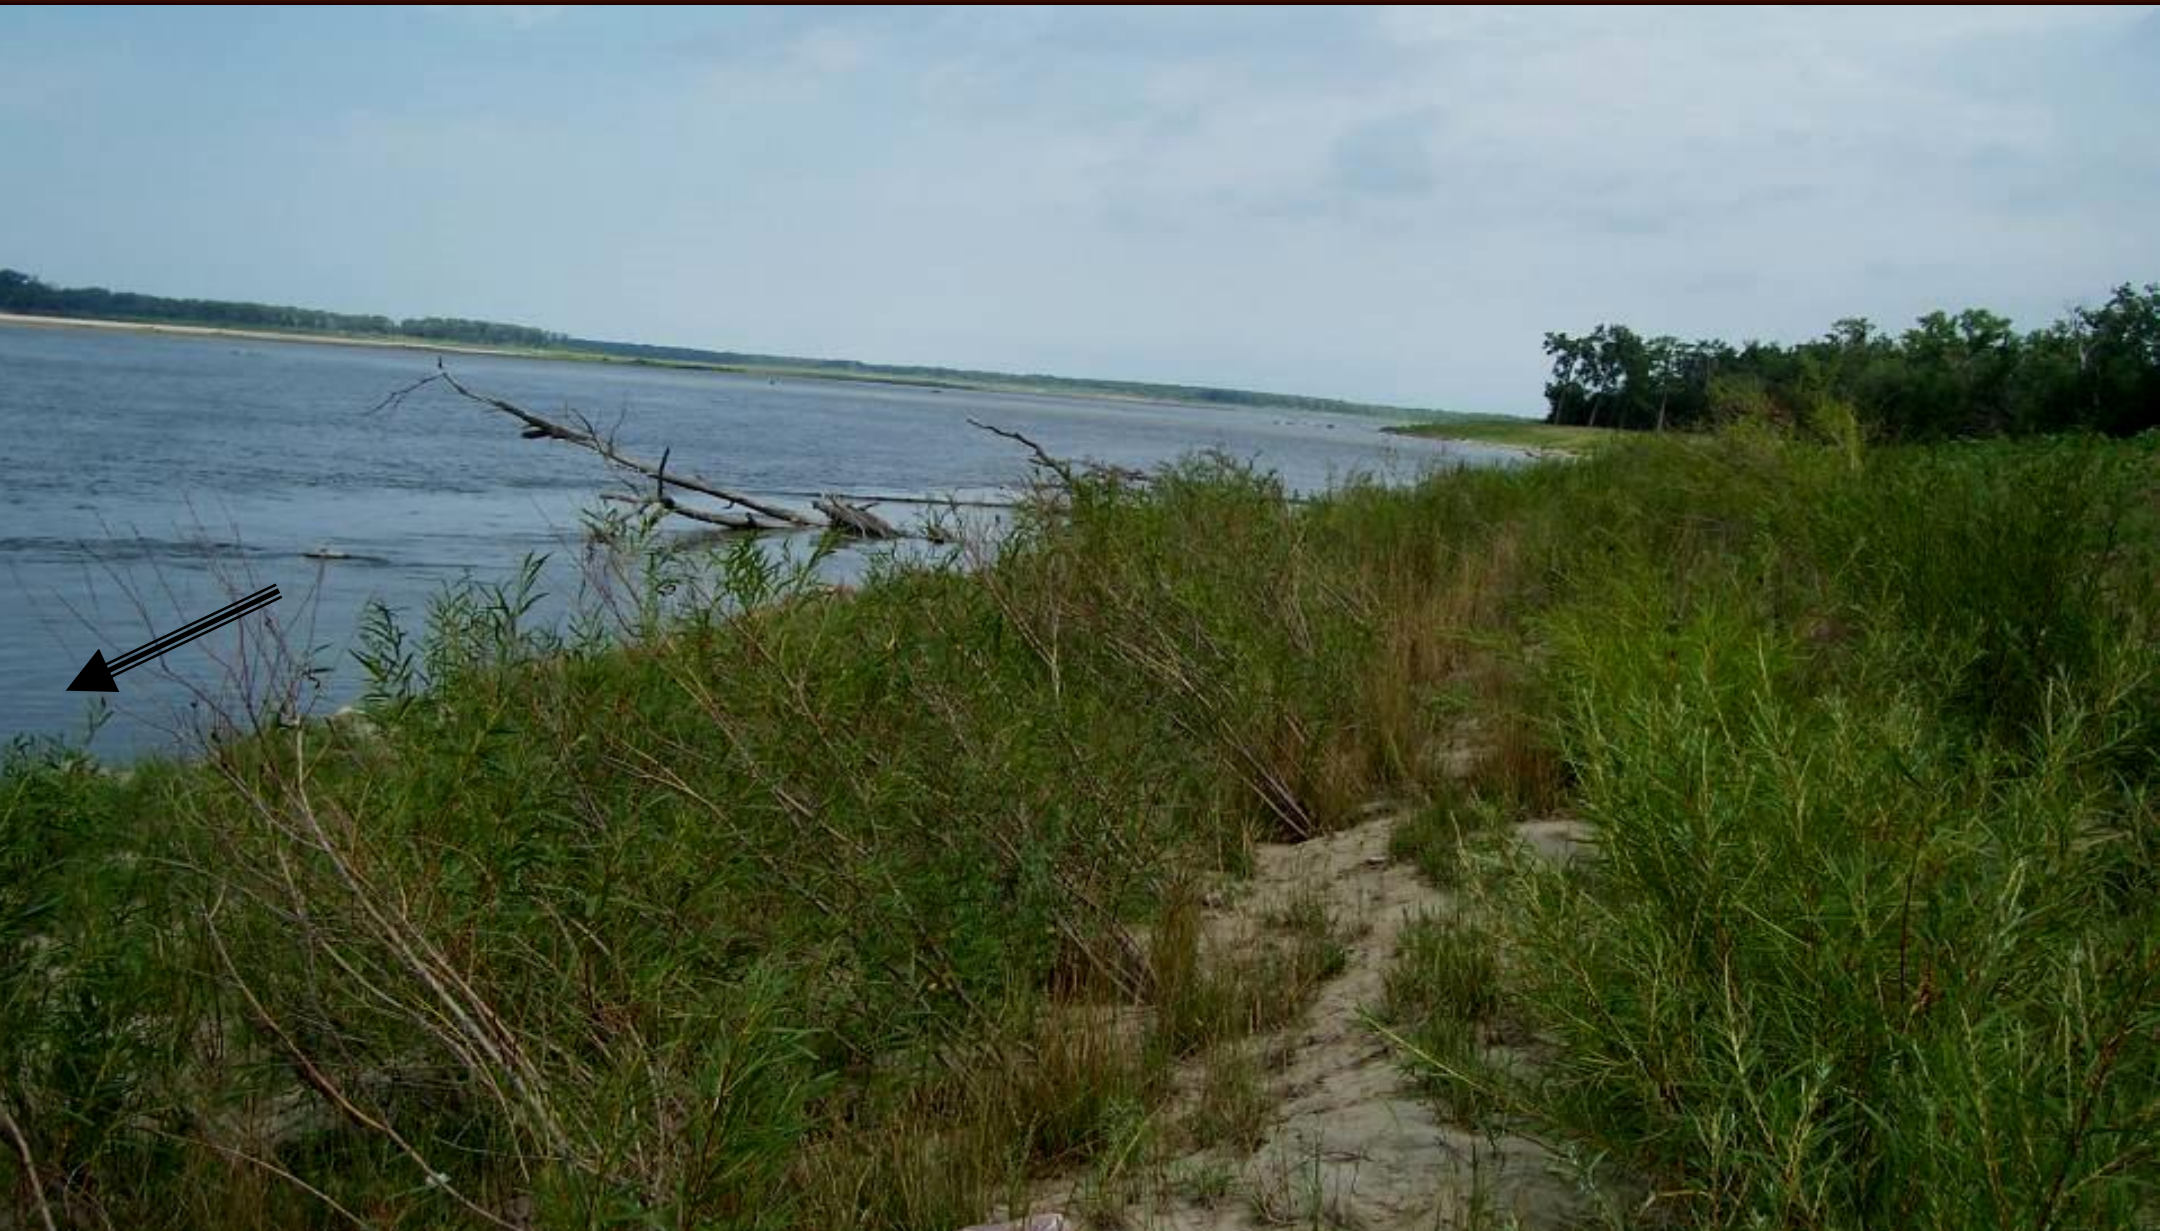
3 MONTHS LATER- MISSOURI R.@L & C-PIX BY DERRICK 8-1-2008

Close-up of willow pole plantings 3 months after installation.

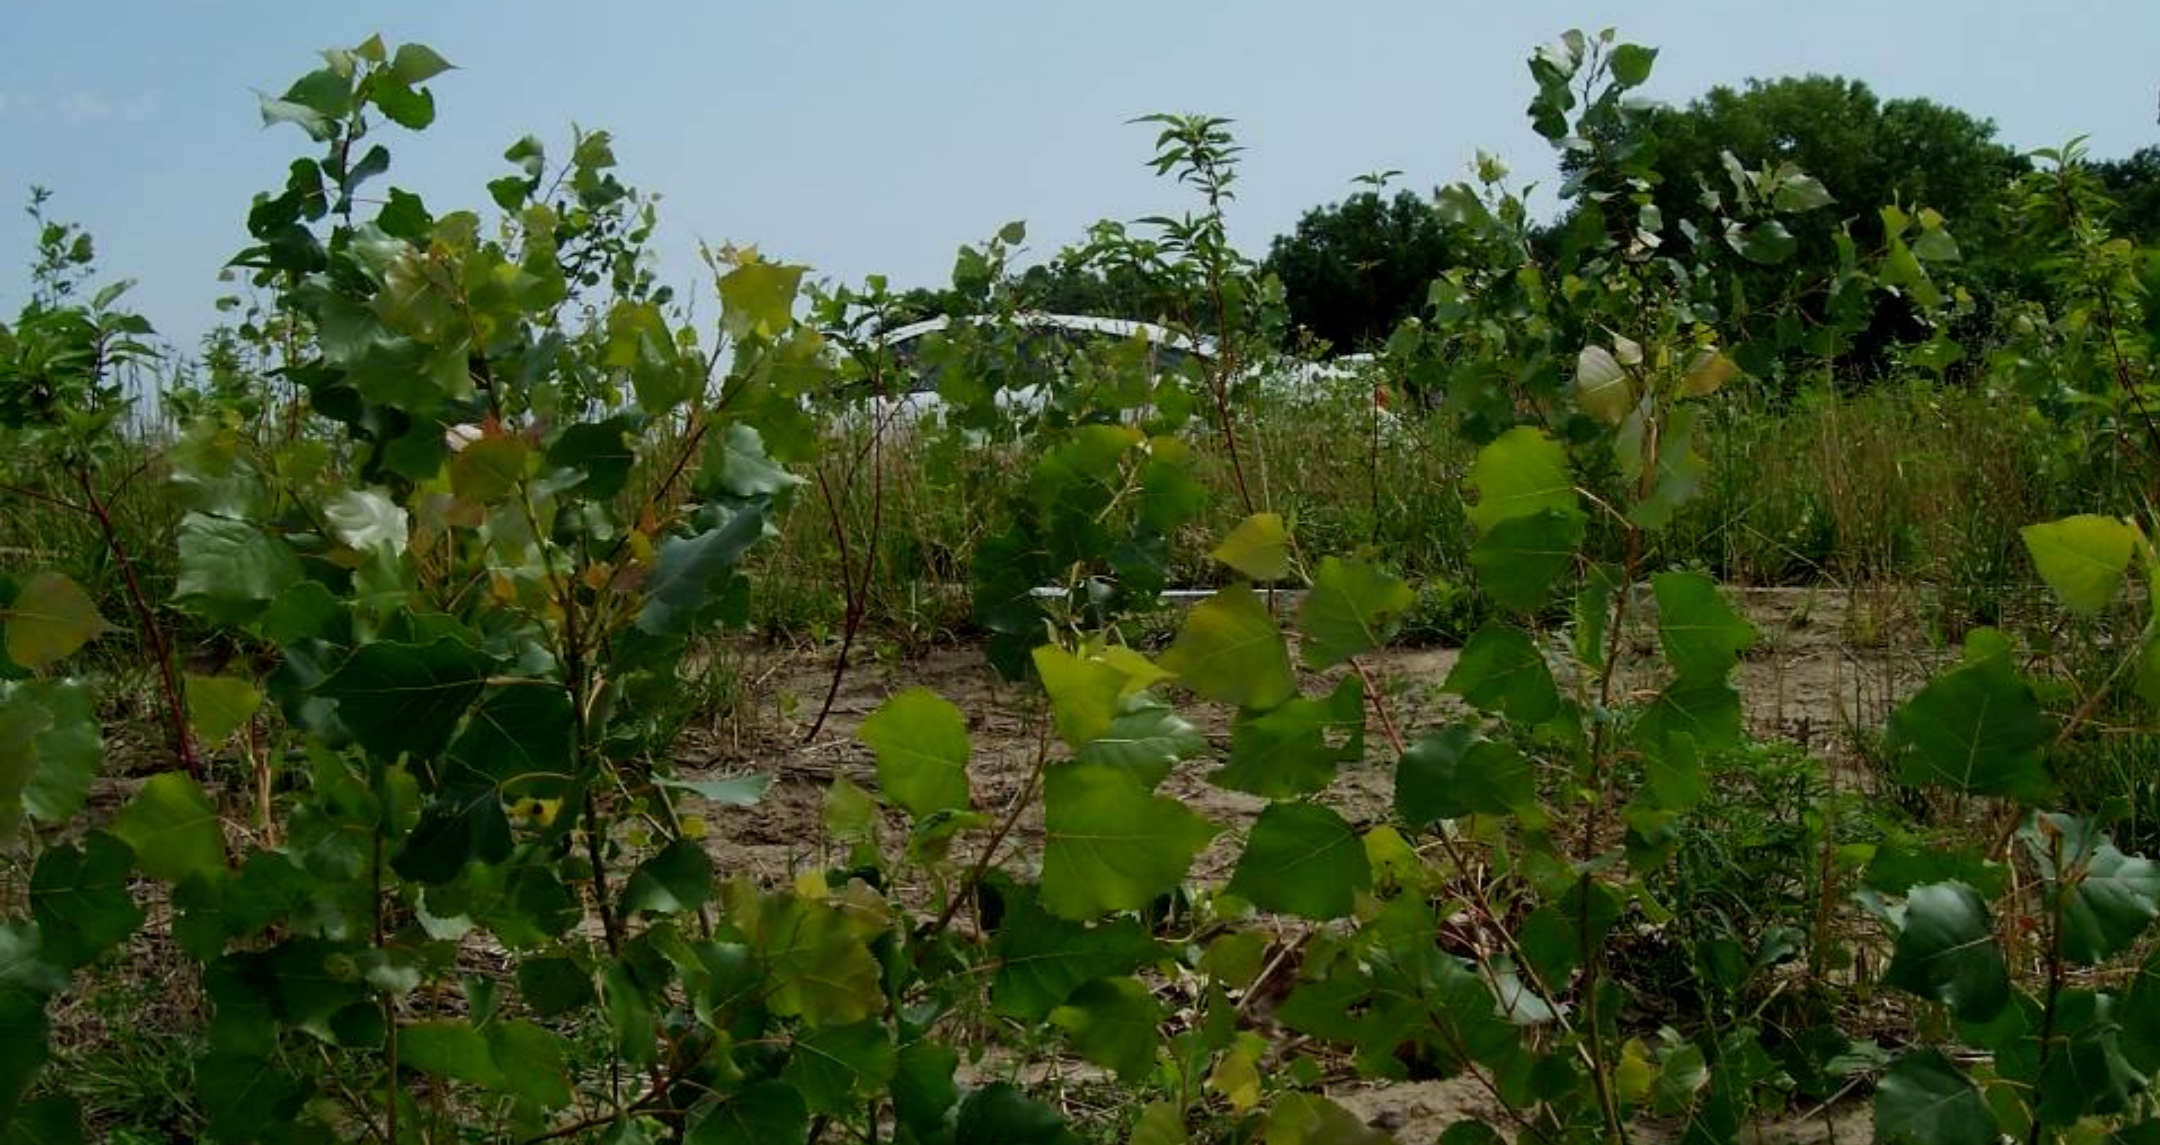
3 MONTHS LATER- MISSOURI R.@L & C-PIX BY DERRICK 8-1-2008

Mid to upper bank plantings. Cottonwoods 22" to 48" tall, Red Osier Dogwoods 16" to 31" tall. 3 ft between rows, from 12" to 18" spacing between plants in a row.

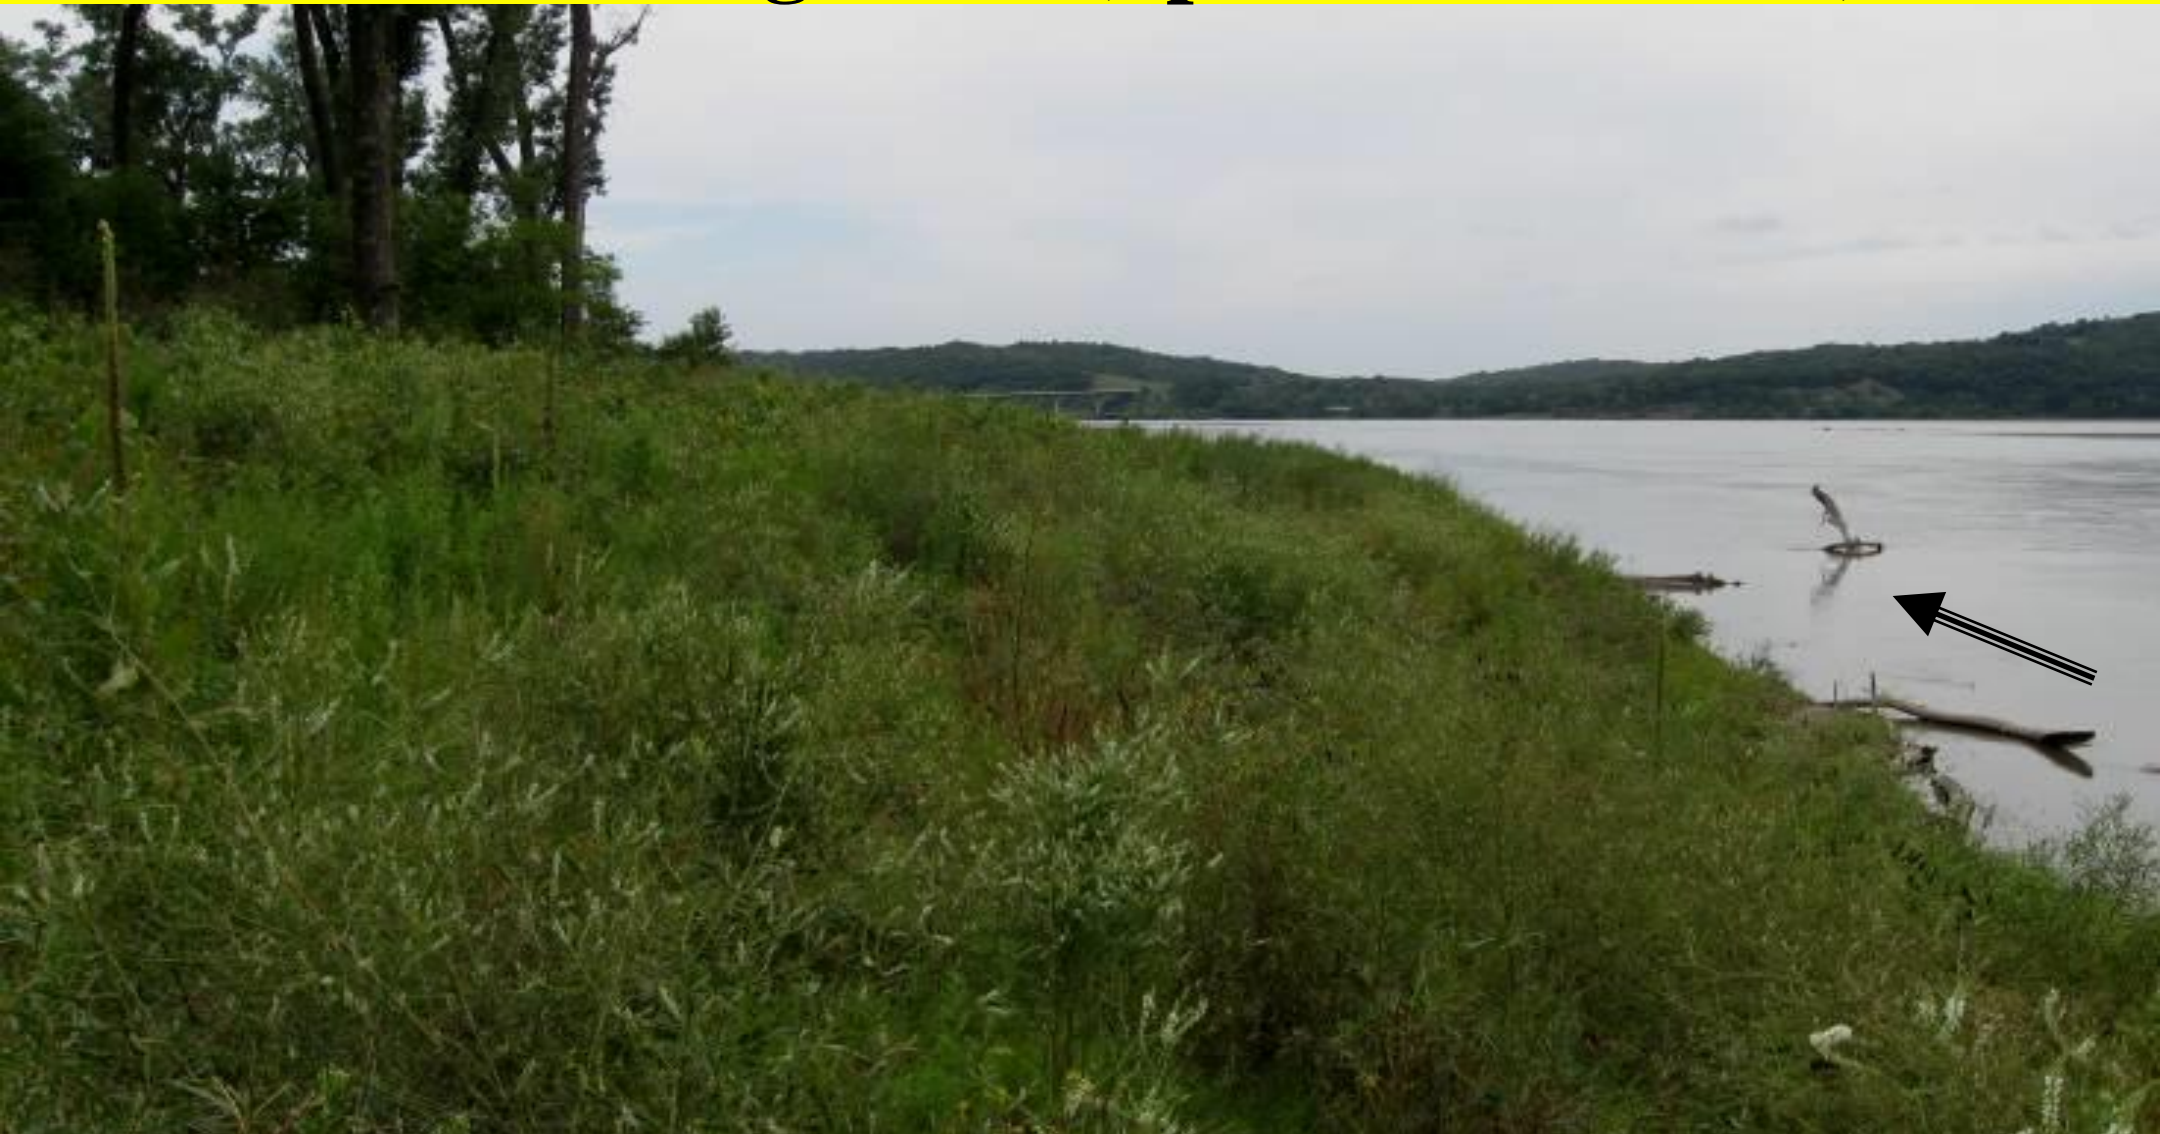
16 MONTHS LATER- MISSOURI R.@L & C-PIX BY DERRICK 8-6-09

16 MONTHS LATER-Looking DS @ willow & cottonwood growth (up to 6 ft for both).

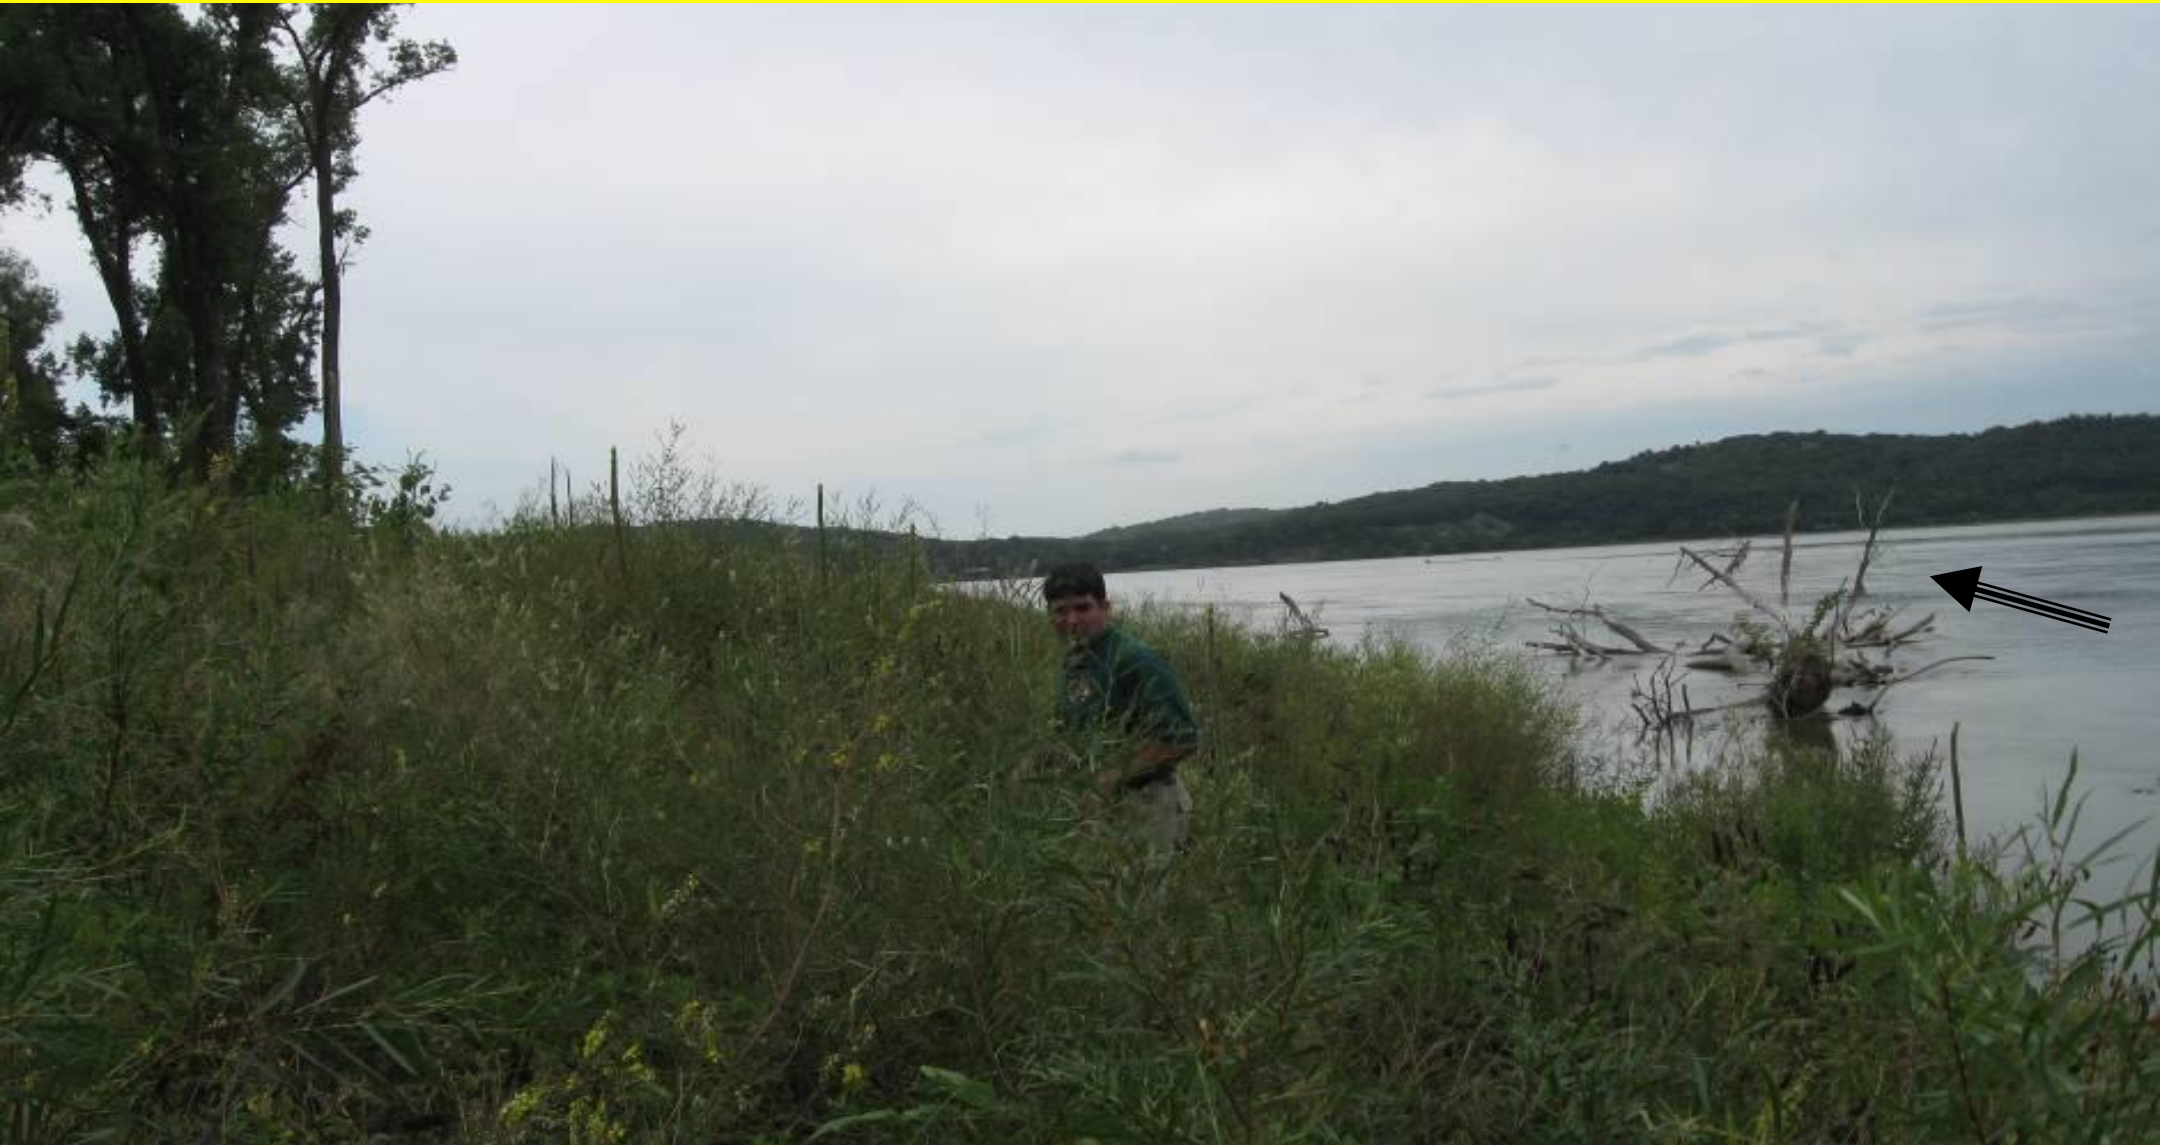
16 MONTHS LATER- MISSOURI R.@L & C-PIX BY DERRICK 8-6-09

16 MONTHS LATER-Looking DS @ dense & robust willow growth. Coverage of ground is excellent here.

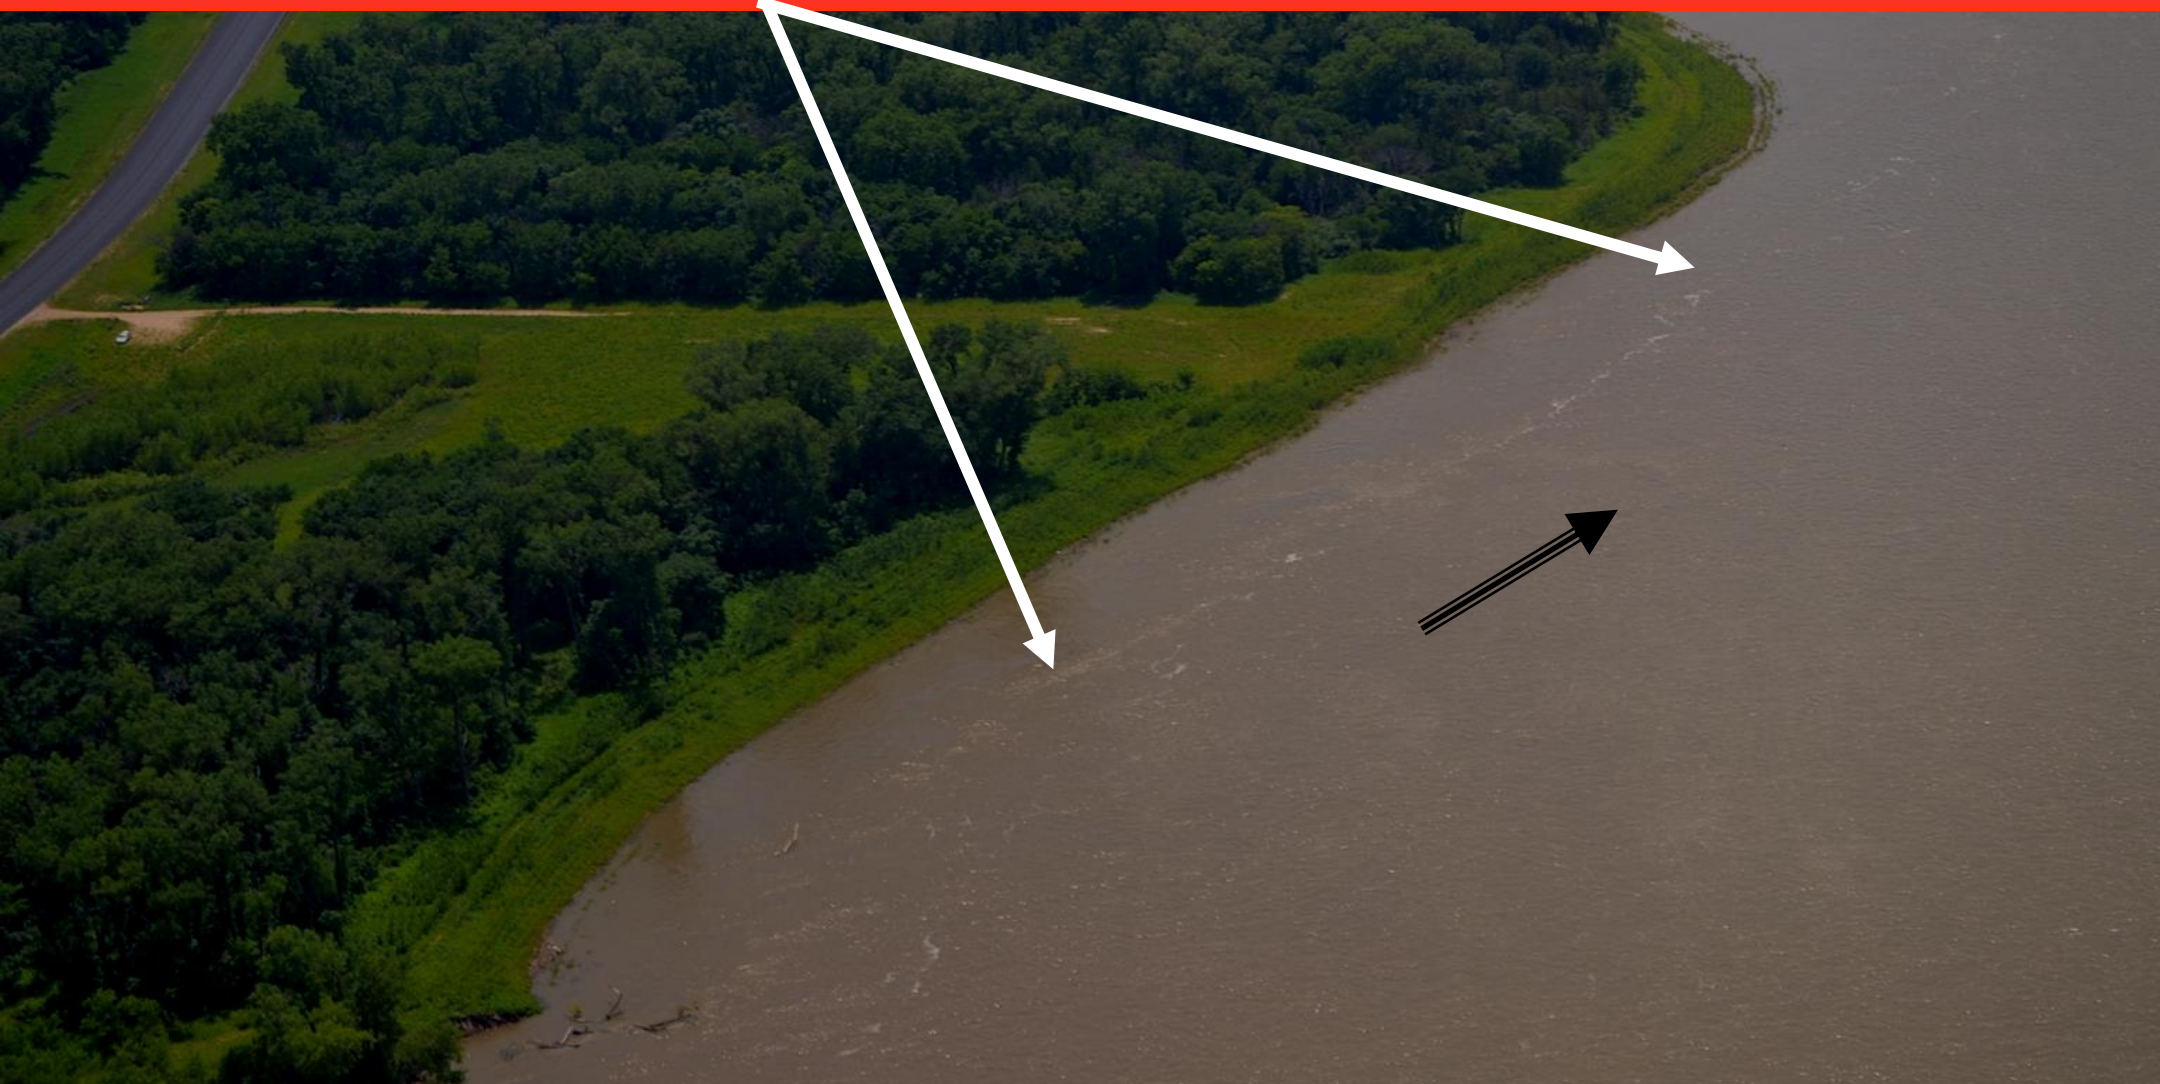
38 MONTHS LATER- MISSOURI R.@L & C-FROM TED HALL 6-29-11

GREAT FLOOD OF 2011-Looking DS. Clearly visible foam line indicates the influence of the Locked Logs, (slower water nearer bank). Logs are submerged at least 8 to 10 ft.

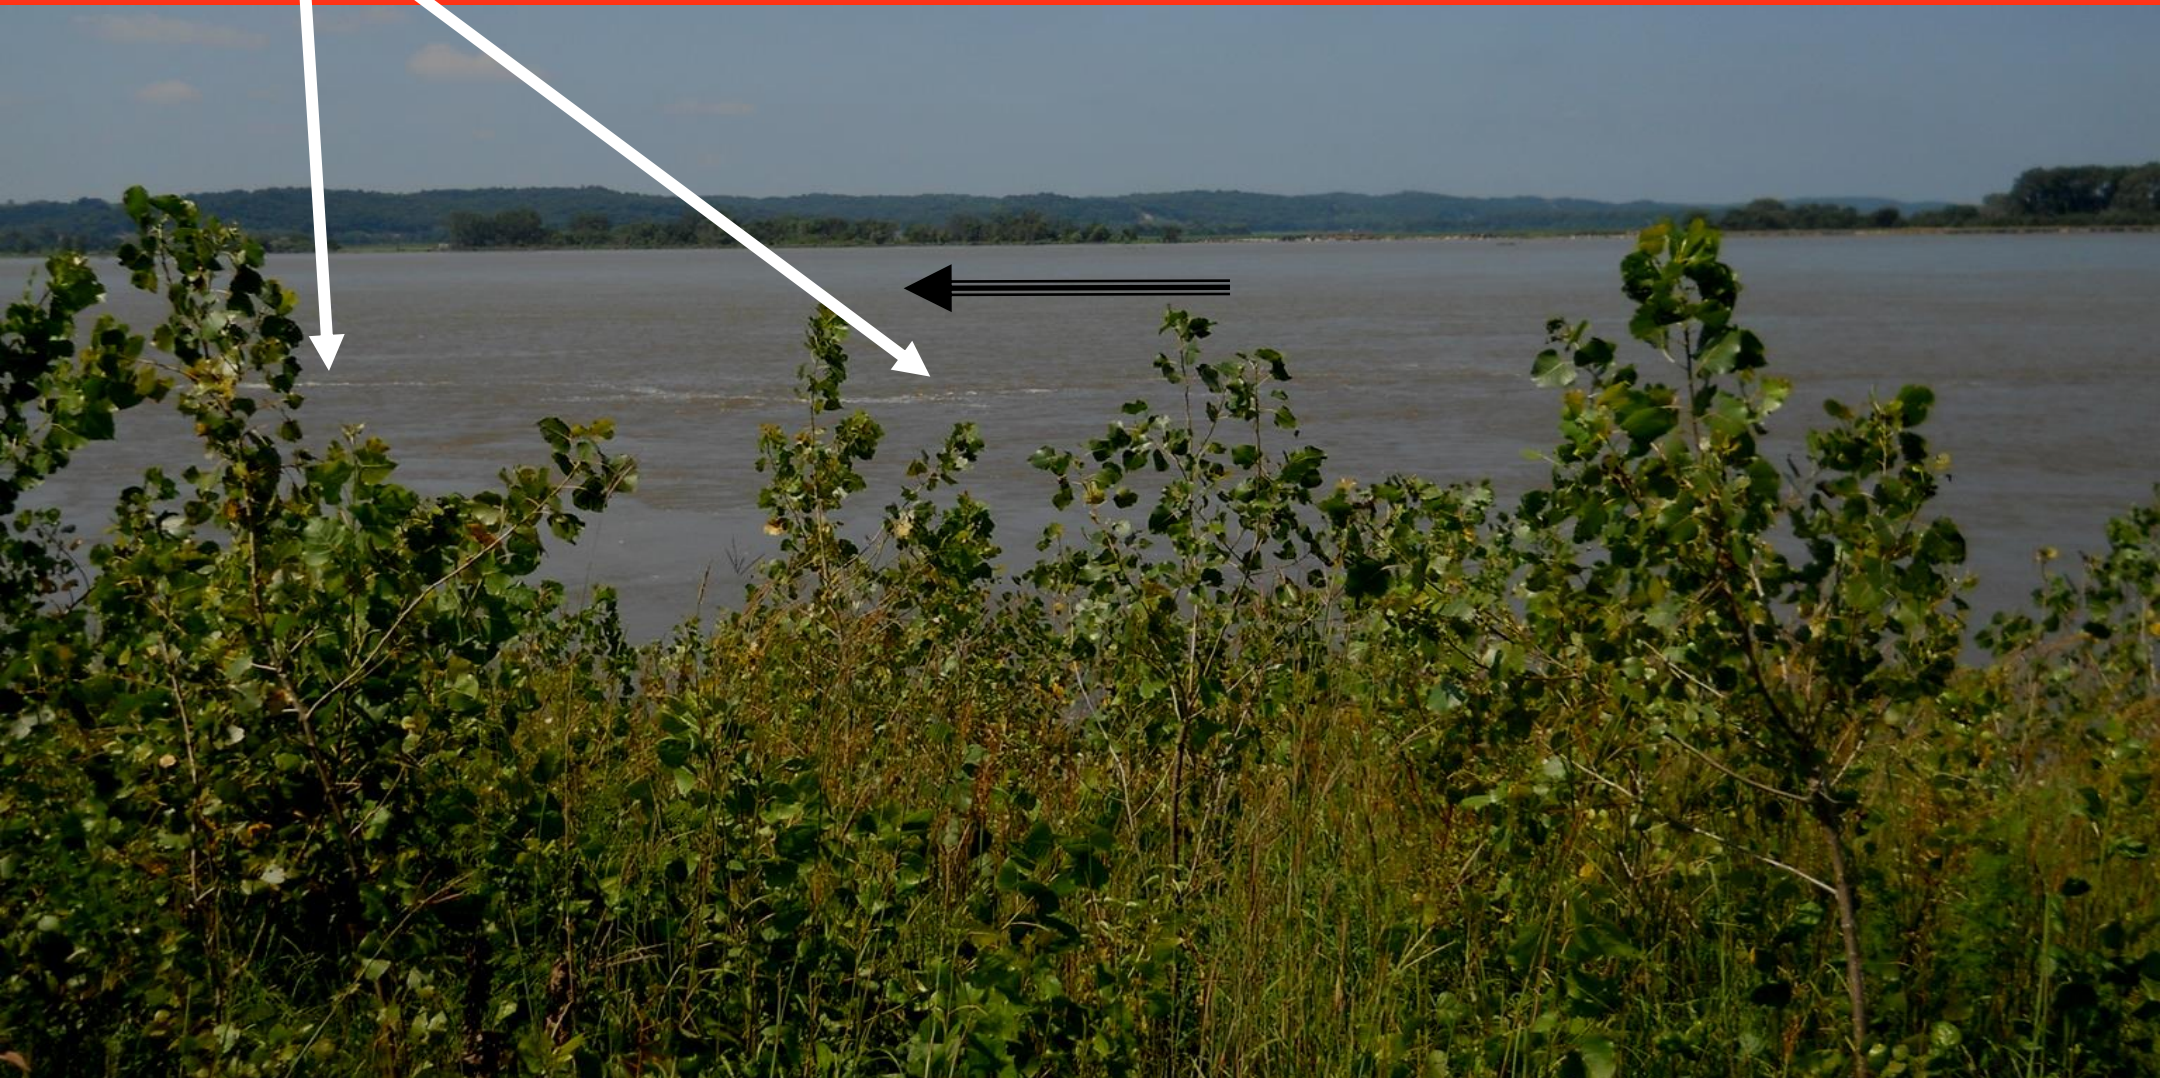
40 MONTHS LATER- MISSOURI R.@L & C-PIX BY DERRICK 7-30-11

**2 FT BELOW GREAT FLOOD OF 2011 CREST-Looking @
foam line approx. 100 ft. into channel caused by the reduction in
flow velocity due to the Locked Logs**

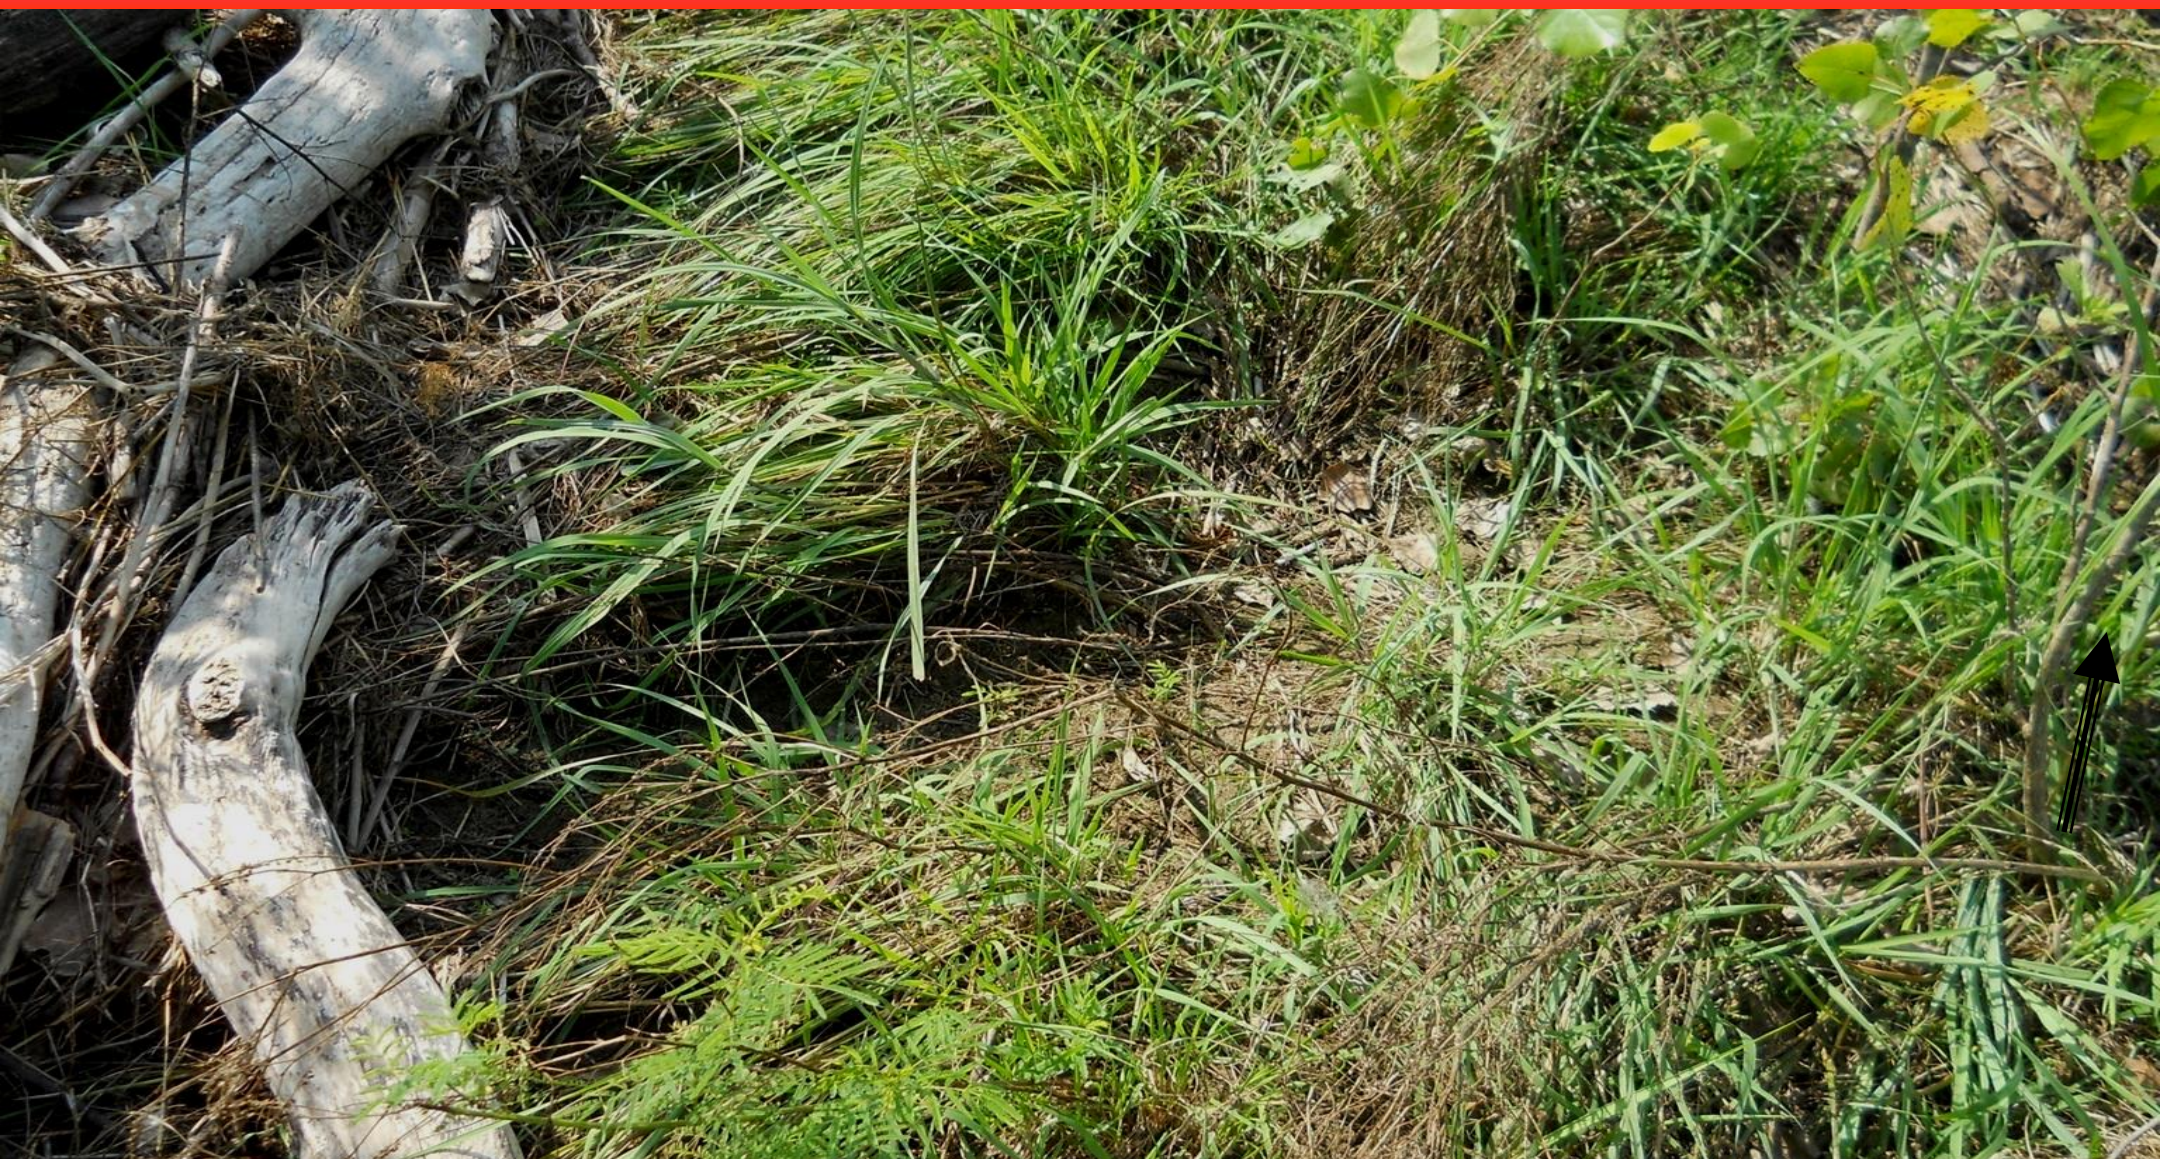
40 MONTHS LATER- MISSOURI R.@L & C-PIX BY DERRICK 7-30-11

2 FT BELOW GREAT FLOOD OF 2011 CREST-Close-up of recently flooded plants showing very little ill effects.
