**COMBINATIONS OF RESISTIVE
& REDIRECTIVE METHODS:
CASE STUDY- Duck Creek East of
Eastern Avenue, Davenport, Iowa
Constructed June-July. 2008**

**Longitudinal Peaked Stone Toe
Protection {LFSTP} with interspaced
Short Bendway Weirs & Locked Logs**

LONGITUDINAL PEAKED STONE TOE PROTECTION {LPSTP}

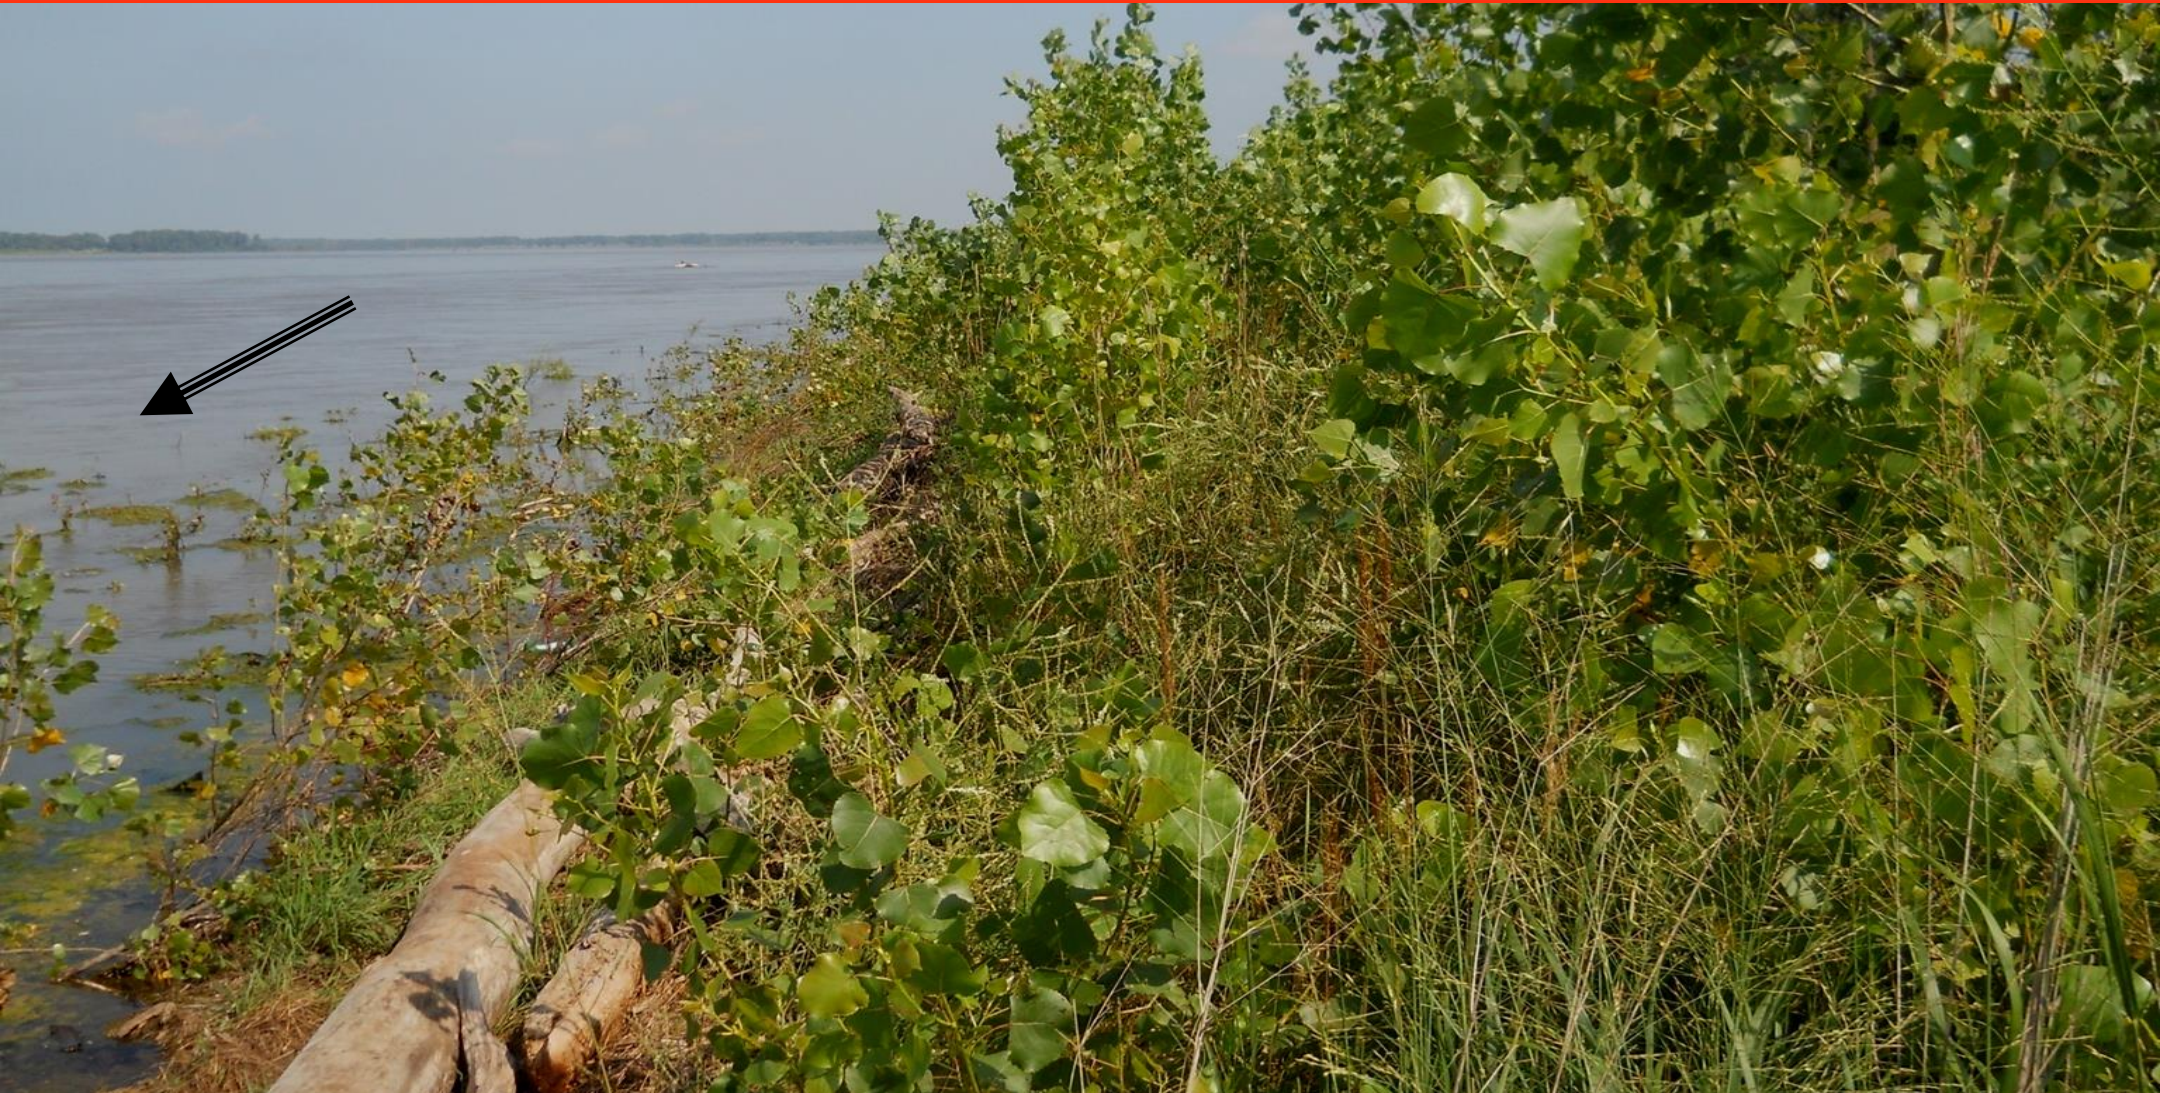
40 MONTHS LATER- MISSOURI R.@L & C-PIX BY DERRICK 7-30-11

2 FT BELOW GREAT FLOOD OF 2011 CREST-Almost all of project had very dense & robust veg at the flood stage elevation & above. No erosion! Wave wash not an issue.

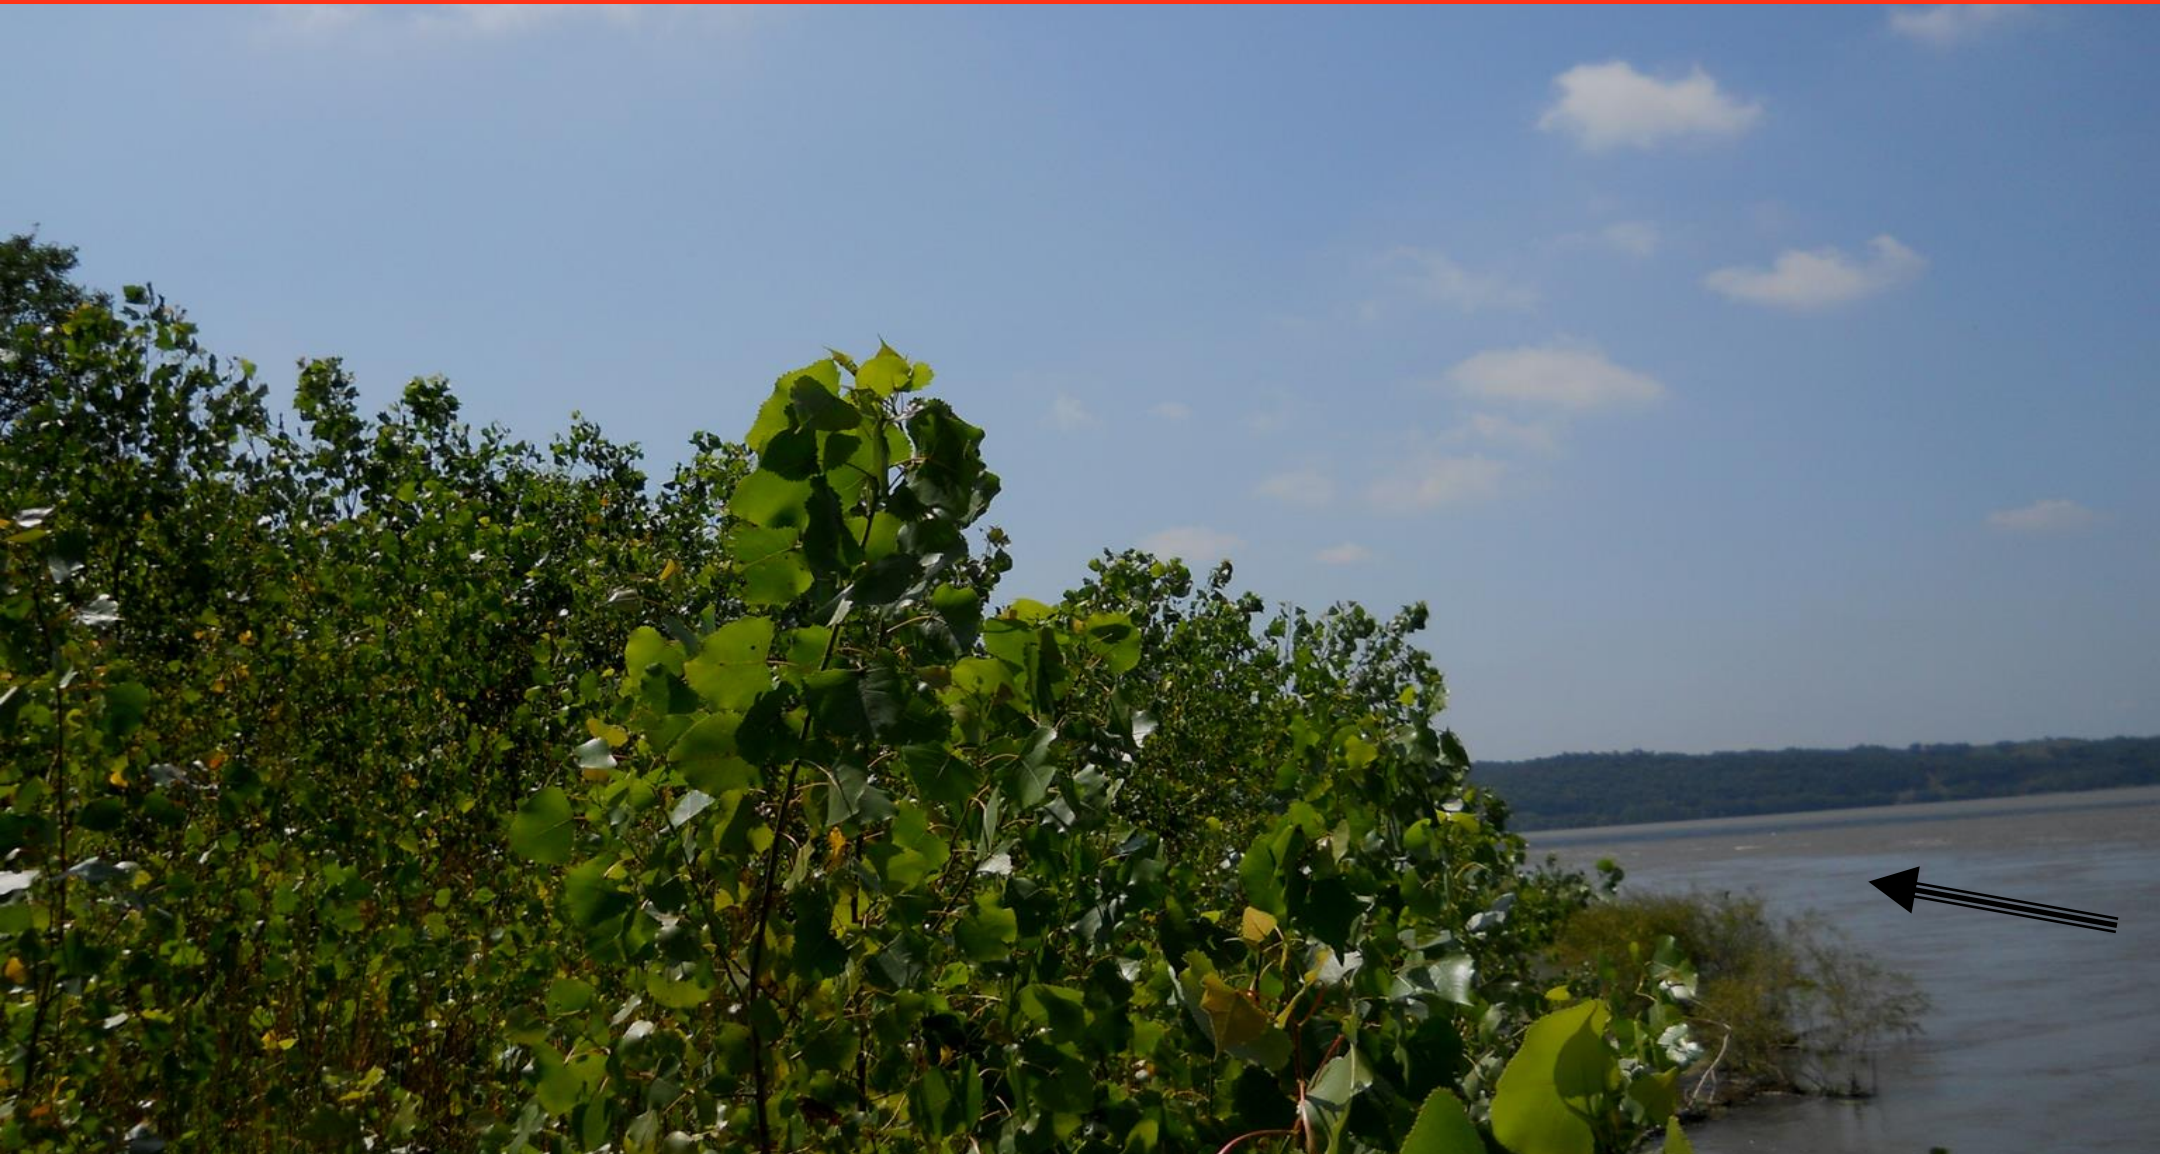
40 MONTHS LATER- MISSOURI R.@L & C-PIX BY DERRICK 7-30-11

**2 FT BELOW GREAT FLOOD OF 2011 CREST-Looking DS @
dense forest of dogwood & cottonwood. Typical.**

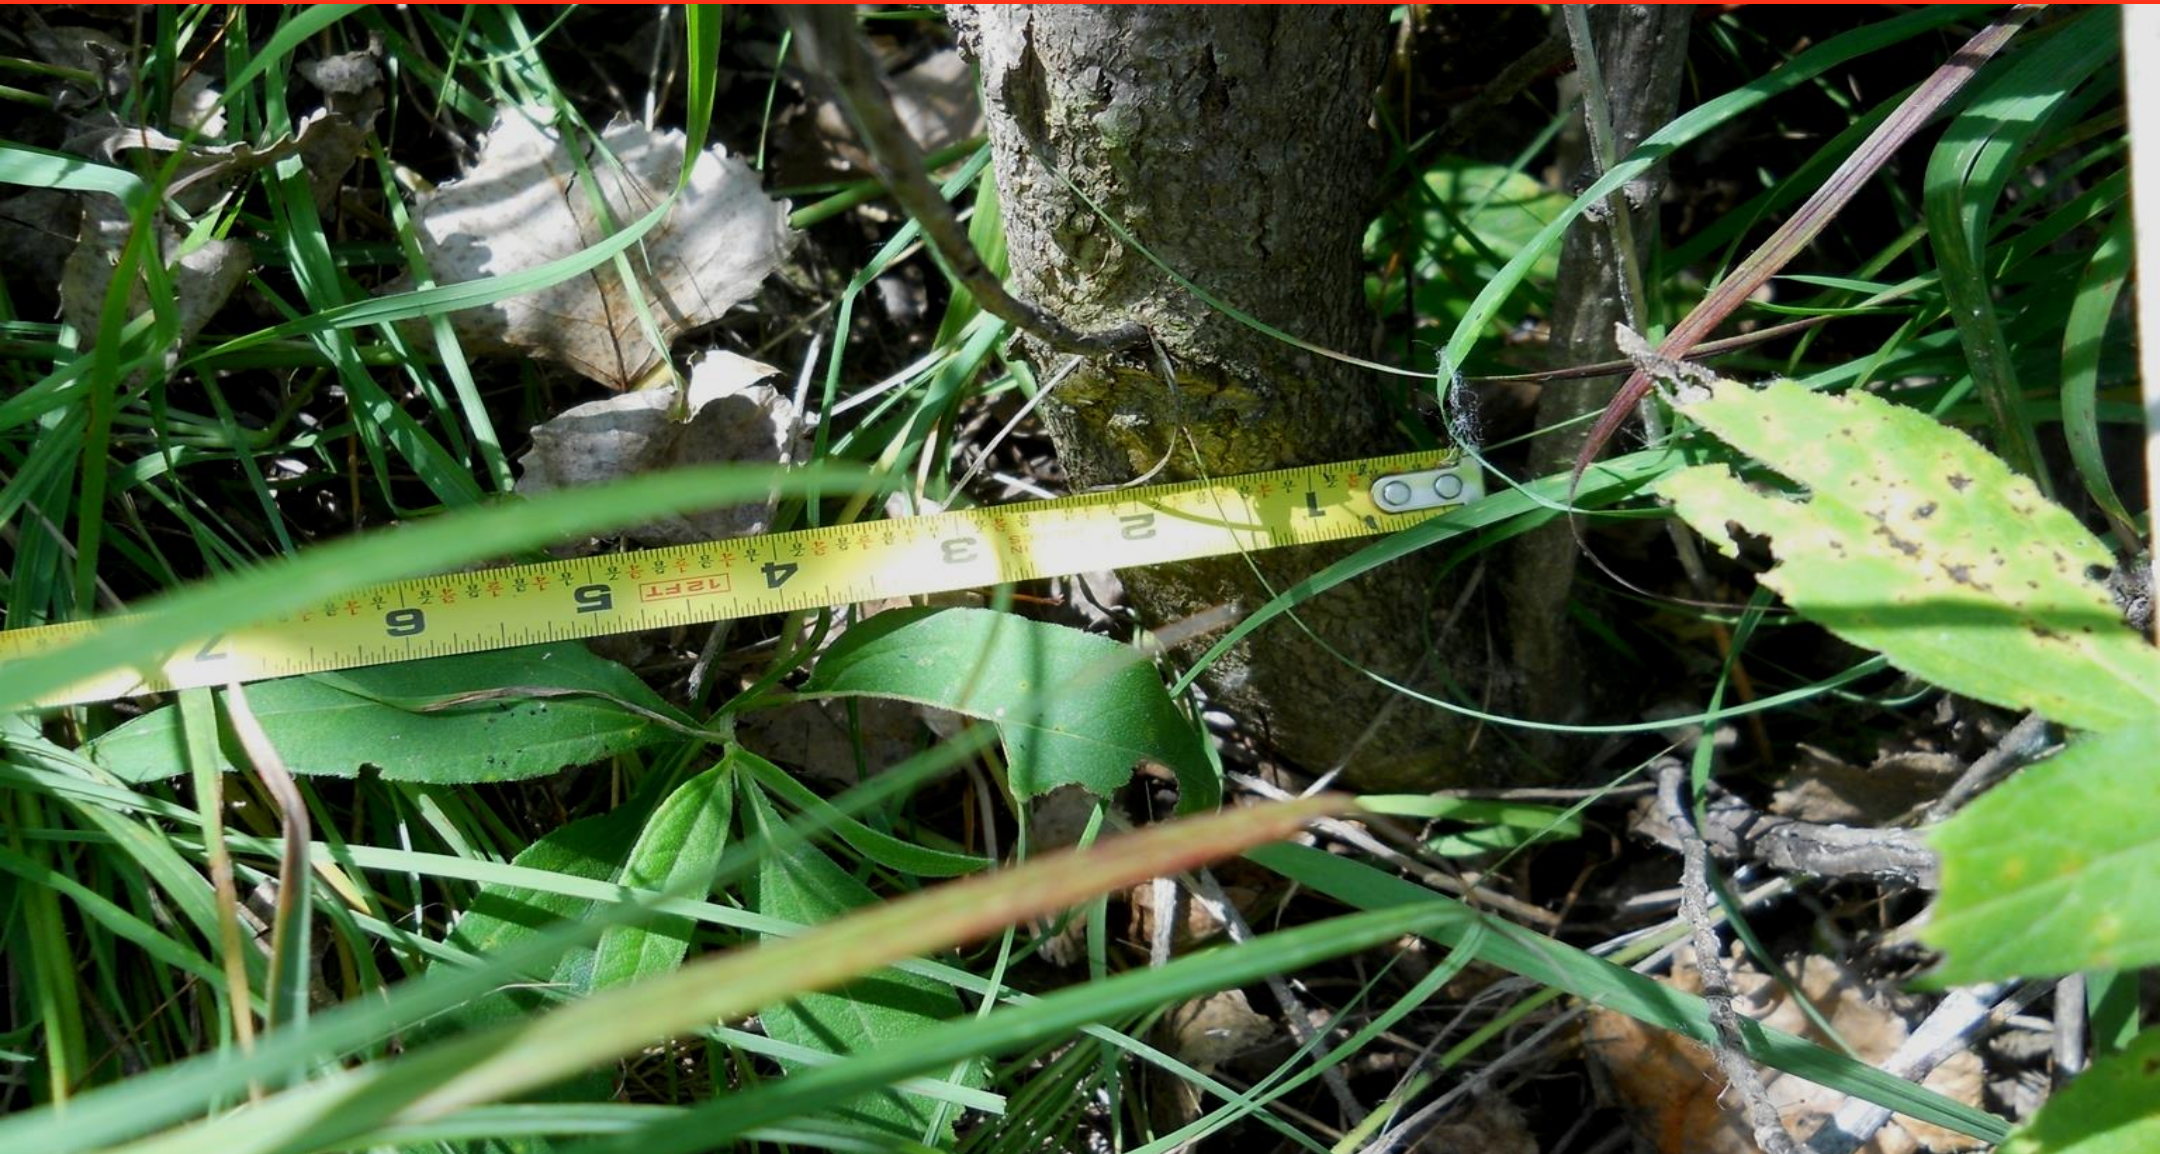
40 MONTHS LATER- MISSOURI R.@L & C-PIX BY DERRICK 7-30-11

**2 FT BELOW GREAT FLOOD OF 2011 CREST-Looking @ 2.5 inch
base diameter of planted cottonwood. 14-16 ft tall.**
