CAZENOVIA CR. @ STEPHENSON ST. BRIDGE

**REPLACEMENT OF ONE BANK
OF A CONCRETE-LINED
CHANNEL**

**HAW CREEK, PIKE COUNTY, MISSOURI-
TRIB TO SALT RIVER**

GOODWIN CREEK, MS.

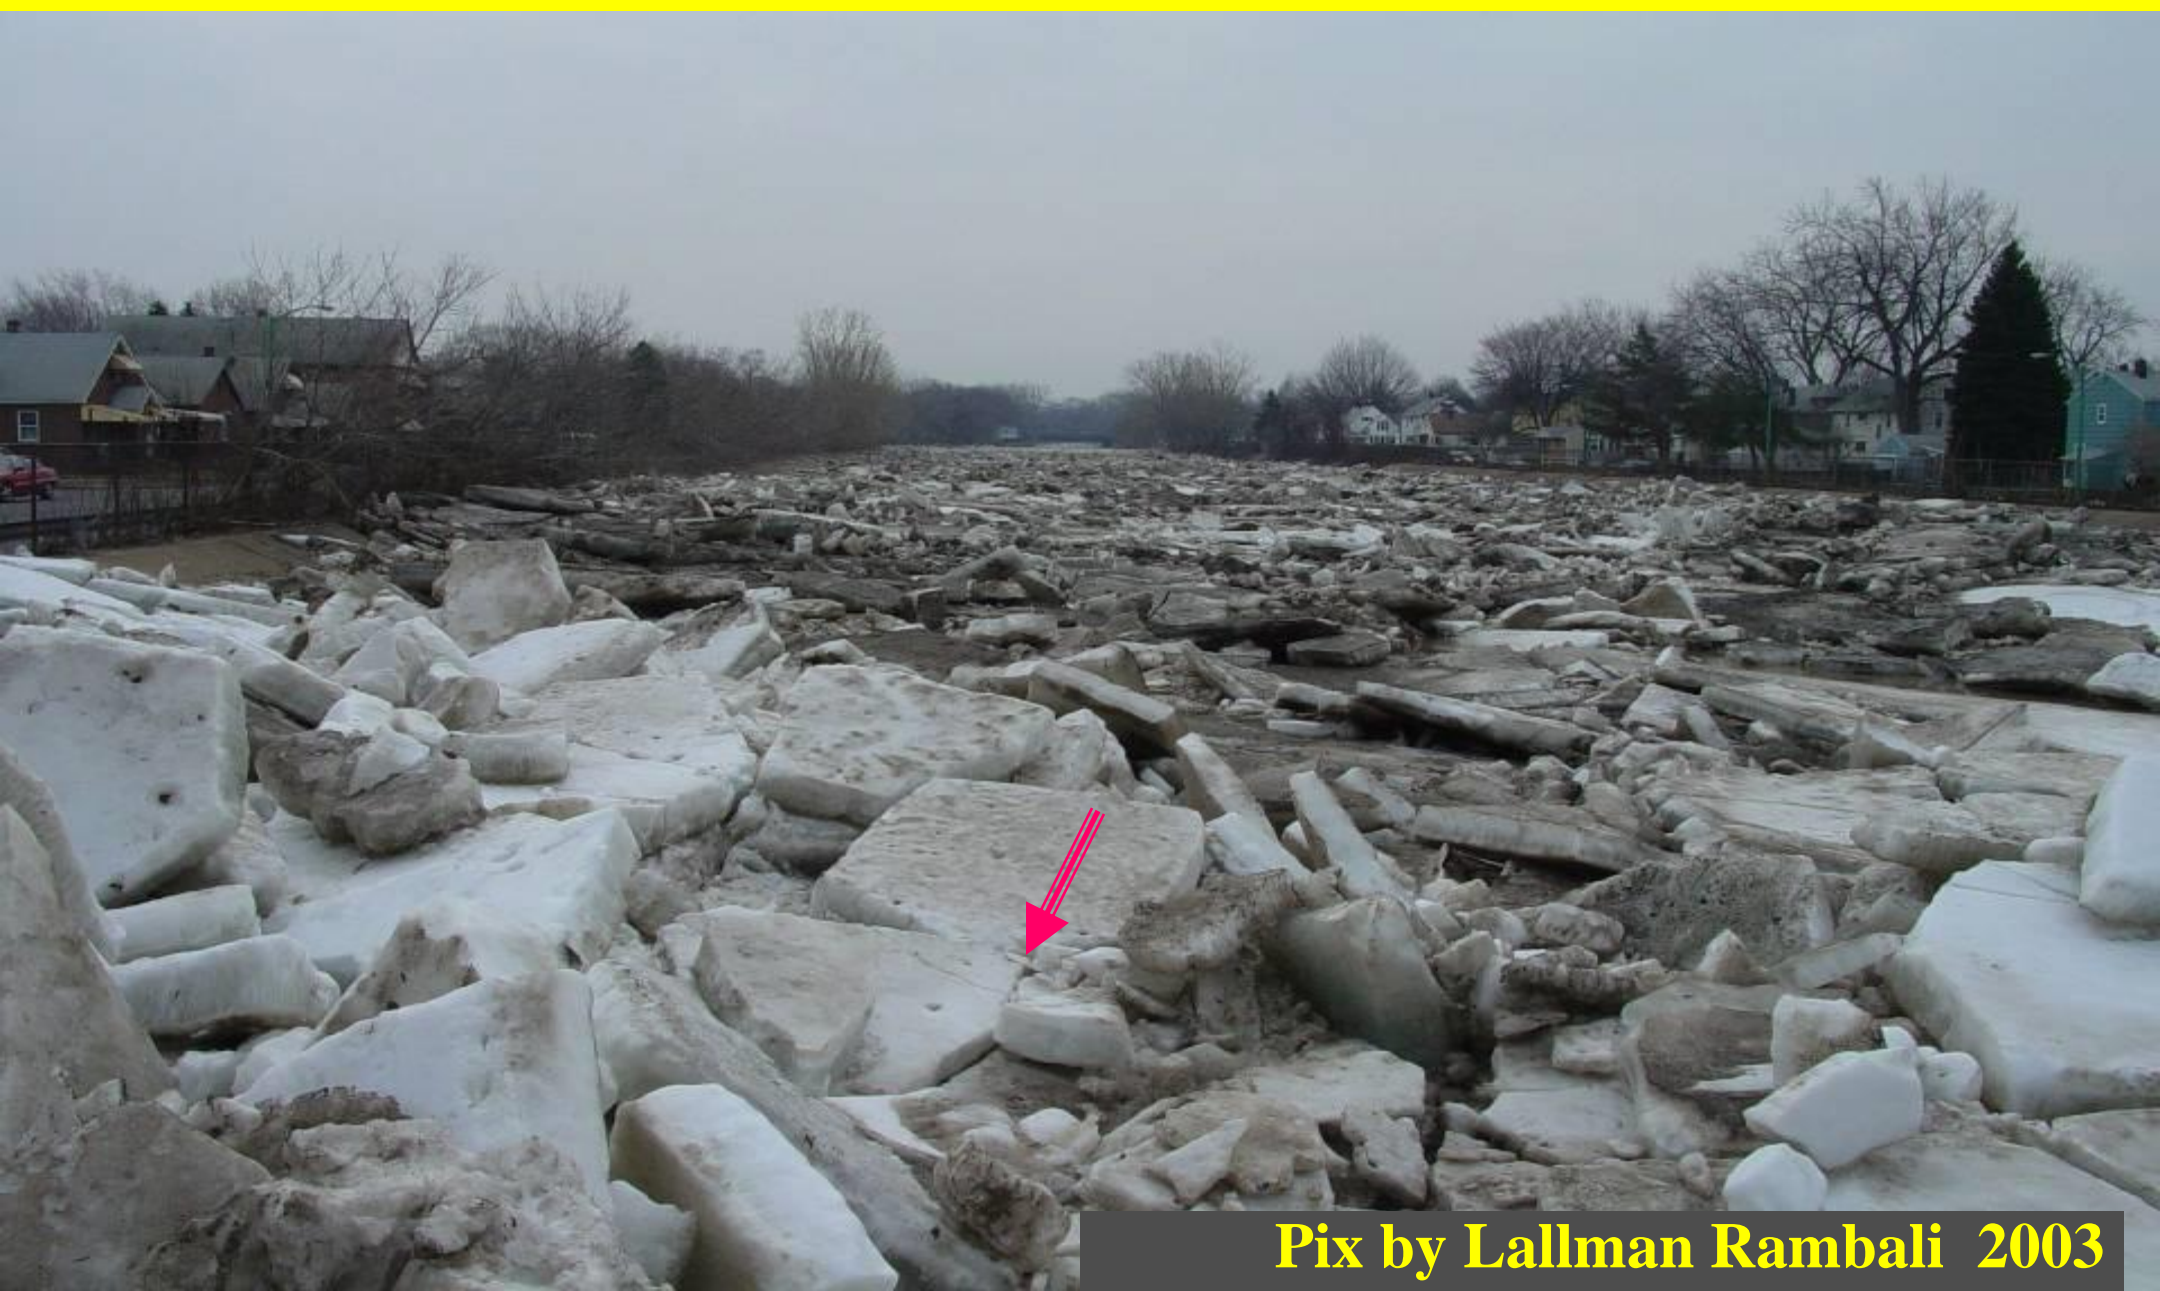
From Stephenson St. bridge, looking US.

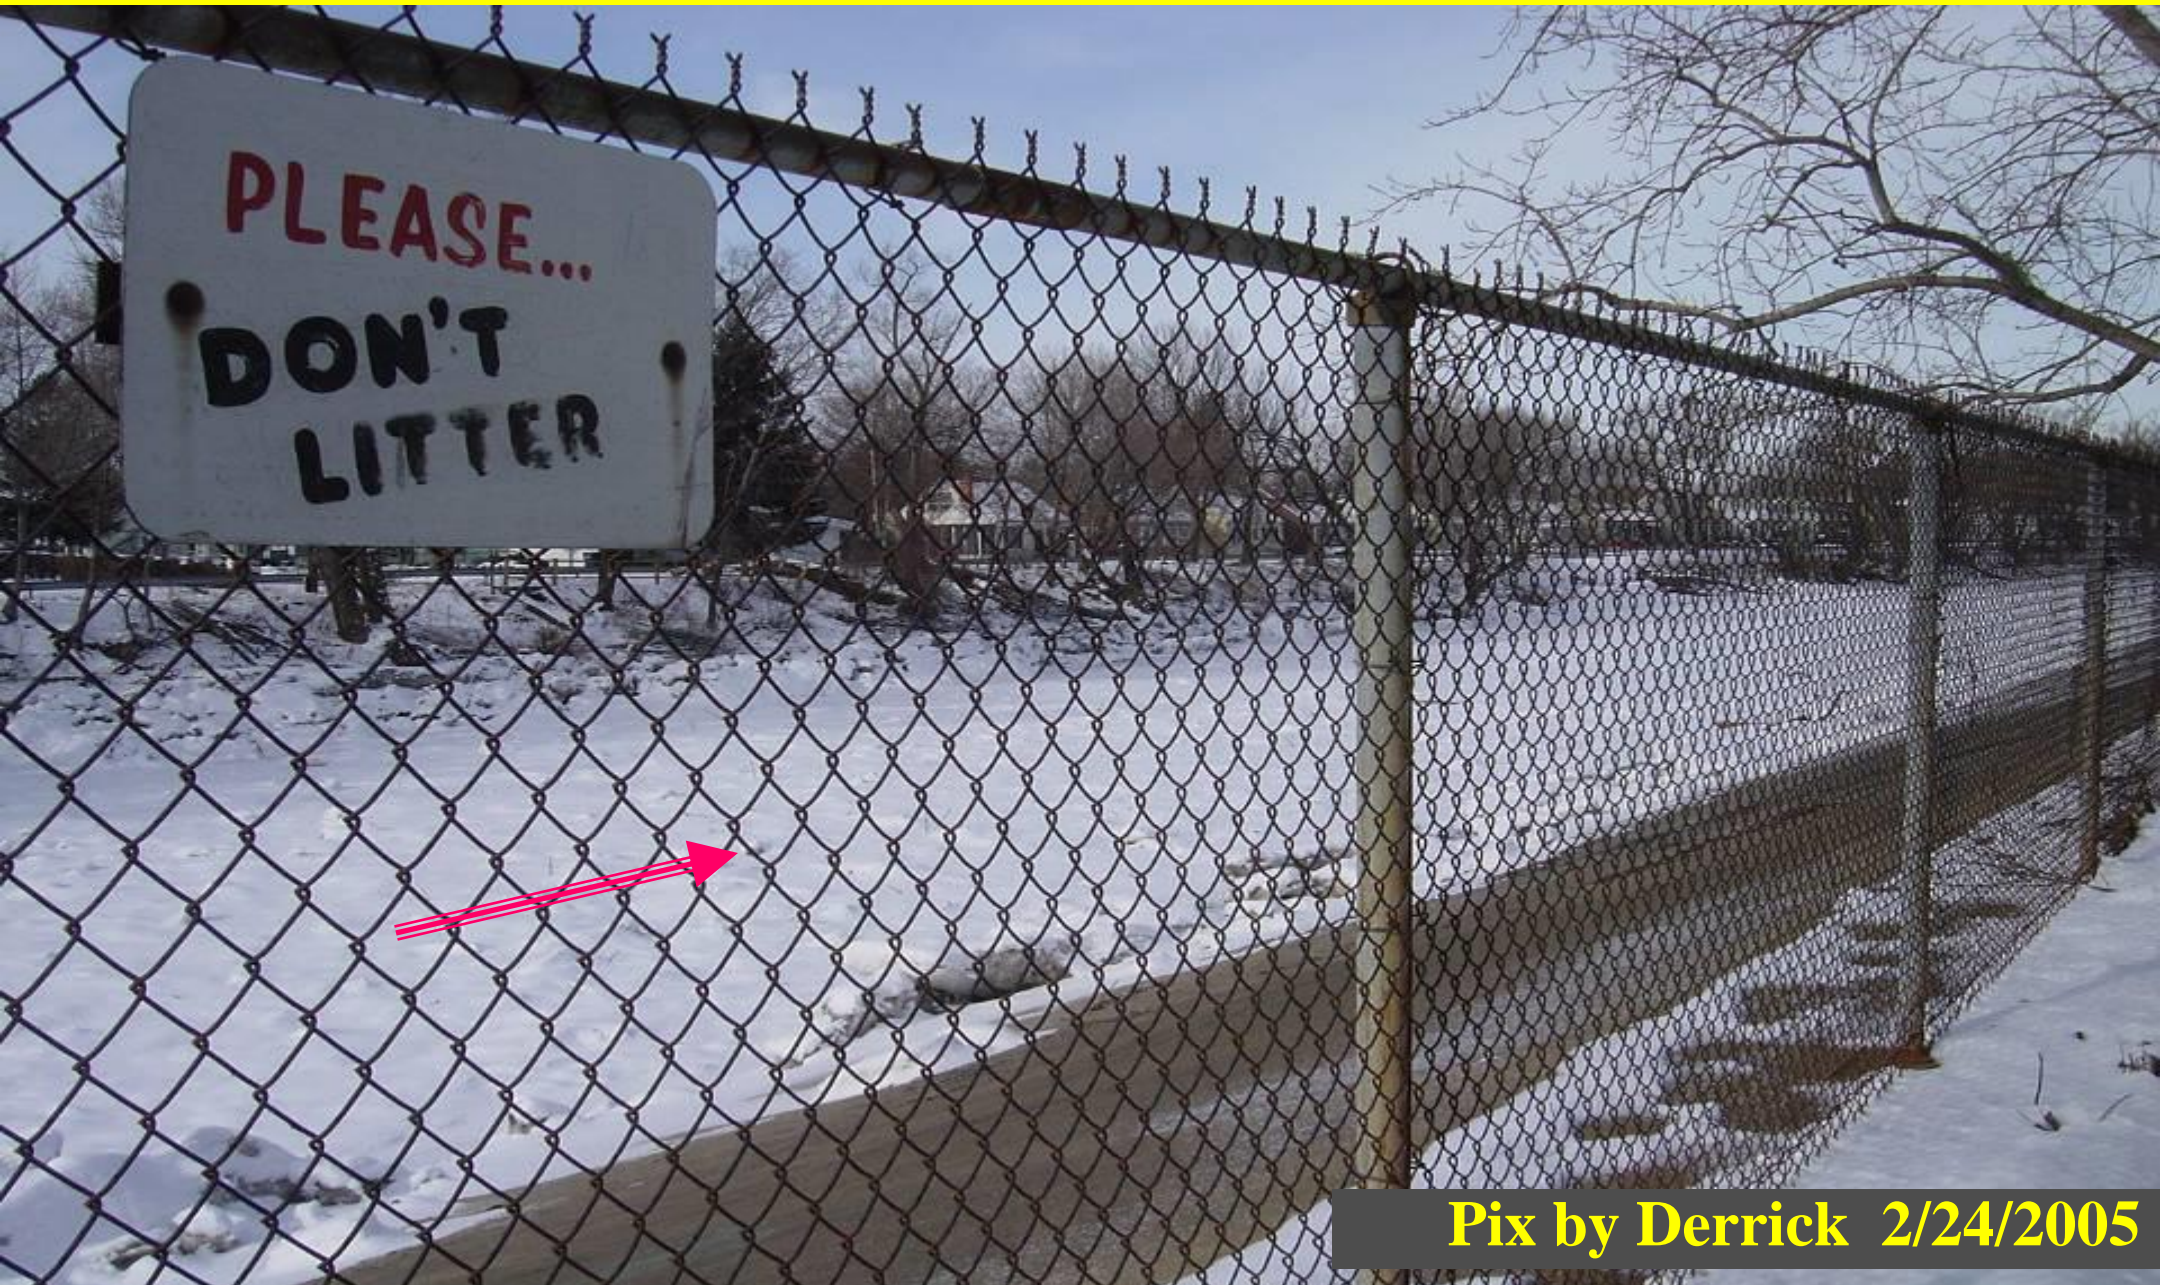
Looking across stream, left bank in background.

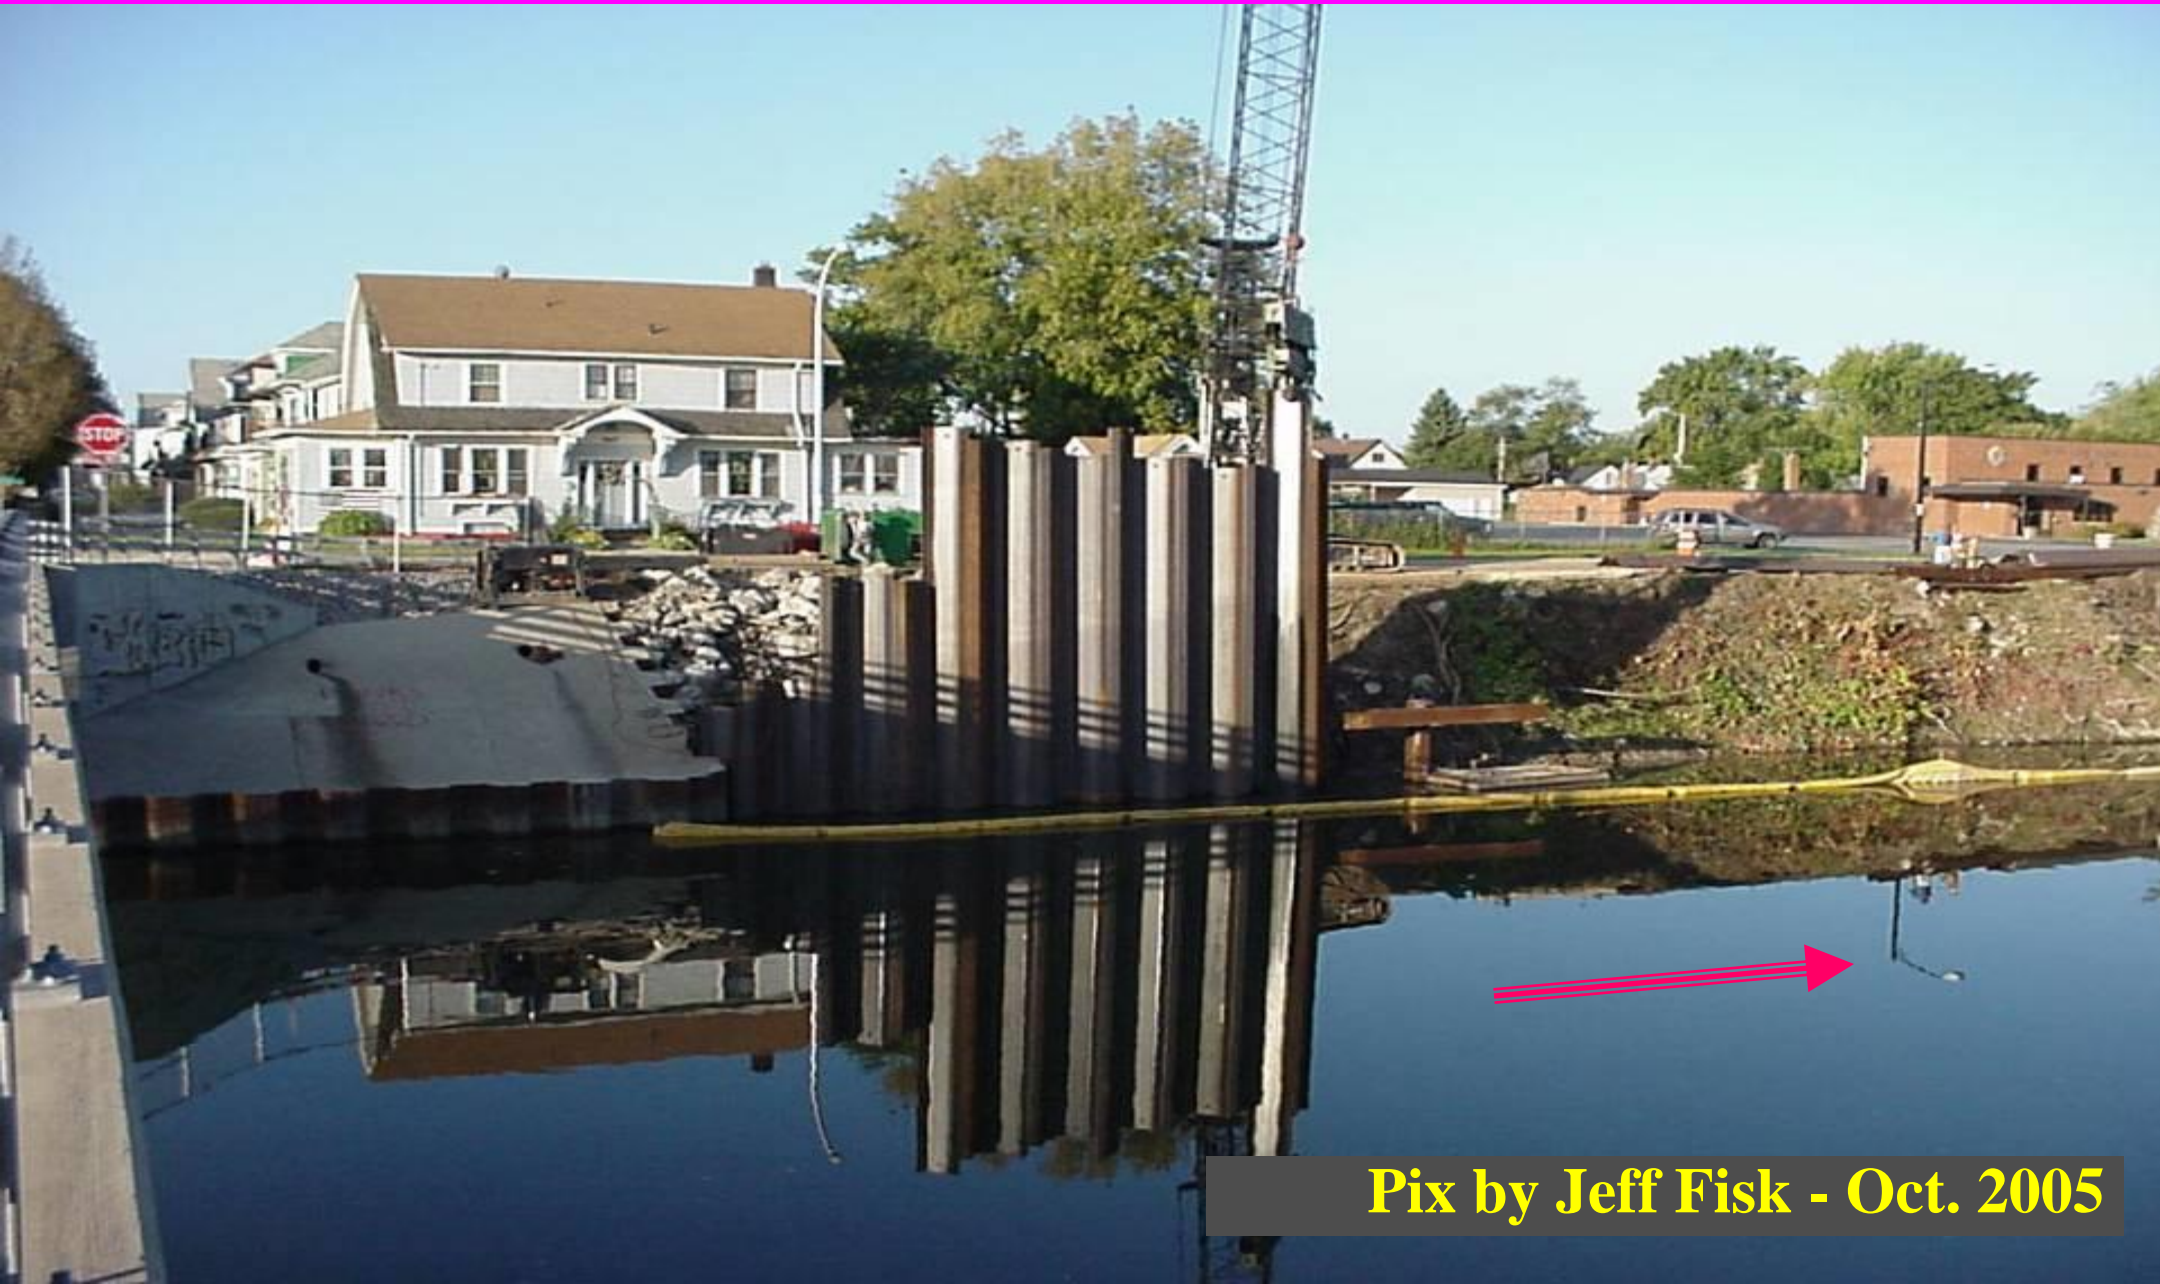
Looking across @ left bank, US end of project.

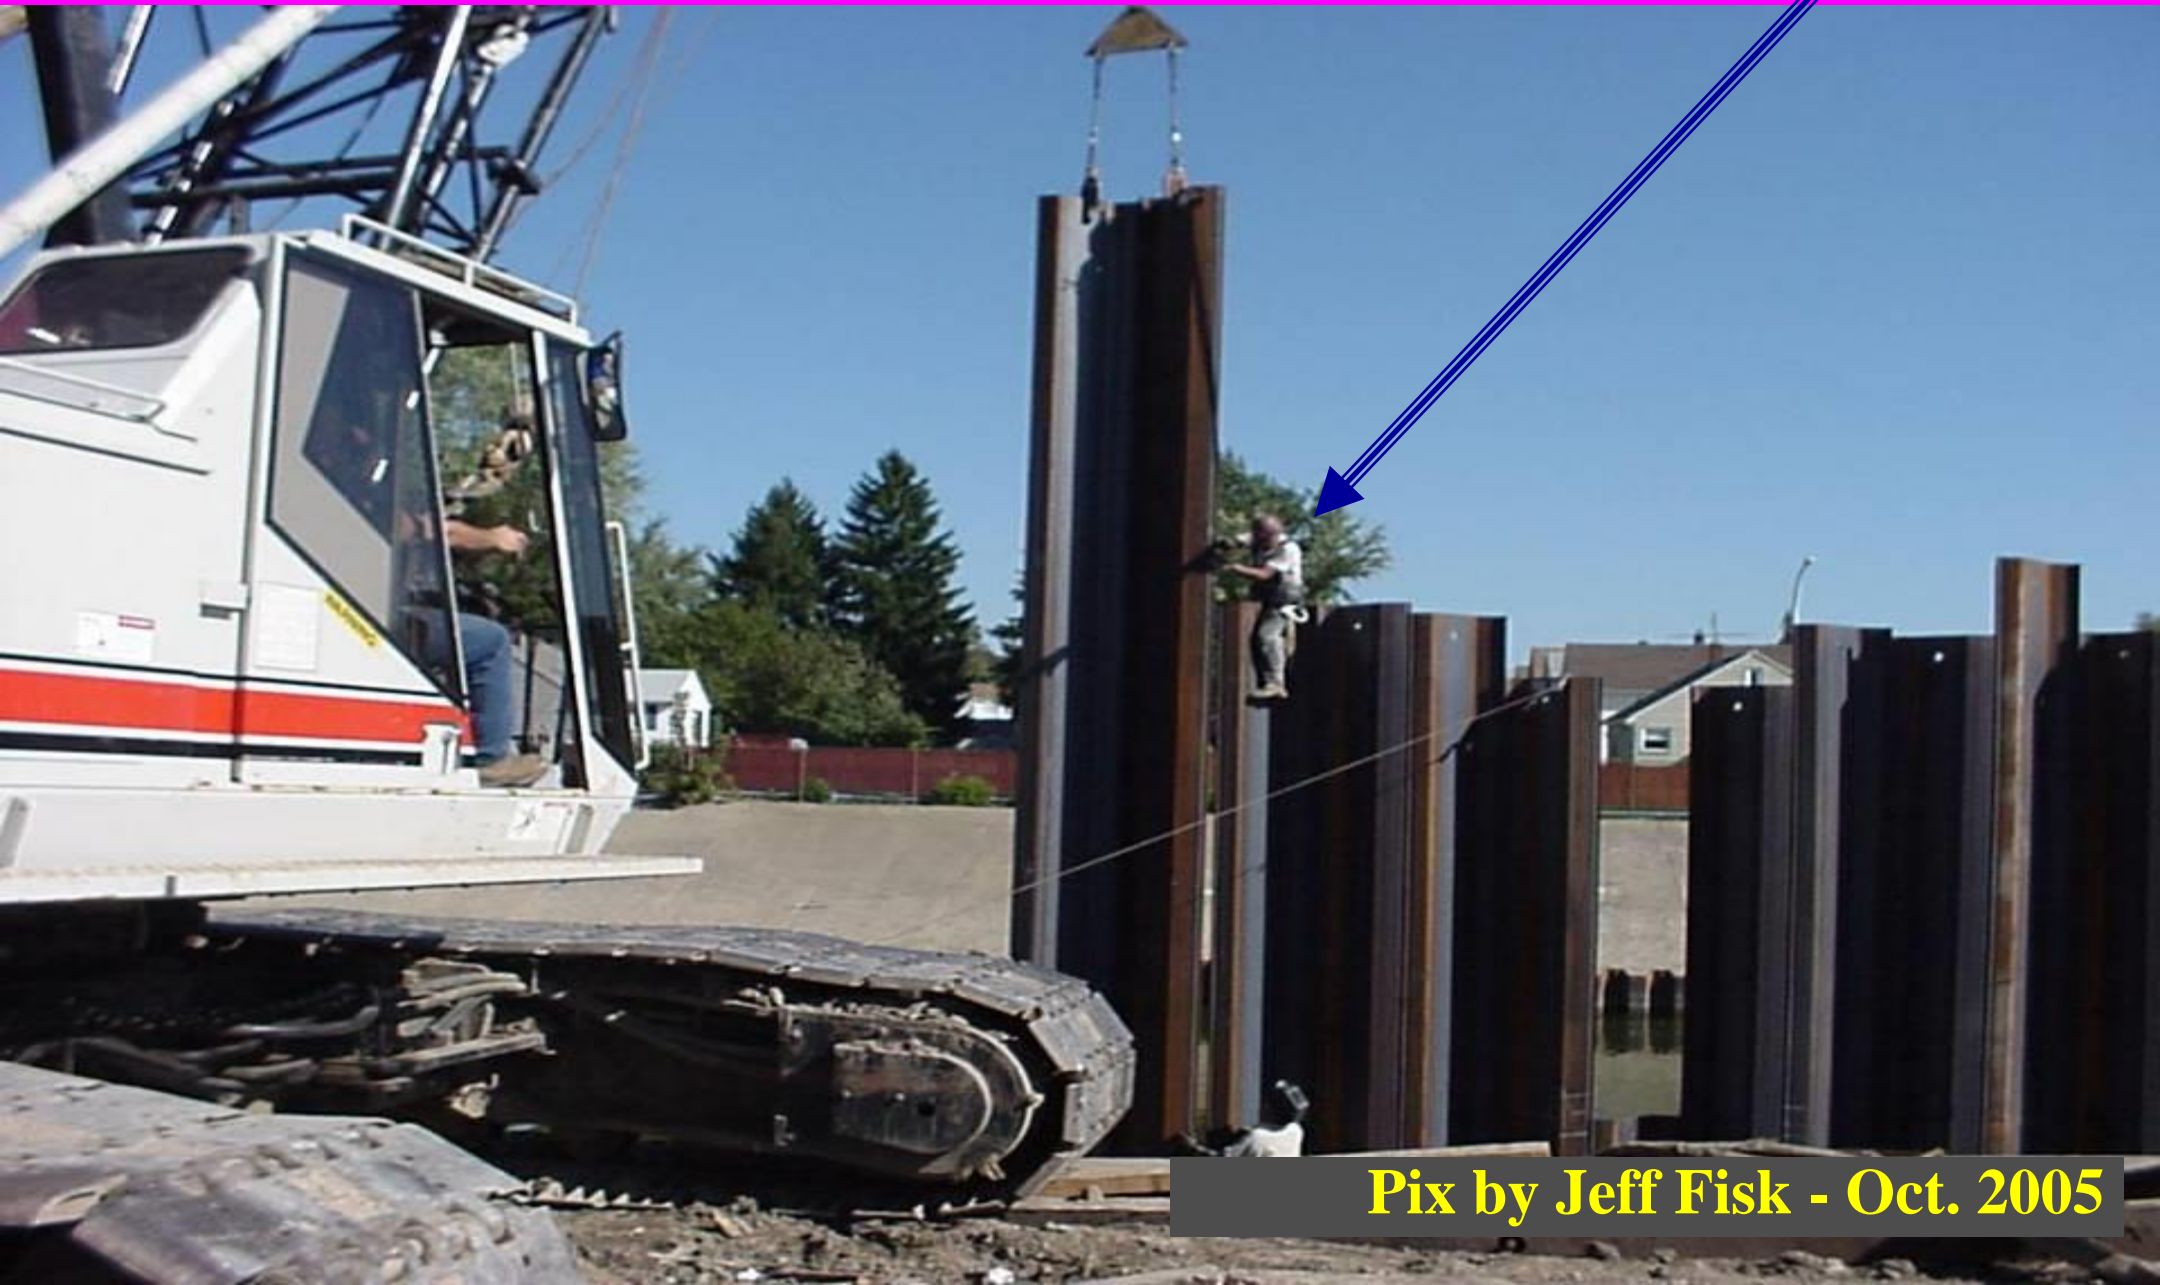
Positioning & driving sheetpile. Note worker.

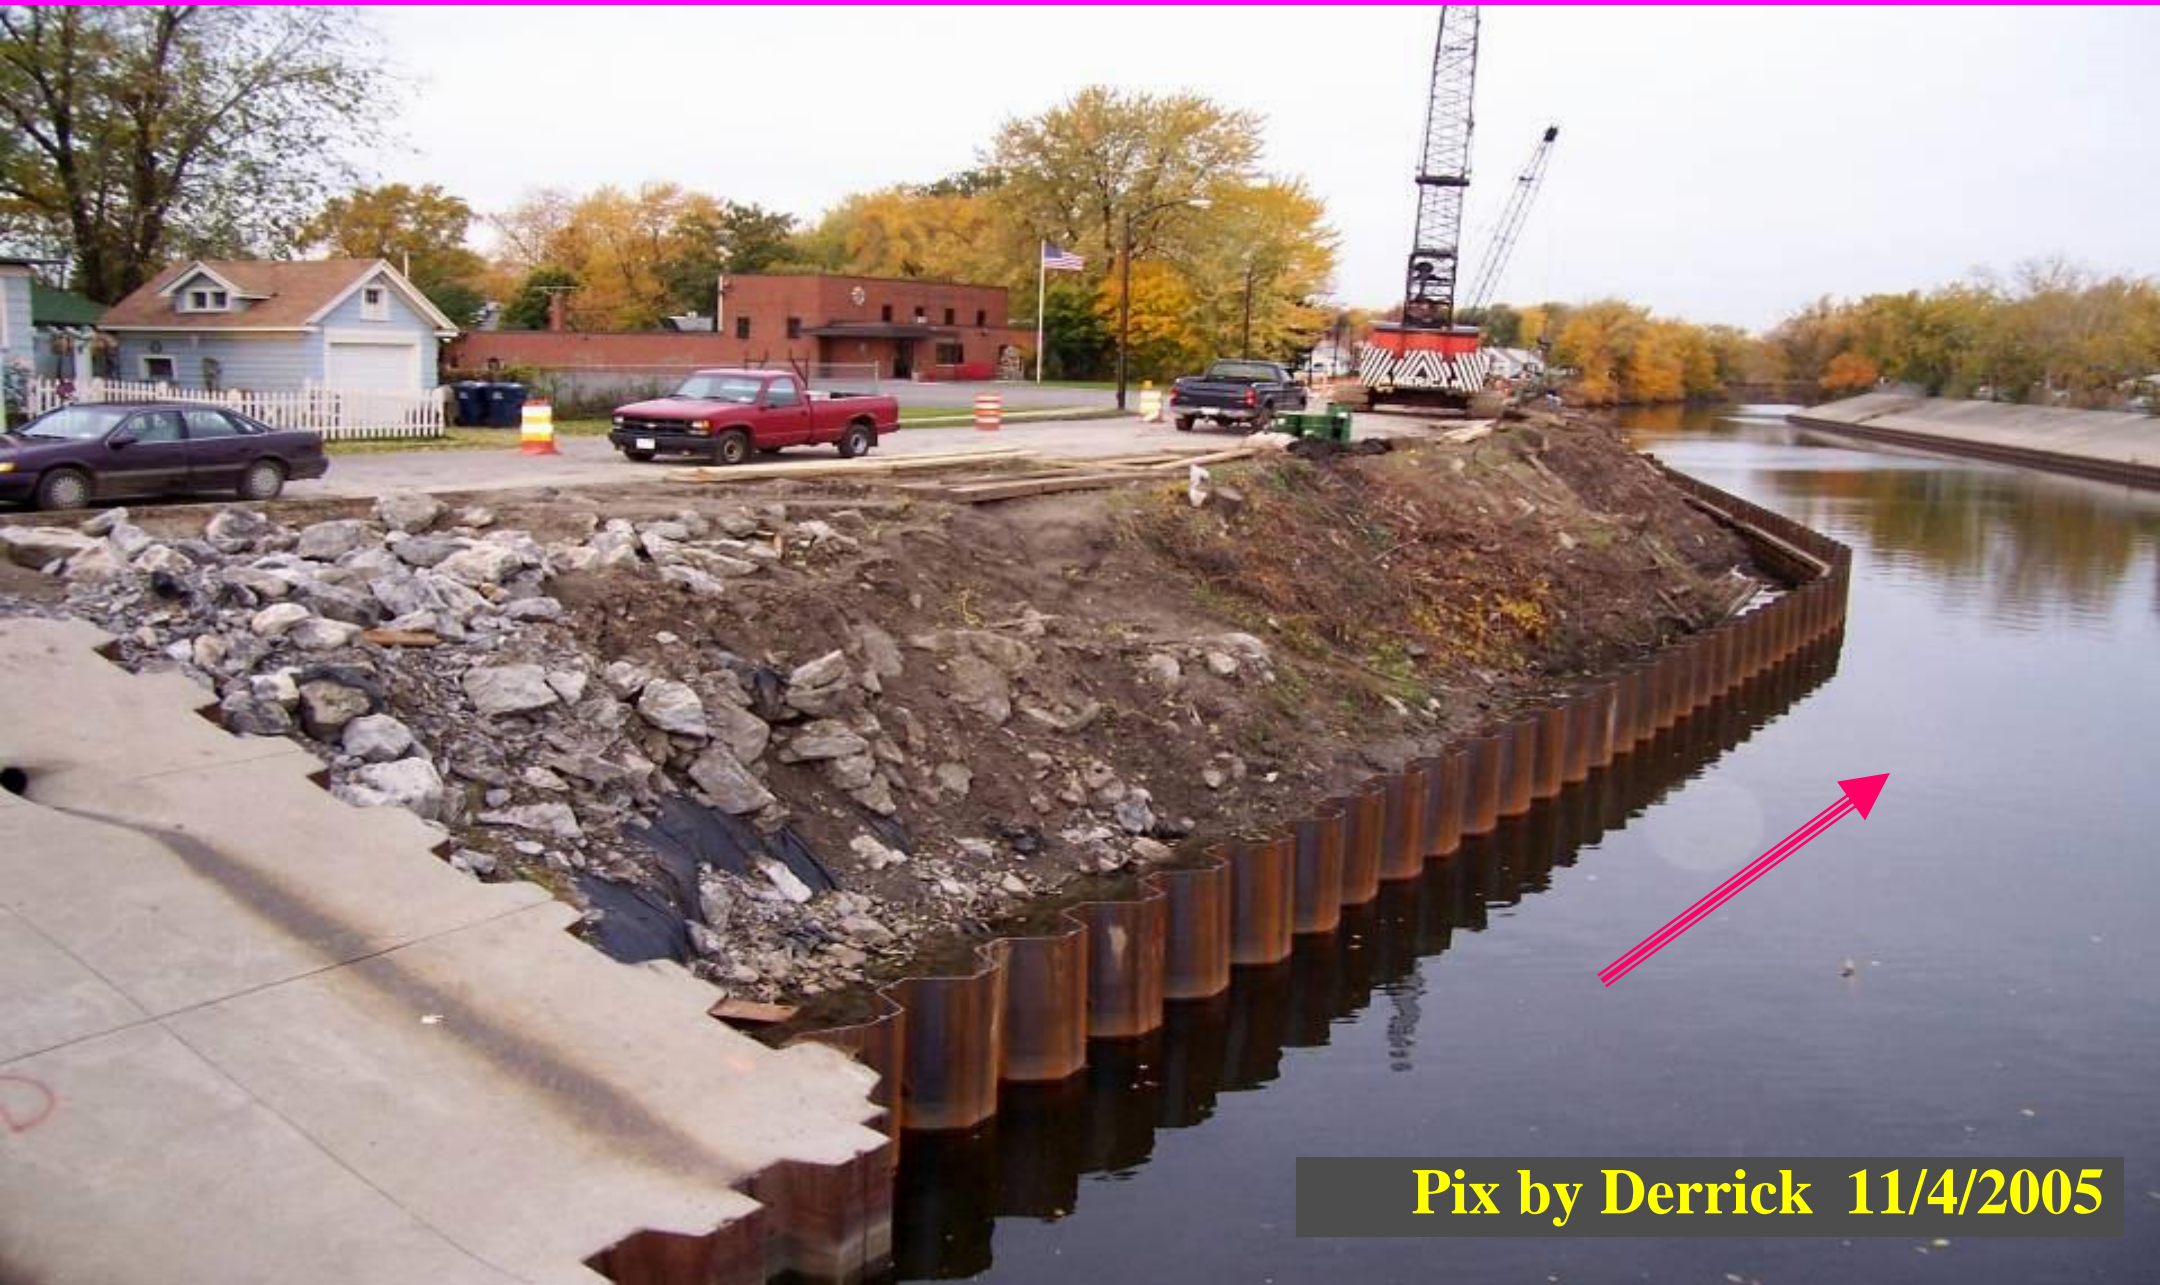
Looking DS. Old sheetpile removed, new installed.

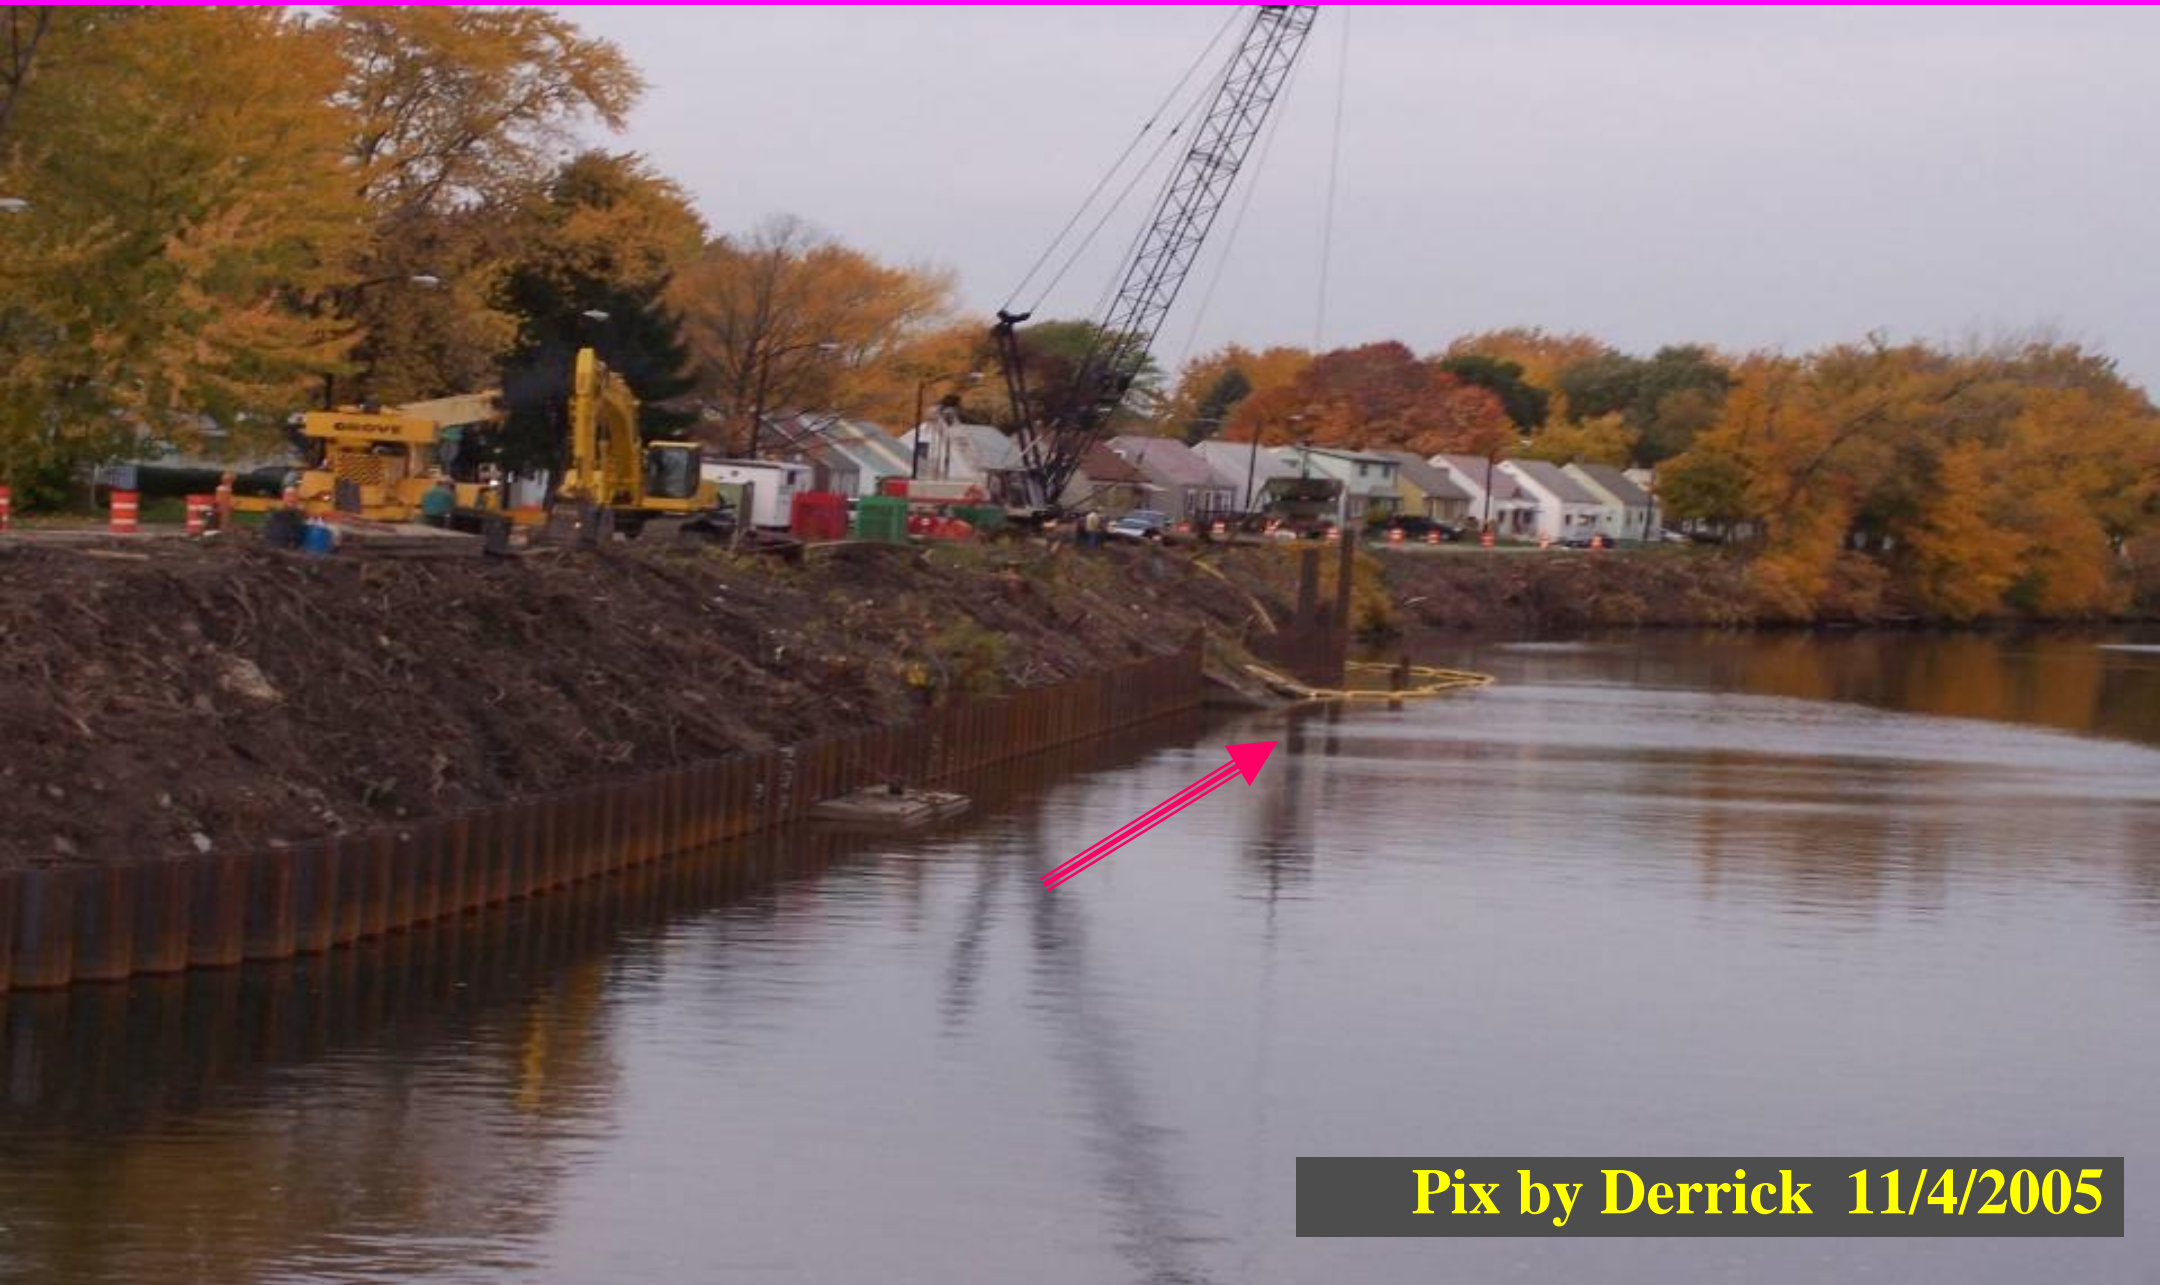
Looking DS. Driving sheetpile toe. Project is 1,000 ft long.

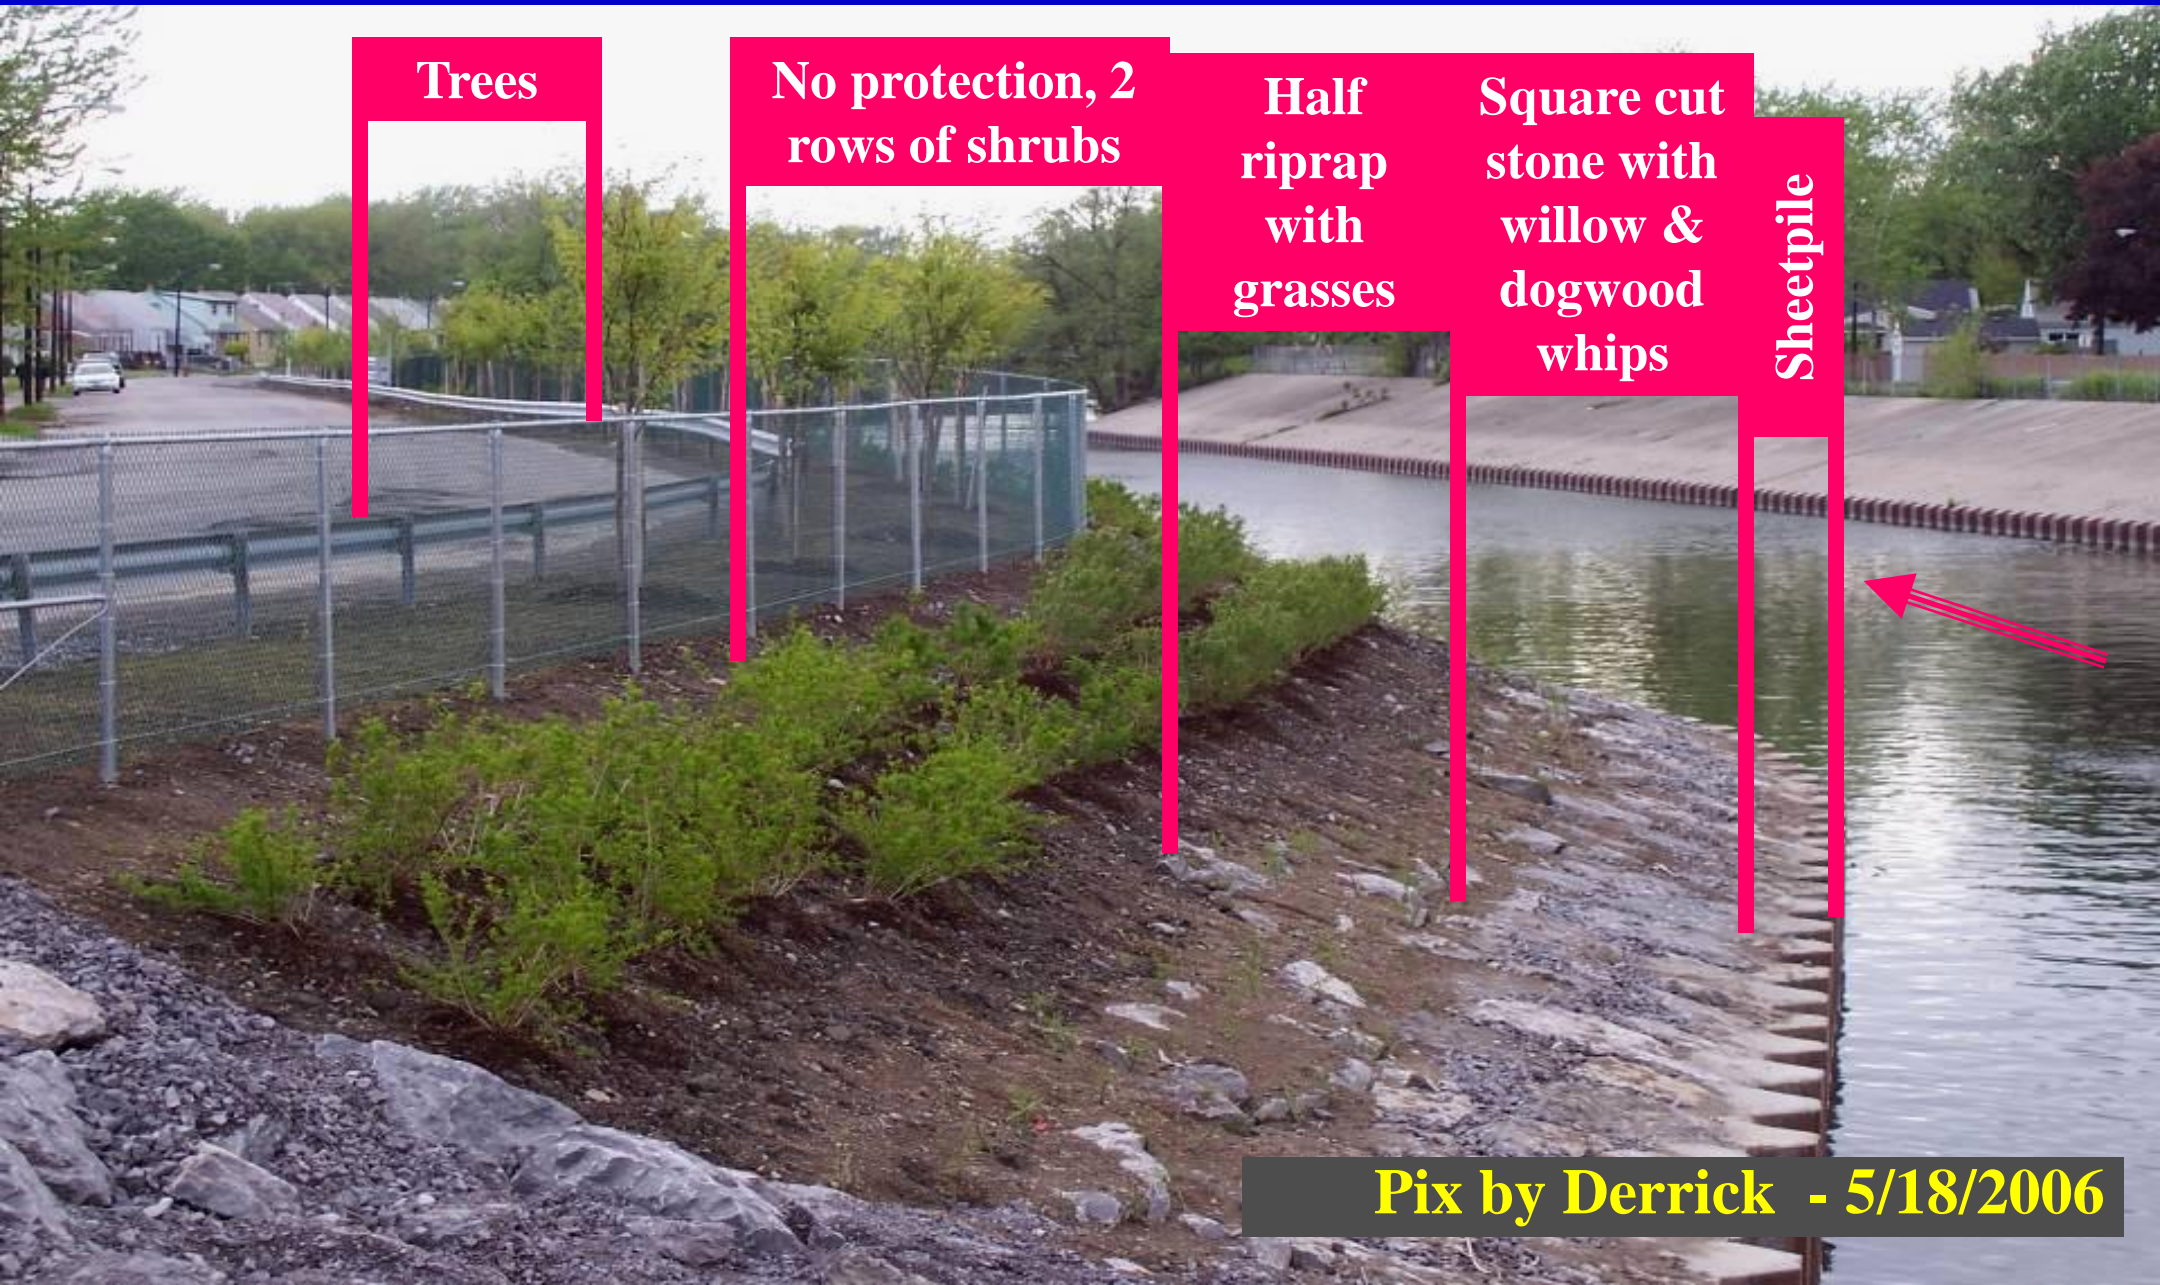
Looking DS. Trees-fence-shrubs-riprap-stone-sheetpile.

**No protection, 2
rows of shrubs**

**Half
riprap
with
grasses**

**Square cut
stone with
willow &
dogwood
whips**

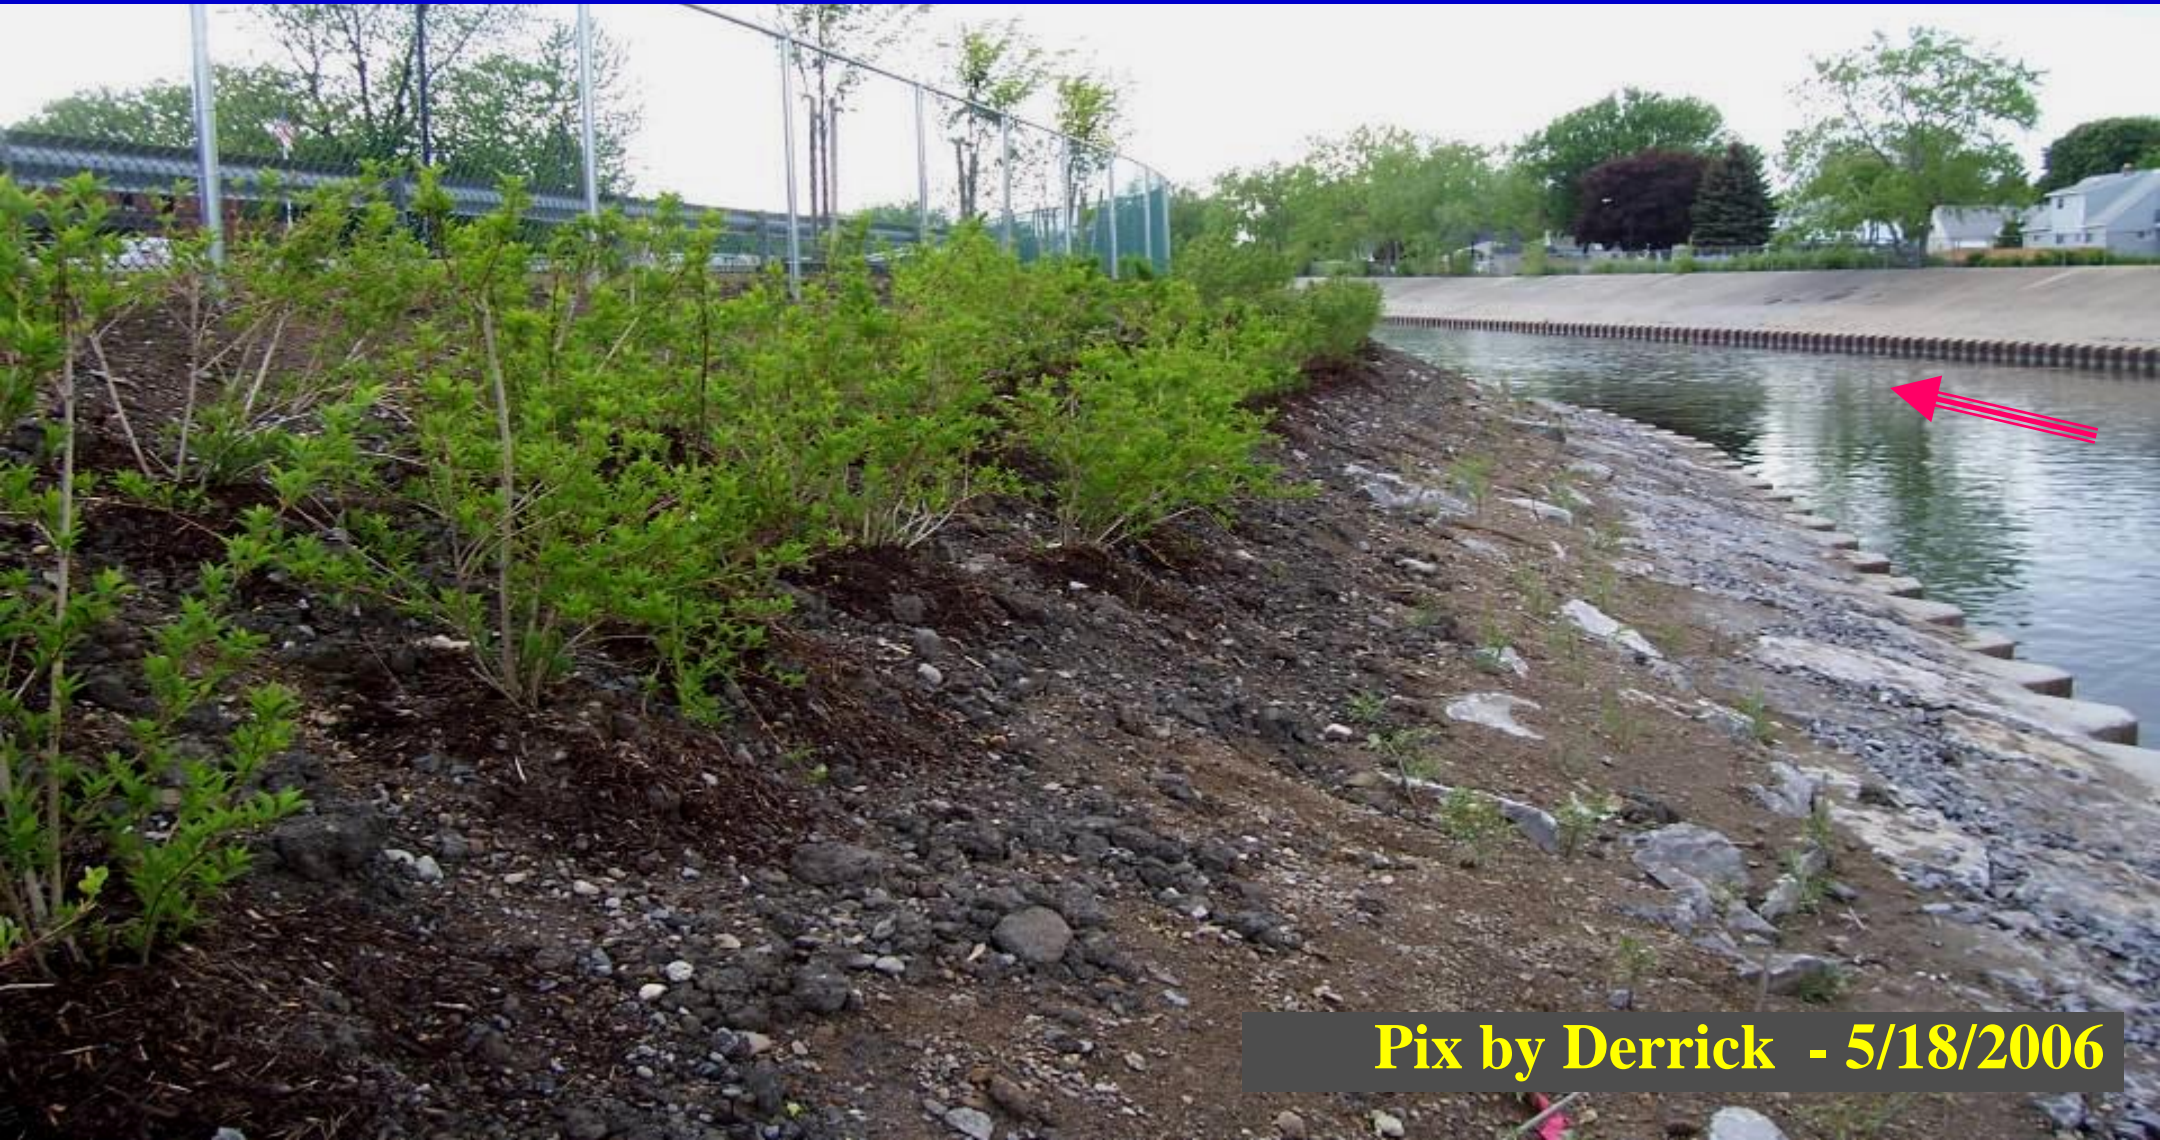
Looking DS. Close-up of soil-choked riprap mid-bank & upper bank shrubs. Note engineered soil-clay-gravel-organic mix for stability & plant growth of shrubs.
