CAZENOVIA CR. @ STEPHENSON ST. BRIDGE

**REPLACEMENT OF ONE BANK
OF A CONCRETE-LINED
CHANNEL**

**HAW CREEK, PIKE COUNTY, MISSOURI-
TRIB TO SALT RIVER**

GOODWIN CREEK, MS.

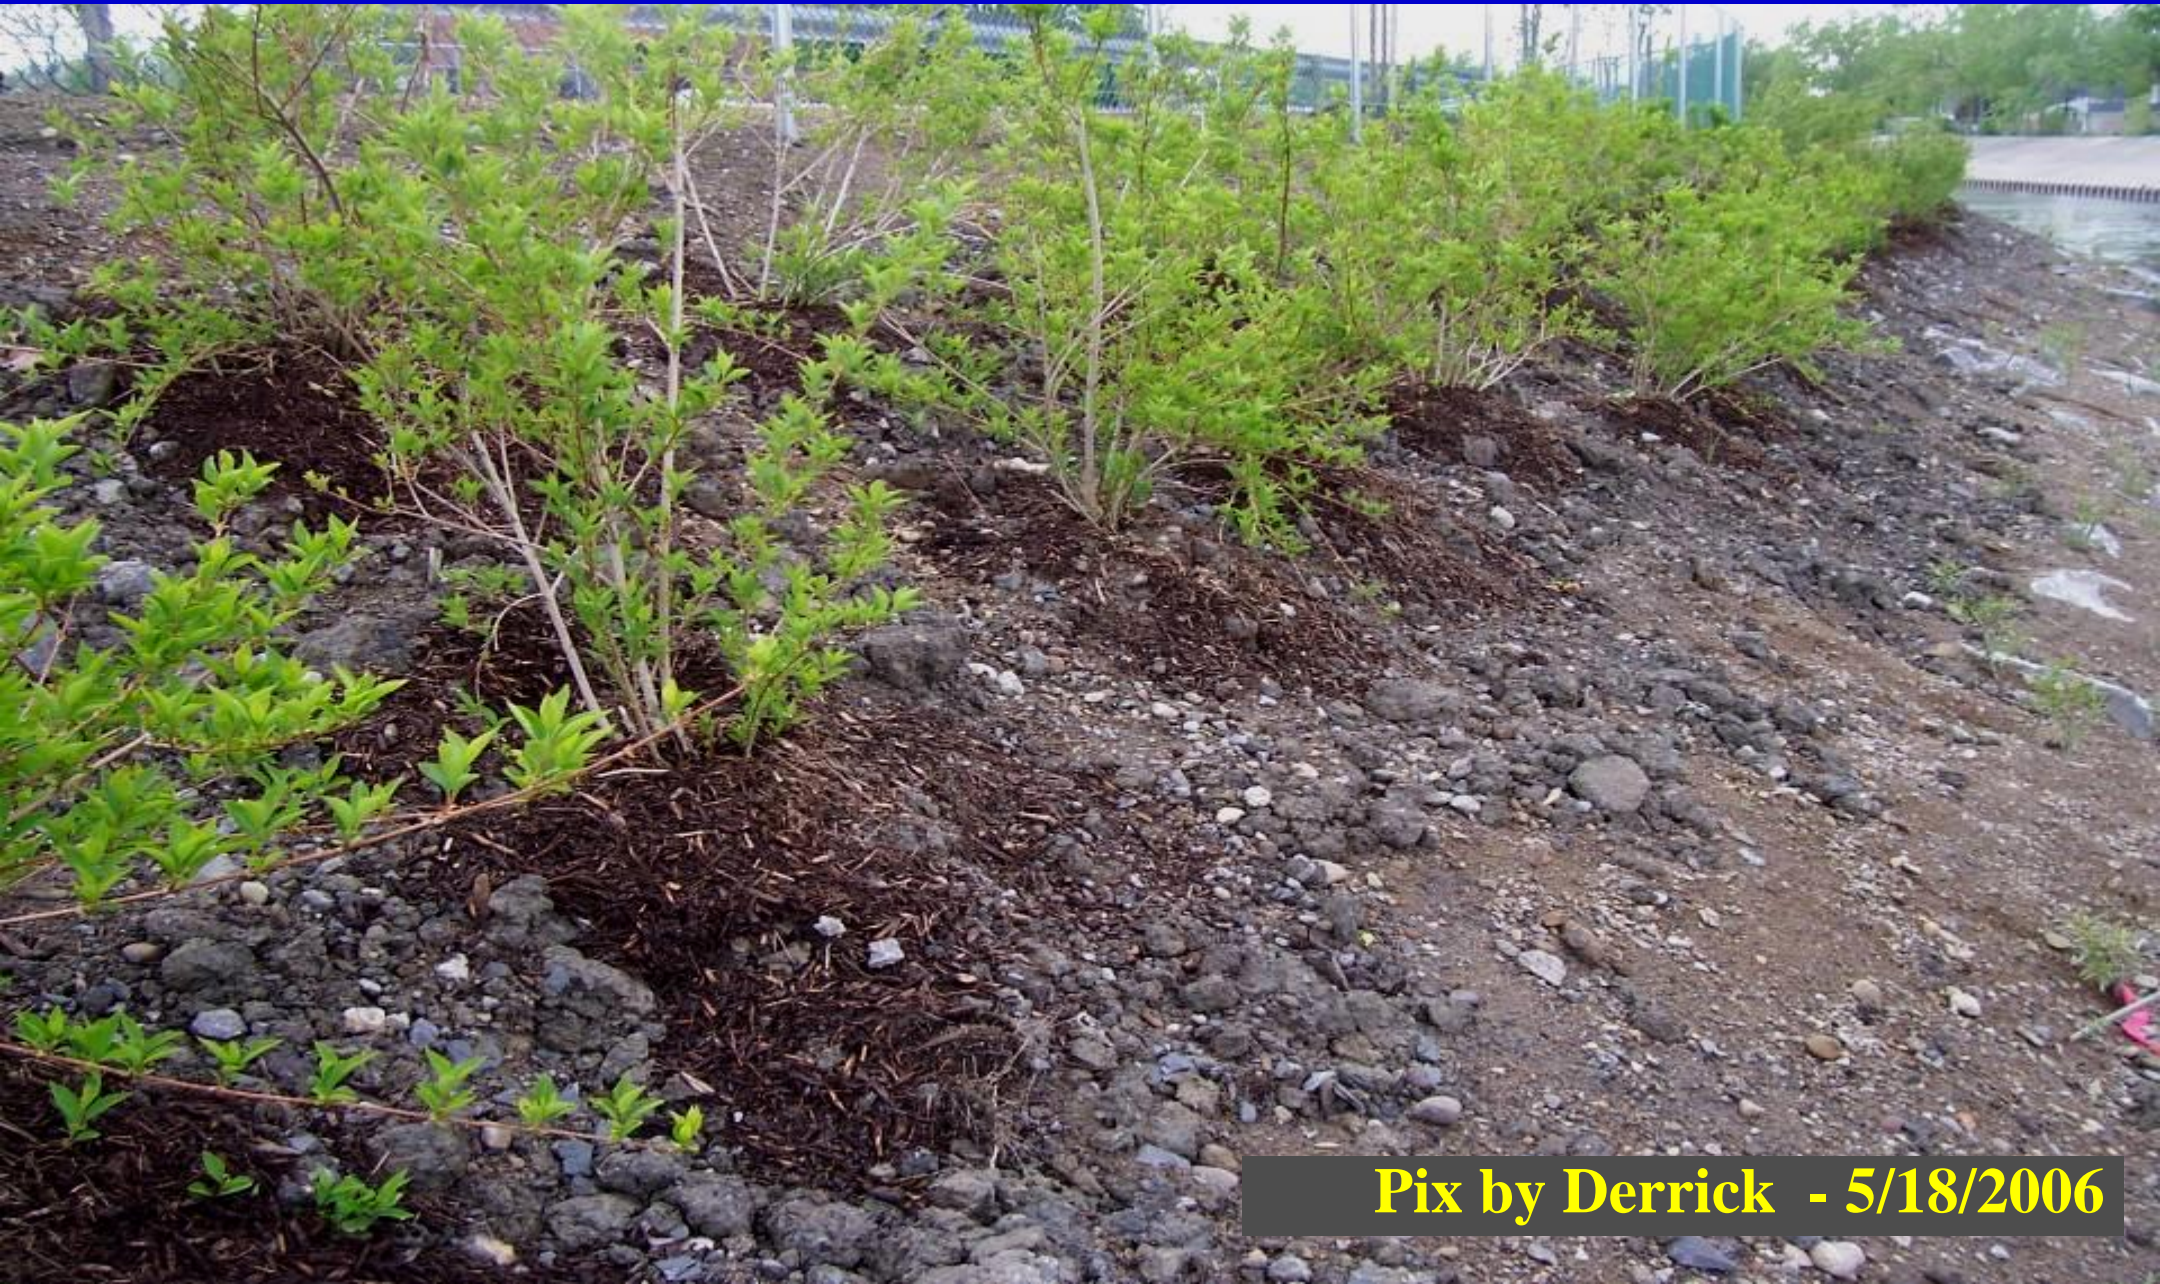
Robust upper bank rooted stock shrubs.

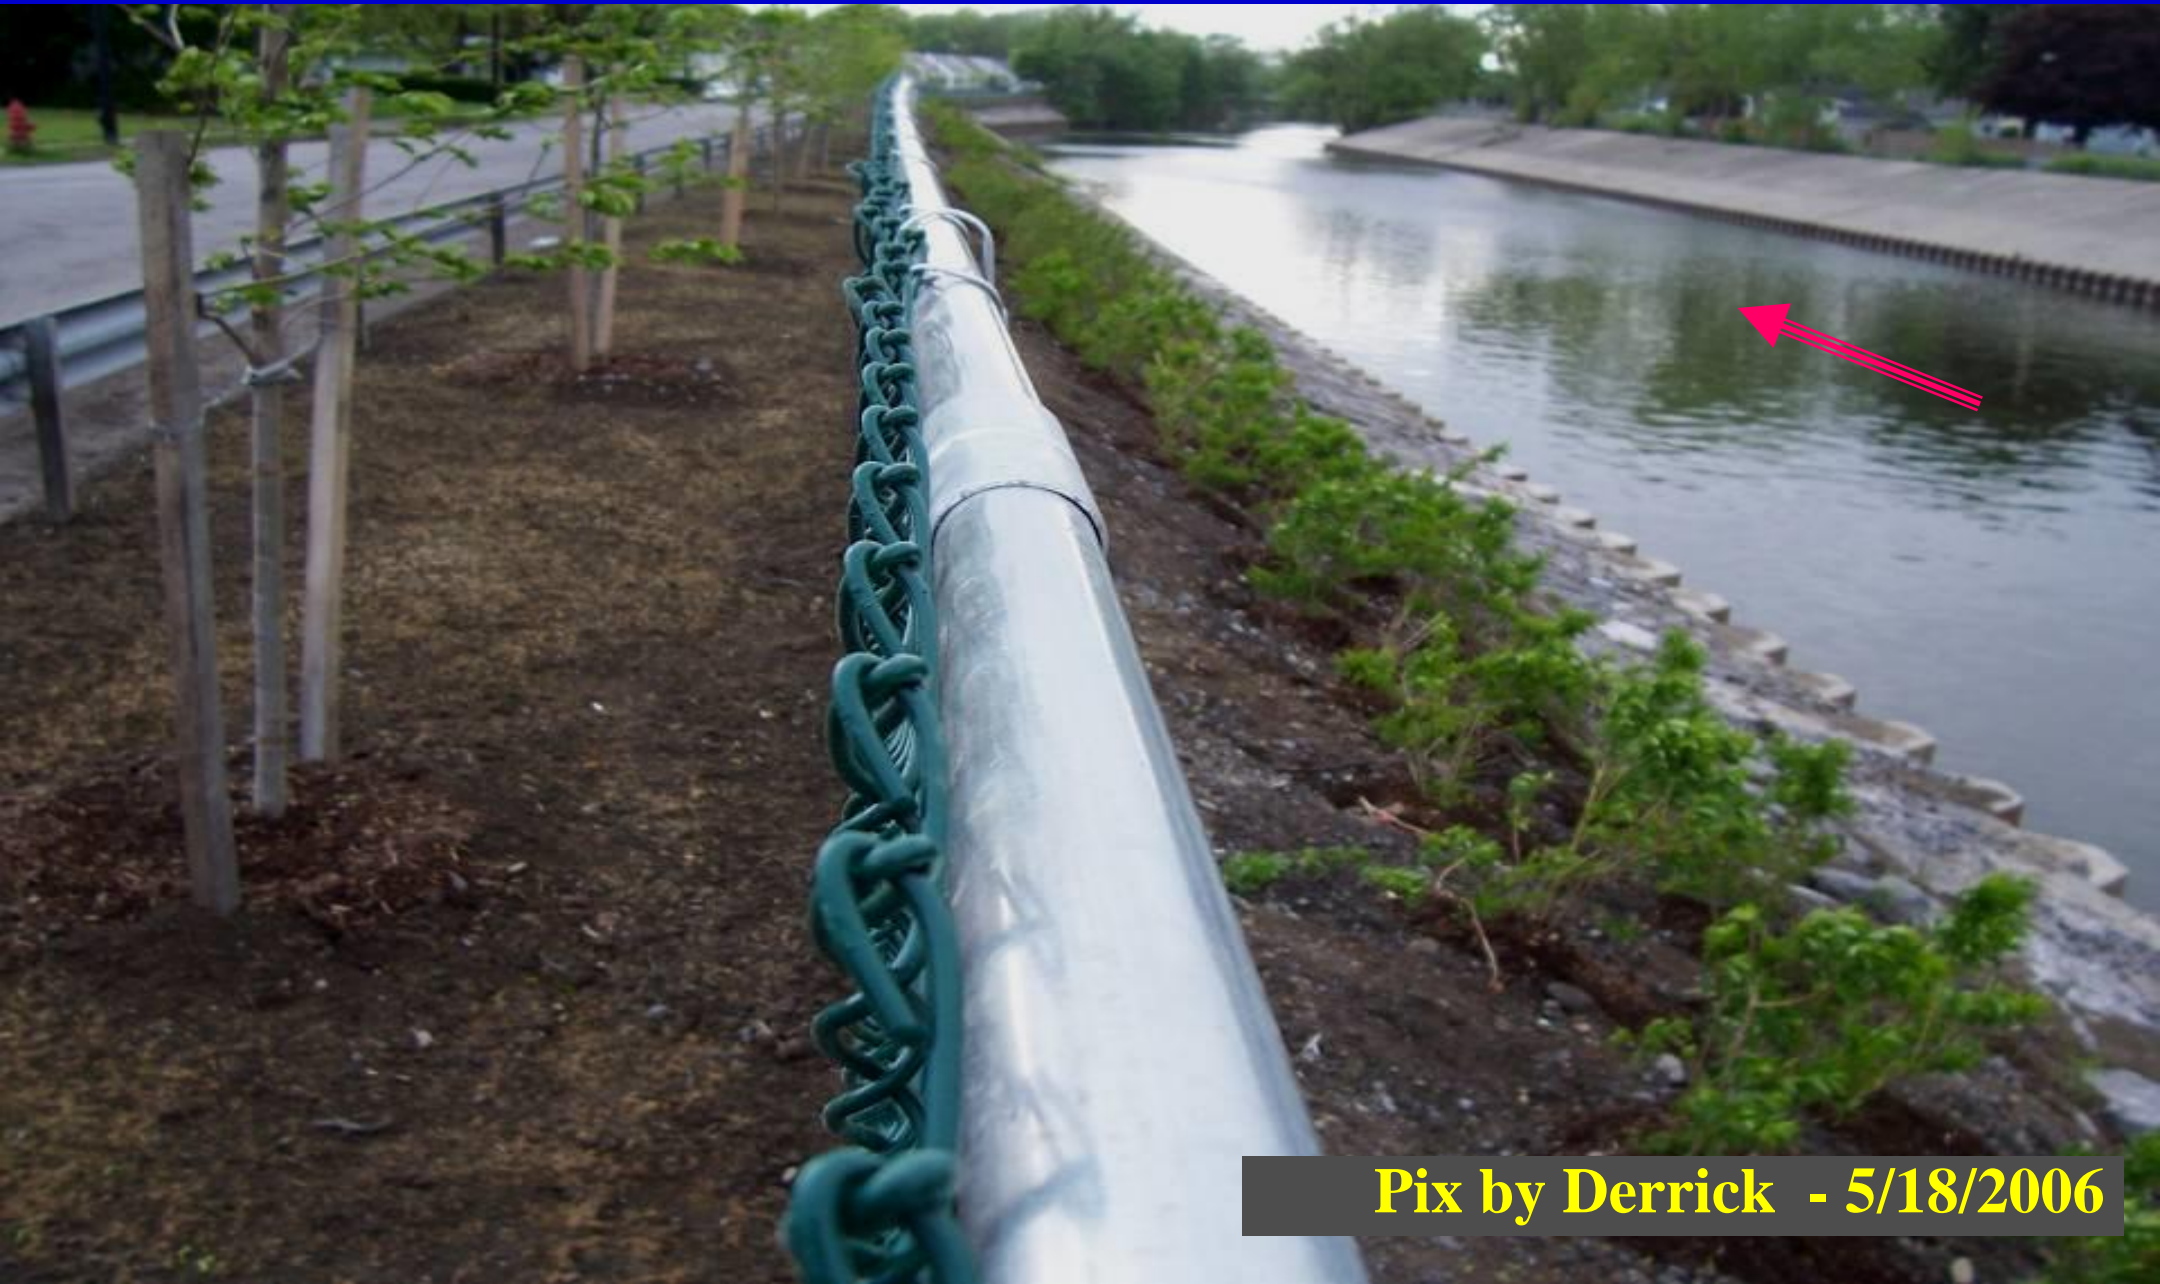
Looking DS. Shrubs and top-bank trees.

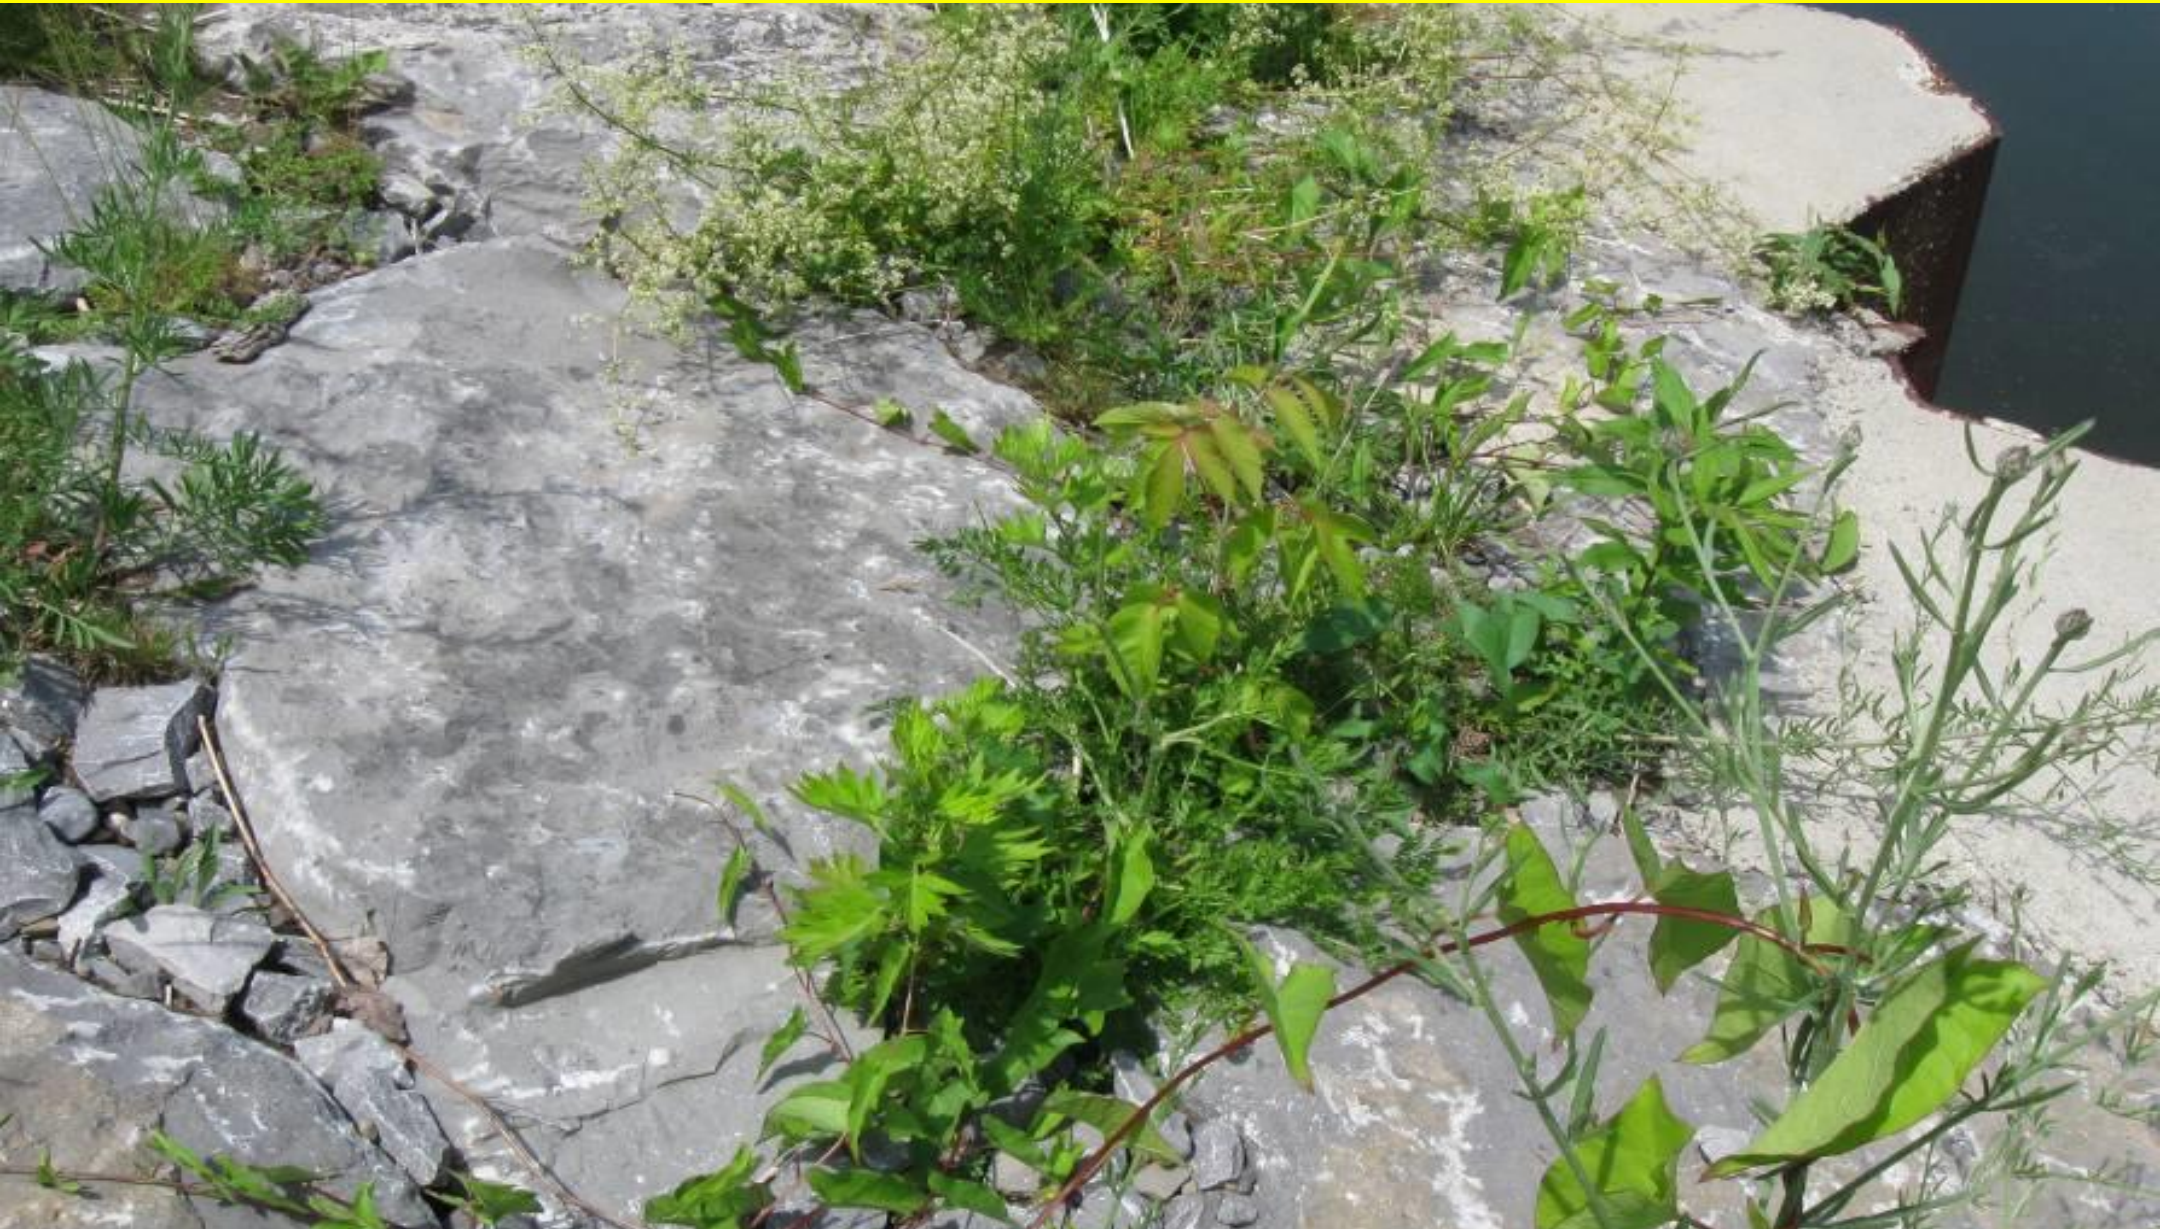
Vines & some veg growing amongst large toe stone.

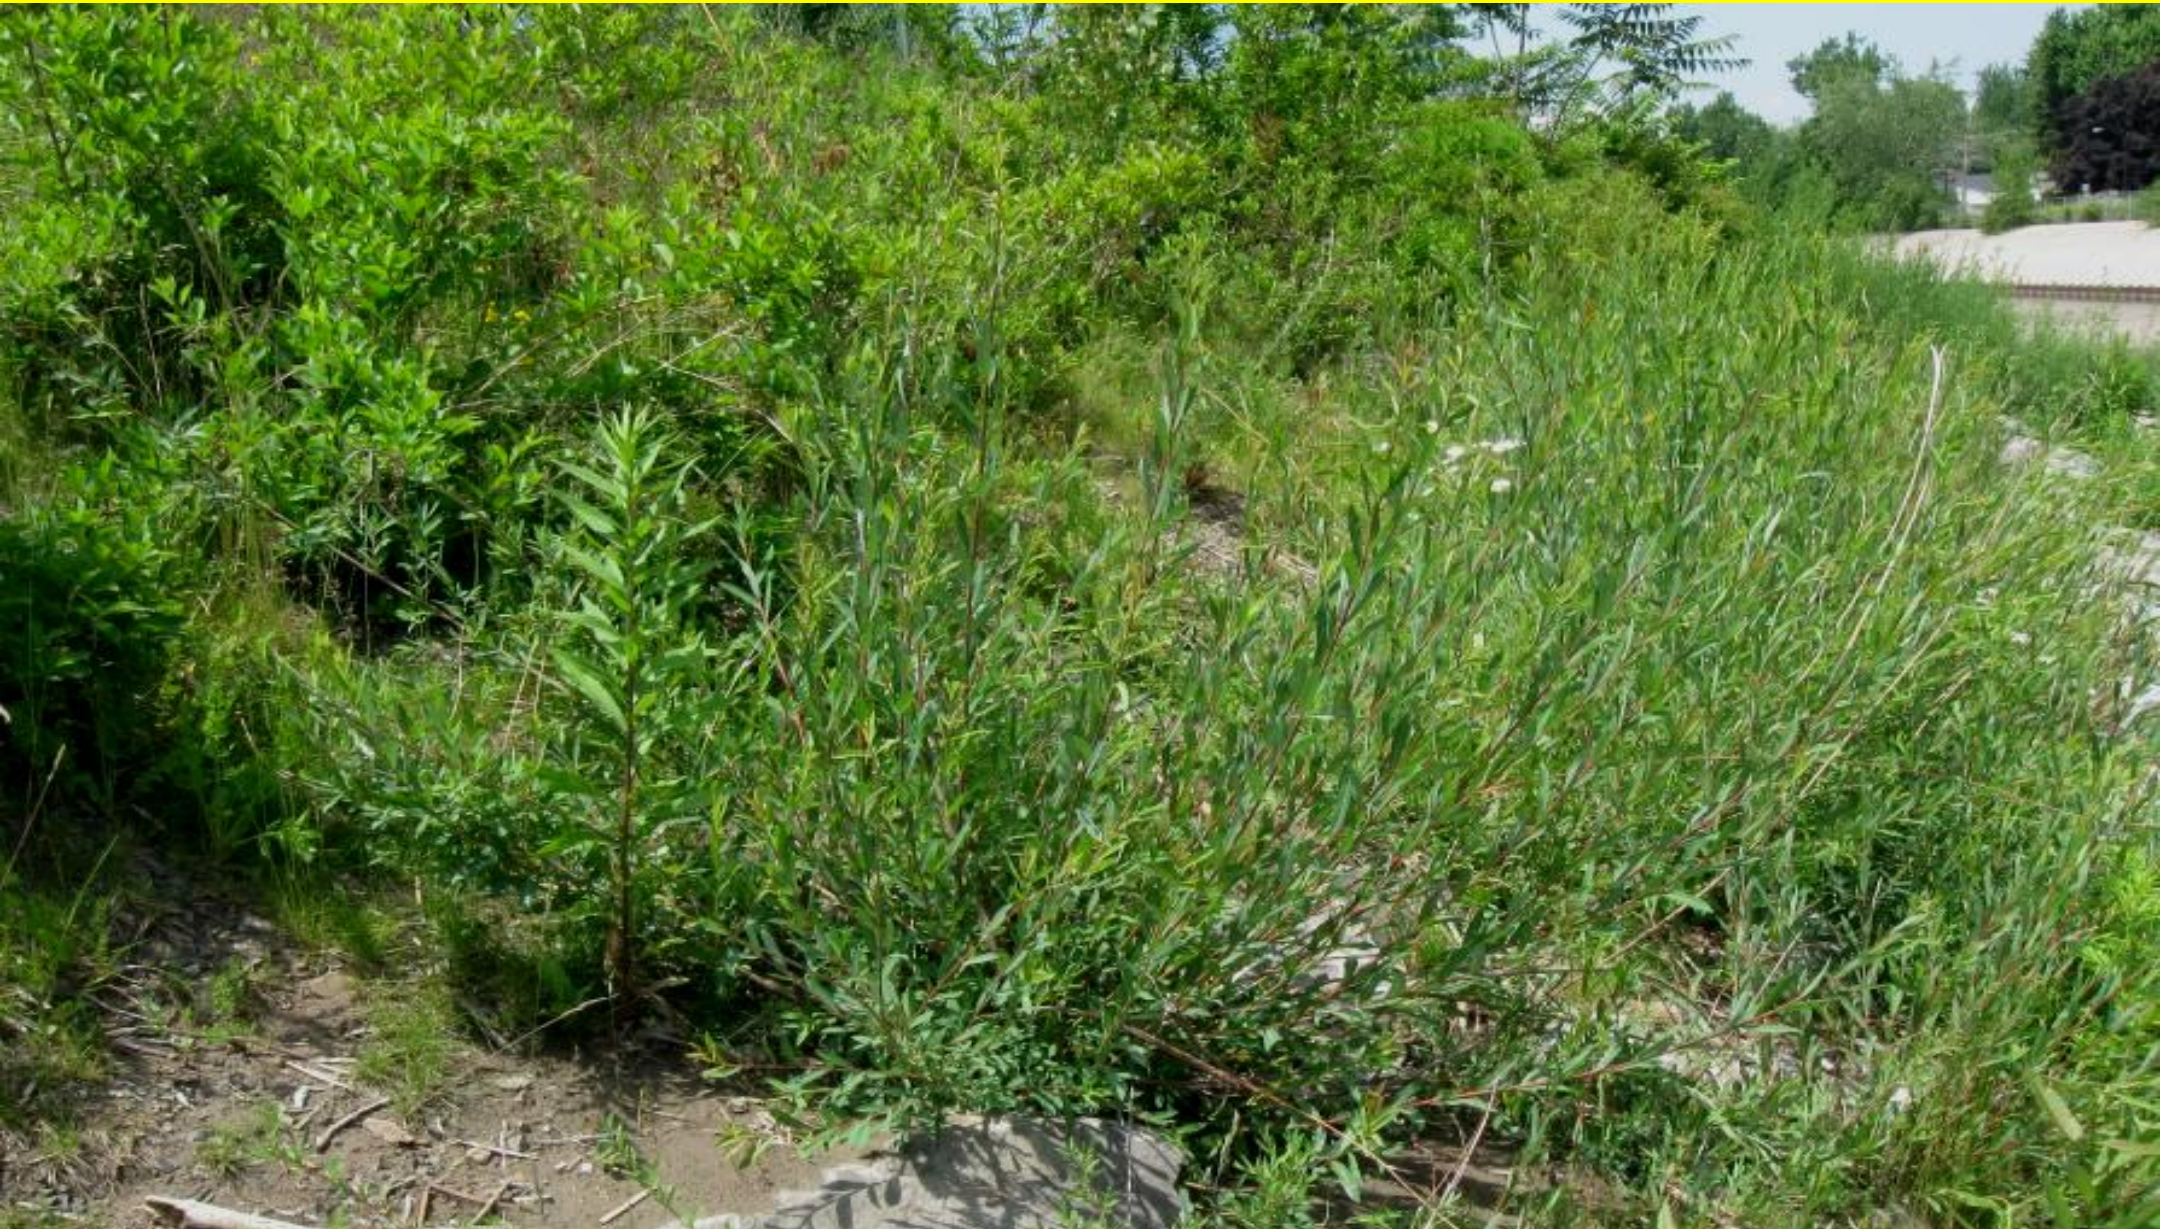
Close up of robust mid & upper bank veg.

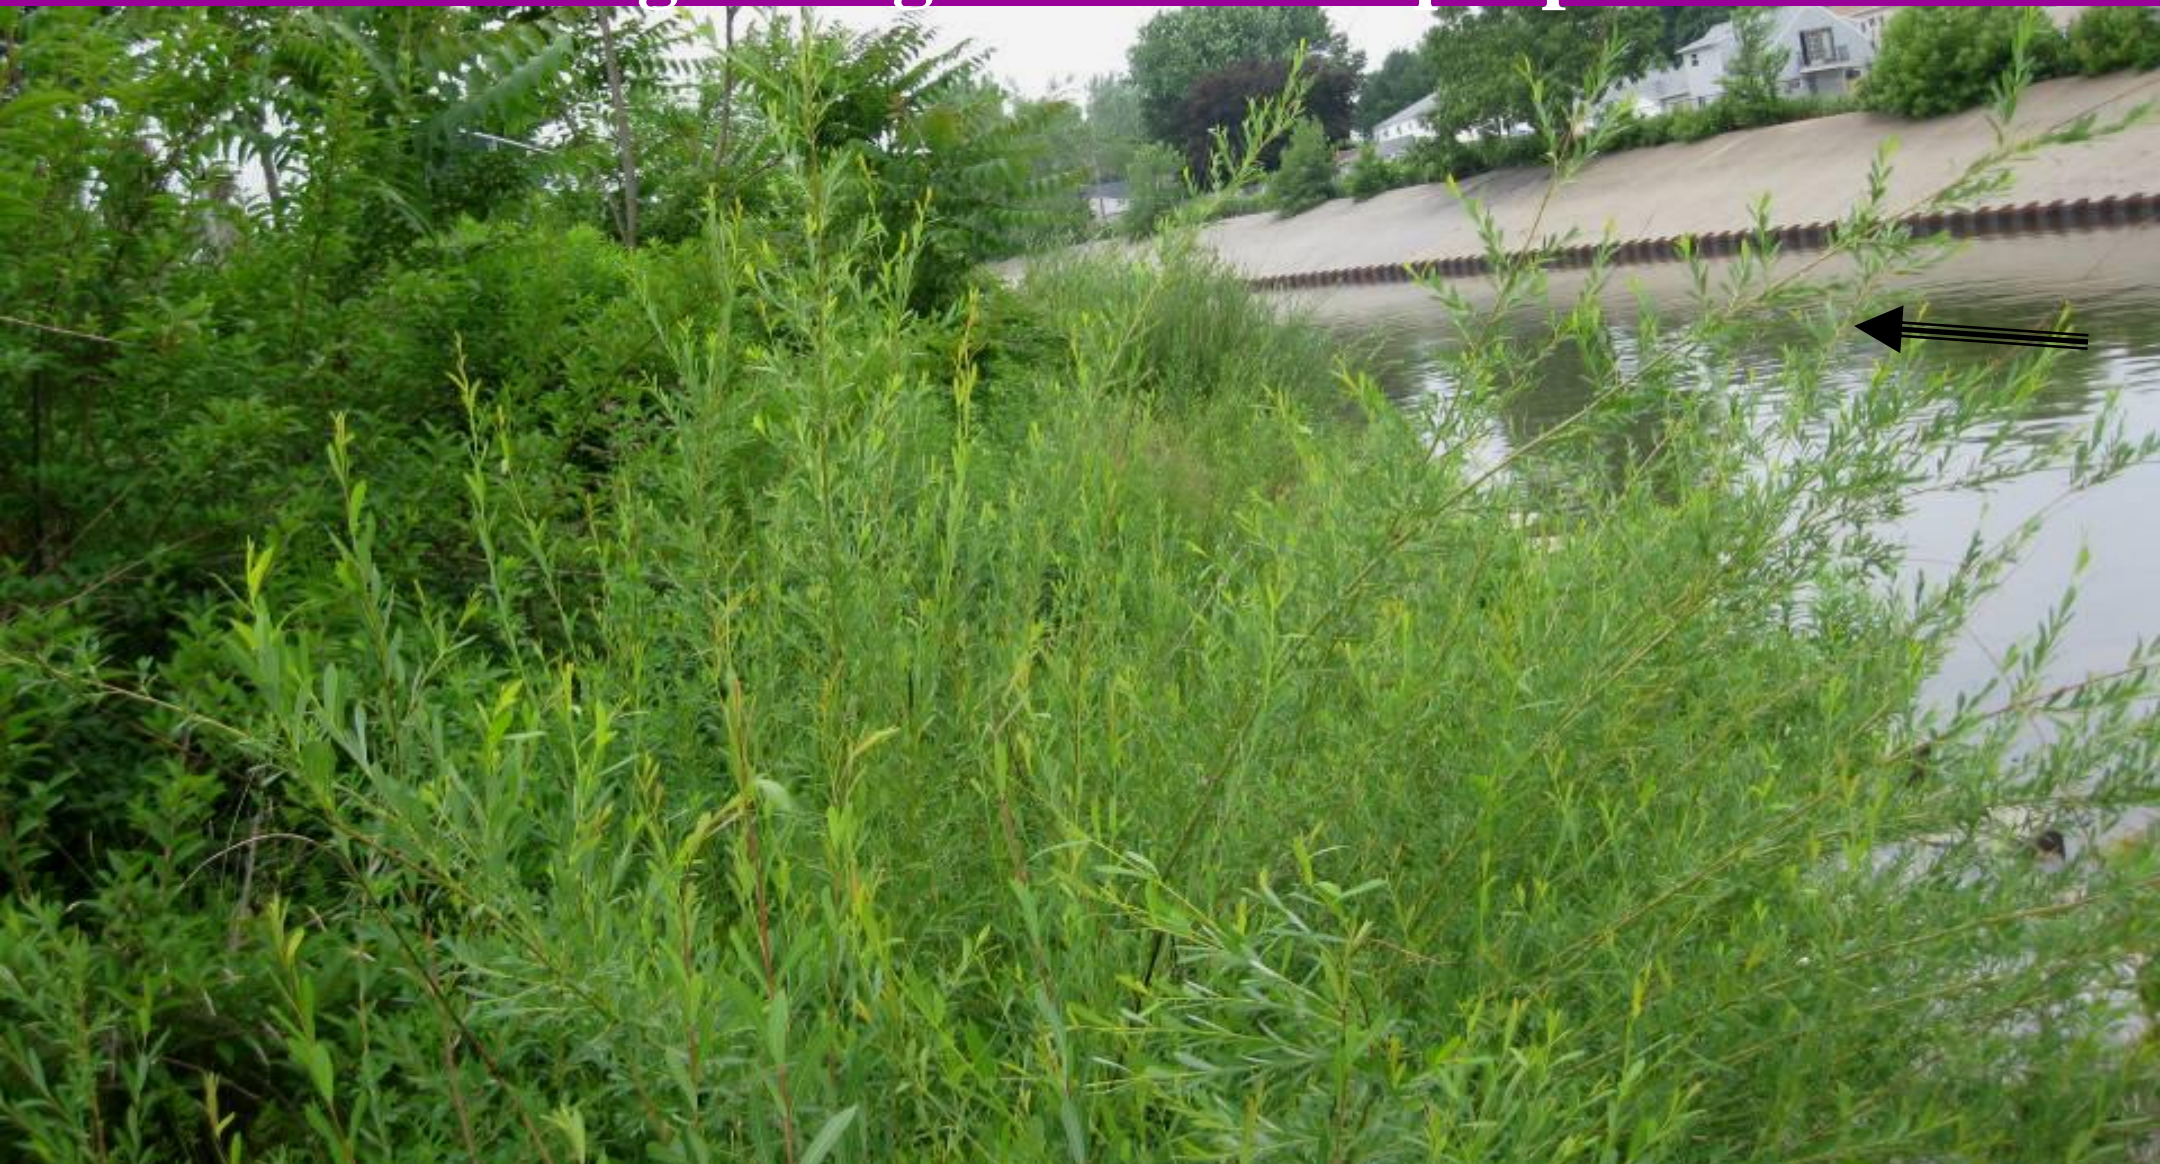
**4.66 years after completion. From the bank looking DS.
Willow is growing well in the riprap section.**

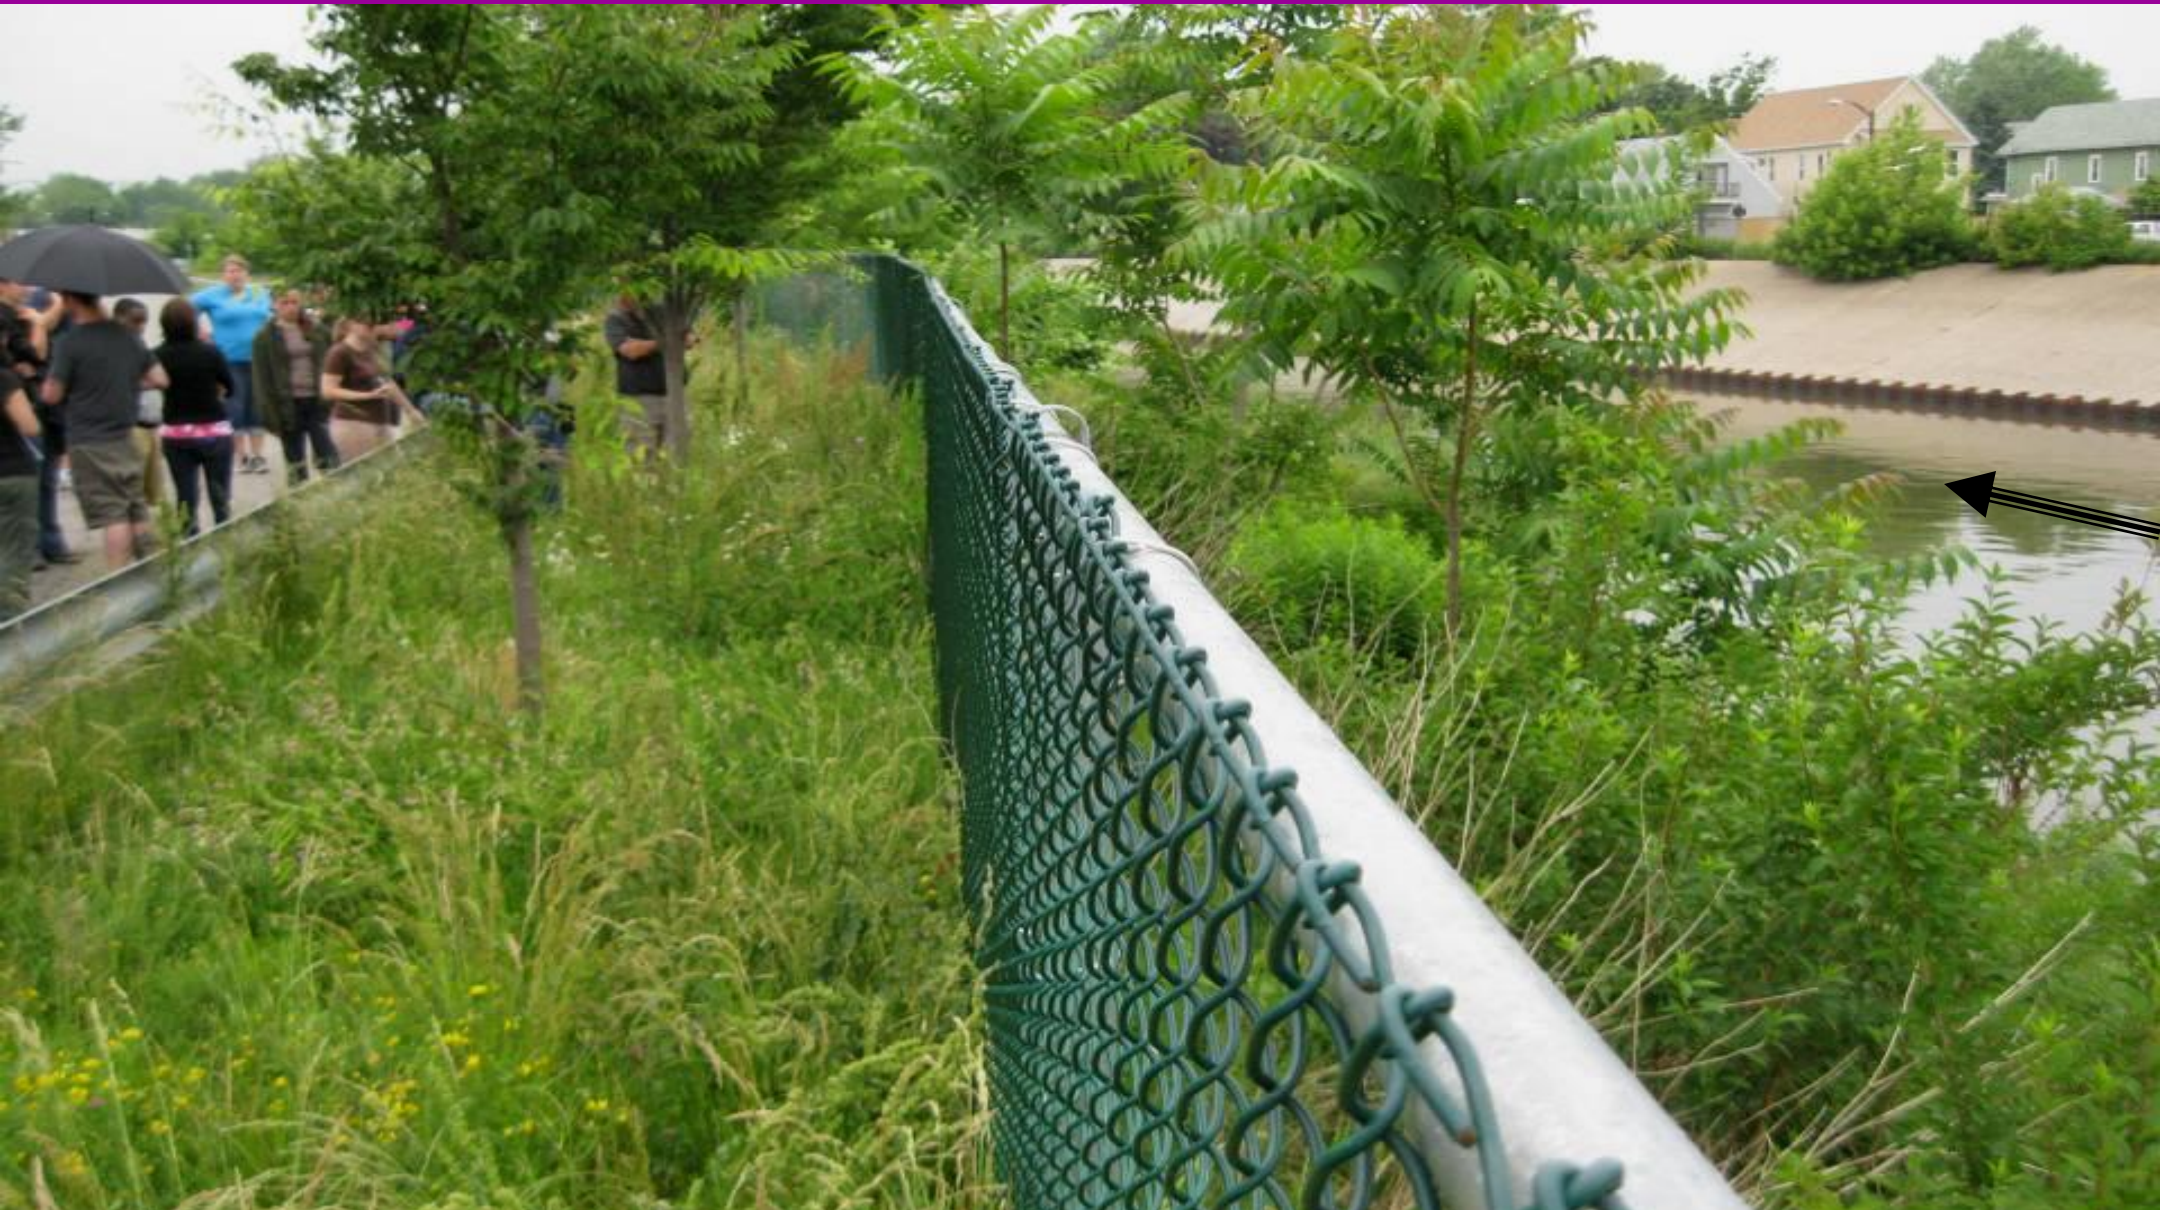
4.66 years after completion. Looking at top bank.

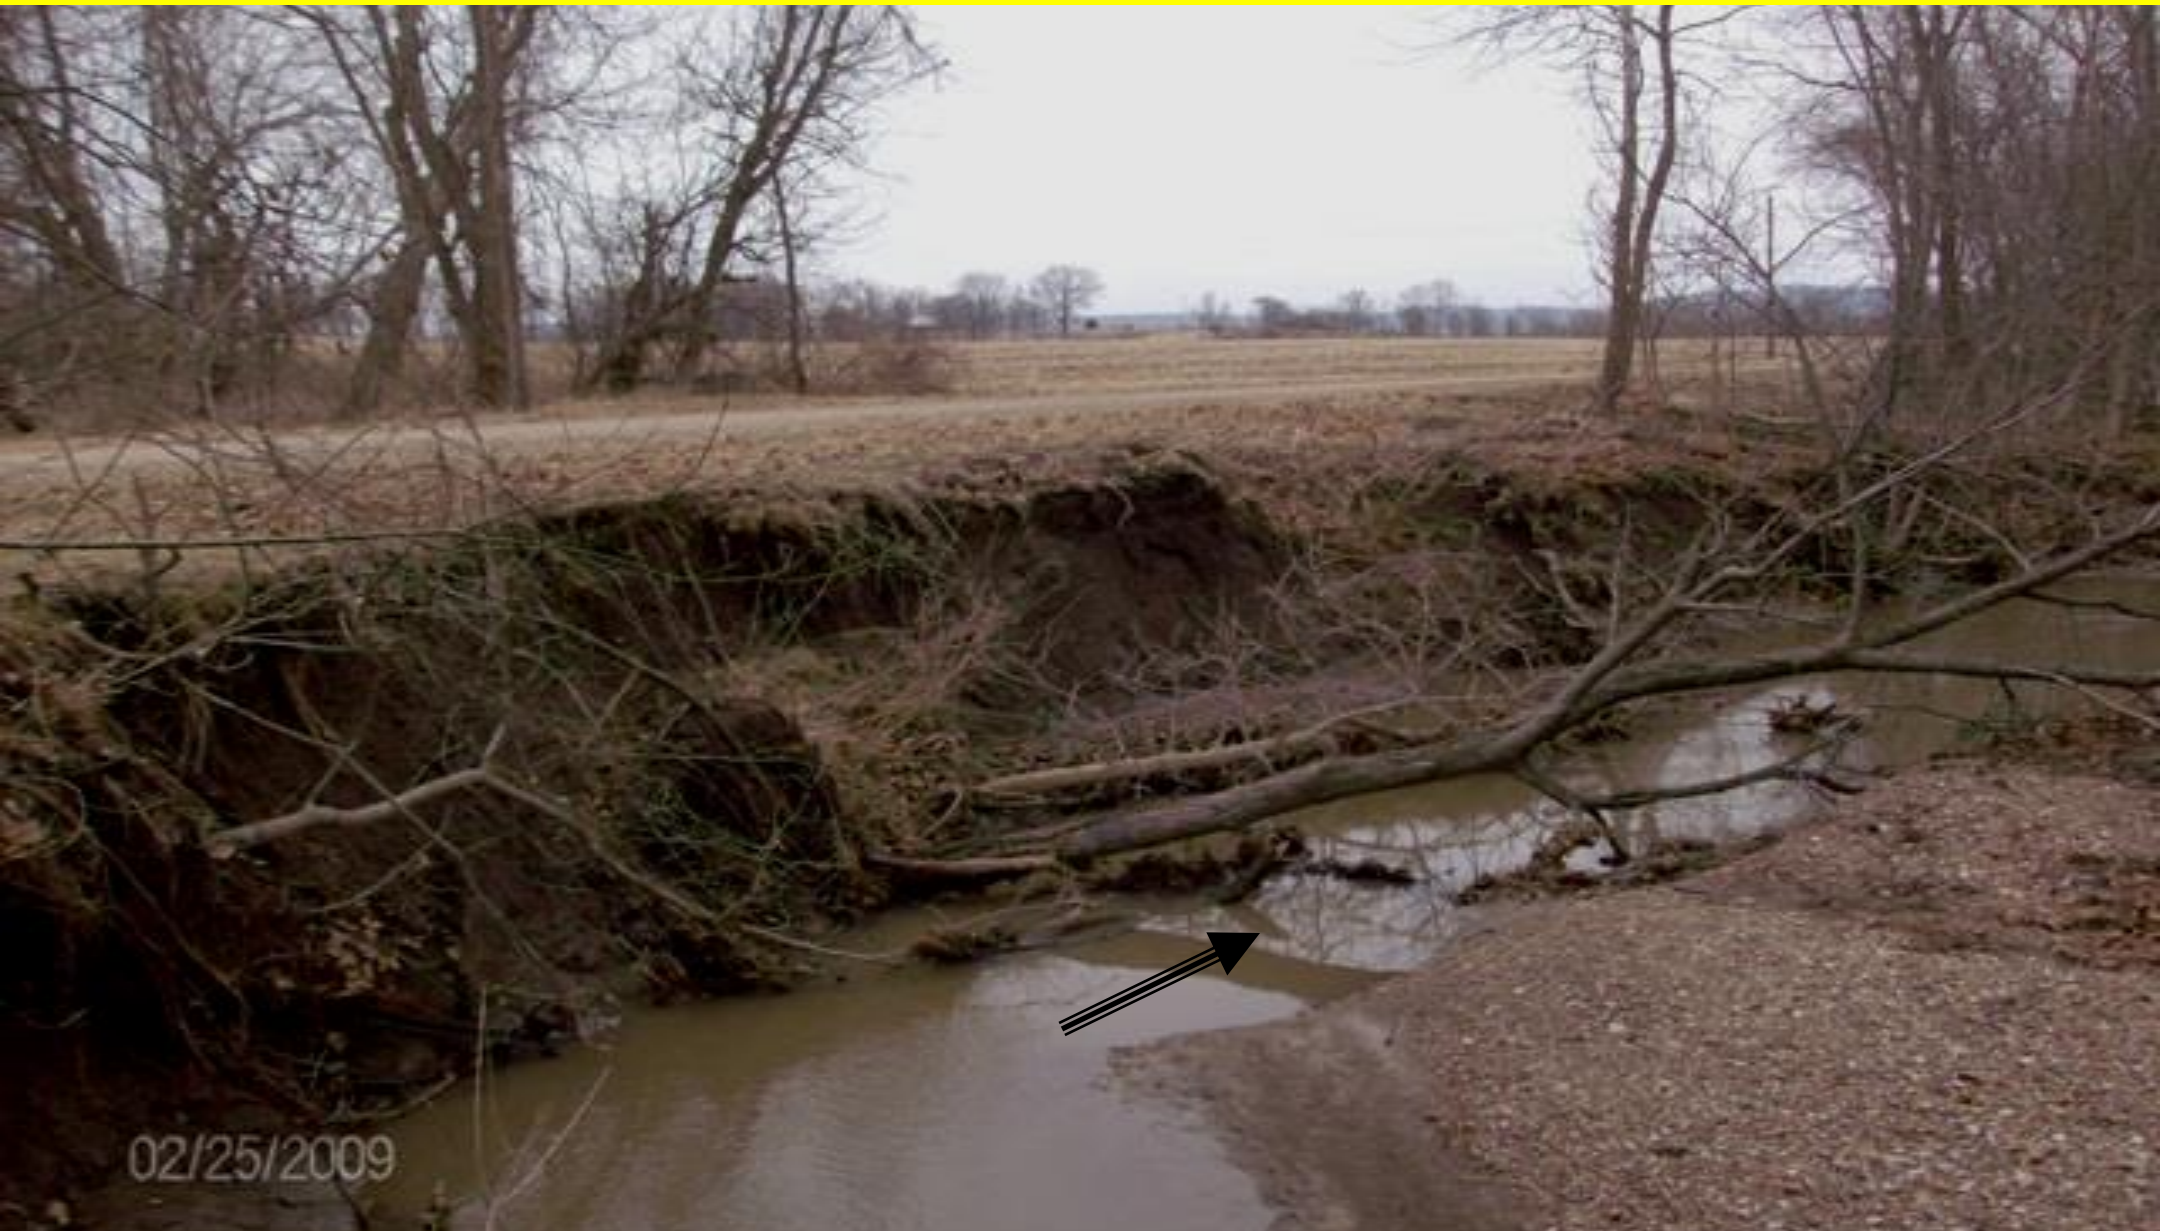
Looking DS @ the lower end of the project bend

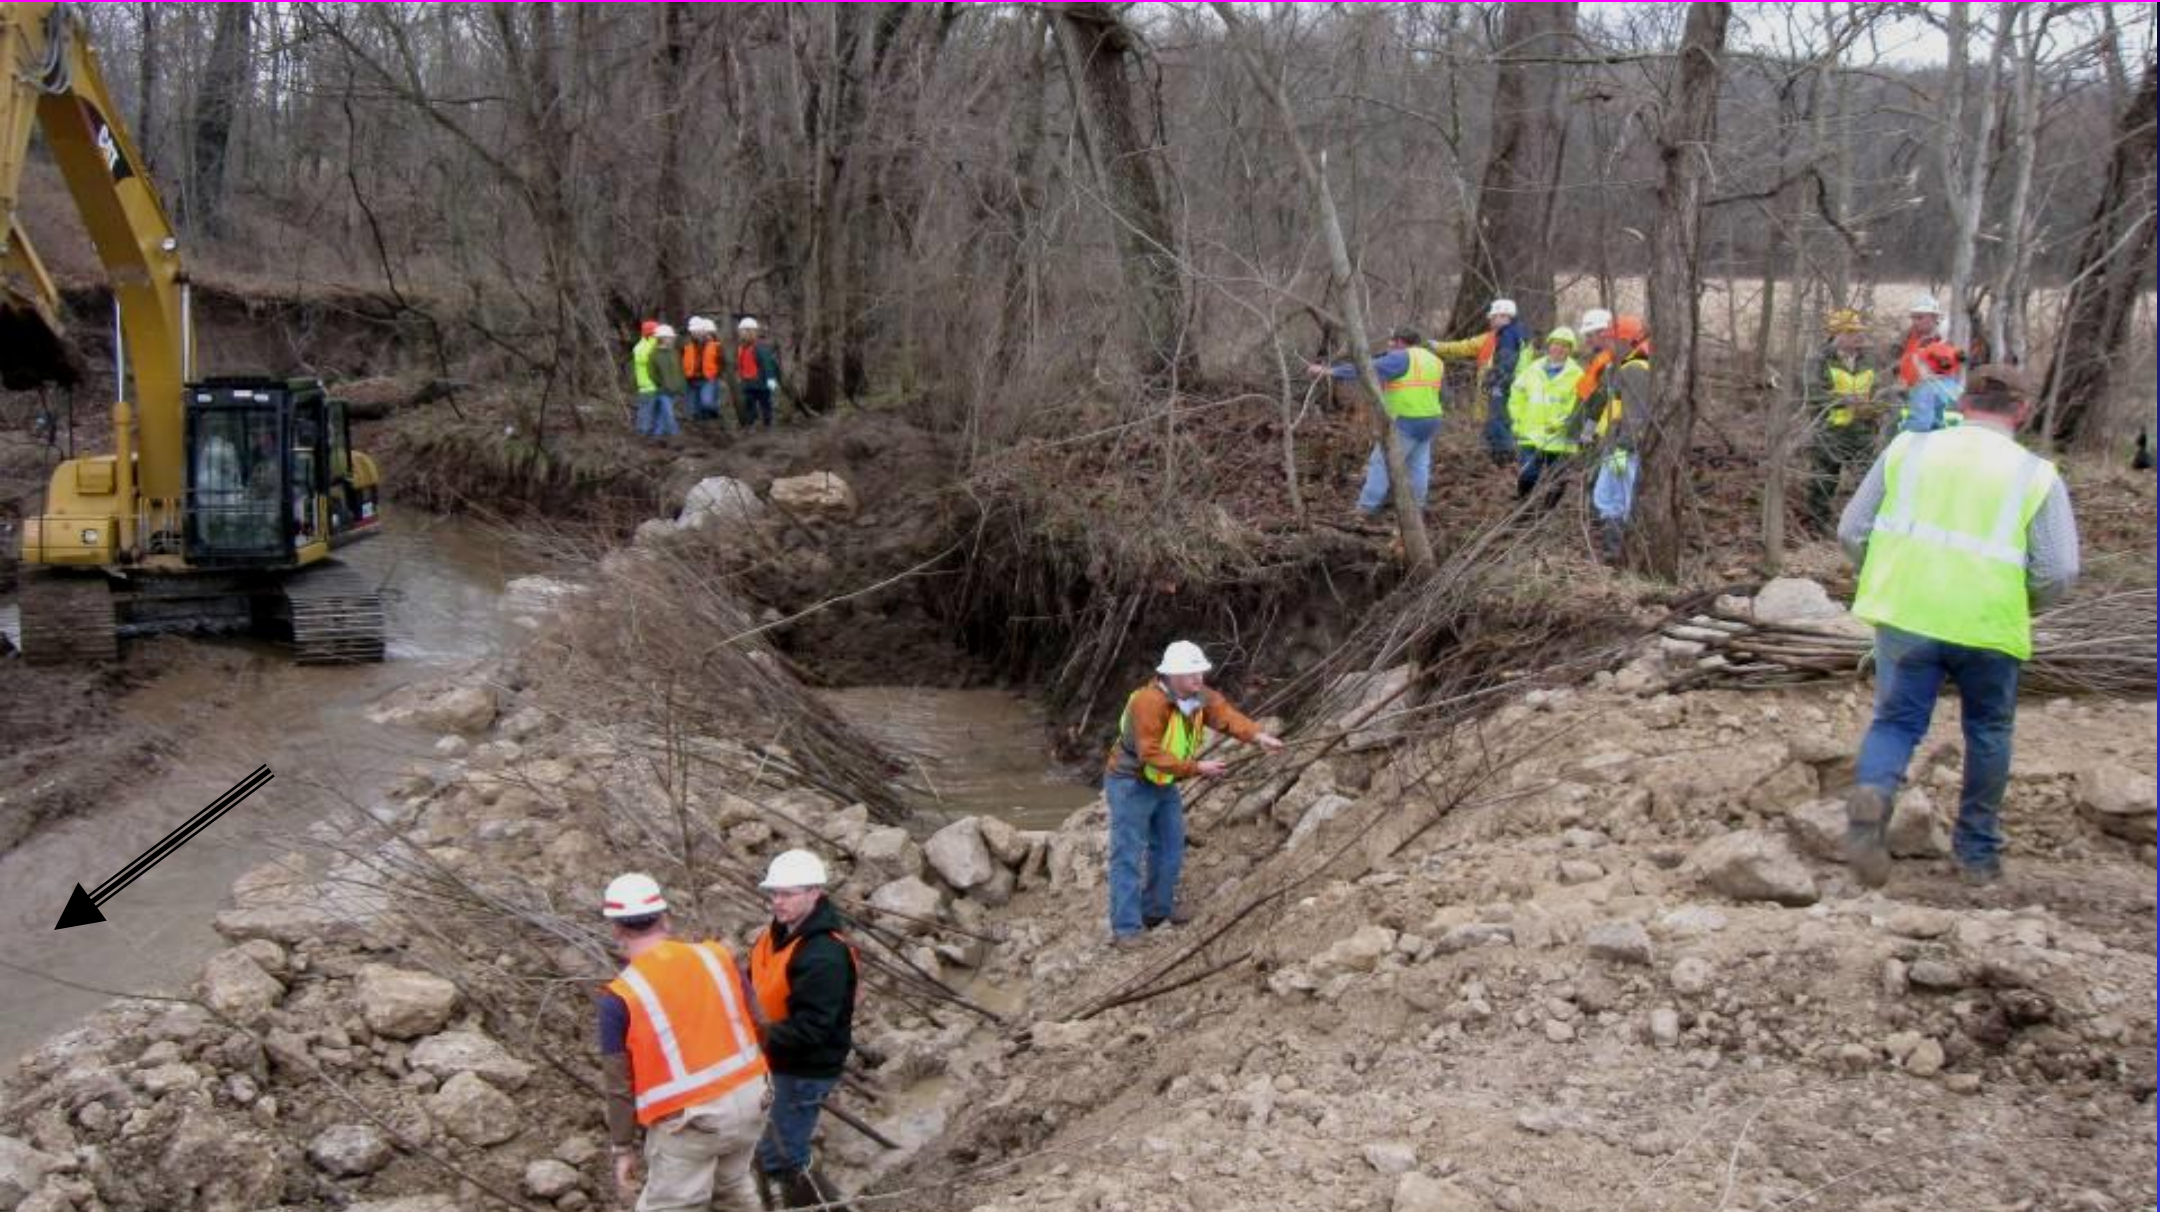
Looking US. Class laying willow poles against eroding bank.
