CAZENOVIA CR. @ STEPHENSON ST. BRIDGE

**REPLACEMENT OF ONE BANK
OF A CONCRETE-LINED
CHANNEL**

**HAW CREEK, PIKE COUNTY, MISSOURI-
TRIB TO SALT RIVER**

GOODWIN CREEK, MS.

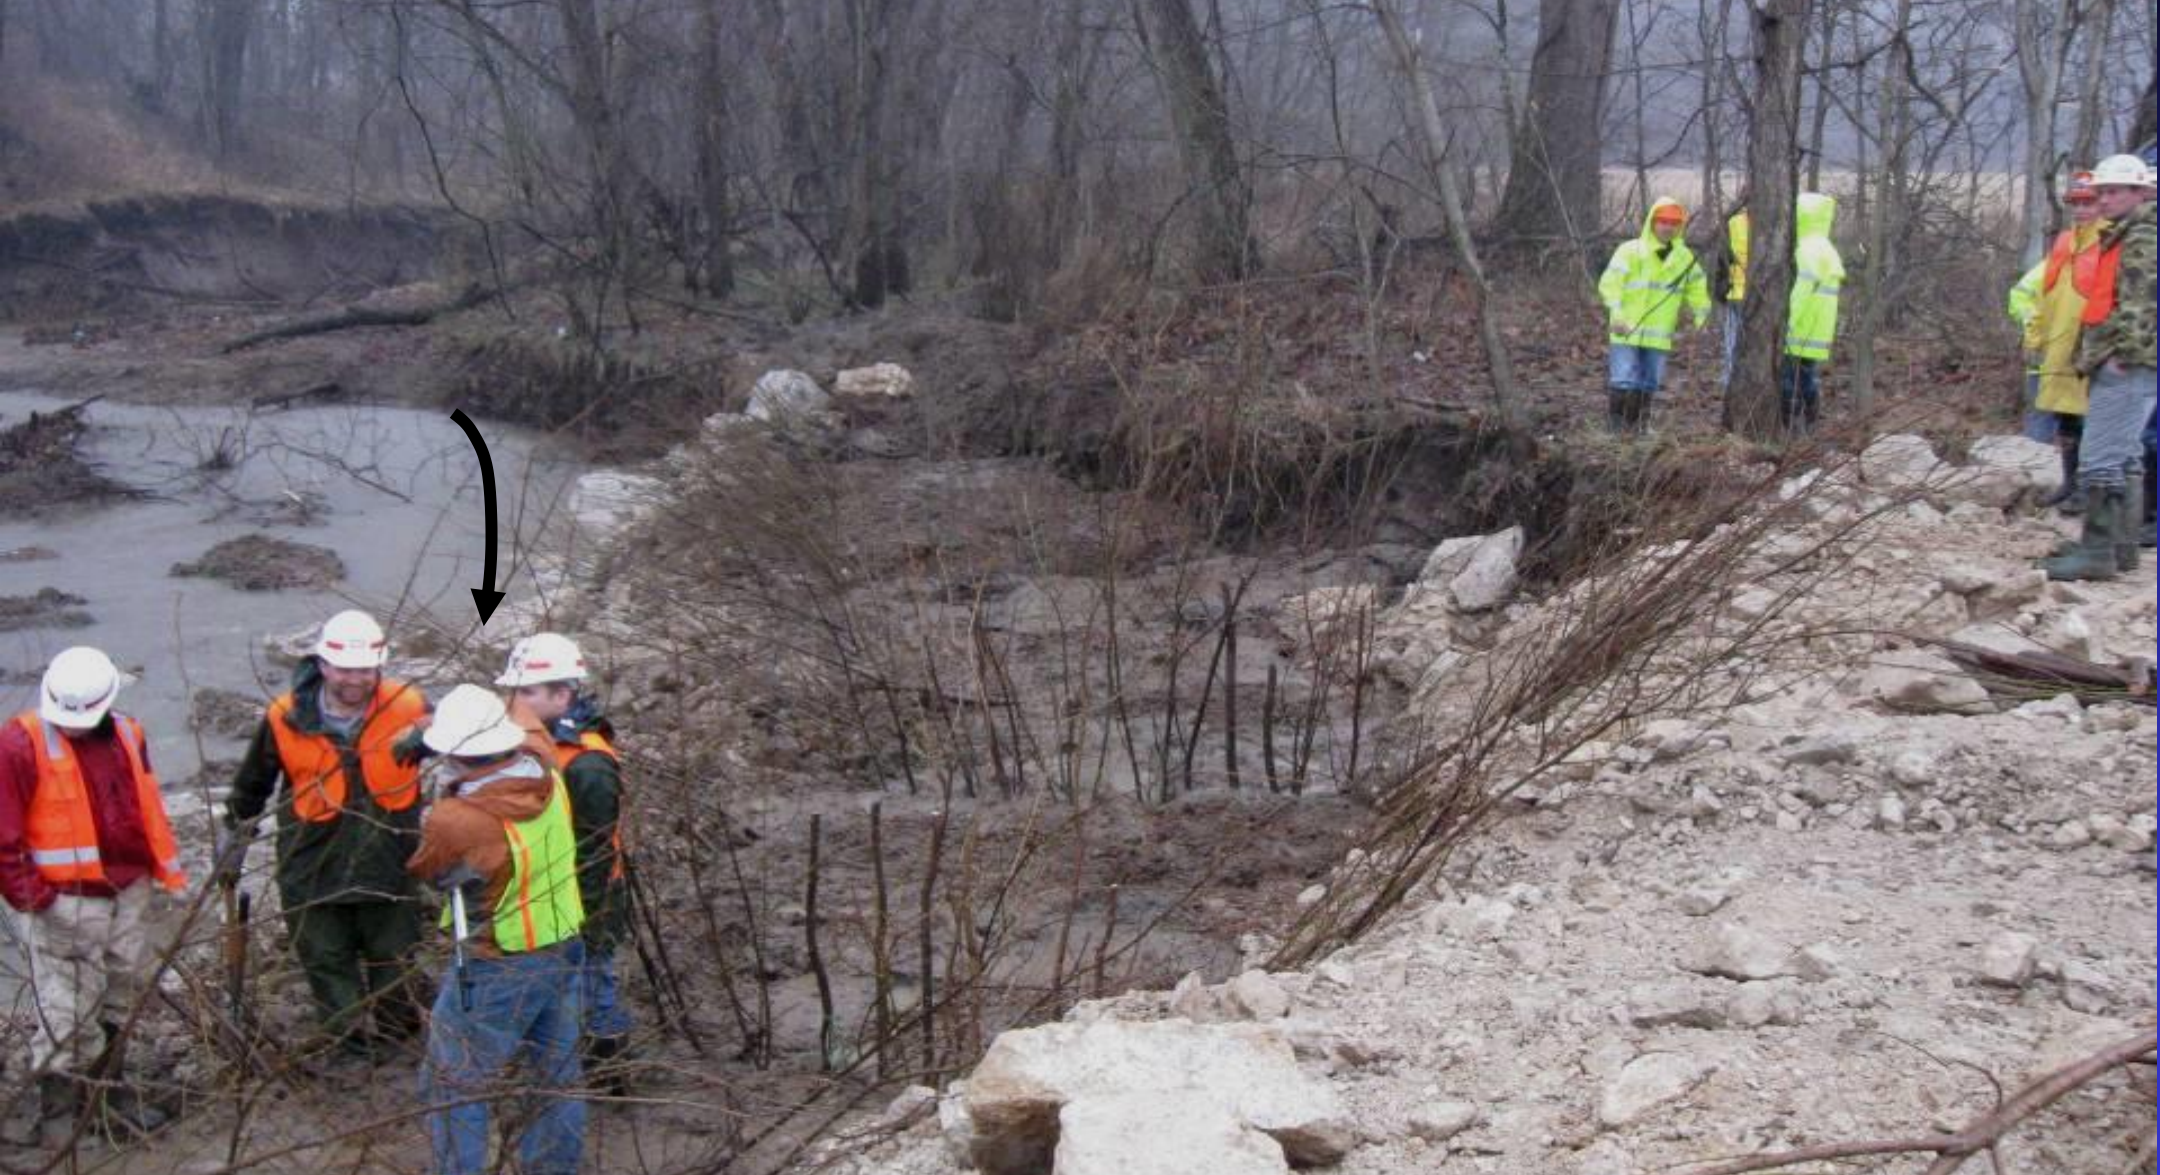
**Looking US. Installing Living Dikes perpendicular to high flow,
Live Siltation & Live Poles are parallel with the stream.**

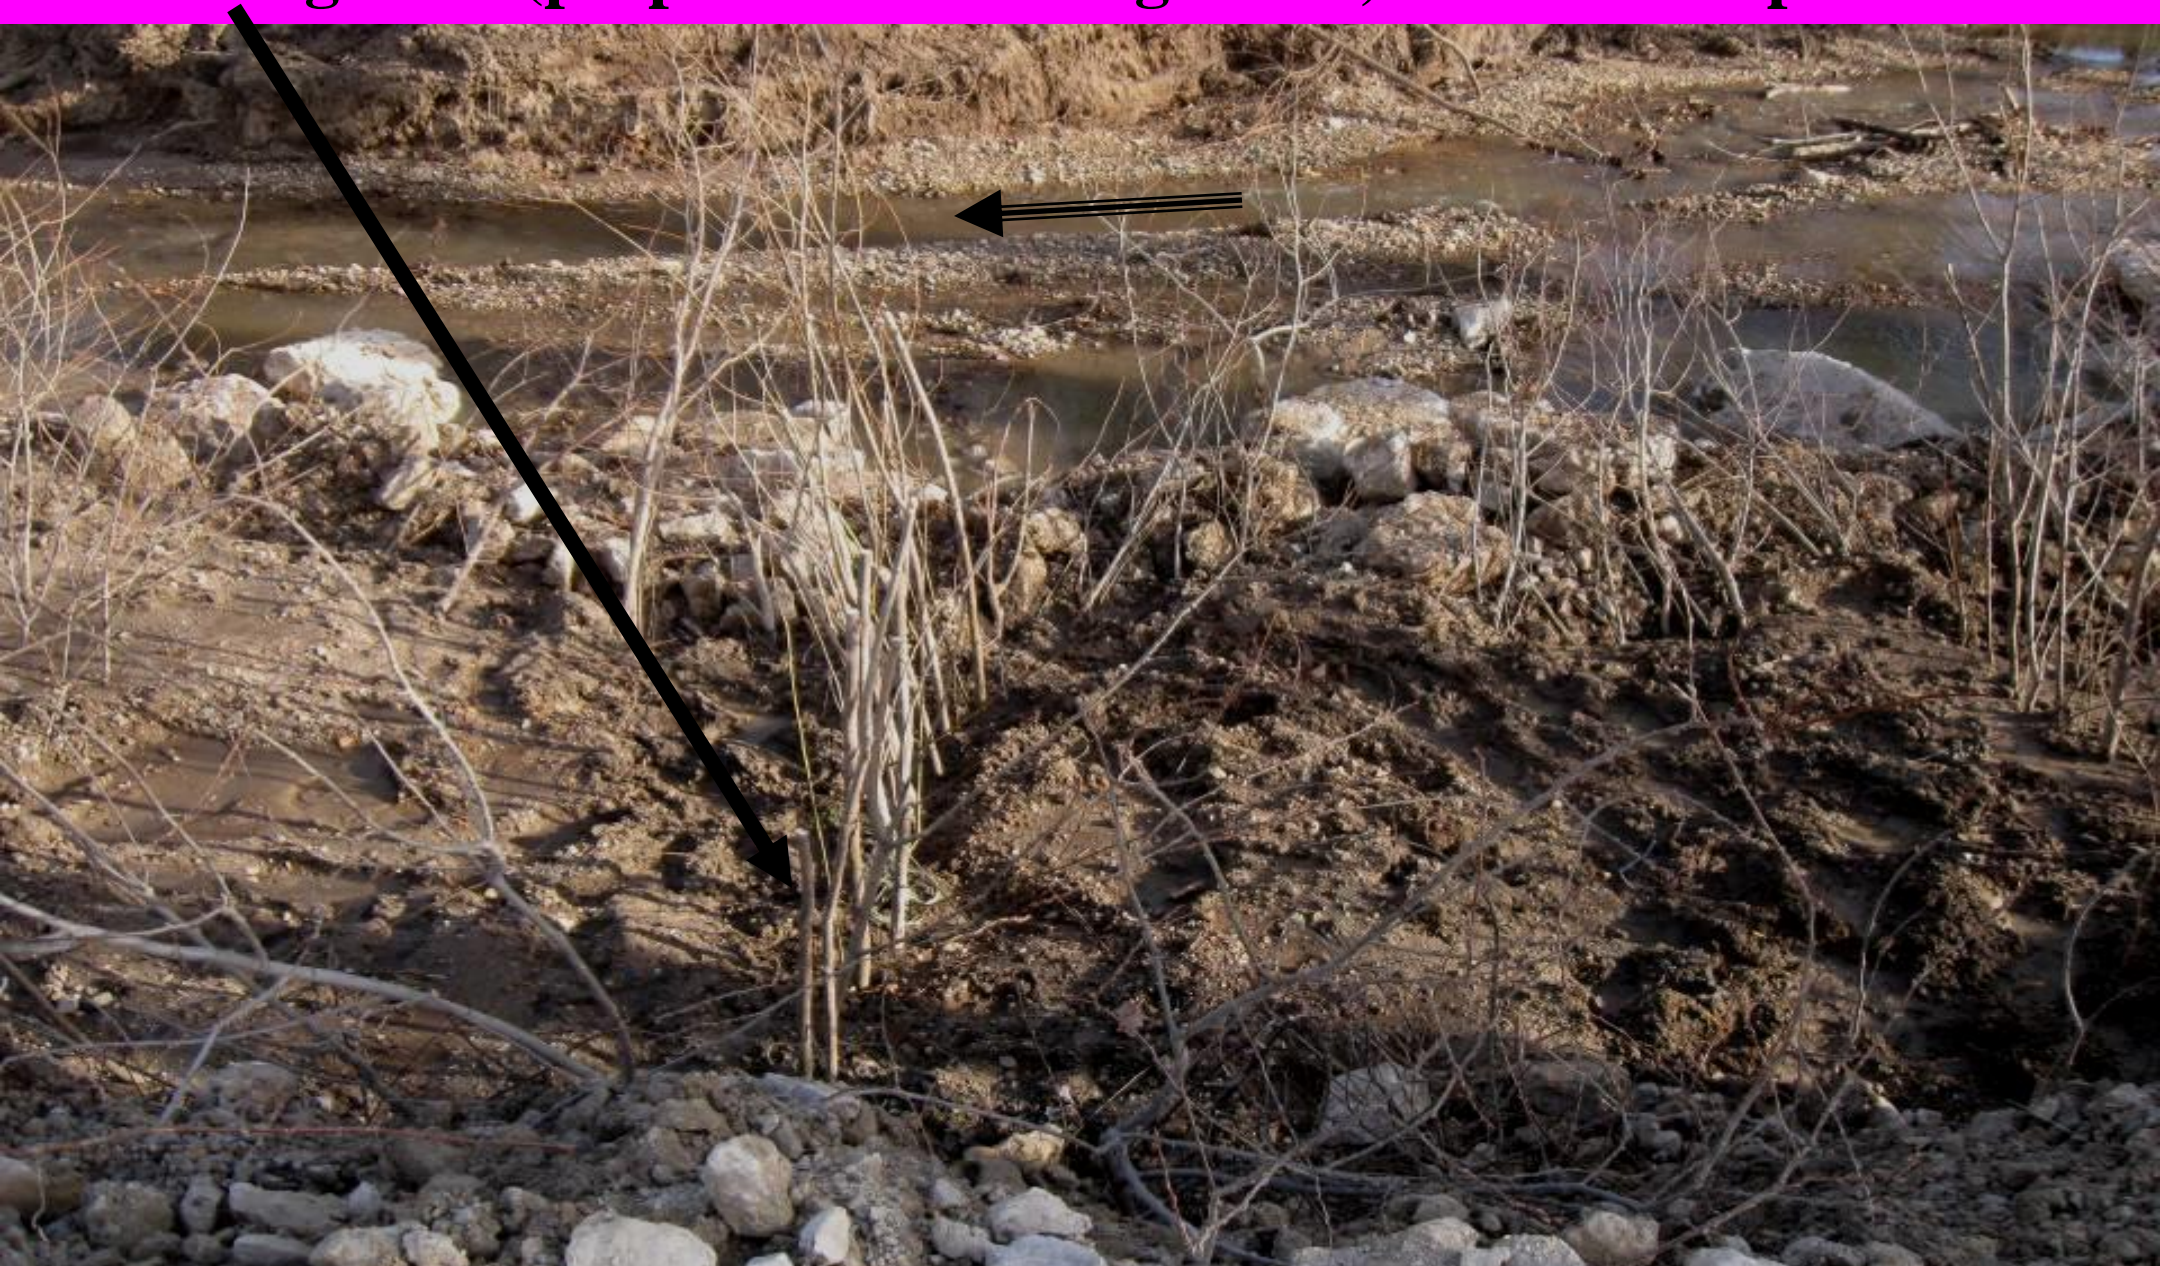
A Living Dike (perpendicular to high flow) on the floodplain bench.

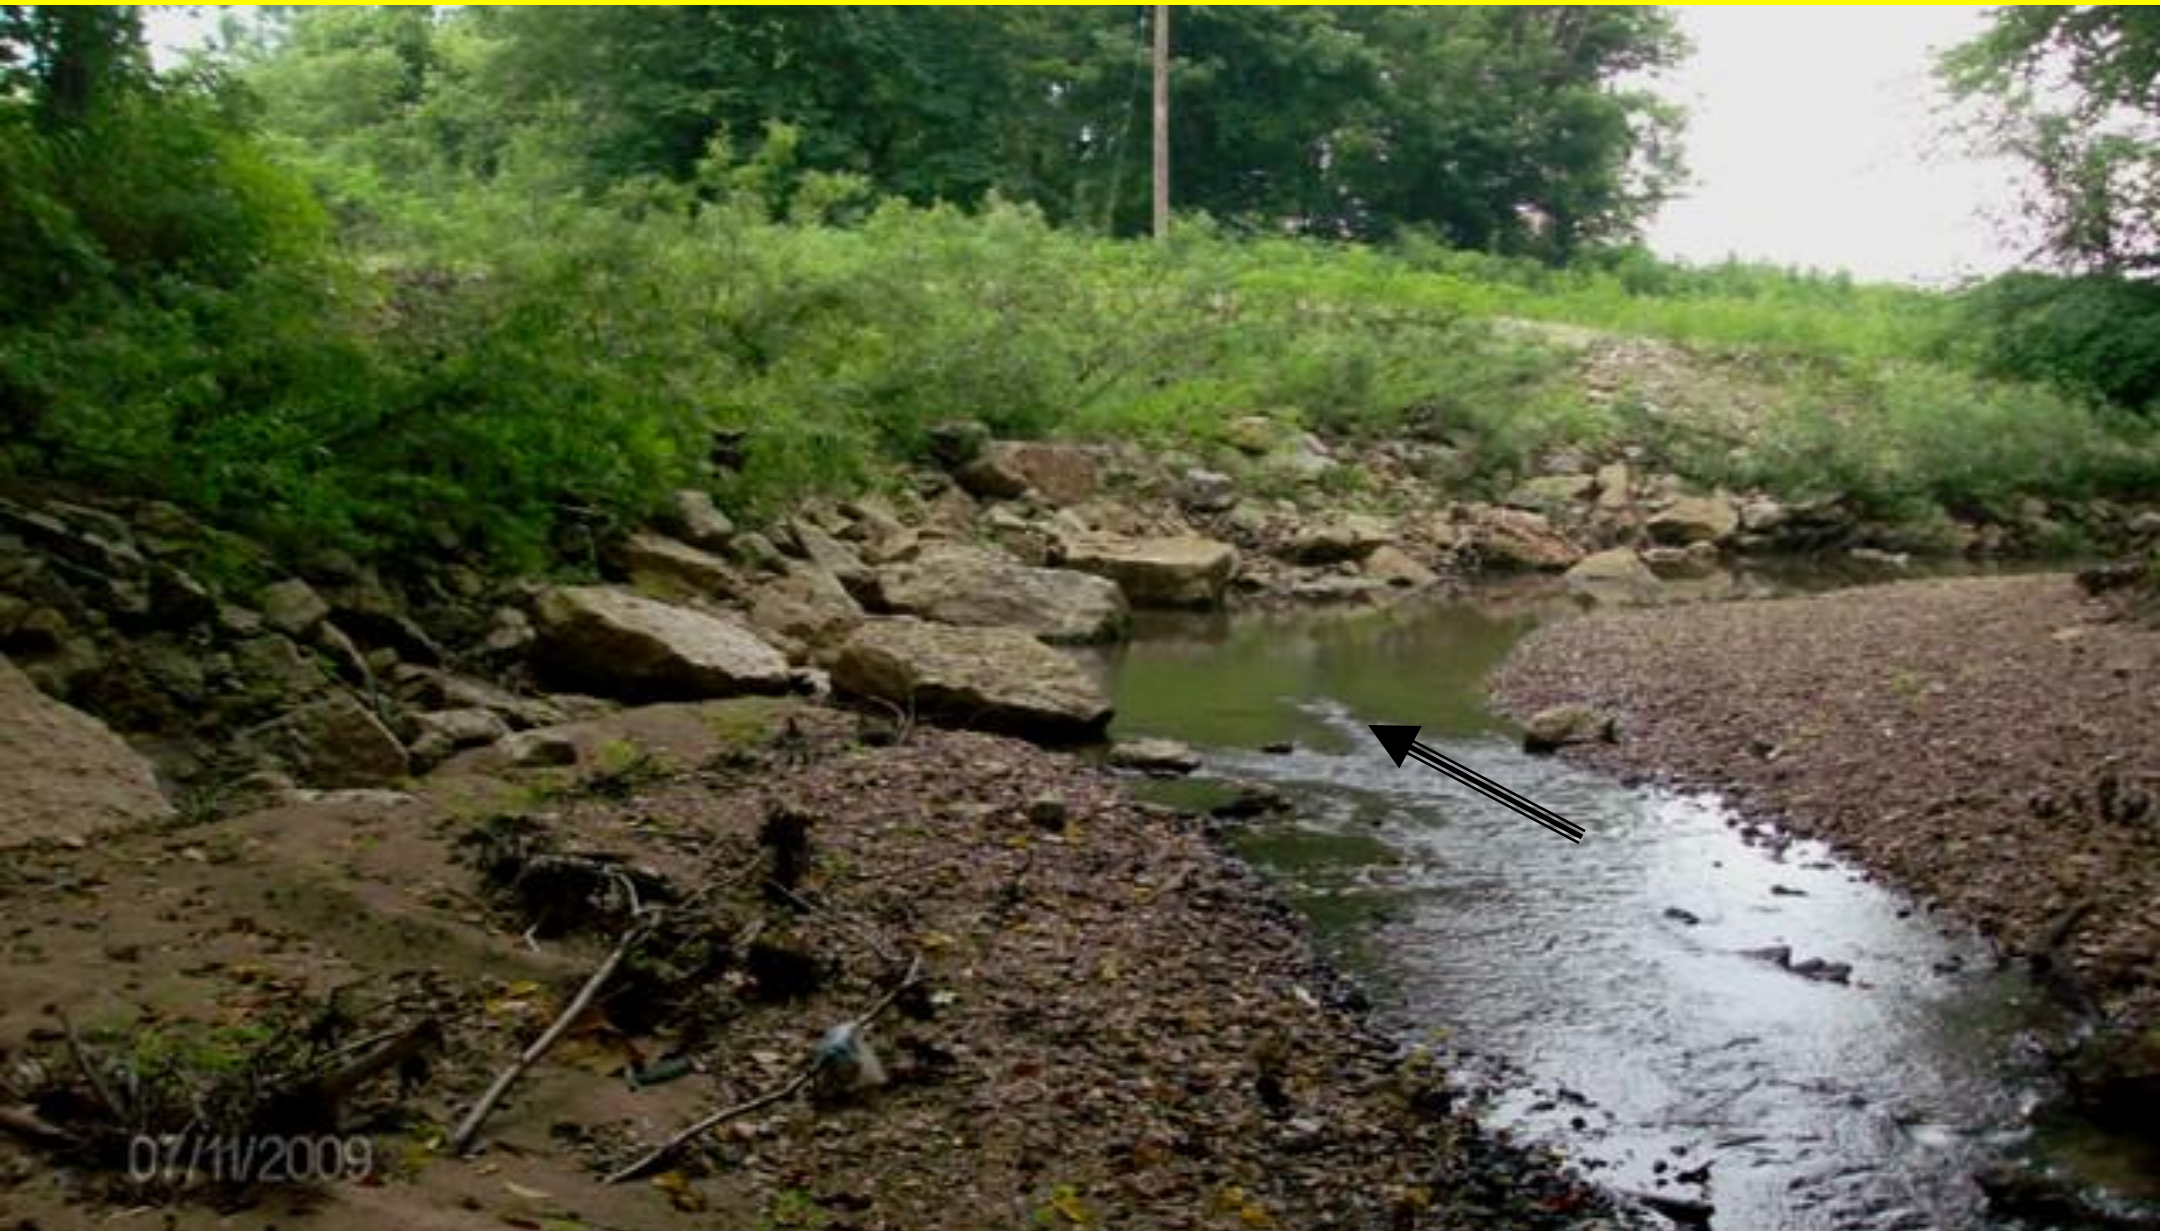
4 MONTHS LATER-Looking DS @ the project bend.

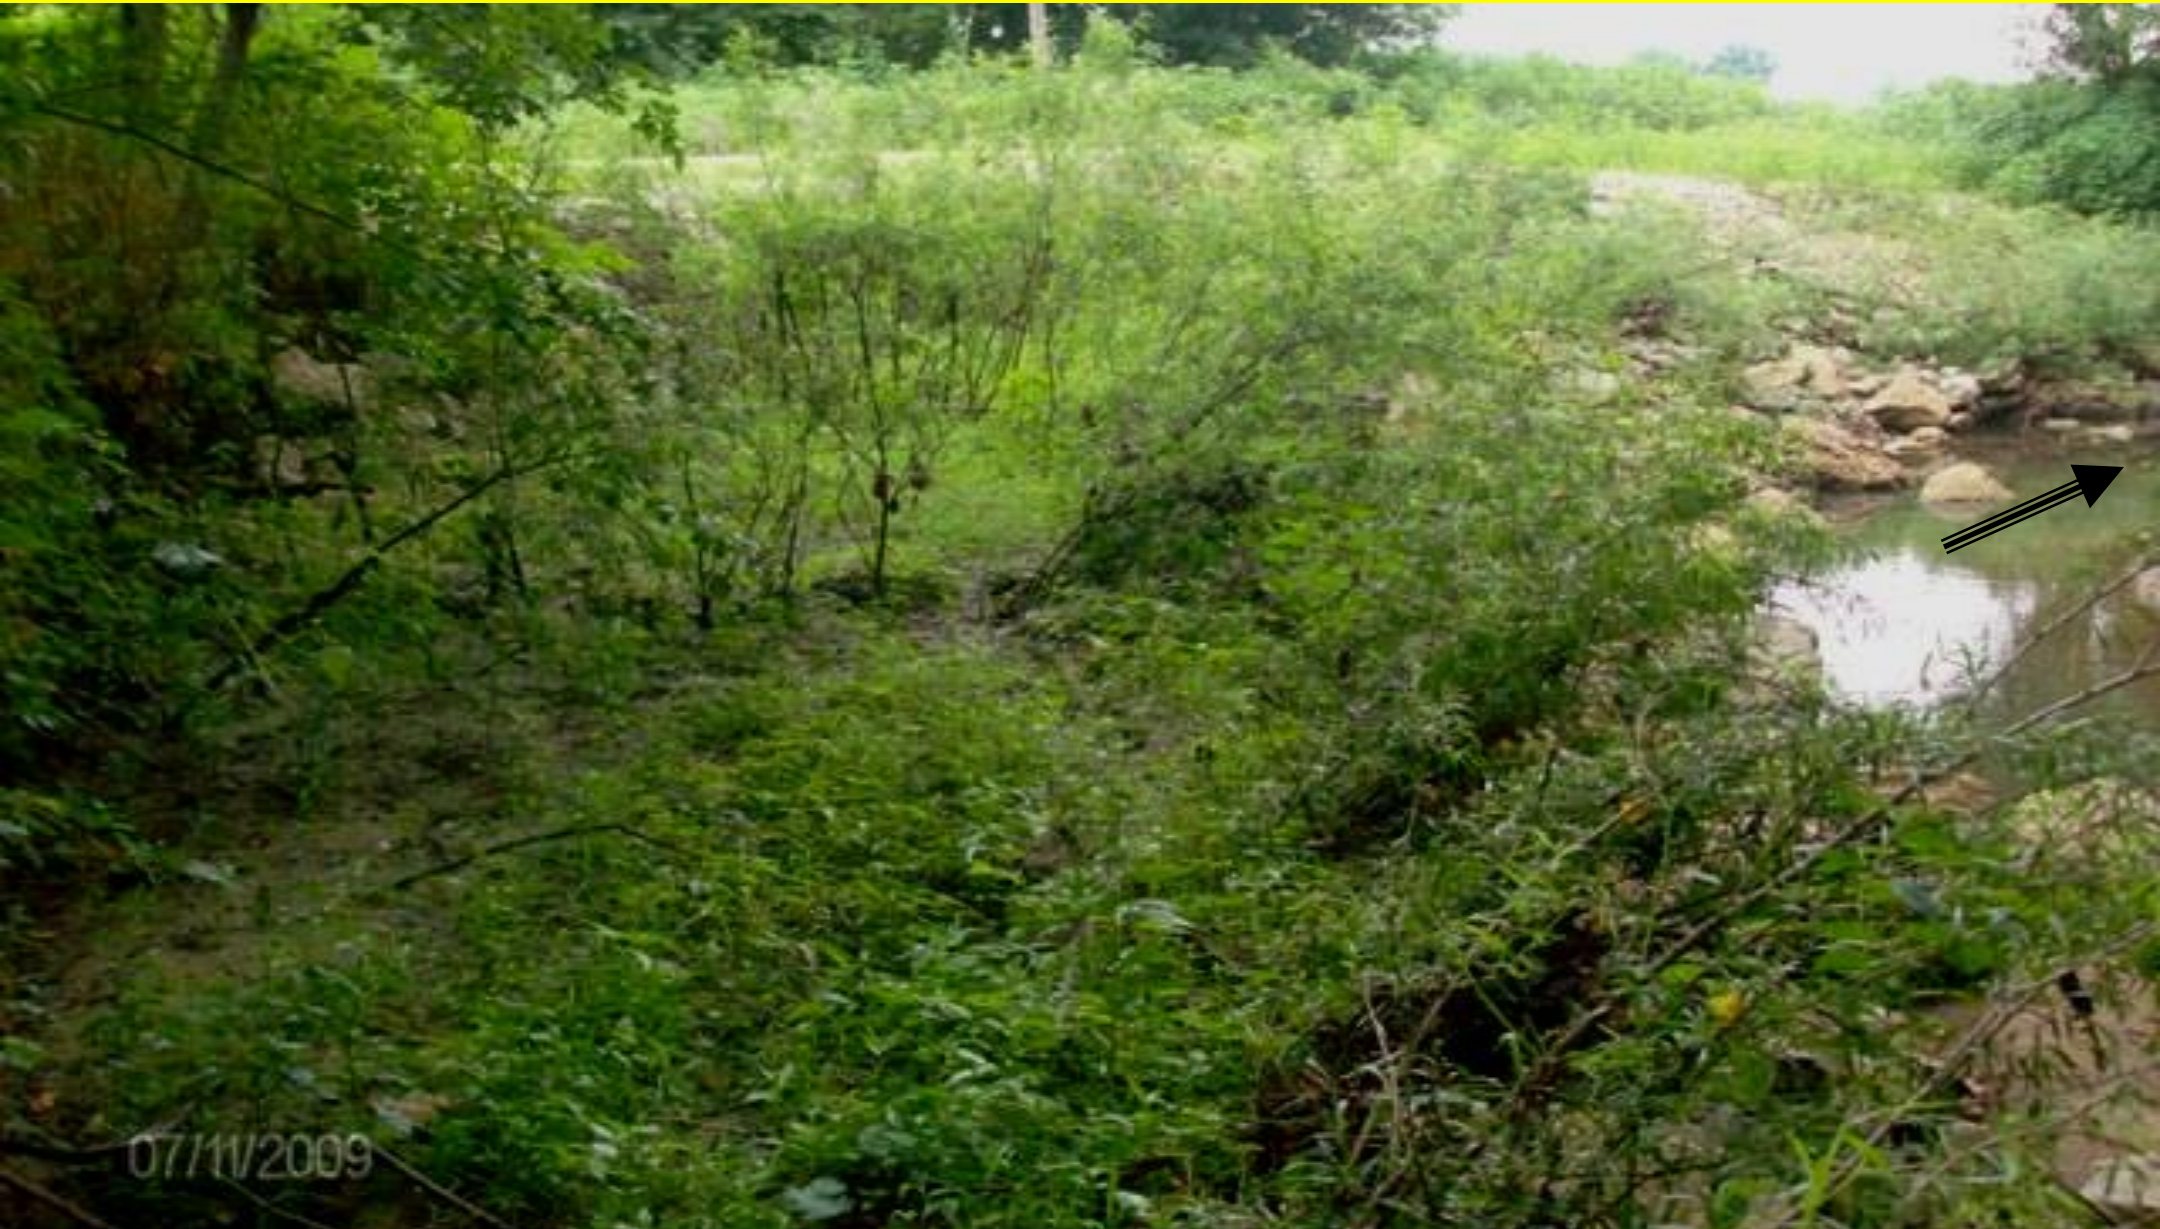
4 MONTHS LATER-Looking DS @ floodplain bench

**After 4 months, great growth
from the 500 willows we
planted! LaDon says the
floodplain bench has about
6 inches of sediment
deposition on it.**

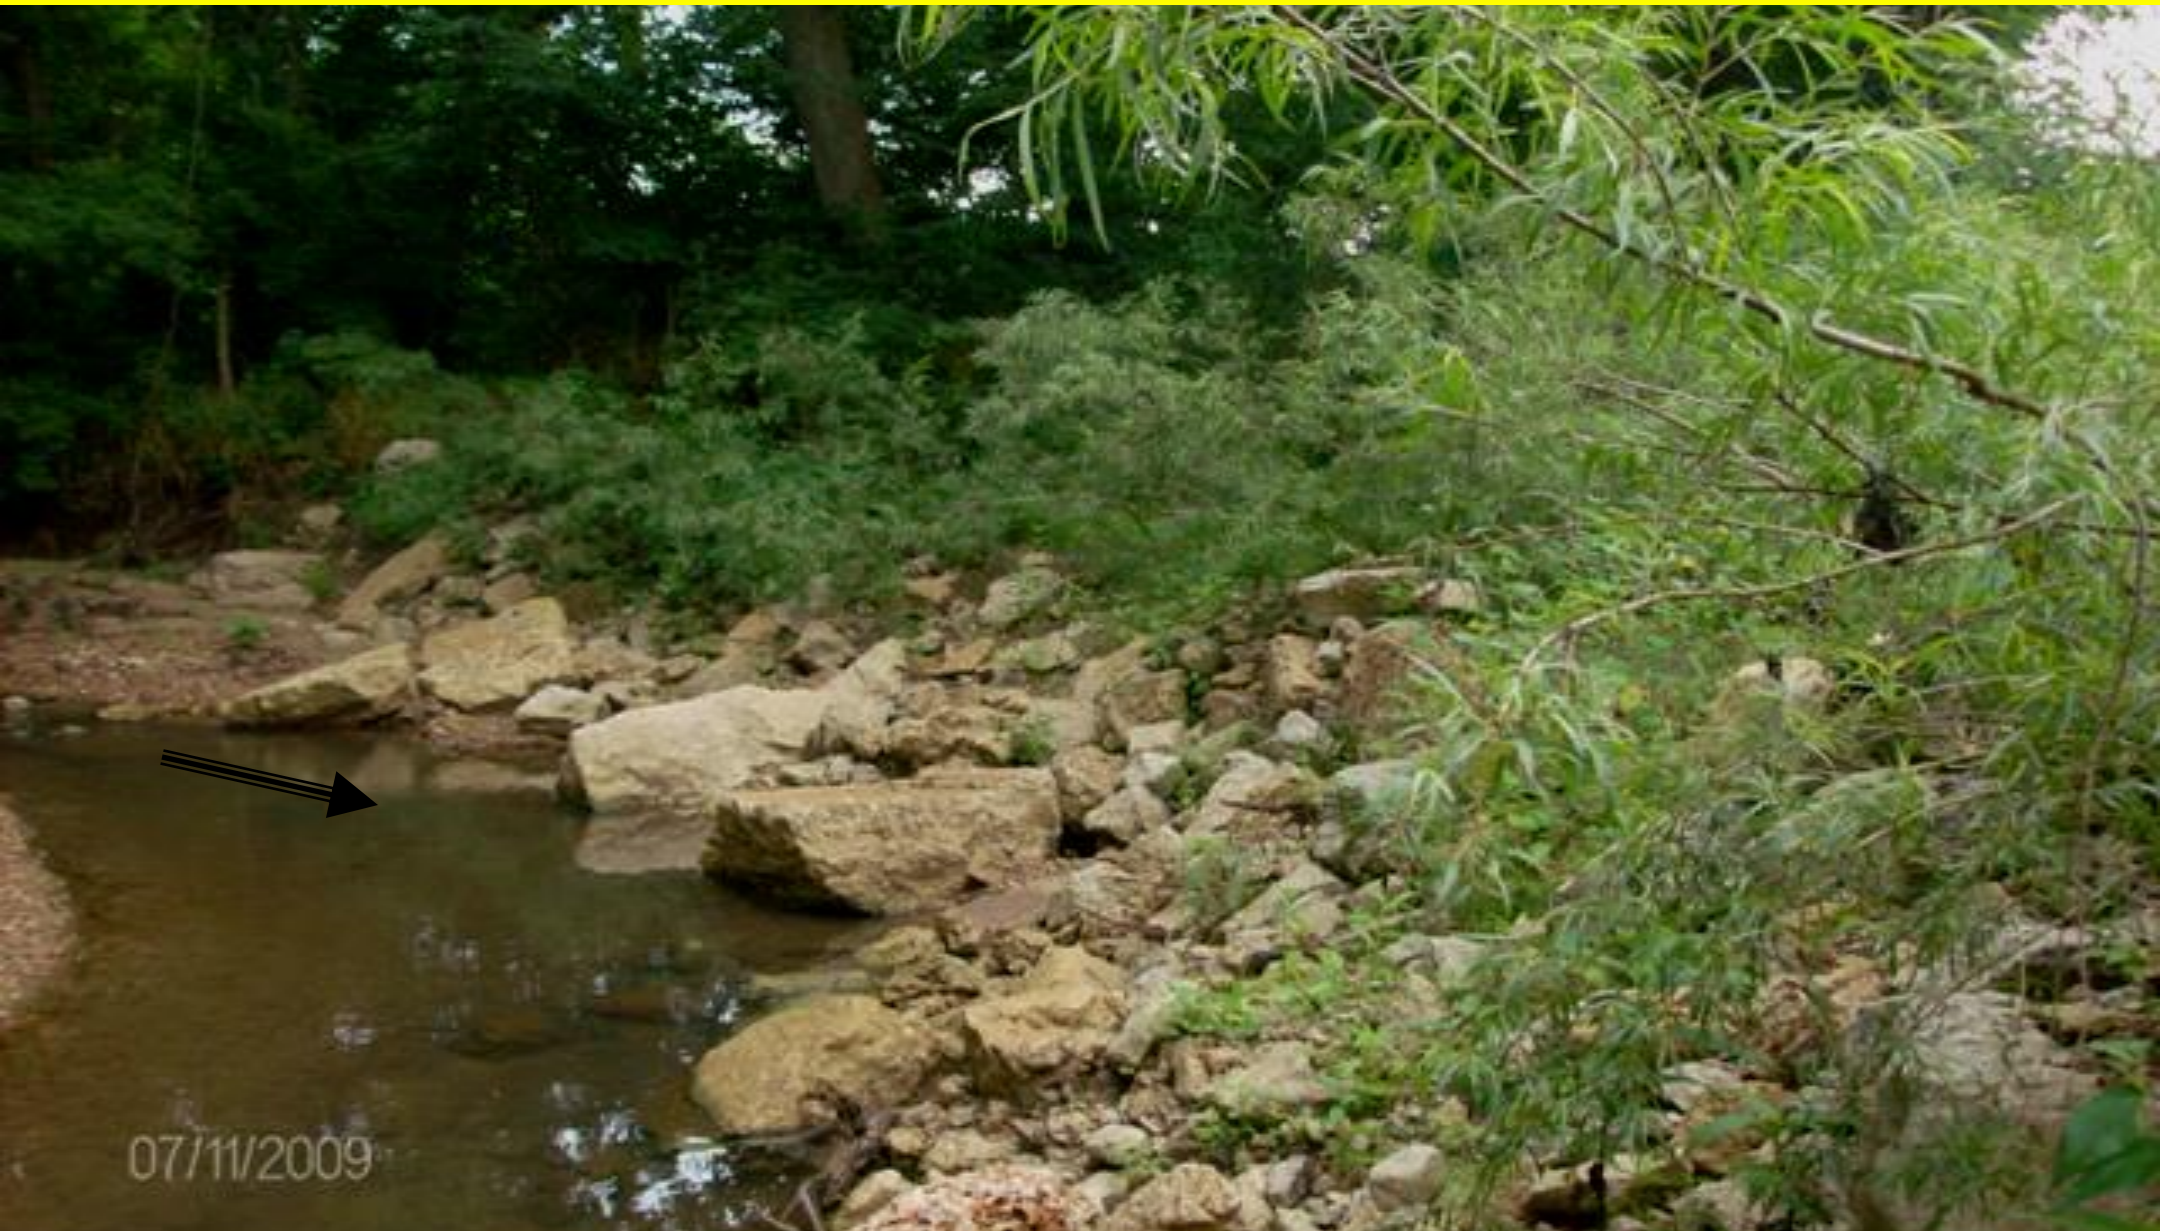
4 MONTHS LATER-Looking US @ SSBW, LPSTP & Live Siltation

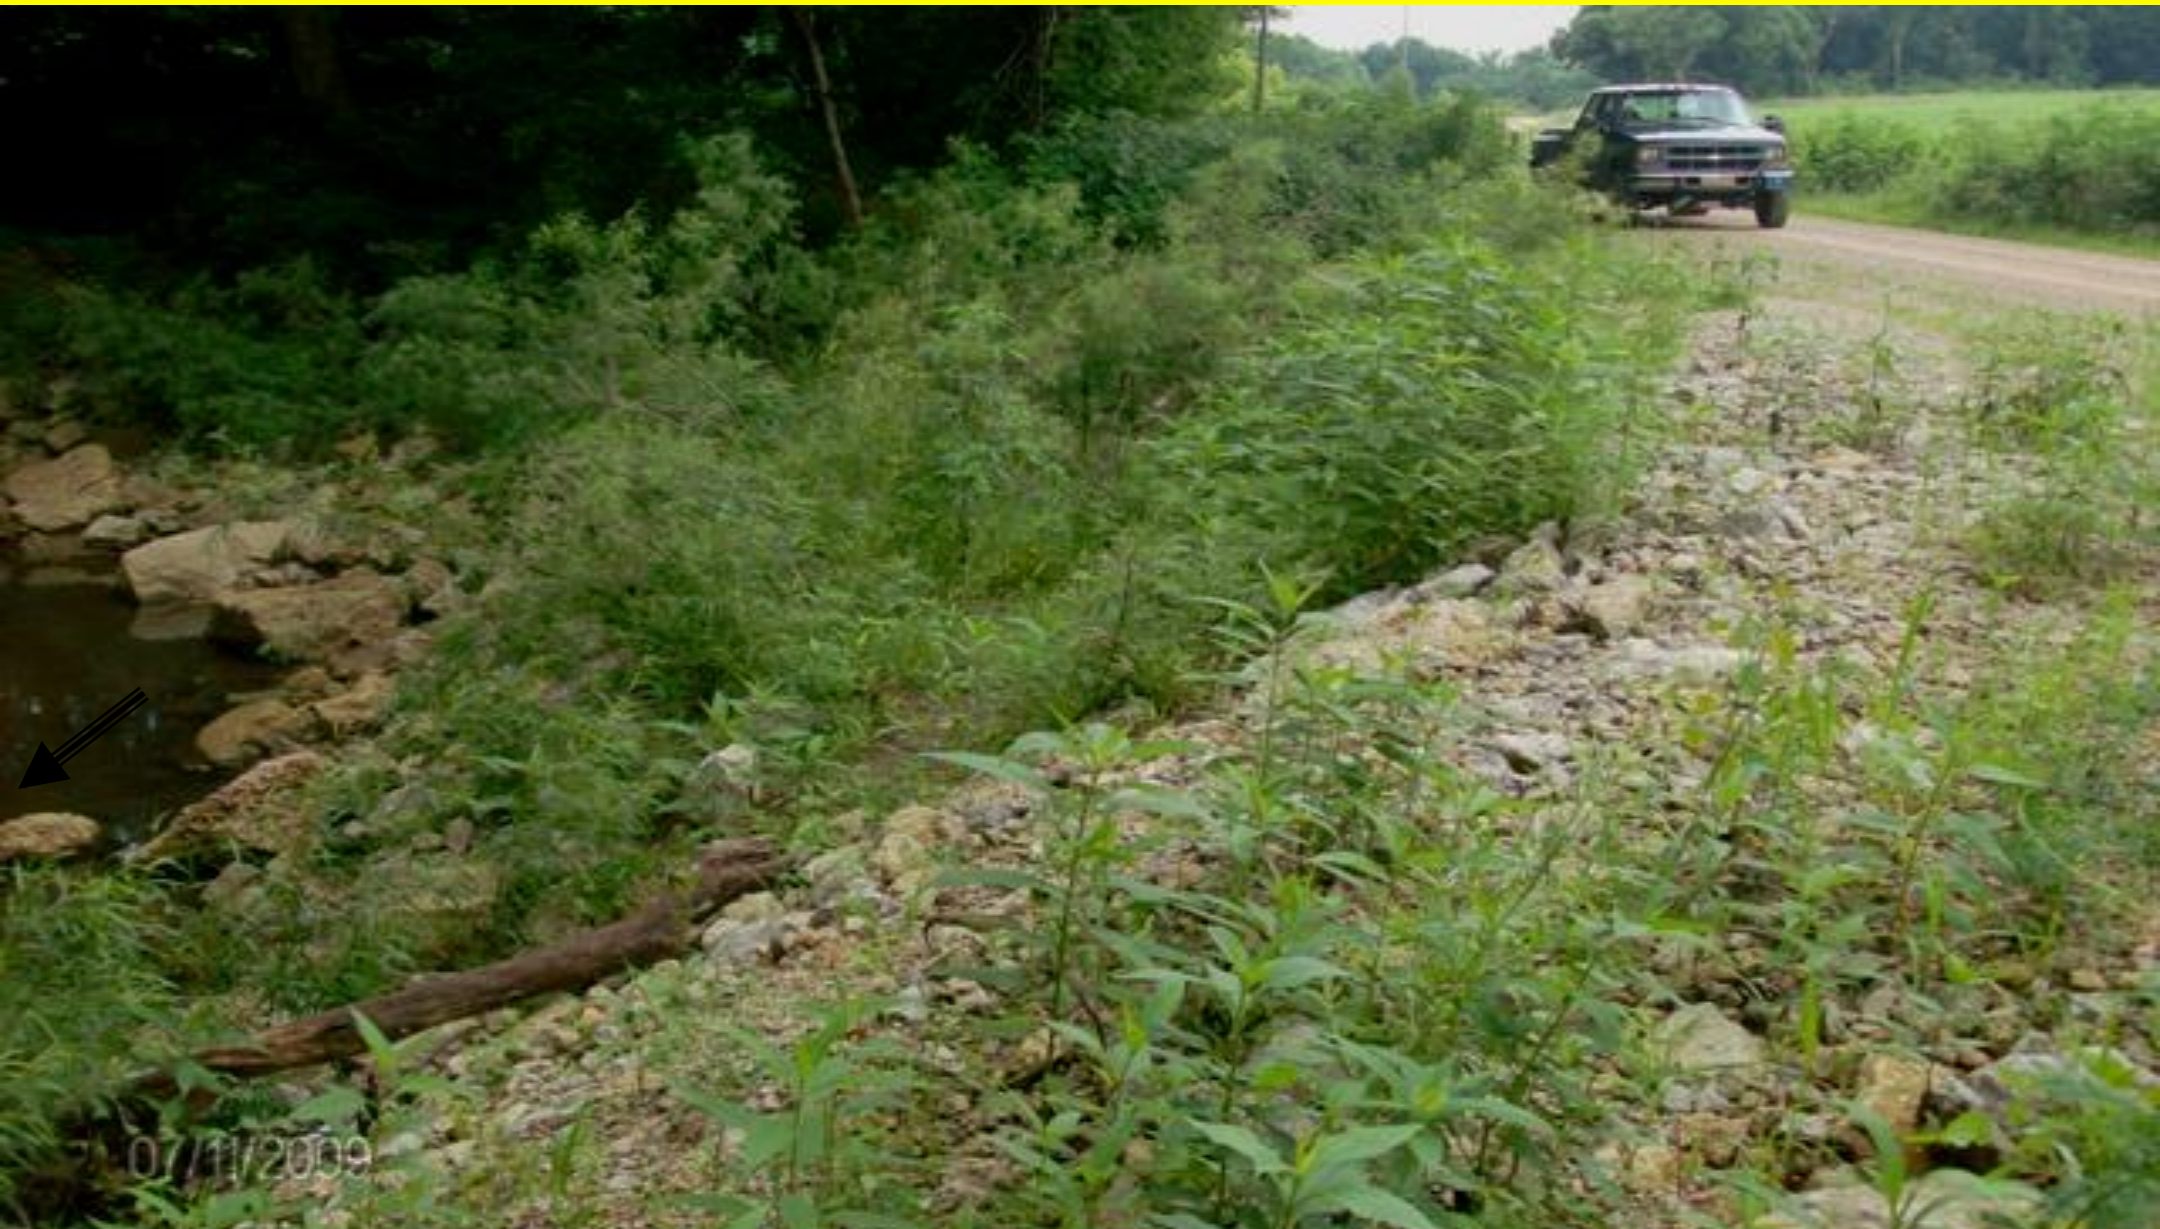
4 MONTHS LATER-Looking US @ project & road

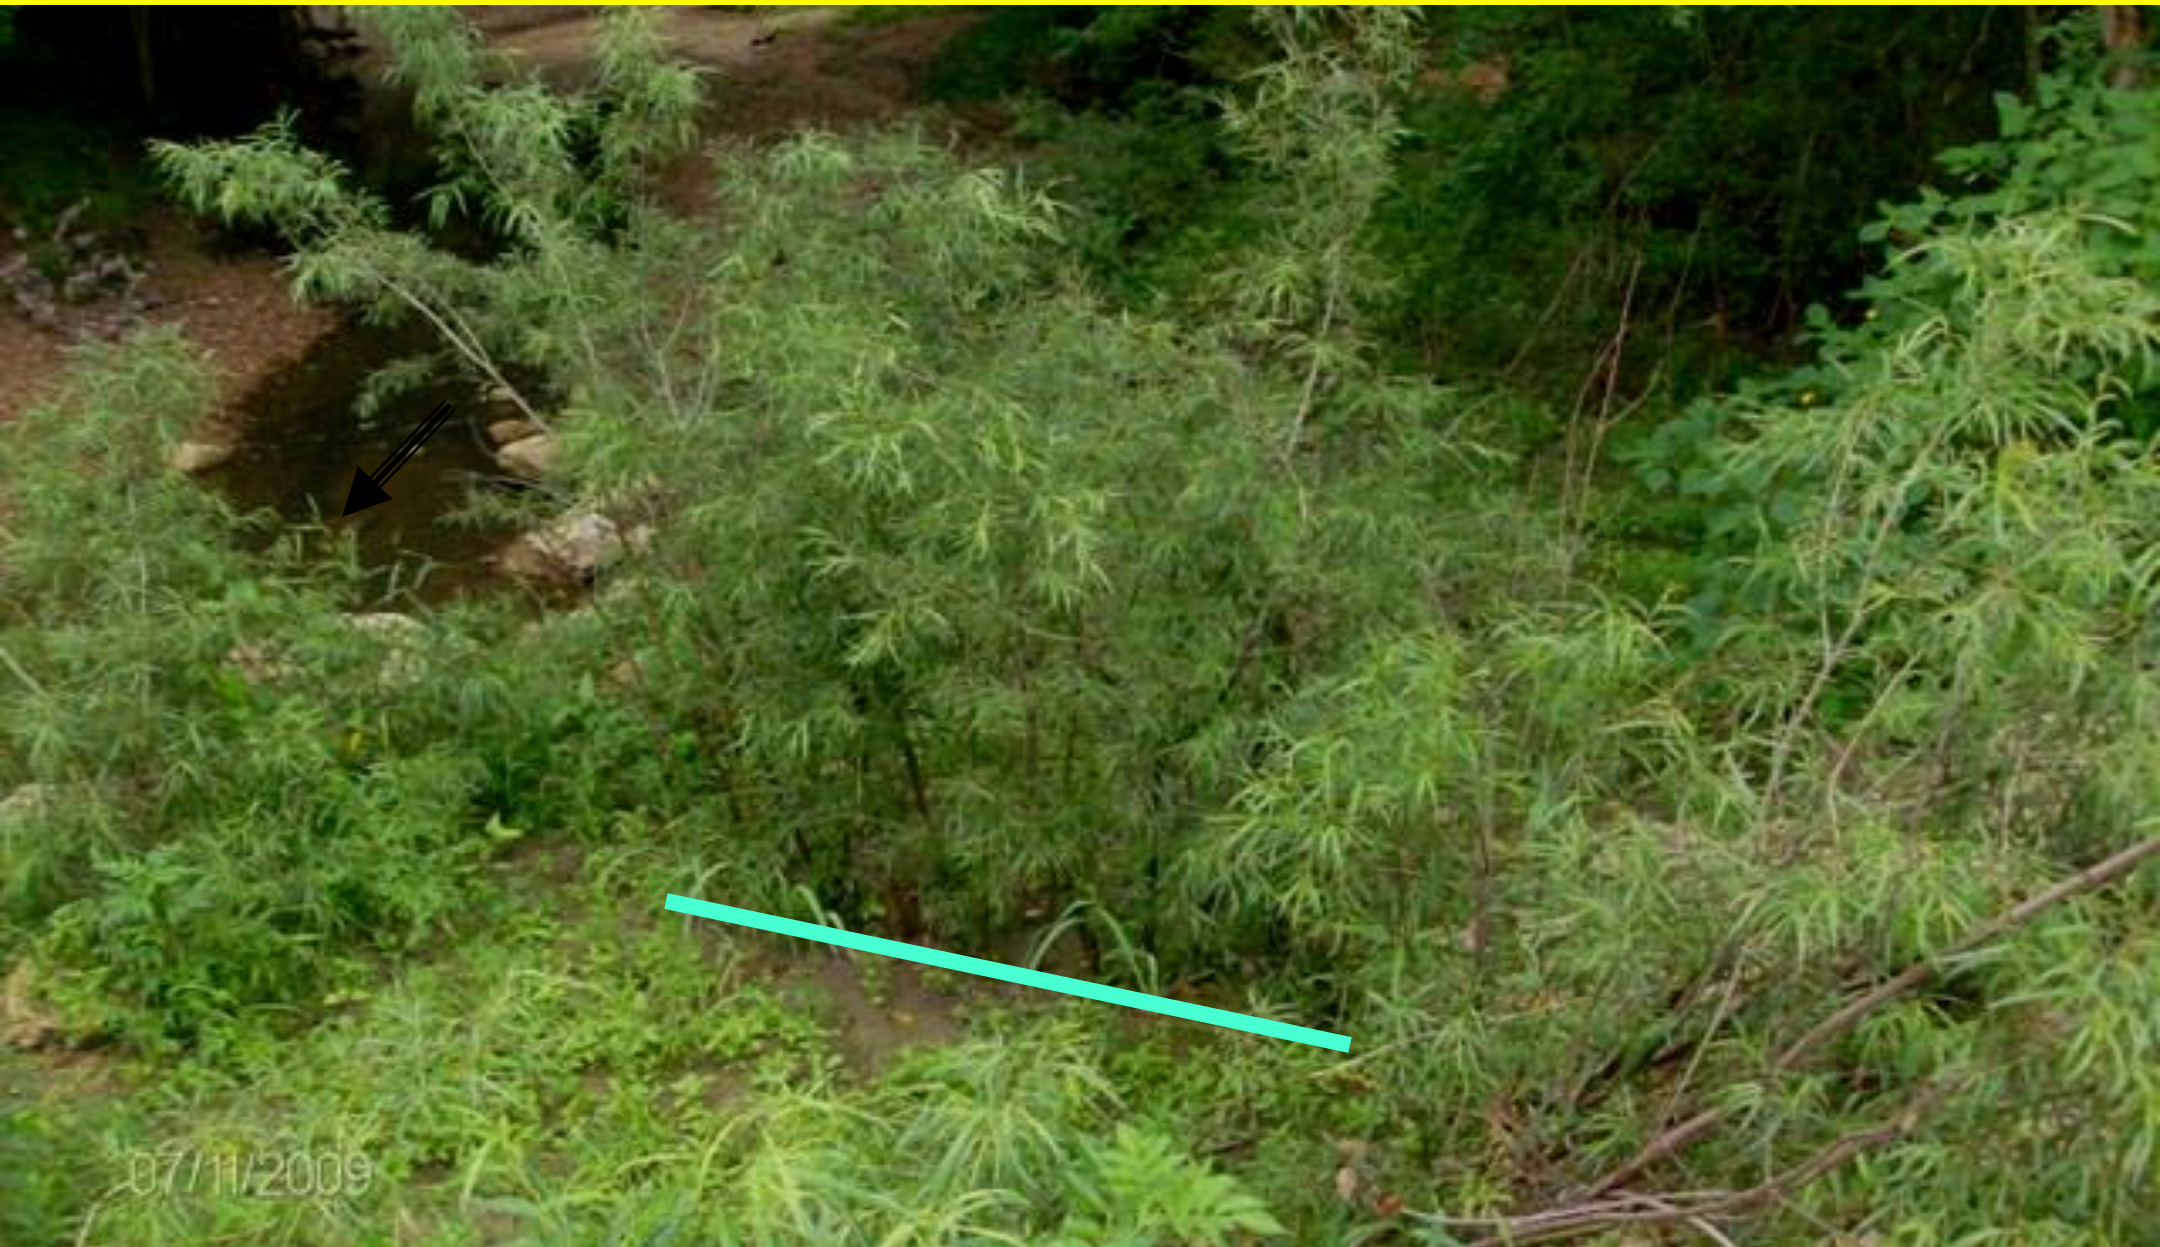
4 MONTHS LATER-Looking US @ a Living Dike on the floodplain bench

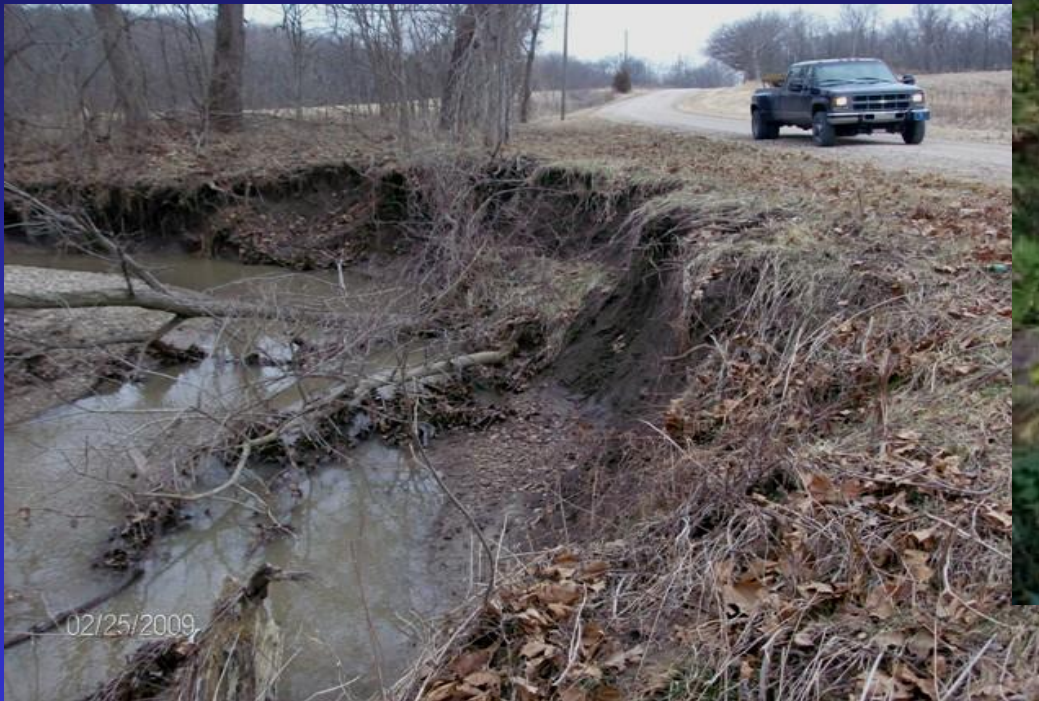
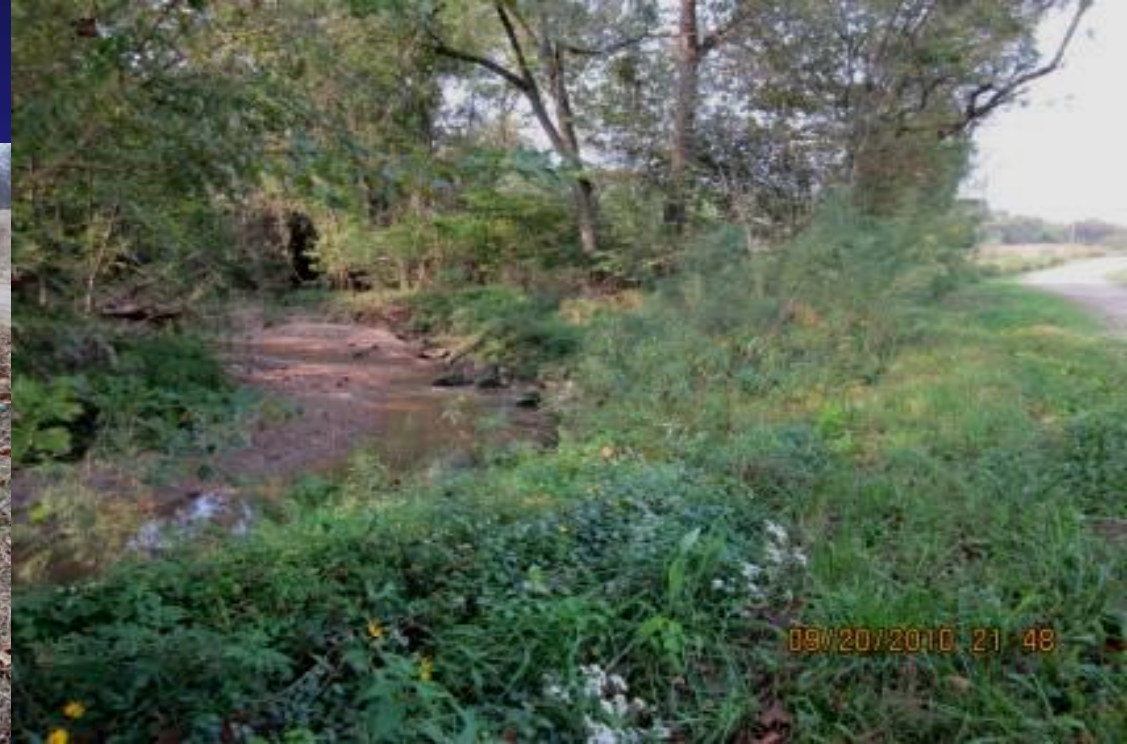
Looking upstream from road

**March 2009-bank 4 feet
from road**

**Sep 2010-notice how wide
the shoulder appears now**
