CAZENOVIA CR. @ STEPHENSON ST. BRIDGE

**REPLACEMENT OF ONE BANK
OF A CONCRETE-LINED
CHANNEL**

**HAW CREEK, PIKE COUNTY, MISSOURI-
TRIB TO SALT RIVER**

GOODWIN CREEK, MS.

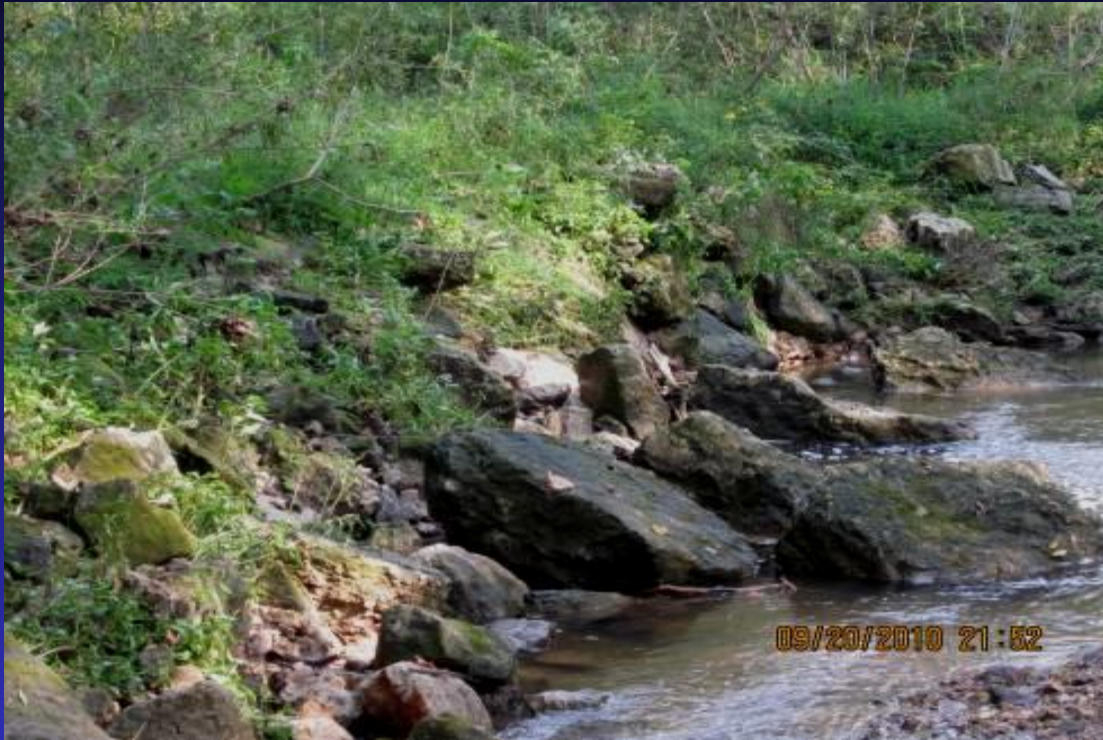
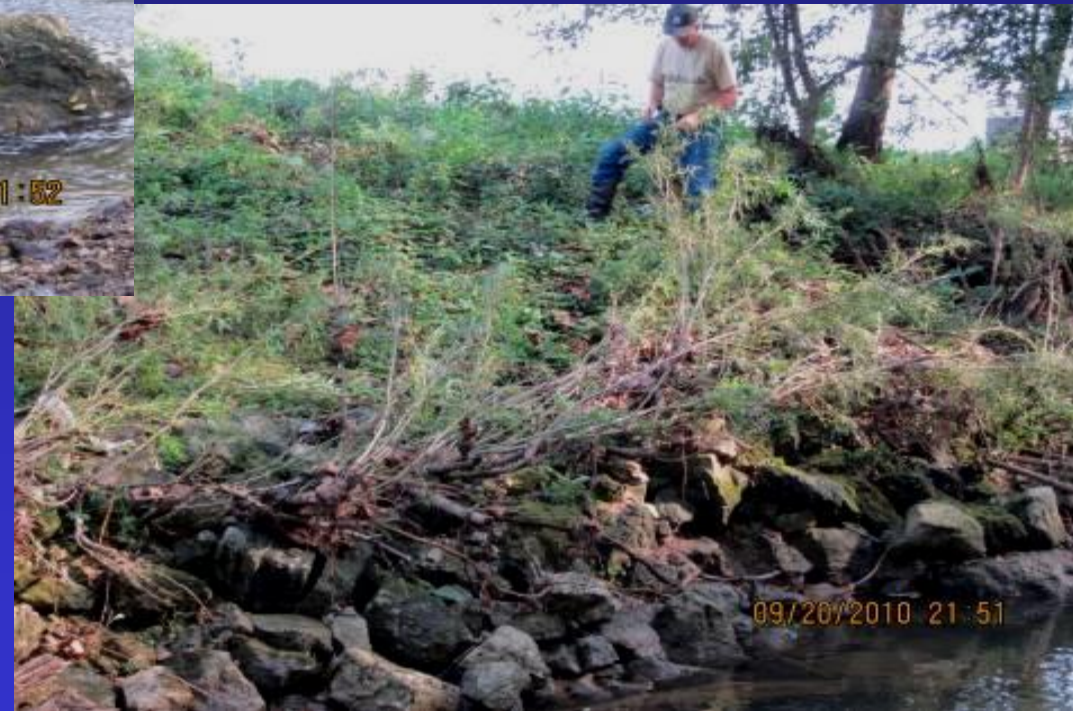
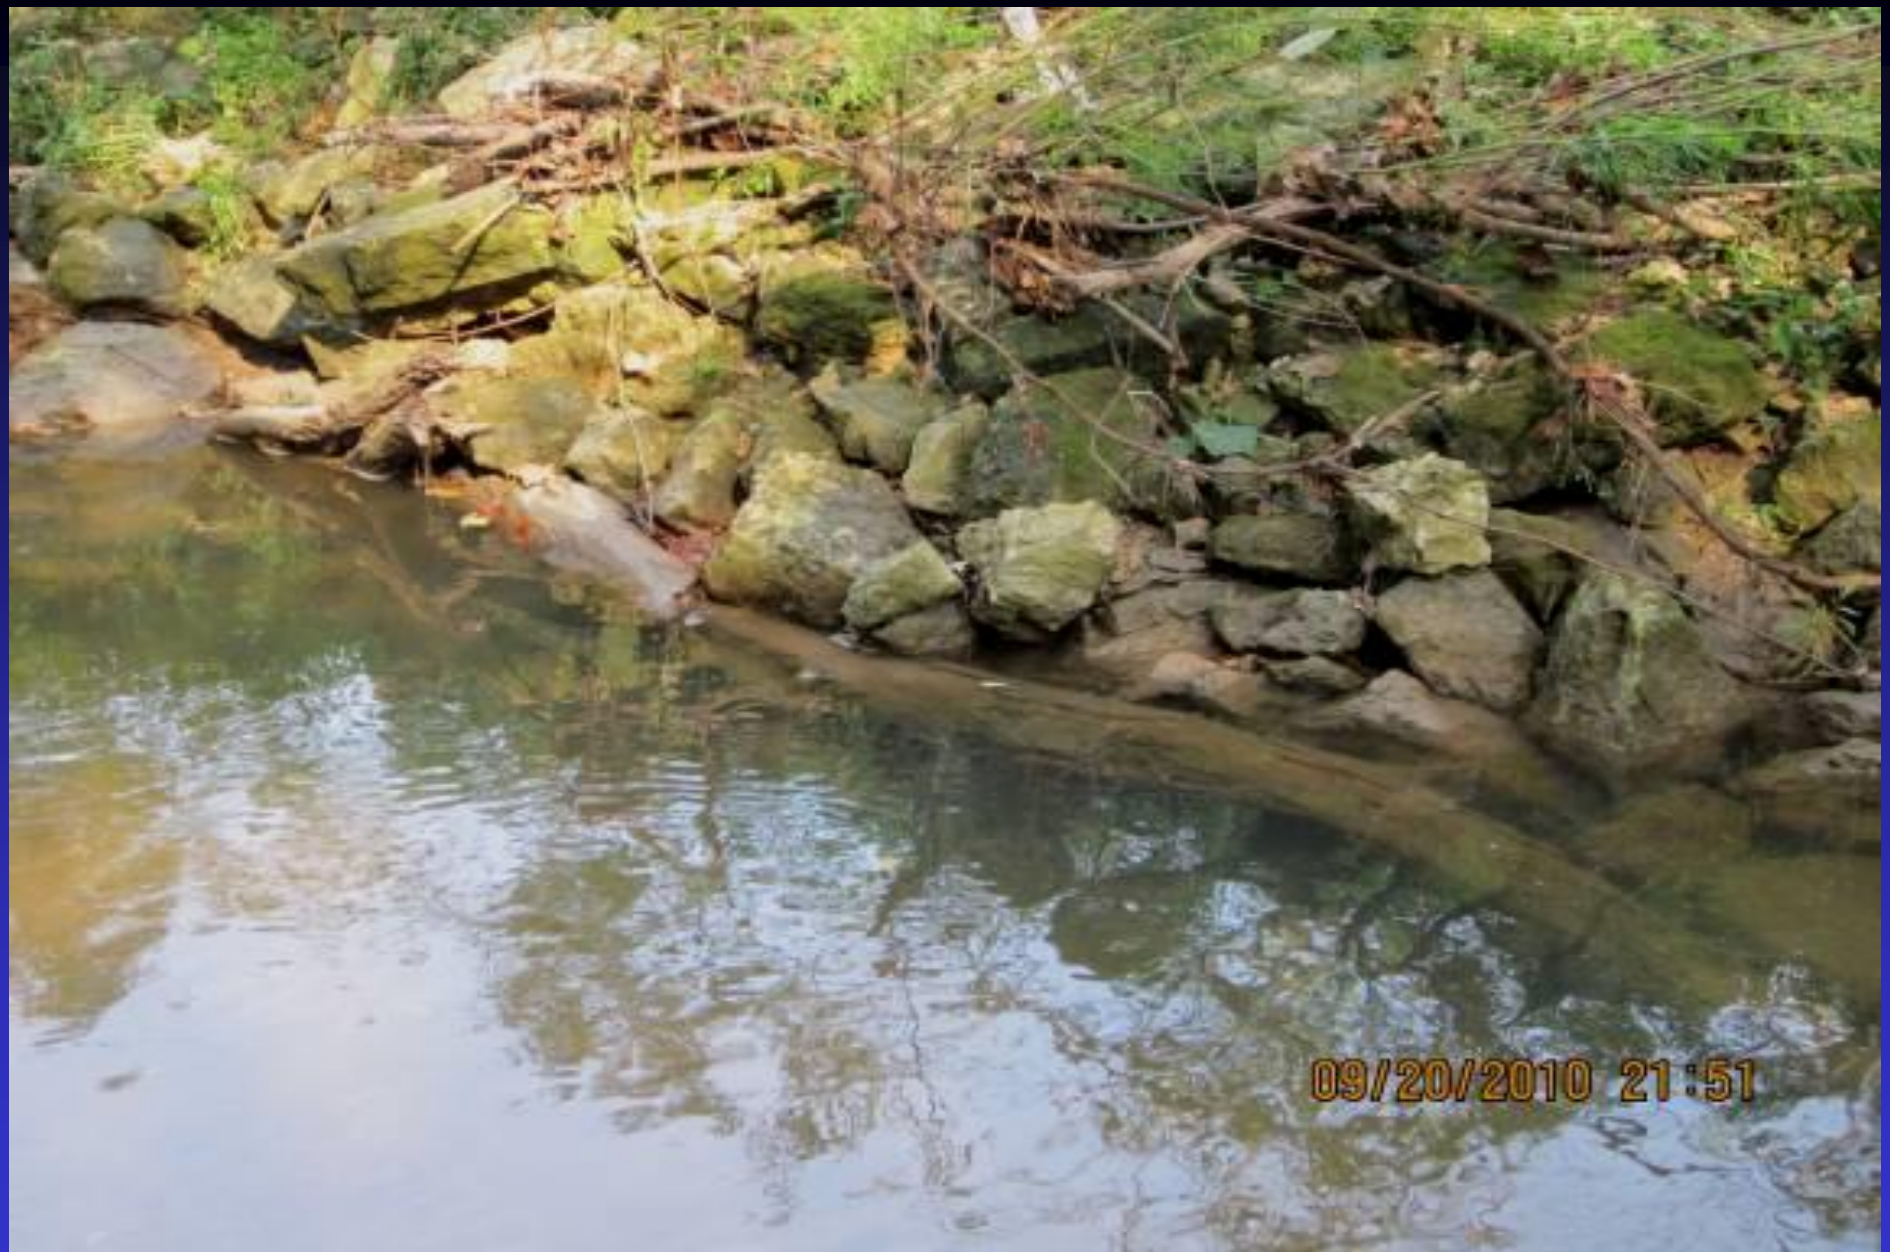
Short Bendway Weirs & Rock toe

Locked Log still in place

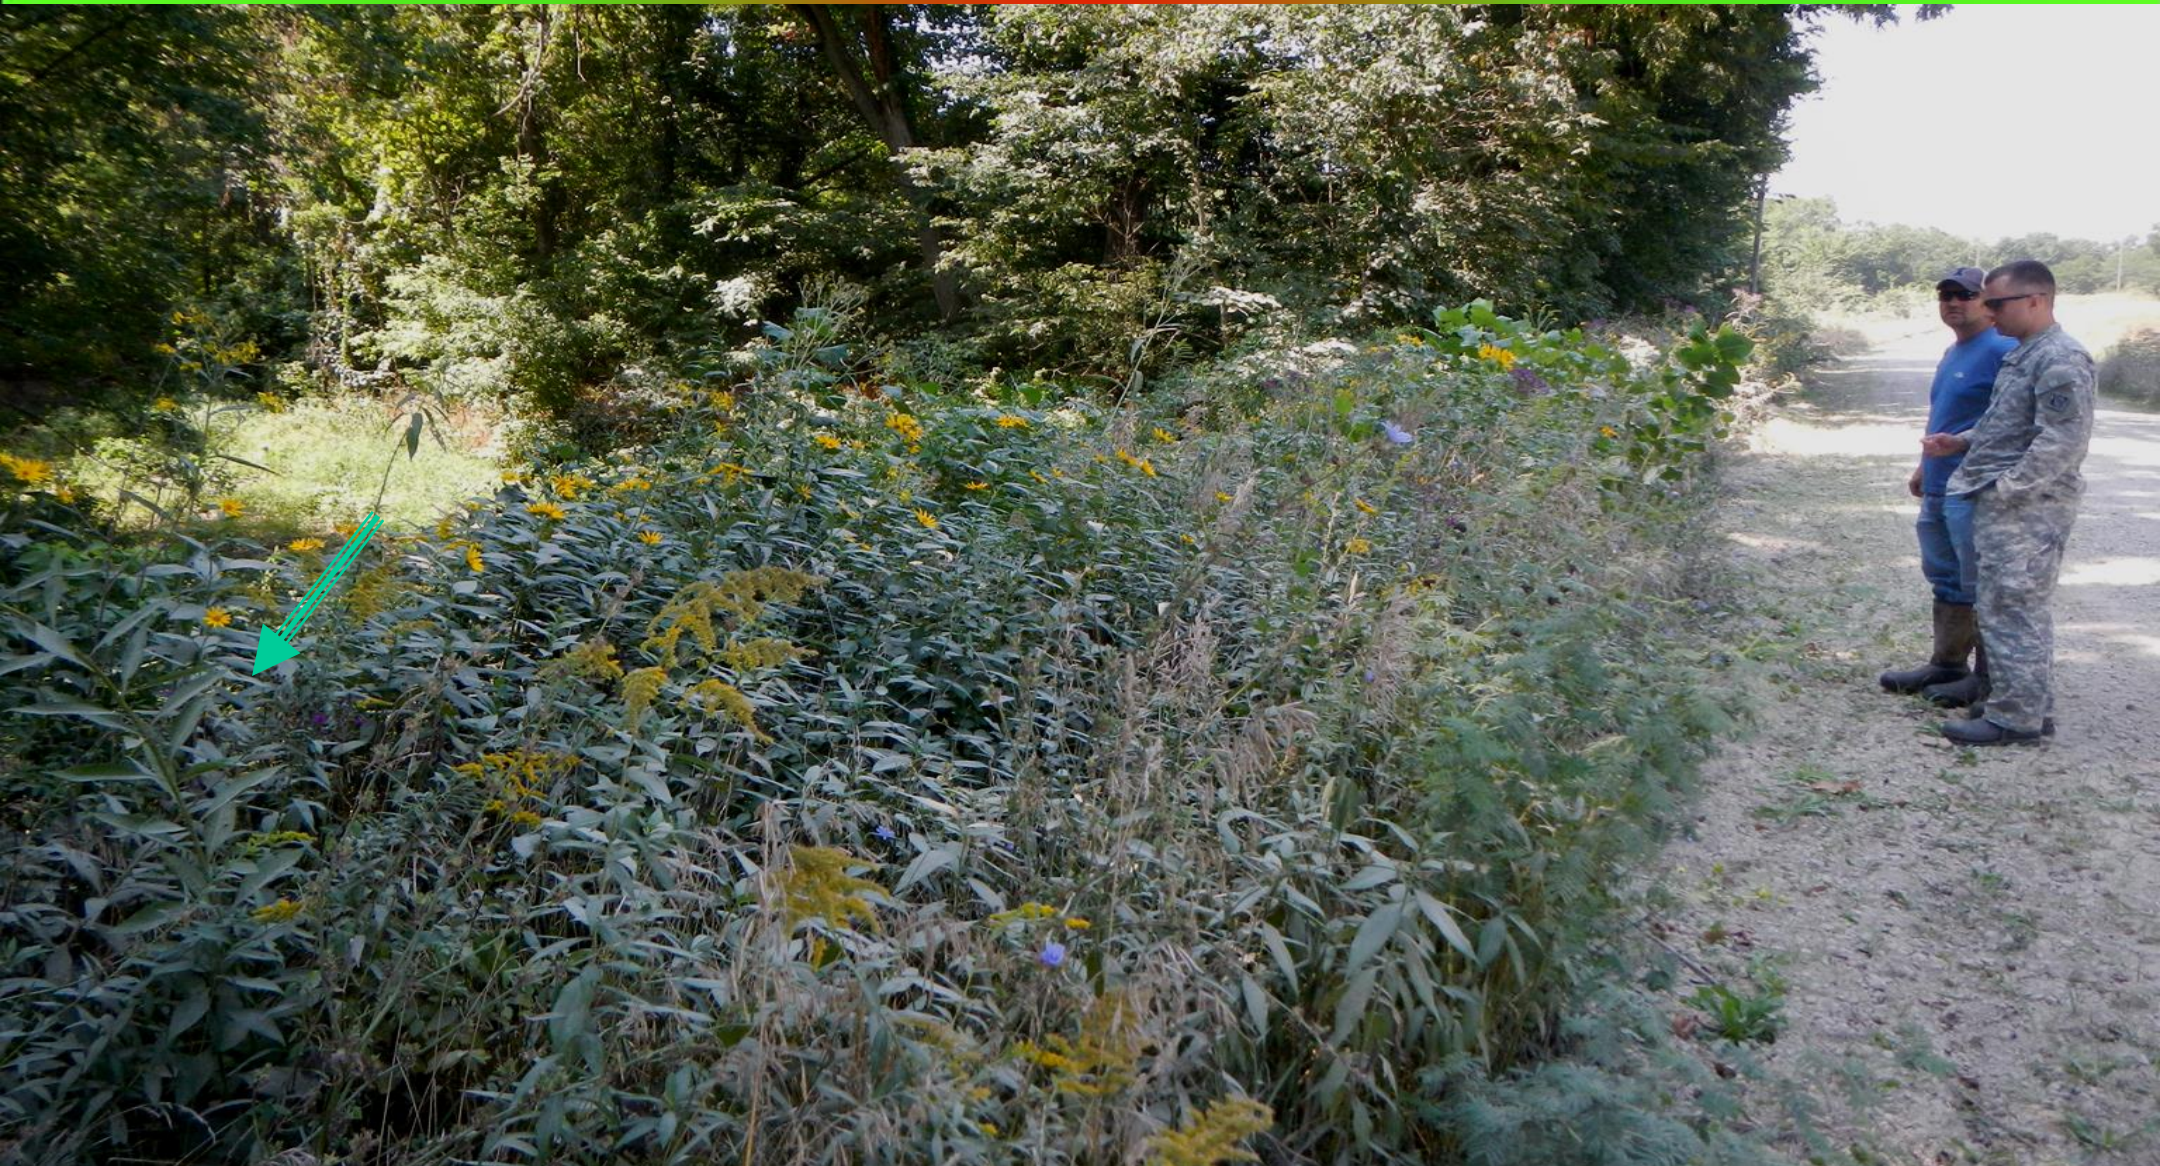
4.5 YEARS LATER-From the road shoulder, looking US @ the project floodplain bench. Where is it? The stream?

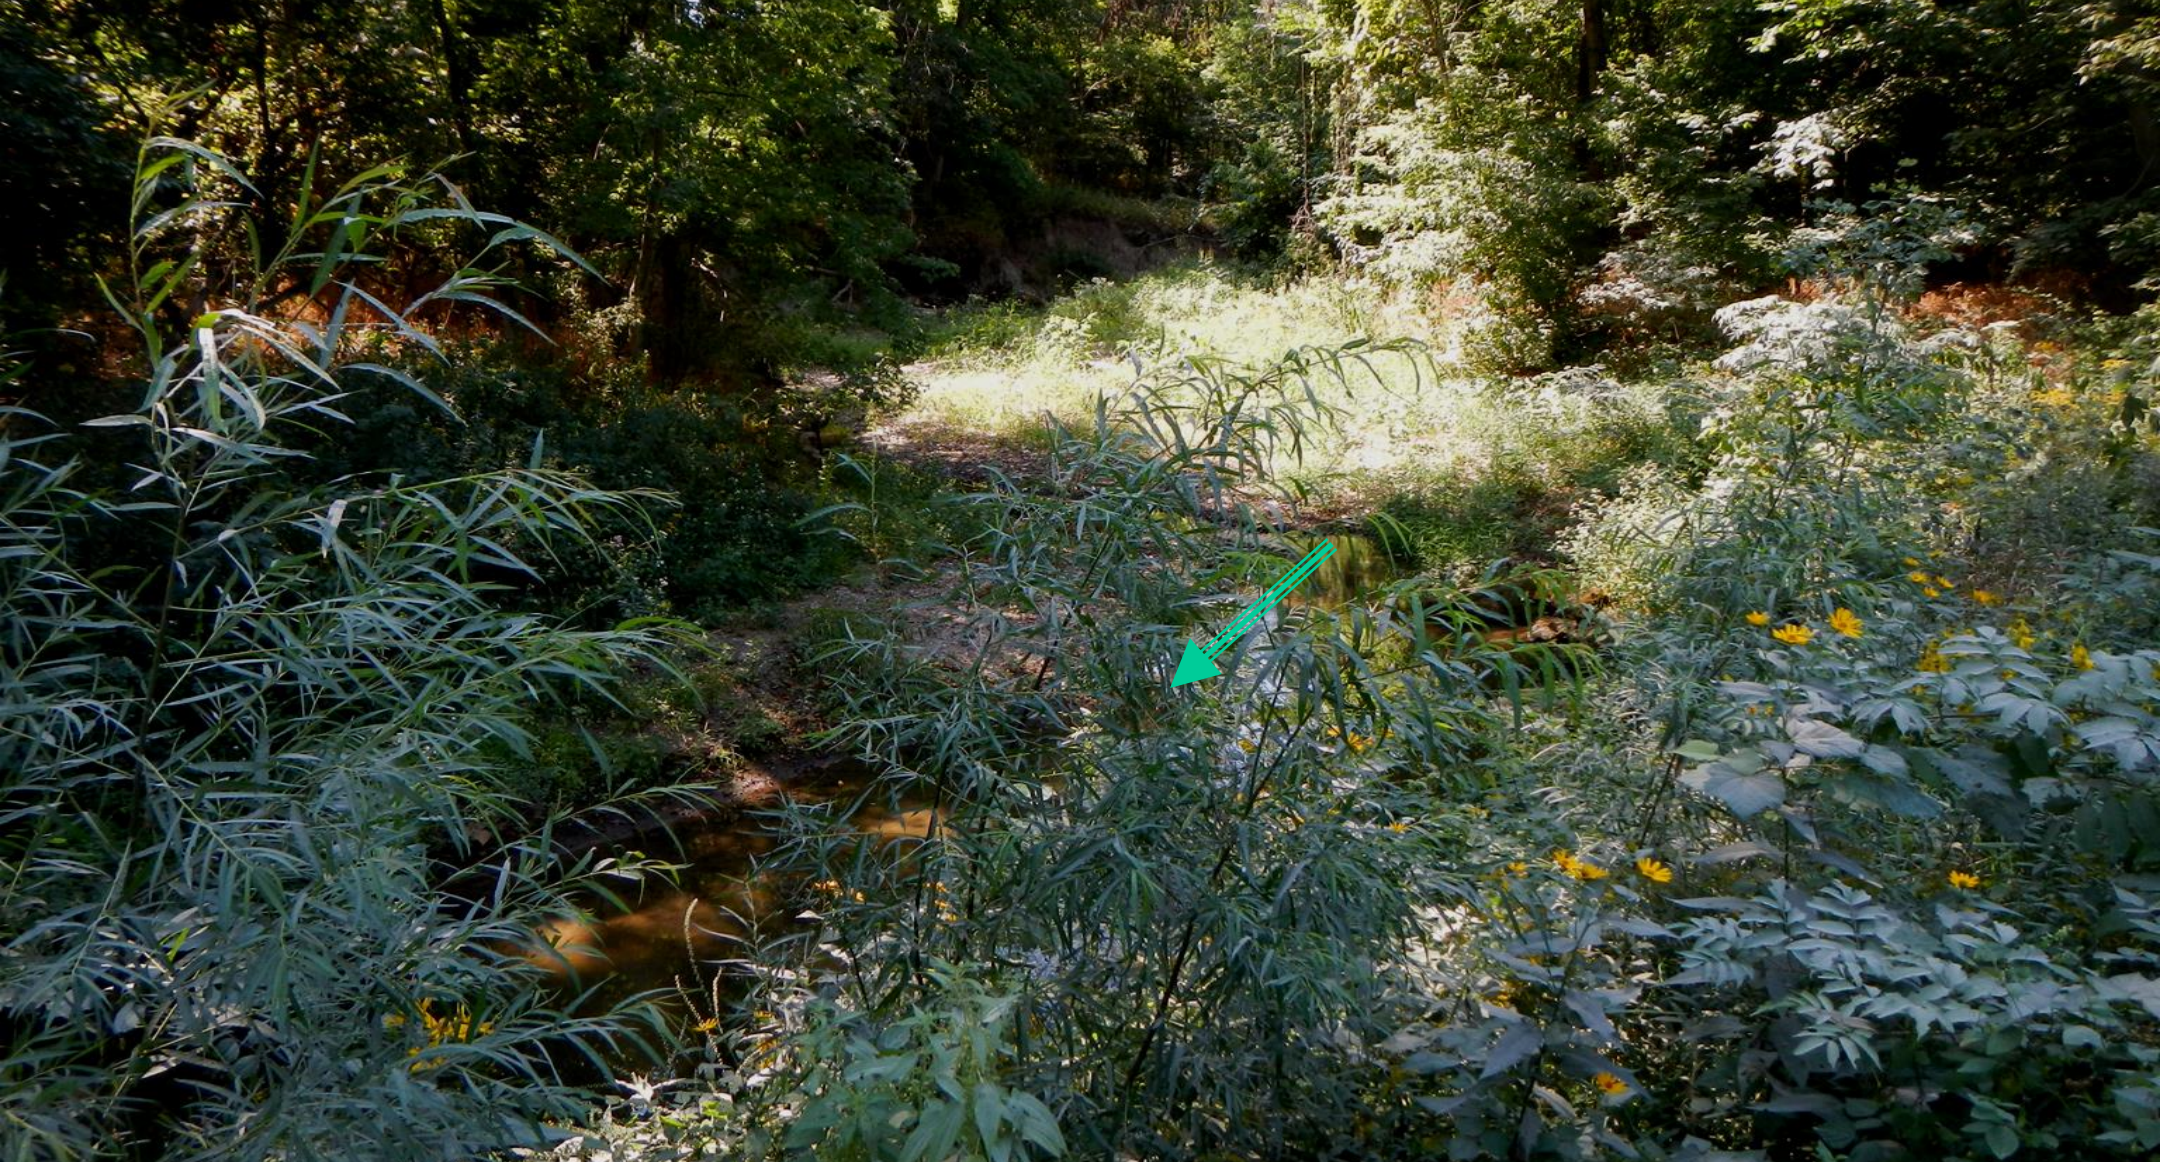
4.5 YEARS LATER-From top bank, looking US @ the floodplain bench & stream. Planted willow crowded out by lots of plants!

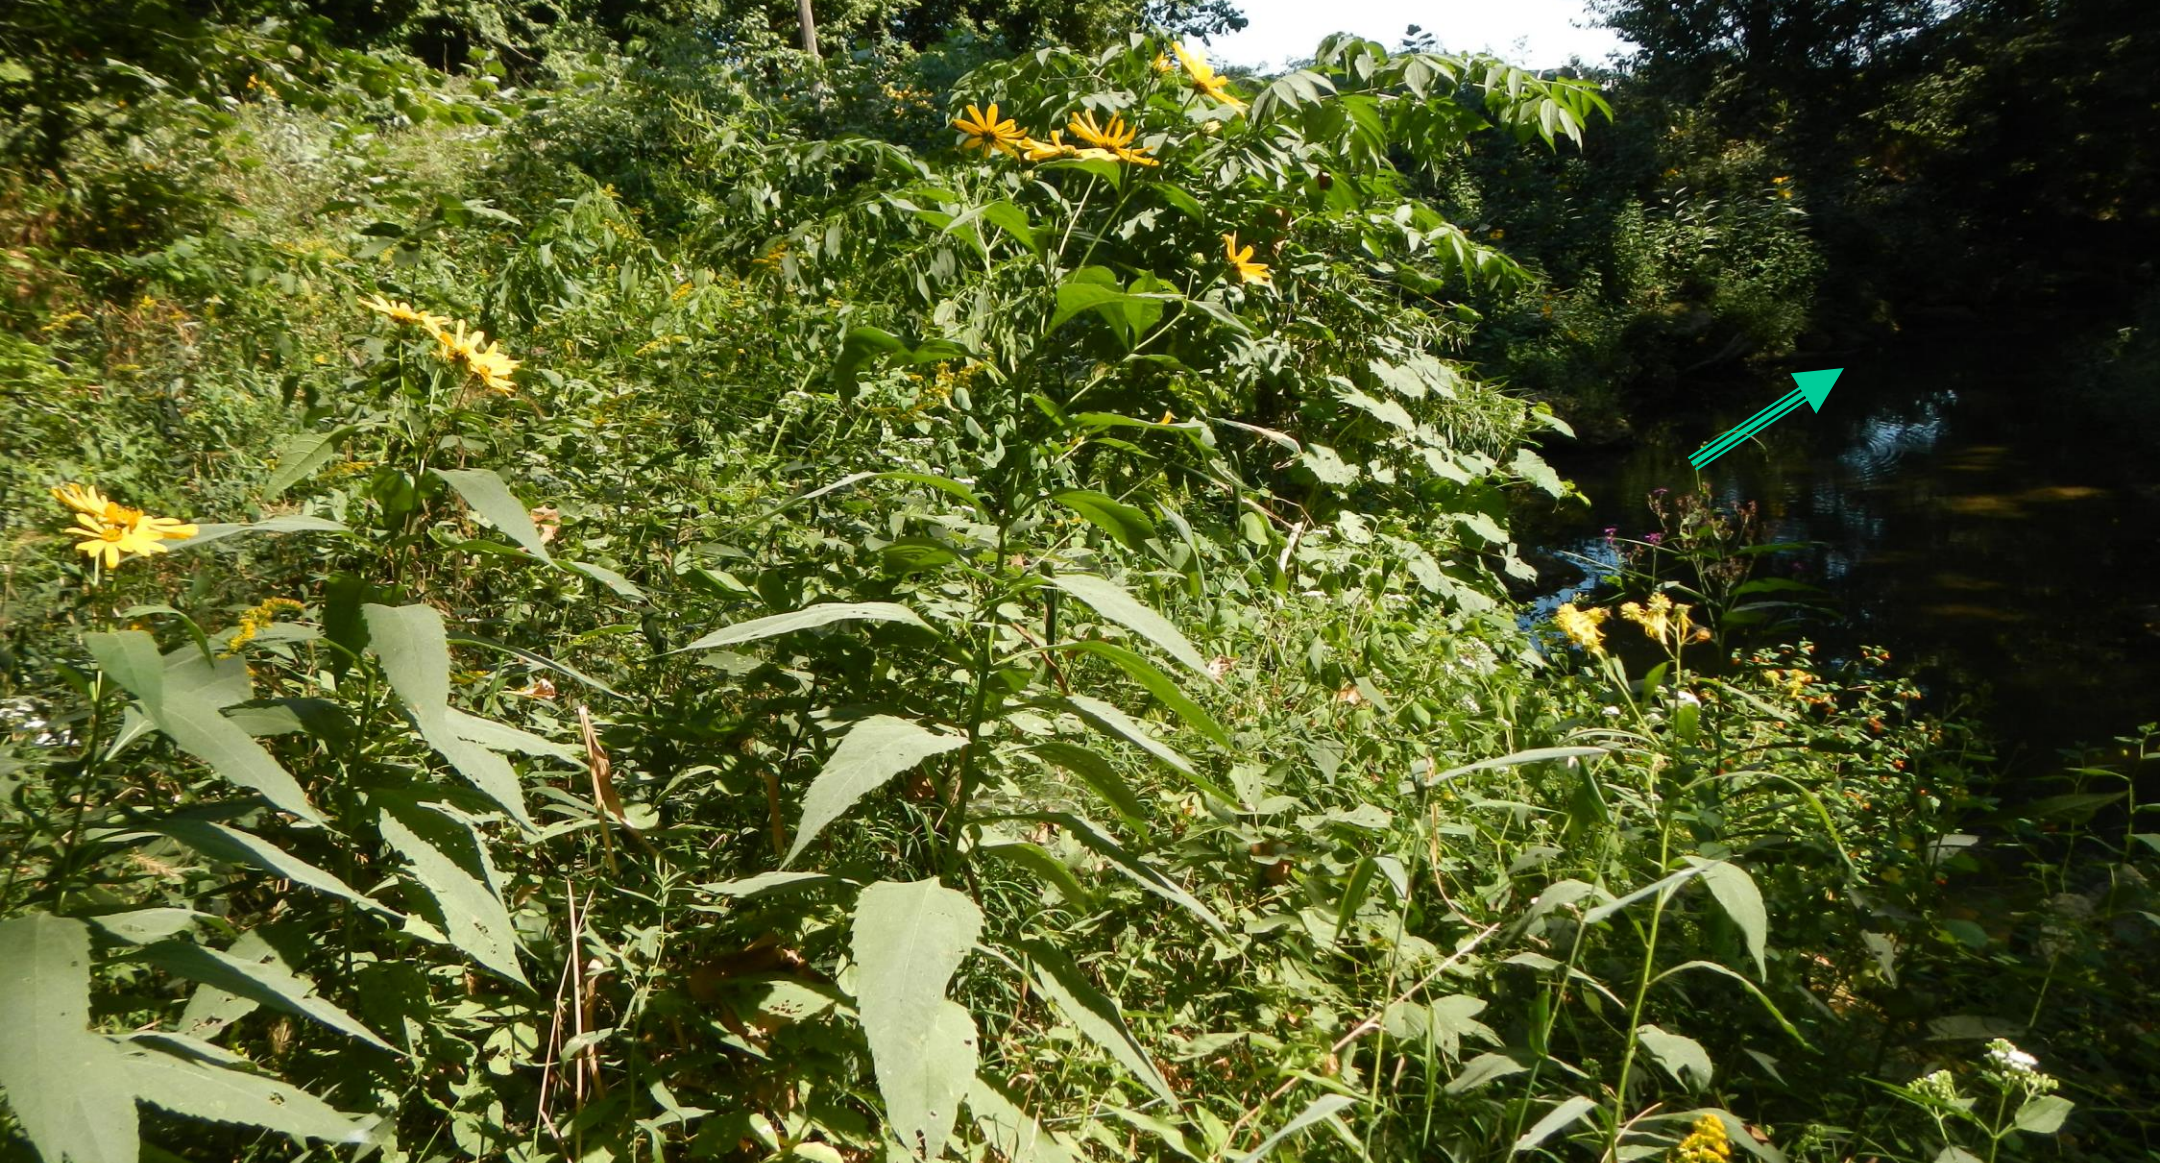
4.5 YEARS LATER-Looking DS @ floodplain bench & stream. Great shade, cover, structure, insect production..

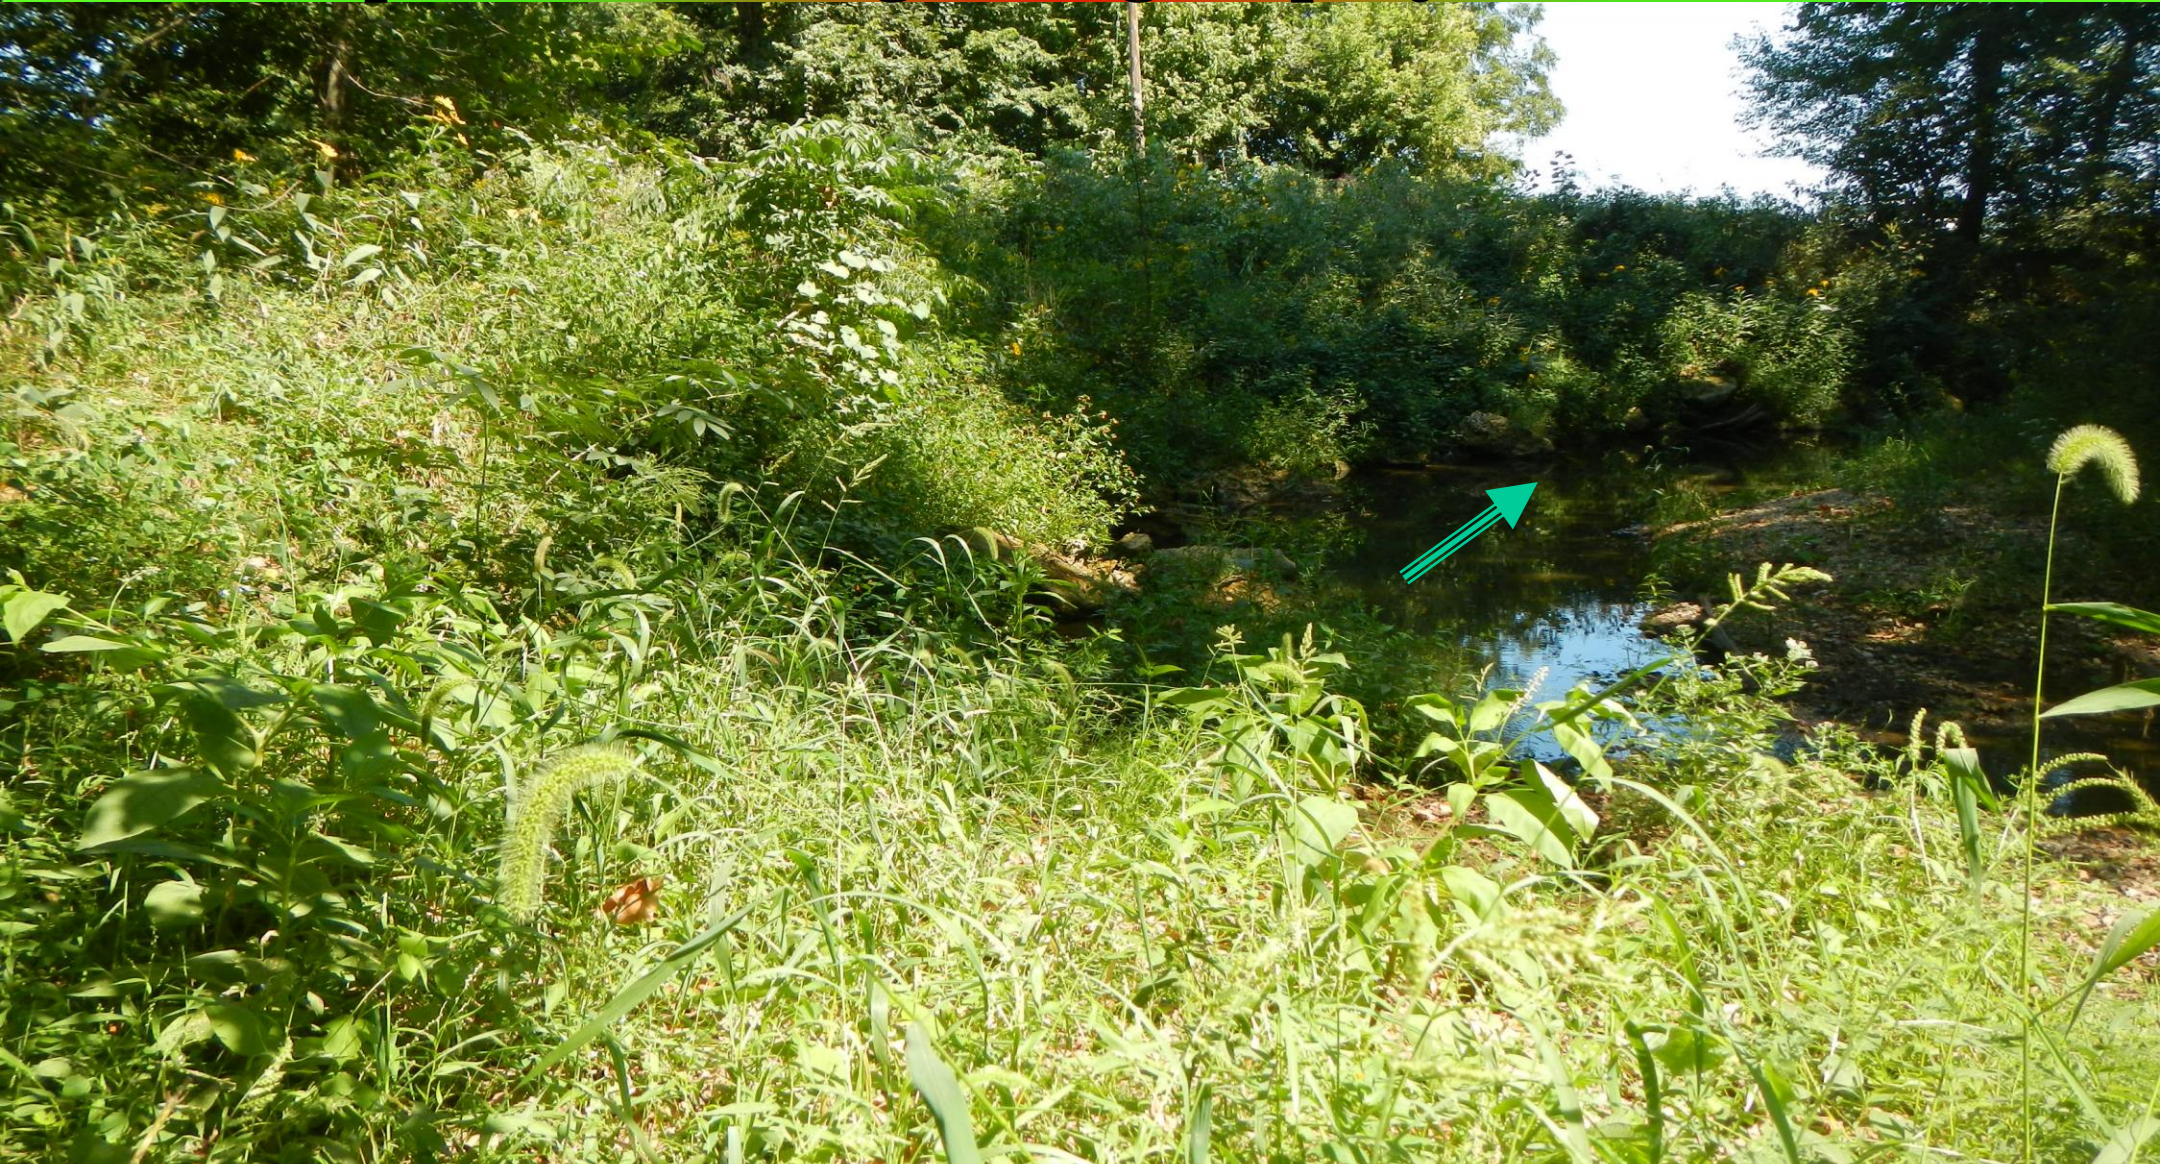
**We planted only willows. Rob
Gramke, regulatory, St. Louis
Corps, noted after a quick look,
that there were over 20
herbaceous & woody species, & 7
species of trees, all on the
floodplain bench !!!!!!!**

4.5 YEARS LATER-Looking DS @ stream & grown-up floodplain bench veg hiding all project structures!!

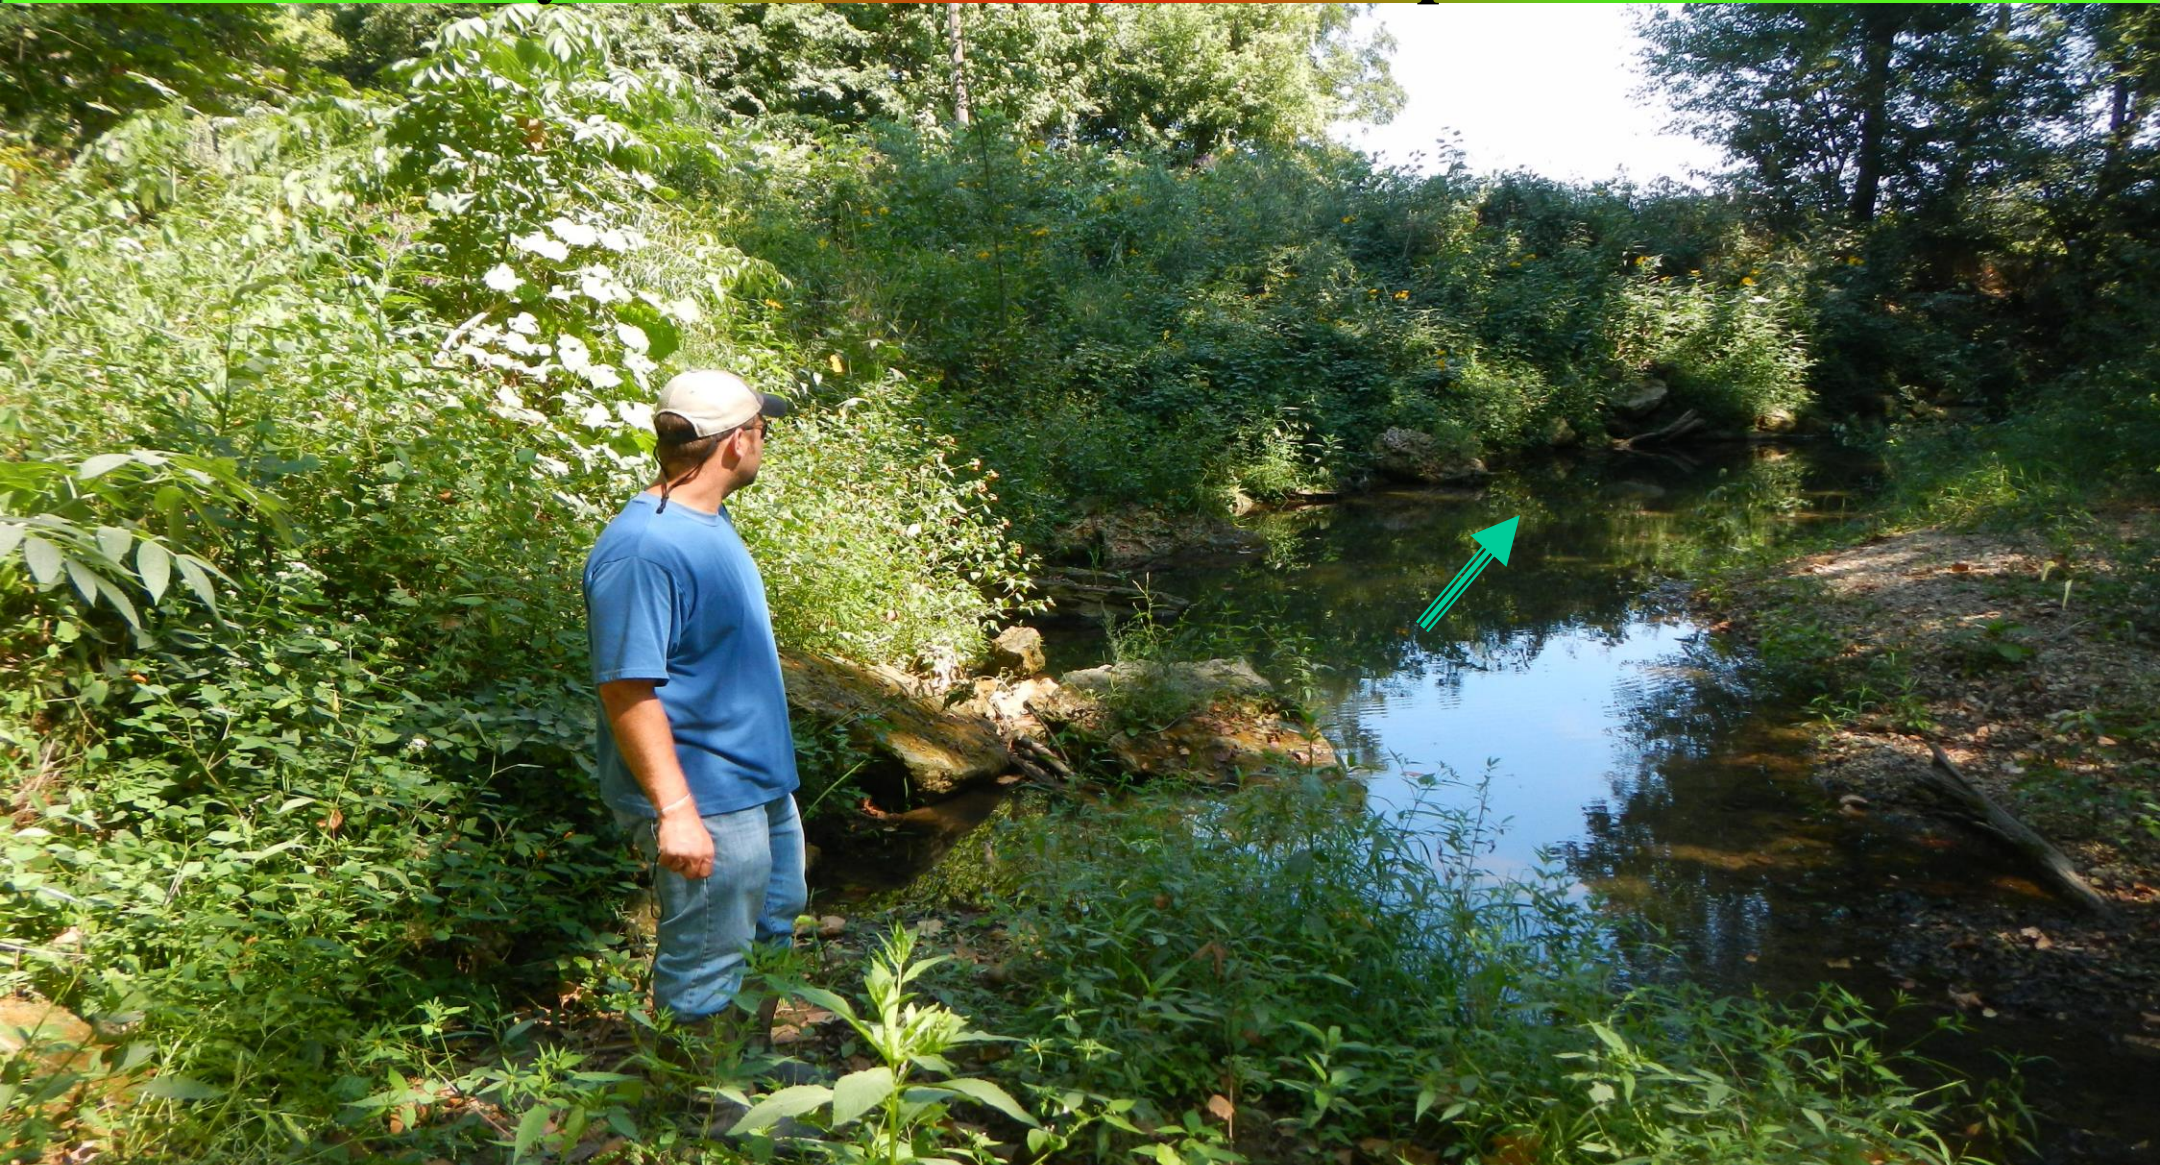
4.5 YEARS LATER-Looking DS @ stream, Short Bendway Weirs, LPSTP, & floodplain bench...

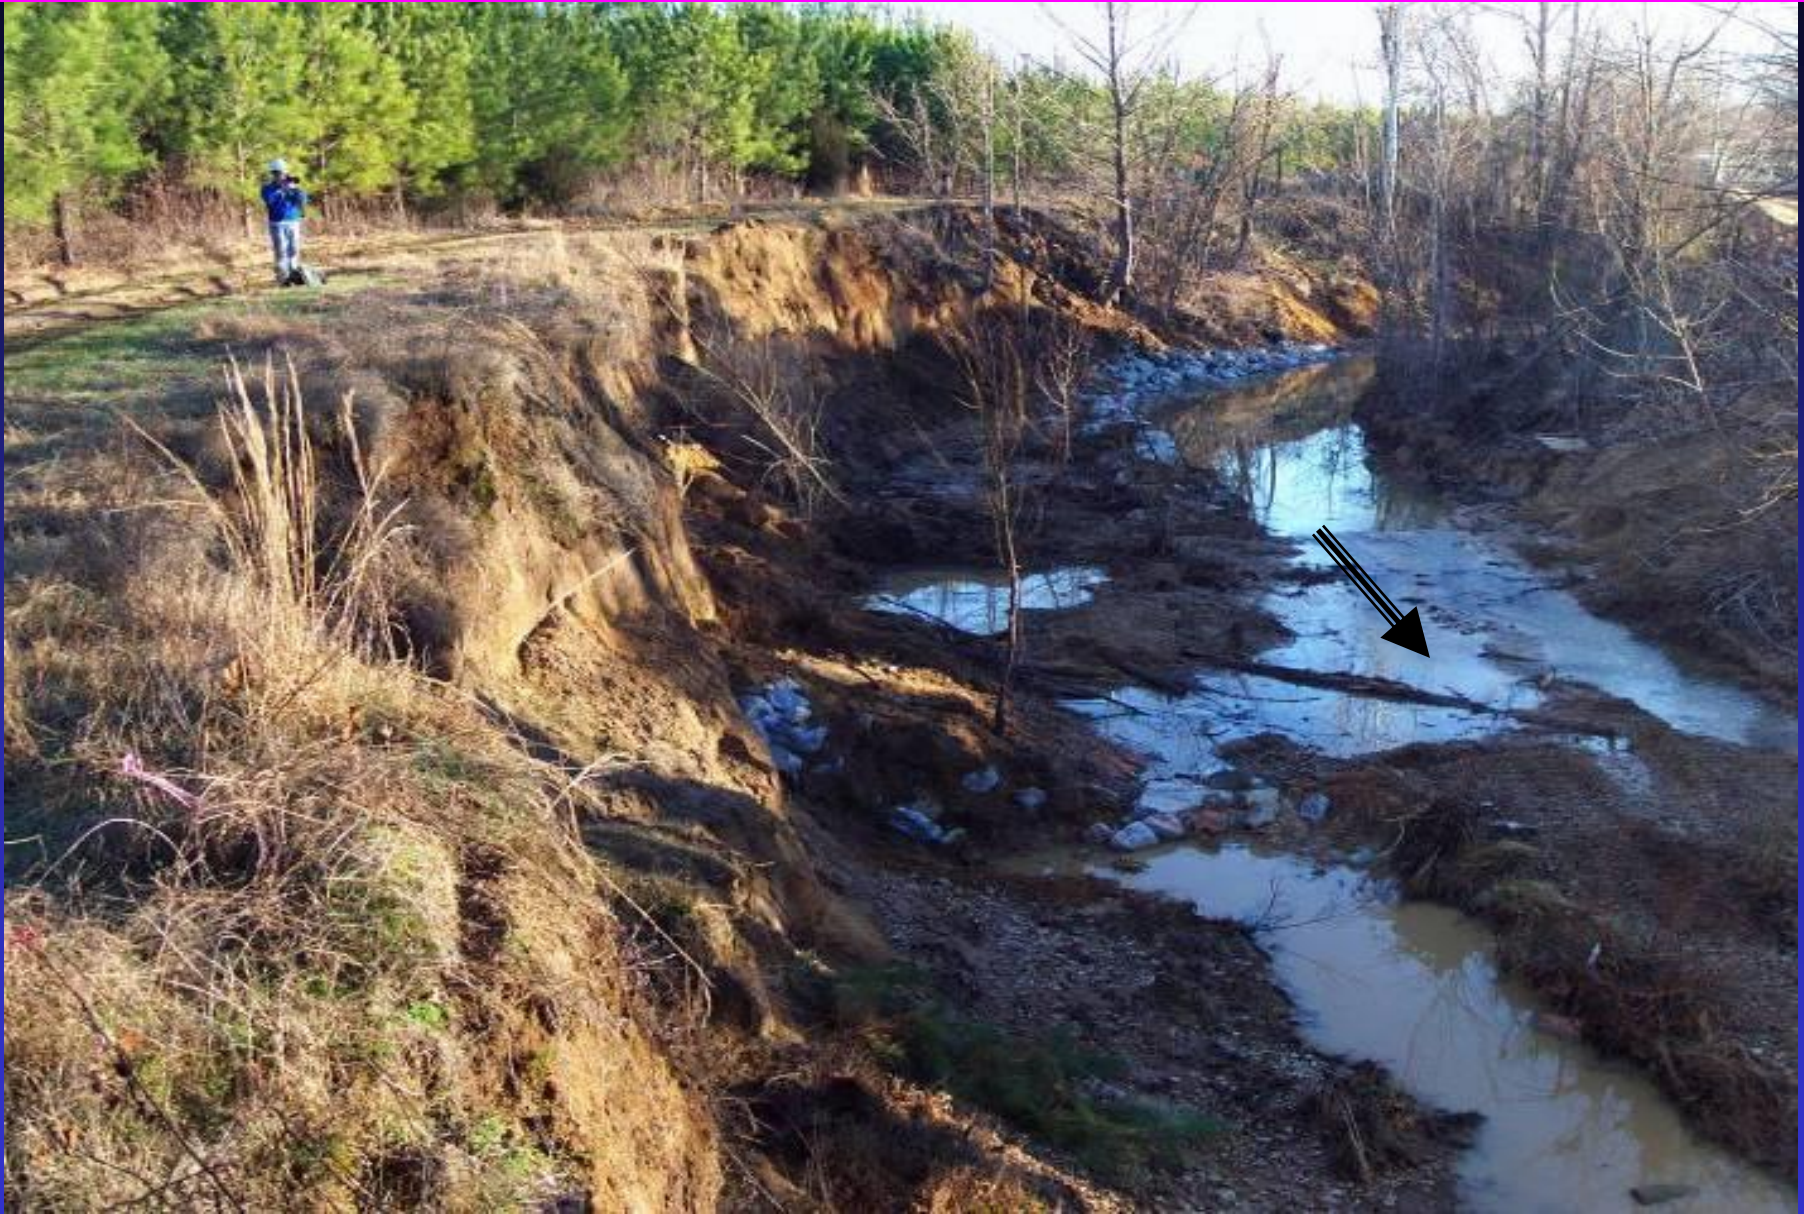
Looking US, Feb. 2007 - BEND #1

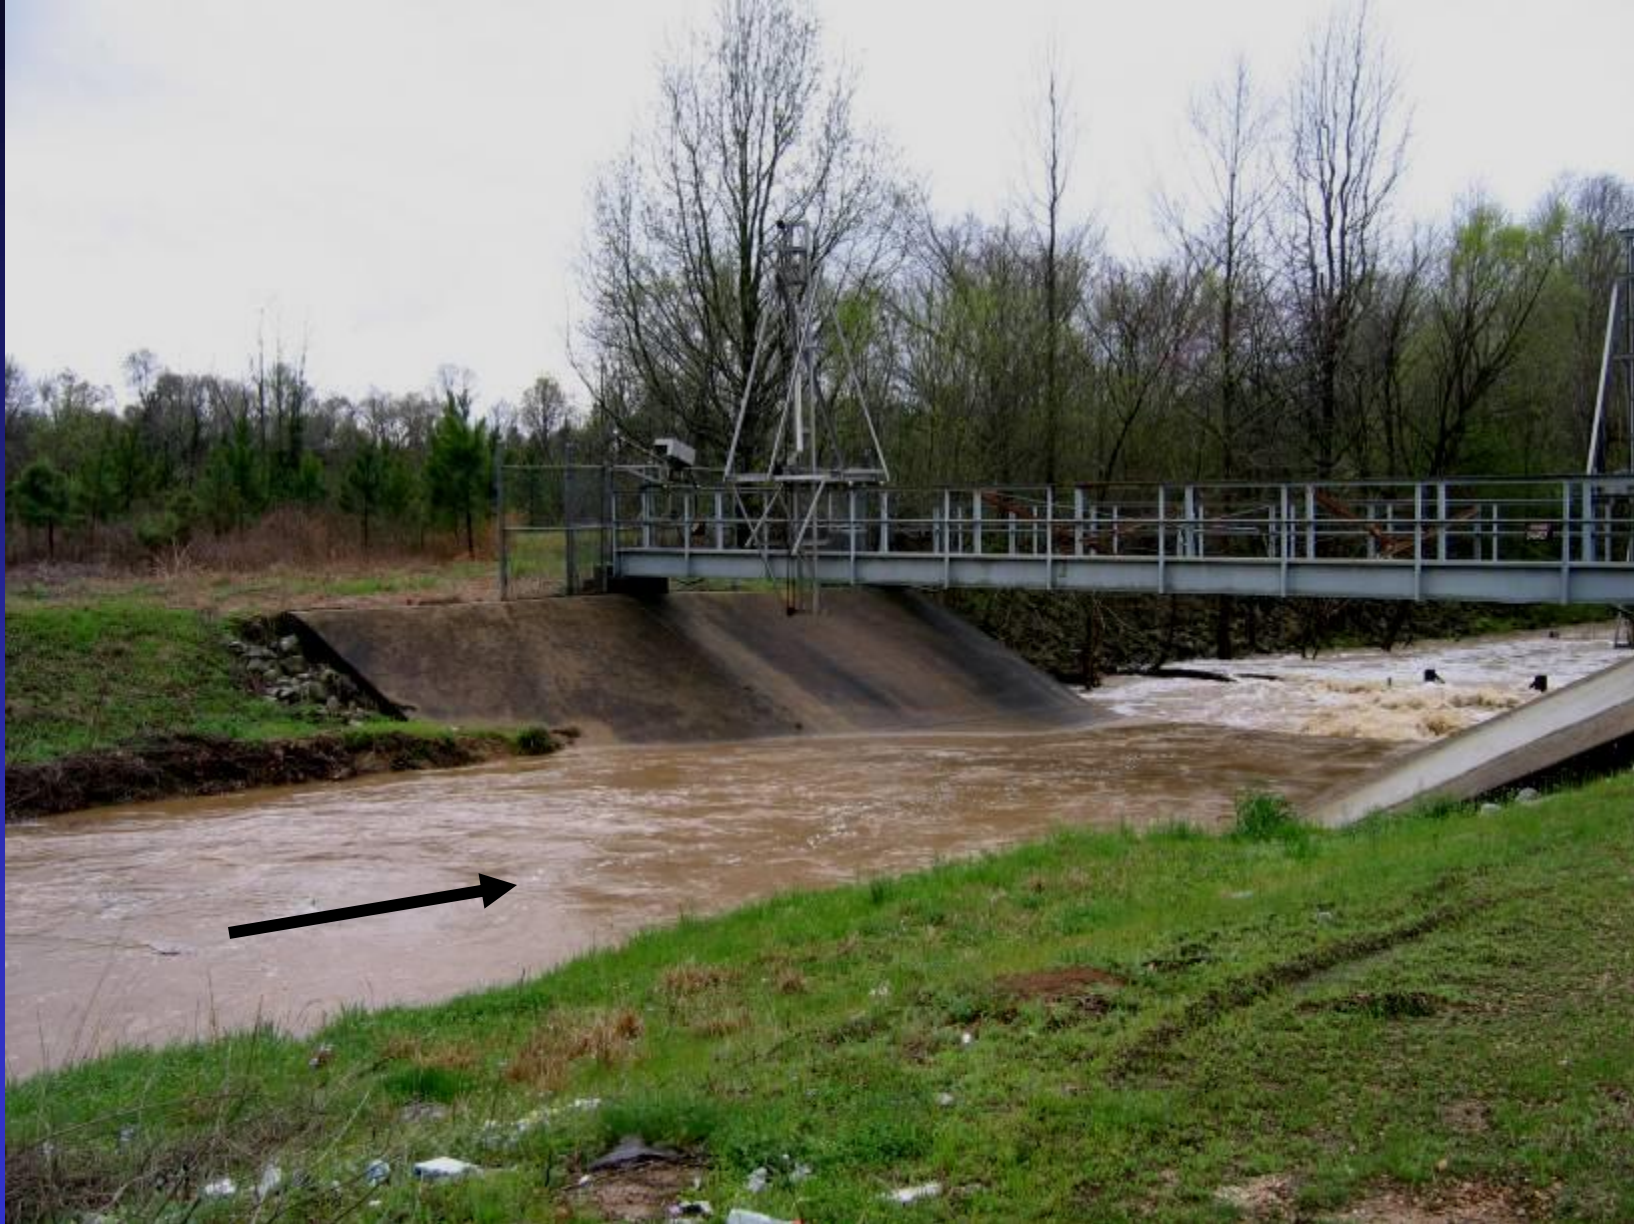
Looking DS at supercritical flume-good hydro data

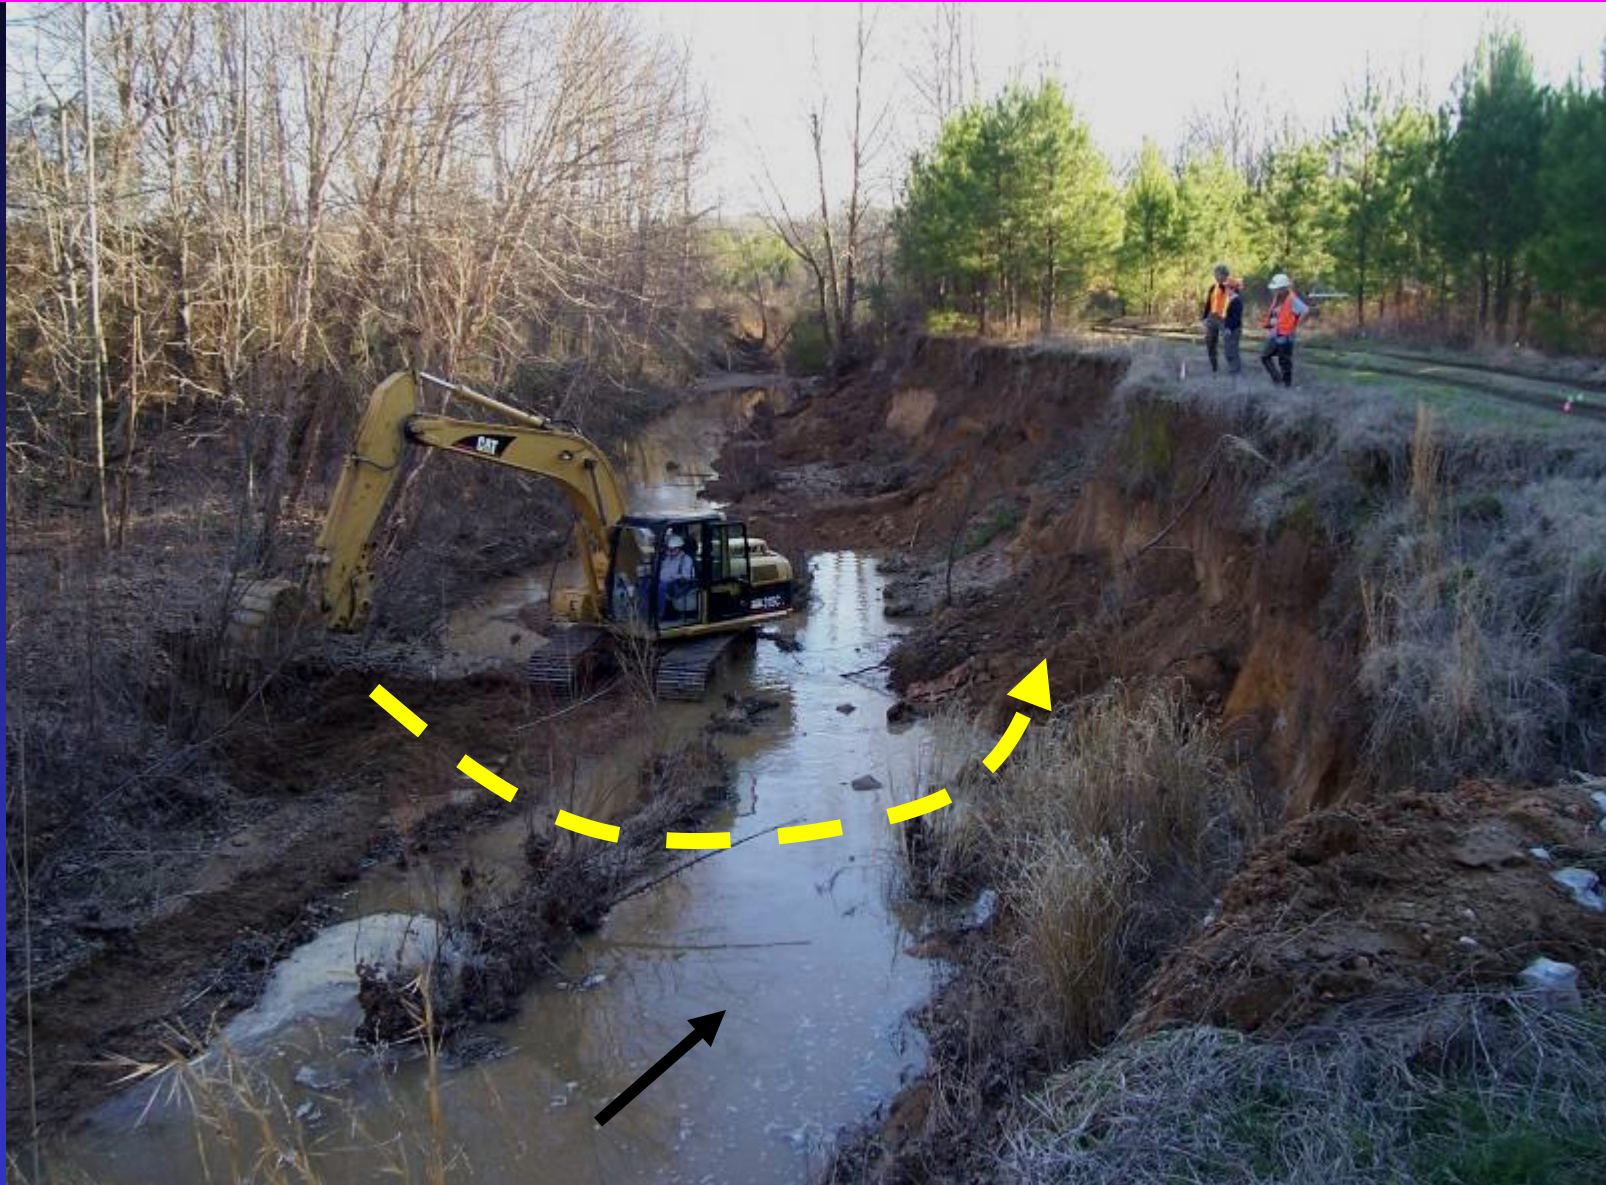
Looking DS, digging floodplain bench & placing soil along toe of right bank
