CAZENOVIA CR. @ STEPHENSON ST. BRIDGE

**REPLACEMENT OF ONE BANK
OF A CONCRETE-LINED
CHANNEL**

**HAW CREEK, PIKE COUNTY, MISSOURI-
TRIB TO SALT RIVER**

GOODWIN CREEK, MS.

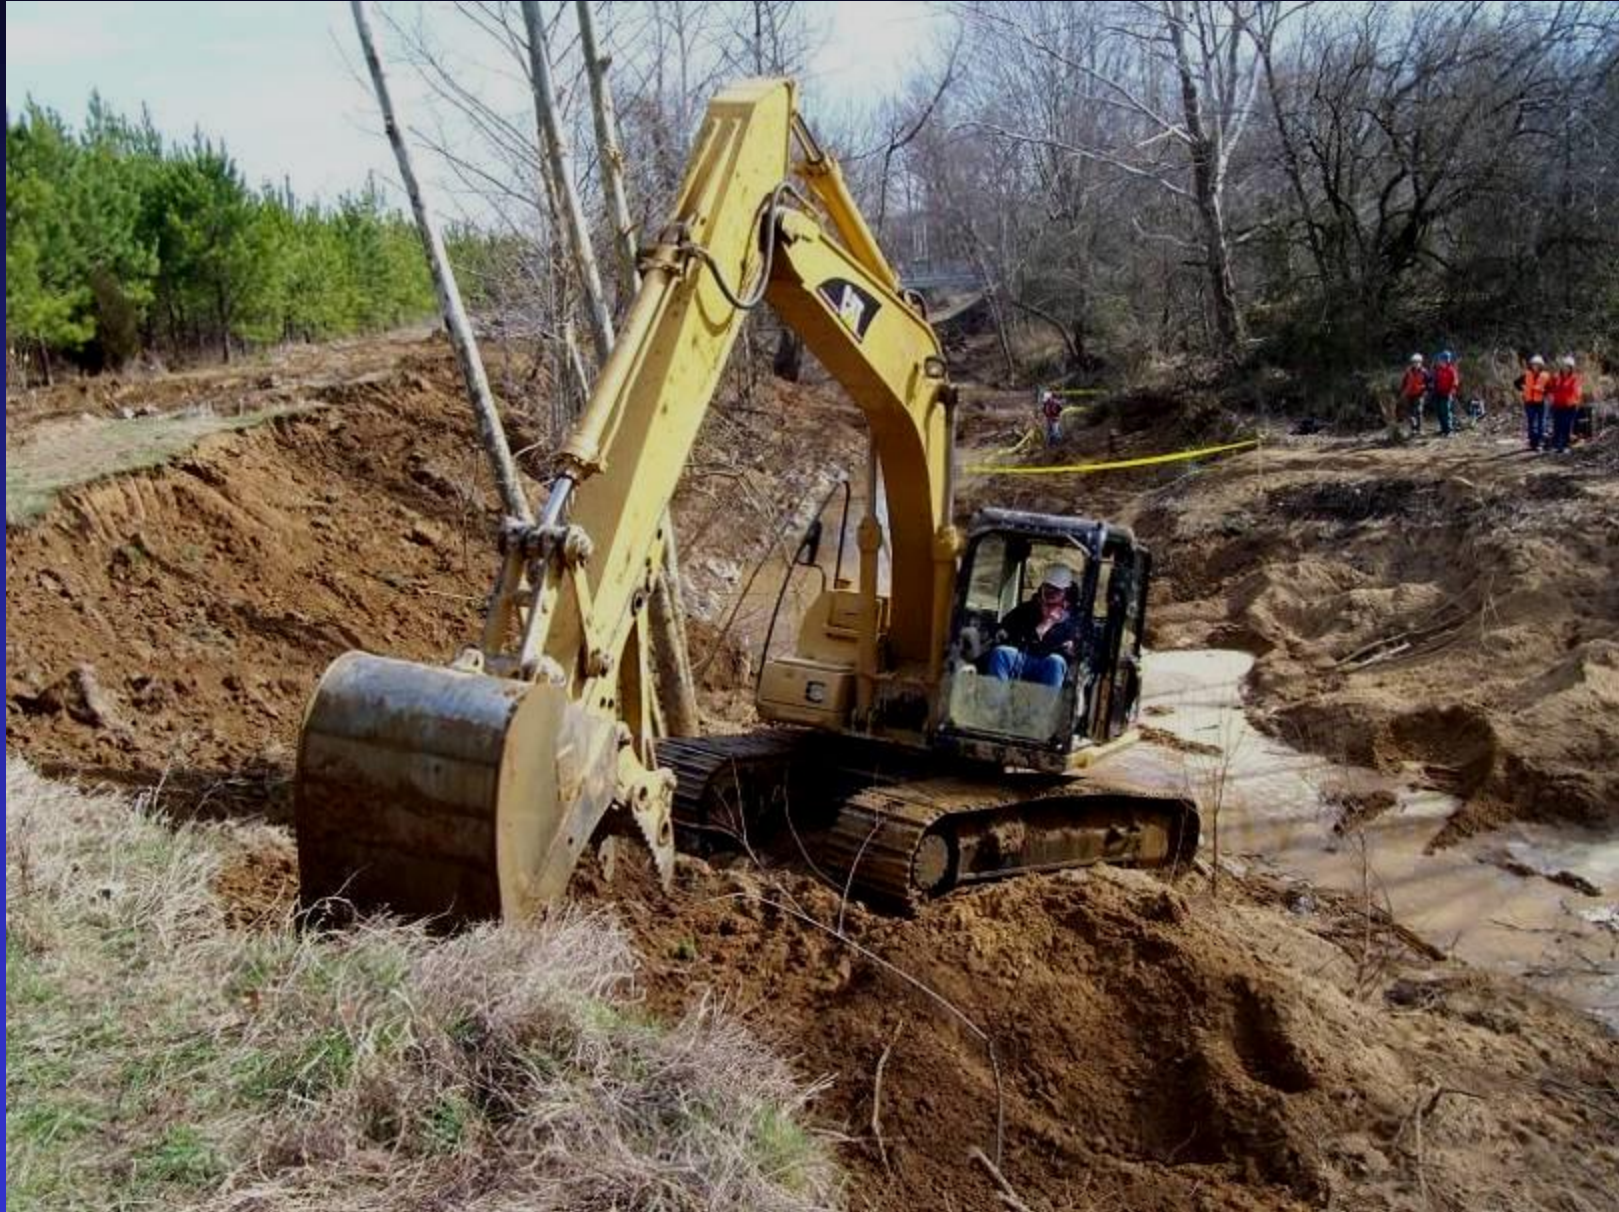
Sloping upper bank - BEND #1

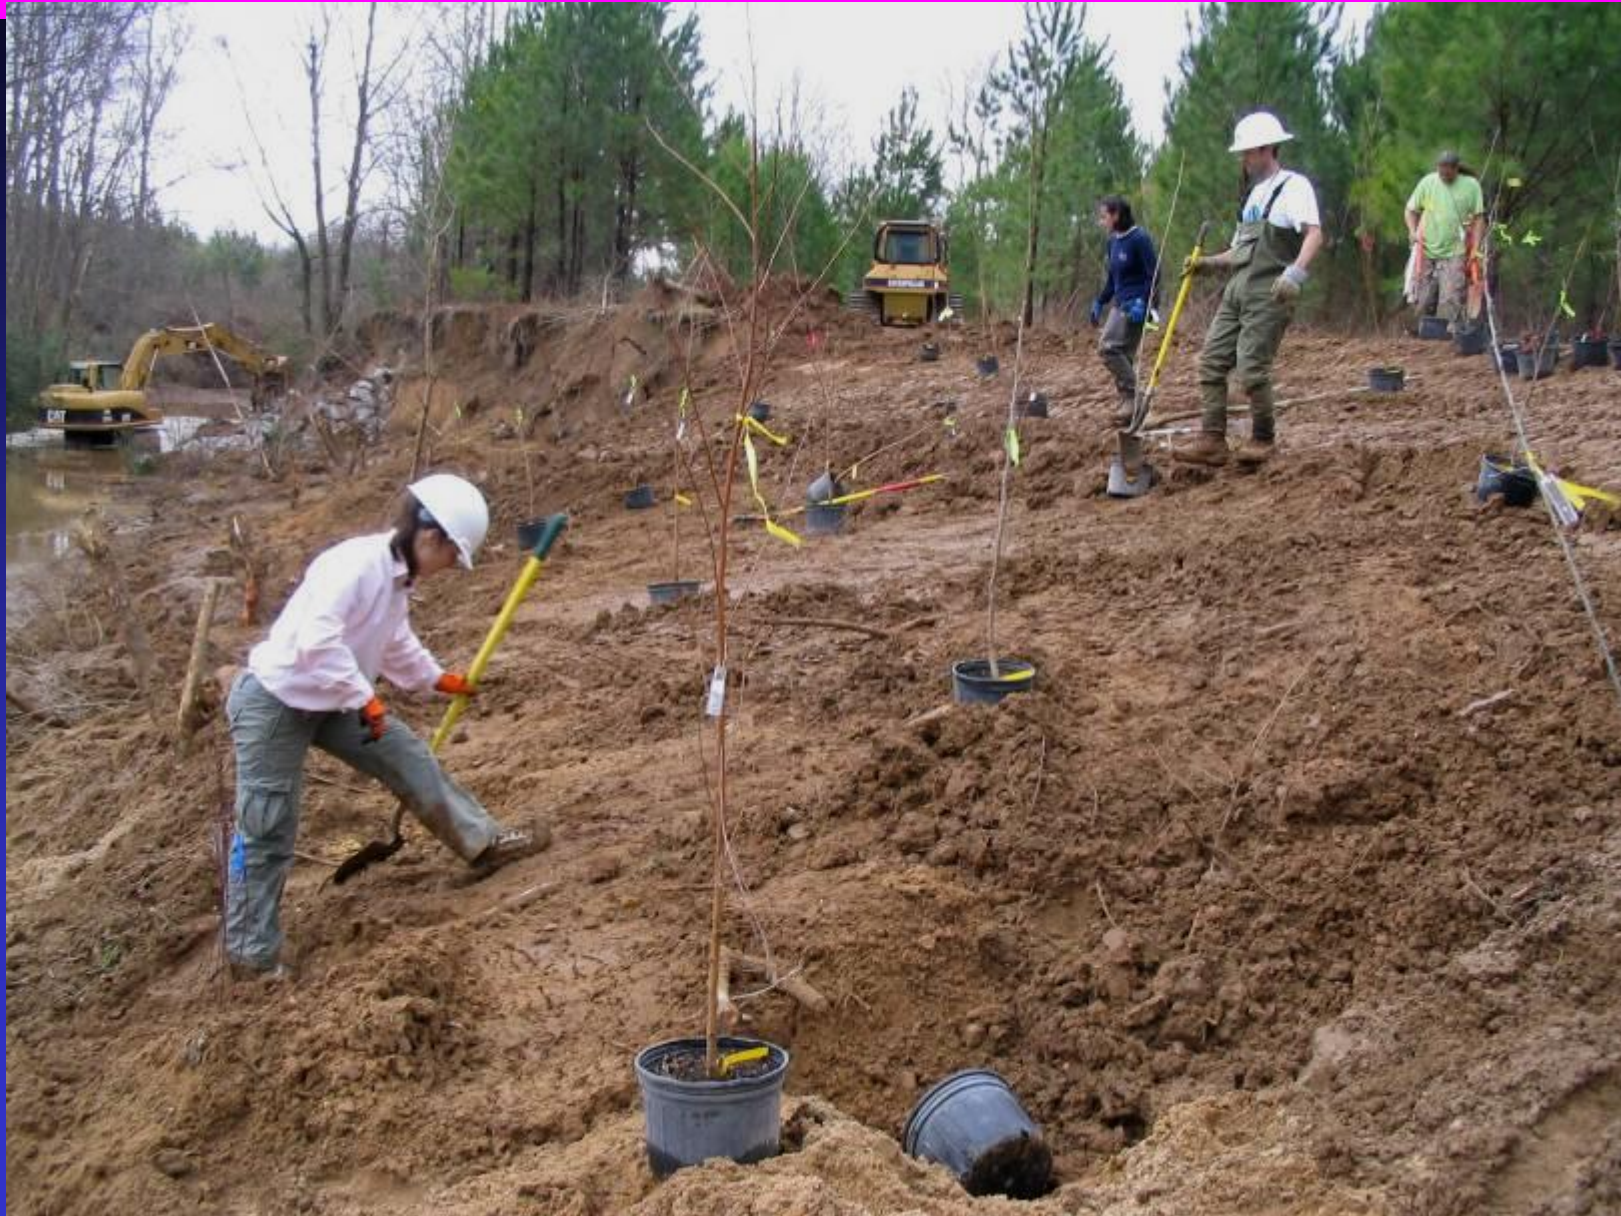
Positioning & planting RPM trees & shrubs - BEND #1

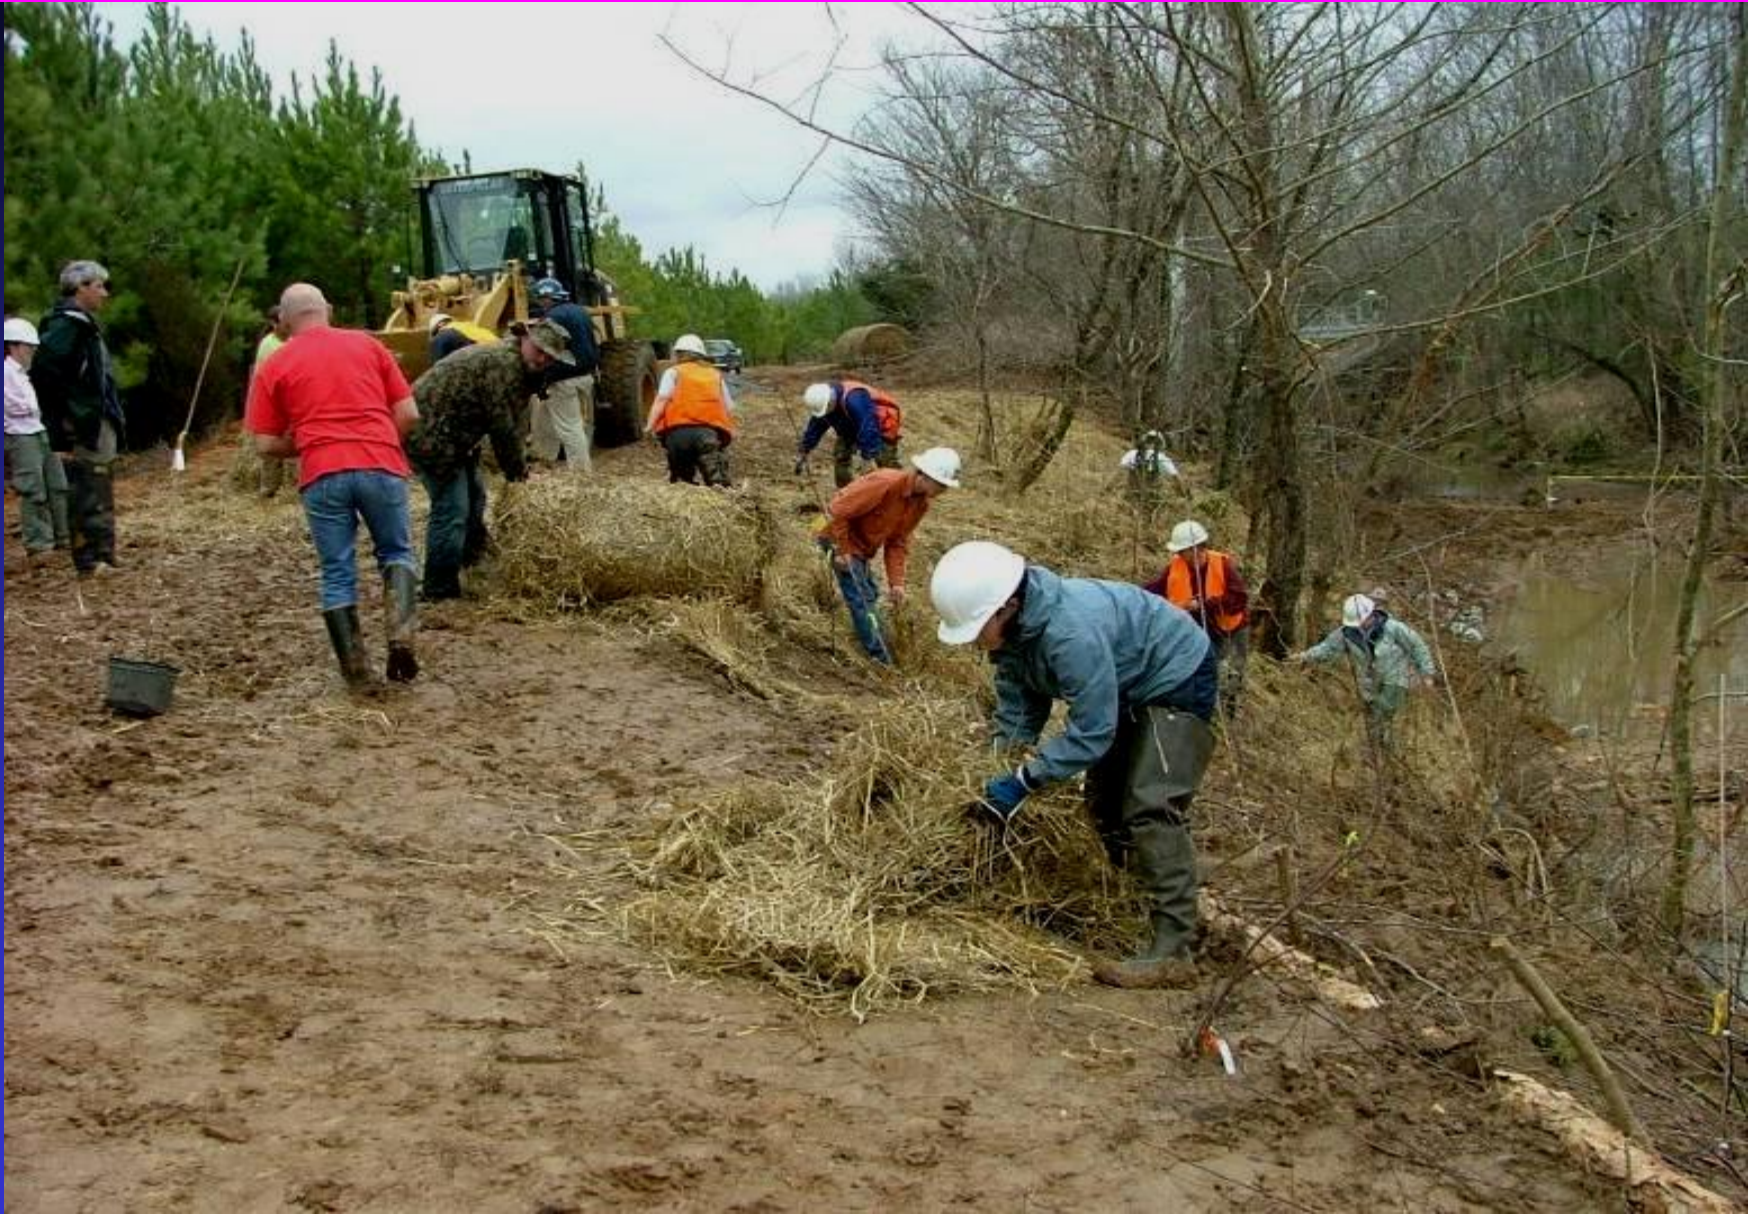
Rolling and spreading hay mulch - BEND #1

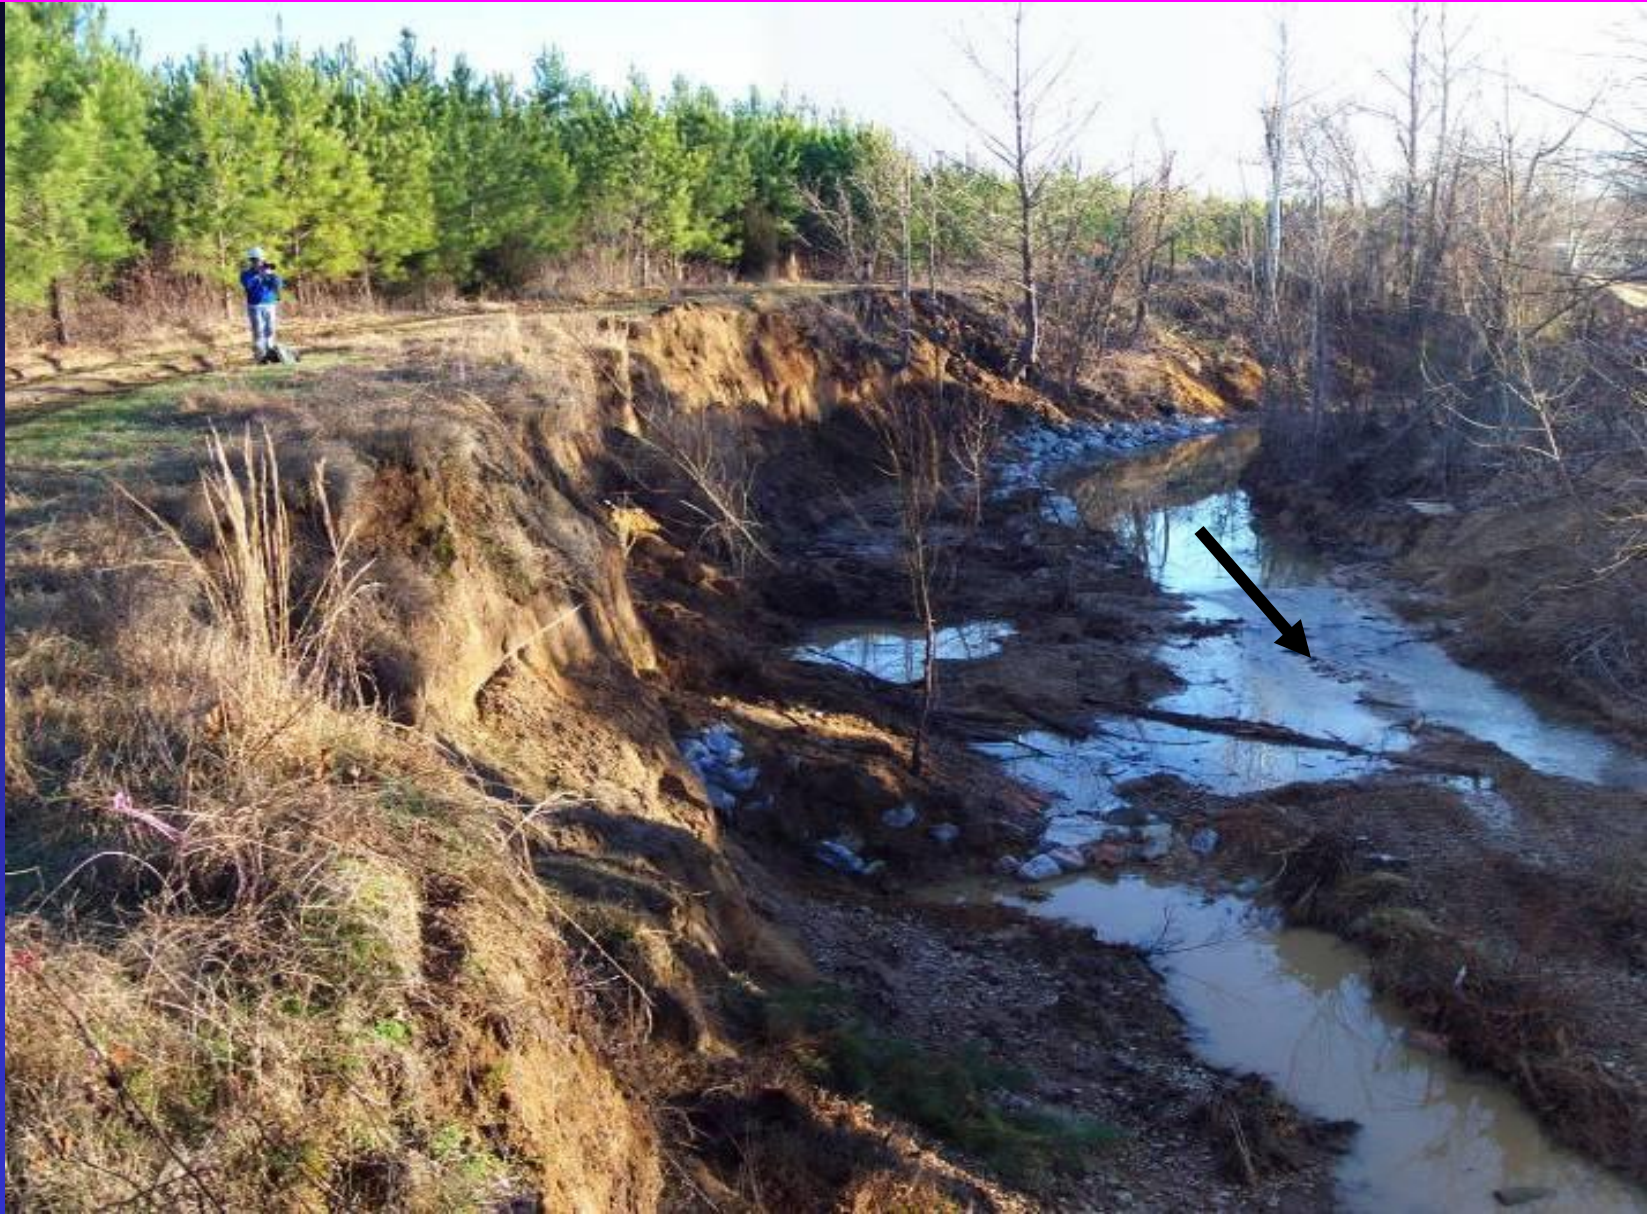
Looking US, Feb 2007 - BEND #1

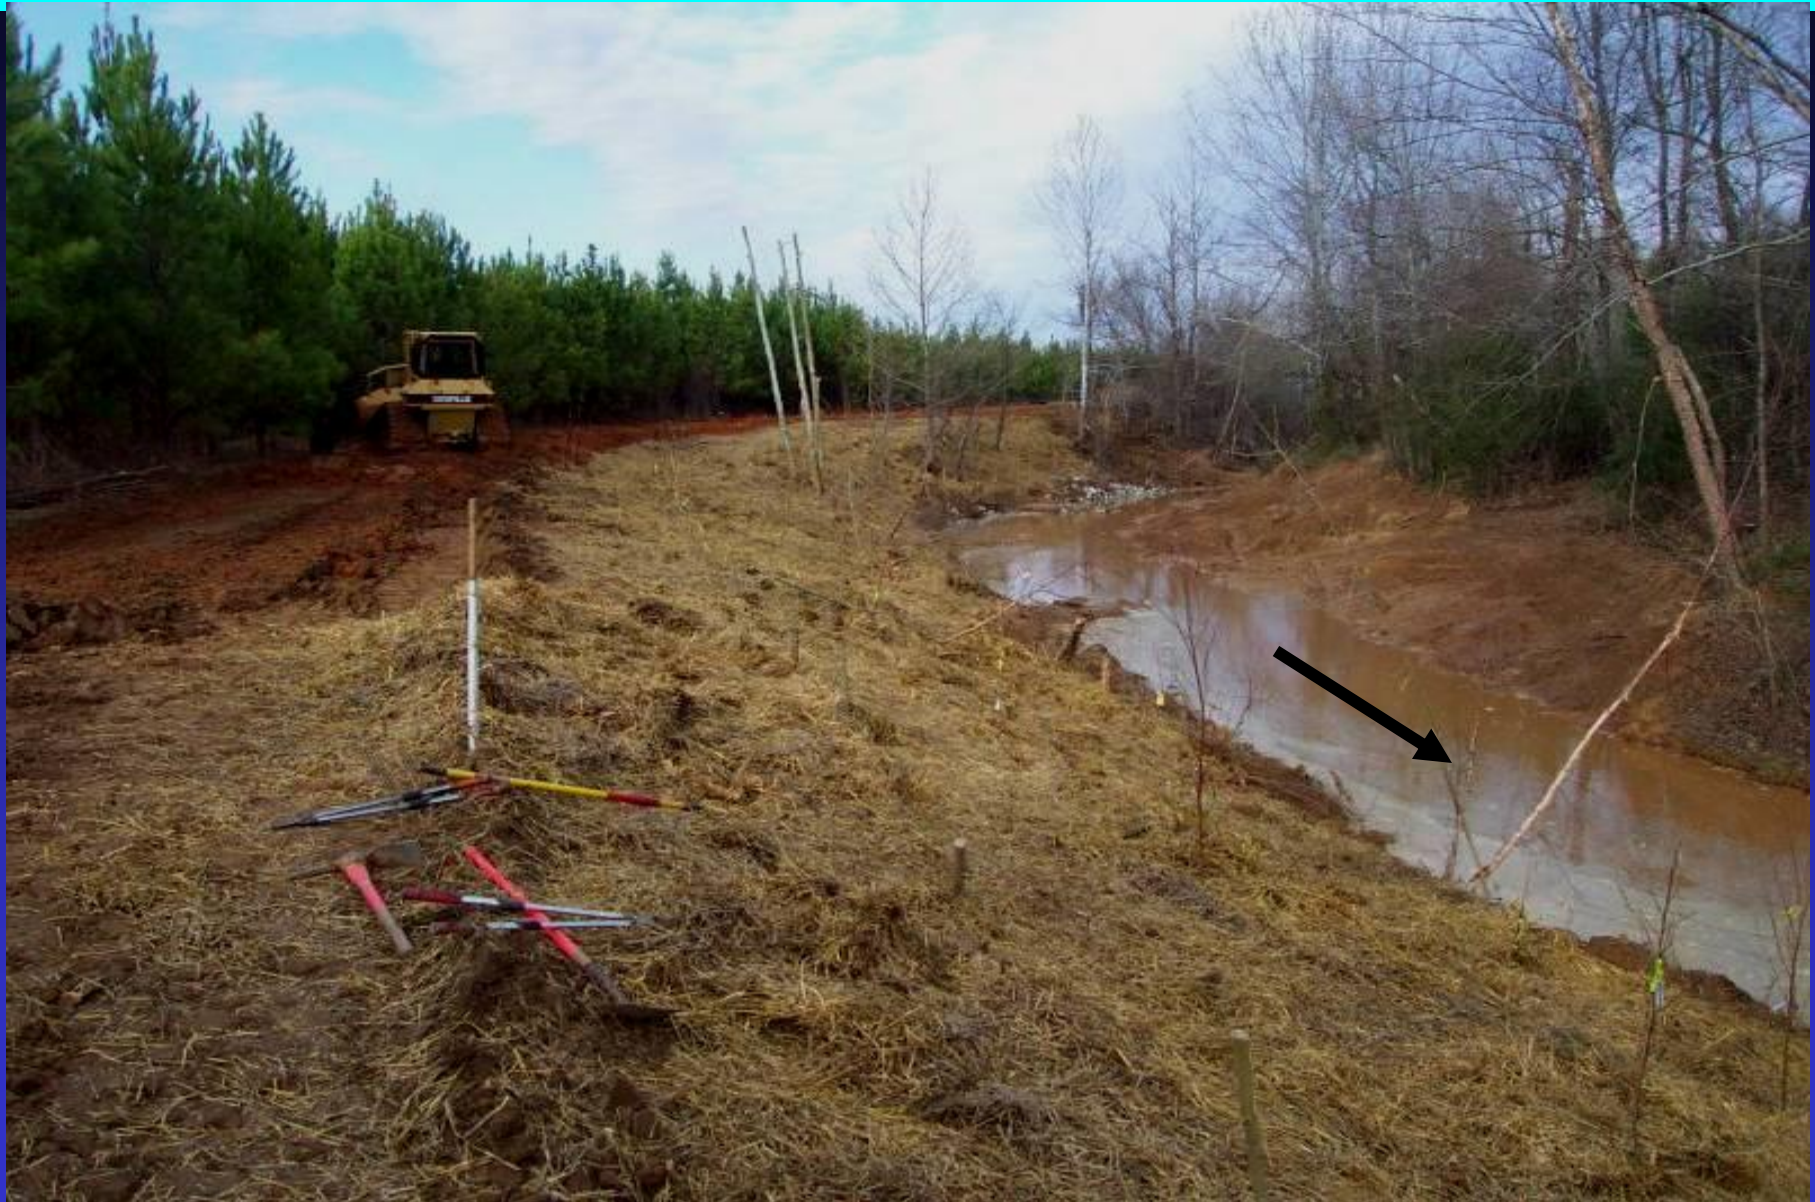
Looking US – Construction Complete - BEND #1

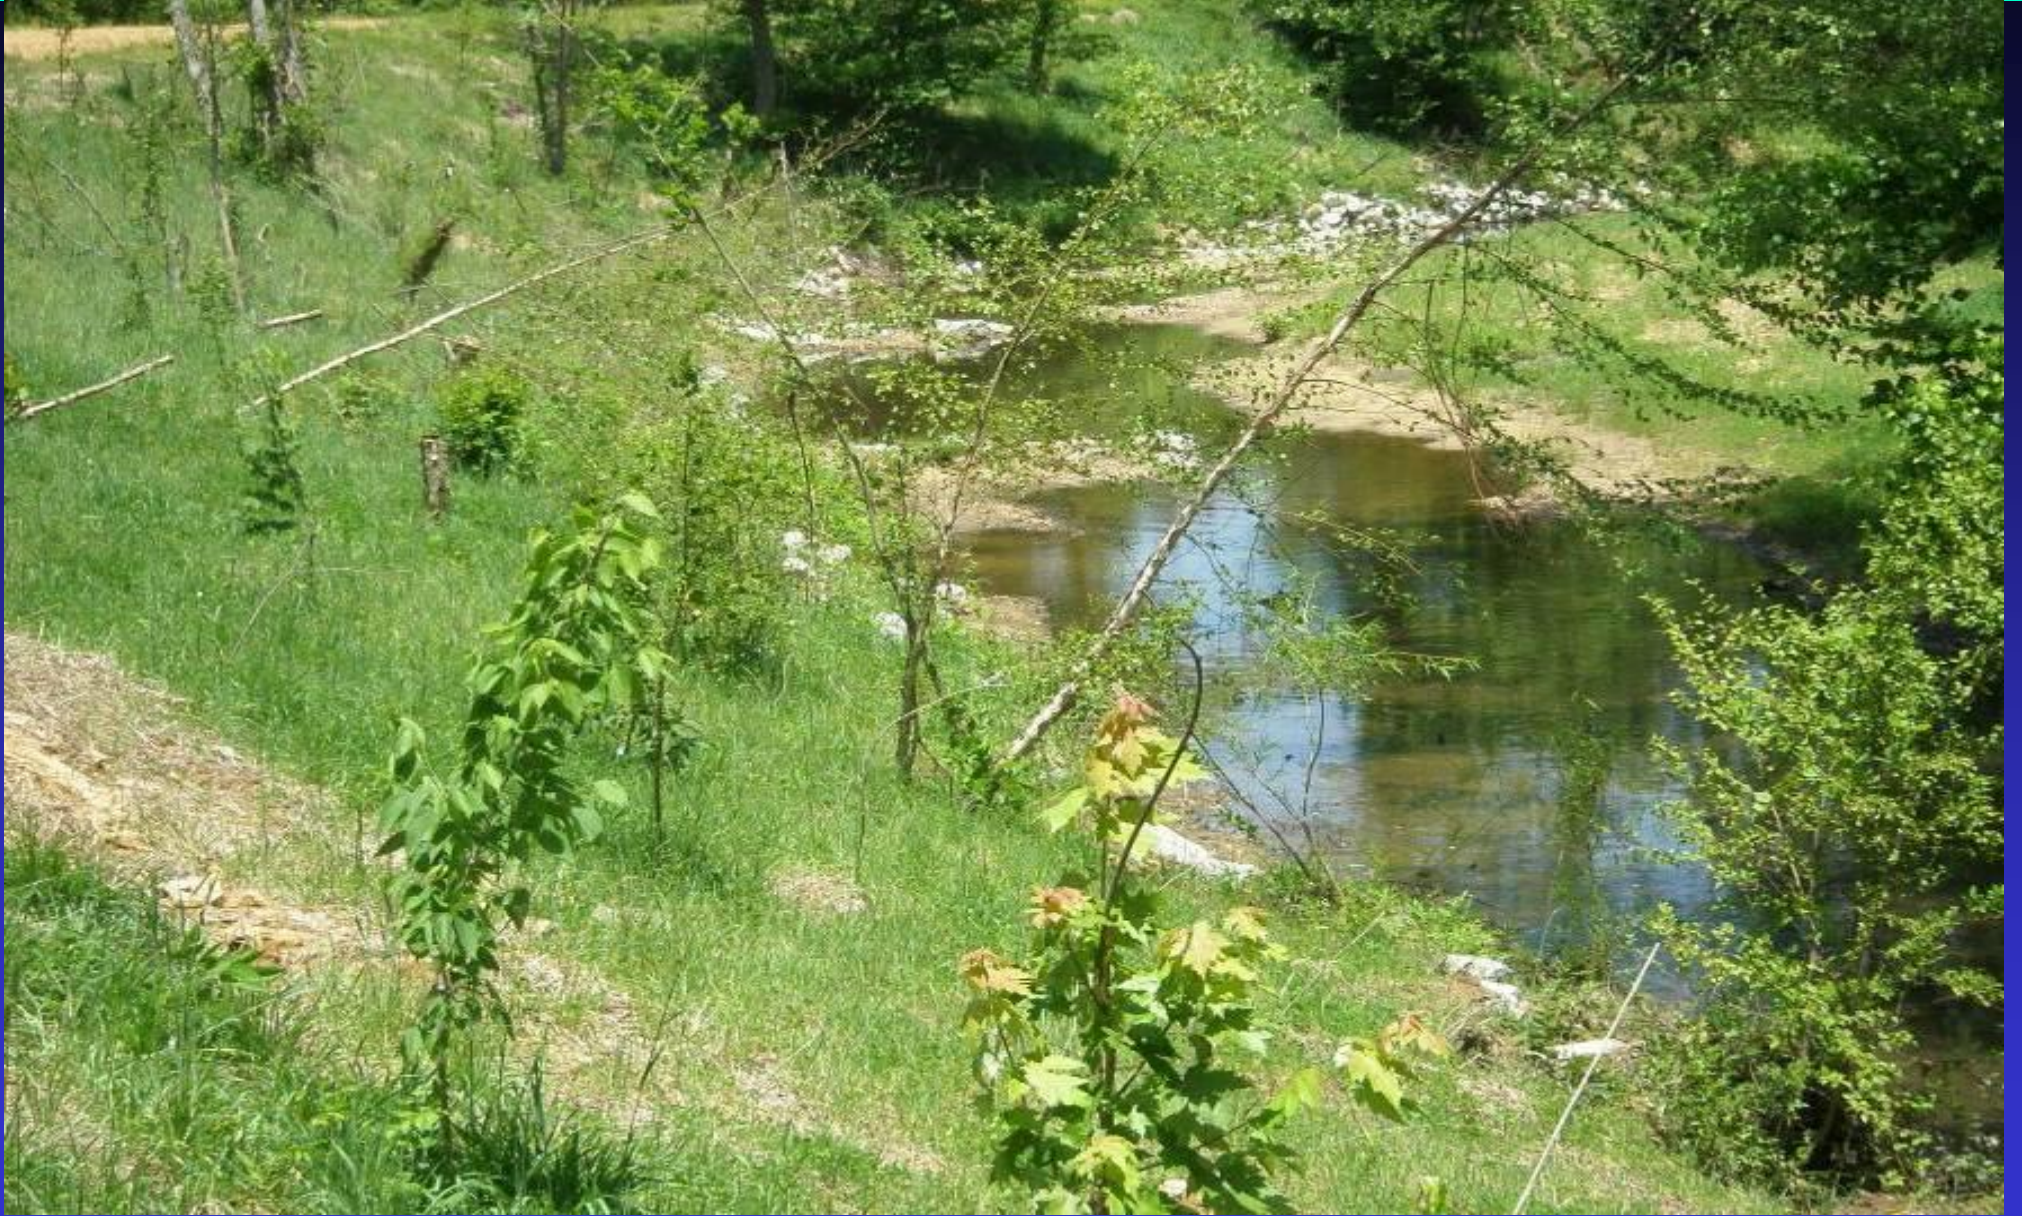
Looking US @ Bend #1 – 2.5 months later

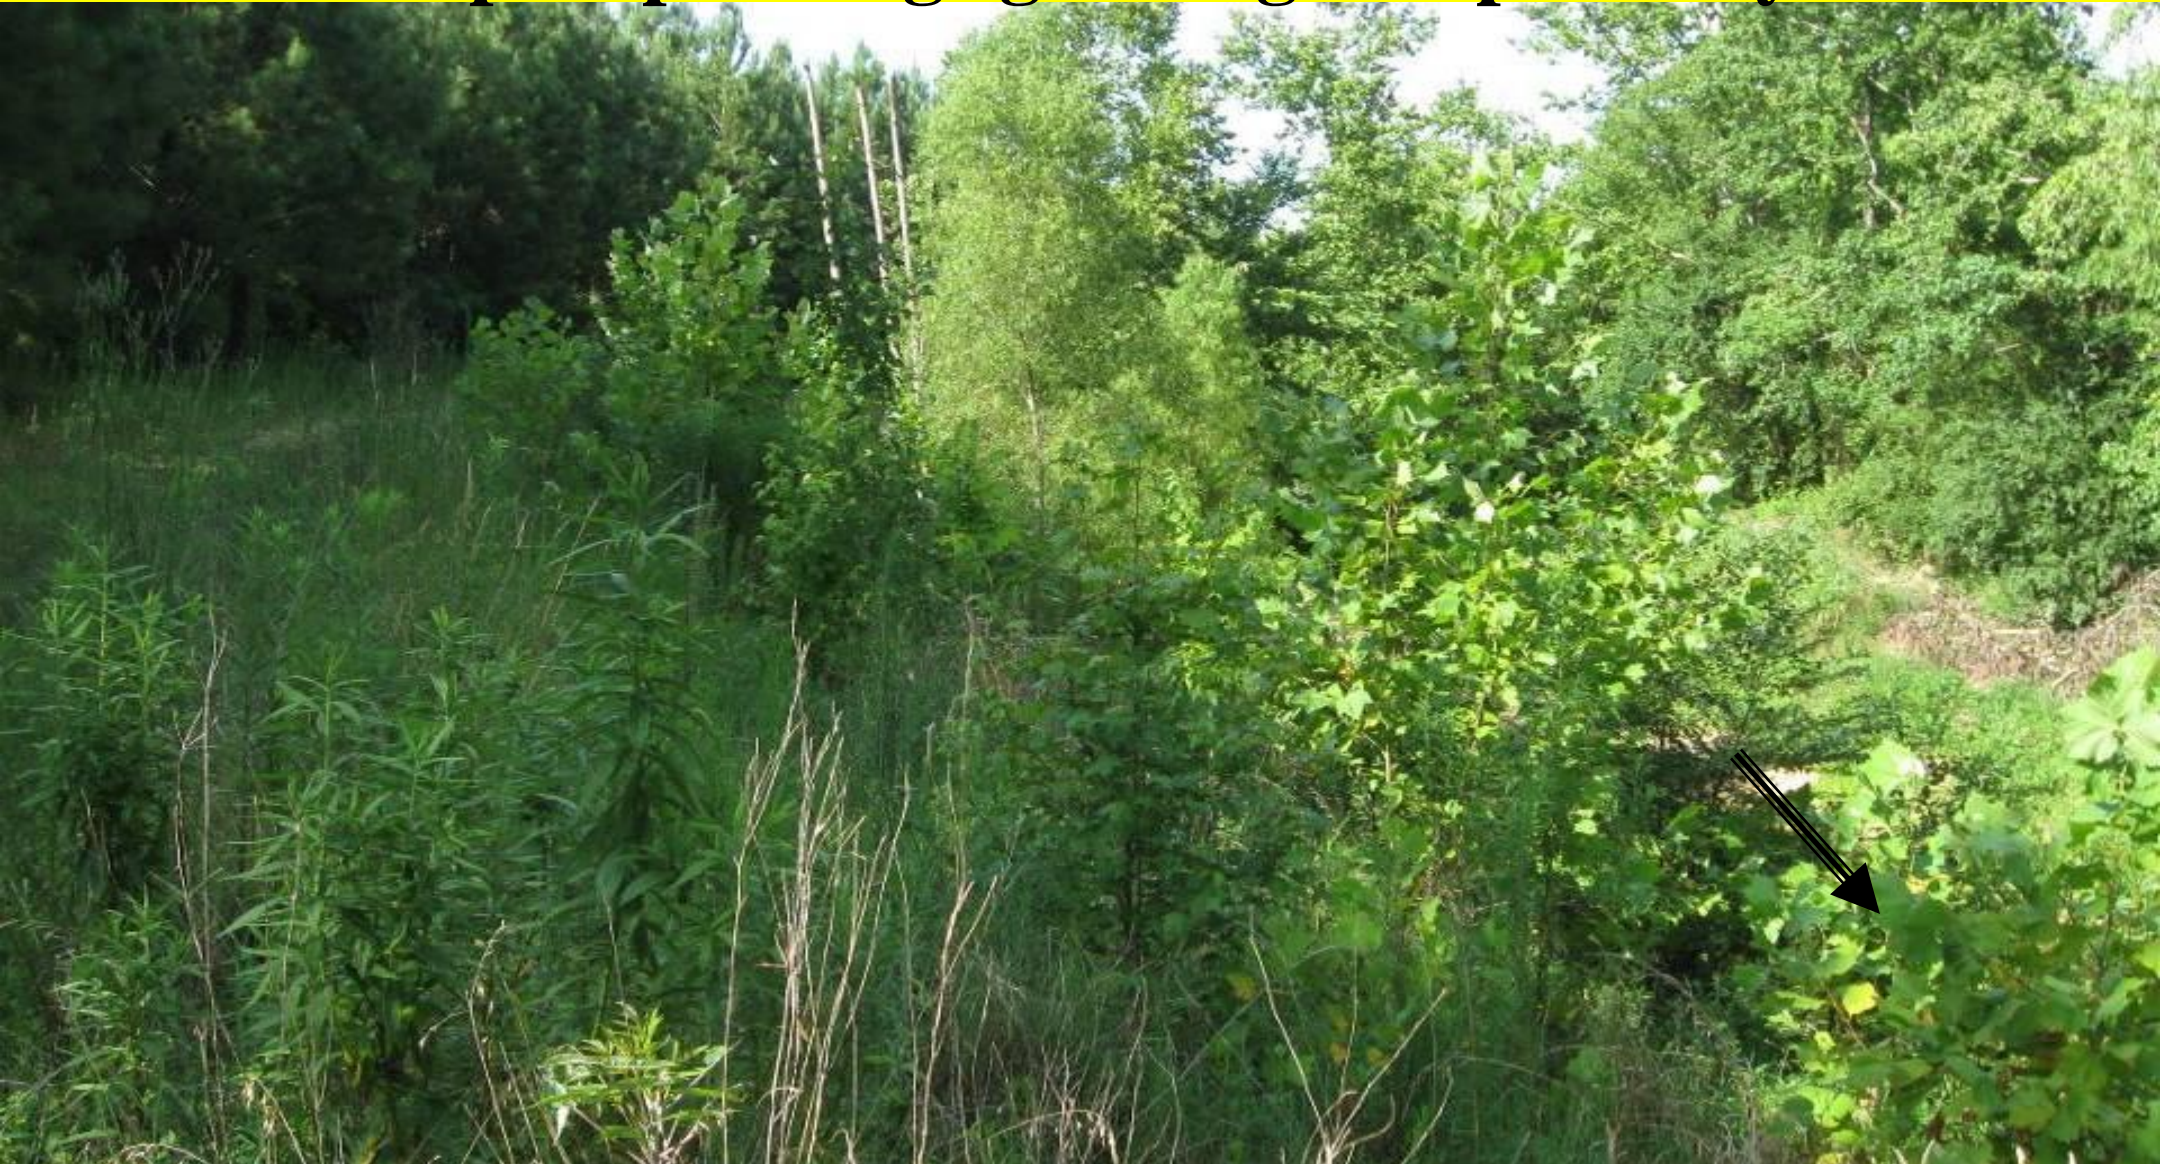
2.4 YEARS LATER-Looking US @ Bend #1 – Rooted stock & pole plantings growing exceptionally well!

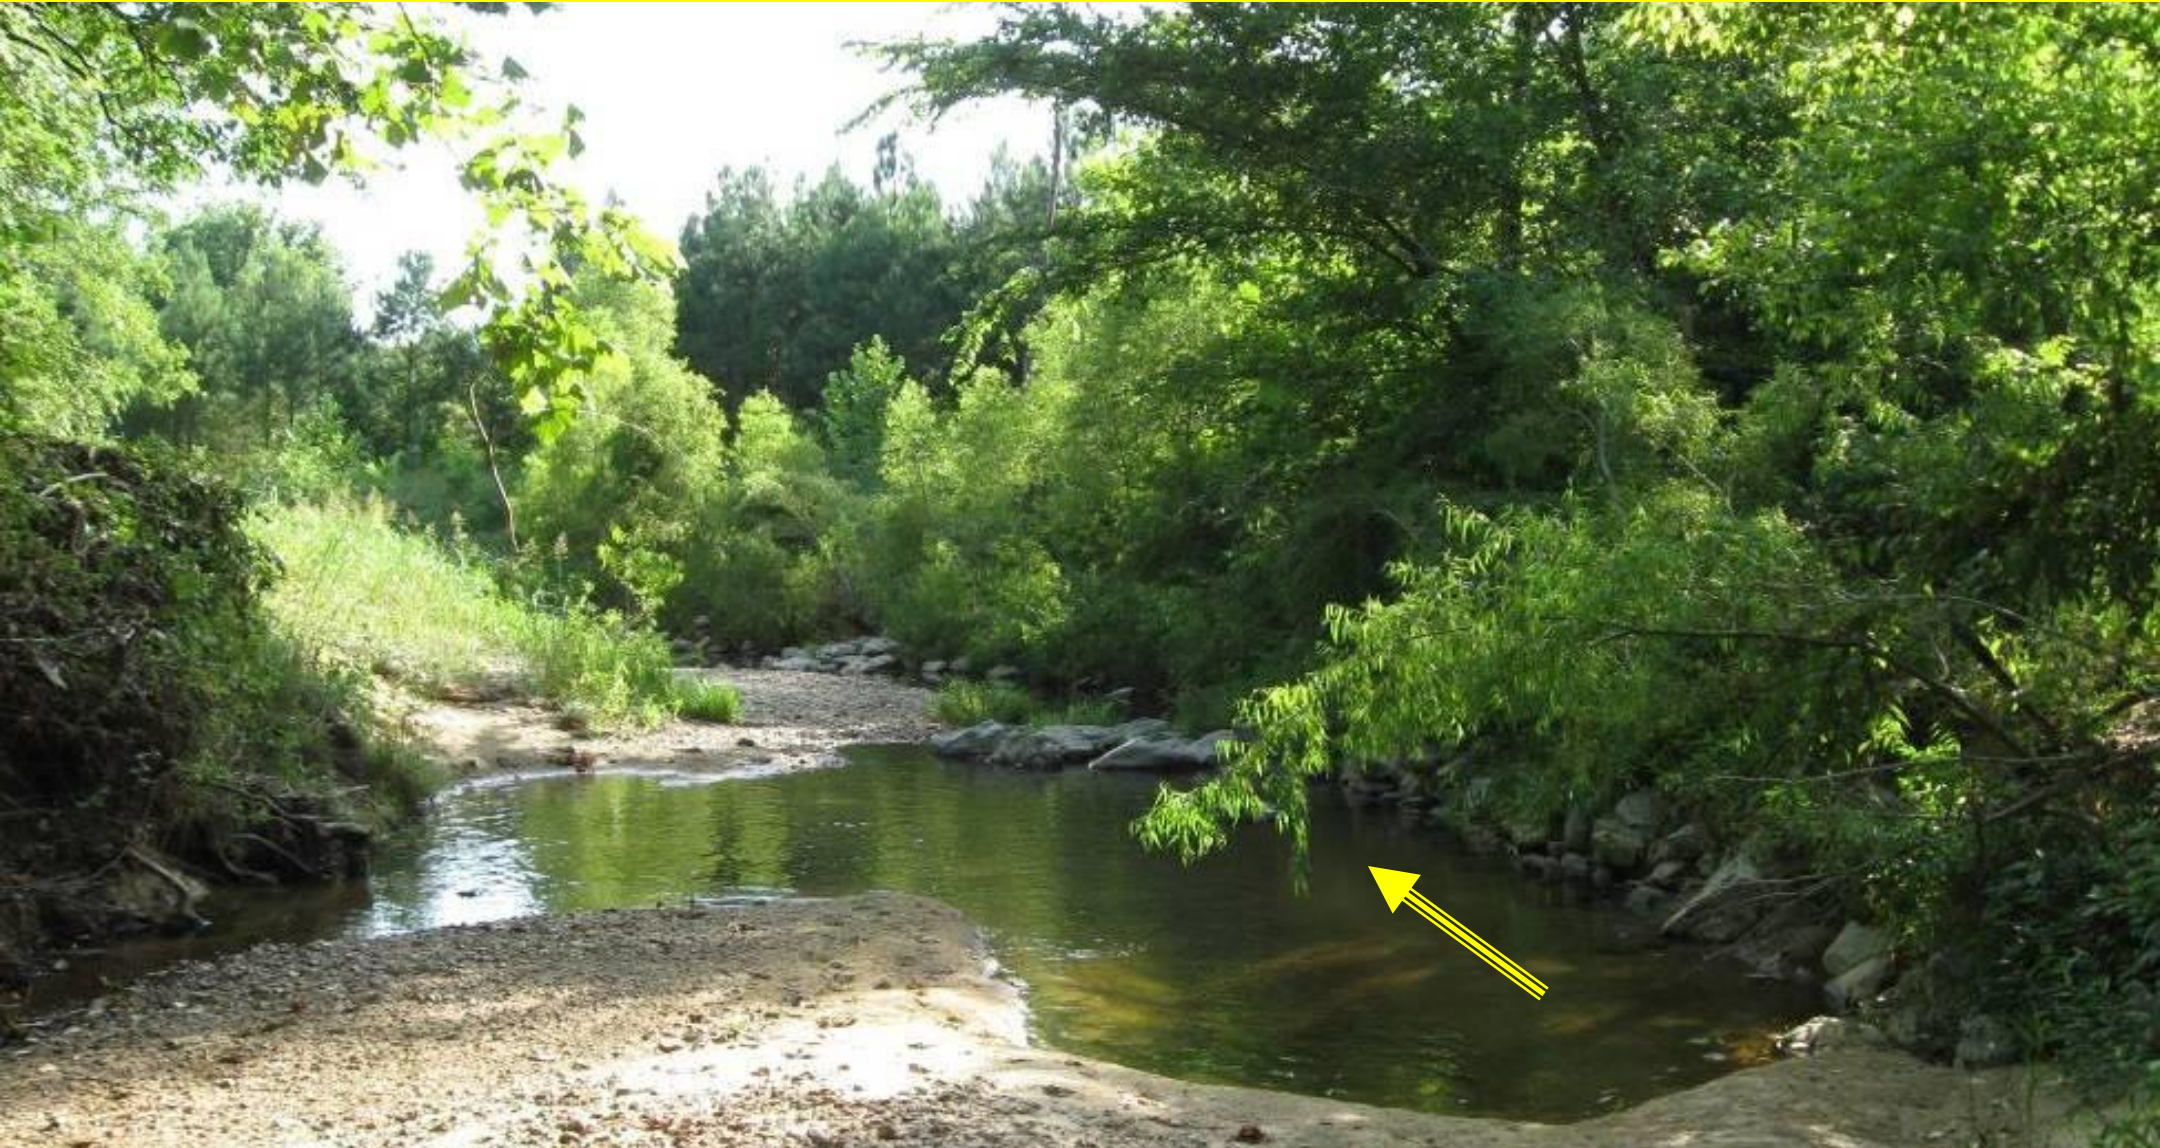
**2.4 YEARS LATER-Looking DS @ upper end of Bend #1.
THIS IS WHAT WATER SEES!!!!**

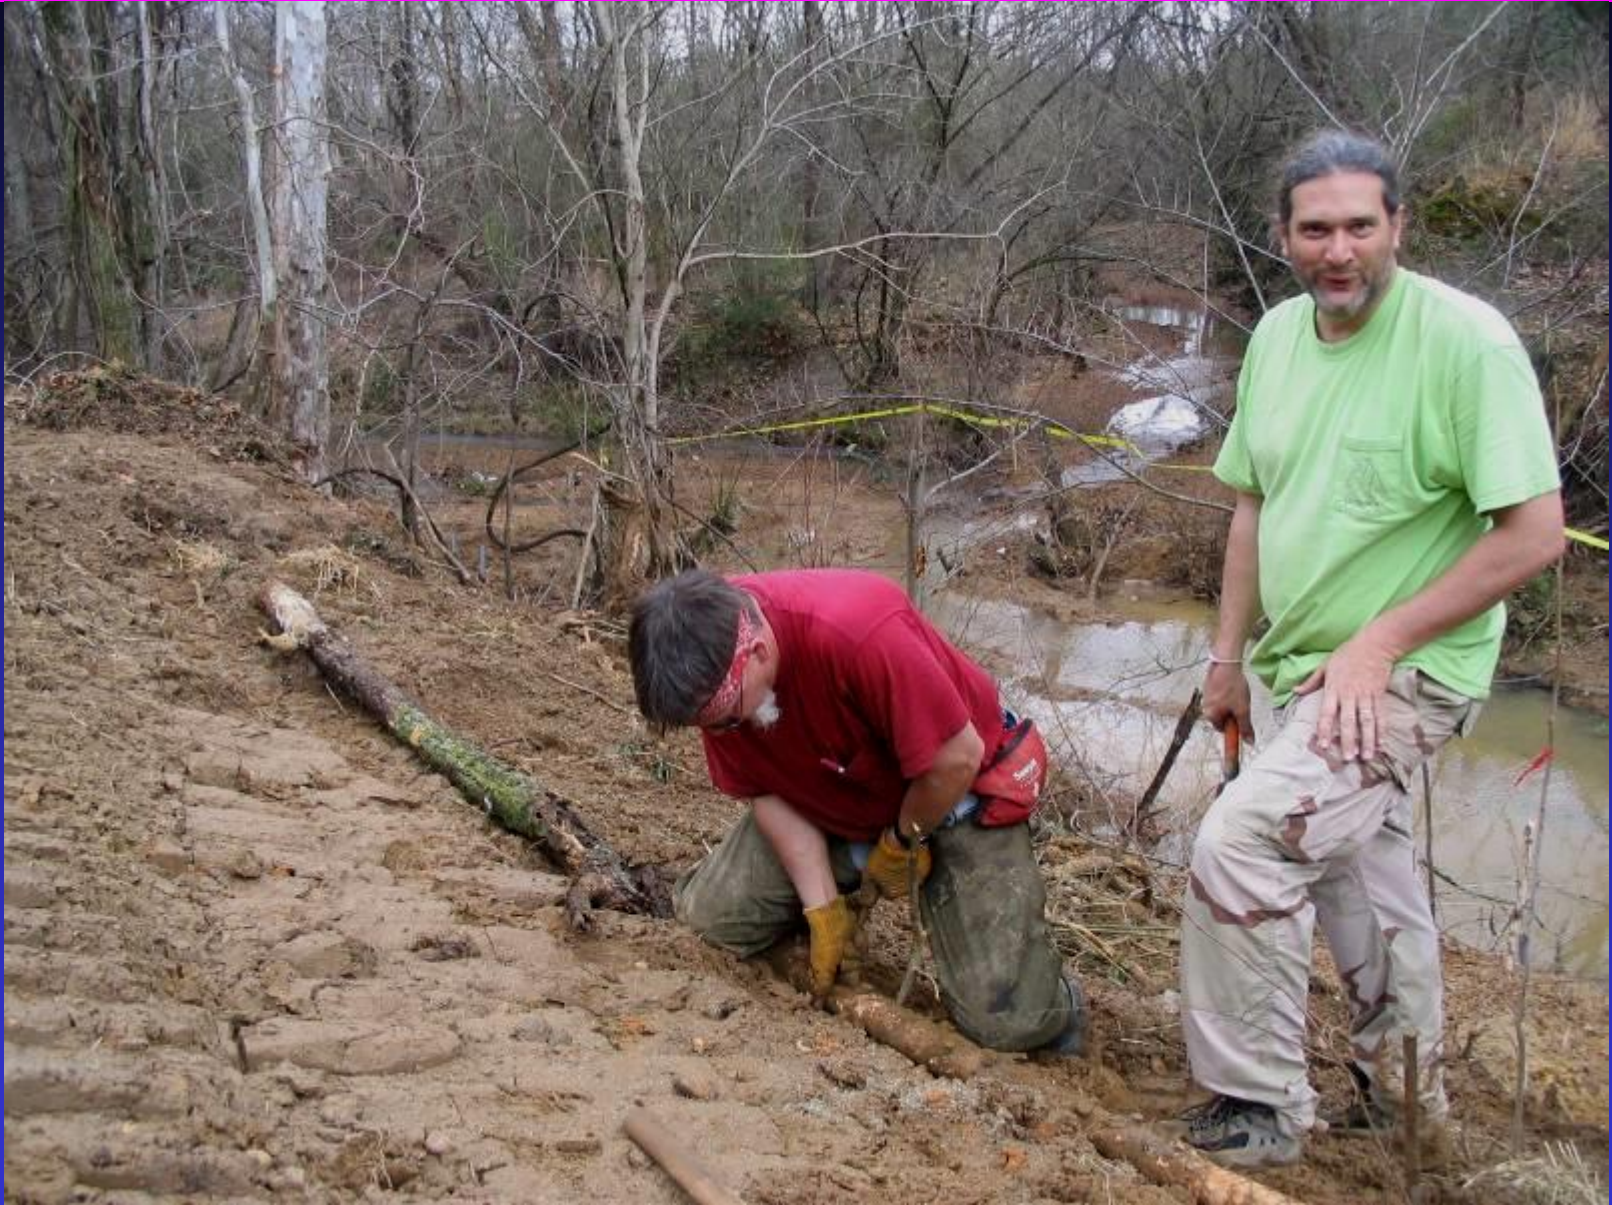
Soil was soft enough in places Live Stakes could be pushed in - BEND #1

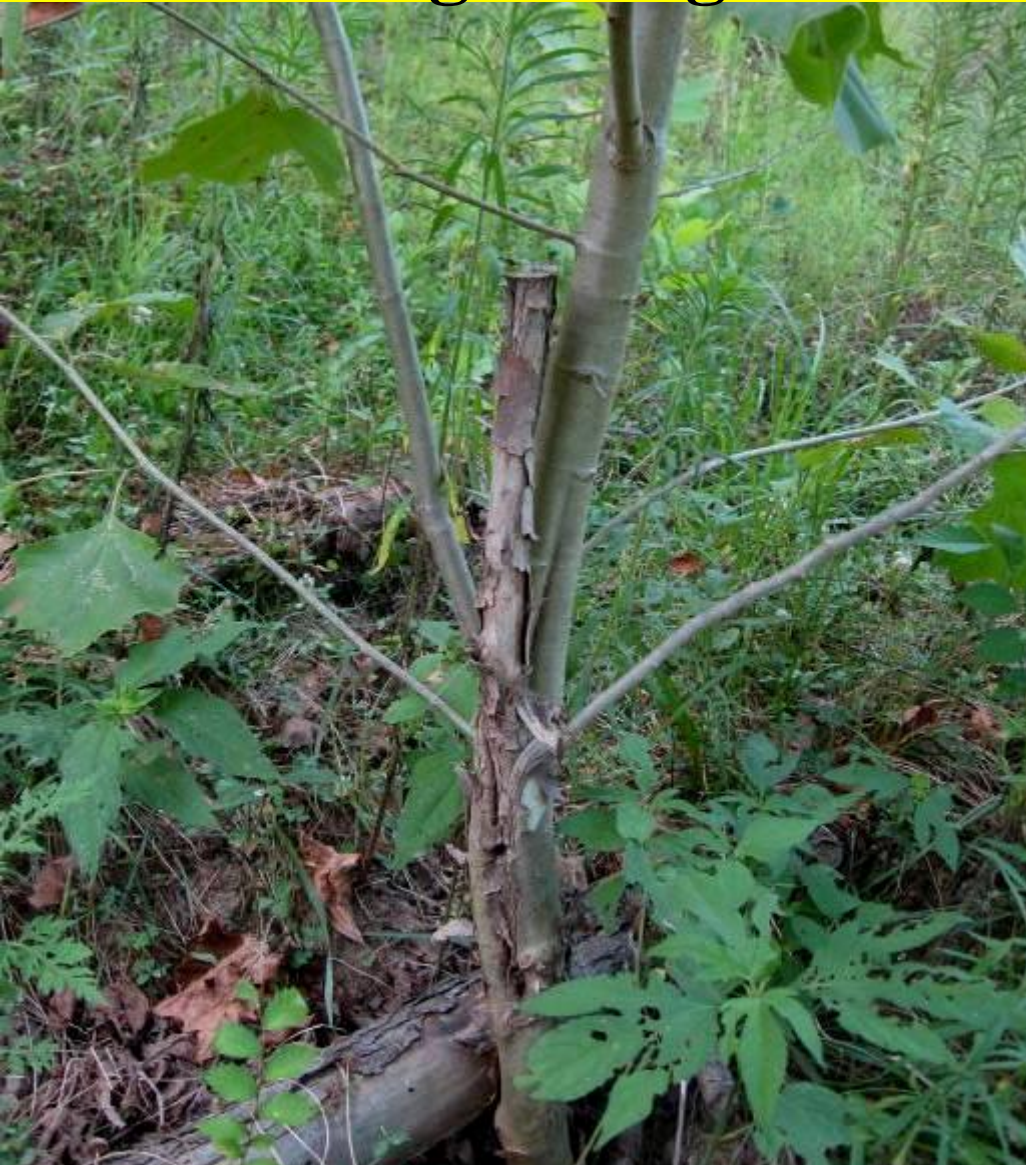
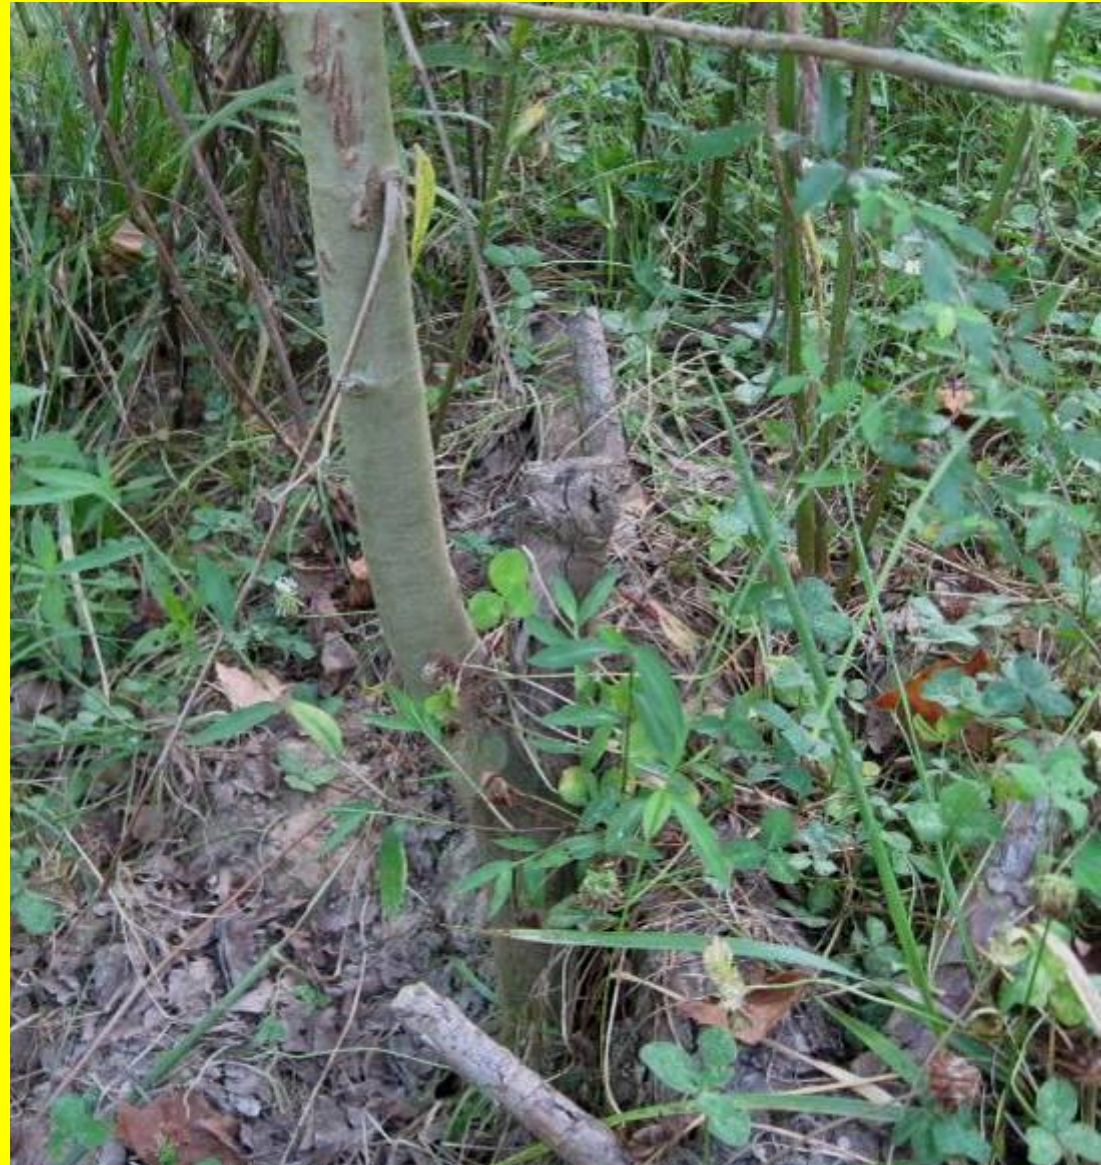
2.4 YEARS LATER-Upper bank Sycamore Live Stakes are growing well. Several are 6 to 12 ft tall.
