CAZENOVIA CR. @ STEPHENSON ST. BRIDGE

**REPLACEMENT OF ONE BANK
OF A CONCRETE-LINED
CHANNEL**

**HAW CREEK, PIKE COUNTY, MISSOURI-
TRIB TO SALT RIVER**

GOODWIN CREEK, MS.

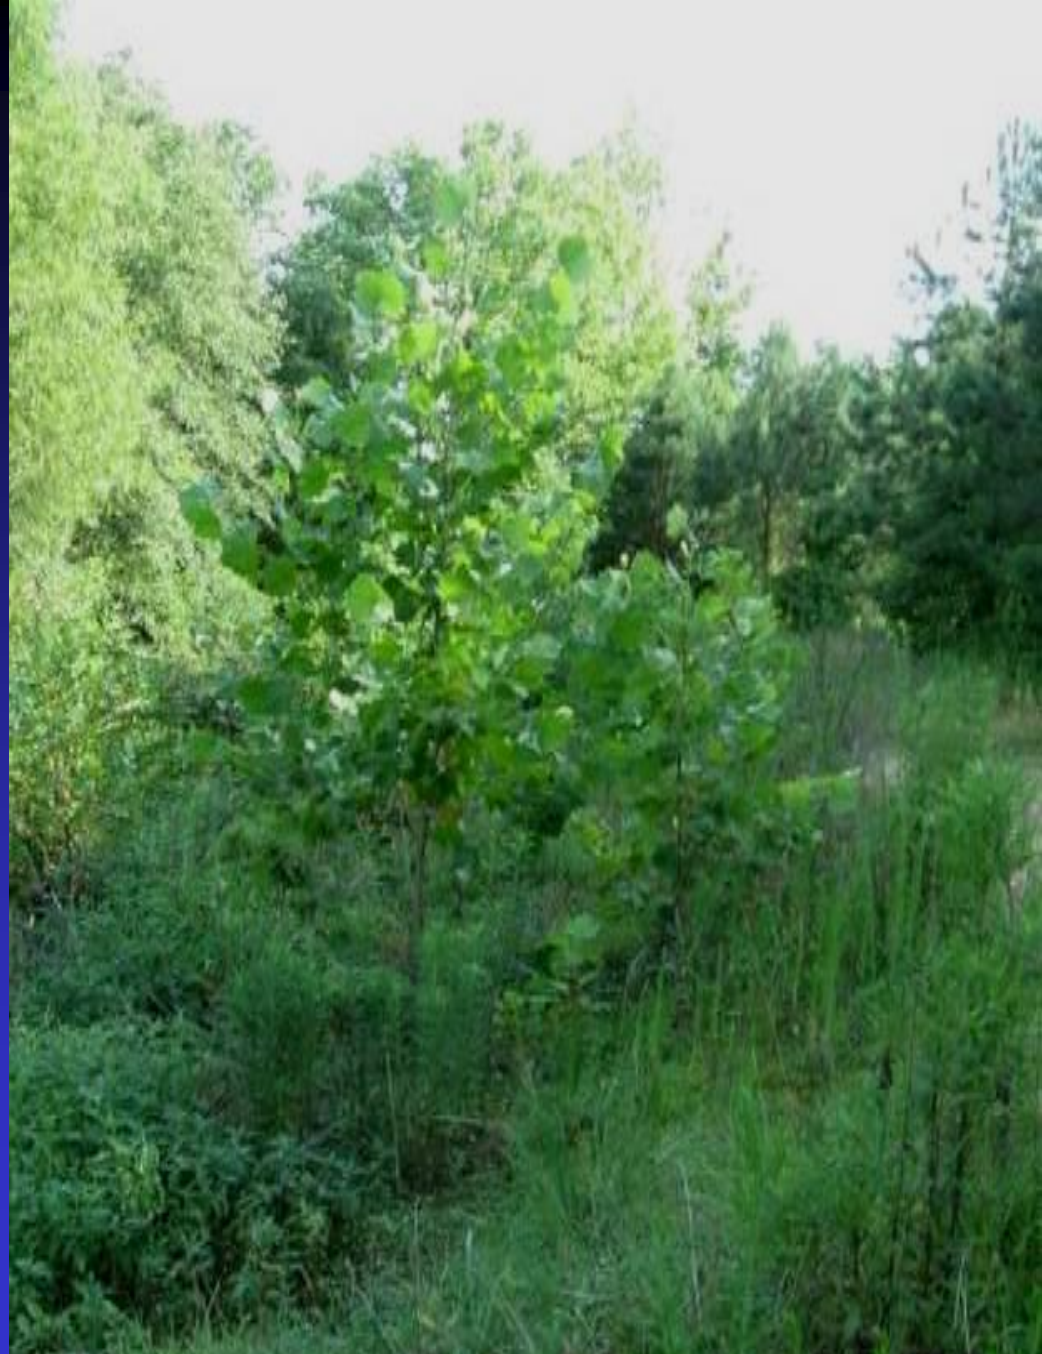
**2.4 YEARS LATER-
Sycamore Live Stakes
growing well on upper
third of bank (10-12 ft
above base flow water
surface elevation).**

**Sycamore Live Stakes are
6-12 ft tall with robust
growth.**

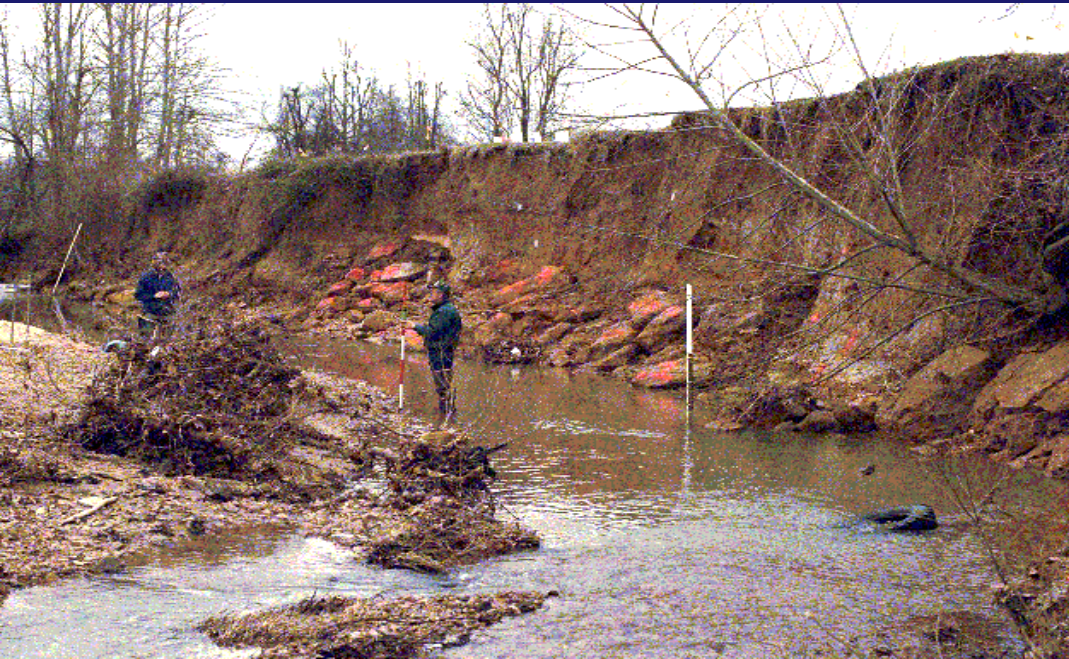
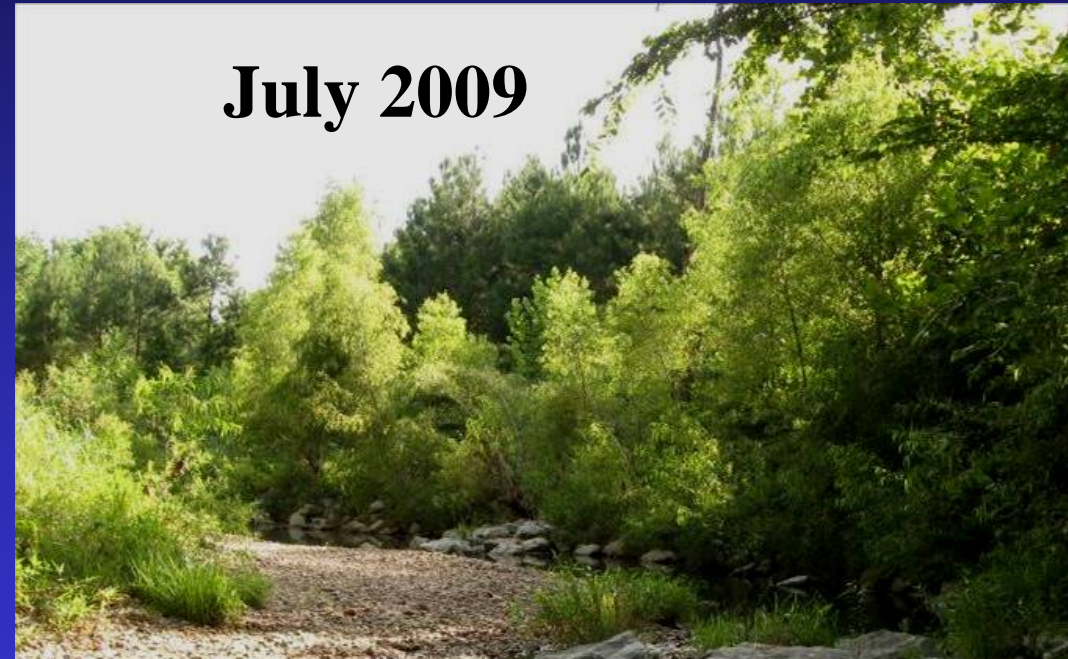
**Looking downstream, what a
difference 2 years after the project
was completed makes !!**
